**Flood Control Project Maintenance
Levee Inspections**

2012 Channel Summary Report

Fairfield Suisun Sewer District

2012 Channel Inspection Results

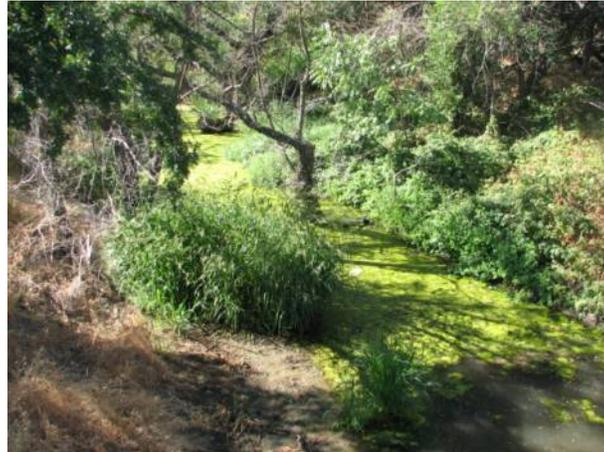
Levee Mile Report Line	1
Start Levee Mile	0.00
End Levee Mile	0.00
Location	
Category	Channels
Item	Vegetation & Obstructions
Looking downstream at Manual Campos. (2012)	
johngw_c_20120806_089.jpg

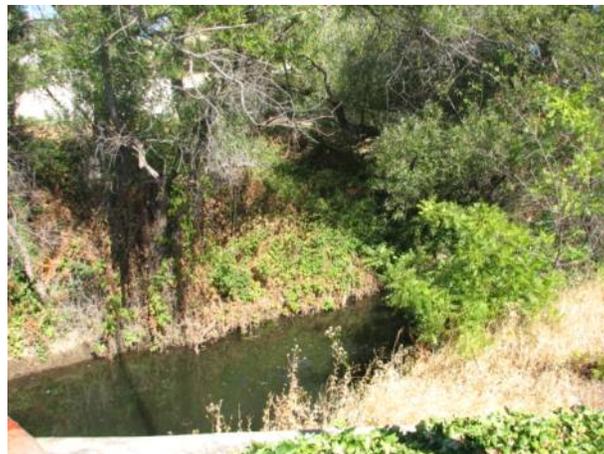
Levee Mile Report Line	1
Start Levee Mile	0.00
End Levee Mile	0.00
Location	
Category	Channels
Item	Vegetation & Obstructions
Looking upstream at Manula Campos. (2012)	
johngw_c_20120806_090.jpg

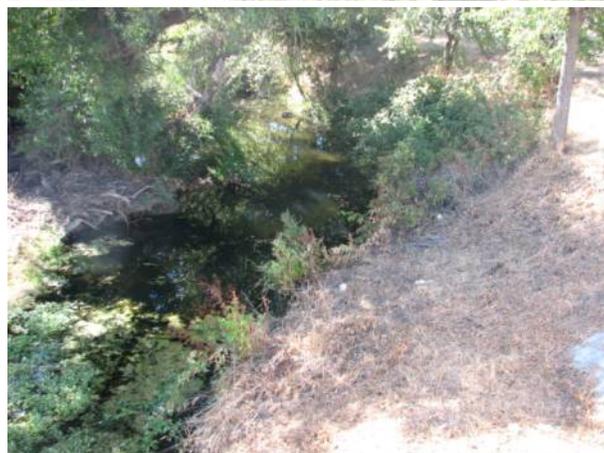
Levee Mile Report Line	1
Start Levee Mile	0.00
End Levee Mile	0.00
Location	
Category	Channels
Item	Vegetation & Obstructions
Looking downstream at Dickson Hill.(2012)	
johngw_c_20120806_091.jpg

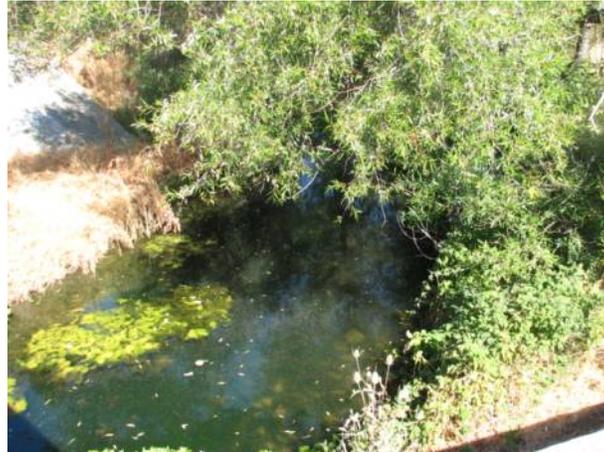
Levee Mile Report Line	1
Start Levee Mile	0.00
End Levee Mile	0.00
Location	
Category	Channels
Item	Vegetation & Obstructions
Looking upstream at Dickson Hill. (2012)	
johngw_c_20120806_092.jpg

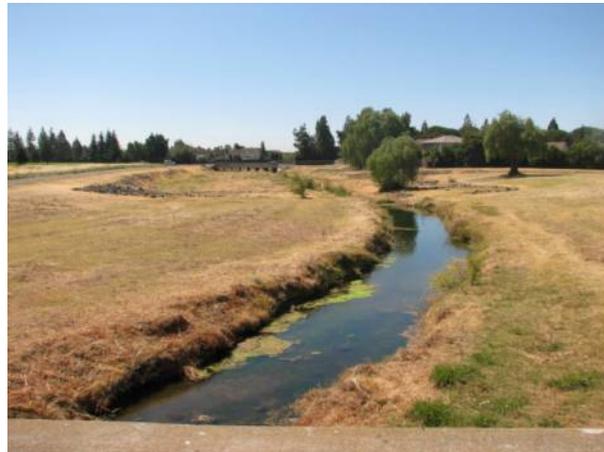
Levee Mile Report Line	1
Start Levee Mile	0.00
End Levee Mile	0.00
Location	
Category	Channels
Item	Vegetation & Obstructions
Looking downstream from Gulf Dr. (2012)	
johngw_c_20120806_093.jpg

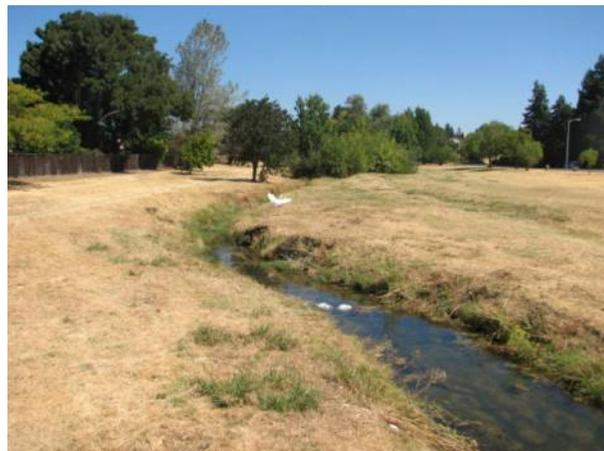
Levee Mile Report Line	1
Start Levee Mile	0.00
End Levee Mile	0.00
Location	
Category	Channels
Item	Vegetation & Obstructions
Looking upstream from Gulf Dr. (2012)	
johngw_c_20120806_094.jpg

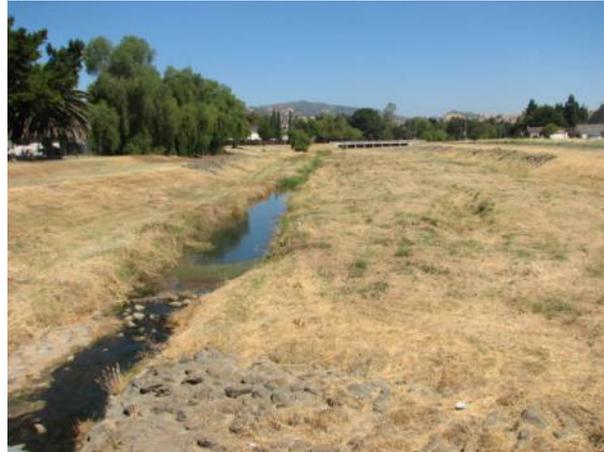
Levee Mile Report Line	1
Start Levee Mile	0.00
End Levee Mile	0.00
Location	
Category	Channels
Item	Vegetation & Obstructions
Looking upstream from Cement Hill Rd. (2012)	
johngw_c_20120806_095.jpg

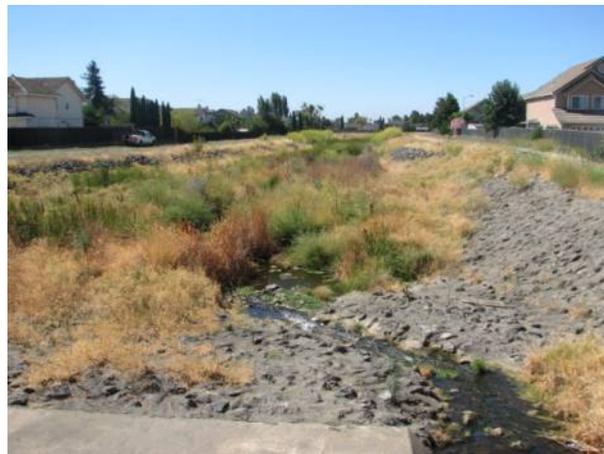
Levee Mile Report Line	6
Start Levee Mile	0.00
End Levee Mile	0.00
Location	
Category	Channels
Item	Vegetation & Obstructions
Looking downstream from Cement Hill Rd. (2012)	
johngw_c_20120806_096.jpg

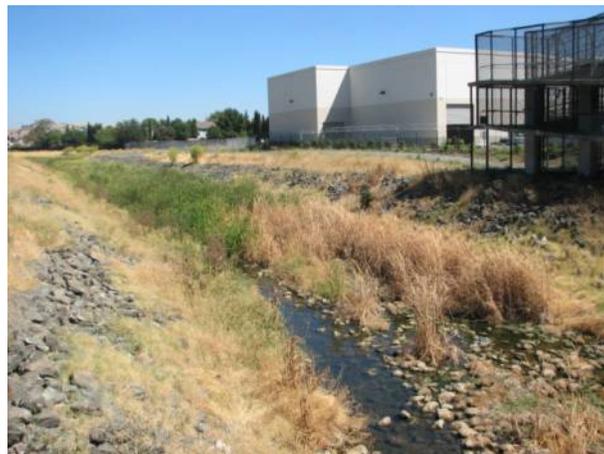
Levee Mile Report Line	11
Start Levee Mile	0.00
End Levee Mile	0.00
Location	
Category	Channels
Item	Vegetation & Obstructions
Looking upstream from Airbase Parkway. (2012)	
johngw_c_20120806_098.jpg

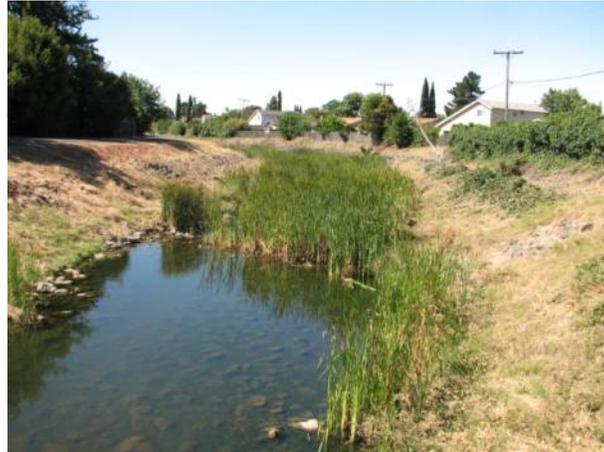
Levee Mile Report Line	16
Start Levee Mile	0.00
End Levee Mile	0.00
Location	
Category	Channels
Item	Vegetation & Obstructions
The photo is looking downstream at Nightingale. (2011)	
johngw_c_20120611_010.jpg

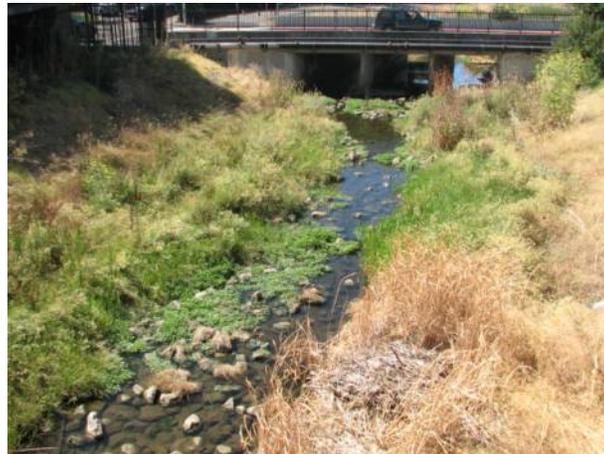
Levee Mile Report Line	16
Start Levee Mile	0.00
End Levee Mile	0.00
Location	
Category	Channels
Item	Vegetation & Obstructions
Looking downstream from Airbase Parkway.(2012)	
johngw_c_20120806_099.jpg

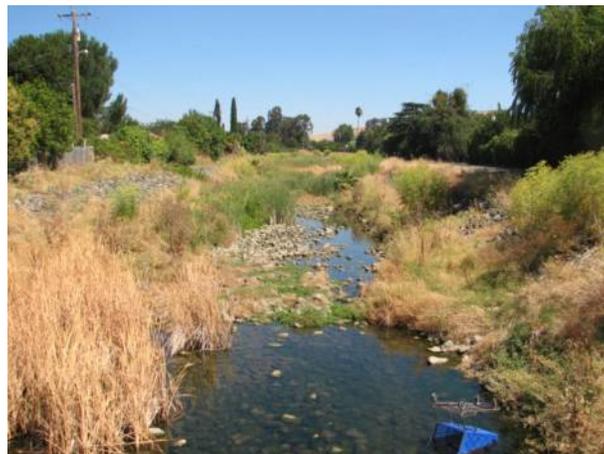
Levee Mile Report Line	21
Start Levee Mile	0.00
End Levee Mile	0.00
Location	
Category	Channels
Item	Vegetation & Obstructions
Looking upstream from Meadowlark Dr. (2012)	
johngw_c_20120806_100.jpg

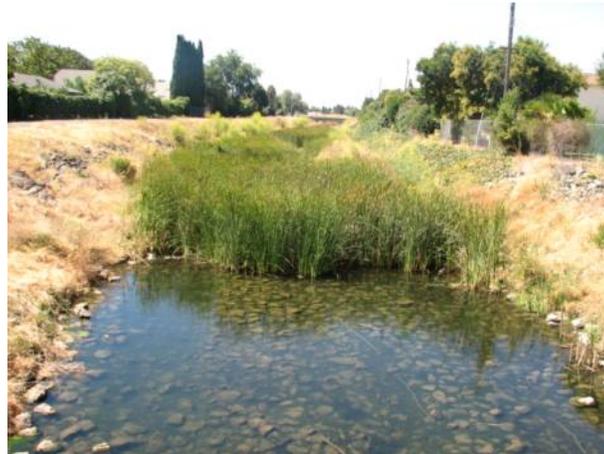
Levee Mile Report Line	26
Start Levee Mile	0.00
End Levee Mile	0.00
Location	
Category	Channels
Item	Vegetation & Obstructions
Looking downstream from Meadowlark Dr. (2012)	
johngw_c_20120806_101.jpg

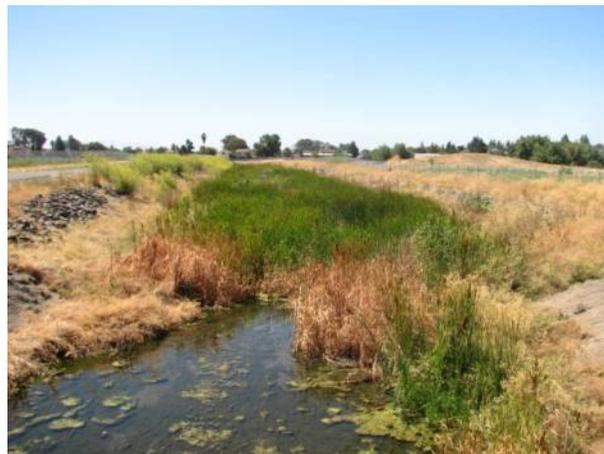
Levee Mile Report Line	36
Start Levee Mile	0.00
End Levee Mile	0.00
Location	
Category	Channels
Item	Vegetation & Obstructions
Looking downstream from E. Tabor Ave. (2012)	
johngw_c_20120806_103.jpg

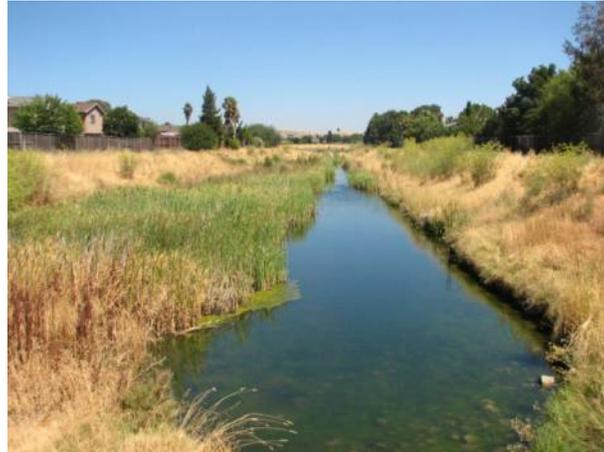
Looking upstream from Mathew Rd. (2012)

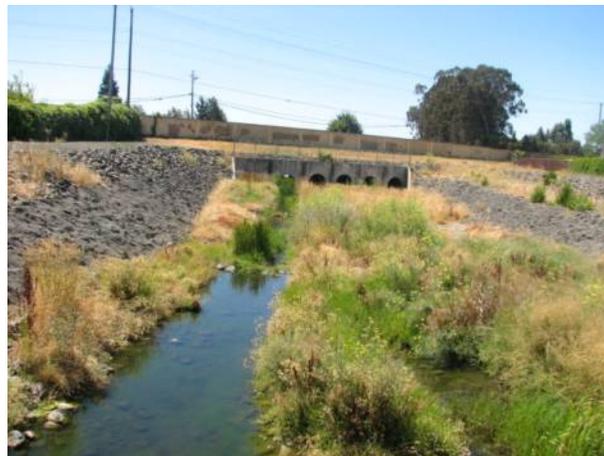
Looking downstream from Mathew Rd. (2012)

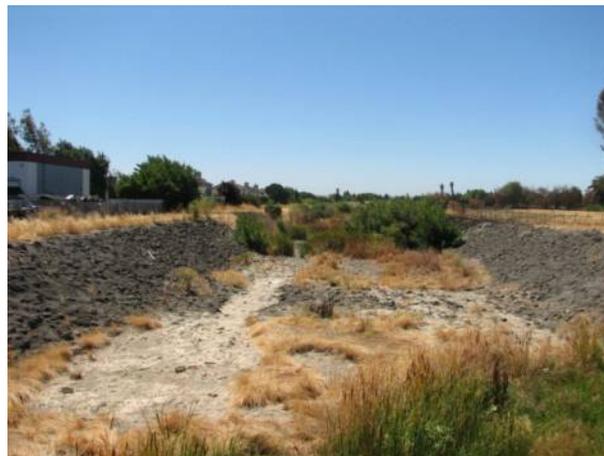
Looking downstream from Railroad Ave. (2012)

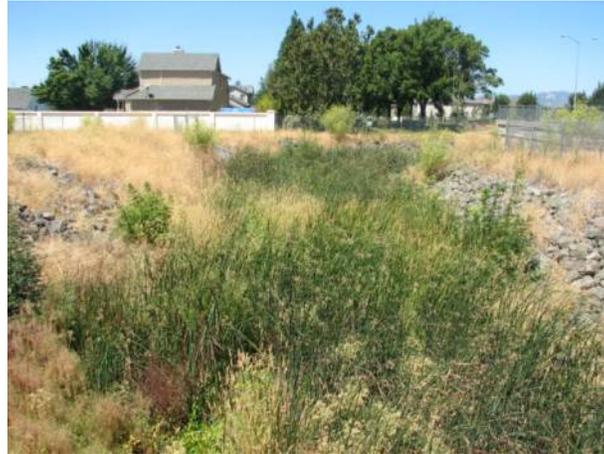
Levee Mile Report Line	61
Start Levee Mile	0.00
End Levee Mile	0.00
Location	
Category	Channels
Item	Vegetation & Obstructions
Looking upstream from Sunset Ave. Trees and brush should be cut and sprayed. (2012)	
johngw_c_20120806_107.jpg

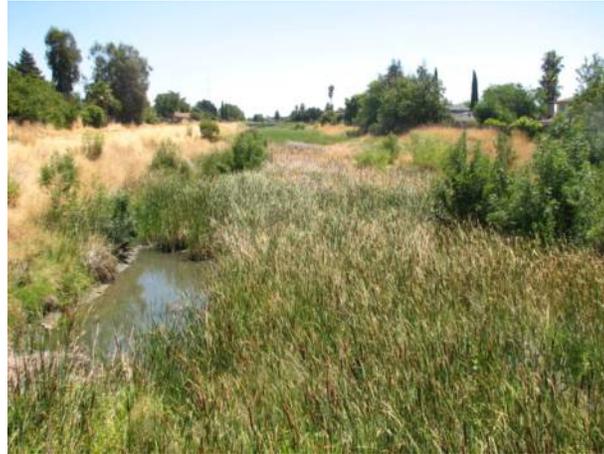
Levee Mile Report Line	76
Start Levee Mile	0.00
End Levee Mile	0.00
Location	
Category	Channels
Item	Vegetation & Obstructions
Looking downstream from Blossom Rd. Trees and brush should be removed. (2012)	
johngw_c_20120806_110.jpg

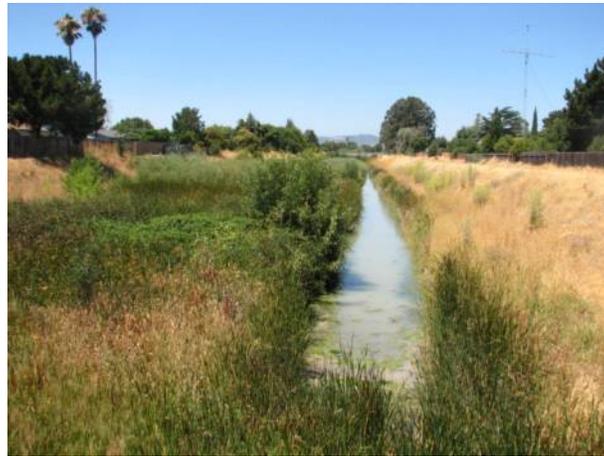
Levee Mile Report Line	81
Start Levee Mile	0.00
End Levee Mile	0.00
Location	
Category	Channels
Item	Vegetation & Obstructions
Looking upstream from Worley Rd. (2012)	
johngw_c_20120806_111.jpg

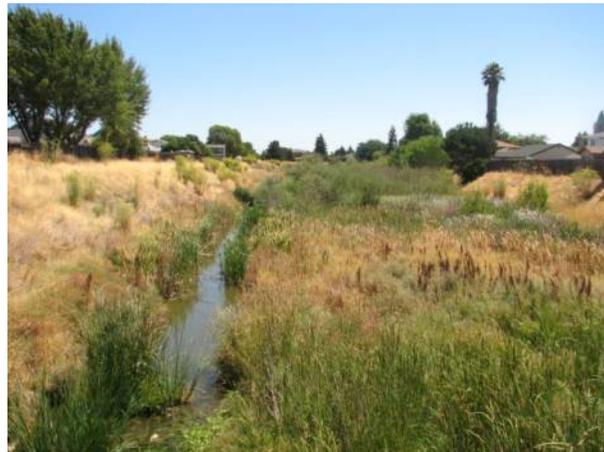
Levee Mile Report Line	86
Start Levee Mile	0.00
End Levee Mile	0.00
Location	
Category	Channels
Item	Vegetation & Obstructions
Looking downstream from Worley Rd. (2012)	
johngw_c_20120806_112.jpg

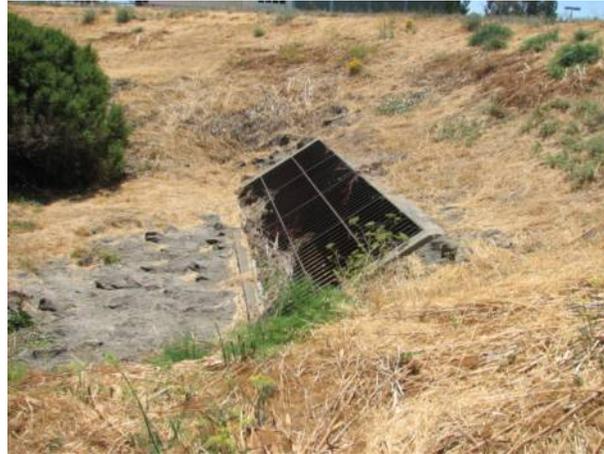
Levee Mile Report Line	1
Start Levee Mile	0.00
End Levee Mile	0.00
Location	
Category	Channels
Item	Vegetation & Obstructions
Looking at the inlet to Ledgewood Creek from the retention basin. (2012)	
johngw_c_20120808_122.jpg

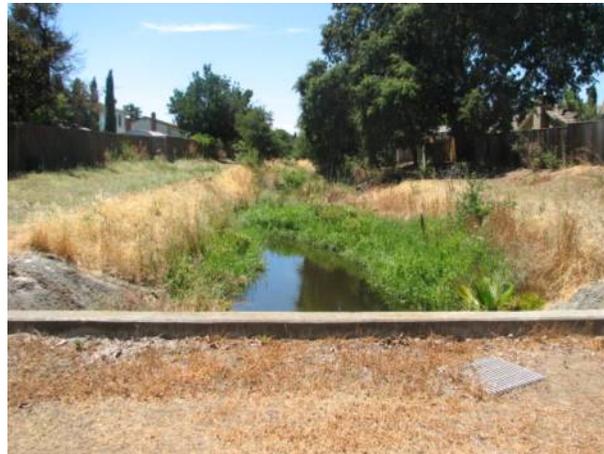
Levee Mile Report Line	1
Start Levee Mile	0.00
End Levee Mile	0.00
Location	
Category	Channels
Item	Vegetation & Obstructions
Looking downstream from the top of the outlet of the retention basin. (2012)	
johngw_c_20120808_123.jpg

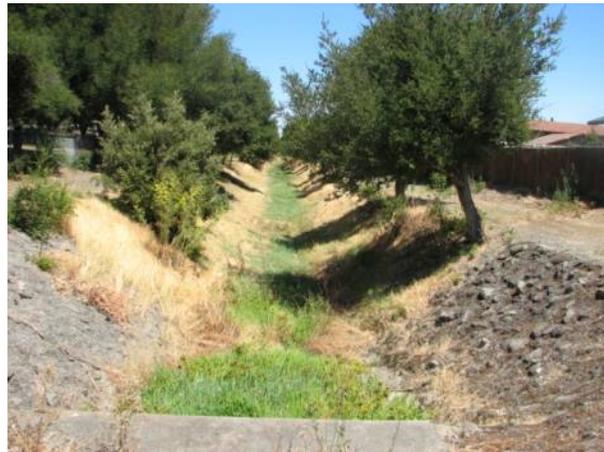
Levee Mile Report Line	1
Start Levee Mile	0.00
End Levee Mile	0.00
Location	
Category	Channels
Item	Vegetation & Obstructions
Looking upstream from Astoria Dr. (2012)	
johngw_c_20120808_124.jpg

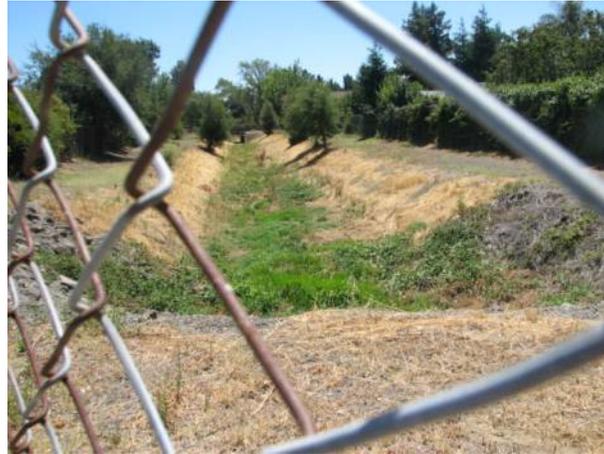
Levee Mile Report Line	6
Start Levee Mile	0.00
End Levee Mile	0.00
Location	
Category	Channels
Item	Vegetation & Obstructions
Looking downstream from Astoria Dr. (2012)	
johngw_c_20120808_125.jpg

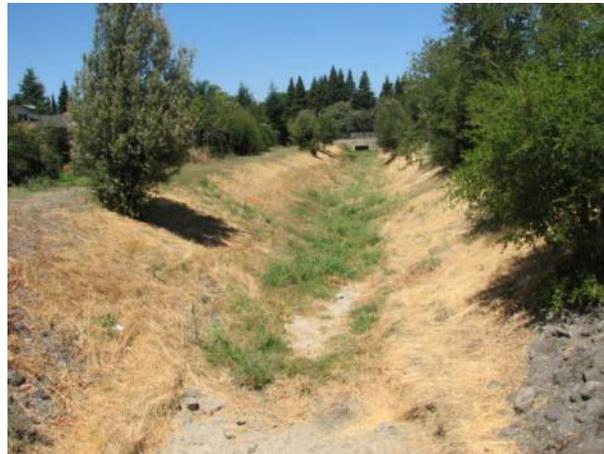
Levee Mile Report Line	11
Start Levee Mile	0.00
End Levee Mile	0.00
Location	
Category	Channels
Item	Vegetation & Obstructions
Looking upstream towards Astoria Dr. from Springfield Dr. (2012)	
johngw_c_20120808_126.jpg

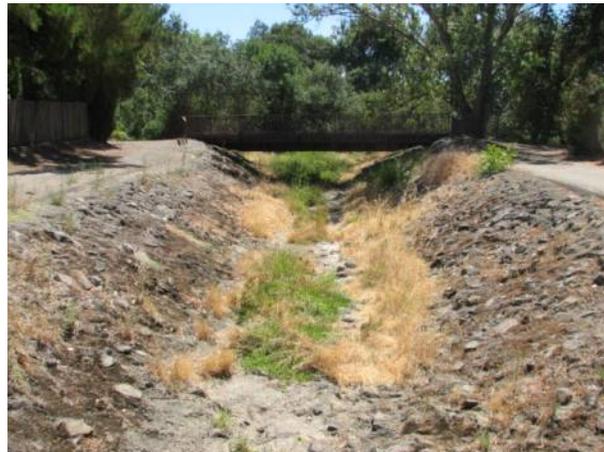
Levee Mile Report Line	16
Start Levee Mile	0.00
End Levee Mile	0.00
Location	
Category	Channels
Item	Vegetation & Obstructions
Looking downstream from Springfield Dr. (2012)	
johngw_c_20120808_127.jpg

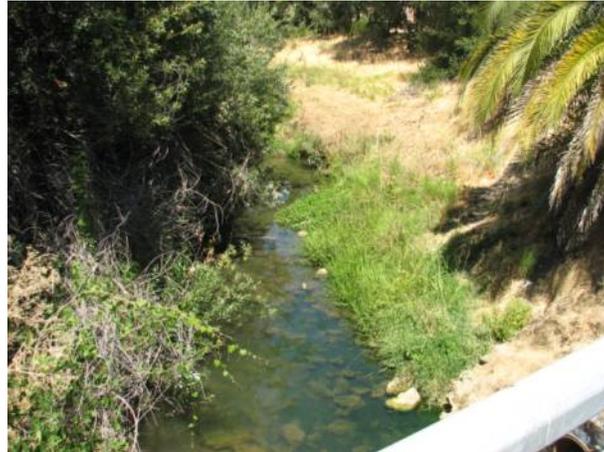
Looking upstream from Rockville Rd. (2012)

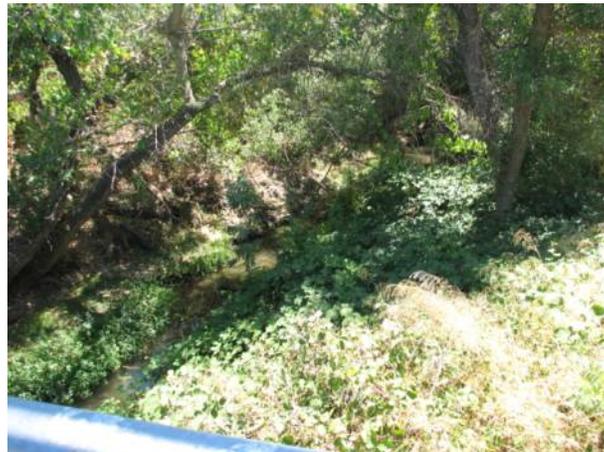
Looking downstream from Rockville Rd. (2012)

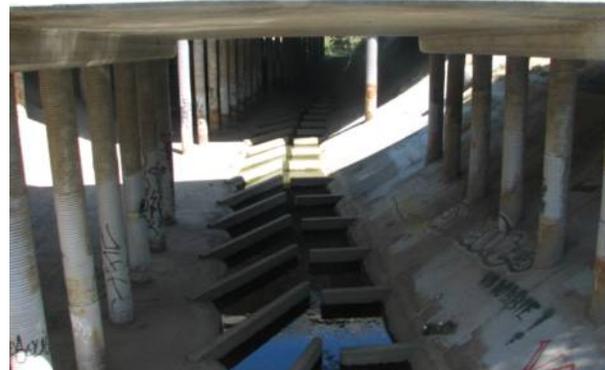
Levee Mile Report Line	31
Start Levee Mile	0.00
End Levee Mile	0.00
Location	
Category	Channels
Item	Vegetation & Obstructions
Looking upstream under I-80 from Automall Parkway. (2012)	
johngw_c_20120808_131.jpg

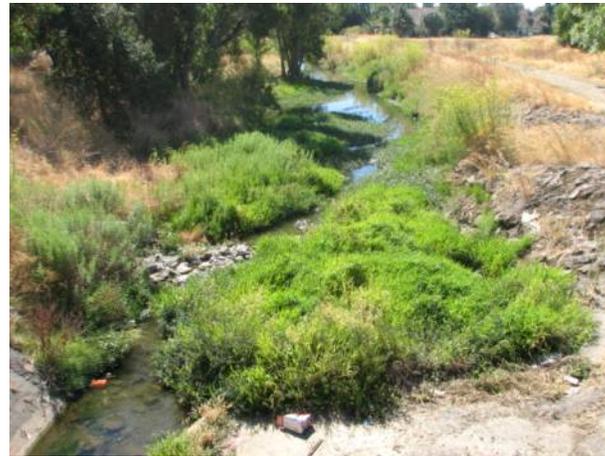
Levee Mile Report Line	36
Start Levee Mile	0.00
End Levee Mile	0.00
Location	
Category	Channels
Item	Vegetation & Obstructions
Looking downstream from Automall Parkway. (2012)	
johngw_c_20120808_132.jpg

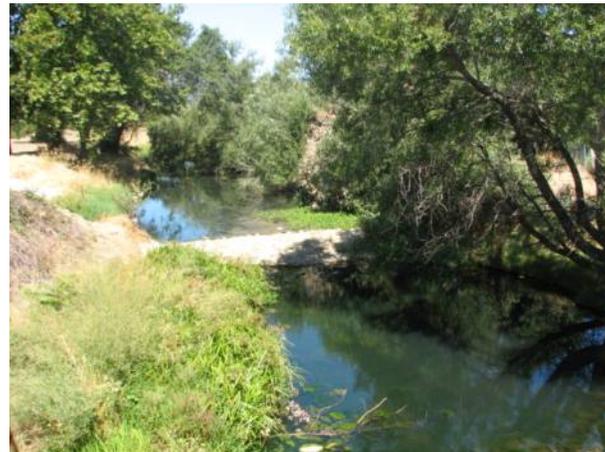
Levee Mile Report Line	41
Start Levee Mile	0.00
End Levee Mile	0.00
Location	
Category	Channels
Item	Vegetation & Obstructions
Looking upstream from Woolner Ave. 2012)	
johngw_c_20120808_133.jpg

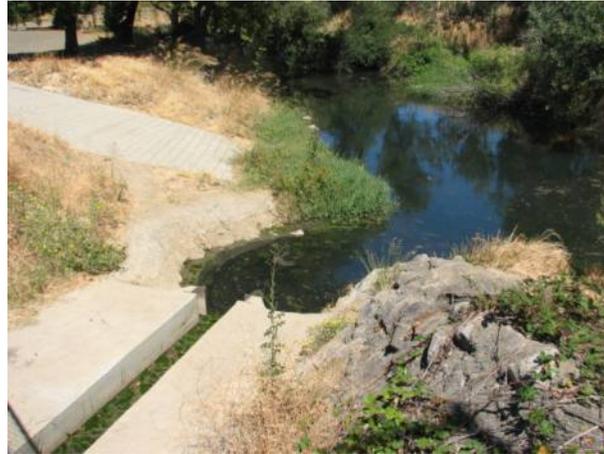
Looking at the inlet of the historical channel from Wollner Ave. (2012)

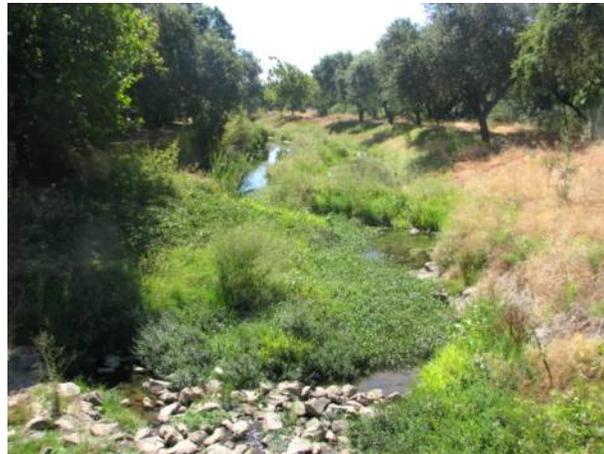
Looking downstream from Woolner Ave. (2012)

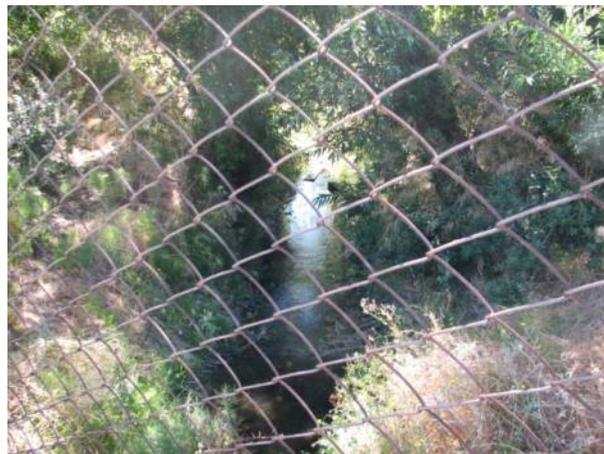
Looking downstream at the historical channel from Woolner Ave. (2012)

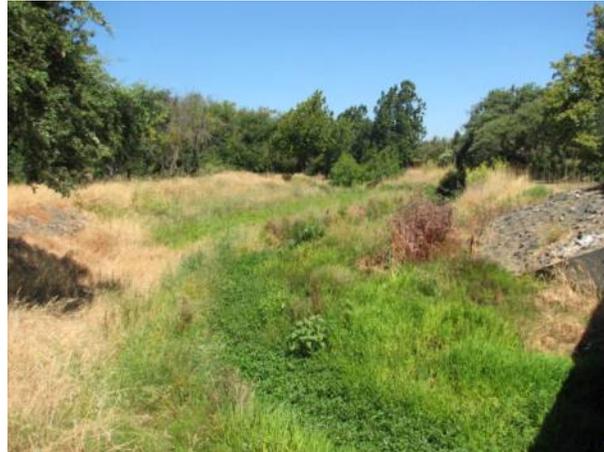
Levee Mile Report Line	51
Start Levee Mile	0.00
End Levee Mile	0.00
Location	
Category	Channels
Item	Vegetation & Obstructions
Looking upstream from Beck Ave. (2012)	
johngw_c_20120808_137.jpg

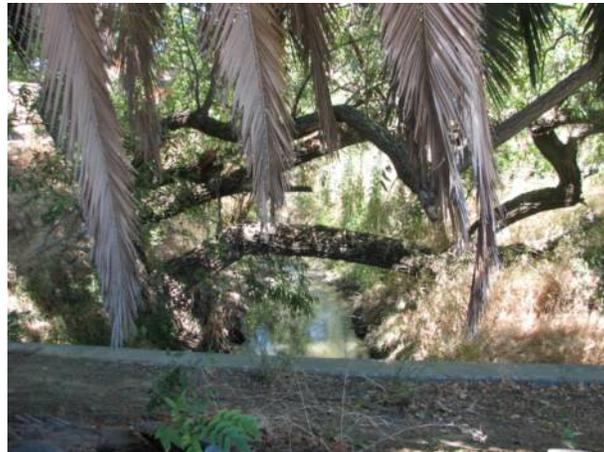
Levee Mile Report Line	51
Start Levee Mile	0.00
End Levee Mile	0.00
Location	
Category	Channels
Item	Vegetation & Obstructions
Looking upstream at the historical channel from Beck Ave. (2012)	
johngw_c_20120808_138.jpg

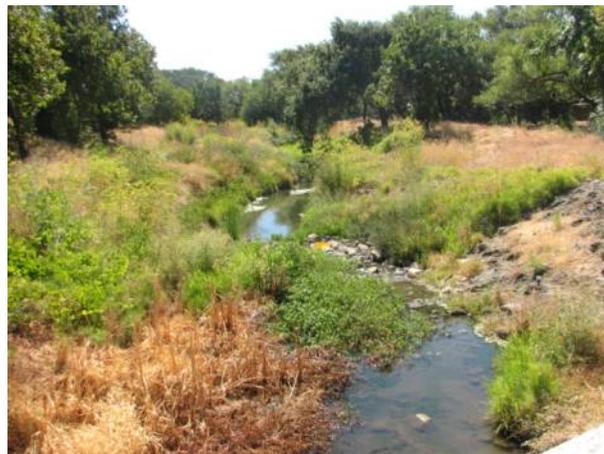
Levee Mile Report Line	56
Start Levee Mile	0.00
End Levee Mile	0.00
Location	
Category	Channels
Item	Vegetation & Obstructions
Looking downstream from Beck Ave. (2012)	
johngw_c_20120808_139.jpg

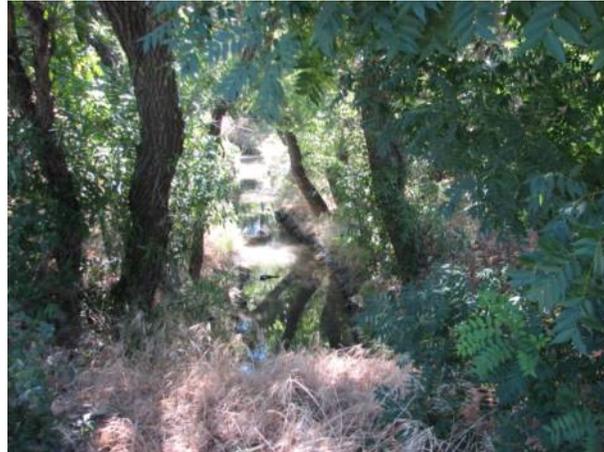
Levee Mile Report Line	56
Start Levee Mile	0.00
End Levee Mile	0.00
Location	
Category	Channels
Item	Vegetation & Obstructions
Looking downstream at the historical channel from Beck Ave. (2012)	
johngw_c_20120808_140.jpg

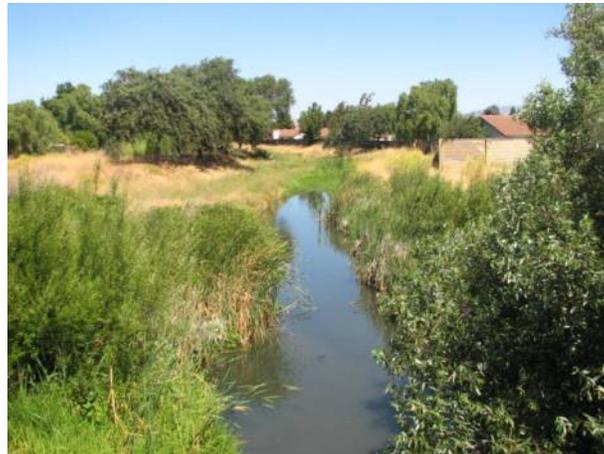
Levee Mile Report Line	61
Start Levee Mile	0.00
End Levee Mile	0.00
Location	
Category	Channels
Item	Vegetation & Obstructions
Looking upstream from Highway 12. (2012)	
johngw_c_20120808_141.jpg

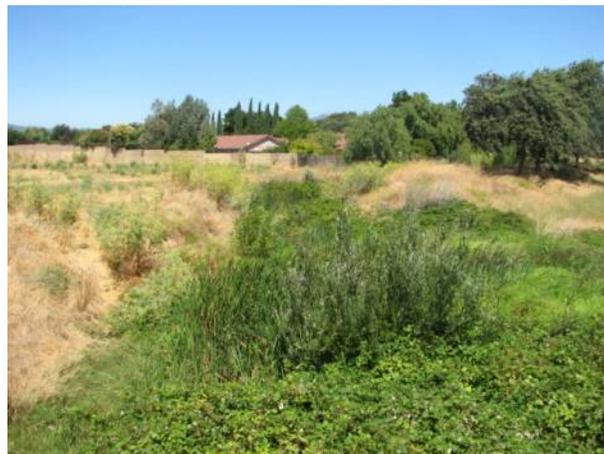
Levee Mile Report Line	61
Start Levee Mile	0.00
End Levee Mile	0.00
Location	
Category	Channels
Item	Vegetation & Obstructions
Looking upstream at the outlet of the historical channel from Highway 12. (2012)	
johngw_c_20120808_142.jpg

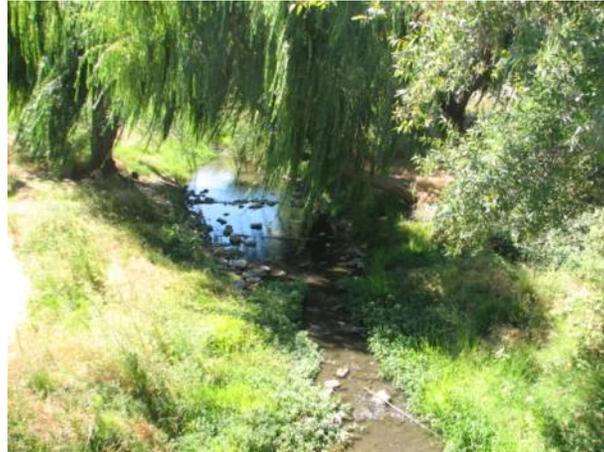
Levee Mile Report Line	66
Start Levee Mile	0.00
End Levee Mile	0.00
Location	
Category	Channels
Item	Vegetation & Obstructions
Looking downstream from Highway 12. (2012)	
johngw_c_20120808_143.jpg

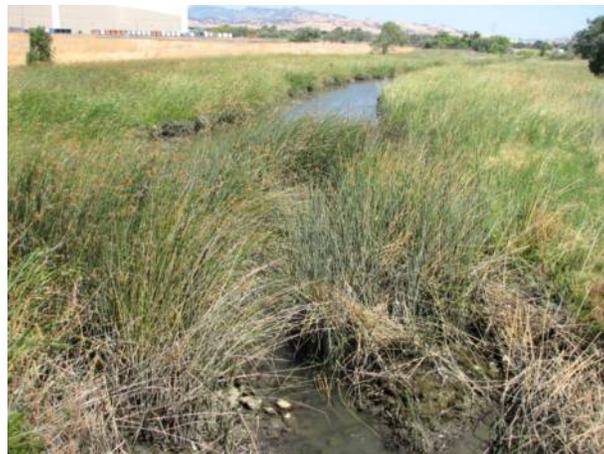
Levee Mile Report Line	71
Start Levee Mile	0.00
End Levee Mile	0.00
Location	
Category	Channels
Item	Vegetation & Obstructions
Looking upstream from Cordelia Rd. (2012)	
johngw_c_20120808_144.jpg

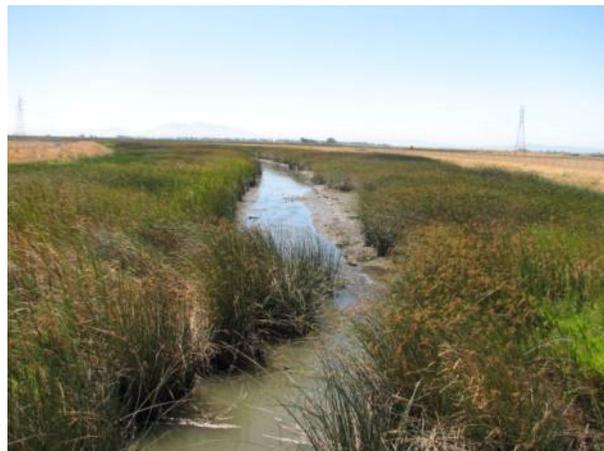
Levee Mile Report Line	76
Start Levee Mile	0.00
End Levee Mile	0.00
Location	
Category	Channels
Item	Vegetation & Obstructions
Looking downstream at low tide from Cordelia Rd. (2012)	
johngw_c_20120808_145.jpg

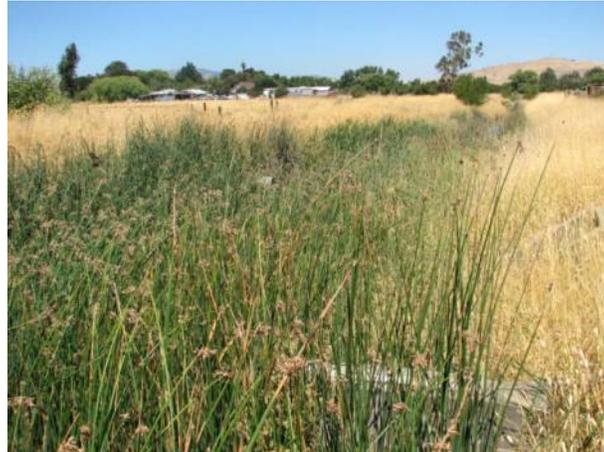
LMIR No.	Check Point	View	Item	Location	Rating	Inspector Comment	GPS Latitude & Longitude	Photo	Issue No
1	Bella Vista Dr	Up	Vegetation & Obstructions		M	Inspector Comments: Vegetation growth (such as cat tails, bull rushes, bushes or saplings) or other obstructions block approximately 25% of the FCW.	38.253280 ° -122.000670 °	Y	1
2		Up	Shoaling / Sedimentation		A		38.253280 ° -122.000670 °		2
3		Up	Erosion / Bank Caving		A		38.253280 ° -122.000670 °		3
4		Up	Revetments		N	Inspector Comments: This item does not apply to this inspection.	38.253280 ° -122.000670 °		4
5		Up	Encroachments		A	Inspector Comments: No Trash, debris, excavation, structures, or other obstructions present within the project easement area.	38.253280 ° -122.000670 °		5
6		Down	Vegetation & Obstructions		M	Inspector Comments: Vegetation growth (such as cat tails, bull rushes, bushes or saplings) or other obstructions block approximately 50% of the FCW.	38.253280 ° -122.000670 °	Y	6

Levee Mile Report Line	1
Start Levee Mile	0.00
End Levee Mile	0.00
Location	
Category	Channels
Item	Vegetation & Obstructions
Looking upstream on Mccoy Creek at Bella Vista Dr. The control structure is over grown with cattails. (2012)	
johngw_c_20120807_113.jpg

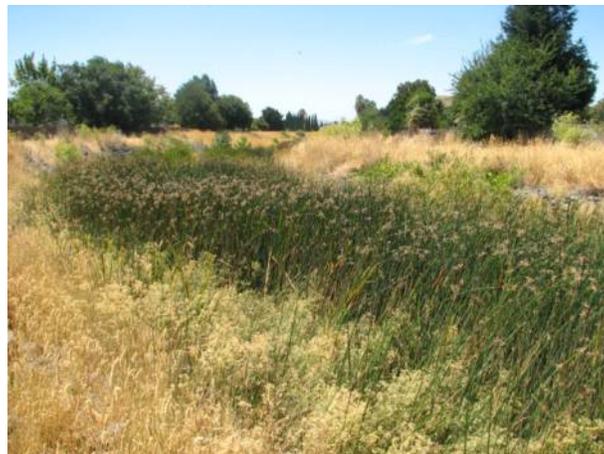
Levee Mile Report Line	6
Start Levee Mile	0.00
End Levee Mile	0.00
Location	
Category	Channels
Item	Vegetation & Obstructions
Looking downstream at Bella Vista Dr. (2012)	
johngw_c_20120807_114.jpg

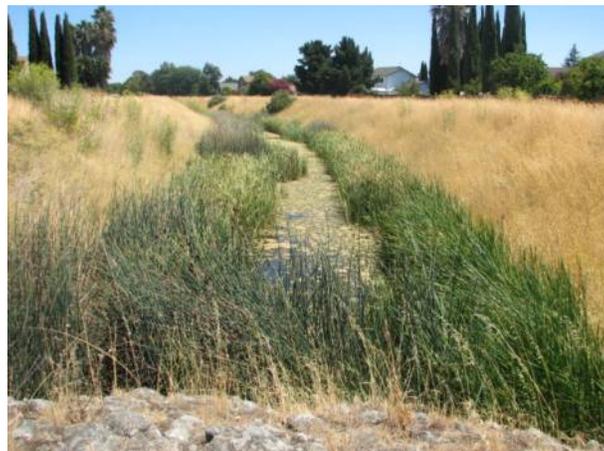
Levee Mile Report Line	11
Start Levee Mile	0.00
End Levee Mile	0.00
Location	
Category	Channels
Item	Vegetation & Obstructions
Looking upstream at Emporer Dr. (2012)	
johngw_c_20120807_115.jpg

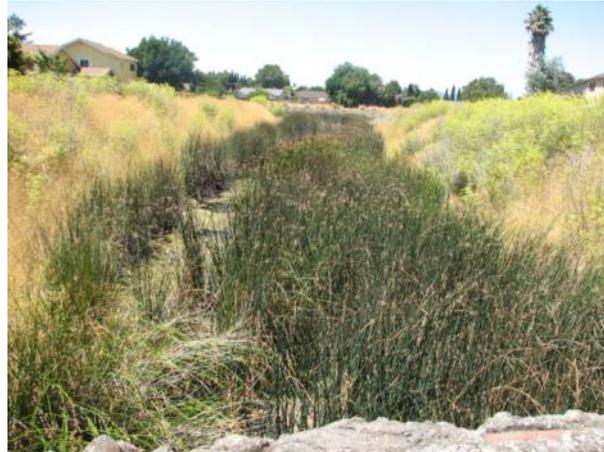
Levee Mile Report Line	16
Start Levee Mile	0.00
End Levee Mile	0.00
Location	
Category	Channels
Item	Vegetation & Obstructions
Looking downstream towards Laural Creek at Emporer Dr. (2012)	
johngw_c_20120807_116.jpg

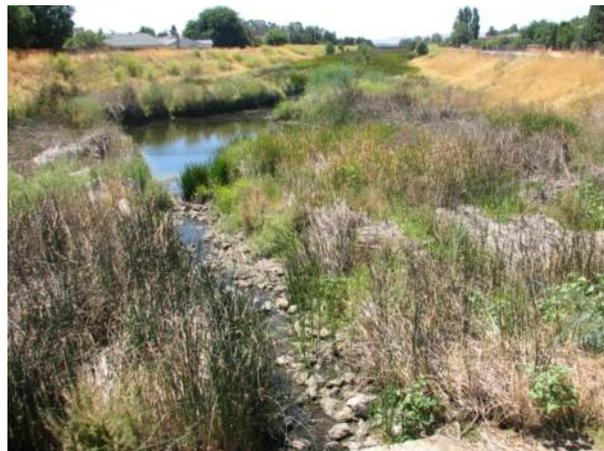
LMIR No.	Check Point	View	Item	Location	Rating	Inspector Comment	GPS Latitude & Longitude	Photo	Issue No
26		Down	Vegetation & Obstructions		M	Inspector Comments: Log jams, snags, vegetation growth (such as cat tails, bull rushes, bushes or saplings) or other obstructions block approximately 25% of the FCW.	38.248542 ° -122.006378 °	Y	26
27		Down	Shoaling / Sedimentation		A		38.248542 ° -122.006378 °		27
28		Down	Erosion / Bank Caving		A		38.248542 ° -122.006378 °		28
29		Down	Revetments		A	Inspector Comments: Existing riprap protection is properly maintained and is undamaged. Riprap clearly visible.	38.248542 ° -122.006378 °		29
30		Down	Encroachments		A	Inspector Comments: No Trash, debris, excavation, structures, or other obstructions present within the project easement area.	38.248542 ° -122.006378 °		30
31	Anderson Dr	Up	Vegetation & Obstructions		M	Inspector Comments: Vegetation growth (such as cat tails, bull rushes, bushes or saplings) or other obstructions block approximately 25% of the FCW.	38.241288 ° -122.012057 °	Y	31

Levee Mile Report Line	26
Start Levee Mile	0.00
End Levee Mile	0.00
Location	
Category	Channels
Item	Vegetation & Obstructions
Looking downstream at Pintail Dr. (2012)	
johngw_c_20120807_118.jpg

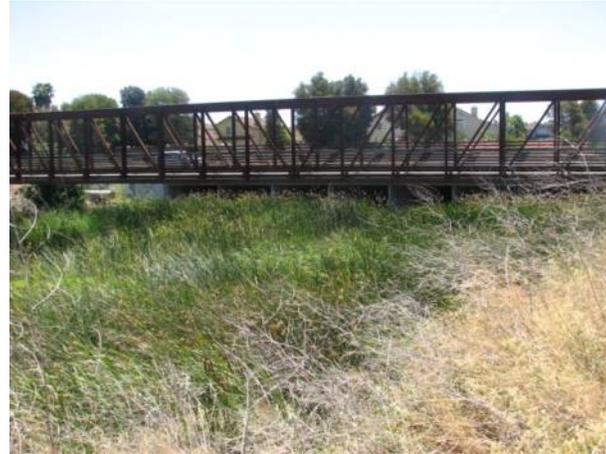
Levee Mile Report Line	31
Start Levee Mile	0.00
End Levee Mile	0.00
Location	
Category	Channels
Item	Vegetation & Obstructions
Looking downstream at Highway 12 towards Anderson Dr. (2012)	
johngw_c_20120807_119.jpg

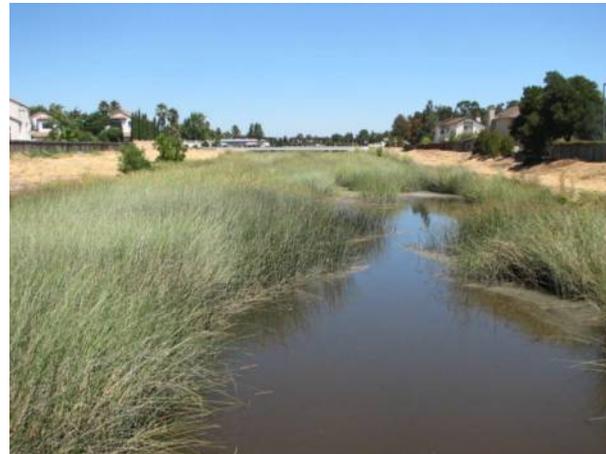
Levee Mile Report Line	31
Start Levee Mile	0.00
End Levee Mile	0.00
Location	
Category	Channels
Item	Vegetation & Obstructions
Looking upstream at Anderson Dr. (2012)	
johngw_c_20120807_120.jpg

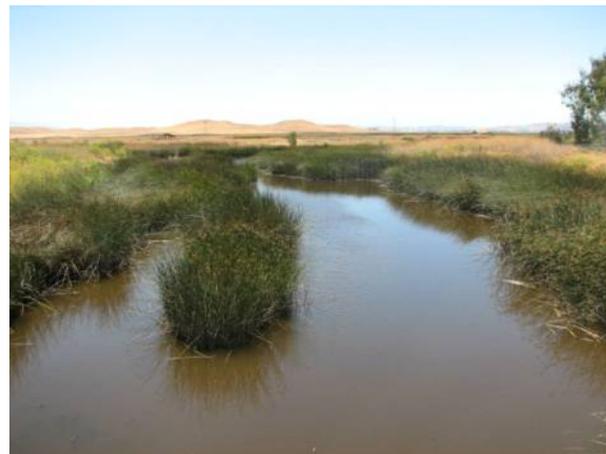
Levee Mile Report Line	36
Start Levee Mile	0.00
End Levee Mile	0.00
Location	
Category	Channels
Item	Vegetation & Obstructions
Looking downstream towards Suisun Bay at Anderson Dr. (2012)	
johngw_c_20120807_121.jpg

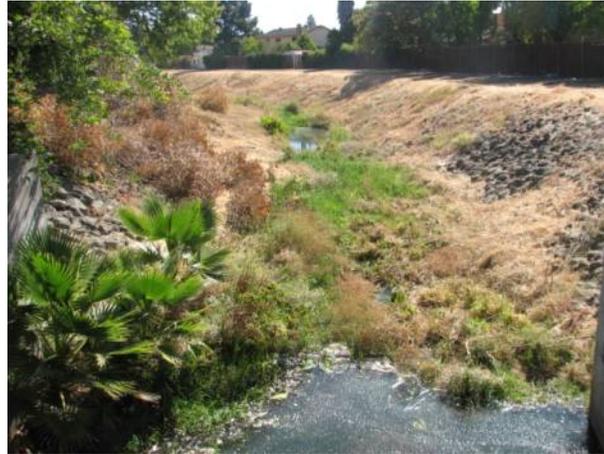
Levee Mile Report Line	1
Start Levee Mile	0.00
End Levee Mile	0.00
Location	
Category	Channels
Item	Vegetation & Obstructions
<p>This is looking downstream from N. Texas St. Palm trees should be removed before they get too large. (2012)</p>	
<p>johngw_c_20120806_082.jpg</p>

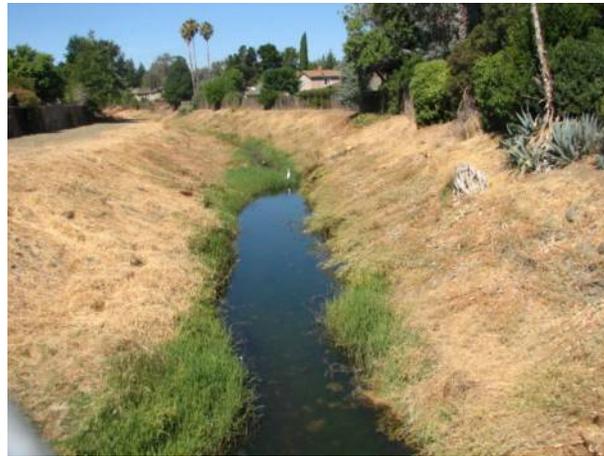
Levee Mile Report Line	6
Start Levee Mile	0.00
End Levee Mile	0.00
Location	
Category	Channels
Item	Vegetation & Obstructions
<p>Looking upstream at Camrose Ave. (2012)</p>	
<p>johngw_c_20120806_083.jpg</p>

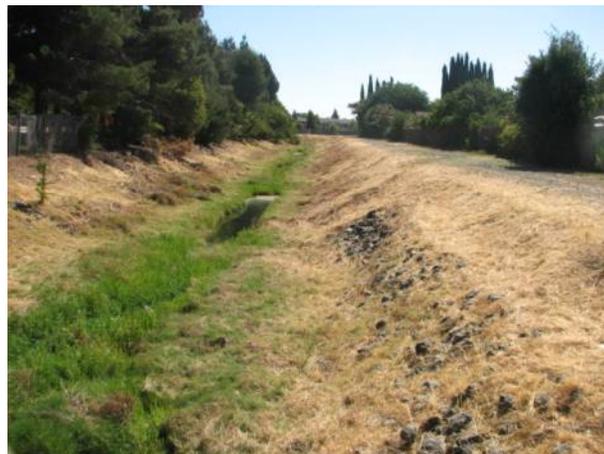
Levee Mile Report Line	11
Start Levee Mile	0.00
End Levee Mile	0.00
Location	
Category	Channels
Item	Vegetation & Obstructions
<p>Looking downstream at Camrose Ave. (2012)</p>	
<p>johngw_c_20120806_084.jpg</p>

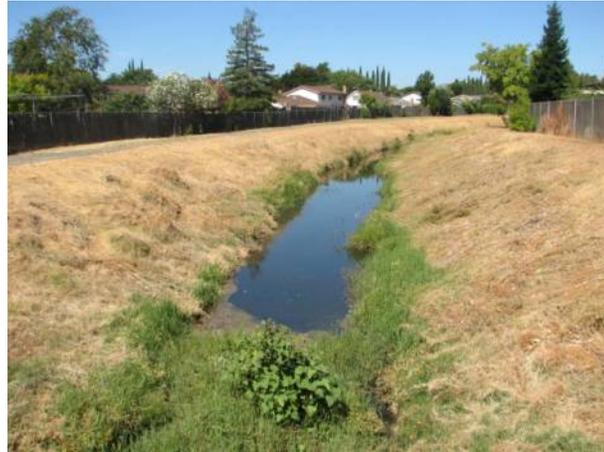
Levee Mile Report Line	16
Start Levee Mile	0.00
End Levee Mile	0.00
Location	
Category	Channels
Item	Vegetation & Obstructions
Looking upstream from Dover Ave. (2012)	
johngw_c_20120806_085.jpg

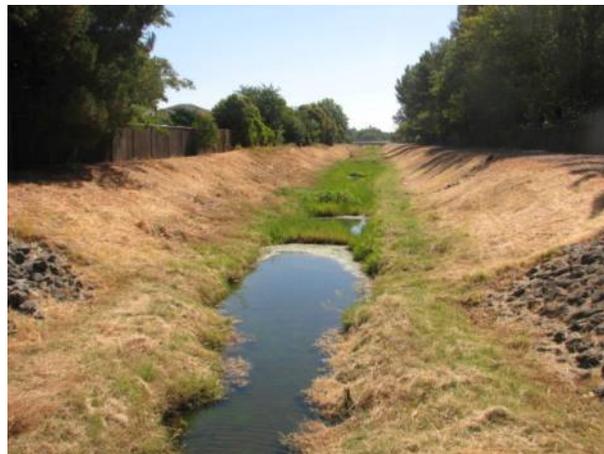
Levee Mile Report Line	21
Start Levee Mile	0.00
End Levee Mile	0.00
Location	
Category	Channels
Item	Vegetation & Obstructions
Looking downstream from Dover Ave. (2012)	
johngw_c_20120806_086.jpg

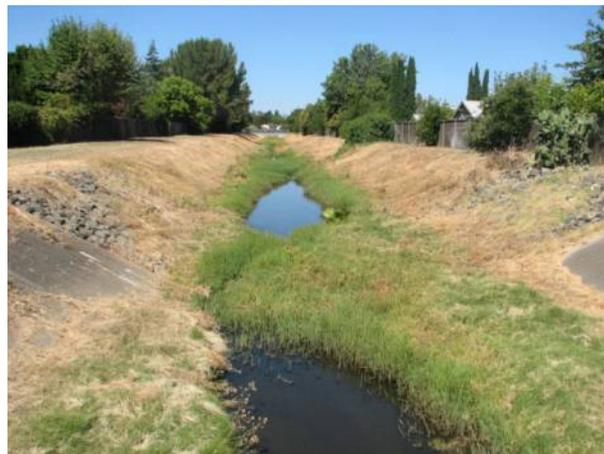
Levee Mile Report Line	26
Start Levee Mile	0.00
End Levee Mile	0.00
Location	
Category	Channels
Item	Vegetation & Obstructions
Looking upstream from Gulf Dr. (2012)	
johngw_c_20120806_087.jpg

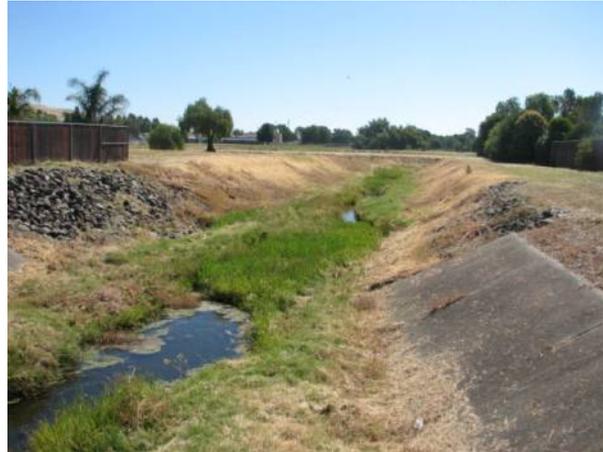
Levee Mile Report Line	31
Start Levee Mile	0.00
End Levee Mile	0.00
Location	
Category	Channels
Item	Vegetation & Obstructions
Looking downstream towards Laurel Creek from Gulf Dr. (2012)	
johngw_c_20120806_088.jpg
