**Flood Control Project Maintenance
Levee Inspections
2014 Channel Summary Report
Overall Unit and Item Ratings**

Fairfield Suisun Sewer District

Flood Control Project Maintenance
Unit Cover Sheet
2014 Channel Inspection Results

Levee Inspection Report By Mile - Channel 2014

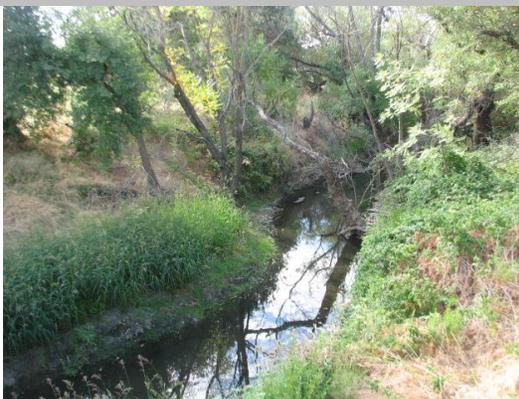
Photo 1 of 8 : CH_2014_NA0035_15_1_20140723_00031.jpg

Check Point / View				
Cement Hill Rd / Up				
Rating **	A	Issue No.	1	GPS Lat/Long
Issue Type +	Ma	Location *		38.279936 °
Category	Rivers, Channels & Designated Flood			-122.018353 °
Item	Vegetation & Obstructions			
DWR ID	DWR_NA0035_15_c_2012_1			
Action/Comments				
Inspector Comments: Minimal, scattered obstructions or vegetation. The flow is not impeded.

Looking downstream from Manual Campos Parkway towards Dickson Hill Rd. Summer 2014

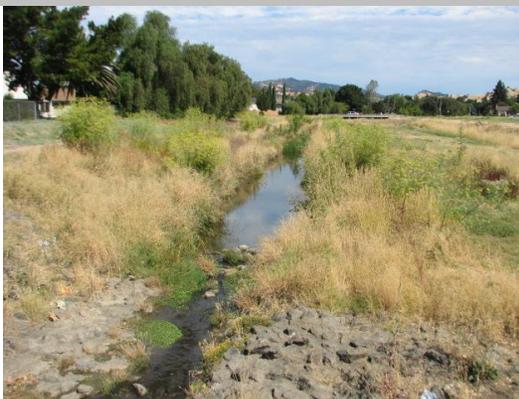
Photo 2 of 8 : CH_2014_NA0035_15_1_20140723_00026.jpg

A view looking upstream from Cement Hill Rd. Summer 2014

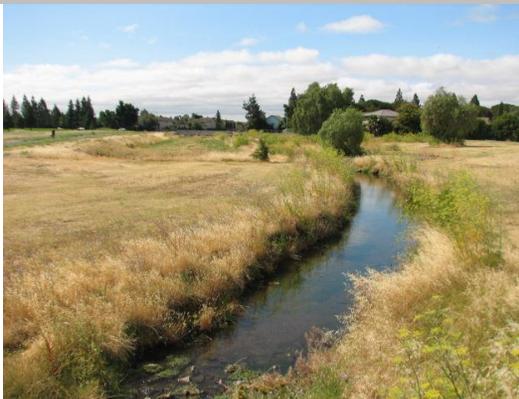
Photo 3 of 8 : CH_2014_NA0035_15_1_20140723_00027.jpg

Looking downstream from Gulf Dr. towards Union Ave. Diversion and Cement Hill Rd. Summer 2014 (38.281994 -122.019612)

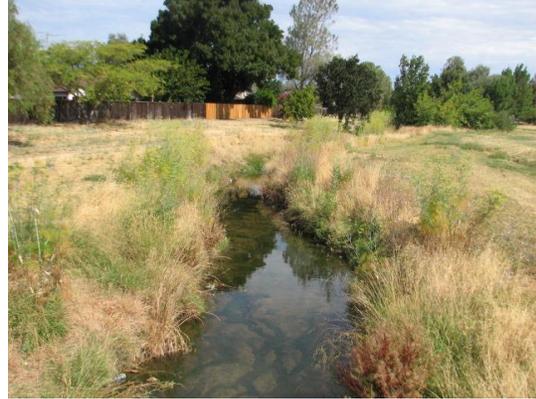
Photo 4 of 8 : CH_2014_NA0035_15_1_20140723_00028.jpg

Check Point / View				
Cement Hill Rd / Up (cont)				
Rating **	A	Issue No.	1 (cont)	GPS Lat/Long
Issue Type +	Ma	Location *		38.279936 °
Category	Rivers, Channels & Designated Flood			-122.018353 °
Item	Vegetation & Obstructions			
DWR ID	DWR_NA0035_15_c_2012_1			
Action/Comments				
Inspector Comments: Minimal, scattered obstructions or vegetation. The flow is not impeded.

Due to city expansion upstream I have extended my crossing. Looking upstream from Gulf Dr. Summer 2014

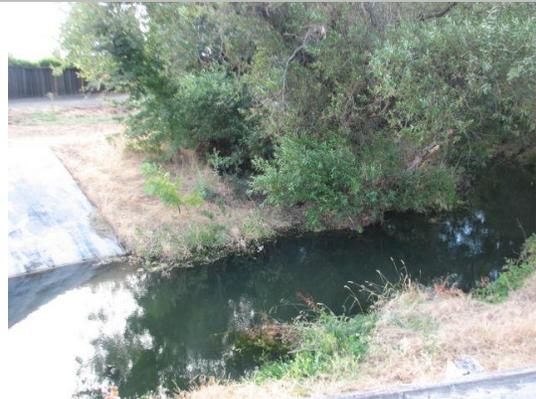
Photo 5 of 8 : CH_2014_NA0035_15_1_20140723_00030.jpg

Looking downstream from Dickson Hill Rd. towards Gulf Dr. Summer 2014

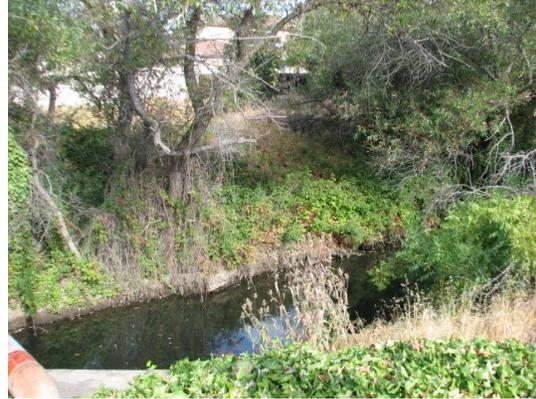
Photo 6 of 8 : CH_2014_NA0035_15_1_20140723_00032.jpg

Check Point / View				
Cement Hill Rd / Up (cont)				
Rating **	A	Issue No.	1 (cont)	GPS Lat/Long
Issue Type +	Ma	Location *		38.279936 °
Category	Rivers, Channels & Designated Flood			-122.018353 °
Item	Vegetation & Obstructions			
DWR ID	DWR_NA0035_15_c_2012_1			
Action/Comments				
Inspector Comments: Minimal, scattered obstructions or vegetation. The flow is not impeded.

Looking upstream from Manual Campos Parkway Summer 2014
(38.292725 -122.022666)

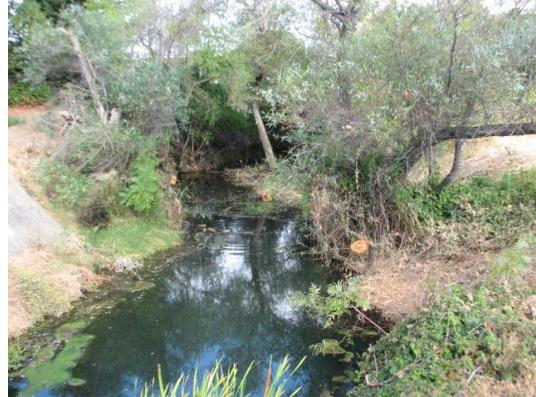
Photo 8 of 8 : CH_2014_NA0035_15_1_20140723_00029.jpg

Check Point / View				
Cement Hill Rd / Up (cont)				
Rating **	A	Issue No.	1 (cont)	GPS Lat/Long
Issue Type +	Ma	Location *		38.279936 °
Category	Rivers, Channels & Designated Flood			-122.018353 °
Item	Vegetation & Obstructions			
DWR ID	DWR_NA0035_15_c_2012_1			
Action/Comments				
Inspector Comments: Minimal, scattered obstructions or vegetation. The flow is not impeded.

Looking downstream from Dickson Hill Dr. towards Gulf Dr. Summer 2014 (38.289815 -122.0208)

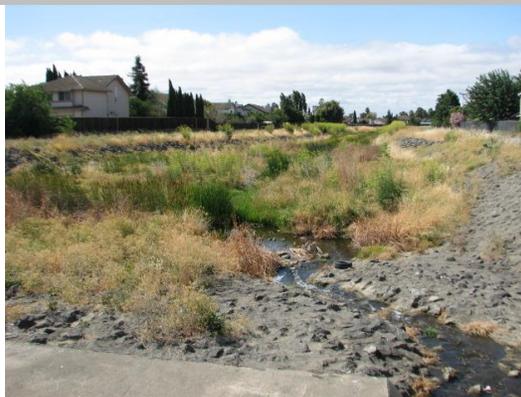
Photo 1 of 2 : CH_2014_NA0035_15_6_20140723_00034.jpg

Check Point / View			
Cement Hill Rd / Down			
Rating **	A	Issue No.	6
Issue Type +	Ma	Location *	
Category	Rivers, Channels & Designated Flood		GPS Lat/Long
Item	Vegetation & Obstructions		
DWR ID	DWR_NA0035_15_c_2012_6		
Action/Comments			
Inspector Comments: Minimal, scattered obstructions or vegetation. The flow is not impeded.

A view looking downstream from Cement Hill Rd. Summer 2014

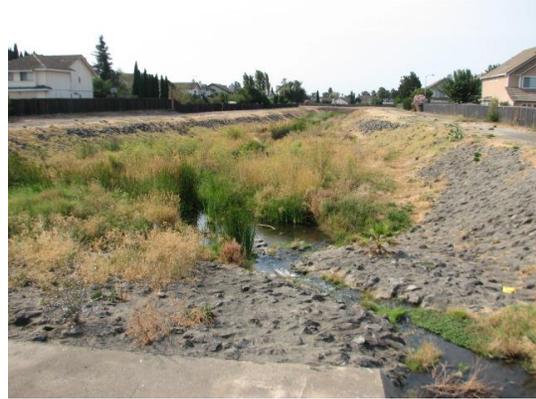
Photo 2 of 2 : CH_2014_NA0035_15_6_20140616_00008.jpg

Check Point / View			
Cement Hill Rd / Down (cont)			
Rating **	A	Issue No.	6 (cont)
Issue Type +	Ma	Location *	GPS Lat/Long
Category	Rivers, Channels & Designated Flood		38.279937 °
Item	Vegetation & Obstructions		-122.018353 °
DWR ID	DWR_NA0035_15_c_2012_6		
Action/Comments			
Inspector Comments: Minimal, scattered obstructions or vegetation. The flow is not impeded.

Looking downstream at Cement Hill Road (Summer 2013)

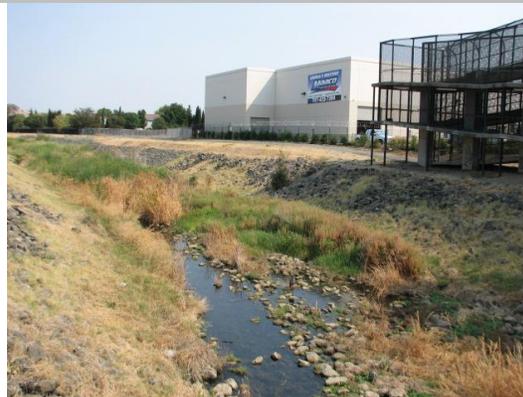
Photo 1 of 2 : CH_2014_NA0035_15_11_20140616_00009.jpg

Check Point / View			
Air Base Parkway / Up			
Rating **	A	Issue No.	11
Issue Type +	Ma	Location *	GPS Lat/Long
Category	Rivers, Channels & Designated Flood		38.272637 °
Item	Vegetation & Obstructions		-122.016114 °
DWR ID	DWR_NA0035_15_c_2012_11		
Action/Comments			
Inspector Comments: Minimal, scattered obstructions or vegetation. The flow is not impeded.

Looking upstream at Air Base Parkway (Summer 2013)

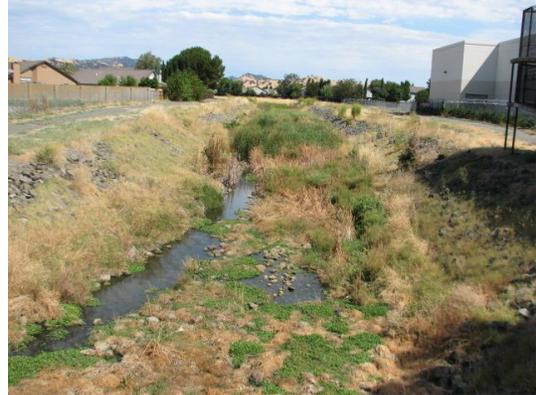
Photo 2 of 2 : CH_2014_NA0035_15_11_20140723_00035.jpg

Check Point / View				
Air Base Parkway / Up (cont)				
Rating **	A	Issue No.	11 (cont)	GPS Lat/Long
Issue Type +	Ma	Location *		38.272637 °
Category	Rivers, Channels & Designated Flood			-122.016114 °
Item	Vegetation & Obstructions			
DWR ID	DWR_NA0035_15_c_2012_11			
Action/Comments				
Inspector Comments: Minimal, scattered obstructions or vegetation. The flow is not impeded.

Looking upstream from Air Base Pkwy. Summer 2014

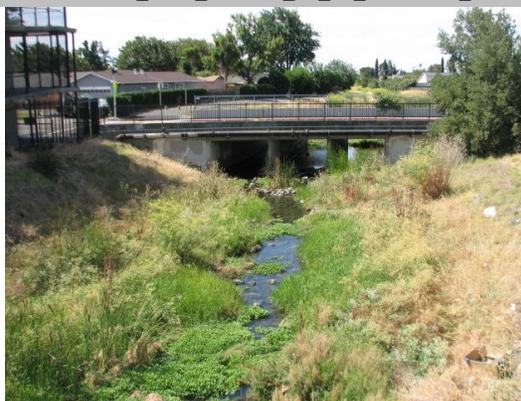
Photo 1 of 2 : CH_2014_NA0035_15_16_20140723_00036.jpg

Check Point / View				
Air Base Parkway / Down				
Rating **	A	Issue No.	16	GPS Lat/Long
Issue Type +	Ma	Location *		38.272633 °
Category	Rivers, Channels & Designated Flood			-122.016110 °
Item	Vegetation & Obstructions			
DWR ID	DWR_NA0035_15_c_2012_16			
Action/Comments				
Inspector Comments: Minimal, scattered obstructions or vegetation. The flow is not impeded.

A view looking towards Nightingale from Air Base Pkwy. Summer 2014

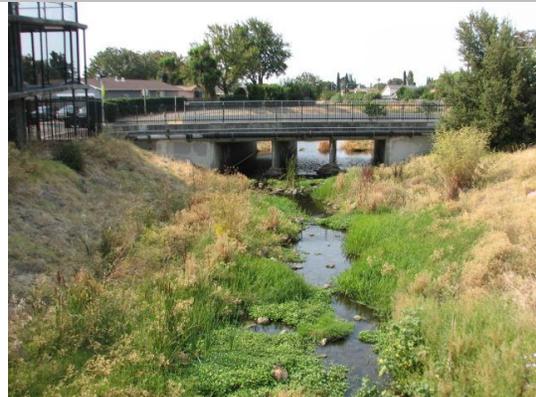
Photo 2 of 2 : CH_2014_NA0035_15_16_20140616_00011.jpg

Check Point / View				
Air Base Parkway / Down (cont)				
Rating **	A	Issue No.	16 (cont)	GPS Lat/Long
Issue Type +	Ma	Location *		38.272633 °
Category	Rivers, Channels & Designated Flood			-122.016110 °
Item	Vegetation & Obstructions			
DWR ID	DWR_NA0035_15_c_2012_16			
Action/Comments				
Inspector Comments: Minimal, scattered obstructions or vegetation. The flow is not impeded.

Looking downstream towards Nightingale at Air Base Parkway (Summer 2013)

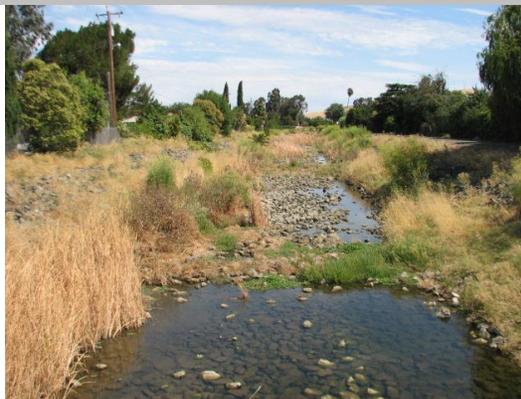
Photo 1 of 2 : CH_2014_NA0035_15_21_20140723_00037.jpg

Check Point / View			
Meadowlark Dr / Up			
Rating **	A	Issue No. 21	GPS Lat/Long
Issue Type +	Ma	Location *	38.268244 °
Category	Rivers, Channels & Designated Flood		-122.017216 °
Item	Vegetation & Obstructions		
DWR ID	DWR_NA0035_15_c_2012_21		
Action/Comments			
Inspector Comments: Minimal, scattered obstructions or vegetation. The flow is not impeded. The palm trees should be removed.

Looking upstream from Meadowlark Dr. Summer 2014

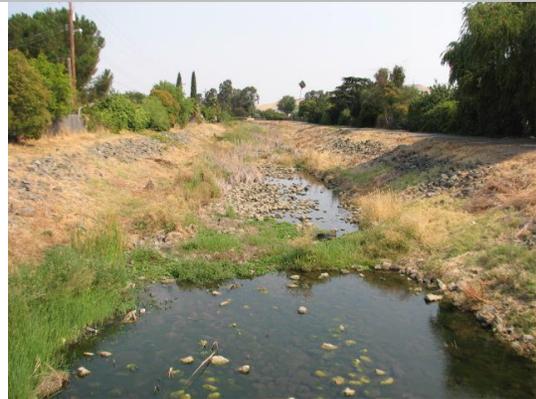
Photo 2 of 2 : CH_2014_NA0035_15_21_20140616_00012.jpg

Check Point / View				
Meadowlark Dr / Up (cont)				
Rating **	A	Issue No.	21 (cont)	GPS Lat/Long
Issue Type +	Ma	Location *		38.268244 °
Category	Rivers, Channels & Designated Flood			-122.017216 °
Item	Vegetation & Obstructions			
DWR ID	DWR_NA0035_15_c_2012_21			
Action/Comments				
Inspector Comments: Minimal, scattered obstructions or vegetation. The flow is not impeded. The palm trees should be removed.

Looking upstream at Meadowlark Drive (Summer 2013)

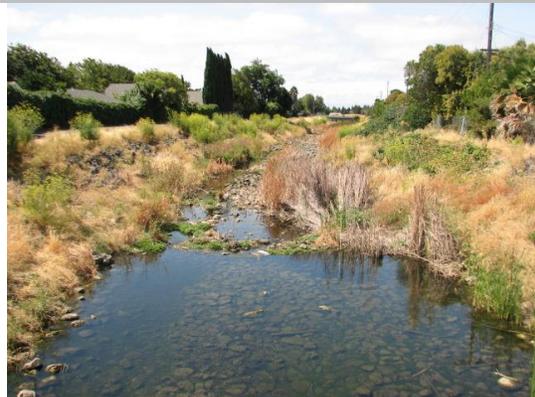
Photo 1 of 2 : CH_2014_NA0035_15_26_20140723_00038.jpg

Check Point / View			
Meadowlark Dr / Down			
Rating **	A	Issue No.	26
Issue Type +	Ma	Location *	38.268245 °
Category	Rivers, Channels & Designated Flood		-122.017216 °
Item	Vegetation & Obstructions		
DWR ID	DWR_NA0035_15_c_2012_26		
Action/Comments			
Inspector Comments: Minimal, scattered obstructions or vegetation. The flow is not impeded.

A view looking downstream from Meadowlark Dr. Summer 2014

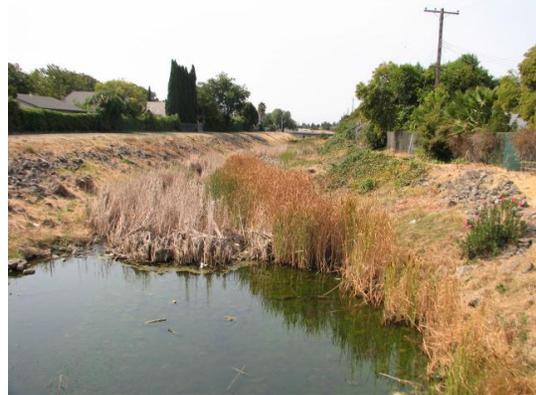
Photo 2 of 2 : CH_2014_NA0035_15_26_20140616_00013.jpg

Check Point / View				
Meadowlark Dr / Down (cont)				
Rating **	A	Issue No.	26 (cont)	GPS Lat/Long
Issue Type +	Ma	Location *		38.268245 °
Category	Rivers, Channels & Designated Flood			-122.017216 °
Item	Vegetation & Obstructions			
DWR ID	DWR_NA0035_15_c_2012_26			
Action/Comments				
Inspector Comments: Minimal, scattered obstructions or vegetation. The flow is not impeded.

Looking downstream at Meadowlark Drive (Summer 2013)

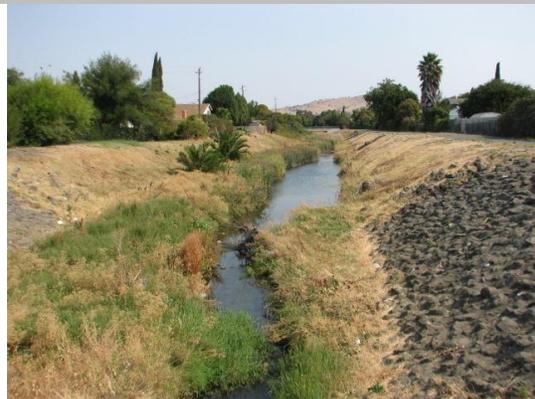
Photo 3 of 3 : CH_2014_NA0035_15_31_20140616_00014.jpg

Looking upstream at E. Tabor Avenue (Summer 2013)

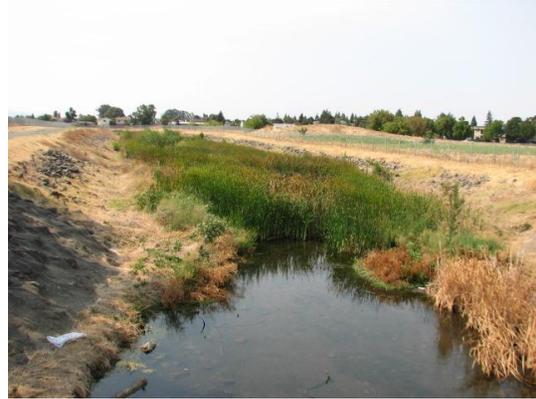
Photo 1 of 2 : CH_2014_NA0035_15_36_20140616_00015.jpg

Check Point / View			
East Tabor Ave / Down			
Rating **	A	Issue No.	36
Issue Type +	Ma	Location *	GPS Lat/Long
Category	Rivers, Channels & Designated Flood		-122.018316 °
Item	Vegetation & Obstructions		
DWR ID	DWR_NA0035_15_c_2012_36		
Action/Comments			
Inspector Comments: Minimal, scattered obstructions or vegetation. The flow is not impeded.

Looking downstream at E. Tabor Avenue (Summer 2013)

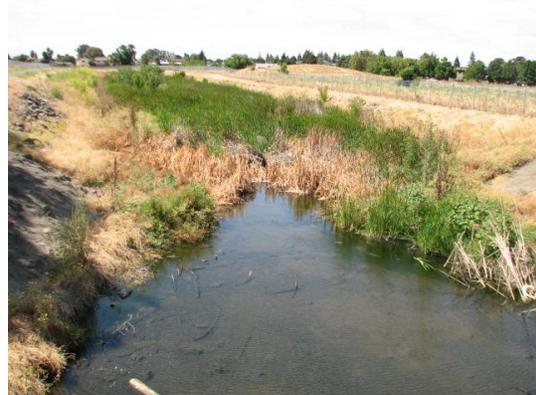
Photo 2 of 2 : CH_2014_NA0035_15_36_20140723_00041.jpg

Looking downstream from E. Tabor Ave. Summer 2014

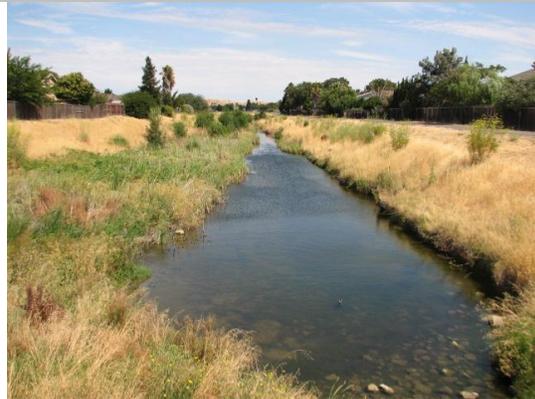
Photo 1 of 2 : CH_2014_NA0035_15_41_20140723_00042.jpg

Check Point / View				
Matthew Rd / Up				
Rating **	A	Issue No.	41	GPS Lat/Long
Issue Type +	Ma	Location *		38.259229 °
Category	Rivers, Channels & Designated Flood			-122.017713 °
Item	Vegetation & Obstructions			
DWR ID	DWR_NA0035_15_c_2012_41			
Action/Comments				
Inspector Comments: Minimal, scattered obstructions or vegetation. The flow is not impeded.

Looking upstream from Matthew Rd. Summer 2014

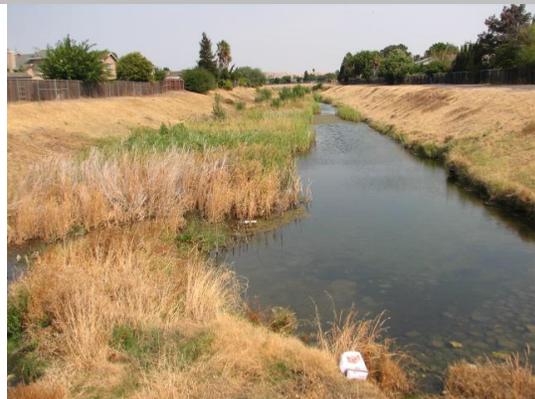
Photo 2 of 2 : CH_2014_NA0035_15_41_20140616_00016.jpg

Looking upstream at Matthews Road (Summer 2013)

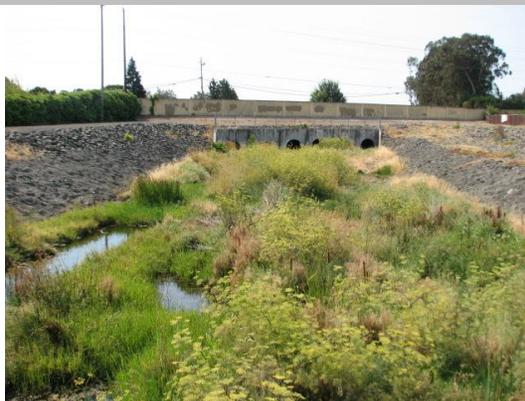
Photo 1 of 2 : CH_2014_NA0035_15_46_20140616_00018.jpg

Check Point / View			
Matthew Rd / Down			
Rating **	A	Issue No. 46	GPS Lat/Long
Issue Type +	Ma	Location *	38.259230 °
Category	Rivers, Channels & Designated Flood		-122.017714 °
Item	Vegetation & Obstructions		
DWR ID	DWR_NA0035_15_c_2012_46		
Action/Comments			
Inspector Comments: Minimal, scattered obstructions or vegetation. The flow is not impeded. This area is the same as upstream Railroad Avenue.

Looking downstream at Matthews Road (Summer 2013)

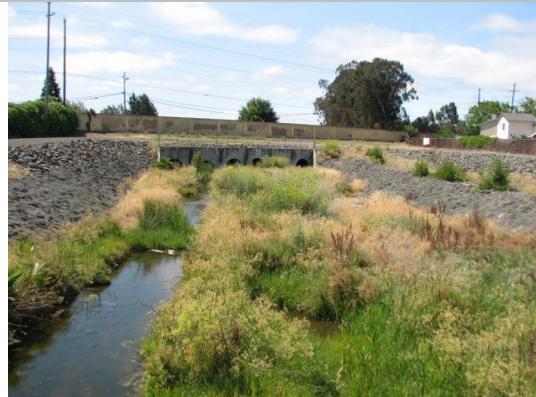
Photo 2 of 2 : CH_2014_NA0035_15_46_20140723_00044.jpg

Check Point / View				
Matthew Rd / Down (cont)				
Rating **	A	Issue No.	46 (cont)	GPS Lat/Long
Issue Type +	Ma	Location *		38.259230 °
Category	Rivers, Channels & Designated Flood			-122.017714 °
Item	Vegetation & Obstructions			
DWR ID	DWR_NA0035_15_c_2012_46			
Action/Comments				
Inspector Comments: Minimal, scattered obstructions or vegetation. The flow is not impeded. This area is the same as upstream Railroad Avenue.

Looking downstream towards the five pipes that go under the railroad from Matthews Rd. Summer 2014

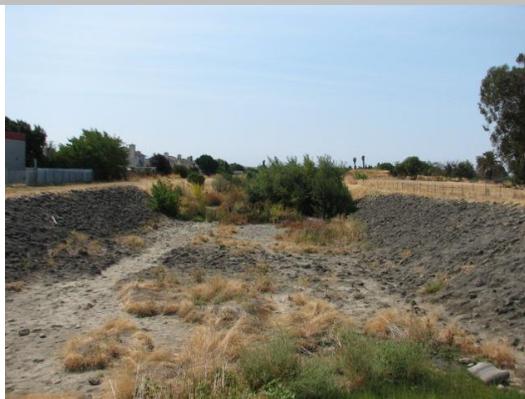
Photo 1 of 2 : CH_2014_NA0035_15_56_20140616_00019.jpg

Check Point / View			
Railroad Ave / Down			
Rating **	A	Issue No.	56
Issue Type +	Ma	Location *	
Category	Rivers, Channels & Designated Flood		GPS Lat/Long
Item	Vegetation & Obstructions		
DWR ID	DWR_NA0035_15_c_2012_56		
Action/Comments			
Inspector Comments: Minimal scattered obstruction or vegetation. The flow is not impeded.

Looking downstream at Railroad Avenue. Suggest removal of woody vegetation. (Summer 2013)

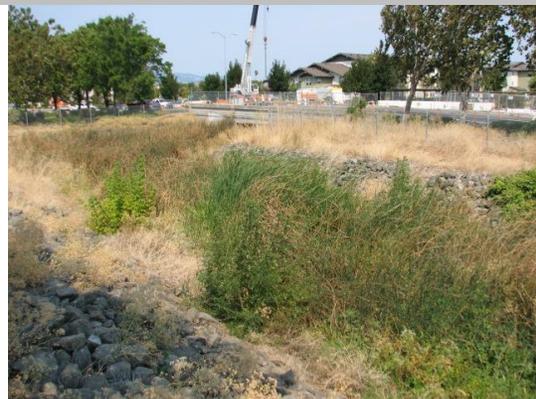
Photo 1 of 2 : CH_2014_NA0035_15_61_20140616_00020.jpg

Check Point / View			
SunsetAve / Up			
Rating **	A	Issue No.	61
Issue Type +	Ma	Location *	
Category	Rivers, Channels & Designated Flood		GPS Lat/Long
Item	Vegetation & Obstructions		
DWR ID	DWR_NA0035_15_c_2012_61		
Action/Comments			
Inspector Comments: Minimal scattered obstructions or vegetation. The flow is not impeded.

Looking upstream at Sunset Avenue (Summer 2013)

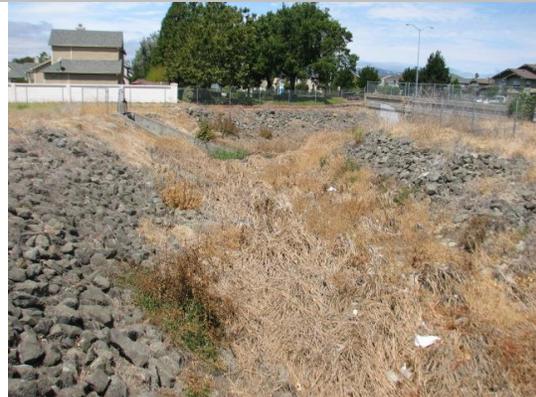
Photo 2 of 2 : CH_2014_NA0035_15_61_20140723_00046.jpg

Check Point / View				
SunsetAve / Up (cont)				
Rating **	A	Issue No.	61 (cont)	GPS Lat/Long
Issue Type +	Ma	Location *		38.253421 °
Category	Rivers, Channels & Designated Flood			-122.020125 °
Item	Vegetation & Obstructions			
DWR ID	DWR_NA0035_15_c_2012_61			
Action/Comments				
Inspector Comments: Minimal scattered obstructions or vegetation. The flow is not impeded.

Looking upstream the woody vegetation has been removed from Sunset Ave. Summer 2014

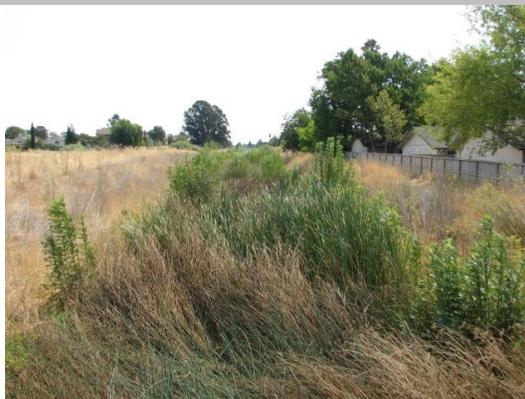
Photo 1 of 2 : CH_2014_NA0035_15_66_20140616_00021.jpg

Check Point / View			
SunsetAve / Down			
Rating **	U	Issue No.	66
Issue Type +	Ma	Location *	
Category	Rivers, Channels & Designated Flood		GPS Lat/Long
Item	Vegetation & Obstructions		
DWR ID	DWR_NA0035_15_c_2012_66		
Action/Comments			
Inspector Comments: Vegetation growth (such as cat tails, bull rushes, bushes or saplings) or other obstructions block approximately 50% of the FCW.

Looking downstream at Sunset Avenue suggest removal of woody vegetation and reeds. (Summer 2013)

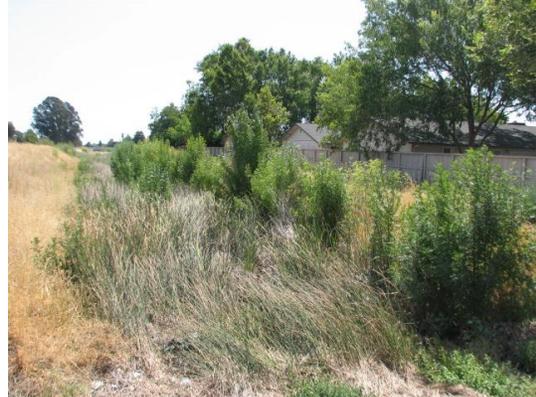
Photo 2 of 2 : CH_2014_NA0035_15_66_20140723_00047.jpg

Check Point / View				
SunsetAve / Down (cont)				
Rating **	U	Issue No.	66 (cont)	GPS Lat/Long
Issue Type +	Ma	Location *		38.253418 °
Category	Rivers, Channels & Designated Flood			-122.020125 °
Item	Vegetation & Obstructions			
DWR ID	DWR_NA0035_15_c_2012_66			
Action/Comments				
Inspector Comments: Vegetation growth (such as cat tails, bull rushes, bushes or saplings) or other obstructions block approximately 50% of the FCW.

Looking downstream from Sunset Ave. Woody vegetation needs to be removed blocks flow. Summer 2014

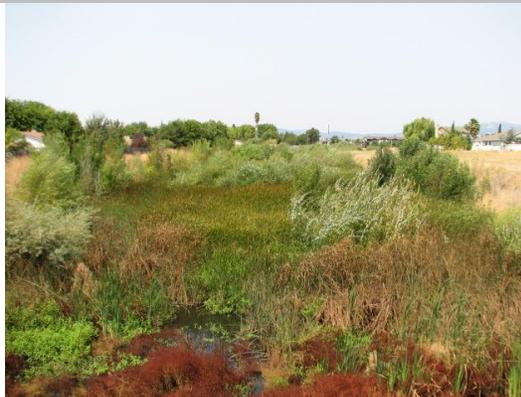
Photo 1 of 2 : CH_2014_NA0035_15_71_20140616_00022.jpg

Check Point / View			
Blossom Rd / Up			
Rating **	M	Issue No. 71	GPS Lat/Long
Issue Type +	Ma	Location *	38.253382 °
Category	Rivers, Channels & Designated Flood		-122.014862 °
Item	Vegetation & Obstructions		
DWR ID	DWR_NA0035_15_c_2012_71		
Action/Comments			
Inspector Comments: Vegetation growth, cat tails, bushes, or saplings block 25% of the channel.

Looking upstream at Blossom Road. Suggest removal of woody vegetation. (Summer 2013)

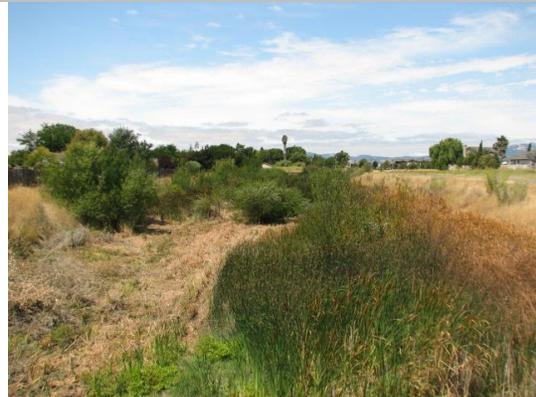
Photo 2 of 2 : CH_2014_NA0035_15_71_20140723_00048.jpg

Check Point / View				
Blossom Rd / Up (cont)				
Rating **	M	Issue No.	71 (cont)	GPS Lat/Long
Issue Type +	Ma	Location *		38.253382 °
Category	Rivers, Channels & Designated Flood			-122.014862 °
Item	Vegetation & Obstructions			
DWR ID	DWR_NA0035_15_c_2012_71			
Action/Comments				
Inspector Comments: Vegetation growth, cat tails, bushes, or saplings block 25% of the channel.

Looking upstream from Blossom Rd. Some woody vegetation needs to be removed. Summer 2014

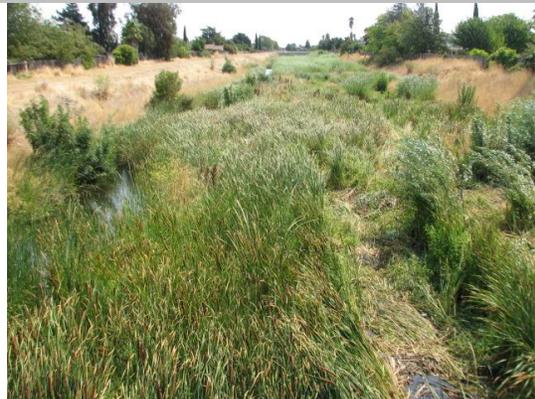
Photo 1 of 2 : CH_2014_NA0035_15_76_20140616_00023.jpg

Check Point / View			
Blossom Rd / Down			
Rating **	A	Issue No. 76	GPS Lat/Long
Issue Type +	Ma	Location *	38.253325 °
Category	Rivers, Channels & Designated Flood		-122.014818 °
Item	Vegetation & Obstructions		
DWR ID	DWR_NA0035_15_c_2012_76		
Action/Comments			
Inspector Comments: Snags, vegetation growth (such as cat tails, bull rushes, bushes or saplings) or other obstructions block approximately 50% of the FCW.

Looking downstream at Blossom Road. (Summer 2013)

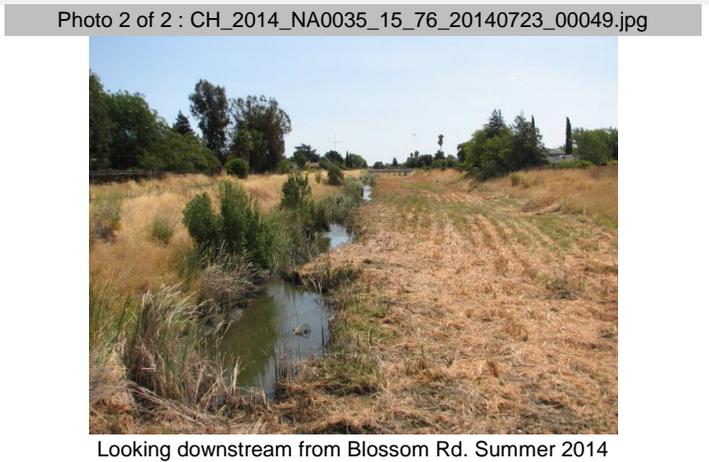
Check Point / View			
Blossom Rd / Down (cont)			
Rating **	A	Issue No.	76 (cont)
Issue Type +	Ma	Location *	GPS Lat/Long
Category	Rivers, Channels & Designated Flood		38.253325 °
Item	Vegetation & Obstructions		-122.014818 °
DWR ID	DWR_NA0035_15_c_2012_76		
Action/Comments			
Inspector Comments: Snags, vegetation growth (such as cat tails, bull rushes, bushes or saplings) or other obstructions block approximately 50% of the FCW.

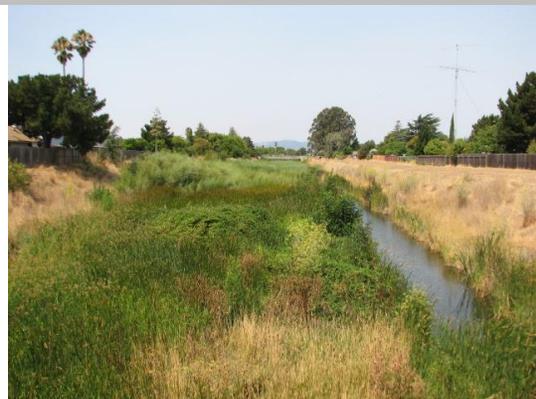
Photo 1 of 2 : CH_2014_NA0035_15_81_20140616_00024.jpg

Check Point / View			
Worley Rd / Up			
Rating **	A	Issue No.	81
Issue Type +	Ma	Location *	
Category	Rivers, Channels & Designated Flood		GPS Lat/Long
Item	Vegetation & Obstructions		
DWR ID	DWR_NA0035_15_c_2012_81		
Action/Comments			
Inspector Comments: Minimal scattered obstructions or vegetation. The flow is not impeded.

Looking upstream at Worley Road. (Summer 2013)

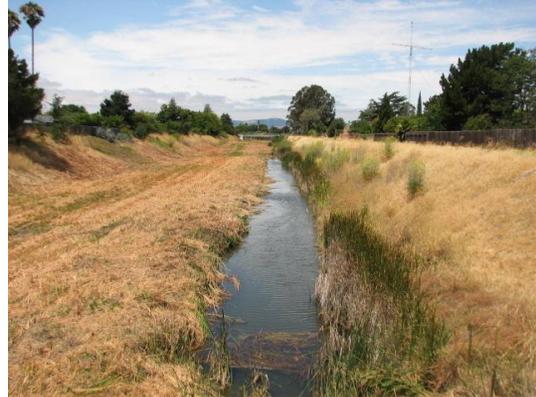
Photo 2 of 2 : CH_2014_NA0035_15_81_20140723_00050.jpg

Check Point / View				
Worley Rd / Up (cont)				
Rating **	A	Issue No.	81 (cont)	GPS Lat/Long
Issue Type +	Ma	Location *		38.253311 °
Category	Rivers, Channels & Designated Flood			-122.009841 °
Item	Vegetation & Obstructions			
DWR ID	DWR_NA0035_15_c_2012_81			
Action/Comments				
Inspector Comments: Minimal scattered obstructions or vegetation. The flow is not impeded.

A view looking upstream from Worley Rd. Summer 2014

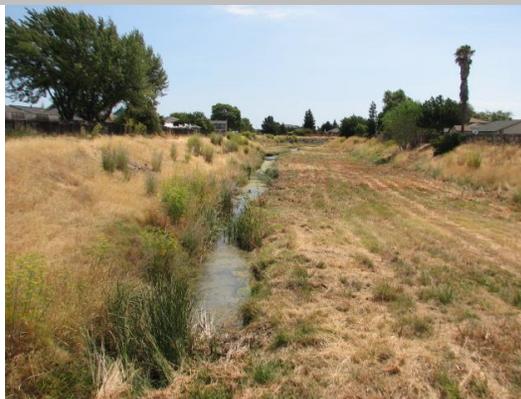
Photo 1 of 2 : CH_2014_NA0035_15_86_20140723_00051.jpg

Check Point / View			
Worley Rd / Down			
Rating **	A	Issue No. 86	GPS Lat/Long
Issue Type +	Ma	Location *	38.253311 °
Category	Rivers, Channels & Designated Flood		-122.009841 °
Item	Vegetation & Obstructions		
DWR ID	DWR_NA0035_15_c_2012_86		
Action/Comments			
Inspector Comments: Vegetation growth (such as cat tails, bull rushes, bushes or saplings) or other obstructions block approximately 50% of the FCW.

A view looking downstream from Worley Rd. Summer 2014

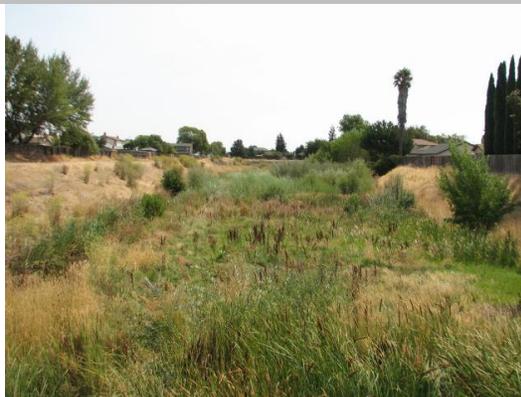
Photo 2 of 2 : CH_2014_NA0035_15_86_20140616_00025.jpg

Check Point / View			
Worley Rd / Down (cont)			
Rating **	A	Issue No. 86 (cont)	GPS Lat/Long
Issue Type +	Ma	Location *	38.253311 °
Category	Rivers, Channels & Designated Flood		-122.009841 °
Item	Vegetation & Obstructions		
DWR ID	DWR_NA0035_15_c_2012_86		
Action/Comments			
Inspector Comments: Vegetation growth (such as cat tails, bull rushes, bushes or saplings) or other obstructions block approximately 50% of the FCW.

Looking downstream at Worley Road. (Summer 2013)

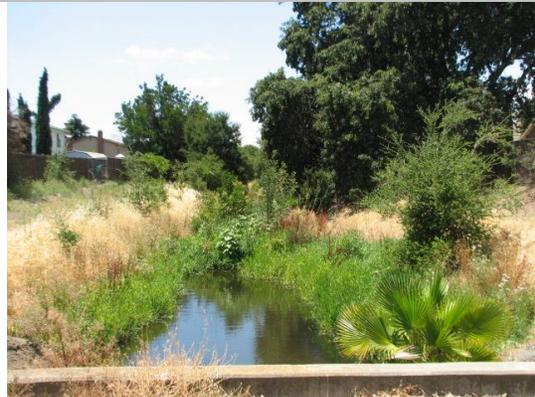
Photo 1 of 6 : CH_2014_NA0035_17_1_20140723_00031.jpg

Check Point / View				
Astoria Drive / Up				
Rating **	A	Issue No.	1	GPS Lat/Long
Issue Type +	Ma	Location *		38.256104 °
Category	Rivers, Channels & Designated Flood			-122.073648 °
Item	Vegetation & Obstructions			
DWR ID	DWR_NA0035_17_c_2012_1			
Action/Comments				
Inspector Comments: Minimal, scattered obstructions or vegetation.

The outlet from the retention basin. Woody vegetation is starting to block the channel. Summer 2014 (38.257791 -122.069683)

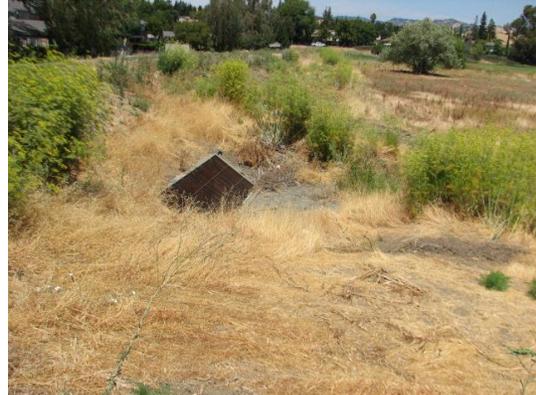
Photo 3 of 6 : CH_2014_NA0035_17_1_20140723_00030.jpg

Check Point / View				
Astoria Drive / Up (cont)				
Rating **	A	Issue No.	1 (cont)	GPS Lat/Long
Issue Type +	Ma	Location *		38.256104 °
Category	Rivers, Channels & Designated Flood			-122.073648 °
Item	Vegetation & Obstructions			
DWR ID	DWR_NA0035_17_c_2012_1			
Action/Comments				
Inspector Comments: Minimal, scattered obstructions or vegetation.

The inlet from the retention basin. All woody vegetation has been removed. Summer 2014

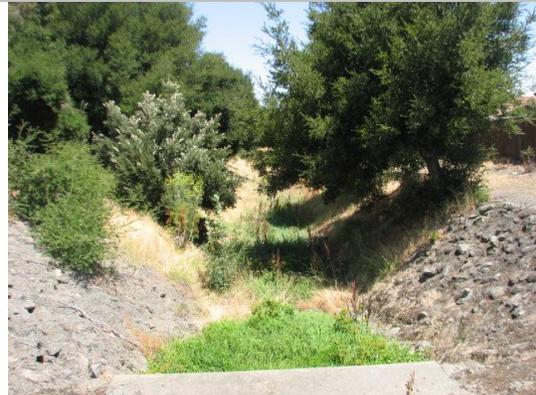
Photo 4 of 6 : CH_2014_NA0035_17_1_20140723_00032.jpg

Looking upstream from Astoria Dr. Trees need to be trimmed up or removed from channel. Summer 2014

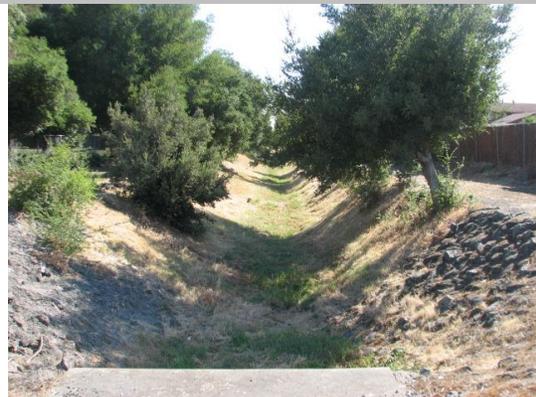
Photo 5 of 6 : CH_2014_NA0035_17_1_20140616_00002.jpg

Looking upstream at Astoria Drive. (Summer 2013)

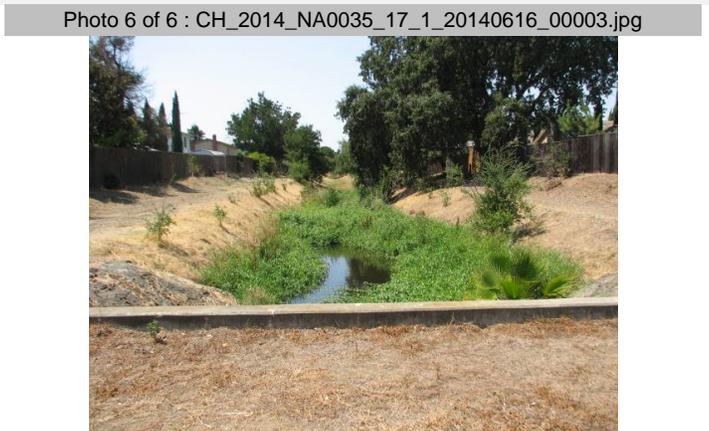
Check Point / View			
Astoria Drive / Up (cont)			
Rating **	A	Issue No.	1 (cont)
Issue Type +	Ma	Location *	GPS Lat/Long
Category	Rivers, Channels & Designated Flood		38.256104 °
Item	Vegetation & Obstructions		-122.073648 °
DWR ID	DWR_NA0035_17_c_2012_1		
Action/Comments			
Inspector Comments: Minimal, scattered obstructions or vegetation.

Outlet side of the pipe into Ledgewood Creek towards Astoria Drive. (Summer 2013)

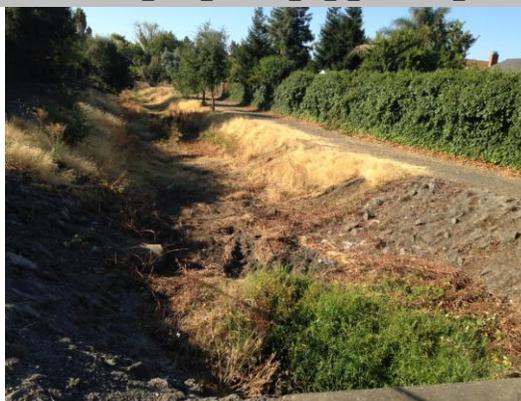
Photo 1 of 3 : CH_2014_NA0035_17_6_20140827_00055.jpg

Check Point / View			
Astoria Drive / Down			
Rating **	A	Issue No. 6	GPS Lat/Long
Issue Type +	Ma	Location *	38.256147 °
Category	Rivers, Channels & Designated Flood		-122.073892 °
Item	Vegetation & Obstructions		
DWR ID	DWR_NA0035_17_c_2012_6		
Action/Comments			
Inspector Comments: Vegetation has been maintained and does not appear to impede flow.

Corrected view of blackberries from Astoria Drive. Aug. 27, 2014

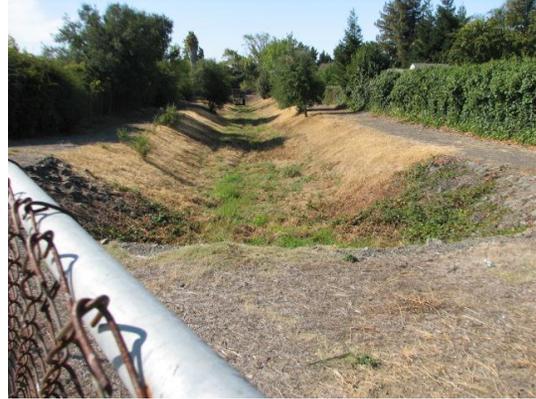
Photo 2 of 3 : CH_2014_NA0035_17_6_20140616_00004.jpg

Check Point / View				
Astoria Drive / Down (cont)				
Rating **	A	Issue No.	6 (cont)	GPS Lat/Long
Issue Type +	Ma	Location *		38.256147 °
Category	Rivers, Channels & Designated Flood			-122.073892 °
Item	Vegetation & Obstructions			
DWR ID	DWR_NA0035_17_c_2012_6			
Action/Comments				
Inspector Comments: Vegetation has been maintained and does not appear to impede flow.

Looking downstream at Astoria Drive. (Summer 2013)

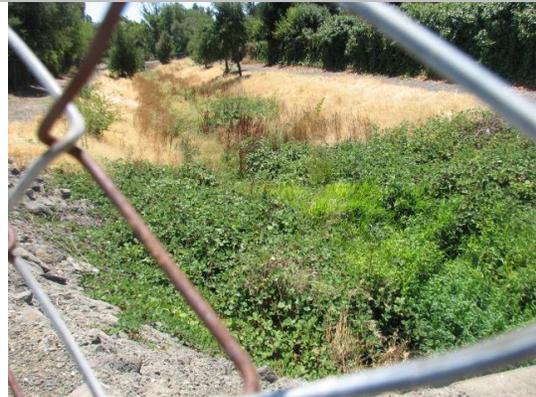
Photo 3 of 3 : CH_2014_NA0035_17_6_20140723_00033.jpg

Looking downstream from Astoria Dr. Blackberries need to be removed as they will impede the flow. Summer 2014

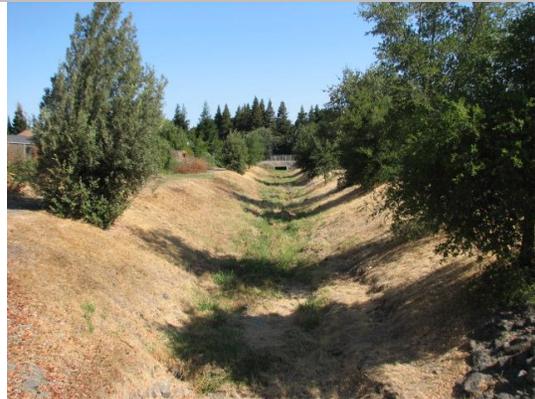
Photo 1 of 2 : CH_2014_NA0035_17_11_20140616_00005.jpg

Check Point / View				
Springfield Dr. / Up				
Rating **	A	Issue No.	11	GPS Lat/Long
Issue Type +	Ma	Location *		38.254594 °
Category	Rivers, Channels & Designated Flood			-122.073608 °
Item	Vegetation & Obstructions			
DWR ID	DWR_NA0035_17_c_2012_11			
Action/Comments				
Inspector Comments: Minimal, scattered obstructions or vegetation. The flow is not impeded.

Looking upstream at Springfield Drive (Summer 2013)

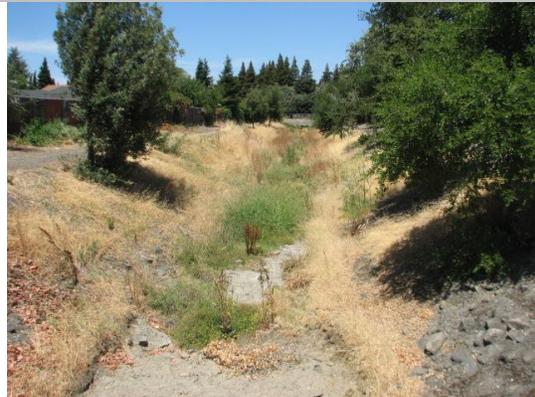
Photo 2 of 2 : CH_2014_NA0035_17_11_20140724_00034.jpg

A view looking upstream from Springfield Dr. Summer 2014

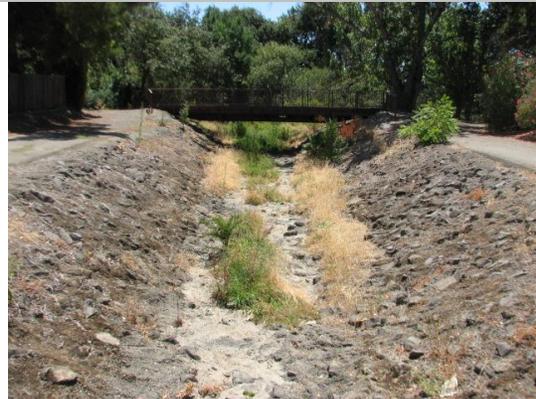
Photo 1 of 2 : CH_2014_NA0035_17_16_20140724_00035.jpg

Check Point / View				
Springfield Dr. / Down				
Rating **	A	Issue No.	16	GPS Lat/Long
Issue Type +	Ma	Location *		38.254594 °
Category	Rivers, Channels & Designated Flood			-122.073608 °
Item	Vegetation & Obstructions			
DWR ID	DWR_NA0035_17_c_2012_16			
Action/Comments				
Inspector Comments: Minimal, scattered obstructions or vegetation. The flow is not impeded.

A view looking downstream from Springfield Dr. towards the junction of main channel. Summer 2014

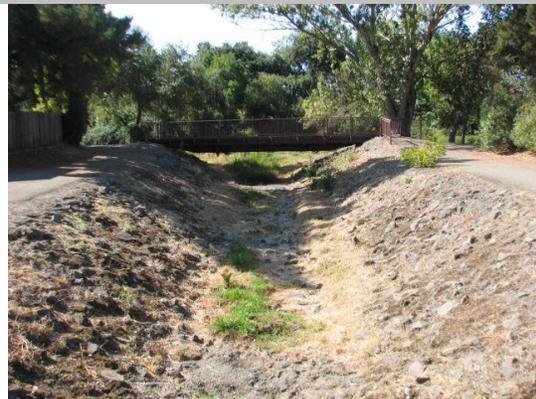
Photo 2 of 2 : CH_2014_NA0035_17_16_20140616_00007.jpg

Looking downstream at Springfield Drive. (Summer 2013)

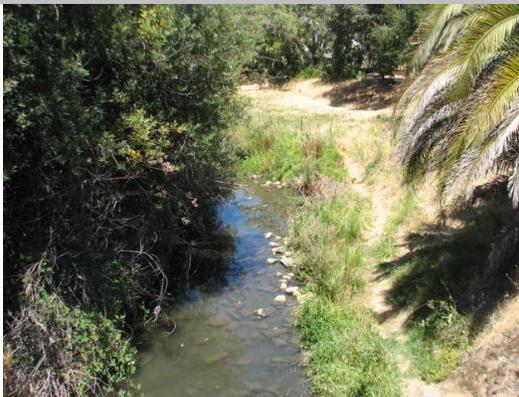
Photo 1 of 2 : CH_2014_NA0035_17_21_20140724_00036.jpg

Check Point / View				
Rockville Road / Up				
Rating **	A	Issue No.	21	GPS Lat/Long
Issue Type +	Ma	Location *		38.249841 °
Category	Rivers, Channels & Designated Flood			-122.072646 °
Item	Vegetation & Obstructions			
DWR ID	DWR_NA0035_17_c_2012_21			
Action/Comments				
Inspector Comments: Minimal, scattered obstructions or vegetation. The flow is not impeded.

Looking upstream from Rockville Rd. Summer 2014

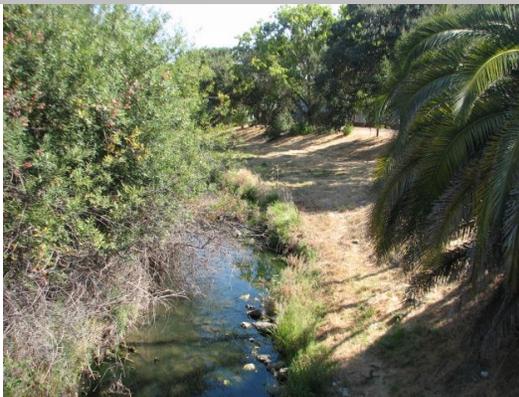
Photo 2 of 2 : CH_2014_NA0035_17_21_20140616_00009.jpg

Looking upstream at Rockville Road. (Summer 2013)

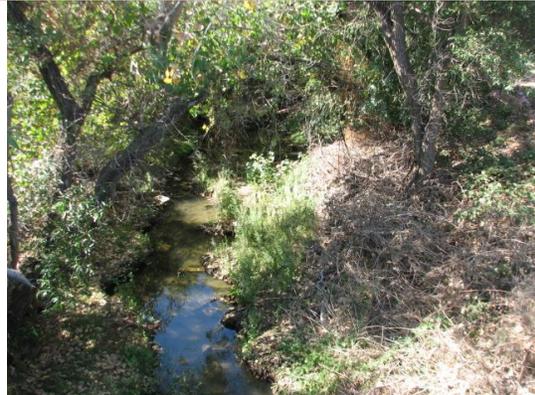
Photo 1 of 2 : CH_2014_NA0035_17_26_20140616_00012.jpg

Check Point / View				
Rockville Road / Down				
Rating **	A	Issue No.	26	GPS Lat/Long
Issue Type +	Ma	Location *		38.249840 °
Category	Rivers, Channels & Designated Flood			-122.072644 °
Item	Vegetation & Obstructions			
DWR ID	DWR_NA0035_17_c_2012_26			
Action/Comments				
Inspector Comments: Minimal, scattered obstructions or vegetation. The flow is not impeded.

Looking downstream at Rockville Road. (Summer 2013)

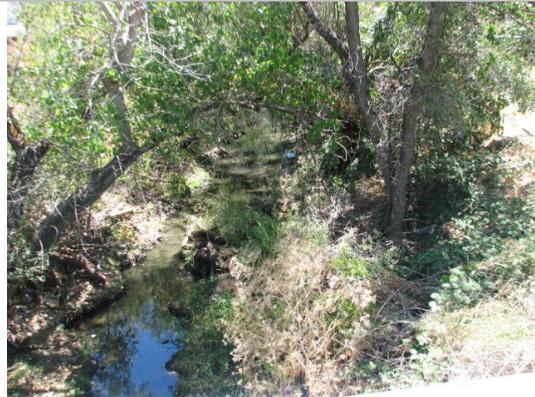
Photo 2 of 2 : CH_2014_NA0035_17_26_20140724_00037.jpg

Looking downstream from Rockville Rd. Summer 2014

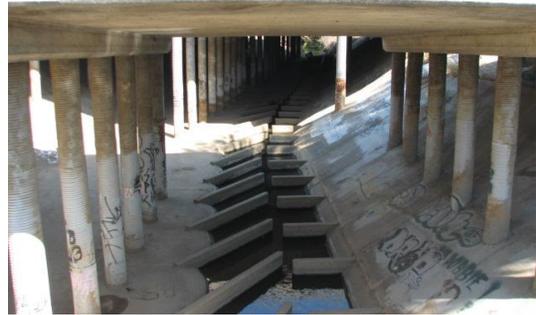
Photo 2 of 2 : CH_2014_NA0035_17_31_20140616_00013.jpg

Check Point / View			
Auto Mall Parkway / Up (cont)			
Rating **	A	Issue No.	31 (cont)
Issue Type +	Ma	Location *	GPS Lat/Long
Category	Rivers, Channels & Designated Flood		38.247663 °
Item	Vegetation & Obstructions		-122.071997 °
DWR ID	DWR_NA0035_17_c_2012_31		
Action/Comments			
Inspector Comments: Minimal, scattered obstructions or vegetation. The flow is not impeded.

Looking upstream under I-80 at Auto Mall Parkway. (Summer 2013)

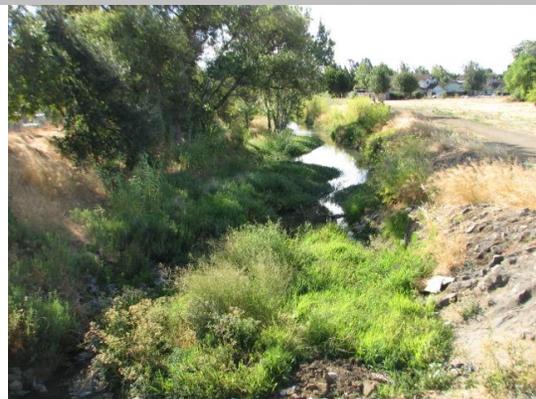
Photo 1 of 3 : CH_2014_NA0035_17_36_20140724_00039.jpg

Check Point / View			
Auto Mall Parkway / Down			
Rating **	A	Issue No. 36	GPS Lat/Long
Issue Type +	Ma	Location *	38.247663 °
Category	Rivers, Channels & Designated Flood		-122.072325 °
Item	Vegetation & Obstructions		
DWR ID	DWR_NA0035_17_c_2012_36		
Action/Comments			
Inspector Comments: Minimal, scattered obstructions or vegetation. The flow is not impeded.

Looking downstream from Auto Mall Pkwy. Summer 2014

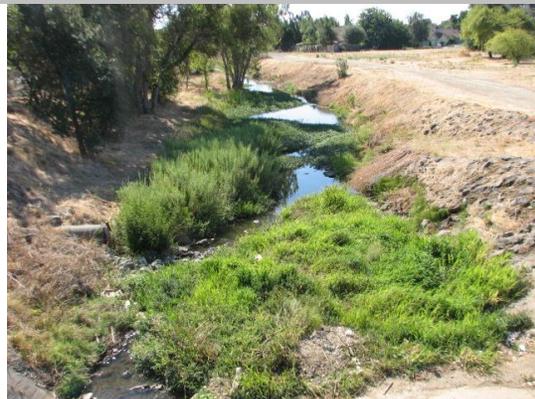
Photo 3 of 3 : CH_2014_NA0035_17_36_20140616_00015.jpg

Looking downstream at Auto Mall Parkway. (Summer 2013)

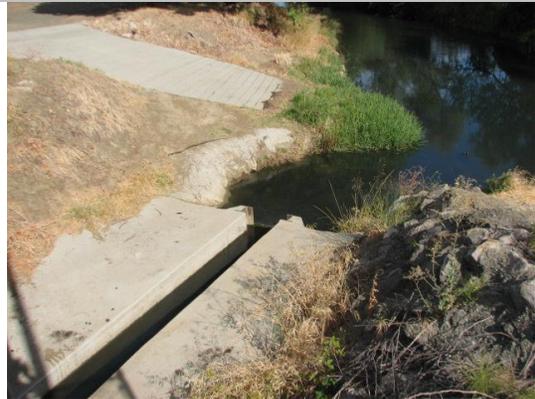
Photo 1 of 4 : CH_2014_NA0035_17_41_20140724_00041.jpg

Check Point / View				
Woolner Avenue / Up				
Rating **	A	Issue No.	41	GPS Lat/Long
Issue Type +	Ma	Location *		38.245251 °
Category	Rivers, Channels & Designated Flood			-122.068347 °
Item	Vegetation & Obstructions			
DWR ID	DWR_NA0035_17_c_2012_41			
Action/Comments				
Inspector Comments: Minimal, scattered obstructions or vegetation. The flow is not impeded.

The inlet of the historical channel. Summer 2014

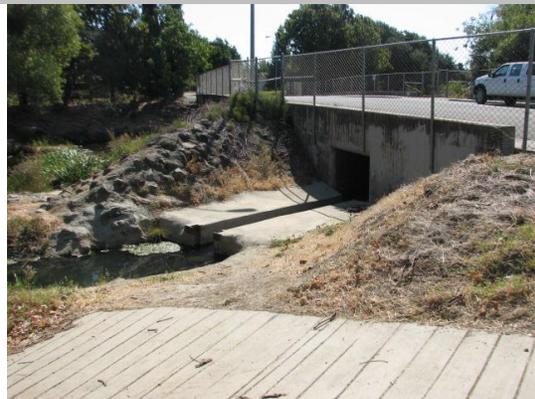
Photo 2 of 4 : CH_2014_NA0035_17_41_20140616_00016.jpg

The inlet of the historical channel. (Summer 2013)

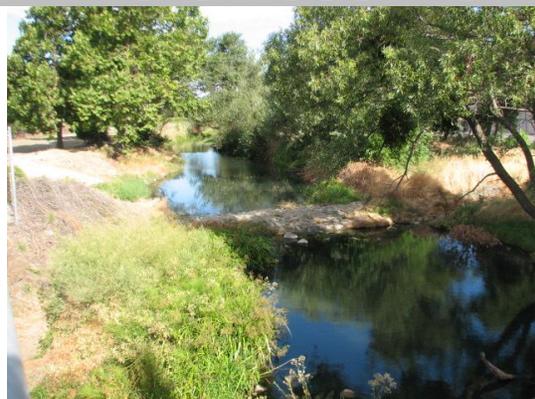
Photo 3 of 4 : CH_2014_NA0035_17_41_20140724_00040.jpg

A view looking upstream from Woolner Ave. Summer 2014

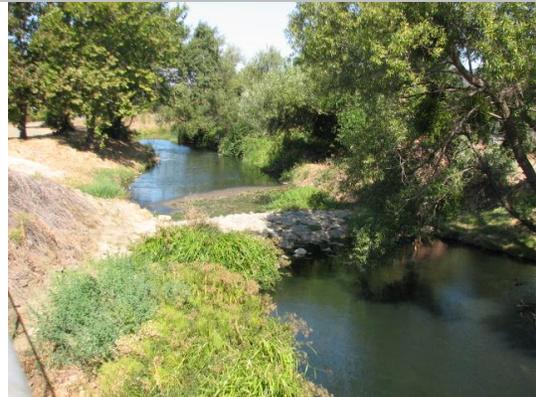
Photo 4 of 4 : CH_2014_NA0035_17_41_20140616_00017.jpg

Check Point / View			
Woolner Avenue / Up (cont)			
Rating **	A	Issue No.	41 (cont)
Issue Type +	Ma	Location *	GPS Lat/Long
Category	Rivers, Channels & Designated Flood		-122.068347 °
Item	Vegetation & Obstructions		
DWR ID	DWR_NA0035_17_c_2012_41		
Action/Comments			
Inspector Comments: Minimal, scattered obstructions or vegetation. The flow is not impeded.

Looking upstream at Woolner Avenue. (Summer 2013)

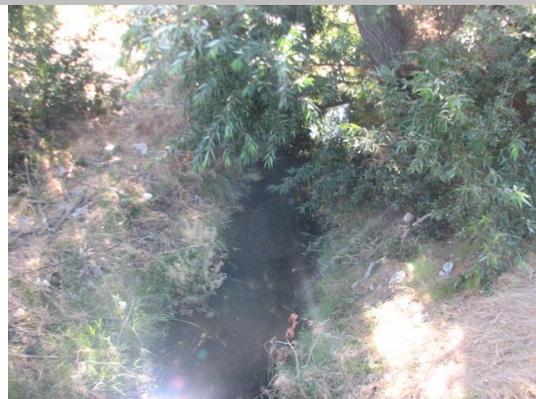
Photo 1 of 4 : CH_2014_NA0035_17_46_20140616_00018.jpg

Check Point / View			
Woolner Avenue / Down			
Rating **	A	Issue No.	46
Issue Type +	Ma	Location *	GPS Lat/Long
Category	Rivers, Channels & Designated Flood		38.245252 °
Item	Vegetation & Obstructions		-122.068347 °
DWR ID	DWR_NA0035_17_c_2012_46		
Action/Comments			
Inspector Comments: Minimal, scattered obstructions or vegetation. The flow is not impeded.

Looking downstream At the historical channel at Woolner Avenue. (Summer 2013)

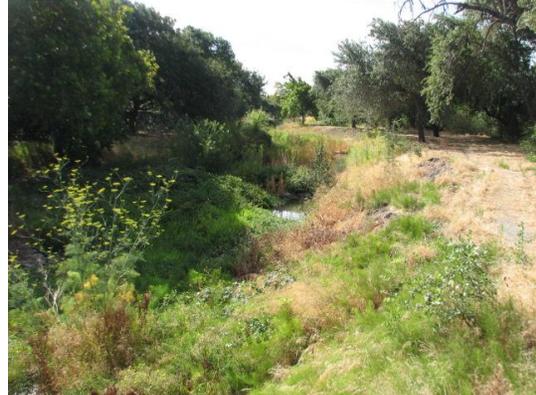
Photo 2 of 4 : CH_2014_NA0035_17_46_20140724_00043.jpg

Check Point / View			
Woolner Avenue / Down (cont)			
Rating **	A	Issue No. 46 (cont)	GPS Lat/Long
Issue Type +	Ma	Location *	38.245252 °
Category	Rivers, Channels & Designated Flood		-122.068347 °
Item	Vegetation & Obstructions		
DWR ID	DWR_NA0035_17_c_2012_46		
Action/Comments			
Inspector Comments: Minimal, scattered obstructions or vegetation. The flow is not impeded.

Looking downstream at the main channel from Woolner Ave. Summer 2014

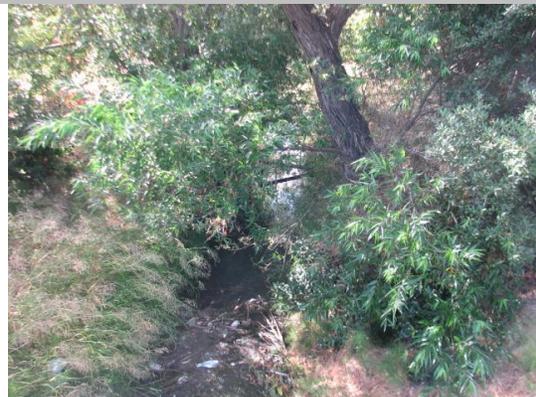
Photo 3 of 4 : CH_2014_NA0035_17_46_20140724_00042.jpg

Looking at the downstream side of the historical channel from Woolner Ave. Summer 2014

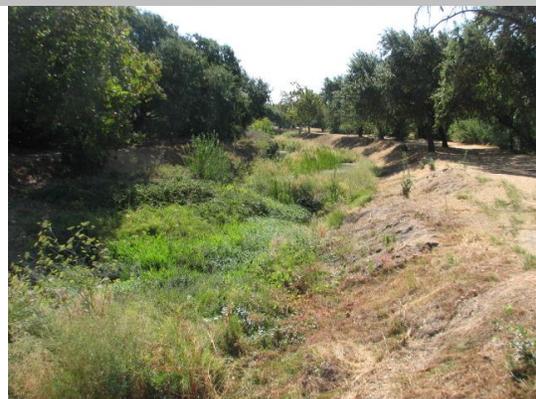
Photo 4 of 4 : CH_2014_NA0035_17_46_20140616_00019.jpg

Looking downstream at Woolner Avenue. (Summer 2013)

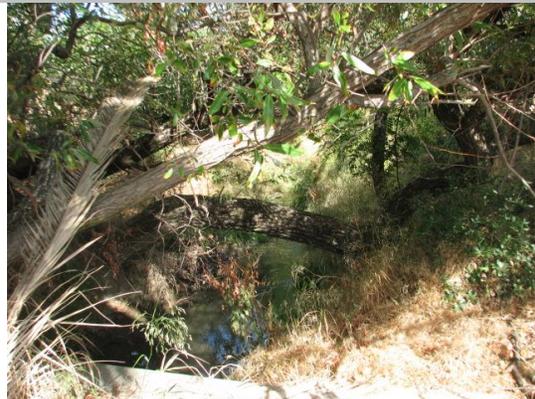
Photo 1 of 4 : CH_2014_NA0035_17_51_20140724_00045.jpg

Check Point / View			
Beck Avenue / Up			
Rating **	A	Issue No.	51
Issue Type +	Ma	Location *	GPS Lat/Long
Category	Rivers, Channels & Designated Flood		38.243683 °
Item	Vegetation & Obstructions		-122.066470 °
DWR ID	DWR_NA0035_17_c_2012_51		
Action/Comments			
Inspector Comments: Minimal, scattered obstructions or vegetation. The flow is not impeded.

Upstream view of the historical channel from Beck Ave. Summer 2014

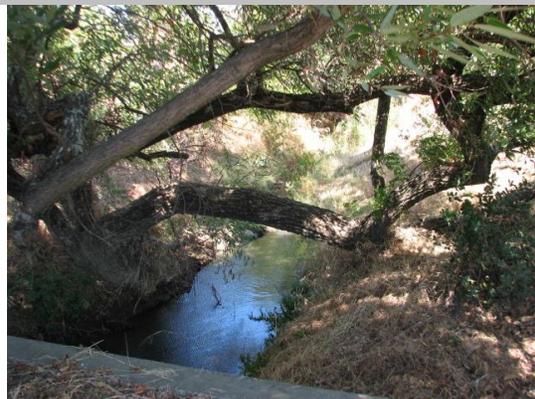
Photo 2 of 4 : CH_2014_NA0035_17_51_20140616_00020.jpg

Upstream view of the historical channel at Beck Avenue. (Summer 2013)

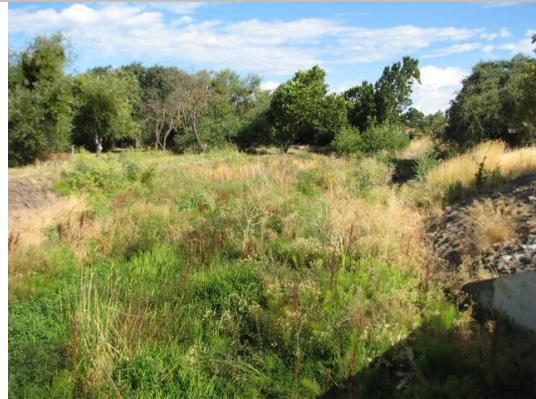
Photo 3 of 4 : CH_2014_NA0035_17_51_20140724_00044.jpg

Check Point / View				
Beck Avenue / Up (cont)				
Rating **	A	Issue No.	51 (cont)	GPS Lat/Long
Issue Type +	Ma	Location *		38.243683 °
Category	Rivers, Channels & Designated Flood			-122.066470 °
Item	Vegetation & Obstructions			
DWR ID	DWR_NA0035_17_c_2012_51			
Action/Comments				
Inspector Comments: Minimal, scattered obstructions or vegetation. The flow is not impeded.

A view of the upstream from Beck Ave. Summer 2014

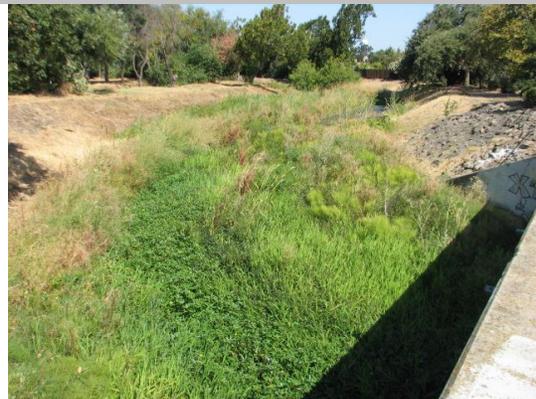
Photo 4 of 4 : CH_2014_NA0035_17_51_20140616_00021.jpg

Looking upstream at Beck Avenue. (Summer 2013)

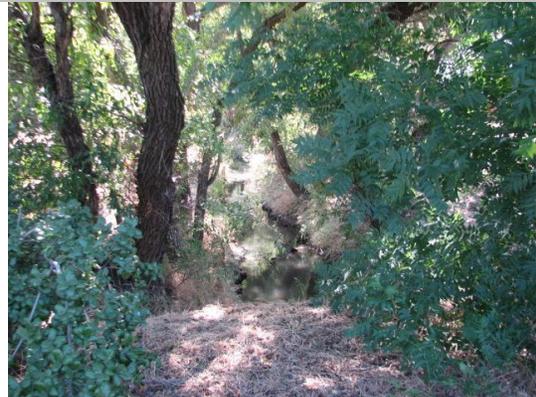
Photo 1 of 4 : CH_2014_NA0035_17_56_20140616_00022.jpg

Check Point / View				
Beck Avenue / Down				
Rating **	A	Issue No.	56	GPS Lat/Long
Issue Type +	Ma	Location *		38.243682 °
Category	Rivers, Channels & Designated Flood			-122.066469 °
Item	Vegetation & Obstructions			
DWR ID	DWR_NA0035_17_c_2012_56			
Action/Comments				
Inspector Comments: Minimal, scattered obstructions or vegetation. The flow is not impeded.

A downstream view of the historical channel at Beck Avenue. (Summer 2013)

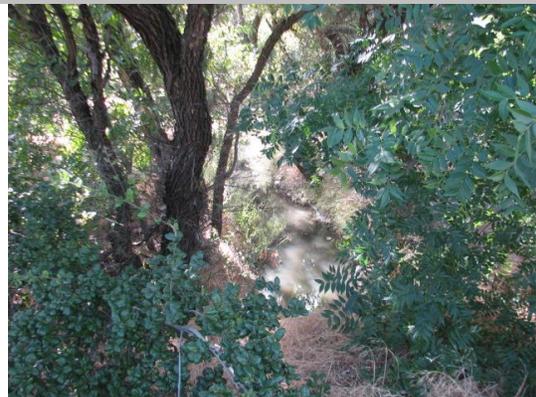
Photo 2 of 4 : CH_2014_NA0035_17_56_20140724_00046.jpg

The historical channel from Beck Ave. looking downstream. Summer 2014
