**Flood Control Project Maintenance
Levee Inspections
2014 Channel Summary Report
Overall Unit and Item Ratings**

Fairfield Suisun Sewer District

Flood Control Project Maintenance
Unit Cover Sheet
2014 Channel Inspection Results

Levee Inspection Report By Mile - Channel 2014

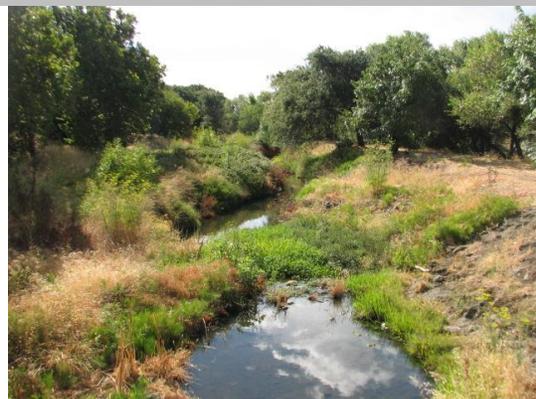
Photo 3 of 4 : CH_2014_NA0035_17_56_20140724_00047.jpg

Downstream view of the main channel from Beck Ave. Summer 2014

Check Point / View			
Beck Avenue / Down (cont)			
Rating **	A	Issue No.	56 (cont)
Issue Type +	Ma	Location *	GPS Lat/Long
Category	Rivers, Channels & Designated Flood		38.243682 °
Item	Vegetation & Obstructions		-122.066469 °
DWR ID	DWR_NA0035_17_c_2012_56		
Action/Comments			
Inspector Comments: Minimal, scattered obstructions or vegetation. The flow is not impeded.

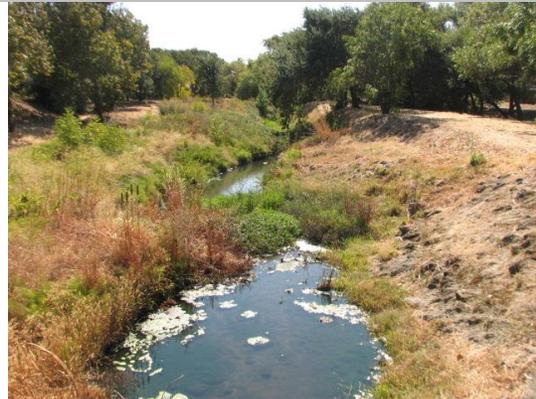
Photo 4 of 4 : CH_2014_NA0035_17_56_20140616_00023.jpg

Looking downstream at Beck Avenue. (Summer 2013)

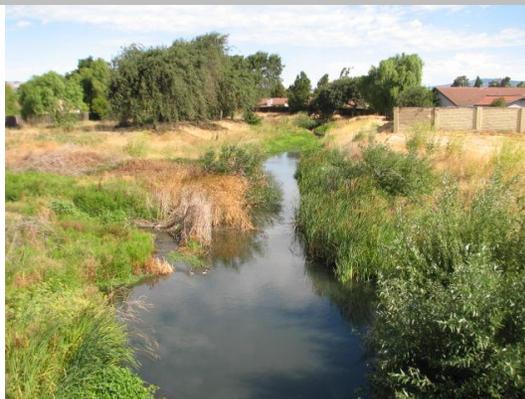
Photo 1 of 4 : CH_2014_NA0035_17_61_20140724_00048.jpg

Check Point / View			
Highway 12 / Up			
Rating **	A	Issue No.	61
Issue Type +	Ma	Location *	
Category	Rivers, Channels & Designated Flood		GPS Lat/Long
Item	Vegetation & Obstructions		
DWR ID	DWR_NA0035_17_c_2012_61		
Action/Comments			
Inspector Comments: Minimal scattered obstruction or vegetation. The flow is not impeded.

Upstream view of the main channel from Highway 12. Summer 2014

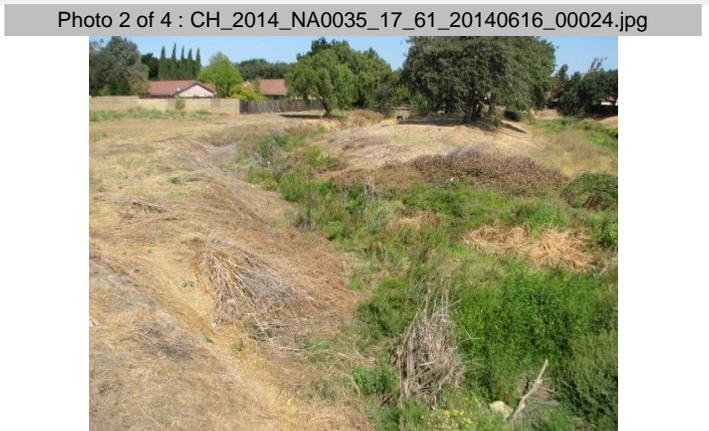
Check Point / View				
Highway 12 / Up (cont)				
Rating **	A	Issue No.	61 (cont)	GPS Lat/Long
Issue Type +	Ma	Location *		38.240567 °
Category	Rivers, Channels & Designated Flood			-122.062387 °
Item	Vegetation & Obstructions			
DWR ID	DWR_NA0035_17_c_2012_61			
Action/Comments				
Inspector Comments: Minimal scattered obstruction or vegetation. The flow is not impeded.

A view looking upstream of the historical channel at Highway 12. (Summer 2013)

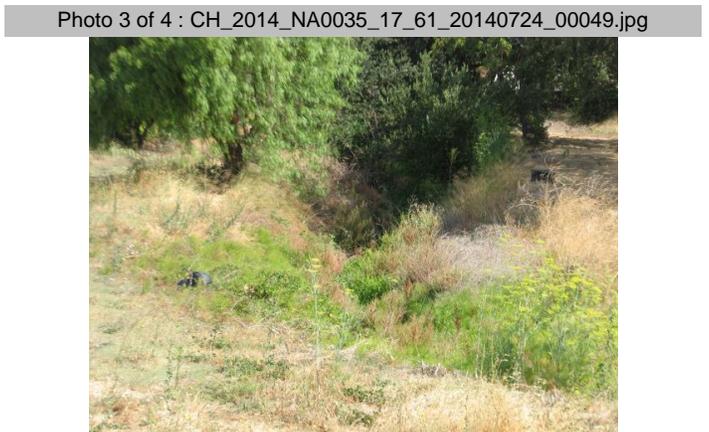
The outlet of the historical channel looking upstream from Highway 12. Summer 2014

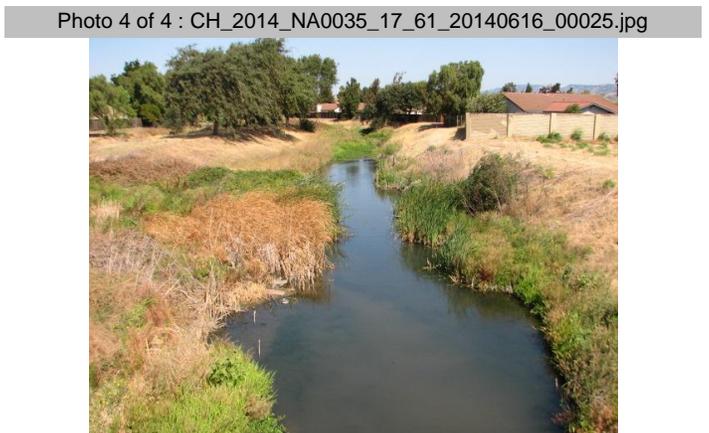
Looking upstream at Highway 12. (Summer 2013)

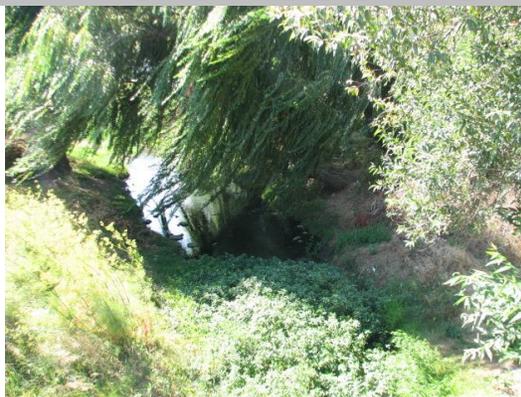
Photo 1 of 2 : CH_2014_NA0035_17_66_20140616_00026.jpg

Check Point / View				
Highway 12 / Down				
Rating **	A	Issue No.	66	GPS Lat/Long
Issue Type +	Ma	Location *		38.240567 °
Category	Rivers, Channels & Designated Flood			-122.062390 °
Item	Vegetation & Obstructions			
DWR ID	DWR_NA0035_17_c_2012_66			
Action/Comments				
Inspector Comments: Minimal, scattered obstructions or vegetation. The flow is not impeded.

Looking downstream at Highway 12. (Summer 2013)

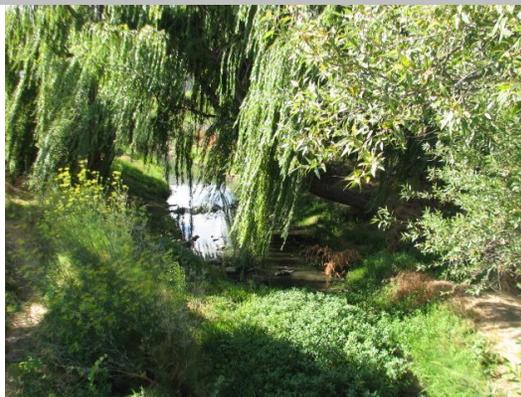
Photo 2 of 2 : CH_2014_NA0035_17_66_20140724_00050.jpg

Looking downstream from Highway 12. Summer 2014

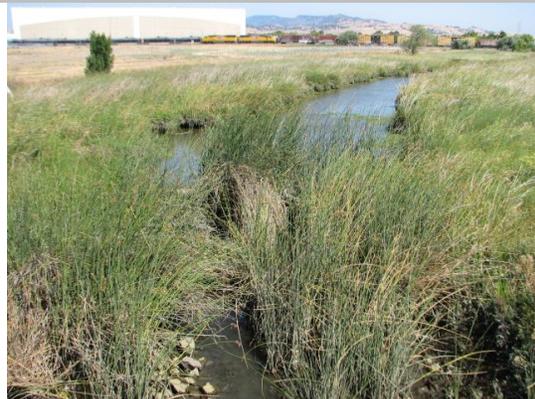
Photo 1 of 2 : CH_2014_NA0035_17_71_20140616_00027.jpg

Check Point / View				
Cordelia Road / Up				
Rating **	M	Issue No.	71	GPS Lat/Long
Issue Type +	Ma	Location *		38.233331 °
Category	Rivers, Channels & Designated Flood			-122.058608 °
Item	Vegetation & Obstructions			
DWR ID	DWR_NA0035_17_c_2012_71			
Action/Comments				
Inspector Comments: Vegetation growth of cattails or other obstruction impede the flow.

Looking upstream at Cordelia Road. (Summer 2013)

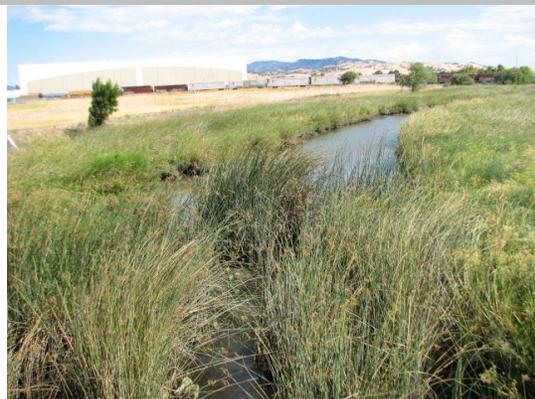
Photo 2 of 2 : CH_2014_NA0035_17_71_20140724_00053.jpg

An upstream view of the channel from Cordlia Rd. Summer 2014

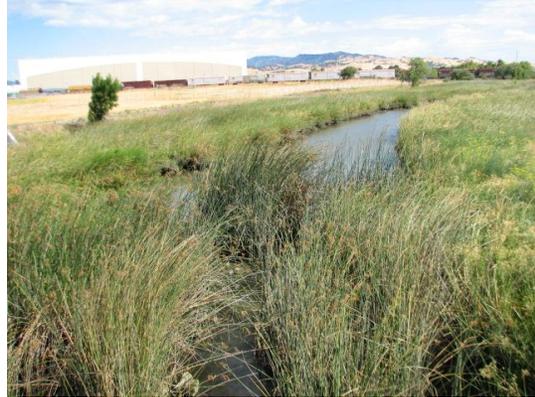
Photo 1 of 2 : CH_2014_NA0035_17_72_20140724_00052.jpg

Rating **	M	Issue No.	72	GPS Lat/Long
Issue Type +	Ma	Location *		38.233330 °
Category	Rivers, Channels & Designated Flood			-122.058608 °
Item	Shoaling / Sedimentation			
DWR ID	DWR_NA0035_17_c_2012_72			
Action/Comments				
Inspector Comments: Aquatic grasses present onshoal. No trees or brush is present on shoal, and channel flow is not impeded.

Cattails and sedimentation at Cordelia Rd. needs to be dredged to open the channel up. Summer 2014

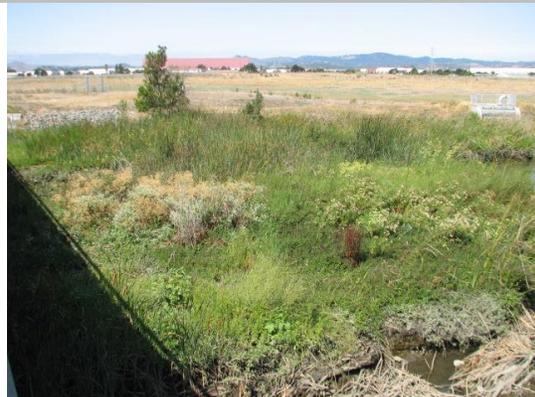
Photo 2 of 2 : CH_2014_NA0035_17_72_20140616_00028.jpg

Sedimentation upstream at Cordelia Road. (Summer 2013)

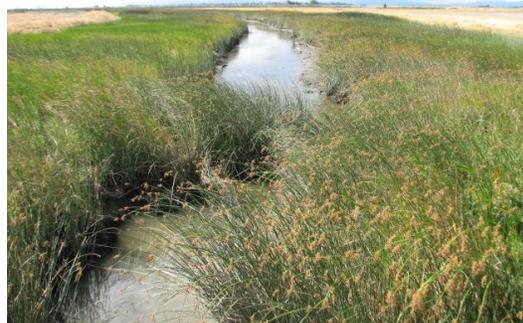
Photo 1 of 2 : CH_2014_NA0035_17_76_20140724_00054.jpg

Check Point / View			
Cordelia Road / Down			
Rating **	A	Issue No. 76	GPS Lat/Long
Issue Type +	Ma	Location *	38.233331 °
Category	Rivers, Channels & Designated Flood		-122.058607 °
Item	Vegetation & Obstructions		
DWR ID	DWR_NA0035_17_c_2012_76		
Action/Comments			
Inspector Comments: Minimal, scattered obstructions or vegetation. The flow is not impeded.

A downstream view of the channel from Cordelia Rd. Summer 2014

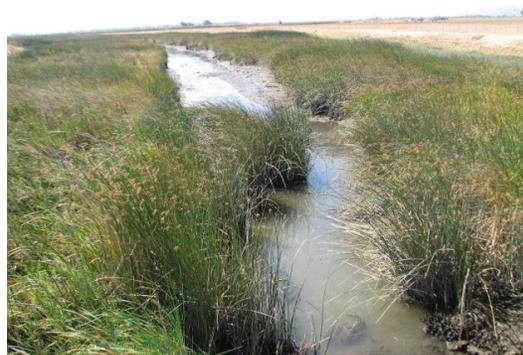
Photo 2 of 2 : CH_2014_NA0035_17_76_20140616_00029.jpg

Check Point / View				
Cordelia Road / Down (cont)				
Rating **	A	Issue No.	76 (cont)	GPS Lat/Long
Issue Type +	Ma	Location *		38.233331 °
Category	Rivers, Channels & Designated Flood			-122.058607 °
Item	Vegetation & Obstructions			
DWR ID	DWR_NA0035_17_c_2012_76			
Action/Comments				
Inspector Comments: Minimal, scattered obstructions or vegetation. The flow is not impeded.

Looking downstream towards Suisun Bay at Cordelia Road. (Summer 2013)

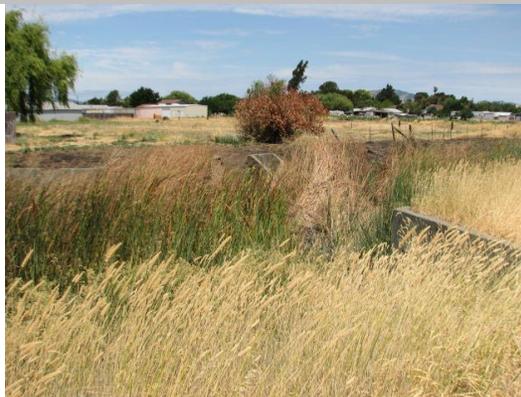
Photo 1 of 4 : CH_2014_NA0035_14_1_20140723_00011.jpg

Check Point / View				
Bella Vista Dr / Up				
Rating **	M	Issue No.	1	GPS Lat/Long
Issue Type +	Ma	Location *		38.253220 °
Category	Rivers, Channels & Designated Flood			-122.000589 °
Item	Vegetation & Obstructions			
DWR ID	DWR_NA0035_14_c_2012_1			
Action/Comments				
Inspector Comments: Vegetation growth (such as cat tails, bull rushes, bushes or saplings) or other obstructions block approximately 25% of the FCW.

Control structure is blocked by cattails. Remove or spray vegetation to open structure. Summer 2014

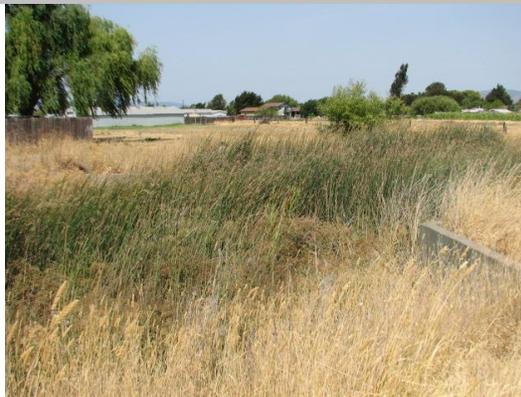
Photo 2 of 4 : CH_2014_NA0035_14_1_20140616_00001.jpg

Looking upstream at Bella Vista Avenue. Cannot see control structure. Suggest removal of tulies. (Summer 2013)

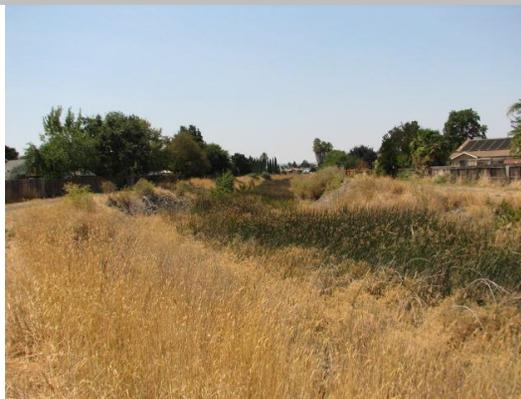
Photo 1 of 3 : CH_2014_NA0035_14_6_20140616_00002.jpg

Check Point / View			
Bella Vista Dr / Down			
Rating **	M	Issue No.	6
Issue Type +	Ma	Location *	38.253219 °
Category	Rivers, Channels & Designated Flood		-122.000587 °
Item	Vegetation & Obstructions		
DWR ID	DWR_NA0035_14_c_2012_6		
Action/Comments			
Inspector Comments: Vegetation growth (such as cat tails, bull rushes, bushes or saplings) or other obstructions block approximately 50% of the FCW.

Looking downstream at Bella Vista Avenue. (Summer 2013)

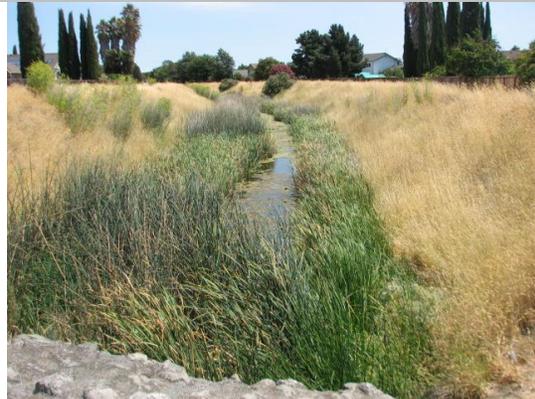
Photo 1 of 4 : CH_2014_NA0035_14_11_20140723_00013.jpg

Check Point / View				
Emperor Dr / Up				
Rating **	A	Issue No.	11	GPS Lat/Long
Issue Type +	Ma	Location *		38.250672 °
Category	Rivers, Channels & Designated Flood			-122.004419 °
Item	Vegetation & Obstructions			
DWR ID	DWR_NA0035_14_c_2012_11			
Action/Comments				
Inspector Comments: Cattials need to be sprayed or removed at street crossing.

A view looking upstream from Emperor Dr. Summer 2014

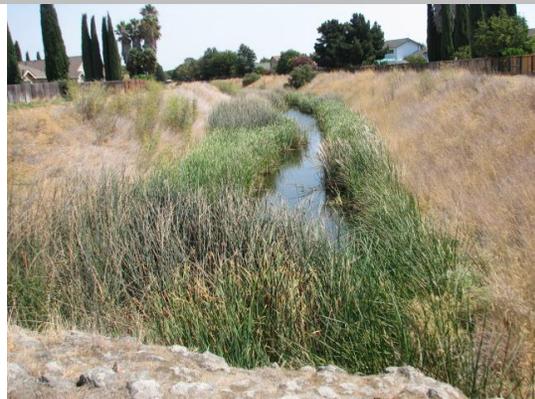
Photo 2 of 4 : CH_2014_NA0035_14_11_20140616_00003.jpg

Looking upstream at Emperor Drive. (Summer 2013)

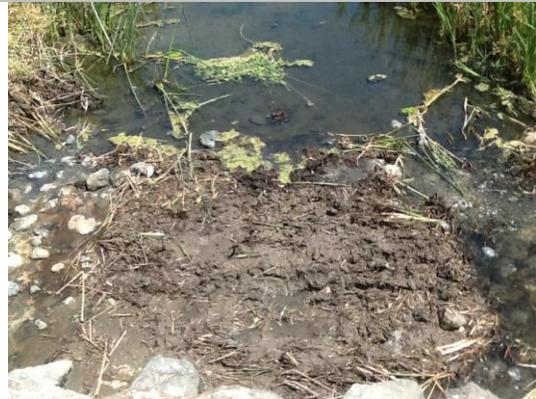
Photo 4 of 4 : CH_2014_NA0035_14_11_20140829_00024.jpg

Check Point / View			
Emporer Dr / Up (cont)			
Rating **	A	Issue No.	11 (cont)
Issue Type +	Ma	Location *	GPS Lat/Long
Category	Rivers, Channels & Designated Flood		38.250672 °
Item	Vegetation & Obstructions		-122.004419 °
DWR ID	DWR_NA0035_14_c_2012_11		
Action/Comments			
Inspector Comments: Cattials need to be sprayed or removed at street crossing.

Additional view upstream after the LMA cleared vegetation, summer 2014.

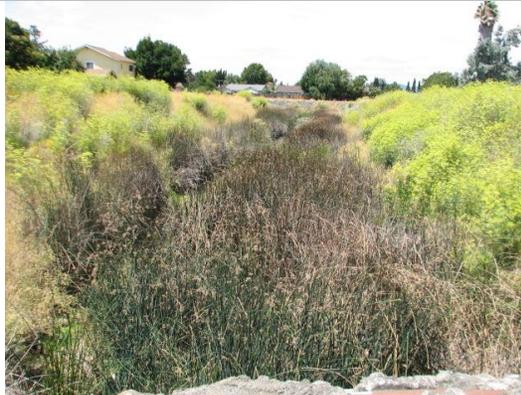
Photo 1 of 2 : CH_2014_NA0035_14_16_20140723_00014.jpg

Check Point / View			
Emporer Dr / Down			
Rating **	M	Issue No. 16	GPS Lat/Long
Issue Type +	Ma	Location *	38.250671 °
Category	Rivers, Channels & Designated Flood		-122.004419 °
Item	Vegetation & Obstructions		
DWR ID	DWR_NA0035_14_c_2012_16		
Action/Comments			
Inspector Comments: Cattails need to be sprayed or removed at street crossing. Try to maintain 50 ft. to 100 ft. clearance.

Looking downstream from Emperor Dr. Need to clear vegetation 50-100 feet from roadway. Summer 2014

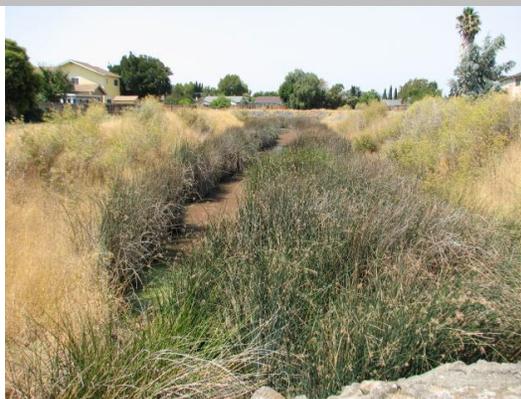
Photo 2 of 2 : CH_2014_NA0035_14_16_20140616_00004.jpg

Check Point / View				
Emporer Dr / Down (cont)				
Rating **	M	Issue No.	16 (cont)	GPS Lat/Long
Issue Type +	Ma	Location *		38.250671 °
Category	Rivers, Channels & Designated Flood			-122.004419 °
Item	Vegetation & Obstructions			
DWR ID	DWR_NA0035_14_c_2012_16			
Action/Comments				
Inspector Comments: Cattails need to be sprayed or removed at street crossing. Try to maintain 50 ft. to 100 ft. clearance.

Looking downstream towards the junction of Laurel Creek. (Summer 2013)

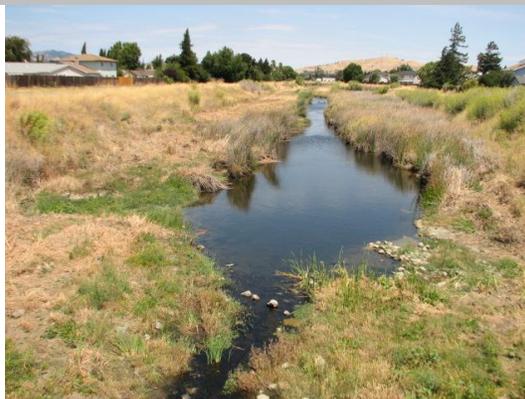
Photo 1 of 2 : CH_2014_NA0035_14_21_20140723_00015.jpg

Check Point / View			
Pintail Ave / Up			
Rating **	A	Issue No.	21
Issue Type +	Ma	Location *	GPS Lat/Long
Category	Rivers, Channels & Designated Flood		38.248501 °
Item	Vegetation & Obstructions		-122.006344 °
DWR ID	DWR_NA0035_14_c_2012_21		
Action/Comments			
Inspector Comments: Minimal scattered obstruction or vegetation. The flow is not impeded. The beaver dam has been removed from the center of channel.

A view looking upstream from Pintail Dr. Summer 2014

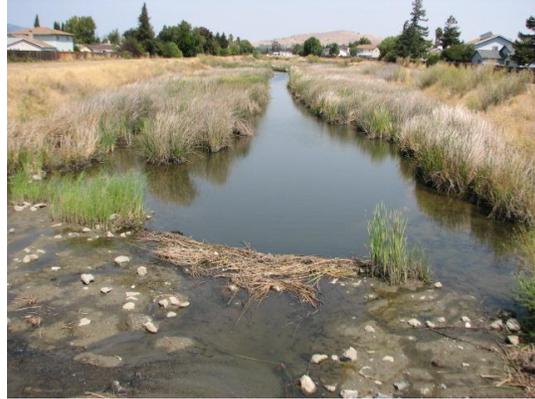
Photo 2 of 2 : CH_2014_NA0035_14_21_20140616_00005.jpg

Check Point / View			
Pintail Ave / Up (cont)			
Rating **	A	Issue No.	21 (cont)
Issue Type +	Ma	Location *	GPS Lat/Long
Category	Rivers, Channels & Designated Flood		38.248501 °
Item	Vegetation & Obstructions		-122.006344 °
DWR ID	DWR_NA0035_14_c_2012_21		
Action/Comments			
Inspector Comments: Minimal scattered obstruction or vegetation. The flow is not impeded. The beaver dam has been removed from the center of channel.

Looking upstream at Pintail Drive. (Summer 2013)

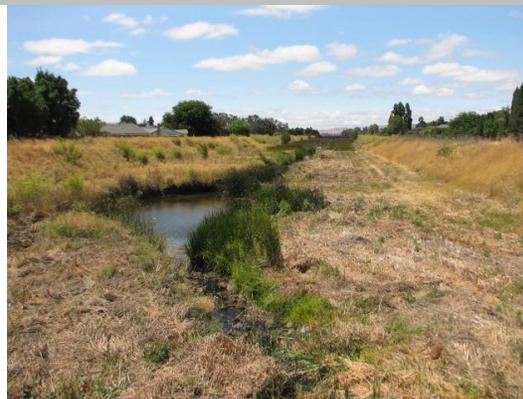
Photo 1 of 2 : CH_2014_NA0035_14_26_20140723_00016.jpg

Check Point / View			
Pintail Ave / Down			
Rating **	A	Issue No.	26
Issue Type +	Ma	Location *	GPS Lat/Long
Category	Rivers, Channels & Designated Flood		38.248501 °
Item	Vegetation & Obstructions		-122.006346 °
DWR ID	DWR_NA0035_14_c_2012_26		
Action/Comments			
Inspector Comments: Log jams, snags, vegetation growth (such as cat tails, bull rushes, bushes or saplings) or other obstructions block approximately 25% of the FCW.

A view lookingh downstream from Pintail Dr. Summer 2014

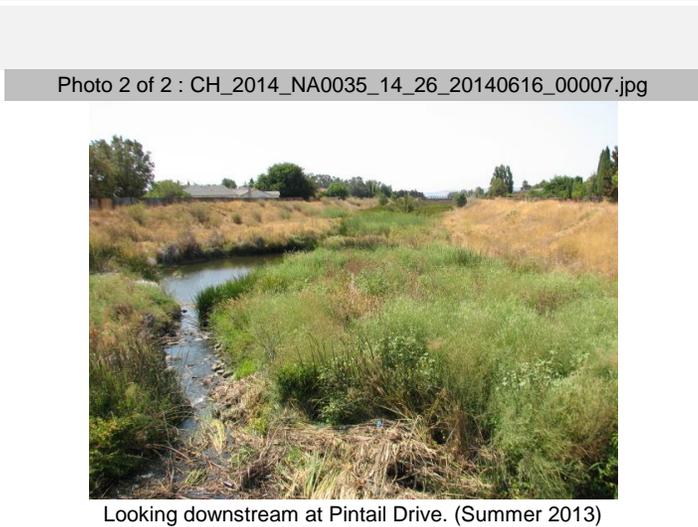
Check Point / View			
Pintail Ave / Down (cont)			
Rating **	A	Issue No.	26 (cont)
Issue Type +	Ma	Location *	GPS Lat/Long
Category	Rivers, Channels & Designated Flood		38.248501 °
Item	Vegetation & Obstructions		-122.006346 °
DWR ID	DWR_NA0035_14_c_2012_26		
Action/Comments			
Inspector Comments: Log jams, snags, vegetation growth (such as cat tails, bull rushes, bushes or saplings) or other obstructions block approximately 25% of the FCW.

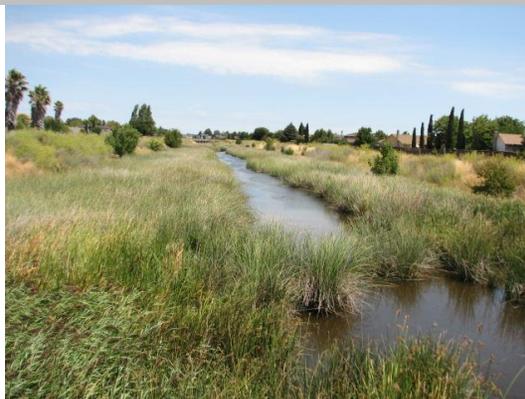
Photo 1 of 2 : CH_2014_NA0035_14_31_20140723_00017.jpg

Check Point / View			
Anderson Dr / Up			
Rating **	M	Issue No.	31
Issue Type +	Ma	Location *	GPS Lat/Long
Category	Rivers, Channels & Designated Flood		38.241561 °
Item	Vegetation & Obstructions		-122.012180 °
DWR ID	DWR_NA0035_14_c_2012_31		
Action/Comments			
Inspector Comments: Vegetation growth (such as cat tails, bull rushes, bushes or saplings) or other obstructions block approximately 25% of the FCW.

A view looking upstream from Highway 12. (38.243757 -122.010557) Summer 2014

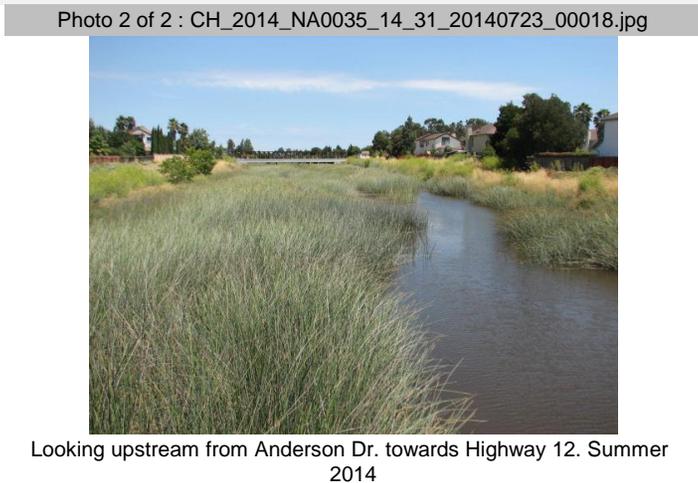
Check Point / View			
Anderson Dr / Up (cont)			
Rating **	M	Issue No.	31 (cont)
Issue Type +	Ma	Location *	GPS Lat/Long
Category	Rivers, Channels & Designated Flood		38.241561 °
Item	Vegetation & Obstructions		-122.012180 °
DWR ID	DWR_NA0035_14_c_2012_31		
Action/Comments			
Inspector Comments: Vegetation growth (such as cat tails, bull rushes, bushes or saplings) or other obstructions block approximately 25% of the FCW.

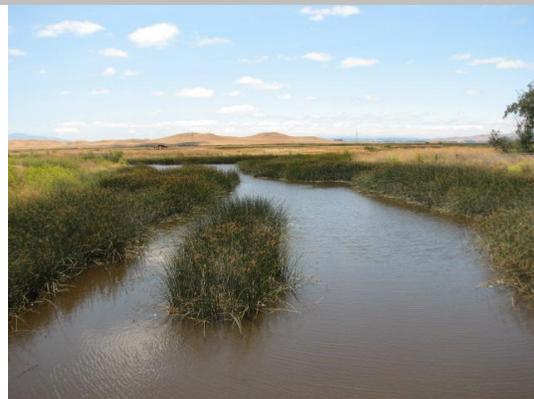
Photo 1 of 2 : CH_2014_NA0035_14_36_20140723_00019.jpg

Looking downstream towards Suisun Bay from Anderson Dr. Summer 2014

Check Point / View			
Anderson Dr / Down			
Rating **	A	Issue No. 36	GPS Lat/Long
Issue Type +	Ma	Location *	38.241562 °
Category	Rivers, Channels & Designated Flood		-122.012180 °
Item	Vegetation & Obstructions		
DWR ID	DWR_NA0035_14_c_2012_36		
Action/Comments			
Inspector Comments: Cattails should be sprayed or cleared 50 ft. to 100 ft. from road crossing.

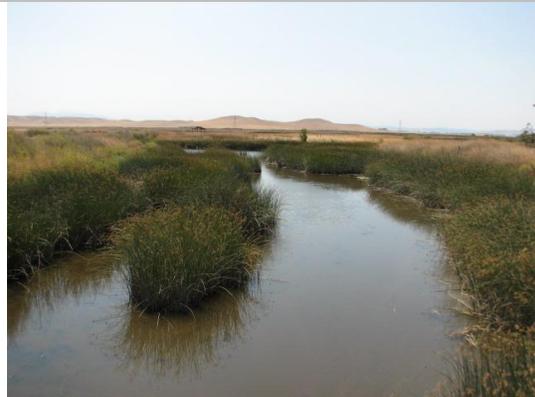
Photo 2 of 2 : CH_2014_NA0035_14_36_20140616_00010.jpg

Looking downstream towards Suisun Bay at Anderson Drive. (Summer 2013)

Check Point / View				
Anderson Dr / Down (cont)				
Rating **	A	Issue No.	36 (cont)	GPS Lat/Long
Issue Type +	Ma	Location *		38.241562 °
Category	Rivers, Channels & Designated Flood			-122.012180 °
Item	Vegetation & Obstructions			
DWR ID	DWR_NA0035_14_c_2012_36			
Action/Comments				
Inspector Comments: Cattails should be sprayed or cleared 50 ft. to 100 ft. from road crossing.

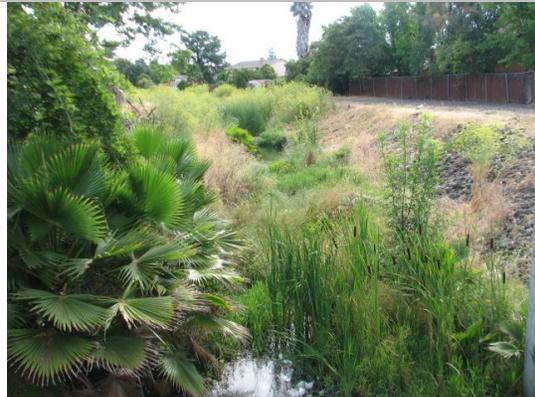
Photo 2 of 3 : CH_2014_NA0035_16_6_20140723_00008.jpg

Looking downstream from N. Texas St. Remove palm tree and heavy vegetation. Summer 2014

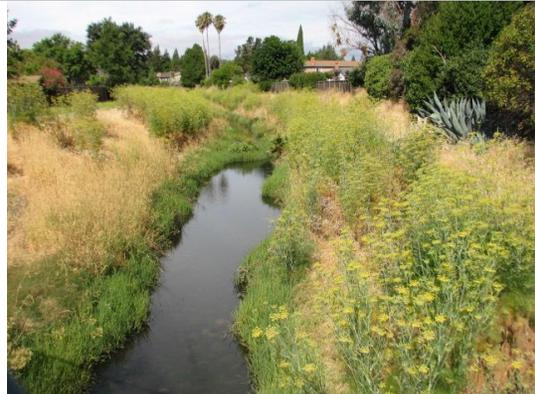
Photo 1 of 2 : CH_2014_NA0035_16_11_20140723_00009.jpg

Check Point / View				
Camrose Ave / Up				
Rating **	A	Issue No.	11	GPS Lat/Long
Issue Type +	Ma	Location *		38.281544 °
Category	Rivers, Channels & Designated Flood			-122.030546 °
Item	Vegetation & Obstructions			
DWR ID	DWR_NA0035_16_c_2012_11			
Action/Comments				
Inspector Comments: Minimal, scattered obstructions or vegetation. The flow is not impeded.

Looking upstream from Camrose Ave. Summer 2014

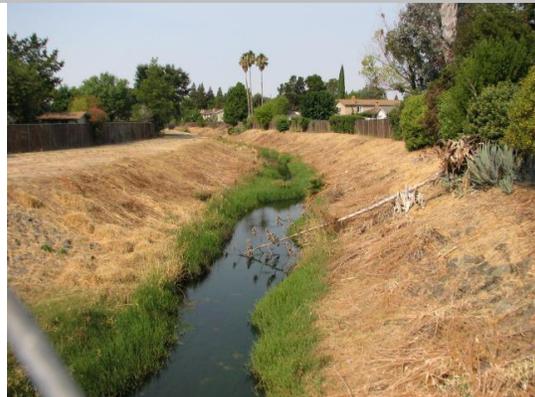
Photo 2 of 2 : CH_2014_NA0035_16_11_20140616_00002.jpg

Looking upstream at Camrose Avenue (Summer 2013)

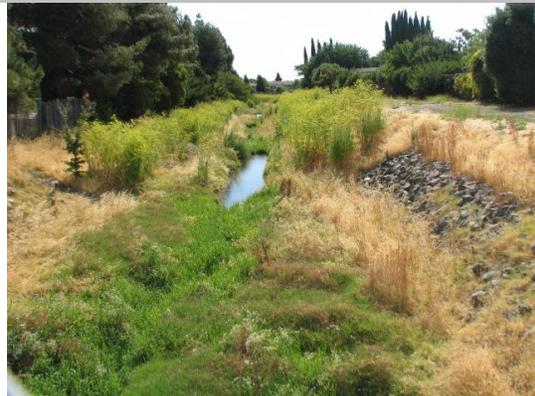
Photo 1 of 2 : CH_2014_NA0035_16_16_20140723_00010.jpg

Check Point / View				
Camrose Ave / Down				
Rating **	A	Issue No.	16	GPS Lat/Long
Issue Type +	Ma	Location *		38.281544 °
Category	Rivers, Channels & Designated Flood			-122.030543 °
Item	Vegetation & Obstructions			
DWR ID	DWR_NA0035_16_c_2012_16			
Action/Comments				
Inspector Comments: Minimal, scattered obstructions or vegetation. The flow is not impeded.

A view downstream from Camrose Ave. Summer 2014

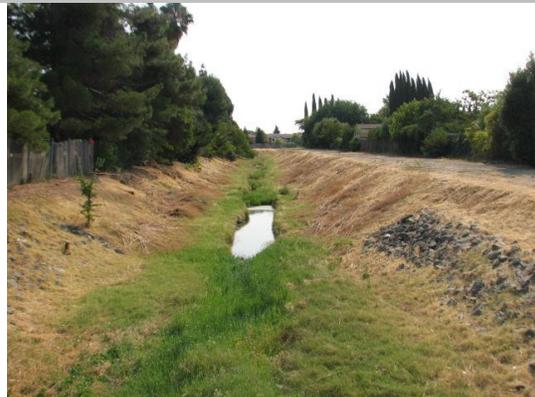
Photo 2 of 2 : CH_2014_NA0035_16_16_20140616_00003.jpg

Looking downstream at Camrose Avenue. (Summer 2013)

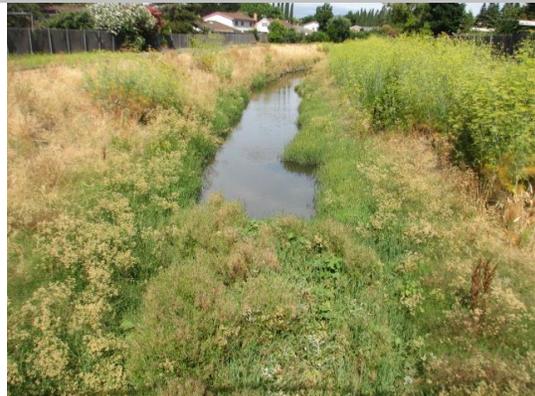
Photo 1 of 2 : CH_2014_NA0035_16_21_20140723_00011.jpg

Check Point / View				
Dover Ave / Up				
Rating **	A	Issue No.	21	GPS Lat/Long
Issue Type +	Ma	Location *		38.280944 °
Category	Rivers, Channels & Designated Flood			-122.025035 °
Item	Vegetation & Obstructions			
DWR ID	DWR_NA0035_16_c_2012_21			
Action/Comments				
Inspector Comments: Minimal, scattered obstructions or vegetation. The flow is not impeded.

A view looking upstream from Dover Ave. Summer 2014

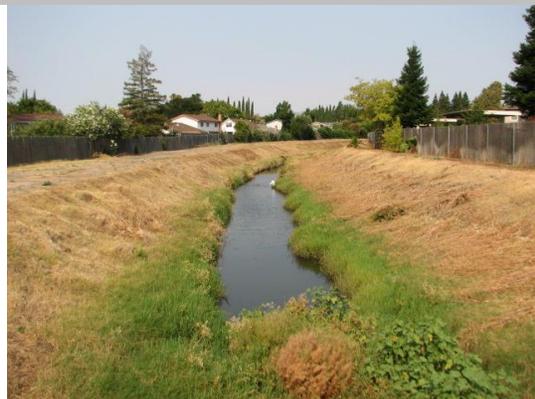
Photo 2 of 2 : CH_2014_NA0035_16_21_20140616_00004.jpg

Looking upstream at Dover Avenue. (Summer 2013)

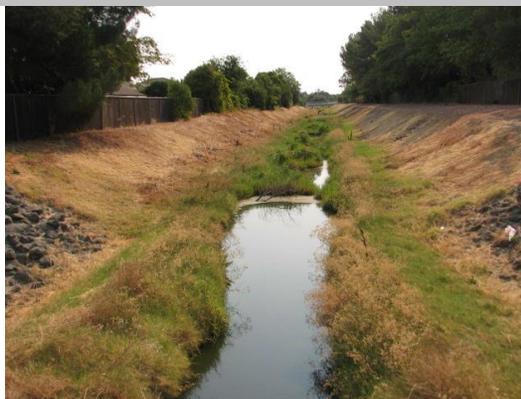
Photo 2 of 2 : CH_2014_NA0035_16_26_20140616_00005.jpg

Check Point / View			
Dover Ave / Down (cont)			
Rating **	A	Issue No.	26 (cont)
Issue Type +	Ma	Location *	GPS Lat/Long
Category	Rivers, Channels & Designated Flood		38.280946 °
Item	Vegetation & Obstructions		-122.025034 °
DWR ID	DWR_NA0035_16_c_2012_26		
Action/Comments			
Inspector Comments: Minimal, scattered obstructions or vegetation. The flow is not impeded.

Looking downstream at Dover Avenue. (Summer 2013)

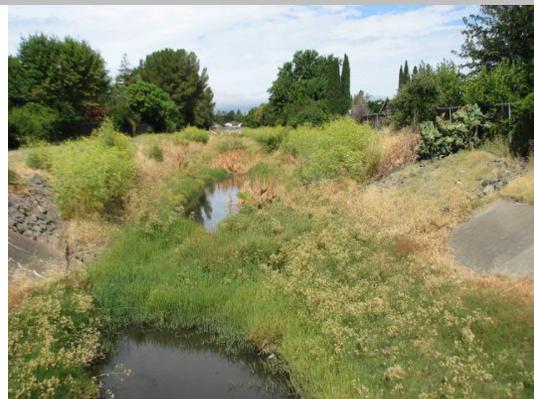
Photo 1 of 2 : CH_2014_NA0035_16_31_20140723_00013.jpg

Check Point / View			
Gulf Dr / Up			
Rating **	A	Issue No.	31
Issue Type +	Ma	Location *	GPS Lat/Long
Category	Rivers, Channels & Designated Flood		38.280937 °
Item	Vegetation & Obstructions		-122.020628 °
DWR ID	DWR_NA0035_16_c_2012_31		
Action/Comments			
Inspector Comments: Minimal, scattered obstructions or vegetation. The flow is not impeded.

A view looking upstream from Gulf Dr. Summer 2014

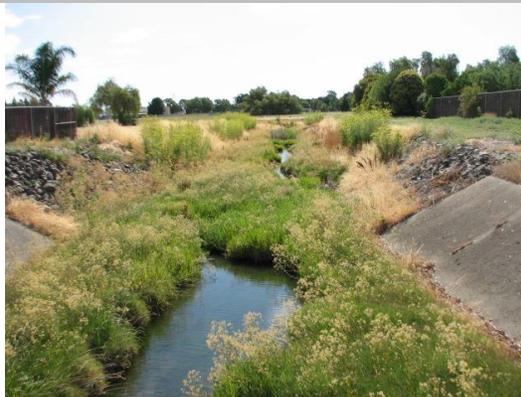
Photo 1 of 2 : CH_2014_NA0035_16_36_20140723_00014.jpg

Check Point / View			
Gulf Dr / Down			
Rating **	A	Issue No. 36	GPS Lat/Long
Issue Type +	Ma	Location *	38.280937 °
Category	Rivers, Channels & Designated Flood		-122.020629 °
Item	Vegetation & Obstructions		
DWR ID	DWR_NA0035_16_c_2012_36		
Action/Comments			
Inspector Comments: Minimal, scattered obstructions or vegetation. The flow is not impeded.

A view looking downstream from Gulf Dr. Summer 2014

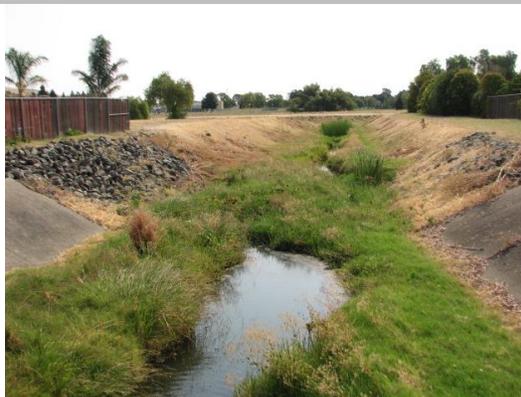
Photo 2 of 2 : CH_2014_NA0035_16_36_20140616_00007.jpg

Check Point / View				
Gulf Dr / Down (cont)				
Rating **	A	Issue No.	36 (cont)	GPS Lat/Long
Issue Type +	Ma	Location *		38.280937 °
Category	Rivers, Channels & Designated Flood			-122.020629 °
Item	Vegetation & Obstructions			
DWR ID	DWR_NA0035_16_c_2012_36			
Action/Comments				
Inspector Comments: Minimal, scattered obstructions or vegetation. The flow is not impeded.

Looking downstream towards Laurel Creek at Gulf Drive. (Summer 2013)
