**Flood Control Project Maintenance**  
**2015 Structure Summary Report**  
**Overall Unit and Item Ratings**

## DWR Sacramento Maintenance Yard

### Cache Creek Settling Basin Weir And Drainage Structure

**Flood Control Project Maintenance**

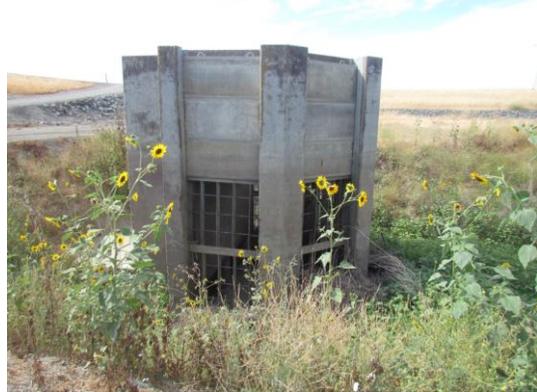
Photo 1 of 3 : ST\_2015\_NA0055\_12\_24\_20150707\_00012.jpg

View of the inlet structure at the south end of the weir. Summer 2015.

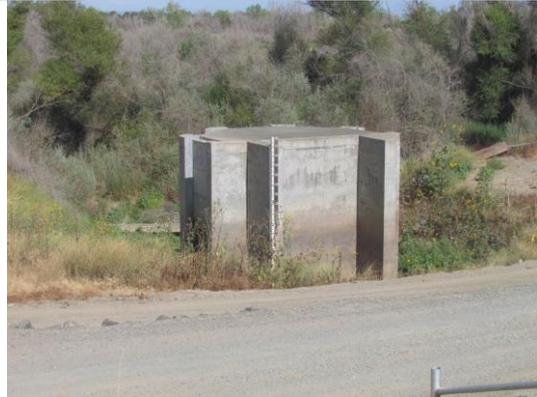
Photo 2 of 3 : ST\_2015\_NA0055\_12\_24\_20150707\_00013.jpg

View of the back of the inlet structure at the south end of the weir. Summer 2015.

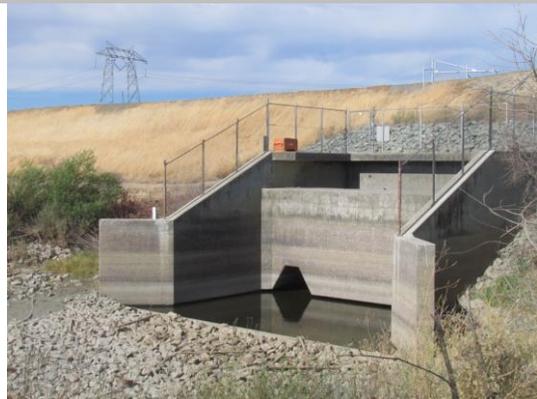
Photo 3 of 3 : ST\_2015\_NA0055\_12\_24\_20150707\_00014.jpg

View of the outlet structure at the south end of the weir. Summer 2015.

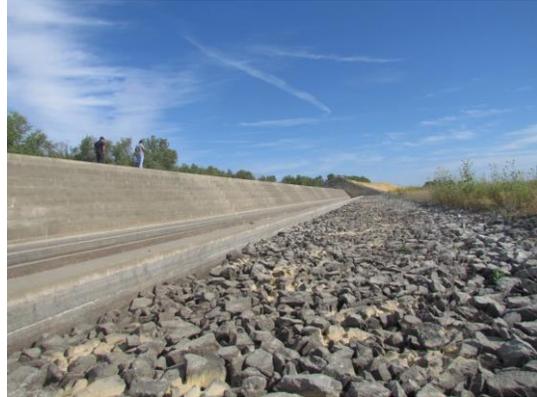
Photo 1 of 2 : ST\_2015\_NA0055\_12\_5\_20150707\_00010.jpg

LM Start	<b>0.00</b>	Rating **	A	Issue No.	<b>5</b>
LM End	<b>0.00</b>	Issue Type +	Ma	Location *	CR
Category	Structures & Concrete Lined Channels		GPS Latitude/Longitude		
			Start	End	
Item	Revetments		38.682460 °	38.687350 °	
			-121.672930 °	-121.673740 °	
DWR ID	DWR_NA0055_12_t_2012_5				
Action/Comments					
Inspector Comments: Existing riprap protection is properly maintained. Riprap is clearly visible and undamaged.

View of the revetment and weir looking to the north. Summer 2015.

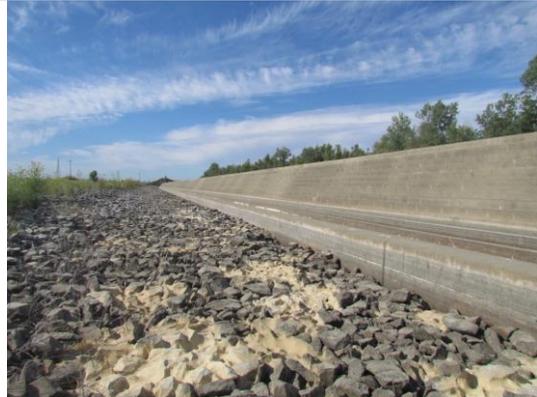
Photo 2 of 2 : ST\_2015\_NA0055\_12\_5\_20150707\_00011.jpg

View of the revetment and weir looking to the south. Summer 2015.

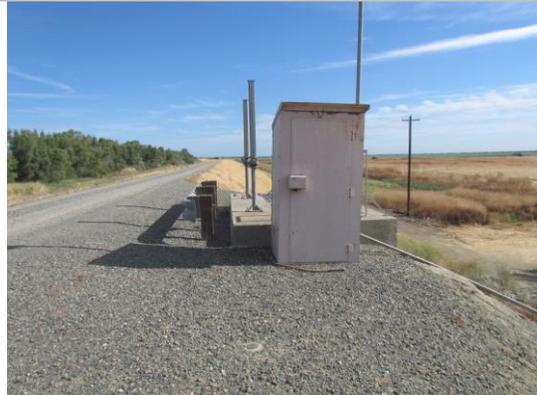
Photo 1 of 2 : ST\_2015\_NA0055\_12\_14\_20150707\_00006.jpg

LM Start	<b>0.00</b>	Rating **	A	Issue No.	<b>14</b>
LM End	<b>0.00</b>	Issue Type +	Ma	Location *	CR
Category	Structures & Concrete Lined Channels		GPS Latitude/Longitude		
			Start	End	
Item	Manual Gate Operators		38.682460 °	38.687350 °	
			-121.672930 °	-121.673740 °	
DWR ID	DWR_NA0055_12_t_2012_14				
Action/Comments					
Inspector Comments: The gates are tested once a year with safety and dams.

View of the control structure on the south end of the Cobble Weir. Summer 2015.

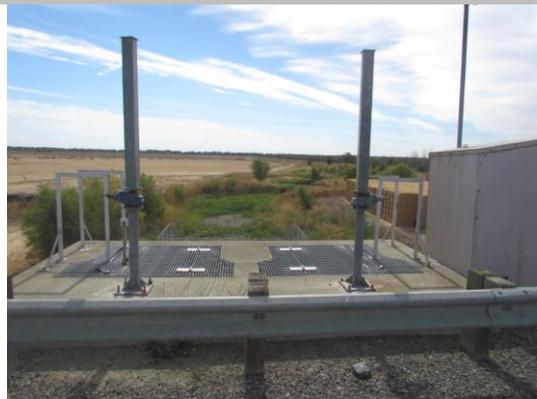
Photo 2 of 2 : ST\_2015\_NA0055\_12\_14\_20150707\_00007.jpg

View of the control structure for the flap gates to the outlet structure. Summer 2015.

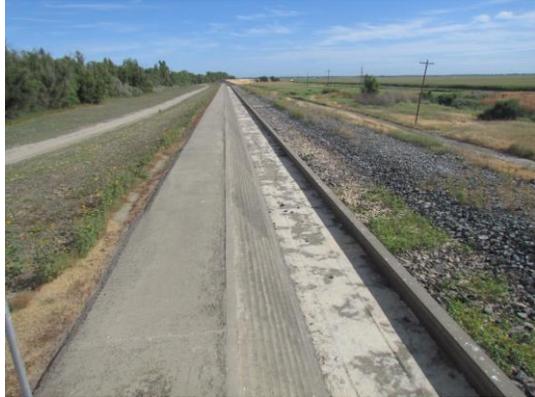
Photo 1 of 2 : ST\_2015\_NA0055\_12\_15\_20150707\_00008.jpg

LM Start	<b>0.00</b>	Rating **	A	Issue No.	<b>15</b>
LM End	<b>0.00</b>	Issue Type +	Ma	Location *	CR
Category	Structures & Concrete Lined Channels		GPS Latitude/Longitude		
			Start	End	
Item	Concrete Surfaces		38.682460 °	38.687350 °	
			-121.672930 °	-121.673740 °	
DWR ID	DWR_NA0055_12_t_2012_15				
Action/Comments					
Inspector Comments: Negligible spalling, scaling or cracking.

View of the Cobble Weir from the South end. Summer 2015.

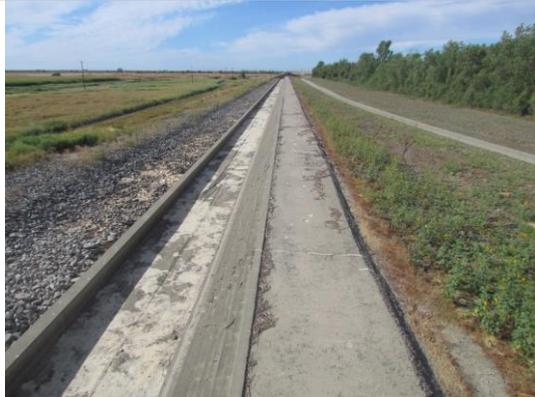
Photo 2 of 2 : ST\_2015\_NA0055\_12\_15\_20150707\_00009.jpg

View of the Cobble Weir from the North end. Summer 2015.

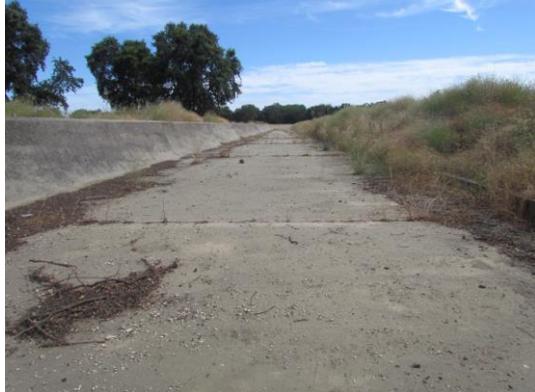
Photo 1 of 5 : ST\_2015\_NA0055\_2\_24\_20150819\_00018.jpg

View of the weir looking Northeast (38.75888, -121.66538). Summer 2015.

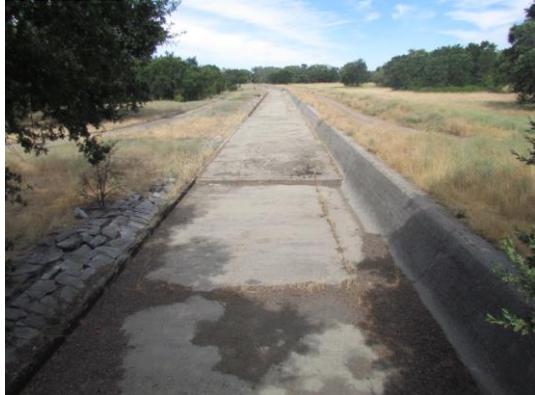
Photo 2 of 5 : ST\_2015\_NA0055\_2\_24\_20150819\_00019.jpg

View of the weir looking Northwest (38.764678, -121.635606). Summer 2015.

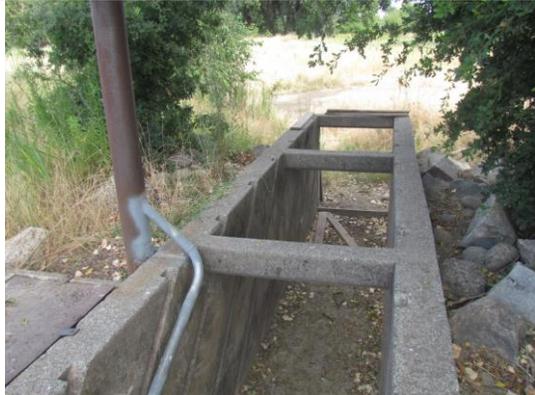
Photo 3 of 5 : ST\_2015\_NA0055\_2\_24\_20150707\_00016.jpg

View of the fish ladder from the outlet side (38.764235, -121.646939). Summer 2015.

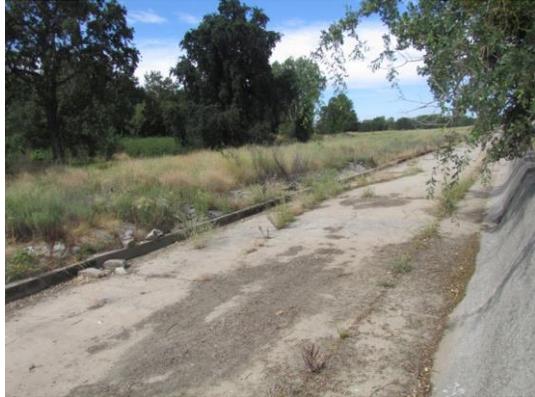
Photo 4 of 5 : ST\_2015\_NA0055\_2\_24\_20150819\_00020.jpg

View of the weir looking to the Southwest from the fish ladder. Summer 2015.

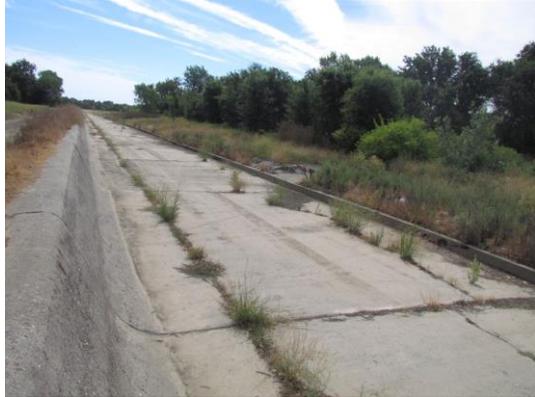
Photo 5 of 5 : ST\_2015\_NA0055\_2\_24\_20150819\_00017.jpg

View of the weir looking to the Northeast from the fish ladder. Summer 2015.

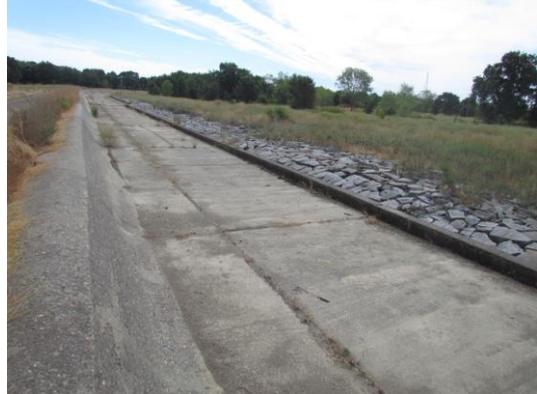
Photo 1 of 1 : ST\_2015\_NA0055\_2\_5\_20150707\_00008.jpg

LM Start	<b>0.00</b>	Rating **	A	Issue No.	<b>5</b>
LM End	<b>0.00</b>	Issue Type +	Ma	Location *	CR
Category	Structures & Concrete Lined Channels		GPS Latitude/Longitude		
			Start	End	
Item	Revetments		38.758880 °	38.764680 °	
			-121.665380 °	-121.635430 °	
DWR ID	DWR_NA0055_2_t_2012_5				
Action/Comments					
Inspector Comments: Existing riprap protection is properly maintained and is undamaged. Riprap clearly visible.

View of the revetment looking downstream. Summer 2015.

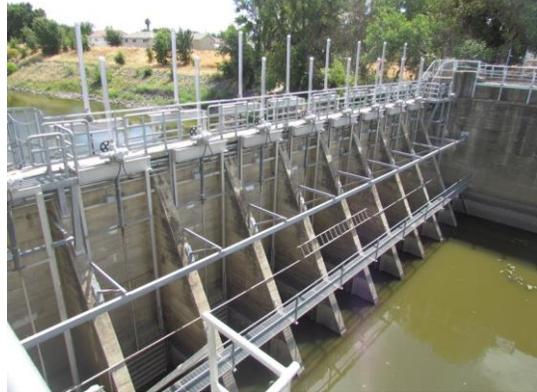
Photo 1 of 4 : ST\_2015\_NA0055\_41\_1\_20150707\_00009.jpg

View of the inlet side of the structure. Summer 2015.

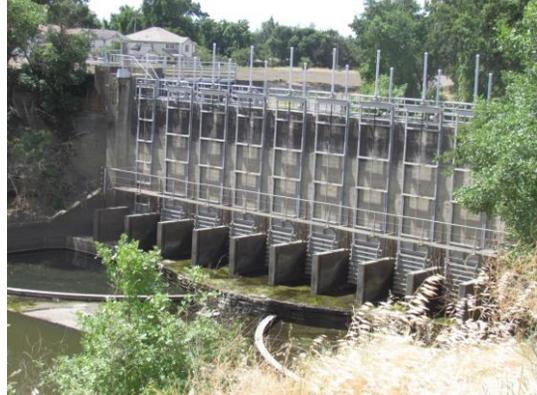
Photo 2 of 4 : ST\_2015\_NA0055\_41\_1\_20150707\_00010.jpg

View of the outlet side of the structure. Summer 2015.

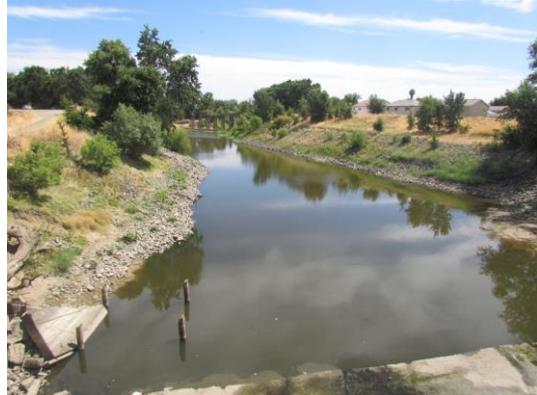
Photo 3 of 4 : ST\_2015\_NA0055\_41\_1\_20150707\_00011.jpg

View of the channel looking downstream. Summer 2015.

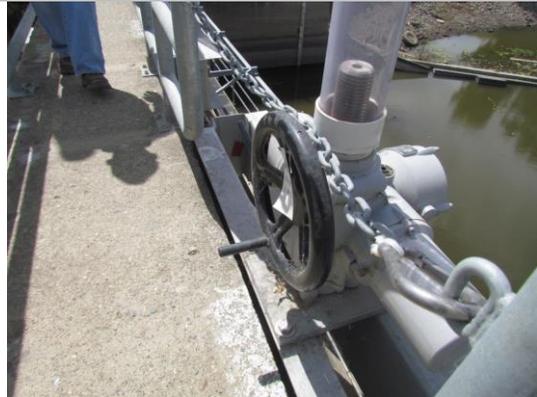
Photo 1 of 2 : ST\_2015\_NA0055\_41\_14\_20150707\_00007.jpg

LM Start	<b>0.00</b>	Rating **	A	Issue No.	<b>14</b>
LM End	<b>0.00</b>	Issue Type +	Ma	Location *	
Category	Structures & Concrete Lined Channels		GPS Latitude/Longitude		
			Start	End	
Item	Manual Gate Operators		38.799560 °	38.799320 °	
			-121.725530 °	-121.724850 °	
DWR ID	DWR_NA0055_41_t_2012_14				
Action/Comments					
Inspector Comments: The manual gates were not tested but appears to be operational.

Close-up view of the wheel for the flap gate. Summer 2015.

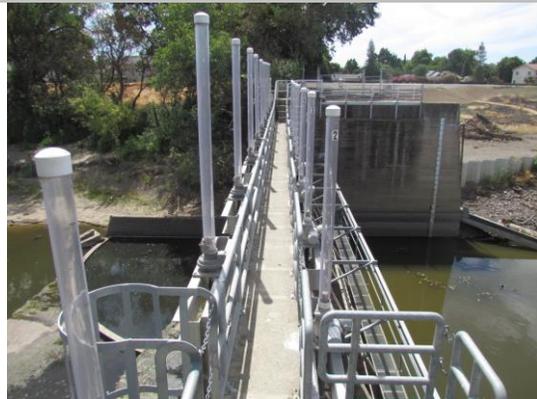
Photo 2 of 2 : ST\_2015\_NA0055\_41\_14\_20150707\_00008.jpg

View of the control structure to manually close the flap gates. Summer 2015.

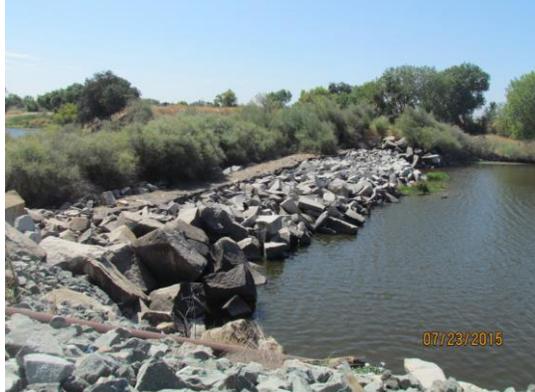
Photo 1 of 5 : ST\_2015\_XX0000\_52\_24\_20150724\_00006.jpg

View of the structure looking to the south end. Summer 2015.

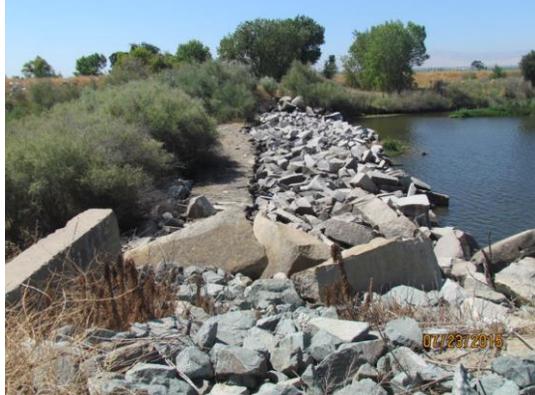
Photo 2 of 5 : ST\_2015\_XX0000\_52\_24\_20150724\_00007.jpg

View of the structure looking to the south end. Summer 2015.

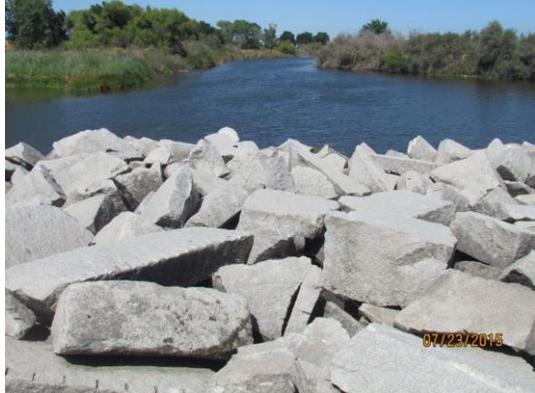
Photo 3 of 5 : ST\_2015\_XX0000\_52\_24\_20150724\_00008.jpg

View of the riprap on the structure looking downstream. Summer 2015.

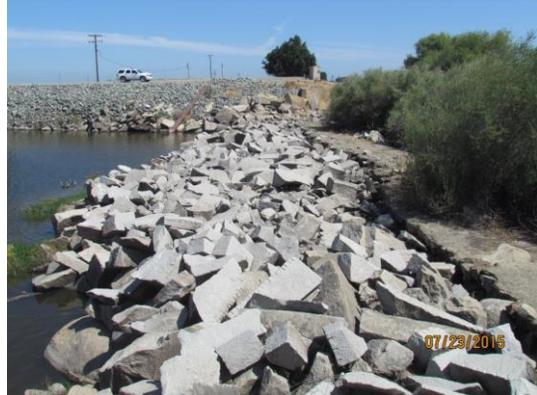
Photo 4 of 5 : ST\_2015\_XX0000\_52\_24\_20150724\_00009.jpg

View of the structure looking to the north end. Summer 2015.

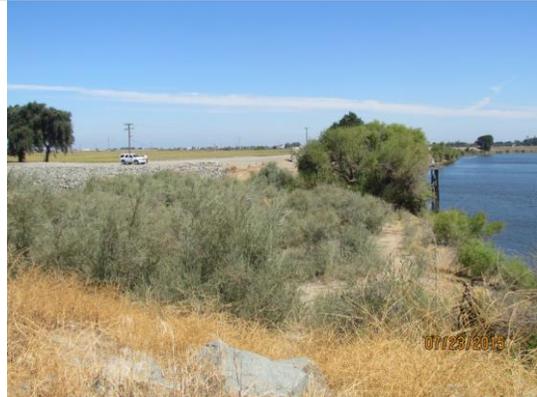
Photo 5 of 5 : ST\_2015\_XX0000\_52\_24\_20150724\_00010.jpg

View of the inlet side of the structure looking to the north. Summer 2015.

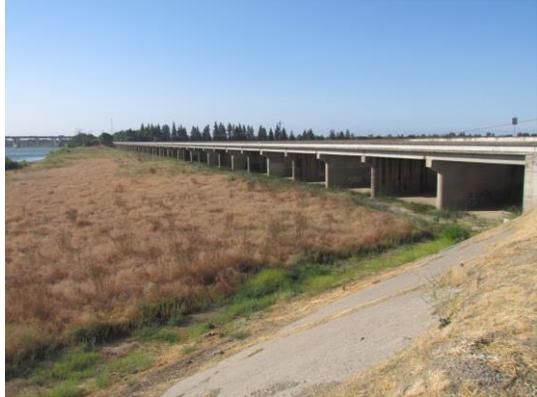
Photo 1 of 3 : ST\_2015\_NA0055\_1\_24\_20150708\_00011.jpg

View of the inlet side of the structure looking to the southwest. Summer 2015.

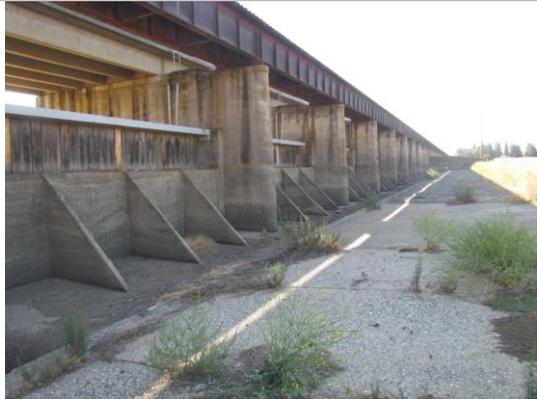
Photo 2 of 3 : ST\_2015\_NA0055\_1\_24\_20150708\_00012.jpg

View of the outlet side of the structure looking to the northeast. Summer 2015.

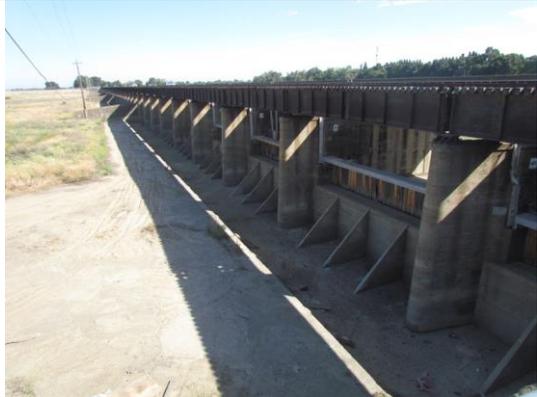
Photo 3 of 3 : ST\_2015\_NA0055\_1\_24\_20150708\_00013.jpg

View of the outlet side of the structure looking to the northwest. Summer 2015.
