**Flood Control Project Maintenance
Levee Inspections**

2011 Channel Summary Report

DWR Sutter Maintenance Yard

Flood Control Project Maintenance
Unit Cover Sheet
2011 Channel Inspection Results

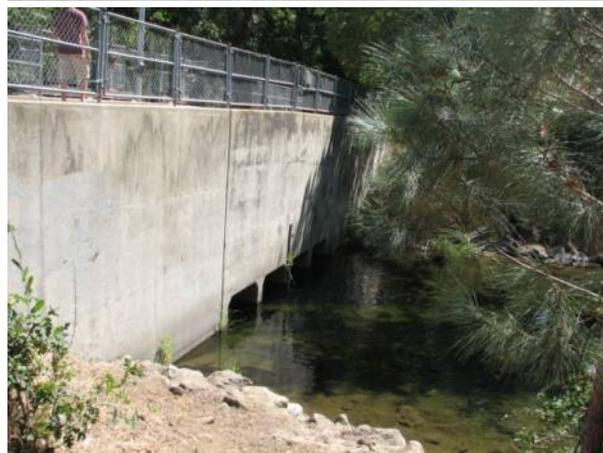
Levee Mile Report Line	6
Start Levee Mile	0.00
End Levee Mile	0.00
Location	
Category	Channels
Item	Vegetation & Obstructions
Downstream from Big Chico Creek Control Structure,	
cathom_c_20110831_067.jpg

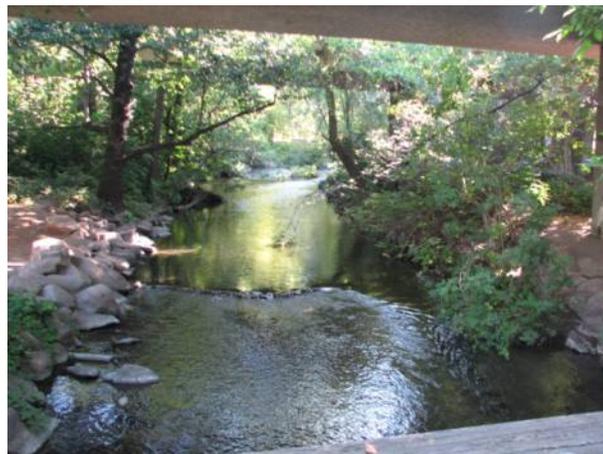
Levee Mile Report Line	21
Start Levee Mile	0.00
End Levee Mile	0.00
Location	
Category	Channels
Item	Vegetation & Obstructions
<p>This photo is looking upstream from Highway 99 bike path bridge. Near Villombrosa Avenue.</p>	
<p>cathom_c_20110831_068.jpg</p>

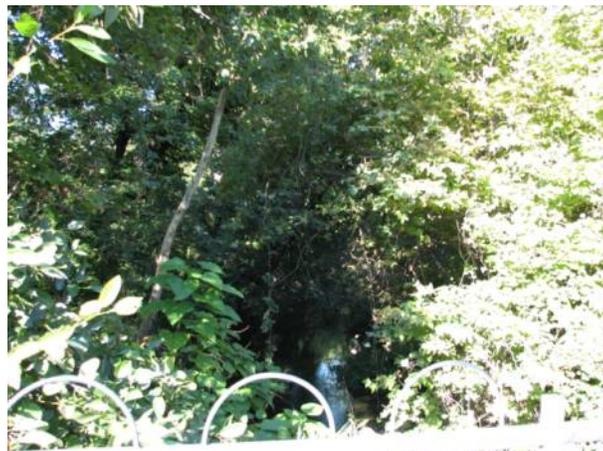
Levee Mile Report Line	36
Start Levee Mile	0.00
End Levee Mile	0.00
Location	
Category	Channels
Item	Vegetation & Obstructions
<p>This view is looking downstream from Esplanade Avenue.</p>	
<p>cathom_c_20110824_009.jpg</p>

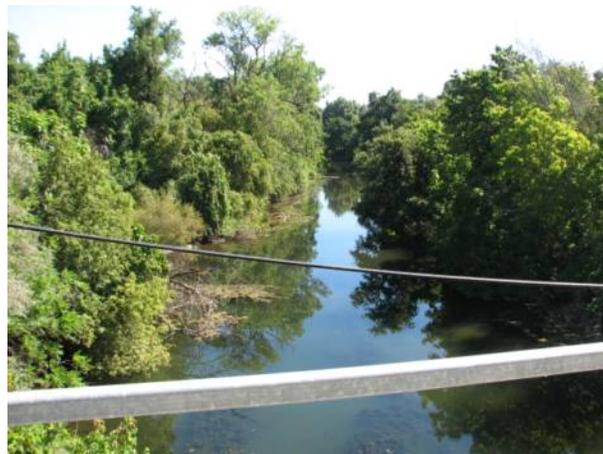
Levee Mile Report Line	51
Start Levee Mile	0.00
End Levee Mile	0.00
Location	
Category	Channels
Item	Vegetation & Obstructions
<p>This photo is looking upstream from River Road at Mud Creek, near the confluence with the Sacramento River.</p>	
<p>cathom_c_20110831_073.jpg</p>

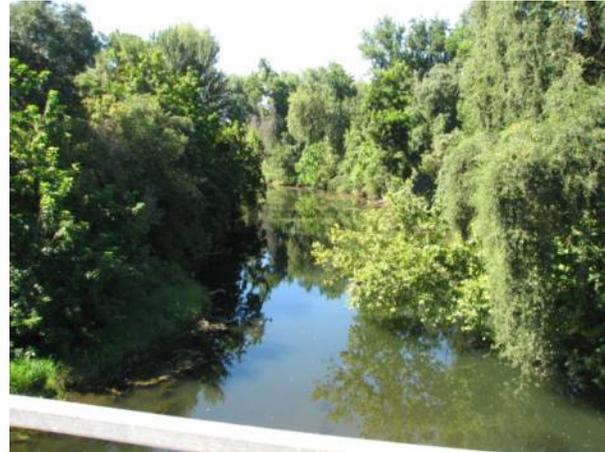
Levee Mile Report Line	56
Start Levee Mile	0.00
End Levee Mile	0.00
Location	
Category	Channels
Item	Vegetation & Obstructions
<p>This photo is looking downstream from the River Road bridge, near the confluence of the Sacramento River.</p>	
<p>cathom_c_20110831_074.jpg</p>

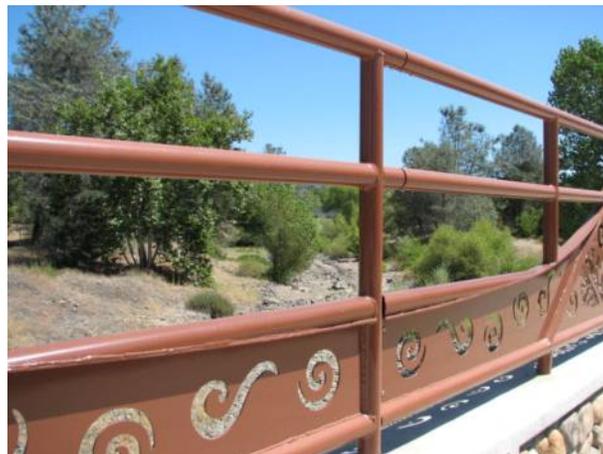
Levee Mile Report Line	11
Start Levee Mile	0.00
End Levee Mile	0.00
Location	
Category	Channels
Item	Vegetation & Obstructions
<p>This view is looking up stream from Manzanita Avenue, new bridge is in place.</p>	
<p>cathom_c_20110829_041.jpg</p>

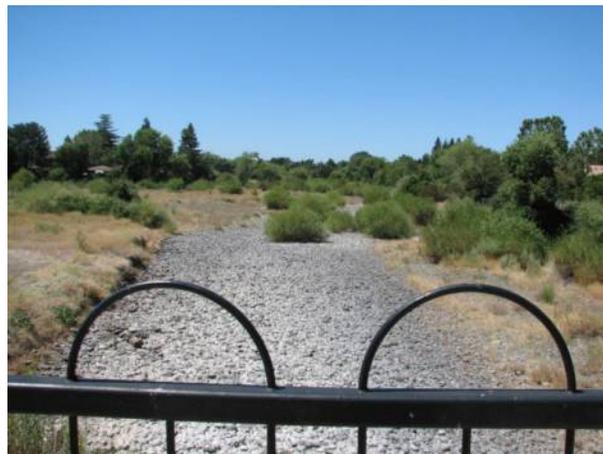
Levee Mile Report Line	26
Start Levee Mile	0.00
End Levee Mile	0.00
Location	
Category	Channels
Item	Vegetation & Obstructions
<p>This photo is looking down stream from the bike path at the extension of Madrone Avenue.</p>	
<p>cathom_c_20110829_044.jpg</p>

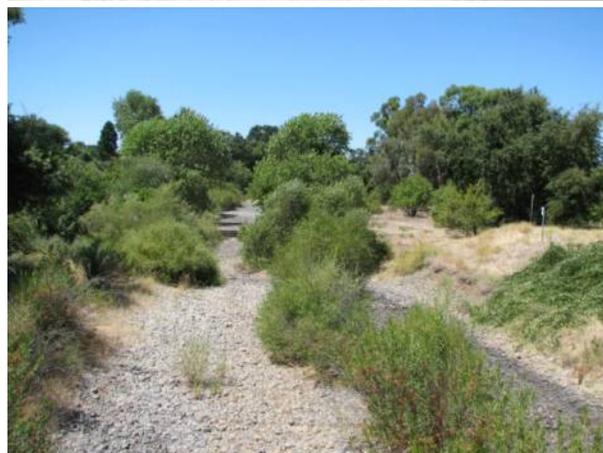
Levee Mile Report Line	36
Start Levee Mile	0.00
End Levee Mile	0.00
Location	
Category	Channels
Item	Vegetation & Obstructions
<p>This photo is looking down stream from the Mariposa Avenue bridge.</p>	
<p>cathom_c_20110830_047.jpg</p>

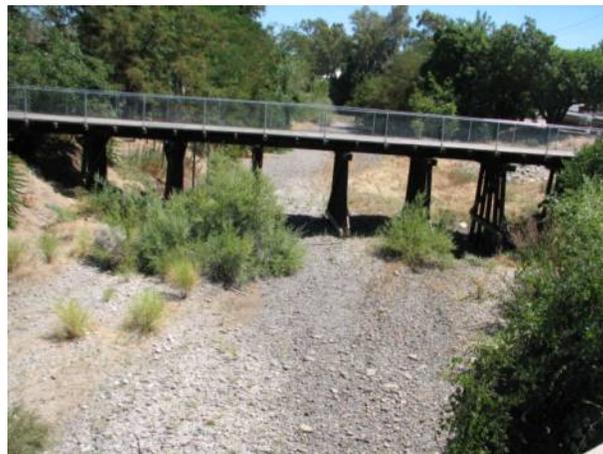
Levee Mile Report Line	51
Start Levee Mile	0.00
End Levee Mile	0.00
Location	
Category	Channels
Item	Vegetation & Obstructions
This view is looking up stream from Esplanade Avenue bridge.	
cathom_c_20110830_050.jpg

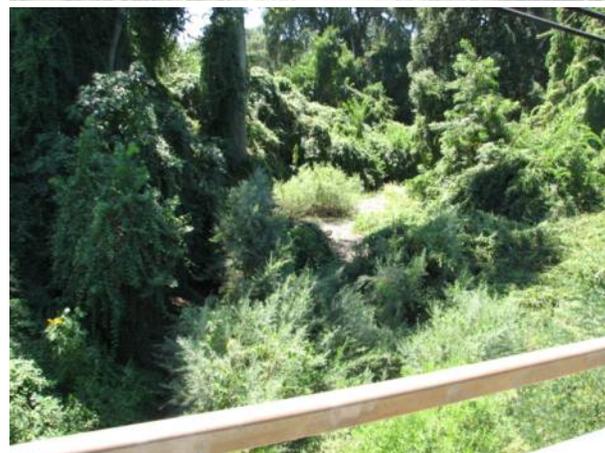
Levee Mile Report Line	66
Start Levee Mile	0.00
End Levee Mile	0.00
Location	
Category	Channels
Item	Vegetation & Obstructions
<p>This photo is looking down stream from Highway 32, Nord Avenue bridge.</p>	
<p>cathom_c_20110830_053.jpg</p>

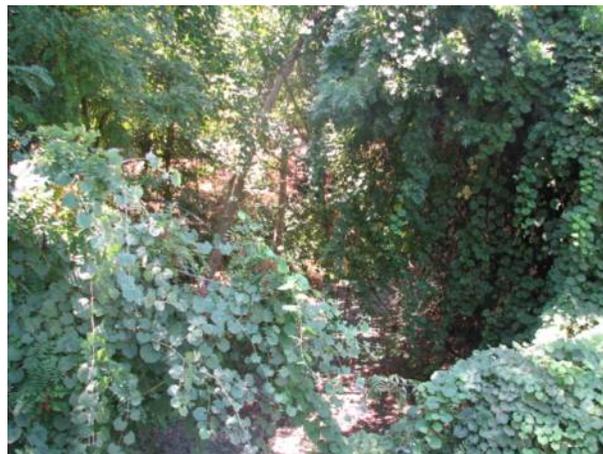
Levee Mile Report Line	78
Start Levee Mile	0.00
End Levee Mile	0.00
Location	
Category	Channels
Item	Erosion / Bank Caving
Down stream at Oak Avenue.	
cathom_c_20110824_024.jpg

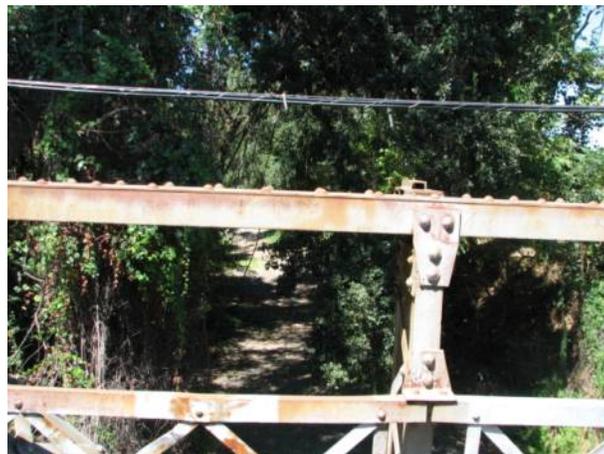
Levee Mile Report Line	89
Start Levee Mile	0.00
End Levee Mile	0.00
Location	
Category	Channels
Item	Revetments
<p>This view is looking downstream at the channel at the Grape Way bridge. Vegetation obstructing the view of revetment should be removed.</p>	
<p>cathom_c_20110830_062.jpg</p>

79		Down	Revetments		M	Inspector Comments: Unwanted vegetation must be cleared and sprayed with an appropriate herbicide.	39.735560 ° -121.890970 °	Y	79
80		Down	Encroachments		A	Inspector Comments: No Trash, debris, excavation, structures, or other obstructions present within the project easement area.	39.735560 ° -121.890970 °		80
81	Grape Way	Up	Vegetation & Obstructions		A	Inspector Comments: Scattered obstructions and vegetation.	39.722700 ° -121.912520 °		81
82		Up	Shoaling / Sedimentation		A	Inspector Comments: No shoaling or sedimentation observed.	39.722700 ° -121.912520 °		82
83		Up	Erosion / Bank Caving		A	Inspector Comments: No head cutting or horizontal deviation observed.	39.722700 ° -121.912520 °		83
84		Up	Revetments		M	Inspector Comments: Unable to see revetment, unwanted vegetation must be cleared and sprayed with an appropriate herbicide.	39.722700 ° -121.912520 °	Y	84

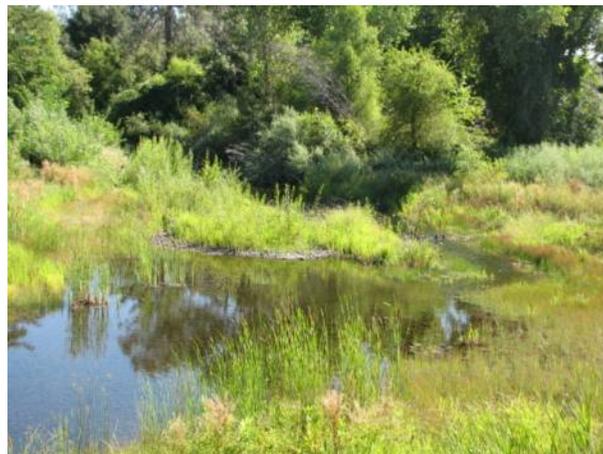
Levee Mile Report Line	6
Start Levee Mile	0.00
End Levee Mile	0.00
Location	
Category	Channels
Item	Vegetation & Obstructions
<p>This photo is looking downstream from the control structure.</p>	
<p>cathom_c_20110831_077.jpg</p>

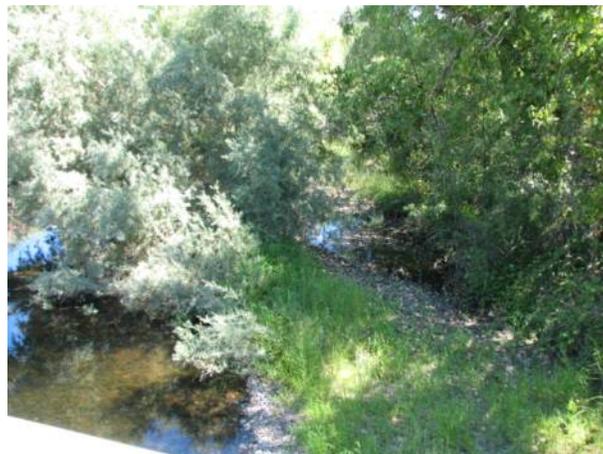
Levee Mile Report Line	21
Start Levee Mile	0.00
End Levee Mile	0.00
Location	
Category	Channels
Item	Vegetation & Obstructions
<p>This photo is looking upstream from Forrest Avenue bridge. Shoaling and vegetation in the channel.</p>	
<p>cathom_c_20110901_080.jpg</p>

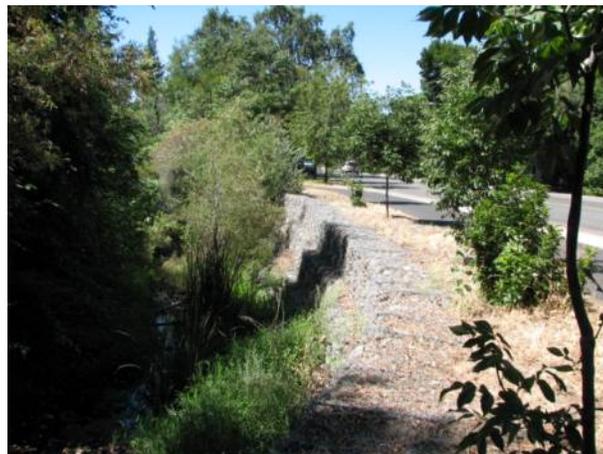
Levee Mile Report Line	36
Start Levee Mile	0.00
End Levee Mile	0.00
Location	
Category	Channels
Item	Vegetation & Obstructions
<p>This photo is looking downstream at the erosion repair site, down stream of Highway 99 on Humbolt Road. There is vegetation in the channel, the flow does not appear impeded.</p>	
<p>cathom_c_20110901_083.jpg</p>

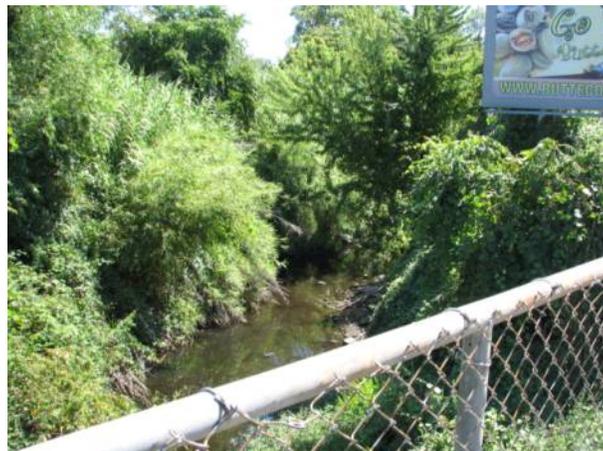
Levee Mile Report Line	51
Start Levee Mile	0.00
End Levee Mile	0.00
Location	
Category	Channels
Item	Vegetation & Obstructions
<p>This photo is looking upstream from Olive Street bridge.</p>	
<p>cathom_c_20110901_086.jpg</p>

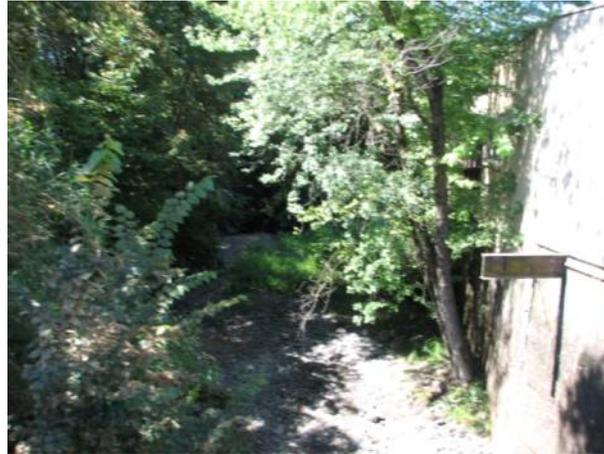
cathom_c_20110901_087.jpg

This photo is looking downstream from the Olive Street bridge. There is an existing structure on the right bank of the channel.

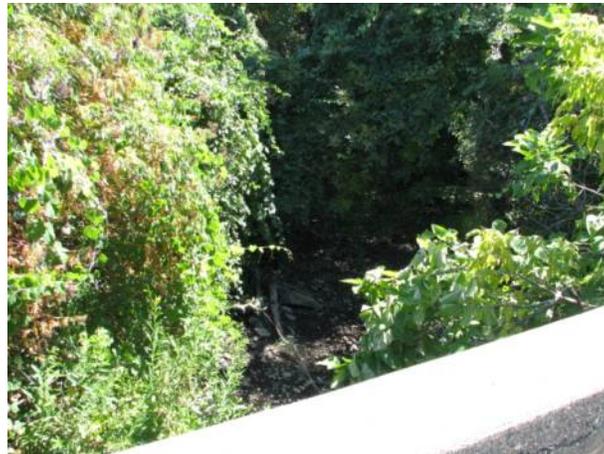
cathom_c_20110901_088.jpg

This photo is looking upstream from the Broadway St. bridge.

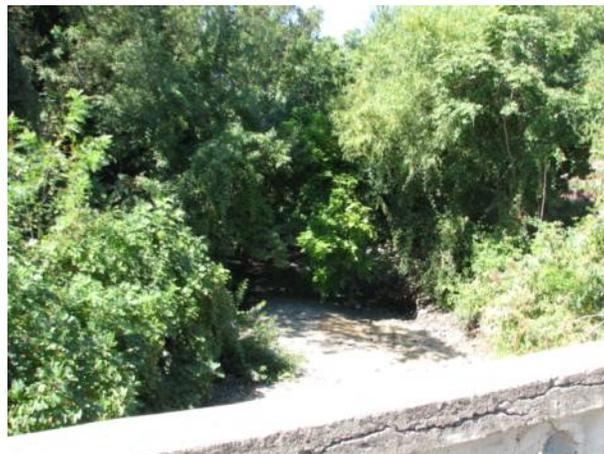
cathom_c_20110901_089.jpg

This photo is looking downstream from Broadway St. bridge.

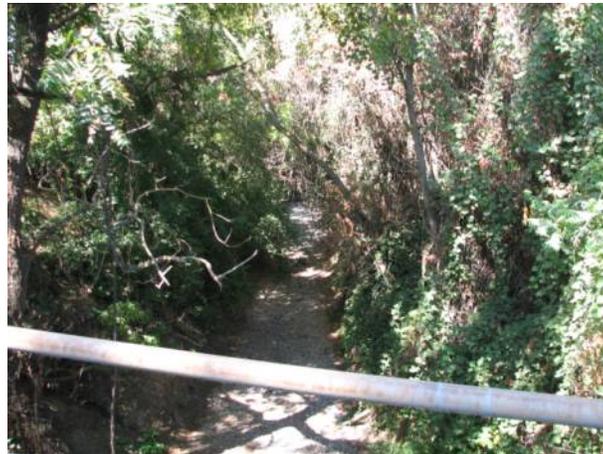
Levee Mile Report Line	76
Start Levee Mile	0.00
End Levee Mile	0.00
Location	
Category	Channels
Item	Vegetation & Obstructions
This photo is looking upstream from Lone Pine Avenue.	
cathom_c_20110901_091.jpg
