**Flood Control Project Maintenance
Levee Inspections**

2015 Channel Summary Report

DWR Sutter Maintenance Yard

2015 Channel Inspection Results

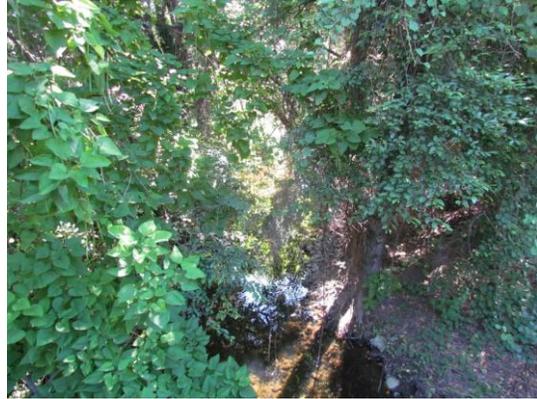
Photo 1 of 1 : CH_2015_NA0060_5_31_20150812_00020.jpg

Check Point / View			
Esplanade / Up			
Rating **	A	Issue No.	31
Issue Type +	Ma	Location *	39.731810 °
Category	Rivers, Channels & Designated Flood		-121.841870 °
Item	Vegetation & Obstructions		
DWR ID	DWR_NA0060_5_c_2012_31		
Action/Comments			
Inspector Comments: Scattered obstructions and vegetation. The flow is not impeded.

View of the channel facing upstream.

Rating **	A	Issue No.	32
Issue Type +	Ma	Location *	39.731810 °
Category	Rivers, Channels & Designated Flood		-121.841870 °
Item	Shoaling / Sedimentation		
DWR ID	DWR_NA0060_5_c_2012_32		
Action/Comments			
Inspector Comments: No shoaling or sedimentation observed.

Rating **	A	Issue No.	33
Issue Type +	Ma	Location *	39.731810 °
Category	Rivers, Channels & Designated Flood		-121.841870 °
Item	Erosion / Bank Caving		
DWR ID	DWR_NA0060_5_c_2012_33		
Action/Comments			
Inspector Comments: No erosion observed.

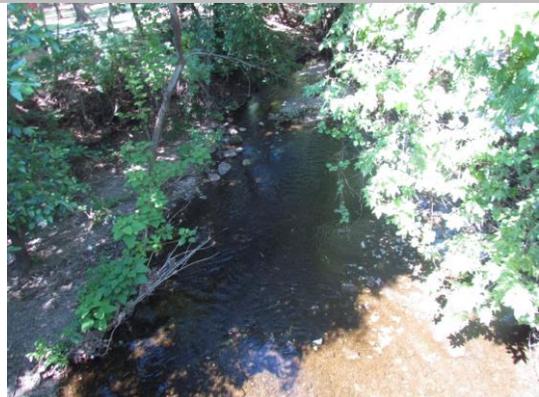
Photo 1 of 1 : CH_2015_NA0060_5_36_20150812_00019.jpg

Check Point / View			
Esplanade / Down			
Rating **	A	Issue No.	36
Issue Type +	Ma	Location *	39.731810 °
Category	Rivers, Channels & Designated Flood		-121.841870 °
Item	Vegetation & Obstructions		
DWR ID	DWR_NA0060_5_c_2012_36		
Action/Comments			
Inspector Comments: Scattered obstructions and vegetation. The flow is not impeded.

View of the channel facing downstream.

Check Point / View				GPS Lat/Long	No Photos
Esplanade / Down (cont)					
Rating **	A	Issue No.	37		
Issue Type +	Ma	Location *		39.731810 °	
Category	Rivers, Channels & Designated Flood			-121.841870 °	
Item	Shoaling / Sedimentation				
DWR ID	DWR_NA0060_5_c_2012_37				
Action/Comments					
Inspector Comments: No shoaling or sedimentation observed.

Rating **	A	Issue No.	38	GPS Lat/Long	
Issue Type +	Ma	Location *		39.731810 °	No Photos
Category	Rivers, Channels & Designated Flood			-121.841870 °	
Item	Erosion / Bank Caving				
DWR ID	DWR_NA0060_5_c_2012_38				
Action/Comments					
Inspector Comments: No erosion observed.

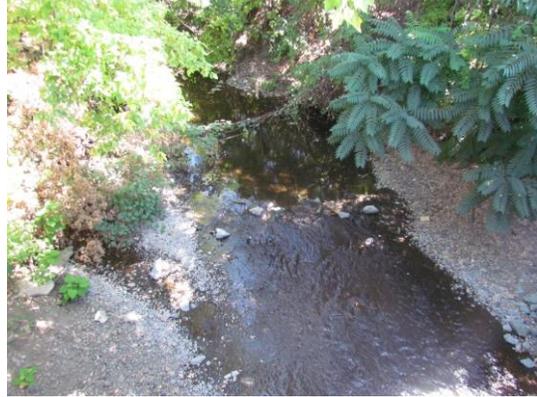
Photo 1 of 1 : CH_2015_NA0060_5_41_20150812_00017.jpg

Check Point / View			
Hwy 32 / Up			
Rating **	A	Issue No.	41
Issue Type +	Ma	Location *	39.725776 °
Category	Rivers, Channels & Designated Flood		-121.851207 °
Item	Vegetation & Obstructions		
DWR ID	DWR_NA0060_5_c_2012_41		
Action/Comments			
Inspector Comments: Scattered obstructions and vegetation. The flow is not impeded.

View of the channel facing upstream.

Rating **	A	Issue No.	42
Issue Type +	Ma	Location *	39.725776 °
Category	Rivers, Channels & Designated Flood		-121.851207 °
Item	Shoaling / Sedimentation		
DWR ID	DWR_NA0060_5_c_2012_42		
Action/Comments			
Inspector Comments: No shoaling or sedimentation observed.

Check Point / View			
Hwy 32 / Up (cont)			
Rating **	A	Issue No.	43
Issue Type +	Ma	Location *	39.725776 °
Category	Rivers, Channels & Designated Flood		-121.851207 °
Item	Erosion / Bank Caving		
DWR ID	DWR_NA0060_5_c_2012_43		
Action/Comments			
Inspector Comments: No erosion observed.

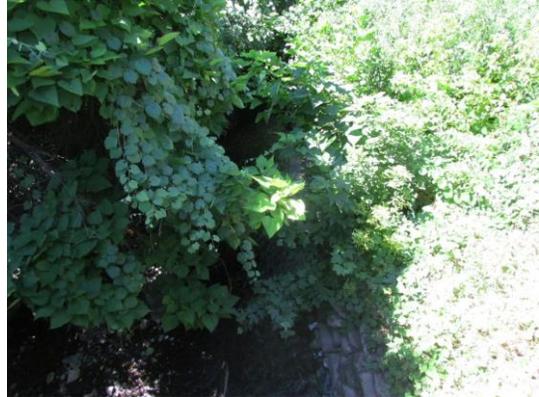
Photo 1 of 1 : CH_2015_NA0060_5_46_20150812_00018.jpg

Check Point / View				
Hwy 32 / Down				
Rating **	M	Issue No.	46	GPS Lat/Long
Issue Type +	Ma	Location *		39.725776 °
Category	Rivers, Channels & Designated Flood			-121.851207 °
Item	Vegetation & Obstructions			
DWR ID	DWR_NA0060_5_c_2012_46			
Action/Comments				
Inspector Comments: Moderate vegetation on north bank. The flow is not impeded.

View of the channel facing downstream.

Rating **	A	Issue No.	47	GPS Lat/Long
Issue Type +	Ma	Location *		39.725776 °
Category	Rivers, Channels & Designated Flood			-121.851207 °
Item	Shoaling / Sedimentation			
DWR ID	DWR_NA0060_5_c_2012_47			
Action/Comments				
Inspector Comments: No shoaling or sedimentation observed.

Rating **	A	Issue No.	48	GPS Lat/Long
Issue Type +	Ma	Location *		39.725776 °
Category	Rivers, Channels & Designated Flood			-121.851207 °
Item	Erosion / Bank Caving			
DWR ID	DWR_NA0060_5_c_2012_48			
Action/Comments				
Inspector Comments: No erosion observed.

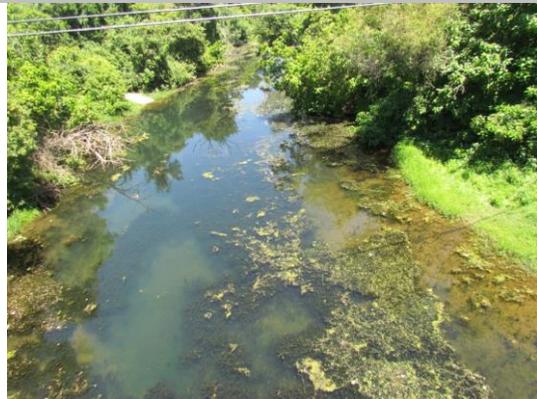
Photo 1 of 1 : CH_2015_NA0060_5_51_20150812_00015.jpg

Check Point / View				
Mud Creek at River Rd / Up				
Rating **	A	Issue No.	51	GPS Lat/Long
Issue Type +	Ma	Location *		39.704580 °
Category	Rivers, Channels & Designated Flood			-121.939320 °
Item	Vegetation & Obstructions			
DWR ID	DWR_NA0060_5_c_2012_51			
Action/Comments				
Inspector Comments: Scattered obstructions and vegetation. The flow is not impeded.

View of Mud Creek at River Road facing upstream.

Rating **	A	Issue No.	52	GPS Lat/Long
Issue Type +	Ma	Location *		39.704580 °
Category	Rivers, Channels & Designated Flood			-121.939320 °
Item	Shoaling / Sedimentation			
DWR ID	DWR_NA0060_5_c_2012_52			
Action/Comments				
Inspector Comments: No shoaling or sedimentation observed.

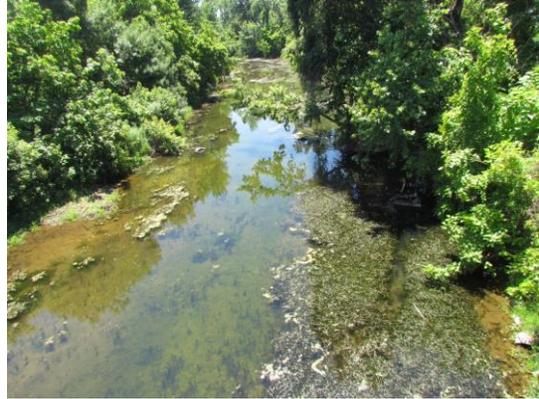
Photo 1 of 1 : CH_2015_NA0060_5_56_20150812_00016.jpg

Check Point / View			
Mud Creek at River Rd / Down			
Rating **	A	Issue No.	56
Issue Type +	Ma	Location *	GPS Lat/Long
Category	Rivers, Channels & Designated Flood		-121.939320 °
Item	Vegetation & Obstructions		
DWR ID	DWR_NA0060_5_c_2012_56		
Action/Comments			
Inspector Comments: Scattered obstructions and vegetation. The flow is not impeded.

View of Mud Creek at River Road facing downstream.

Rating **	A	Issue No.	57
Issue Type +	Ma	Location *	GPS Lat/Long
Category	Rivers, Channels & Designated Flood		-121.939320 °
Item	Shoaling / Sedimentation		
DWR ID	DWR_NA0060_5_c_2012_57		
Action/Comments			
Inspector Comments: No shoaling or sedimentation observed.

Rating **	A	Issue No.	53
Issue Type +	Ma	Location *	GPS Lat/Long
Category	Rivers, Channels & Designated Flood		-121.939320 °
Item	Erosion / Bank Caving		
DWR ID	DWR_NA0060_5_c_2012_53		
Action/Comments			
Inspector Comments: No erosion observed.

Check Point / View				
Mud Creek at River Rd / Down (cont)				
Rating **	A	Issue No.	58	GPS Lat/Long
Issue Type +	Ma	Location *		39.704580 °
Category	Rivers, Channels & Designated Flood			-121.939320 °
Item	Erosion / Bank Caving			
DWR ID	DWR_NA0060_5_c_2012_58			
Action/Comments				
Inspector Comments: No erosion observed.

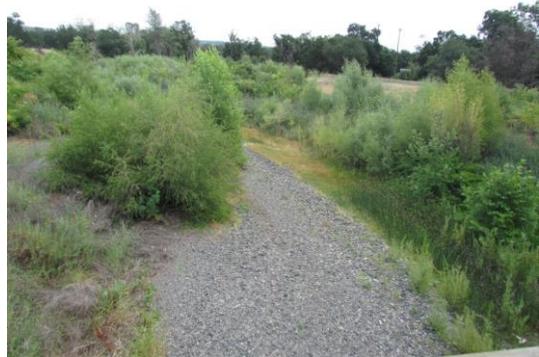
Photo 1 of 1 : CH_2015_NA0060_6_1_20150821_00039.jpg

Check Point / View			
Diversion Structure / Up			
Rating **	A	Issue No.	1
Issue Type +	Ma	Location *	39.761590 °
Category	Rivers, Channels & Designated Flood		-121.797320 °
Item	Vegetation & Obstructions		
DWR ID	DWR_NA0060_6_c_2012_1		
Action/Comments			
Inspector Comments: Minimal, scattered obstructions and small trees. The flow is not impeded.

View of the channel facing upstream.

Rating **	A	Issue No.	2
Issue Type +	Ma	Location *	39.761590 °
Category	Rivers, Channels & Designated Flood		-121.797320 °
Item	Shoaling / Sedimentation		
DWR ID	DWR_NA0060_6_c_2012_2		
Action/Comments			
Inspector Comments: No shoaling or sedimentation observed.

Rating **	A	Issue No.	3
Issue Type +	Ma	Location *	39.761590 °
Category	Rivers, Channels & Designated Flood		-121.797320 °
Item	Erosion / Bank Caving		
DWR ID	DWR_NA0060_6_c_2012_3		
Action/Comments			
Inspector Comments: No head cutting or horizontal deviation observed.

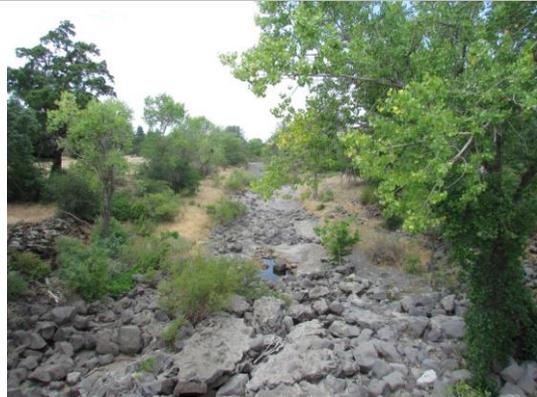
Photo 1 of 1 : CH_2015_NA0060_6_6_20150821_00040.jpg

Check Point / View			
Diversion Structure / Down			
Rating **	A	Issue No. 6	GPS Lat/Long
Issue Type +	Ma	Location *	39.761590 °
Category	Rivers, Channels & Designated Flood		-121.797320 °
Item	Vegetation & Obstructions		
DWR ID	DWR_NA0060_6_c_2012_6		
Action/Comments			
Inspector Comments: Minimal, scattered obstructions or vegetation. The flow is not impeded.

View of the channel facing downstream.

Check Point / View			
Diversion Structure / Down (cont)			
Rating **	A	Issue No. 7	GPS Lat/Long
Issue Type +	Ma	Location *	39.761590 °
Category	Rivers, Channels & Designated Flood		-121.797320 °
Item	Shoaling / Sedimentation		
DWR ID	DWR_NA0060_6_c_2012_7		
Action/Comments			
Inspector Comments: No shoaling or sedimentation observed.

Rating **	A	Issue No. 8	GPS Lat/Long
Issue Type +	Ma	Location *	39.761590 °
Category	Rivers, Channels & Designated Flood		-121.797320 °
Item	Erosion / Bank Caving		
DWR ID	DWR_NA0060_6_c_2012_8		
Action/Comments			
Inspector Comments: No head cutting or horizontal deviation observed.

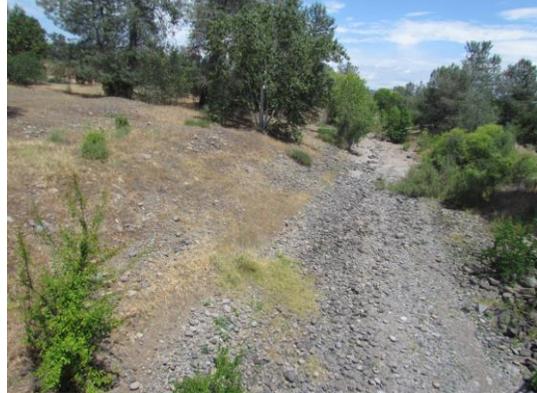
Photo 1 of 1 : CH_2015_NA0060_6_11_20150821_00041.jpg

Check Point / View			
Manzanita Ave / Up			
Rating **	A	Issue No.	11
Issue Type +	Ma	Location *	39.760390 °
Category	Rivers, Channels & Designated Flood		-121.801621 °
Item	Vegetation & Obstructions		
DWR ID	DWR_NA0060_6_c_2012_11		
Action/Comments			
Inspector Comments: Minimal, scattered obstructions or vegetation. The flow is not impeded.

View of the channel facing upstream.

Rating **	A	Issue No.	12
Issue Type +	Ma	Location *	39.760390 °
Category	Rivers, Channels & Designated Flood		-121.801621 °
Item	Shoaling / Sedimentation		
DWR ID	DWR_NA0060_6_c_2012_12		
Action/Comments			
Inspector Comments: Minimal shoaling or sedimentation observed.

Check Point / View				GPS Lat/Long	No Photos
Manzanita Ave / Up (cont)					
Rating **	A	Issue No.	13		
Issue Type +	Ma	Location *		39.760390 °	
Category	Rivers, Channels & Designated Flood			-121.801621 °	
Item	Erosion / Bank Caving				
DWR ID	DWR_NA0060_6_c_2012_13				
Action/Comments					
Inspector Comments: No head cutting or horizontal deviation observed.

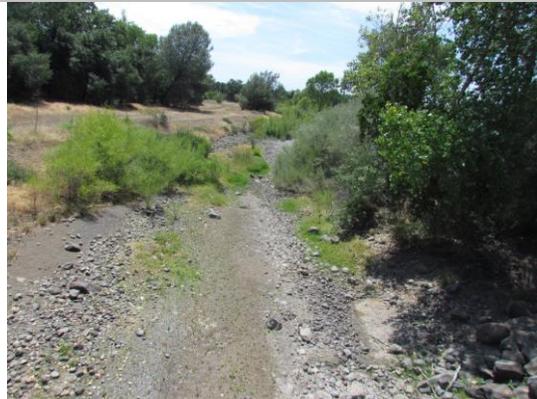
Photo 1 of 1 : CH_2015_NA0060_6_16_20150821_00042.jpg

Check Point / View			
Manzanita Ave / Down			
Rating **	A	Issue No.	16
Issue Type +	Ma	Location *	39.760390 °
Category	Rivers, Channels & Designated Flood		-121.801621 °
Item	Vegetation & Obstructions		
DWR ID	DWR_NA0060_6_c_2012_16		
Action/Comments			
Inspector Comments: Minimal, scattered obstructions or vegetation. The flow is not impeded.

View of the channel facing downstream.

Rating **	A	Issue No.	17
Issue Type +	Ma	Location *	39.760390 °
Category	Rivers, Channels & Designated Flood		-121.801621 °
Item	Shoaling / Sedimentation		
DWR ID	DWR_NA0060_6_c_2012_17		
Action/Comments			
Inspector Comments: No shoaling or sedimentation observed.

Rating **	A	Issue No.	18
Issue Type +	Ma	Location *	39.760390 °
Category	Rivers, Channels & Designated Flood		-121.801621 °
Item	Erosion / Bank Caving		
DWR ID	DWR_NA0060_6_c_2012_18		
Action/Comments			
Inspector Comments: Some head cutting or horizontal deviation observed due to high water in past years.

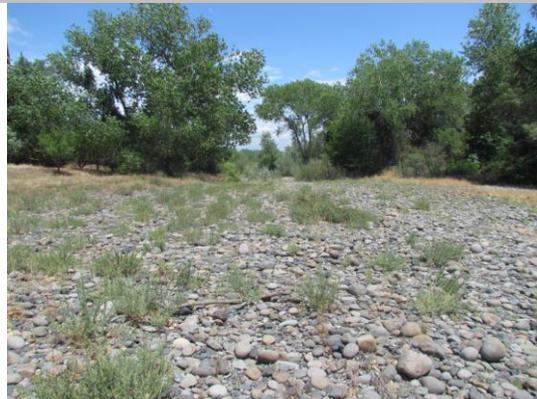
Photo 1 of 1 : CH_2015_NA0060_6_21_20150821_00044.jpg

Check Point / View			
Bike Path Bridge at Madrone Ave / Up			
Rating **	A	Issue No.	21
Issue Type +	Ma	Location *	39.755400 °
Category	Rivers, Channels & Designated Flood		-121.814580 °
Item	Vegetation & Obstructions		
DWR ID	DWR_NA0060_6_c_2012_21		
Action/Comments			
Inspector Comments: Minimal, scattered obstructions or vegetation. The flow is not impeded.

View of the channel facing upstream.

Check Point / View				GPS Lat/Long	No Photos
Bike Path Bridge at Madrone Ave / Up (cont)					
Rating **	A	Issue No.	22		
Issue Type +	Ma	Location *		39.755400 °	
Category	Rivers, Channels & Designated Flood			-121.814580 °	
Item	Shoaling / Sedimentation				
DWR ID	DWR_NA0060_6_c_2012_22				
Action/Comments					
Inspector Comments: Minimal shoaling or sedimentation observed.

Rating **	A	Issue No.	23	GPS Lat/Long	No Photos
Issue Type +	Ma	Location *		39.755400 °	
Category	Rivers, Channels & Designated Flood			-121.814580 °	
Item	Erosion / Bank Caving				
DWR ID	DWR_NA0060_6_c_2012_23				
Action/Comments					
Inspector Comments: No head cutting or horizontal deviation observed.

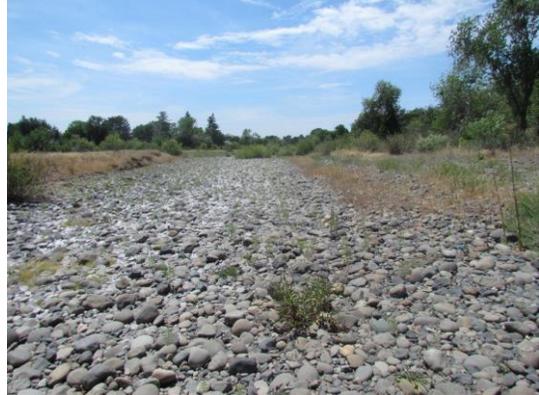
Photo 1 of 1 : CH_2015_NA0060_6_26_20150821_00043.jpg

Check Point / View			
Bike Path Bridge at Madrone Ave / Down			
Rating **	A	Issue No.	26
Issue Type +	Ma	Location *	39.755400 °
Category	Rivers, Channels & Designated Flood		-121.814580 °
Item	Vegetation & Obstructions		
DWR ID	DWR_NA0060_6_c_2012_26		
Action/Comments			
Inspector Comments: Minimal, scattered obstructions or vegetation. The flow is not impeded.

View of the channel facing downstream.

Rating **	A	Issue No.	27	GPS Lat/Long
Issue Type +	Ma	Location *		39.755400 °
Category	Rivers, Channels & Designated Flood			-121.814580 °
Item	Shoaling / Sedimentation			
DWR ID	DWR_NA0060_6_c_2012_27			
Action/Comments				
Inspector Comments: No shoaling or sedimentation observed.

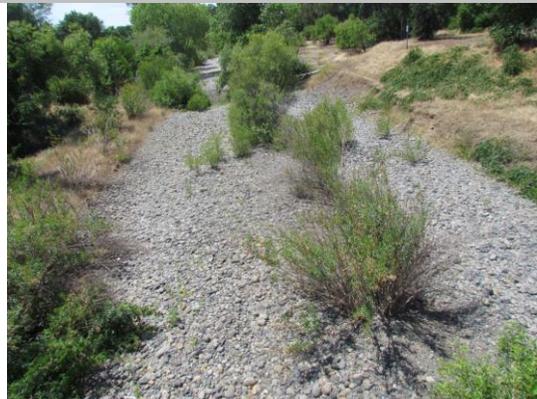
Photo 1 of 1 : CH_2015_NA0060_6_36_20150821_00046.jpg

Check Point / View			
Mariposa Ave / Down			
Rating **	A	Issue No. 36	GPS Lat/Long
Issue Type +	Ma	Location *	39.752730 °
Category	Rivers, Channels & Designated Flood		-121.824560 °
Item	Vegetation & Obstructions		
DWR ID	DWR_NA0060_6_c_2012_36		
Action/Comments			
Inspector Comments: Minimal, scattered obstructions or vegetation. The flow is not impeded.

View of the channel facing downstream.

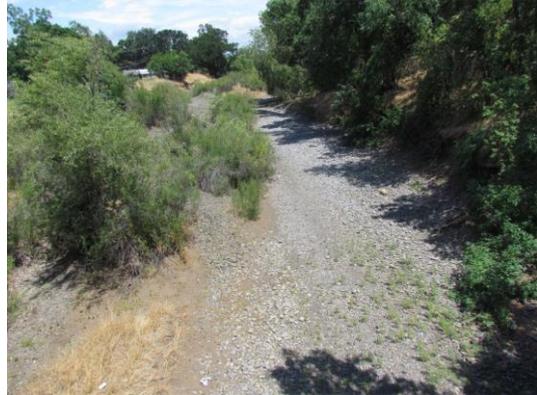
Photo 1 of 1 : CH_2015_NA0060_6_41_20150821_00047.jpg

Check Point / View				
5th Ave / Up				
Rating **	A	Issue No.	41	GPS Lat/Long
Issue Type +	Ma	Location *		39.753307 °
Category	Rivers, Channels & Designated Flood			-121.829234 °
Item	Vegetation & Obstructions			
DWR ID	DWR_NA0060_6_c_2012_41			
Action/Comments				
Inspector Comments: Minimal, scattered obstructions or vegetation. The flow is not impeded.

View of the channel facing upstream.

Rating **	A	Issue No.	42	GPS Lat/Long
Issue Type +	Ma	Location *		39.753307 °
Category	Rivers, Channels & Designated Flood			-121.829234 °
Item	Shoaling / Sedimentation			
DWR ID	DWR_NA0060_6_c_2012_42			
Action/Comments				
Inspector Comments: Minimal shoaling or sedimentation observed, but doesn't impede the flow of the channel.

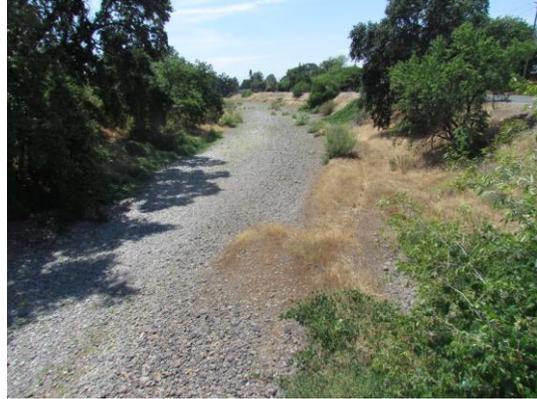
Photo 1 of 1 : CH_2015_NA0060_6_46_20150821_00048.jpg

Check Point / View			
5th Ave / Down			
Rating **	A	Issue No.	46
Issue Type +	Ma	Location *	39.753307 °
Category	Rivers, Channels & Designated Flood		-121.829234 °
Item	Vegetation & Obstructions		
DWR ID	DWR_NA0060_6_c_2012_46		
Action/Comments			
Inspector Comments: Minimal, scattered obstructions or vegetation. The flow is not impeded.

View of the channel facing downstream.

Rating **	A	Issue No.	47
Issue Type +	Ma	Location *	39.753307 °
Category	Rivers, Channels & Designated Flood		-121.829234 °
Item	Shoaling / Sedimentation		
DWR ID	DWR_NA0060_6_c_2012_47		
Action/Comments			
Inspector Comments: Minimal shoaling or sedimentation present, but the flow is not impeded.

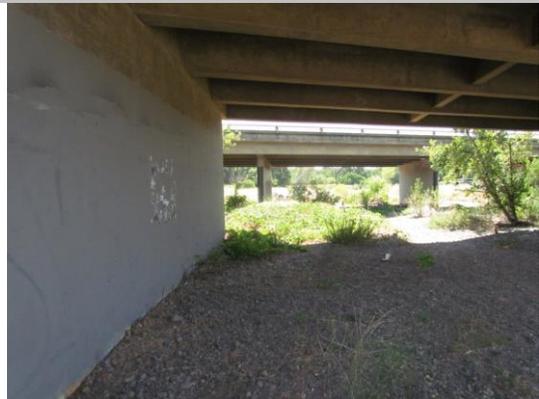
Photo 1 of 1 : CH_2015_NA0060_6_96_20150821_00050.jpg

Check Point / View			
Highway 99 / Down			
Rating **	A	Issue No.	96
Issue Type +	Ma	Location *	39.751220 °
Category	Rivers, Channels & Designated Flood		-121.840042 °
Item	Vegetation & Obstructions		
DWR ID	DWR_NA0060_6_c_2015_96		
Action/Comments			
Inspector Comments: Minimal, scattered obstructions or vegetation. The flow is not impeded.

View of the channel facing downstream.

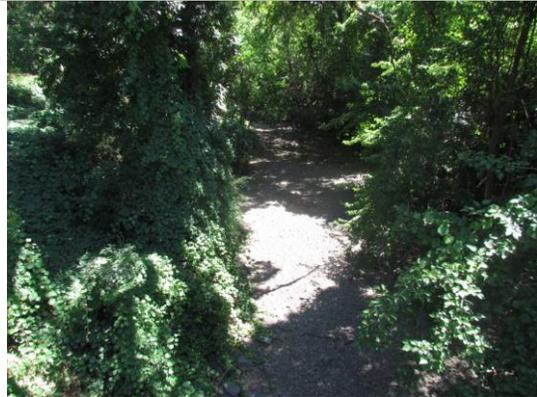
Photo 1 of 1 : CH_2015_NA0060_6_111_20150820_00030.jpg

Check Point / View			
Mangrove Avenue / Up			
Rating **	A	Issue No.	111
Issue Type +	Ma	Location *	39.750979 °
Category	Rivers, Channels & Designated Flood		-121.844711 °
Item	Vegetation & Obstructions		
DWR ID	DWR_NA0060_6_c_2015_111		
Action/Comments			
Inspector Comments: Minimal, scattered obstructions or vegetation. The flow is not impeded.

View of the channel facing upstream.

Rating **	A	Issue No.	112
Issue Type +	Ma	Location *	39.750979 °
Category	Rivers, Channels & Designated Flood		-121.844711 °
Item	Shoaling / Sedimentation		
DWR ID	DWR_NA0060_6_c_2015_112		
Action/Comments			
Inspector Comments: No shoaling or sedimentation observed.

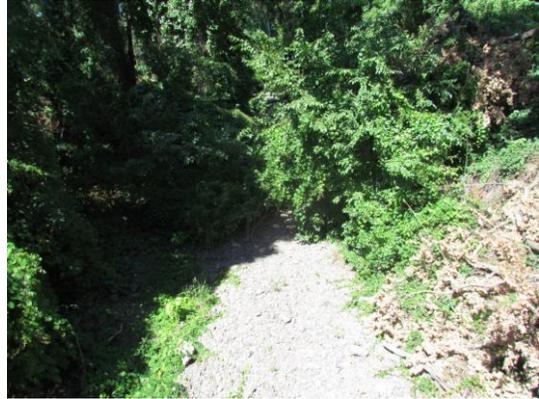
Photo 1 of 1 : CH_2015_NA0060_6_116_20150820_00029.jpg

Check Point / View			
Mangrove Avenue / Down			
Rating **	M	Issue No.	116
Issue Type +	Ma	Location *	GPS Lat/Long
Category	Rivers, Channels & Designated Flood		39.750979 °
Item	Vegetation & Obstructions		-121.844711 °
DWR ID	DWR_NA0060_6_c_2015_116		
Action/Comments			
Inspector Comments: Minimal, scattered obstructions and vegetation may impede the flow of the channel.

View of the channel facing downstream.

Rating **	A	Issue No.	117
Issue Type +	Ma	Location *	GPS Lat/Long
Category	Rivers, Channels & Designated Flood		39.750979 °
Item	Shoaling / Sedimentation		-121.844711 °
DWR ID	DWR_NA0060_6_c_2015_117		
Action/Comments			
Inspector Comments: No shoaling or sedimentation observed.

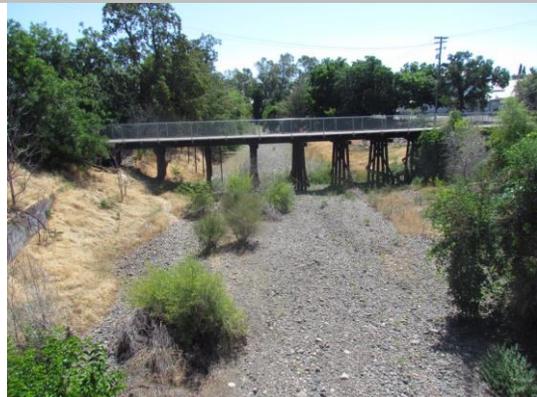
Photo 1 of 1 : CH_2015_NA0060_6_51_20150821_00033.jpg

Check Point / View			
Esplanade / Up			
Rating **	A	Issue No. 51	GPS Lat/Long
Issue Type +	Ma	Location *	39.749458 °
Category	Rivers, Channels & Designated Flood		-121.854296 °
Item	Vegetation & Obstructions		
DWR ID	DWR_NA0060_6_c_2012_51		
Action/Comments			
Inspector Comments: Minimal, scattered obstructions or vegetation. The flow is not impeded.

View of the channel facing upstream.

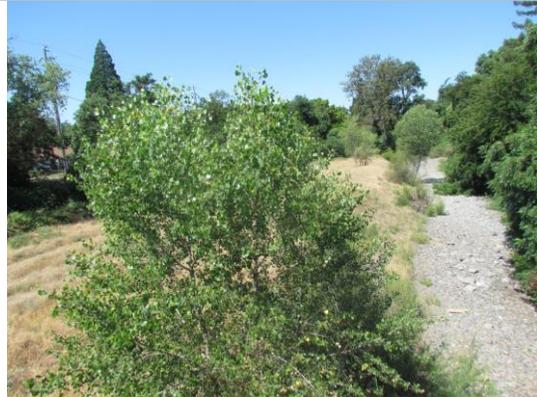
Photo 1 of 1 : CH_2015_NA0060_6_56_20150821_00031.jpg

Check Point / View			
Esplanade / Down			
Rating **	A	Issue No.	56
Issue Type +	Ma	Location *	39.749458 °
Category	Rivers, Channels & Designated Flood		-121.854296 °
Item	Vegetation & Obstructions		
DWR ID	DWR_NA0060_6_c_2012_56		
Action/Comments			
Inspector Comments: Minimal, scattered obstructions or vegetation. The flow is not impeded.

View of the channel facing downstream.

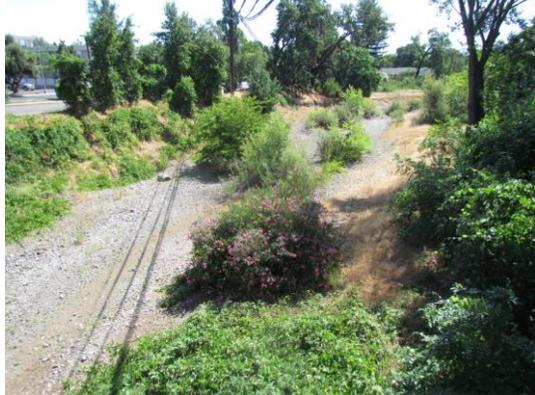
Photo 1 of 1 : CH_2015_NA0060_6_101_20150821_00036.jpg

Check Point / View			
Holly Avenue / Up			
Rating **	A	Issue No.	101
			GPS Lat/Long
Issue Type +	Ma	Location *	39.749209 °
Category	Rivers, Channels & Designated Flood		-121.865682 °
Item	Vegetation & Obstructions		
DWR ID	DWR_NA0060_12_c_2015_101		
Action/Comments			
Inspector Comments: Minimal, scattered obstructions or vegetation. The flow is not impeded.

View of the channel facing upstream.

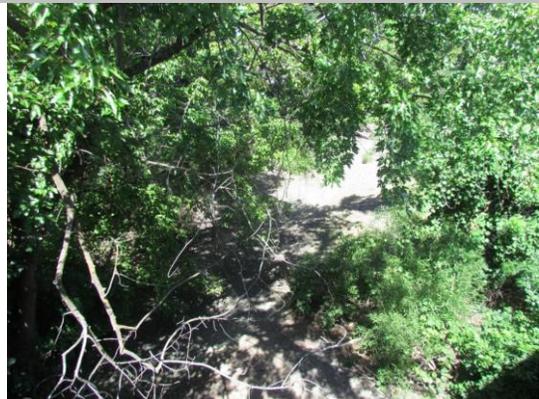
Photo 1 of 1 : CH_2015_NA0060_6_106_20150821_00037.jpg

Check Point / View			
Holly Avenue / Down			
Rating **	A	Issue No.	106
Issue Type +	Ma	Location *	39.749209 °
Category	Rivers, Channels & Designated Flood		-121.865682 °
Item	Vegetation & Obstructions		
DWR ID	DWR_NA0060_6_c_2015_106		
Action/Comments			
Inspector Comments: Minimal, scattered obstructions or vegetation. The flow is not impeded.

View of the channel facing downstream.

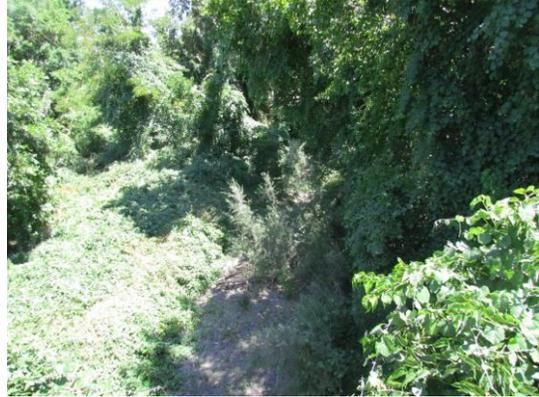
Photo 1 of 1 : CH_2015_NA0060_6_61_20150820_00028.jpg

Check Point / View				
Hwy 32 / Up				
Rating **	A	Issue No.	61	GPS Lat/Long
Issue Type +	Ma	Location *		39.741277 °
Category	Rivers, Channels & Designated Flood			-121.881402 °
Item	Vegetation & Obstructions			
DWR ID	DWR_NA0060_6_c_2012_61			
Action/Comments				
Inspector Comments: Vegetation exists but does not impede the flow.

View of the channel facing upstream.

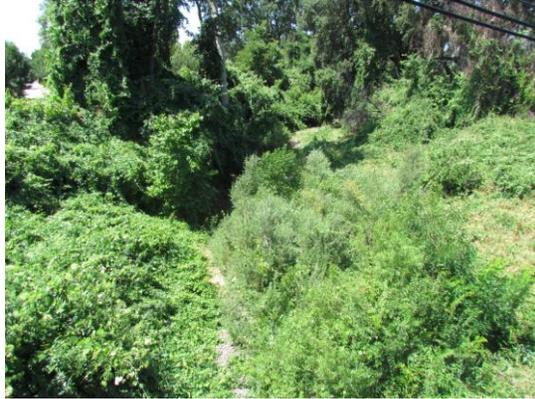
Photo 1 of 1 : CH_2015_NA0060_6_66_20150820_00027.jpg

Check Point / View			
Hwy 32 / Down			
Rating **	A	Issue No. 66	GPS Lat/Long
Issue Type +	Ma	Location *	39.741277 °
Category	Rivers, Channels & Designated Flood		-121.881402 °
Item	Vegetation & Obstructions		
DWR ID	DWR_NA0060_6_c_2012_66		
Action/Comments			
Inspector Comments: Vegetation exists but does not impede the flow.

View of the channel facing downstream.

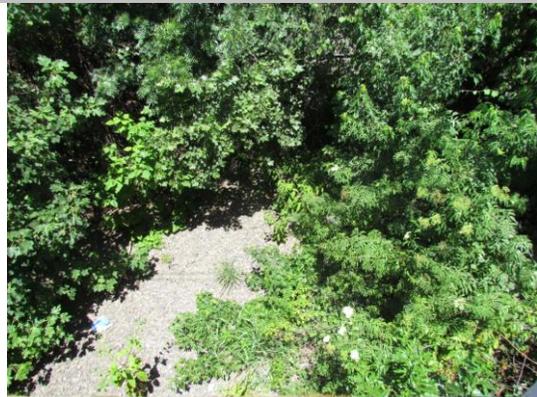
Photo 1 of 1 : CH_2015_NA0060_6_71_20150820_00026.jpg

Check Point / View			
Oak Ave. / Up			
Rating **	M	Issue No.	71
Issue Type +	Ma	Location *	39.735560 °
Category	Rivers, Channels & Designated Flood		-121.890970 °
Item	Vegetation & Obstructions		
DWR ID	DWR_NA0060_6_c_2012_71		
Action/Comments			
Inspector Comments: Scattered obstructions and vegetation.

View of the channel facing upstream.

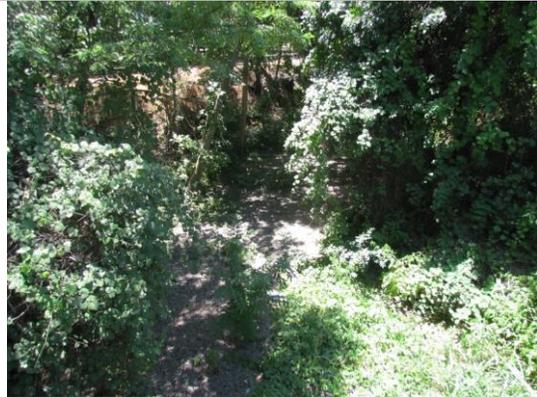
Photo 1 of 1 : CH_2015_NA0060_6_76_20150820_00025.jpg

Check Point / View				
Oak Ave. / Down				
Rating **	A	Issue No.	76	GPS Lat/Long
Issue Type +	Ma	Location *		39.735560 °
Category	Rivers, Channels & Designated Flood			-121.890970 °
Item	Vegetation & Obstructions			
DWR ID	DWR_NA0060_6_c_2012_76			
Action/Comments				
Inspector Comments: scattered obstructions and vegetation, but doesn't impede the flow.

View of the channel facing downstream.

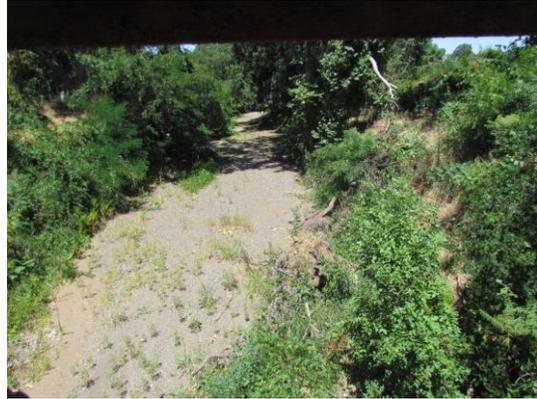
Photo 1 of 1 : CH_2015_NA0060_6_81_20150820_00024.jpg

Check Point / View				
Grape Way / Up				
Rating **	A	Issue No.	81	GPS Lat/Long
Issue Type +	Ma	Location *		39.722724 °
Category	Rivers, Channels & Designated Flood			-121.912363 °
Item	Vegetation & Obstructions			
DWR ID	DWR_NA0060_6_c_2012_81			
Action/Comments				
Inspector Comments: Scattered obstructions and vegetation, but doesn't impede the flow.

View of the channel facing upstream.

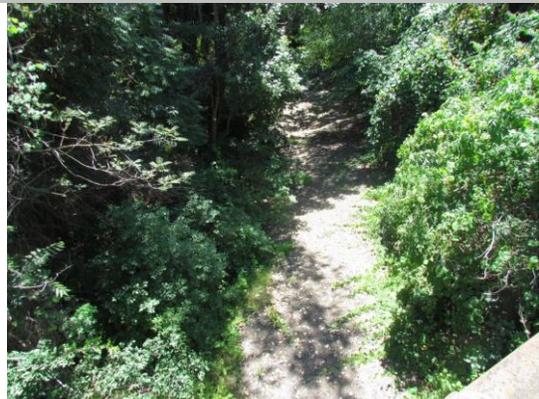
Photo 1 of 1 : CH_2015_NA0060_6_86_20150820_00023.jpg

Check Point / View				
Grape Way / Down				
Rating **	A	Issue No.	86	GPS Lat/Long
Issue Type +	Ma	Location *		39.722724 °
Category	Rivers, Channels & Designated Flood			-121.912363 °
Item	Vegetation & Obstructions			
DWR ID	DWR_NA0060_6_c_2012_86			
Action/Comments				
Inspector Comments: Scattered obstructions and vegetation, but doesn't impede the flow of the channel.

View of the channel facing downstream.

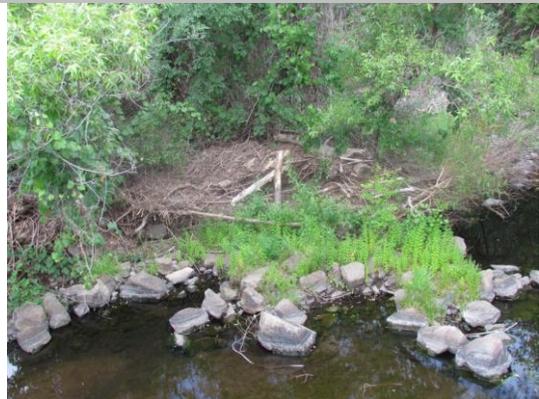
Photo 1 of 2 : CH_2015_NA0060_12_6_20150728_00038.jpg

Check Point / View			
Little Chico Ck Control Structure / Down			
Rating **	M	Issue No.	6
Issue Type +	Ma	Location *	39.733681 °
Category	Rivers, Channels & Designated Flood		-121.771865 °
Item	Vegetation & Obstructions		
DWR ID	DWR_NA0060_12_c_2012_6		
Action/Comments			
Inspector Comments: Scattered obstructions and vegetation. The flow is not impeded. Willow trees should be removed in the future.

View of the channel facing downstream.

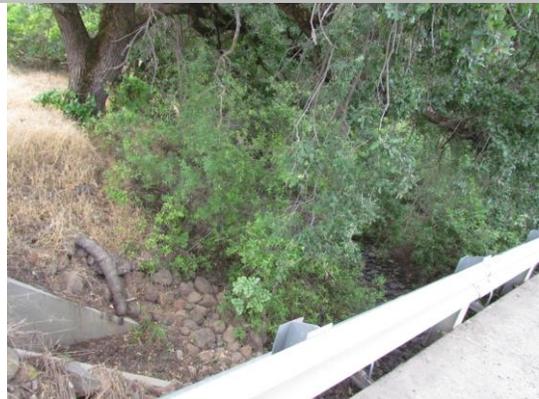
Photo 1 of 1 : CH_2015_NA0060_12_11_20150728_00039.jpg

Check Point / View			
Bruce Rd / Up			
Rating **	M	Issue No.	11
Issue Type +	Ma	Location *	39.733316 °
Category	Rivers, Channels & Designated Flood		-121.787540 °
Item	Vegetation & Obstructions		
DWR ID	DWR_NA0060_12_c_2012_11		
Action/Comments			
Inspector Comments: The vegetation obstructed the view of the channel. Flow may be impeded in the high water event.

Photo of the channel facing upstream.

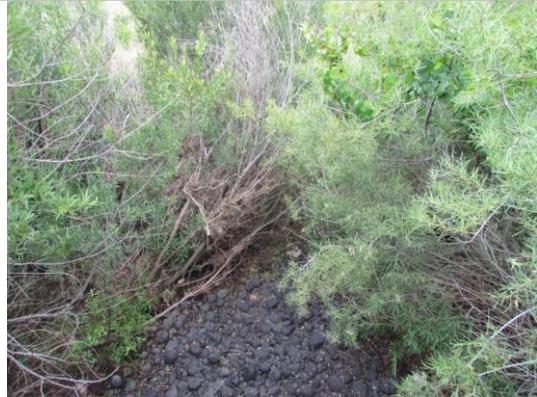
Photo 1 of 1 : CH_2015_NA0060_12_16_20150728_00040.jpg

Check Point / View				
Bruce Rd / Down				
Rating **	U	Issue No.	16	GPS Lat/Long
Issue Type +	Ma	Location *		39.733316 °
Category	Rivers, Channels & Designated Flood			-121.787540 °
Item	Vegetation & Obstructions			
DWR ID	DWR_NA0060_12_c_2012_16			
Action/Comments				
Inspector Comments: The vegetation obstructed the view of the channel. Flow may be impeded in high water.

Photo of the channel from the bridge facing downstream.

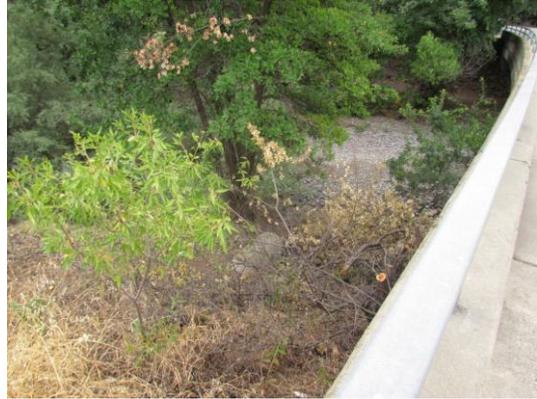
Photo 1 of 1 : CH_2015_NA0060_12_21_20150724_00031.jpg

Check Point / View			
Forest Ave / Up			
Rating **	A	Issue No.	21
Issue Type +	Ma	Location *	39.737400 °
Category	Rivers, Channels & Designated Flood		-121.804530 °
Item	Vegetation & Obstructions		
DWR ID	DWR_NA0060_12_c_2012_21		
Action/Comments			
Inspector Comments: Minimal, scattered obstructions and vegetation. The flow does not appear impeded.

View of the channel from the bridge facing upstream.

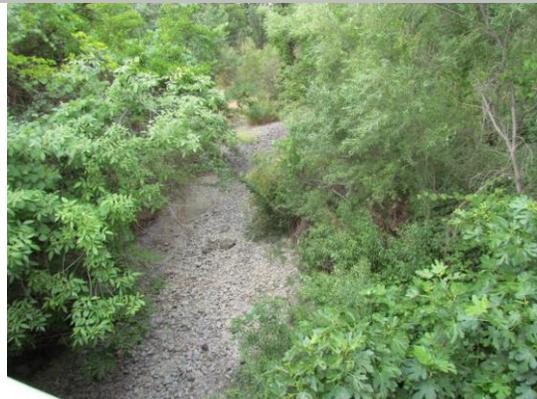
Photo 1 of 1 : CH_2015_NA0060_12_26_20150724_00033.jpg

Check Point / View			
Forest Ave / Down			
Rating **	M	Issue No.	26
Issue Type +	Ma	Location *	39.737400 °
Category	Rivers, Channels & Designated Flood		-121.804530 °
Item	Vegetation & Obstructions		
DWR ID	DWR_NA0060_12_c_2012_26		
Action/Comments			
Inspector Comments: Moderate vegetation observed. Flow may be obstructed in high water.

View of the channel from the bridge facing downstream.

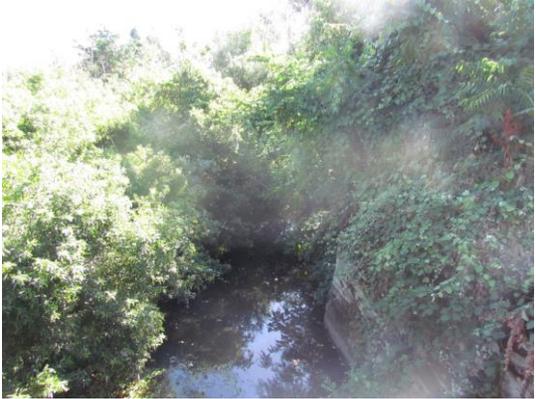
Photo 1 of 1 : CH_2015_NA0060_12_82_20150724_00017.jpg

Check Point / View				
Bruce Street / Up				
Rating **	M	Issue No.	82	GPS Lat/Long
Issue Type +	Ma	Location *		39.733204 °
Category	Rivers, Channels & Designated Flood			-121.819610 °
Item	Vegetation & Obstructions			
DWR ID	DWR_NA0060_12_c_2015_82			
Action/Comments				
Inspector Comments: There is vegetation in the channel and it appears to potentially impede the flow.

View of the channel from the bridge facing upstream.

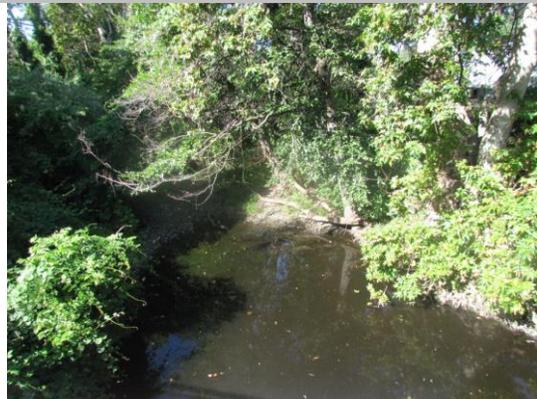
Photo 1 of 1 : CH_2015_NA0060_12_89_20150724_00018.jpg

Check Point / View			
Bruce Street / Down			
Rating **	A	Issue No.	89
Issue Type +	Ma	Location *	39.733204 °
Category	Rivers, Channels & Designated Flood		-121.819610 °
Item	Vegetation & Obstructions		
DWR ID	DWR_NA0060_12_c_2015_89		
Action/Comments			
Inspector Comments: Channel was free of vegetation.

View of the channel from the bridge facing downstream.

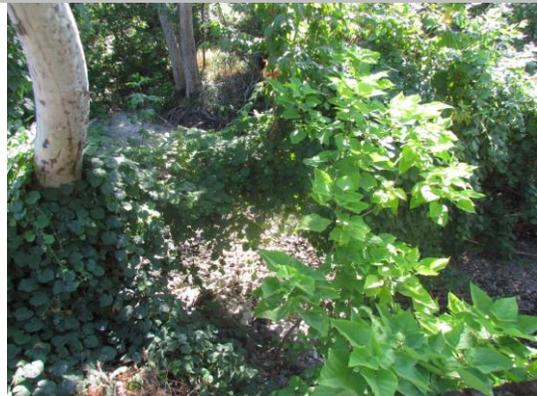
Photo 1 of 1 : CH_2015_NA0060_12_41_20150724_00020.jpg

Check Point / View				
Boucher St / Up				
Rating **	M	Issue No.	41	GPS Lat/Long
Issue Type +	Ma	Location *		39.730240 °
Category	Rivers, Channels & Designated Flood			-121.823800 °
Item	Vegetation & Obstructions			
DWR ID	DWR_NA0060_12_c_2012_41			
Action/Comments				
Inspector Comments: There is vegetation in the channel and overhanging the channel, the flow does not appear impeded.

View of the channel from the bridge facing upstream.

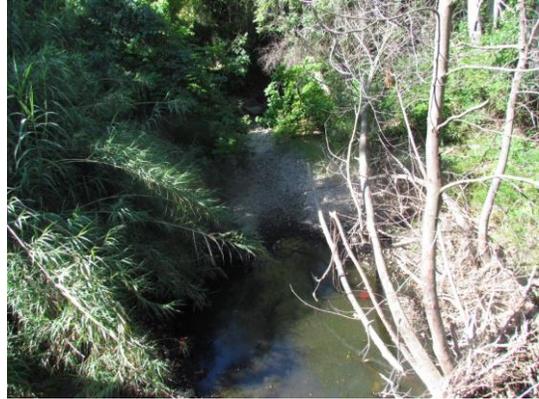
Photo 1 of 1 : CH_2015_NA0060_12_46_20150724_00019.jpg

Check Point / View				
Boucher St / Down				
Rating **	M	Issue No.	46	GPS Lat/Long
Issue Type +	Ma	Location *		39.730240 °
Category	Rivers, Channels & Designated Flood			-121.823800 °
Item	Vegetation & Obstructions			
DWR ID	DWR_NA0060_12_c_2012_46			
Action/Comments				
Inspector Comments: There is vegetation in the channel, overhanging the channel, and arundo. The flow does appear slightly impeded.

View of the channel from the bridge facing downstream.

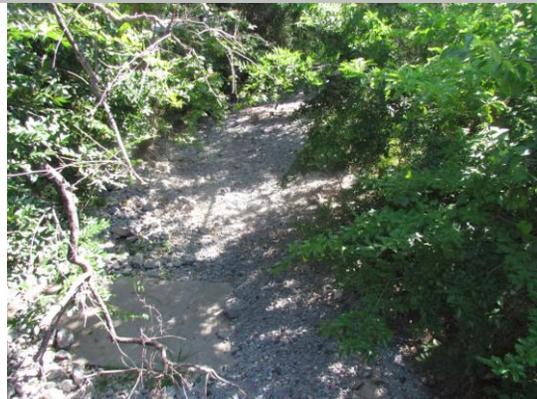
Photo 1 of 1 : CH_2015_NA0060_12_51_20150724_00021.jpg

Check Point / View			
Olive St / Up			
Rating **	A	Issue No.	51
Issue Type +	Ma	Location *	39.726792 °
Category	Rivers, Channels & Designated Flood		-121.829713 °
Item	Vegetation & Obstructions		
DWR ID	DWR_NA0060_12_c_2012_51		
Action/Comments			
Inspector Comments: There is vegetation in the channel, it does not appear to impeded the flow.

View of the channel from the bridge facing upstream.

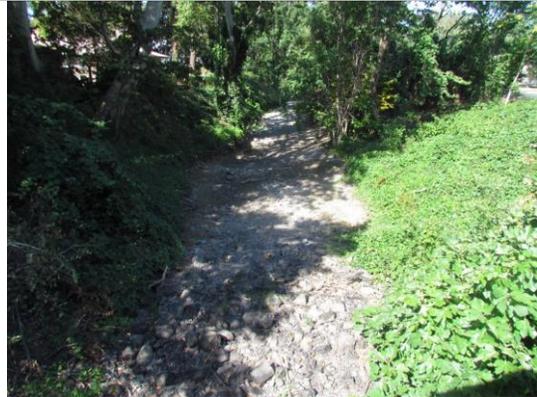
Photo 1 of 1 : CH_2015_NA0060_12_56_20150724_00022.jpg

Check Point / View				
Olive St / Down				
Rating **	A	Issue No.	56	GPS Lat/Long
Issue Type +	Ma	Location *		39.726792 °
Category	Rivers, Channels & Designated Flood			-121.829713 °
Item	Vegetation & Obstructions			
DWR ID	DWR_NA0060_12_c_2012_56			
Action/Comments				
Inspector Comments: There is vegetation in the channel, the flow does not appear impeded.

View of the channel from the bridge facing downstream.

Rating **	A	Issue No.	57	GPS Lat/Long
Issue Type +	Ma	Location *		39.726792 °
Category	Rivers, Channels & Designated Flood			-121.829713 °
Item	Shoaling / Sedimentation			
DWR ID	DWR_NA0060_12_c_2012_57			
Action/Comments				
Inspector Comments: There is minimal sedimentation in the channel, the flow does not appear impeded.

Rating **	M	Issue No.	60	GPS Lat/Long
Issue Type +	En	Location *		39.726792 °
Category	Rivers, Channels & Designated Flood			-121.829713 °
Item	Encroachments			
DWR ID	DWR_NA0060_12_c_2012_60			
Action/Comments				
Inspector Comments: There is a structure on the right bank of the channel, no permit found.

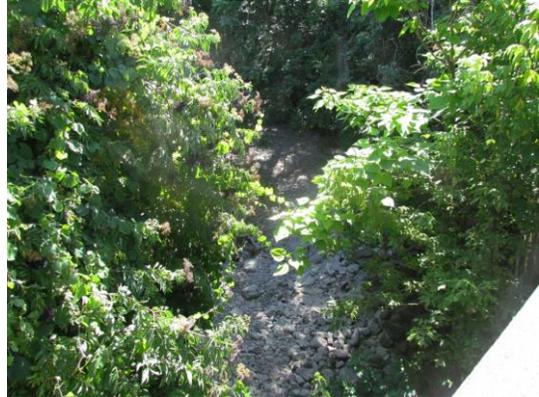
Photo 1 of 1 : CH_2015_NA0060_12_61_20150724_00023.jpg

Check Point / View			
Broadway St / Up			
Rating **	A	Issue No. 61	GPS Lat/Long
Issue Type +	Ma	Location *	39.724328 °
Category	Rivers, Channels & Designated Flood		-121.835233 °
Item	Vegetation & Obstructions		
DWR ID	DWR_NA0060_12_c_2012_61		
Action/Comments			
Inspector Comments: There is vegetation in the channel, the flow does not appear impeded.

View of the channel from the bridge facing upstream.

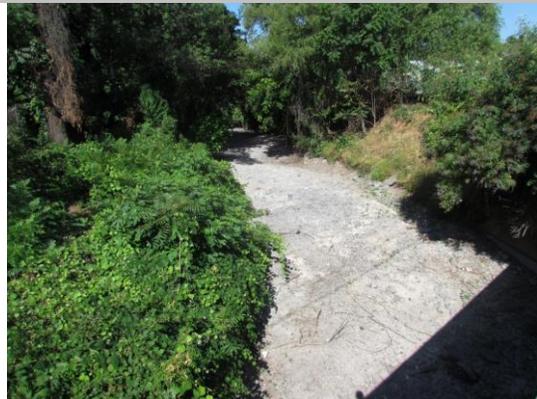
Photo 1 of 1 : CH_2015_NA0060_12_66_20150724_00024.jpg

Check Point / View			
Broadway St / Down			
Rating **	A	Issue No.	66
Issue Type +	Ma	Location *	39.724328 °
Category	Rivers, Channels & Designated Flood		-121.835233 °
Item	Vegetation & Obstructions		
DWR ID	DWR_NA0060_12_c_2012_66		
Action/Comments			
Inspector Comments: There is vegetation in the channel, the flow does not appear impeded.

View of the channel from the bridge facing downstream.

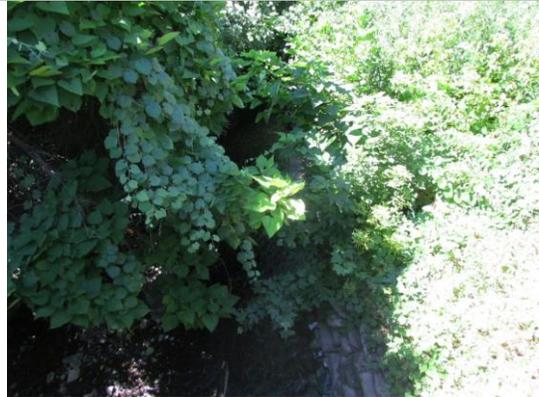
Photo 1 of 1 : CH_2015_NA0060_12_94_20150724_00025.jpg

Check Point / View				
Ivy Street / Up				
Rating **	A	Issue No.	94	GPS Lat/Long
Issue Type +	Ma	Location *		39.720476 °
Category	Rivers, Channels & Designated Flood			-121.838990 °
Item	Vegetation & Obstructions			
DWR ID	DWR_NA0060_5_c_2015_94			
Action/Comments				
Inspector Comments: Vegetation is present in the channel. The flow does not appear to be impeded.

View of the channel from the bridge facing upstream.

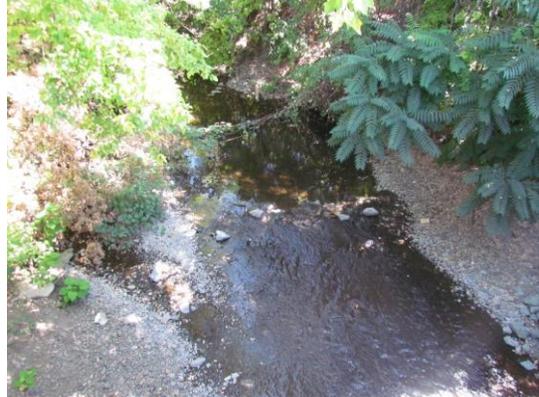
Photo 1 of 1 : CH_2015_NA0060_12_99_20150724_00026.jpg

Check Point / View			
Ivy Street / Down			
Rating **	A	Issue No.	99
Issue Type +	Ma	Location *	39.720476 °
Category	Rivers, Channels & Designated Flood		-121.838990 °
Item	Vegetation & Obstructions		
DWR ID	DWR_NA0060_12_c_2015_99		
Action/Comments			
Inspector Comments: The channel appeared to be free of any vegetation that would impede the flow.

View of the channel from the bridge facing downstream.

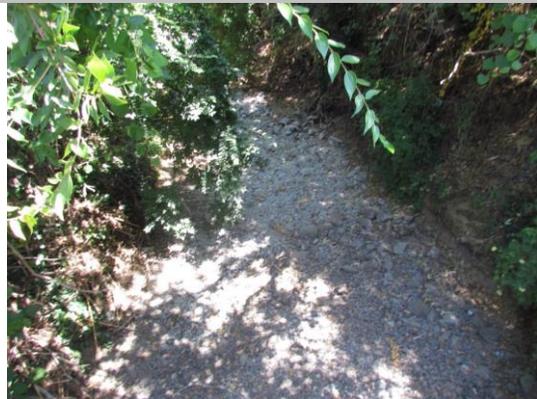
Photo 1 of 1 : CH_2015_NA0060_12_104_20150724_00027.jpg

Check Point / View			
Walnut Street / Up			
Rating **	A	Issue No.	104
Issue Type +	Ma	Location *	39.718434 °
Category	Rivers, Channels & Designated Flood		-121.843512 °
Item	Vegetation & Obstructions		
DWR ID	DWR_NA0060_12_c_2015_104		
Action/Comments			
Inspector Comments: The channel appeared to be free of any vegetation that would impede the flow.

View of the channel from the bridge facing upstream.

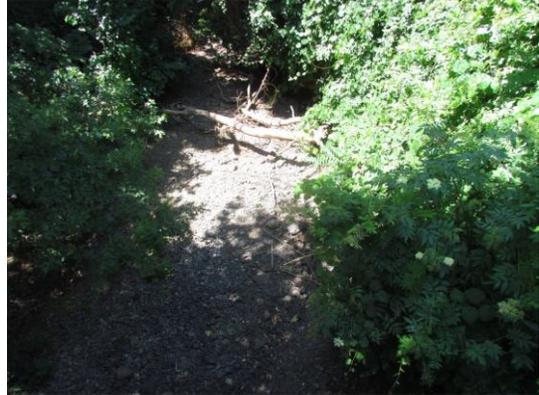
Photo 1 of 1 : CH_2015_NA0060_12_109_20150724_00028.jpg

Check Point / View				
Walnut Street / Down				
Rating **	A	Issue No.	109	GPS Lat/Long
Issue Type +	Ma	Location *		39.718434 °
Category	Rivers, Channels & Designated Flood			-121.843512 °
Item	Vegetation & Obstructions			
DWR ID	DWR_NA0060_12_c_2015_109			
Action/Comments				
Inspector Comments: The channel appeared free of any vegetation that would impede the flow.

View of the channel from the bridge facing downstream.

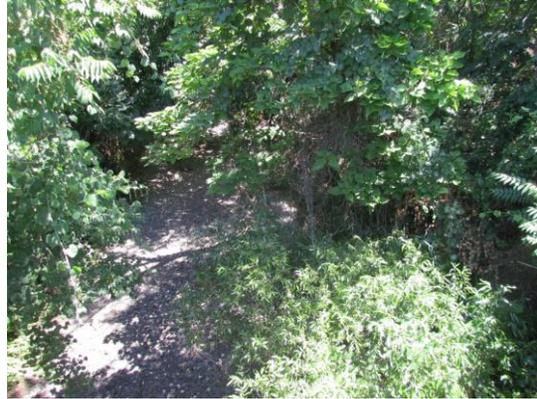
Photo 1 of 1 : CH_2015_NA0060_12_71_20150724_00029.jpg

Check Point / View			
Lone Pine Avenue / Up			
Rating **	A	Issue No.	71
Issue Type +	Ma	Location *	GPS Lat/Long
Category	Rivers, Channels & Designated Flood		39.703260 °
Item	Vegetation & Obstructions		-121.868470 °
DWR ID	DWR_NA0060_12_c_2012_71		
Action/Comments			
Inspector Comments: There is vegetation in the channel, the flow does not appear impeded.

View of the channel from the bridge facing upstream.

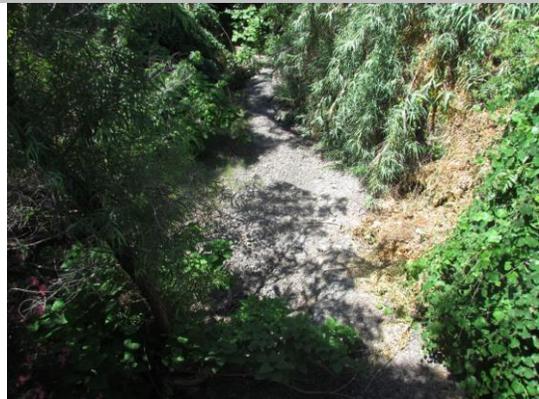
Photo 1 of 1 : CH_2015_NA0060_12_76_20150724_00030.jpg

Check Point / View				
Lone Pine Avenue / Down				
Rating **	A	Issue No.	76	GPS Lat/Long
Issue Type +	Ma	Location *		39.703260 °
Category	Rivers, Channels & Designated Flood			-121.868470 °
Item	Vegetation & Obstructions			
DWR ID	DWR_NA0060_12_c_2012_76			
Action/Comments				
Inspector Comments: There is vegetation in the channel, the flow does not appear impeded.

View of the channel facing downstream.
