**Flood Control Project Maintenance
Levee Inspections**
2016 Channel Summary Report
Overall Unit and Item Ratings

2016 Channel Inspection Results

DWR Sutter Maintenance Yard

Channel
Big Chico Creek

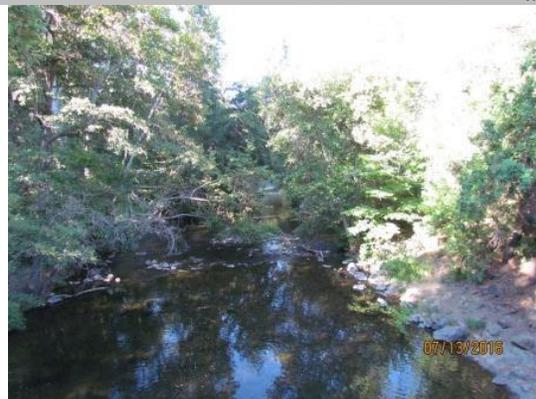
Photo 1 of 1 : CH_2016_NA0060_5_6_20160718_00015.jpg

Check Point / View			
Big Chico Creek Control Structure / Down			
Rating **	A	Issue No.	6
Issue Type +	Ma	Location *	39.761840 °
Category	Rivers, Channels & Designated Flood		-121.792590 °
Item	Vegetation & Obstructions		
DWR ID	DWR_NA0060_5_c_2012_6		
Action/Comments			
Inspector Comments: Minimal, scattered obstructions and vegetation. The flow is not impeded.

View of the downstream side of the channel from the structure.

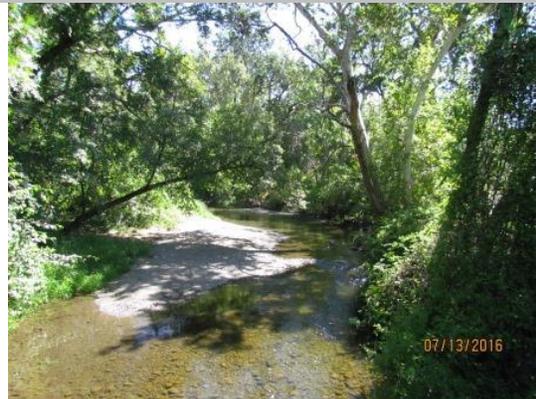
Photo 1 of 1 : CH_2016_NA0060_5_11_20160718_00016.jpg

Check Point / View			
Manzanita Ave. / Up			
Rating **	A	Issue No.	11
Issue Type +	Ma	Location *	39.758224 °
Category	Rivers, Channels & Designated Flood		-121.795853 °
Item	Vegetation & Obstructions		
DWR ID	DWR_NA0060_5_c_2012_11		
Action/Comments			
Inspector Comments: Minimal, scattered obstructions and vegetation. The flow is not impeded.

This photo is looking upstream on Manzanita Ave.

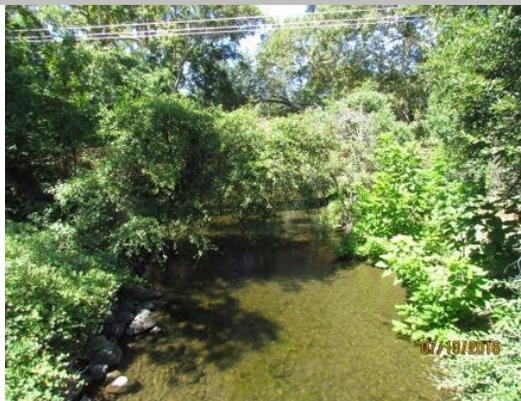
Photo 1 of 1 : CH_2016_NA0060_5_16_20160718_00017.jpg

Check Point / View			
Manzanita Ave. / Down			
Rating **	A	Issue No.	16
Issue Type +	Ma	Location *	39.758224 °
Category	Rivers, Channels & Designated Flood		-121.795853 °
Item	Vegetation & Obstructions		
DWR ID	DWR_NA0060_5_c_2012_16		
Action/Comments			
Inspector Comments: Minimal, scattered obstructions and vegetation. The flow is not impeded.

This photo is looking downstream on Manzanita Ave.

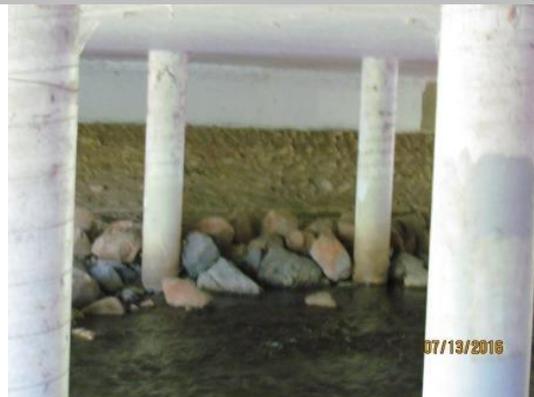
Photo 1 of 1 : CH_2016_NA0060_5_19_20160718_00018.jpg

Rating **	A	Issue No.	19
Issue Type +	Ma	Location *	39.758224 °
Category	Rivers, Channels & Designated Flood		-121.795853 °
Item	Revetments		
DWR ID	DWR_NA0060_5_c_2012_19		
Action/Comments			
Inspector Comments: Riprap is visible and appears properly maintained.

View of revetment under the bridge right bank.

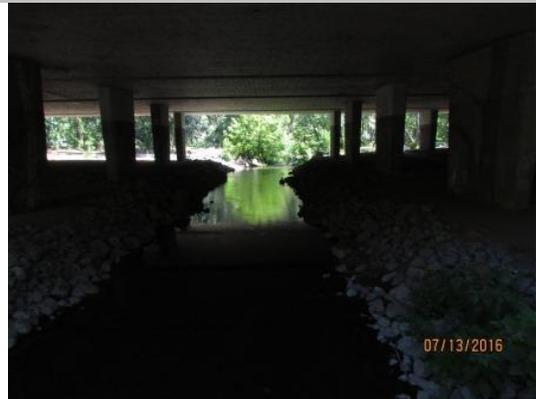
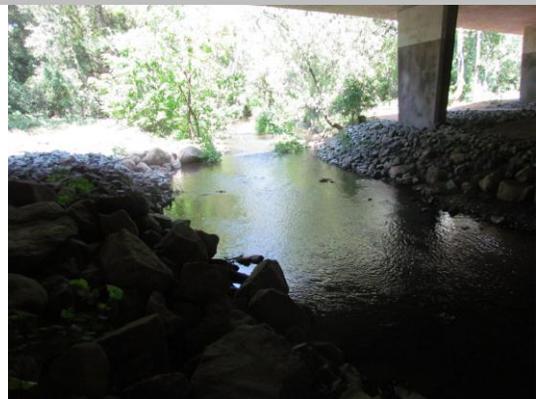
Check Point / View			
Hwy 99 Bridge / Up			
Rating **	A	Issue No.	21
Issue Type +	Ma	Location *	GPS Lat/Long
Category	Rivers, Channels & Designated Flood		39.738490 °
Item	Vegetation & Obstructions		-121.822810 °
DWR ID	DWR_NA0060_5_c_2012_21		
Action/Comments			
Inspector Comments: Minimal scattered obstructions or vegetation. The flow is not impeded.

View of the channel from under Highway 99 facing upstream, 2016.

View of the channel from under Highway 99 facing upstream.

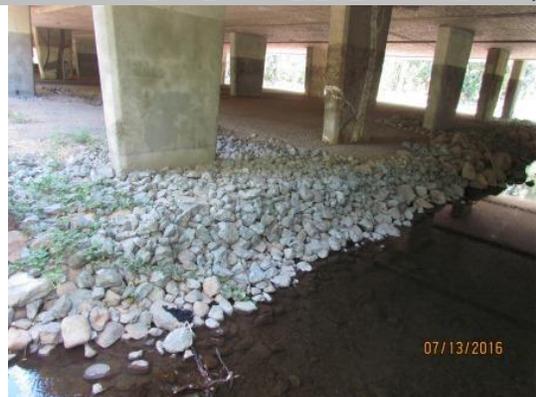
Photo 1 of 1 : CH_2016_NA0060_5_24_20160718_00020.jpg

Rating **	A	Issue No.	24	GPS Lat/Long
Issue Type +	Ma	Location *		39.738490 °
Category	Rivers, Channels & Designated Flood			-121.822810 °
Item	Revetments			
DWR ID	DWR_NA0060_5_c_2012_24			
Action/Comments				
Inspector Comments: Existing riprap protection is properly maintained and is undamaged. Riprap clearly visible.

View of revetment along channel, looking upstream.

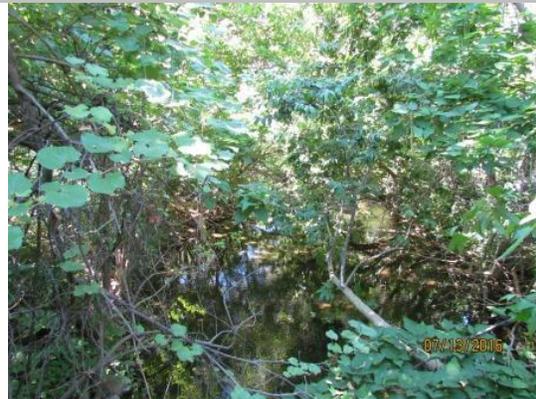
Photo 1 of 1 : CH_2016_NA0060_5_26_20160718_00021.jpg

Check Point / View			
Hwy 99 Bridge / Down			
Rating **	M	Issue No.	26
Issue Type +	Ma	Location *	39.738490 °
Category	Rivers, Channels & Designated Flood		-121.822810 °
Item	Vegetation & Obstructions		
DWR ID	DWR_NA0060_5_c_2012_26		
Action/Comments			
Inspector Comments: Scattered obstructions and vegetation, and may impede the flow of the channel.

View of the channel facing downstream.

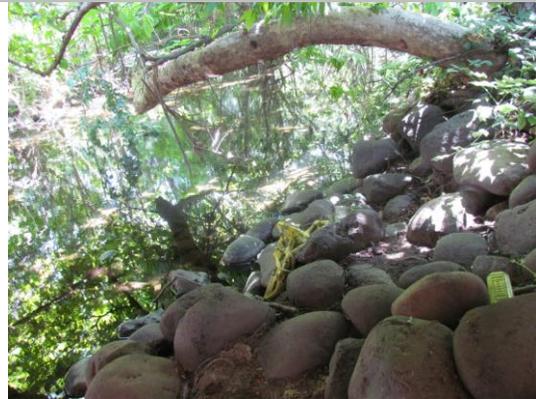
Photo 1 of 1 : CH_2016_NA0060_5_29_20160701_00007.jpg

Rating **	A	Issue No.	29	GPS Lat/Long
Issue Type +	Ma	Location *		39.738490 °
Category	Rivers, Channels & Designated Flood			-121.822810 °
Item	Revetments			
DWR ID	DWR_NA0060_5_c_2012_29			
Action/Comments				
Inspector Comments: Existing riprap protection is properly maintained and is undamaged. Riprap clearly visible.

View of the type of riprap that lines the channel.

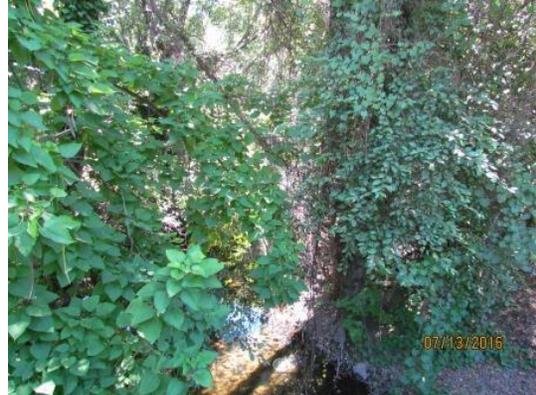
Photo 1 of 1 : CH_2016_NA0060_5_31_20160718_00022.jpg

Check Point / View			
Esplanade / Up			
Rating **	A	Issue No.	31
Issue Type +	Ma	Location *	
Category	Rivers, Channels & Designated Flood		GPS Lat/Long
Item	Vegetation & Obstructions		
DWR ID	DWR_NA0060_5_c_2012_31		
Action/Comments			
Inspector Comments: Scattered obstructions and vegetation. The flow is not impeded.

View of the channel facing upstream.

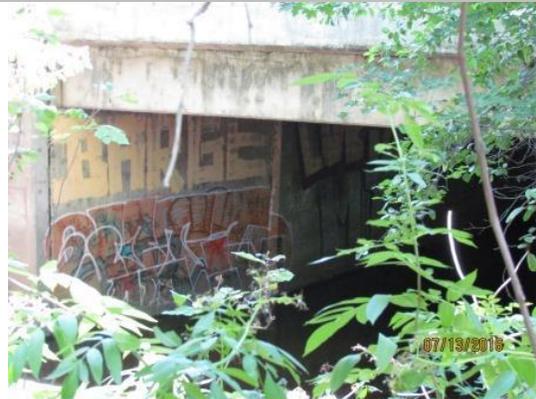
Photo 1 of 1 : CH_2016_NA0060_5_34_20160718_00023.jpg

Check Point / View			
Esplanade / Up (cont)			
Rating **	N	Issue No. 34	GPS Lat/Long
Issue Type +	Ma	Location *	39.731810 °
Category	Rivers, Channels & Designated Flood		-121.841870 °
Item	Revetments		
DWR ID	DWR_NA0060_5_c_2012_34		
Action/Comments			
Inspector Comments: No revetments present.

No visible revetment.

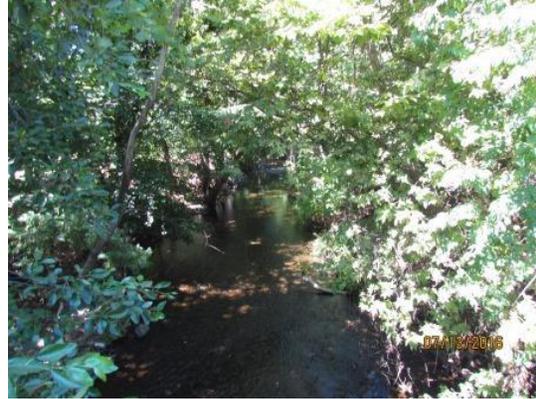
Photo 1 of 1 : CH_2016_NA0060_5_36_20160901_00032.jpg

Check Point / View			
Esplanade / Down			
Rating **	M	Issue No. 36	GPS Lat/Long
Issue Type +	Ma	Location *	39.731810 °
Category	Rivers, Channels & Designated Flood		-121.841870 °
Item	Vegetation & Obstructions		
DWR ID	DWR_NA0060_5_c_2012_36		
Action/Comments			
Inspector Comments: Scattered obstructions and vegetation, and may impede the flow of the channel.

View of the channel facing downstream.

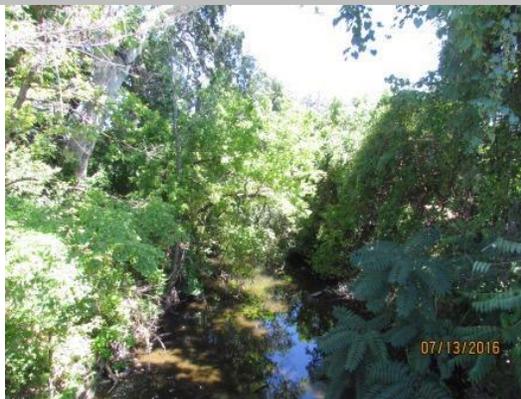
Photo 1 of 1 : CH_2016_NA0060_5_41_20160718_00025.jpg

Check Point / View			
Hwy 32 / Up			
Rating **	M	Issue No. 41	GPS Lat/Long
Issue Type +	Ma	Location *	39.725776 °
Category	Rivers, Channels & Designated Flood		-121.851207 °
Item	Vegetation & Obstructions		
DWR ID	DWR_NA0060_5_c_2012_41		
Action/Comments			
Inspector Comments: Scattered obstructions and vegetation. The flow is not impeded.

View of the channel facing upstream.

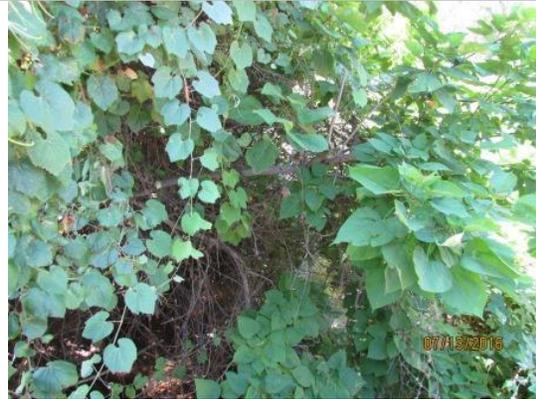
Photo 1 of 1 : CH_2016_NA0060_5_46_20160718_00026.jpg

Check Point / View				
Hwy 32 / Down				
Rating **	M	Issue No.	46	GPS Lat/Long
Issue Type +	Ma	Location *		39.725776 °
Category	Rivers, Channels & Designated Flood			-121.851207 °
Item	Vegetation & Obstructions			
DWR ID	DWR_NA0060_5_c_2012_46			
Action/Comments				
Inspector Comments: Moderate vegetation on north bank. The flow is not impeded.

View of the channel facing downstream.

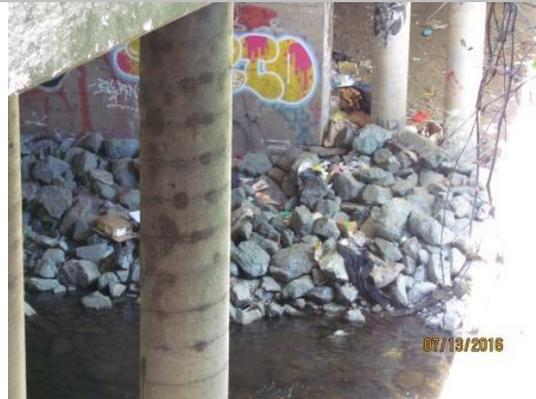
Photo 1 of 1 : CH_2016_NA0060_5_49_20160718_00027.jpg

Rating **	A	Issue No.	49	GPS Lat/Long
Issue Type +	Ma	Location *		39.725776°
Category	Rivers, Channels & Designated Flood			-121.851207°
Item	Revetments			
DWR ID	DWR_NA0060_5_c_2012_49			
Action/Comments				
Inspector Comments: Revetments present.

View of revetment around the bridge structure.

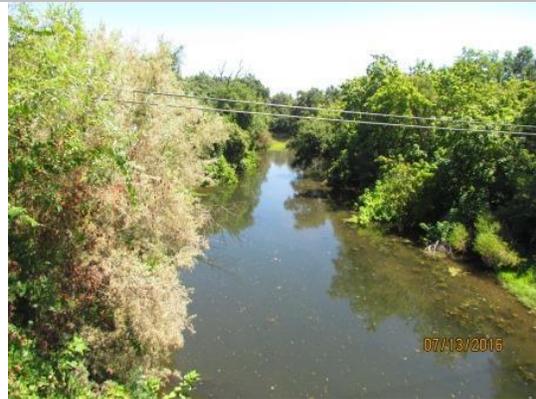
Photo 1 of 1 : CH_2016_NA0060_5_51_20160718_00028.jpg

Check Point / View			
Mud Creek at River Rd / Up			
Rating **	A	Issue No. 51	GPS Lat/Long
Issue Type +	Ma	Location *	39.704580 °
Category	Rivers, Channels & Designated Flood		-121.939320 °
Item	Vegetation & Obstructions		
DWR ID	DWR_NA0060_5_c_2012_51		
Action/Comments			
Inspector Comments: Scattered obstructions and vegetation. The flow is not impeded.

View of Mud Creek at River Road facing upstream.

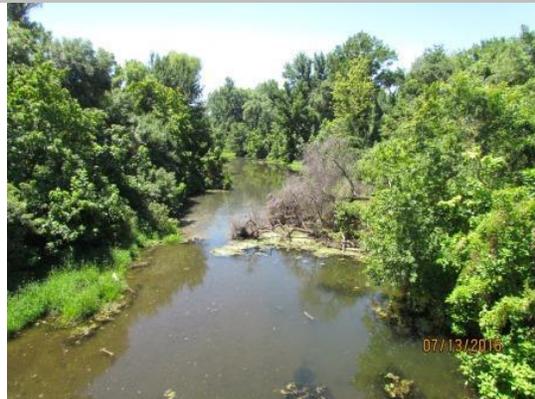
Photo 1 of 2 : CH_2016_NA0060_5_56_20160718_00029.jpg

Check Point / View			
Mud Creek at River Rd / Down			
Rating **	M	Issue No.	56
Issue Type +	Ma	Location *	39.704580 °
Category	Rivers, Channels & Designated Flood		-121.939320 °
Item	Vegetation & Obstructions		
DWR ID	DWR_NA0060_5_c_2012_56		
Action/Comments			
Inspector Comments: Scattered obstructions and vegetation. Downed tree in Mud Creek at River Road facing downstream. This could impede flow.

View of Mud Creek at River Road facing downstream.

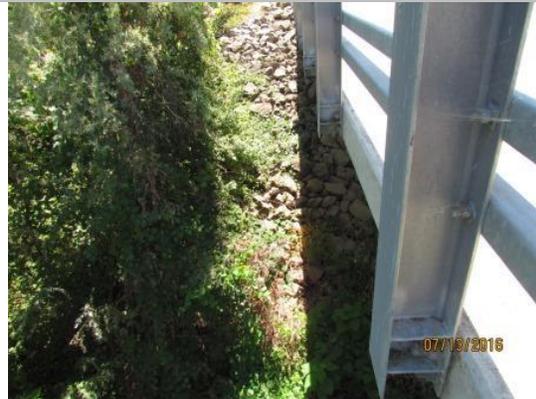
Photo 1 of 1 : CH_2016_NA0060_5_59_20160718_00031.jpg

Rating **	A	Issue No.	59
Issue Type +	Ma	Location *	GPS Lat/Long
Category	Rivers, Channels & Designated Flood		39.704580 °
Item	Revetments		-121.939320 °
DWR ID	DWR_NA0060_5_c_2012_59		
Action/Comments			
Inspector Comments: Some of the riprap is covered with vegetation.

View of revetment around the bridge abutment.

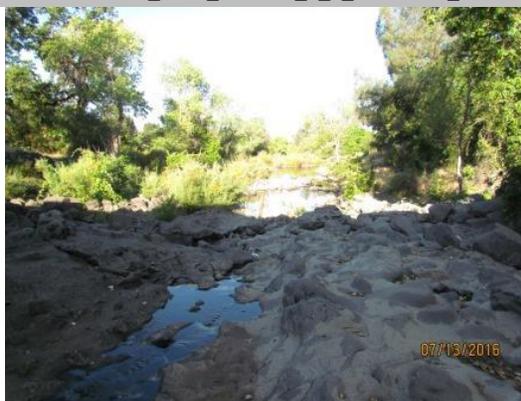
Photo 1 of 1 : CH_2016_NA0060_6_6_20160719_00031.jpg

Check Point / View			
Diversion Structure / Down			
Rating **	A	Issue No. 6	GPS Lat/Long
Issue Type +	Ma	Location *	39.761590 °
Category	Rivers, Channels & Designated Flood		-121.797320 °
Item	Vegetation & Obstructions		
DWR ID	DWR_NA0060_6_c_2012_6		
Action/Comments			
Inspector Comments: Minimal, scattered obstructions or vegetation. The flow is not impeded.

View of the channel facing downstream.

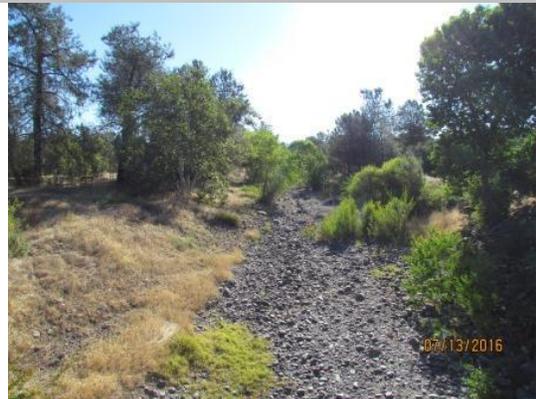
Photo 1 of 1 : CH_2016_NA0060_6_11_20160719_00032.jpg

Check Point / View			
Manzanita Ave / Up			
Rating **	A	Issue No.	11
Issue Type +	Ma	Location *	GPS Lat/Long
Category	Rivers, Channels & Designated Flood		39.760390 °
Item	Vegetation & Obstructions		-121.801621 °
DWR ID	DWR_NA0060_6_c_2012_11		
Action/Comments			
Inspector Comments: Minimal, scattered obstructions or vegetation. The flow is not impeded.

View of the channel facing upstream.

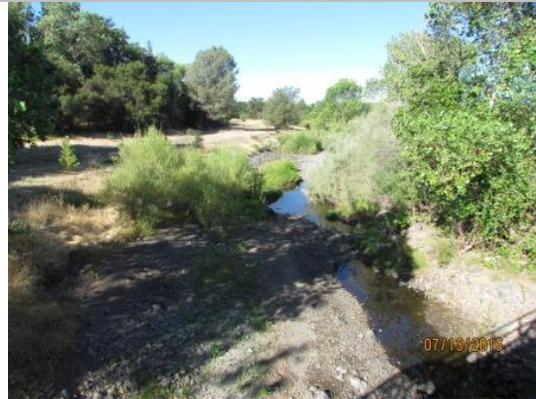
Photo 1 of 1 : CH_2016_NA0060_6_16_20160719_00033.jpg

Check Point / View			
Manzanita Ave / Down			
Rating **	A	Issue No.	16
Issue Type +	Ma	Location *	39.760390 °
Category	Rivers, Channels & Designated Flood		-121.801621 °
Item	Vegetation & Obstructions		
DWR ID	DWR_NA0060_6_c_2012_16		
Action/Comments			
Inspector Comments: Minimal, scattered obstructions or vegetation. The flow is not impeded.

View of the channel facing downstream.

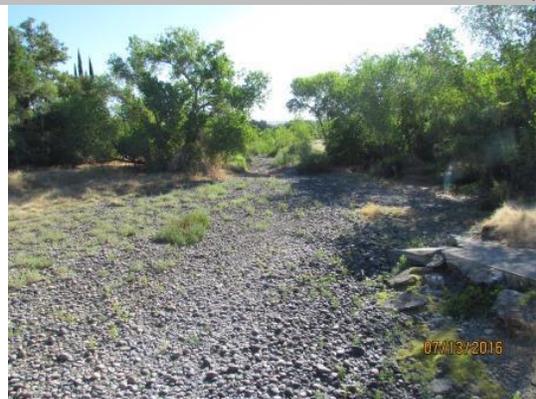
Photo 1 of 1 : CH_2016_NA0060_6_21_20160719_00034.jpg

Check Point / View			
Bike Path Bridge at Madrone Ave / Up			
Rating **	A	Issue No. 21	GPS Lat/Long
Issue Type +	Ma	Location *	39.755400 °
Category	Rivers, Channels & Designated Flood		-121.814580 °
Item	Vegetation & Obstructions		
DWR ID	DWR_NA0060_6_c_2012_21		
Action/Comments			
Inspector Comments: Minimal, scattered obstructions or vegetation. The flow is not impeded.

View of the channel facing upstream.

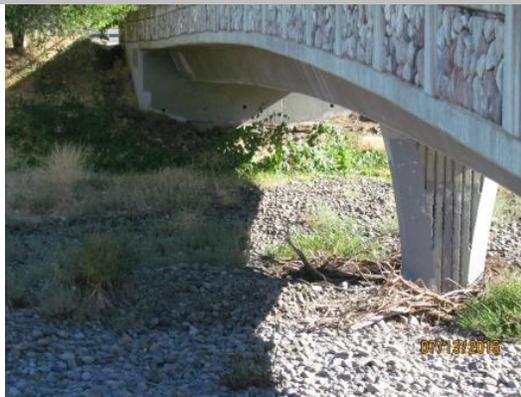
Photo 1 of 1 : CH_2016_NA0060_6_24_20160719_00036.jpg

Rating **	A	Issue No.	24
Issue Type +	Ma	Location *	39.755400 °
Category	Rivers, Channels & Designated Flood		-121.814580 °
Item	Revetments		
DWR ID	DWR_NA0060_6_c_2012_24		
Action/Comments			
Inspector Comments: Riprap at the foot of the bridge seems to have slid down towards the channel in previous high water events, but the integrity and capacity of the channel is not affected.

View looking upstern, no revetment at bridge abutment.

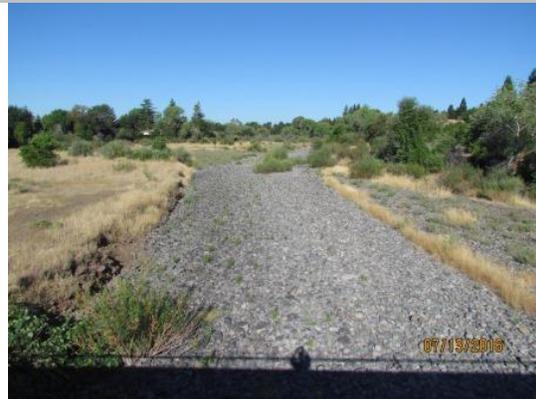
Photo 1 of 1 : CH_2016_NA0060_6_26_20160719_00035.jpg

Check Point / View			
Bike Path Bridge at Madrone Ave / Down			
Rating **	A	Issue No.	26
Issue Type +	Ma	Location *	39.755400 °
Category	Rivers, Channels & Designated Flood		-121.814580 °
Item	Vegetation & Obstructions		
DWR ID	DWR_NA0060_6_c_2012_26		
Action/Comments			
Inspector Comments: Minimal, scattered obstructions or vegetation. The flow is not impeded.

View of the channel facing downstream.

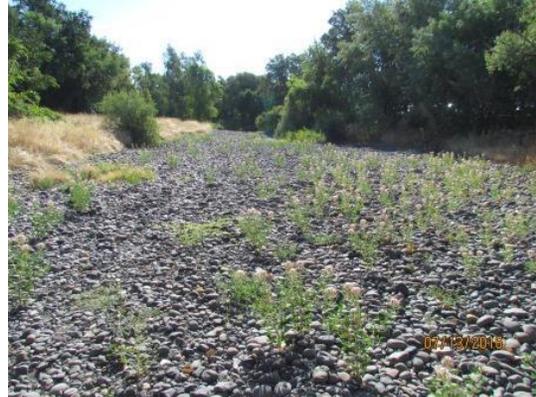
Photo 1 of 1 : CH_2016_NA0060_6_31_20160719_00038.jpg

Check Point / View			
Mariposa Ave / Up			
Rating **	A	Issue No. 31	GPS Lat/Long
Issue Type +	Ma	Location *	39.752730 °
Category	Rivers, Channels & Designated Flood		-121.824560 °
Item	Vegetation & Obstructions		
DWR ID	DWR_NA0060_6_c_2012_31		
Action/Comments			
Inspector Comments: Minimal, scattered obstructions or vegetation. The flow is not impeded.

View of the channel facing upstream.

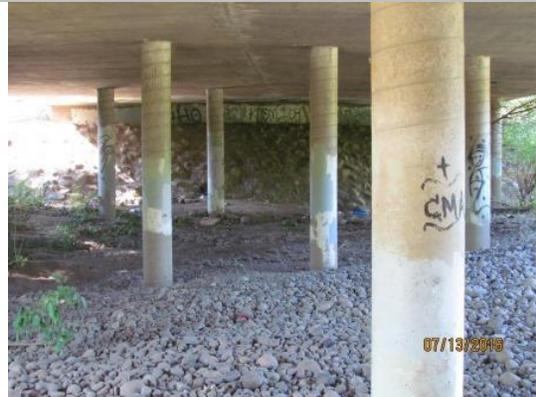
Photo 1 of 1 : CH_2016_NA0060_6_34_20160719_00041.jpg

Check Point / View			
Mariposa Ave / Up (cont)			
Rating **	A	Issue No.	34
Issue Type +	Ma	Location *	39.752730 °
Category	Rivers, Channels & Designated Flood		-121.824560 °
Item	Revetments		
DWR ID	DWR_NA0060_6_c_2012_34		
Action/Comments			
Inspector Comments: Revetment on slope up to the bridge abutment, both sides.

View of right bank, revetment on slope up to the bridge abutment, both sides.

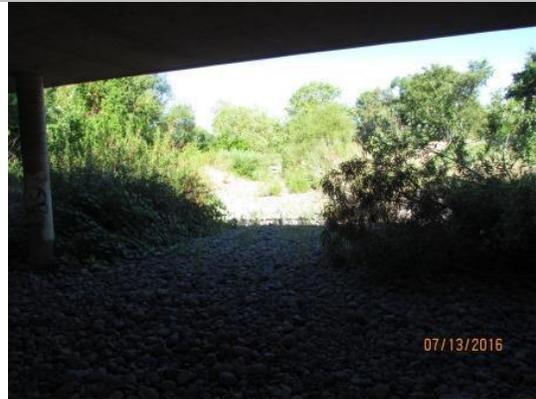
Photo 1 of 2 : CH_2016_NA0060_6_36_20160719_00039.jpg

Check Point / View				
Mariposa Ave / Down				
Rating **	A	Issue No.	36	GPS Lat/Long
Issue Type +	Ma	Location *		39.752730 °
Category	Rivers, Channels & Designated Flood			-121.824560 °
Item	Vegetation & Obstructions			
DWR ID	DWR_NA0060_6_c_2012_36			
Action/Comments				
Inspector Comments: Minimal, scattered obstructions or vegetation. The flow is not impeded.

View of the channel facing downstream, 2016.

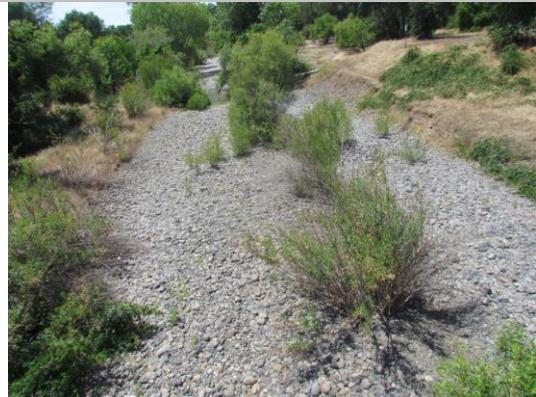
Photo 2 of 2 : CH_2016_NA0060_6_36_20160701_00008.jpg

View of the channel facing downstream, 2015.

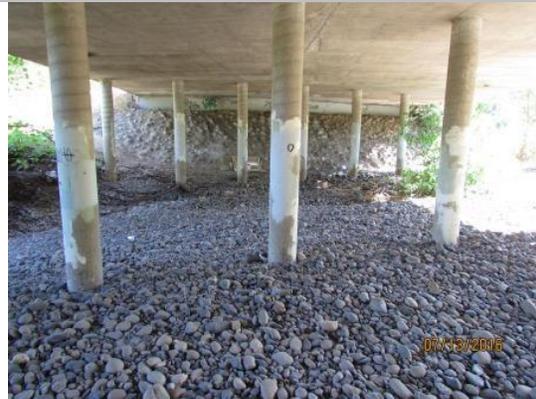
Photo 1 of 1 : CH_2016_NA0060_6_39_20160719_00040.jpg

Rating **	A	Issue No. 39	GPS Lat/Long
Issue Type +	Ma	Location *	39.752730 °
Category	Rivers, Channels & Designated Flood		-121.824560 °
Item	Revetments		
DWR ID	DWR_NA0060_6_c_2012_39		
Action/Comments			
Inspector Comments: Revetment on slope up to the bridge abutment, both sides.

View looking at left bank, revetment on slope up to the bridge abutment, both sides.

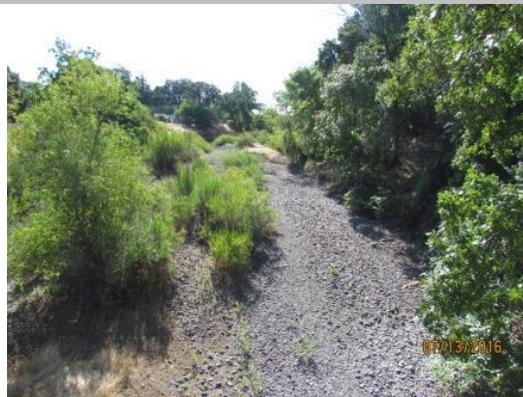
Photo 1 of 1 : CH_2016_NA0060_6_41_20160719_00042.jpg

Check Point / View			
5th Ave / Up			
Rating **	A	Issue No. 41	GPS Lat/Long
Issue Type +	Ma	Location *	39.753307 °
Category	Rivers, Channels & Designated Flood		-121.829234 °
Item	Vegetation & Obstructions		
DWR ID	DWR_NA0060_6_c_2012_41		
Action/Comments			
Inspector Comments: Minimal, scattered obstructions or vegetation. The flow is not impeded.

View of the channel facing upstream.

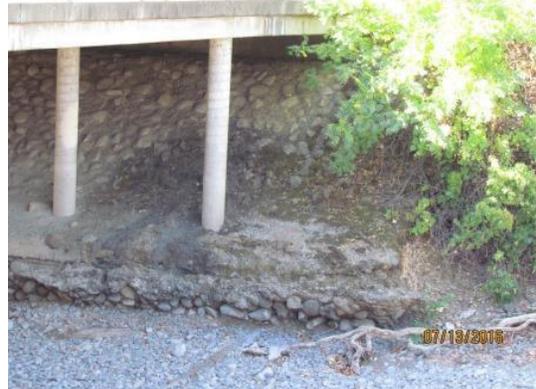
Photo 1 of 1 : CH_2016_NA0060_6_44_20160719_00044.jpg

Check Point / View				
5th Ave / Up (cont)				
Rating **	A	Issue No.	44	GPS Lat/Long
Issue Type +	Ma	Location *		39.753307 °
Category	Rivers, Channels & Designated Flood			-121.829234 °
Item	Revetments			
DWR ID	DWR_NA0060_6_c_2012_44			
Action/Comments				
Inspector Comments: Existing riprap protecting is properly maintained and is undamaged. Riprap clearly visible

View of right bank, revetment on slope up to the bridge abutment, both sides.

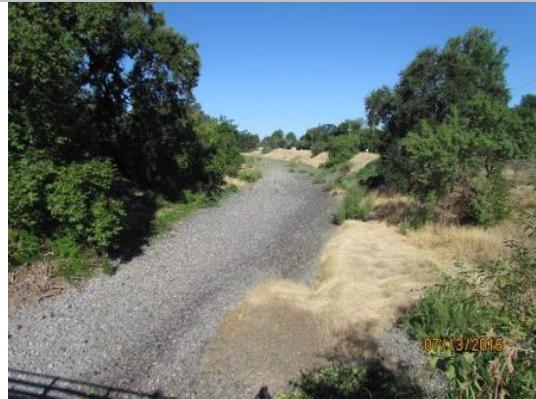
Photo 1 of 1 : CH_2016_NA0060_6_46_20160719_00045.jpg

Check Point / View			
5th Ave / Down			
Rating **	A	Issue No.	46
Issue Type +	Ma	Location *	
Category	Rivers, Channels & Designated Flood		GPS Lat/Long
Item	Vegetation & Obstructions		
DWR ID	DWR_NA0060_6_c_2012_46		
Action/Comments			
Inspector Comments: Minimal, scattered obstructions or vegetation. The flow is not impeded.

View of channel facing downstream.

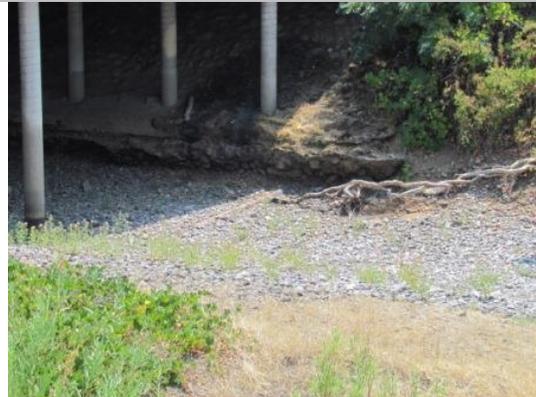
Photo 2 of 2 : CH_2016_NA0060_6_48_20160701_00013.jpg

Check Point / View				
5th Ave / Down (cont)				
Rating **	M	Issue No.	48 (cont)	GPS Lat/Long
Issue Type +	Ma	Location *		39.753307 °
Category	Rivers, Channels & Designated Flood			-121.829234 °
Item	Erosion / Bank Caving			
DWR ID	DWR_NA0060_6_c_2012_48			
Action/Comments				
Inspector Comments: Erosion around bridge footing and south bank of channel.

Erosion around bridge footing and south bank of channel.

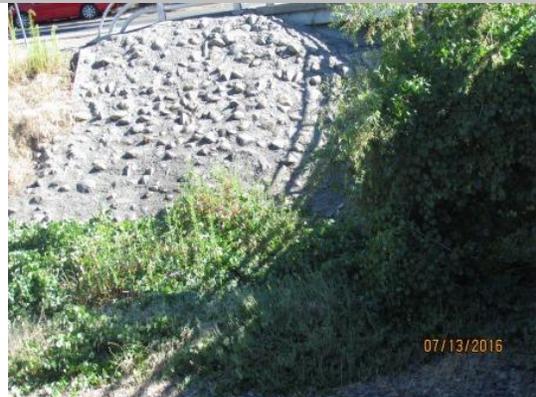
Photo 1 of 1 : CH_2016_NA0060_6_49_20160719_00046.jpg

Rating **	A	Issue No.	49	GPS Lat/Long
Issue Type +	Ma	Location *		39.753307 °
Category	Rivers, Channels & Designated Flood			-121.829234 °
Item	Revetments			
DWR ID	DWR_NA0060_6_c_2012_49			
Action/Comments				
Inspector Comments: Existing riprap protection is properly maintained and is undamaged. Riprap clearly visible.

View of left bank, revetment on slope up to the bridge abutment, both sides.

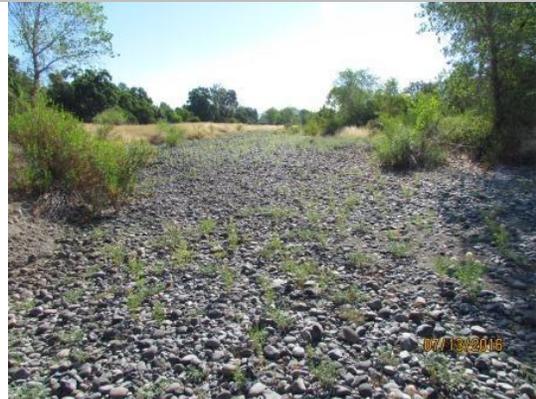
Photo 1 of 1 : CH_2016_NA0060_6_91_20160719_00047.jpg

Check Point / View			
Highway 99 / Up			
Rating **	A	Issue No. 91	GPS Lat/Long
Issue Type +	Ma	Location *	39.751220 °
Category	Rivers, Channels & Designated Flood		-121.840042 °
Item	Vegetation & Obstructions		
DWR ID	DWR_NA0060_6_c_2015_91		
Action/Comments			
Inspector Comments: Minimal, scattered obstructions or vegetation. The flow is not impeded.

View of the channel facing upstream.

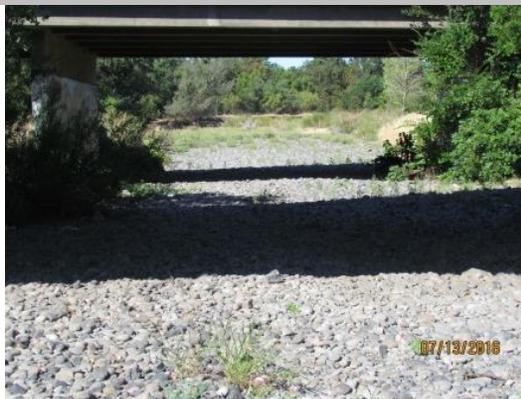
Photo 1 of 2 : CH_2016_NA0060_6_96_20160719_00048.jpg

Check Point / View			
Highway 99 / Down			
Rating **	A	Issue No. 96	GPS Lat/Long
Issue Type +	Ma	Location *	39.751220 °
Category	Rivers, Channels & Designated Flood		-121.840042 °
Item	Vegetation & Obstructions		
DWR ID	DWR_NA0060_6_c_2015_96		
Action/Comments			
Inspector Comments: Minimal, scattered obstructions or vegetation. The flow is not impeded.

View of the channel facing downstream.

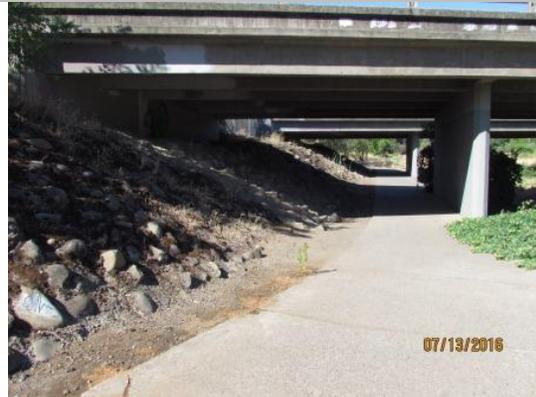
Photo 1 of 1 : CH_2016_NA0060_6_99_20160719_00050.jpg

Check Point / View			
Highway 99 / Down (cont)			
Rating **	A	Issue No.	99
Issue Type +	Ma	Location *	GPS Lat/Long
Category	Rivers, Channels & Designated Flood		39.751220 °
Item	Revetments		-121.840042 °
DWR ID	DWR_NA0060_6_c_2015_99		
Action/Comments			
Inspector Comments: Existing riprap protection is properly maintained and is undamaged. Riprap clearly visible.

View of left bank, revetment on slope up to the bridge abutment, both sides.

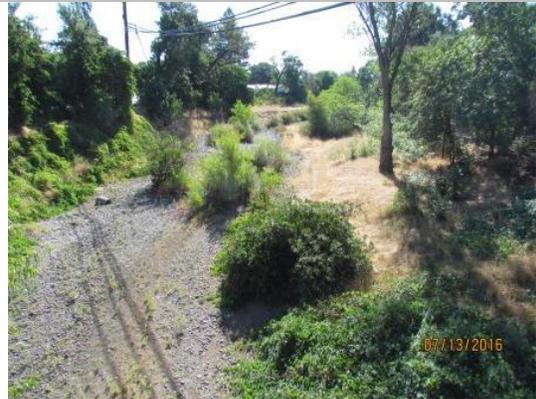
Photo 1 of 1 : CH_2016_NA0060_6_111_20160719_00051.jpg

Check Point / View			
Mangrove Avenue / Up			
Rating **	A	Issue No.	111
			GPS Lat/Long
Issue Type +	Ma	Location *	39.750979 °
Category	Rivers, Channels & Designated Flood		-121.844711 °
Item	Vegetation & Obstructions		
DWR ID	DWR_NA0060_6_c_2015_111		
Action/Comments			
Inspector Comments: Minimal, scattered obstructions or vegetation. The flow is not impeded.

View of the channel facing upstream.

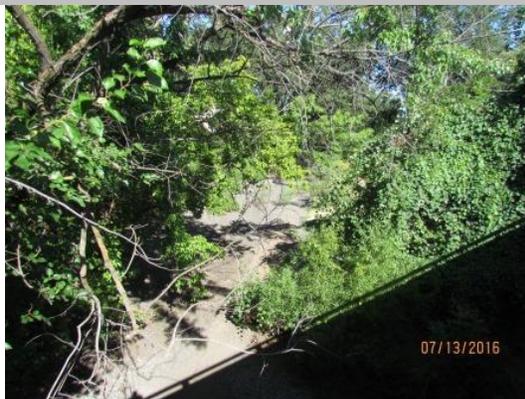
Photo 1 of 1 : CH_2016_NA0060_6_116_20160719_00052.jpg

Check Point / View			
Mangrove Avenue / Down			
Rating **	M	Issue No. 116	GPS Lat/Long
Issue Type +	Ma	Location *	39.750979 °
Category	Rivers, Channels & Designated Flood		-121.844711 °
Item	Vegetation & Obstructions		
DWR ID	DWR_NA0060_6_c_2015_116		
Action/Comments			
Inspector Comments: Minimal, scattered obstructions and vegetation may impede the flow of the channel.

View of the channel facing downstream.

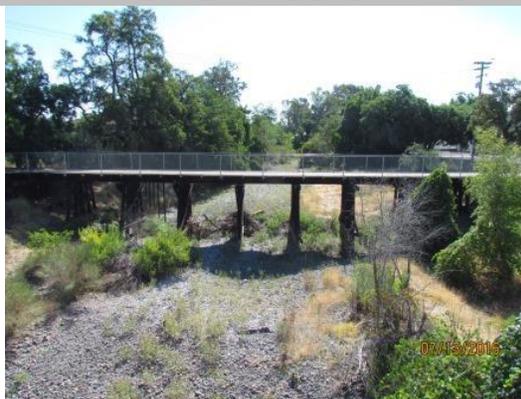
Photo 1 of 1 : CH_2016_NA0060_6_51_20160719_00053.jpg

Check Point / View			
Esplanade / Up			
Rating **	A	Issue No. 51	GPS Lat/Long
Issue Type +	Ma	Location *	39.749458 °
Category	Rivers, Channels & Designated Flood		-121.854296 °
Item	Vegetation & Obstructions		
DWR ID	DWR_NA0060_6_c_2012_51		
Action/Comments			
Inspector Comments: Minimal, scattered obstructions or vegetation. The flow is not impeded.

View of the channel facing upstream.

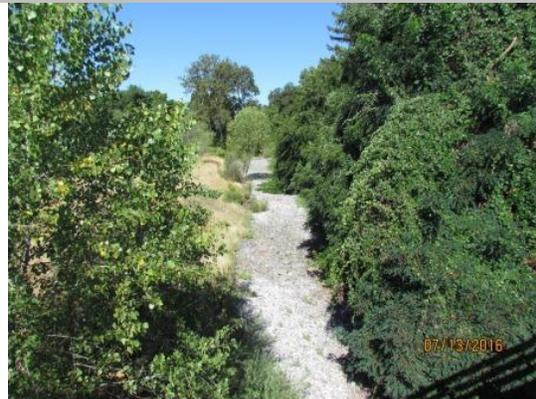
Photo 1 of 1 : CH_2016_NA0060_6_56_20160719_00056.jpg

Check Point / View			
Esplanade / Down			
Rating **	M	Issue No.	56
Issue Type +	Ma	Location *	39.749458 °
Category	Rivers, Channels & Designated Flood		-121.854296 °
Item	Vegetation & Obstructions		
DWR ID	DWR_NA0060_6_c_2012_56		
Action/Comments			
Inspector Comments: Vegetation & scattered obstructions. The flow may be impeded.

View of the channel facing downstream.

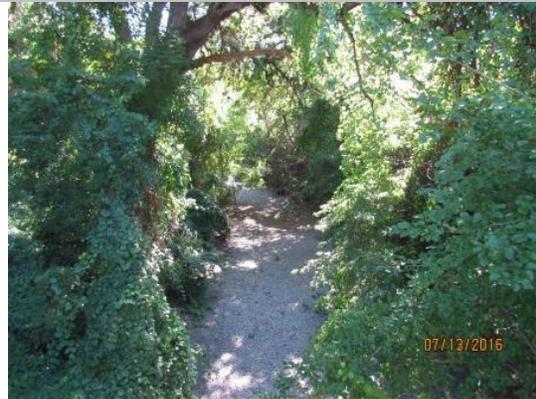
Photo 1 of 1 : CH_2016_NA0060_6_101_20160719_00057.jpg

Check Point / View			
Holly Avenue / Up			
Rating **	M	Issue No. 101	GPS Lat/Long
Issue Type +	Ma	Location *	39.749209 °
Category	Rivers, Channels & Designated Flood		-121.865682 °
Item	Vegetation & Obstructions		
DWR ID	DWR_NA0060_12_c_2015_101		
Action/Comments			
Inspector Comments: Minimal, scattered obstructions and vegetation. The flow may be impeded.

View of the channel facing upstream.

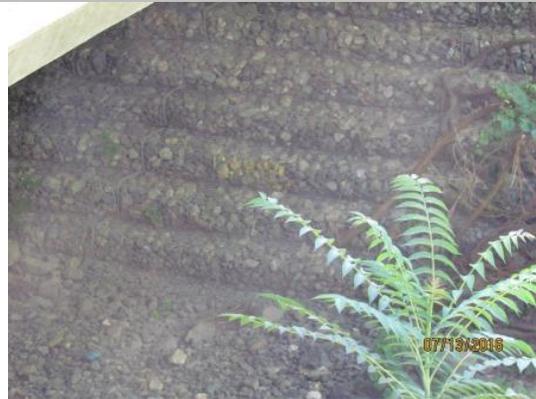
Photo 1 of 1 : CH_2016_NA0060_6_104_20160719_00058.jpg

Check Point / View			
Holly Avenue / Up (cont)			
Rating **	A	Issue No.	104
Issue Type +	Ma	Location *	
Category	Rivers, Channels & Designated Flood		GPS Lat/Long
Item	Revetments		
DWR ID	DWR_NA0060_6_c_2015_104		
Action/Comments			
Inspector Comments: Gabion wall revetment at bridge abutment, right bank.

View of gabion wall revetment at bridge abutment, right bank.

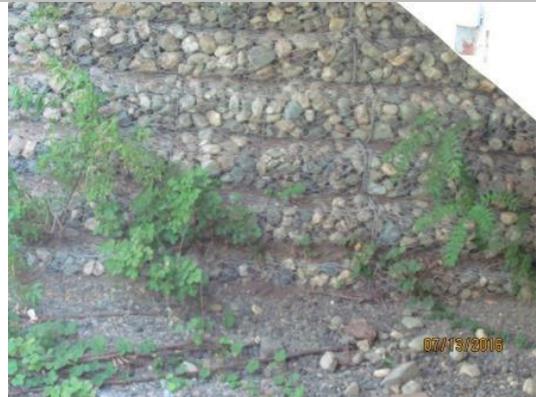
Photo 1 of 1 : CH_2016_NA0060_6_109_20160719_00059.jpg

Check Point / View			
Holly Avenue / Down (cont)			
Rating **	A	Issue No.	109
Issue Type +	Ma	Location *	39.749209 °
Category	Rivers, Channels & Designated Flood		-121.865682 °
Item	Revetments		
DWR ID	DWR_NA0060_6_c_2015_109		
Action/Comments			
Inspector Comments: Gabion wall revetment at bridge abutment, right bank.

View of gabion wall revetment at bridge abutment, right bank.

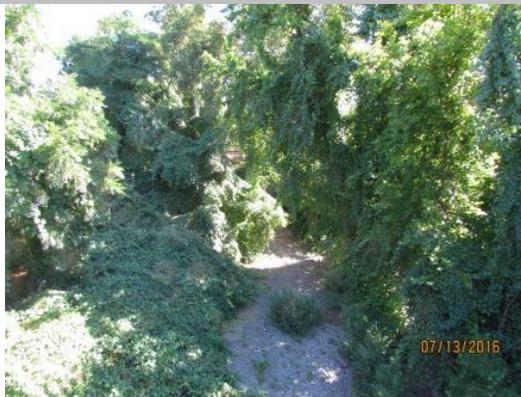
Photo 1 of 1 : CH_2016_NA0060_6_61_20160719_00061.jpg

Check Point / View			
Hwy 32 / Up			
Rating **	M	Issue No. 61	GPS Lat/Long
Issue Type +	Ma	Location *	39.741277 °
Category	Rivers, Channels & Designated Flood		-121.881402 °
Item	Vegetation & Obstructions		
DWR ID	DWR_NA0060_6_c_2012_61		
Action/Comments			
Inspector Comments: Vegetation exists and may impede the flow.

View of the channel facing upstream.

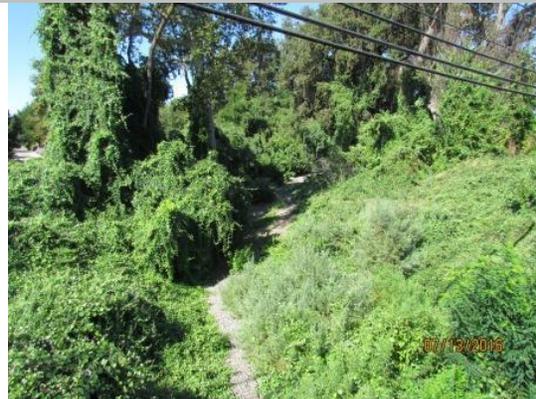
Photo 1 of 1 : CH_2016_NA0060_6_66_20160719_00062.jpg

Check Point / View				
Hwy 32 / Down				
Rating **	M	Issue No.	66	GPS Lat/Long
Issue Type +	Ma	Location *		39.741277 °
Category	Rivers, Channels & Designated Flood			-121.881402 °
Item	Vegetation & Obstructions			
DWR ID	DWR_NA0060_6_c_2012_66			
Action/Comments				
Inspector Comments: Vegetation exists and may impede the flow.

View of the channel facing downstream.

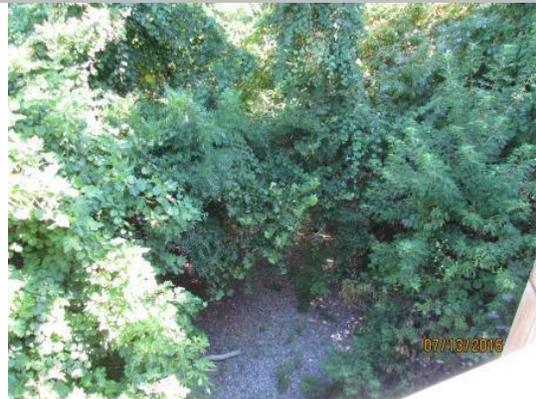
Photo 1 of 1 : CH_2016_NA0060_6_71_20160719_00063.jpg

Check Point / View				
Oak Ave. / Down				
Rating **	M	Issue No.	71	GPS Lat/Long
Issue Type +	Ma	Location *		39.735560 °
Category	Rivers, Channels & Designated Flood			-121.890970 °
Item	Vegetation & Obstructions			
DWR ID	DWR_NA0060_6_c_2012_71			
Action/Comments				
Inspector Comments: Scattered obstructions and vegetation, and may impede the flow of the channel.

View of the channel facing upstream.

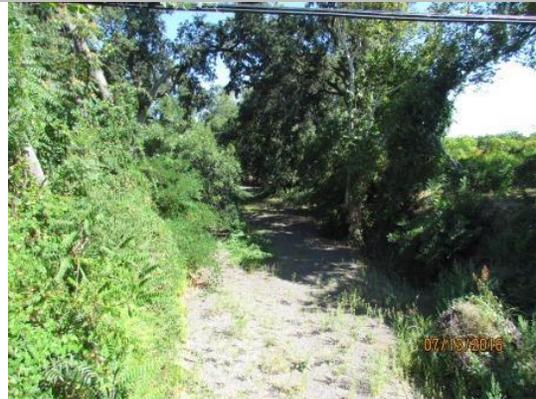
Photo 1 of 1 : CH_2016_NA0060_6_81_20160719_00064.jpg

Check Point / View			
Grape Way / Up			
Rating **	A	Issue No. 81	GPS Lat/Long
Issue Type +	Ma	Location *	39.722724 °
Category	Rivers, Channels & Designated Flood		-121.912363 °
Item	Vegetation & Obstructions		
DWR ID	DWR_NA0060_6_c_2012_81		
Action/Comments			
Inspector Comments: Scattered obstructions and vegetation, but doesn't impede the flow.

View of the channel facing upstream.

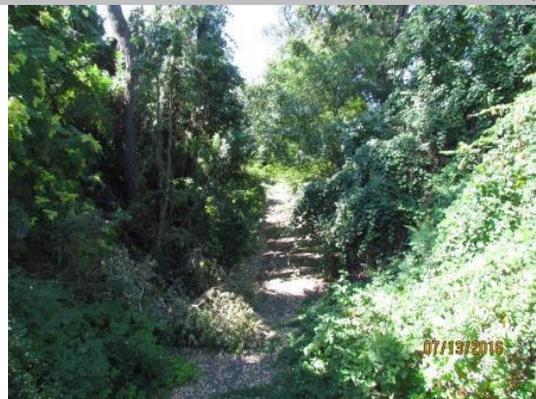
Photo 1 of 1 : CH_2016_NA0060_6_86_20160719_00065.jpg

Check Point / View			
Grape Way / Down			
Rating **	M	Issue No. 86	GPS Lat/Long
Issue Type +	Ma	Location *	39.722724 °
Category	Rivers, Channels & Designated Flood		-121.912363 °
Item	Vegetation & Obstructions		
DWR ID	DWR_NA0060_6_c_2012_86		
Action/Comments			
Inspector Comments: Scattered obstructions and vegetation, and may impede the flow of the channel.

View of the channel facing downstream.

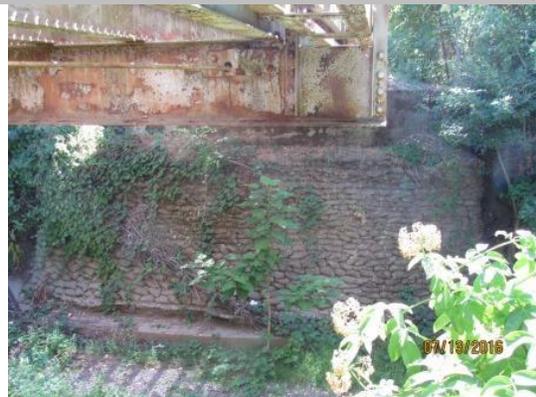
Photo 1 of 1 : CH_2016_NA0060_6_89_20160719_00066.jpg

Rating **	A	Issue No. 89	GPS Lat/Long
Issue Type +	Ma	Location *	39.722724 °
Category	Rivers, Channels & Designated Flood		-121.912363 °
Item	Revetments		
DWR ID	DWR_NA0060_6_c_2012_89		
Action/Comments			
Inspector Comments: Revetments are in place and maintained properly. Concrete sandbag revetment at bridge abutments, both sides.

View of concrete sandbag revetment at bridge abutments, both sides.

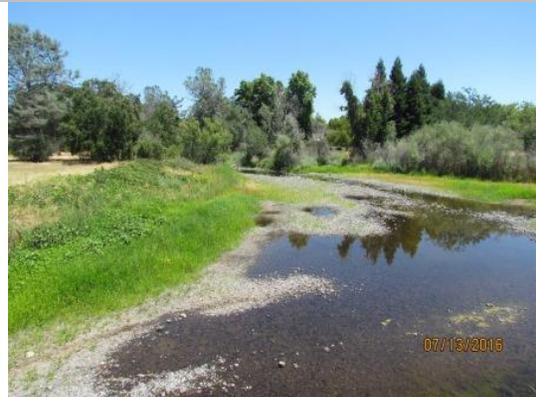
Photo 1 of 1 : CH_2016_NA0060_12_1_20160719_00025.jpg

Check Point / View			
Little Chico Ck Control Structure / Up			
Rating **	A	Issue No.	1
Issue Type +	Ma	Location *	39.733681 °
Category	Rivers, Channels & Designated Flood		-121.771865 °
Item	Vegetation & Obstructions		
DWR ID	DWR_NA0060_12_c_2012_1		
Action/Comments			
Inspector Comments: Minimal, scattered obstructions and vegetation. The flow is not impeded.

This is the upstream side at the Little Chico Control Structure.

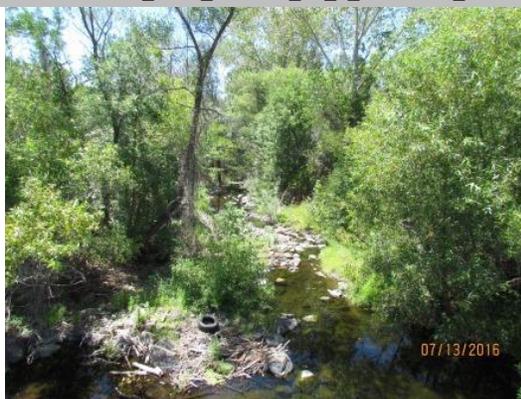
Photo 1 of 1 : CH_2016_NA0060_12_6_20160719_00026.jpg

Check Point / View			
Little Chico Ck Control Structure / Down			
Rating **	M	Issue No.	6
Issue Type +	Ma	Location *	39.733681 °
Category	Rivers, Channels & Designated Flood		-121.771865 °
Item	Vegetation & Obstructions		
DWR ID	DWR_NA0060_12_c_2012_6		
Action/Comments			
Inspector Comments: Scattered obstructions and vegetation. The flow is not impeded. Willow trees should be removed in the future.

This is the downstream side at the Little Chico Control Structure.

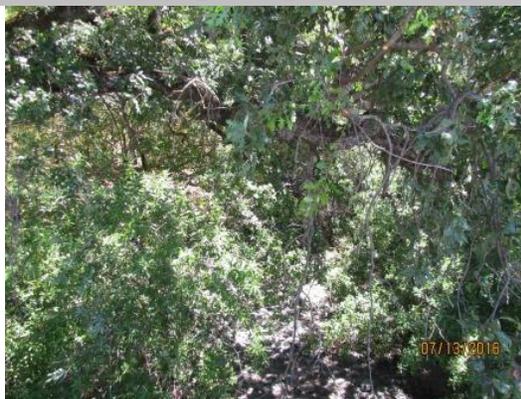
Photo 1 of 1 : CH_2016_NA0060_12_11_20160719_00027.jpg

Check Point / View			
Bruce Rd / Up			
Rating **	M	Issue No.	11
Issue Type +	Ma	Location *	39.733316 °
Category	Rivers, Channels & Designated Flood		-121.787540 °
Item	Vegetation & Obstructions		
DWR ID	DWR_NA0060_12_c_2012_11		
Action/Comments			
Inspector Comments: The vegetation obstructed the view of the channel. Flow may be impeded in the high water event.

Photo of the channel facing upstream.

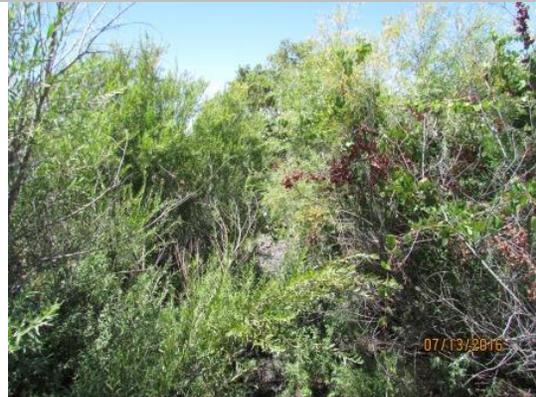
Photo 1 of 1 : CH_2016_NA0060_12_16_20160719_00028.jpg

Check Point / View				
Bruce Rd / Down				
Rating **	U	Issue No.	16	GPS Lat/Long
Issue Type +	Ma	Location *		39.733316 °
Category	Rivers, Channels & Designated Flood			-121.787540 °
Item	Vegetation & Obstructions			
DWR ID	DWR_NA0060_12_c_2012_16			
Action/Comments				
Inspector Comments: The vegetation obstructed the view of the channel. Flow may be impeded in high water.

Photo of the channel from the bridge facing downstream.

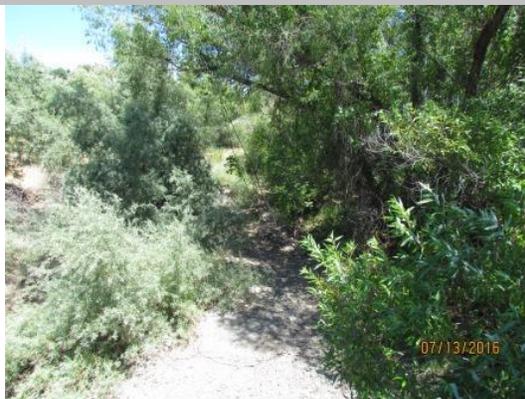
Photo 1 of 1 : CH_2016_NA0060_12_21_20160719_00029.jpg

Check Point / View			
Forest Ave / Up			
Rating **	M	Issue No. 21	GPS Lat/Long
Issue Type +	Ma	Location *	39.737400 °
Category	Rivers, Channels & Designated Flood		-121.804530 °
Item	Vegetation & Obstructions		
DWR ID	DWR_NA0060_12_c_2012_21		
Action/Comments			
Inspector Comments: Scattered obstructions and vegetation, and may impede the flow of the channel.

View of the channel from the bridge facing upstream.

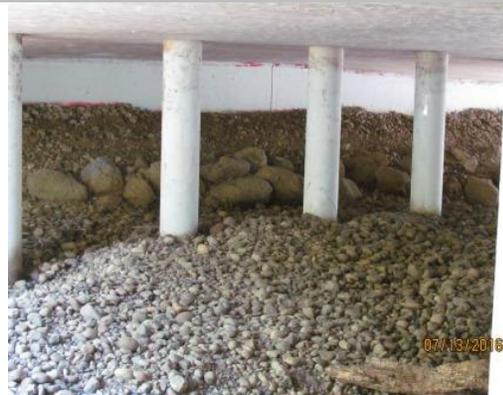
Photo 1 of 2 : CH_2016_NA0060_12_24_20160719_00030.jpg

Rating **	A	Issue No.	24
			GPS Lat/Long
Issue Type +	Ma	Location *	39.737400 °
Category	Rivers, Channels & Designated Flood		-121.804530 °
Item	Revetments		
DWR ID	DWR_NA0060_12_c_2012_24		
Action/Comments			
Inspector Comments: Revetments present.

View of large revetment on right bank.

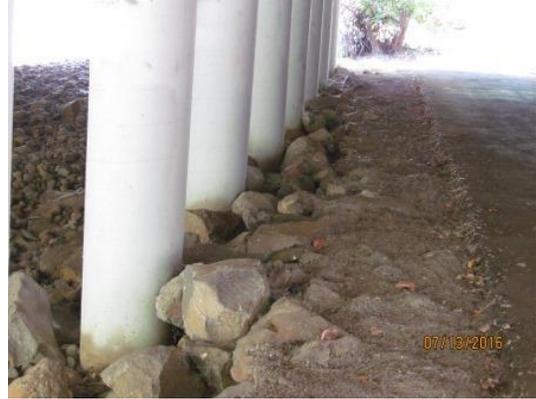
Photo 2 of 2 : CH_2016_NA0060_12_24_20160719_00031.jpg

Check Point / View				
Forest Ave / Up (cont)				
Rating **	A	Issue No.	24 (cont)	GPS Lat/Long
Issue Type +	Ma	Location *		39.737400 °
Category	Rivers, Channels & Designated Flood			-121.804530 °
Item	Revetments			
DWR ID	DWR_NA0060_12_c_2012_24			
Action/Comments				
Inspector Comments: Revetments present.

View of large revetment on left bank.

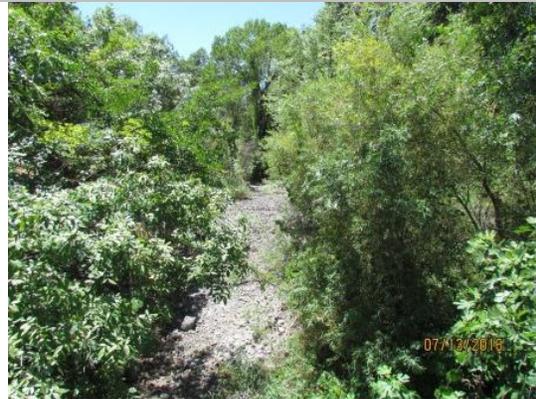
Photo 1 of 1 : CH_2016_NA0060_12_26_20160719_00034.jpg

Check Point / View			
Forest Ave / Down			
Rating **	M	Issue No. 26	GPS Lat/Long
Issue Type +	Ma	Location *	39.737400 °
Category	Rivers, Channels & Designated Flood		-121.804530 °
Item	Vegetation & Obstructions		
DWR ID	DWR_NA0060_12_c_2012_26		
Action/Comments			
Inspector Comments: Moderate vegetation observed. Flow may be obstructed in high water.

View of the channel from the bridge facing downstream.

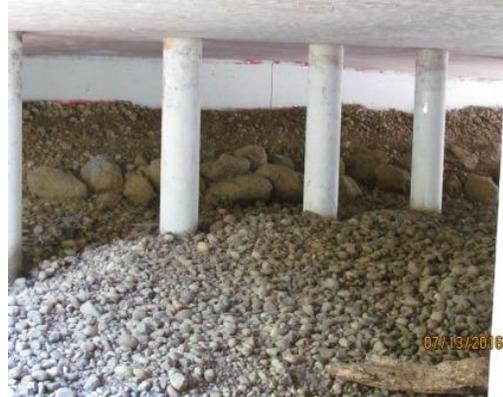
Photo 1 of 2 : CH_2016_NA0060_12_29_20160719_00032.jpg

Check Point / View				
Forest Ave / Down (cont)				
Rating **	A	Issue No.	29	GPS Lat/Long
Issue Type +	Ma	Location *		39.737400 °
Category	Rivers, Channels & Designated Flood			-121.804530 °
Item	Revetments			
DWR ID	DWR_NA0060_12_c_2012_29			
Action/Comments				
Inspector Comments: Revetments present.

View of large revetment on right bank.

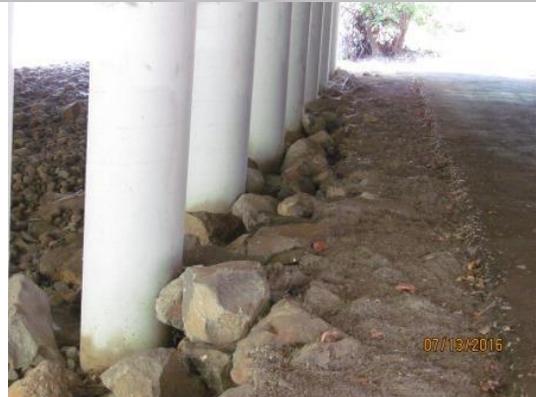
Photo 2 of 2 : CH_2016_NA0060_12_29_20160719_00033.jpg

View of large revetment on left bank.

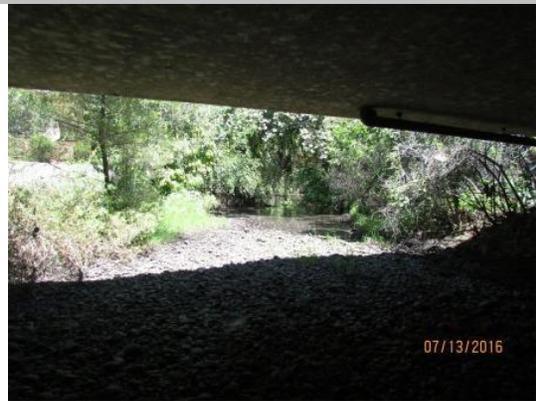
Photo 1 of 2 : CH_2016_NA0060_12_31_20160719_00035.jpg

Check Point / View				
Repair site upstream of Hwy 99 / Up				
Rating **	A	Issue No.	31	GPS Lat/Long
Issue Type +	Ma	Location *		39.735670 °
Category	Rivers, Channels & Designated Flood			-121.814510 °
Item	Vegetation & Obstructions			
DWR ID	DWR_NA0060_12_c_2012_31			
Action/Comments				
Inspector Comments: Scattered vegetation. The flow does not appear impeded.

View looking upstream from bridge.

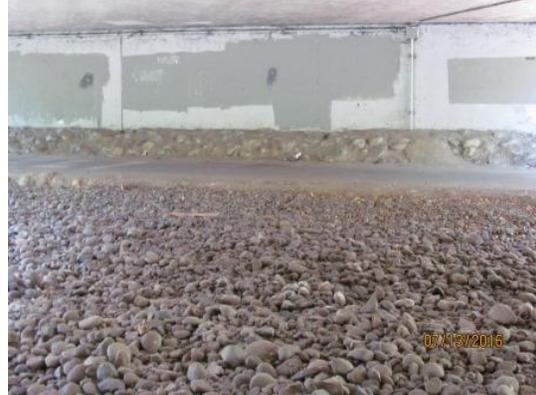
Photo 1 of 1 : CH_2016_NA0060_12_34_20160719_00037.jpg

Rating **	A	Issue No.	34	GPS Lat/Long
Issue Type +	Ma	Location *		39.735670 °
Category	Rivers, Channels & Designated Flood			-121.814510 °
Item	Revetments			
DWR ID	DWR_NA0060_12_c_2012_34			
Action/Comments				
Inspector Comments: Riprap is visible and appears properly maintained.

View of revetment at bridge abutment right bank.

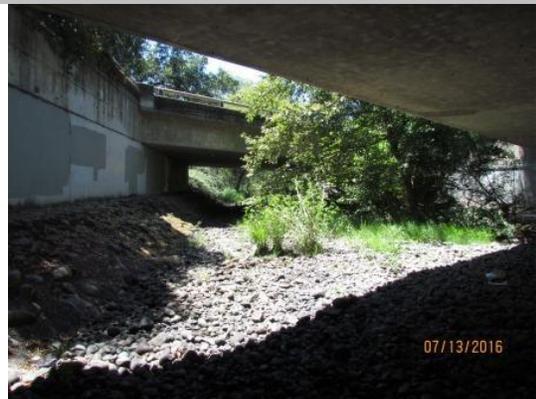
Photo 1 of 2 : CH_2016_NA0060_12_36_20160719_00038.jpg

Check Point / View				
Repair site upstream of Hwy 99 / Down				
Rating **	M	Issue No.	36	GPS Lat/Long
Issue Type +	Ma	Location *		39.735670 °
Category	Rivers, Channels & Designated Flood			-121.814510 °
Item	Vegetation & Obstructions			
DWR ID	DWR_NA0060_12_c_2012_36			
Action/Comments				
Inspector Comments: There is vegetation in the channel, the flow may be impeded in high water.

View looking downstream from the bridge.

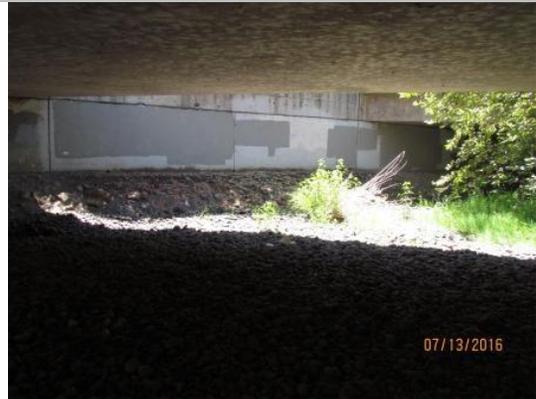
Photo 1 of 1 : CH_2016_NA0060_12_39_20160719_00040.jpg

Rating **	A	Issue No.	39	GPS Lat/Long
Issue Type +	Ma	Location *		39.735670 °
Category	Rivers, Channels & Designated Flood			-121.814510 °
Item	Revetments			
DWR ID	DWR_NA0060_12_c_2012_39			
Action/Comments				
Inspector Comments: Riprap is visible and appears properly maintained.

View of the revetment along the abutment of the bridge on the left bank.

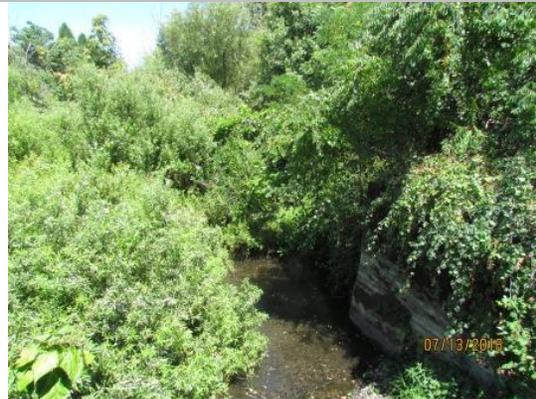
Photo 1 of 1 : CH_2016_NA0060_12_82_20160719_00041.jpg

Check Point / View				
Bruce Street / Up				
Rating **	M	Issue No.	82	GPS Lat/Long
Issue Type +	Ma	Location *		39.733204 °
Category	Rivers, Channels & Designated Flood			-121.819610 °
Item	Vegetation & Obstructions			
DWR ID	DWR_NA0060_12_c_2015_82			
Action/Comments				
Inspector Comments: There is vegetation in the channel and it appears to potentially impede the flow.

View of the channel from the bridge facing upstream.

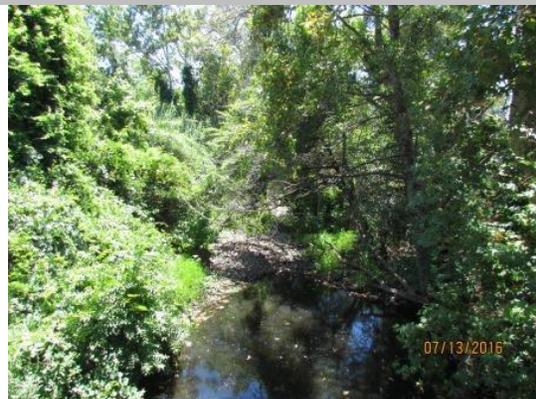
Photo 1 of 1 : CH_2016_NA0060_12_89_20160719_00042.jpg

Check Point / View			
Bruce Street / Down			
Rating **	A	Issue No. 89	GPS Lat/Long
Issue Type +	Ma	Location *	39.733204 °
Category	Rivers, Channels & Designated Flood		-121.819610 °
Item	Vegetation & Obstructions		
DWR ID	DWR_NA0060_12_c_2015_89		
Action/Comments			
Inspector Comments: Channel was free of vegetation.

View of the channel from the bridge facing downstream.

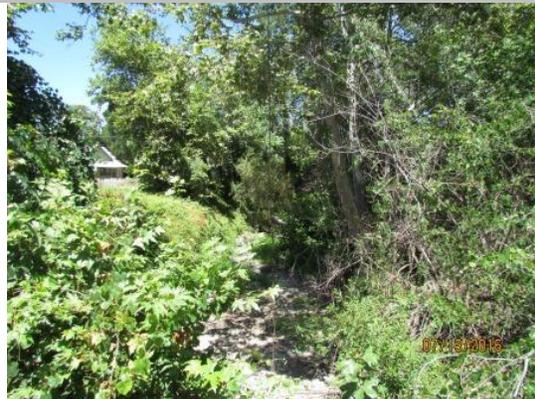
Photo 1 of 1 : CH_2016_NA0060_12_41_20160719_00043.jpg

Check Point / View			
Boucher St / Up			
Rating **	M	Issue No.	41
Issue Type +	Ma	Location *	39.730240 °
Category	Rivers, Channels & Designated Flood		-121.823800 °
Item	Vegetation & Obstructions		
DWR ID	DWR_NA0060_12_c_2012_41		
Action/Comments			
Inspector Comments: There is vegetation in the channel and overhanging the channel, the flow does not appear impeded.

View of the channel from the bridge facing upstream.
