**Flood Control Project Maintenance
Levee Inspections**
2016 Channel Summary Report
Overall Unit and Item Ratings

2016 Channel Inspection Results

DWR Sutter Maintenance Yard

Channel
Big Chico Creek

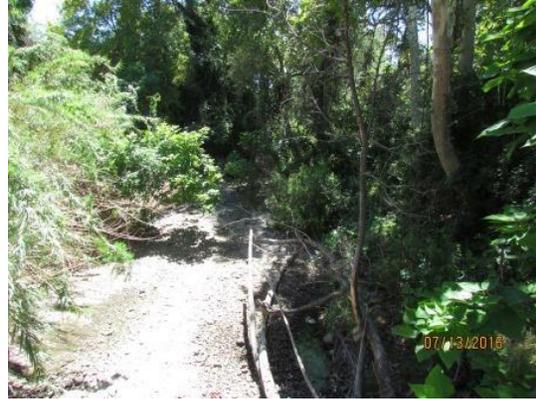
Photo 1 of 1 : CH_2016_NA0060_12_46_20160719_00044.jpg

Check Point / View				
Boucher St / Down				
Rating **	M	Issue No.	46	GPS Lat/Long
Issue Type +	Ma	Location *		39.730240 °
Category	Rivers, Channels & Designated Flood			-121.823800 °
Item	Vegetation & Obstructions			
DWR ID	DWR_NA0060_12_c_2012_46			
Action/Comments				
Inspector Comments: There is vegetation in the channel, overhanging the channel, and arundo. The flow does appear slightly impeded.

View of the channel from the bridge facing downstream.

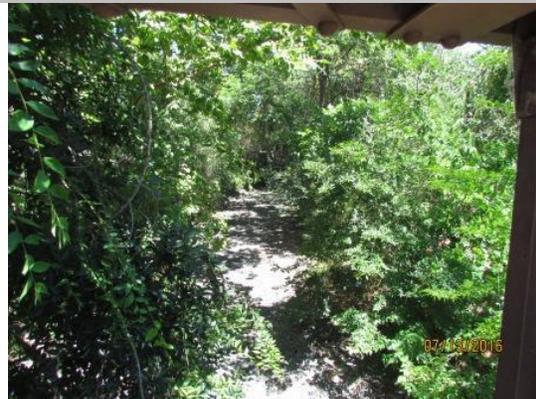
Photo 1 of 1 : CH_2016_NA0060_12_51_20160719_00045.jpg

Check Point / View			
Olive St / Up			
Rating **	A	Issue No.	51
Issue Type +	Ma	Location *	39.726792 °
Category	Rivers, Channels & Designated Flood		-121.829713 °
Item	Vegetation & Obstructions		
DWR ID	DWR_NA0060_12_c_2012_51		
Action/Comments			
Inspector Comments: There is vegetation in the channel, it does not appear to impeded the flow.

View of the channel from the bridge facing upstream.

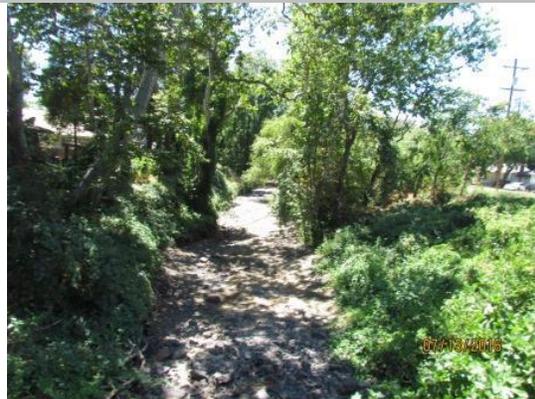
Photo 1 of 1 : CH_2016_NA0060_12_56_20160719_00046.jpg

Check Point / View				
Olive St / Down				
Rating **	A	Issue No.	56	GPS Lat/Long
Issue Type +	Ma	Location *		39.726792 °
Category	Rivers, Channels & Designated Flood			-121.829713 °
Item	Vegetation & Obstructions			
DWR ID	DWR_NA0060_12_c_2012_56			
Action/Comments				
Inspector Comments: There is vegetation in the channel, the flow does not appear impeded.

View of the channel from the bridge facing downstream.

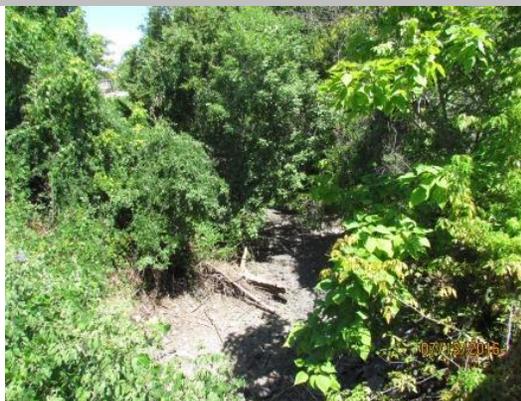
Photo 1 of 1 : CH_2016_NA0060_12_61_20160719_00047.jpg

Check Point / View				
Broadway St / Up				
Rating **	M	Issue No.	61	GPS Lat/Long
Issue Type +	Ma	Location *		39.724328 °
Category	Rivers, Channels & Designated Flood			-121.835233 °
Item	Vegetation & Obstructions			
DWR ID	DWR_NA0060_12_c_2012_61			
Action/Comments				
Inspector Comments: Scattered obstructions and vegetation, and may impede the flow of the channel.

View of the channel from the bridge facing upstream.

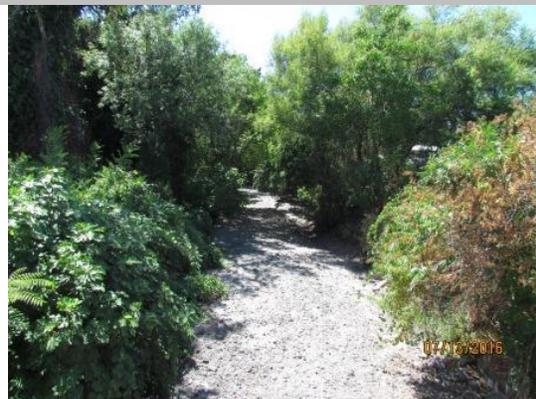
Photo 1 of 1 : CH_2016_NA0060_12_66_20160719_00048.jpg

Check Point / View			
Broadway St / Down			
Rating **	A	Issue No. 66	GPS Lat/Long
Issue Type +	Ma	Location *	39.724328 °
Category	Rivers, Channels & Designated Flood		-121.835233 °
Item	Vegetation & Obstructions		
DWR ID	DWR_NA0060_12_c_2012_66		
Action/Comments			
Inspector Comments: There is vegetation in the channel, the flow does not appear impeded.

View of the channel from the bridge facing downstream.

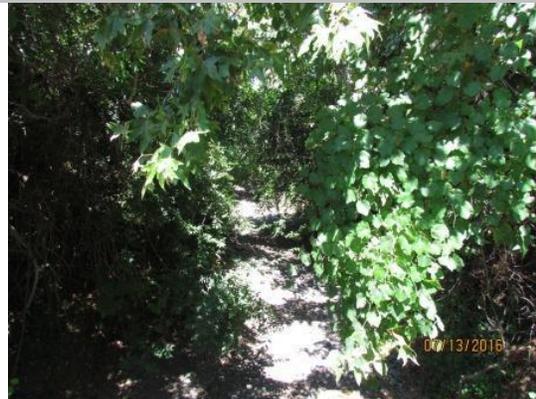
Photo 1 of 1 : CH_2016_NA0060_12_94_20160720_00049.jpg

Check Point / View				
Ivy Street / Up				
Rating **	M	Issue No.	94	GPS Lat/Long
Issue Type +	Ma	Location *		39.720476 °
Category	Rivers, Channels & Designated Flood			-121.838990 °
Item	Vegetation & Obstructions			
DWR ID	DWR_NA0060_5_c_2015_94			
Action/Comments				
Inspector Comments: Scattered obstructions and vegetation, and may impede the flow of the channel.

View of the channel from the bridge facing upstream.

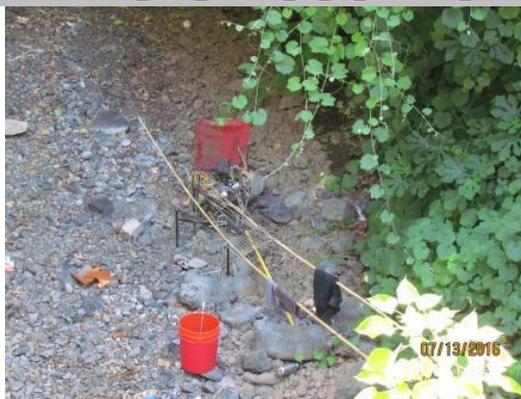
Photo 1 of 1 : CH_2016_NA0060_12_98_20160720_00050.jpg

Rating **	M	Issue No.	98
Issue Type +	Ma	Location *	39.720476 °
Category	Rivers, Channels & Designated Flood		-121.838990 °
Item	Encroachments		
DWR ID	DWR_NA0060_12_c_2015_98		
Action/Comments			
Inspector Comments: The channel appeared to be the place the homeless have set up camp, suggest that they be removed/relocated.

This view is just a portion of a homeless camp that is set up under the bridge.

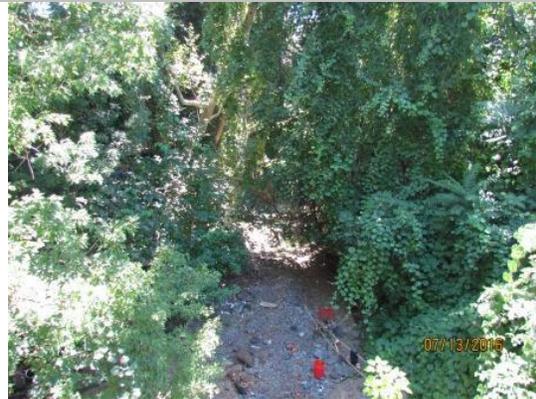
Photo 1 of 1 : CH_2016_NA0060_12_99_20160720_00051.jpg

Check Point / View				
Ivy Street / Down				
Rating **	M	Issue No.	99	GPS Lat/Long
Issue Type +	Ma	Location *		39.720476 °
Category	Rivers, Channels & Designated Flood			-121.838990 °
Item	Vegetation & Obstructions			
DWR ID	DWR_NA0060_12_c_2015_99			
Action/Comments				
Inspector Comments: Scattered obstructions and vegetation, and may impede the flow of the channel.

View of the channel from the bridge facing downstream.

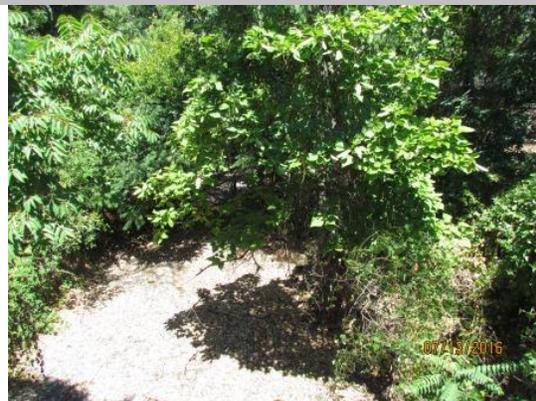
Photo 1 of 1 : CH_2016_NA0060_12_104_20160720_00052.jpg

Check Point / View			
Walnut Street / Up			
Rating **	A	Issue No. 104	GPS Lat/Long
Issue Type +	Ma	Location *	39.718434 °
Category	Rivers, Channels & Designated Flood		-121.843512 °
Item	Vegetation & Obstructions		
DWR ID	DWR_NA0060_12_c_2015_104		
Action/Comments			
Inspector Comments: The channel appeared to be free of any vegetation that would impede the flow.

View of the channel from the bridge facing upstream.

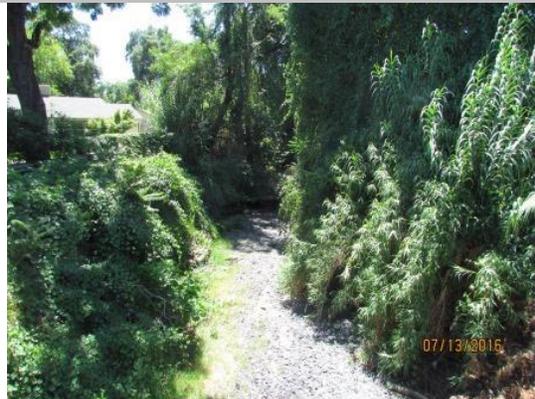
Photo 1 of 1 : CH_2016_NA0060_12_109_20160720_00053.jpg

Check Point / View			
Walnut Street / Down			
Rating **	A	Issue No. 109	GPS Lat/Long
Issue Type +	Ma	Location *	39.718434 °
Category	Rivers, Channels & Designated Flood		-121.843512 °
Item	Vegetation & Obstructions		
DWR ID	DWR_NA0060_12_c_2015_109		
Action/Comments			
Inspector Comments: The channel appeared free of any vegetation that would impede the flow.

View of the channel from the bridge facing downstream.

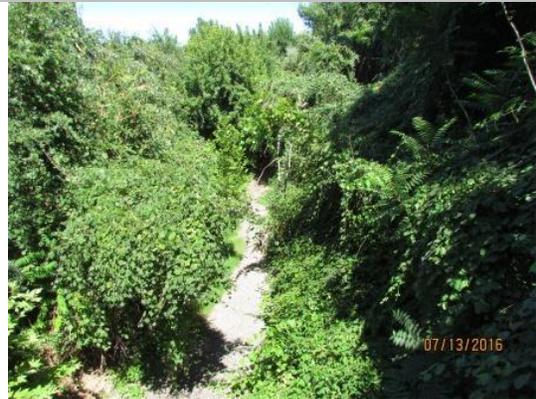
Photo 1 of 1 : CH_2016_NA0060_12_71_20160720_00054.jpg

Check Point / View			
Lone Pine Avenue / Up			
Rating **	M	Issue No. 71	GPS Lat/Long
Issue Type +	Ma	Location *	39.703260 °
Category	Rivers, Channels & Designated Flood		-121.868470 °
Item	Vegetation & Obstructions		
DWR ID	DWR_NA0060_12_c_2012_71		
Action/Comments			
Inspector Comments: Scattered obstructions and vegetation, and may impede the flow of the channel.

View of the channel from the bridge facing upstream.

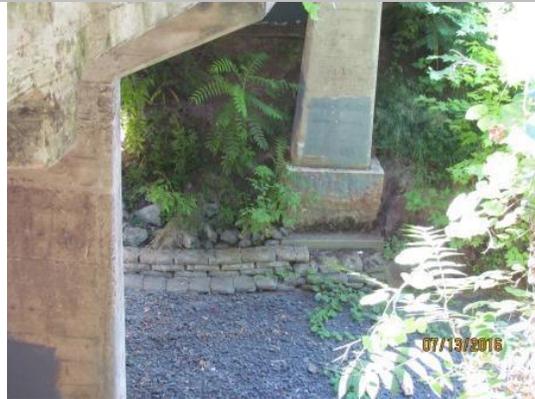
Photo 1 of 1 : CH_2016_NA0060_12_74_20160720_00055.jpg

Check Point / View				
Lone Pine Avenue / Up (cont)				
Rating **	N	Issue No.	74	GPS Lat/Long
Issue Type +	Ma	Location *		39.703260 °
Category	Rivers, Channels & Designated Flood			-121.868470 °
Item	Revetments			
DWR ID	DWR_NA0060_12_c_2012_74			
Action/Comments				
Inspector Comments: No riprap observed at this site.

View of concrete filled sandbags used for riprap at bridge abutments on both sides.

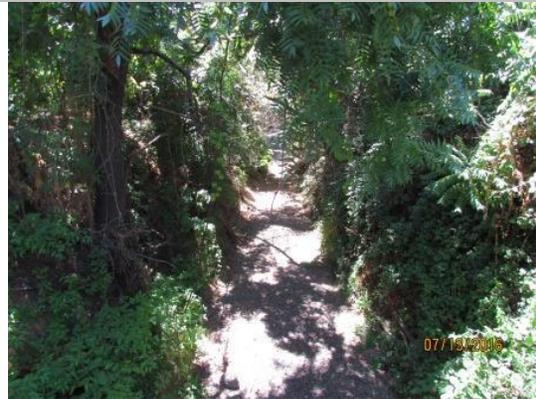
Photo 1 of 1 : CH_2016_NA0060_12_76_20160720_00056.jpg

Check Point / View			
Lone Pine Avenue / Down			
Rating **	A	Issue No. 76	GPS Lat/Long
Issue Type +	Ma	Location *	39.703260 °
Category	Rivers, Channels & Designated Flood		-121.868470 °
Item	Vegetation & Obstructions		
DWR ID	DWR_NA0060_12_c_2012_76		
Action/Comments			
Inspector Comments: There is vegetation in the channel, the flow does not appear impeded.

View of the channel facing downstream.
