## Flood Control Project Maintenance

## 2011 Structure Summary Report

## DWR Sutter Maintenance Yard

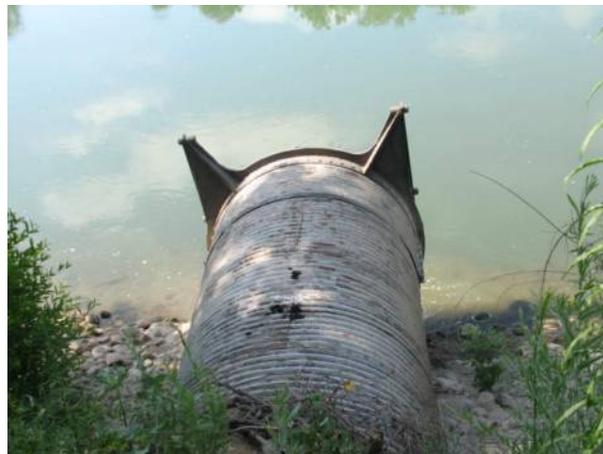
Levee Mile Report Line	1
Start Levee Mile	0.00
End Levee Mile	0.00
Location	
Category	Structures
Item	Photo Documentation
08/04/2011 Butte Slough Drainage structure outfall.	
jeto_t_20110809_011.jpg

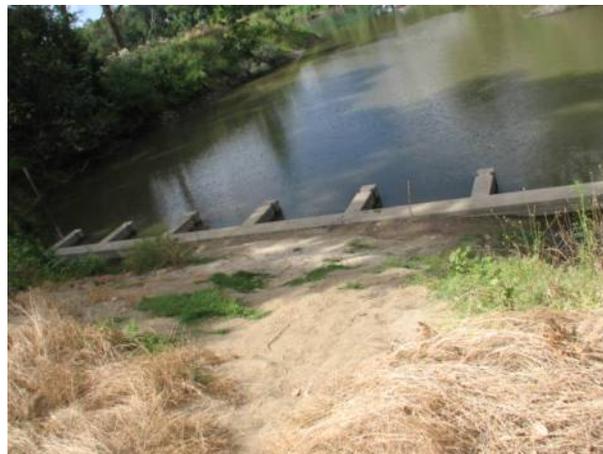
Levee Mile Report Line	1
Start Levee Mile	0.00
End Levee Mile	0.00
Location	
Category	Structures
Item	Photo Documentation
08/04/2011 View of the Butte Slough Outfall Structure on the water side.	
jeto_t_20110809_009.jpg

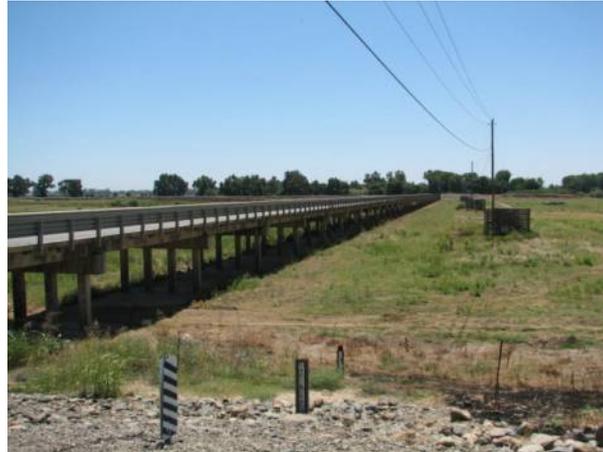
Levee Mile Report Line	1
Start Levee Mile	0.00
End Levee Mile	0.00
Location	
Category	Structures
Item	Photo Documentation
<p>This is a view of the Colusa Weir structure from the left bank of the levee.</p>	
<p>cathom_t_20110809_011.jpg</p>

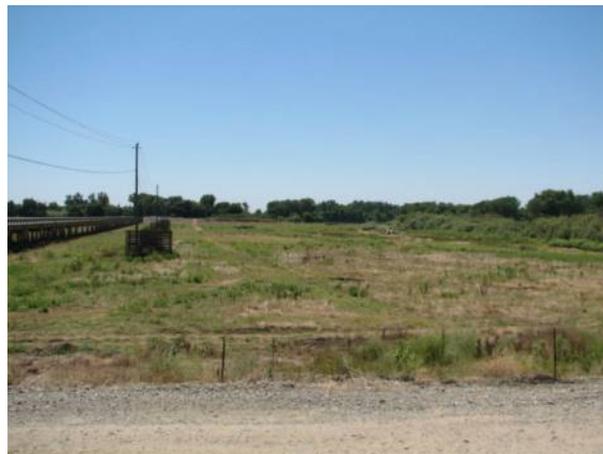
6	0.00	0.00	Structures	Encroachments		M	Inspector Comments: Trash, debris is present but will not inhibit project operations and maintenance or emergency operations.	39.232135 ° -121.996253 °	39.232135 ° -121.996253 °	6 Y
7	0.00	0.00	Structures	Culverts: Inlets / Outlets		N	Inspector Comments: This item does not apply to this inspection.	39.232135 ° -121.996253 °	39.232135 ° -121.996253 °	7
8	0.00	0.00	Structures	Culverts: Breaks / Holes / Cracks		N	Inspector Comments: This item does not apply to this inspection.	39.232135 ° -121.996253 °	39.232135 ° -121.996253 °	8
9	0.00	0.00	Structures	Metal Pipes		N	Inspector Comments: This item does not apply to this inspection.	39.232135 ° -121.996253 °	39.232135 ° -121.996253 °	9
10	0.00	0.00	Structures	Trash Racks		N	Inspector Comments: This item does not apply to this inspection.	39.232135 ° -121.996253 °	39.232135 ° -121.996253 °	10
11	0.00	0.00	Structures	Flap Gates		N	Inspector Comments: This item does not apply to this inspection.	39.232135 ° -121.996253 °	39.232135 ° -121.996253 °	11

Levee Mile Report Line	6
Start Levee Mile	0.00
End Levee Mile	0.00
Location	
Category	Structures
Item	Encroachments
<p>This photo shows some of the debris in the channel.</p>	
<p>cathom_t_20110809_013.jpg</p>

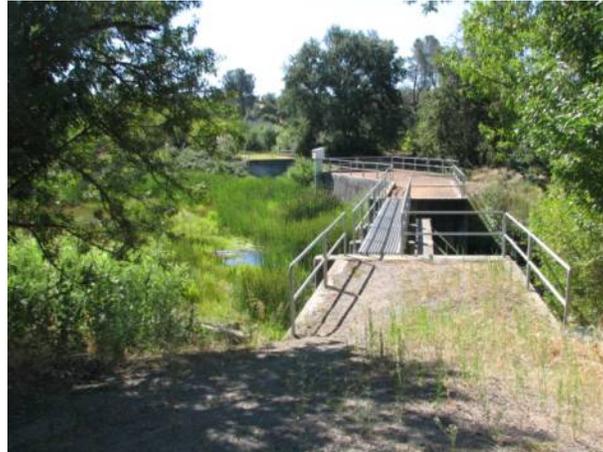
Levee Mile Report Line	1
Start Levee Mile	0.00
End Levee Mile	0.00
Location	
Category	Structures
Item	Photo Documentation
This is a view of the structure.	
cathom_t_20110906_028.jpg

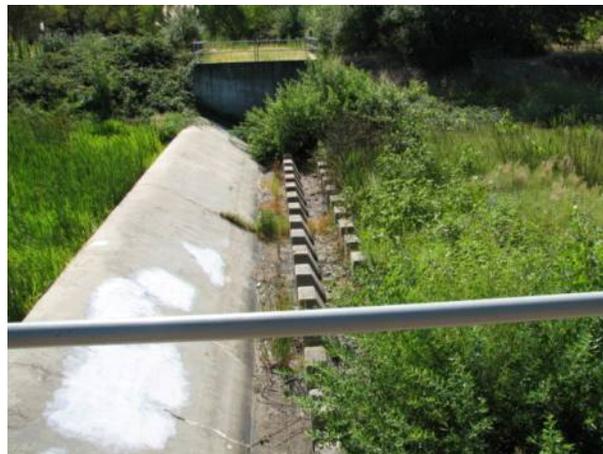
Levee Mile Report Line	1
Start Levee Mile	0.00
End Levee Mile	0.00
Location	
Category	Structures
Item	Photo Documentation
This is a view of the weir.	
cathom_t_20110906_029.jpg

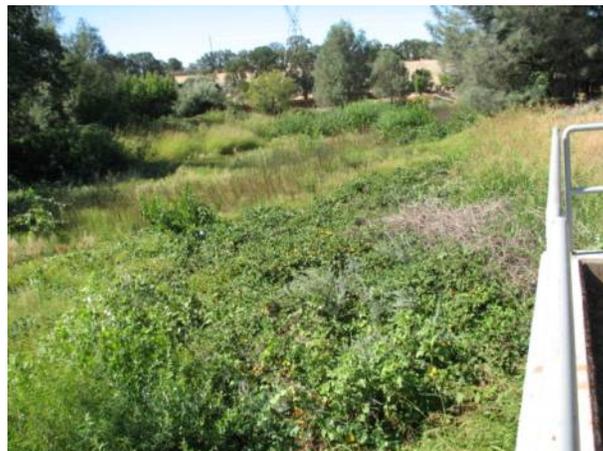
Levee Mile Report Line	2
Start Levee Mile	0.00
End Levee Mile	0.00
Location	
Category	Structures
Item	Vegetation & Obstructions
This is a view looking upstream.	
cathom_t_20110906_030.jpg

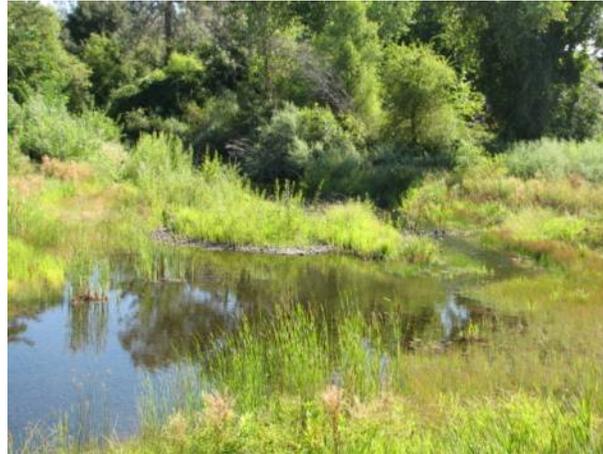
cathom\_t\_20110906\_031.jpg

This is a view looking downstream.

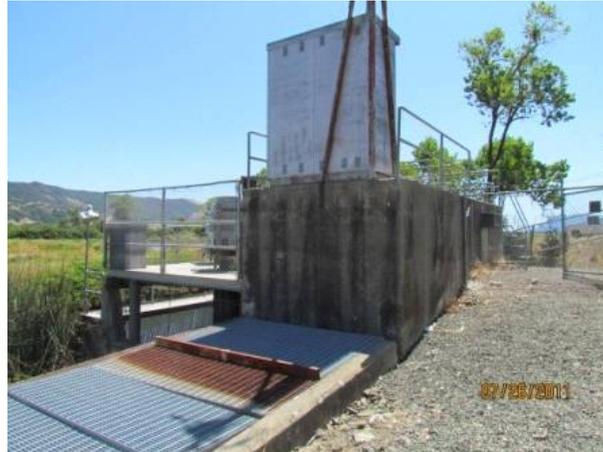
Levee Mile Report Line	3
Start Levee Mile	0.00
End Levee Mile	0.00
Location	
Category	Pump Stations
Item	Plant Building
View of the pumping plant.	
pkazi_t_20110808_037.jpg

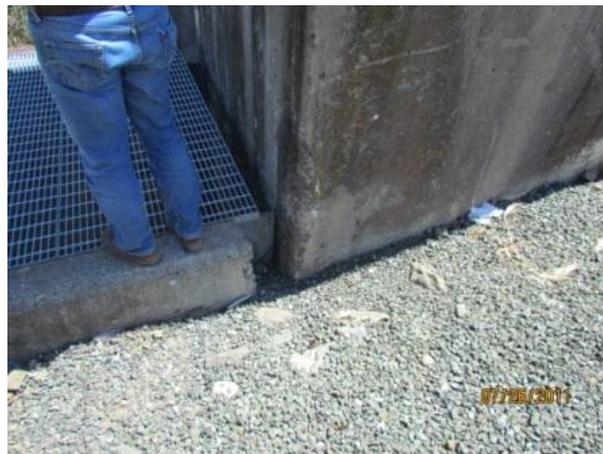
Levee Mile Report Line	3
Start Levee Mile	0.00
End Levee Mile	0.00
Location	
Category	Pump Stations
Item	Plant Building
View of the settlement adjacent to the structure.	
pkazi_t_20110808_039.jpg

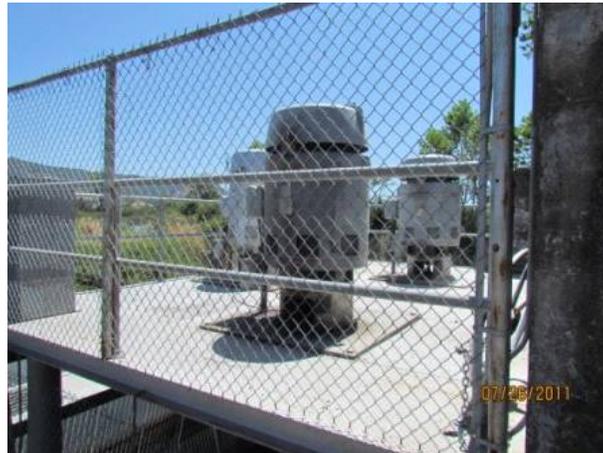
pkazi\_t\_20110808\_040.jpg

View of the fences at the plant.

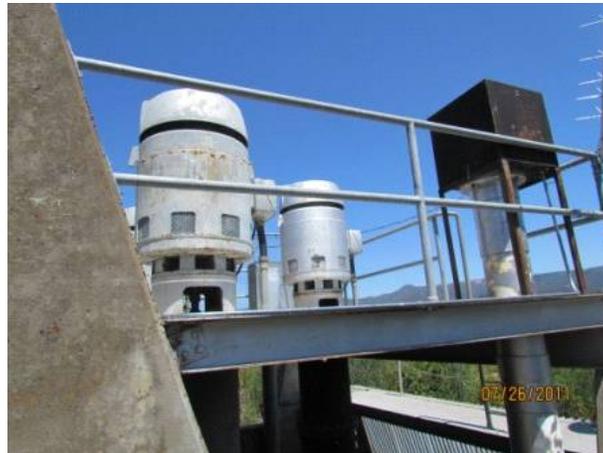
pkazi\_t\_20110808\_042.jpg

Levee Mile Report Line	7
Start Levee Mile	0.00
End Levee Mile	0.00
Location	
Category	Pump Stations
Item	Pumps

View of the pumps.

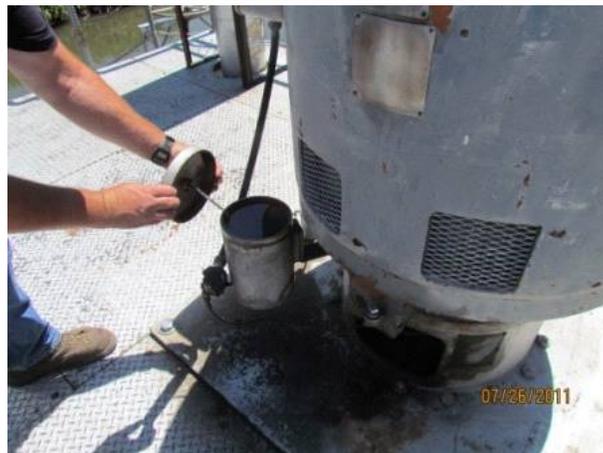
pkazi\_t\_20110808\_043.jpg

Levee Mile Report Line	7
Start Levee Mile	0.00
End Levee Mile	0.00
Location	
Category	Pump Stations
Item	Pumps

View of the lubrication level of the pump.

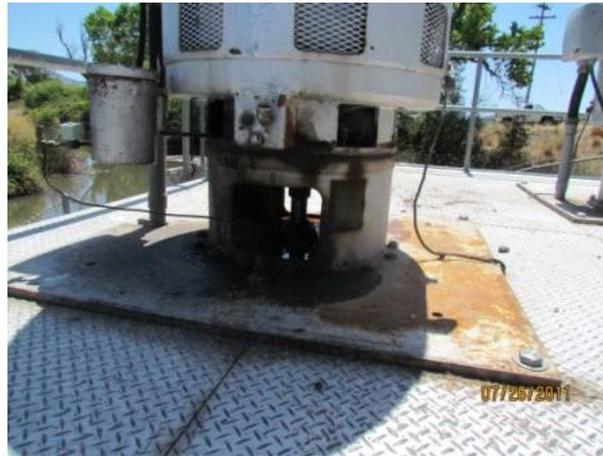
pkazi\_t\_20110808\_044.jpg

View of a pump.

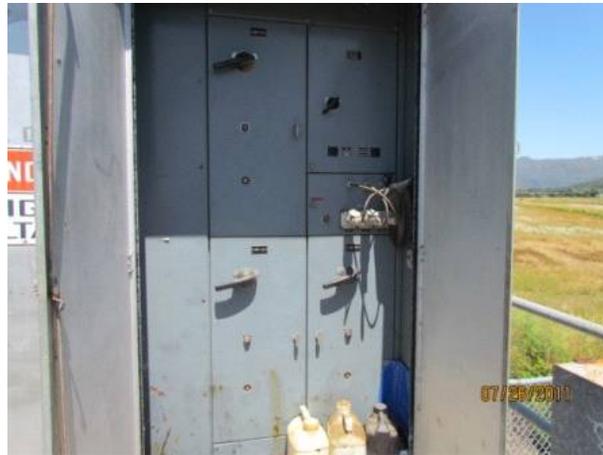
pkazi\_t\_20110808\_045.jpg

Levee Mile Report Line	10
Start Levee Mile	0.00
End Levee Mile	0.00
Location	
Category	Pump Stations
Item	Pump Control Systems

View of the pump control systems.

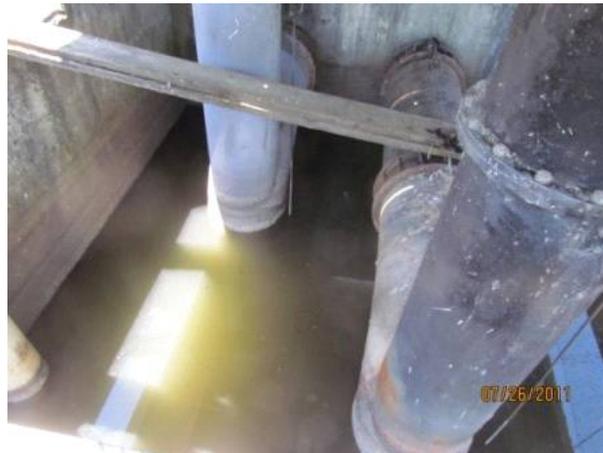
pkazi\_t\_20110808\_046.jpg

Levee Mile Report Line	11
Start Levee Mile	0.00
End Levee Mile	0.00
Location	
Category	Pump Stations
Item	Sumps/Wet Well

View of the wet well.

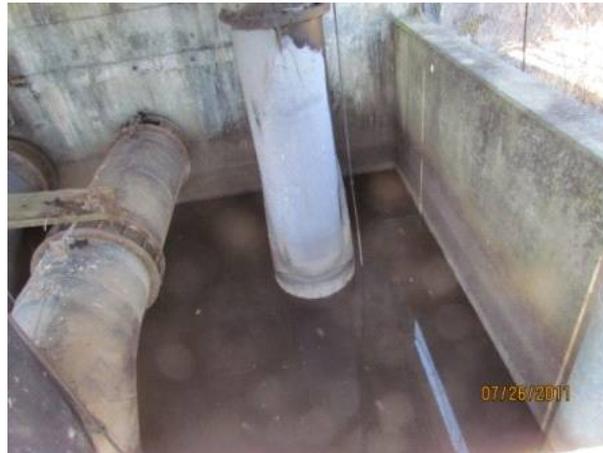
pkazi\_t\_20110808\_047.jpg

View of the wet well.

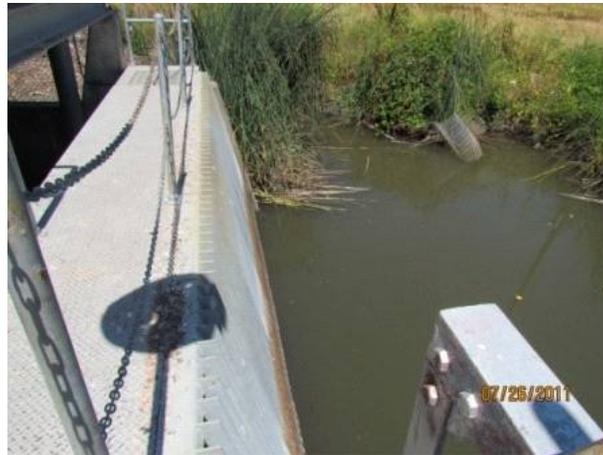
pkazi\_t\_20110808\_048.jpg

Levee Mile Report Line	12
Start Levee Mile	0.00
End Levee Mile	0.00
Location	
Category	Pump Stations
Item	Trash Racks

View of the trash racks.

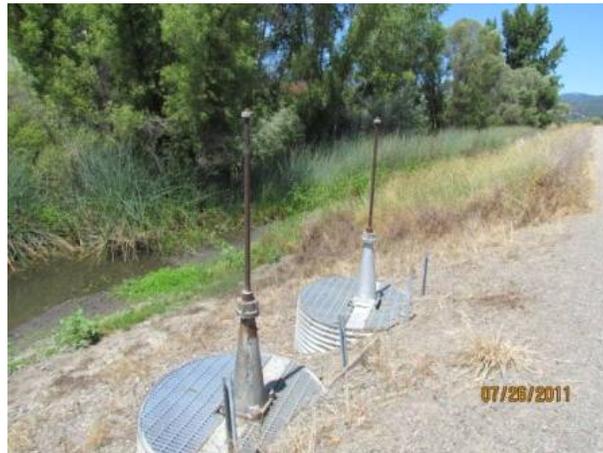
pkazi\_t\_20110808\_049.jpg

Levee Mile Report Line	14
Start Levee Mile	0.00
End Levee Mile	0.00
Location	
Category	Pump Stations
Item	Sluice / Slide Gates

View of the slide gates.

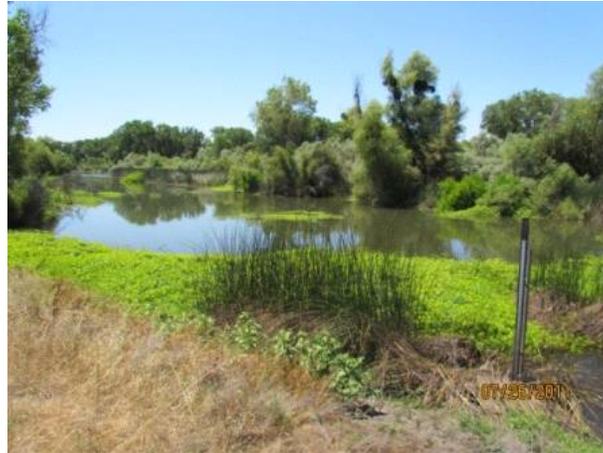
Levee Mile Report Line	18
Start Levee Mile	0.00
End Levee Mile	0.00
Location	
Category	Pump Stations
Item	Flap Gates
Vegetation growth near the flap gate opening.	
pkazi_t_20110808_051.jpg

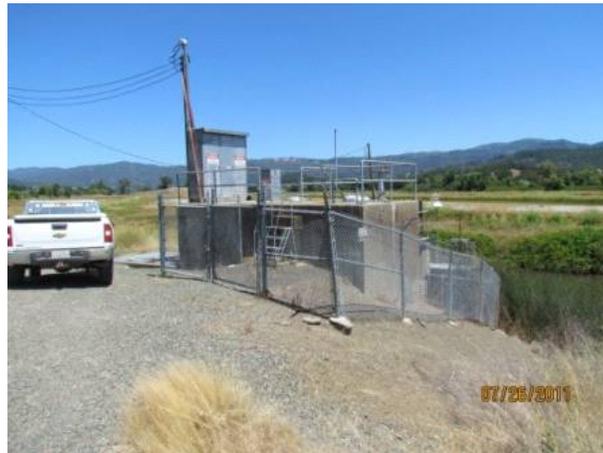
Levee Mile Report Line	20
Start Levee Mile	0.00
End Levee Mile	0.00
Location	
Category	Pump Stations
Item	Security Fencing
View of the security fencing.	
pkazi_t_20110808_052.jpg

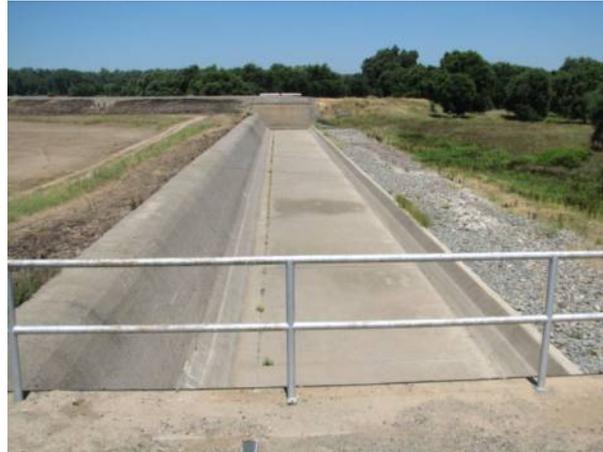
Levee Mile Report Line	1
Start Levee Mile	0.00
End Levee Mile	0.00
Location	
Category	Structures
Item	Photo Documentation
<p>This is a view of the Moulton Weir taken from the right bank levee.</p>	
<p>cathom_t_20110809_010.jpg</p>

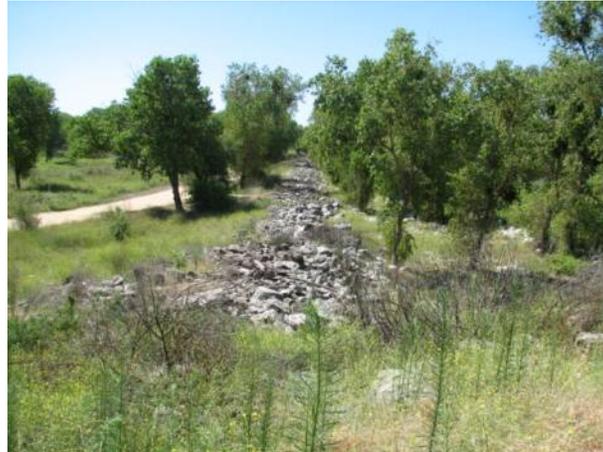
Levee Mile Report Line	1
Start Levee Mile	0.00
End Levee Mile	0.00
Location	
Category	Structures
Item	Photo Documentation
This view is from the north end of the structure looking south.	
cathom_t_20110726_001.jpg

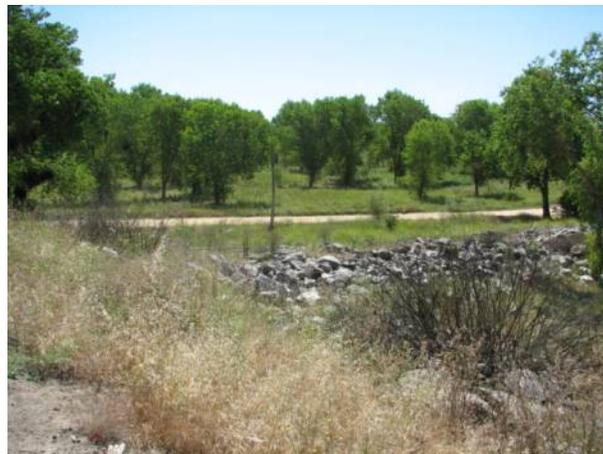
Levee Mile Report Line	1
Start Levee Mile	0.00
End Levee Mile	0.00
Location	
Category	Structures
Item	Photo Documentation
This view is of the north end of Nelson Weir.	
cathom_t_20110726_002.jpg

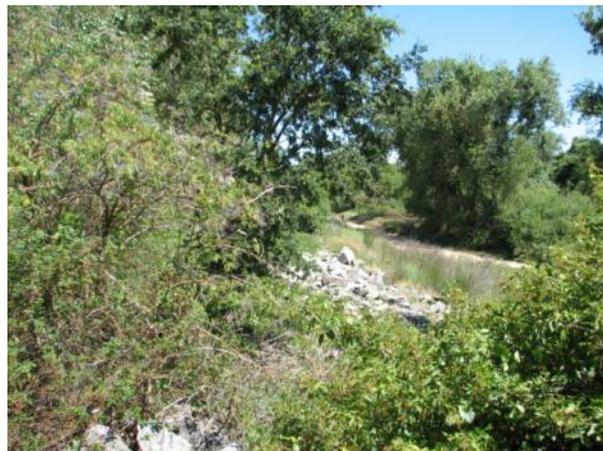
Levee Mile Report Line	1
Start Levee Mile	0.00
End Levee Mile	0.00
Location	
Category	Structures
Item	Photo Documentation
This view is of the south end of Nelson Weir.	
cathom_t_20110726_003.jpg

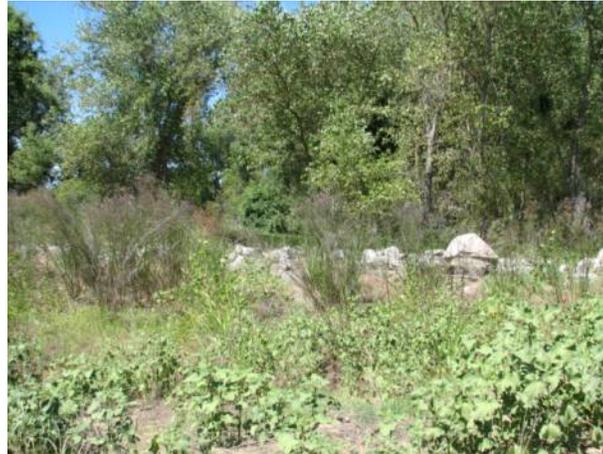
cathom\_t\_20110726\_004.jpg

This is a view of the vegetation in front of the weir.

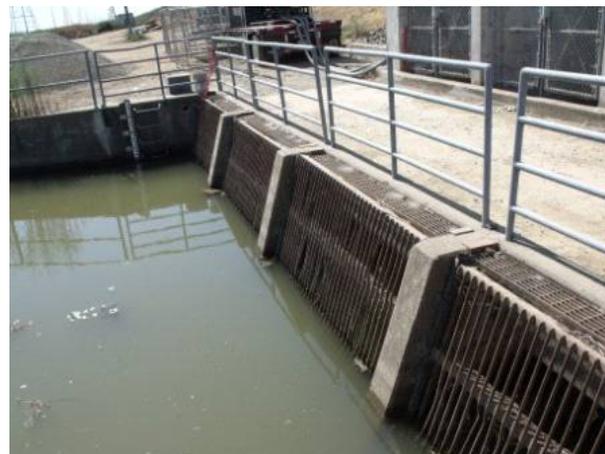
Levee Mile Report Line	12
Start Levee Mile	0.00
End Levee Mile	0.00
Location	
Category	Pump Stations
Item	Trash Racks
08/24/2011 Photo shows properly maintained trash rack.	
jeto_t_20110829_049.jpg

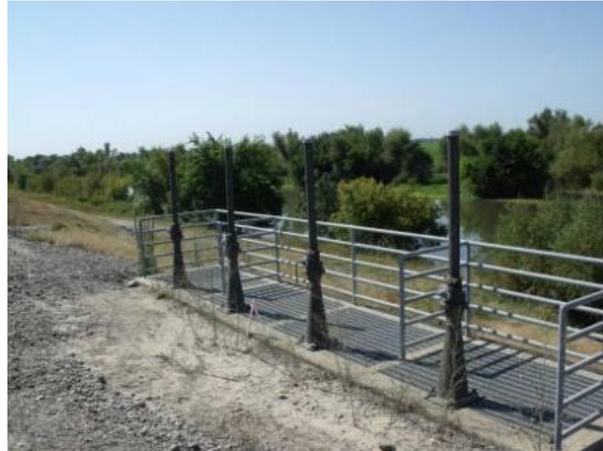
Levee Mile Report Line	16
Start Levee Mile	0.00
End Levee Mile	0.00
Location	
Category	Pump Stations
Item	Manual Gate Operators
08/24/2011 Photo shows sluice gate operators. Note: operators can be operated either mechanically or manually.	
jeto_t_20110829_050.jpg

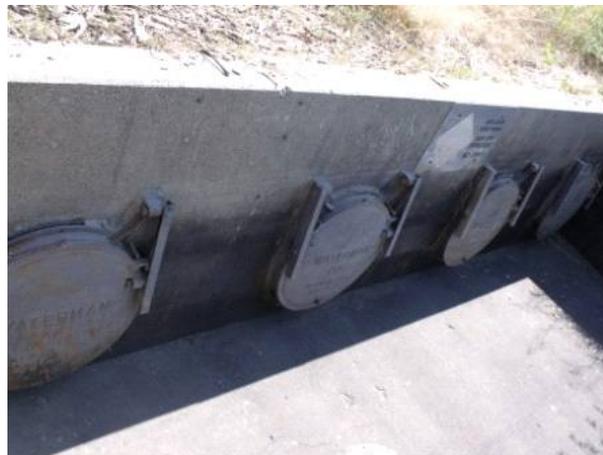
Levee Mile Report Line	18
Start Levee Mile	0.00
End Levee Mile	0.00
Location	
Category	Pump Stations
Item	Flap Gates
08/24/2011 Photo shows flap gates and concrete outfall structure.	
jeto_t_20110829_051.jpg

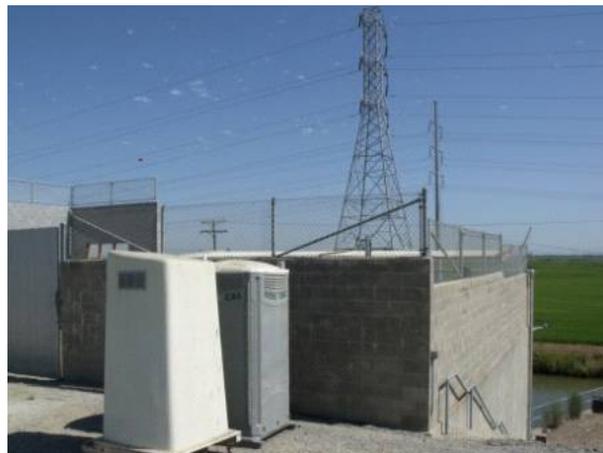
Levee Mile Report Line	20
Start Levee Mile	0.00
End Levee Mile	0.00
Location	
Category	Pump Stations
Item	Security Fencing
08/24/2011 Photo shows masonry brick wall which encloses the pump plant.	
jeto_t_20110829_052.jpg

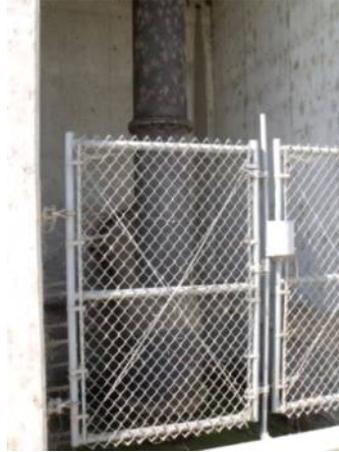
Levee Mile Report Line	21
Start Levee Mile	0.00
End Levee Mile	0.00
Location	
Category	Pump Stations
Item	Intake and Discharge Pipes
08/24/2011 Photo shows pump intake pipe TYP.	
jeto_t_20110829_053.jpg

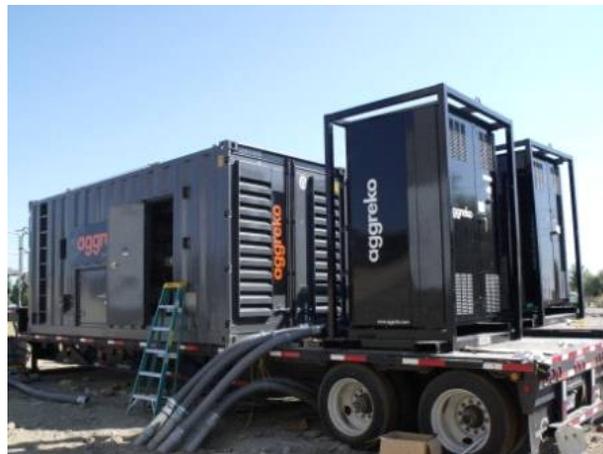
Levee Mile Report Line	8
Start Levee Mile	0.00
End Levee Mile	0.00
Location	
Category	Pump Stations
Item	Power
08/24/2011 Photo shows two generators which are being kept on site for emergency operation of the pumps.	
jeto_t_20110825_042.jpg

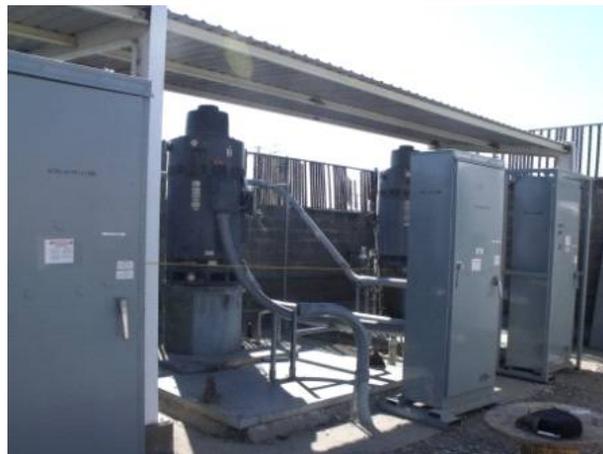
Levee Mile Report Line	9
Start Levee Mile	0.00
End Levee Mile	0.00
Location	
Category	Pump Stations
Item	Motors, Engines, Fans & Gear Reducers
08/24/2011 Photo shows motors in place at site.	
jeto_t_20110825_040.jpg

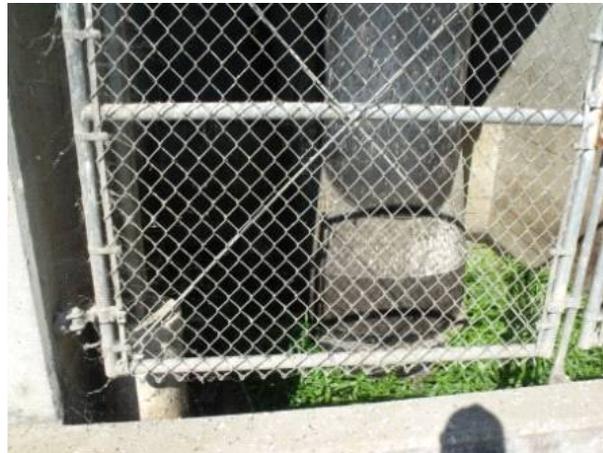
Levee Mile Report Line	12
Start Levee Mile	0.00
End Levee Mile	0.00
Location	
Category	Pump Stations
Item	Trash Racks
08/24/2011 Photo shows row of trash racks (six).	
jeto_t_20110825_045.jpg

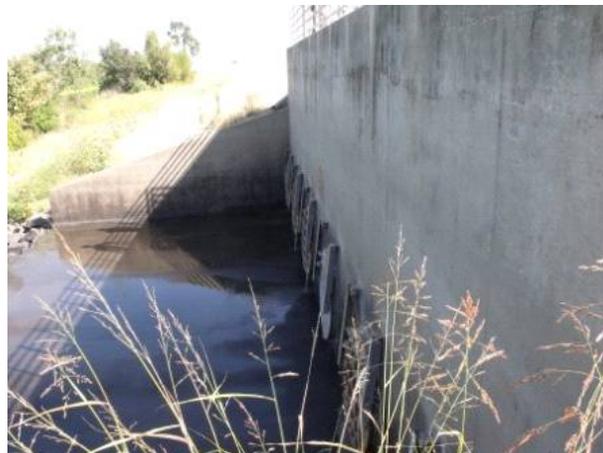
Levee Mile Report Line	18
Start Levee Mile	0.00
End Levee Mile	0.00
Location	
Category	Pump Stations
Item	Flap Gates
08/24/2011 Photo shows flap gates. Note water is the result of the motor/pump testing.	
jeto_t_20110825_046.jpg

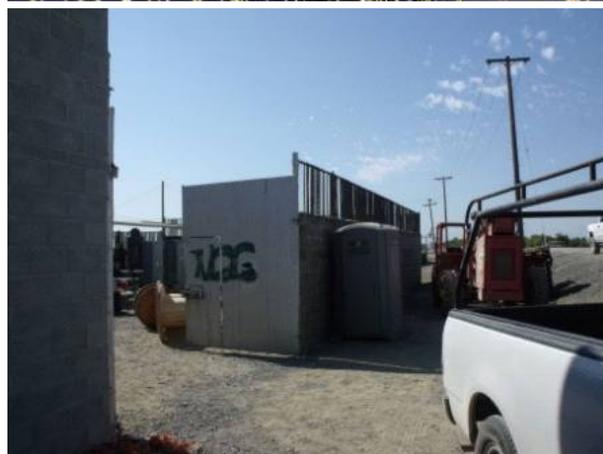
Levee Mile Report Line	20
Start Levee Mile	0.00
End Levee Mile	0.00
Location	
Category	Pump Stations
Item	Security Fencing
08/24/2011 Photo shows masonry block wall which encloses the site.	
jeto_t_20110825_038.jpg

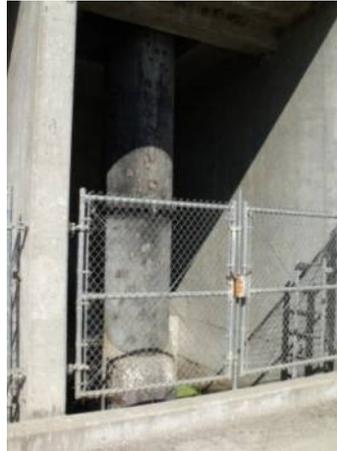
Levee Mile Report Line	21
Start Levee Mile	0.00
End Levee Mile	0.00
Location	
Category	Pump Stations
Item	Intake and Discharge Pipes
08/24/2011 Photo shows intake pipe TYP.	
jeto_t_20110825_043.jpg

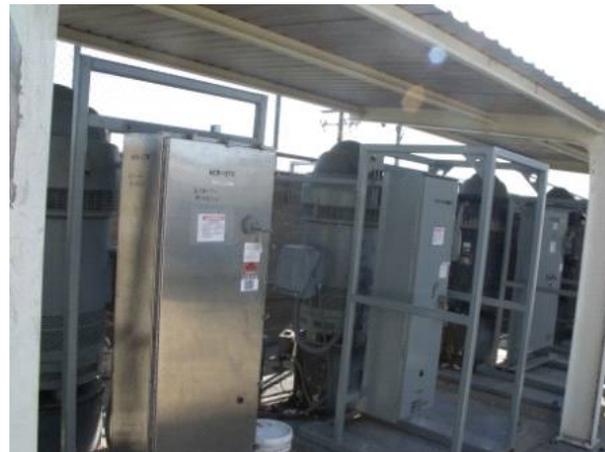
Levee Mile Report Line	10
Start Levee Mile	0.00
End Levee Mile	0.00
Location	
Category	Pump Stations
Item	Pump Control Systems
08/24/2011 Photo shows new control panels, which are being installed as part of the new construction.	
jeto_t_20110825_036.jpg

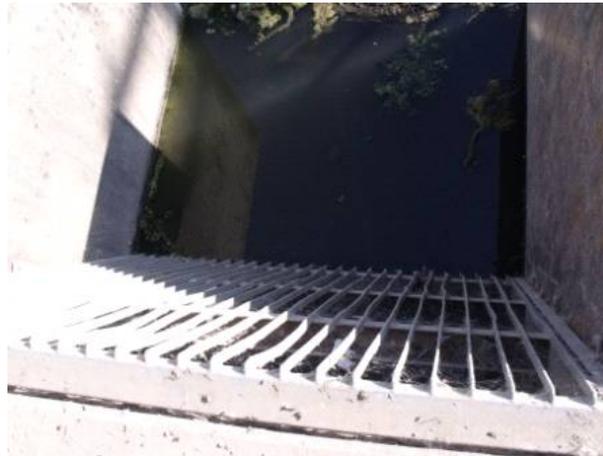
Levee Mile Report Line	12
Start Levee Mile	0.00
End Levee Mile	0.00
Location	
Category	Pump Stations
Item	Trash Racks
08/24/2011 Photo shows trash rack free of debris and other material.	
jeto_t_20110825_033.jpg

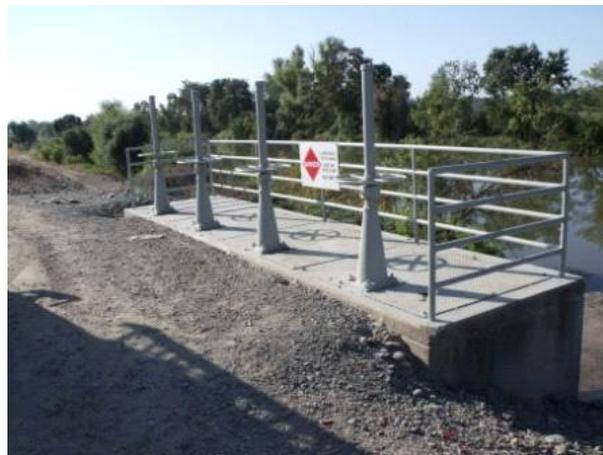
Levee Mile Report Line	16
Start Levee Mile	0.00
End Levee Mile	0.00
Location	
Category	Pump Stations
Item	Manual Gate Operators
08/24/2011 Photo shows manual gate operators.	
jeto_t_20110825_030.jpg

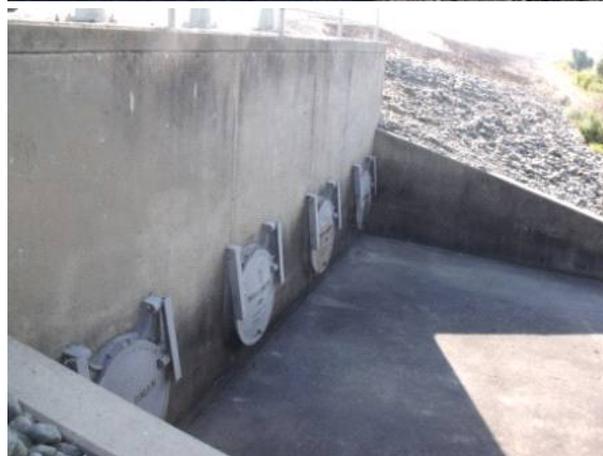
Levee Mile Report Line	18
Start Levee Mile	0.00
End Levee Mile	0.00
Location	
Category	Pump Stations
Item	Flap Gates
08/24/2011 Photo shows flap gates and concrete outfall structure.	
jeto_t_20110825_031.jpg

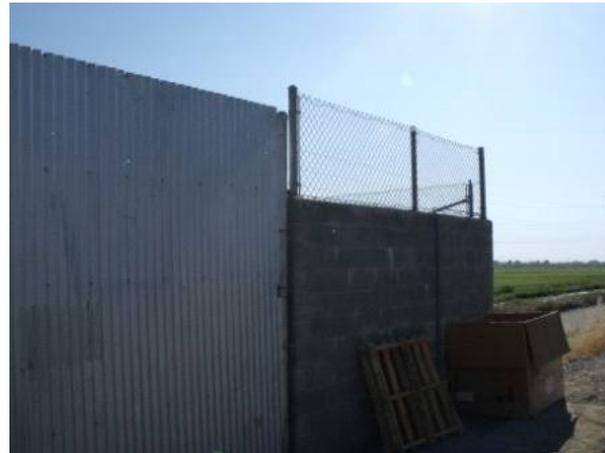
Levee Mile Report Line	20
Start Levee Mile	0.00
End Levee Mile	0.00
Location	
Category	Pump Stations
Item	Security Fencing
08/24/2011 Photo shows masonry brick wall which encloses the entire structure.	
jeto_t_20110825_034.jpg

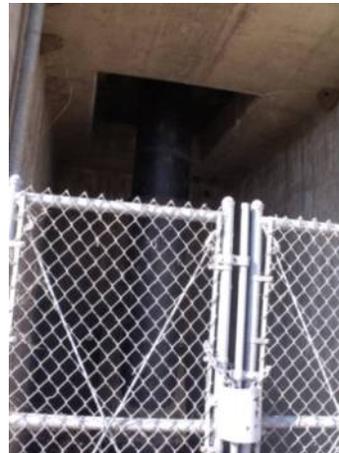
Levee Mile Report Line	21
Start Levee Mile	0.00
End Levee Mile	0.00
Location	
Category	Pump Stations
Item	Intake and Discharge Pipes
08/24/2011 Photo shows Intake pipe TYP.	
jeto_t_20110825_032.jpg

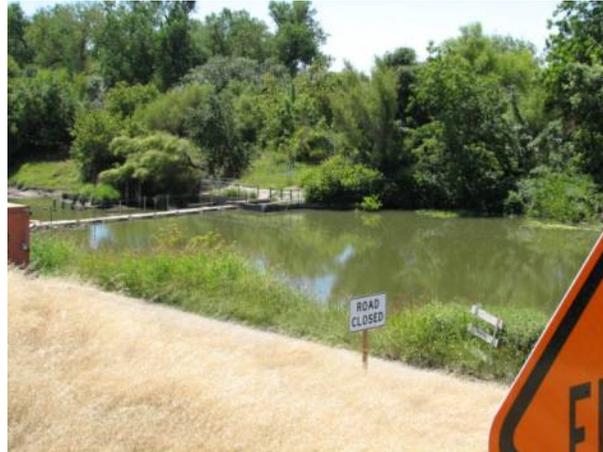
Levee Mile Report Line	1
Start Levee Mile	0.00
End Levee Mile	0.00
Location	
Category	Structures
Item	Photo Documentation
<p>This is a view of the upstream side of the Sutter Bypass Weir No. 2.</p>	
<p>cathom_t_20110726_005.jpg</p>

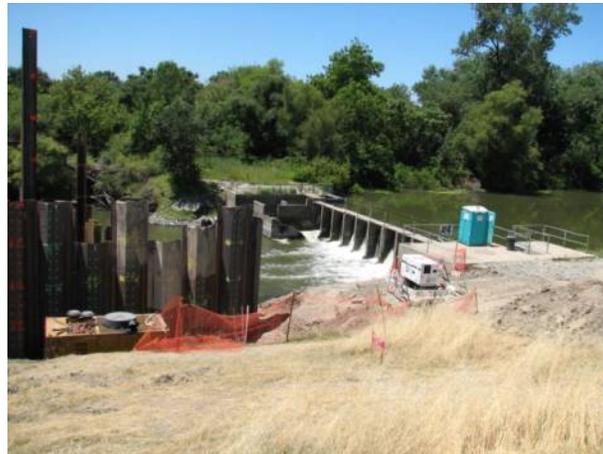
Levee Mile Report Line	1
Start Levee Mile	0.00
End Levee Mile	0.00
Location	
Category	Structures
Item	Photo Documentation
<p>This is a view of the downstream side of the Sutter Bypass Weir No. 2. New construction of the replacement for weir no. 2 has already started.</p>	
<p>cathom_t_20110726_006.jpg</p>

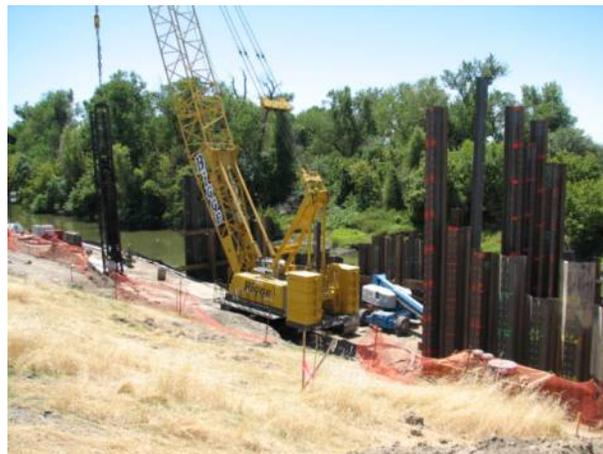
Levee Mile Report Line	1
Start Levee Mile	0.00
End Levee Mile	0.00
Location	
Category	Structures
Item	Photo Documentation
<p>This is a view of the downstream work for the replacement weir.</p>	
<p>cathom_t_20110726_007.jpg</p>

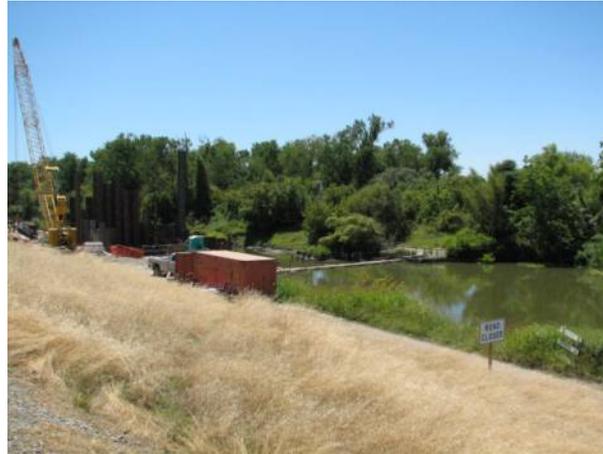
This is a view of the upstream side of the weir.

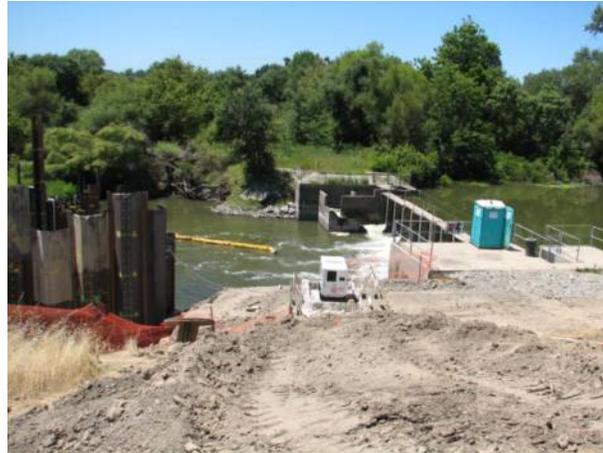
This is a view of the downstream side of the weir.

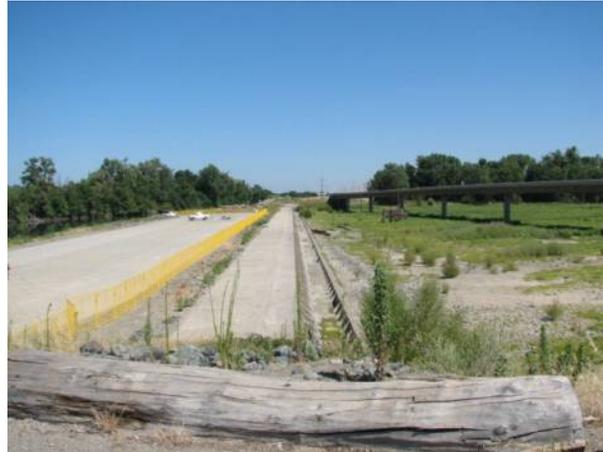
Levee Mile Report Line	1
Start Levee Mile	0.00
End Levee Mile	0.00
Location	
Category	Structures
Item	Photo Documentation
This view is of the Tisdale Weir from the right bank levee.	
cathom_t_20110809_014.jpg

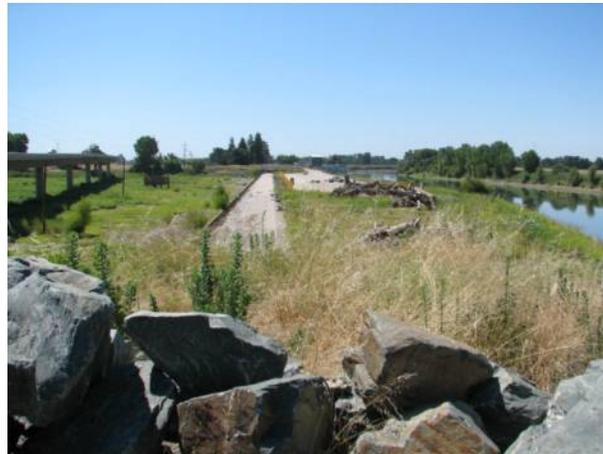
Levee Mile Report Line	1
Start Levee Mile	0.00
End Levee Mile	0.00
Location	
Category	Structures
Item	Photo Documentation
This view of the Tisdale Weir is from the left bank levee.	
cathom_t_20110809_015.jpg

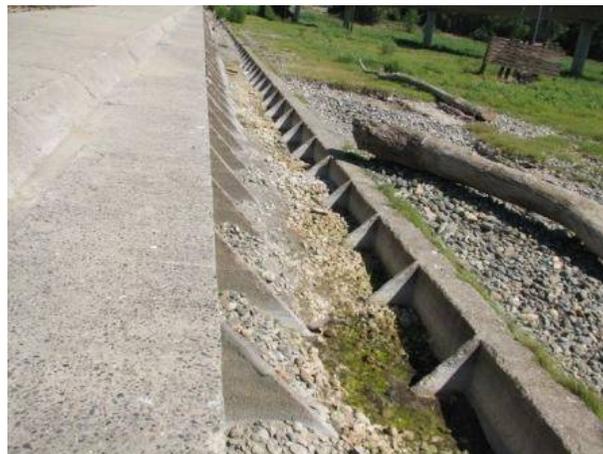
Levee Mile Report Line	3
Start Levee Mile	0.00
End Levee Mile	0.00
Location	
Category	Structures
Item	Shoaling / Sedimentation
This photo shows some sediment in the weir.	
cathom_t_20110810_016.jpg

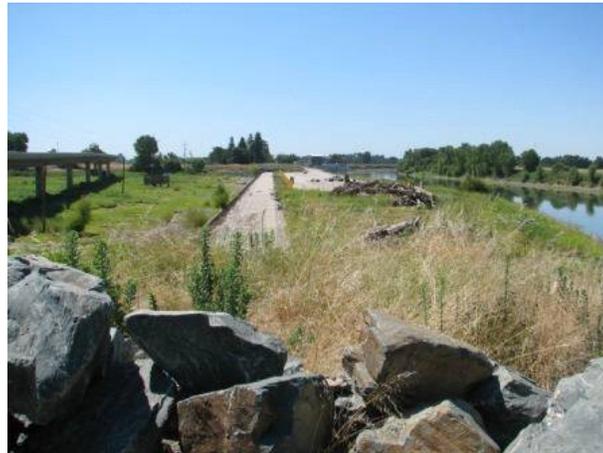
6	0.00	0.00	Structures	Encroachments		M	Inspector Comments: There is some debris in the channel.	39.026713 ° -121.821995 °	39.026713 ° -121.821995 °	6 Y
7	0.00	0.00	Structures	Culverts: Inlets / Outlets		N	Inspector Comments: This item does not apply to this inspection.	39.026713 ° -121.821995 °	39.026713 ° -121.821995 °	7
8	0.00	0.00	Structures	Culverts: Breaks / Holes / Cracks		N	Inspector Comments: This item does not apply to this inspection.	39.026713 ° -121.821995 °	39.026713 ° -121.821995 °	8
9	0.00	0.00	Structures	Metal Pipes		N	Inspector Comments: This item does not apply to this inspection.	39.026713 ° -121.821995 °	39.026713 ° -121.821995 °	9
10	0.00	0.00	Structures	Trash Racks		N	Inspector Comments: This item does not apply to this inspection.	39.026713 ° -121.821995 °	39.026713 ° -121.821995 °	10
11	0.00	0.00	Structures	Flap Gates		N	Inspector Comments: This item does not apply to this inspection.	39.026713 ° -121.821995 °	39.026713 ° -121.821995 °	11

Levee Mile Report Line	6
Start Levee Mile	0.00
End Levee Mile	0.00
Location	
Category	Structures
Item	Encroachments
<p>This photo shows the pile of debris in front of the weir.</p>	
<p>cathom_t_20110810_017.jpg</p>

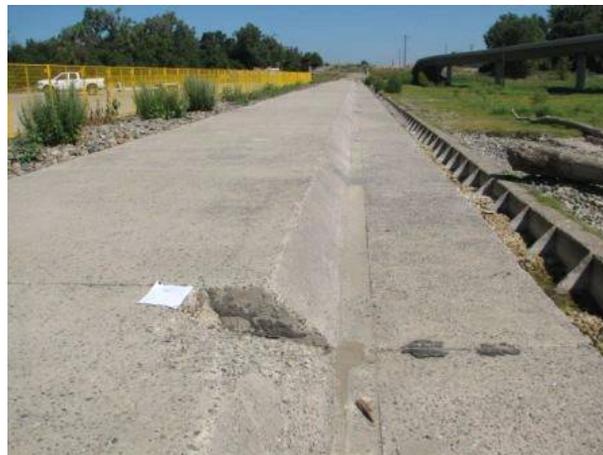
LMR No.	Levee Mile		Category	Item	Location *	Rating **	Action/Comment	GPS Latitude/Longitude		Issue No.
	Start	End						Start	End	Photo
15	0.00	0.00	Structures	Concrete Surfaces		A	Inspector Comments: Negligible spalling, scaling or cracking.	39.026713 ° -121.821995 °	39.026713 ° -121.821995 °	15 Y
16	0.00	0.00	Structures	Concrete Tilting / Settlement		A	Inspector Comments: There are no significant areas of tilting, sliding or settlement that would endanger the integrity of the project.	39.026713 ° -121.821995 °	39.026713 ° -121.821995 °	16
17	0.00	0.00	Structures	Concrete Foundations		A	Inspector Comments: No scouring / erosion or undermining near the structure.	39.026713 ° -121.821995 °	39.026713 ° -121.821995 °	17
18	0.00	0.00	Structures	Security Fencing		N	Inspector Comments: This item does not apply to this inspection.	39.026713 ° -121.821995 °	39.026713 ° -121.821995 °	18
19	0.00	0.00	Structures	Closure Structures		N	Inspector Comments: This item does not apply to this inspection.	39.026713 ° -121.821995 °	39.026713 ° -121.821995 °	19

Levee Mile Report Line	15
Start Levee Mile	0.00
End Levee Mile	0.00
Location	
Category	Structures
Item	Concrete Surfaces
<p>This photo shows some surface damage.</p>	
<p>cathom_t_20110810_018.jpg</p>

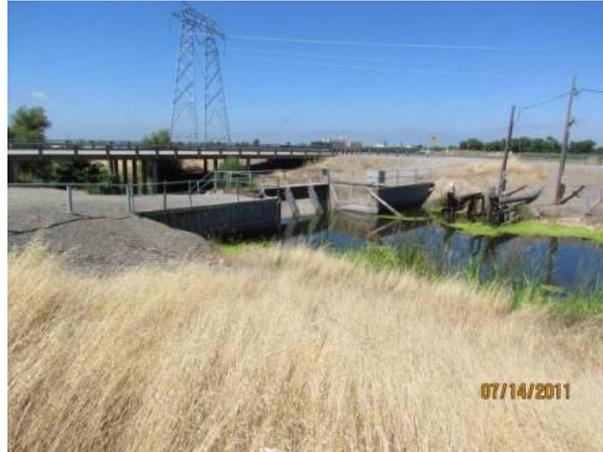
Levee Mile Report Line	1
Start Levee Mile	
End Levee Mile	
Location	
Category	Structures
Item	Photo Documentation
View of the upstream side of the Wadsworth Canal Weir No. 4.	
rduffey_t_20110726_015.jpg

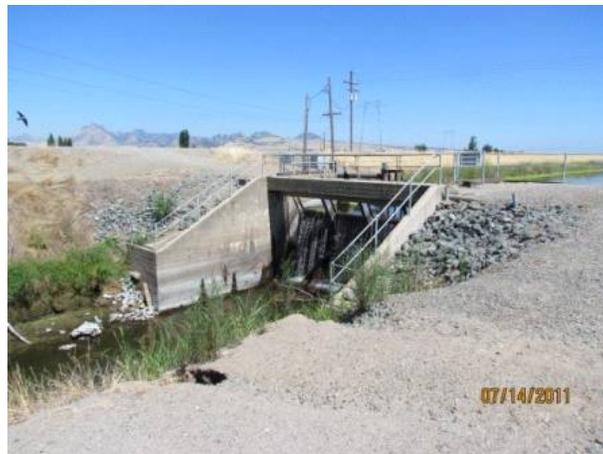
Levee Mile Report Line	4
Start Levee Mile	0.00
End Levee Mile	0.00
Location	
Category	Structures
Item	Erosion / Bank Caving
View of the downstream side of the wadsworth canal weir No. 4 erosion along channel.	
rduffey_t_20110817_018.jpg
