**Flood Control Project Maintenance**  
**2016 Structure Summary Report**  
**Overall Unit and Item Ratings**

**DWR Sutter Maintenance Yard**

**Butte Slough Drainage Structure**

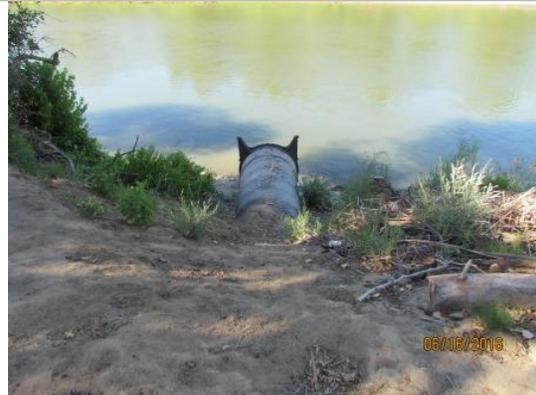
Photo 1 of 6 : ST\_2016\_NA0060\_38\_1\_20160617\_00006.jpg

Butte Slough Drainage structure on the water side.

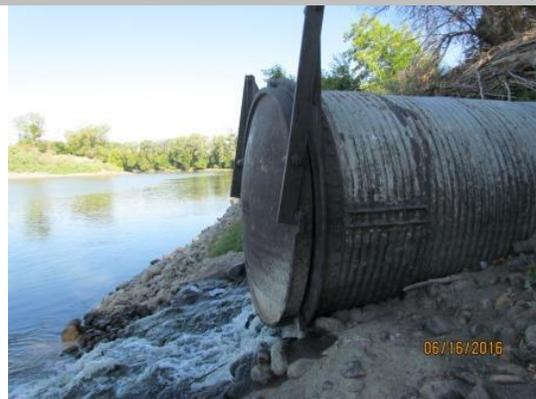
Photo 2 of 6 : ST\_2016\_NA0060\_38\_1\_20160617\_00007.jpg

Butte Slough Drainage structure outfall.

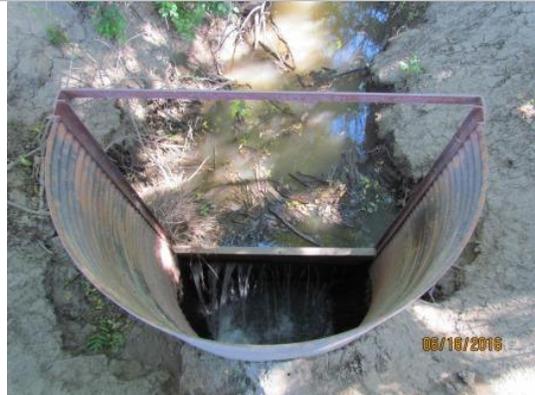
Photo 4 of 6 : ST\_2016\_NA0060\_38\_1\_20160617\_00009.jpg

Top view of the Butte Slough Drainage structure on the land side.

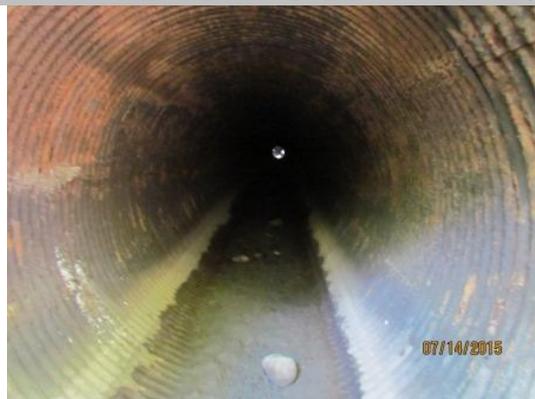
Photo 5 of 6 : ST\_2016\_NA0060\_38\_1\_20160615\_00004.jpg

View of the pipe from the landside.

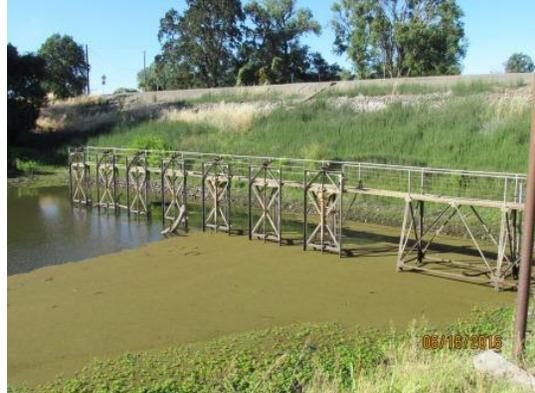
Photo 1 of 6 : ST\_2016\_NA0060\_42\_1\_20160617\_00006.jpg

View of the Butte Slough Outfall Structure on the land side.

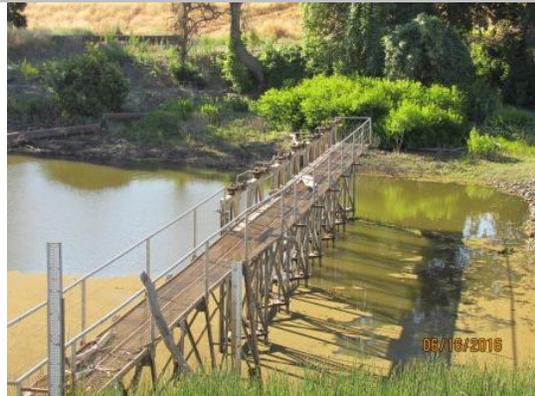
Photo 2 of 6 : ST\_2016\_NA0060\_42\_1\_20160617\_00005.jpg

Another view of the Butte Slough Outfall Structure on the land side.

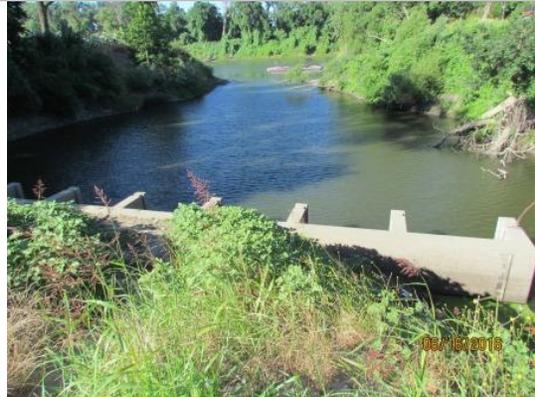
Photo 4 of 6 : ST\_2016\_NA0060\_42\_1\_20160617\_00008.jpg

View of the Butte Slough Outfall Structure facing Sacramento River.

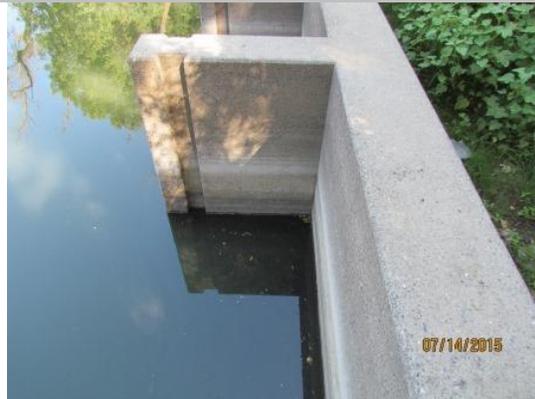
Photo 5 of 6 : ST\_2016\_NA0060\_42\_1\_20160615\_00003.jpg

View of the stop log slots on the water side.

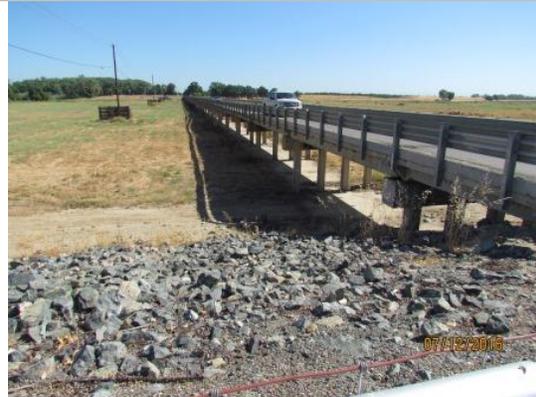
Photo 1 of 4 : ST\_2016\_NA0060\_55\_1\_20160718\_00010.jpg

View of the weir from the right bank.

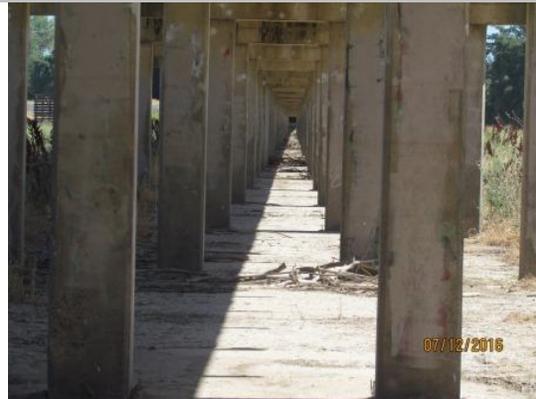
Photo 2 of 4 : ST\_2016\_NA0060\_55\_1\_20160718\_00012.jpg

View of the weir looking north.

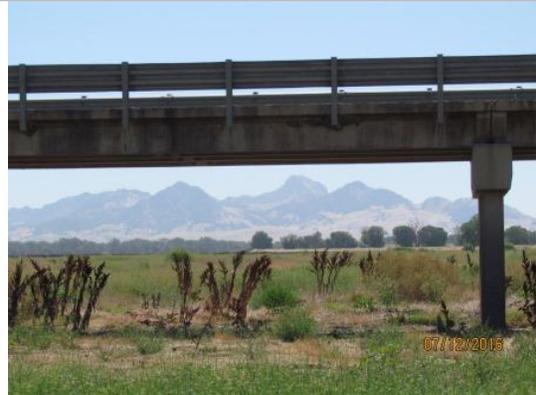
Photo 4 of 4 : ST\_2016\_NA0060\_55\_1\_20160718\_00013.jpg

This is the downstream view of the Colusa Weir structure.

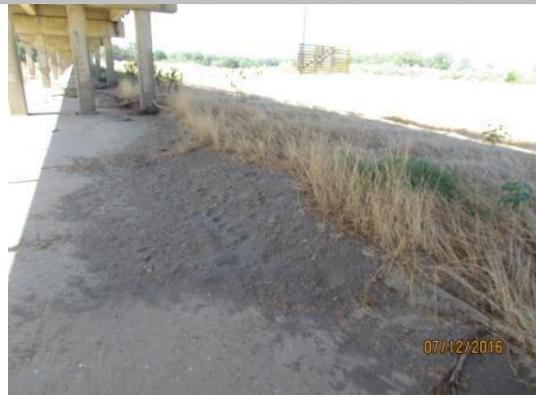
Photo 1 of 2 : ST\_2016\_NA0060\_55\_3\_20160718\_00014.jpg

LM Start	<b>0.00</b>	Rating **	M	Issue No.	<b>3</b>
LM End	<b>0.00</b>	Issue Type +	Ma	Location *	
Category	Structures & Concrete Lined Channels			GPS Latitude/Longitude	
				Start	End
Item	Shoaling / Sedimentation			39.232135 °	39.232135 °
				-121.996253 °	-121.996253 °
DWR ID	DWR_NA0060_55_t_2012_3				
Action/Comments					
Inspector Comments: Minimal sedimentation present.

View of minimal sedimentation present.

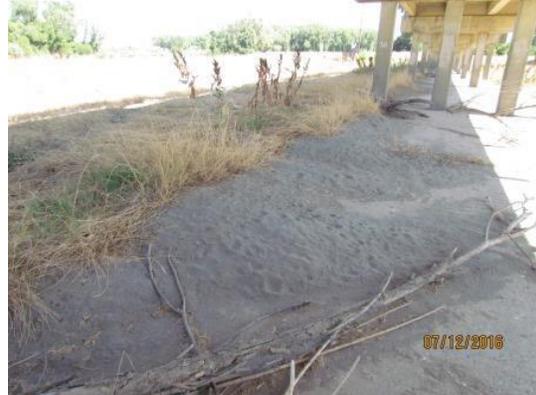
Photo 2 of 2 : ST\_2016\_NA0060\_55\_3\_20160718\_00015.jpg

LM Start	<b>0.00</b>	Rating **	M	Issue No.	<b>3 (cont)</b>
LM End	<b>0.00</b>	Issue Type +	Ma	Location *	
Category	Structures & Concrete Lined Channels		GPS Latitude/Longitude		
			Start	End	
Item	Shoaling / Sedimentation		39.232135 °	39.232135 °	
			-121.996253 °	-121.996253 °	
DWR ID	DWR_NA0060_55_t_2012_3				
Action/Comments					
Inspector Comments: Minimal sedimentation present.

Minimal sedimentation present.

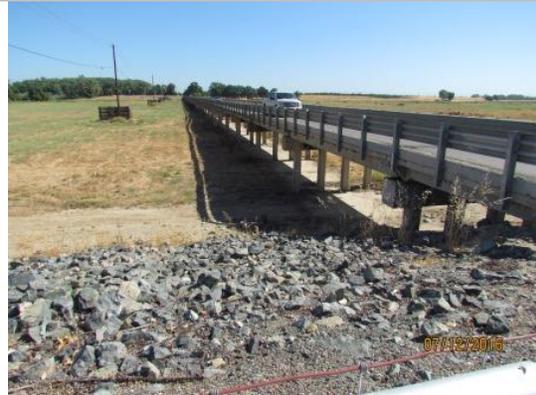
Photo 1 of 4 : ST\_2016\_NA0060\_55\_5\_20160718\_00016.jpg

LM Start	<b>0.00</b>	Rating **	A	Issue No.	<b>5</b>
LM End	<b>0.00</b>	Issue Type +	Ma	Location *	
Category	Structures & Concrete Lined Channels		GPS Latitude/Longitude		
			Start	End	
Item	Revetments		39.232135 °	39.232135 °	
			-121.996253 °	-121.996253 °	
DWR ID	DWR_NA0060_55_t_2012_5				
Action/Comments					
Inspector Comments: Existing riprap protection is properly maintained and is undamaged. Riprap clearly visible.

View of the weir and the riprap.

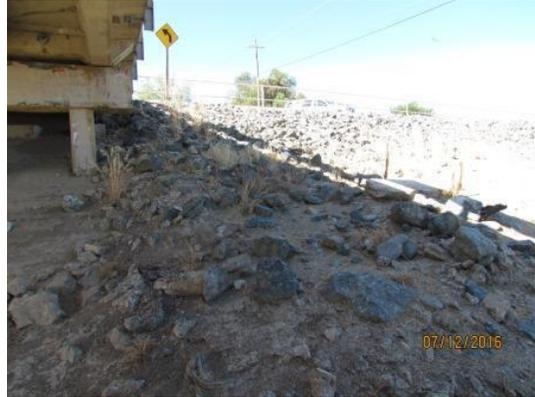
Photo 2 of 4 : ST\_2016\_NA0060\_55\_5\_20160718\_00017.jpg

LM Start	<b>0.00</b>	Rating **	A	Issue No.	<b>5 (cont)</b>
LM End	<b>0.00</b>	Issue Type +	Ma	Location *	
Category	Structures & Concrete Lined Channels			GPS Latitude/Longitude	
				Start	End
Item	Revetments			39.232135 °	39.232135 °
				-121.996253 °	-121.996253 °
DWR ID	DWR_NA0060_55_t_2012_5				
Action/Comments					
Inspector Comments: Existing riprap protection is properly maintained and is undamaged. Riprap clearly visible.

View of the weir and the riprap.

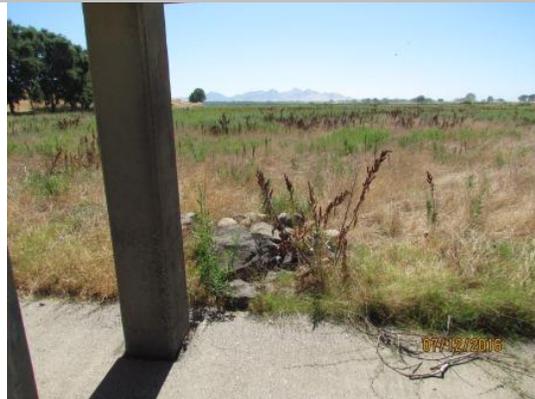
Photo 3 of 4 : ST\_2016\_NA0060\_55\_5\_20160718\_00018.jpg

View of riprap at the columns of the bridge.

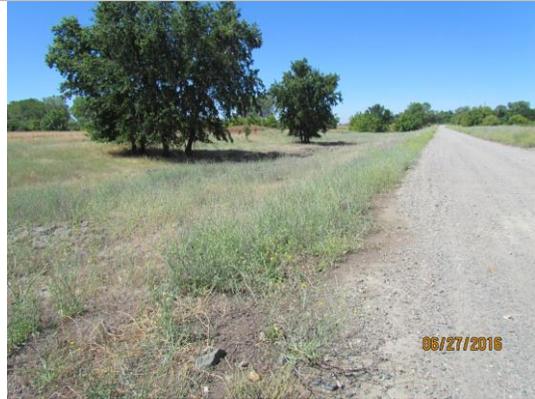
Photo 1 of 2 : ST\_2016\_NA0060\_225\_2\_20160701\_00004.jpg

View of the vegetation on downstream of the weir.

LM Start	<b>0.00</b>	Rating **	M	Issue No.	<b>2</b>
LM End	<b>0.00</b>	Issue Type +	Ma	Location *	LS
Category	Structures & Concrete Lined Channels		GPS Latitude/Longitude		
			Start	End	
Item	Vegetation & Obstructions		39.569247 °	39.569247 °	
			-121.982569 °	-121.982569 °	
DWR ID	DWR_NA0060_225_t_2013_2				
Action/Comments					
Inspector Comments: Spray the vegetation for approximately 100 feet on both sides of the weir.

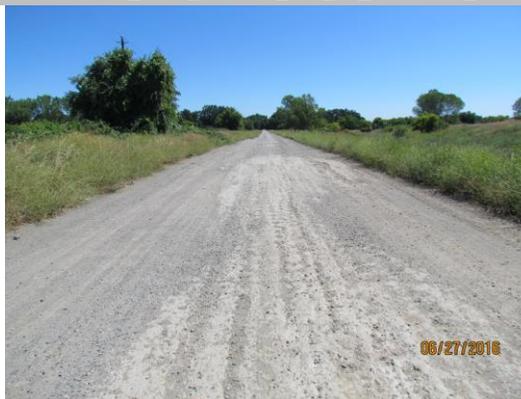
Photo 1 of 1 : ST\_2016\_NA0060\_225\_15\_20160701\_00007.jpg

View of the concrete crown roadway on the top of the weir.

LM Start	<b>0.00</b>	Rating **	A	Issue No.	<b>15</b>
LM End	<b>0.00</b>	Issue Type +	Ma	Location *	LS
Category	Structures & Concrete Lined Channels		GPS Latitude/Longitude		
			Start	End	
Item	Concrete Surfaces		39.569248 °	39.569248 °	
			-121.982569 °	-121.982569 °	
DWR ID	DWR_NA0060_225_t_2013_15				
Action/Comments					
Inspector Comments: Farm equipment needs to stay off of the weir to prevent further damage to the concrete surface.

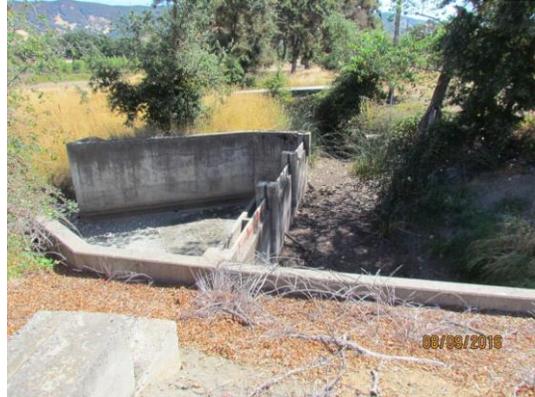
Photo 1 of 1 : ST\_2016\_NA0060\_7\_1\_20160810\_00009.jpg

View of the weir.

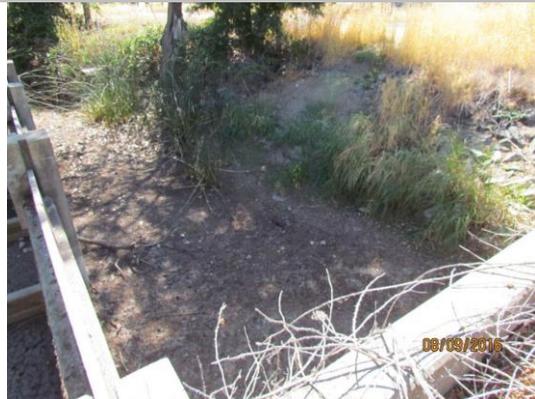
Photo 1 of 2 : ST\_2016\_NA0060\_7\_2\_20160810\_00016.jpg

LM Start	<b>0.00</b>	Rating **	A	Issue No.	<b>2</b>
LM End	<b>0.00</b>	Issue Type +	Ma	Location *	
Category	Structures & Concrete Lined Channels		GPS Latitude/Longitude		
			Start	End	
Item	Vegetation & Obstructions		39.126317 °	39.126317 °	
			-122.882733 °	-122.882733 °	
DWR ID	DWR_NA0009_7_t_2012_2				
Action/Comments					
Inspector Comments: There was minimal vegetation growth, but it will not impede the flow of water through the culvert.

View of the inlet of the structure.

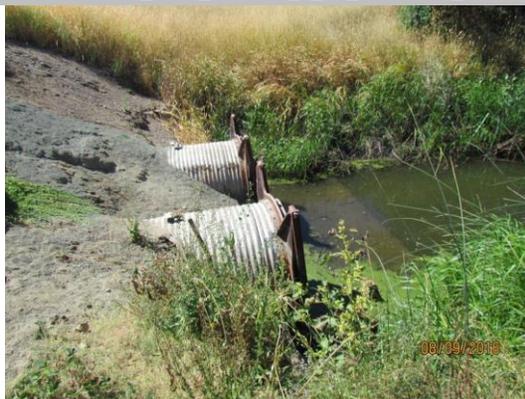
Photo 1 of 1 : ST\_2016\_NA0060\_7\_11\_20160810\_00014.jpg

LM Start	<b>0.00</b>	Rating **	A	Issue No.	<b>11</b>
LM End	<b>0.00</b>	Issue Type +	Ma	Location *	
Category	Structures & Concrete Lined Channels		GPS Latitude/Longitude		
			Start	End	
Item	Flap Gates		39.126317 °	39.126317 °	
			-122.882733 °	-122.882733 °	
DWR ID	DWR_NA0009_7_t_2012_11				
Action/Comments					
Inspector Comments: The flap gates appeared to be in working condition.

View of the flap gates.

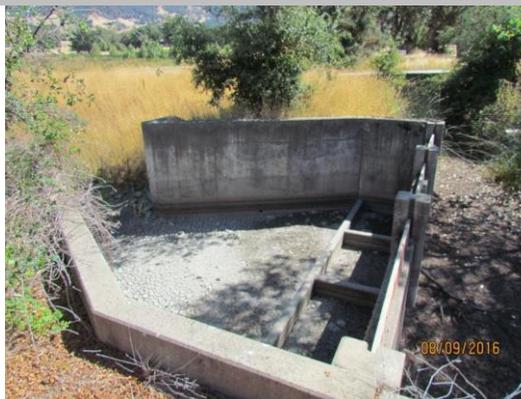
Photo 1 of 1 : ST\_2016\_NA0060\_7\_15\_20160810\_00015.jpg

LM Start	<b>0.00</b>	Rating **	A	Issue No.	<b>15</b>
LM End	<b>0.00</b>	Issue Type +	Ma	Location *	
Category	Structures & Concrete Lined Channels		GPS Latitude/Longitude		
			Start	End	
Item	Concrete Surfaces		39.126317 °	39.126317 °	
			-122.882733 °	-122.882733 °	
DWR ID	DWR_NA0009_7_t_2012_15				
Action/Comments					
Inspector Comments: There was minimal cracking and scaling on the concrete structure, but it didn't appear to threaten the structural integrity.

View of the concrete structure.

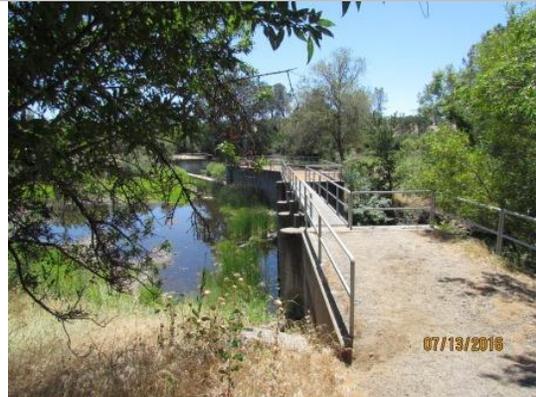
Photo 1 of 5 : ST\_2016\_NA0060\_9\_1\_20160718\_00009.jpg

View of the control structure looking south.

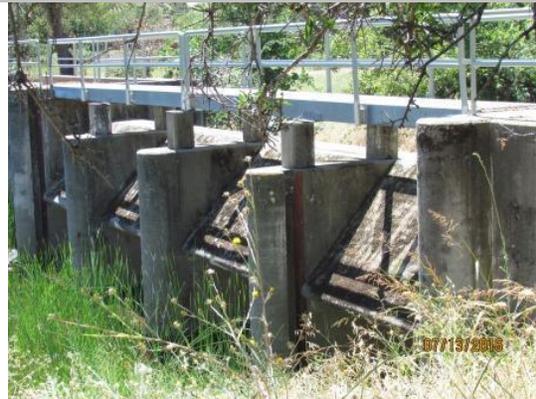
Photo 2 of 5 : ST\_2016\_NA0060\_9\_1\_20160718\_00014.jpg

This is a photo of the downstream side of the control structure.

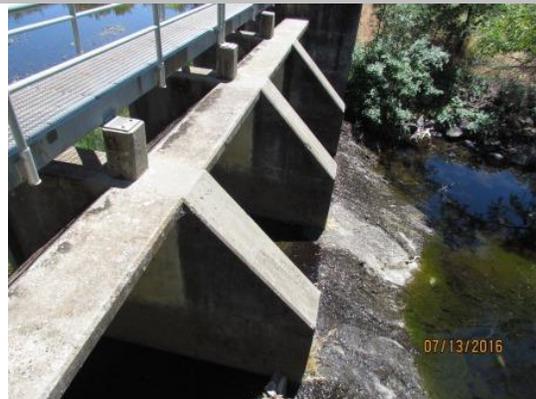
Photo 3 of 5 : ST\_2016\_NA0060\_9\_1\_20160718\_00015.jpg

This is a photo of the downstream side of the control structure.

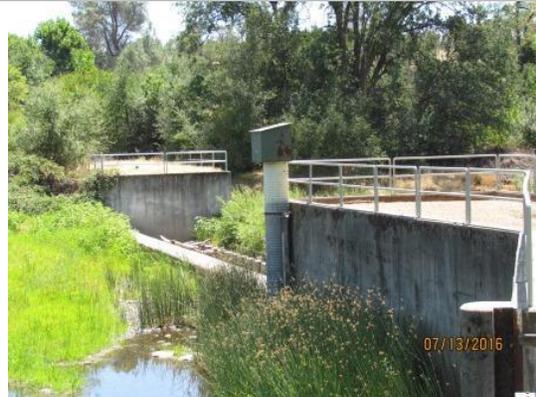
Photo 4 of 5 : ST\_2016\_NA0060\_9\_1\_20160718\_00016.jpg

View of weir looking downstream.

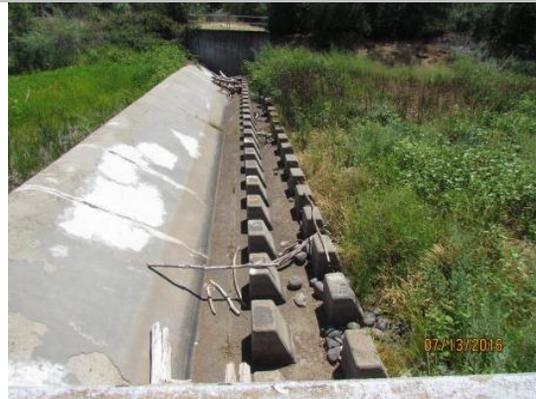
Photo 5 of 5 : ST\_2016\_NA0060\_9\_1\_20160718\_00010.jpg

View of the weir looking south.

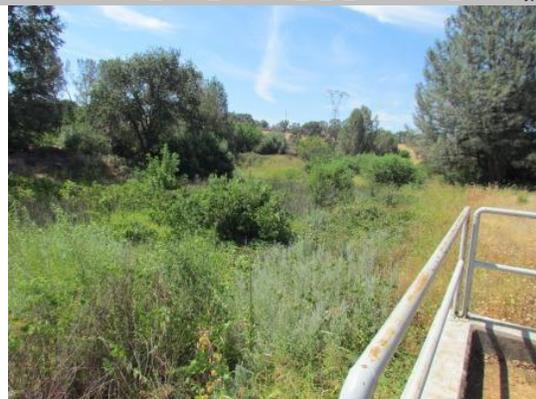
Photo 1 of 3 : ST\_2016\_NA0060\_9\_2\_20160701\_00006.jpg

LM Start	<b>0.00</b>	Rating **	M	Issue No.	<b>2</b>
LM End	<b>0.00</b>	Issue Type +	Ma	Location *	
Category	Structures & Concrete Lined Channels			GPS Latitude/Longitude	
				Start	End
Item	Vegetation & Obstructions			39.733767 °	39.733767 °
				-121.771915 °	-121.771915 °
DWR ID	DWR_NA0060_9_t_2012_2				
Action/Comments					
Inspector Comments: There is some vegetation, a few small trees, and some wood debris trapped in the weir. The flow may be impeded.

This is a view looking downstream.

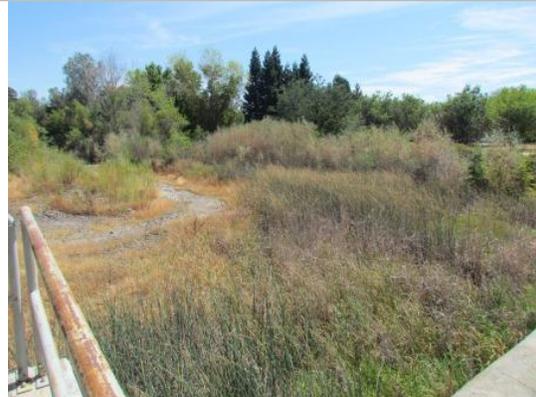
Photo 2 of 3 : ST\_2016\_NA0060\_9\_2\_20160701\_00007.jpg

LM Start	<b>0.00</b>	Rating **	M	Issue No.	<b>2 (cont)</b>
LM End	<b>0.00</b>	Issue Type +	Ma	Location *	
Category	Structures & Concrete Lined Channels		GPS Latitude/Longitude		
			Start	End	
Item	Vegetation & Obstructions		39.733767 °	39.733767 °	
			-121.771915 °	-121.771915 °	
DWR ID	DWR_NA0060_9_t_2012_2				
Action/Comments					
Inspector Comments: There is some vegetation, a few small trees, and some wood debris trapped in the weir. The flow may be impeded.

This is a view looking upstream.

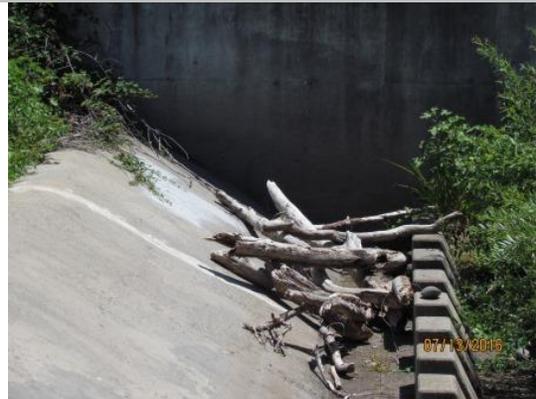
Photo 3 of 3 : ST\_2016\_NA0060\_9\_2\_20160718\_00013.jpg

View of wood debris trapped in weir.

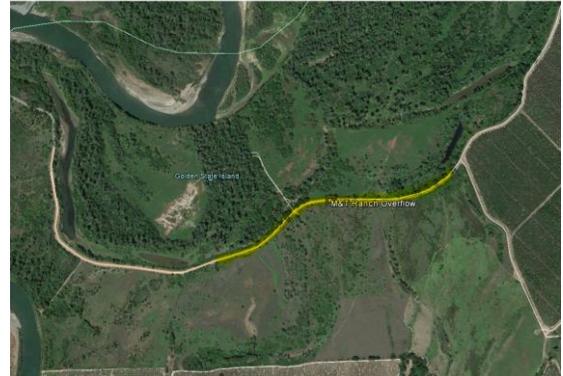
Photo 1 of 1 : ST\_2016\_NA0060\_228\_1\_20160613\_00001.jpg

The structure location is highlighted and is shown in relation to the Sacramento River.

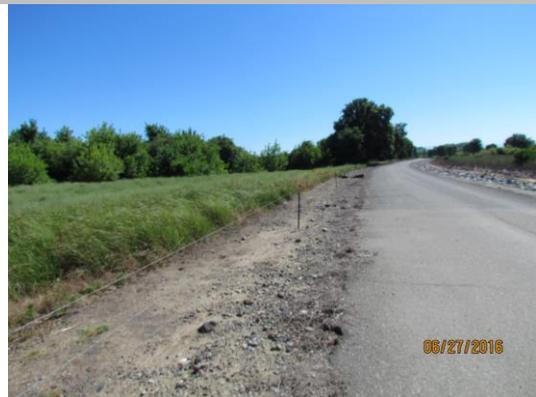
Photo 1 of 1 : ST\_2016\_NA0060\_228\_2\_20160628\_00006.jpg

View of the vegetation on upstream side of the weir.

LM Start	<b>0.00</b>	Rating **	M	Issue No.	<b>2</b>
LM End	<b>0.00</b>	Issue Type +	Ma	Location *	WS
Category	Structures & Concrete Lined Channels		GPS Latitude/Longitude		
			Start	End	
Item	Vegetation & Obstructions		39.674690 °	39.674690 °	
			-121.947013 °	-121.947013 °	
DWR ID	DWR_NA0014_228_t_2013_2				
Action/Comments					
Inspector Comments: The vegetation should be sprayed back approximately 20 feet from both sides of the weir.

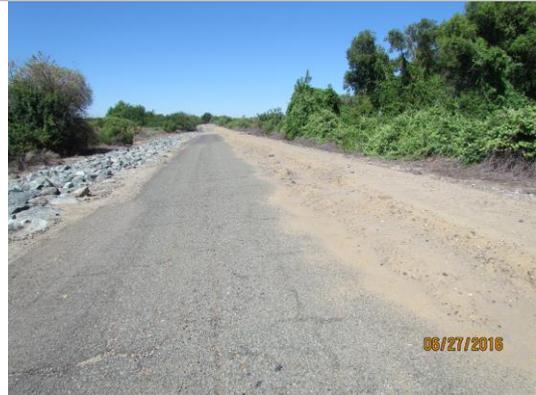
Photo 1 of 2 : ST\_2016\_NA0060\_228\_4\_20160628\_00005.jpg

View of the erosion on the upstream side of the weir during 2016 inspection.

LM Start	<b>0.00</b>	Rating **	M	Issue No.	<b>4</b>
LM End	<b>0.00</b>	Issue Type +	Ma	Location *	WS
Category	Structures & Concrete Lined Channels		GPS Latitude/Longitude		
			Start	End	
Item	Erosion / Bank Caving		39.668789 °	39.668789 °	
			-121.957170 °	-121.957170 °	
DWR ID	DWR_NA0014_228_t_2013_4				
Action/Comments					
Inspector Comments: The soil erosion on the upstream side of the weir needs repair.

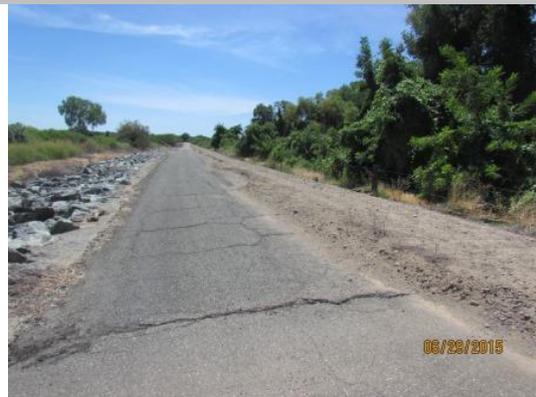
Photo 2 of 2 : ST\_2016\_NA0060\_228\_4\_20160613\_00003.jpg

View of the erosion of the material that was placed on the upstream side of the weir.

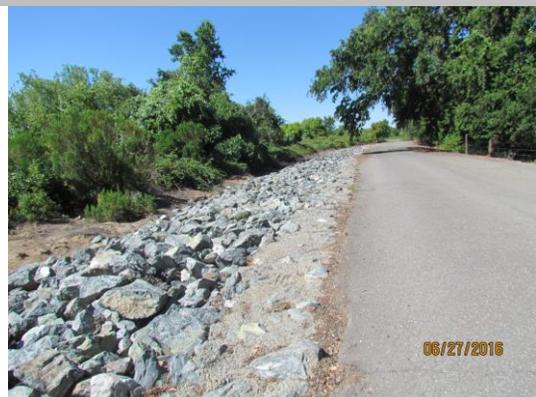
Photo 1 of 1 : ST\_2016\_NA0060\_228\_5\_20160628\_00004.jpg

LM Start	<b>0.00</b>	Rating **	A	Issue No.	<b>5</b>
LM End	<b>0.00</b>	Issue Type +	Ma	Location *	WS
Category	Structures & Concrete Lined Channels		GPS Latitude/Longitude		
			Start	End	
Item	Revetments		39.674690 °	39.674690 °	
			-121.947010 °	-121.947010 °	
DWR ID	DWR_NA0014_228_t_2013_5				
Action/Comments					
Inspector Comments: Existing riprap protection is properly maintained.

View of the revetments on the downstream of the weir.

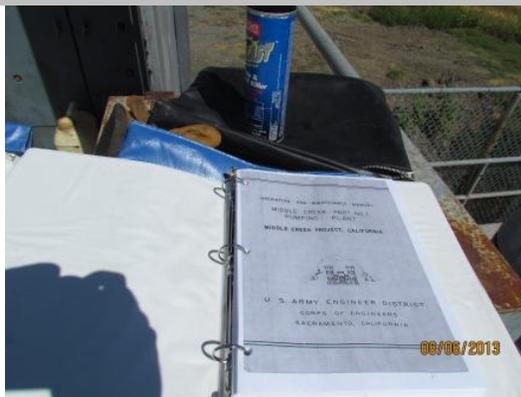
Photo 1 of 1 : ST\_2016\_NA0060\_17\_2\_20160613\_00001.jpg

LM Start	<b>0.00</b>	Rating **	A	Issue No.	<b>2</b>
LM End	<b>0.00</b>	Issue Type +	Ma	Location *	
Category	Pump Stations		GPS Latitude/Longitude		
			Start	End	
Item	Operation & Maintenance Manual		39.142300 °	39.142300 °	
			-122.902350 °	-122.902350 °	
DWR ID	DWR_NA0060_17_t_2012_2				
Action/Comments					
Inspector Comments: The O&M manual was present at the pumping plant.

View of the O&M manual.

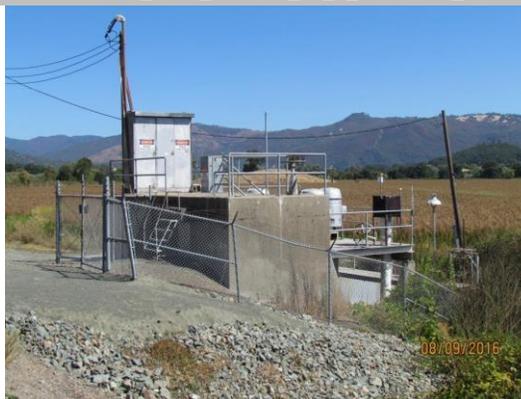
Photo 1 of 2 : ST\_2016\_NA0060\_17\_3\_20160811\_00017.jpg

LM Start	<b>0.00</b>	Rating **	M	Issue No.	<b>3</b>
LM End	<b>0.00</b>	Issue Type +	Ma	Location *	
Category	Pump Stations		GPS Latitude/Longitude		
			Start	End	
Item	Plant Building		39.142300 °	39.142300 °	
			-122.902350 °	-122.902350 °	
DWR ID	DWR_NA0060_17_t_2012_3				
Action/Comments					
Inspector Comments: The plant building was in good structural condition with no major cracks that could threaten the integrity of the building. However, the adjacent structure had some differential settlement.

View of the pumping plant.

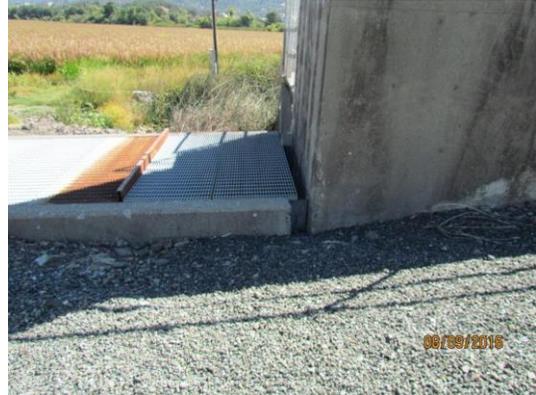
Photo 2 of 2 : ST\_2016\_NA0060\_17\_3\_20160811\_00018.jpg

LM Start	<b>0.00</b>	Rating **	M	Issue No.	<b>3 (cont)</b>
LM End	<b>0.00</b>	Issue Type +	Ma	Location *	
Category	Pump Stations			GPS Latitude/Longitude	
				Start	End
Item	Plant Building			39.142300 °	39.142300 °
				-122.902350 °	-122.902350 °
DWR ID	DWR_NA0060_17_t_2012_3				
Action/Comments					
Inspector Comments: The plant building was in good structural condition with no major cracks that could threaten the integrity of the building. However, the adjacent structure had some differential settlement.

View of the settlement next to the pumping plant.

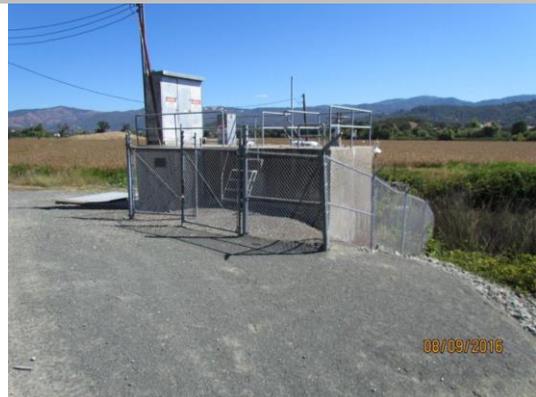
Photo 1 of 1 : ST\_2016\_NA0060\_17\_5\_20160811\_00019.jpg

LM Start	<b>0.00</b>	Rating **	A	Issue No.	<b>5</b>
LM End	<b>0.00</b>	Issue Type +	Ma	Location *	
Category	Pump Stations			GPS Latitude/Longitude	
				Start	End
Item	Safety			39.142300 °	39.142300 °
				-122.902350 °	-122.902350 °
DWR ID	DWR_NA0060_17_t_2012_5				
Action/Comments					
Inspector Comments: No safety hazard was present around the plant. All of the guard rails and fences were secured and in good condition.

View of the security fence and guard rails around the pumping plant.

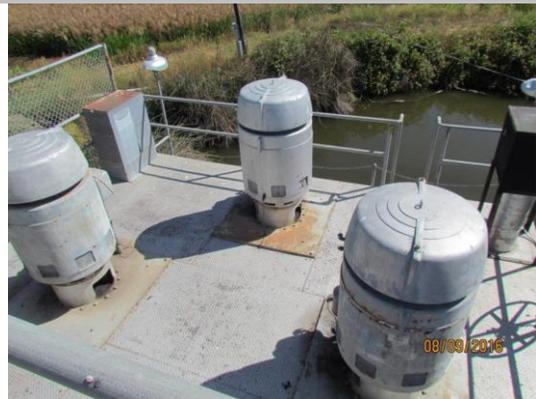
Photo 1 of 3 : ST\_2016\_NA0060\_17\_7\_20160811\_00020.jpg

LM Start	<b>0.00</b>	Rating **	A	Issue No.	<b>7</b>
LM End	<b>0.00</b>	Issue Type +	Ma	Location *	
Category	Pump Stations		GPS Latitude/Longitude		
			Start	End	
Item	Pumps		39.142300 °	39.142300 °	
			-122.902350 °	-122.902350 °	
DWR ID	DWR_NA0060_17_t_2012_7				
Action/Comments					
Inspector Comments: The pumps appeared to be in good working condition and properly maintained including proper lubrication level.

View of the pumps in the plant.

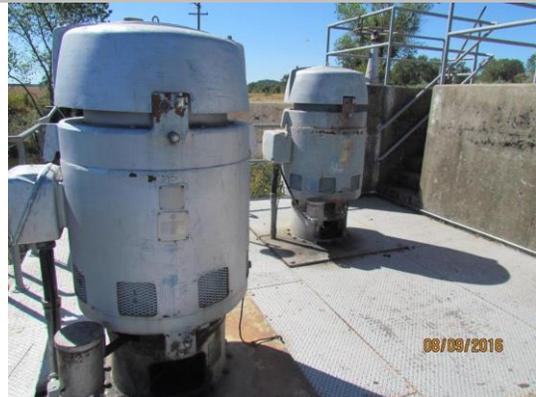
Photo 2 of 3 : ST\_2016\_NA0060\_17\_7\_20160811\_00022.jpg

View of two of the pumps.

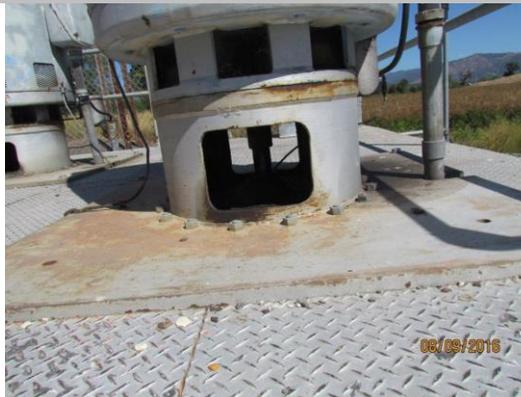
Photo 3 of 3 : ST\_2016\_NA0060\_17\_7\_20160811\_00021.jpg

LM Start	<b>0.00</b>	Rating **	A	Issue No.	<b>7 (cont)</b>
LM End	<b>0.00</b>	Issue Type +	Ma	Location *	
Category	Pump Stations			GPS Latitude/Longitude	
				Start	End
Item	Pumps			39.142300 °	39.142300 °
				-122.902350 °	-122.902350 °
DWR ID	DWR_NA0060_17_t_2012_7				
Action/Comments					
Inspector Comments: The pumps appeared to be in good working condition and properly maintained including proper lubrication level.

View of bottom of the pump.

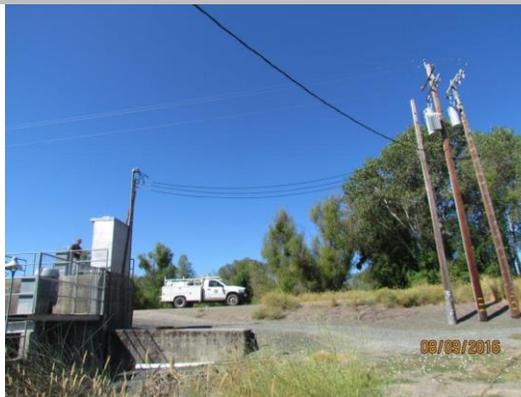
Photo 1 of 1 : ST\_2016\_NA0060\_17\_8\_20160811\_00023.jpg

LM Start	<b>0.00</b>	Rating **	A	Issue No.	<b>8</b>
LM End	<b>0.00</b>	Issue Type +	Ma	Location *	
Category	Pump Stations			GPS Latitude/Longitude	
				Start	End
Item	Power			39.142300 °	39.142300 °
				-122.902350 °	-122.902350 °
DWR ID	DWR_NA0060_17_t_2012_8				
Action/Comments					
Inspector Comments: The power source appeared to be reliable and safe.

View of the power source of the plant.

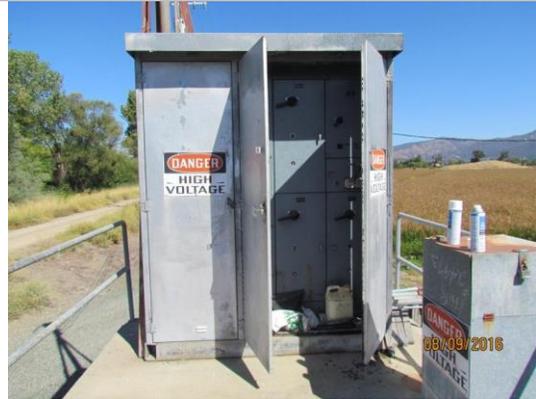
Photo 1 of 1 : ST\_2016\_NA0060\_17\_11\_20160811\_00024.jpg

LM Start	<b>0.00</b>	Rating **	A	Issue No.	<b>11</b>
LM End	<b>0.00</b>	Issue Type +	Ma	Location *	
Category	Pump Stations		GPS Latitude/Longitude		
			Start	End	
Item	Pump Control Systems		39.142300 °	39.142300 °	
			-122.902350 °	-122.902350 °	
DWR ID	DWR_NA0060_17_t_2012_11				
Action/Comments					
Inspector Comments: The pump control systems appeared to be operational and free of damage.

View of the pump control systems.

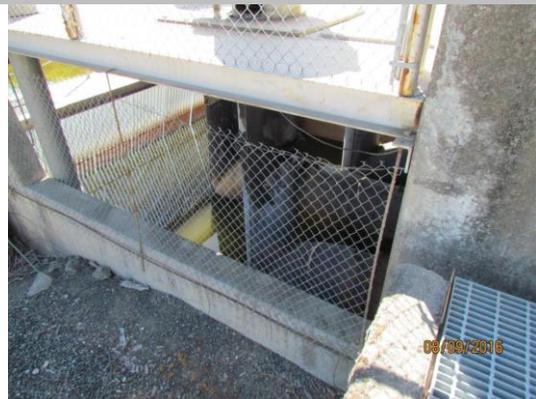
Photo 1 of 1 : ST\_2016\_NA0060\_17\_12\_20160811\_00025.jpg

LM Start	<b>0.00</b>	Rating **	A	Issue No.	<b>12</b>
LM End	<b>0.00</b>	Issue Type +	Ma	Location *	
Category	Pump Stations		GPS Latitude/Longitude		
			Start	End	
Item	Sumps/Wet Well		39.142300 °	39.142300 °	
			-122.902350 °	-122.902350 °	
DWR ID	DWR_NA0060_17_t_2013_12				
Action/Comments					
Inspector Comments: Wet wells were clear of debris.

View of the wet well.

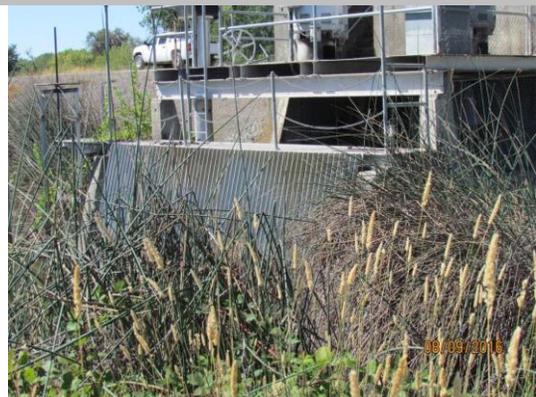
Photo 1 of 1 : ST\_2016\_NA0060\_17\_13\_20160811\_00026.jpg

LM Start	<b>0.00</b>	Rating **	A	Issue No.	<b>13</b>
LM End	<b>0.00</b>	Issue Type +	Ma	Location *	
Category	Pump Stations		GPS Latitude/Longitude		
			Start	End	
Item	Trash Racks		39.142300 °	39.142300 °	
			-122.902350 °	-122.902350 °	
DWR ID	DWR_NA0060_17_t_2012_13				
Action/Comments					
Inspector Comments: Trash racks appeared to be in good condition and free of debris.

View of the trash racks.

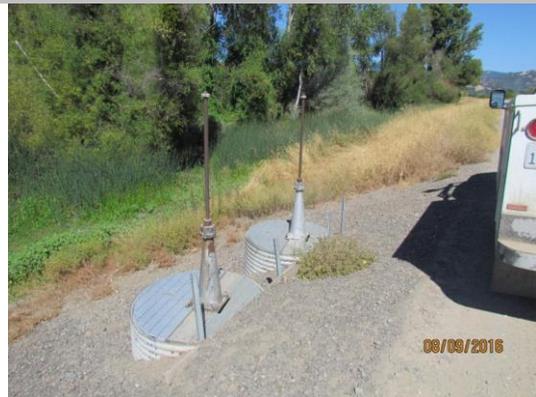
Photo 1 of 1 : ST\_2016\_NA0060\_17\_15\_20160811\_00027.jpg

LM Start	<b>0.00</b>	Rating **	A	Issue No.	<b>15</b>
LM End	<b>0.00</b>	Issue Type +	Ma	Location *	
Category	Pump Stations		GPS Latitude/Longitude		
			Start	End	
Item	Sluice / Slide Gates		39.142300 °	39.142300 °	
			-122.902350 °	-122.902350 °	
DWR ID	DWR_NA0060_17_t_2013_15				
Action/Comments					
Inspector Comments: The slide gates appeared to be in a good working condition.

View of the slide gates.

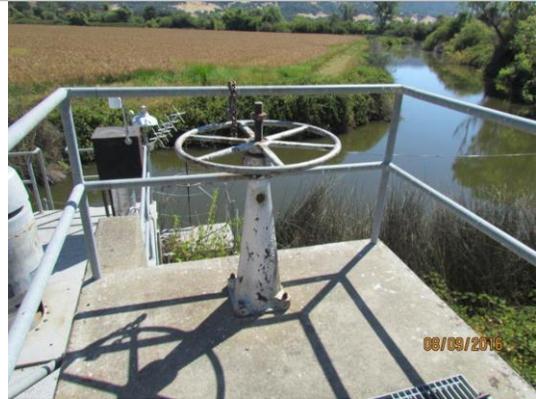
Photo 1 of 2 : ST\_2016\_NA0060\_17\_17\_20160811\_00028.jpg

LM Start	<b>0.00</b>	Rating **	A	Issue No.	<b>17</b>
LM End	<b>0.00</b>	Issue Type +	Ma	Location *	
Category	Pump Stations		GPS Latitude/Longitude		
			Start	End	
Item	Manual Gate Operators		39.142300 °	39.142300 °	
			-122.902350 °	-122.902350 °	
DWR ID	DWR_NA0060_17_t_2012_17				
Action/Comments					
Inspector Comments: The manual gate operators appeared to be in good working condition.

View of one of the manual operators at the plant.

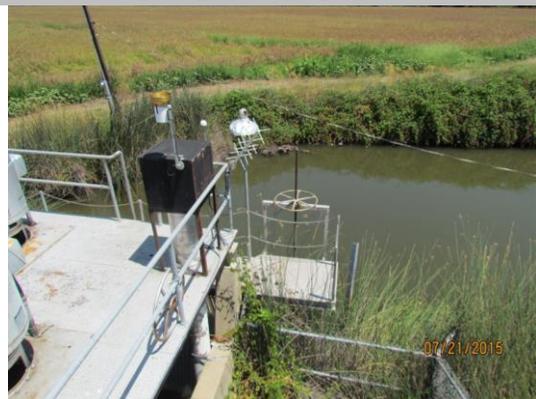
Photo 2 of 2 : ST\_2016\_NA0060\_17\_17\_20160613\_00014.jpg

View of another manual gate operator at the plant.

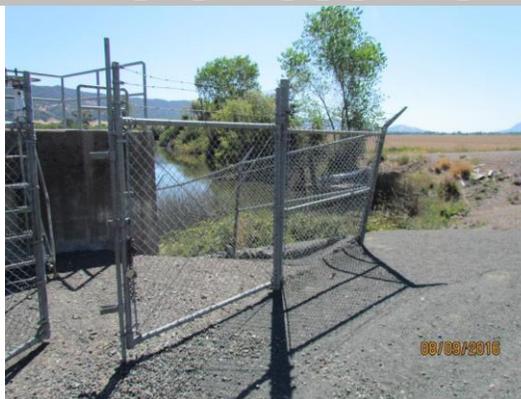
Photo 1 of 1 : ST\_2016\_NA0060\_17\_21\_20160811\_00029.jpg

LM Start	<b>0.00</b>	Rating **	A	Issue No.	<b>21</b>
LM End	<b>0.00</b>	Issue Type +	Ma	Location *	
Category	Pump Stations		GPS Latitude/Longitude		
			Start	End	
Item	Security Fencing		39.142300 °	39.142300 °	
			-122.902350 °	-122.902350 °	
DWR ID	DWR_NA0060_17_t_2012_21				
Action/Comments					
Inspector Comments: Security fencing appeared to be in good condition.

View of the security fencing around the plant.

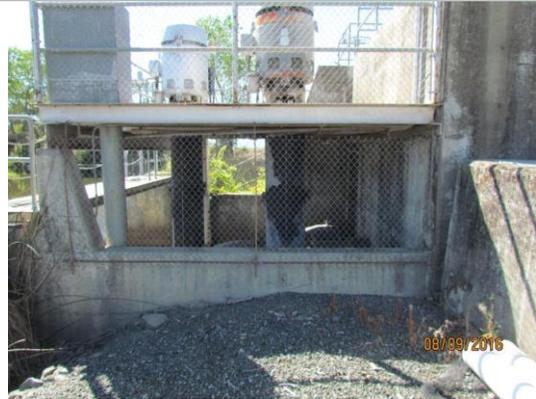
Photo 1 of 1 : ST\_2016\_NA0060\_17\_22\_20160811\_00030.jpg

LM Start	<b>0.00</b>	Rating **	A	Issue No.	<b>22</b>
LM End	<b>0.00</b>	Issue Type +	Ma	Location *	
Category	Pump Stations			GPS Latitude/Longitude	
				Start	End
Item	Intake and Discharge Pipes			39.142300 °	39.142300 °
				-122.902350 °	-122.902350 °
DWR ID	DWR_NA0060_17_t_2012_22				
Action/Comments					
Inspector Comments: The pipes appeared to be in good working condition.

View of the intake pipes.

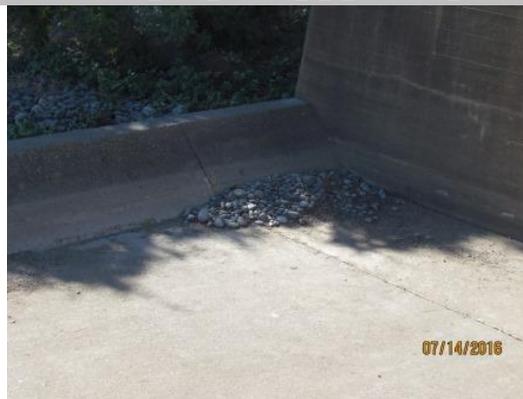
Photo 1 of 1 : ST\_2016\_NA0060\_4\_2\_20160718\_00012.jpg

LM Start	<b>0.00</b>	Rating **	A	Issue No.	<b>2</b>
LM End	<b>0.00</b>	Issue Type +	Ma	Location *	
Category	Structures & Concrete Lined Channels		GPS Latitude/Longitude		
			Start	End	
Item	Vegetation & Obstructions		39.338242 °	39.338242 °	
			-122.022073 °	-122.022073 °	
DWR ID	DWR_NA0060_4_t_2012_2				
Action/Comments					
Inspector Comments: Minimal, scattered obstructions or vegetation. The flow is not impeded.

View of a small amount of soil and rock in the weir near the right abutment.

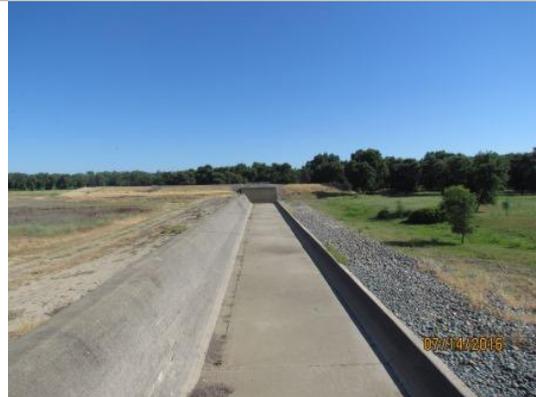
Photo 1 of 1 : ST\_2016\_NA0060\_4\_5\_20160718\_00013.jpg

LM Start	<b>0.00</b>	Rating **	A	Issue No.	<b>5</b>
LM End	<b>0.00</b>	Issue Type +	Ma	Location *	
Category	Structures & Concrete Lined Channels		GPS Latitude/Longitude		
			Start	End	
Item	Revetments		39.338242 °	39.338242 °	
			-122.022073 °	-122.022073 °	
DWR ID	DWR_NA0060_4_t_2012_5				
Action/Comments					
Inspector Comments: Existing riprap protection is properly maintained and is undamaged. Riprap clearly visible.

View of revetment at outfall of weir.

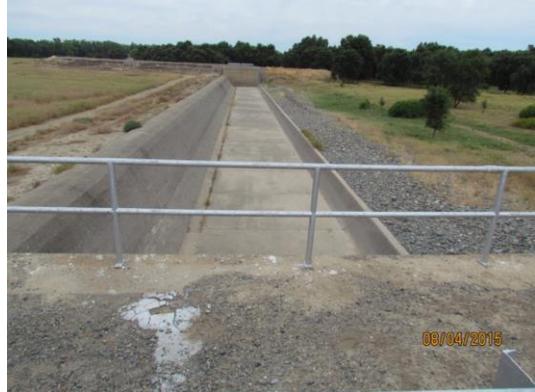
Photo 1 of 2 : ST\_2016\_NA0060\_4\_23\_20160701\_00005.jpg

LM Start	<b>0.00</b>	Rating **	A	Issue No.	<b>23</b>
LM End	<b>0.00</b>	Issue Type +	Ma	Location *	
Category	Structures & Concrete Lined Channels		GPS Latitude/Longitude		
			Start	End	
Item	Safety		39.338242 °	39.338242 °	
			-122.022073 °	-122.022073 °	
DWR ID	DWR_NA0060_4_t_2012_23				
Action/Comments					
Inspector Comments: Safety hardware installed. Adequate protection for fall hazards exist. No hazardous conditions that might affect the operation of the structure exist.

View of the safety railing installed on the weir.

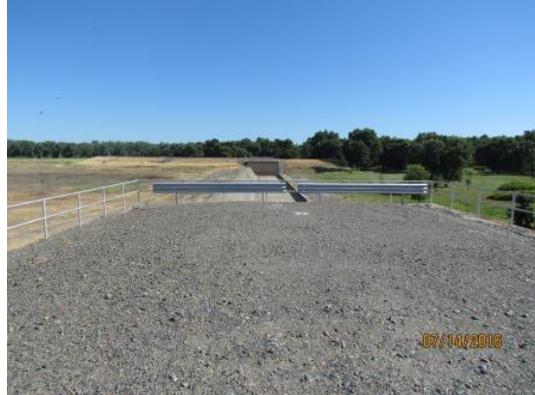
Photo 2 of 2 : ST\_2016\_NA0060\_4\_23\_20160718\_00015.jpg

View of the safety railing installed with added guard rail on the weir,

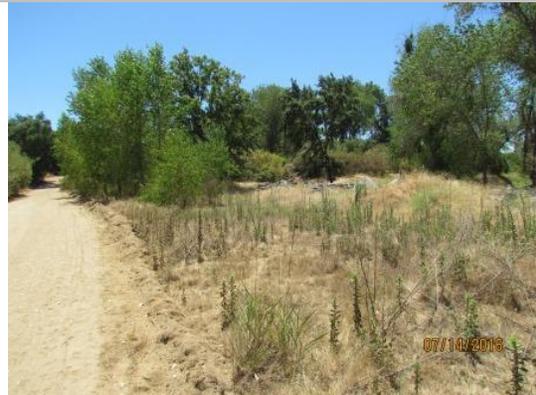
Photo 1 of 2 : ST\_2016\_NA0060\_54\_2\_20160720\_00011.jpg

LM Start	<b>0.00</b>	Rating **	M	Issue No.	<b>2</b>
LM End	<b>0.00</b>	Issue Type +	Ma	Location *	
Category	Structures & Concrete Lined Channels			GPS Latitude/Longitude	
				Start	End
Item	Vegetation & Obstructions			38.895500 °	38.887450 °
				-121.616950 °	-121.615330 °
DWR ID	DWR_NA0060_54_t_2012_2				
Action/Comments					
Inspector Comments: Minimal, scattered obstructions or vegetation. The vegetation should be cleared and trees trimmed up. May impede flow in a high water event.

View of the vegetation that is overgrowing the weir.

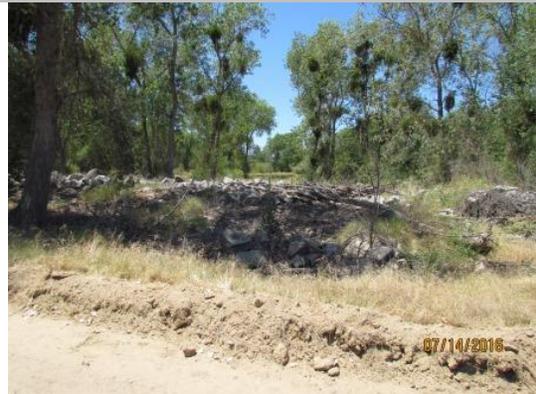
Photo 2 of 2 : ST\_2016\_NA0060\_54\_2\_20160720\_00010.jpg

View of the obstructions facing the left bank.

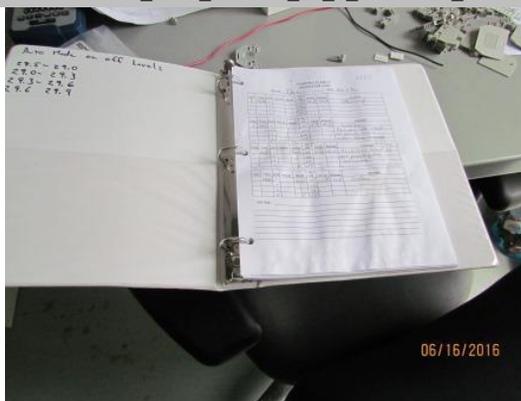
Photo 1 of 1 : ST\_2016\_NA0060\_21\_1\_20160621\_00017.jpg

LM Start	<b>0.00</b>	Rating **	A	Issue No.	<b>1</b>
LM End	<b>0.00</b>	Issue Type +	Ma	Location *	
Category	Pump Stations		GPS Latitude/Longitude		
			Start	End	
Item	Operating Log		38.931815 °	38.931815 °	
			-121.634331 °	-121.634331 °	
DWR ID	DWR_NA0060_21_t_2012_1				
Action/Comments					
Inspector Comments: The operating log is kept on site.

View of the operating log.

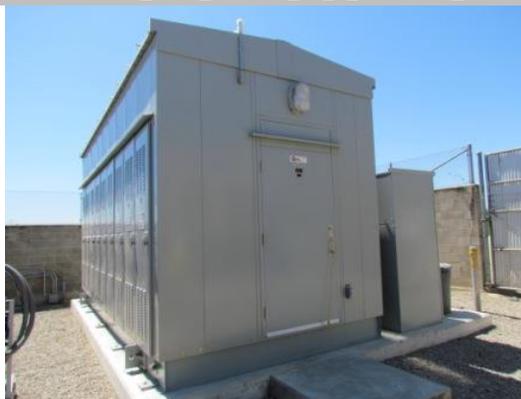
Photo 1 of 2 : ST\_2016\_NA0060\_21\_3\_20160615\_00002.jpg

LM Start	<b>0.00</b>	Rating **	A	Issue No.	<b>3</b>
LM End	<b>0.00</b>	Issue Type +	Ma	Location *	
Category	Pump Stations		GPS Latitude/Longitude		
			Start	End	
Item	Plant Building		38.931815 °	38.931815 °	
			-121.634331 °	-121.634331 °	
DWR ID	DWR_NA0060_21_t_2012_3				
Action/Comments					
Inspector Comments: Plant building is mostly complete and appears to be in good working order. The project is currently under construction.

View of plant building under construction.

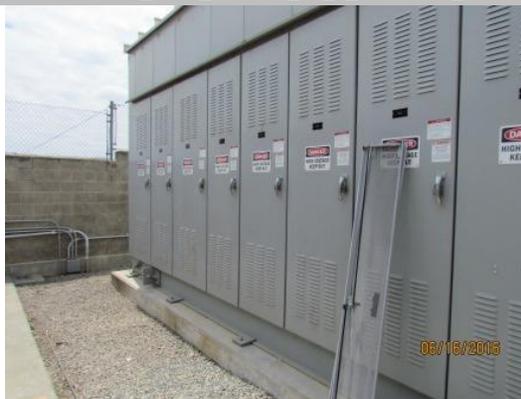
Photo 2 of 2 : ST\_2016\_NA0060\_21\_3\_20160621\_00032.jpg

LM Start	<b>0.00</b>	Rating **	A	Issue No.	<b>3 (cont)</b>
LM End	<b>0.00</b>	Issue Type +	Ma	Location *	
Category	Pump Stations		GPS Latitude/Longitude		
			Start	End	
Item	Plant Building		38.931815 °	38.931815 °	
			-121.634331 °	-121.634331 °	
DWR ID	DWR_NA0060_21_t_2012_3				
Action/Comments					
Inspector Comments: Plant building is mostly complete and appears to be in good working order. The project is currently under construction.

View of the side of the plant building.

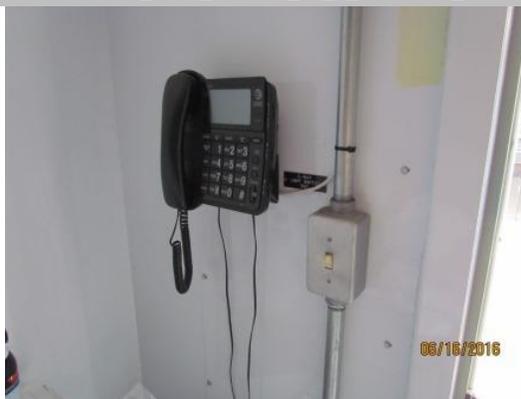
Photo 1 of 1 : ST\_2016\_NA0060\_21\_4\_20160621\_00018.jpg

LM Start	<b>0.00</b>	Rating **	A	Issue No.	<b>4</b>
LM End	<b>0.00</b>	Issue Type +	Ma	Location *	
Category	Pump Stations		GPS Latitude/Longitude		
			Start	End	
Item	Communications		38.931815 °	38.931815 °	
			-121.634331 °	-121.634331 °	
DWR ID	DWR_NA0060_21_t_2012_4				
Action/Comments					
Inspector Comments: Cell phones and two-way radios are available to pump station operators. The remote control operating system (SCADA) is currently being tested and should be ready by the start of flood season.

View of the telephone in the operating room.

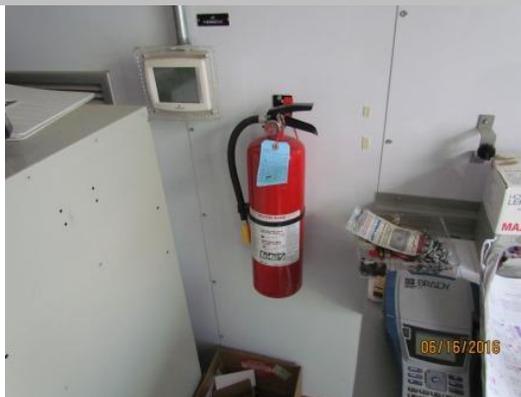
Photo 1 of 3 : ST\_2016\_NA0060\_21\_5\_20160621\_00020.jpg

LM Start	<b>0.00</b>	Rating **	A	Issue No.	<b>5</b>
LM End	<b>0.00</b>	Issue Type +	Ma	Location *	
Category	Pump Stations		GPS Latitude/Longitude		
			Start	End	
Item	Safety		38.931815 °	38.931815 °	
			-121.634331 °	-121.634331 °	
DWR ID	DWR_NA0060_21_t_2012_5				
Action/Comments					
Inspector Comments: Site is under construction safety wear is required during construction (hard hat, vest and eyewear). There is missing safety railing above the inlet grates on the LS.

View of the fire extinguisher inside the operating room.

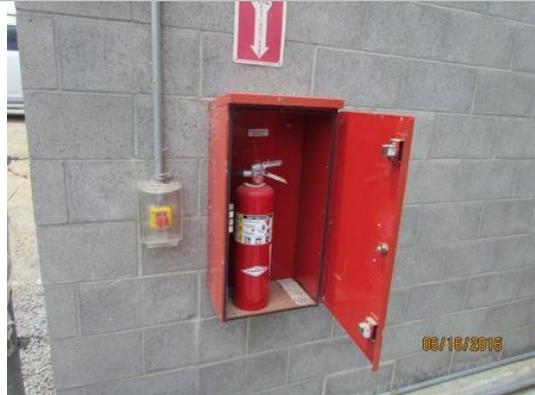
Photo 2 of 3 : ST\_2016\_NA0060\_21\_5\_20160621\_00019.jpg

LM Start	<b>0.00</b>	Rating **	A	Issue No.	<b>5 (cont)</b>
LM End	<b>0.00</b>	Issue Type +	Ma	Location *	
Category	Pump Stations		GPS Latitude/Longitude		
			Start	End	
Item	Safety		38.931815 °	38.931815 °	
			-121.634331 °	-121.634331 °	
DWR ID	DWR_NA0060_21_t_2012_5				
Action/Comments					
Inspector Comments: Site is under construction safety wear is required during construction (hard hat, vest and eyewear). There is missing safety railing above the inlet grates on the LS.

View of the fire extinguisher and emergency shutoff switch.

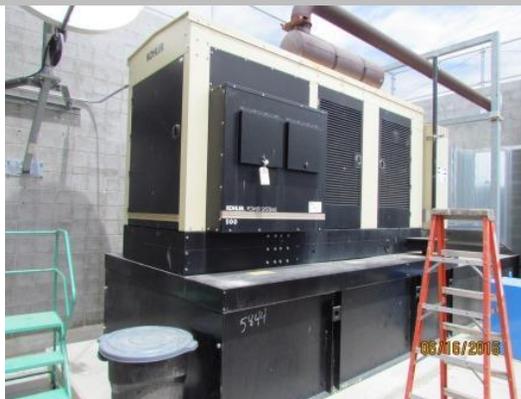
Photo 1 of 1 : ST\_2016\_NA0060\_21\_8\_20160621\_00021.jpg

LM Start	<b>0.00</b>	Rating **	A	Issue No.	<b>8</b>
LM End	<b>0.00</b>	Issue Type +	Ma	Location *	
Category	Pump Stations		GPS Latitude/Longitude		
			Start	End	
Item	Power		38.931815 °	38.931815 °	
			-121.634331 °	-121.634331 °	
DWR ID	DWR_NA0060_21_t_2012_8				
Action/Comments					
Inspector Comments: The structure is on the grid with emergency backup generator.

View of the emergency backup generator.

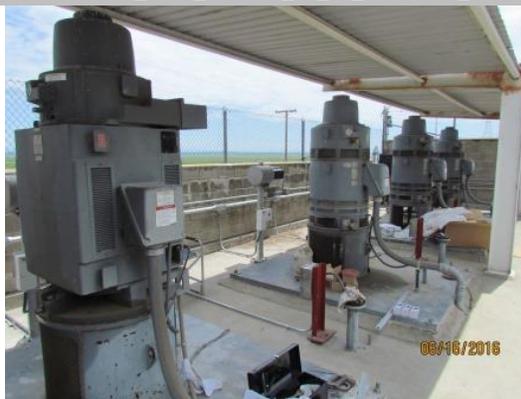
Photo 1 of 1 : ST\_2016\_NA0060\_21\_10\_20160621\_00022.jpg

LM Start	<b>0.00</b>	Rating **	A	Issue No.	<b>10</b>
LM End	<b>0.00</b>	Issue Type +	Ma	Location *	
Category	Pump Stations		GPS Latitude/Longitude		
			Start	End	
Item	Motors, Engines, Fans & Gear Reducers		38.931815 °	38.931815 °	
			-121.634331 °	-121.634331 °	
DWR ID	DWR_NA0060_21_t_2012_10				
Action/Comments					
Inspector Comments: These items appear to be maintained and in operating condition.

Photo shows pump motors, which appear to be in operating condition.

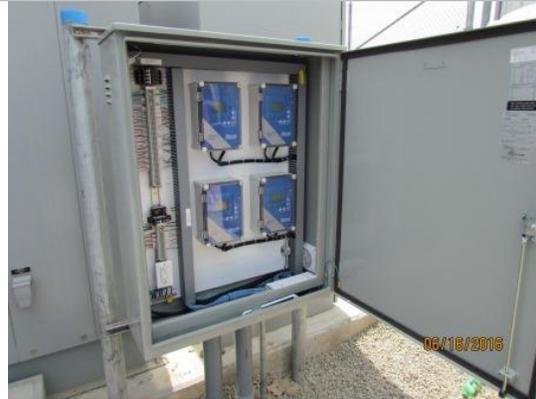
Photo 1 of 2 : ST\_2016\_NA0060\_21\_11\_20160621\_00025.jpg

LM Start	<b>0.00</b>	Rating **	A	Issue No.	<b>11</b>
LM End	<b>0.00</b>	Issue Type +	Ma	Location *	
Category	Pump Stations		GPS Latitude/Longitude		
			Start	End	
Item	Pump Control Systems		38.931815 °	38.931815 °	
			-121.634331 °	-121.634331 °	
DWR ID	DWR_NA0060_21_t_2012_11				
Action/Comments					
Inspector Comments: Pump control systems on site are new and appear to be in working order.

View of the flow meters.

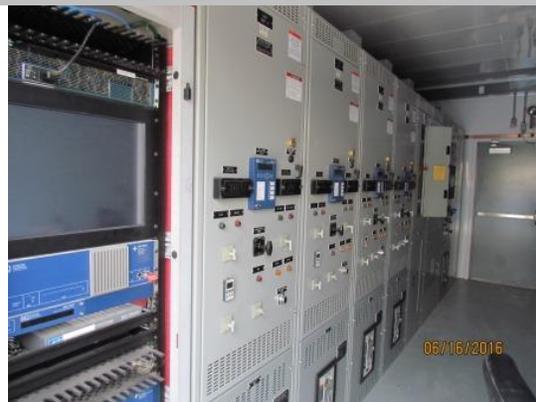
Photo 2 of 2 : ST\_2016\_NA0060\_21\_11\_20160621\_00023.jpg

View of the control room.

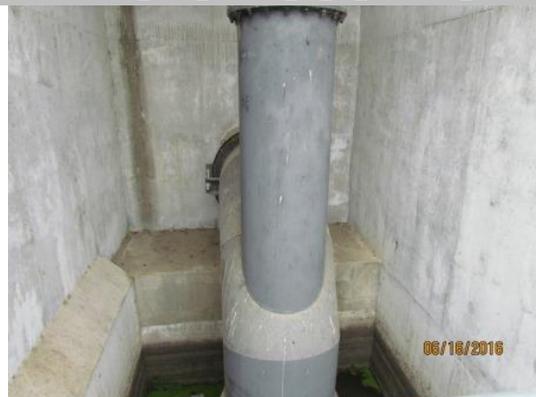
Photo 1 of 1 : ST\_2016\_NA0060\_21\_12\_20160621\_00026.jpg

LM Start	<b>0.00</b>	Rating **	A	Issue No.	<b>12</b>
LM End	<b>0.00</b>	Issue Type +	Ma	Location *	
Category	Pump Stations		GPS Latitude/Longitude		
			Start	End	
Item	Sumps/Wet Well		38.931815 °	38.931815 °	
			-121.634331 °	-121.634331 °	
DWR ID	DWR_NA0060_21_t_2012_12				
Action/Comments					
Inspector Comments: Sumps are clear and free of debris.

View of the wet well. Typical.

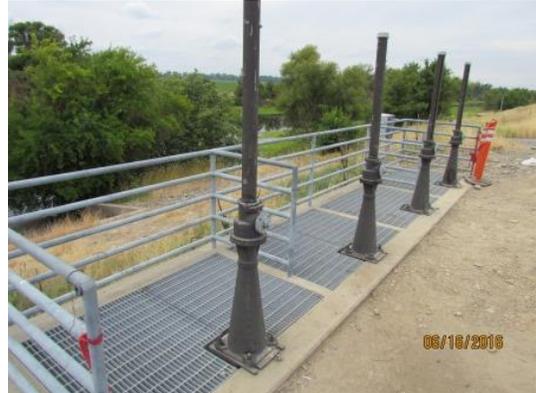
Photo 1 of 1 : ST\_2016\_NA0060\_21\_17\_20160621\_00028.jpg

LM Start	<b>0.00</b>	Rating **	A	Issue No.	<b>17</b>
LM End	<b>0.00</b>	Issue Type +	Ma	Location *	
Category	Pump Stations		GPS Latitude/Longitude		
			Start	End	
Item	Manual Gate Operators		38.931815 °	38.931815 °	
			-121.634331 °	-121.634331 °	
DWR ID	DWR_NA0060_21_t_2012_17				
Action/Comments					
Inspector Comments: Manual gate operators appear to be in good working condition.

Photo shows sluice gate operators. Note: Operators can be operated either manually with a hand crank or with externally powered drill.

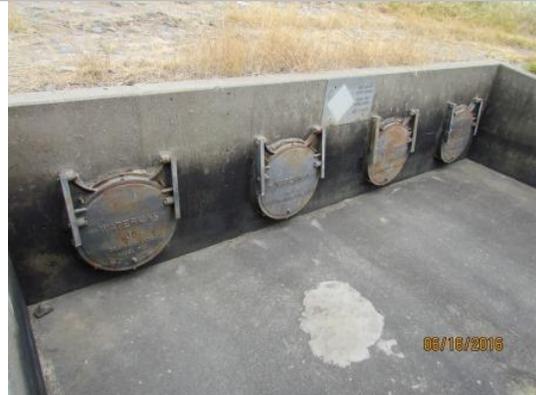
Photo 1 of 1 : ST\_2016\_NA0060\_21\_19\_20160621\_00029.jpg

LM Start	<b>0.00</b>	Rating **	A	Issue No.	<b>19</b>
LM End	<b>0.00</b>	Issue Type +	Ma	Location *	
Category	Pump Stations		GPS Latitude/Longitude		
			Start	End	
Item	Flap Gates		38.931815 °	38.931815 °	
			-121.634331 °	-121.634331 °	
DWR ID	DWR_NA0060_21_t_2012_19				
Action/Comments					
Inspector Comments: Flap gates are in proper working condition, they show no obvious signs of damage.

Photo shows flap gates and concrete outfall structure.

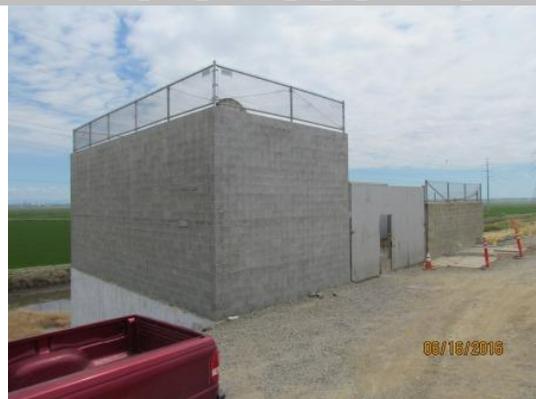
Photo 1 of 1 : ST\_2016\_NA0060\_21\_21\_20160621\_00030.jpg

LM Start	<b>0.00</b>	Rating **	A	Issue No.	<b>21</b>
LM End	<b>0.00</b>	Issue Type +	Ma	Location *	
Category	Pump Stations		GPS Latitude/Longitude		
			Start	End	
Item	Security Fencing		38.931815 °	38.931815 °	
			-121.634331 °	-121.634331 °	
DWR ID	DWR_NA0060_21_t_2012_21				
Action/Comments					
Inspector Comments: Site is currently secured by a masonry brick wall.

Photo shows masonry brick wall which encloses the pump plant.
