**Flood Control Project Maintenance**  
**2016 Structure Summary Report**  
**Overall Unit and Item Ratings**

**DWR Sutter Maintenance Yard**

**Butte Slough Drainage Structure**

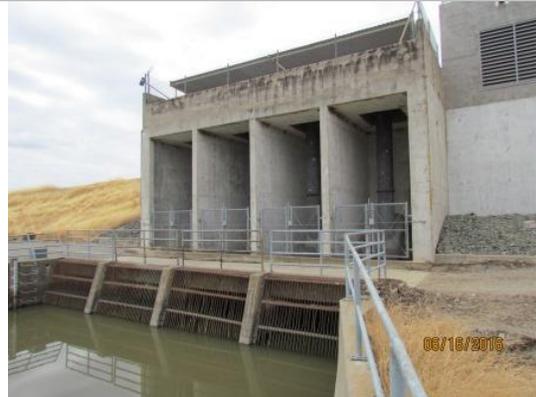
Photo 1 of 3 : ST\_2016\_NA0060\_21\_22\_20160621\_00031.jpg

LM Start	<b>0.00</b>	Rating **	A	Issue No.	<b>22</b>
LM End	<b>0.00</b>	Issue Type +	Ma	Location *	
Category	Pump Stations		GPS Latitude/Longitude		
			Start	End	
Item	Intake and Discharge Pipes		38.931815 °	38.931815 °	
			-121.634331 °	-121.634331 °	
DWR ID	DWR_NA0060_21_t_2012_22				
Action/Comments					
Inspector Comments: No visible deficiencies observed in the pipe's condition.

View of the intake wells.

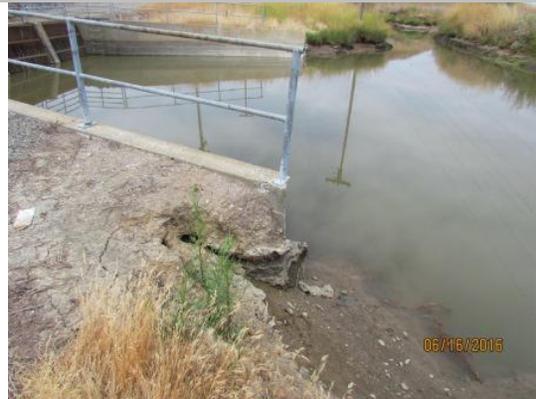
Photo 2 of 3 : ST\_2016\_NA0060\_21\_22\_20160621\_00035.jpg

View of the erosion at the intake walls.

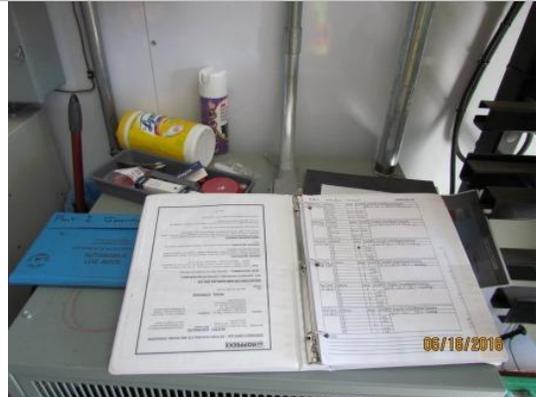
Photo 1 of 1 : ST\_2016\_NA0060\_22\_1\_20160621\_00019.jpg

LM Start	<b>0.00</b>	Rating **	A	Issue No.	<b>1</b>
LM End	<b>0.00</b>	Issue Type +	Ma	Location *	
Category	Pump Stations		GPS Latitude/Longitude		
			Start	End	
Item	Operating Log		39.026449 °	39.026449 °	
			-121.726937 °	-121.726937 °	
DWR ID	DWR_NA0060_22_t_2012_1				
Action/Comments					
Inspector Comments: Operation log is located at the site.

View of the operating log.

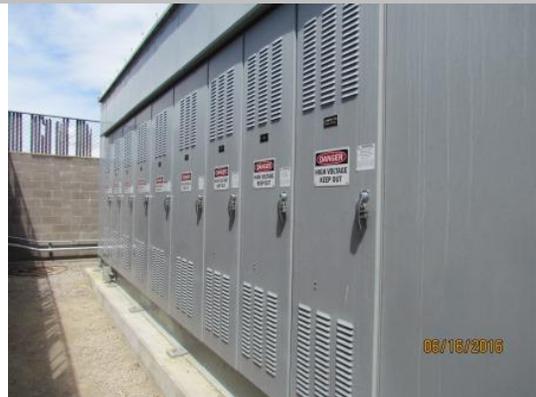
Photo 1 of 1 : ST\_2016\_NA0060\_22\_3\_20160621\_00020.jpg

LM Start	<b>0.00</b>	Rating **	A	Issue No.	<b>3</b>
LM End	<b>0.00</b>	Issue Type +	Ma	Location *	
Category	Pump Stations		GPS Latitude/Longitude		
			Start	End	
Item	Plant Building		39.026449 °	39.026449 °	
			-121.726937 °	-121.726937 °	
DWR ID	DWR_NA0060_22_t_2012_3				
Action/Comments					
Inspector Comments: Plant building is currently under construction. Minor concrete spalling has been noted but it should not prevent the structure from performing as intended.

View of the side of the plant building.

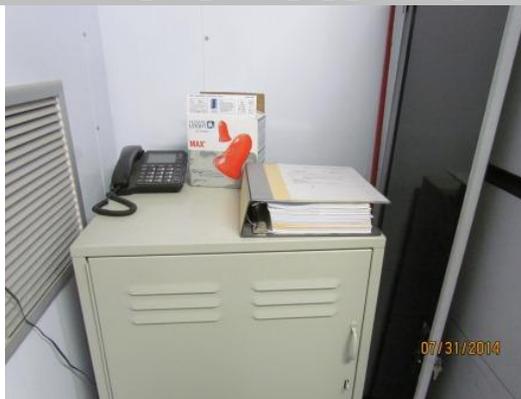
Photo 1 of 1 : ST\_2016\_NA0060\_22\_4\_20160615\_00004.jpg

LM Start	<b>0.00</b>	Rating **	A	Issue No.	<b>4</b>
LM End	<b>0.00</b>	Issue Type +	Ma	Location *	
Category	Pump Stations		GPS Latitude/Longitude		
			Start	End	
Item	Communications		39.026449 °	39.026449 °	
			-121.726937 °	-121.726937 °	
DWR ID	DWR_NA0060_22_t_2012_4				
Action/Comments					
Inspector Comments: Operator has two-way radio and cellular phone available to them. The remote control system is currently being tested and should be ready by the start of flood season.

View of the on-site telephone.

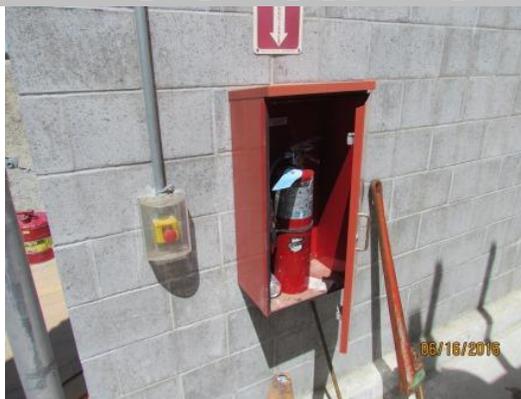
Photo 1 of 2 : ST\_2016\_NA0060\_22\_5\_20160621\_00021.jpg

LM Start	<b>0.00</b>	Rating **	A	Issue No.	<b>5</b>
LM End	<b>0.00</b>	Issue Type +	Ma	Location *	
Category	Pump Stations		GPS Latitude/Longitude		
			Start	End	
Item	Safety		39.026449 °	39.026449 °	
			-121.726937 °	-121.726937 °	
DWR ID	DWR_NA0060_22_t_2012_5				
Action/Comments					
Inspector Comments: Site is under construction safety wear is required during construction (hard hat, vest and eyewear). Some of the hazards may include moving equipment.

View of the emergency shutoff switch and fire extinguisher.

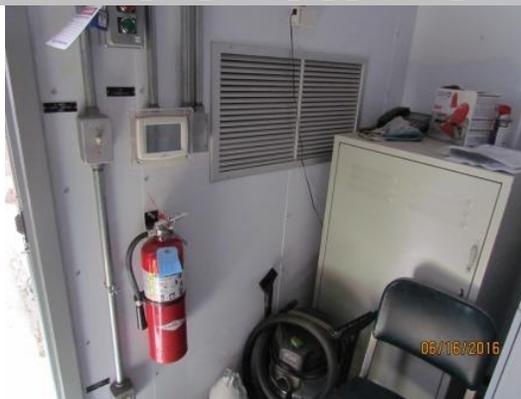
Photo 2 of 2 : ST\_2016\_NA0060\_22\_5\_20160621\_00022.jpg

View of the fire extinguisher inside the operating room.

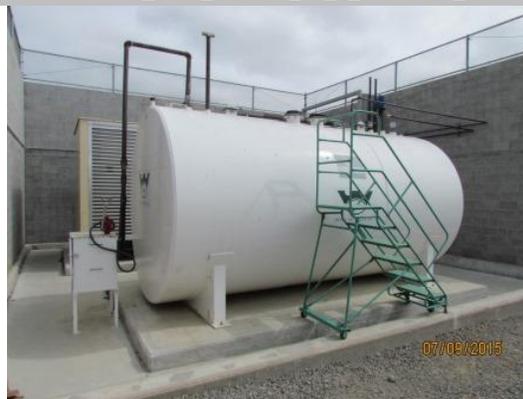
Photo 1 of 2 : ST\_2016\_NA0060\_22\_8\_20160615\_00006.jpg

LM Start	<b>0.00</b>	Rating **	A	Issue No.	<b>8</b>
LM End	<b>0.00</b>	Issue Type +	Ma	Location *	
Category	Pump Stations		GPS Latitude/Longitude		
			Start	End	
Item	Power		39.026449 °	39.026449 °	
			-121.726937 °	-121.726937 °	
DWR ID	DWR_NA0060_22_t_2012_8				
Action/Comments					
Inspector Comments: The structure is on the grid with emergency backup generator.

View of the emergency backup generator fuel tank.

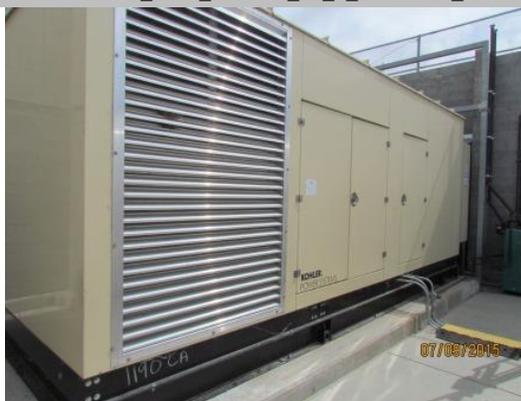
Photo 2 of 2 : ST\_2016\_NA0060\_22\_8\_20160615\_00007.jpg

LM Start	<b>0.00</b>	Rating **	A	Issue No.	<b>8 (cont)</b>
LM End	<b>0.00</b>	Issue Type +	Ma	Location *	
Category	Pump Stations			GPS Latitude/Longitude	
				Start	End
Item	Power			39.026449 °	39.026449 °
				-121.726937 °	-121.726937 °
DWR ID	DWR_NA0060_22_t_2012_8				
Action/Comments					
Inspector Comments: The structure is on the grid with emergency backup generator.

View of the emergency backup generator.

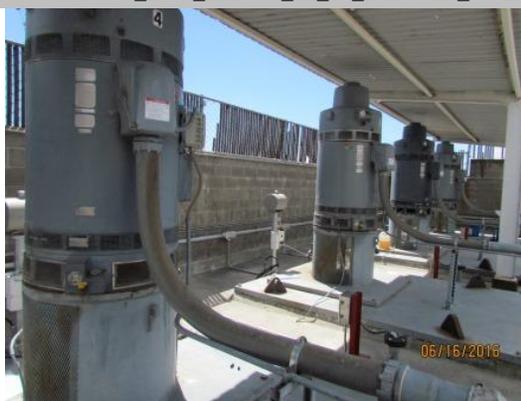
Photo 1 of 1 : ST\_2016\_NA0060\_22\_10\_20160621\_00023.jpg

LM Start	<b>0.00</b>	Rating **	A	Issue No.	<b>10</b>
LM End	<b>0.00</b>	Issue Type +	Ma	Location *	
Category	Pump Stations			GPS Latitude/Longitude	
				Start	End
Item	Motors, Engines, Fans & Gear Reducers			39.026449 °	39.026449 °
				-121.726937 °	-121.726937 °
DWR ID	DWR_NA0060_22_t_2012_10				
Action/Comments					
Inspector Comments: These items appear to be maintained and in operating condition.

View of the pump motors.

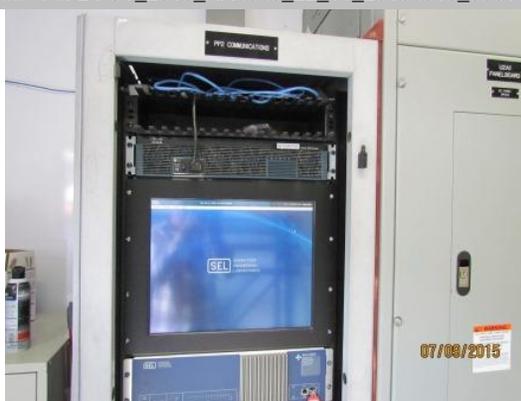
Photo 1 of 2 : ST\_2016\_NA0060\_22\_11\_20160615\_00010.jpg

LM Start	<b>0.00</b>	Rating **	A	Issue No.	<b>11</b>
LM End	<b>0.00</b>	Issue Type +	Ma	Location *	
Category	Pump Stations			GPS Latitude/Longitude	
				Start	End
Item	Pump Control Systems			39.026449 °	39.026449 °
				-121.726937 °	-121.726937 °
DWR ID	DWR_NA0060_22_t_2012_11				
Action/Comments					
Inspector Comments: Pump control systems on site are new and appear to be in working order.

View of the pump control computer.

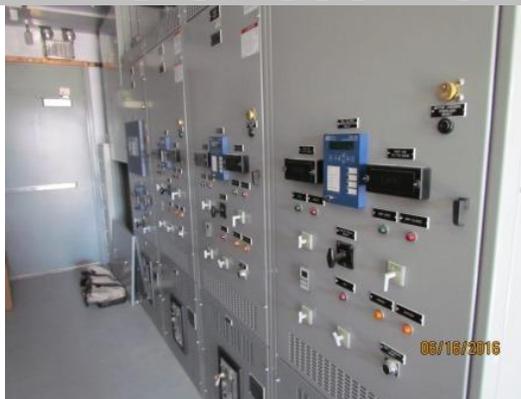
Photo 2 of 2 : ST\_2016\_NA0060\_22\_11\_20160621\_00024.jpg

LM Start	<b>0.00</b>	Rating **	A	Issue No.	<b>11 (cont)</b>
LM End	<b>0.00</b>	Issue Type +	Ma	Location *	
Category	Pump Stations			GPS Latitude/Longitude	
				Start	End
Item	Pump Control Systems			39.026449 °	39.026449 °
				-121.726937 °	-121.726937 °
DWR ID	DWR_NA0060_22_t_2012_11				
Action/Comments					
Inspector Comments: Pump control systems on site are new and appear to be in working order.

View of the manual electrical pump controls.

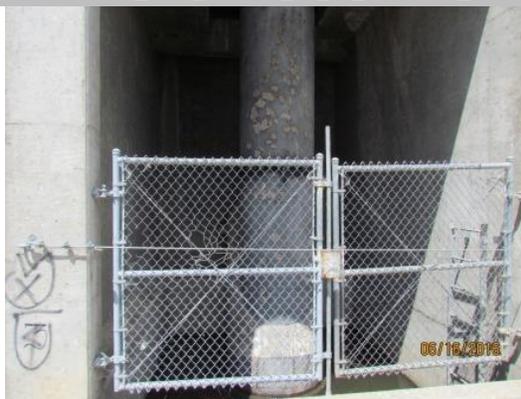
Photo 1 of 1 : ST\_2016\_NA0060\_22\_12\_20160621\_00025.jpg

LM Start	<b>0.00</b>	Rating **	A	Issue No.	<b>12</b>
LM End	<b>0.00</b>	Issue Type +	Ma	Location *	
Category	Pump Stations			GPS Latitude/Longitude	
				Start	End
Item	Sumps/Wet Well			39.026449 °	39.026449 °
				-121.726937 °	-121.726937 °
DWR ID	DWR_NA0060_22_t_2012_12				
Action/Comments					
Inspector Comments: Sumps appear to be in good working condition.

View of the sump, typical.

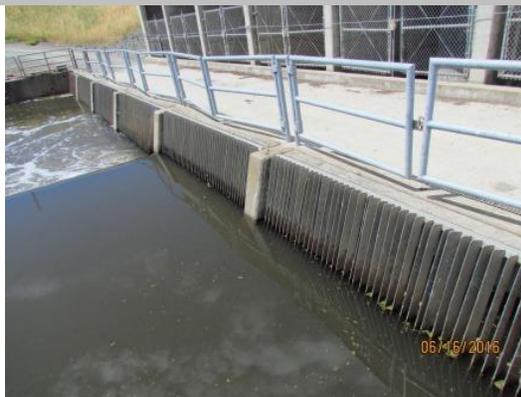
Photo 1 of 1 : ST\_2016\_NA0060\_22\_13\_20160621\_00026.jpg

LM Start	<b>0.00</b>	Rating **	A	Issue No.	<b>13</b>
LM End	<b>0.00</b>	Issue Type +	Ma	Location *	
Category	Pump Stations			GPS Latitude/Longitude	
				Start	End
Item	Trash Racks			39.026449 °	39.026449 °
				-121.726937 °	-121.726937 °
DWR ID	DWR_NA0060_22_t_2012_13				
Action/Comments					
Inspector Comments: Trash rack is secure and free of debris.

View of the trash racks.

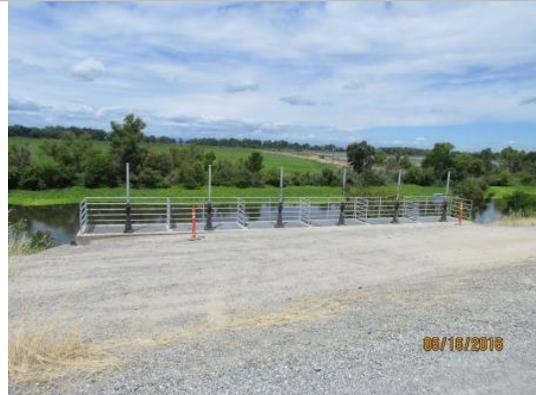
Photo 1 of 1 : ST\_2016\_NA0060\_22\_17\_20160621\_00027.jpg

LM Start	<b>0.00</b>	Rating **	A	Issue No.	<b>17</b>
LM End	<b>0.00</b>	Issue Type +	Ma	Location *	
Category	Pump Stations		GPS Latitude/Longitude		
			Start	End	
Item	Manual Gate Operators		39.026449 °	39.026449 °	
			-121.726937 °	-121.726937 °	
DWR ID	DWR_NA0060_22_t_2012_17				
Action/Comments					
Inspector Comments: Manual gate operators appear to be in good working condition.

Photo shows controls for sluice gates.

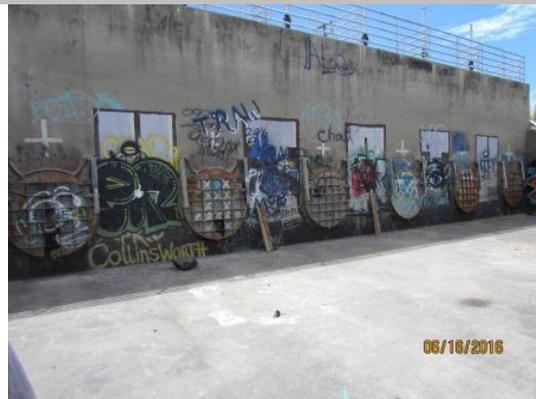
Photo 1 of 1 : ST\_2016\_NA0060\_22\_19\_20160621\_00031.jpg

LM Start	<b>0.00</b>	Rating **	A	Issue No.	<b>19</b>
LM End	<b>0.00</b>	Issue Type +	Ma	Location *	
Category	Pump Stations		GPS Latitude/Longitude		
			Start	End	
Item	Flap Gates		39.026449 °	39.026449 °	
			-121.726937 °	-121.726937 °	
DWR ID	DWR_NA0060_22_t_2012_19				
Action/Comments					
Inspector Comments: Flap gates are in proper working condition, they show no signs of corrosion or damage.

View of the flap gates.

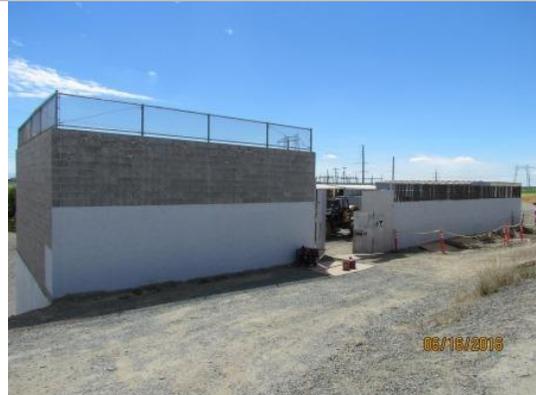
Photo 1 of 1 : ST\_2016\_NA0060\_22\_21\_20160621\_00032.jpg

LM Start	<b>0.00</b>	Rating **	A	Issue No.	<b>21</b>
LM End	<b>0.00</b>	Issue Type +	Ma	Location *	
Category	Pump Stations		GPS Latitude/Longitude		
			Start	End	
Item	Security Fencing		39.026449 °	39.026449 °	
			-121.726937 °	-121.726937 °	
DWR ID	DWR_NA0060_22_t_2012_21				
Action/Comments					
Inspector Comments: Site is currently secured by a masonry brick wall.

View of masonry block wall which encloses the site.

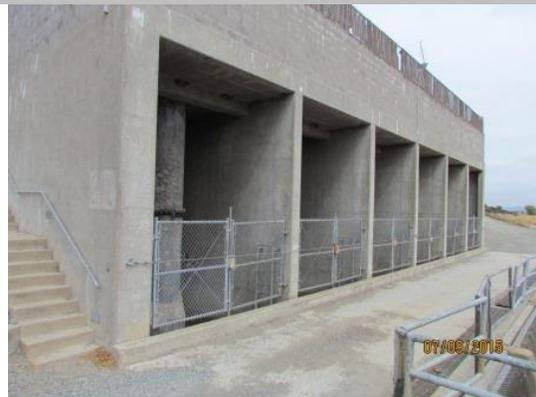
Photo 1 of 2 : ST\_2016\_NA0060\_22\_22\_20160615\_00017.jpg

LM Start	<b>0.00</b>	Rating **	A	Issue No.	<b>22</b>
LM End	<b>0.00</b>	Issue Type +	Ma	Location *	
Category	Pump Stations		GPS Latitude/Longitude		
			Start	End	
Item	Intake and Discharge Pipes		39.026449 °	39.026449 °	
			-121.726937 °	-121.726937 °	
DWR ID	DWR_NA0060_22_t_2012_22				
Action/Comments					
Inspector Comments: No visible deficiencies observed in the pipe's condition.

Closer view of the sump wells.

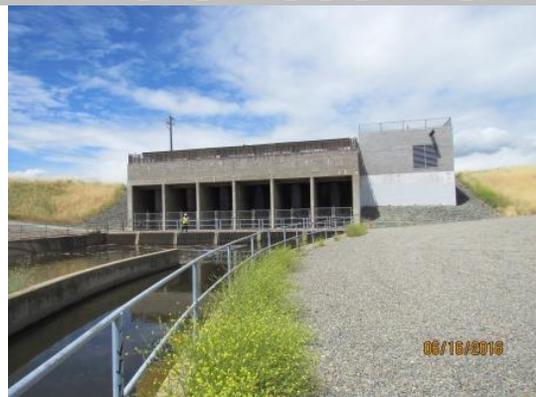
Photo 2 of 2 : ST\_2016\_NA0060\_22\_22\_20160621\_00033.jpg

View of the intake structure.

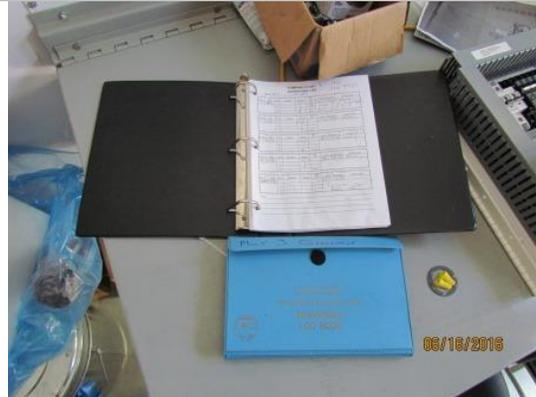
Photo 1 of 1 : ST\_2016\_NA0060\_23\_1\_20160621\_00014.jpg

LM Start	<b>0.00</b>	Rating **	A	Issue No.	<b>1</b>
LM End	<b>0.00</b>	Issue Type +	Ma	Location *	
Category	Pump Stations		GPS Latitude/Longitude		
			Start	End	
Item	Operating Log		39.120096 °	39.120096 °	
			-121.779234 °	-121.779234 °	
DWR ID	DWR_NA0060_23_t_2012_1				
Action/Comments					
Inspector Comments: Operation log is at the site.

View of the Operating Log.

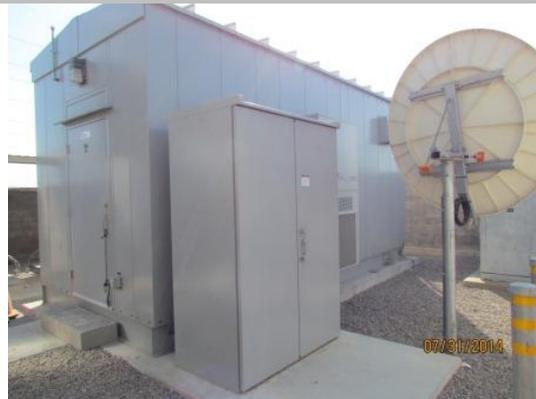
Photo 1 of 1 : ST\_2016\_NA0060\_23\_3\_20160615\_00002.jpg

LM Start	<b>0.00</b>	Rating **	A	Issue No.	<b>3</b>
LM End	<b>0.00</b>	Issue Type +	Ma	Location *	
Category	Pump Stations		GPS Latitude/Longitude		
			Start	End	
Item	Plant Building		39.120096 °	39.120096 °	
			-121.779230 °	-121.779230 °	
DWR ID	DWR_NA0060_23_t_2012_3				
Action/Comments					
Inspector Comments: Plant building appears to be in good working condition. The project is currently under construction.

View of the Plant control building.

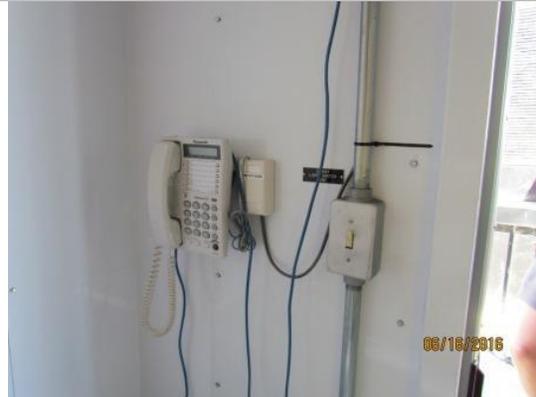
Photo 1 of 1 : ST\_2016\_NA0060\_23\_4\_20160621\_00015.jpg

LM Start	<b>0.00</b>	Rating **	A	Issue No.	<b>4</b>
LM End	<b>0.00</b>	Issue Type +	Ma	Location *	
Category	Pump Stations		GPS Latitude/Longitude		
			Start	End	
Item	Communications		39.120096 °	39.120096 °	
			-121.779230 °	-121.779230 °	
DWR ID	DWR_NA0060_23_t_2012_4				
Action/Comments					
Inspector Comments: Operator has two-way radio and cellular phone available to them. The remote control operation system (SCADA) is currently being tested and should be ready by the start of flood season.

View of the telephone inside the operating room.

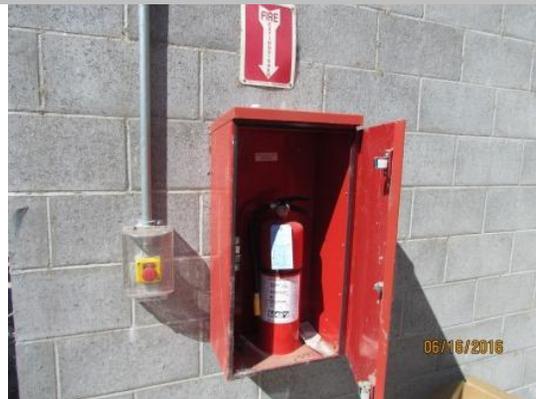
Photo 1 of 2 : ST\_2016\_NA0060\_23\_5\_20160621\_00016.jpg

LM Start	<b>0.00</b>	Rating **	A	Issue No.	<b>5</b>
LM End	<b>0.00</b>	Issue Type +	Ma	Location *	
Category	Pump Stations		GPS Latitude/Longitude		
			Start	End	
Item	Safety		39.120096 °	39.120096 °	
			-121.779230 °	-121.779230 °	
DWR ID	DWR_NA0060_23_t_2012_5				
Action/Comments					
Inspector Comments: Site is under construction safety wear is required during construction (hard hat, vest and eyewear). Some of the hazards may include moving equipment.

View of the fire extinguisher and emergency shut off.

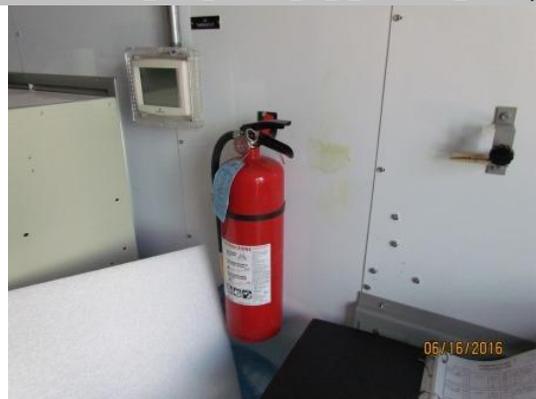
Photo 2 of 2 : ST\_2016\_NA0060\_23\_5\_20160621\_00017.jpg

View of the fire extinguisher in the operating room.

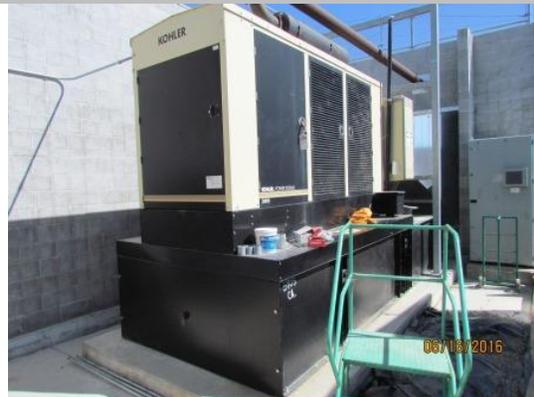
Photo 1 of 2 : ST\_2016\_NA0060\_23\_8\_20160621\_00018.jpg

LM Start	<b>0.00</b>	Rating **	A	Issue No.	<b>8</b>
LM End	<b>0.00</b>	Issue Type +	Ma	Location *	
Category	Pump Stations		GPS Latitude/Longitude		
			Start	End	
Item	Power		39.120096 °	39.120096 °	
			-121.779230 °	-121.779230 °	
DWR ID	DWR_NA0060_23_t_2012_8				
Action/Comments					
Inspector Comments: The structure is on the grid with emergency generator backup.

View of the emergency backup generator.

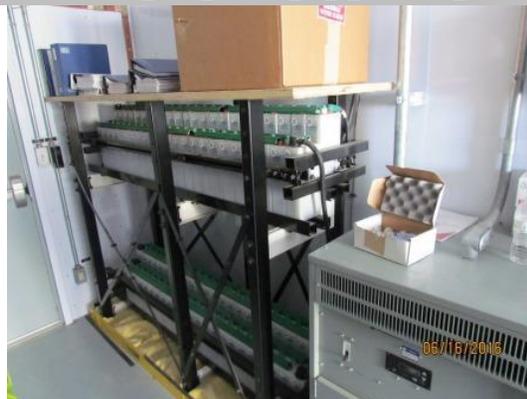
Photo 2 of 2 : ST\_2016\_NA0060\_23\_8\_20160621\_00022.jpg

LM Start	<b>0.00</b>	Rating **	A	Issue No.	<b>8 (cont)</b>
LM End	<b>0.00</b>	Issue Type +	Ma	Location *	
Category	Pump Stations		GPS Latitude/Longitude		
			Start	End	
Item	Power		39.120096°	39.120096°	
			-121.779230°	-121.779230°	
DWR ID	DWR_NA0060_23_t_2012_8				
Action/Comments					
Inspector Comments: The structure is on the grid with emergency generator backup.

View of the backup battery bank.

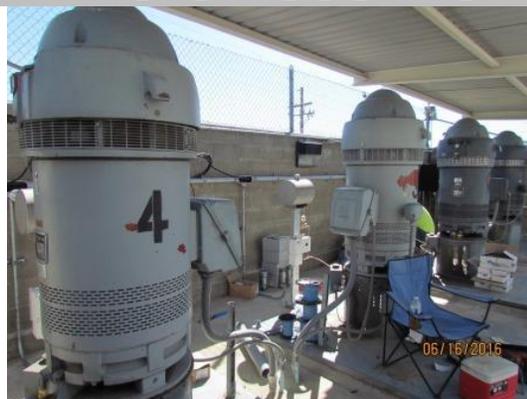
Photo 1 of 1 : ST\_2016\_NA0060\_23\_10\_20160621\_00019.jpg

LM Start	<b>0.00</b>	Rating **	A	Issue No.	<b>10</b>
LM End	<b>0.00</b>	Issue Type +	Ma	Location *	
Category	Pump Stations		GPS Latitude/Longitude		
			Start	End	
Item	Motors, Engines, Fans & Gear Reducers		39.120096°	39.120096°	
			-121.779230°	-121.779230°	
DWR ID	DWR_NA0060_23_t_2012_10				
Action/Comments					
Inspector Comments: These items appear to be maintained and in operating condition.

View of the motors.

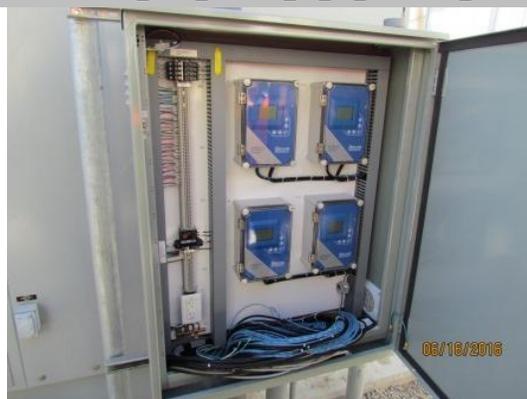
Photo 1 of 2 : ST\_2016\_NA0060\_23\_11\_20160621\_00021.jpg

LM Start	<b>0.00</b>	Rating **	A	Issue No.	<b>11</b>
LM End	<b>0.00</b>	Issue Type +	Ma	Location *	
Category	Pump Stations		GPS Latitude/Longitude		
			Start	End	
Item	Pump Control Systems		39.120096°	39.120096°	
			-121.779230°	-121.779230°	
DWR ID	DWR_NA0060_23_t_2012_11				
Action/Comments					
Inspector Comments: Pump control systems on site are new and appear to be in working order.

View of the flow meters.

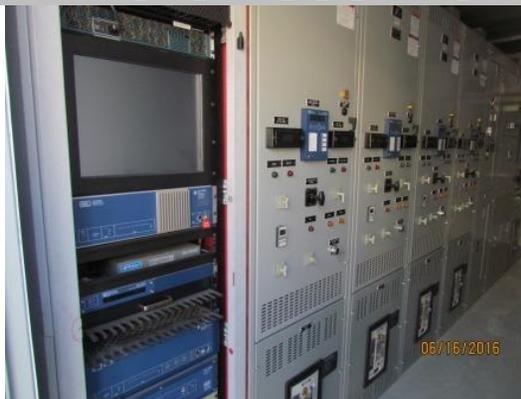
Photo 2 of 2 : ST\_2016\_NA0060\_23\_11\_20160621\_00020.jpg

LM Start	<b>0.00</b>	Rating **	A	Issue No.	<b>11 (cont)</b>
LM End	<b>0.00</b>	Issue Type +	Ma	Location *	
Category	Pump Stations		GPS Latitude/Longitude		
			Start	End	
Item	Pump Control Systems		39.120096°	39.120096°	
			-121.779230°	-121.779230°	
DWR ID	DWR_NA0060_23_t_2012_11				
Action/Comments					
Inspector Comments: Pump control systems on site are new and appear to be in working order.

View of the pump computer and control panels

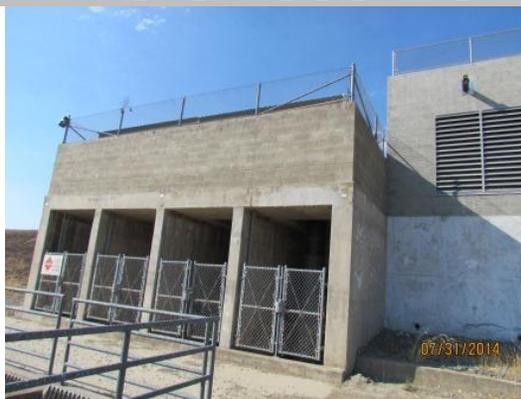
Photo 1 of 2 : ST\_2016\_NA0060\_23\_12\_20160615\_00008.jpg

LM Start	<b>0.00</b>	Rating **	A	Issue No.	<b>12</b>
LM End	<b>0.00</b>	Issue Type +	Ma	Location *	
Category	Pump Stations		GPS Latitude/Longitude		
			Start	End	
Item	Sumps/Wet Well		39.120096°	39.120096°	
			-121.779230°	-121.779230°	
DWR ID	DWR_NA0060_23_t_2012_12				
Action/Comments					
Inspector Comments: Sumps are clear and free of debris.

View of the wet wells with controlled access.

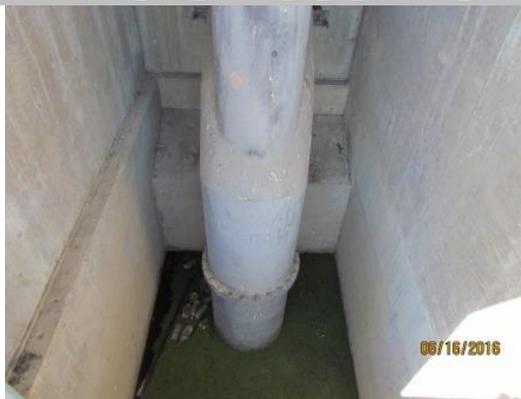
Photo 2 of 2 : ST\_2016\_NA0060\_23\_12\_20160621\_00023.jpg

View of the wet well.

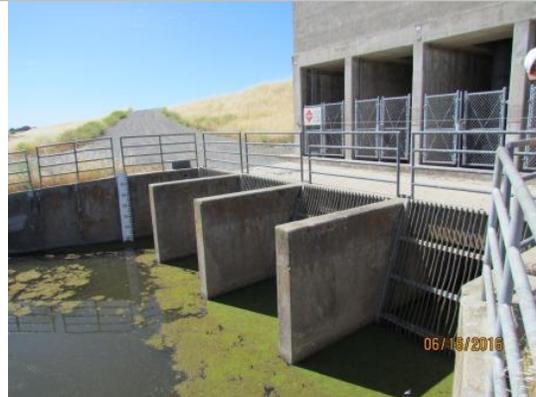
Photo 1 of 2 : ST\_2016\_NA0060\_23\_13\_20160621\_00024.jpg

LM Start	<b>0.00</b>	Rating **	A	Issue No.	<b>13</b>
LM End	<b>0.00</b>	Issue Type +	Ma	Location *	
Category	Pump Stations		GPS Latitude/Longitude		
			Start	End	
Item	Trash Racks		39.120096°	39.120096°	
			-121.779230°	-121.779230°	
DWR ID	DWR_NA0060_23_t_2012_13				
Action/Comments					
Inspector Comments: No debris present on trash racks, they appear to be in good condition.

View of the trash racks.

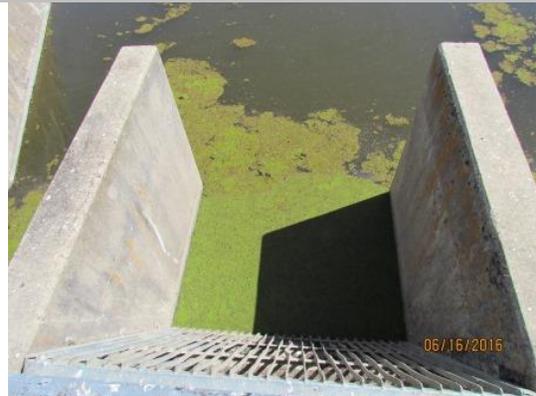
Photo 2 of 2 : ST\_2016\_NA0060\_23\_13\_20160621\_00025.jpg

View of the trash rack free of debris, total of four similar racks.

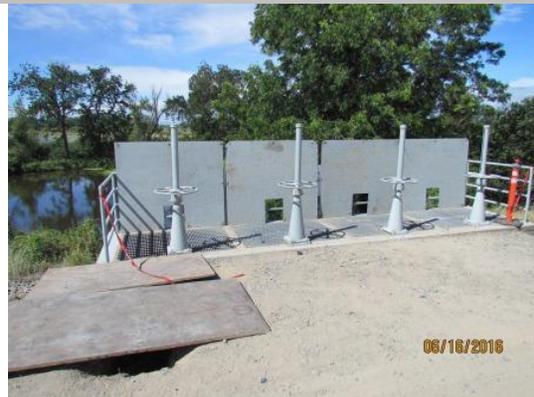
Photo 1 of 1 : ST\_2016\_NA0060\_23\_17\_20160621\_00026.jpg

LM Start	<b>0.00</b>	Rating **	A	Issue No.	<b>17</b>
LM End	<b>0.00</b>	Issue Type +	Ma	Location *	
Category	Pump Stations		GPS Latitude/Longitude		
			Start	End	
Item	Manual Gate Operators		39.120096 °	39.120096 °	
			-121.779230 °	-121.779230 °	
DWR ID	DWR_NA0060_23_t_2012_17				
Action/Comments					
Inspector Comments: Manual gate operators appear to be in good working condition.

Photo shows manual gate operators.

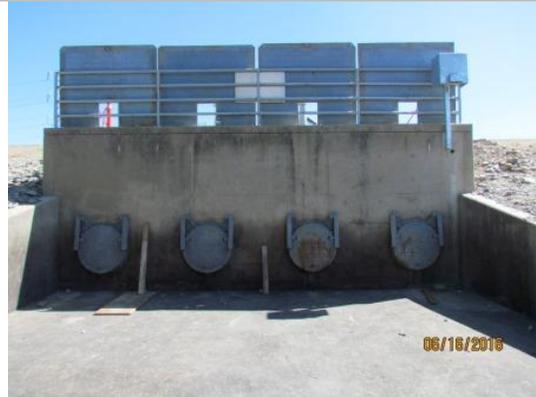
Photo 1 of 1 : ST\_2016\_NA0060\_23\_19\_20160621\_00027.jpg

LM Start	<b>0.00</b>	Rating **	A	Issue No.	<b>19</b>
LM End	<b>0.00</b>	Issue Type +	Ma	Location *	
Category	Pump Stations		GPS Latitude/Longitude		
			Start	End	
Item	Flap Gates		39.120096 °	39.120096 °	
			-121.779230 °	-121.779230 °	
DWR ID	DWR_NA0060_23_t_2012_19				
Action/Comments					
Inspector Comments: Flap gates appear to be in proper working condition, there are no apparent signs of significant corrosion or damage.

Photo shows flap gates and concrete outfall structure.

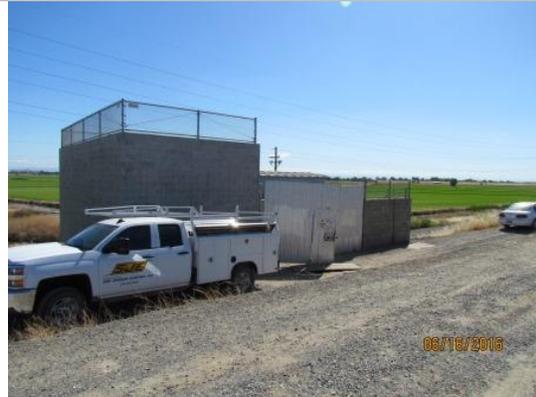
Photo 1 of 1 : ST\_2016\_NA0060\_23\_21\_20160621\_00028.jpg

LM Start	<b>0.00</b>	Rating **	A	Issue No.	<b>21</b>
LM End	<b>0.00</b>	Issue Type +	Ma	Location *	
Category	Pump Stations		GPS Latitude/Longitude		
			Start	End	
Item	Security Fencing		39.120096 °	39.120096 °	
			-121.779230 °	-121.779230 °	
DWR ID	DWR_NA0060_23_t_2012_21				
Action/Comments					
Inspector Comments: Site is currently secured by a masonry brick wall.

Photo shows masonry brick wall which encloses the entire structure.

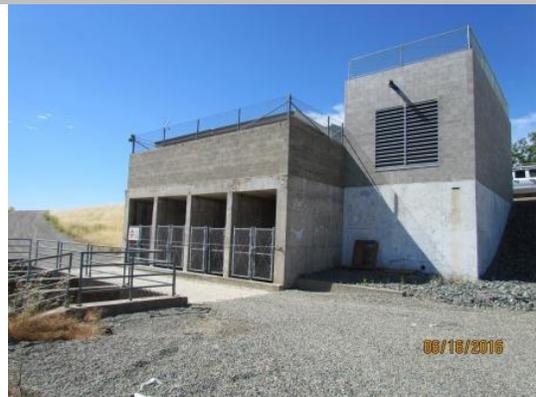
Photo 1 of 1 : ST\_2016\_NA0060\_23\_22\_20160621\_00029.jpg

LM Start	<b>0.00</b>	Rating **	A	Issue No.	<b>22</b>
LM End	<b>0.00</b>	Issue Type +	Ma	Location *	
Category	Pump Stations		GPS Latitude/Longitude		
			Start	End	
Item	Intake and Discharge Pipes		39.120096 °	39.120096 °	
			-121.779230 °	-121.779230 °	
DWR ID	DWR_NA0060_23_t_2012_22				
Action/Comments					
Inspector Comments: No visible deficiencies observed in the pipe's condition.

View of the structure intake.

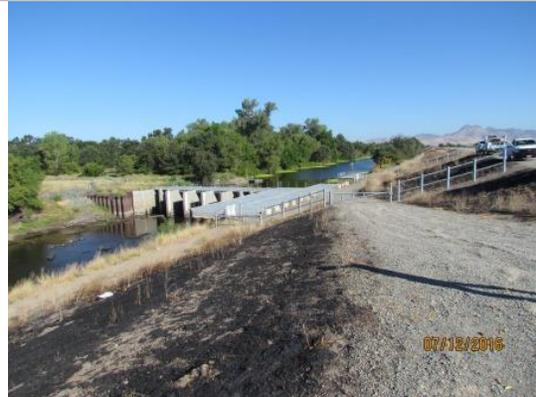
Photo 1 of 5 : ST\_2016\_NA0060\_10\_1\_20160720\_00006.jpg

View of the weir from the levee crown looking upstream.

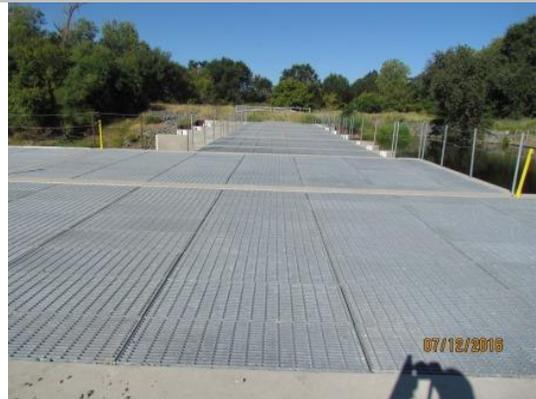
Photo 2 of 5 : ST\_2016\_NA0060\_10\_1\_20160720\_00011.jpg

View across the weir from the left bank.

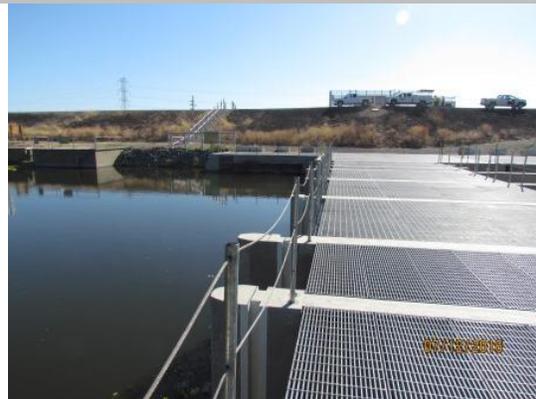
Photo 3 of 5 : ST\_2016\_NA0060\_10\_1\_20160720\_00008.jpg

View across the weir from the right bank.

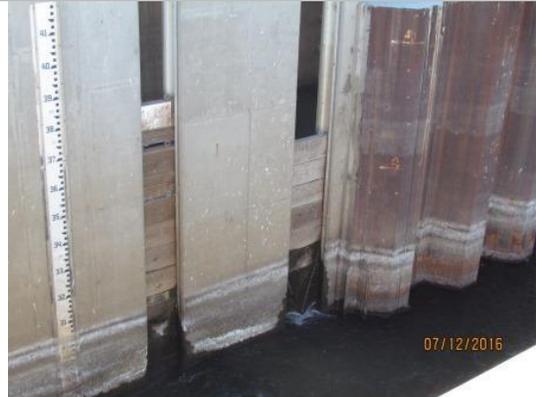
Photo 4 of 5 : ST\_2016\_NA0060\_10\_1\_20160720\_00010.jpg

View of the entrance of the fish ladder.

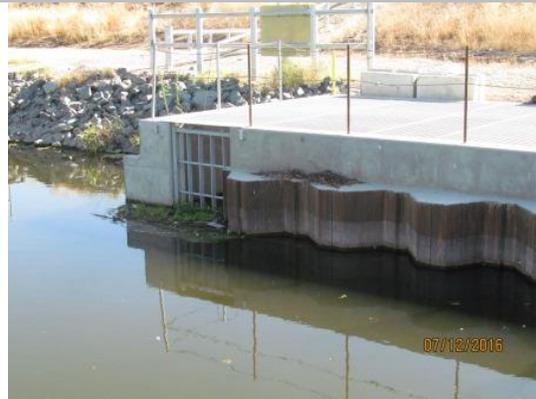
Photo 5 of 5 : ST\_2016\_NA0060\_10\_1\_20160720\_00009.jpg

View of the exit of the fish ladder.

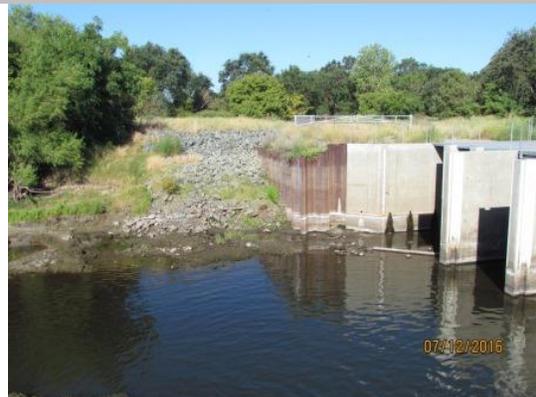
Photo 1 of 2 : ST\_2016\_NA0060\_10\_5\_20160720\_00012.jpg

LM Start	<b>0.00</b>	Rating **	A	Issue No.	<b>5</b>
LM End	<b>0.00</b>	Issue Type +	Ma	Location *	
Category	Structures & Concrete Lined Channels		GPS Latitude/Longitude		
			Start	End	
Item	Revetments		39.102763 °	39.102763 °	
			-121.758738 °	-121.758738 °	
DWR ID	DWR_NA0060_10_t_2012_5				
Action/Comments					
Inspector Comments: Existing riprap protection is properly maintained and is undamaged. Riprap clearly visible.

View of the revetment on both side of the downstream slopes.

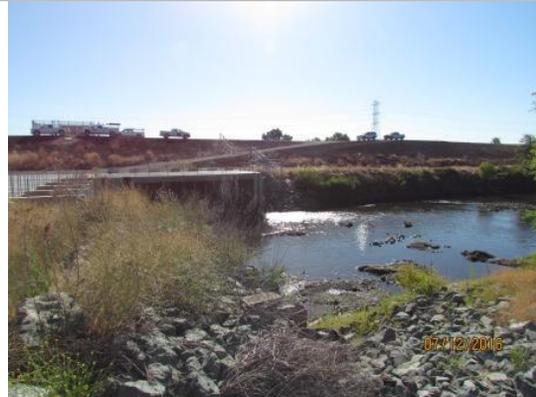
Photo 2 of 2 : ST\_2016\_NA0060\_10\_5\_20160720\_00013.jpg

LM Start	<b>0.00</b>	Rating **	A	Issue No.	<b>5 (cont)</b>
LM End	<b>0.00</b>	Issue Type +	Ma	Location *	
Category	Structures & Concrete Lined Channels		GPS Latitude/Longitude		
			Start	End	
Item	Revetments		39.102763 °	39.102763 °	
			-121.758738 °	-121.758738 °	
DWR ID	DWR_NA0060_10_t_2012_5				
Action/Comments					
Inspector Comments: Existing riprap protection is properly maintained and is undamaged. Riprap clearly visible.

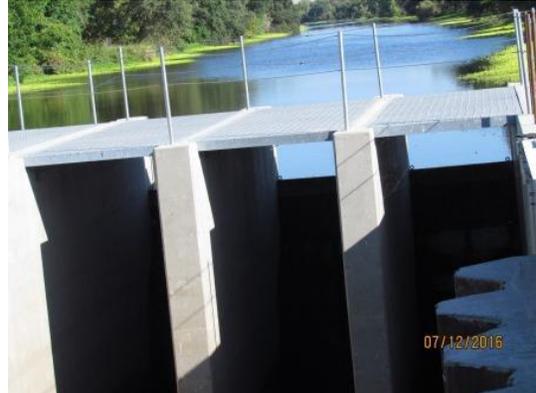
Photo 1 of 2 : ST\_2016\_NA0060\_10\_12\_20160720\_00014.jpg

LM Start	<b>0.00</b>	Rating **	A	Issue No.	<b>12</b>
LM End	<b>0.00</b>	Issue Type +	Ma	Location *	
Category	Structures & Concrete Lined Channels		GPS Latitude/Longitude		
			Start	End	
Item	Sluice/Slide Gates		39.102763 °	39.102763 °	
			-121.758738 °	-121.758738 °	
DWR ID	DWR_NA0060_10_t_2012_12				
Action/Comments					
Inspector Comments: Gates open and close freely with minor leakage. Sill is free of sediment and other obstructions. Gates and lifters have been maintained.

View of slide gates looking upstream.

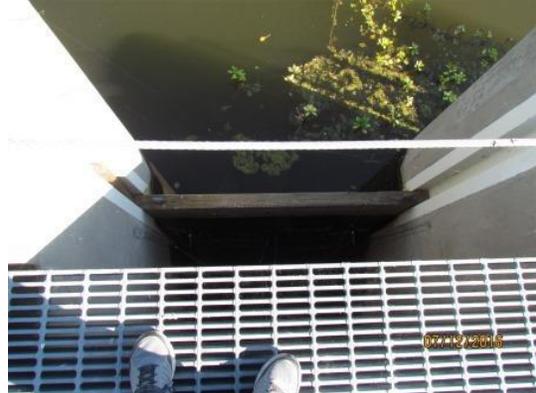
Photo 2 of 2 : ST\_2016\_NA0060\_10\_12\_20160720\_00015.jpg

Close up view of one of the slide gates.

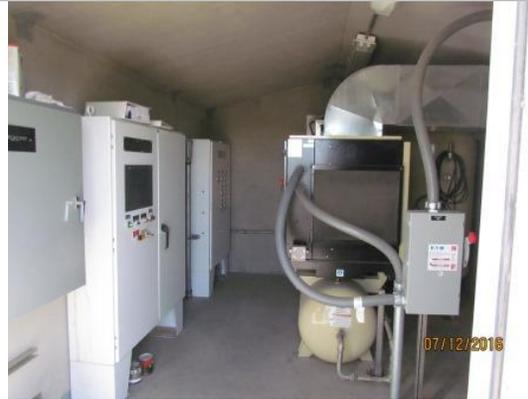
Photo 1 of 5 : ST\_2016\_NA0060\_10\_13\_20160720\_00016.jpg

LM Start	<b>0.00</b>	Rating **	A	Issue No.	<b>13</b>
LM End	<b>0.00</b>	Issue Type +	Ma	Location *	
Category	Structures & Concrete Lined Channels		GPS Latitude/Longitude		
			Start	End	
Item	Electric Gate Operators		39.102763 °	39.102763 °	
			-121.758738 °	-121.758738 °	
DWR ID	DWR_NA0060_10_t_2012_13				
Action/Comments					
Inspector Comments: The sluice gates are opened and closed by the inflation/deflation of a bladder. The compressors' are located in the building on the left bank of the levee crown and are functioning properly.

View of the number one compressor.

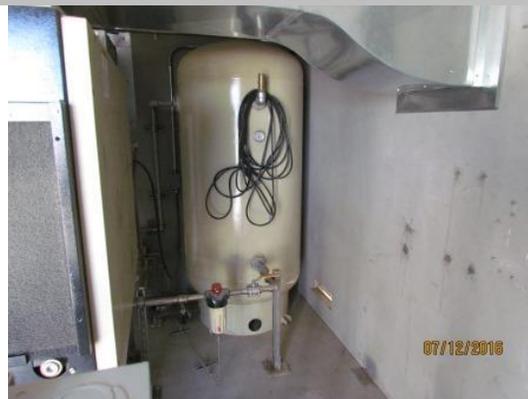
Photo 2 of 5 : ST\_2016\_NA0060\_10\_13\_20160720\_00020.jpg

View of the number two compressor.

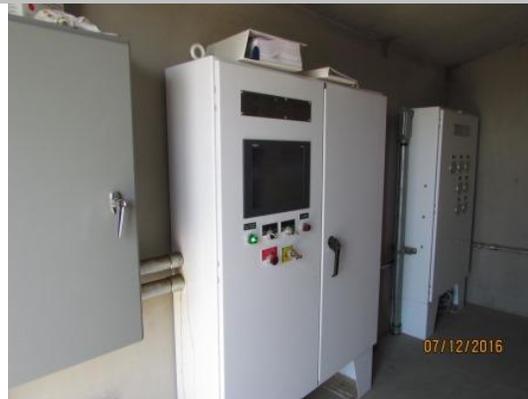
Photo 3 of 5 : ST\_2016\_NA0060\_10\_13\_20160720\_00017.jpg

View of the electronics panel.

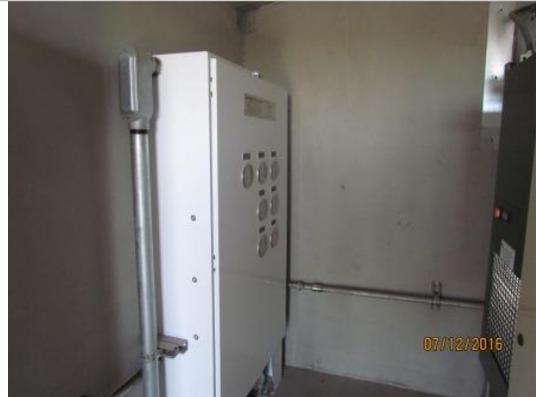
Photo 4 of 5 : ST\_2016\_NA0060\_10\_13\_20160720\_00022.jpg

View of the pressure gages.

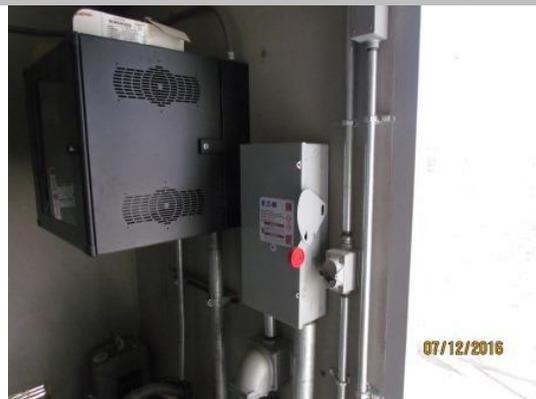
Photo 5 of 5 : ST\_2016\_NA0060\_10\_13\_20160720\_00018.jpg

View of the automatic shutoff switch.

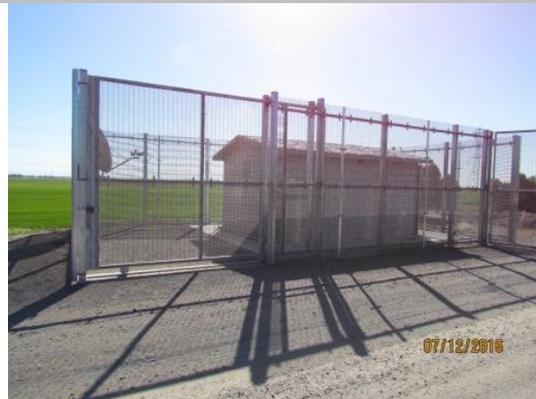
Photo 2 of 2 : ST\_2016\_NA0060\_10\_18\_20160720\_00030.jpg

LM Start	<b>0.00</b>	Rating **	A	Issue No.	<b>18</b>
LM End	<b>0.00</b>	Issue Type +	Ma	Location *	
Category	Structures & Concrete Lined Channels		GPS Latitude/Longitude		
			Start	End	
Item	Security Fencing		39.102763 °	39.102763 °	
			-121.758738 °	-121.758738 °	
DWR ID	DWR_NA0060_10_t_2012_18				
Action/Comments					
Inspector Comments: Safety / security fencing is good condition and provides protection against falling or unauthorized access. Gates open and close freely, locks are in place, and there is little corrosion on metal parts. The fence is very close to the hing point of the slope and does not allow access around the out side of the fence in this location.

View of security fence around the compressor building.

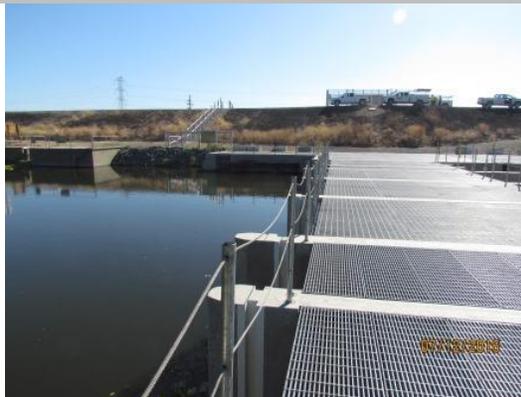
Photo 1 of 2 : ST\_2016\_NA0060\_10\_21\_20160720\_00027.jpg

LM Start	<b>0.00</b>	Rating **	A	Issue No.	<b>21</b>
LM End	<b>0.00</b>	Issue Type +	Ma	Location *	
Category	Structures & Concrete Lined Channels		GPS Latitude/Longitude		
			Start	End	
Item	Other Metallic Items		39.102763 °	39.102763 °	
			-121.758738 °	-121.758738 °	
DWR ID	DWR_NA0060_10_t_2012_21				
Action/Comments					
Inspector Comments: All metal decks are protected from corrosion damage, and show no rust or deterioration that would cause a safety concern.

View of metallic decking looking from the right bank.

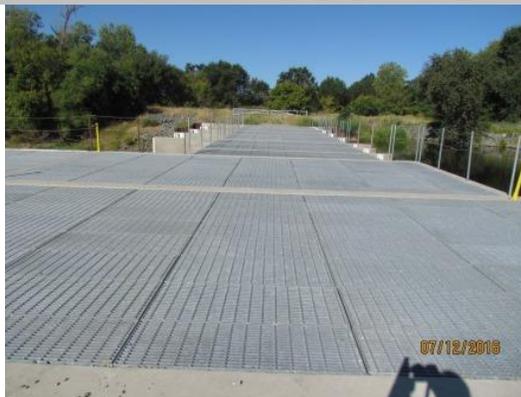
Photo 2 of 2 : ST\_2016\_NA0060\_10\_21\_20160720\_00028.jpg

View of metallic decking looking from the left bank.

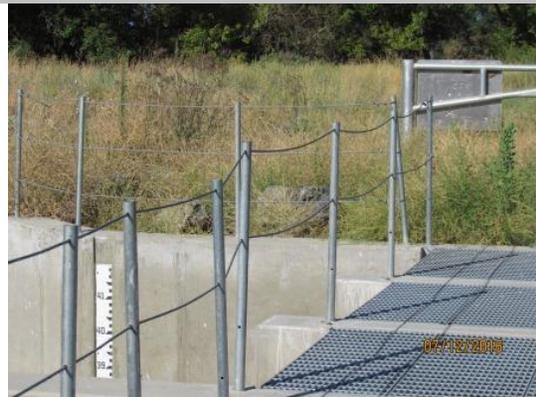
Photo 1 of 3 : ST\_2016\_NA0060\_10\_23\_20160720\_00025.jpg

LM Start	<b>0.00</b>	Rating **	A	Issue No.	<b>23</b>
LM End	<b>0.00</b>	Issue Type +	Ma	Location *	
Category	Structures & Concrete Lined Channels		GPS Latitude/Longitude		
			Start	End	
Item	Safety		39.102763 °	39.102763 °	
			-121.758738 °	-121.758738 °	
DWR ID	DWR_NA0060_10_t_2012_23				
Action/Comments					
Inspector Comments: Safety hardware installed. Adequate protection for fall hazards exist. No hazardous conditions that might affect the operation of the structure. Fire extinguisher is located in the compressor building and is current.

View of the typical safety fence around the decking of the fish ladder and weir.

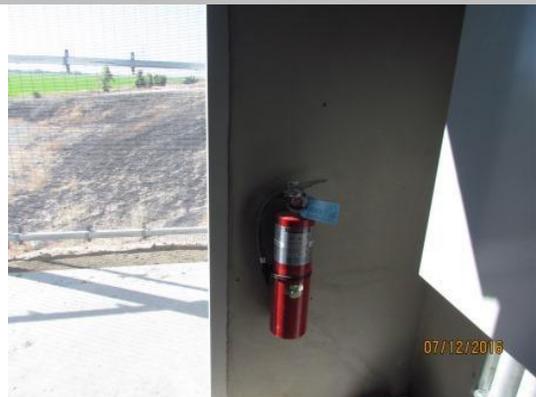
Photo 2 of 3 : ST\_2016\_NA0060\_10\_23\_20160720\_00026.jpg

View of the fire extinguisher in the compressor building.

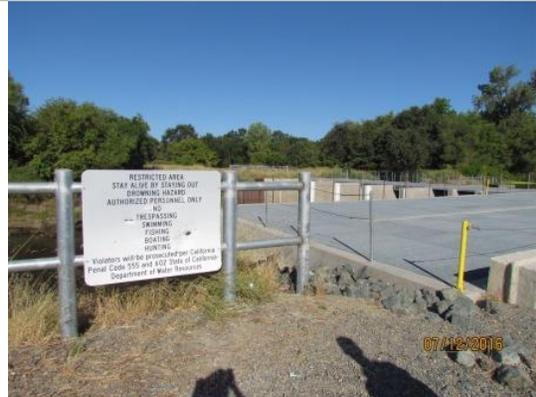
Photo 3 of 3 : ST\_2016\_NA0060\_10\_23\_20160720\_00024.jpg

View of railing at the entrance of the weir.

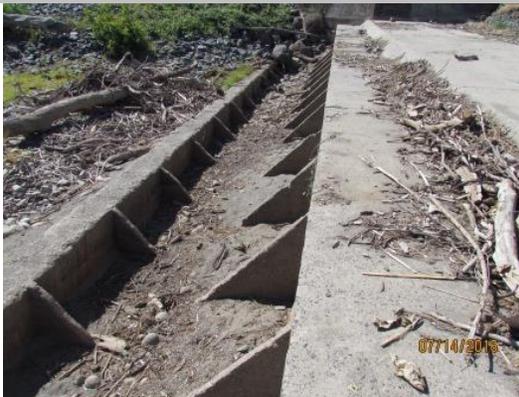
Photo 3 of 3 : ST\_2016\_NA0060\_3\_2\_20160725\_00019.jpg

LM Start	<b>0.00</b>	Rating **	M	Issue No.	<b>2 (cont)</b>
LM End	<b>0.00</b>	Issue Type +	Ma	Location *	
Category	Structures & Concrete Lined Channels			GPS Latitude/Longitude	
				Start	End
Item	Vegetation & Obstructions			39.026713 °	39.026713 °
				-121.821995 °	-121.821995 °
DWR ID	DWR_NA0060_3_t_2012_2				
Action/Comments					
Inspector Comments: Minimal, scattered logs in the weir and on the upstream side. The flow is not impeded.

View of the logs & debris found on the weir facing the right bank of the channel.

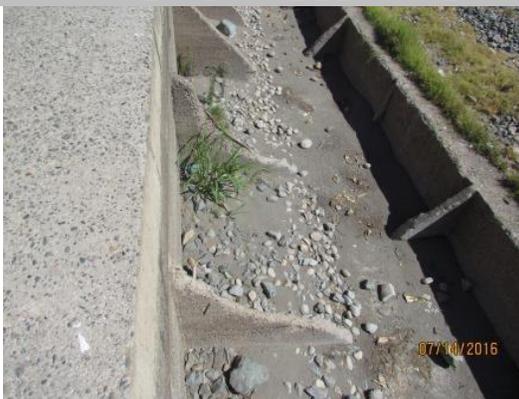
Photo 1 of 2 : ST\_2016\_NA0060\_3\_3\_20160725\_00023.jpg

LM Start	<b>0.00</b>	Rating **	M	Issue No.	<b>3</b>
LM End	<b>0.00</b>	Issue Type +	Ma	Location *	
Category	Structures & Concrete Lined Channels			GPS Latitude/Longitude	
				Start	End
Item	Shoaling / Sedimentation			39.026713 °	39.026713 °
				-121.821995 °	-121.821995 °
DWR ID	DWR_NA0060_3_t_2012_3				
Action/Comments					
Inspector Comments: Minimal shoaling or sedimentation present.

View of the sediment buildup in the weir.

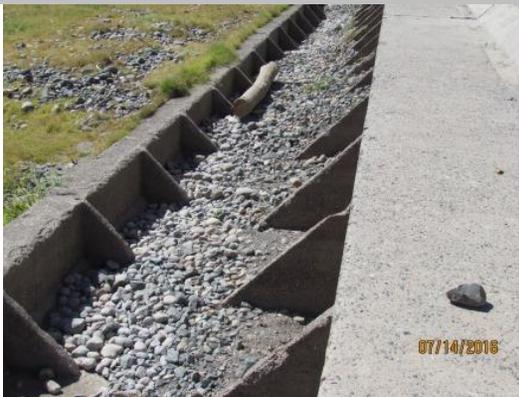
Photo 2 of 2 : ST\_2016\_NA0060\_3\_3\_20160725\_00022.jpg

View of the sediment buildup in the weir facing the right bank of the channel.

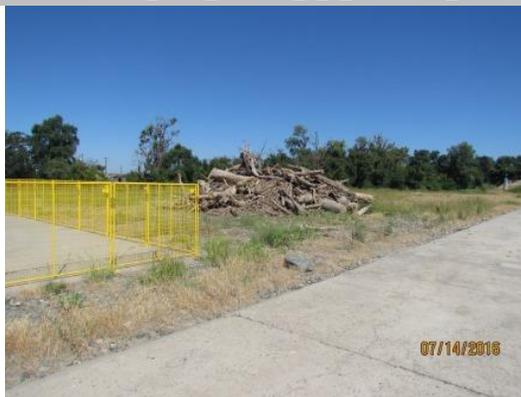
Photo 1 of 1 : ST\_2016\_NA0060\_3\_6\_20160725\_00024.jpg

LM Start	<b>0.00</b>	Rating **	M	Issue No.	<b>6</b>
LM End	<b>0.00</b>	Issue Type +	Ma	Location *	
Category	Structures & Concrete Lined Channels		GPS Latitude/Longitude		
			Start	End	
Item	Encroachments		39.026713 °	39.026713 °	
			-121.821995 °	-121.821995 °	
DWR ID	DWR_NA0060_3_t_2012_6				
Action/Comments					
Inspector Comments: There is a large pile of debris near the upstream of the structure.

View of the large pile of debris near the upstream of the structure at the north end of the parking lot..

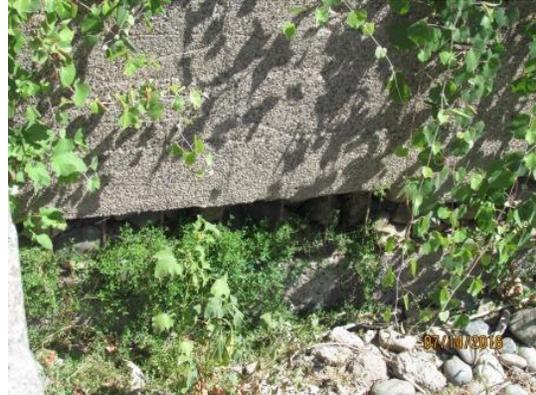
Photo 5 of 10 : ST\_2016\_NA0060\_3\_15\_20160725\_00035.jpg

LM Start	<b>0.00</b>	Rating **	M	Issue No.	<b>15 (cont)</b>
LM End	<b>0.00</b>	Issue Type +	Ma	Location *	
Category	Structures & Concrete Lined Channels			GPS Latitude/Longitude	
				Start	End
Item	Concrete Surfaces			39.026713 °	39.026713 °
				-121.821995 °	-121.821995 °
DWR ID	DWR_NA0060_3_t_2012_15				
Action/Comments					
Inspector Comments: Spalling, scaling and cracking on main surface of structure and wing walls.

Closer view of missing concrete and exposed rebar at the base of the left side abutment.

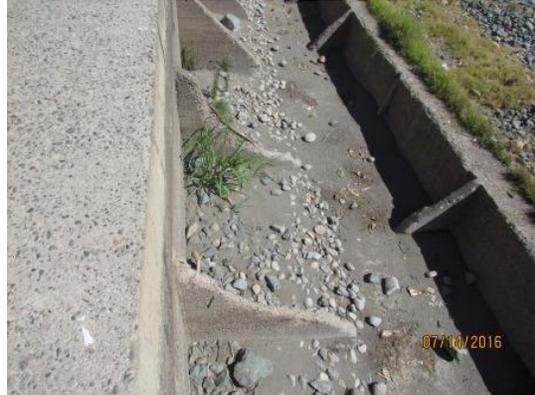
Photo 8 of 10 : ST\_2016\_NA0060\_3\_15\_20160725\_00031.jpg

LM Start	<b>0.00</b>	Rating **	M	Issue No.	<b>15 (cont)</b>
LM End	<b>0.00</b>	Issue Type +	Ma	Location *	
Category	Structures & Concrete Lined Channels			GPS Latitude/Longitude	
				Start	End
Item	Concrete Surfaces			39.026713 °	39.026713 °
				-121.821995 °	-121.821995 °
DWR ID	DWR_NA0060_3_t_2012_15				
Action/Comments					
Inspector Comments: Spalling, scaling and cracking on main surface of structure and wing walls.

View of the deteriorating baffle's and exposed rebar.

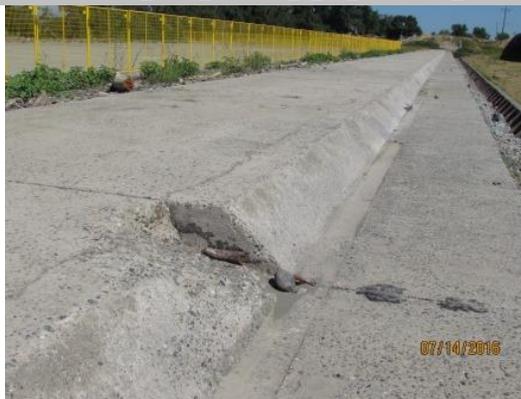
Photo 1 of 1 : ST\_2016\_NA0060\_3\_22\_20160725\_00025.jpg

LM Start	<b>0.00</b>	Rating **	A	Issue No.	<b>22</b>
LM End	<b>0.00</b>	Issue Type +	Ma	Location *	
Category	Structures & Concrete Lined Channels		GPS Latitude/Longitude		
			Start	End	
Item	Monolith Joints		39.026713 °	39.026713 °	
			-121.821995 °	-121.821995 °	
DWR ID	DWR_NA0060_3_t_2012_22				
Action/Comments					
Inspector Comments: The monolith joint material is in good condition, But there is concrete damage at some of the monolithic joints.

View of concrete damage at some of the monolithic joints, does not seem to be impeding the structure's functions.

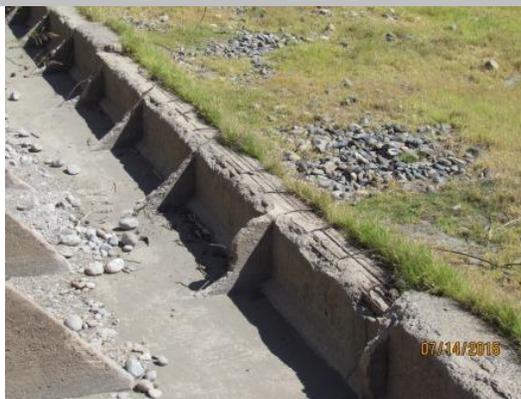
Photo 1 of 2 : ST\_2016\_NA0060\_3\_23\_20160725\_00027.jpg

LM Start	<b>0.00</b>	Rating **	M	Issue No.	<b>23</b>
LM End	<b>0.00</b>	Issue Type +	Ma	Location *	
Category	Structures & Concrete Lined Channels		GPS Latitude/Longitude		
			Start	End	
Item	Safety		39.026713 °	39.026713 °	
			-121.821995 °	-121.821995 °	
DWR ID	DWR_NA0060_3_t_2012_23				
Action/Comments					
Inspector Comments: Concrete should be repaired to conceal the exposed rebar. Safety fence is protecting the structure from the public parking lot.

View of the concrete that needs to be repaired to conceal the exposed rebar.

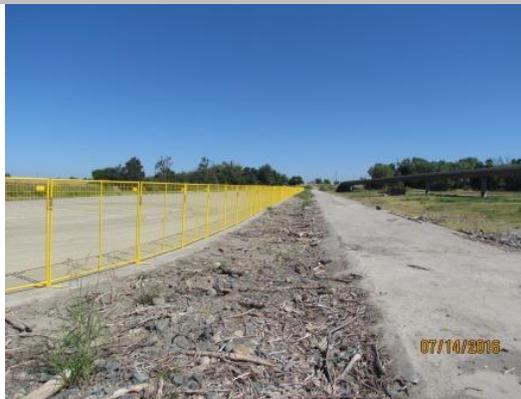
Photo 2 of 2 : ST\_2016\_NA0060\_3\_23\_20160725\_00026.jpg

View of safety fence separating the weir from the public parking lot.
