**Flood Control Project Maintenance
Levee Inspections
LMA District Cover Sheet
Spring 2011 Levee Inspection Results**

Reclamation District No. 0003 Grand Island

Spring 2011 Levee Inspection Results

Waterway	Bank	Unit Miles
Unit No. 01 Left Bank Steamboat Slough	Left	11.03

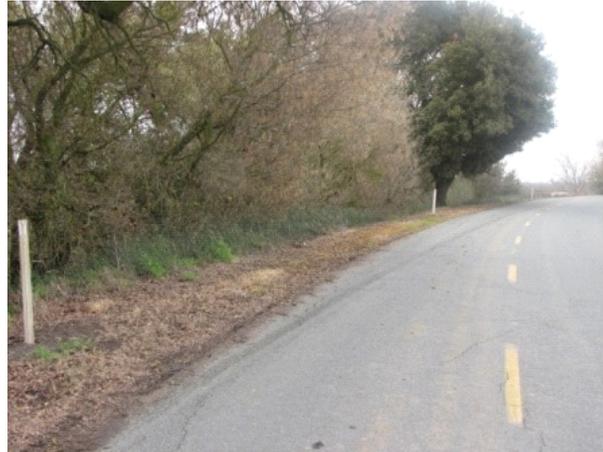
Levee Mile Report Line	15
Start Levee Mile	1.28
End Levee Mile	1.33
Location	Land Side
Category	Earthen Levee
Item	Trim / Thin Trees
Looking northeast at dense vegetation on waterside slope.	
richard_s_20110318_448.jpg

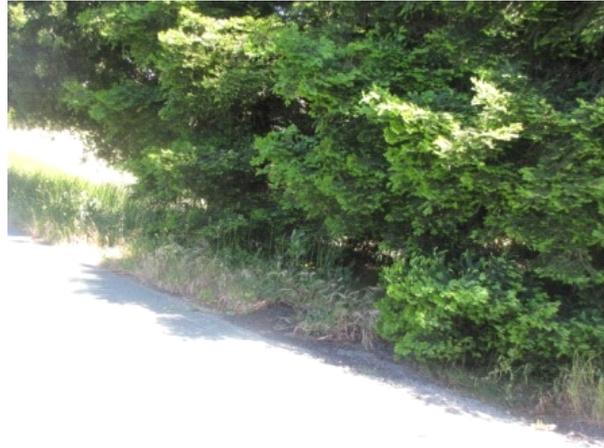
Levee Mile Report Line	18
Start Levee Mile	1.60
End Levee Mile	1.60
Location	Land Side
Category	Earthen Levee
Item	Trim / Thin Trees
Looking southeast at dense trees on landside shoulder and slope.	
richard_s_20110215_020.jpg

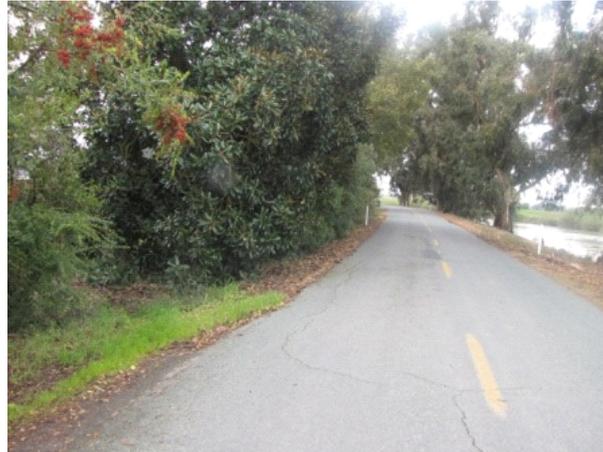
Levee Mile Report Line	21
Start Levee Mile	1.64
End Levee Mile	1.66
Location	Land Side
Category	Earthen Levee
Item	Encroachments
Looking southwest at dense landscaping on landside shoulder and slope.	
richard_s_20110318_449.jpg

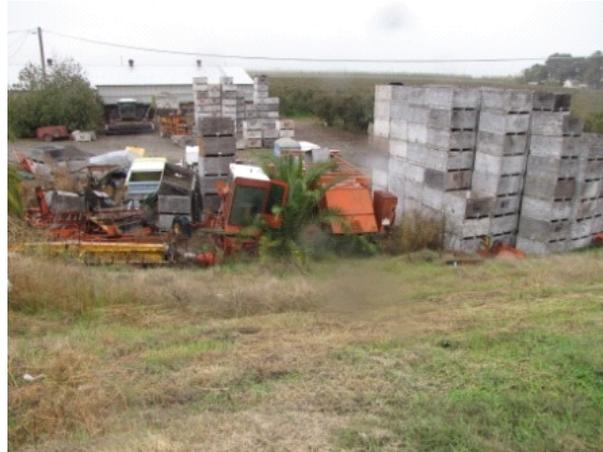
Levee Mile Report Line	26
Start Levee Mile	2.11
End Levee Mile	2.11
Location	Land Side
Category	Earthen Levee
Item	Encroachments
Looking north at equipment and storage containers at landside toe.	
richard_s_20110215_054.jpg

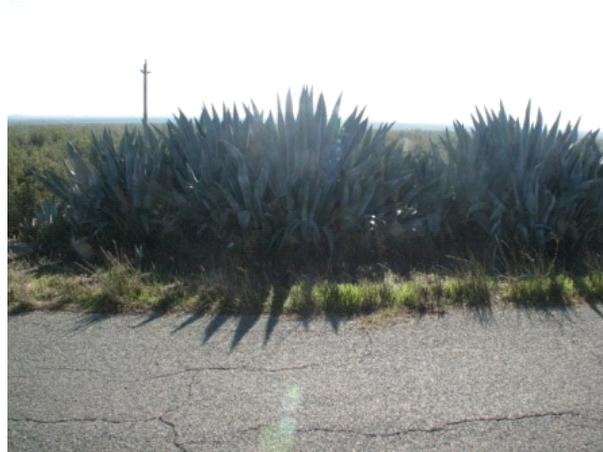
Levee Mile Report Line	38
Start Levee Mile	3.33
End Levee Mile	3.33
Location	Land Side
Category	Earthen Levee
Item	Encroachments
Large cactus on upper levee slope obstructs access and visibility.	
richard_s_20110215_038.jpg

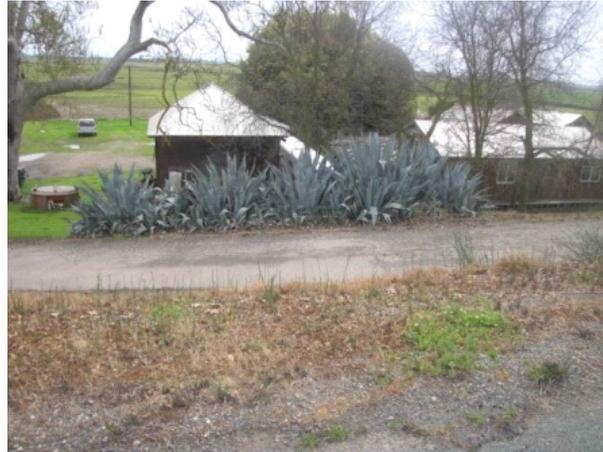
Levee Mile Report Line	49
Start Levee Mile	5.33
End Levee Mile	5.33
Location	Land Side
Category	Earthen Levee
Item	Vegetation
Looking west a century plants on landside slope next to a ramp.	
richard_s_20110318_450.jpg

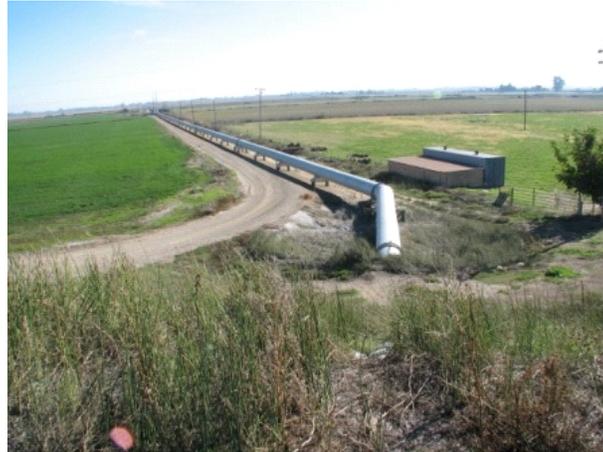
Levee Mile Report Line	59
Start Levee Mile	6.76
End Levee Mile	6.76
Location	Land Side
Category	Earthen Levee
Item	Encroachments
Interior drainage discharge pipe penetrates levee.	
richard_s_20110215_043.jpg

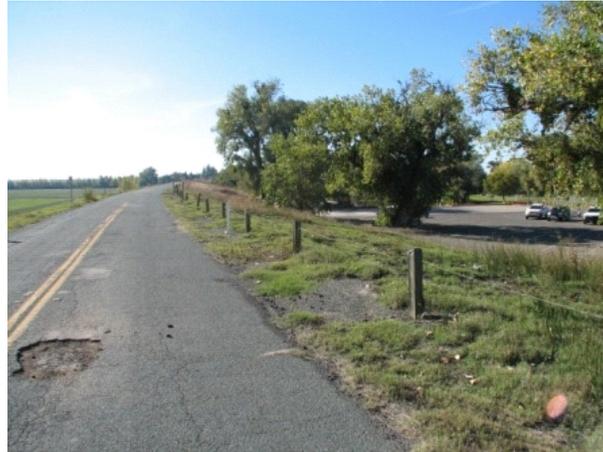
Levee Mile Report Line	63
Start Levee Mile	7.22
End Levee Mile	7.49
Location	Water Side
Category	Earthen Levee
Item	Vegetation
Vegetation on levee slope near boat launch is partially obstructive.	
richard_s_20110215_044.jpg

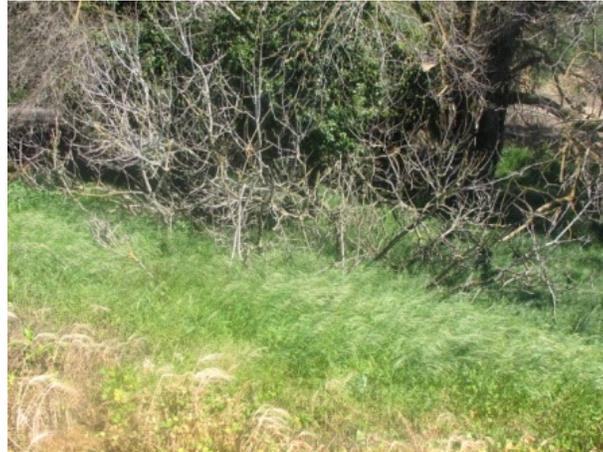
richard_s_20110215_051.jpg

Front view of dense trees at landside toe.

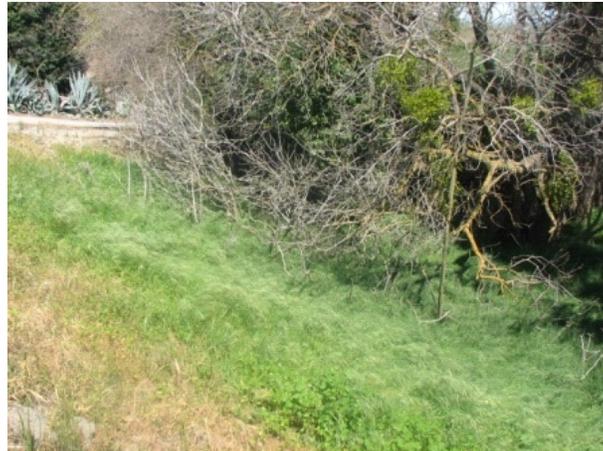
richard_s_20110215_052.jpg

Levee Mile Report Line	68
Start Levee Mile	7.81
End Levee Mile	7.83
Location	Water Side
Category	Earthen Levee
Item	Encroachments

Side view of dense trees at landside toe.

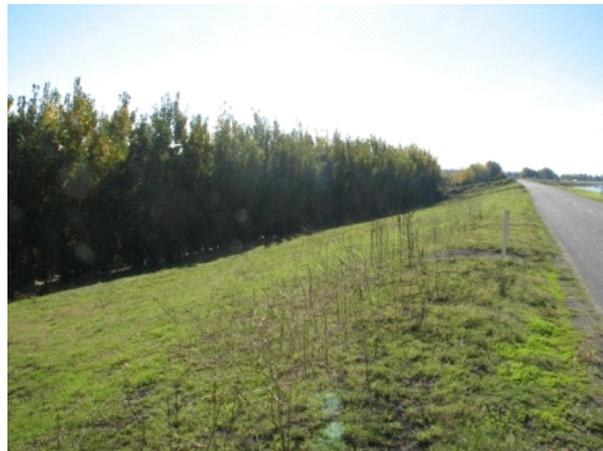
richard_s_20110215_046.jpg

Levee Mile Report Line	69
Start Levee Mile	7.84
End Levee Mile	8.31
Location	Land Side
Category	Earthen Levee
Item	Encroachments

Trees within 10' of levee toe obstruct access and visibility of levee toe.

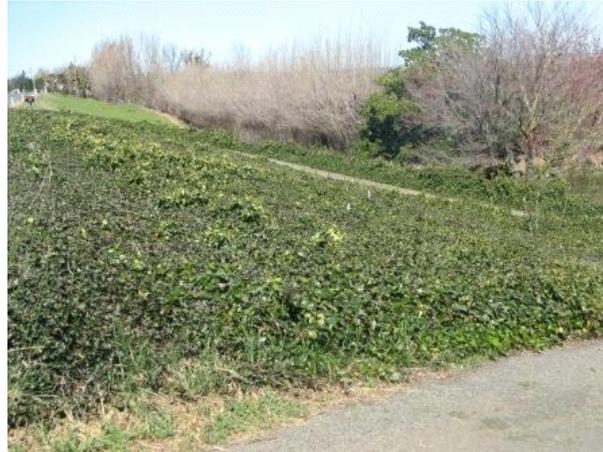
Levee Mile Report Line	71
Start Levee Mile	7.95
End Levee Mile	8.00
Location	Land Side
Category	Earthen Levee
Item	Encroachments
Landscaping (Ivy) on landside slope blocking view of levee from LM 7.95 to 8.00	
richard_s_20110215_025.jpg

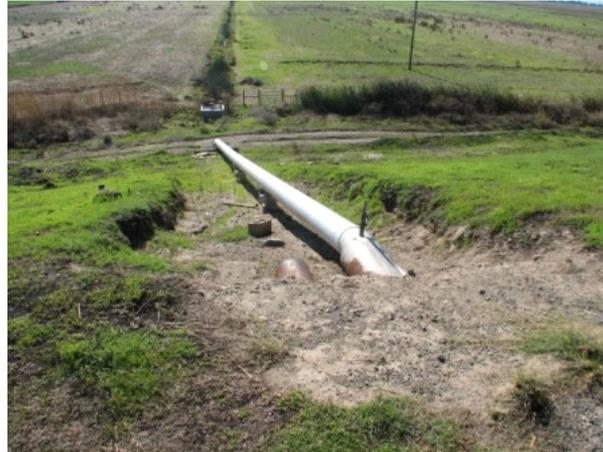
Levee Mile Report Line	84
Start Levee Mile	9.19
End Levee Mile	9.19
Location	Water Side
Category	Earthen Levee
Item	Encroachments
Pipe penetration showing newer pipe next to abandoned pipe.	
richard_s_20110215_048.jpg

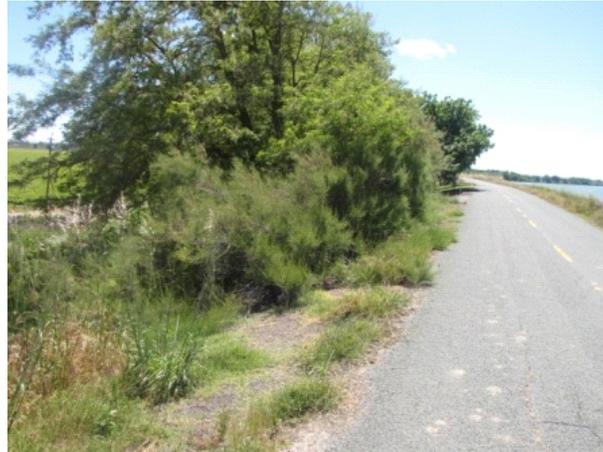
Levee Mile Report Line	86
Start Levee Mile	10.20
End Levee Mile	10.22
Location	Land Side
Category	Earthen Levee
Item	Trim / Thin Trees
Looking north at updated picture (5/10) of dense trees on landside slope.	
richard_s_20110215_029.jpg

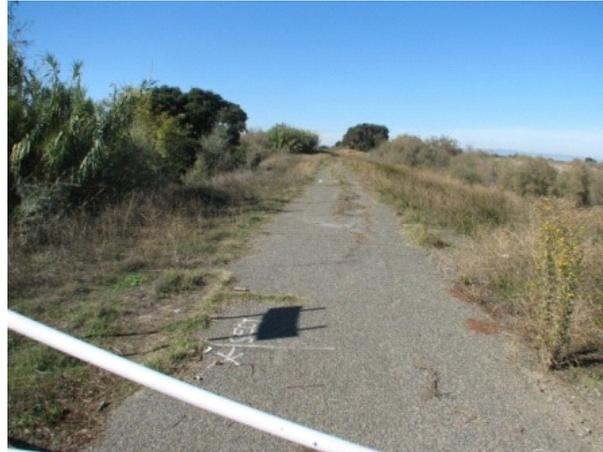
richard_s_20110215_071.jpg

Photo of obstructive vegetation on levee slopes.

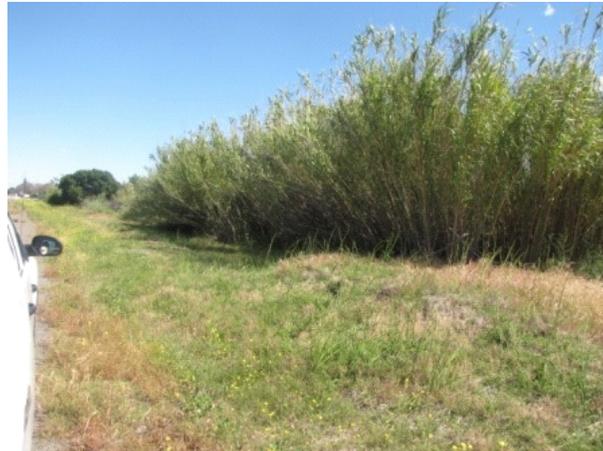
richard_s_20110215_056.jpg

Levee Mile Report Line	6
Start Levee Mile	0.31
End Levee Mile	0.33
Location	Water Side
Category	Earthen Levee
Item	Vegetation

Looking northeast at bamboo on waterside slope.

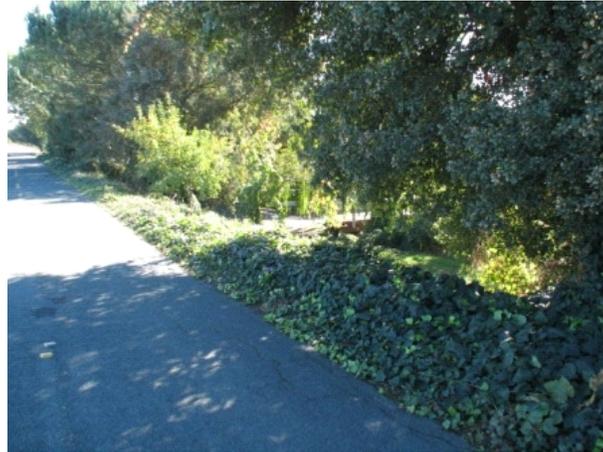
Levee Mile Report Line	10
Start Levee Mile	1.93
End Levee Mile	1.98
Location	Water Side
Category	Earthen Levee
Item	Encroachments
Landscaping on levee slope obstructs visibility and access.	
richard_s_20110215_070.jpg

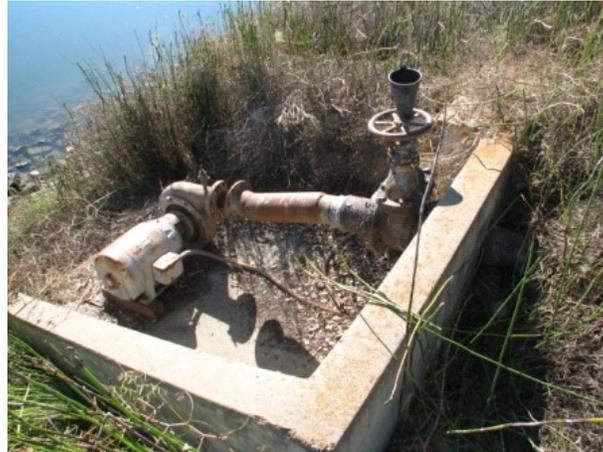
Levee Mile Report Line	18
Start Levee Mile	3.39
End Levee Mile	3.39
Location	Water Side
Category	Earthen Levee
Item	Encroachments
Pipe penetration closure valve in open position.	
richard_s_20110215_065.jpg

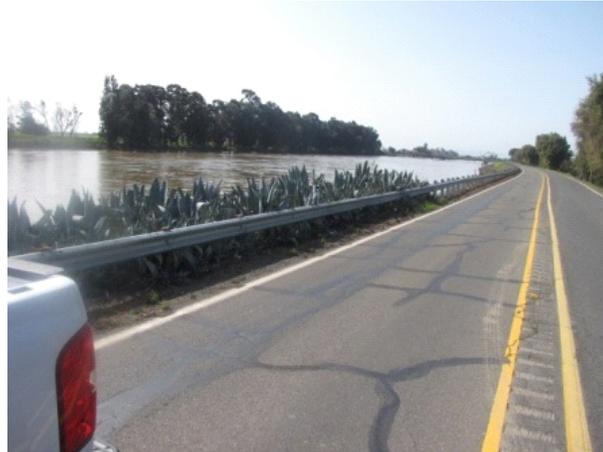
Levee Mile Report Line	24
Start Levee Mile	4.22
End Levee Mile	4.22
Location	Land Side
Category	Earthen Levee
Item	Vegetation
Looking southeast a cactus on waterside shoulder and slope.	
richard_s_20110318_457.jpg

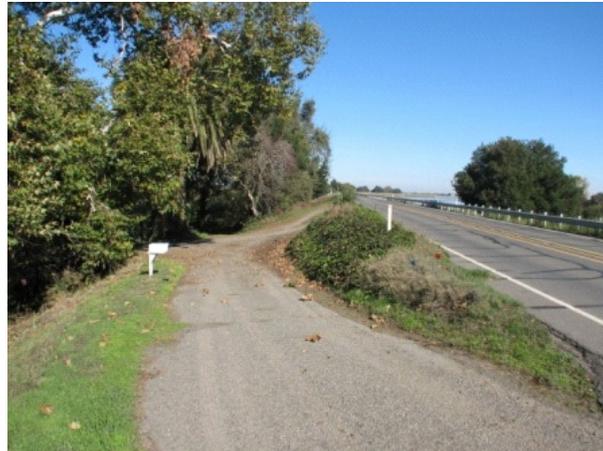
Levee Mile Report Line	27
Start Levee Mile	4.36
End Levee Mile	4.42
Location	Land Side
Category	Earthen Levee
Item	Encroachments
Landscaping on levee slope and toe obstructs access and visibility.	
richard_s_20110215_073.jpg

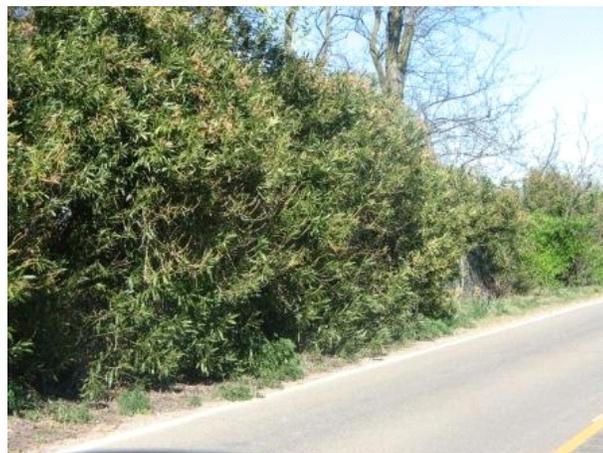
Levee Mile Report Line	34
Start Levee Mile	5.94
End Levee Mile	6.00
Location	Land Side
Category	Earthen Levee
Item	Encroachments
Oleander on landside shoulder blocking view of levee slope from LM 5.94 to 6.00	
richard_s_20110215_057.jpg

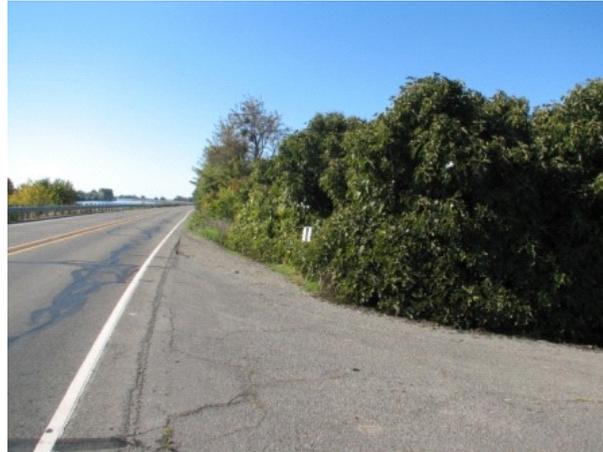
Levee Mile Report Line	34
Start Levee Mile	5.94
End Levee Mile	6.00
Location	Land Side
Category	Earthen Levee
Item	Encroachments
Landscaping on levee slope and toe obstructs access and visibility.	
richard_s_20110215_058.jpg

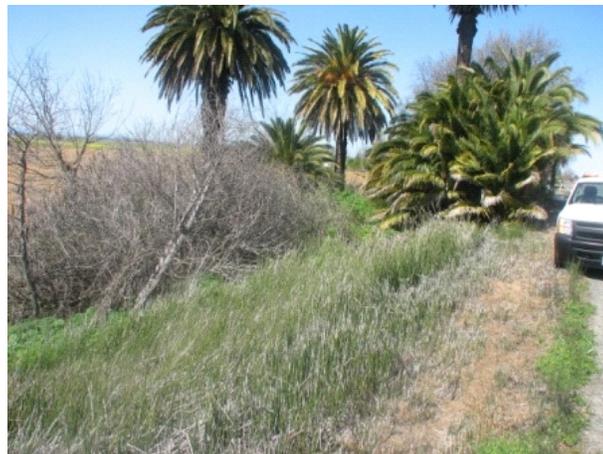
Levee Mile Report Line	37
Start Levee Mile	7.02
End Levee Mile	7.04
Location	Land Side
Category	Earthen Levee
Item	Trim / Thin Trees
Dense trees at landside toe and shoulder	
richard_s_20110215_059.jpg

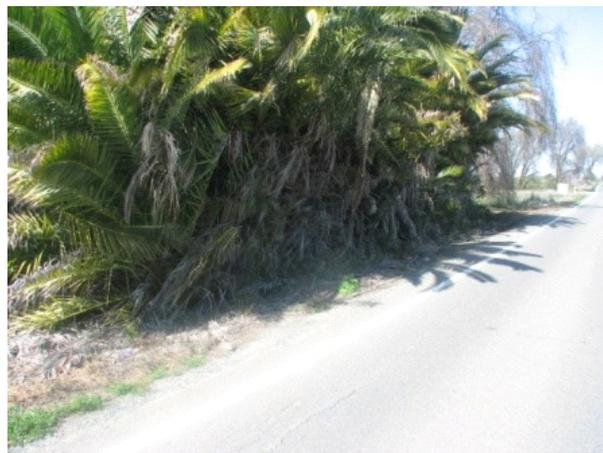
Levee Mile Report Line	37
Start Levee Mile	7.02
End Levee Mile	7.04
Location	Land Side
Category	Earthen Levee
Item	Trim / Thin Trees
Front view of palm trees on landside shoulder	
richard_s_20110215_060.jpg

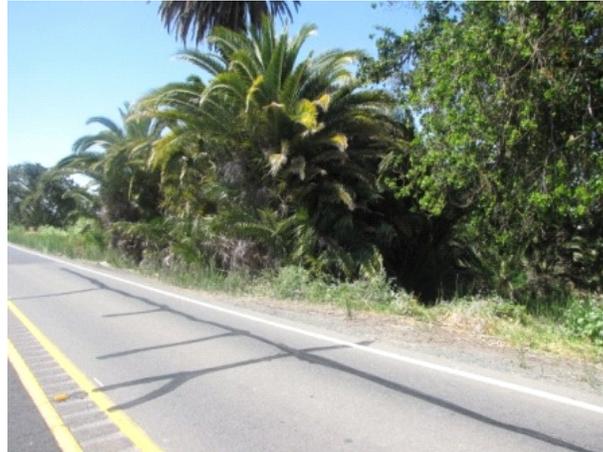
Levee Mile Report Line	37
Start Levee Mile	7.02
End Levee Mile	7.04
Location	Land Side
Category	Earthen Levee
Item	Trim / Thin Trees
Looking southwest at updated dense veg on landside slope.	
richard_s_20110215_061.jpg

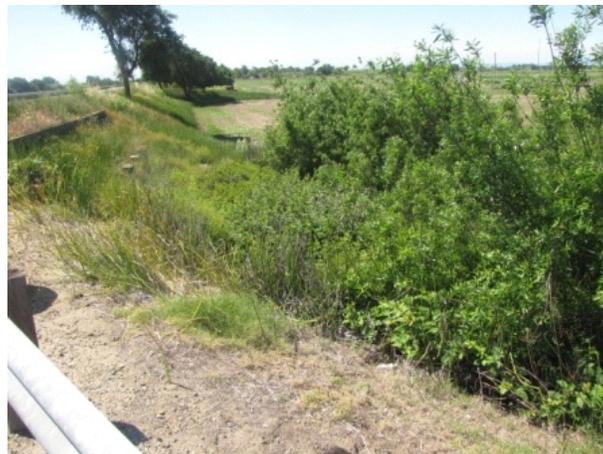
Levee Mile Report Line	38
Start Levee Mile	7.16
End Levee Mile	7.16
Location	Land Side
Category	Earthen Levee
Item	Vegetation
Looking southwest at dense veg. on landside toe.	
richard_s_20110215_062.jpg

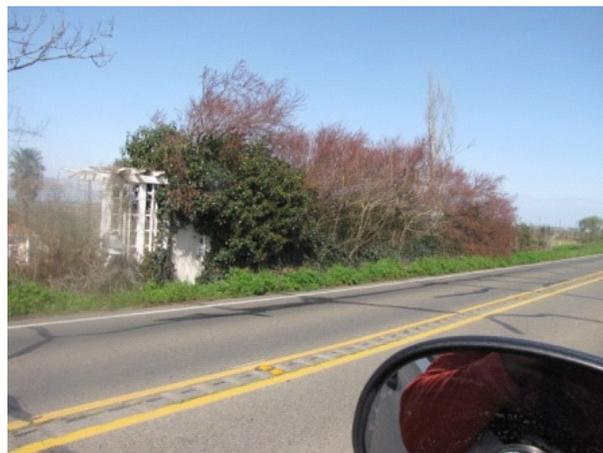
Levee Mile Report Line	39
Start Levee Mile	7.38
End Levee Mile	7.38
Location	Land Side
Category	Earthen Levee
Item	Encroachments
Looking northwest a dense landscaping on landside shoulder and slope.	
richard_s_20110318_458.jpg

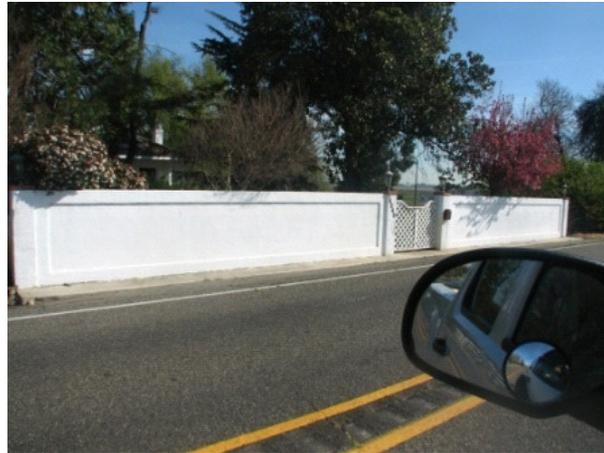
richard_s_20110215_063.jpg

Block/Concrete fence on landside shoulder at LM 10.13

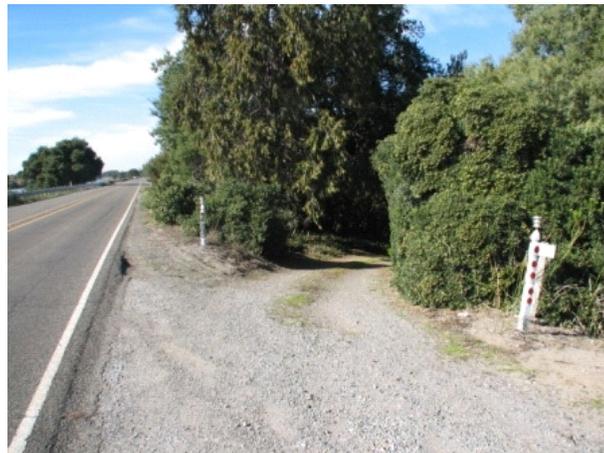
richard_s_20110215_067.jpg

Levee Mile Report Line	55
Start Levee Mile	10.74
End Levee Mile	10.74
Location	Land Side
Category	Earthen Levee
Item	Encroachments

Landscaping on levee slope and toe obstructs access and visibility.

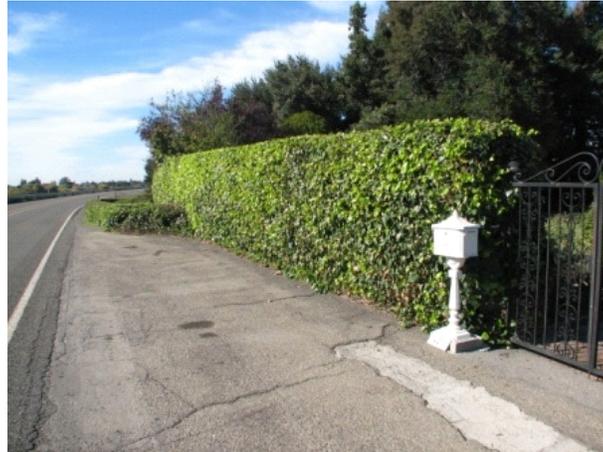
Levee Mile Report Line	56
Start Levee Mile	10.98
End Levee Mile	10.98
Location	Land Side
Category	Earthen Levee
Item	Encroachments
Landscaping on levee slope obstructs access and visibility.	
richard_s_20110215_068.jpg

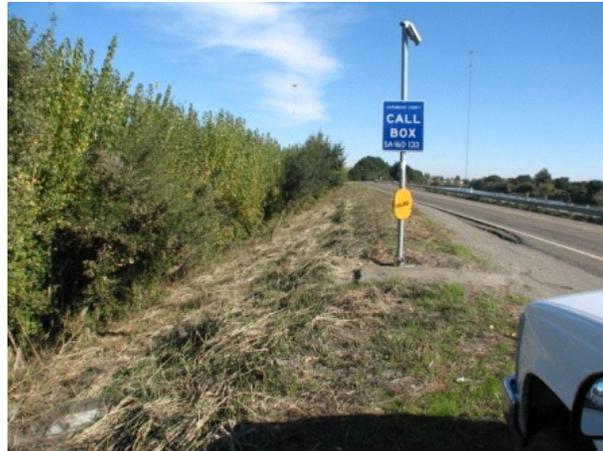
Levee Mile Report Line	58
Start Levee Mile	11.12
End Levee Mile	11.35
Location	Land Side
Category	Earthen Levee
Item	Encroachments
Landscaping trees on levee slope an toe obstruct access and visibility.	
richard_s_20110215_069.jpg

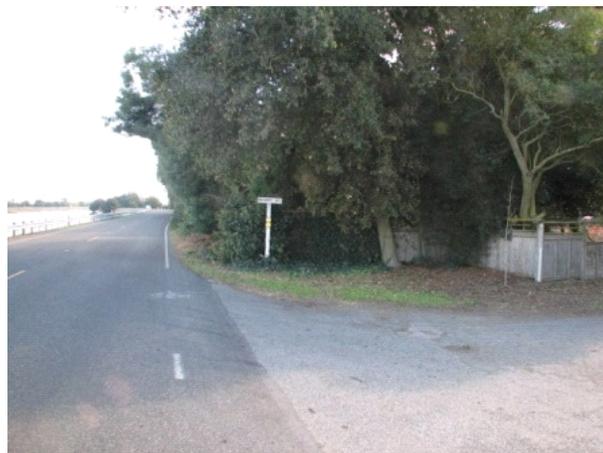
Levee Mile Report Line	75
Start Levee Mile	15.84
End Levee Mile	15.93
Location	Land Side
Category	Earthen Levee
Item	Encroachments
Landscaping on levee slope and toe obstruct access and visibility.	
richard_s_20110215_072.jpg

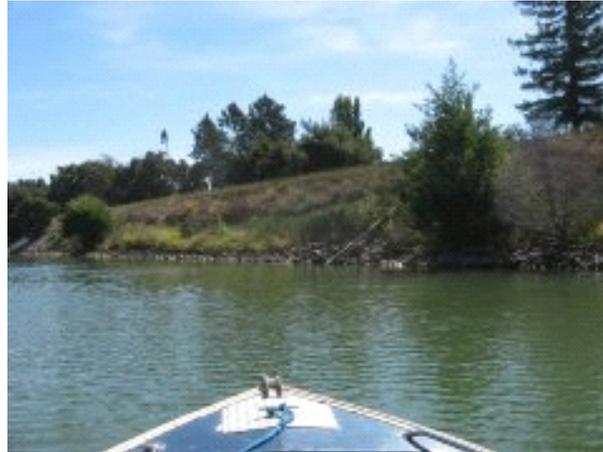
Levee Mile Report Line	77
Start Levee Mile	16.80
End Levee Mile	16.88
Location	Water Side
Category	Supplemental
Item	USACE Erosion Survey
2009: no berm, 1.5:1 slope, no stability issues, sands and silts, 5.23 ft/s [2009 SiteID:SAC_31-6_R]	
richard_s_20110215_064.JPG
