**Flood Control Project Maintenance
Levee Inspections**

Maintenance Issue Types Only, Levee Inspection Report By Mile - Fall 2015

Reclamation District No. 0003 Grand Island

Waterway	Bank	Unit Miles	Inspection Start/End	Inspector
Unit No. 01 Left Bank Steamboat Slough	Left	10.95	09/22/2015 09/22/2015	Richard Willoughby

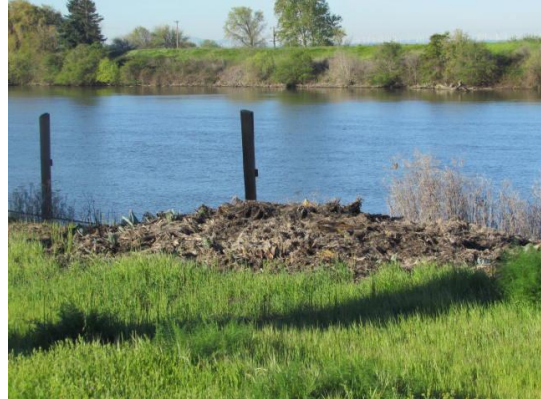
Photo 1 of 2 : FA_2015_RD0003_24_60_20150914_00047.jpg

LM Start	5.08	Rating **	A/W	Issue No.	60
LM End	5.08	Issue Type +	Ma	Location *	WS
Category	Earthen Levee			GPS Latitude/Longitude	
				Start	End
Item	Vegetation			38.242873 °	38.242873 °
				-121.600817 °	-121.600817 °
DWR ID	DWR_RD0003_01_s _ 2013_60				
Action/Comments					
Remove the wild growth other than native grasses from the levee slopes.					
Inspector Comments: Century plant on waterward slope.

Looking west at mowed/removed century plant on waterward slope.

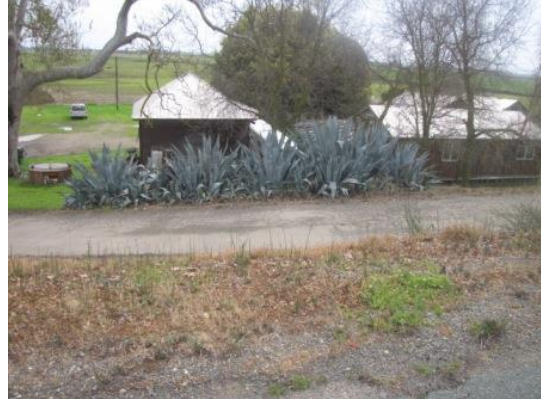
Photo 2 of 2 : FA_2015_RD0003_24_61_20150914_00050.jpg

LM Start	5.29	Rating **	U	Issue No.	61 (cont)
LM End	5.29	Issue Type +	Ma	Location *	LS
Category	Earthen Levee			GPS Latitude/Longitude	
				Start	End
Item	Vegetation			38.239886 °	38.239886 °
				-121.601752 °	-121.601752 °
DWR ID	DWR_RD0003_01_s _ 2012_61				
Action/Comments					
Remove the wild growth other than native grasses from the levee slopes.					
Inspector Comments: Century plant on landside slope next to ramp.

Looking west at century plants on landside slope next to ramp.

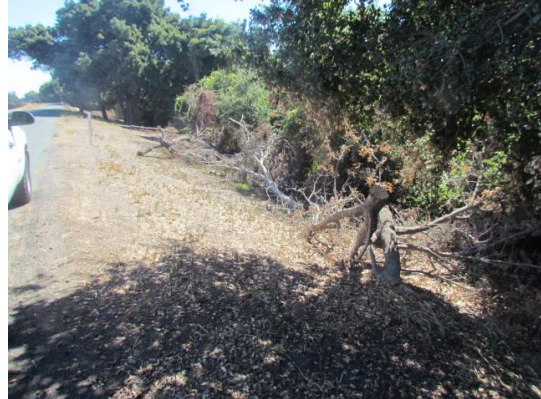
Photo 1 of 1 : FA_2015_RD0003_25_154_20150914_00085.jpg

LM Start	1.50	Rating **	A/W	Issue No.	154
LM End	1.50	Issue Type +	Ma	Location *	WS
Category	Earthen Levee			GPS Latitude/Longitude	
				Start	End
Item	Encroachments			38.169204 °	38.169204 °
				-121.628268 °	-121.628268 °
DWR ID	DWR_RD0003_02_f_2014_154				
Action/Comments					
Tree or limb					
Inspector Comments: Downed tree limbs on waterward slope.

Looking northeast at tree limbs on waterward slope.

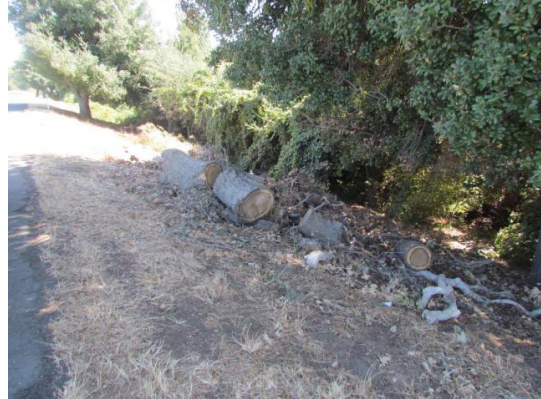
Photo 1 of 1 : FA_2015_RD0003_25_140_20150925_00100.jpg

LM Start	2.01	Rating **	M	Issue No.	140
LM End	2.01	Issue Type +	Ma	Location *	WS
Category	Earthen Levee			GPS Latitude/Longitude	
				Start	End
Item	Encroachments			38.165740 °	38.165740 °
				-121.619970 °	-121.619970 °
DWR ID	DWR_RD0003_02_f_2015_140				
Action/Comments					
Prunings					
Inspector Comments: Prunings piles on waterward slope.

Looking at tree branches and tree limbs on waterward shoulder and slope.

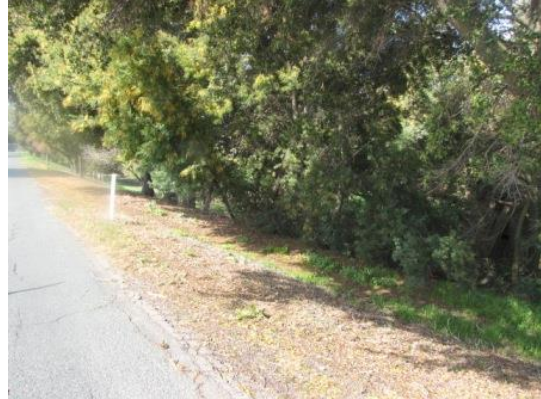
Photo 1 of 1 : FA_2015_RD0003_25_7_20150914_00007.jpg

LM Start	3.20	Rating **	A/W	Issue No.	7
LM End	3.20	Issue Type +	Ma	Location *	LS
Category	Earthen Levee			GPS Latitude/Longitude	
				Start	End
Item	Trim / Thin Trees			38.167808 °	38.167808 °
				-121.599557 °	-121.599557 °
DWR ID	DWR_RD0003_02_s _ 2012_7				
Action/Comments					
Trim trees to at least five feet above ground level.

Looking west at dense vegetation on landside slope and toe.

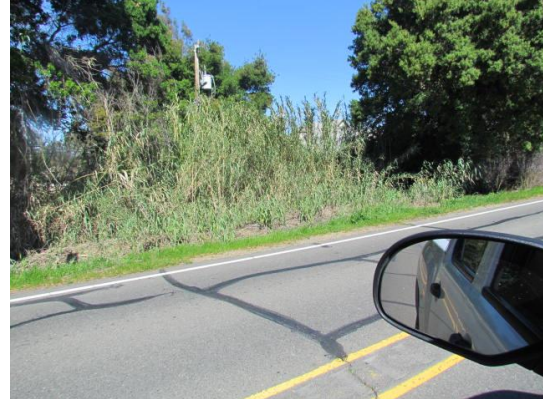
Photo 1 of 2 : FA_2015_RD0003_25_952_20150914_00096.jpg

LM Start	3.77	Rating **	M	Issue No.	952
LM End	3.77	Issue Type +	Ma	Location *	LS
Category	Earthen Levee			GPS Latitude/Longitude	
				Start	End
Item	Vegetation			38.174430 °	38.174430 °
				-121.593372 °	-121.593372 °
DWR ID	DWR_RD0003_02_s _ 2012_952				
Action/Comments					
Remove the wild growth other than native grasses from the levee slopes.					
Inspector Comments: Dense bamboo on landward slope.

Looking northwest at bamboo on landside slope.

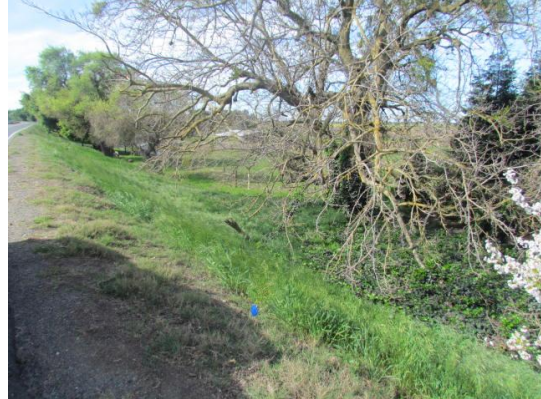
Photo 1 of 1 : FA_2015_RD0003_25_10_20150914_00010.jpg

LM Start	4.24	Rating **	M	Issue No.	10
LM End	4.24	Issue Type +	Ma	Location *	LS
Category	Earthen Levee			GPS Latitude/Longitude	
				Start	End
Item	Trim / Thin Trees			38.180361 °	38.180361 °
				-121.589127 °	-121.589127 °
DWR ID	DWR_RD0003_02_s_2012_10				
Action/Comments					
Trim trees to at least five feet above ground level.

Looking west at untrimmed tree on landward slope.

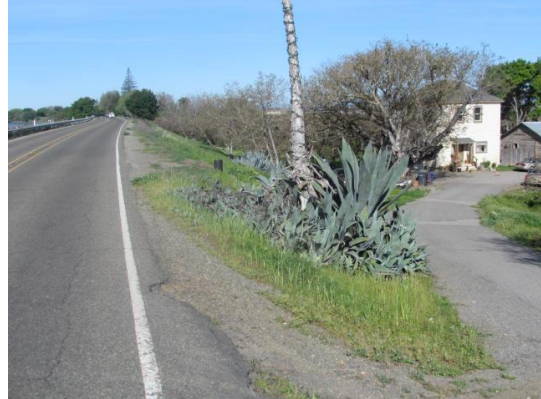
Photo 1 of 2 : FA_2015_RD0003_25_81_20150914_00065.jpg

Looking west at century plant on landward slope. (Spring 2015)

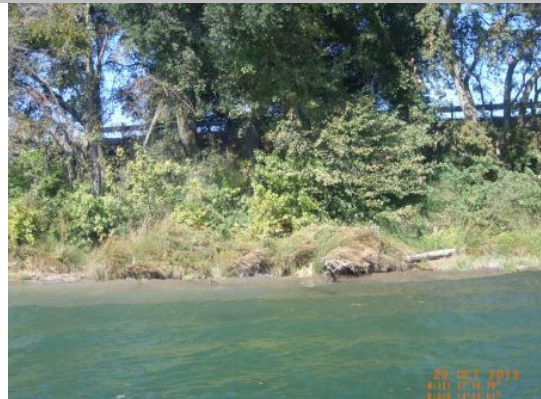
Photo 1 of 2 : USACE2013A_SAC_26-3_R_5.jpg

LM Start	11.33	Rating **	M	Issue No.	1
LM End	11.42	Issue Type +	Ma	Location *	WS
Category	Supplemental			GPS Latitude/Longitude	
				Start	End
Item	2015 USACE Erosion Survey, DRAFT			38.239870 °	38.239983 °
				-121.520989 °	-121.519361 °
DWR ID					
Action/Comments					
Inspector Comments: 2009 - Hole left in levee toe from a fallen tree. Could be repaired under maintenance. 2010 - Minor new erosion. 2015: Minor new erosion at toe. [2015 Site ID: SAC_26-3_R]

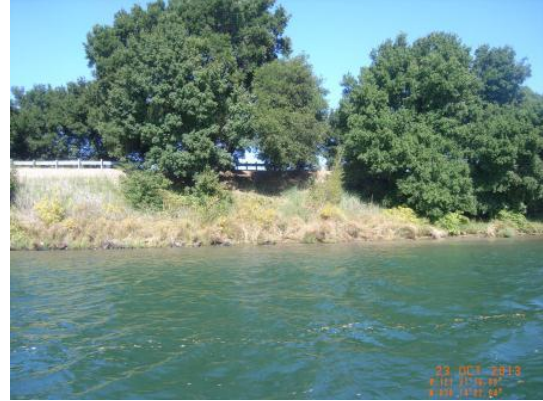
Photo 2 of 2 : USACE2013A_SAC_26-3_R_8.jpg

LM Start	11.33	Rating **	M	Issue No.	1 (cont)
LM End	11.42	Issue Type +	Ma	Location *	WS
Category	Supplemental			GPS Latitude/Longitude	
				Start	End
Item	2015 USACE Erosion Survey, DRAFT			38.239870 °	38.239983 °
				-121.520989 °	-121.519361 °
DWR ID					
Action/Comments					
Inspector Comments: 2009 - Hole left in levee toe from a fallen tree. Could be repaired under maintenance. 2010 - Minor new erosion. 2015: Minor new erosion at toe. [2015 Site ID: SAC_26-3_R]

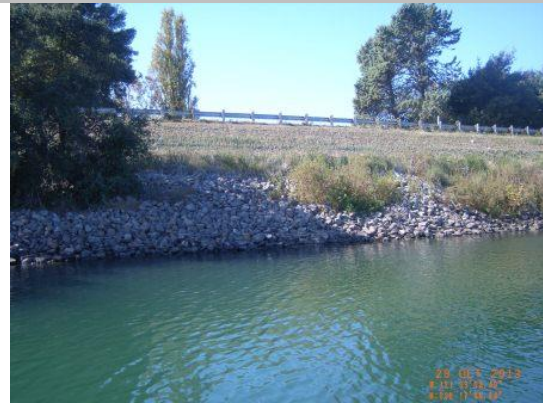
Photo 1 of 1 : USACE2013A_SAC_31-6_R_5.jpg

LM Start	16.54	Rating **	M	Issue No.	20
LM End	16.63	Issue Type +	Ma	Location *	WS
Category	Supplemental			GPS Latitude/Longitude	
				Start	End
Item	2015 USACE Erosion Survey, DRAFT			38.294757 °	38.295730 °
				-121.565376 °	-121.566295 °
DWR ID					
Action/Comments					
Inspector Comments: 1997 - Erosion of supper sandy levee material above the water line, straight reach. 1999 - Small pocket repaired with rock. 2005 - Downstream 400 ft have been repaired. 2011 - Site is overgrown with vegetation. 2015: Site appears stable, may consider removal if no change after the next large storm event. [2015 Site ID: SAC_31-6_R]
