**Flood Control Project Maintenance  
Levee Inspections**

## Maintenance Issue Types Only, Levee Inspection Report By Mile - Fall 2016

### Reclamation District No. 0003 Grand Island

Waterway	Bank	Unit Miles	Inspection Start/End	Inspector
Unit No. 01 Left Bank Steamboat Slough	Left	10.95	09/27/2016 09/27/2016	Richard Willoughby

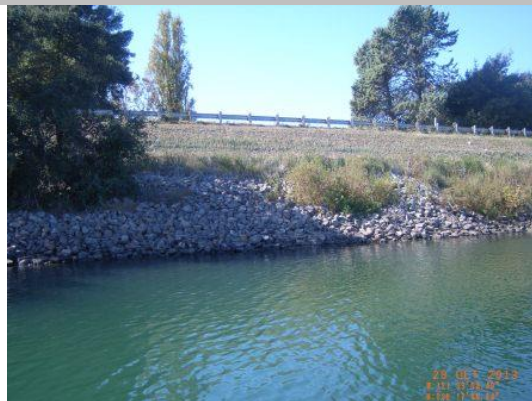
Photo 1 of 1 : FA\_2016\_RD0003\_25\_20\_20160915\_00027.jpg

LM Start	16.54	Rating **	M	Issue No.	20
LM End	16.63	Issue Type +	Ma	Location *	WS
Category	Supplemental			GPS Latitude/Longitude	
				Start	End
Item	2015 USACE Erosion Survey, DRAFT			38.294757°	38.295730°
				-121.565376°	-121.566295°
DWR ID	DWR_RD0003_02_s_2016_20				
Comment Code					
Inspector Comment					
1997 - Erosion of supper sandy levee material above the water line, straight reach. 1999 - Small pocket repaired with rock. 2005 - Downstream 400 ft have been repaired. 2011 - Site is overgrown with vegetation. 2015: Site appears stable, may consider removal if no change after the next large storm event. [2015 Site ID: SAC_31-6_R]

USACE 2013 Photo #1

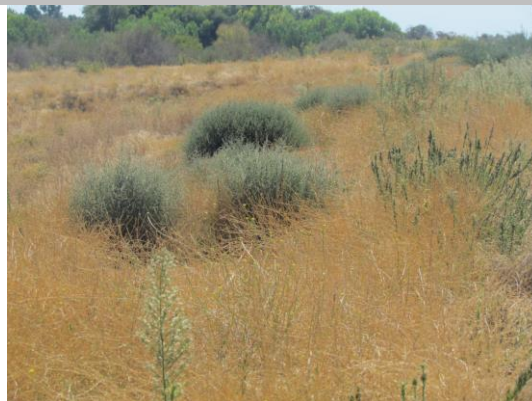
Photo 1 of 1 : FA\_2016\_RD0003\_610\_2\_20160929\_00007.jpg

LM Start	0.00	Rating **	M	Issue No.	2
LM End	0.43	Issue Type +	Ma	Location *	LS
Category	Earthen Levee			GPS Latitude/Longitude	
				Start	End
Item	Vegetation			38.182300°	38.176041°
				-121.653499°	-121.653739°
DWR ID	DWR_RD0003_03_f_2016_2				
Comment Code					
V2 : Remove the wild growth other than native grasses from the levee slopes.					
Inspector Comment

Looking east at typical view of landward slope.

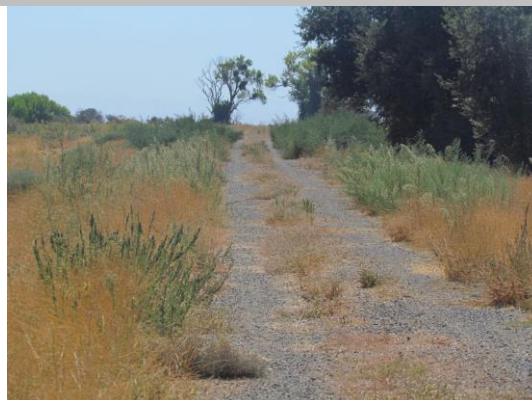
Photo 1 of 1 : FA\_2016\_RD0003\_610\_8\_20160929\_00006.jpg

LM Start	0.00	Rating **	M	Issue No.	8
LM End	0.43	Issue Type +	Ma	Location *	WS
Category	Earthen Levee			GPS Latitude/Longitude	
				Start	End
Item	Vegetation			38.182300 °	38.176041 °
				-121.653501 °	-121.653739 °
DWR ID	DWR_RD0003_03_f_2016_8				
Comment Code					
V2 : Remove the wild growth other than native grasses from the levee slopes.					
Inspector Comment

Looking east at typical view of levee slopes.
