**Flood Control Project Maintenance
Levee Inspections**

Maintenance Issue Types Only, Levee Inspection Report By Mile - Fall 2017

Reclamation District No. 0003 Grand Island

Waterway	Bank	Unit Miles	Inspection Start/End	Inspector
Unit No. 01 Left Bank Steamboat Slough	Left	10.95	09/18/2017 09/18/2017	Dave Torres

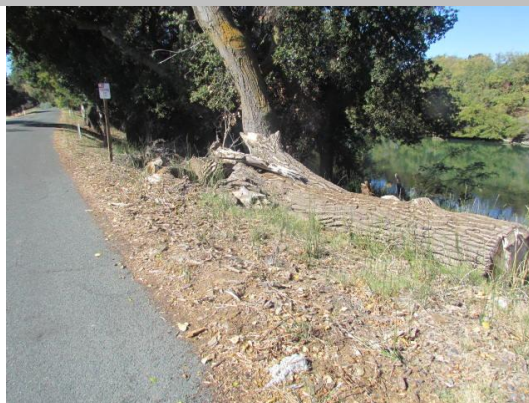
Photo 3 of 4 : FA_2017_RD0003_24_19_20170911_00024.jpg

Looking west at tree branch on waterward shoulder and slope. (Fall 2014)

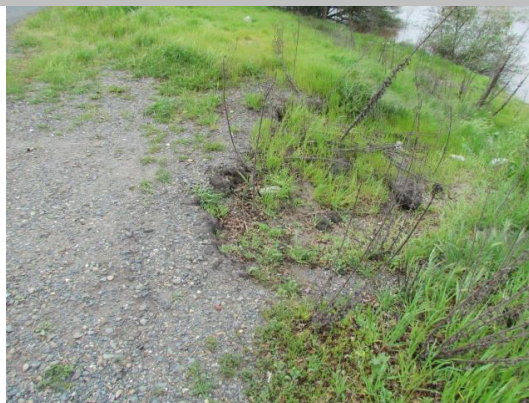
Photo 1 of 2 : FA_2017_RD0003_24_65_20170911_00053.jpg

LM Start	0.98	Rating **	M	Issue No.	65
LM End	0.98	Issue Type +	Ma	Location *	WS
Category	Earthen Levee			GPS Latitude/Longitude	
				Start	End
Item	Slope Stability			38.292392 °	38.292392 °
				-121.582717 °	-121.582717 °
DWR ID	DWR_RD0003_01_f_2015_65				
Comment Code					
S2 : Repair the levee slope damaged by foot traffic and prevent access where possible.					
Inspector Comment					
Waterward levee damage caused by foot traffic.

Looking west at foot erosion on waterward slope (Spring 2016)

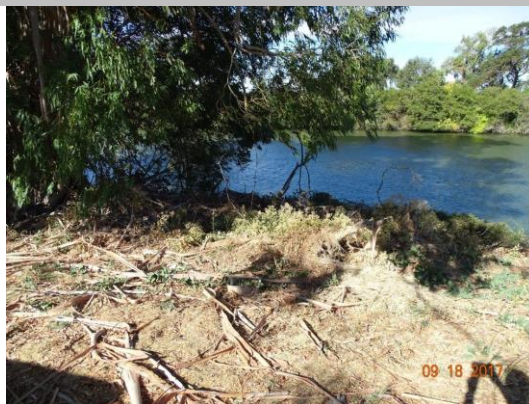
Photo 1 of 1 : FA_2017_RD0003_24_82_20170929_00175.jpg

LM Start	2.66	Rating **	M	Issue No.	82
LM End	2.66	Issue Type +	Ma	Location *	WS
Category	Earthen Levee			GPS Latitude/Longitude	
				Start	End
Item	Encroachments			38.271128 °	38.271128 °
				-121.588634 °	-121.588634 °
DWR ID	DWR_RD0003_01_f_2017_82				
Comment Code					
TR : Tree or limb					
Inspector Comment

Looking southwest at waterside slope.

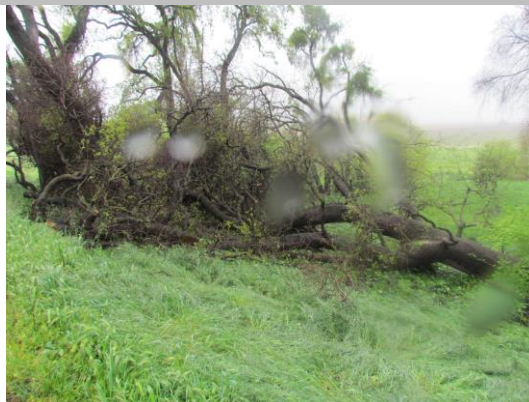
Photo 1 of 2 : FA_2017_RD0003_24_58_20170911_00048.jpg

LM Start	5.46	Rating **	U	Issue No.	58
LM End	5.46	Issue Type +	Ma	Location *	LS
Category	Earthen Levee			GPS Latitude/Longitude	
				Start	End
Item	Encroachments			38.237515 °	38.237515 °
				-121.602225 °	-121.602225 °
DWR ID	DWR_RD0003_01_s_2017_58				
Comment Code					
TR : Tree or limb					
Inspector Comment					
Downed tree with large root ball on landward slope.

Looking east at fallen tree on landward slope and toe.

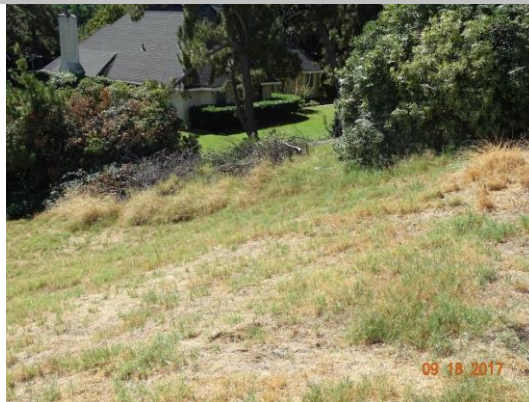
Photo 1 of 2 : FA_2017_RD0003_24_94_20170929_00180.jpg

LM Start	8.39	Rating **	M	Issue No.	94
LM End	8.39	Issue Type +	Ma	Location *	LS
Category	Earthen Levee			GPS Latitude/Longitude	
				Start	End
Item	Encroachments			38.197202 °	38.197202 °
				-121.612962 °	-121.612962 °
DWR ID	DWR_RD0003_01_s_2013_94				
Comment Code					
PR : Prunings					
Inspector Comment					
Prunings on landward slope.

Looking south at landside slope.

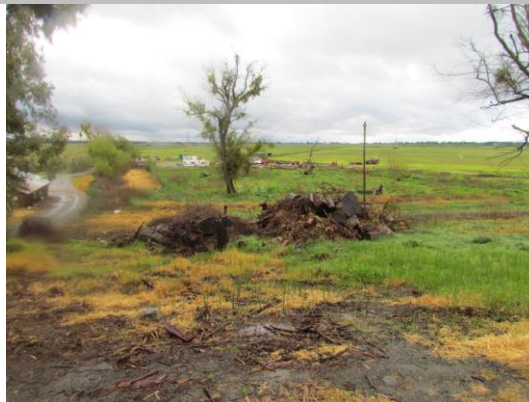
Photo 1 of 1 : FA_2017_RD0003_24_59_20170911_00050.jpg

LM Start	8.88	Rating **	M	Issue No.	59
LM End	8.88	Issue Type +	Ma	Location *	LS
Category	Earthen Levee			GPS Latitude/Longitude	
				Start	End
Item	Encroachments			38.193217 °	38.193217 °
				-121.620050 °	-121.620050 °
DWR ID	DWR_RD0003_01_s_2017_59				
Comment Code					
PR : Prunings					
Inspector Comment					
Pruning pile on landward slope

Looking east at pruning piles on landward berm.

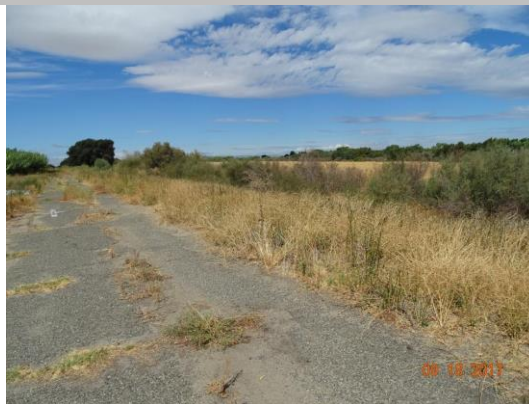
Photo 1 of 2 : FA_2017_RD0003_25_151_20171009_00274.jpg

LM Start	0.31	Rating **	U	Issue No.	151
LM End	0.35	Issue Type +	Ma	Location *	LS
Category	Earthen Levee			GPS Latitude/Longitude	
				Start	End
Item	Vegetation			38.174235 °	38.174109 °
				-121.648479 °	-121.647870 °
DWR ID	DWR_RD0003_02_s_2016_151				
Comment Code					
V2 : Remove the wild growth other than native grasses from the levee slopes.					
Inspector Comment

Looking west at landside slope.

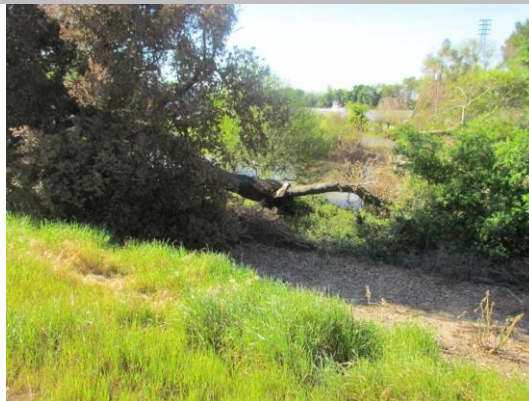
Photo 2 of 3 : FA_2017_RD0003_25_129_20170911_00088.jpg

LM Start	1.57	Rating **	U	Issue No.	129 (cont)	
LM End	1.57	Issue Type +	Ma	Location *	WS	
Category	Earthen Levee			GPS Latitude/Longitude		
				Start	End	
Item	Encroachments			38.168700 °	38.168700 °	
				-121.627233 °	-121.627233 °	
DWR ID	DWR_RD0003_02_s_2017_129					
Comment Code						
TR : Tree or limb						
Inspector Comment						
Large fallen tree on waterside slope.

Looking east at fallen tree on waterward slope.

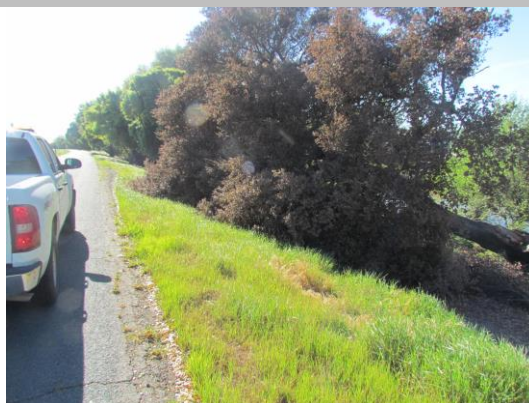
Photo 3 of 3 : FA_2017_RD0003_25_129_20170911_00089.jpg

Looking northeast at fallen tree on waterward slope.

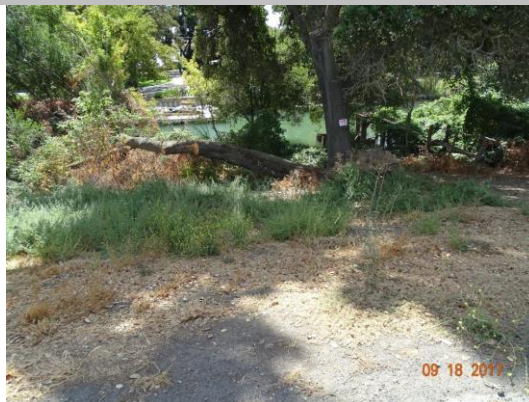
Photo 1 of 3 : FA_2017_RD0003_25_130_20171009_00278.jpg

LM Start	1.67	Rating **	M	Issue No.	130
LM End	1.67	Issue Type +	Ma	Location *	WS
Category	Earthen Levee			GPS Latitude/Longitude	
				Start	End
Item	Encroachments			38.167880 °	38.167880 °
				-121.625572 °	-121.625572 °
DWR ID	DWR_RD0003_02_s_2017_130				
Comment Code					
TR : Tree or limb					
Inspector Comment					
Fallen tree on waterside slope.

Looking south at the waterside slope.

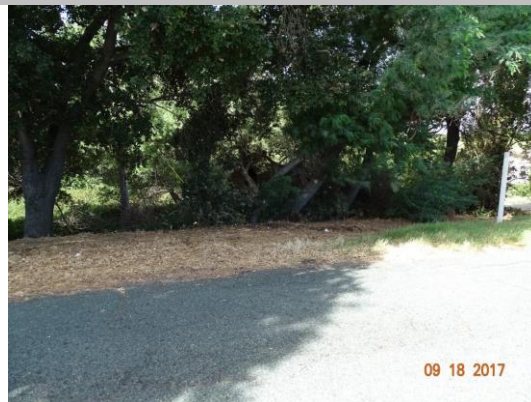
Photo 1 of 2 : FA_2017_RD0003_25_7_20171009_00282.jpg

LM Start	3.20	Rating **	M	Issue No.	7
LM End	3.20	Issue Type +	Ma	Location *	LS
Category	Earthen Levee			GPS Latitude/Longitude	
				Start	End
Item	Trim / Thin Trees			38.167808 °	38.167808 °
				-121.599557 °	-121.599557 °
DWR ID	DWR_RD0003_02_s_2012_7				
Comment Code					
T1 : Trim trees to at least five feet above ground level.					
Inspector Comment					
Dense vegetation on landside slope and toe.

Looking northwest at the landside slope.

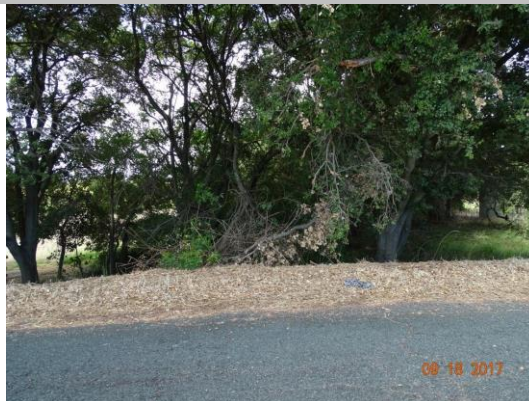
Photo 1 of 1 : FA_2017_RD0003_25_154_20171009_00283.jpg

LM Start	3.30	Rating **	U	Issue No.	154
LM End	3.30	Issue Type +	Ma	Location *	LS
Category	Earthen Levee			GPS Latitude/Longitude	
				Start	End
Item	Encroachments			38.168750 °	38.168750 °
				-121.598152 °	-121.598152 °
DWR ID	DWR_RD0003_02_f_2017_154				
Comment Code					
TR : Tree or limb					
Inspector Comment					
Downed tree on landside slope.

Looking northwest at the landside slope.

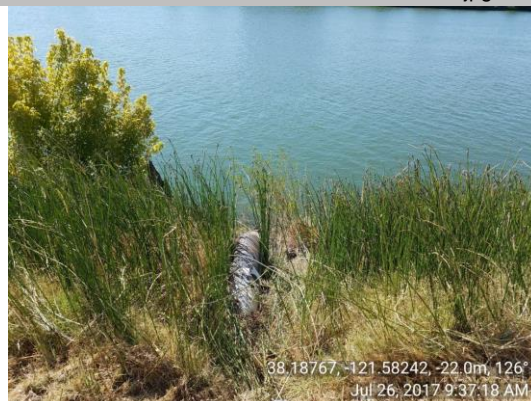
Photo 1 of 3 : LEVAL_FA_2017_278_2362.jpg

LM Start	4.86	Rating **	A/W	Issue No.	127
LM End	4.87	Issue Type +	Ma	Location *	
Category	Supplemental			GPS Latitude/Longitude	
				Start	End
Item	2017 Storm Damage			38.187528 °	38.187781 °
				-121.582394 °	-121.582331 °
DWR ID	DWR_RD0003_02_f_2017_127				
Comment Code					
Inspector Comment					
Levee Evaluation Comments					
Description:District station 256+60 to 257+96, Sec. 19, T. 4 N. R. 4 E., M.D.M. Approximately 136 linear feet erosion and sloughing exists along the water side slope of the Sacramento River (Unit 2). The erosion commences approximately 1/4 of the way down the slope from the crown and extends to the rip rap.					
Site ID No:278					
Site Designation:LMA-104					
Repair Type: Erosion					
Rating:Area of Concern					
Field Date:7/26/2017					
Notes:

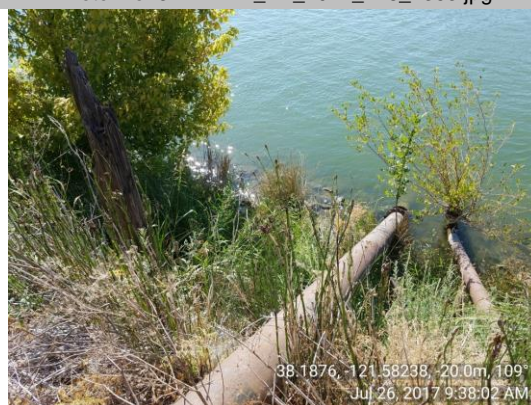
Photo 2 of 3 : LEVAL_FA_2017_278_2363.jpg

LM Start	4.86	Rating **	A/W	Issue No.	127 (cont)
LM End	4.87	Issue Type +	Ma	Location *

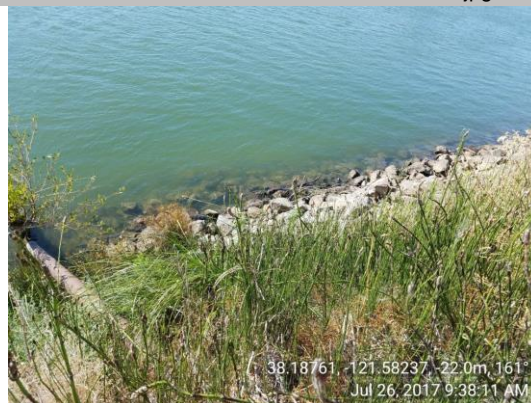
Photo 3 of 3 : LEVAL_FA_2017_278_2364.jpg

LM Start	4.86	Rating **	A/W	Issue No.	127 (cont)	
LM End	4.87	Issue Type +	Ma	Location *		
Category	Supplemental			GPS Latitude/Longitude		
				Start	End	
Item	2017 Storm Damage			38.187528 °	38.187781 °	
				-121.582394 °	-121.582331 °	
DWR ID	DWR_RD0003_02_f_2017_127					
Comment Code						
Inspector Comment						
Levee Evaluation Comments						
Description:District station 256+60 to 257+96, Sec. 19, T. 4 N. R. 4 E., M.D.M. Approximately 136 linear feet erosion and sloughing exists along the water side slope of the Sacramento River (Unit 2). The erosion commences approximately 1/4 of the way down the slope from the crown and extends to the rip rap.						
Site ID No:278						
Site Designation:LMA-104						
Repair Type: Erosion						
Rating:Area of Concern						
Field Date:7/26/2017						
Notes:

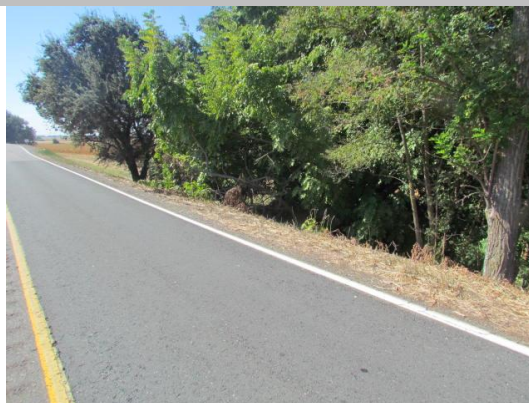
Photo 2 of 2 : FA_2017_RD0003_25_14_20170911_00021.jpg

LM Start	4.94	Rating **	U	Issue No.	14 (cont)	
LM End	4.98	Issue Type +	Ma	Location *	LS	
Category	Earthen Levee			GPS Latitude/Longitude		
				Start		End
Item	Trim / Thin Trees			38.188344 °		38.188748 °
				-121.581414 °		-121.580743 °
DWR ID	DWR_RD0003_02_s_2012_14					
Comment Code						
T2 : Thin trees to allow visibility of the ground and room to flood fight.						
Inspector Comment						
Dense untrimmed trees on landside slope and toe.

Looking southwest at untrimmed trees on landward toe. (Spring 2016)

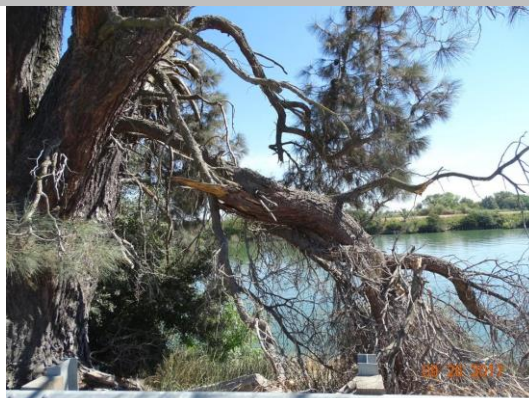
Photo 1 of 1 : FA_2017_RD0003_25_162_20171009_00284.jpg

LM Start	8.11	Rating **	U	Issue No.	162
LM End	8.11	Issue Type +	Ma	Location *	WS
Category	Earthen Levee			GPS Latitude/Longitude	
				Start	End
Item	Encroachments			38.224110 °	38.224110 °
				-121.557216 °	-121.557216 °
DWR ID	DWR_RD0003_02_f_2017_162				
Comment Code					
TR : Tree or limb					
Inspector Comment

Looking east at the waterside slope.

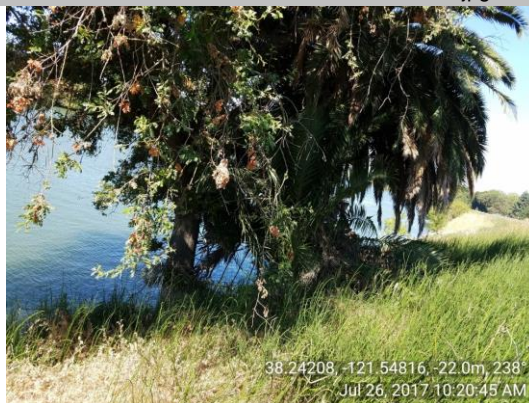
Photo 1 of 3 : LEVAL_FA_2017_279_2371.jpg

LM Start	9.82	Rating **	A/W	Issue No.	137
LM End	9.84	Issue Type +	Ma	Location *	
Category	Supplemental			GPS Latitude/Longitude	
				Start	End
Item	2017 Storm Damage			38.242006 °	38.241950 °
				-121.548117 °	-121.547681 °
DWR ID	DWR_RD0003_02_f_2017_137				
Comment Code					
Inspector Comment					
Levee Evaluation Comments Description: District station 518+55 to 519+81 , Sec. 33, T. 5 N. R. 4 E., M.D.M. Approximately 126 linear feet of erosion and sloughing exists along the water side slope of the Sacramento River (Unit 2). The erosion commences approximately 1/4 of the way down the slope from the crown and extends into the rip rap. Site ID No: 279 Site Designation: LMA-105 Repair Type: Erosion Rating: Area of Concern Field Date: 7/26/2017 Notes:

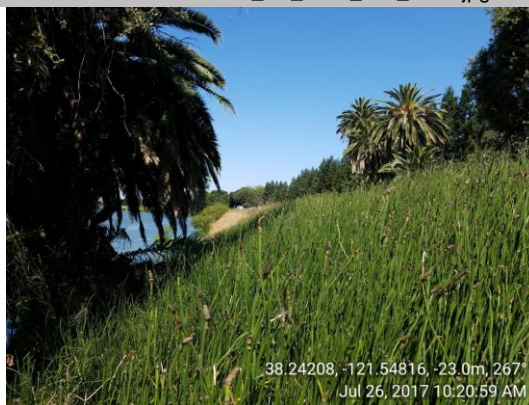
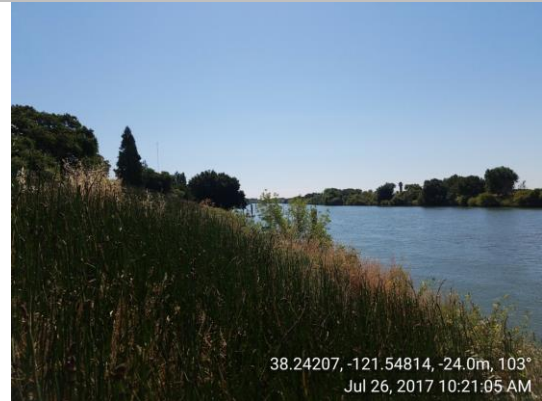
Photo 2 of 3 : LEVAL_FA_2017_279_2372.jpg

LM Start	9.82	Rating **	A/W	Issue No.	137 (cont)
LM End	9.84	Issue Type +	Ma	Location *	
Category	Supplemental		GPS Latitude/Longitude		
			Start	End	
Item	2017 Storm Damage		38.242006 °	38.241950 °	
			-121.548117 °	-121.547681 °	
DWR ID	DWR_RD0003_02_f_2017_137				
Comment Code					
Inspector Comment					
<p>Levee Evaluation Comments</p> <p>Description: District station 518+55 to 519+81, Sec. 33, T. 5 N. R. 4 E., M.D.M. Approximately 126 linear feet of erosion and sloughing exists along the water side slope of the Sacramento River (Unit 2). The erosion commences approximately 1/4 of the way down the slope from the crown and extends into the rip rap.</p> <p>Site ID No: 279</p> <p>Site Designation: LMA-105</p> <p>Repair Type: Erosion</p> <p>Rating: Area of Concern</p> <p>Field Date: 7/26/2017</p> <p>Notes:</p>

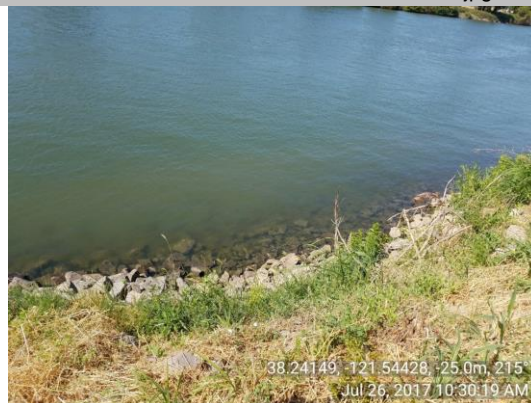
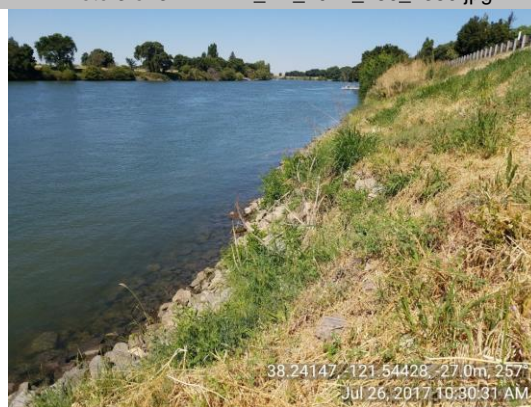
Photo 2 of 3 : LEVAL_FA_2017_280_2379.jpg

LM Start	10.01	Rating **	A/W	Issue No.	138 (cont)	
LM End	10.03	Issue Type +	Ma	Location *		
Category	Supplemental			GPS Latitude/Longitude		
				Start	End	
Item	2017 Storm Damage			38.241481 °	38.241439 °	
				-121.544569 °	-121.544353 °	
DWR ID	DWR_RD0003_02_f_2017_138					
Comment Code						
Inspector Comment						
Levee Evaluation Comments						
Description: District station 528+97 to 529+58, Sec. 33, T. 5 N. R. 4 E., M.D.M. Approximately 61 linear feet of erosion and sloughing exists along the water side slope of the Sacramento River (Unit 2). The erosion commences approximately 1/2 of the way down the slope from the crown and extends into the rip rap.						
Site ID No: 280						
Site Designation: LMA-106						
Repair Type: Erosion						
Rating: Area of Concern						
Field Date: 7/26/2017						
Notes:

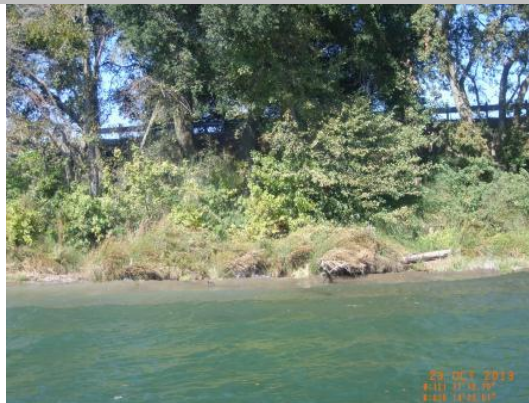
Photo 1 of 2 : FA_2017_RD0003_25_1_20170911_00001.jpg

LM Start	11.33	Rating **	M	Issue No.	1
LM End	11.42	Issue Type +	Ma	Location *	WS
Category	Supplemental			GPS Latitude/Longitude	
				Start	End
Item	2015 USACE Erosion Survey, DRAFT			38.239870 °	38.239983 °
				-121.520989 °	-121.519361 °
DWR ID	DWR_RD0003_02_s_2016_1				
Comment Code					
Inspector Comment					
2009 - Hole left in levee toe from a fallen tree. Could be repaired under maintenance. 2010 - Minor new erosion. 2015: Minor new erosion at toe. [2015 Site ID: SAC_26-3_R]

USACE 2013 Photo #1

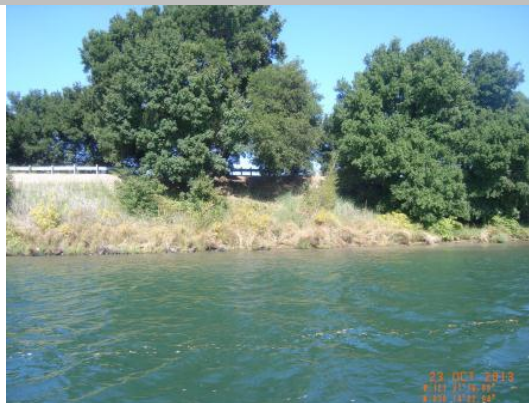
Photo 2 of 2 : FA_2017_RD0003_25_1_20170911_00002.jpg

USACE 2013 Photo #2

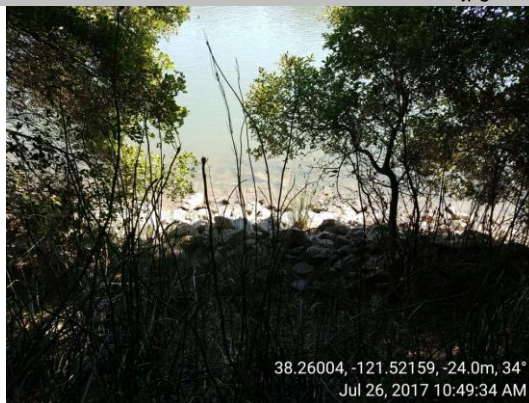
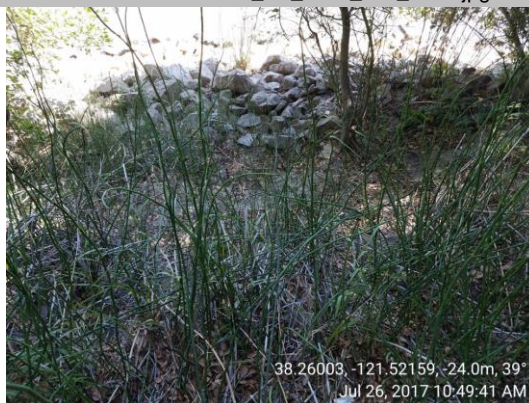
Photo 1 of 3 : LEVAL_FA_2017_281_2381.jpg

LM Start	13.15	Rating **	A/W	Issue No.	139
LM End	13.17	Issue Type +	Ma	Location *	
Category	Supplemental			GPS Latitude/Longitude	
				Start	End
Item	2017 Storm Damage			38.260042 °	38.260219 °
				-121.521581 °	-121.521803 °
DWR ID	DWR_RD0003_02_f_2017_139				
Comment Code					
Inspector Comment					
Levee Evaluation Comments					
Description: District station 694+80 to 695+69, Sec. 27, 1. 5 N. R. 4 E., M.D.M. Approximately 89 linear feet of erosion and sloughing exists along the water side slope of the Sacramento River (Unit 2). The erosion commences approximately 1/2 of the way down the slope from the crown and extends into the rip rap.					
Site ID No: 281					
Site Designation: LMA-107					
Repair Type: Erosion					
Rating: Area of Concern					
Field Date: 7/26/2017					
Notes:

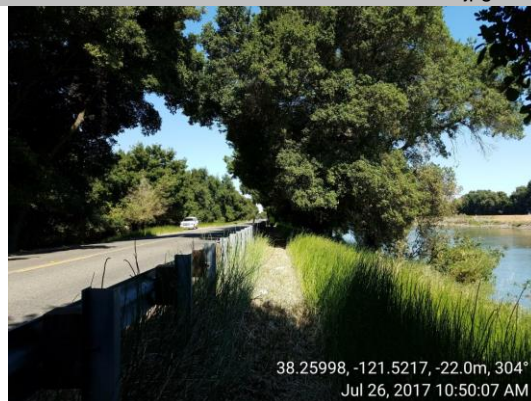
Photo 3 of 3 : LEVAL_FA_2017_281_2384.jpg

LM Start	13.15	Rating **	A/W	Issue No.	139 (cont)	
LM End	13.17	Issue Type +	Ma	Location *		
Category	Supplemental			GPS Latitude/Longitude		
				Start	End	
Item	2017 Storm Damage			38.260042 °	38.260219 °	
				-121.521581 °	-121.521803 °	
DWR ID	DWR_RD0003_02_f_2017_139					
Comment Code						
Inspector Comment						
Levee Evaluation Comments						
Description: District station 694+80 to 695+69, Sec. 27, 1. 5 N. R. 4 E., M.D.M. Approximately 89 linear feet of erosion and sloughing exists along the water side slope of the Sacramento River (Unit 2). The erosion commences approximately 1/2 of the way down the slope from the crown and extends into the rip rap.						
Site ID No: 281						
Site Designation: LMA-107						
Repair Type: Erosion						
Rating: Area of Concern						
Field Date: 7/26/2017						
Notes:

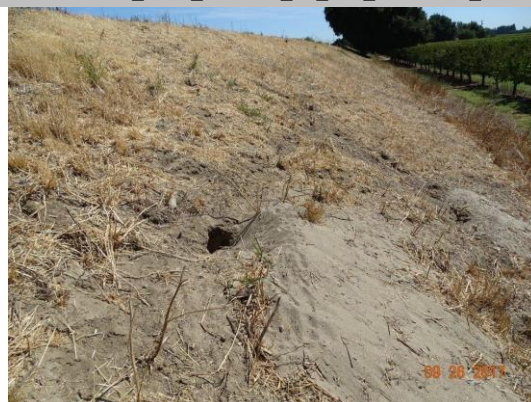
Photo 1 of 1 : FA_2017_RD0003_25_169_20171009_00289.jpg

Looking southeast at the landside slope.

LM Start	13.86	Rating **	M	Issue No.	169
LM End	13.86	Issue Type +	Ma	Location *	LS
Category	Earthen Levee			GPS Latitude/Longitude	
				Start	End
Item	Animal Control			38.267084 °	38.267084 °
				-121.530939 °	-121.530939 °
DWR ID	DWR_RD0003_02_f_2017_169				
Comment Code					
A1 : Exterminate rodents and backfill and compact or grout burrows.					
Inspector Comment

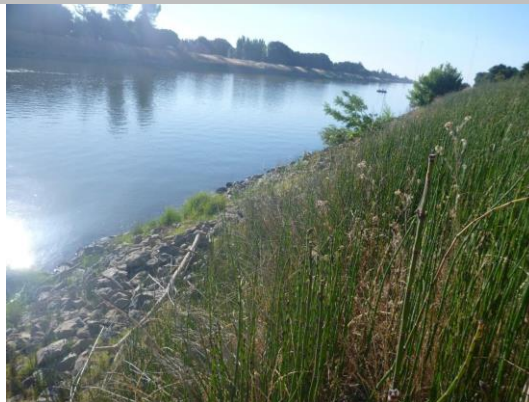
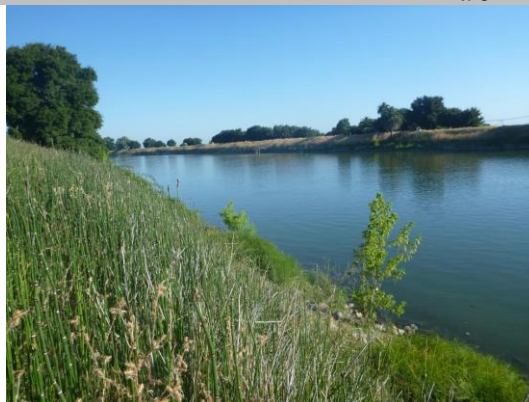
Photo 1 of 3 : LEVAL_FA_2017_282_2408.jpg

LM Start	15.00	Rating **	A/W	Issue No.	142
LM End	15.07	Issue Type +	Ma	Location *	
Category	Supplemental			GPS Latitude/Longitude	
				Start	End
Item	2017 Storm Damage			38.278806 °	38.279444 °
				-121.545817 °	-121.546647 °
DWR ID	DWR_RD0003_02_f_2017_142				
Comment Code					
Inspector Comment					
Levee Evaluation Comments					
Description:District station 792+44 to 795+74, Sec. 16, T. 5 N. R. 4 E., M.D.M. Approximately 330 linear feet of erosion and sloughing exists along the water side slope of the Sacramento River (Unit 2). The erosion commences approximately 1/2 of the way down the slope from the crown and extends into the rip rap.					
Site ID No:282					
Site Designation:LMA-108					
Repair Type: Erosion					
Rating:Area of Concern					
Field Date:7/28/2017					
Notes: no berm

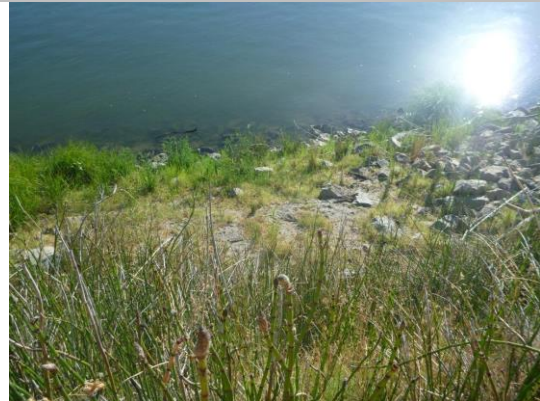
Photo 3 of 3 : LEVAL_FA_2017_282_2410.jpg

LM Start	15.00	Rating **	A/W	Issue No.	142 (cont)	
LM End	15.07	Issue Type +	Ma	Location *		
Category	Supplemental			GPS Latitude/Longitude		
				Start	End	
Item	2017 Storm Damage			38.278806 °	38.279444 °	
				-121.545817 °	-121.546647 °	
DWR ID	DWR_RD0003_02_f_2017_142					
Comment Code						
Inspector Comment						
Levee Evaluation Comments						
Description: District station 792+44 to 795+74, Sec. 16, T. 5 N. R. 4 E., M.D.M. Approximately 330 linear feet of erosion and sloughing exists along the water side slope of the Sacramento River (Unit 2). The erosion commences approximately 1/2 of the way down the slope from the crown and extends into the rip rap.						
Site ID No: 282						
Site Designation: LMA-108						
Repair Type: Erosion						
Rating: Area of Concern						
Field Date: 7/28/2017						
Notes: no berm

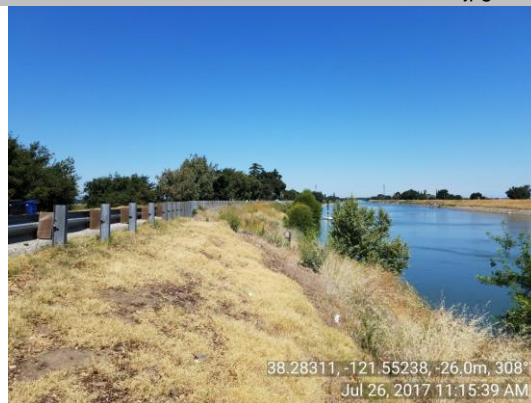
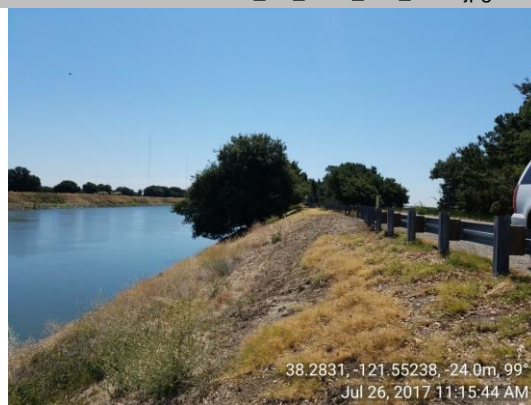
Photo 2 of 3 : LEVAL_FA_2017_283_2389.jpg

LM Start	15.46	Rating **	A/W	Issue No.	149 (cont)
LM End	15.47	Issue Type +	Ma	Location *	
Category	Supplemental			GPS Latitude/Longitude	
				Start	End
Item	2017 Storm Damage			38.283119 °	38.283172 °
				-121.552250 °	-121.552347 °
DWR ID	DWR_RD0003_02_f_2017_149				
Comment Code					
Inspector Comment					
Levee Evaluation Comments					
Description:District station 816+64 to 816+97, Sec. 16, T. 5 N. R. 4 E., M.D.M. Approximately 33 linear feet of erosion exists along the water side slope of the Sacramento River (Unit 2). The erosion commences approximately 1/2 ofthe way down the slope from the crown and extends into the rip rap. A section of rip rap has eroded away in this location.					
Site ID No:283					
Site Designation:LMA-109					
Repair Type: Erosion					
Rating:Area of Concern					
Field Date:7/26/2017					
Notes:

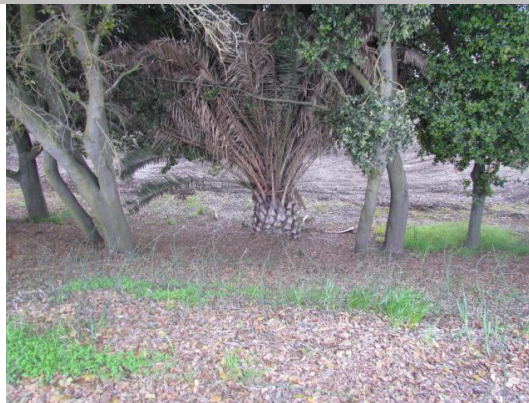
Photo 1 of 1 : FA_2017_RD0003_25_95_20170911_00080.jpg

LM Start	15.70	Rating **	U	Issue No.	95
LM End	15.70	Issue Type +	Ma	Location *	LS
Category	Earthen Levee			GPS Latitude/Longitude	
				Start	End
Item	Vegetation			38.285347 °	38.285347 °
				-121.555534 °	-121.555534 °
DWR ID	DWR_RD0003_02_s_2013_95				
Comment Code					
V7 : Trees / Woody Vegetation					
Inspector Comment					
Palm tree on landside slope and toe.

Looking west at Palm tree at landward toe.

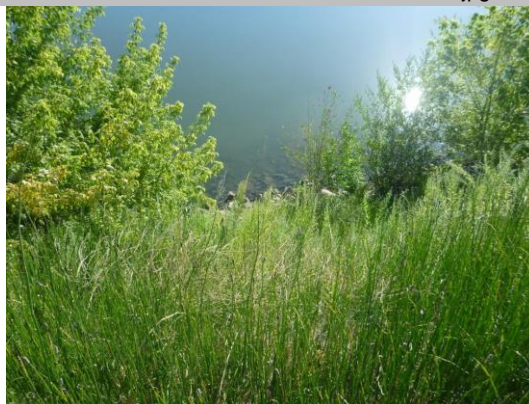
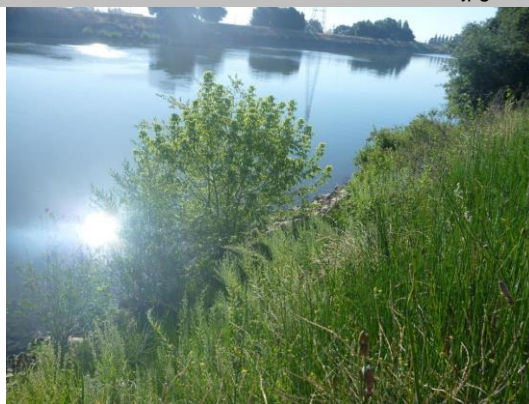
Photo 1 of 2 : LEVAL_FA_2017_284_2413.jpg

LM Start	16.54	Rating **	A/W	Issue No.	150
LM End	16.56	Issue Type +	Ma	Location *	
Category	Supplemental			GPS Latitude/Longitude	
				Start	End
Item	2017 Storm Damage			38.294717 °	38.294986 °
				-121.565417 °	-121.565661 °
DWR ID	DWR_RD0003_02_f_2017_150				
Comment Code					
Inspector Comment					
Levee Evaluation Comments					
Description:District station 873+61 to 874+83, Sec. 08, T. 5 N. R. 4 E., M.D.M. Approximately 122 linear feet of erosion exists along the water side slope of the Sacramento River (Unit 2). The erosion commences approximately 1/2 of the way down the slope from the crown and extends beyond the rip rap. A section of rip rap has eroded away in this location.					
Site ID No:284					
Site Designation:LMA-110					
Repair Type: Erosion					
Rating:Area of Concern					
Field Date:7/28/2017					
Notes: no berm

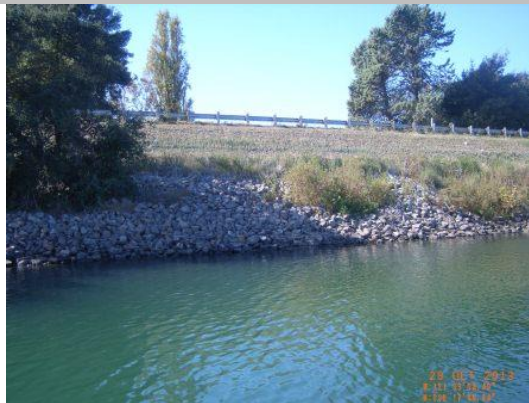
Photo 1 of 1 : FA_2017_RD0003_25_20_20170911_00026.jpg

LM Start	16.54	Rating **	A/W	Issue No.	20
LM End	16.63	Issue Type +	Ma	Location *	WS
Category	Supplemental			GPS Latitude/Longitude	
				Start	End
Item	2015 USACE Erosion Survey, DRAFT			38.294757 °	38.295730 °
				-121.565376 °	-121.566295 °
DWR ID	DWR_RD0003_02_s _ 2016_20				
Comment Code					
Inspector Comment					
1997 - Erosion of supper sandy levee material above the water line, straight reach. 1999 - Small pocket repaired with rock. 2005 - Downstream 400 ft have been repaired. 2011 - Site is overgrown with vegetation. 2015: Site appears stable, may consider removal if no change after the next large storm event. [2015 Site ID: SAC_31-6_R]

USACE 2013 Photo #1

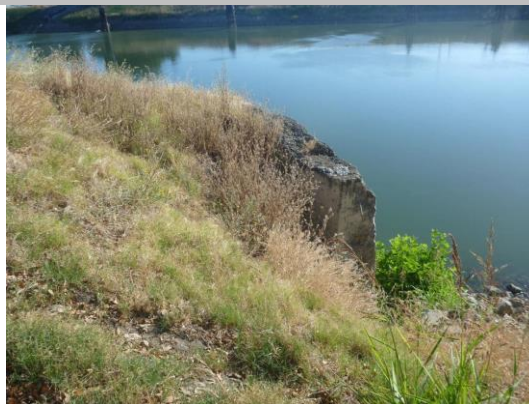
Photo 1 of 3 : LEVAL_FA_2017_285_2419.jpg

LM Start	16.90	Rating **	A/W	Issue No.	152
LM End	16.90	Issue Type +	Ma	Location *	
Category	Supplemental			GPS Latitude/Longitude	
				Start	End
Item	2017 Storm Damage			38.298914 °	38.298997 °
				-121.569156 °	-121.569217 °
DWR ID	DWR_RD0003_02_f_2017_152				
Comment Code					
Inspector Comment					
Levee Evaluation Comments					
Description:District station 892+36 to 892+70, Sec. 08, T. 5 N. R. 4 E., M.D.M. Approximately 34 linear feet of erosion exists along the water side slope of the Sacramento River (Unit 2). The erosion commences approximately 1/2 of the way down the slope from the crown and extends into the rip rap. A section of rip rap has eroded away in this location.					
Site ID No:285					
Site Designation:LMA-111					
Repair Type: Erosion					
Rating:Area of Concern					
Field Date:7/28/2017					
Notes: highway on crown

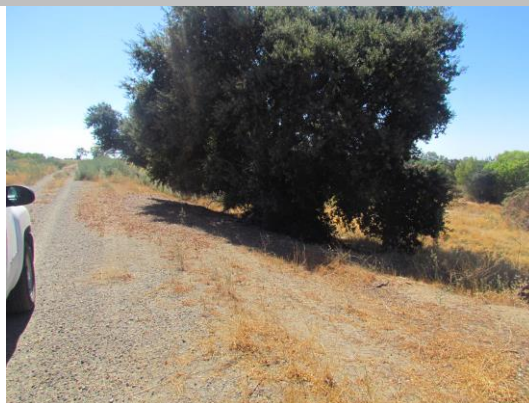
Photo 1 of 1 : FA_2017_RD0003_610_5_20170911_00002.jpg

LM Start	0.15	Rating **	M	Issue No.	5
LM End	0.18	Issue Type +	Ma	Location *	WS
Category	Earthen Levee			GPS Latitude/Longitude	
				Start	End
Item	Trim / Thin Trees			38.180150 °	38.179722 °
				-121.653645 °	-121.653663 °
DWR ID	DWR_RD0003_03_s_2013_5				
Comment Code					
T1 : Trim trees to at least five feet above ground level.					
Inspector Comment					
Untrimmed trees on waterward slope.

Looking southeast at untrimmed trees on waterward slope and toe.
