**Flood Control Project Maintenance
Levee Inspections**

Maintenance Issue Types Only, Levee Inspection Report By Mile - Fall 2018

Reclamation District No. 0003 Grand Island

Waterway	Bank	Unit Miles	Inspection Start/End	Inspector
Unit No. 01 Left Bank Steamboat Slough	Left	10.95	10/16/2018 10/16/2018	David Julian

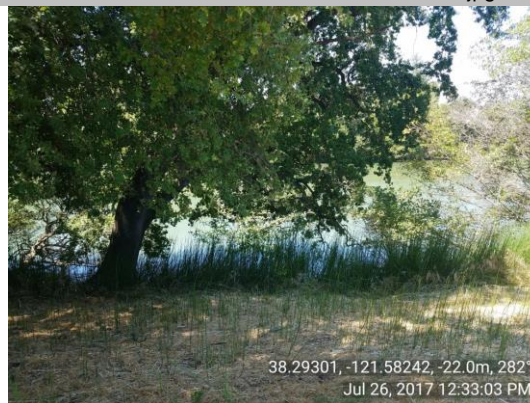
Photo 2 of 3 : LEVAL_FA_2018_275_2398.jpg

LM Start	0.91	Rating **	A/W	Issue No.	53
LM End	0.97	Issue Type +	Ma	Location *	
Category	Supplemental			GPS Latitude/Longitude	
				Start	End
Item	2017 Storm Damage			38.293381 °	38.292617 °
				-121.582450 °	-121.582675 °
DWR ID	DWR_RD0003_01_s_2018_53				
Comment Code					
Inspector Comment					
Levee Evaluation Comments					
Description: District station 48+20 to 51+06, Sec. 07, T. 5 N. R. 4 E., M.D.M. An erosion site exists along approximately 286 linear feet of the water side slope of Steamboat Slough (Unit 1). The erosion begins approximately 1/2 of the way down the slope from the crown to the waterside toe. Erosion is undercutting existing trees.					
Site ID No: 275					
Site Designation: LMA-101					
Repair Type: Erosion					
Rating: Serious					
Field Date: 7/26/2017					
Notes:

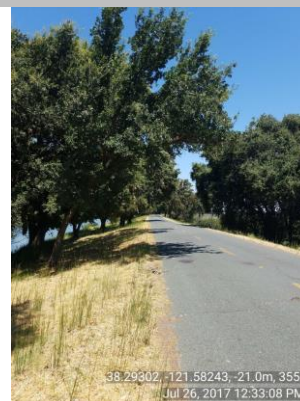
Photo 3 of 3 : LEVAL_FA_2018_275_2399.jpg

LM Start	0.91	Rating **	A/W	Issue No.	53 (cont)	
LM End	0.97	Issue Type +	Ma	Location *		
Category	Supplemental			GPS Latitude/Longitude		
				Start	End	
Item	2017 Storm Damage			38.293381 °	38.292617 °	
				-121.582450 °	-121.582675 °	
DWR ID	DWR_RD0003_01_s_2018_53					
Comment Code						
Inspector Comment						
Levee Evaluation Comments						
Description: District station 48+20 to 51+06, Sec. 07, T. 5 N. R. 4 E., M.D.M. An erosion site exists along approximately 286 linear feet of the water side slope of Steamboat Slough (Unit 1). The erosion begins approximately 1/2 of the way down the slope from the crown to the waterside toe. Erosion is undercutting existing trees.						
Site ID No: 275						
Site Designation: LMA-101						
Repair Type: Erosion						
Rating: Serious						
Field Date: 7/26/2017						
Notes:

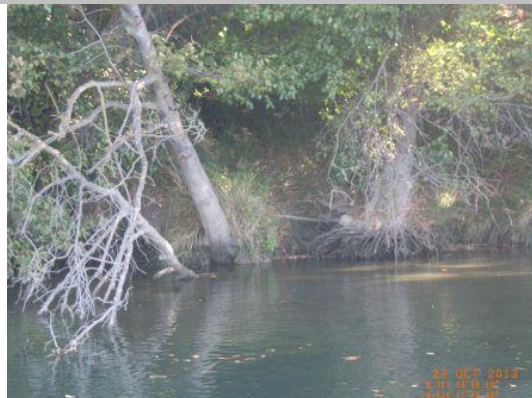
Photo 2 of 2 : FA_2018_RD0003_24_56_20181023_00167.jpg

LM Start	1.03	Rating **	U	Issue No.	56 (cont)	
LM End	1.18	Issue Type +	Ma	Location *	WS	
Category	Supplemental			GPS Latitude/Longitude		
				Start		End
Item	2017 USACE Erosion Survey, DRAFT			38.291695 °		38.289575 °
				-121.582993 °		-121.583092 °
DWR ID	DWR_RD0003_01_f_2018_56					
Comment Code						
Inspector Comment						
2017 Site ID: STM 24.8 L						
Status: Eroding						
2018: Pockets of erosion that are deep into the levee toe that I would consider critical (Djulian).						
2017 Field Notes: New erosion at toe.						
Site History: 2008 - Area closed sign on bank. Newly fallen trees at both ends and pop outs along the bank. 2010 - Site extended downstream. 2011 - New erosion at the toe. More trees popouts.						
2013 - Short vertical sections observed at the downstream end.

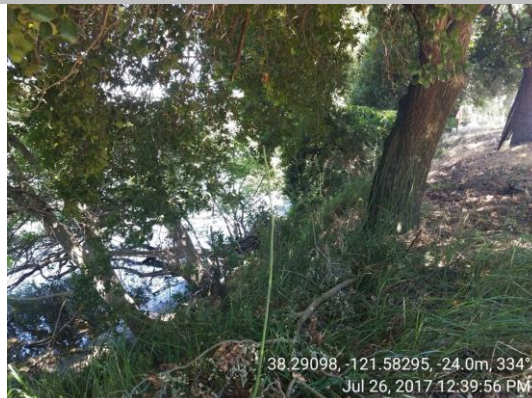
Photo 2 of 3 : FA_2018_RD0003_24_60_20180925_00045.jpg

LM Start	1.09	Rating **	A/W	Issue No.	60 (cont)	
LM End	1.10	Issue Type +	Ma	Location *		
Category	Supplemental			GPS Latitude/Longitude		
				Start	End	
Item	2017 Storm Damage			38.290819 °	38.290706 °	
				-121.582942 °	-121.582939 °	
DWR ID	DWR_RD0003_01_f _ 2017_60					
Comment Code						
Inspector Comment						
Levee Evaluation Comments						
Description: District station 57+57 to 57+98, Sec. 18, 1. 5 N. R. 4 E., M.D.M. An erosion site exists along approximately 41 linear feet of the water side slope of Steamboat Slough (Unit 1). The erosion commences approximately 1/2 of the way down the slope from the crown to the waterside toe.						
Site ID No: 276						
Site Designation: LMA-102						
Repair Type: Erosion						
Rating: Area of Concern						
Field Date: 7/26/2017						
Notes:

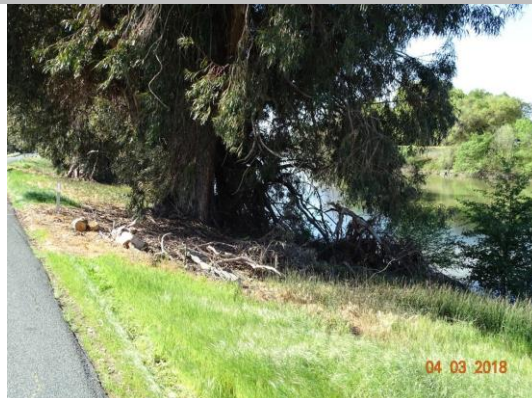
Photo 1 of 1 : FA_2018_RD0003_24_54_20180925_00039.jpg

LM Start	1.91	Rating **	M	Issue No.	54
LM End	1.91	Issue Type +	Ma	Location *	WS
Category	Earthen Levee			GPS Latitude/Longitude	
				Start	End
Item	Encroachments			38.280638 °	38.280638 °
				-121.588457 °	-121.588457 °
DWR ID	DWR_RD0003_01_s_2018_54				
Comment Code					
TR : Tree or limb					
Inspector Comment					
Remove tree trimmings.

Cut branches on waterside slope.

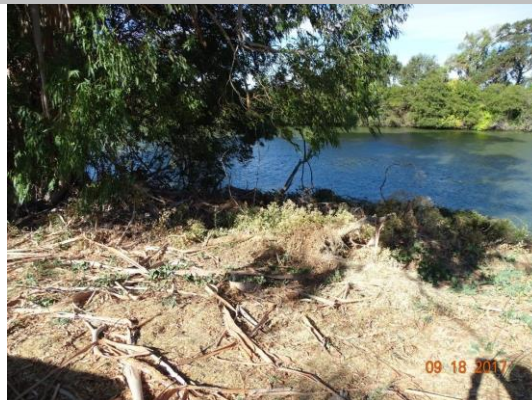
Photo 1 of 1 : FA_2018_RD0003_24_82_20180925_00070.jpg

LM Start	2.66	Rating **	M	Issue No.	82
LM End	2.66	Issue Type +	Ma	Location *	WS
Category	Earthen Levee			GPS Latitude/Longitude	
				Start	End
Item	Encroachments			38.271128 °	38.271128 °
				-121.588634 °	-121.588634 °
DWR ID	DWR_RD0003_01_f_2017_82				
Comment Code					
TR : Tree or limb					
Inspector Comment					
Tree limbs should be removed water side slope.

Looking southwest at waterside slope.

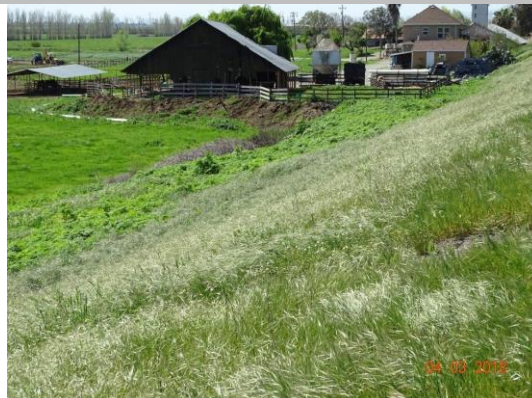
Photo 1 of 1 : FA_2018_RD0003_24_86_20180925_00073.jpg

LM Start	6.85	Rating **	M	Issue No.	86
LM End	6.92	Issue Type +	Ma	Location *	LS
Category	Earthen Levee			GPS Latitude/Longitude	
				Start	End
Item	Vegetation			38.217905 °	38.217060 °
				-121.603158 °	-121.603717 °
DWR ID	DWR_RD0003_01_s_2018_86				
Comment Code					
V2 : Remove the wild growth other than native grasses from the levee slopes.					
Inspector Comment					
Dense vegetation along landside toe.

Dense vegetation along landside toe prevents inspection and access (Spring 2018).

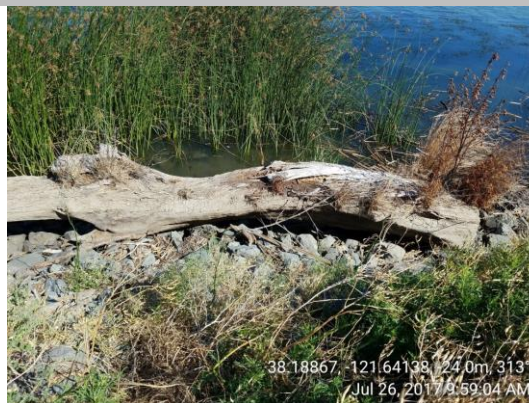
Photo 2 of 3 : FA_2018_RD0003_24_72_20180925_00057.jpg

LM Start	10.15	Rating **	A/W	Issue No.	72	
LM End	10.21	Issue Type +	Ma	Location *		
Category	Supplemental			GPS Latitude/Longitude		
				Start	End	
Item	2017 Storm Damage			38.188431 °	38.187803 °	
				-121.641703 °	-121.642478 °	
DWR ID	DWR_RD0003_01_f_2017_72					
Comment Code						
Inspector Comment						
Levee Evaluation Comments						
Description:District station 536+35 to 539+47, Sec. 16, T. 4 N. R. 3 E., M.D.M. The waterside slope experienced sloughing and erosion along approximately 312 linear feet of Steamboat Slough (Unit 1). Sloughing commences at approximately 1/4 ofthe way down the slope from the crown and extends to the rip rap.						
Site ID No:277						
Site Designation:LMA-103						
Repair Type: Erosion						
Rating:Area of Concern						
Field Date:7/26/2017						
Notes:

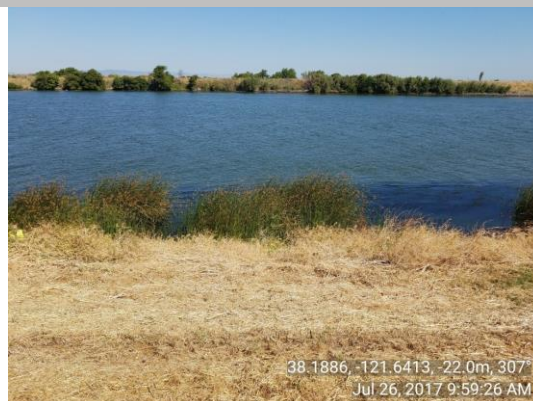
Photo 3 of 3 : FA_2018_RD0003_24_72_20180925_00058.jpg

LM Start	10.15	Rating **	A/W	Issue No.	72 (cont)
LM End	10.21	Issue Type +	Ma	Location *	
Category	Supplemental			GPS Latitude/Longitude	
				Start	End
Item	2017 Storm Damage			38.188431°	38.187803°
				-121.641703°	-121.642478°
DWR ID	DWR_RD0003_01_f_2017_72				
Comment Code					
Inspector Comment					
<p>Levee Evaluation Comments</p> <p>Description: District station 536+35 to 539+47, Sec. 16, T. 4 N. R. 3 E., M.D.M. The waterside slope experienced sloughing and erosion along approximately 312 linear feet of Steamboat Slough (Unit 1). Sloughing commences at approximately 1/4 of the way down the slope from the crown and extends to the rip rap.</p> <p>Site ID No: 277</p> <p>Site Designation: LMA-103</p> <p>Repair Type: Erosion</p> <p>Rating: Area of Concern</p> <p>Field Date: 7/26/2017</p> <p>Notes:</p>

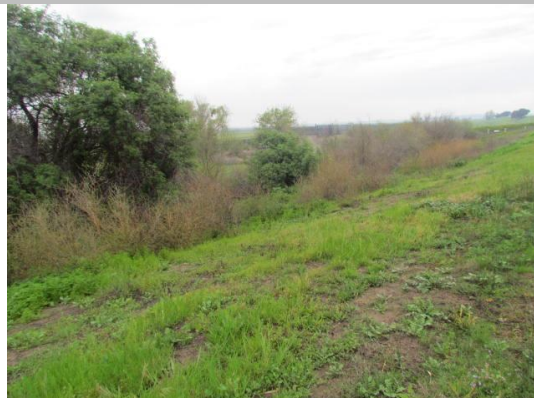
Photo 2 of 2 : FA_2018_RD0003_25_151_20180925_00126.jpg

LM Start	0.31	Rating **	U	Issue No.	151 (cont)
LM End	0.35	Issue Type +	Ma	Location *	LS
Category	Earthen Levee			GPS Latitude/Longitude	
				Start	End
Item	Vegetation			38.174235 °	38.174109 °
				-121.648479 °	-121.647870 °
DWR ID	DWR_RD0003_02_s_2016_151				
Comment Code					
V2 : Remove the wild growth other than native grasses from the levee slopes.					
Inspector Comment					
Remove young willows along landside toe.

Looking west at dense vegetation at landward toe.

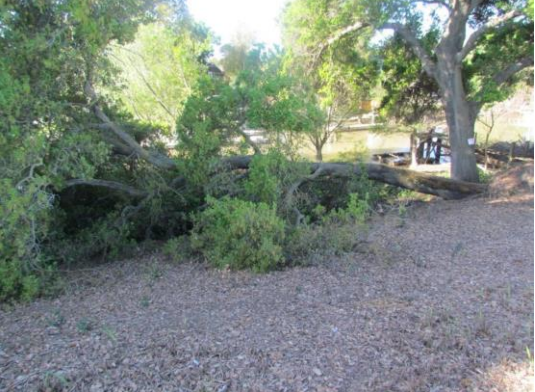
Photo 3 of 3 : FA_2018_RD0003_25_130_20180925_00093.jpg

Looking south at fallen tree on waterward slope.

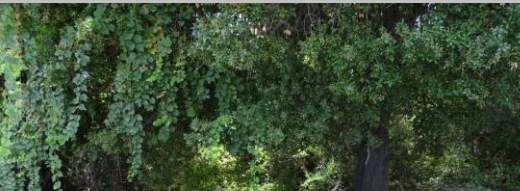
Photo 1 of 2 : FA_2018_RD0003_25_140_20180925_00108.jpg

Looking south at the waterside slope.

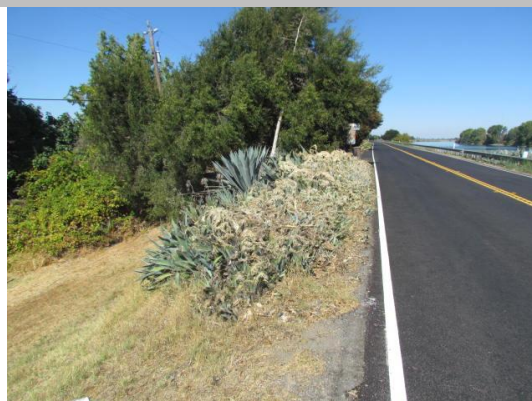
Photo 1 of 1 : FA_2018_RD0003_25_143_20180925_00114.jpg

LM Start	4.11	Rating **	U	Issue No.	143
LM End	4.11	Issue Type +	Ma	Location *	LS
Category	Earthen Levee			GPS Latitude/Longitude	
				Start	End
Item	Vegetation			38.178782 °	38.178782 °
				-121.590418 °	-121.590418 °
DWR ID	DWR_RD0003_02_f_2015_143				
Comment Code					
V7 : Trees / Woody Vegetation					
Inspector Comment					
Large century plants on landside shoulder and slope.

Looking north at century plants on landward shoulder and slope.

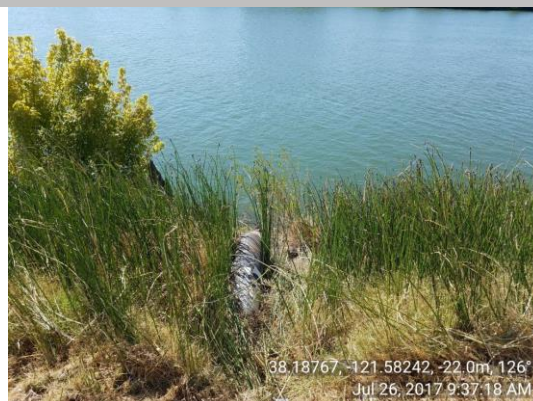
Photo 1 of 3 : FA_2018_RD0003_25_127_20180925_00086.jpg

LM Start	4.86	Rating **	A/W	Issue No.	127
LM End	4.87	Issue Type +	Ma	Location *	
Category	Supplemental			GPS Latitude/Longitude	
				Start	End
Item	2017 Storm Damage			38.187528°	38.187781°
				-121.582394°	-121.582331°
DWR ID	DWR_RD0003_02_f_2017_127				
Comment Code					
Inspector Comment					
Levee Evaluation Comments					
Description: District station 256+60 to 257+96, Sec. 19, T. 4 N. R. 4 E., M.D.M. Approximately 136 linear feet erosion and sloughing exists along the water side slope of the Sacramento River (Unit 2). The erosion commences approximately 1/4 of the way down the slope from the crown and extends to the rip rap.					
Site ID No: 278					
Site Designation: LMA-104					
Repair Type: Erosion					
Rating: Area of Concern					
Field Date: 7/26/2017					
Notes:

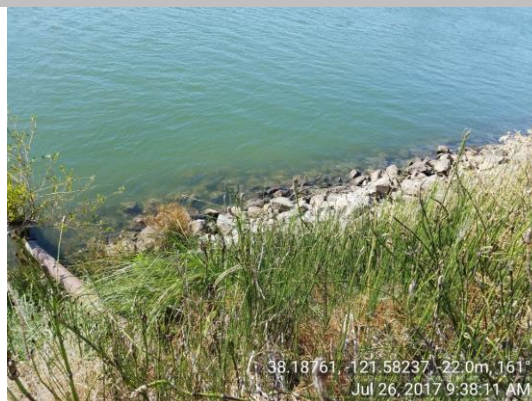
Photo 3 of 3 : FA_2018_RD0003_25_127_20180925_00088.jpg

LM Start	4.86	Rating **	A/W	Issue No.	127 (cont)	
LM End	4.87	Issue Type +	Ma	Location *		
Category	Supplemental			GPS Latitude/Longitude		
				Start	End	
Item	2017 Storm Damage			38.187528 °	38.187781 °	
				-121.582394 °	-121.582331 °	
DWR ID	DWR_RD0003_02_f_2017_127					
Comment Code						
Inspector Comment						
Levee Evaluation Comments						
Description: District station 256+60 to 257+96, Sec. 19, T. 4 N. R. 4 E., M.D.M. Approximately 136 linear feet erosion and sloughing exists along the water side slope of the Sacramento River (Unit 2). The erosion commences approximately 1/4 of the way down the slope from the crown and extends to the rip rap.						
Site ID No: 278						
Site Designation: LMA-104						
Repair Type: Erosion						
Rating: Area of Concern						
Field Date: 7/26/2017						
Notes:

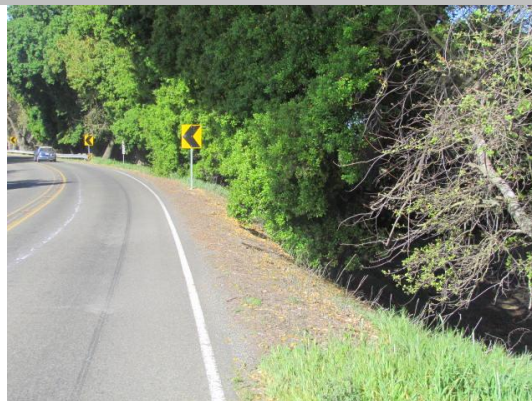
Photo 1 of 1 : FA_2018_RD0003_25_64_20180925_00046.jpg

LM Start	9.56	Rating **	M	Issue No.	64
LM End	9.62	Issue Type +	Ma	Location *	LS
Category	Earthen Levee			GPS Latitude/Longitude	
				Start	End
Item	Trim / Thin Trees			38.242392°	38.242501°
				-121.552862°	-121.551632°
DWR ID	DWR_RD0003_02_s_2012_64				
Comment Code					
T1 : Trim trees to at least five feet above ground level.					
Inspector Comment

Looking southwest at dense trees on landward shoulder and slope.

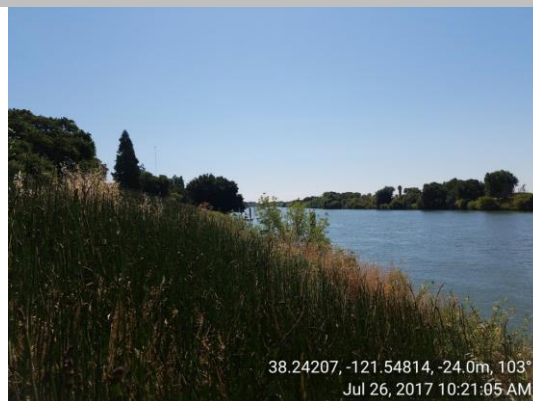
Photo 3 of 3 : FA_2018_RD0003_25_137_20180925_00101.jpg

LM Start	9.82	Rating **	A/W	Issue No.	137 (cont)	
LM End	9.84	Issue Type +	Ma	Location *		
Category	Supplemental			GPS Latitude/Longitude		
				Start	End	
Item	2017 Storm Damage			38.242006 °	38.241950 °	
				-121.548117 °	-121.547681 °	
DWR ID	DWR_RD0003_02_f_2017_137					
Comment Code						
Inspector Comment						
Levee Evaluation Comments						
Description: District station 518+55 to 519+81 , Sec. 33, T. 5 N. R. 4 E., M.D.M. Approximately 126 linear feet of erosion and sloughing exists along the water side slope of the Sacramento River (Unit 2). The erosion commences approximately 1/4 of the way down the slope from the crown and extends into the rip rap.						
Site ID No: 279						
Site Designation: LMA-105						
Repair Type: Erosion						
Rating: Area of Concern						
Field Date: 7/26/2017						
Notes:

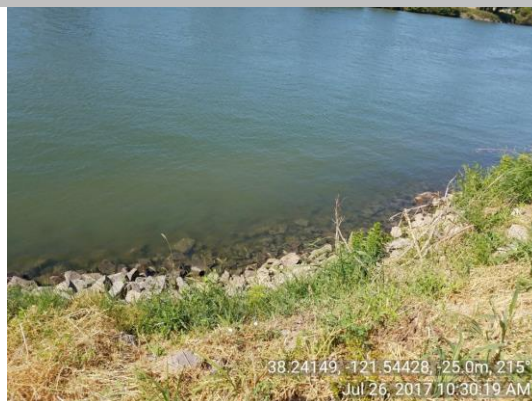
Photo 2 of 3 : FA_2018_RD0003_25_138_20180925_00103.jpg

LM Start	10.01	Rating **	A/W	Issue No.	138 (cont)	
LM End	10.03	Issue Type +	Ma	Location *		
Category	Supplemental			GPS Latitude/Longitude		
				Start	End	
Item	2017 Storm Damage			38.241481 °	38.241439 °	
				-121.544569 °	-121.544353 °	
DWR ID	DWR_RD0003_02_f_2017_138					
Comment Code						
Inspector Comment						
Levee Evaluation Comments						
Description: District station 528+97 to 529+58, Sec. 33, T. 5 N. R. 4 E., M.D.M. Approximately 61 linear feet of erosion and sloughing exists along the water side slope of the Sacramento River (Unit 2). The erosion commences approximately 1/2 of the way down the slope from the crown and extends into the rip rap.						
Site ID No: 280						
Site Designation: LMA-106						
Repair Type: Erosion						
Rating: Area of Concern						
Field Date: 7/26/2017						
Notes:

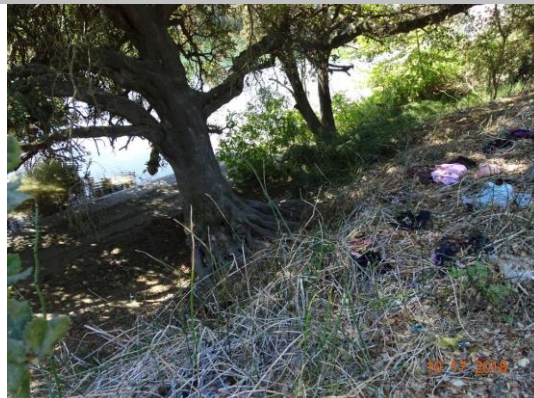
Photo 1 of 3 : FA_2018_RD0003_25_118_20181018_00308.jpg

LM Start	11.33	Rating **	M	Issue No.	118
LM End	11.41	Issue Type +	Ma	Location *	WS
Category	Supplemental			GPS Latitude/Longitude	
				Start	End
Item	2017 USACE Erosion Survey, DRAFT			38.239870 °	38.239992 °
				-121.520989 °	-121.519542 °
DWR ID	DWR_RD0003_02_f_2018_118				
Comment Code					
Inspector Comment					
2017 Site ID: SAC 26.3 R					
Status: Repaired					
2018: Still pocket of erosion into waterside toe.					
2017 Field Notes: Repaired by locals.					
Site History: 2009 - Hole left in levee toe from a fallen tree. Could be repaired under maintenance. 2010 - Minor new erosion. 2015 - Minor new erosion at toe.

View of erosion at the water side toe (October 2018).

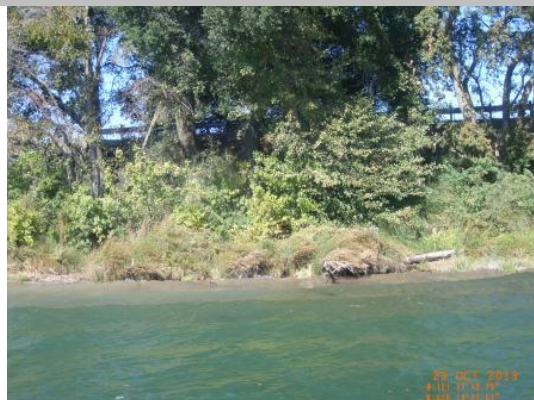
USACE 2013 Photo #1

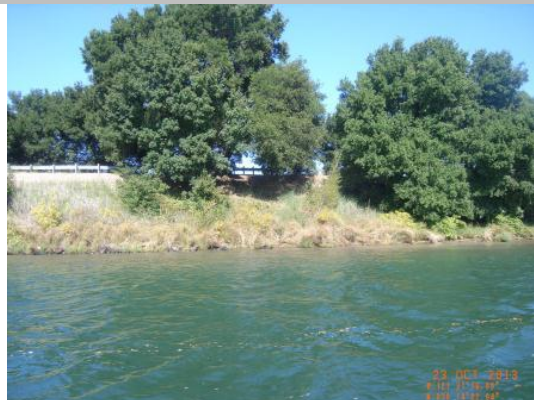
Photo 3 of 3 : FA_2018_RD0003_25_118_20181023_00043.jpg

USACE 2013 Photo #2

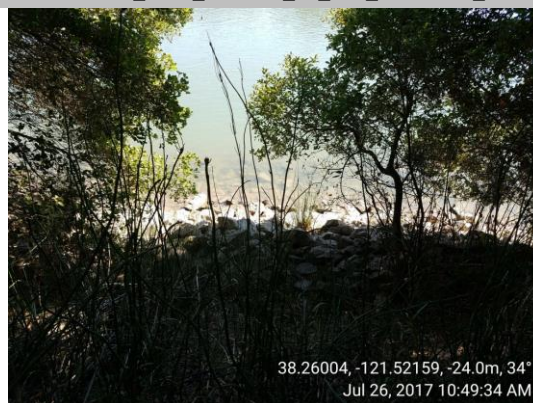
Photo 1 of 3 : FA_2018_RD0003_25_139_20180925_00105.jpg

LM Start	13.15	Rating **	A/W	Issue No.	139
LM End	13.17	Issue Type +	Ma	Location *	
Category	Supplemental			GPS Latitude/Longitude	
				Start	End
Item	2017 Storm Damage			38.260042 °	38.260219 °
				-121.521581 °	-121.521803 °
DWR ID	DWR_RD0003_02_f_2017_139				
Comment Code					
Inspector Comment					
Levee Evaluation Comments					
Description:District station 694+80 to 695+69, Sec. 27, 1. 5 N. R. 4 E., M.D.M. Approximately 89 linear feet of erosion and sloughing exists along the water side slope of the Sacramento River (Unit 2). The erosion commences approximately 1/2 of the way down the slope from the crown and extends into the rip rap.					
Site ID No:281					
Site Designation:LMA-107					
Repair Type: Erosion					
Rating:Area of Concern					
Field Date:7/26/2017					
Notes:

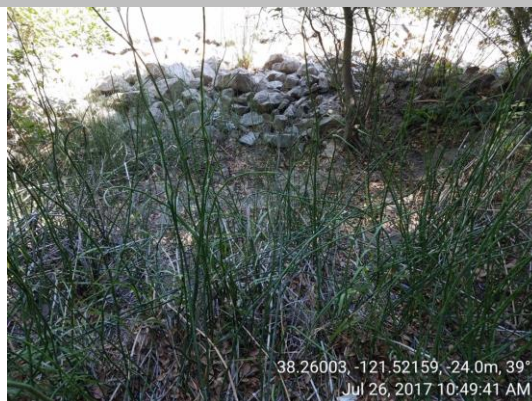
Photo 2 of 3 : FA_2018_RD0003_25_139_20180925_00106.jpg

LM Start	13.15	Rating **	A/W	Issue No.	139 (cont)	
LM End	13.17	Issue Type +	Ma	Location *		
Category	Supplemental			GPS Latitude/Longitude		
				Start	End	
Item	2017 Storm Damage			38.260042 °	38.260219 °	
				-121.521581 °	-121.521803 °	
DWR ID	DWR_RD0003_02_f_2017_139					
Comment Code						
Inspector Comment						
Levee Evaluation Comments						
Description: District station 694+80 to 695+69, Sec. 27, 1. 5 N. R. 4 E., M.D.M. Approximately 89 linear feet of erosion and sloughing exists along the water side slope of the Sacramento River (Unit 2). The erosion commences approximately 1/2 of the way down the slope from the crown and extends into the rip rap.						
Site ID No: 281						
Site Designation: LMA-107						
Repair Type: Erosion						
Rating: Area of Concern						
Field Date: 7/26/2017						
Notes:

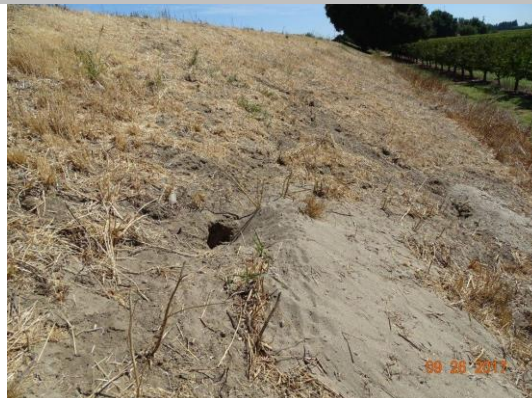
Photo 1 of 1 : FA_2018_RD0003_25_169_20180925_00142.jpg

Looking southeast at the landside slope.

LM Start	13.86	Rating **	A/W	Issue No.	169
LM End	13.86	Issue Type +	Ma	Location *	LS
Category	Earthen Levee			GPS Latitude/Longitude	
				Start	End
Item	Animal Control			38.267084 °	38.267084 °
				-121.530939 °	-121.530939 °
DWR ID	DWR_RD0003_02_f_2017_169				
Comment Code					
A1 : Exterminate rodents and backfill and compact or grout burrows.					
Inspector Comment

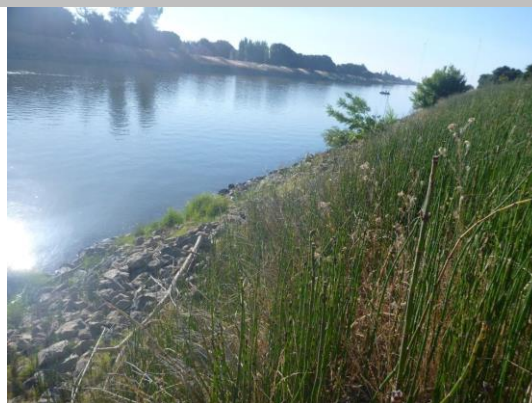
Photo 1 of 3 : FA_2018_RD0003_25_142_20180925_00111.jpg

LM Start	15.00	Rating **	A/W	Issue No.	142
LM End	15.07	Issue Type +	Ma	Location *	
Category	Supplemental			GPS Latitude/Longitude	
				Start	End
Item	2017 Storm Damage			38.278806 °	38.279444 °
				-121.545817 °	-121.546647 °
DWR ID	DWR_RD0003_02_f_2017_142				
Comment Code					
Inspector Comment					
Levee Evaluation Comments					
Description: District station 792+44 to 795+74, Sec. 16, T. 5 N. R. 4 E., M.D.M. Approximately 330 linear feet of erosion and sloughing exists along the water side slope of the Sacramento River (Unit 2). The erosion commences approximately 1/2 of the way down the slope from the crown and extends into the rip rap.					
Site ID No: 282					
Site Designation: LMA-108					
Repair Type: Erosion					
Rating: Area of Concern					
Field Date: 7/28/2017					
Notes: no berm

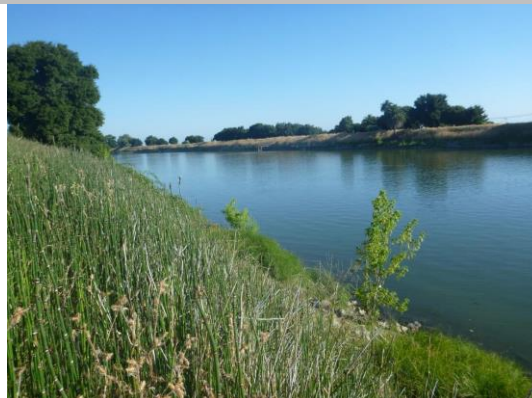
Photo 2 of 3 : FA_2018_RD0003_25_142_20180925_00112.jpg

LM Start	15.00	Rating **	A/W	Issue No.	142 (cont)	
LM End	15.07	Issue Type +	Ma	Location *		
Category	Supplemental			GPS Latitude/Longitude		
				Start	End	
Item	2017 Storm Damage			38.278806 °	38.279444 °	
				-121.545817 °	-121.546647 °	
DWR ID	DWR_RD0003_02_f_2017_142					
Comment Code						
Inspector Comment						
Levee Evaluation Comments						
Description: District station 792+44 to 795+74, Sec. 16, T. 5 N. R. 4 E., M.D.M. Approximately 330 linear feet of erosion and sloughing exists along the water side slope of the Sacramento River (Unit 2). The erosion commences approximately 1/2 of the way down the slope from the crown and extends into the rip rap.						
Site ID No: 282						
Site Designation: LMA-108						
Repair Type: Erosion						
Rating: Area of Concern						
Field Date: 7/28/2017						
Notes: no berm

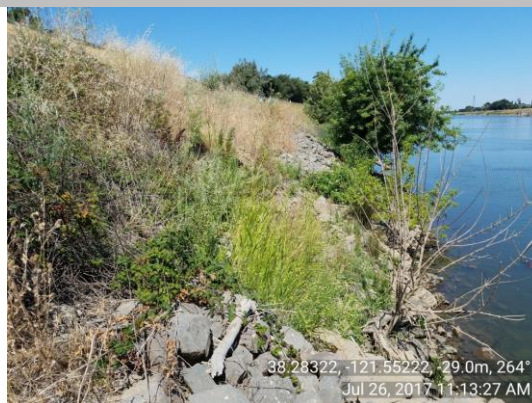
Photo 1 of 3 : FA_2018_RD0003_25_149_20180925_00120.jpg

LM Start	15.46	Rating **	A/W	Issue No.	149
LM End	15.47	Issue Type +	Ma	Location *	
Category	Supplemental			GPS Latitude/Longitude	
				Start	End
Item	2017 Storm Damage			38.283119 °	38.283172 °
				-121.552250 °	-121.552347 °
DWR ID	DWR_RD0003_02_f _ 2017_149				
Comment Code					
Inspector Comment					
Levee Evaluation Comments					
Description:District station 816+64 to 816+97, Sec. 16, T. 5 N. R. 4 E., M.D.M. Approximately 33 linear feet of erosion exists along the water side slope of the Sacramento River (Unit 2). The erosion commences approximately 1/2 ofthe way down the slope from the crown and extends into the rip rap. A section of rip rap has eroded away in this location.					
Site ID No:283					
Site Designation:LMA-109					
Repair Type: Erosion					
Rating:Area of Concern					
Field Date:7/26/2017					
Notes:

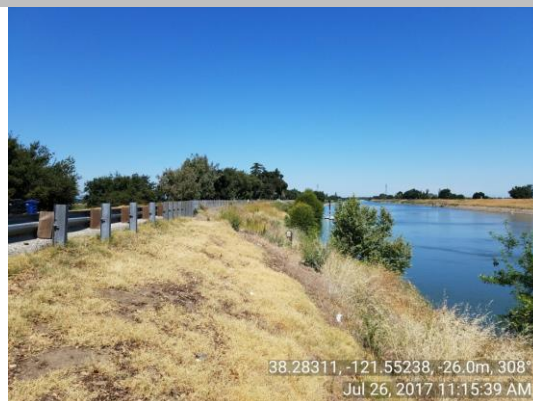
Photo 2 of 3 : FA_2018_RD0003_25_149_20180925_00121.jpg

LM Start	15.46	Rating **	A/W	Issue No.	149 (cont)
LM End	15.47	Issue Type +	Ma	Location *	
Category	Supplemental			GPS Latitude/Longitude	
				Start	End
Item	2017 Storm Damage			38.283119 °	38.283172 °
				-121.552250 °	-121.552347 °
DWR ID	DWR_RD0003_02_f_2017_149				
Comment Code					
Inspector Comment					
Levee Evaluation Comments					
Description:District station 816+64 to 816+97, Sec. 16, T. 5 N. R. 4 E., M.D.M. Approximately 33 linear feet of erosion exists along the water side slope of the Sacramento River (Unit 2). The erosion commences approximately 1/2 ofthe way down the slope from the crown and extends into the rip rap. A section of rip rap has eroded away in this location.					
Site ID No:283					
Site Designation:LMA-109					
Repair Type: Erosion					
Rating:Area of Concern					
Field Date:7/26/2017					
Notes:

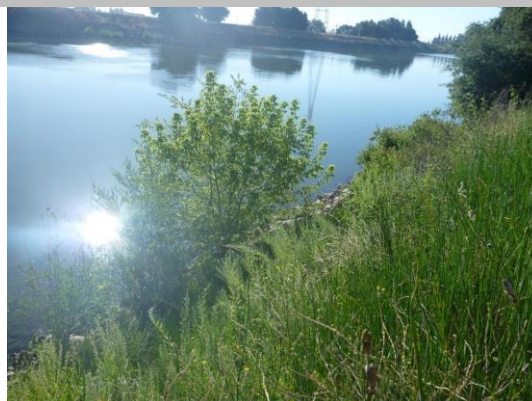
Photo 2 of 2 : FA_2018_RD0003_25_150_20180925_00124.jpg

LM Start	16.54	Rating **	A/W	Issue No.	150 (cont)
LM End	16.56	Issue Type +	Ma	Location *	
Category	Supplemental			GPS Latitude/Longitude	
				Start	End
Item	2017 Storm Damage			38.294717 °	38.294986 °
				-121.565417 °	-121.565661 °
DWR ID	DWR_RD0003_02_f_2017_150				
Comment Code					
Inspector Comment					
Levee Evaluation Comments					
Description:District station 873+61 to 874+83, Sec. 08, T. 5 N. R. 4 E., M.D.M. Approximately 122 linear feet of erosion exists along the water side slope of the Sacramento River (Unit 2). The erosion commences approximately 1/2 of the way down the slope from the crown and extends beyond the rip rap. A section of rip rap has eroded away in this location.					
Site ID No:284					
Site Designation:LMA-110					
Repair Type: Erosion					
Rating:Area of Concern					
Field Date:7/28/2017					
Notes: no berm

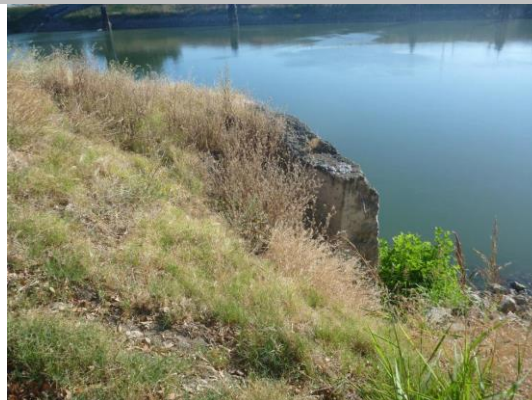
Photo 1 of 3 : FA_2018_RD0003_25_152_20180925_00127.jpg

LM Start	16.90	Rating **	A/W	Issue No.	152
LM End	16.90	Issue Type +	Ma	Location *	
Category	Supplemental			GPS Latitude/Longitude	
				Start	End
Item	2017 Storm Damage			38.298914 °	38.298997 °
				-121.569156 °	-121.569217 °
DWR ID	DWR_RD0003_02_f_2017_152				
Comment Code					
Inspector Comment					
Levee Evaluation Comments					
Description:District station 892+36 to 892+70, Sec. 08, T. 5 N. R. 4 E., M.D.M. Approximately 34 linear feet of erosion exists along the water side slope of the Sacramento River (Unit 2). The erosion commences approximately 1/2 of the way down the slope from the crown and extends into the rip rap. A section of rip rap has eroded away in this location.					
Site ID No:285					
Site Designation:LMA-111					
Repair Type: Erosion					
Rating:Area of Concern					
Field Date:7/28/2017					
Notes: highway on crown

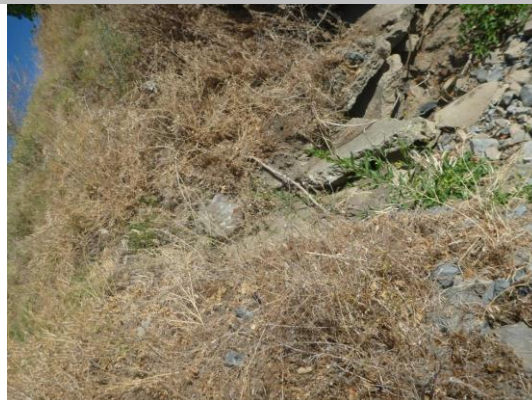
Photo 3 of 3 : FA_2018_RD0003_25_152_20180925_00129.jpg

LM Start	16.90	Rating **	A/W	Issue No.	152 (cont)
LM End	16.90	Issue Type +	Ma	Location *	
Category	Supplemental			GPS Latitude/Longitude	
				Start	End
Item	2017 Storm Damage			38.298914 °	38.298997 °
				-121.569156 °	-121.569217 °
DWR ID	DWR_RD0003_02_f _ 2017_152				
Comment Code					
Inspector Comment					
Levee Evaluation Comments					
Description:District station 892+36 to 892+70, Sec. 08, T. 5 N. R. 4 E., M.D.M. Approximately 34 linear feet of erosion exists along the water side slope of the Sacramento River (Unit 2). The erosion commences approximately 1/2 of the way down the slope from the crown and extends into the rip rap. A section of rip rap has eroded away in this location.					
Site ID No:285					
Site Designation:LMA-111					
Repair Type: Erosion					
Rating:Area of Concern					
Field Date:7/28/2017					
Notes: highway on crown
