**Flood Control Project Maintenance
Levee Inspections**

Maintenance Issue Types Only, Levee Inspection Report By Mile - Fall 2019

Reclamation District No. 0003 Grand Island

Waterway	Bank	Unit Miles	Inspection Start/End	Inspector
Unit No. 01 Left Bank Steamboat Slough	Left	10.95	10/30/2019 10/30/2019	David Julian

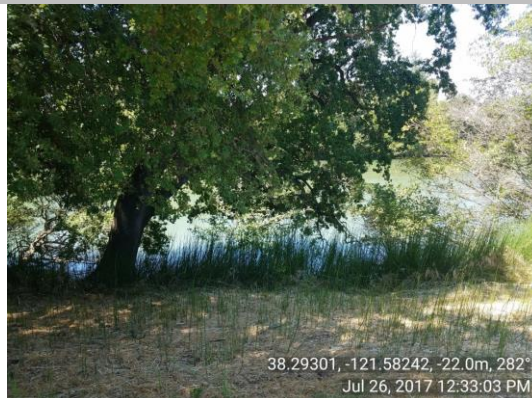
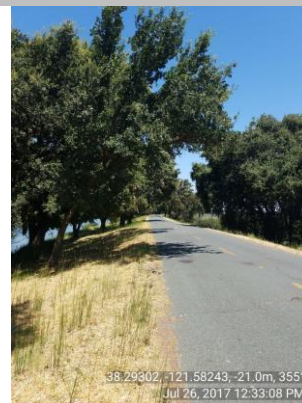
LM Start	0.91	Rating **	A/W	Issue No.	53 (cont)
LM End	0.97	Issue Type +	Ma	Location *	WS
Category	Supplemental			GPS Latitude/Longitude	
				Start	End
Item	2017 Storm Damage			38.293381°	38.292617°
				-121.582450°	-121.582675°

Repair Type: Erosion

Comment Code					
Inspector Comment					
2017 Site ID: STM 25.0 L					
Status: Critical					
2017 Field Notes: Upgraded to critical. Site has eroded to near vertical at upstream end.					
Site History: 1997 - Erosion of sandy levee on top left bank. Site is downstream of a rock section. Large riparian trees on the bank. 1999 - Upstream half of the reach repaired with rock, except for a 30 ft reach at the upstream end. 2001 - Rock repair on the upstream and downstream ends; no revetment at the trees. 2002 - Rock repair is starting to slide off the geotextile at the upstream end. 2005 - One new small tree has fallen. 2006 - 50 ft pocket at the downstream end and at the upstream end with new rock in between. 2007 - Upstream end has been repaired. 2008 - Area closed sign on bank. Newly fallen trees at both ends and pop outs along the bank. 2010 - Site extended downstream. 2011 - New erosion at the toe. More trees popouts. 2013 - Short vertical sections observed at the downstream end. 2015 - Significant new erosion, large oak tree on verge of popping out. 2016 - Sites 24.8 and 25 were combined.

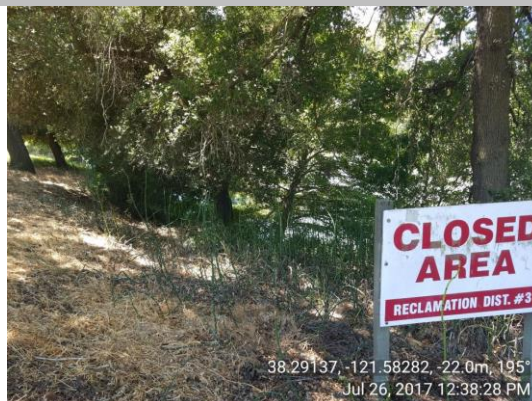
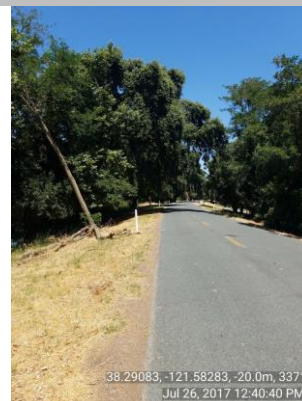
LM Start	1.09	Rating **	A/W	Issue No.	60
LM End	1.10	Issue Type +	Ma	Location *	WS
Category	Supplemental			GPS Latitude/Longitude	
				Start	End
Item	2017 Storm Damage			38.290819 °	38.290706 °
				-121.582942 °	-121.582939 °
DWR ID	LMA-102				
Comment Code					
Inspector Comment					
Levee Evaluation Comments					
Description:District station 57+57 to 57+98, Sec. 18, 1. 5 N. R. 4 E., M.D.M. An erosion site exists along approximately 41 linear feet of the water side slope of Steamboat Slough (Unit 1). The erosion commences approximately 1/2 of the way down the slope from the crown to the waterside toe.					
Site ID No:276					
Site Designation:LMA-102					
Repair Type: Erosion					
Rating:Area of Concern					
Field Date:7/26/2017					
Notes:

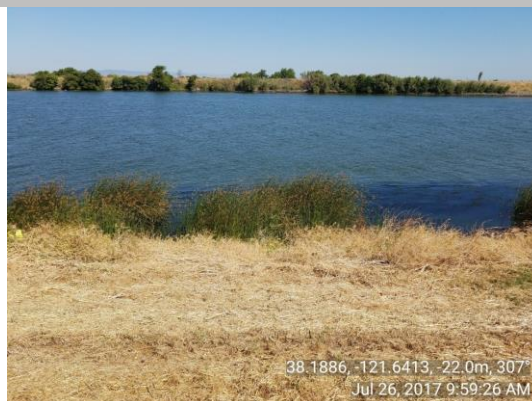
LM Start	10.15	Rating **	A/W	Issue No.	72 (cont)	
LM End	10.21	Issue Type +	Ma	Location *	WS	
Category	Supplemental			GPS Latitude/Longitude		
				Start	End	
Item	2017 Storm Damage			38.188431 °	38.187803 °	
				-121.641703 °	-121.642478 °	
DWR ID	LMA-103					
Comment Code						
Inspector Comment						
Levee Evaluation Comments						
Description:District station 536+35 to 539+47, Sec. 16, T. 4 N. R. 3 E., M.D.M. The waterside slope experienced sloughing and erosion along approximately 312 linear feet of Steamboat Slough (Unit 1). Sloughing commences at approximately 1/4 of the way down the slope from the crown and extends to the rip rap.						
Site ID No:277						
Site Designation:LMA-103						
Repair Type: Erosion						
Rating:Area of Concern						
Field Date:7/26/2017						
Notes:

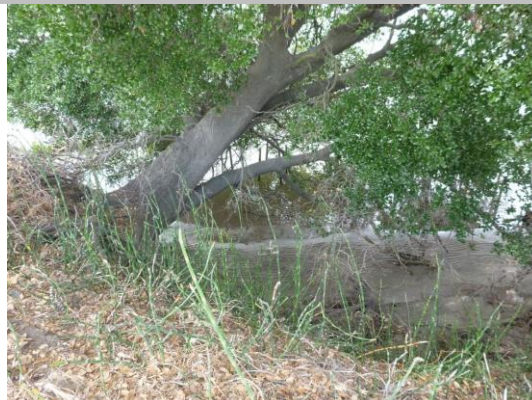
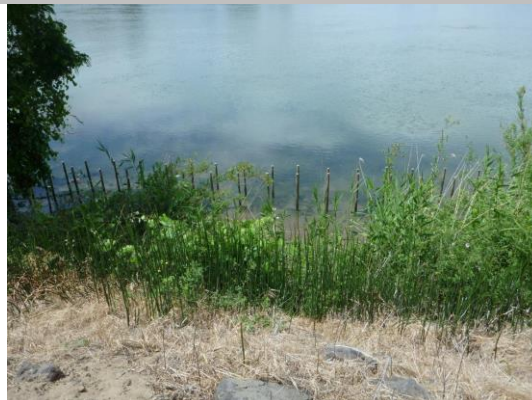
LM Start	10.67	Rating **	A/W	Issue No.	73 (cont)
LM End	10.92	Issue Type +	Ma	Location *	WS
Category	Supplemental			GPS Latitude/Longitude	
				Start	End
Item	2017 Storm Damage			38.183810 °	38.182480 °
				-121.648780 °	-121.653150 °
DWR ID	DWR_RD0003_01_R_2012_03				
Comment Code					
Inspector Comment					
Levee Evaluation Comments					
Description:					
Site ID No:63					
Site Designation:DWR_RD0003_01_R_2012_03					
Repair Type: Erosion					
Rating:Serious					
Field Date:6/8/2017					
Notes: scattered erosion scarps caving into levee crown, within erosion limit crown width ranges from 15 to 30', several trees with exposed tree roots and leaning into the river.

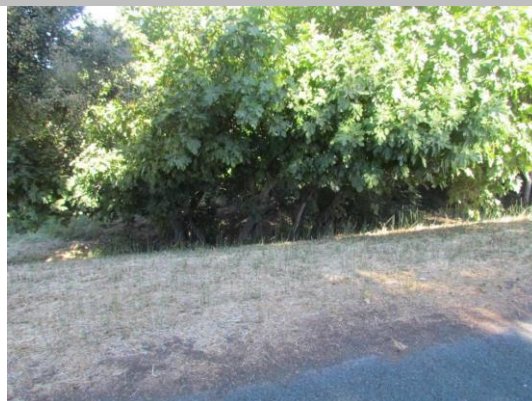
Photo 2 of 2 : FA_2019_RD0003_25_7_20190826_00007.jpg

Looking north at fig tree at landward toe.

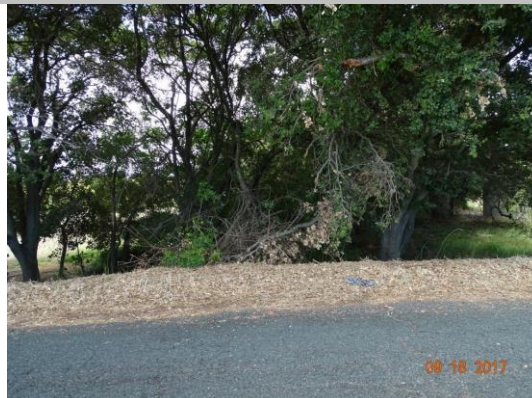
Photo 1 of 1 : FA_2019_RD0003_25_154_20190826_00139.jpg

LM Start	3.30	Rating **	M	Issue No.	154
LM End	3.30	Issue Type +	Ma	Location *	LS
Category	Earthen Levee			GPS Latitude/Longitude	
				Start	End
Item	Encroachments			38.168750 °	38.168750 °
				-121.598152 °	-121.598152 °
DWR ID	DWR_RD0003_02_f_2017_154				
Comment Code					
TR : Tree or limb					
Inspector Comment					
There is a downed tree on the landside slope.

Looking northwest at the landside slope.

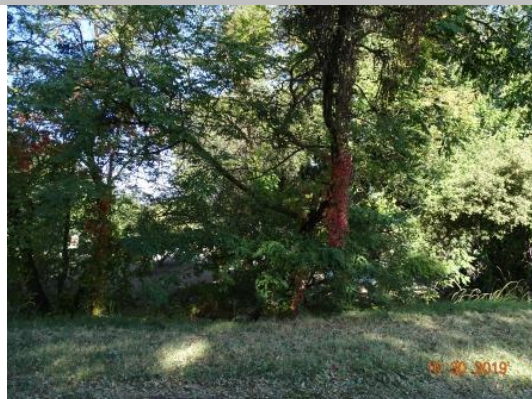
Photo 1 of 1 : FA_2019_RD0003_25_179_20191031_00353.jpg

LM Start	3.40	Rating **	M	Issue No.	179
LM End	3.40	Issue Type +	Ma	Location *	LS
Category	Earthen Levee			GPS Latitude/Longitude	
				Start	End
Item	Encroachments			38.169861 °	38.169861 °
				-121.596926 °	-121.596926 °
DWR ID	DWR_RD0003_02_s_2018_179				
Comment Code					
TR : Tree or limb					
Inspector Comment					
Fallen tree on the landside slope.

View of fallen tree on the landside slope (Fall 2019).

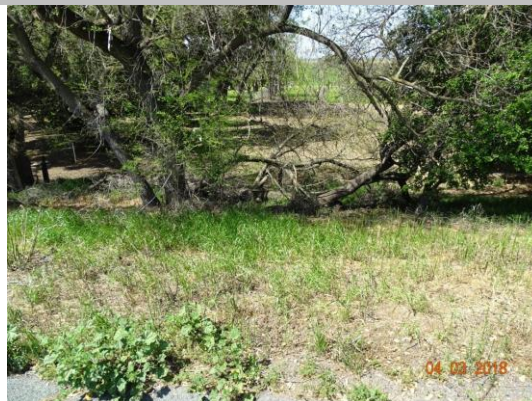
Photo 1 of 1 : FA_2019_RD0003_25_180_20190826_00156.jpg

LM Start	3.44	Rating **	M	Issue No.	180
LM End	3.44	Issue Type +	Ma	Location *	LS
Category	Earthen Levee			GPS Latitude/Longitude	
				Start	End
Item	Encroachments			38.170293 °	38.170293 °
				-121.596497 °	-121.596497 °
DWR ID	DWR_RD0003_02_s_2018_180				
Comment Code					
TR : Tree or limb					
Inspector Comment					
Fallen tree at landside toe blocks access.

Fallen tree at landside toe should be removed.

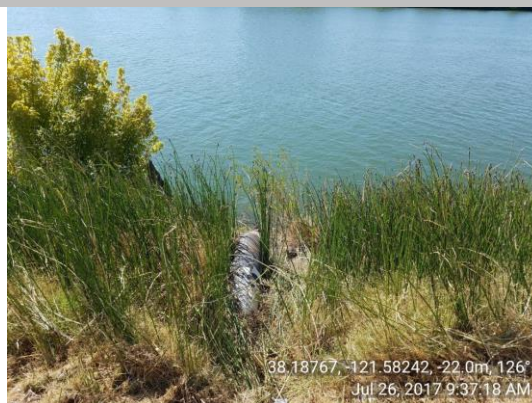
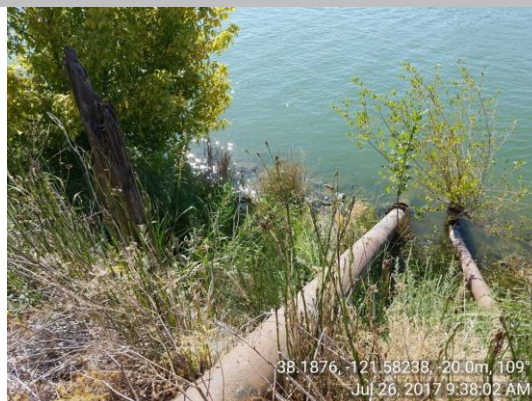
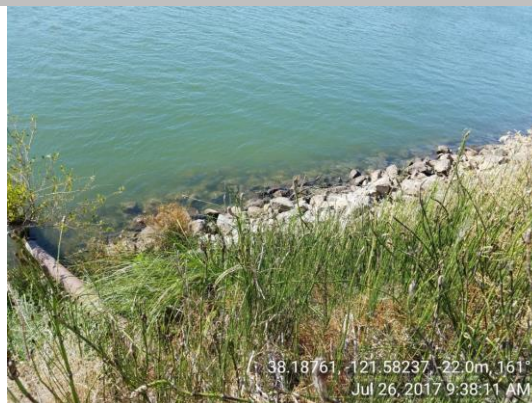
LM Start	4.86	Rating **	A/W	Issue No.	127
LM End	4.87	Issue Type +	Ma	Location *	WS
Category	Supplemental			GPS Latitude/Longitude	
				Start	End
Item	2017 Storm Damage			38.187528 °	38.187781 °
				-121.582394 °	-121.582331 °
DWR ID	LMA-104				
Comment Code					
Inspector Comment					
Levee Evaluation Comments					
Description: District station 256+60 to 257+96, Sec. 19, T. 4 N. R. 4 E., M.D.M. Approximately 136 linear feet erosion and sloughing exists along the water side slope of the Sacramento River (Unit 2). The erosion commences approximately 1/4 of the way down the slope from the crown and extends to the rip rap.					
Site ID No: 278					
Site Designation: LMA-104					
Repair Type: Erosion					
Rating: Area of Concern					
Field Date: 7/26/2017					
Notes:

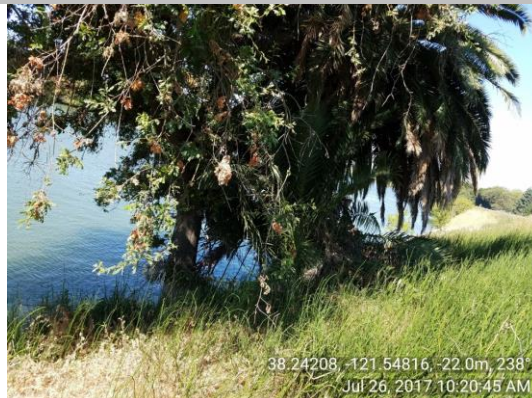
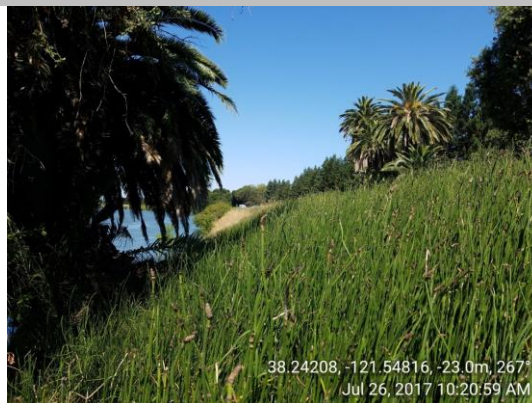
LM Start	9.82	Rating **	A/W	Issue No.	137 (cont)	
LM End	9.84	Issue Type +	Ma	Location *	WS	
Category	Supplemental			GPS Latitude/Longitude		
				Start	End	
Item	2017 Storm Damage			38.242006°	38.241950°	
				-121.548117°	-121.547681°	
DWR ID	LMA-105					
Comment Code						
Inspector Comment						
Levee Evaluation Comments						
Description: District station 518+55 to 519+81 , Sec. 33, T. 5 N. R. 4 E., M.D.M. Approximately 126 linear feet of erosion and sloughing exists along the water side slope of the Sacramento River (Unit 2). The erosion commences approximately 1/4 of the way down the slope from the crown and extends into the rip rap.						
Site ID No: 279						
Site Designation: LMA-105						
Repair Type: Erosion						
Rating: Area of Concern						
Field Date: 7/26/2017						
Notes:

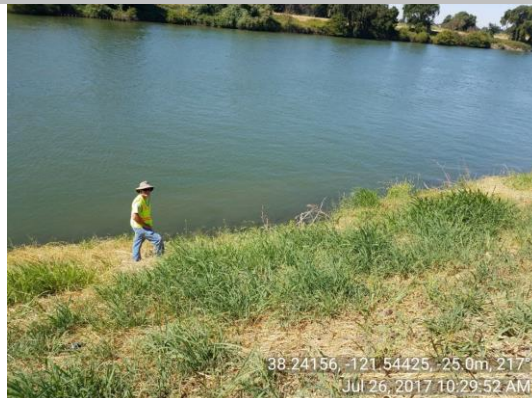
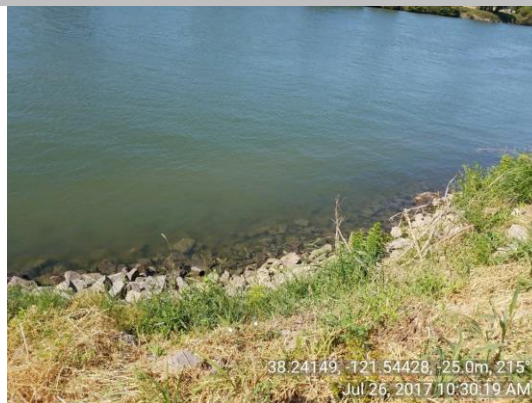
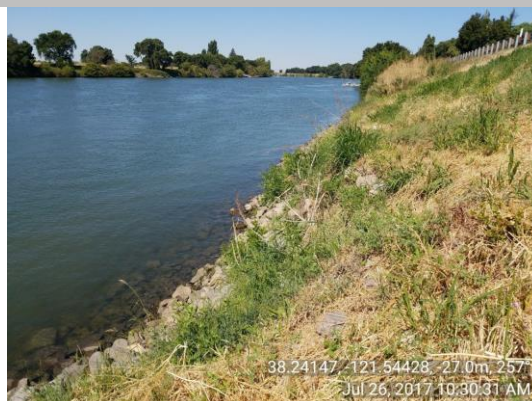
LM Start	10.01	Rating **	A/W	Issue No.	138 (cont)	
LM End	10.03	Issue Type +	Ma	Location *	WS	
Category	Supplemental			GPS Latitude/Longitude		
				Start	End	
Item	2017 Storm Damage			38.241481 °	38.241439 °	
				-121.544569 °	-121.544353 °	
DWR ID	LMA-106					
Comment Code						
Inspector Comment						
Levee Evaluation Comments						
Description: District station 528+97 to 529+58, Sec. 33, T. 5 N. R. 4 E., M.D.M. Approximately 61 linear feet of erosion and sloughing exists along the water side slope of the Sacramento River (Unit 2). The erosion commences approximately 1/2 of the way down the slope from the crown and extends into the rip rap.						
Site ID No: 280						
Site Designation: LMA-106						
Repair Type: Erosion						
Rating: Area of Concern						
Field Date: 7/26/2017						
Notes:

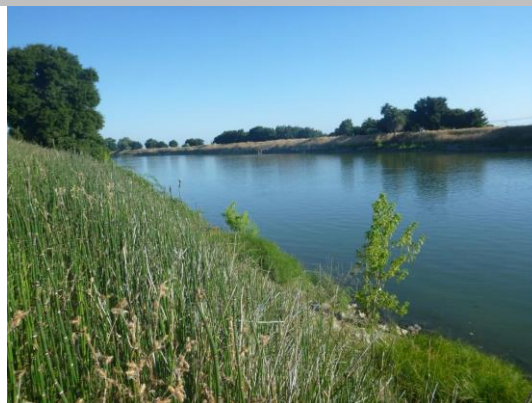
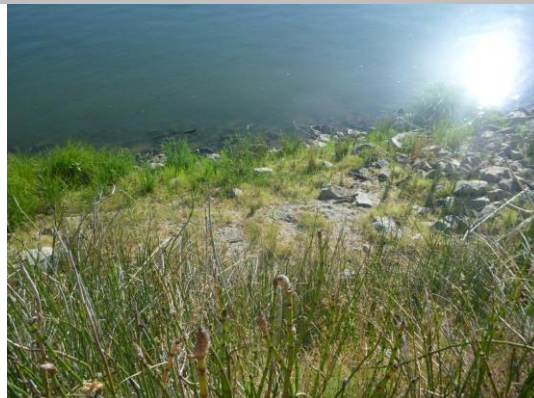
LM Start	15.00	Rating **	A/W	Issue No.	142 (cont)	
LM End	15.07	Issue Type +	Ma	Location *	WS	
Category	Supplemental			GPS Latitude/Longitude		
				Start	End	
Item	2017 Storm Damage			38.278806 °	38.279444 °	
				-121.545817 °	-121.546647 °	
DWR ID	LMA-108					
Comment Code						
Inspector Comment						
Levee Evaluation Comments						
Description: District station 792+44 to 795+74, Sec. 16, T. 5 N. R. 4 E., M.D.M. Approximately 330 linear feet of erosion and sloughing exists along the water side slope of the Sacramento River (Unit 2). The erosion commences approximately 1/2 of the way down the slope from the crown and extends into the rip rap.						
Site ID No: 282						
Site Designation: LMA-108						
Repair Type: Erosion						
Rating: Area of Concern						
Field Date: 7/28/2017						
Notes: no berm

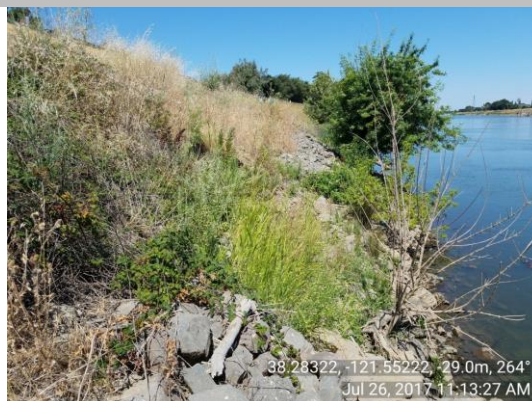
Photo 1 of 3 : FA_2019_RD0003_25_149_20190826_00128.jpg

LM Start	15.46	Rating **	A/W	Issue No.	149
LM End	15.47	Issue Type +	Ma	Location *	WS
Category	Supplemental			GPS Latitude/Longitude	
				Start	End
Item	2017 Storm Damage			38.283119 °	38.283172 °
				-121.552250 °	-121.552347 °
DWR ID	LMA-109				
Comment Code					
Inspector Comment					
Levee Evaluation Comments					
Description:District station 816+64 to 816+97, Sec. 16, T. 5 N. R. 4 E., M.D.M. Approximately 33 linear feet of erosion exists along the water side slope of the Sacramento River (Unit 2). The erosion commences approximately 1/2 ofthe way down the slope from the crown and extends into the rip rap. A section of rip rap has eroded away in this location.					
Site ID No:283					
Site Designation:LMA-109					
Repair Type: Erosion					
Rating:Area of Concern					
Field Date:7/26/2017					
Notes:

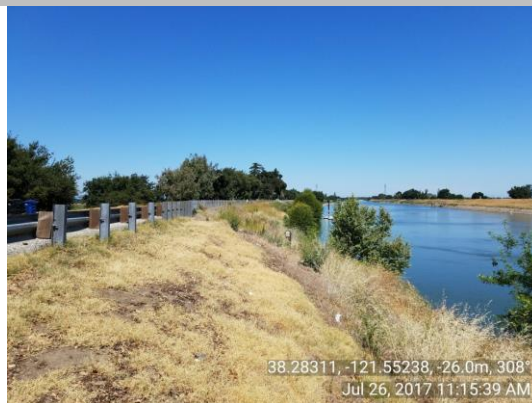
Photo 2 of 3 : FA_2019_RD0003_25_149_20190826_00129.jpg

LM Start	15.46	Rating **	A/W	Issue No.	149 (cont)
LM End	15.47	Issue Type +	Ma	Location *	WS

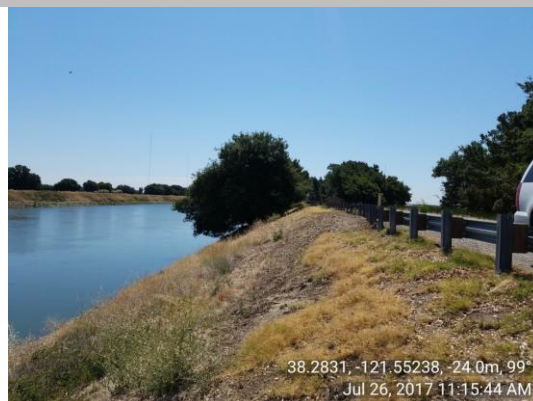
Photo 3 of 3 : FA_2019_RD0003_25_149_20190826_00130.jpg

LM Start	15.46	Rating **	A/W	Issue No.	149 (cont)
LM End	15.47	Issue Type +	Ma	Location *	WS
Category	Supplemental			GPS Latitude/Longitude	
				Start	End
Item	2017 Storm Damage			38.283119 °	38.283172 °
				-121.552250 °	-121.552347 °
DWR ID	LMA-109				
Comment Code					
Inspector Comment					
Levee Evaluation Comments					
Description:District station 816+64 to 816+97, Sec. 16, T. 5 N. R. 4 E., M.D.M. Approximately 33 linear feet of erosion exists along the water side slope of the Sacramento River (Unit 2). The erosion commences approximately 1/2 ofthe way down the slope from the crown and extends into the rip rap. A section of rip rap has eroded away in this location.					
Site ID No:283					
Site Designation:LMA-109					
Repair Type: Erosion					
Rating:Area of Concern					
Field Date:7/26/2017					
Notes:

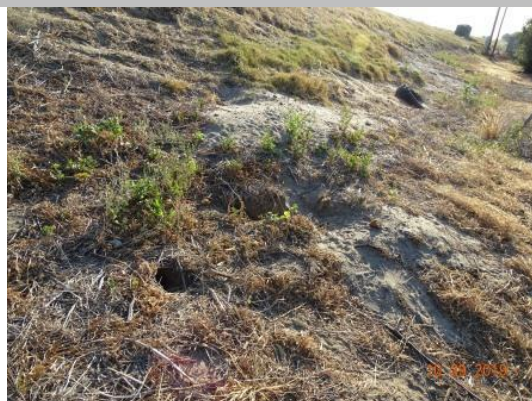
Photo 1 of 3 : FA_2019_RD0003_25_119_20191030_00312.jpg

LM Start	16.07	Rating **	U	Issue No.	119
LM End	16.07	Issue Type +	Ma	Location *	LS
Category	Earthen Levee			GPS Latitude/Longitude	
				Start	End
Item	Animal Control			38.289377 °	38.289377 °
				-121.560002 °	-121.560002 °
DWR ID	DWR_RD0003_02_f_2019_119				
Comment Code					
A1 : Exterminate rodents and backfill and compact or grout burrows.					
Inspector Comment					
There are many fresh rodent holes in landside slope.

View looking downstream at fresh rodent holes in landside slope (Fall 2019).

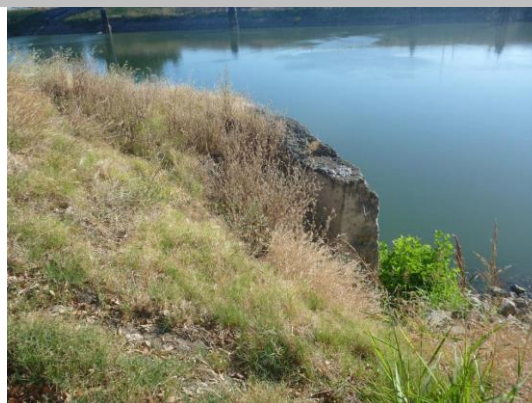
Photo 1 of 3 : FA_2019_RD0003_25_152_20190826_00135.jpg

LM Start	16.90	Rating **	A/W	Issue No.	152
LM End	16.90	Issue Type +	Ma	Location *	WS
Category	Supplemental			GPS Latitude/Longitude	
				Start	End
Item	2017 Storm Damage			38.298914 °	38.298997 °
				-121.569156 °	-121.569217 °
DWR ID	LMA-111				
Comment Code					
Inspector Comment					
Levee Evaluation Comments					
Description:District station 892+36 to 892+70, Sec. 08, T. 5 N. R. 4 E., M.D.M. Approximately 34 linear feet of erosion exists along the water side slope of the Sacramento River (Unit 2). The erosion commences approximately 1/2 of the way down the slope from the crown and extends into the rip rap. A section of rip rap has eroded away in this location.					
Site ID No:285					
Site Designation:LMA-111					
Repair Type: Erosion					
Rating:Area of Concern					
Field Date:7/28/2017					
Notes: highway on crown

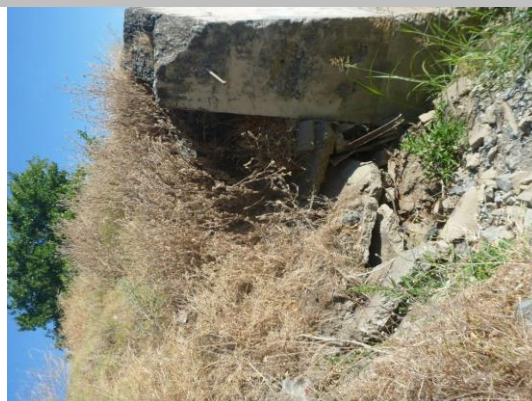
Photo 2 of 3 : FA_2019_RD0003_25_152_20190826_00136.jpg

LM Start	16.90	Rating **	A/W	Issue No.	152 (cont)
LM End	16.90	Issue Type +	Ma	Location *	WS
Category	Supplemental			GPS Latitude/Longitude	
				Start	End
Item	2017 Storm Damage			38.298914 °	38.298997 °
				-121.569156 °	-121.569217 °
DWR ID	LMA-111				
Comment Code					
Inspector Comment					
Levee Evaluation Comments					
Description:District station 892+36 to 892+70, Sec. 08, T. 5 N. R. 4 E., M.D.M. Approximately 34 linear feet of erosion exists along the water side slope of the Sacramento River (Unit 2). The erosion commences approximately 1/2 of the way down the slope from the crown and extends into the rip rap. A section of rip rap has eroded away in this location.					
Site ID No:285					
Site Designation:LMA-111					
Repair Type: Erosion					
Rating:Area of Concern					
Field Date:7/28/2017					
Notes: highway on crown

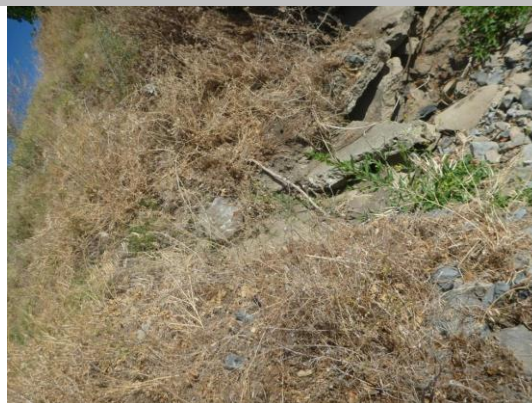
Photo 3 of 3 : FA_2019_RD0003_25_152_20190826_00137.jpg

LM Start	16.90	Rating **	A/W	Issue No.	152 (cont)
LM End	16.90	Issue Type +	Ma	Location *	WS
