**Flood Control Project Maintenance
Levee Inspections**

Maintenance Issue Types Only, Levee Inspection Report By Mile - Fall 2020

Reclamation District No. 0003 Grand Island

Waterway	Bank	Unit Miles	Inspection Start/End	Inspector
Unit No. 01 Left Bank Steamboat Slough	Left	10.95	10/15/2020 10/15/2020	David Julian

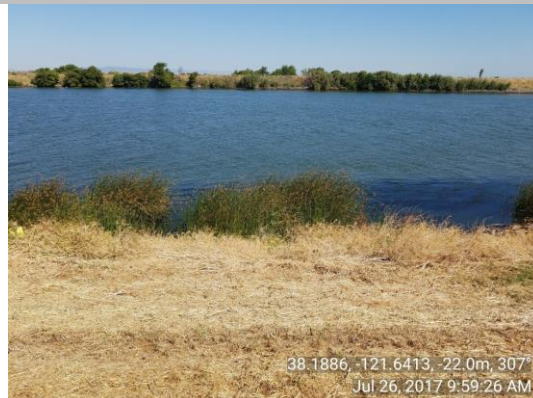
Photo 3 of 3 : FA_2020_RD0003_24_72_20200910_00035.jpg

LM Start	10.15	Rating **	U	Issue No.	72 (cont)
LM End	10.21	Issue Type +	Ma	Location *	WS
Category	Earthen Levee			GPS Latitude/Longitude	
				Start	End
Item	Erosion / Bank Caving			38.188431 °	38.187803 °
				-121.641703 °	-121.642478 °
DWR ID	LMA-103

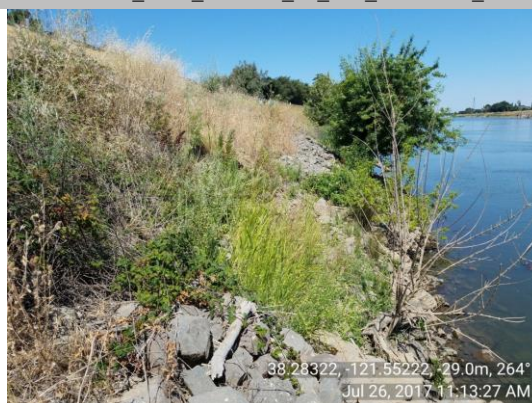
Photo 1 of 1 : FA_2020_RD0003_25_149_20200910_00084.jpg

LM Start	15.46	Rating **	A/W	Issue No.	149
LM End	15.47	Issue Type +	Ma	Location *	WS
Category	Earthen Levee			GPS Latitude/Longitude	
				Start	End
Item	Erosion / Bank Caving			38.283119 °	38.283172 °
				-121.552250 °	-121.552347 °
DWR ID	LMA-109				
Comment Code					
E1 : Note and monitor erosion site.					
Inspector Comment					
This was a 2017 Storm Damage site. Approximately 33 linear feet of erosion. The erosion commences approximately 1/2 of the way down the slope from the crown and extends into the rip rap. A section of rip rap has eroded away in this location. Site ID No:283 Site Designation:LMA-109 4/8/2020 Field Notes: Very minor erosion into waterside toe. Monitor.
