**Flood Control Project Maintenance
Levee Inspections**

Maintenance Issue Types Only, Levee Inspection Report By Mile - Fall 2021

Reclamation District No. 0003 Grand Island

Waterway	Bank	Unit Miles	Inspection Start/End	Inspector
Unit No. 01 Left Bank Steamboat Slough	Left	10.95	10/06/2021 10/06/2021	David Julian

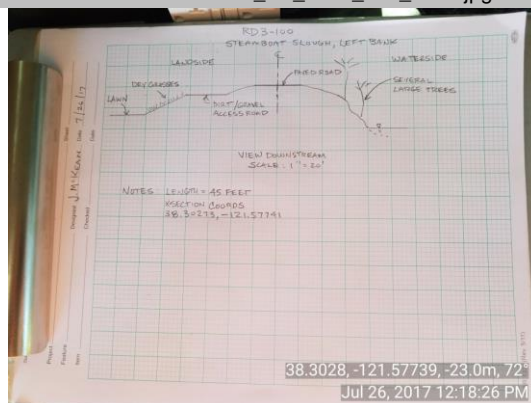
Photo 3 of 3 : LEVAL_FA_2021_274_2395.jpg

LM Start	0.18	Rating **	A/W	Issue No.	52 (cont)
LM End	0.21	Issue Type +	Ma	Location *	WS
Category	Supplemental			GPS Latitude/Longitude	
				Start	End
Item	2017 Storm Damage			38.302981 °	38.302778 °
				-121.577336 °	-121.577683 °
DWR ID	LMA-100

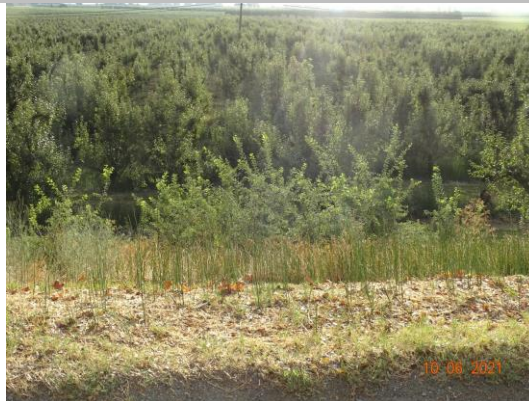
Photo 1 of 1 : FA_2021_RD0003_24_135_20211006_00291.jpg

LM Start	1.16	Rating **	U	Issue No.	135	
LM End	1.16	Issue Type +	Ma	Location *	LS	
Category	Earthen Levee			GPS Latitude/Longitude		
				Start		End
Item	Vegetation			38.289813 °	38.289813 °	
				-121.582793 °	-121.582793 °	
DWR ID	DWR_RD0003_01_f_2021_135					
Comment Code						
V2 : Remove the wild growth other than native grasses from the levee slopes.						
Inspector Comment						
New oak trees beginning to establish on landside toe.

View looking downslope at new oak trees on the landside toe (Fall 2021).

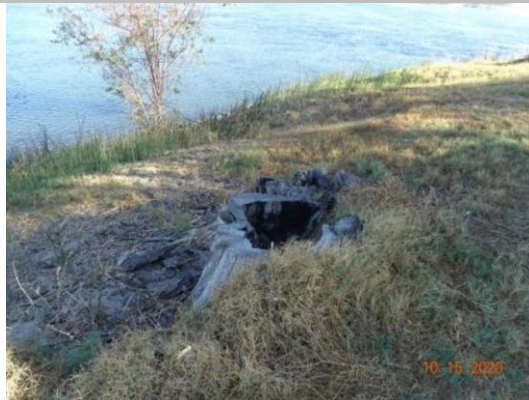
Photo 1 of 1 : FA_2021_RD0003_24_155_20210830_00066.jpg

LM Start	8.92	Rating **	N	Issue No.	155
LM End	8.92	Issue Type +	Ma	Location *	WS
Category	Earthen Levee			GPS Latitude/Longitude	
				Start	End
Item	Trim / Thin Trees			38.192985 °	38.192985 °
				-121.620712 °	-121.620712 °
DWR ID	DWR_RD0003_01_f_2020_155				
Comment Code					
T5 : Tree stumps.					
Inspector Comment					
Stump on the waterside hinge.

View of tree stump on the waterside slope (Fall 2020).

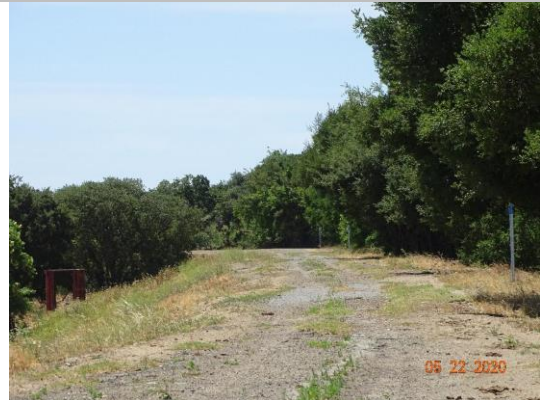
Photo 1 of 3 : UCIP_FA_2021_69662_85972.jpg

Comment Code						
Inspector Comment						
DS_ID:22206 FS_ID:69662 EP_NO: N/A Repair Type: Non-Urgent EVAL Issue: Unauthorized Encroachment, installed decades prior Crossing Status: Found UCIP Comments: 05/22/2020 Record remains Non-Urgent due to missing permit and crossing being abandoned. (S. Donovan - DWR UCIP)02/11/2014 Pipe appears abandoned and should be verified as having been done so properly. (G. Wylie - DWR UCIP) FIELD_STRUCT_DESC: *ABANDONED* 36-inch corrugated metal drainage pipe through the levee, 15.0 feet below the crown. Slide gate in a 48-inch corrugated metal pipe (CMP) riser on the waterside (WS) shoulder. Flap gate at the WS toe has been sealed shut with sealant. [Additional Reference(s): DWR Levee Log, 1993, (HLM 10.90), referenced as 24.0 feet below the crown. USACE Sacramento O&M Manual 104, February 1960, (RM 15.20), referenced as invert elevation 24.0 feet below the crown]. FS Date: 5/22/2020 8:07:00 AM

Overview of the levee crown looking d/s.

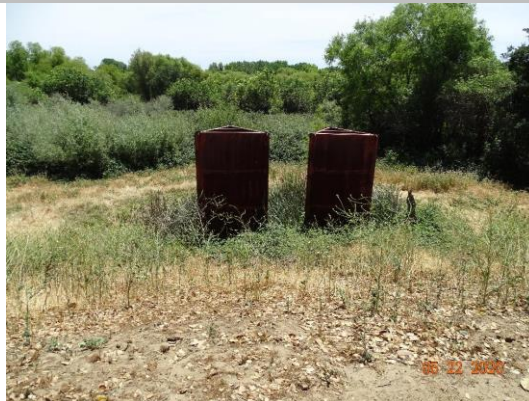
Photo 2 of 3 : UCIP_FA_2021_69662_85967.jpg

LS view: Steel weir on the levee toe.

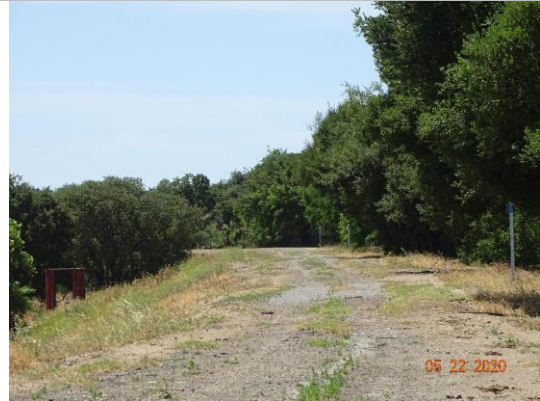
Photo 1 of 3 : UCIP_FA_2021_69663_85978.jpg

DS_ID:22349
FS_ID:69663
EP_NO: N/A
Repair Type: Non-Urgent
EVAL Issue: Unauthorized Encroachment, installed decades prior
Crossing Status: Found
UCIP Comments: 05/22/2020 Record remains Non-Urgent due to missing permit and crossing being abandoned. (S. Donovan - DWR UCIP)02/11/2014 Pipe appears abandoned and should be verified as having been filled with grout. (G. Wylie - DWR UCIP)
FIELD_STRUCT_DESC: *ABANDONED* 36-inch corrugated metal drainage pipe through the levee, 15.0 feet below the crown. Slide gate in a 48-inch corrugated metal pipe (CMP) riser on the waterside (WS) shoulder. Steel intake weir at the landside (LS) toe. Steel plate welded over the pipe on the WS toe. [Additional Reference(s): DWR Levee Log, 1993, (HLM 10.90), referenced as 24.0 feet below the crown. USACE Sacramento O&M Manual 104, February 1960, (RM 15.20), referenced as invert elevation 24.0 feet below the crown].
FS Date: 5/22/2020 8:28:00 AM

Overview of the levee crown looking d/s.

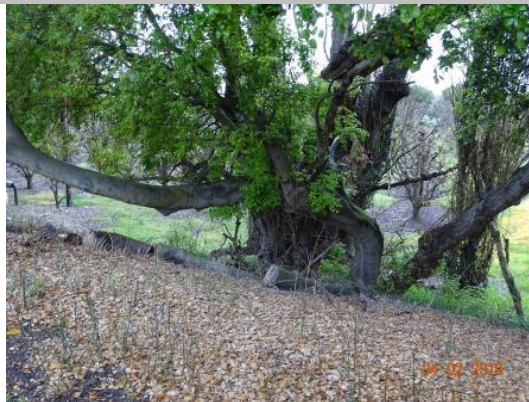
Photo 1 of 1 : FA_2021_RD0003_25_162_20210830_00089.jpg

LM Start	11.43	Rating **	M	Issue No.	162
LM End	11.43	Issue Type +	Ma	Location *	LS
Category	Earthen Levee			GPS Latitude/Longitude	
				Start	End
Item	Encroachments			38.240198 °	38.240198 °
				-121.519290 °	-121.519290 °
DWR ID	DWR_RD0003_02_s_2019_162				
Comment Code					
TR : Tree or limb					
Inspector Comment					
Remove tree limbs from the landside slope.

View looking downslope at fallen tree limbs on the landside slope (Spring 2019).

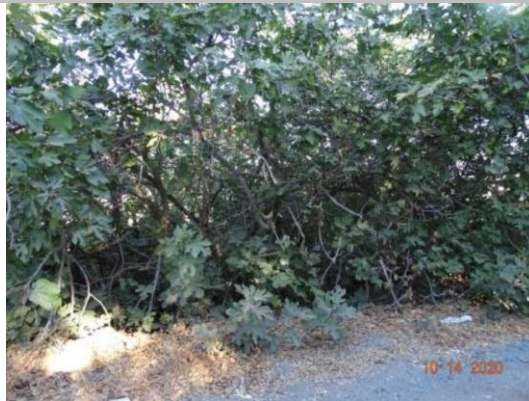
Photo 1 of 1 : FA_2021_RD0003_25_116_20210830_00055.jpg

LM Start	11.51	Rating **	U	Issue No.	116	
LM End	11.51	Issue Type +	Ma	Location *	LS	
Category	Earthen Levee			GPS Latitude/Longitude		
				Start		End
Item	Trim / Thin Trees			38.240787 °		38.240787 °
				-121.517902 °		-121.517902 °
DWR ID	DWR_RD0003_02_f_2020_116					
Comment Code						
T2 : Thin trees to allow visibility of the ground and room to flood fight.						
Inspector Comment						
Trim the fig tree on the landside.

View of thick fig tree on the landside slope (Fall 2020).

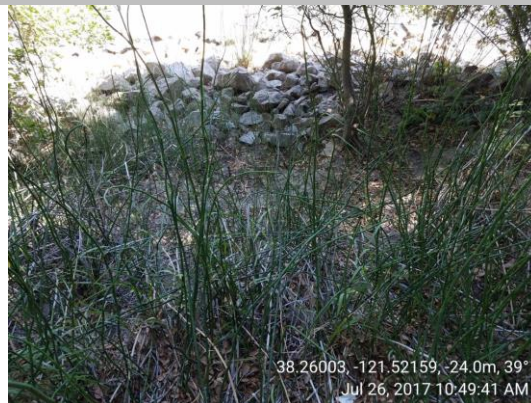
Photo 1 of 1 : FA_2021_RD0003_25_139_20210830_00072.jpg

LM Start	13.15	Rating **	M	Issue No.	139
LM End	13.17	Issue Type +	Ma	Location *	WS
Category	Earthen Levee			GPS Latitude/Longitude	
				Start	End
Item	Erosion / Bank Caving			38.260042 °	38.260219 °
				-121.521581 °	-121.521803 °
DWR ID	LMA-107				
Comment Code					
E2 : Schedule repair of erosion site prior to the next inspection.					
Inspector Comment					
This was a 2017 Storm Damage site. Approximately 89 linear feet of erosion and sloughing. The erosion commences approximately 1/2 of the way down the slope from the crown and extends into the rip rap. Site ID No:281 Site Designation:LMA-107 4/8/2020 Field Notes: Evidence of minor sloughing.

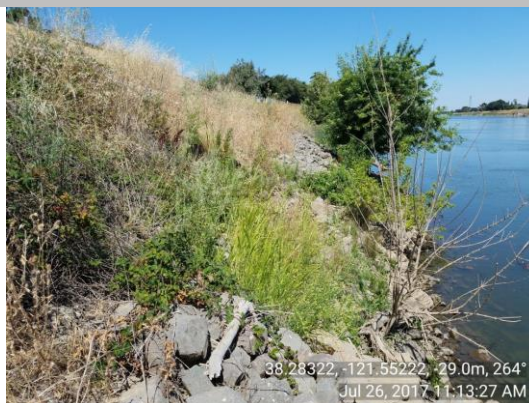
Photo 1 of 1 : FA_2021_RD0003_25_149_20210830_00079.jpg

LM Start	15.46	Rating **	A/W	Issue No.	149
LM End	15.47	Issue Type +	Ma	Location *	WS
Category	Earthen Levee			GPS Latitude/Longitude	
				Start	End
Item	Erosion / Bank Caving			38.283119 °	38.283172 °
				-121.552250 °	-121.552347 °
DWR ID	LMA-109				
Comment Code					
E1 : Note and monitor erosion site.					
Inspector Comment					
This was a 2017 Storm Damage site. Approximately 33 linear feet of erosion. The erosion commences approximately 1/2 of the way down the slope from the crown and extends into the rip rap. A section of rip rap has eroded away in this location. Site ID No:283 Site Designation:LMA-109 4/8/2020 Field Notes: Very minor erosion into waterside toe. Monitor.

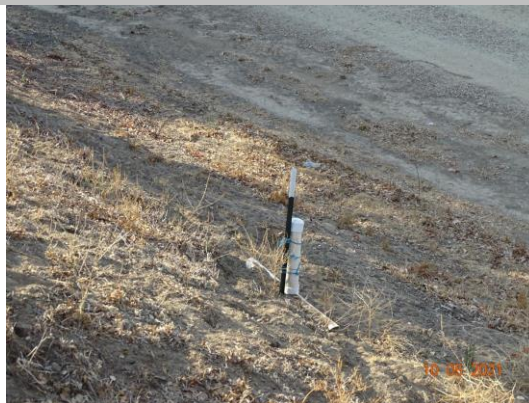
Photo 1 of 1 : FA_2021_RD0003_25_133_20211014_00291.jpg

LM Start	15.81	Rating **	M	Issue No.	133
LM End	15.81	Issue Type +	Ma	Location *	LS
Category	Earthen Levee			GPS Latitude/Longitude	
				Start	End
Item	Animal Control			38.286577 °	38.286577 °
				-121.556954 °	-121.556954 °
DWR ID	DWR_RD0003_02_f_2021_133				
Comment Code					
A1 : Exterminate rodents and backfill and compact or grout burrows.					
Inspector Comment					
A couple fresh rodent holes. LMA is baiting.

View looking downstream at rodent bait station on the landside slope (Fall 2021).

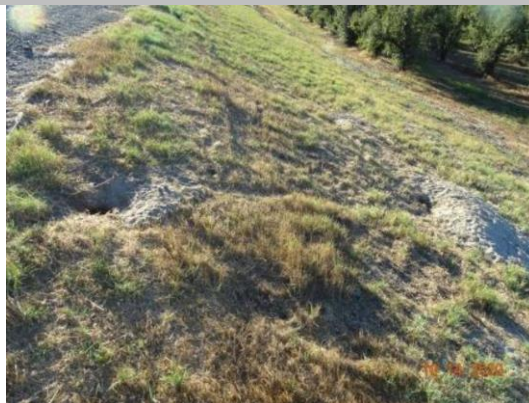
Photo 1 of 1 : FA_2021_RD0003_25_106_20210830_00048.jpg

LM Start	15.99	Rating **	A/W	Issue No.	106
LM End	15.99	Issue Type +	Ma	Location *	LS
Category	Earthen Levee			GPS Latitude/Longitude	
				Start	End
Item	Animal Control			38.288582 °	38.288582 °
				-121.558950 °	-121.558950 °
DWR ID	DWR_RD0003_02_f_2020_106				
Comment Code					
A1 : Exterminate rodents and backfill and compact or grout burrows.					
Inspector Comment					
Animal holes have been covered over. Monitor.

View looking downstream at animal holes on the landside shoulder and slope (Fall 2020).

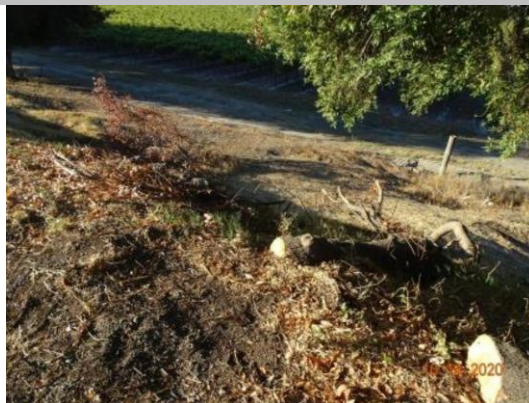
Photo 1 of 1 : FA_2021_RD0003_25_105_20210830_00047.jpg

LM Start	16.93	Rating **	M	Issue No.	105
LM End	16.93	Issue Type +	Ma	Location *	LS
Category	Earthen Levee			GPS Latitude/Longitude	
				Start	End
Item	Encroachments			38.299233 °	38.299233 °
				-121.569667 °	-121.569667 °
DWR ID	DWR_RD0003_02_f_2020_105				
Comment Code					
TR : Tree or limb					
Inspector Comment

View of down tree limb on the landside slope (Fall 2020).

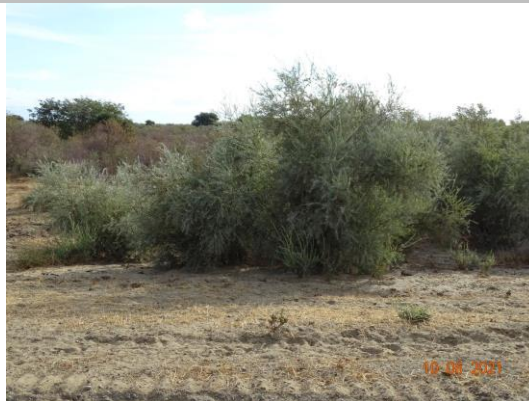
Photo 1 of 1 : FA_2021_RD0003_610_1_20211006_00003.jpg

LM Start	0.30	Rating **	M	Issue No.	1
LM End	0.30	Issue Type +	Ma	Location *	LS
Category	Earthen Levee			GPS Latitude/Longitude	
				Start	End
Item	Vegetation			38.177955 °	38.177955 °
				-121.653710 °	-121.653710 °
DWR ID	DWR_RD0003_03_f_2021_1				
Comment Code					
V2 : Remove the wild growth other than native grasses from the levee slopes.					
Inspector Comment					
Willows on the landside slope.

View of willows on the landside slope (Fall 2021).
