**Flood Control Project Maintenance
Levee Inspections**

Maintenance Issue Types Only, Levee Inspection Report By Mile - Fall 2022

Reclamation District No. 0003 Grand Island

Waterway	Bank	Unit Miles	Inspection Start/End	Inspector
Unit No. 01 Left Bank Steamboat Slough	Left	10.95	09/06/2022 09/06/2022	Saskia Donovan

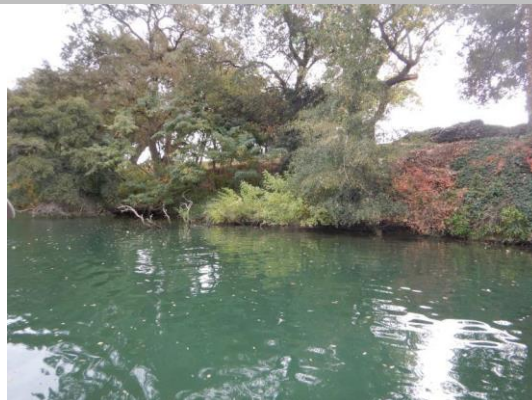
Photo 1 of 2 : FA_2022_RD0003_24_49_20220831_00016.jpg

LM Start	0.18	Rating **	A/W	Issue No.	49 (cont)
LM End	0.24	Issue Type +	Ma	Location *	WS

USACE 2018 Erosion Photo #1

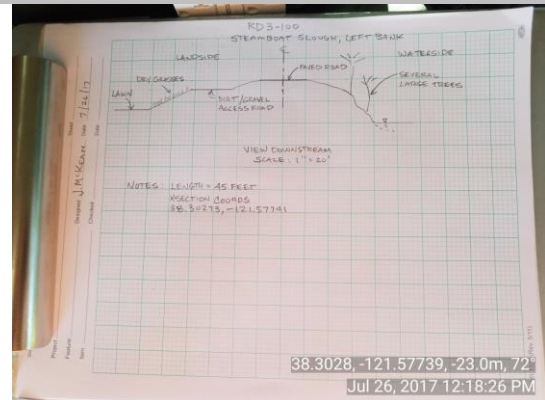
Photo 3 of 3 : LEVAL_FA_2022_274_2395.jpg

LM Start	0.18	Rating **	A/W	Issue No.	52 (cont)
LM End	0.21	Issue Type +	Ma	Location *	WS
Category	Supplemental			GPS Latitude/Longitude	
				Start	End
Item	2017 Storm Damage			38.302981 °	38.302778 °
				-121.577336 °	-121.577683 °
DWR ID	LMA-100

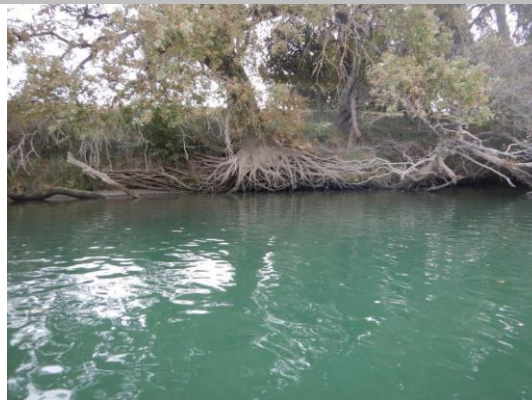
Photo 2 of 2 : FA_2022_RD0003_24_46_20220831_00014.jpg

LM Start	0.91	Rating **	A/W	Issue No.	46 (cont)
LM End	0.96	Issue Type +	Ma	Location *	WS
Category	Supplemental			GPS Latitude/Longitude	
				Start	End
Item	2018 USACE Erosion Survey			38.293386 °	38.292675 °
				-121.582554 °	-121.582741 °
DWR ID	DWR_RD0003_01_s _ 2022_46

USACE 2018 Erosion Photo #2

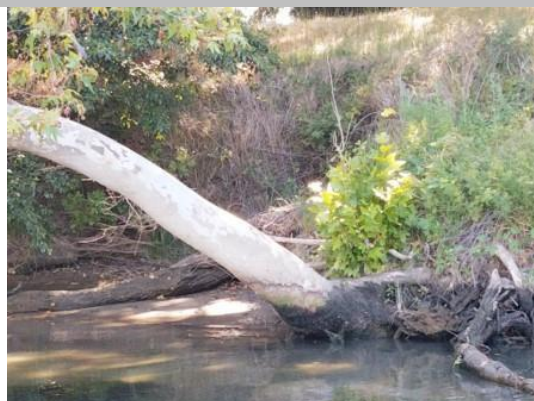
Photo 1 of 2 : FA_2022_RD0003_24_60_20220831_00027.jpg

This was a 2017 Storm Damage site.
An erosion site exists along approximately 41 linear feet of the water side slope.
Site ID No:276
Site Designation:LMA-102
6/18/2020 Boat Inspection:
Significant erosion into waterside prism directly upstream of tree that is leaning into water. That leaning tree is creating an eddy that is causing the erosion. There is also some less significant erosion into the waterside toe upstream of the significant erosion site.

LM Start	1.09	Rating **	U	Issue No.	60 (cont)
LM End	1.10	Issue Type +	Ma	Location *	WS

View from the channel of leaning tree and erosion into waterside prism (Summer 2020).

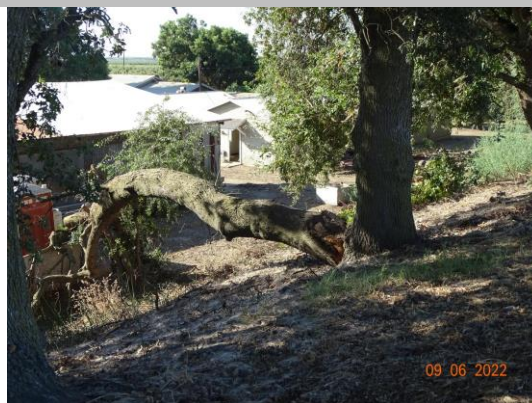
Photo 1 of 1 : FA_2022_RD0003_24_141_20220921_00292.jpg

LM Start	1.40	Rating **	U	Issue No.	141
LM End	1.40	Issue Type +	Ma	Location *	LS
Category	Earthen Levee			GPS Latitude/Longitude	
				Start	End
Item	Trim / Thin Trees			38.286475 °	38.286475 °
				-121.583700 °	-121.583700 °
DWR ID	DWR_RD0003_01_s_2022_141				
Comment Code					
T2 : Tree or limb.					
Inspector Comment

View of the large tree limb on the LS levee slope (Fall 2022).

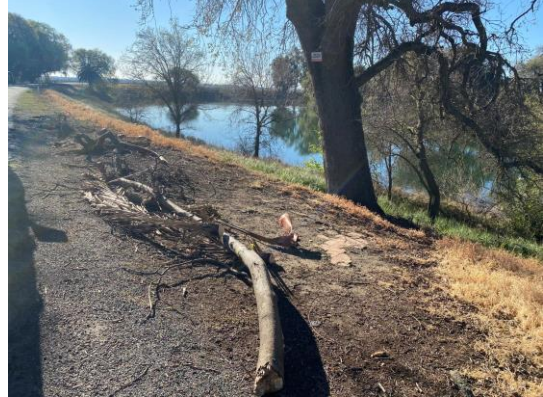
Photo 1 of 1 : FA_2022_RD0003_24_154_20220831_00065.jpg

LM Start	2.31	Rating **	A/W	Issue No.	154
LM End	2.31	Issue Type +	Ma	Location *	WS
Category	Earthen Levee			GPS Latitude/Longitude	
				Start	End
Item	Trim / Thin Trees			38.275362 °	38.275362 °
				-121.589280 °	-121.589280 °
DWR ID	DWR_RD0003_01_s_2022_154				
Comment Code					
T2 : Tree or limb.					
Inspector Comment					
Branches placed on turnout to prevent parked vehicles.

View of tree limbs placed on waterside turnout to prevent vehicle traffic (Spring 2022).

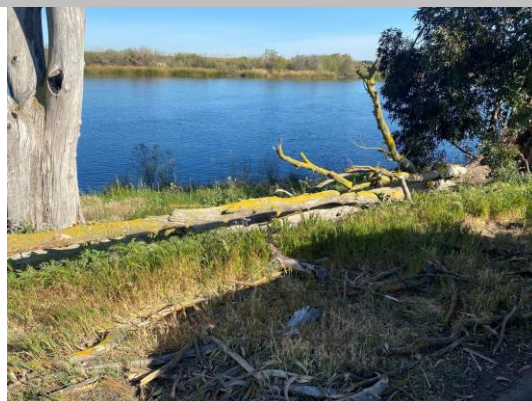
Photo 1 of 1 : FA_2022_RD0003_24_170_20220831_00069.jpg

LM Start	8.77	Rating **	U	Issue No.	170
LM End	8.77	Issue Type +	Ma	Location *	WS
Category	Earthen Levee			GPS Latitude/Longitude	
				Start	End
Item	Trim / Thin Trees			38.193821 °	38.193821 °
				-121.618183 °	-121.618183 °
DWR ID	DWR_RD0003_01_s_2022_170				
Comment Code					
T2 : Tree or limb.					
Inspector Comment

View of down tree limb on the waterside shoulder (Spring 2022).

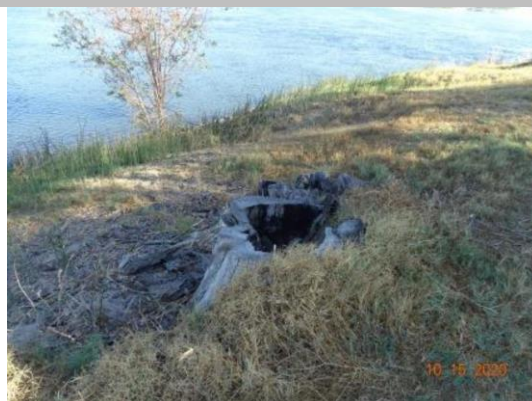
Photo 1 of 1 : FA_2022_RD0003_24_155_20220831_00066.jpg

LM Start	8.92	Rating **	N	Issue No.	155
LM End	8.92	Issue Type +	Ma	Location *	WS
Category	Earthen Levee			GPS Latitude/Longitude	
				Start	End
Item	Trim / Thin Trees			38.192985 °	38.192985 °
				-121.620712 °	-121.620712 °
DWR ID	DWR_RD0003_01_f_2020_155				
Comment Code					
T5 : Tree stumps.					
Inspector Comment					
Stump on the waterside hinge.

View of tree stump on the waterside slope (Fall 2020).

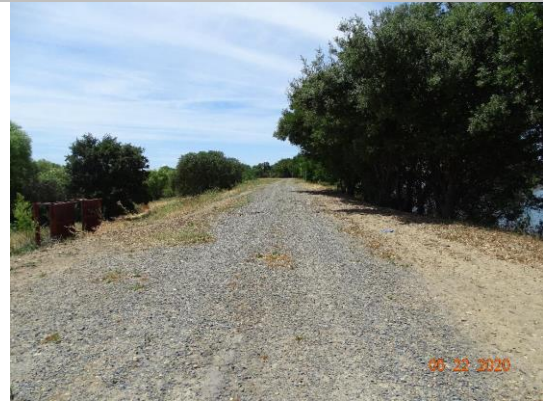
Photo 1 of 3 : UCIP_FA_2022_69661_85964.jpg

LM Start	10.82	Rating **	M	Issue No.	210
LM End	10.82	Issue Type +	Ma	Location *	
Category	Supplemental			GPS Latitude/Longitude	
				Start	End
Item	DWR UCIP LMA Responsibility			38.183044 °	38.183044 °
				-121.651367 °	-121.651367 °
DWR ID	22350				
Comment Code					
Inspector Comment					
DS_ID:22350 FS_ID:69661 EP_NO: N/A Repair Type: Non-Urgent EVAL Issue: Crossing Status: Not Found UCIP Comments: 05/22/2020 Record upgraded to Non-Urgent due to missing permit. No signs of pipe found during inspection. Geophysical study (07-24-2018) suggests no pipe present at this location. (S. Donovan - DWR UCIP) FIELD_STRUCT_DESC: 36-inch corrugated metal drainage pipe through the levee, invert elevation 24.0 feet below the crown. [Additional Reference(s): DWR Levee Log, 1993, (HLM 10.90). USACE Sacramento O&M Manual 104, February 1960, (RM 15.20)]. FS Date: 5/22/2020 7:49:00 AM

Overview of the levee crown looking d/s.

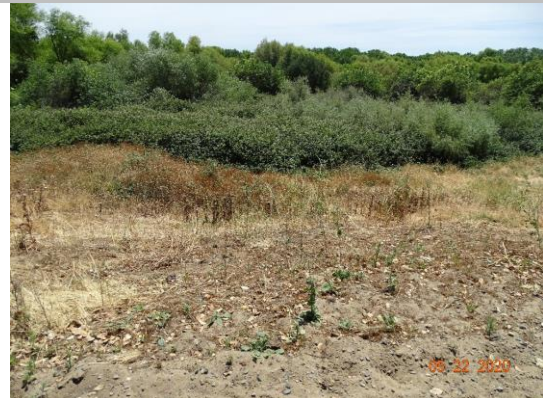
Photo 2 of 3 : UCIP_FA_2022_69661_85965.jpg

LS view: Looking down the levee slope.

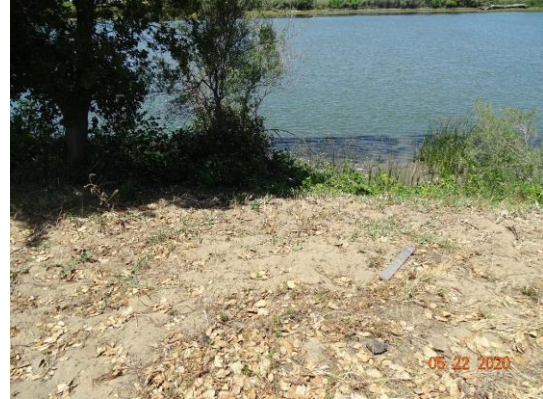
Photo 3 of 3 : UCIP_FA_2022_69661_85966.jpg

WS view: Looking down the levee slope.

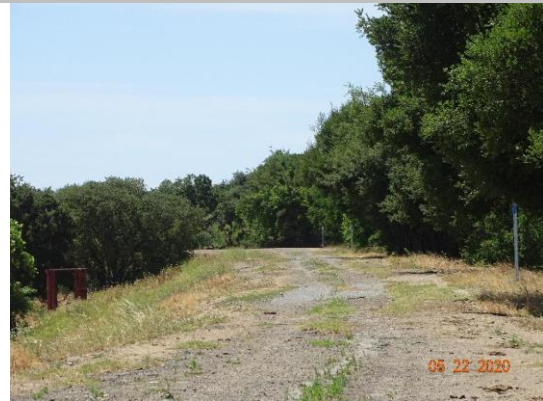
Photo 1 of 3 : UCIP_FA_2022_69662_85972.jpg

DS_ID:22206
 FS_ID:69662
 EP_NO: N/A
 Repair Type: Non-Urgent
 EVAL Issue:
 Crossing Status: Found
 UCIP Comments: 05/22/2020 Record remains Non-Urgent due to missing permit and crossing being abandoned. (S. Donovan - DWR UCIP)02/11/2014 Pipe appears abandoned and should be verified as having been done so properly. (G. Wylie - DWR UCIP)
 FIELD_STRUCT_DESC: *ABANDONED* 36-inch corrugated metal drainage pipe through the levee, 15.0 feet below the crown. Slide gate in a 48-inch corrugated metal pipe (CMP) riser on the waterside (WS) shoulder. Flap gate at the WS toe has been sealed shut with sealant.
 [Additional Reference(s): DWR Levee Log, 1993, (HLM 10.90), referenced as 24.0 feet below the crown. USACE Sacramento O&M Manual 104, February 1960, (RM 15.20), referenced as invert elevation 24.0 feet below the crown].
 FS Date: 5/22/2020 8:07:00 AM

Overview of the levee crown looking d/s.

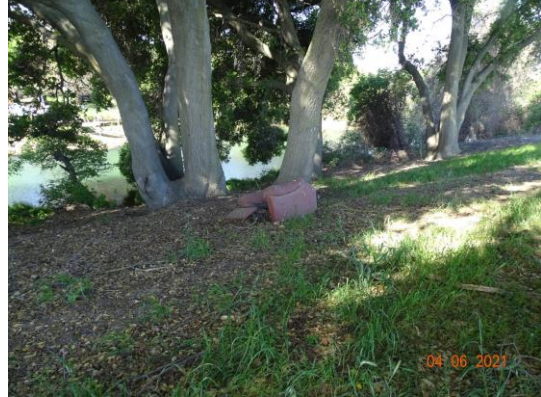
Photo 1 of 1 : FA_2022_RD0003_25_222_20220831_00136.jpg

LM Start	1.53	Rating **	M	Issue No.	222
LM End	1.53	Issue Type +	Ma	Location *	WS
Category	Earthen Levee			GPS Latitude/Longitude	
				Start	End
Item	Encroachments			38.168908 °	38.168908 °
				-121.627748 °	-121.627748 °
DWR ID	DWR_RD0003_02_f_2019_222				
Comment Code					
GA : Garbage					
Inspector Comment					
Remove discarded chair from waterside slope.

View of discarded chair on the waterside slope (Spring 2021).

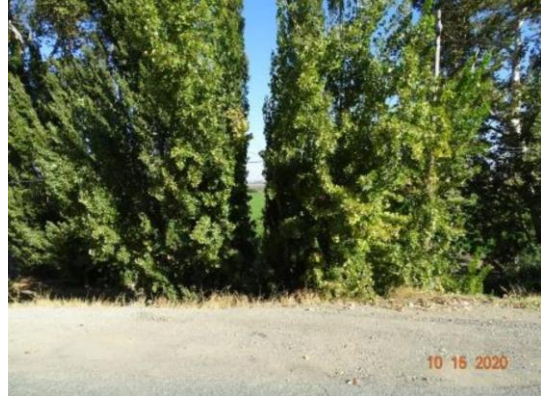
Photo 1 of 1 : FA_2022_RD0003_25_163_20220831_00095.jpg

LM Start	2.44	Rating **	M	Issue No.	163
LM End	2.44	Issue Type +	Ma	Location *	LS
Category	Earthen Levee			GPS Latitude/Longitude	
				Start	End
Item	Trim / Thin Trees			38.164342 °	38.164342 °
				-121.612455 °	-121.612455 °
DWR ID	DWR_RD0003_02_f_2020_163				
Comment Code					
T1 : Trim and thin trees to at least five feet above ground level to allow visibility of the ground and room to flood fight.					
Inspector Comment

View of trees partially blocking the view down the landside slope (Fall 2020).

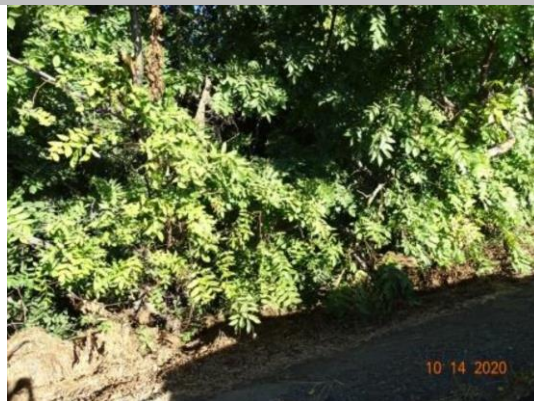
Photo 1 of 1 : FA_2022_RD0003_25_14_20220831_00006.jpg

LM Start	4.95	Rating **	U	Issue No.	14
LM End	4.95	Issue Type +	Ma	Location *	LS
Category	Earthen Levee			GPS Latitude/Longitude	
				Start	End
Item	Trim / Thin Trees			38.188526 °	38.188526 °
				-121.581179 °	-121.581179 °
DWR ID	DWR_RD0003_02_f_2020_14				
Comment Code					
T1 : Trim and thin trees to at least five feet above ground level to allow visibility of the ground and room to flood fight.					
Inspector Comment					
There are untrimmed trees on the landside slope and toe.

View of untrimmed trees on the landside slope (Fall 2020).

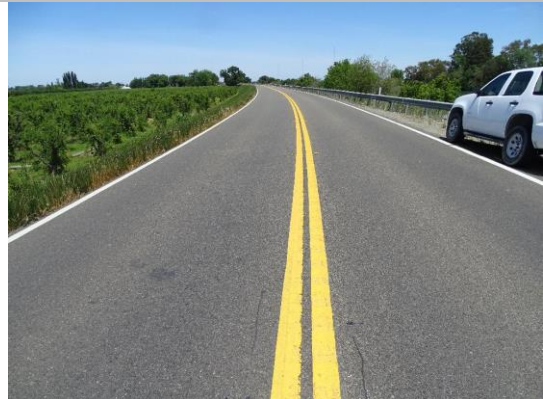
Photo 1 of 3 : UCIP_FA_2022_77006_113084.jpg

LM Start	6.07	Rating **	M	Issue No.	956	
LM End	6.07	Issue Type +	Ma	Location *		
Category	Supplemental			GPS Latitude/Longitude		
				Start		End
Item	DWR UCIP LMA Responsibility			38.195513 °	38.195513 °	
				-121.562812 °	-121.562812 °	
DWR ID	22239					
Comment Code						
Inspector Comment						
DS_ID:22239 FS_ID:77006 EP_NO: N/A Repair Type: Non-Urgent EVAL Issue: Crossing Status: Not Found UCIP Comments: 05/19/2022 Not found, unauthorized and abandoned encroachment found in LL and O&M, pipe replaced by DSID 22238, non-urgent. (A. McDonald - DWR UCIP) FIELD_STRUCT_DESC: *ABANDONED* 10-inch steel pipe of an unknown purpose through the levee, invert elevation 2.8 feet below the crown. Pipe is capped on the waterside (WS) end. [Additional Reference(s): DWR Levee Log, 1993. USACE Sacramento O&M Manual 104, February 1960, (RM 20.99)]. FS Date: 5/19/2022

Levee overview looking US

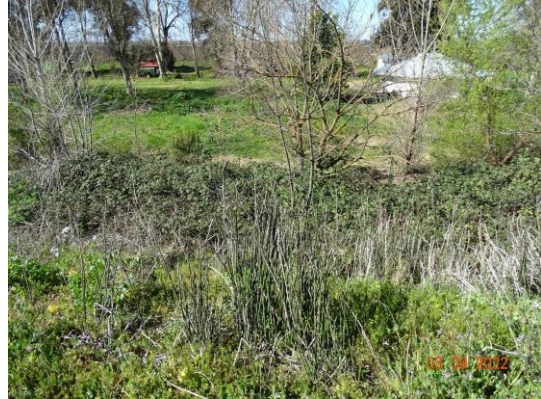
Photo 1 of 1 : FA_2022_RD0003_25_179_20220831_00108.jpg

LM Start	8.45	Rating **	U	Issue No.	179
LM End	8.45	Issue Type +	Ma	Location *	LS
Category	Earthen Levee			GPS Latitude/Longitude	
				Start	End
Item	Vegetation			38.229049 °	38.229049 °
				-121.557230 °	-121.557230 °
DWR ID	DWR_RD0003_02_s_2022_179				
Comment Code					
V2 : Remove the wild growth and woody vegetation other than native grasses from the levee slopes.					
Inspector Comment					
There are blackberries on the landside slope.

View of blackberries on the landside toe (Spring 2022).

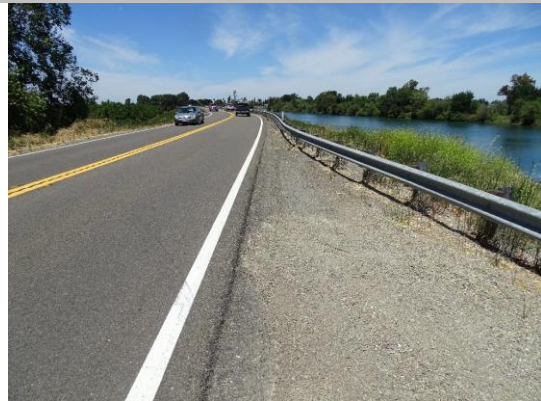
Photo 1 of 3 : UCIP_FA_2022_77154_114738.jpg

Comment Code						
Inspector Comment						
DS_ID:22261						
FS_ID:77154						
EP_NO: N/A						
Repair Type: Non-Urgent						
EVAL Issue:						
Crossing Status: Not Found						
UCIP Comments: 06/09/2022 Abandoned, not found, unauthorized encroachment, USACE legacy system pipe, non-urgent. (A. McDonald - DWR UCIP)						
FIELD_STRUCT_DESC: *ABANDONED* 10-inch steel gravity drainage pipe through the levee, invert elevation 5.8 feet below the crown.						
Concrete pad and retaining wall on the waterside (WS) slope.						
[Additional Reference(s): DWR Levee Log, 1993. USACE Sacramento O&M Manual 104, February 1960, (RM 23.43)].						
FS Date: 6/9/2022

Levee overview looking US

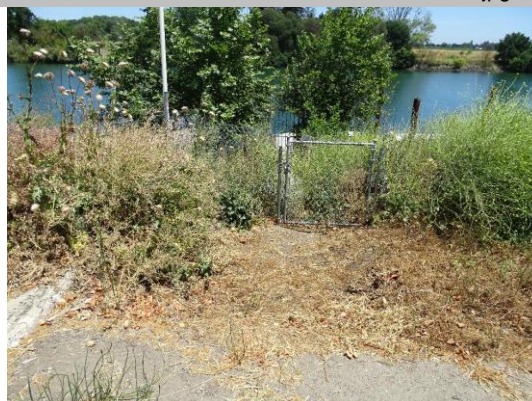
Photo 2 of 3 : UCIP_FA_2022_77154_114740.jpg

WS overview, gate, walkway, and dock on slope and river

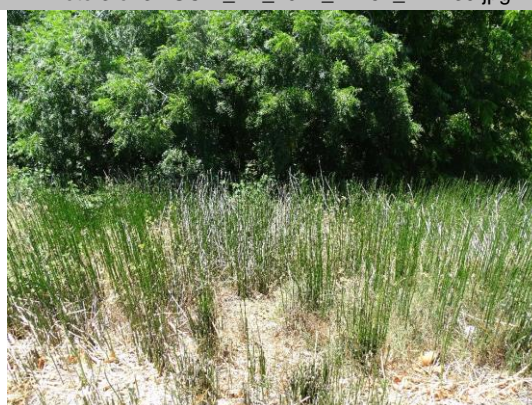
Photo 3 of 3 : UCIP_FA_2022_77154_114739.jpg

LS overview

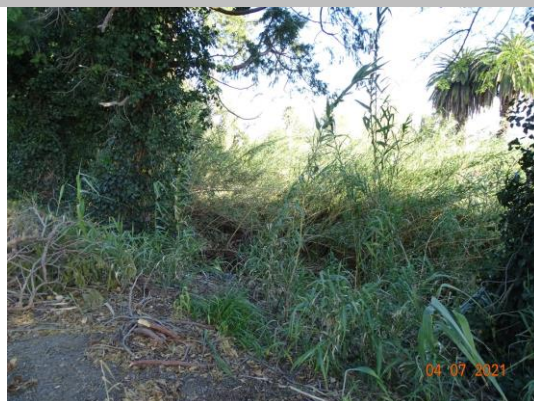
Photo 1 of 1 : FA_2022_RD0003_25_145_20220831_00079.jpg

LM Start	10.17	Rating **	U	Issue No.	145
LM End	10.18	Issue Type +	Ma	Location *	LS
Category	Earthen Levee			GPS Latitude/Longitude	
				Start	End
Item	Vegetation			38.241075 °	38.241027 °
				-121.541843 °	-121.541633 °
DWR ID	DWR_RD0003_02_s_2021_145				
Comment Code					
V2 : Remove the wild growth and woody vegetation other than native grasses from the levee slopes.					
Inspector Comment					
There is arundo on the landside slope.

View of thick arundo on the landside slope (Spring 2021).

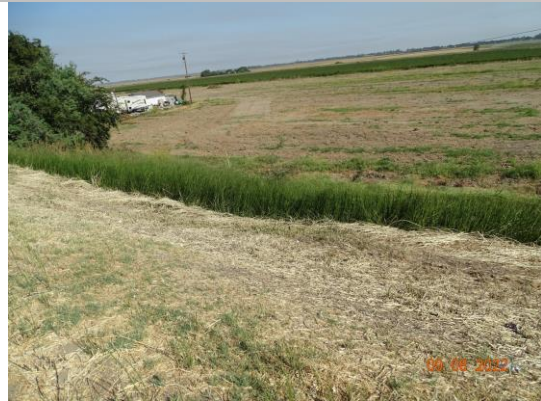
Photo 1 of 1 : FA_2022_RD0003_25_281_20220923_00181.jpg

LM Start	10.54	Rating **	M	Issue No.	281
LM End	10.63	Issue Type +	Ma	Location *	LS
Category	Earthen Levee			GPS Latitude/Longitude	
				Start	End
Item	Vegetation			38.239449 °	38.239072 °
				-121.535176 °	-121.533683 °
DWR ID	DWR_RD0003_02_f_2022_281				
Comment Code					
V1 : Control annual grass and weeds on the levee slopes and easements.					
Inspector Comment					
Grasses are getting to tall on lower LS slope and needs to be mowed.

View of the grass along the lower LS slope (Fall 2022).

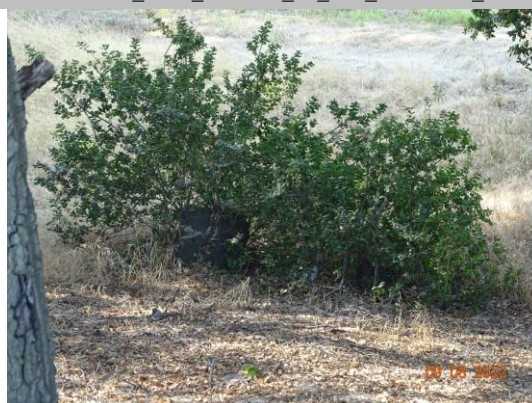
Photo 1 of 1 : FA_2022_RD0003_25_135_20220923_00179.jpg

LM Start	12.88	Rating **	N	Issue No.	135
LM End	12.88	Issue Type +	Ma	Location *	LS
Category	Earthen Levee			GPS Latitude/Longitude	
				Start	End
Item	Trim / Thin Trees			38.257244 °	38.257244 °
				-121.518037 °	-121.518037 °
DWR ID	DWR_RD0003_02_s_2018_135				
Comment Code					
T5 : Tree stumps.					
Inspector Comment					
There is a tree stump at levee toe.

View of the tree stump at the LS toe (Fall 2022).

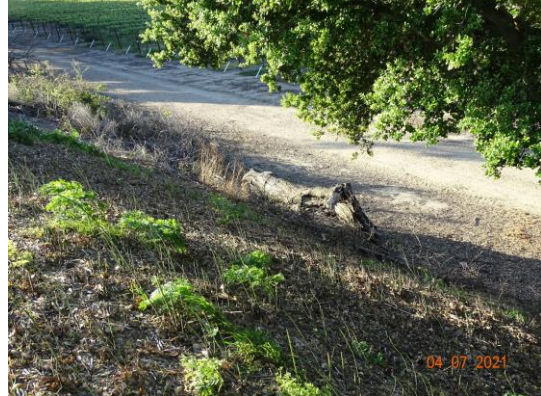
Photo 1 of 1 : FA_2022_RD0003_25_185_20220831_00113.jpg

LM Start	15.39	Rating **	M	Issue No.	185
LM End	15.39	Issue Type +	Ma	Location *	LS
Category	Earthen Levee			GPS Latitude/Longitude	
				Start	End
Item	Trim / Thin Trees			38.282427 °	38.282427 °
				-121.551348 °	-121.551348 °
DWR ID	DWR_RD0003_02_f_2019_185				
Comment Code					
T2 : Tree or limb.					
Inspector Comment

View of down tree limb on the landside toe (Spring 2021).

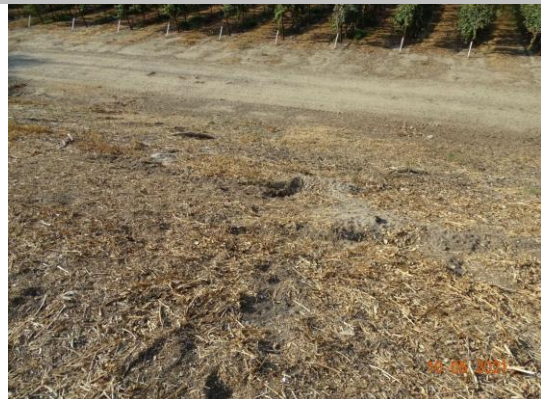
Photo 1 of 1 : FA_2022_RD0003_25_151_20220831_00085.jpg

LM Start	15.41	Rating **	U	Issue No.	151
LM End	15.43	Issue Type +	Ma	Location *	LS
Category	Earthen Levee			GPS Latitude/Longitude	
				Start	End
Item	Animal Control			38.282541 °	38.282703 °
				-121.551577 °	-121.551863 °
DWR ID	DWR_RD0003_02_f_2021_151				
Comment Code					
A1 : Exterminate rodents and backfill and compact or grout burrows.					
Inspector Comment					
The LMA has been baiting and there is less activity but holes still need to be backfilled.

View looking downslope at fresh rodent holes in the landside slope (Fall 2021).

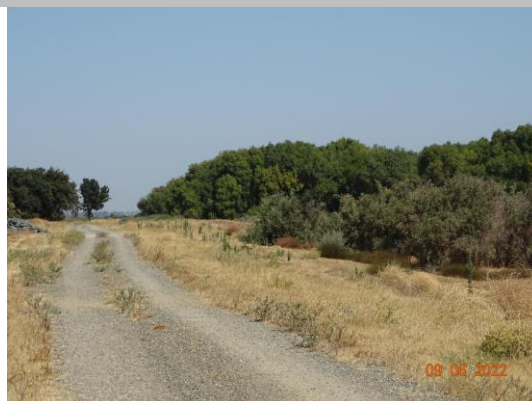
Photo 1 of 1 : FA_2022_RD0003_610_1_20220923_00004.jpg

LM Start	0.30	Rating **	M	Issue No.	1
LM End	0.30	Issue Type +	Ma	Location *	LS
Category	Earthen Levee			GPS Latitude/Longitude	
				Start	End
Item	Vegetation			38.177955 °	38.177955 °
				-121.653710 °	-121.653710 °
DWR ID	DWR_RD0003_03_f_2021_1				
Comment Code					
V2 : Remove the wild growth and woody vegetation other than native grasses from the levee slopes.					
Inspector Comment					
Willows on the landside slope.

View of the willows on the LS looking north (Fall 2022).

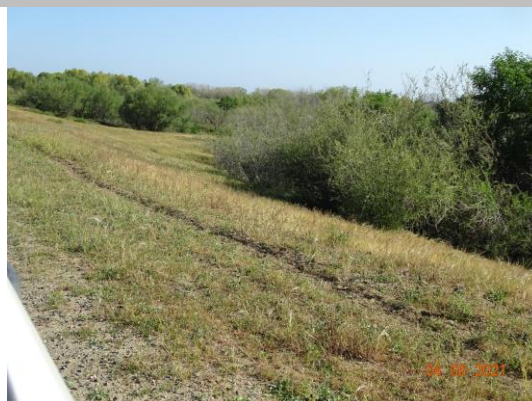
Photo 1 of 1 : FA_2022_RD0003_610_5_20220831_00002.jpg

LM Start	0.37	Rating **	M	Issue No.	5
LM End	0.37	Issue Type +	Ma	Location *	LS
Category	Earthen Levee			GPS Latitude/Longitude	
				Start	End
Item	Vegetation			38.176857 °	38.176857 °
				-121.653785 °	-121.653785 °
DWR ID	DWR_RD0003_03_s_2020_5				
Comment Code					
V2 : Remove the wild growth and woody vegetation other than native grasses from the levee slopes.					
Inspector Comment					
Trim willows back from landside slope.

View of willows on the landside slope (Spring 2021).
