**Flood Control Project Maintenance  
Levee Inspections**

**Maintenance Issue Types Only, Levee Inspection Report By Mile - Fall 2023**

**Reclamation District No. 0003 Grand Island**

Waterway	Bank	Unit Miles	Inspection Start/End	Inspector
Unit No. 01 Left Bank Steamboat Slough	Left	10.95	10/23/2023 10/23/2023	Brooks Weisser

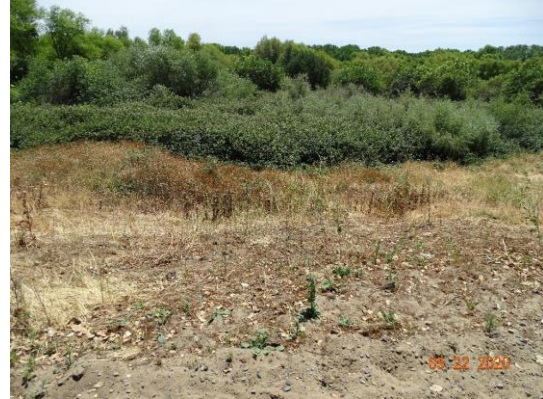
Photo 2 of 3 : UCIP\_FA\_2023\_69661\_85965.jpg

LM Start	<b>10.82</b>	Rating **	M	Issue No.	<b>210 (cont)</b>
LM End	<b>10.82</b>	Issue Type +	Ma	Location *	
Category	Supplemental			GPS Latitude/Longitude	
				Start	End
Item	DWR UCIP LMA Responsibility			38.183044°	38.183044°
				-121.651367°	-121.651367°
DWR ID	22350

LS view: Looking down the levee slope.

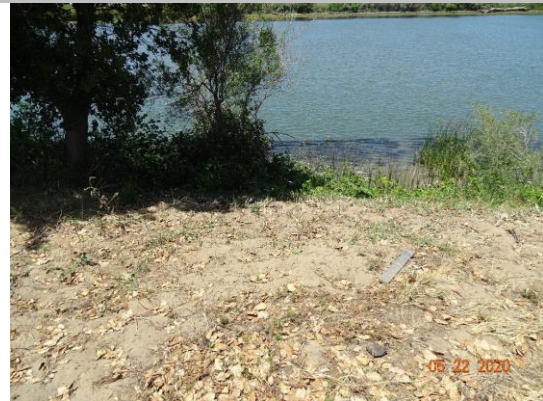
Photo 3 of 3 : UCIP\_FA\_2023\_69661\_85966.jpg

LM Start	<b>10.82</b>	Rating **	M	Issue No.	<b>210 (cont)</b>
LM End	<b>10.82</b>	Issue Type +	Ma	Location *

WS view: Looking down the levee slope.

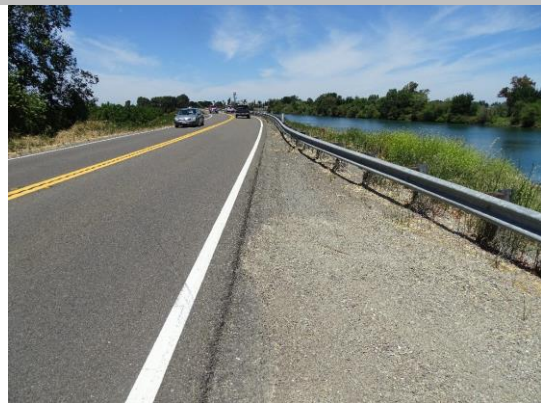
Photo 1 of 3 : UCIP\_FA\_2023\_77154\_114738.jpg

LM Start	8.48	Rating **	M	Issue No.	958	
LM End	8.48	Issue Type +	Ma	Location *		
Category	Supplemental			GPS Latitude/Longitude		
				Start	End	
Item	DWR UCIP LMA Responsibility			38.229477°	38.229477°	
				-121.557255°	-121.557255°	
DWR ID	22261					
Comment Code						
Inspector Comment						
DS_ID:22261 FS_ID:77154 EP_NO: N/A Repair Type: Non-Urgent EVAL Issue: Crossing Status: Not Found UCIP Comments: 06/09/2022 Abandoned, not found, unauthorized encroachment, USACE legacy system pipe, non-urgent. (A. McDonald - DWR UCIP) FIELD_STRUCT_DESC: 10-inch steel gravity drainage pipe through the levee, invert elevation 5.8 feet below the crown. Concrete pad and retaining wall on the waterside (WS) slope. [Additional Reference(s): DWR Levee Log, 1993. USACE Sacramento O&M Manual 104, February 1960, (RM 23.43)]. FS Date: 6/9/2022

Levee overview looking US

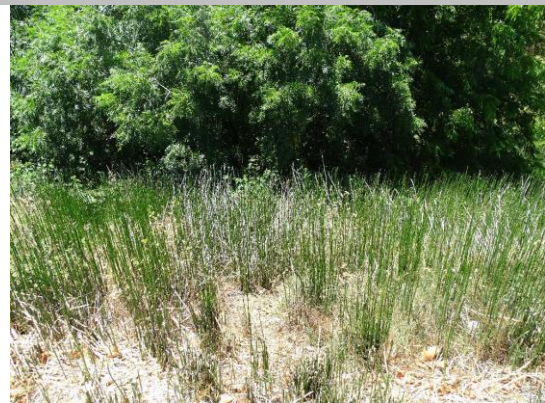
Photo 3 of 3 : UCIP\_FA\_2023\_77154\_114739.jpg

LM Start	<b>8.48</b>	Rating **	M	Issue No.	<b>958 (cont)</b>
LM End	<b>8.48</b>	Issue Type +	Ma	Location *

LS overview

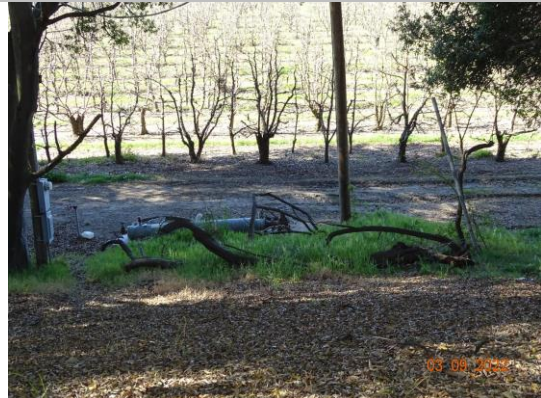
Photo 1 of 1 : FA\_2023\_RD0003\_25\_189\_20231019\_00107.jpg

LM Start	13.10	Rating **	M	Issue No.	189
LM End	13.10	Issue Type +	Ma	Location *	LS
Category	Earthen Levee			GPS Latitude/Longitude	
				Start	End
Item	Trim / Thin Trees			38.259363°	38.259363°
				-121.521007°	-121.521007°
DWR ID	DWR_RD0003_02_f_2021_189				
Comment Code					
T2 : Tree or limb.					
Inspector Comment					
Remove downed tree limb at landside toe.

View of downed tree limb on the landside toe (Spring 2022).

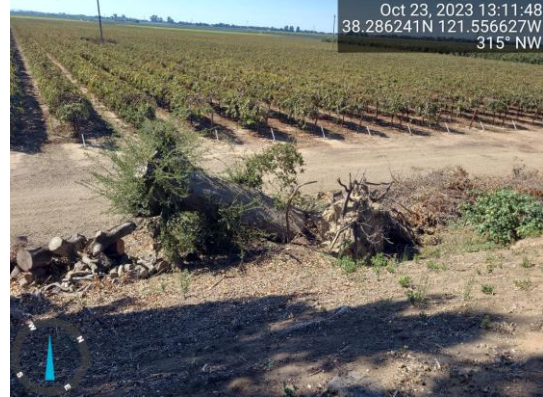
Photo 1 of 1 : FA\_2023\_RD0003\_25\_42\_20231025\_00224.jpg

LM Start	15.78	Rating **	M	Issue No.	42
LM End	15.78	Issue Type +	Ma	Location *	LS
Category	Earthen Levee			GPS Latitude/Longitude	
				Start	End
Item	Trim / Thin Trees			38.286236°	38.286236°
				-121.556601°	-121.556601°
DWR ID	DWR_RD0003_02_f_2023_42				
Comment Code					
T3 : Fallen tree with root ball.					
Inspector Comment					
Fallen tree trunk and root ball need to be removed and regraded.

View of a fallen tree trunk and root ball (Fall 2023).

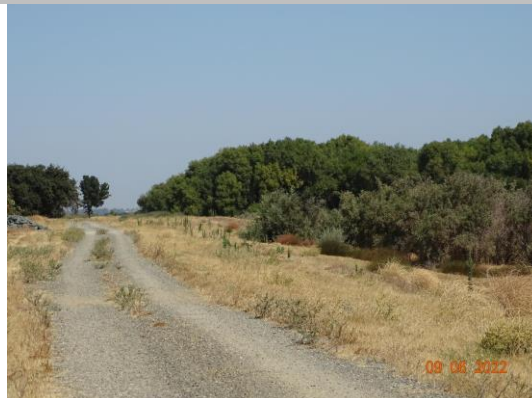
Photo 1 of 1 : FA\_2023\_RD0003\_610\_1\_20231019\_00001.jpg

LM Start	0.30	Rating **	M	Issue No.	1
LM End	0.30	Issue Type +	Ma	Location *	LS
Category	Earthen Levee			GPS Latitude/Longitude	
				Start	End
Item	Vegetation			38.177955°	38.177955°
				-121.653710°	-121.653710°
DWR ID	DWR_RD0003_03_f_2021_1				
Comment Code					
V2 : Remove the wild growth and woody vegetation other than native grasses from the levee slopes.					
Inspector Comment					
Willows are on the landside slope.

View of the willows on the LS looking north (Fall 2022).
