**Flood Control Project Maintenance
Levee Inspections**

Fall 2013 Levee Maintenance Deficiency Summary Report

**Flood Control Project Maintenance
Levee Inspections
LMA District Cover Sheet
Fall 2013 Levee Inspection Results**

Reclamation District No. 0010 Honcut

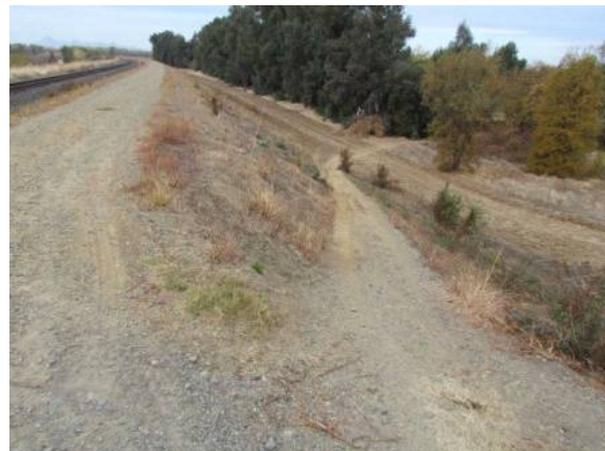
Levee Mile Report Line	8
Start Levee Mile	0.71
End Levee Mile	0.71
Location	Land Side
Category	Earthen Levee
Item	Slope Stability
This photo was taken from the crown looking down the landward slope at an ATV access road that has been formed over time to provide access to the waterward side. Fall 2013.	
mhoffman_f_20131115_695.JPG

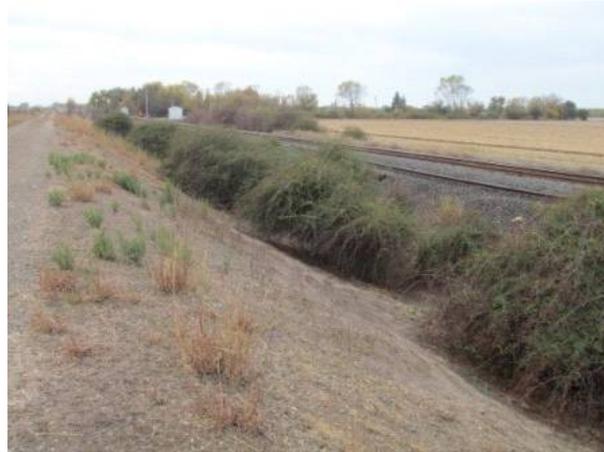
This photo was taken from the levee crown facing south looking down the landward slope at wild roses growing near the toe. Fall 2013.

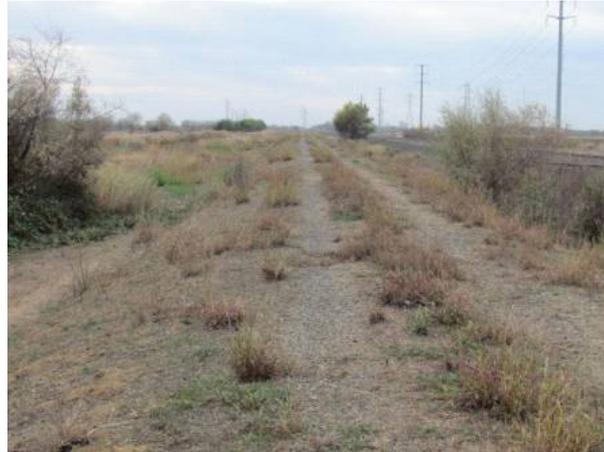
This photo was taken from the levee crown facing south looking at vegetation present on the crown. Fall 2013.

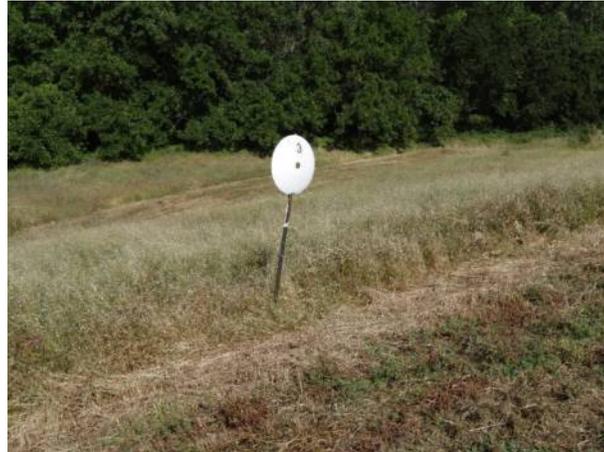
Levee Mile Report Line	1
Start Levee Mile	0.37
End Levee Mile	0.37
Location	Land Side
Category	Supplemental
Item	DWR UCIP Field Study
Enter photo 1 description or comment here.	
UCIP_11488.jpg

1	0.37	0.37	Supplemental	DWR UCIP Field Study	WS	U En	Inspector Comments: FS_ID:19289 EP_NO: N/A Repair Type: Urgent Crossing Status: Found UCIP Comments: Dense vegetation limits the inspector's visibility to identify signs of pipe failure (leaks) along the slope. Recommend removing vegetation along pipe alignment to conduct proper inspection of structure and appurtances. FIELD_STRUCT_DESC: 24-inch CM pipe through the levee, 25.6 feet below the crown. Two CM cutoff walls around pipe at both shoulders. Flap gate on the waterward end. Concrete headwall, saddle and apron on the waterward end. (USACE-1953). This entry matches the Drainage or Irrigation Structure referenced in O&M manual (Station 106+00). FS Date: 4/30/2013	39.169021 °	-121.610670 °	1 Y
DWR ID: DWR_RD0010_02_f_2013_1

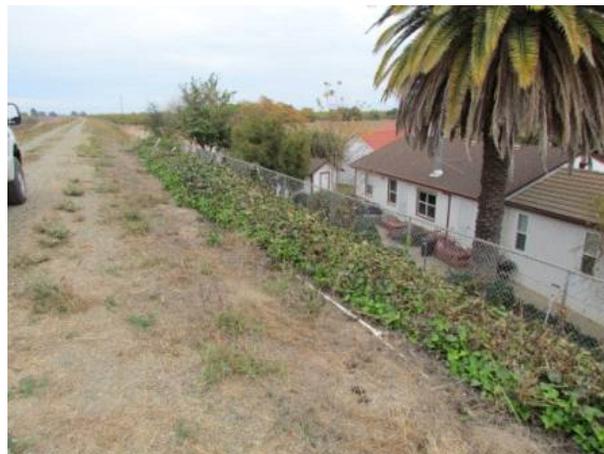
Levee Mile Report Line	6
Start Levee Mile	1.35
End Levee Mile	1.35
Location	Land Side
Category	Earthen Levee
Item	Vegetation
This photo was taken from the crown looking down the landward slope at landscaping and a fence. Fall 2013.	
mhoffman_f_20131115_696.JPG

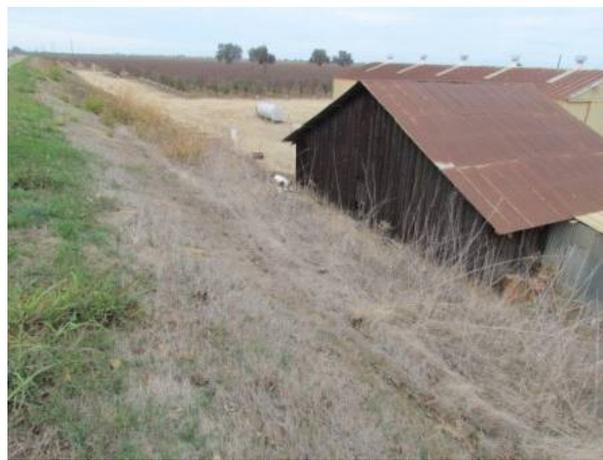
Levee Mile Report Line	10
Start Levee Mile	2.13
End Levee Mile	2.13
Location	Land Side
Category	Earthen Levee
Item	Encroachments

This photo was taken from the crown facing north looking down the landward levee slope at an outbuilding near the levee toe. Fall 2013.

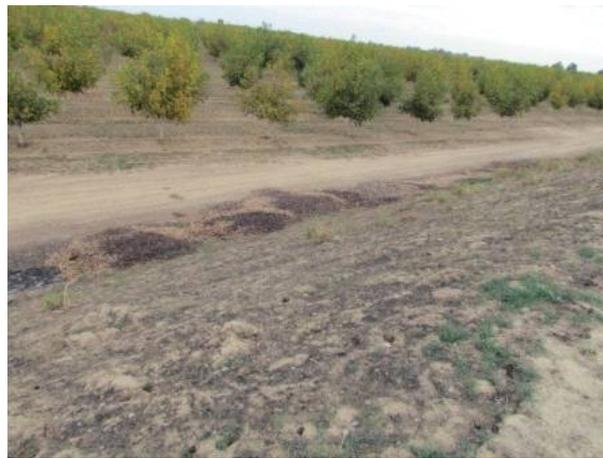
Levee Mile Report Line	11
Start Levee Mile	3.02
End Levee Mile	3.02
Location	Land Side
Category	Earthen Levee
Item	Encroachments

This photo was taken from the crown facing south looking down the landward slope at a pile of walnut hulls at the levee toe. Fall 2013.

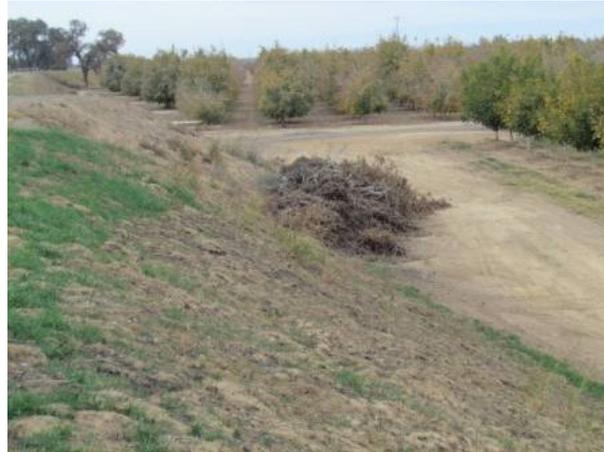
This photo was taken from the levee crown facing north looking down the landward levee slope at a pruning pile near the levee toe. Fall 2013.

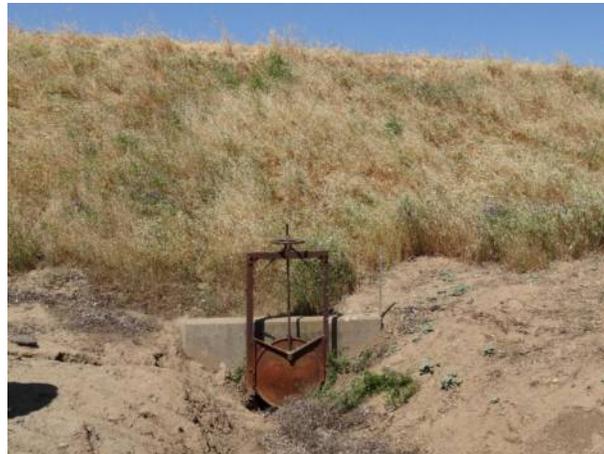
Levee Mile Report Line	14
Start Levee Mile	3.11
End Levee Mile	3.11
Location	Land Side
Category	Supplemental
Item	DWR UCIP Field Study

14	3.11	3.11	Supplemental	DWR UCIP Field Study	LS	M En	Inspector Comments: FS_ID:19292 EP_NO: N/A Repair Type: Non-Urgent Crossing Status: Found UCIP Comments: Dense vegetation limits the inspector's visibility to identify signs of pipe failure (leaks) along the slope. Recommend removing vegetation along pipe alignment to conduct proper inspection of structure and appurtenances. FIELD_STRUCT_DESC: 30-inch CM drainpipe through the levee, 22.5 feet below the crown. Flap gate on the waterward end. Metal marker on waterward shoulder. FS Date: 4/30/2013	39.208213 °	-121.609894 °	24 Y
----	------	------	--------------	----------------------	----	---------	---	-------------	---------------	---------

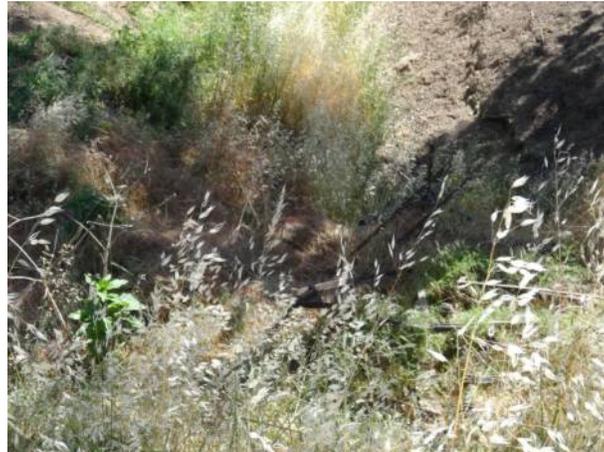
Levee Mile Report Line	15
Start Levee Mile	3.31
End Levee Mile	3.31
Location	Land Side
Category	Supplemental
Item	DWR UCIP Field Study

15	3.31	3.31	Supplemental	DWR UCIP Field Study	LS	M En	Inspector Comments: FS_ID:17820 EP_NO: N/A Repair Type: Non-Urgent Crossing Status: Found UCIP Comments: FIELD_STRUCT_DESC: 36-inch CM drainpipe through the levee, 24.0 feet below the crown. Two CM cutoff walls around pipe at both shoulders. Flap gate on the waterward end. Slide gate on the landward end. Concrete headwalls at both ends. (USACE-1953). This entry matches the Drainage or Irrigation Structure referenced in O&M manual (Station 259+76). FS Date: 4/30/2013	39.211024 °	-121.610281 °	25 Y
----	------	------	--------------	----------------------	----	---------	--	-------------	---------------	---------

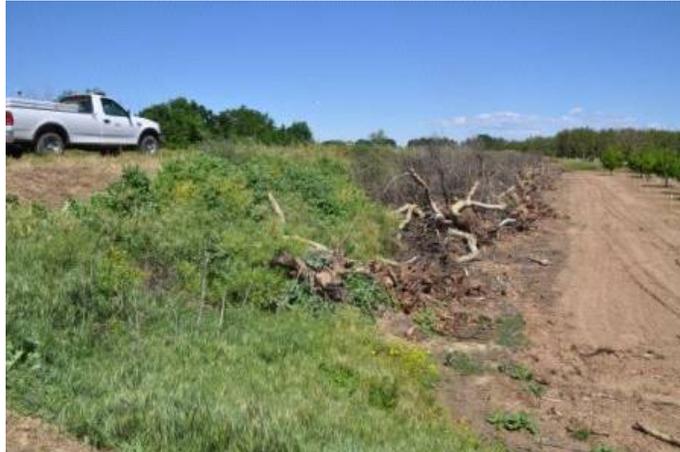
Levee Mile Report Line	43
Start Levee Mile	9.31
End Levee Mile	9.37
Location	Land Side
Category	Earthen Levee
Item	Encroachments
RD 10, Unit 2 - pruning piles on L/S levee slope.	
mhoffman_f_20130917_054.JPG

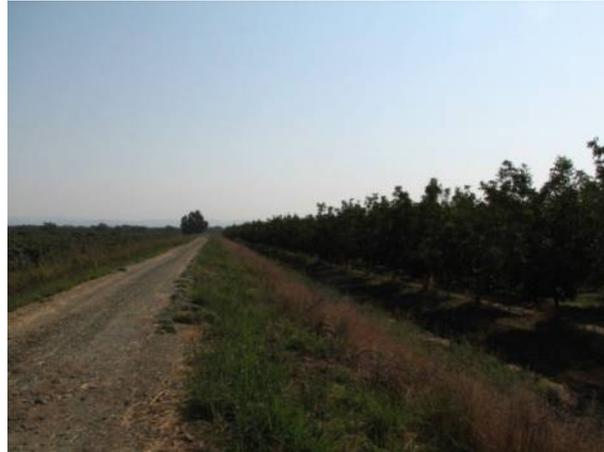
Levee mile 0.18, the landside slope.

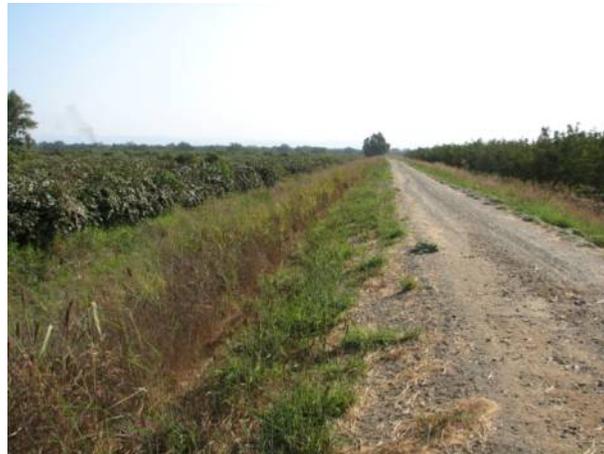
Levee Mile Report Line	2
Start Levee Mile	0.06
End Levee Mile	1.24
Location	Water Side
Category	Earthen Levee
Item	Vegetation

Levee mile 0.18, the waterside slope.

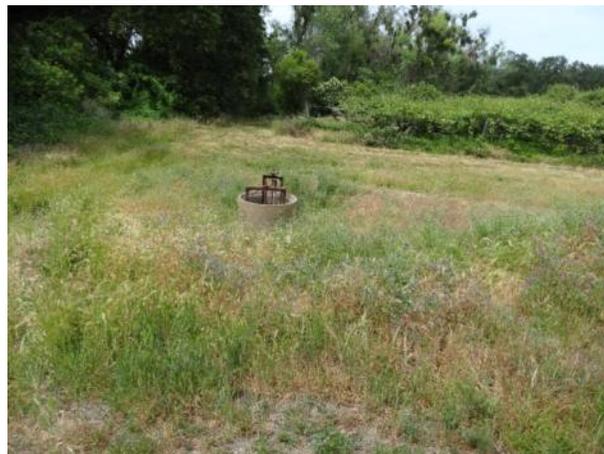
Levee Mile Report Line	6
Start Levee Mile	0.18
End Levee Mile	0.18
Location	Water Side
Category	Supplemental
Item	DWR UCIP Field Study

DWR ID: DWR_RD0010_03_f_2013_8										
6	0.18	0.18	Supplemental	DWR UCIP Field Study	LS	M En	Inspector Comments: FS_ID:17859 EP_NO: N/A Repair Type: Non-Urgent Crossing Status: Found UCIP Comments: FIELD_STRUCT_DESC: 24-inch CM pipe through the levee, 6.0 feet below the crown. Slide gate in concrete standpipe on the waterward end. FS Date: 5/1/2013	39.310139 ° 39.310139 °	-121.616080 ° -121.616080 °	10 Y
DWR ID: DWR_RD0010_03_f_2013_10										
7	1.24	1.35	Earthen Levee	Vegetation	WS	C Ma	V2 : Remove the wild growth other than native grasses from the levee slopes.	39.307080 ° -121.597484 °	39.306479 ° -121.595453 °	7
DWR ID: DWR_RD0010_03_f_2012_7										
8	1.27	1.27	Earthen Levee	Encroachments	LS	A En	DE : Debris	39.307034 ° -121.597219 °	39.307034 ° -121.597219 °	2
DWR ID: DWR_RD0010_03_s_2012_2										
9	1.39	1.39	Earthen Levee	Encroachments	LS	A En	DE : Debris	39.306431 ° -121.595058 °	39.306431 ° -121.595058 °	9

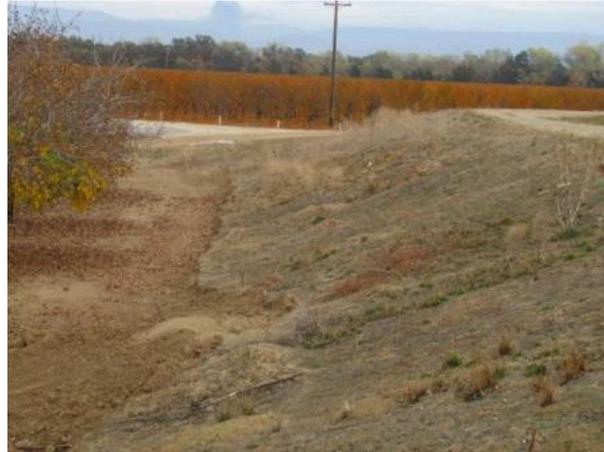
This photo was taken from the levee crown facing north looking down the waterward slope at agricultural tilling causing a cut at the levee toe. Fall 2013.

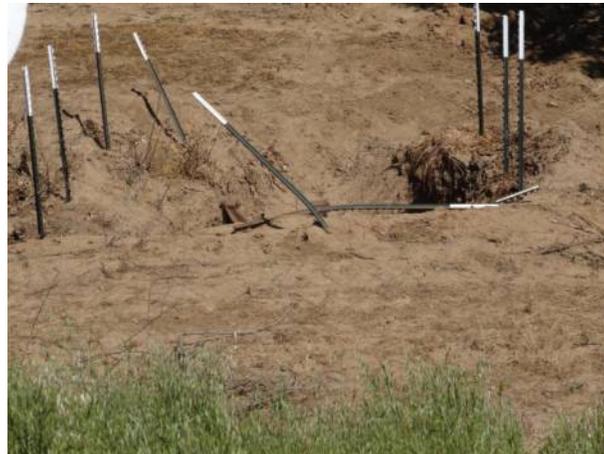
Levee Mile Report Line	14
Start Levee Mile	1.89
End Levee Mile	1.89
Location	Water Side
Category	Supplemental
Item	DWR UCIP Field Study

DWR ID: DWR_RD0010_03_f_2013_13		
14	1.89	1.89	Supplemental	DWR UCIP Field Study	WS	M	Inspector Comments: FS_ID:17861 EP_NO: N/A Repair Type: Non-Urgent Crossing Status: Found UCIP Comments: FIELD_STRUCT_DESC: 24-inch CM drainpipe through the levee, 15.0 feet below the crown. Two CM cutoff walls around pipe at both shoulders. Flap gate on the waterward end. Slide gate on the landward end. Concrete headwall at both toes. (USACE-1953). This entry matches the Drainage or Irrigation Structure referenced in O&M manual (Station 134+06). FS Date: 5/1/2013	39.303089 ° 39.303089 °	-121.587968 ° -121.587968 °	14 Y
								DWR ID: DWR_RD0010_03_f_2013_14

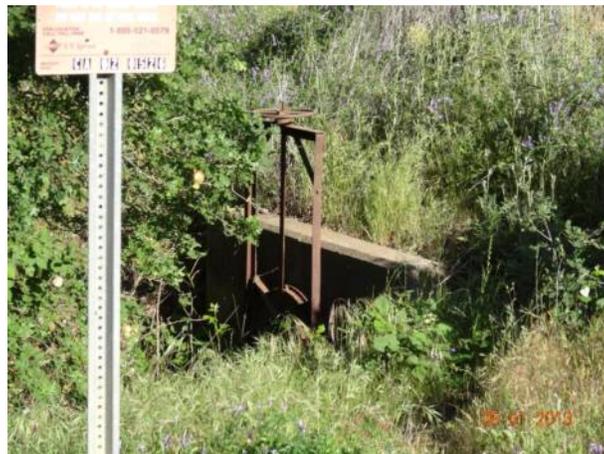
Levee Mile Report Line	15
Start Levee Mile	3.00
End Levee Mile	3.00
Location	Water Side
Category	Supplemental
Item	DWR UCIP Field Study

LMIR No.	Levee Mile		Category	Item	Location	Rating	Action/Comment	GPS Latitude/Longitude		Issue No. Photo
	Start	End						Start	End	
15	3.00	3.00	Supplemental	DWR UCIP Field Study	WS	M En	Inspector Comments: FS_ID:19288 EP_NO: N/A Repair Type: Non-Urgent Crossing Status: Found UCIP Comments: Dense vegetation limits the inspector's visibility to identify signs of pipe failure (leaks) along the slope. Recommend removing vegetation along pipe alignment to conduct proper inspection of structure and appurtenances. FIELD_STRUCT_DESC: 24-inch pipe through the levee, 12.0 feet below the crown. Two CM cutoff walls around pipe at both shoulders. Flap gate on the waterward end. Slide gate on the landward end. Concrete headwall at the landward toe. (USACE-1953). This entry matches the Drainage or Irrigation Structure referenced in O&M manual (Station 192+33). FS Date: 5/1/2013	39.298561 °	-121.569977 °	15 Y
