**Flood Control Project Maintenance
Levee Inspections**

Fall 2015 Levee Maintenance Deficiency Summary Report

Sacramento River Basin

Reclamation District No. 0010 Honcut

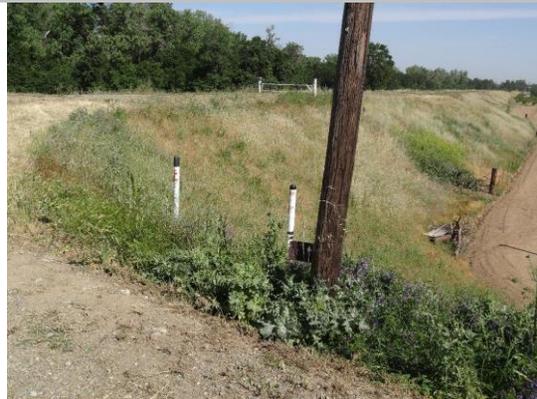
Photo 2 of 2 : UCIP_FA_2015_3234.jpg

Markers visible on landward slope.

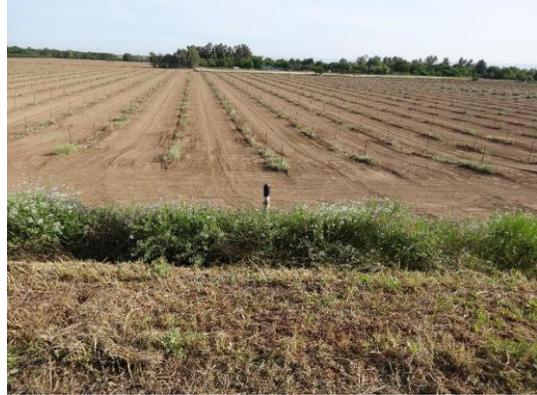
Photo 1 of 2 : UCIP_FA_2015_3229.jpg

LM Start	0.23	Rating **	M	Issue No.	50
LM End	0.23	Issue Type +	En	Location *	N/A
Category	Supplemental			GPS Latitude/Longitude	
				Start	End
Item	DWR UCIP Field Study			39.163407 °	39.163407 °
				-121.605645 °	-121.605645 °
DWR ID					
Action/Comments					
Inspector Comments: FS_ID:27712 DS_ID:24653 EP_NO: N/A FS_HLM: 0.23 Repair Type: Non-Urgent Crossing Status: Indicator Found

Marker visible on landward side.

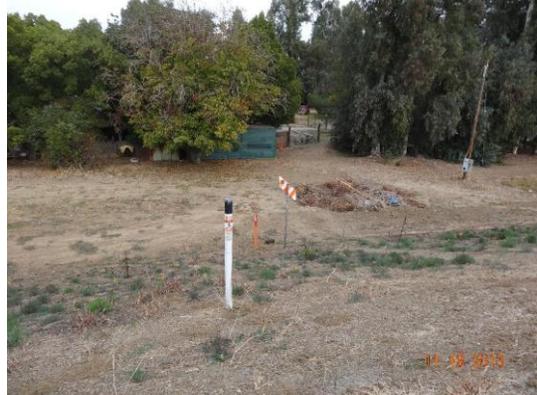
Photo 3 of 3 : UCIP_FA_2015_2813.jpg

LM Start	0.41	Rating **	M	Issue No.	51 (cont)
LM End	0.41	Issue Type +	En	Location *	N/A
Category	Supplemental			GPS Latitude/Longitude	
				Start	End
Item	DWR UCIP Field Study			39.162847 °	39.162847 °
				-121.602440 °	-121.602440 °
DWR ID					
Action/Comments					
Inspector Comments: FS_ID:24806 DS_ID:21257 EP_NO: 13015 FS_HLM: 0.41 Repair Type: Non-Urgent Crossing Status: Found

View of landward side--gas marker and conduit line marker.

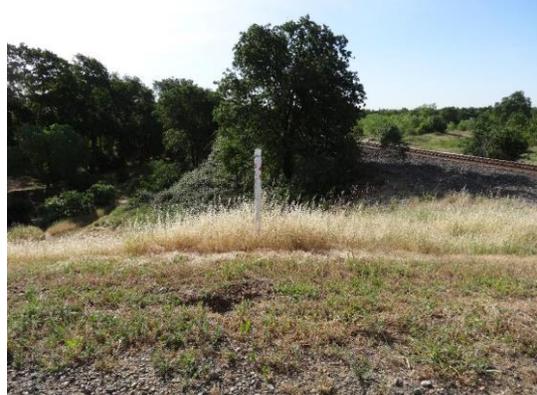
Photo 2 of 2 : UCIP_FA_2015_3236.jpg

LM Start	0.72	Rating **	M	Issue No.	54 (cont)	
LM End	0.72	Issue Type +	En	Location *	LS	
Category	Supplemental			GPS Latitude/Longitude		
			Start	End		
Item	DWR UCIP Field Study			39.161229 °	39.161229 °	
				-121.597072 °	-121.597072 °	
DWR ID						
Action/Comments						
Inspector Comments: FS_ID:27715 DS_ID:24656 EP_NO: N/A FS_HLM: 0.72 Repair Type: Non-Urgent Crossing Status: Indicator Found UCIP Comments: Need to contact owner--unable to determine if crossing is authorized (no permit found) also need to determine if crossing goes through levee. FIELD_STRUCT_DESC: Fiber optic line markers on levee slope unable to determine if line goes through levee. FS Date: 04/29/2013

View of marker located on waterward side.

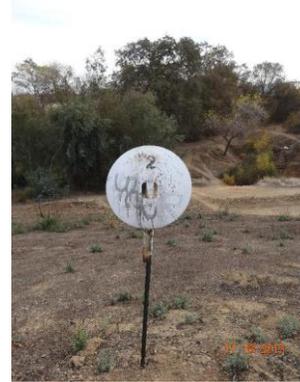
Photo 3 of 3 : UCIP_FA_2015_3331.jpg

LM Start	0.74	Rating **	U	Issue No.	55 (cont)
LM End	0.74	Issue Type +	En	Location *	LS
Category	Supplemental			GPS Latitude/Longitude	
			Start	End	
Item	DWR UCIP Field Study			39.161497 °	39.161497 °
				-121.596816 °	-121.596816 °
DWR ID					
Action/Comments					
Inspector Comments: FS_ID:27735 DS_ID:21258 EP_NO: N/A FS_HLM: 0.75 Repair Type: Urgent Crossing Status: Found UCIP Comments: Damaged flap gate on waterward side and damaged stem on screw gate on landward side. Need to contact owner to determine if crossing is still active. If crossing is still in use owner will need to address damage on flap gate and screw gate. If crossing is no longer in use owner will need to contact the CVFPB to comply with Title 23. This crossing is referenced in the USACE Periodic Inspection as item USACE_CESPK_HON1_2013_p_0053 and 0057. FIELD_STRUCT_DESC: 24-inch CM drainpipe through the levee, 31.0 feet below the crown. Two CM cutoff walls around pipe and concrete headwall at both ends. Flap gate on the waterward end. Slide gate on the landward end. Discharges into 6-foot concrete splash apron. (USACE-1953). This entry matches the Drainage or Irrigation Structure referenced in O&M manual (Station 46+60). FS Date: 04/29/2013

View of waterward side--Marker indicates crossing is labelled as 2.

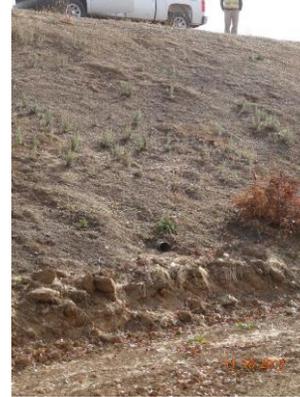
Photo 1 of 1 : UCIP_FA_2015_3332.jpg

LM Start	0.89	Rating **	M	Issue No.	56
LM End	0.89	Issue Type +	En	Location *	LS
Category	Supplemental			GPS Latitude/Longitude	
				Start	End
Item	DWR UCIP Field Study			39.163341 °	39.163341 °
				-121.595340 °	-121.595340 °
DWR ID					
Action/Comments					
Inspector Comments: FS_ID:40545 DS_ID:21260 EP_NO: 4555 FS_HLM: 0.901 Repair Type: Non-Urgent Crossing Status: Indicator Found UCIP Comments: Pipe is approximately 4-6 inches in diameter located near the toe of levee. Crossing is approximately 50 feet downstream of 24-inch pipe. Need to contact owner to determine status of this crossing and to verify the purpose of crossing. If crossing is no longer in use owner will need to contact the CVFPB to comply with Title 23. FIELD_STRUCT_DESC: Abandoned 6-inch steel drainpipe through the levee, 1.0 feet below the crown. Siphon breaker on the waterward shoulder. Pump located at landward toe. Revetment around discharge end of pipe, draining into ditch at waterward toe. Pipe is not buried on berms, gravel pad over pipe across levee crown for vehicular access. Pipe retained through levee under Permit No. 4555 (1964). FS Date: 04/29/2013

Pipe through levee near waterward toe.

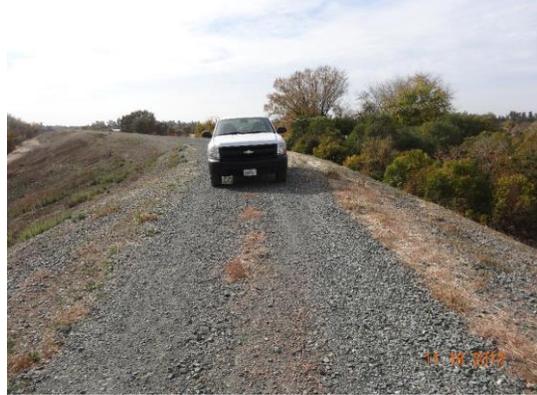
Photo 2 of 3 : UCIP_FA_2015_3254.jpg

LM Start	1.33	Rating **	M	Issue No.	57 (cont)
LM End	1.33	Issue Type +	En	Location *	LS
Category	Supplemental			GPS Latitude/Longitude	
				Start	End
Item	DWR UCIP Field Study			39.168583 °	39.168583 °
				-121.590929 °	-121.590929 °
DWR ID					
Action/Comments					
Inspector Comments: FS_ID:27725 DS_ID:21262 EP_NO: N/A FS_HLM: 1.33 Repair Type: Non-Urgent Crossing Status: Found UCIP Comments: Crossing appears not to be in use--need to contact owner. Need to coordinate with owner to determine status of crossing. If crossing is no longer in use owner will need to contact the CVFPB to comply with Title 23. This crossing is referenced in the USACE Periodic Inspection as item USACE_CESPK_HON1_2013_p_0012. FIELD_STRUCT_DESC: 10-inch steel pipe through the levee, 7.3 feet below the crown. Siphon breaker in CM riser on the waterward slope. Pump on the waterward berm-pump not present. Switch house on the waterward slope-no switch house present. 24-inch concrete standpipe at the landward toe. (USACE-1955). This entry matches the Drainage or Irrigation Structure referenced in O&M manual (Station 14+82). Concrete pad is still present on waterward side. FS Date: 04/29/2013

View of levee crown looking upstream.

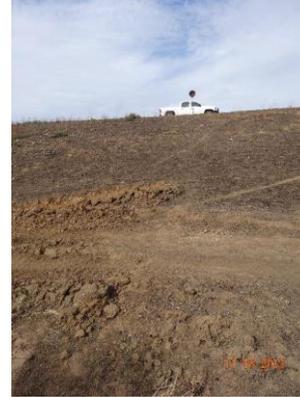
Photo 3 of 3 : UCIP_FA_2015_2853.jpg

LM Start	1.41	Rating **	M	Issue No.	60 (cont)	
LM End	1.41	Issue Type +	En	Location *	LS	
Category	Supplemental			GPS Latitude/Longitude		
			Start	End		
Item	DWR UCIP Field Study			39.169080 °	39.169080 °	
				-121.589478 °	-121.589478 °	
DWR ID						
Action/Comments						
Inspector Comments: FS_ID:42872 DS_ID:21318 EP_NO: N/A FS_HLM: 1.42 Repair Type: Non-Urgent Crossing Status: Found UCIP Comments: Holes present on pipe wall. Need to contact owner to notify of issue with pipe. Also need to contact DWR Inspector and CVFPB to determine how to address issue. This crossing is referenced in the USACE Periodic Inspection as item USACE_CESPK_HON1_2013_p_0140. Pipe should be 30-inch instead of 36-inch mentioned Periodic Inspection. FIELD_STRUCT_DESC: 30-inch CM pipe through the levee, approximately 30 feet below the crown. Two CM cutoff walls around the pipe on both sides. Saddle and splash apron at the discharge end of the pipe. Concrete saddle and apron on waterward side. (USACE-1955). This entry matches the Drainage or Irrigation Structure referenced in O&M manual (Station 10+38). FS Date: 04/29/2013

View of waterward slope.

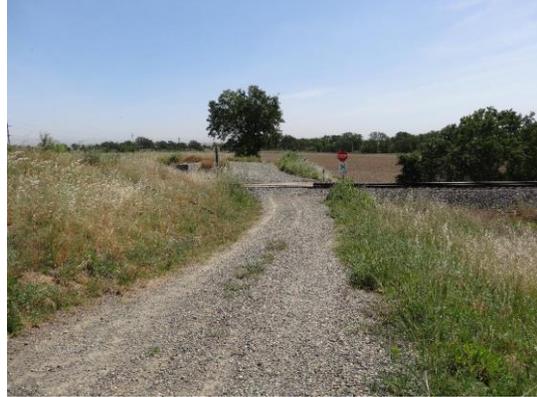
Photo 2 of 3 : UCIP_FA_2015_3353.jpg

LM Start	1.59	Rating **	M	Issue No.	61 (cont)
LM End	1.59	Issue Type +	En	Location *	LS
Category	Supplemental			GPS Latitude/Longitude	
				Start	End
Item	DWR UCIP Field Study			39.169234 °	39.169234 °
				-121.586203 °	-121.586203 °
DWR ID					
Action/Comments					
Inspector Comments: FS_ID:27791 DS_ID:21268 EP_NO: N/A FS_HLM: 1.598 Repair Type: Non-Urgent Crossing Status: Found UCIP Comments: Vegetation has been cleared from slope. This crossing is referenced in the USACE Periodic Inspection as item USACE_CESPK_HON1_2013_p_0158. FIELD_STRUCT_DESC: 24-inch CM drainpipe through the levee, 30.0 feet below the crown. Flap gate on the waterward end. Slide gate on the landward end. Concrete saddle and apron on waterward side. (USACE-1955). This entry matches the Drainage or Irrigation Structure referenced in O&M manual (Station 1+00). FS Date: 04/29/2013

View of levee crown looking downstream.

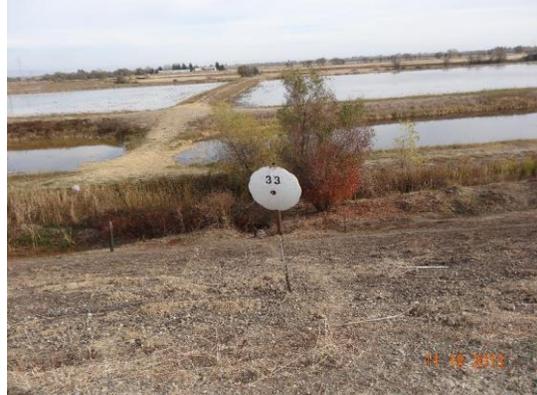
Photo 3 of 3 : UCIP_FA_2015_3333.jpg

LM Start	2.14	Rating **	M	Issue No.	62 (cont)
LM End	2.14	Issue Type +	En	Location *	LS
Category	Supplemental			GPS Latitude/Longitude	
				Start	End
Item	DWR UCIP Field Study			39.176936 °	39.176936 °
				-121.584848 °	-121.584848 °
DWR ID					
Action/Comments					
Inspector Comments: FS_ID:27745 DS_ID:21271 EP_NO: N/A FS_HLM: 2.15 Repair Type: Non-Urgent Crossing Status: Found

View of waterward side--marker indicating crossing visible on waterward shoulder.

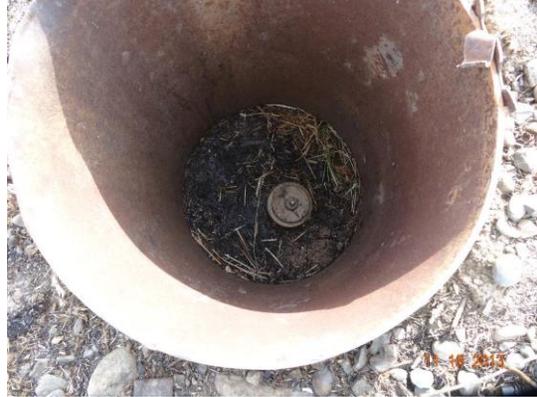
Photo 2 of 3 : UCIP_FA_2015_2883.jpg

Inspector Comments: FS_ID:24815
 DS_ID:21272
 EP_NO: 14020
 FS_HLM: 2.79
 Repair Type: Urgent
 Crossing Status: Indicator Found
 UCIP Comments: Unable to determine status of crossing--sink hole was observed as part of the USACE Periodic Inspection Report dated May 2013. Need to coordinate with owner to determine status of crossing. If crossing is no longer in use owner will need to contact the CVFPB to comply with Title 23. Need to confirm with Finney to determine if pump and controls belong to pipe crossing located on landward side. This crossing is referenced in the USACE Periodic Inspection as item USACE_CESPK_HON1_2013_p_0192.
 FIELD_STRUCT_DESC: 10-inch steel drainpipe sleeved through a 16-inch steel pipe, 5.0 feet below the crown. Annular gap grouted. Concrete cutoff wall around pipe at center of levee. Siphon breaker at waterward shoulder. Flap gate and concrete headwall at waterward end. (Permit No. 14020-1986)

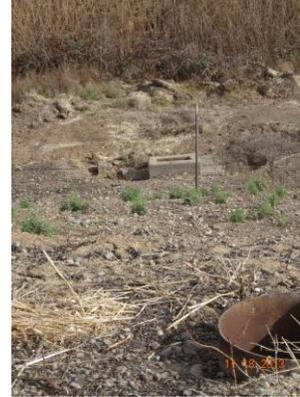
Photo 3 of 3 : UCIP_FA_2015_2884.jpg

LM Start	2.78	Rating **	U	Issue No.	64 (cont)
LM End	2.78	Issue Type +	En	Location *	LS
Category	Supplemental			GPS Latitude/Longitude	
				Start	End
Item	DWR UCIP Field Study			39.186134 °	39.186134 °
				-121.583719 °	-121.583719 °
DWR ID					
Action/Comments					
Inspector Comments: FS_ID:24815 DS_ID:21272 EP_NO: 14020 FS_HLM: 2.79 Repair Type: Urgent Crossing Status: Indicator Found UCIP Comments: Unable to determine status of crossing--sink hole was observed as part of the USACE Periodic Inspection Report dated May 2013. Need to coordinate with owner to determine status of crossing. If crossing is no longer in use owner will need to contact the CVFPB to comply with Title 23. Need to confirm with Finney to determine if pump and controls belong to pipe crossing located on landward side. This crossing is referenced in the USACE Periodic Inspection as item USACE_CESPK_HON1_2013_p_0192. FIELD_STRUCT_DESC: 10-inch steel drainpipe sleeved through a 16-inch steel pipe, 5.0 feet below the crown. Annular gap grouted. Concrete cutoff wall around pipe at center of levee. Siphon breaker at waterward shoulder. Flap gate and concrete headwall at waterward end. (Permit No. 14020-1986) FS Date: 04/29/2013

View of waterward side--concrete box located located at waterward toe.

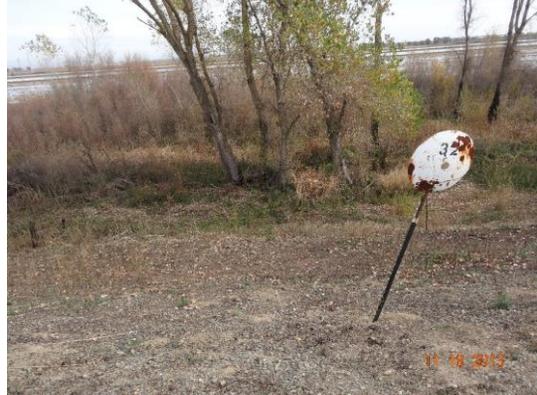
Photo 1 of 3 : UCIP_FA_2015_2885.jpg

View of waterward slope.

Inspector Comments: FS_ID:24816
 DS_ID:21317
 EP_NO: N/A
 FS_HLM: 3.36
 Repair Type: Non-Urgent
 Crossing Status: Indicator Found
 UCIP Comments: Indicator marker visible on WS; Dense vegetation on waterward toe and landward side access limits the inspector's visibility to identify signs of pipe failure (leaks) along the slope. Recommend removing vegetation along pipe alignment to conduct proper inspection of structure and appurtances. Access to landward side will need to be coordinated with railroad. Need to coordinate with owner to determine status of crossing. If crossing is no longer in use owner will need to contact the CVFPB to comply with Title 23. This crossing is referenced in the USACE Periodic Inspection as item USACE_CESPK_HON1_2013_p_0204.
 FIELD_STRUCT_DESC: 24-inch CM drainpipe through the levee, 23.0 feet below the crown. Flap gate on waterward end. Concrete headwall at both toes. Siphon breaker on waterward shoulder-unable to find. Concrete saddle and apron on waterward side. (USACE-1953). This entry matches the Drainage or Irrigation Structure referenced in O&M manual (Station 299+56).

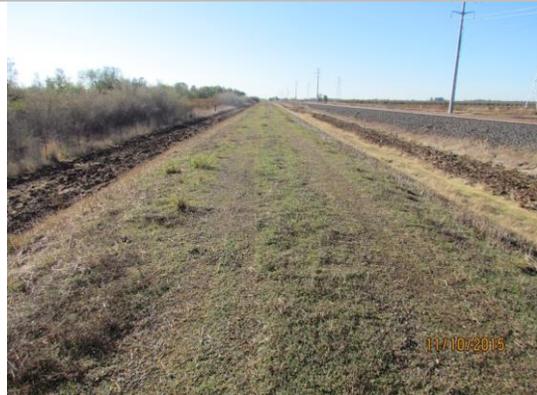
Photo 1 of 1 : FA_2015_RD0010_163_28_20151113_00024.jpg

LM Start	3.57	Rating **	A/W	Issue No.	28
LM End	7.64	Issue Type +	Ma	Location *	CR
Category	Earthen Levee			GPS Latitude/Longitude	
				Start	End
Item	Crown Surface / Depressions / Rutting			39.197526 °	39.255993 °
				-121.582294 °	-121.574930 °
DWR ID	DWR_RD0010_01_f_2015_28				
Action/Comments					
Add appropriate material and re-grade the levee to bring the crown above the design elevation. Inspector Comments: Crown needs to be re-graded. LMA is in the proces of regrading the levee in correspondence with DWR.

View of the crown of the levee looking downstream. Fall 2015.

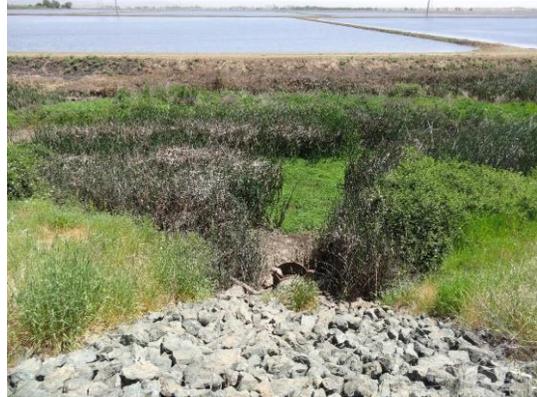
Photo 1 of 3 : UCIP_FA_2015_2227.jpg

LM Start	4.90	Rating **	U	Issue No.	67
LM End	4.90	Issue Type +	En	Location *	CR
Category	Supplemental			GPS Latitude/Longitude	
				Start	End
Item	DWR UCIP Field Study			39.216591 °	39.216591 °
				-121.579919 °	-121.579919 °
DWR ID					
Action/Comments					
Inspector Comments: FS_ID:24872 DS_ID:21275 EP_NO: N/A FS_HLM: 4.92 Repair Type: Urgent Crossing Status: Found UCIP Comments: limited access; steep slopes, and dense vegetation; New riprap has been placed along pipe alignment need to contact owner to determine work authorization. Also need to find out if the design for riprap was due to slope failure at this location. This crossing is referenced in the USACE Periodic Inspection as item USACE_CESPK_HON1_2013_p_0246. FIELD_STRUCT_DESC: 36-inch CM pipe through the levee, 20.0 feet below the crown. Two CM cutoff walls around pipe at both shoulders. Flap gate on the waterward end. Concrete headwall at waterward toe. Grouted cobble headwall at the landward toe. Concrete saddle and apron on waterward side. (USACE-1953). This entry matches the Drainage or Irrigation Structure referenced in O&M manual (Station 381+76.24). FS Date: 04/29/2013

View of waterward side during April.

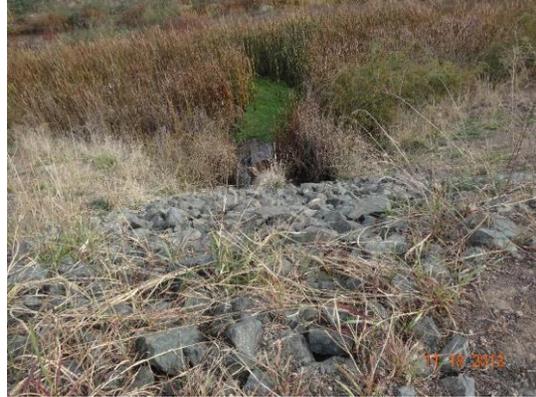
Photo 2 of 3 : UCIP_FA_2015_2228.jpg

Inspector Comments: FS_ID:24872
 DS_ID:21275
 EP_NO: N/A
 FS_HLM: 4.92
 Repair Type: Urgent
 Crossing Status: Found
 UCIP Comments: limited access; steep slopes, and dense vegetation; New riprap has been placed along pipe alignment need to contact owner to determine work authorization. Also need to find out if the design for riprap was due to slope failure at this location. This crossing is referenced in the USACE Periodic Inspection as item USACE_CESPK_HON1_2013_p_0246.
 FIELD_STRUCT_DESC: 36-inch CM pipe through the levee, 20.0 feet below the crown. Two CM cutoff walls around pipe at both shoulders. Flap gate on the waterward end. Concrete headwall at waterward toe. Grouted cobble headwall at the landward toe. Concrete saddle and apron on waterward side. (USACE-1953). This entry matches the Drainage or Irrigation Structure referenced in O&M manual (Station 381+76.24).
 FS Date: 04/29/2013

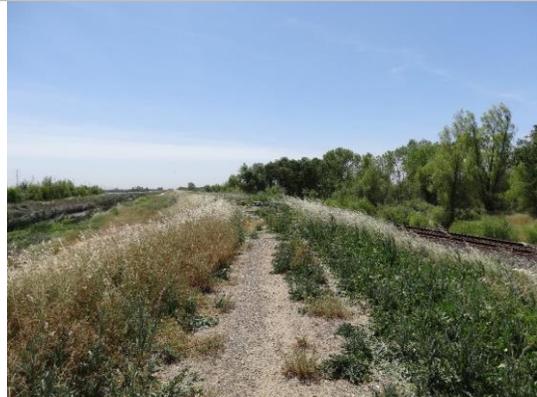
Photo 1 of 3 : UCIP_FA_2015_3366.jpg

LM Start	6.14	Rating **	M	Issue No.	68
LM End	6.14	Issue Type +	En	Location *	CR
Category	Supplemental			GPS Latitude/Longitude	
				Start	End
Item	DWR UCIP Field Study			39.234389 °	39.234389 °
				-121.577620 °	-121.577620 °
DWR ID					
Action/Comments					
Inspector Comments: FS_ID:27531 DS_ID:21277 EP_NO: 6127 FS_HLM: 6.16 Repair Type: Non-Urgent Crossing Status: Indicator Found UCIP Comments: Recommend removing vegetation along pipe alignment to conduct proper inspection of structure and appurtenances. FIELD_STRUCT_DESC: Two 1-inch aluminum conduits through the levee, 3.0 feet below the crown. Cutoff wall around conduits at center of levee. (Permit No. 6217-1968) FS Date: 04/29/2013

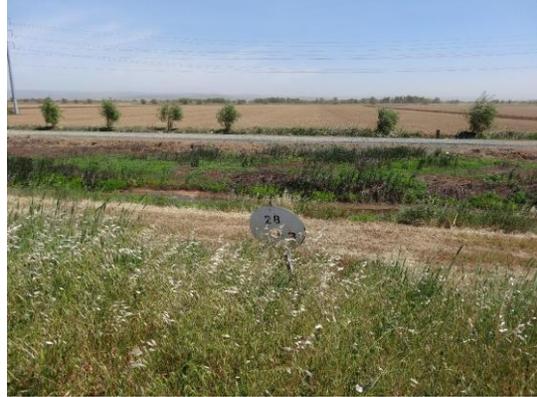
Photo 3 of 3 : UCIP_FA_2015_2673.jpg

LM Start	6.31	Rating **	M	Issue No.	69 (cont)	
LM End	6.31	Issue Type +	En	Location *	CR	
Category	Supplemental			GPS Latitude/Longitude		
			Start	End		
Item	DWR UCIP Field Study			39.236827 °	39.236827 °	
				-121.577262 °	-121.577262 °	
DWR ID						
Action/Comments						
Inspector Comments: FS_ID:24438 DS_ID:21278 EP_NO: N/A FS_HLM: 6.33 Repair Type: Non-Urgent Crossing Status: Found

Marker visible on waterward shoulder.

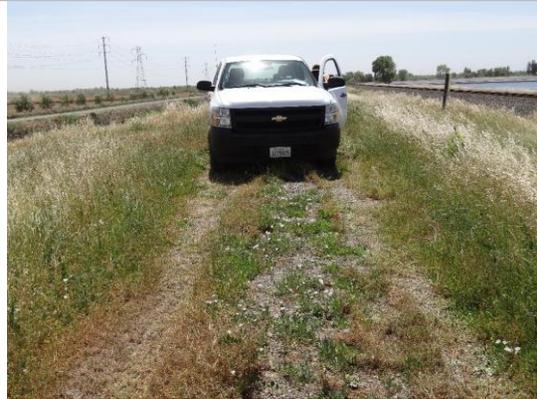
Photo 1 of 3 : UCIP_FA_2015_3369.jpg

LM Start	6.65	Rating **	M	Issue No.	70	
LM End	6.65	Issue Type +	En	Location *	CR	
Category	Supplemental			GPS Latitude/Longitude		
			Start	End		
Item	DWR UCIP Field Study			39.241726 °	39.241726 °	
				-121.576488 °	-121.576488 °	
DWR ID						
Action/Comments						
Inspector Comments: FS_ID:27532 DS_ID:21279 EP_NO: N/A FS_HLM: 6.673 Repair Type: Non-Urgent Crossing Status: Found UCIP Comments: Need to clear sediment near gate. Need to coordinate with owner to determine status of crossing. If crossing is no longer in use owner will need to contact the CVFPB to comply with Title 23. This crossing is referenced in the USACE Periodic Inspection as item USACE_CESPK_HON1_2013_p_0291-294. FIELD_STRUCT_DESC: 16-inch-steel pipe through the levee, 10.3 feet below the crown. Cutoff wall around pipe at center of levee. Slide gate on the waterward end. Pipe exposed across irrigation canal on landward side. (USACE-1953). This entry matches the Drainage or Irrigation Structure referenced in O&M manual (Station 473+58). FS Date: 04/29/2013

View of levee looking downstream.

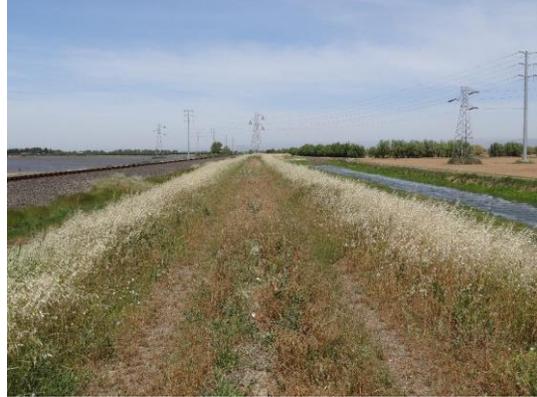
Photo 2 of 3 : UCIP_FA_2015_3370.jpg

View of levee looking upstream.

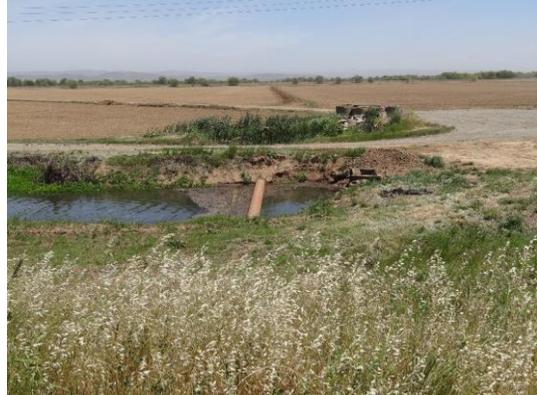
Photo 3 of 3 : UCIP_FA_2015_3371.jpg

View of waterward side--pipe goes through Simmerly Slough.

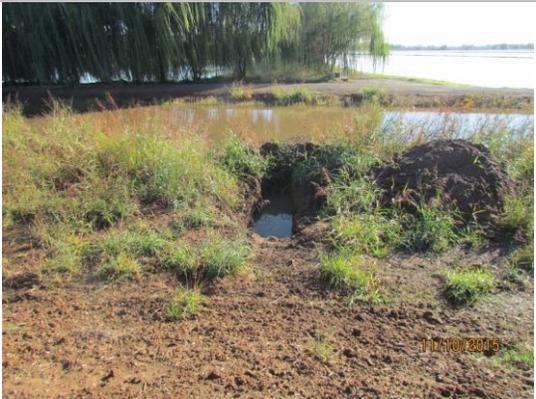
Photo 1 of 4 : FA_2015_RD0010_163_27_20151113_00020.jpg

LM Start	6.82	Rating **	M	Issue No.	27
LM End	6.82	Issue Type +	En	Location *	WS
Category	Earthen Levee		GPS Latitude/Longitude		
			Start	End	
Item	Encroachments		39.244203 °	39.244203 °	
			-121.576246 °	-121.576246 °	
DWR ID	DWR_RD0010_01_f_2015_27				
Action/Comments					
Pipe Inspector Comments: LMA has talked to landowner about the pipe and trench before about digging on the levee. This is a new trench.

The trench is dug by the farmer for a pipe. Fall 2015.

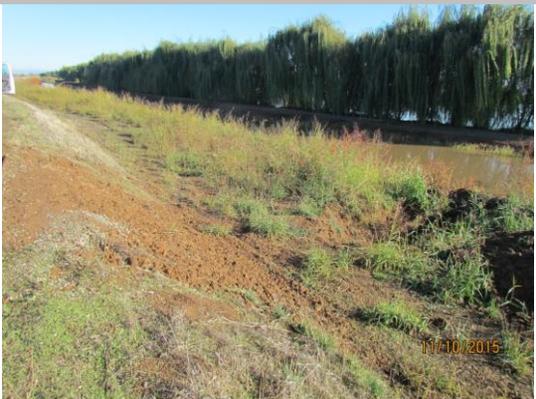
Photo 2 of 4 : FA_2015_RD0010_163_27_20151113_00021.jpg

View of the trench on the waterward side of the levee looking upstream. Works seem to have been done on the levee slope as well. Fall 2015.

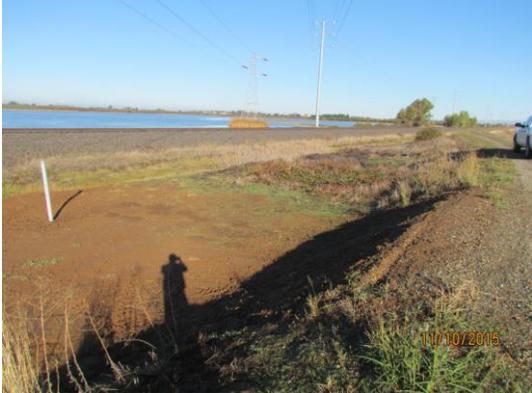
Photo 4 of 4 : FA_2015_RD0010_163_27_20151113_00023.jpg

Perspective view of the culvert on the landward side of the levee looking upstream. Fall 2015.

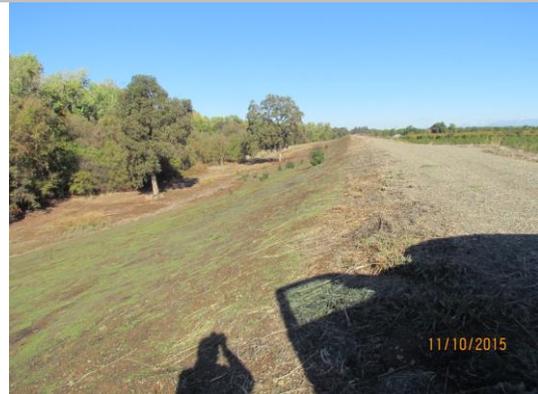
Photo 1 of 1 : FA_2015_RD0010_164_25_20151113_00020.jpg

LM Start	0.03	Rating **	A	Issue No.	25
LM End	11.36	Issue Type +	Ma	Location *	WS
Category	Earthen Levee			GPS Latitude/Longitude	
				Start	End
Item	Vegetation			39.164091 °	39.310068 °
				-121.610076 °	-121.616287 °
DWR ID	DWR_RD0010_02_f_2015_25				
Action/Comments					
Control annual grass and weeds on the levee slopes and easements. Inspector Comments: Levee has been burned and dragged.

View of the vegetation on the waterward side of the levee looking upstream. Fall 2015.

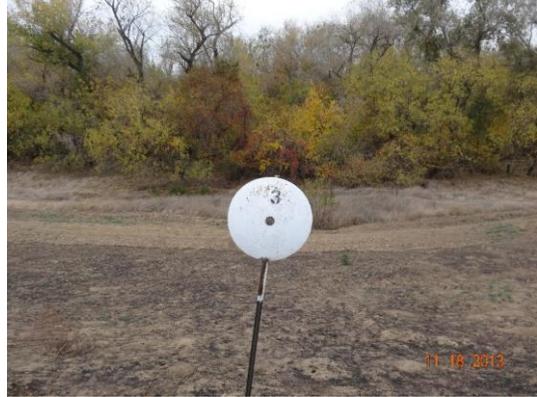
Photo 1 of 3 : UCIP_FA_2015_3372.jpg

View of waterward side.

Inspector Comments: FS_ID:27533
 DS_ID:21280
 EP_NO: N/A
 FS_HLM: 0.38
 Repair Type: Non-Urgent
 Crossing Status: Found

UCIP Comments: Recommend removing vegetation and debris along pipe alignment (debris blocking gate on waterward side and vegetation blocking access to screw gate on landward side). Need to coordinate with owner to determine status of crossing. If crossing is no longer in use owner will need to contact the CVFPB to comply with Title 23. This crossing is referenced in the USACE Periodic Inspection as item USACE_CESPK_HON2_2013_p_0027.

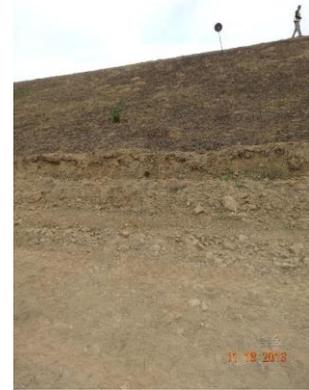
Photo 2 of 3 : UCIP_FA_2015_3373.jpg

View of waterward slope.

Inspector Comments: FS_ID:27533
 DS_ID:21280
 EP_NO: N/A
 FS_HLM: 0.38
 Repair Type: Non-Urgent
 Crossing Status: Found

UCIP Comments: Recommend removing vegetation and debris along pipe alignment (debris blocking gate on waterward side and vegetation blocking access to screw gate on landward side). Need to coordinate with owner to determine status of crossing. If crossing is no longer in use owner will need to contact the CVFPB to comply with Title 23. This crossing is referenced in the USACE Periodic Inspection as item USACE_CESPK_HON2_2013_p_0027.

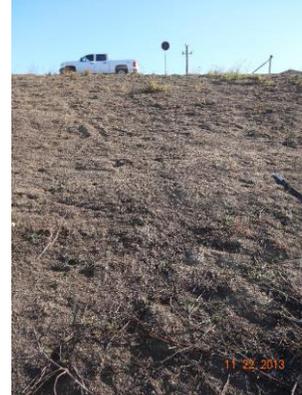
Photo 2 of 3 : UCIP_FA_2015_2911.jpg

View of waterward slope side.

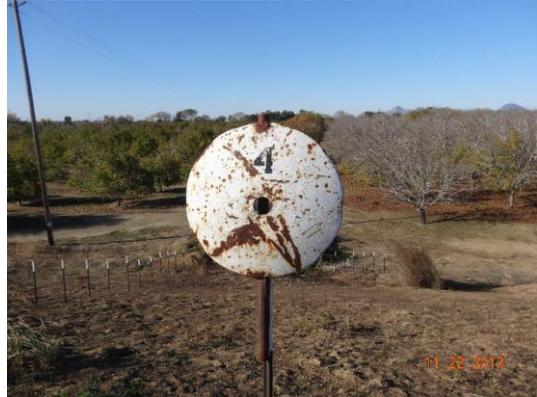
Photo 3 of 3 : UCIP_FA_2015_2912.jpg

Marker visible on waterward side--No. 4.

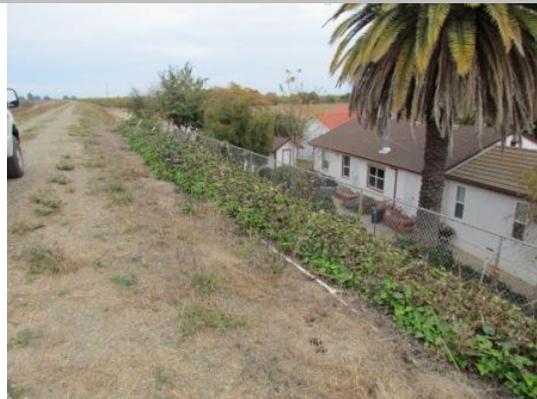
Photo 1 of 2 : FA_2015_RD0010_164_9_20151030_00001.jpg

LM Start	1.34	Rating **	M	Issue No.	9
LM End	1.34	Issue Type +	En	Location *	LS
Category	Earthen Levee			GPS Latitude/Longitude	
				Start	End
Item	Vegetation			39.182957 °	39.182957 °
				-121.609800 °	-121.609800 °
DWR ID	DWR_RD0010_02_s_2012_9				
Action/Comments					
Landscaping

This photo was taken from the crown looking down the landward slope at landscaping and a fence. Fall 2013.

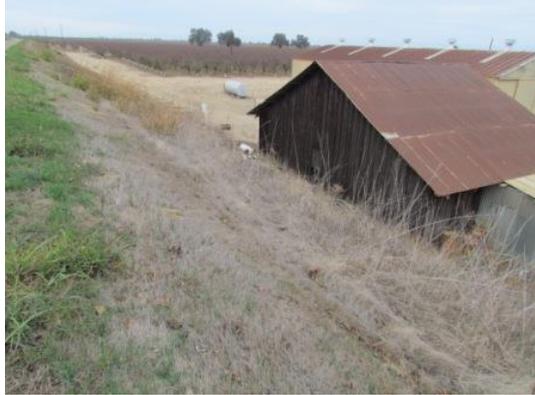
Photo 1 of 1 : FA_2015_RD0010_164_65_20151030_00002.jpg

LM Start	2.12	Rating **	M	Issue No.	65
LM End	2.12	Issue Type +	En	Location *	LS
Category	Earthen Levee			GPS Latitude/Longitude	
				Start	End
Item	Encroachments			39.194178 °	39.194178 °
				-121.607880 °	-121.607880 °
DWR ID	DWR_RD0010_02_f_2013_65				
Action/Comments					
Building

This photo was taken from the crown facing north looking down the landward levee slope at an outbuilding near the levee toe. Fall 2013.

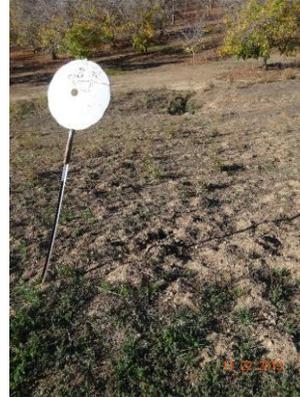
Photo 1 of 2 : UCIP_FA_2015_2961.jpg

LM Start	3.10	Rating **	M	Issue No.	75
LM End	3.10	Issue Type +	En	Location *	LS
Category	Supplemental			GPS Latitude/Longitude	
				Start	End
Item	DWR UCIP Field Study			39.208193 °	39.208193 °
				-121.609909 °	-121.609909 °
DWR ID					
Action/Comments					
Inspector Comments: FS_ID:27773 DS_ID:21283 EP_NO: N/A FS_HLM: 3.11 Repair Type: Non-Urgent Crossing Status: Found UCIP Comments: High rodent activity along pipe alignment--animal control would be beneficial. This crossing is referenced in the USACE Periodic Inspection as item USACE_CESPK_HON2_2013_p_0150. FIELD_STRUCT_DESC: 30-inch CM drainpipe through the levee, 22.5 feet below the crown. Flap gate on the waterward end. Metal marker on waterward shoulder. FS Date: 04/30/2013

View of waterward side--burrow activity present on slope.

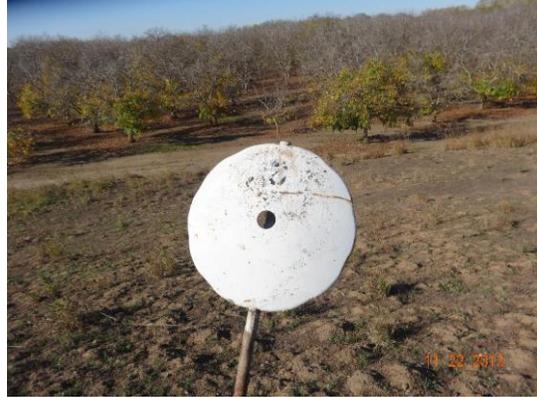
Photo 2 of 2 : UCIP_FA_2015_2986.jpg

Marker visible on waterward side.

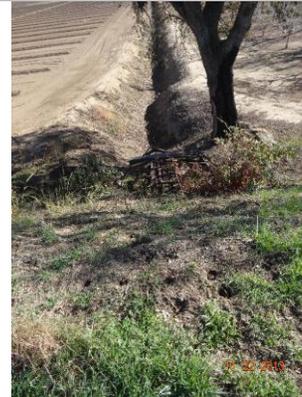
Photo 1 of 3 : UCIP_FA_2015_2114.jpg

LM Start	3.29	Rating **	M	Issue No.	76
LM End	3.29	Issue Type +	En	Location *	LS
Category	Supplemental			GPS Latitude/Longitude	
			Start	End	
Item	DWR UCIP Field Study			39.210995 °	39.210995 °
DWR ID				-121.610164 °	-121.610164 °
Action/Comments					
Inspector Comments: FS_ID:24824 DS_ID:21284 EP_NO: N/A FS_HLM: 3.3 Repair Type: Non-Urgent Crossing Status: Found UCIP Comments: Remove concrete piece preventing complete closure of screw gate on landward side. This crossing is referenced in the USACE Periodic Inspection as item USACE_CESPK_HON2_2013_p_0152. FIELD_STRUCT_DESC: 36-inch CM drainpipe through the levee, 24.0 feet below the crown. Two CM cutoff walls around pipe at both shoulders. Flap gate on the waterward end. Slide gate on the landward end. Concrete headwalls at both ends. (USACE-1953). This entry matches the Drainage or Irrigation Structure referenced in O&M manual (Station 259+76). FS Date: 04/30/2013

View of landward side--barrier used to discourage damage to crossing near toe.

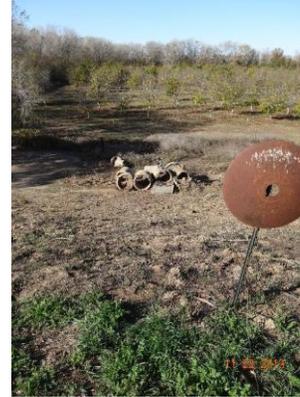
Photo 2 of 3 : UCIP_FA_2015_2115.jpg

Overview of waterward slope--barrier placed at toe to discourage damage to crossing.

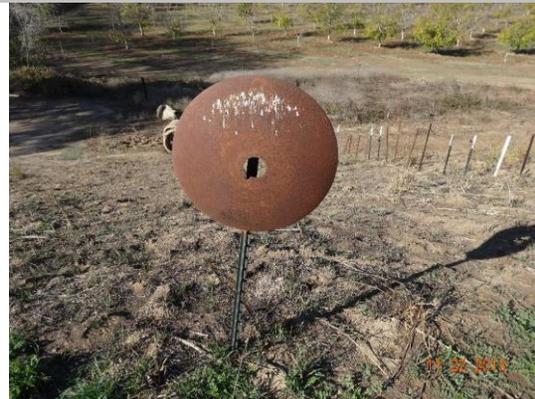
Photo 3 of 3 : UCIP_FA_2015_2116.jpg

Marker visible on waterward side.

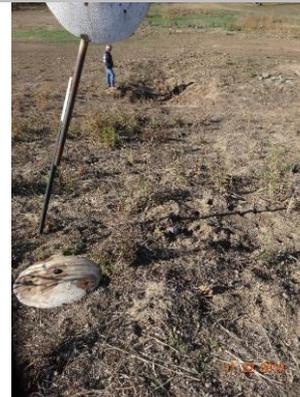
Photo 2 of 3 : UCIP_FA_2015_2118.jpg

View of waterward slope--burrow activity present.

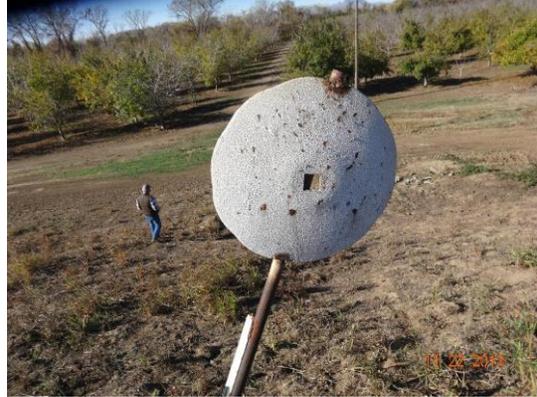
Photo 3 of 3 : UCIP_FA_2015_2119.jpg

Marker visible on waterward side.

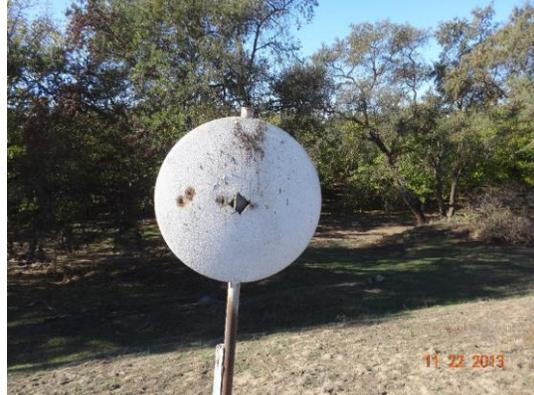
Photo 2 of 3 : UCIP_FA_2015_2121.jpg

View of marker located on waterward shoulder, no reference number is visible.

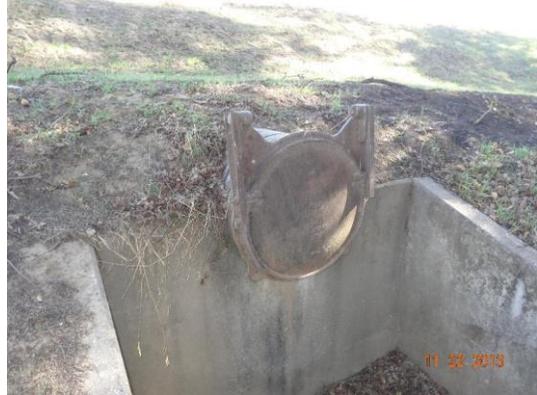
Photo 3 of 3 : UCIP_FA_2015_2129.jpg

View of flapgate on concrete head wall on waterward side.

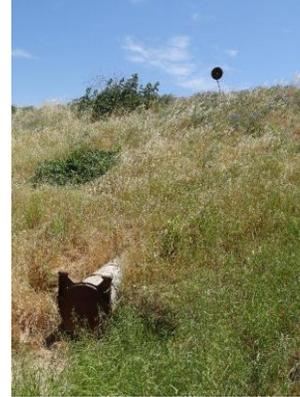
Photo 2 of 3 : UCIP_FA_2015_2849.jpg

View of waterward side--dense vegetation on slope.

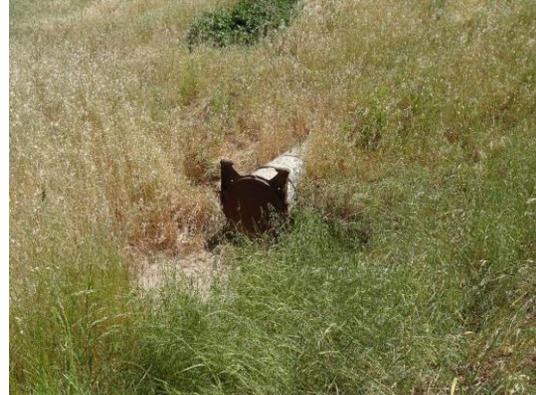
Photo 3 of 3 : UCIP_FA_2015_2850.jpg

View of flap gate on waterward side.

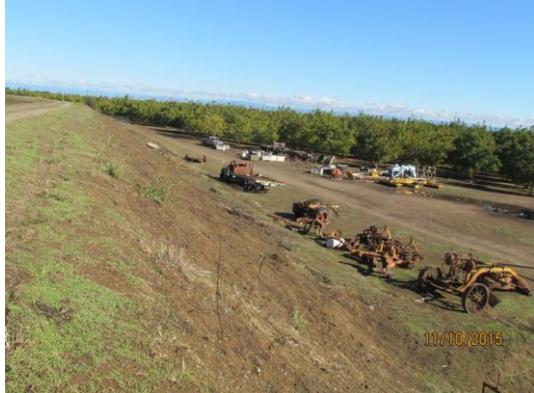
Photo 1 of 1 : FA_2015_RD0010_164_31_20151113_00023.jpg

LM Start	4.44	Rating **	M	Issue No.	31
LM End	4.44	Issue Type +	En	Location *	LS
Category	Earthen Levee			GPS Latitude/Longitude	
				Start	End
Item	Encroachments			39.226946 °	39.226946 °
				-121.613048 °	-121.613048 °
DWR ID	DWR_RD0010_02_f_2015_31				
Action/Comments					
Equipment

View of the equipment at the toe of the levee on the landward side of the levee looking upstream. Fall 2015.

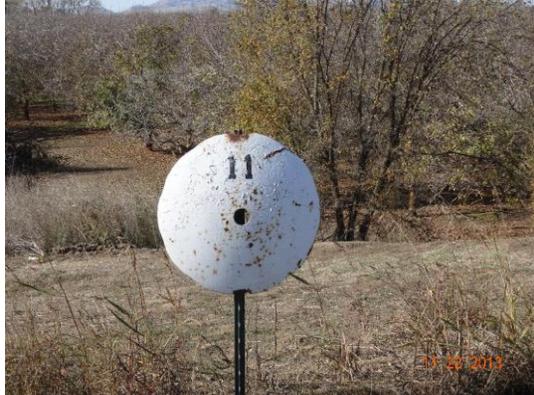
Photo 1 of 3 : UCIP_FA_2015_2987.jpg

Marker visible on waterward shoulder, Reference ID No. 11 for crossing.

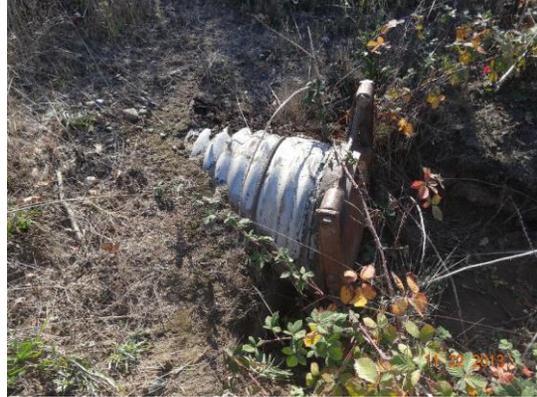
Photo 2 of 3 : UCIP_FA_2015_2988.jpg

View of flap gate located on waterward side.

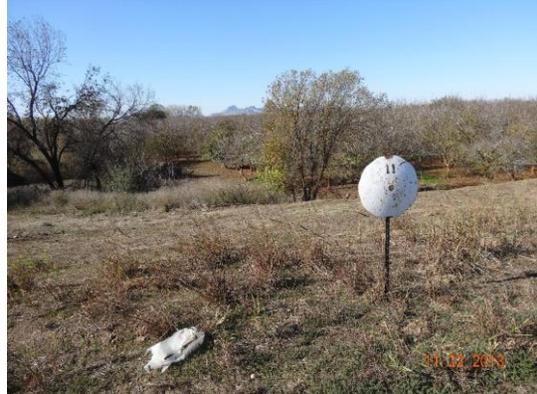
Photo 3 of 3 : UCIP_FA_2015_2989.jpg

View of waterward side.

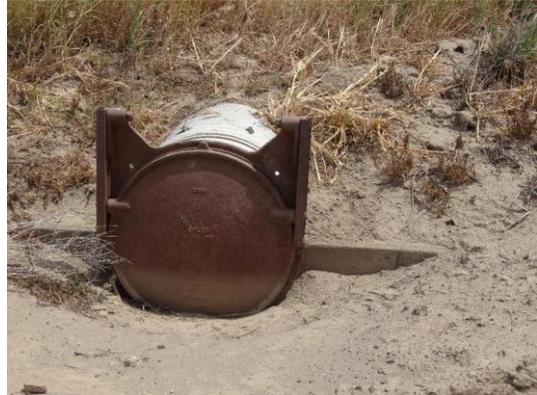
Photo 1 of 3 : UCIP_FA_2015_3355.jpg

Flap gate and concrete headwall visible on waterward side.

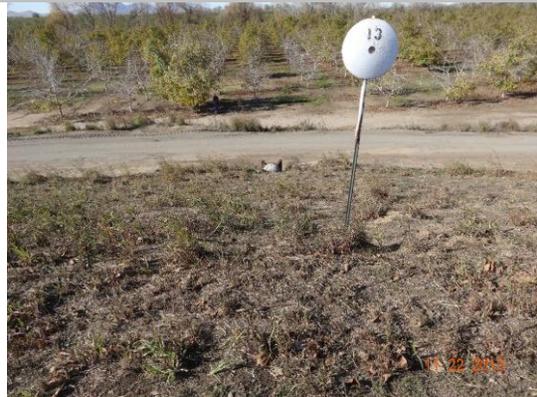
Photo 2 of 3 : UCIP_FA_2015_3356.jpg

View of marker located on waterward shoulder, pipe is reference as No. 13.

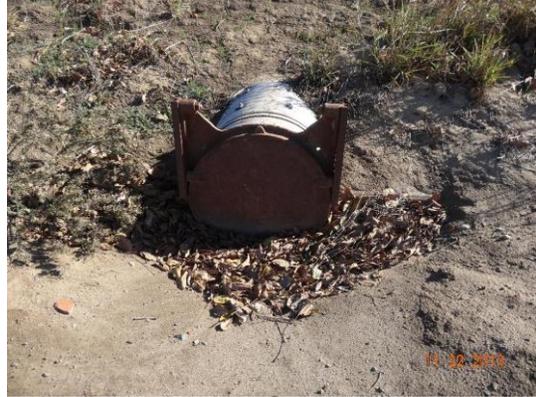
Photo 3 of 3 : UCIP_FA_2015_3357.jpg

View of flap gate located on waterward side.

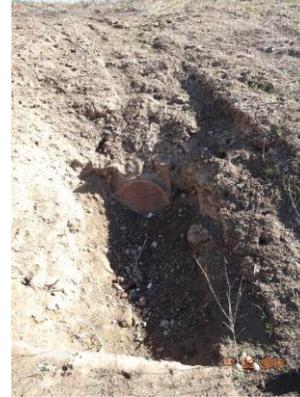
Photo 3 of 3 : UCIP_FA_2015_2148.jpg

View of flap gate and concrete distribution box on waterward side.

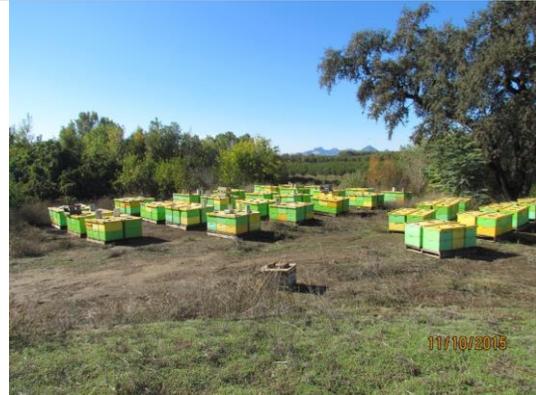
Photo 1 of 1 : FA_2015_RD0010_164_34_20151113_00024.jpg

LM Start	7.86	Rating **	M	Issue No.	34
LM End	7.86	Issue Type +	En	Location *	CR
Category	Earthen Levee			GPS Latitude/Longitude	
				Start	End
Item	Encroachments			39.272290 °	39.272290 °
				-121.613080 °	-121.613080 °
DWR ID	DWR_RD0010_02_f_2015_34				
Action/Comments					
Building

View of the beehives on the crown of the levee. Fall 2015.

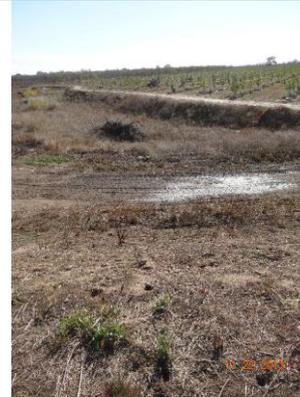
Photo 1 of 3 : UCIP_FA_2015_3046.jpg

View of landward side.

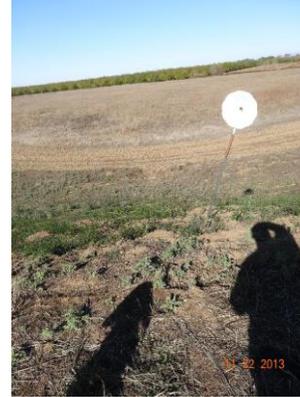
Photo 2 of 3 : UCIP_FA_2015_3047.jpg

View of waterward side.

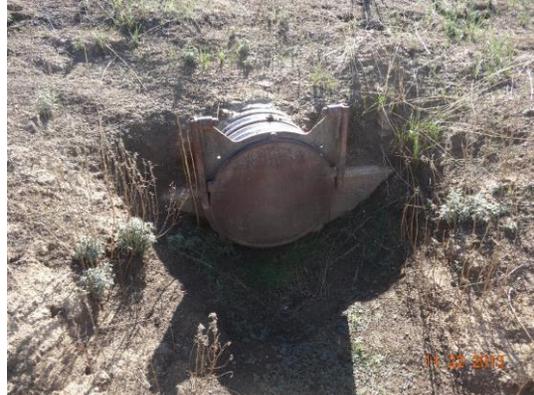
Photo 3 of 3 : UCIP_FA_2015_3048.jpg

View of flap gate visible on waterward side.

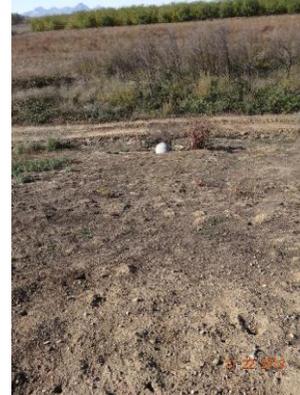
Photo 1 of 3 : UCIP_FA_2015_2161.jpg

View of waterward side.

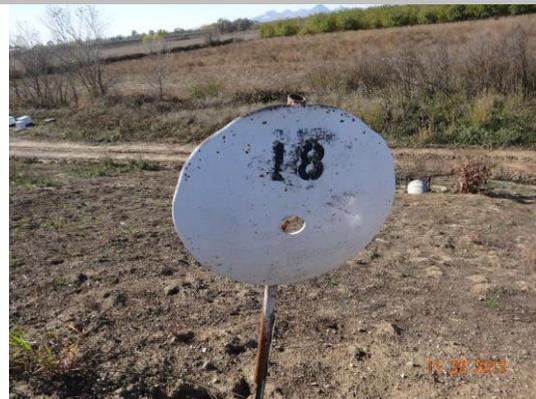
Photo 2 of 3 : UCIP_FA_2015_2162.jpg

Marker visible on waterward shoulder, crossing is referenced as No. 18.

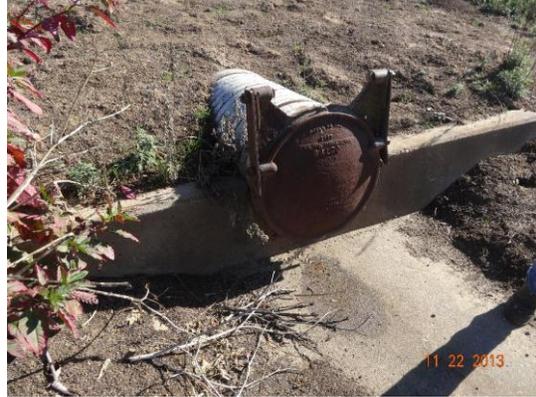
Photo 3 of 3 : UCIP_FA_2015_2163.jpg

View of flap gate visible on waterward side.

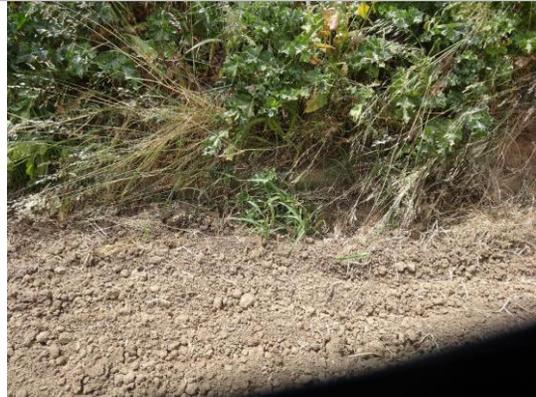
Photo 1 of 3 : UCIP_FA_2015_2800.jpg

View of concrete headwall visible through dense vegetation.

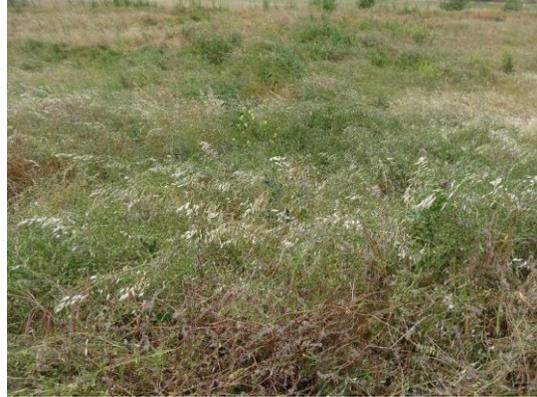
Photo 2 of 3 : UCIP_FA_2015_2801.jpg

View of waterward slope.

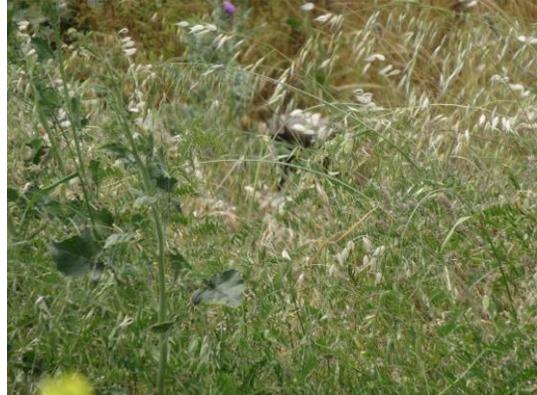
Photo 3 of 3 : UCIP_FA_2015_2802.jpg

Dense vegetation on landward side.

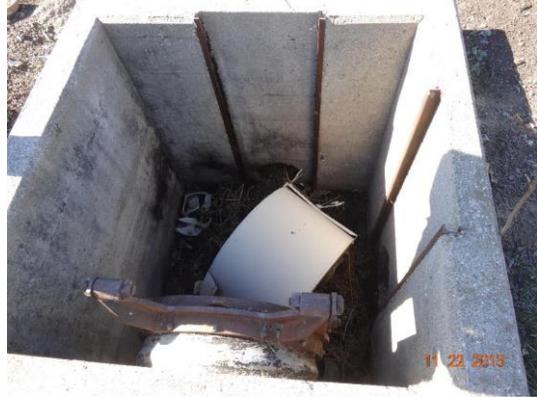
Photo 1 of 3 : UCIP_FA_2015_2803.jpg

View of concrete distribution box located on waterward side.

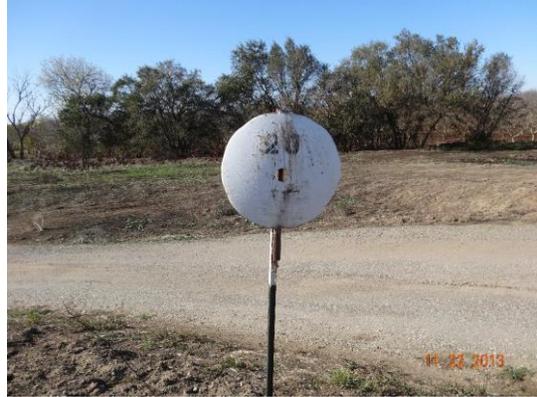
Photo 3 of 3 : UCIP_FA_2015_2805.jpg

Marker visible on waterward side shoulder, crossing is referenced as No. 20.

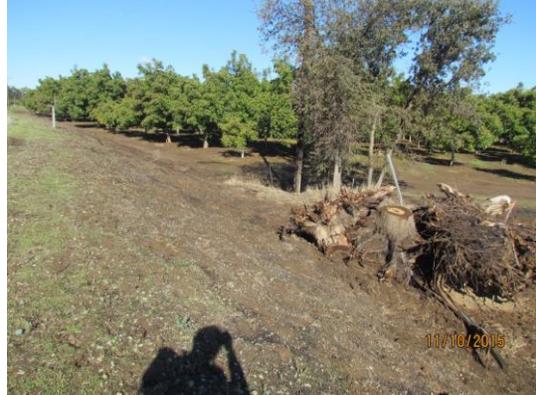
Photo 1 of 1 : FA_2015_RD0010_164_36_20151113_00025.jpg

LM Start	9.50	Rating **	M	Issue No.	36
LM End	9.50	Issue Type +	En	Location *	LS
Category	Earthen Levee			GPS Latitude/Longitude	
				Start	End
Item	Encroachments			39.289235 °	39.289235 °
				-121.601117 °	-121.601117 °
DWR ID	DWR_RD0010_02_f_2015_36				
Action/Comments					
Tree or limb

View of the wood stumps on the landward side of the levee looking upstream. Fall 2015.

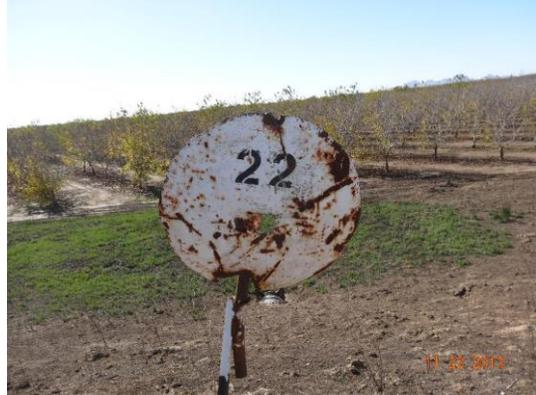
Photo 1 of 3 : UCIP_FA_2015_3049.jpg

LM Start	9.71	Rating **	M	Issue No.	87
LM End	9.71	Issue Type +	En	Location *	LS
Category	Supplemental			GPS Latitude/Longitude	
				Start	End
Item	DWR UCIP Field Study			39.291474 °	39.291474 °
				-121.603677 °	-121.603677 °
DWR ID					
Action/Comments					
Inspector Comments: FS_ID:27776 DS_ID:21301 EP_NO: N/A FS_HLM: 9.74 Repair Type: Non-Urgent Crossing Status: Found UCIP Comments: Recommend removing debris blocking slide gate on landward side. This crossing is referenced in the USACE Periodic Inspection as item USACE_CESPK_HON2_2013_p_0402. FIELD_STRUCT_DESC: 24-inch drainpipe through the levee, 13.0 feet below the crown. Flap gate on the waterward end. Slide gate on the landward end. Concrete headwall at landward toe. FS Date: 04/30/2013

Marker visible on waterward shoulder, crossing referenced as No. 22.

Inspector Comments: FS_ID:27776
 DS_ID:21301
 EP_NO: N/A
 FS_HLM: 9.74
 Repair Type: Non-Urgent
 Crossing Status: Found
 UCIP Comments: Recommend removing debris blocking slide gate on landward side. This crossing is referenced in the USACE Periodic Inspection as item USACE_CESPK_HON2_2013_p_0402.
 FIELD_STRUCT_DESC: 24-inch drainpipe through the levee, 13.0 feet below the crown. Flap gate on the waterward end. Slide gate on the landward end. Concrete headwall at landward toe.
 FS Date: 04/30/2013

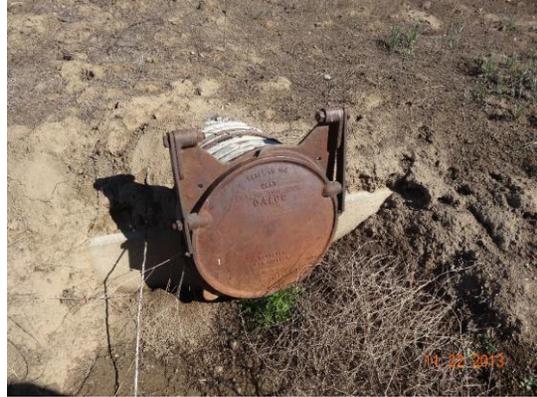
Photo 2 of 3 : UCIP_FA_2015_3050.jpg

View of flap gate located on waterward toe.

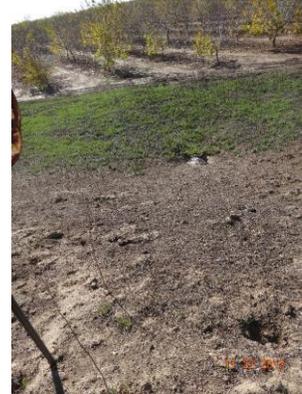
Photo 3 of 3 : UCIP_FA_2015_3051.jpg

View of waterward side.

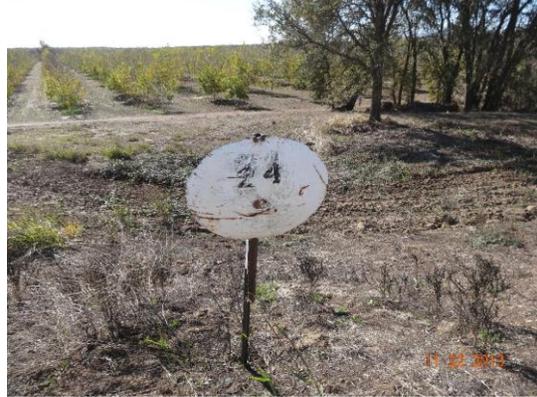
Photo 1 of 3 : UCIP_FA_2015_2164.jpg

LM Start	10.38	Rating **	M	Issue No.	88
LM End	10.38	Issue Type +	En	Location *	LS
Category	Supplemental			GPS Latitude/Longitude	
				Start	End
Item	DWR UCIP Field Study			39.297717 °	39.297717 °
				-121.613160 °	-121.613160 °
DWR ID

Inspector Comments: FS_ID:24838
 DS_ID:21303
 EP_NO: 1069
 FS_HLM: 10.42
 Repair Type: Non-Urgent
 Crossing Status: Found
 UCIP Comments: Unable to find the crossing on landward side-- indicators found of crossing. Need to coordinate with owner to determine status of crossing. If crossing is no longer in use owner will need to contact the CVFPB to comply with Title 23. This crossing is referenced in the USACE Periodic Inspection as item USACE_CESPK_HON2_2013_p_0442.
 FIELD_STRUCT_DESC: 24-inch steel pipe through the levee, 13.0 feet below the crown. Two concrete cutoff walls around pipe at both shoulders. Flap gate and concrete headwall on waterward end. Slide gate and concrete saddle and apron on landward end. (Permit No. 1069-1941) This entry matches the Drainage or Irrigation Structure referenced in O&M manual (Station 638+00).
 FS Date: 04/30/2013

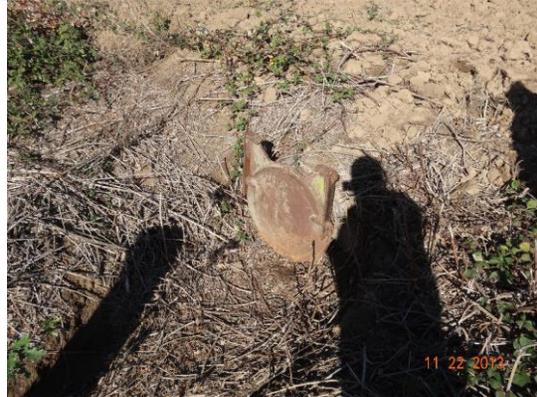
Photo 2 of 3 : UCIP_FA_2015_2165.jpg

Inspector Comments: FS_ID:24838
 DS_ID:21303
 EP_NO: 1069
 FS_HLM: 10.42
 Repair Type: Non-Urgent
 Crossing Status: Found
 UCIP Comments: Unable to find the crossing on landward side-- indicators found of crossing. Need to coordinate with owner to determine status of crossing. If crossing is no longer in use owner will need to contact the CVFPB to comply with Title 23. This crossing is referenced in the USACE Periodic Inspection as item USACE_CESPK_HON2_2013_p_0442.
 FIELD_STRUCT_DESC: 24-inch steel pipe through the levee, 13.0 feet below the crown. Two concrete cutoff walls around pipe at both shoulders. Flap gate and concrete headwall on waterward end. Slide gate and concrete saddle and apron on landward end. (Permit No. 1069-1941) This entry matches the Drainage or Irrigation Structure referenced in O&M manual (Station 638+00).
 FS Date: 04/30/2013

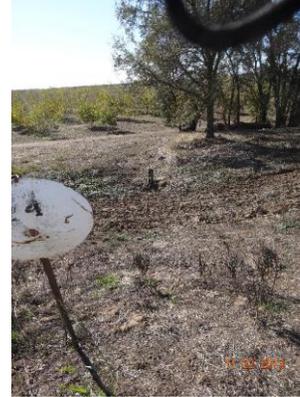
Photo 3 of 3 : UCIP_FA_2015_2166.jpg

LM Start	10.38	Rating **	M	Issue No.	88 (cont)
LM End	10.38	Issue Type +	En	Location *	LS
Category	Supplemental			GPS Latitude/Longitude	
				Start	End
Item	DWR UCIP Field Study			39.297717 °	39.297717 °
DWR ID				-121.613160 °	-121.613160 °
Action/Comments					
Inspector Comments: FS_ID:24838 DS_ID:21303 EP_NO: 1069 FS_HLM: 10.42 Repair Type: Non-Urgent Crossing Status: Found UCIP Comments: Unable to find the crossing on landward side-- indicators found of crossing. Need to coordinate with owner to determine status of crossing. If crossing is no longer in use owner will need to contact the CVFPB to comply with Title 23. This crossing is referenced in the USACE Periodic Inspection as item USACE_CESPK_HON2_2013_p_0442. FIELD_STRUCT_DESC: 24-inch steel pipe through the levee, 13.0 feet below the crown. Two concrete cutoff walls around pipe at both shoulders. Flap gate and concrete headwall on waterward end. Slide gate and concrete saddle and apron on landward end. (Permit No. 1069-1941) This entry matches the Drainage or Irrigation Structure referenced in O&M manual (Station 638+00). FS Date: 04/30/2013

View of waterward side.

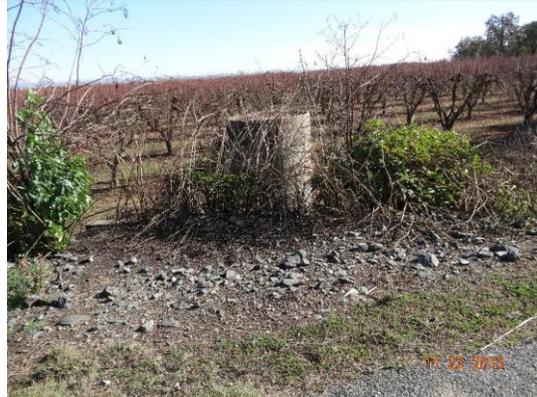
Photo 1 of 4 : UCIP_FA_2015_2167.jpg

LM Start	10.71	Rating **	M	Issue No.	89
LM End	10.71	Issue Type +	En	Location *	LS
Category	Supplemental			GPS Latitude/Longitude	
				Start	End
Item	DWR UCIP Field Study			39.300931 °	39.300931 °
				-121.617490 °	-121.617490 °
DWR ID					
Action/Comments					
Inspector Comments: FS_ID:24839 DS_ID:21304 EP_NO: N/A FS_HLM: 10.75 Repair Type: Non-Urgent Crossing Status: Found UCIP Comments: Rip rap was used to stabilize the waterward slope during high water as a means of emergency repair--unable to determine storm event when repair was performed. Recommend obtaining records of the repair and to determine if crossing is still being used. Need to determine owner. Dense vegetation limits the inspector's visibility to identify signs of pipe failure (leaks) along the slope. Recommend removing vegetation along pipe alignment to conduct proper inspection of structure and appurtances. This crossing is referenced in the USACE Periodic Inspection as item USACE_CESPK_HON2_2013_p_0458 and 460. FIELD_STRUCT_DESC: 24-inch steel pipe through the levee, 5.0 feet below the crown. Slide gate in a 36-inch concrete riser on the landward shoulder. Gate valve in a pump house on the waterward slope. Concrete headwall, saddle and apron on the waterward end. (USACE-1953). This entry matches the Drainage or Irrigation Structure referenced in O&M manual (Station 655+65). FS Date: 04/30/2013

View of standpipe located on landward side.
