**Flood Control Project Maintenance
Levee Inspections**

Fall 2015 Levee Maintenance Deficiency Summary Report

Sacramento River Basin

Reclamation District No. 0010 Honcut

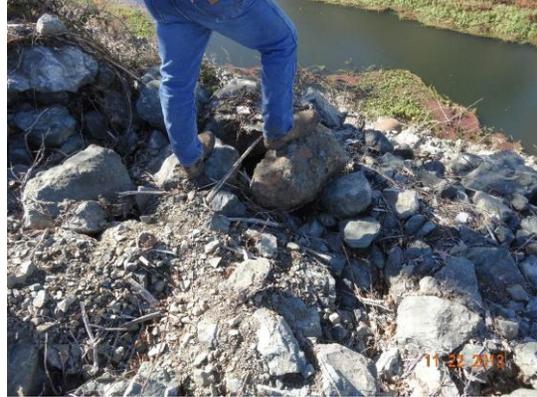
Photo 3 of 4 : UCIP_FA_2015_2171.jpg

LM Start	10.71	Rating **	M	Issue No.	89 (cont)
LM End	10.71	Issue Type +	En	Location *	LS
Category	Supplemental			GPS Latitude/Longitude	
				Start	End
Item	DWR UCIP Field Study			39.300931 °	39.300931 °
				-121.617490 °	-121.617490 °
DWR ID					
Action/Comments					
Inspector Comments: FS_ID:24839 DS_ID:21304 EP_NO: N/A FS_HLM: 10.75 Repair Type: Non-Urgent Crossing Status: Found UCIP Comments: Rip rap was used to stabilize the waterward slope during high water as a means of emergency repair--unable to determine storm event when repair was performed. Recommend obtaining records of the repair and to determine if crossing is still being used. Need to determine owner. Dense vegetation limits the inspector's visibility to identify signs of pipe failure (leaks) along the slope. Recommend removing vegetation along pipe alignment to conduct proper inspection of structure and appurtances. This crossing is referenced in the USACE Periodic Inspection as item USACE_CESPK_HON2_2013_p_0458 and 460. FIELD_STRUCT_DESC: 24-inch steel pipe through the levee, 5.0 feet below the crown. Slide gate in a 36-inch concrete riser on the landward shoulder. Gate valve in a pump house on the waterward slope. Concrete headwall, saddle and apron on the waterward end. (USACE-1953). This entry matches the Drainage or Irrigation Structure referenced in O&M manual (Station 655+65). FS Date: 04/30/2013

View of waterward slope.

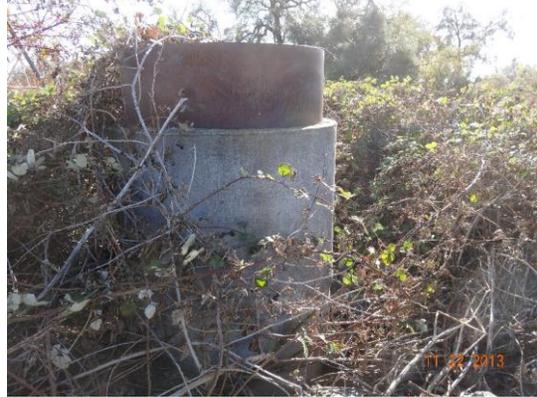
Photo 4 of 4 : UCIP_FA_2015_2172.jpg

LM Start	10.71	Rating **	M	Issue No.	89 (cont)
LM End	10.71	Issue Type +	En	Location *	LS
Category	Supplemental			GPS Latitude/Longitude	
				Start	End
Item	DWR UCIP Field Study			39.300931 °	39.300931 °
DWR ID				-121.617490 °	-121.617490 °
Action/Comments					
Inspector Comments: FS_ID:24839 DS_ID:21304 EP_NO: N/A FS_HLM: 10.75 Repair Type: Non-Urgent Crossing Status: Found UCIP Comments: Rip rap was used to stabilize the waterward slope during high water as a means of emergency repair--unable to determine storm event when repair was performed. Recommend obtaining records of the repair and to determine if crossing is still being used. Need to determine owner. Dense vegetation limits the inspector's visibility to identify signs of pipe failure (leaks) along the slope. Recommend removing vegetation along pipe alignment to conduct proper inspection of structure and appurtenances. This crossing is referenced in the USACE Periodic Inspection as item USACE_CESPK_HON2_2013_p_0458 and 460. FIELD_STRUCT_DESC: 24-inch steel pipe through the levee, 5.0 feet below the crown. Slide gate in a 36-inch concrete riser on the landward shoulder. Gate valve in a pump house on the waterward slope. Concrete headwall, saddle and apron on the waterward end. (USACE-1953). This entry matches the Drainage or Irrigation Structure referenced in O&M manual (Station 655+65). FS Date: 04/30/2013

View of standpipe located on waterward side.

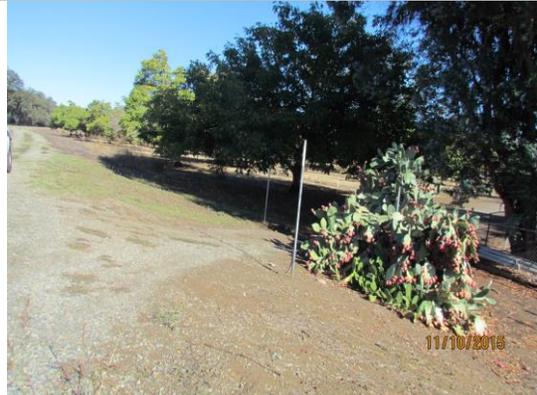
Photo 1 of 1 : FA_2015_RD0010_164_37_20151113_00026.jpg

LM Start	10.94	Rating **	M	Issue No.	37
LM End	10.94	Issue Type +	En	Location *	LS
Category	Earthen Levee			GPS Latitude/Longitude	
				Start	End
Item	Vegetation			39.304087 °	39.304087 °
DWR ID	DWR_RD0010_02_f_2015_37			-121.618086 °	-121.618086 °
Action/Comments					
Landscaping

View of the cactus on the landward side of the levee looking upstream. Fall 2015.

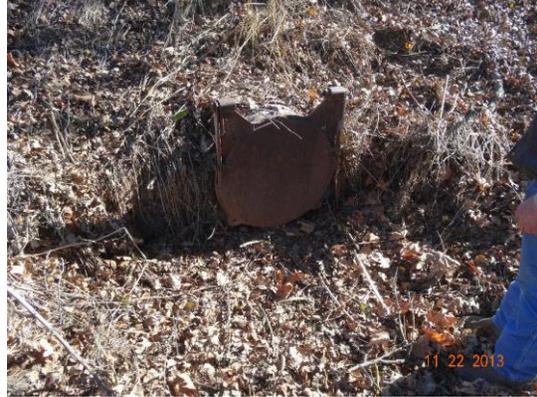
Photo 2 of 3 : UCIP_FA_2015_2174.jpg

LM Start	11.07	Rating **	M	Issue No.	90 (cont)
LM End	11.07	Issue Type +	En	Location *	LS
Category	Supplemental			GPS Latitude/Longitude	
				Start	End
Item	DWR UCIP Field Study			39.305915 °	39.305915 °
DWR ID				-121.617698 °	-121.617698 °
Action/Comments					
Inspector Comments: FS_ID:24840 DS_ID:21305 EP_NO: N/A FS_HLM: 11.11 Repair Type: Non-Urgent Crossing Status: Found UCIP Comments: Burrow activity--large holes found on landward side. Crossing on landward side is blocked. Recommend clearing headwall and crossing. Need to coordinate with owner to determine status of crossing. If crossing is no longer in use owner will need to contact the CVFPB to comply with Title 23. This crossing is referenced in the USACE Periodic Inspection as item USACE_CESPK_HON2_2013_p_0476. FIELD_STRUCT_DESC: 24-inch CM pipe through the levee, 7.5 feet below the crown. Two CM cutoff walls around pipe at both shoulders. Flap gate on the waterward end. Concrete headwall at both toes. Saddle and apron on waterward side. (USACE-1953). This entry matches the Drainage or Irrigation Structure referenced in O&M manual (Station 674+73). FS Date: 04/30/2013

View of flap gate located on waterward side.

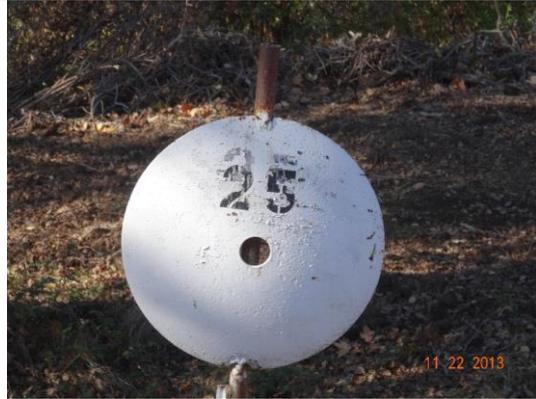
Photo 3 of 3 : UCIP_FA_2015_2175.jpg

LM Start	11.07	Rating **	M	Issue No.	90 (cont)
LM End	11.07	Issue Type +	En	Location *	LS
Category	Supplemental			GPS Latitude/Longitude	
				Start	End
Item	DWR UCIP Field Study			39.305915 °	39.305915 °
				-121.617698 °	-121.617698 °
DWR ID					
Action/Comments					
Inspector Comments: FS_ID:24840 DS_ID:21305 EP_NO: N/A FS_HLM: 11.11 Repair Type: Non-Urgent Crossing Status: Found UCIP Comments: Burrow activity--large holes found on landward side. Crossing on landward side is blocked. Recommend clearing headwall and crossing. Need to coordinate with owner to determine status of crossing. If crossing is no longer in use owner will need to contact the CVFPB to comply with Title 23. This crossing is referenced in the USACE Periodic Inspection as item USACE_CESPK_HON2_2013_p_0476. FIELD_STRUCT_DESC: 24-inch CM pipe through the levee, 7.5 feet below the crown. Two CM cutoff walls around pipe at both shoulders. Flap gate on the waterward end. Concrete headwall at both toes. Saddle and apron on waterward side. (USACE-1953). This entry matches the Drainage or Irrigation Structure referenced in O&M manual (Station 674+73). FS Date: 04/30/2013

Marker visible on waterward side, crossing is referenced as No. 25.

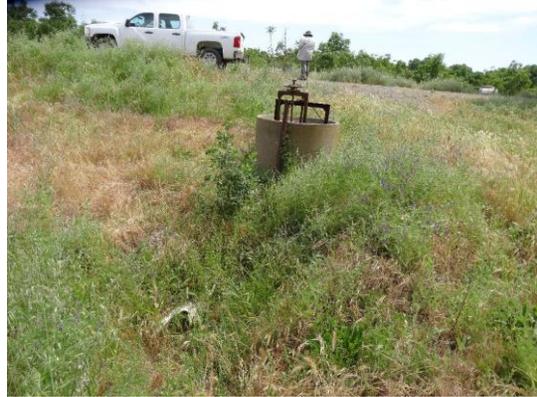
Photo 1 of 3 : UCIP_FA_2015_2187.jpg

LM Start	0.01	Rating **	M	Issue No.	19
LM End	0.01	Issue Type +	En	Location *	WS
Category	Supplemental			GPS Latitude/Longitude	
				Start	End
Item	DWR UCIP Field Study			39.310096 °	39.310096 °
				-121.616250 °	-121.616250 °
DWR ID					
Action/Comments					
Inspector Comments: FS_ID:24841 DS_ID:21306 EP_NO: N/A FS_HLM: 0.17 Repair Type: Non-Urgent Crossing Status: Found UCIP Comments: Debris found inside crossing--recommend removing it. FIELD_STRUCT_DESC: 24-inch CM pipe through the levee, 6.0 feet below the crown. Slide gate in concrete standpipe on the waterward end. FS Date: 05/01/2013

View of concrete standpipe and plastic pipe extension visible on waterward side.

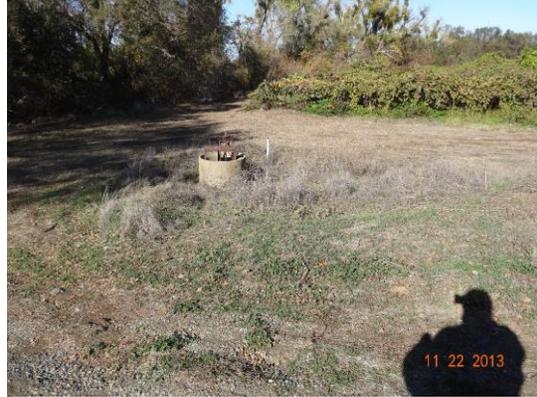
Photo 3 of 3 : UCIP_FA_2015_2189.jpg

LM Start	0.01	Rating **	M	Issue No.	19 (cont)
LM End	0.01	Issue Type +	En	Location *	WS
Category	Supplemental			GPS Latitude/Longitude	
				Start	End
Item	DWR UCIP Field Study			39.310096 °	39.310096 °
				-121.616250 °	-121.616250 °
DWR ID					
Action/Comments					
Inspector Comments: FS_ID:24841 DS_ID:21306 EP_NO: N/A FS_HLM: 0.17 Repair Type: Non-Urgent Crossing Status: Found

View of waterward side.

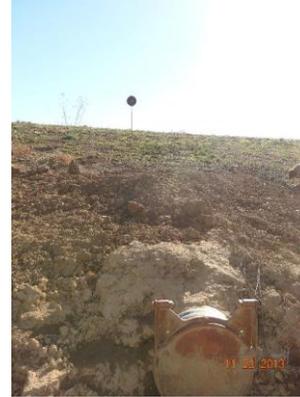
Photo 1 of 3 : UCIP_FA_2015_2190.jpg

LM Start	1.69	Rating **	M	Issue No.	20
LM End	1.69	Issue Type +	En	Location *	WS
Category	Supplemental			GPS Latitude/Longitude	
				Start	End
Item	DWR UCIP Field Study			39.303013 °	39.303013 °
				-121.588124 °	-121.588124 °
DWR ID					
Action/Comments					
Inspector Comments: FS_ID:24842 DS_ID:21307 EP_NO: N/A FS_HLM: 1.88 Repair Type: Non-Urgent Crossing Status: Found UCIP Comments: Sediment deposit inside pipe--Need to coordinate with owner to determine status of crossing. If crossing is no longer in use owner will need to contact the CVFPB to comply with Title 23. FIELD_STRUCT_DESC: 24-inch CM drainpipe through the levee, 15.0 feet below the crown. Two CM cutoff walls around pipe at both shoulders. Flap gate on the waterward end. Slide gate on the landward end. Concrete headwall at both toes. (USACE-1953). This entry matches the Drainage or Irrigation Structure referenced in O&M manual (Station 134+06). FS Date: 05/01/2013

View of waterward slope.

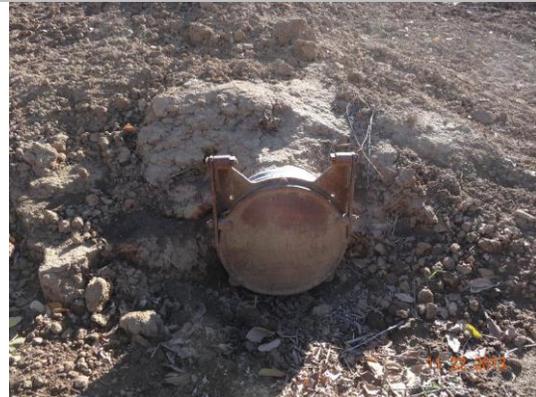
Photo 2 of 3 : UCIP_FA_2015_2191.jpg

View of flap gate located on waterward side.

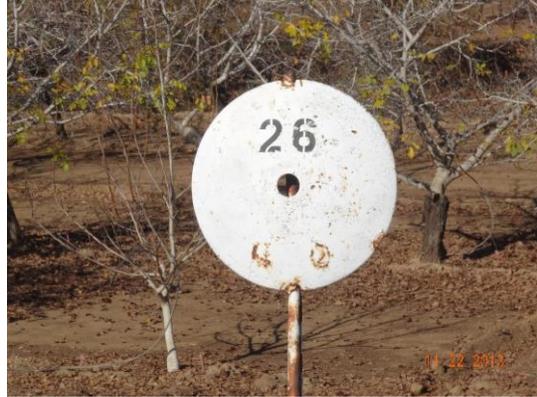
Photo 3 of 3 : UCIP_FA_2015_2192.jpg

LM Start	1.69	Rating **	M	Issue No.	20 (cont)
LM End	1.69	Issue Type +	En	Location *	WS
Category	Supplemental			GPS Latitude/Longitude	
				Start	End
Item	DWR UCIP Field Study			39.303013 °	39.303013 °
				-121.588124 °	-121.588124 °
DWR ID					
Action/Comments					
Inspector Comments: FS_ID:24842 DS_ID:21307 EP_NO: N/A FS_HLM: 1.88 Repair Type: Non-Urgent Crossing Status: Found

Marker visible on waterward side--No. 26.
