**Flood Control Project Maintenance
Levee Inspections**
LMA District Cover Sheet
Spring 2016 Levee Inspection Results

Reclamation District No. 0010 Honcut

Spring 2016 Levee Inspection Results

Waterway		Bank	Unit Miles
Unit No. 01 Simmerly Slough		Right	7.65

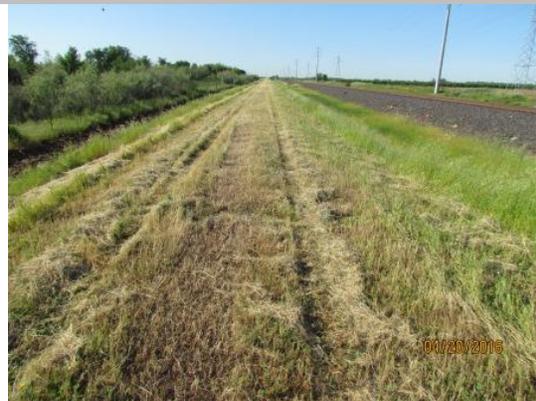
Photo 1 of 1 : SP_2016_RD0010_163_30_20160421_00061.jpg

LM Start	0.02	Rating **	M	Issue No.	30
LM End	7.64	Issue Type +	Ma	Location *	CR
Category	Earthen Levee		GPS Latitude/Longitude		
			Start	End	
Item	Vegetation		39.163680 °	39.256051 °	
			-121.609546 °	-121.574931 °	
DWR ID	DWR_RD0010_01_s_2016_30				
Comment Code					
V1 : Control annual grass and weeds on the levee slopes and easements.					
Inspector Comment

View of vegetation on crown preventing an all season access road.

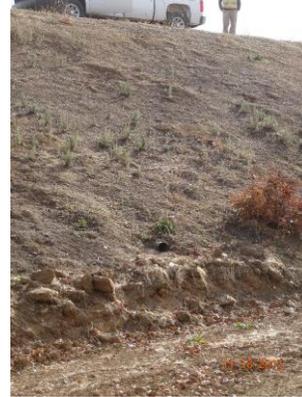
Photo 1 of 1 : UCIP_SP_2016_40545_51418.jpg

Comment Code					
Inspector Comment					
FS_ID:40545 DS_ID:21260 EP_NO: 4555 Repair Type: Non-Urgent Crossing Status: Indicator Found UCIP Comments: Pipe is approximately 4-6 inches in diameter located near the toe of levee. Crossing is approximately 50 feet downstream of 24-inch pipe. Need to contact owner to determine status of this crossing and to verify the purpose of crossing. If crossing is no longer in use owner will need to contact the CVFPB to comply with Title 23. FIELD_STRUCT_DESC: Abandoned 6-inch steel drainpipe through the levee, 1.0 feet below the crown. Siphon breaker on the waterward shoulder. Pump located at landward toe. Revetment around discharge end of pipe, draining into ditch at waterward toe. Pipe is not buried on berms, gravel pad over pipe across levee crown for vehicular access. Pipe retained through levee under Permit No. 4555 (1964). FS Date: 4/29/2013

Pipe through levee near waterward toe.

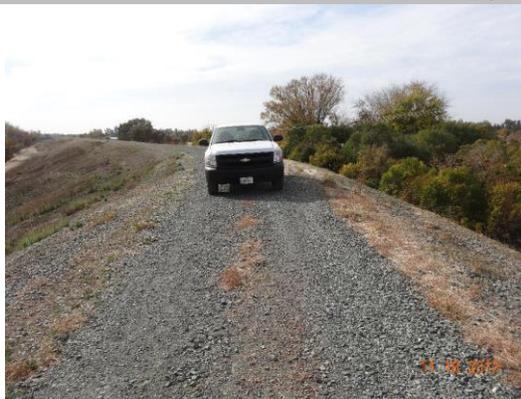
Photo 1 of 2 : UCIP_SP_2016_27725_51386.jpg

FS_ID:27725
 DS_ID:21262
 EP_NO: N/A
 Repair Type: Non-Urgent
 Crossing Status: Found
 UCIP Comments: Crossing appears not to be in use--need to contact owner. Need to coordinate with owner to determine status of crossing. If crossing is no longer in use owner will need to contact the CVFPB to comply with Title 23. This crossing is referenced in the USACE Periodic Inspection as item USACE_CESPK_HON1_2013_p_0012.
 FIELD_STRUCT_DESC: 10-inch steel pipe through the levee, 7.3 feet below the crown. Siphon breaker in CM riser on the waterward slope. Pump on the waterward berm-pump not present. Switch house on the waterward slope-no switch house present. 24-inch concrete standpipe at the landward toe. (USACE-1955). This entry matches the Drainage or Irrigation Structure referenced in O&M manual (Station 14+82).
 Concrete pad is still present on waterward side.
 FS Date: 4/29/2013

View of levee crown looking upstream.

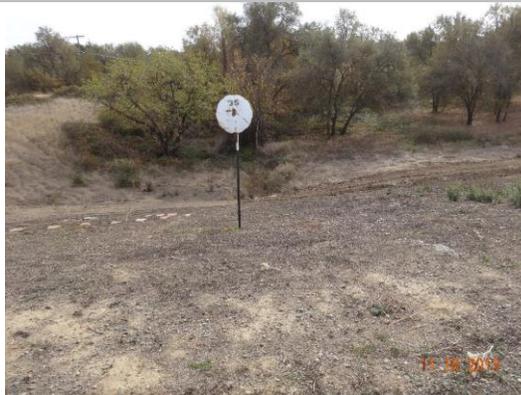
Photo 1 of 2 : UCIP_SP_2016_42872_44588.jpg

Comment Code					
Inspector Comment					
FS_ID:42872 DS_ID:21318 EP_NO: N/A Repair Type: Non-Urgent Crossing Status: Found UCIP Comments: Holes present on pipe wall. Need to contact owner to notify of issue with pipe. Also need to contact DWR Inspector and CVFPB to determine how to address issue. This crossing is referenced in the USACE Periodic Inspection as item USACE_CESPK_HON1_2013_p_0140. Pipe should be 30-inch instead of 36-inch mentioned Periodic Inspection. FIELD_STRUCT_DESC: 30-inch CM pipe through the levee, approximately 30 feet below the crown. Two CM cutoff walls around the pipe on both sides. Saddle and splash apron at the discharge end of the pipe. Concrete saddle and apron on waterward side. (USACE-1955). This entry matches the Drainage or Irrigation Structure referenced in O&M manual (Station 10+38). FS Date: 4/29/2013

View of waterward side--marker present on waterward shoulder.

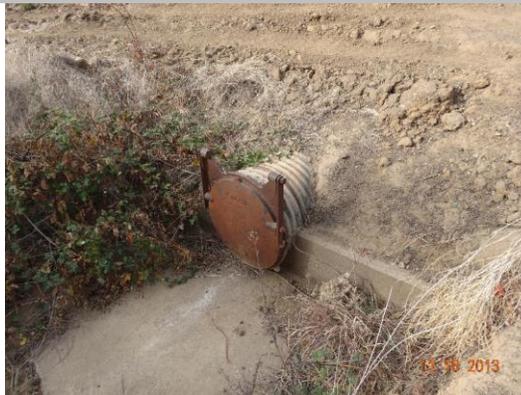
Photo 2 of 2 : UCIP_SP_2016_42872_44587.jpg

View of headwall, pipe, and flap gate located on waterward side.

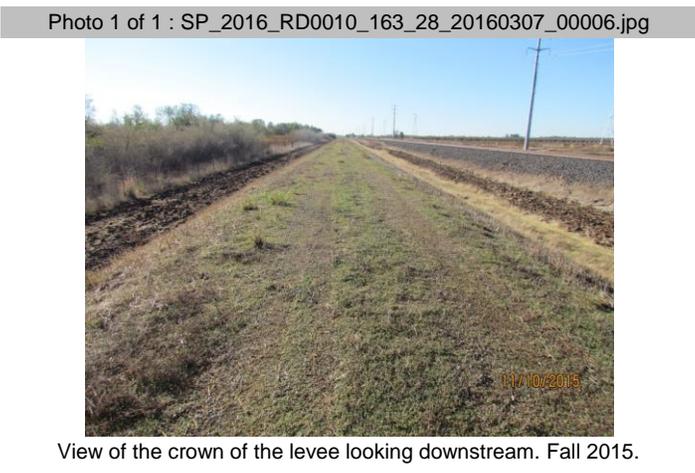
LM Start	3.57	Rating **	A/W	Issue No.	28
LM End	7.64	Issue Type +	Ma	Location *	CR
Category	Earthen Levee			GPS Latitude/Longitude	
				Start	End
Item	Crown Surface / Depressions / Rutting			39.197526 °	39.255993 °
				-121.582294 °	-121.574930 °
DWR ID	DWR_RD0010_01_f_2015_28				
Comment Code					
C1 : Add appropriate material and re-grade the levee to bring the crown above the design elevation.					
Inspector Comment					
Crown needs to be re-graded. LMA is in the proces of regrading the levee in correspondence with DWR.

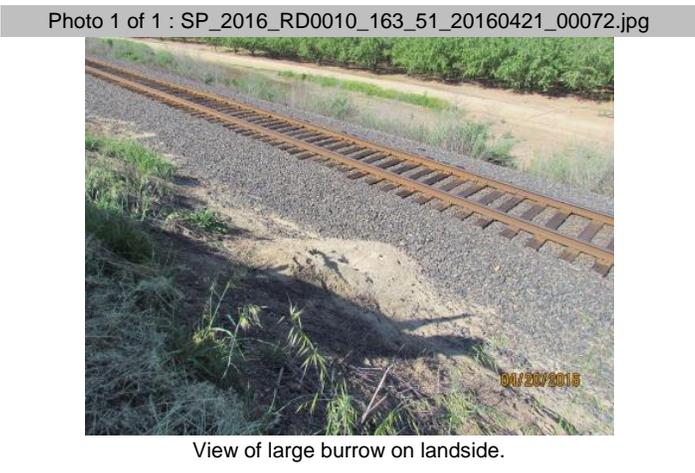
LM Start	3.75	Rating **	U	Issue No.	51
LM End	3.75	Issue Type +	Ma	Location *	LS
Category	Earthen Levee			GPS Latitude/Longitude	
				Start	End
Item	Animal Control			39.200003 °	39.200003 °
				-121.582002 °	-121.582002 °
DWR ID	DWR_RD0010_01_s_2016_51				
Comment Code					
A3 : No rodents visible, but rodent burrows visible; need to backfill and compact or grout burrows.					
Inspector Comment

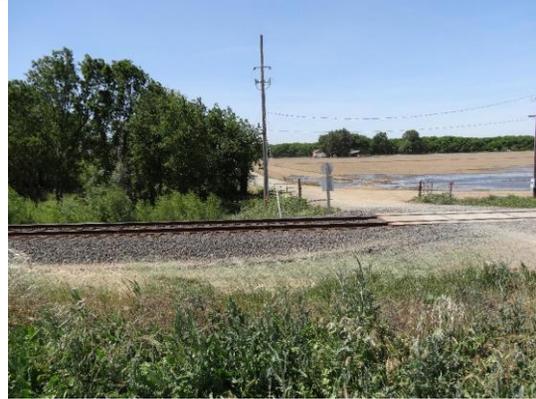
Photo 1 of 2 : UCIP_SP_2016_27531_51124.jpg

LM Start	6.14	Rating **	M	Issue No.	83
LM End	6.14	Issue Type +	En	Location *	LS
Category	Supplemental		GPS Latitude/Longitude		
			Start	End	
Item	DWR UCIP Field Study		39.234389 °	39.234389 °	
			-121.577620 °	-121.577620 °	
DWR ID					
Comment Code					
Inspector Comment					
FS_ID:27531 DS_ID:21277 EP_NO: 6127 Repair Type: Non-Urgent Crossing Status: Indicator Found UCIP Comments: Recommend removing vegetation along pipe alignment to conduct proper inspection of structure and appurtenances. FIELD_STRUCT_DESC: Two 1-inch aluminum conduits through the levee, 3.0 feet below the crown. Cutoff wall around conduits at center of levee. (Permit No. 6217-1968) FS Date: 4/29/2013

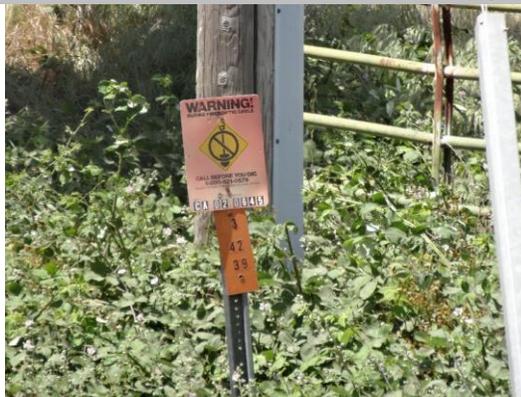
Photo 2 of 2 : UCIP_SP_2016_27531_51123.jpg

LM Start	6.14	Rating **	M	Issue No.	83 (cont)
LM End	6.14	Issue Type +	En	Location *	LS
Category	Supplemental			GPS Latitude/Longitude	
				Start	End
Item	DWR UCIP Field Study			39.234389 °	39.234389 °
				-121.577620 °	-121.577620 °
DWR ID					
Comment Code					
Inspector Comment					
FS_ID:27531 DS_ID:21277 EP_NO: 6127 Repair Type: Non-Urgent Crossing Status: Indicator Found UCIP Comments: Recommend removing vegetation along pipe alignment to conduct proper inspection of structure and appurtenances. FIELD_STRUCT_DESC: Two 1-inch aluminum conduits through the levee, 3.0 feet below the crown. Cutoff wall around conduits at center of levee. (Permit No. 6217-1968) FS Date: 4/29/2013

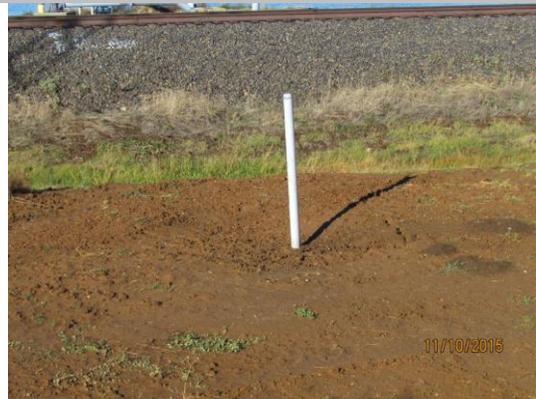
Photo 3 of 8 : SP_2016_RD0010_163_27_20160307_00004.jpg

The culvert seems to be linked to the pipe on the waterward side. Fall 2015.

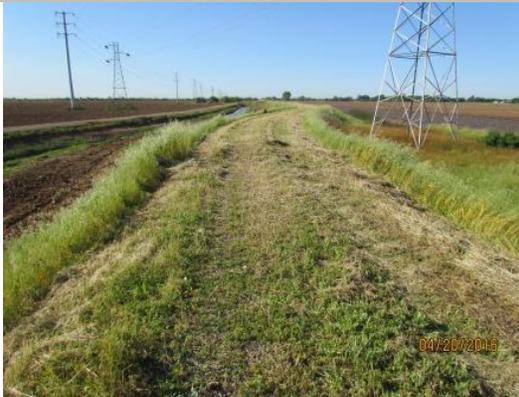
Photo 5 of 8 : SP_2016_RD0010_163_27_20160509_00073.jpg

LM Start	6.82	Rating **	M	Issue No.	27 (cont)
LM End	6.82	Issue Type +	En	Location *	CR
Category	Earthen Levee			GPS Latitude/Longitude	
				Start	End
Item	Encroachments			39.244203 °	39.244203 °
				-121.576246 °	-121.576246 °
DWR ID	DWR_RD0010_01_f_2015_27				
Comment Code					
PI : Pipe					
Inspector Comment					
LMA has talked to landowner about the pipe and trench before about digging on the levee. This is a new trench Fall 2015. Spring 2016; the pipe bored through levee caused depression in crown 11' wide by 6" deep. Land owner is Charley Mathews.

View of depression in crown, caused by an unpermitted pipe crossing. A FIR was created for this issue. Spring 2016.

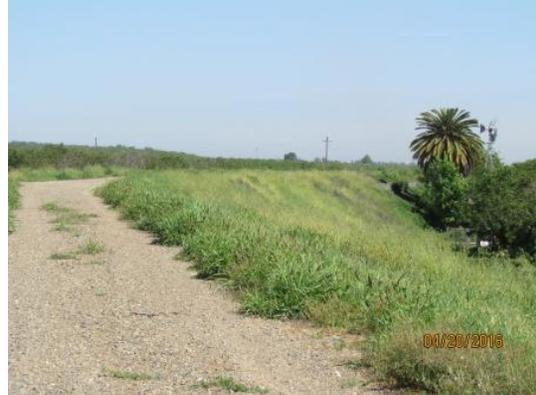
Photo 1 of 1 : SP_2016_RD0010_164_23_20160421_00065.jpg

LM Start	0.10	Rating **	M	Issue No.	23
LM End	11.34	Issue Type +	Ma	Location *	LS
Category	Earthen Levee		GPS Latitude/Longitude		
			Start	End	
Item	Vegetation		39.165167 °	39.309707 °	
			-121.610207 °	-121.616553 °	
DWR ID	DWR_RD0010_02_s_2016_23				
Comment Code					
V1 : Control annual grass and weeds on the levee slopes and easements.					
Inspector Comment

View of typical vegetation on landside looking upstream.

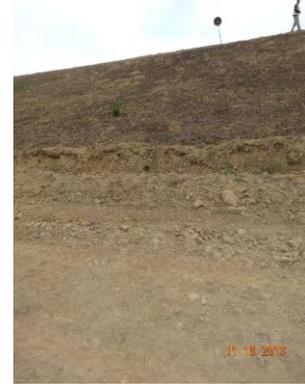
Photo 2 of 2 : UCIP_SP_2016_27533_51137.jpg

Comment Code					
Inspector Comment					
<p>FS_ID:27533 DS_ID:21280 EP_NO: N/A Repair Type: Non-Urgent Crossing Status: Found UCIP Comments: Recommend removing vegetation and debris along pipe alignment (debris blocking gate on waterward side and vegetation blocking access to screw gate on landward side). Need to coordinate with owner to determine status of crossing. If crossing is no longer in use owner will need to contact the CVFPB to comply with Title 23. This crossing is referenced in the USACE Periodic Inspection as item USACE_CESPK_HON2_2013_p_0027. FIELD_STRUCT_DESC: 24-inch CM pipe through the levee, 25.6 feet below the crown. Two CM cutoff walls around pipe at both shoulders. Flap gate on the waterward end. Concrete headwall, saddle and apron on the waterward end. (USACE-1953). This entry matches the Drainage or Irrigation Structure referenced in O&M manual (Station 106+00). FS Date: 4/30/2013</p>

View of waterward slope.

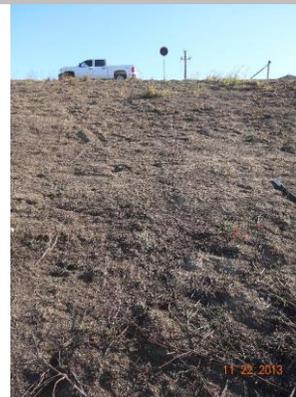
Photo 2 of 2 : UCIP_SP_2016_24821_44639.jpg

Comment Code					
Inspector Comment					
FS_ID:24821 DS_ID:21281 EP_NO: N/A Repair Type: Non-Urgent Crossing Status: Found UCIP Comments: Screw gate on landward side is blocked by sediment. Recommend removing sediment in front of gate. This crossing is referenced in the USACE Periodic Inspection as item USACE_CESPK_HON2_2013_p_0082. FIELD_STRUCT_DESC: 24-inch CM pipe through the levee, 26.0 feet below the crown. Two CM cutoff walls around pipe at both shoulders. Flap gate on the waterward end. Slide gate on landward end. Concrete headwall, saddle and apron on the waterward end. (USACE-1953). This entry matches the Drainage or Irrigation Structure referenced in O&M manual (Station 149+88). FS Date: 4/30/2013

View of waterward slope side.

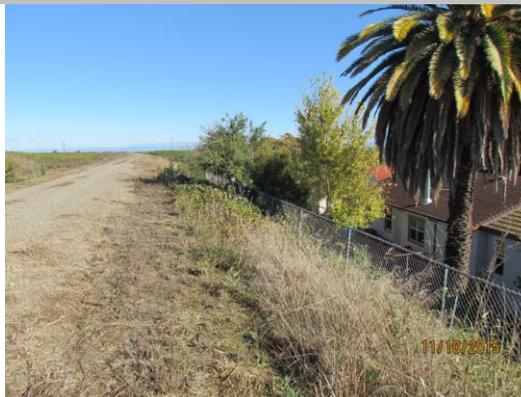
Photo 2 of 2 : SP_2016_RD0010_164_9_20160307_00002.jpg

LM Start	1.34	Rating **	M	Issue No.	9 (cont)
LM End	1.34	Issue Type +	En	Location *	LS
Category	Earthen Levee			GPS Latitude/Longitude	
				Start	End
Item	Vegetation			39.182957 °	39.182957 °
				-121.609800 °	-121.609800 °
DWR ID	DWR_RD0010_02_s_2012_9				
Comment Code					
V6 : Landscaping					
Inspector Comment

View of the landscaping on the landward side of the levee looking upstream. Fall 2015.

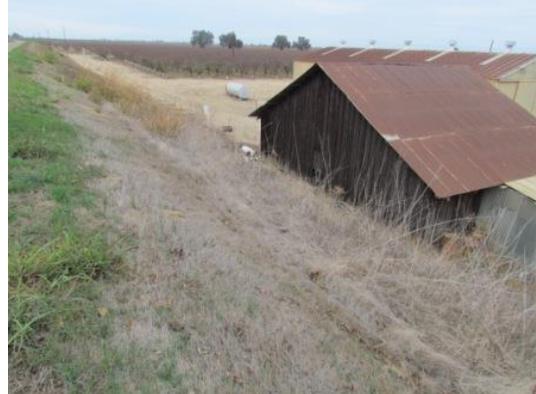
Photo 1 of 1 : SP_2016_RD0010_164_65_20160307_00009.jpg

LM Start	2.12	Rating **	M	Issue No.	65
LM End	2.12	Issue Type +	En	Location *	LS
Category	Earthen Levee		GPS Latitude/Longitude		
			Start	End	
Item	Encroachments		39.194178 °	39.194178 °	
			-121.607880 °	-121.607880 °	
DWR ID	DWR_RD0010_02_f_2013_65				
Comment Code					
BU : Building					
Inspector Comment

This photo was taken from the crown facing north looking down the landward levee slope at an outbuilding near the levee toe. Fall 2013.

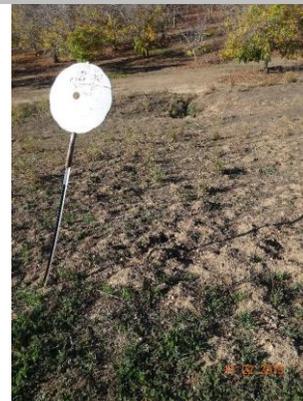
Photo 2 of 2 : UCIP_SP_2016_27773_51460.jpg

View of waterward side--burrow activity present on slope.

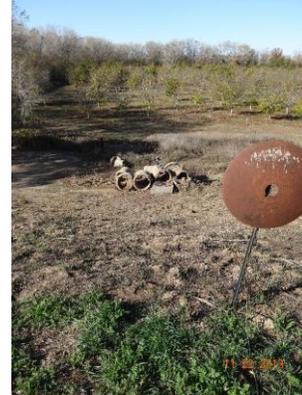
Photo 2 of 2 : UCIP_SP_2016_24824_44657.jpg

Comment Code					
Inspector Comment					
FS_ID:24824 DS_ID:21284 EP_NO: N/A Repair Type: Non-Urgent Crossing Status: Found UCIP Comments: Remove concrete piece preventing complete closure of screw gate on landward side. This crossing is referenced in the USACE Periodic Inspection as item USACE_CESPK_HON2_2013_p_0152. FIELD_STRUCT_DESC: 36-inch CM drainpipe through the levee, 24.0 feet below the crown. Two CM cutoff walls around pipe at both shoulders. Flap gate on the waterward end. Slide gate on the landward end. Concrete headwalls at both ends. (USACE-1953). This entry matches the Drainage or Irrigation Structure referenced in O&M manual (Station 259+76). FS Date: 4/30/2013

Overview of waterward slope--barrier placed at toe to discourage damage to crossing.

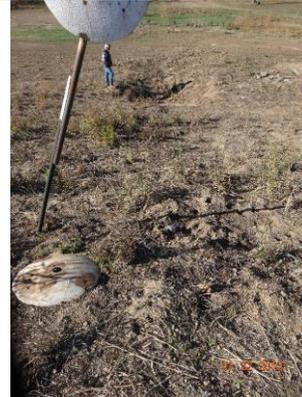
Photo 2 of 3 : UCIP_SP_2016_24825_44663.jpg

View of waterward slope--burrow activity present.

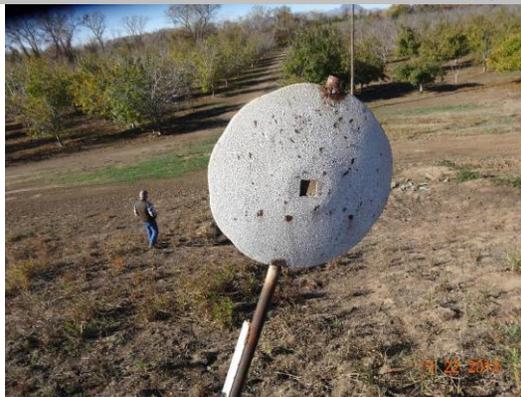
Photo 1 of 2 : UCIP_SP_2016_24825_44664.jpg

Comment Code					
Inspector Comment					
FS_ID:24825 DS_ID:21285 EP_NO: N/A Repair Type: Non-Urgent Crossing Status: Found UCIP Comments: Sediment blocking flap gate and screw gate--recommend removing material. Dense burrow activity present along levee slopes (large holes visible on landward side)--recommend addressing issue. This crossing is referenced in the USACE Periodic Inspection as item USACE_CESPK_HON2_2013_p_0169. FIELD_STRUCT_DESC: 30-inch CM drainpipe through the levee, 19.5 feet below the crown. Two CM cutoff walls around pipe at both shoulders. Flap gate on the waterward end. Slide gate on the landward end. Concrete headwalls at both ends. (USACE-1953). This entry matches the Drainage or Irrigation Structure referenced in O&M manual (Station 277+00). FS Date: 4/30/2013

Marker visible on waterward side.

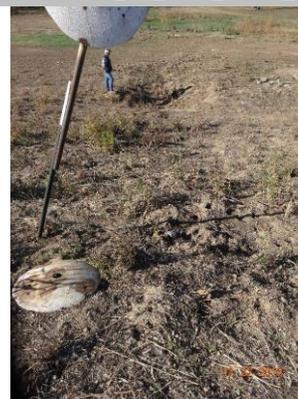
Photo 2 of 2 : UCIP_SP_2016_24825_44663.jpg

LM Start	3.62	Rating **	M	Issue No.	83 (cont)
LM End	3.62	Issue Type +	En	Location *	LS

View of waterward slope--burrow activity present.

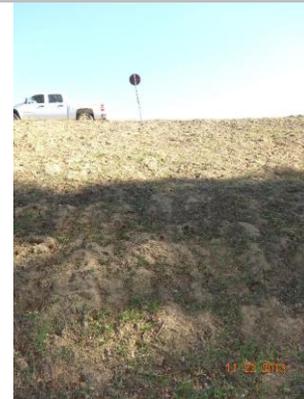
Photo 2 of 2 : UCIP_SP_2016_24826_44668.jpg

Comment Code					
Inspector Comment					
FS_ID:24826 DS_ID:21286 EP_NO: N/A Repair Type: Non-Urgent Crossing Status: Found UCIP Comments: Deformation observed on the top wall of pipe at the entrance of landward side--need to contact owner to address issue. This crossing is referenced in the USACE Periodic Inspection as item USACE_CESPK_HON2_2013_p_0180. FIELD_STRUCT_DESC: 30-inch CM drainpipe through the levee, 21.5 feet below the crown. Two CM cutoff walls around pipe at both shoulders. Flap gate on the waterward end. Slide gate on the landward end. Concrete headwalls at both ends. (USACE-1953). This entry matches the Drainage or Irrigation Structure referenced in O&M manual (Station 294+84). FS Date: 4/30/2013

View of waterward slope.

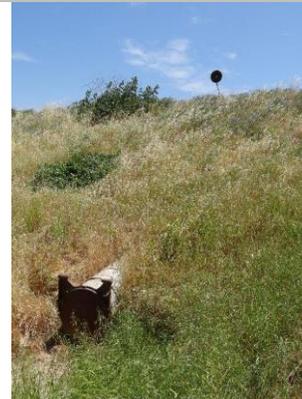
Photo 1 of 2 : UCIP_SP_2016_24751_44375.jpg

Comment Code					
Inspector Comment					
FS_ID:24751 DS_ID:21288 EP_NO: N/A Repair Type: Non-Urgent Crossing Status: Found UCIP Comments: Need to updated photos showing cleared slopes. This crossing is referenced in the USACE Periodic Inspection as item USACE_CESPK_HON2_2013_p_0193. FIELD_STRUCT_DESC: 24-inch CM drainpipe through the levee, 19.0 feet below the crown. Two CM cutoff walls around pipe at both shoulders. Flap gate on the waterward end. Slide gate on the landward side. Concrete headwall, saddle and apron on the waterward end. (USACE-1953). This entry matches the Drainage or Irrigation Structure referenced in O&M manual (Station 322+25). FS Date: 4/30/2013

View of waterward side--dense vegetation on slope.

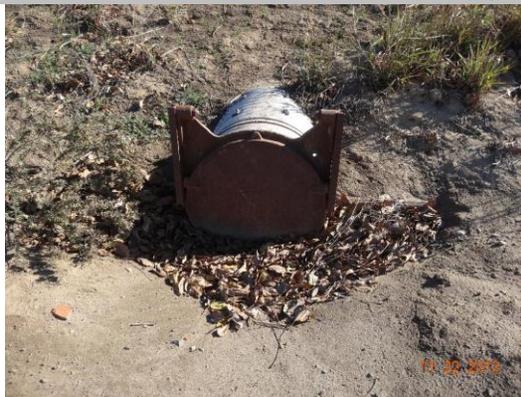
Photo 2 of 2 : UCIP_SP_2016_27793_51517.jpg

Comment Code					
Inspector Comment					
FS_ID:27793 DS_ID:21291 EP_NO: N/A Repair Type: Non-Urgent Crossing Status: Found UCIP Comments: Need to contact owner to remove debris inside concrete distribution box and on slope. This crossing is referenced in the USACE Periodic Inspection as item USACE_CESPK_HON2_2013_p_0244. FIELD_STRUCT_DESC: 30-inch CM drainpipe through the levee, 17.3 feet below the crown. Two CM cutoff walls around pipe at both shoulders. Flap gate on the waterward end. Slide gate on the landward end. Concrete headwalls at both ends. (USACE-1953). This entry matches the Drainage or Irrigation Structure referenced in O&M manual (Station 413+81). FS Date: 4/30/2013

View of flap gate located on waterward side.

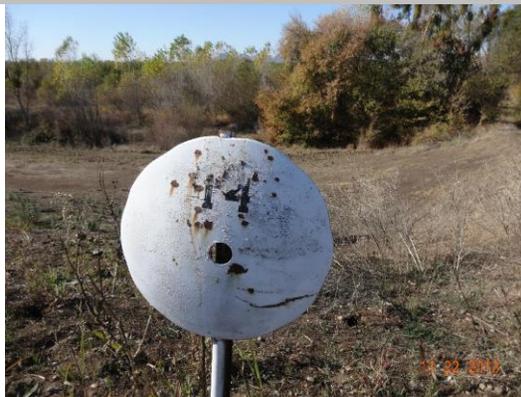
Photo 1 of 2 : UCIP_SP_2016_24830_44693.jpg

Comment Code					
Inspector Comment					
FS_ID:24830 DS_ID:21293 EP_NO: N/A Repair Type: Urgent Crossing Status: Indicator Found UCIP Comments: Both openings of crossing are blocked by sediment--screw gate is damage. Recommend notifying owner to repair screw gate and remove sediment build-up blocking openings. This crossing is referenced in the USACE Periodic Inspection as item USACE_CESPK_HON2_2013_p_0295. FIELD_STRUCT_DESC: 24-inch CM pipe through the levee, 13.0 feet below the crown. Two CM cutoff walls around pipe at both shoulders. Flap gate on the waterward end. Slide gate on the landward side. Concrete headwall, saddle and apron on the waterward end. (USACE-1953). This entry matches the Drainage or Irrigation Structure referenced in O&M manual (Station 471+21). FS Date: 4/30/2013

Marker visible on waterward shoulder, crossing referenced as No. 14.

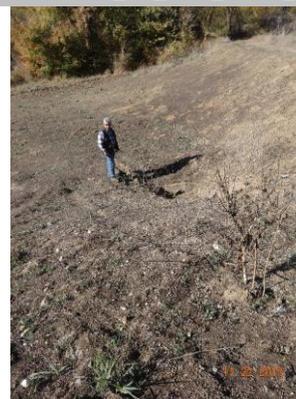
Photo 2 of 2 : UCIP_SP_2016_24830_44692.jpg

LM Start	7.24	Rating **	U	Issue No.	85 (cont)
LM End	7.24	Issue Type +	En	Location *	LS

View of waterward slope.

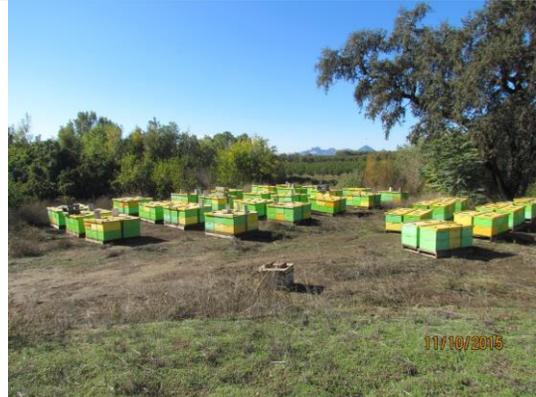
Photo 1 of 1 : SP_2016_RD0010_164_34_20160307_00005.jpg

LM Start	7.86	Rating **	M	Issue No.	34
LM End	7.86	Issue Type +	En	Location *	CR
Category	Earthen Levee		GPS Latitude/Longitude		
			Start	End	
Item	Encroachments		39.272290 °	39.272290 °	
			-121.613080 °	-121.613080 °	
DWR ID	DWR_RD0010_02_f_2015_34				
Comment Code					
MA : Material					
Inspector Comment					
Bee hives have been placed on a wide section of the crown.

View of the beehives on the crown of the levee. Fall 2015.

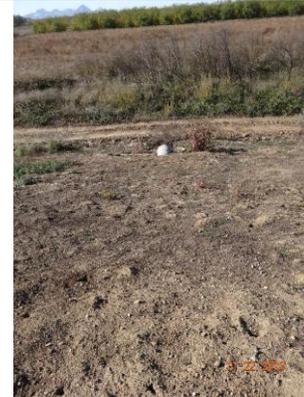
Photo 2 of 2 : UCIP_SP_2016_24834_44714.jpg

Comment Code					
Inspector Comment					
FS_ID:24834 DS_ID:21297 EP_NO: N/A Repair Type: Non-Urgent Crossing Status: Found UCIP Comments: Slide gate missing on landward side. Need to contact owner to determine status of crossing. This crossing is referenced in the USACE Periodic Inspection as item USACE_CESPK_HON2_2013_p_0367. FIELD_STRUCT_DESC: 24-inch CM pipe through the levee, 14.0 feet below the crown. Two CM cutoff walls around pipe at both shoulders. Flap gate on the waterward end. Slide gate on the landward side (missing). Concrete headwall, saddle and apron on the waterward end. Concrete splash apron (6x6 foot) at waterward toe. (USACE-1953). This entry matches the Drainage or Irrigation Structure referenced in O&M manual (Station 565+74). FS Date: 4/30/2013

View of waterward side.

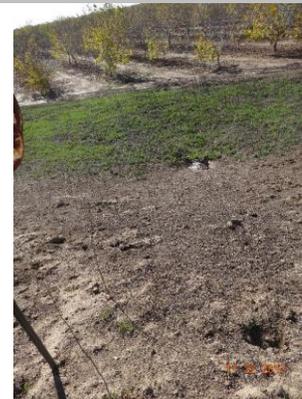
Photo 2 of 2 : UCIP_SP_2016_27776_51482.jpg

LM Start	9.71	Rating **	M	Issue No.	94 (cont)
LM End	9.71	Issue Type +	En	Location *	LS

View of waterward side.

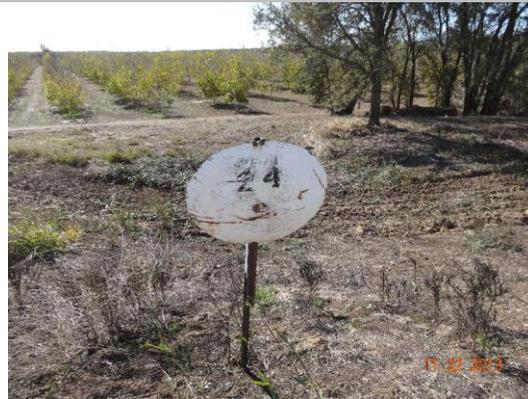
Photo 1 of 2 : UCIP_SP_2016_24838_44737.jpg

LM Start	10.38	Rating **	M	Issue No.	87 (cont)
LM End	10.38	Issue Type +	En	Location *	LS

Marker visible on waterward shoulder, this crossing is reference as No. 24.

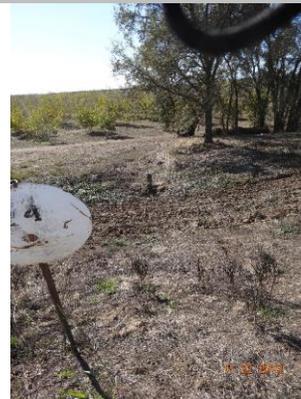
Photo 2 of 2 : UCIP_SP_2016_24838_44741.jpg

View of waterward side.

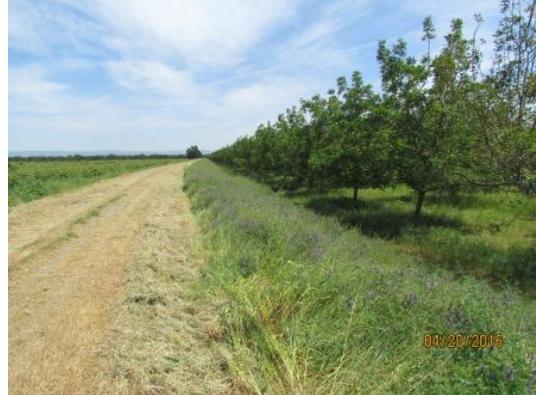
Photo 1 of 1 : SP_2016_RD0010_165_4_20160421_00010.jpg

LM Start	0.01	Rating **	M	Issue No.	4
LM End	2.80	Issue Type +	Ma	Location *	LS
Category	Earthen Levee		GPS Latitude/Longitude		
			Start	End	
Item	Vegetation		39.310111 °	39.298530 °	
			-121.616223 °	-121.569994 °	
DWR ID	DWR_RD0010_03_s_2016_4				
Comment Code					
V1 : Control annual grass and weeds on the levee slopes and easements.					
Inspector Comment

View of typical vegetation on the landside looking upstream.

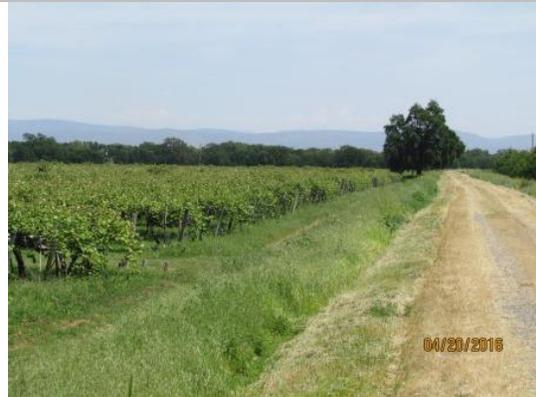
Photo 1 of 1 : SP_2016_RD0010_165_6_20160421_00011.jpg

LM Start	0.01	Rating **	M	Issue No.	6
LM End	2.80	Issue Type +	Ma	Location *	WS
Category	Earthen Levee		GPS Latitude/Longitude		
			Start	End	
Item	Vegetation		39.310111 °	39.298530 °	
			-121.616223 °	-121.569994 °	
DWR ID	DWR_RD0010_03_s_2016_6				
Comment Code					
V1 : Control annual grass and weeds on the levee slopes and easements.					
Inspector Comment

Typical vegetation on the waterside looking upstream.

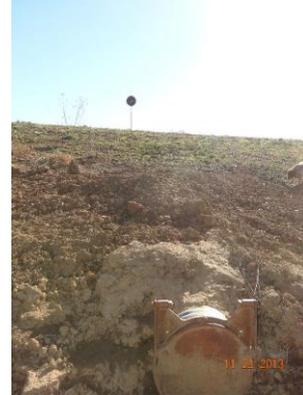
Photo 2 of 2 : UCIP_SP_2016_24842_44762.jpg

Comment Code					
Inspector Comment					
FS_ID:24842 DS_ID:21307 EP_NO: N/A Repair Type: Non-Urgent Crossing Status: Found UCIP Comments: Sediment deposit inside pipe--Need to coordinate with owner to determine status of crossing. If crossing is no longer in use owner will need to contact the CVFPB to comply with Title 23. FIELD_STRUCT_DESC: 24-inch CM drainpipe through the levee, 15.0 feet below the crown. Two CM cutoff walls around pipe at both shoulders. Flap gate on the waterward end. Slide gate on the landward end. Concrete headwall at both toes. (USACE-1953). This entry matches the Drainage or Irrigation Structure referenced in O&M manual (Station 134+06). FS Date: 5/1/2013

View of waterward slope.
