**Flood Control Project Maintenance
Levee Inspections**
LMA District Cover Sheet
Spring 2019 Levee Inspection Results

Reclamation District No. 0010 Honcut

Spring 2019 Levee Inspection Results

Waterway			Bank	Unit Miles
Unit No. 01 Simmerly Slough			Right	7.65
	Spring (March - May)	Summer (June - August)	(September - November) Fall	Winter (December - February)
Unit Maintenance Rating (Fall Only)				
Date of Inspection	5/16/2019 - 5/16/2019			
DWR Inspector	Sterling York			
Accompanied By	Finlay Williams

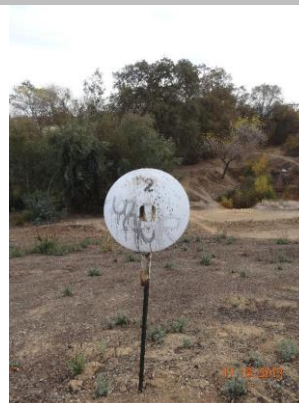
Photo 1 of 3 : UCIP_SP_2019_50058_51415.jpg

LM Start	0.74	Rating **	M	Issue No.	72 (cont)
LM End	0.74	Issue Type +	Ma	Location *

View of WS--Marker indicates crossing is labelled as 2.

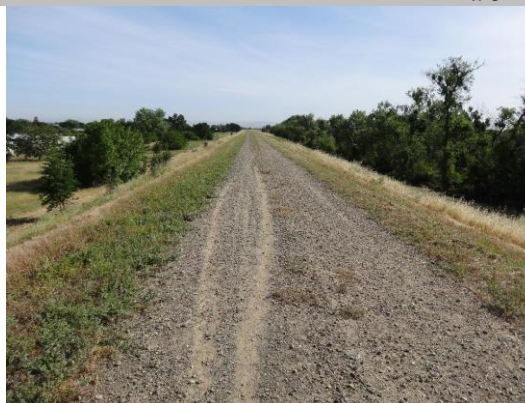
Photo 2 of 3 : UCIP_SP_2019_50058_51410.jpg

View of levee crown looking downstream.

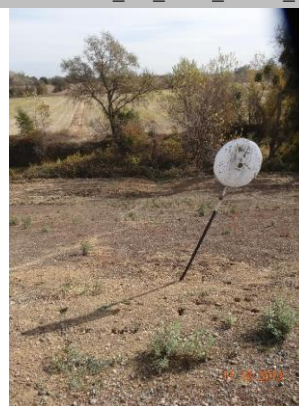
Photo 1 of 3 : UCIP_SP_2019_27748_51453.jpg

Comment Code					
Inspector Comment					
FS_ID:27748 DS_ID:21261 EP_NO: N/A Repair Type: No Action Needed Crossing Status: Found UCIP Comments: 04/29/2013 No signs of damage to levee present during inspection. This crossing is referenced in the USACE Periodic Inspection as item USACE_CESPK_HON1_2013_p_0037 and 0040. (DWR UCIP - O. Magana) FIELD_STRUCT_DESC: 24-inch corrugated metal gravity drainage pipe through the levee, 29.5 feet below the crown. Two corrugated metal cutoff walls around the pipe on each end. Slide gate on the landside (LS) end. Flap gate on the waterside (WS) end. Concrete headwall at the LS toe. [Additional Reference(s): DWR Levee Log, 2005. USACE Sacramento O&M Manual 151, May 1953, (Station 37+66)]. FS Date: 4/29/2013

View of waterward side--slope and marker for pipe crossing.

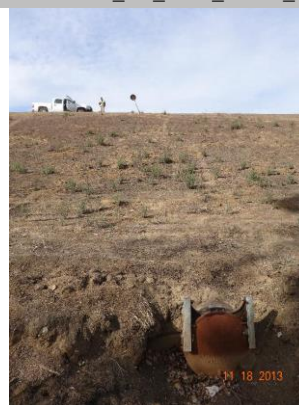
Photo 2 of 3 : UCIP_SP_2019_27748_51450.jpg

LM Start	0.89	Rating **	A/W	Issue No.	73 (cont)
LM End	0.89	Issue Type +	Ma	Location *

View of slope located on waterward side.

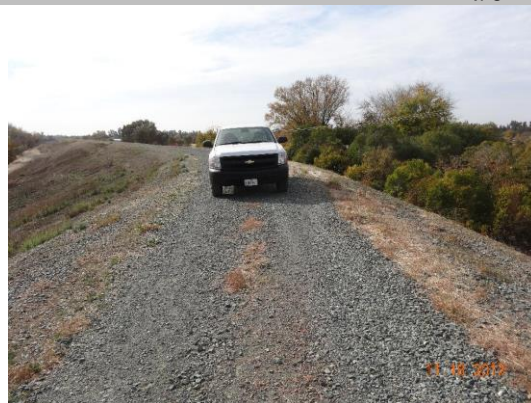
Photo 1 of 3 : UCIP_SP_2019_27725_51386.jpg

Comment Code					
Inspector Comment					
FS_ID:27725 DS_ID:21262 EP_NO: N/A Repair Type: Non-Urgent Crossing Status: Found UCIP Comments: 04/29/2013 Crossing appears not to be in use--need to contact owner. Need to coordinate with owner to determine status of crossing. If crossing is no longer in use owner will need to contact the CVFPB to comply with Title 23. This crossing is referenced in the USACE Periodic Inspection as item USACE_CESPK_HON1_2013_p_0012. (DWR UCIP - O. Magana) FIELD_STRUCT_DESC: 10-inch steel irrigation discharge pipe through the levee, 7.3 feet below the crown. Siphon breaker in a corrugated metal pipe (CMP) riser on the waterside (WS) slope. Pump on the WS berm. Pump not present. Switch house on the WS slope. No switch house present. 24-inch concrete standpipe at the landside (LS) toe. Concrete pad is still present on the WS. [Additional Reference(s): DWR Levee Log, 2005. USACE Sacramento O&M Manual 151, May 1953, (Station 14+82)]. FS Date: 4/29/2013

LM Start	1.33	Rating **	M	Issue No.	75 (cont)
LM End	1.33	Issue Type +	En	Location *

View of levee crown looking upstream.

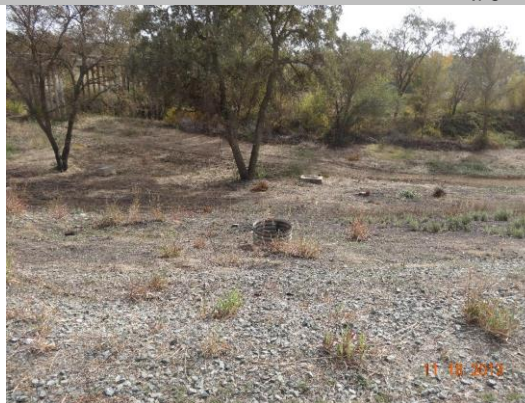
Photo 3 of 3 : UCIP_SP_2019_27725_51384.jpg

Comment Code						
Inspector Comment						
FS_ID:27725 DS_ID:21262 EP_NO: N/A Repair Type: Non-Urgent Crossing Status: Found UCIP Comments: 04/29/2013 Crossing appears not to be in use--need to contact owner. Need to coordinate with owner to determine status of crossing. If crossing is no longer in use owner will need to contact the CVFPB to comply with Title 23. This crossing is referenced in the USACE Periodic Inspection as item USACE_CESPK_HON1_2013_p_0012. (DWR UCIP - O. Magana) FIELD_STRUCT_DESC: 10-inch steel irrigation discharge pipe through the levee, 7.3 feet below the crown. Siphon breaker in a corrugated metal pipe (CMP) riser on the waterside (WS) slope. Pump on the WS berm. Pump not present. Switch house on the WS slope. No switch house present. 24-inch concrete standpipe at the landside (LS) toe. Concrete pad is still present on the WS. [Additional Reference(s): DWR Levee Log, 2005. USACE Sacramento O&M Manual 151, May 1953, (Station 14+82)]. FS Date: 4/29/2013

View of waterward side-slopes cleared.

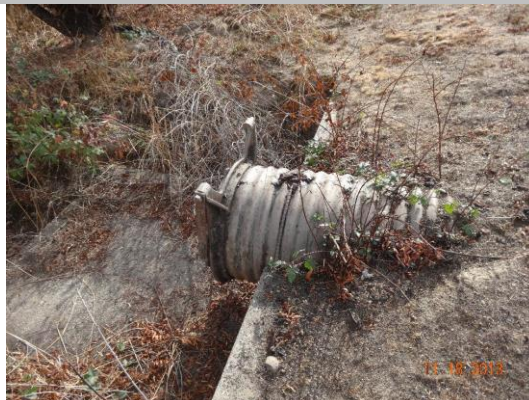
Photo 2 of 3 : UCIP_SP_2019_27745_51432.jpg

View of pipe, headwall, and flap gate located on waterward side.

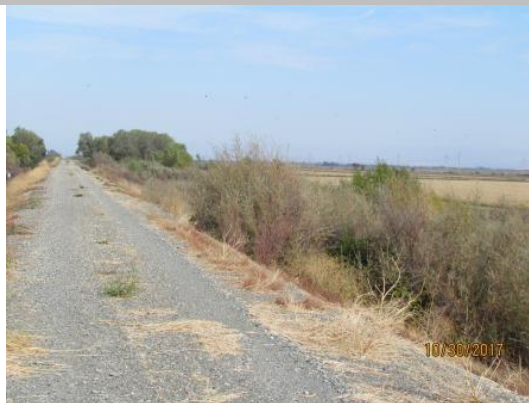
Photo 1 of 1 : SP_2019_RD0010_163_35_20190305_00002.jpg

LM Start	2.70	Rating **	M	Issue No.	35
LM End	2.70	Issue Type +	Ma	Location *	WS
Category	Earthen Levee			GPS Latitude/Longitude	
				Start	End
Item	Trim / Thin Trees			39.184974 °	39.184974 °
				-121.583836 °	-121.583836 °
DWR ID	DWR_RD0010_01_f_2017_35				
Comment Code					
T2 : Thin trees to allow visibility of the ground and room to flood fight.					
Inspector Comment					
Willows on levee slope need to be removed, Spring 2019.

View looking upstream waterside at Willow Trees that need to be removed.

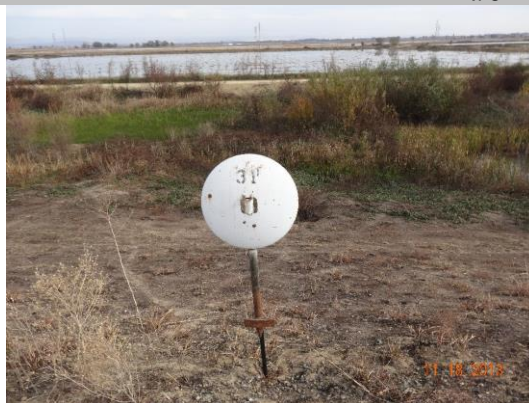
Photo 1 of 3 : UCIP_SP_2019_27746_51436.jpg

LM Start	3.70	Rating **	A/W	Issue No.	84
LM End	3.70	Issue Type +	Ma	Location *	
Category	Supplemental			GPS Latitude/Longitude	
				Start	End
Item	DWR UCIP LMA Responsibility			39.199281 °	39.199281 °
				-121.582091 °	-121.582091 °
DWR ID	21273				
Comment Code					
Inspector Comment					
FS_ID:27746 DS_ID:21273 EP_NO: N/A Repair Type: No Action Needed Crossing Status: Found UCIP Comments: 04/29/2013 This crossing is referenced in the USACE Periodic Inspection as item USACE_CESPK_HON1_2013_p_0217. (DWR UCIP - O. Magana) FIELD_STRUCT_DESC: 24-inch reinforced concrete gravity drainage pipe through the levee, 19.5 feet below the crown. Flap gate on the waterside (WS) end. Concrete headwall at each toe. Concrete saddle and apron on the WS. [Additional Reference(s): DWR Levee Log, 2005. USACE Sacramento O&M Manual 151, May 1953, (Station 317+80)]. FS Date: 4/29/2013

View of waterward side--marker for pipe visible on waterward shoulder.

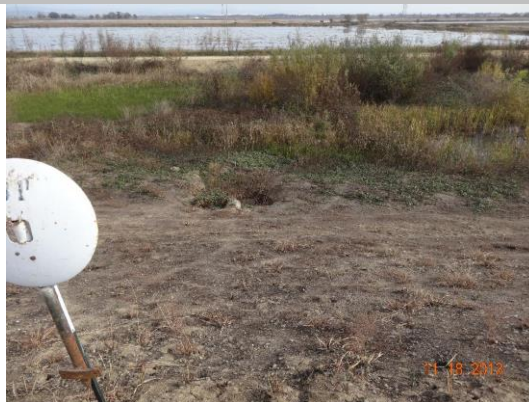
Photo 2 of 3 : UCIP_SP_2019_27746_51435.jpg

LM Start	3.70	Rating **	A/W	Issue No.	84 (cont)
LM End	3.70	Issue Type +	Ma	Location *

View of pipe on waterward toe.

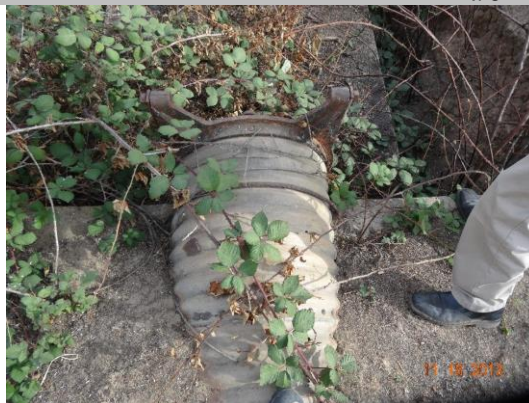
Photo 3 of 3 : UCIP_SP_2019_27746_51439.jpg

Comment Code						
Inspector Comment						
FS_ID:27746						
DS_ID:21273						
EP_NO: N/A						
Repair Type: No Action Needed						
Crossing Status: Found						
UCIP Comments: 04/29/2013 This crossing is referenced in the						
USACE Periodic Inspection as item						
USACE_CESPK_HON1_2013_p_0217. (DWR UCIP - O. Magana)						
FIELD_STRUCT_DESC: 24-inch reinforced concrete gravity drainage						
pipe through the levee, 19.5 feet below the crown. Flap gate on the						
waterside (WS) end. Concrete headwall at each toe. Concrete saddle						
and apron on the WS. [Additional Reference(s): DWR Levee Log, 2005.						
USACE Sacramento O&M Manual 151, May 1953, (Station 317+80)].						
FS Date: 4/29/2013

View of pipe, headwall, and concrete apron on waterward toe.

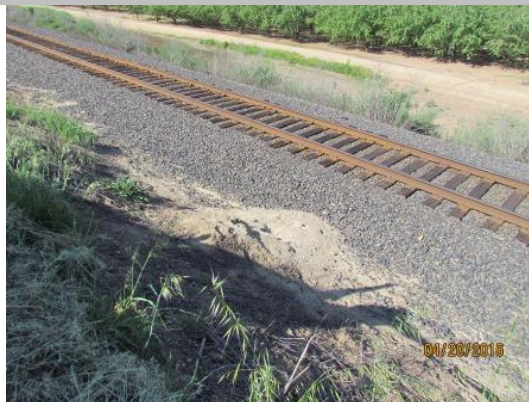
Photo 1 of 1 : SP_2019_RD0010_163_51_20190305_00012.jpg

LM Start	3.75	Rating **	U	Issue No.	51
LM End	3.75	Issue Type +	Ma	Location *	LS
Category	Earthen Levee			GPS Latitude/Longitude	
				Start	End
Item	Animal Control			39.200003 °	39.200003 °
				-121.582002 °	-121.582002 °
DWR ID	DWR_RD0010_01_s_2016_51				
Comment Code					
A3 : No rodents visible, but rodent burrows visible; need to backfill and compact or grout burrows.					
Inspector Comment					
There is a large rodent hole the exceeds 2 cubic feet of dirt and needs to be properly backfilled. Spring 2019.

View of large burrow on landside.

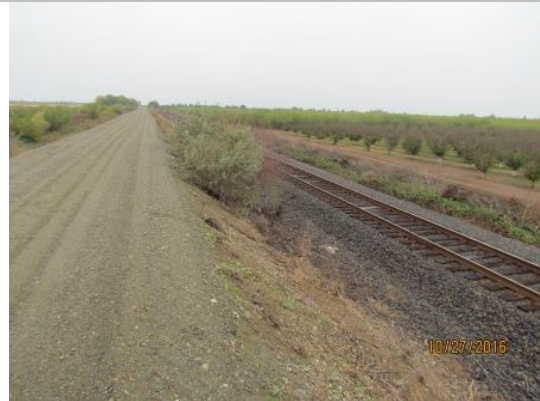
Photo 1 of 1 : SP_2019_RD0010_163_47_20190305_00008.jpg

LM Start	3.93	Rating **	M	Issue No.	47
LM End	3.93	Issue Type +	Ma	Location *	LS
Category	Earthen Levee			GPS Latitude/Longitude	
				Start	End
Item	Trim / Thin Trees			39.202569 °	39.202569 °
				-121.581681 °	-121.581681 °
DWR ID	DWR_RD0010_01_s_2016_47				
Comment Code					
T2 : Thin trees to allow visibility of the ground and room to flood fight.					
Inspector Comment					
Remove small willow tree from the levee slope. Spring 2019.

View of a small willow tree that should be removed on the landside looking down stream.

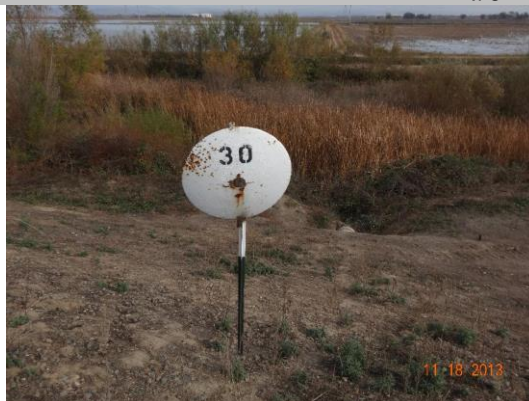
Photo 1 of 3 : UCIP_SP_2019_27747_51441.jpg

LM Start	4.11	Rating **	M	Issue No.	85 (cont)
LM End	4.11	Issue Type +	En	Location *

View of waterwar side--marker indicating crossing located on waterward shoulder.

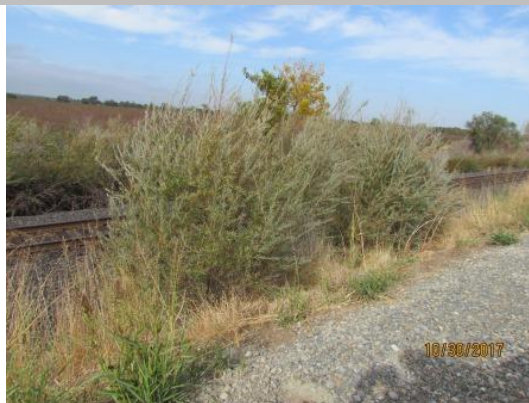
Photo 1 of 1 : SP_2019_RD0010_163_37_20190305_00003.jpg

LM Start	4.83	Rating **	M	Issue No.	37
LM End	4.83	Issue Type +	Ma	Location *	LS
Category	Earthen Levee			GPS Latitude/Longitude	
				Start	End
Item	Trim / Thin Trees			39.215597 °	39.215597 °
				-121.580046 °	-121.580046 °
DWR ID	DWR_RD0010_01_f_2017_37				
Comment Code					
T3 : Trim and thin trees to allow visibility of the ground and room to flood fight.					
Inspector Comment					
Small willow tree on the landside slope should be removed. Spring 2019.

View of small willow trees on the landside slope looking upstream.

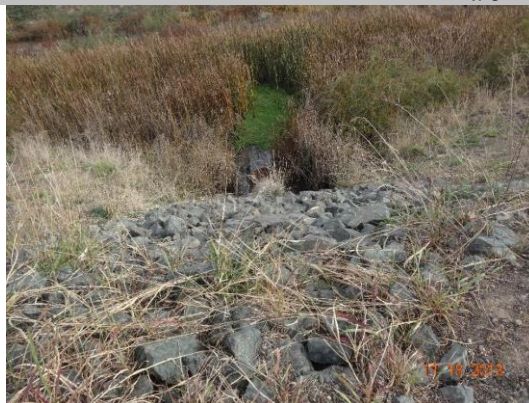
Photo 3 of 3 : UCIP_SP_2019_53138_44810.jpg

View of WS slope covered with rip rap along pipe alignment.

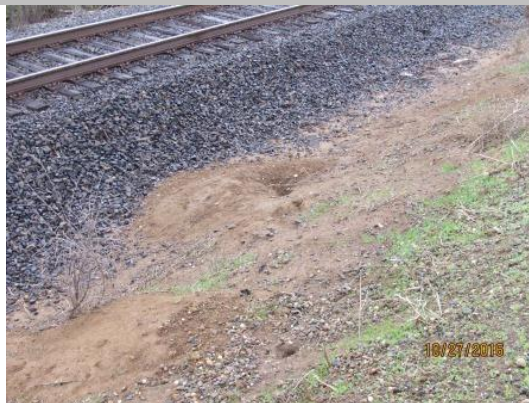
Photo 1 of 1 : SP_2019_RD0010_163_42_20190305_00006.jpg

LM Start	5.04	Rating **	M	Issue No.	42
LM End	5.04	Issue Type +	Ma	Location *	LS
Category	Earthen Levee			GPS Latitude/Longitude	
				Start	End
Item	Animal Control			39.218564 °	39.218564 °
				-121.579682 °	-121.579682 °
DWR ID	DWR_RD0010_01_s_2016_42				
Comment Code					
A3 : No rodents visible, but rodent burrows visible; need to backfill and compact or grout burrows.					
Inspector Comment					
Squirrel holes still are visible but there is no sign of activity, Spring 2019.

View of squirrel holes on landside toe, no sign of activity.

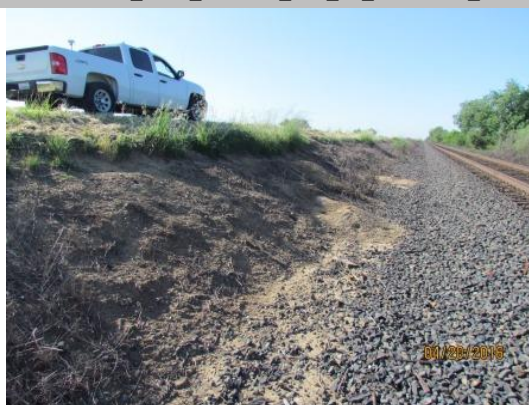
Photo 1 of 1 : SP_2019_RD0010_163_41_20190305_00005.jpg

LM Start	5.45	Rating **	M	Issue No.	41
LM End	5.45	Issue Type +	Ma	Location *	LS
Category	Earthen Levee			GPS Latitude/Longitude	
				Start	End
Item	Animal Control			39.224485 °	39.224485 °
				-121.578944 °	-121.578944 °
DWR ID	DWR_RD0010_01_s_2016_41				
Comment Code					
A3 : No rodents visible, but rodent burrows visible; need to backfill and compact or grout burrows.					
Inspector Comment					
Squirrel holes still are visible but there is no sign of activity, Spring 2019.

View of multiple ground squirrel holes on landside slope looking downstream. There is no evidences of active squirrels.

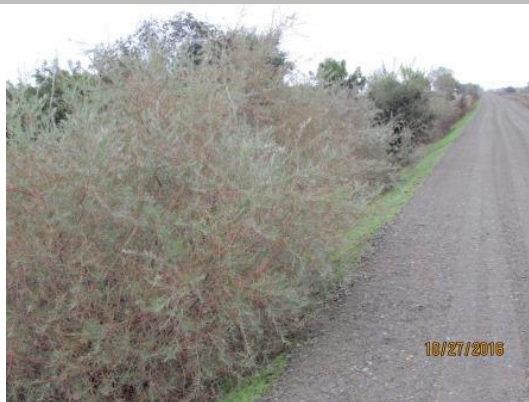
Photo 1 of 1 : SP_2019_RD0010_163_40_20190305_00004.jpg

LM Start	5.60	Rating **	M	Issue No.	40
LM End	5.60	Issue Type +	Ma	Location *	LS
Category	Earthen Levee			GPS Latitude/Longitude	
				Start	End
Item	Trim / Thin Trees			39.226679 °	39.226679 °
				-121.578670 °	-121.578670 °
DWR ID	DWR_RD0010_01_s_2016_40				
Comment Code					
T1 : Trim trees to at least five feet above ground level.					
Inspector Comment					
Remove small willow trees from the levee slope. Spring 2019.

View of willow trees on the landside slope looking upstream.

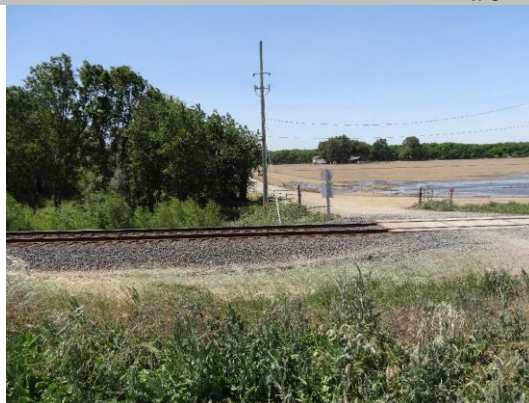
Photo 1 of 3 : UCIP_SP_2019_27531_51124.jpg

Comment Code					
Inspector Comment					
FS_ID:27531 DS_ID:21277 EP_NO: 6127 Repair Type: Non-Urgent Crossing Status: Indicator Found UCIP Comments: 04/29/2013 Recommend removing vegetation along pipe alignment to conduct proper inspection of structure and appurtances. (DWR UCIP - O. Magana) FIELD_STRUCT_DESC: Two 1-inch aluminum electrical conduits through the levee, 3 feet below the crown. Cutoff wall around the conduits at the center of the levee. (Plans to construct a low levee along the bank of the canal authorized under Permit No. 6127, 1968 - Morgan C. Chambers and Edgar Meyer). [Additional Reference(s): DWR Levee Log, 2005]. FS Date: 4/29/2013

LS view overview.

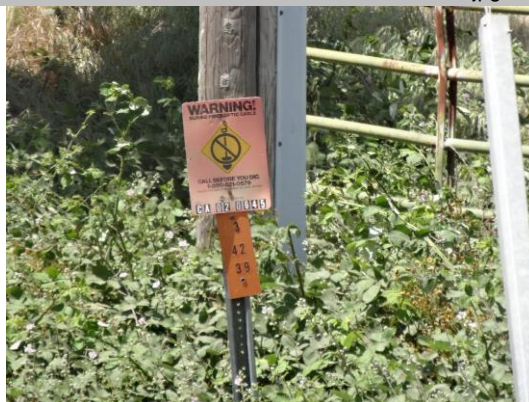
Photo 2 of 3 : UCIP_SP_2019_27531_51123.jpg

Buried fiber optic cable marker located on LS.

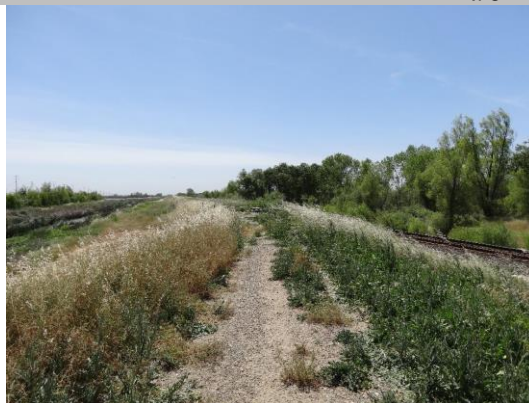
Photo 3 of 3 : UCIP_SP_2019_27531_51122.jpg

Comment Code						
Inspector Comment						
FS_ID:27531 DS_ID:21277 EP_NO: 6127 Repair Type: Non-Urgent Crossing Status: Indicator Found UCIP Comments: 04/29/2013 Recommend removing vegetation along pipe alignment to conduct proper inspection of structure and appurtances. (DWR UCIP - O. Magana) FIELD_STRUCT_DESC: Two 1-inch aluminum electrical conduits through the levee, 3 feet below the crown. Cutoff wall around the conduits at the center of the levee. (Plans to construct a low levee along the bank of the canal authorized under Permit No. 6127, 1968 - Morgan C. Chambers and Edgar Meyer). [Additional Reference(s): DWR Levee Log, 2005]. FS Date: 4/29/2013

View of levee crown.

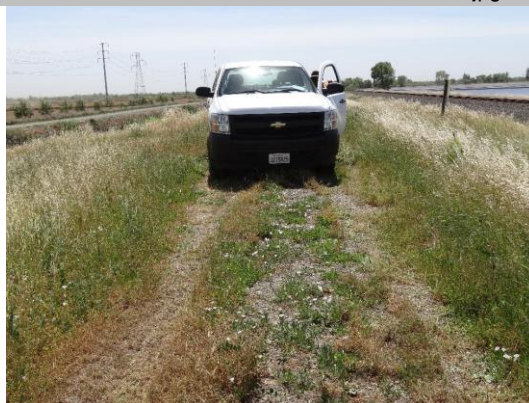
Photo 2 of 3 : UCIP_SP_2019_27532_51128.jpg

View of levee looking downstream.

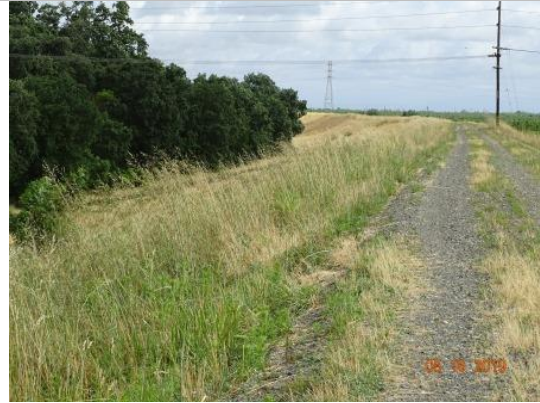
Photo 1 of 1 : SP_2019_RD0010_164_46_20190520_00100.jpg

LM Start	0.33	Rating **	M	Issue No.	46
LM End	8.02	Issue Type +	Ma	Location *	WS
Category	Earthen Levee			GPS Latitude/Longitude	
				Start	End
Item	Vegetation			39.168418 °	39.274334 °
				-121.610641 °	-121.612004 °
DWR ID	DWR_RD0010_02_s_2019_46				
Comment Code					
V1 : Control annual grass and weeds on the levee slopes and easements.					
Inspector Comment					
The annual vegetation needs to be maintained, Spring 2019.

View looking upstream waterside at the annual vegetation that needs maintenance, Spring 2019.

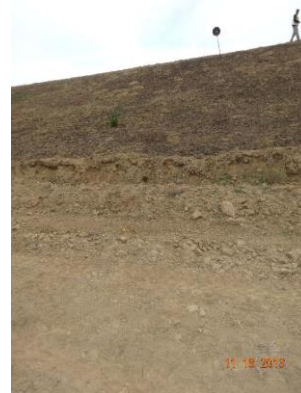
Photo 2 of 3 : UCIP_SP_2019_27533_51137.jpg

Comment Code						
Inspector Comment						
FS_ID:27533 DS_ID:21280 EP_NO: N/A Repair Type: Non-Urgent Crossing Status: Found UCIP Comments: 04/30/2013 Recommend removing vegetation and debris along pipe alignment (debris blocking gate on waterward side and vegetation blocking access to screw gate on landward side). Need to coordinate with owner to determine status of crossing. If crossing is no longer in use owner will need to contact the CVFPB to comply with Title 23. This crossing is referenced in the USACE Periodic Inspection as item USACE_CESPK_HON2_2013_p_0027. (DWR UCIP - O. Magana) FIELD_STRUCT_DESC: 24-inch corrugated metal gravity drainage pipe through the levee, 25.6 feet below the crown. Corrugated metal cutoff wall around the pipe at each shoulder. Flap gate on the waterside (WS) end. Concrete headwall, saddle, and apron on the WS end. [Additional Reference(s): DWR Levee Log, 2005. USACE Sacramento O&M Manual 151, May 1953, (Station 106+00)]. FS Date: 4/30/2013

View of waterward slope.

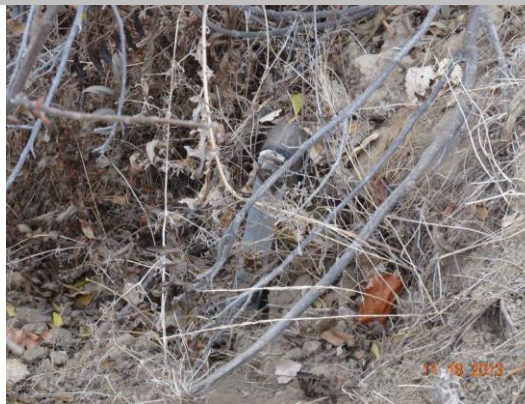
Photo 3 of 3 : UCIP_SP_2019_27533_51138.jpg

Buried flap gate on waterward side.

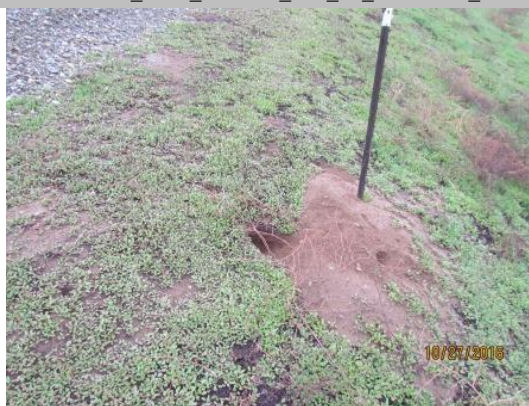
Photo 1 of 1 : SP_2019_RD0010_164_28_20190305_00003.jpg

LM Start	0.38	Rating **	M	Issue No.	28
LM End	0.38	Issue Type +	Ma	Location *	WS
Category	Earthen Levee			GPS Latitude/Longitude	
				Start	End
Item	Animal Control			39.169231 °	39.169231 °
				-121.610711 °	-121.610711 °
DWR ID	DWR_RD0010_02_f_2015_28				
Comment Code					
A3 : No rodents visible, but rodent burrows visible; need to backfill and compact or grout burrows.					
Inspector Comment					
No rodent activity but squirrel hole needs to be backfilled, Spring 2019.

View of squirrel hole on the waterside looking downstream.

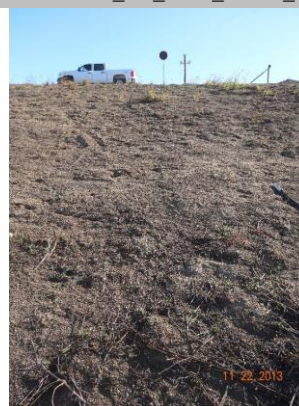
Photo 2 of 3 : UCIP_SP_2019_24821_44639.jpg

Comment Code						
Inspector Comment						
FS_ID:24821 DS_ID:21281 EP_NO: N/A Repair Type: Non-Urgent Crossing Status: Found UCIP Comments: 04/30/2013 Screw gate on landward side is blocked by sediment. Recommend removing sediment in front of gate. This crossing is referenced in the USACE Periodic Inspection as item USACE_CESPK_HON2_2013_p_0082. (DWR UCIP - O. Magana) FIELD_STRUCT_DESC: 24-inch corrugated metal gravity drainage pipe through the levee, 26 feet below the crown. Corrugated metal cutoff wall around the pipe at each shoulder. Flap gate on the waterside (WS) end. Slide gate on the landside (LS) end. Concrete headwall, saddle, and apron on the WS end. [Additional Reference(s): DWR Levee Log, 2005. USACE Sacramento O&M Manual 151, May 1953, (Station 149+88)]. FS Date: 4/30/2013

View of waterward slope side.

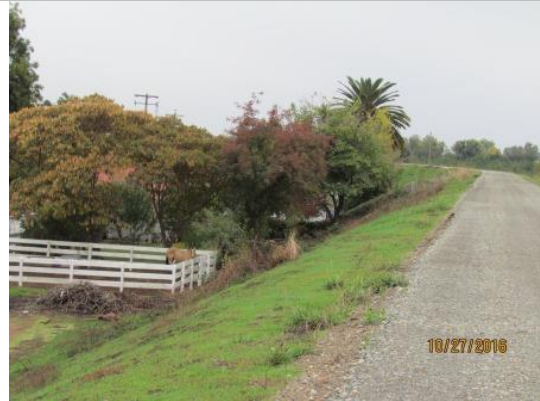
Photo 1 of 1 : SP_2019_RD0010_164_9_20190305_00002.jpg

LM Start	1.34	Rating **	M	Issue No.	9
LM End	1.34	Issue Type +	En	Location *	LS
Category	Earthen Levee			GPS Latitude/Longitude	
				Start	End
Item	Vegetation			39.182957 °	39.182957 °
				-121.609800 °	-121.609800 °
DWR ID	DWR_RD0010_02_s_2012_9				
Comment Code					
V6 : Landscaping					
Inspector Comment					
Landscaping and fence should be removed from the levee toe and slope.

View of homeowners landscaping and fence that encroaches on the landside levee slope, looking downstream.

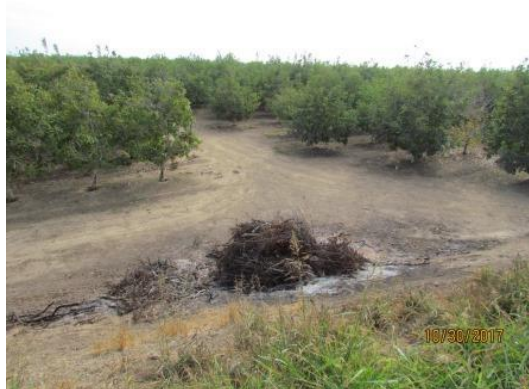
Photo 1 of 1 : SP_2019_RD0010_164_39_20190305_00014.jpg

LM Start	1.80	Rating **	M	Issue No.	39
LM End	1.80	Issue Type +	En	Location *	LS
Category	Earthen Levee			GPS Latitude/Longitude	
				Start	End
Item	Encroachments			39.189467 °	39.189467 °
				-121.607991 °	-121.607991 °
DWR ID	DWR_RD0010_02_s_2016_39				
Comment Code					
PR : Prunings					
Inspector Comment					
Remove prunings from toe of slope, Spring 2019.

View of prunings at landside levee toe.

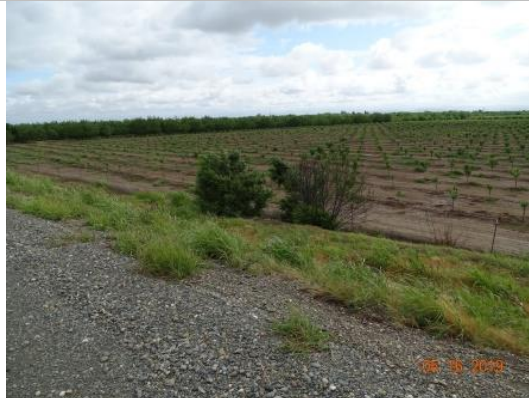
Photo 1 of 1 : SP_2019_RD0010_164_40_20190520_00102.jpg

LM Start	2.71	Rating **	M	Issue No.	40
LM End	2.71	Issue Type +	Ma	Location *	LS
Category	Earthen Levee			GPS Latitude/Longitude	
				Start	End
Item	Trim / Thin Trees			39.202609 °	39.202609 °
				-121.609395 °	-121.609395 °
DWR ID	DWR_RD0010_02_f_2018_40				
Comment Code					
T3 : Trim and thin trees to allow visibility of the ground and room to flood fight.					
Inspector Comment					
Trees less than 4" in diameter should be removed, Spring 2019.

View looking upstream landside of trees at levee toe that need to be removed, Spring 2019.

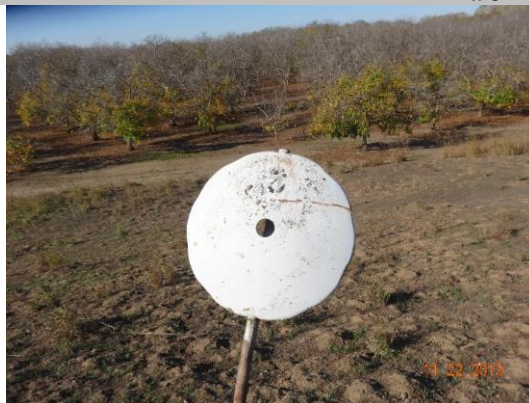
Photo 1 of 3 : UCIP_SP_2019_27773_51461.jpg

LM Start	3.10	Rating **	M	Issue No.	75
LM End	3.10	Issue Type +	En	Location *	
Category	Supplemental			GPS Latitude/Longitude	
				Start	End
Item	DWR UCIP Field Study			39.208193 °	39.208193 °
				-121.609909 °	-121.609909 °
DWR ID	21283				
Comment Code					
Inspector Comment					
FS_ID:27773 DS_ID:21283 EP_NO: N/A Repair Type: Non-Urgent Crossing Status: Found UCIP Comments: 04/30/2013 High rodent activity along pipe alignment--animal control would be beneficial. This crossing is referenced in the USACE Periodic Inspection as item USACE_CESPK_HON2_2013_p_0150. (DWR UCIP - O. Magana) FIELD_STRUCT_DESC: 30-inch corrugated metal gravity drainage pipe through the levee, 22.5 feet below the crown. Flap gate on the waterside (WS) end. Metal marker on the WS shoulder. [Additional Reference(s): DWR Levee Log, 2005]. FS Date: 4/30/2013

Marker visible on waterward side.

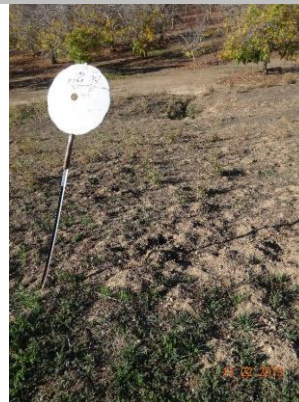
Photo 2 of 3 : UCIP_SP_2019_27773_51460.jpg

View of waterward side--burrow activity present on slope.

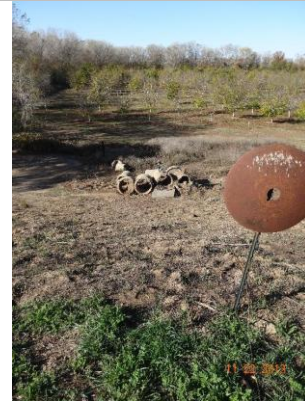
Photo 2 of 3 : UCIP_SP_2019_52889_44657.jpg

Comment Code						
Inspector Comment						
FS_ID:52889 DS_ID:21284 EP_NO: N/A Repair Type: Non-Urgent Crossing Status: Found UCIP Comments: 04/30/2013 Remove concrete piece preventing complete closure of screw gate on landward side. This crossing is referenced in the USACE Periodic Inspection as item USACE_CESPK_HON2_2013_p_0152. (DWR UCIP - O. Magana) FIELD_STRUCT_DESC: 36-inch corrugated metal gravity drainage pipe through the levee, 24 feet below the crown. Corrugated metal cutoff wall around the pipe at each shoulder. Flap gate on the waterside (WS) end. Slide gate on the landside (LS) end. Concrete headwall at each end. [Additional Reference(s): DWR Levee Log, 2005. USACE Sacramento O&M Manual 151, May 1953, (Station 259+76)]. FS Date: 4/30/2013

Overview of waterward slope--barrier placed at toe to discourage damage to crossing.

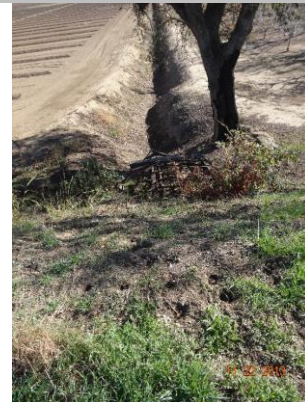
Photo 3 of 3 : UCIP_SP_2019_52889_44656.jpg

View of landward side--barrier used to discourage damage to crossing near toe.

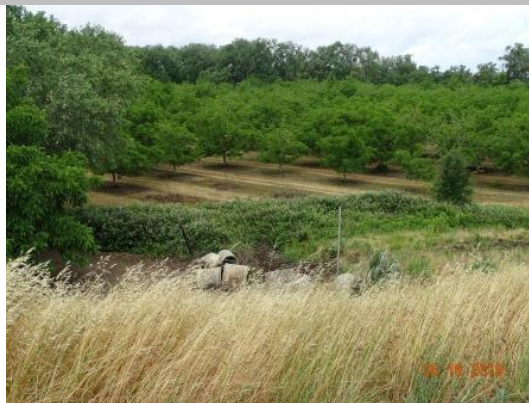
Photo 1 of 1 : SP_2019_RD0010_164_47_20190520_00103.jpg

LM Start	3.30	Rating **	M	Issue No.	47
LM End	3.30	Issue Type +	En	Location *	WS
Category	Earthen Levee			GPS Latitude/Longitude	
				Start	End
Item	Encroachments			39.211085 °	39.211085 °
				-121.610172 °	-121.610172 °
DWR ID	DWR_RD0010_02_s_2019_47				
Comment Code					
DE : Debris					
Inspector Comment					
Remove debris at the levee toe, Spring 2019.

View looking at the waterside levee toe where debris has been stacked, Spring 2019.

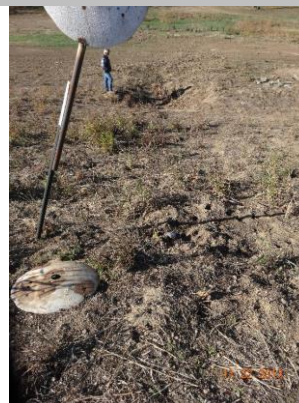
Photo 1 of 1 : SP_2019_RD0010_164_7_20190305_00001.jpg

LM Start	3.60	Rating **	M	Issue No.	7
LM End	3.60	Issue Type +	Ma	Location *	WS
Category	Earthen Levee			GPS Latitude/Longitude	
				Start	End
Item	Animal Control			39.215338 °	39.215338 °
				-121.610751 °	-121.610751 °
DWR ID	DWR_RD0010_02_s_2016_7				
Comment Code					
A3 : No rodents visible, but rodent burrows visible; need to backfill and compact or grout burrows.					
Inspector Comment					
There is no rodent activity, but the holes need to be properly backfilled, Spring 2019.

View of waterward slope--burrow activity present.

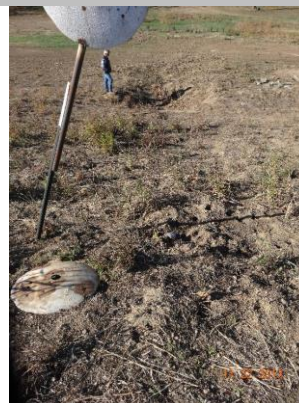
Photo 2 of 3 : UCIP_SP_2019_24825_44663.jpg

View of waterward slope--burrow activity present.

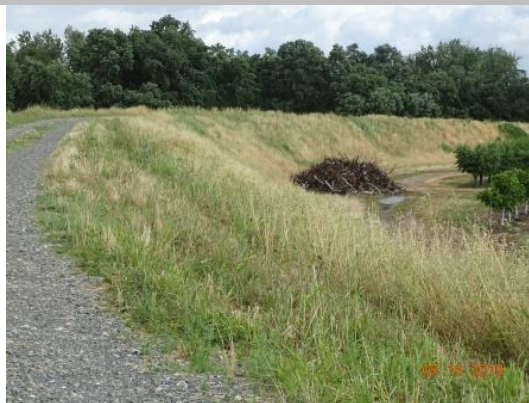
Photo 1 of 1 : SP_2019_RD0010_164_49_20190520_00104.jpg

LM Start	4.31	Rating **	M	Issue No.	49
LM End	4.31	Issue Type +	En	Location *	LS
Category	Earthen Levee			GPS Latitude/Longitude	
				Start	End
Item	Encroachments			39.225101 °	39.225101 °
				-121.613486 °	-121.613486 °
DWR ID	DWR_RD0010_02_s_2019_49				
Comment Code					
PR : Prunings					
Inspector Comment					
Remove prunings from the levee toe, Spring 2019.

View looking upstream landside at prunings on levee toe, Spring 2019.

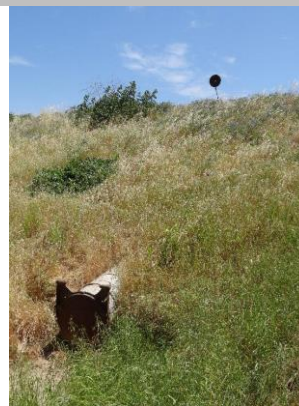
Photo 1 of 3 : UCIP_SP_2019_24751_44375.jpg

Comment Code					
Inspector Comment					
FS_ID:24751 DS_ID:21288 EP_NO: N/A Repair Type: Non-Urgent Crossing Status: Found UCIP Comments: 04/30/2013 Need to updated photos showing cleared slopes. This crossing is referenced in the USACE Periodic Inspection as item USACE_CESPK_HON2_2013_p_0193. (DWR UCIP - O. Magana) FIELD_STRUCT_DESC: 24-inch corrugated metal gravity drainage pipe through the levee, 19 feet below the crown. Corrugated metal cutoff wall around the pipe at each shoulder. Flap gate on the waterside (WS) end. Slide gate on the landside (LS). Concrete headwall, saddle, and apron on the WS end. [Additional Reference(s): DWR Levee Log, 2005. USACE Sacramento O&M Manual 151, May 1953, (Station 322+25)]. FS Date: 4/30/2013

View of waterward side--dense vegetation on slope.

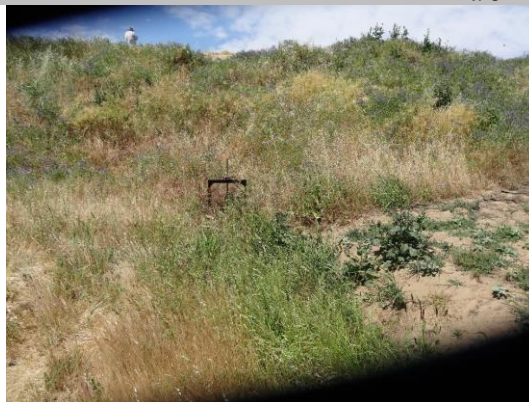
Photo 3 of 3 : UCIP_SP_2019_24751_44373.jpg

View of landward side--dense vegetation.

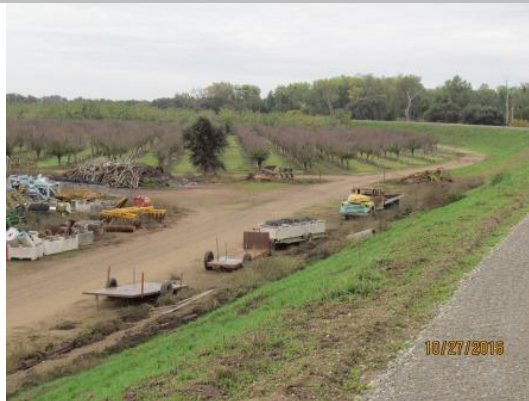
Photo 1 of 1 : SP_2019_RD0010_164_31_20190305_00007.jpg

LM Start	4.44	Rating **	M	Issue No.	31
LM End	4.48	Issue Type +	En	Location *	LS
Category	Earthen Levee			GPS Latitude/Longitude	
				Start	End
Item	Encroachments			39.226946 °	39.227445 °
				-121.613048 °	-121.612718 °
DWR ID	DWR_RD0010_02_f_2015_31				
Comment Code					
EQ : Equipment					
Inspector Comment					
Remove existing equipment from the levee toe.

View of the equipment at the toe of the levee on the landward side of the levee looking downstream.

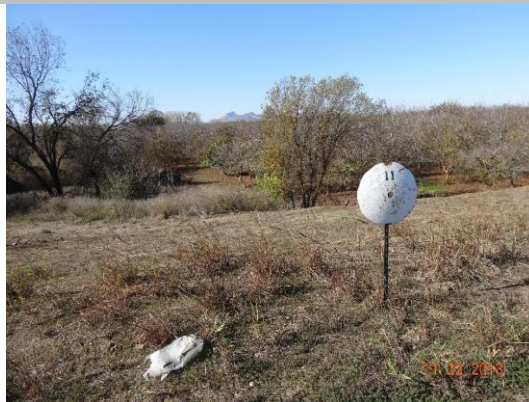
Photo 2 of 3 : UCIP_SP_2019_27774_51470.jpg

View of waterward side.

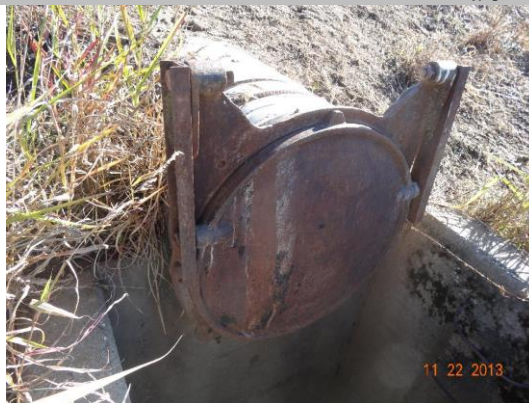
Photo 2 of 3 : UCIP_SP_2019_24828_44684.jpg

View of flap gate located on waterward side.

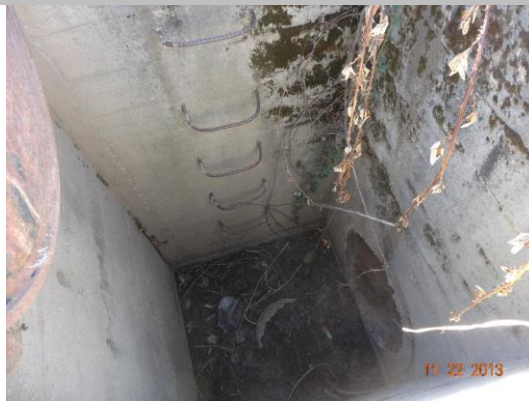
Photo 3 of 3 : UCIP_SP_2019_24828_44683.jpg

Inside view of concrete distribution box.

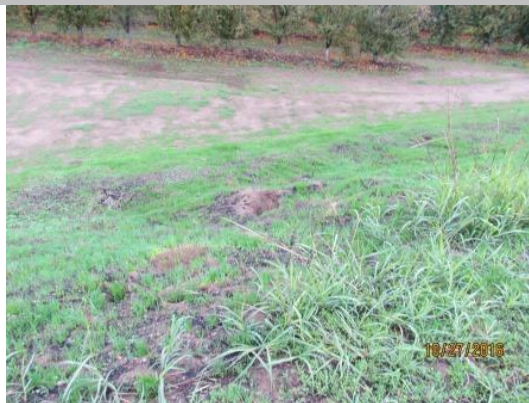
Photo 1 of 1 : SP_2019_RD0010_164_50_20190305_00018.jpg

LM Start	5.20	Rating **	M	Issue No.	50
LM End	5.20	Issue Type +	Ma	Location *	LS
Category	Earthen Levee			GPS Latitude/Longitude	
				Start	End
Item	Animal Control			39.237272 °	39.237272 °
				-121.615424 °	-121.615424 °
DWR ID	DWR_RD0010_02_f_2016_50				
Comment Code					
A3 : No rodents visible, but rodent burrows visible; need to backfill and compact or grout burrows.					
Inspector Comment					
No rodent activity but holes need to be properly backfilled, Spring 2019.

View of rodent hole on landside slope.

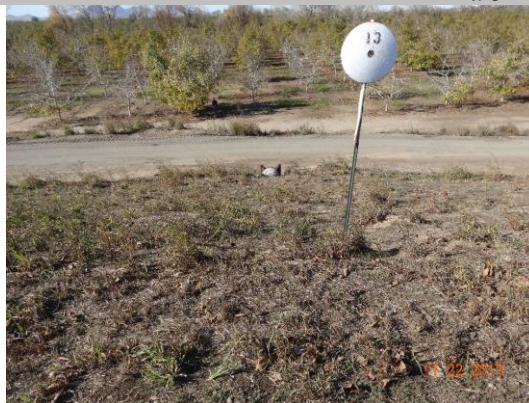
Photo 1 of 3 : UCIP_SP_2019_27793_51514.jpg

Comment Code					
Inspector Comment					
FS_ID:27793 DS_ID:21291 EP_NO: N/A Repair Type: Non-Urgent Crossing Status: Found UCIP Comments: 04/30/2013 Need to conctact owner to remove debris inside concrete distribution box and on slope. This crossing is referenced in the USACE Periodic Inspection as item USACE_CESPK_HON2_2013_p_0244. (DWR UCIP - O. Magana) FIELD_STRUCT_DESC: 30-inch corrugated metal gravity drainage pipe through the levee, 17.3 feet below the crown. Corrugated metal cutoff wall around the pipe at each shoulder. Flap gate on the waterside (WS) end. Slide gate on the landside (LS) end. Concrete headwall at each end. [Additional Reference(s): DWR Levee Log, 2005. USACE Sacramento O&M Manual 151, May 1953, (Station 413+81)]. FS Date: 4/30/2013

View of marker located on waterward shoulder, pipe is reference as No. 13.

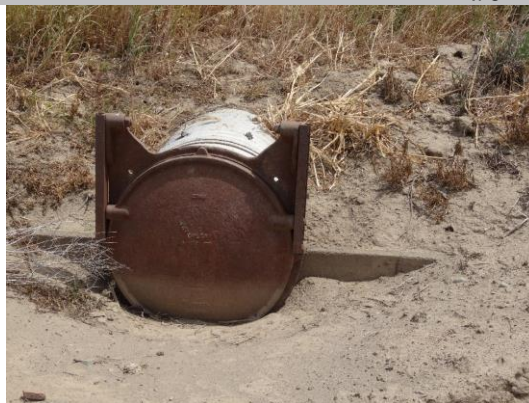
Photo 3 of 3 : UCIP_SP_2019_27793_51513.jpg

Flap gate and concrete headwall visible on waterward side.

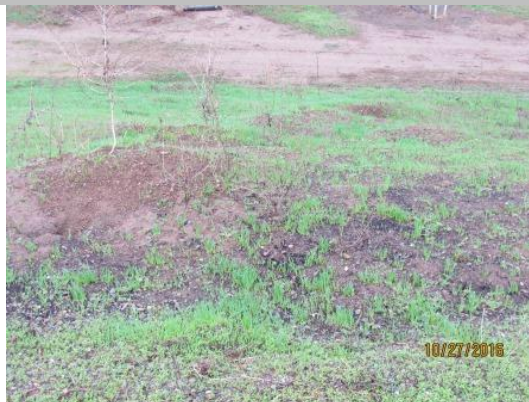
Photo 1 of 1 : SP_2019_RD0010_164_32_20190305_00008.jpg

LM Start	6.72	Rating **	M	Issue No.	32
LM End	6.72	Issue Type +	Ma	Location *	WS
Category	Earthen Levee			GPS Latitude/Longitude	
				Start	End
Item	Animal Control			39.257859 °	39.257859 °
				-121.617667 °	-121.617667 °
DWR ID	DWR_RD0010_02_f_2015_32				
Comment Code					
A3 : No rodents visible, but rodent burrows visible; need to backfill and compact or grout burrows.					
Inspector Comment					
No rodent activity but holes need to be properly backfilled, Spring 2019.

View of rodent holes on waterside levee slope.

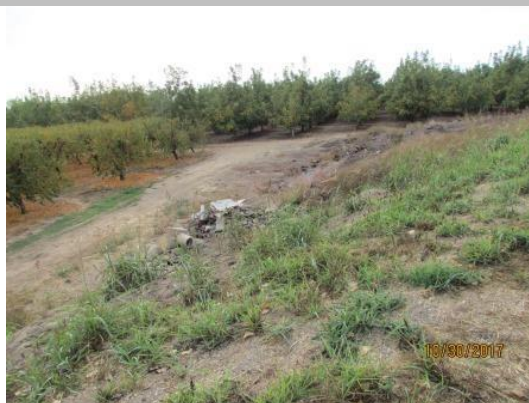
Photo 1 of 1 : SP_2019_RD0010_164_53_20190305_00019.jpg

LM Start	7.07	Rating **	M	Issue No.	53
LM End	7.07	Issue Type +	En	Location *	LS
Category	Earthen Levee			GPS Latitude/Longitude	
				Start	End
Item	Encroachments			39.262290 °	39.262290 °
				-121.614390 °	-121.614390 °
DWR ID	DWR_RD0010_02_s_2016_53				
Comment Code					
DE : Debris					
Inspector Comment					
Remove debris from the levee toe, Spring 2019.

View looking downstream of debris at landside levee toe.

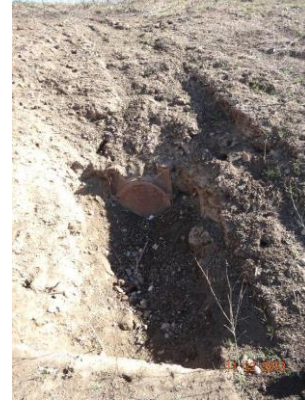
Photo 3 of 3 : UCIP_SP_2019_50059_44697.jpg

Comment Code						
Inspector Comment						
FS_ID:50059 DS_ID:21293 EP_NO: N/A Repair Type: Non-Urgent Crossing Status: Indicator Found UCIP Comments: 7/01/2016 Crossing is blocked by sediment and debris on both WS and LS. Screw gate is missing on LS. (DWR UCIP - omagana)4/30/2013 Both openings of crossing are blocked by sediment--screw gate is damage. Recommend notifying owner to repair screw gate and remove sediment build-up blocking openings. This crossing is referenced in the USACE Periodic Inspection as item USACE_CESPK_HON2_2013_p_0295. (DWR UCIP - omagana) FIELD_STRUCT_DESC: 24-inch corrugated metal gravity drainage pipe through the levee, 13 feet below the crown. Corrugated metal cutoff wall around the pipe at each shoulder. Flap gate on the waterside (WS) end. Slide gate on the landside (LS). Concrete headwall, saddle, and apron on the WS end. [Additional Reference(s): DWR Levee Log, 2005. USACE Sacramento O&M Manual 151, May 1953, (Station 471+21)]. FS Date: 7/1/2016

View of flap gate and concrete distribution box on WS.

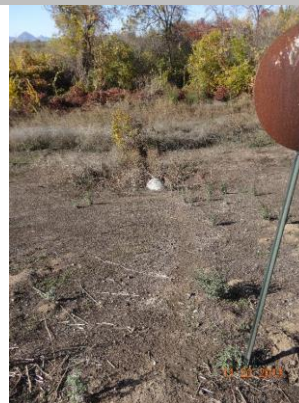
Photo 2 of 3 : UCIP_SP_2019_24831_44699.jpg

View of waterward slope.

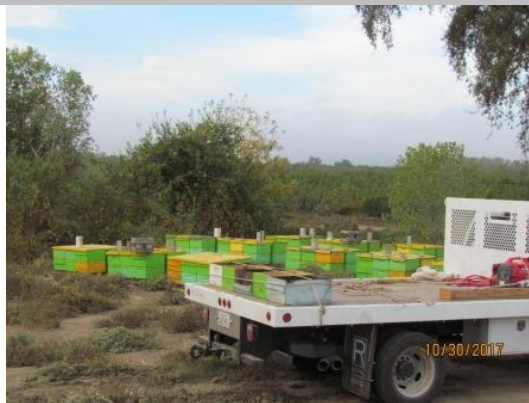
Photo 1 of 2 : SP_2019_RD0010_164_34_20190305_00010.jpg

LM Start	7.86	Rating **	M	Issue No.	34
LM End	7.86	Issue Type +	En	Location *	CR
Category	Earthen Levee			GPS Latitude/Longitude	
				Start	End
Item	Encroachments			39.272290 °	39.272290 °
				-121.613080 °	-121.613080 °
DWR ID	DWR_RD0010_02_f_2015_34				
Comment Code					
MA : Material					
Inspector Comment					
Bee hives have been placed on a wide section of the crown.

View of the beehives still on the crown of the levee.

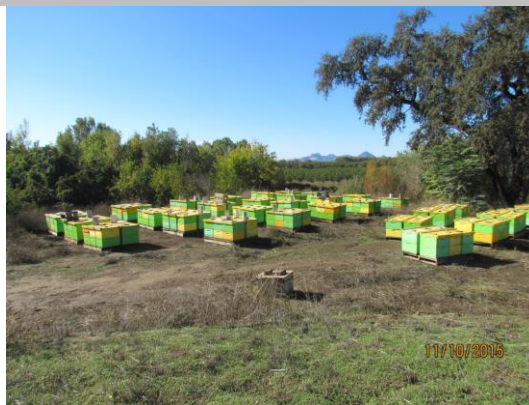
Photo 2 of 2 : SP_2019_RD0010_164_34_20190305_00011.jpg

View of the beehives on the crown of the levee.

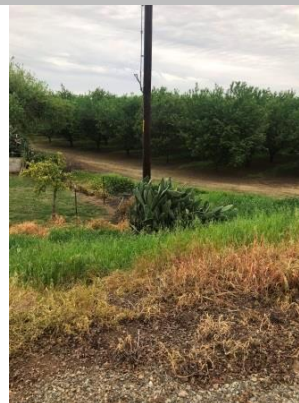
Photo 1 of 1 : SP_2019_RD0010_164_41_20190305_00015.jpg

LM Start	8.02	Rating **	M	Issue No.	41
LM End	8.02	Issue Type +	En	Location *	LS
Category	Earthen Levee			GPS Latitude/Longitude	
				Start	End
Item	Vegetation			39.274334 °	39.274334 °
				-121.611986 °	-121.611986 °
DWR ID	DWR_RD0010_02_s_2018_41				
Comment Code					
V6 : Landscaping					
Inspector Comment					
Remove landscape from the levee toe.

View looking downstream landside of a landscape bush at the levee toe.

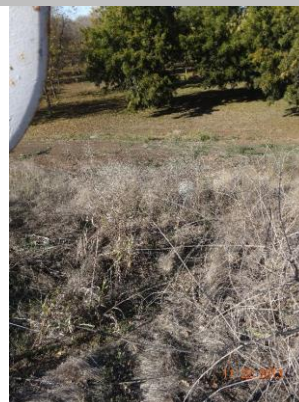
Photo 2 of 3 : UCIP_SP_2019_24832_44704.jpg

View of waterward side.

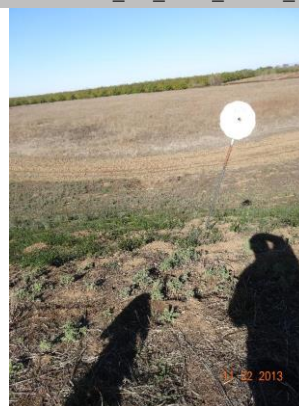
Levee Inspection Report By Mile - Spring 2019

**Flood Control Project Maintenance
Levee Inspections**

Waterway	Bank	Unit Miles	Inspection Start/End	Inspector
Unit No. 01 Simmerly Slough	Right	7.65	05/16/2019 05/16/2019	Sterling York

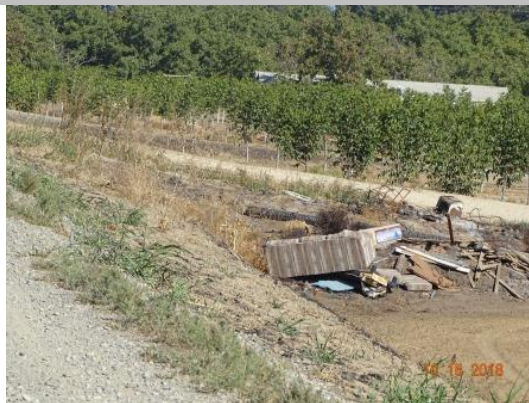
Levee Inspection Report By Mile - Spring 2019

**Flood Control Project Maintenance
Levee Inspections**

Waterway	Bank	Unit Miles	Inspection Start/End	Inspector
Unit No. 01 Simmerly Slough	Right	7.65	05/16/2019 05/16/2019	Sterling York

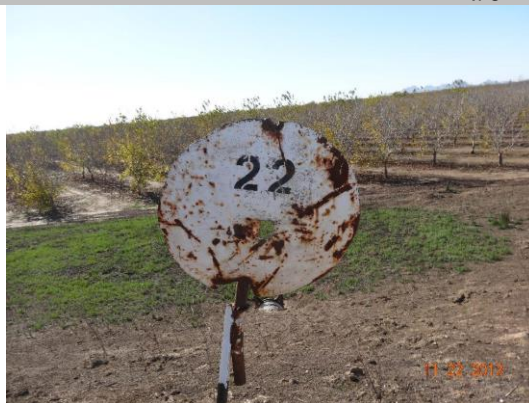
Waterway	Bank	Unit Miles	Inspection Start/End	Inspector
Unit No. 01 Simmerly Slough	Right	7.65	05/16/2019 05/16/2019	Sterling York

Levee Inspection Report By Mile - Spring 2019

Photo 1 of 1 : SP_2019_RD0010_163_65_20190305_00021.jpg

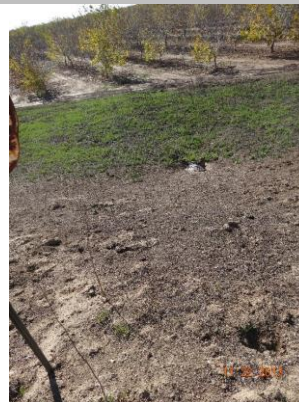
LM Start	1.81	Rating **	M	Issue No.	64
LM End	1.81	Issue Type +	Ma	Location *	LS
Category	Earthen Levee			GPS Latitude/Longitude	
				Start	End
Item	Animal Control			39.172094 °	39.172094 °
				-121.585472 °	-121.585472 °
DWR ID	DWR_RD0010_01_s_2016_64				
Comment Code					
A3 : No rodents visible, but rodent burrows visible; need to backfill and compact or grout burrows.					
Inspector Comment					
Squirrel holes still are visible but there is no sign of activity, Spring 2019.

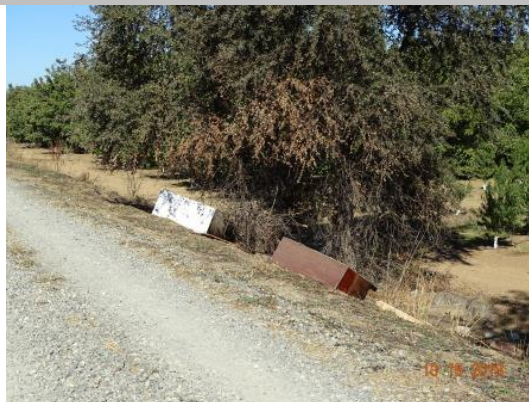
Waterway	Bank	Unit Miles	Inspection Start/End	Inspector
Unit No. 01 Simmerly Slough	Right	7.65	05/16/2019 05/16/2019	Sterling York

Reclamation District No. 0010 Honcut

Comment Code						
Inspector Comment						
FS_ID:27745						
DS_ID:21271						
EP_NO: N/A						
Repair Type: Non-Urgent						
Crossing Status: Found						
UCIP Comments: 04/29/2013 Unable to determine if crossing is still present on landward side--need to confirm. Need to contact owner to determine status of crossing. This crossing is referenced in the USACE Periodic Inspection as item USACE_CESPK_HON1_2013_p_0185. (DWR UCIP - O. Magana)						
FIELD_STRUCT_DESC: 24-inch gravity drainage pipe of an unknown material through the levee, 30 feet below the crown. Flap gate on the waterside (WS) end. Concrete headwall at each toe. [Additional Reference(s): DWR Levee Log, 2005].						
FS Date: 4/29/2013

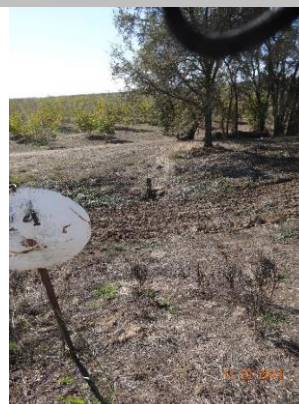
LM Start	2.67	Rating **	M	Issue No.	58
LM End	2.67	Issue Type +	Ma	Location *	LS
Category	Earthen Levee			GPS Latitude/Longitude	
				Start	End
Item	Animal Control			39.184513 °	39.184513 °
				-121.583924 °	-121.583924 °
DWR ID	DWR_RD0010_01_s_2016_58				
Comment Code					
A3 : No rodents visible, but rodent burrows visible; need to backfill and compact or grout burrows.					
Inspector Comment					
Squirrel holes still are visible but there is no sign of activity, Spring 2019.

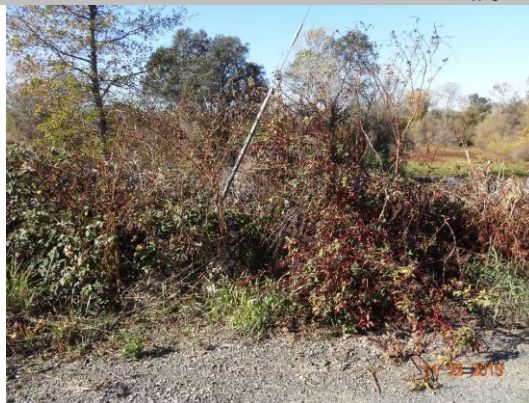
Photo 1 of 3 : UCIP_SP_2019_24839_44745.jpg

Comment Code						
Inspector Comment						
FS_ID:24839 DS_ID:21304 EP_NO: N/A Repair Type: Non-Urgent Crossing Status: Found UCIP Comments: 04/30/2013 Rip rap was used to stabilize the waterward slope during high water as a means of emergency repair--unable to determine storm event when repair was performed. Recommend obtaining records of the repair and to determine if crossing is still being used. Need to determine owner. Dense vegetation limits the inspector's visibility to identify signs of pipe failure (leaks) along the slope. Recommend removing vegetation along pipe alignment to conduct proper inspection of structure and appurtances. This crossing is referenced in the USACE Periodic Inspection as item USACE_CESPK_HON2_2013_p_0458 and 460. (DWR UCIP - O. Magana) FIELD_STRUCT_DESC: 24-inch steel irrigation discharge pipe through the levee, 5 feet below the crown. Slide gate in a 36-inch concrete riser on the landside (LS) shoulder. Gate valve in a pump house on the waterside (WS) slope. Concrete headwall, saddle, and apron on the WS end. [Additional Reference(s): DWR Levee Log, 2005. USACE Sacramento O&M Manual 151, May 1953, (Station 655+65)]. FS Date: 4/30/2013

View of waterward shoulder behind vegetation is standpipe.

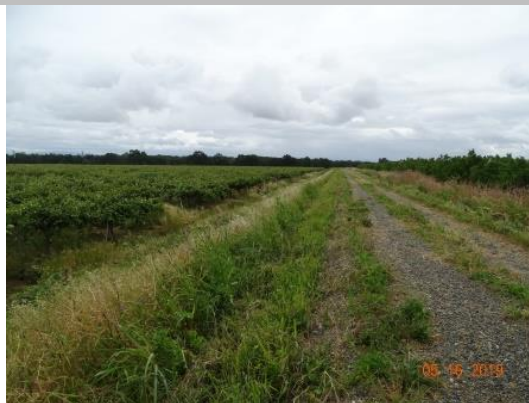
Photo 1 of 1 : SP_2019_RD0010_165_4_20190520_00014.jpg

LM Start	0.48	Rating **	A	Issue No.	4
LM End	1.22	Issue Type +	Ma	Location *	LS
Category	Earthen Levee			GPS Latitude/Longitude	
				Start	End
Item	Vegetation			39.310241 °	39.306432 °
				-121.607481 °	-121.595030 °
DWR ID	DWR_RD0010_03_s_2019_4				
Comment Code					
V1 : Control annual grass and weeds on the levee slopes and easements.					
Inspector Comment					
The annual vegetation needs to be maintained, Spring 2019.

View looking downstream at the landside of the annual vegetation that needs maintenance, Spring 2019.

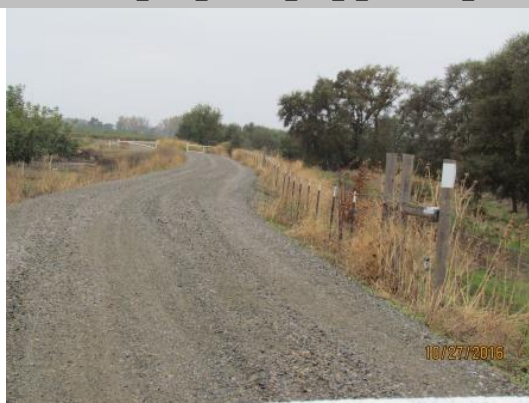
Photo 1 of 1 : SP_2019_RD0010_165_8_20190305_00002.jpg

LM Start	1.08	Rating **	M	Issue No.	8
LM End	1.21	Issue Type +	En	Location *	WS
Category	Earthen Levee			GPS Latitude/Longitude	
				Start	End
Item	Encroachments			39.307106 °	39.306422 °
				-121.597439 °	-121.595205 °
DWR ID	DWR_RD0010_03_s_2016_8				
Comment Code					
FE : Fence					
Inspector Comment					
Unpermitted fence on waterside levee hinge point.

View of an unpermitted fence on waterside levee hinge point.

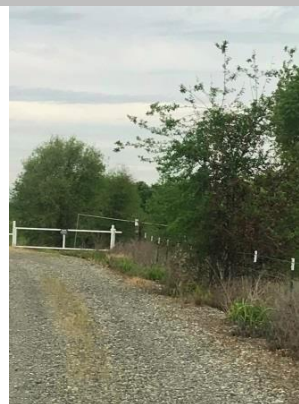
Photo 1 of 1 : SP_2019_RD0010_165_10_20190305_00003.jpg

LM Start	1.10	Rating **	M	Issue No.	10	
LM End	1.10	Issue Type +	Ma	Location *	WS	
Category	Earthen Levee			GPS Latitude/Longitude		
				Start		End
Item	Trim / Thin Trees			39.306995 °		39.306995 °
				-121.597116 °		-121.597116 °
DWR ID	DWR_RD0010_03_s_2018_10					
Comment Code						
T2 : Thin trees to allow visibility of the ground and room to flood fight.						
Inspector Comment						
Tree needs to be trimmed for access and visibility.

View looking downstream waterside of a tree that needs to be trimmed for access and visibility.

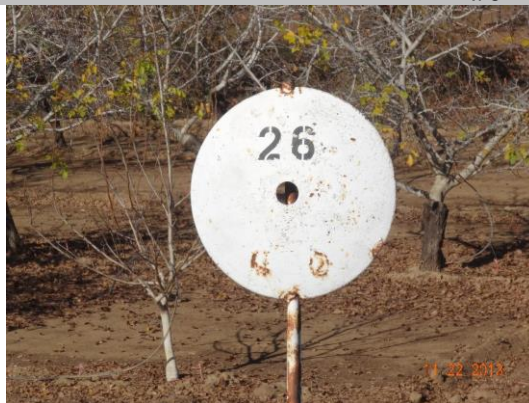
Photo 1 of 3 : UCIP_SP_2019_24842_44764.jpg

Comment Code					
Inspector Comment					
FS_ID:24842					
DS_ID:21307					
EP_NO: N/A					
Repair Type: Non-Urgent					
Crossing Status: Found					
UCIP Comments: 05/01/2013 Sediment deposit inside pipe--Need to coordinate with owner to determine status of crossing. If crossing is no longer in use owner will need to contact the CVFPB to comply with Title 23. (DWR UCIP - O. Magana)					
FIELD_STRUCT_DESC: 24-inch corrugated metal gravity drainage pipe through the levee, 15 feet below the crown. Corrugated metal cutoff wall around the pipe at each shoulder. Flap gate on the waterside (WS) end. Slide gate on the landside (LS) end. Concrete headwall at each toe.					
[Additional Reference(s): DWR Levee Log, 2005. USACE Sacramento O&M Manual 151, May 1953, (Station 134+06)].					
FS Date: 5/1/2013

Marker visible on waterward side--No. 26.

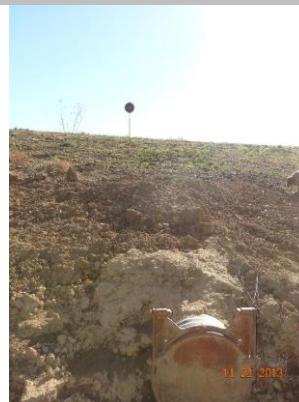
Photo 2 of 3 : UCIP_SP_2019_24842_44762.jpg

View of waterward slope.
