**Flood Control Project Maintenance
Levee Inspections**
LMA District Cover Sheet
Spring 2019 Levee Inspection Results

Reclamation District No. 0010 Honcut

Spring 2019 Levee Inspection Results

Waterway			Bank	Unit Miles
Unit No. 01 Simmerly Slough			Right	7.65
	Spring (March - May)	Summer (June - August)	(September - November) Fall	Winter (December - February)
Unit Maintenance Rating (Fall Only)				
Date of Inspection	5/16/2019 - 5/16/2019			
DWR Inspector	Sterling York			
Accompanied By	Finlay Williams

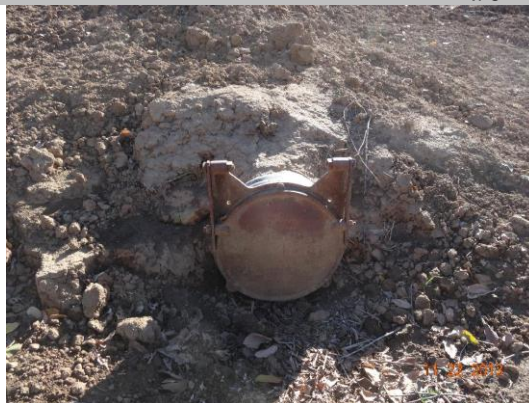
Photo 3 of 3 : UCIP_SP_2019_24842_44763.jpg

Comment Code						
Inspector Comment						
FS_ID:24842						
DS_ID:21307						
EP_NO: N/A						
Repair Type: Non-Urgent						
Crossing Status: Found						
UCIP Comments: 05/01/2013 Sediment deposit inside pipe--Need to coordinate with owner to determine status of crossing. If crossing is no longer in use owner will need to contact the CVFPB to comply with Title 23. (DWR UCIP - O. Magana)						
FIELD_STRUCT_DESC: 24-inch corrugated metal gravity drainage pipe through the levee, 15 feet below the crown. Corrugated metal cutoff wall around the pipe at each shoulder. Flap gate on the waterside (WS) end. Slide gate on the landside (LS) end. Concrete headwall at each toe. [Additional Reference(s): DWR Levee Log, 2005. USACE Sacramento O&M Manual 151, May 1953, (Station 134+06)].						
FS Date: 5/1/2013

View of flap gate located on waterward side.

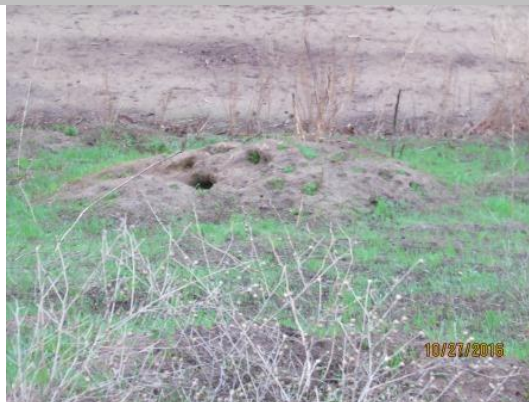
Photo 1 of 1 : SP_2019_RD0010_165_6_20190305_00001.jpg

LM Start	1.72	Rating **	M	Issue No.	6
LM End	1.72	Issue Type +	Ma	Location *	WS
Category	Earthen Levee			GPS Latitude/Longitude	
				Start	End
Item	Animal Control			39.303262 °	39.303262 °
				-121.587680 °	-121.587680 °
DWR ID	DWR_RD0010_03_f_2016_6				
Comment Code					
A3 : No rodents visible, but rodent burrows visible; need to backfill and compact or grout burrows.					
Inspector Comment					
No squirrel activity seen, but rodent holes need to be back filled properly, Spring 2019.

View of waterside slope, no squirrel activity seen, but rodent holes need to be back filled properly.

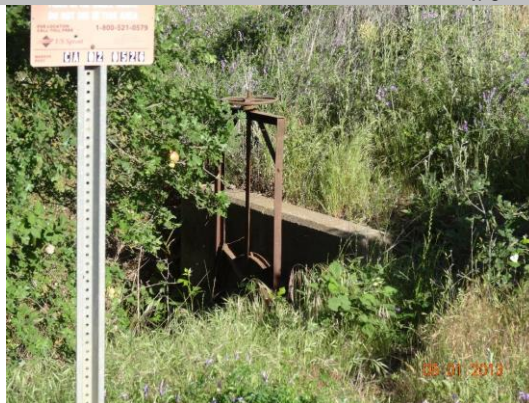
Photo 1 of 2 : UCIP_SP_2019_24883_44820.jpg

FS_ID:24883
DS_ID:21308
EP_NO: N/A
Repair Type: Non-Urgent
Crossing Status: Found
UCIP Comments: 05/01/2013 Dense vegetation limits the inspector's visibility to identify signs of pipe failure (leaks) along the slope. Recommend removing vegetation along pipe alignment to conduct proper inspection of structure and appurtenances. (DWR UCIP - O. Magana)
FIELD_STRUCT_DESC: 24-inch corrugated metal gravity drainage pipe through the levee, 12 feet below the crown. Corrugated metal cutoff wall around the pipe at each shoulder. Flap gate on the waterside (WS) end. Slide gate on the landside (LS) end. Concrete headwall at the LS toe.
[Additional Reference(s): DWR Levee Log, 2005. USACE Sacramento O&M Manual 151, May 1953, (Station 192+33)].
FS Date: 5/1/2013

View of slide gate and concrete headwall located on landward side.

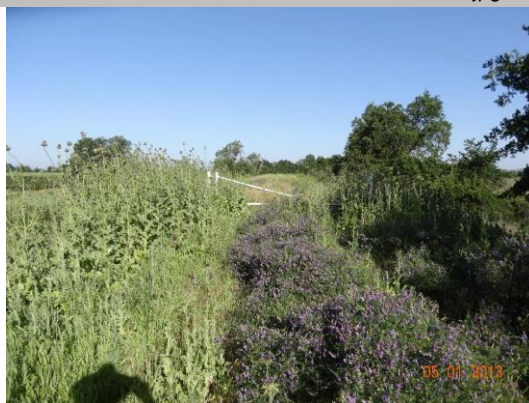
Photo 2 of 2 : UCIP_SP_2019_24883_44821.jpg

View of levee crown--dense vegetation.
