**Flood Control Project Maintenance  
Levee Inspections**  
**LMA District Cover Sheet**  
**Spring 2020 Levee Inspection Results**

**Reclamation District No. 0010 Honcut**

**Spring 2020 Levee Inspection Results**

Waterway			Bank	Unit Miles
Unit No. 01 Simmerly Slough			Right	7.65
	Spring (March - May)	Summer (June - August)	(September - November) Fall	Winter (December - February)
Unit Maintenance Rating (Fall Only)				
Date of Inspection	4/28/2020 - 4/28/2020			
DWR Inspector	Sterling York			
Accompanied By	Finlay Williams

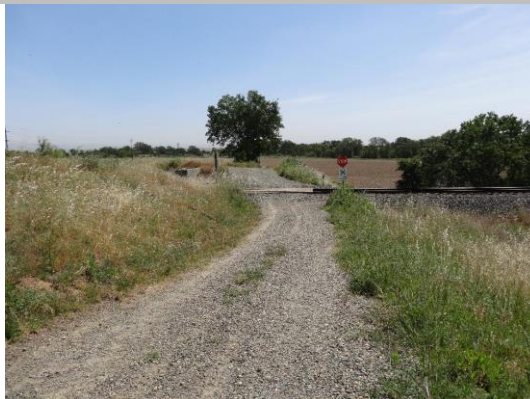
Photo 1 of 3 : UCIP\_SP\_2020\_27791\_51501.jpg

Comment Code						
Inspector Comment						
DS_ID:21268						
FS_ID:27791						
EP_NO: N/A						
Repair Type: Non-Urgent						
Crossing Status: Found						
UCIP Comments: 04/29/2013 Vegetation has been cleared from slope.						
This crossing is referenced in the USACE Periodic Inspection as item						
USACE_CESPK_HON1_2013_p_0158. (DWR UCIP - O. Magana)						
FIELD_STRUCT_DESC: 24-inch corrugated metal gravity drainage						
pipe through the levee, 30 feet below the crown. Flap gate on the						
waterside (WS) end. Slide gate on the landside (LS) end. Concrete						
saddle and apron on the WS. [Additional Reference(s): DWR Levee						
Log, 2005. USACE Sacramento O&M Manual 151, May 1953, (Station						
1+00)].						
FS Date: 4/29/2013

View of levee crown looking downstream.

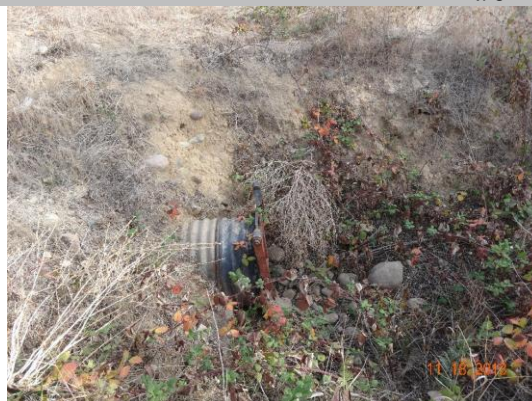
Photo 3 of 3 : UCIP\_SP\_2020\_27791\_51504.jpg

View of pipe and flap gate located on waterward side.

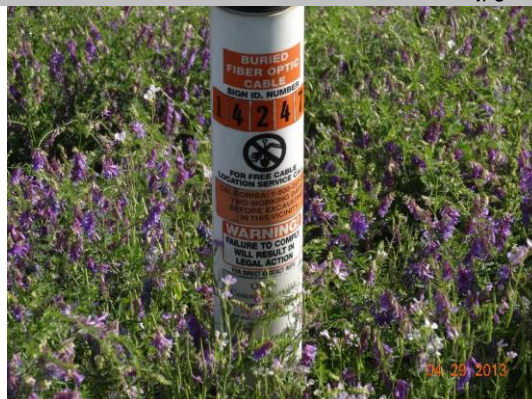
Photo 1 of 2 : UCIP\_SP\_2020\_27712\_51365.jpg

LM Start	0.23	Rating **	M	Issue No.	72
LM End	0.23	Issue Type +	En	Location *	
Category	Supplemental			GPS Latitude/Longitude	
				Start	End
Item	DWR UCIP Field Study			39.163407 °	39.163407 °
				-121.605645 °	-121.605645 °
DWR ID	24653				
Comment Code					
Inspector Comment					
DS_ID:24653					
FS_ID:27712					
EP_NO: N/A					
Repair Type: Non-Urgent					
Crossing Status: Indicator Found					
UCIP Comments: 04/29/2013 Need to contact owner--unable to					
determine if crossing is authorized (no permit found) also need to					
determine if crossing goes through levee. (DWR UCIP - O. Magana)					
FIELD_STRUCT_DESC: Fiber optics line markers on the levee slope.					
Unable to determine if this line goes through the levee. This line was					
field discovered.					
FS Date: 4/29/2013

Contact information for buried fiber optic cable.

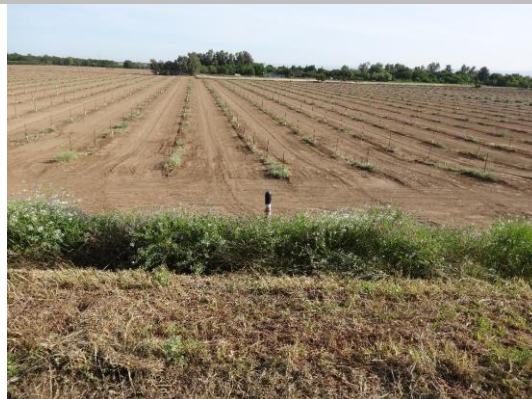
Photo 2 of 2 : UCIP\_SP\_2020\_27712\_51364.jpg

Marker visible on landward side.

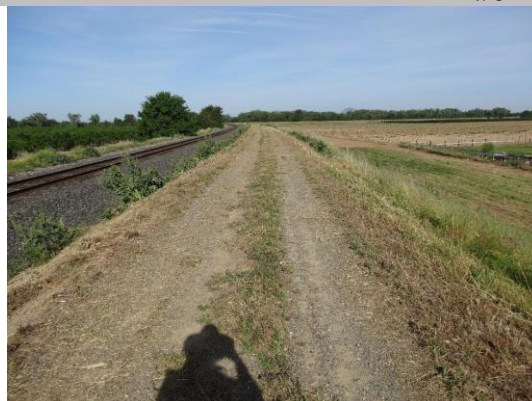
Photo 1 of 3 : UCIP\_SP\_2020\_24806\_44540.jpg

DS\_ID:21257  
 FS\_ID:24806  
 EP\_NO: 13015  
 Repair Type: Non-Urgent  
 Crossing Status: Found  
 UCIP Comments: 04/29/2013 New gravel indicates work was recently completed. Will need to contact owner to obtain information pertaining to work completed. Need to contact owner to determine if crossing is still active and to determine last inspection date. Will need copy of letter showing crossings passed inspection. This crossing is referenced in the USACE Periodic Inspection as item  
 USACE\_CESPK\_HON1\_2013\_p\_0075. (DWR UCIP - O. Magana)  
 FIELD\_STRUCT\_DESC: 4-inch steel natural gas pipeline sleeved through an 8-inch pipe through the levee, 30 feet below the crown. Annular space grouted. Cutoff wall on each end within the levee. (Plans to reinforce an existing 4-inch gas main with a parallel 4-inch main through the levee authorized under Permit No. 13015, 1980 - Pacific Gas and Electric Company [PG&E]). [Additional Reference(s): DWR Levee Log, 2005].

View of levee crown looking upstream.

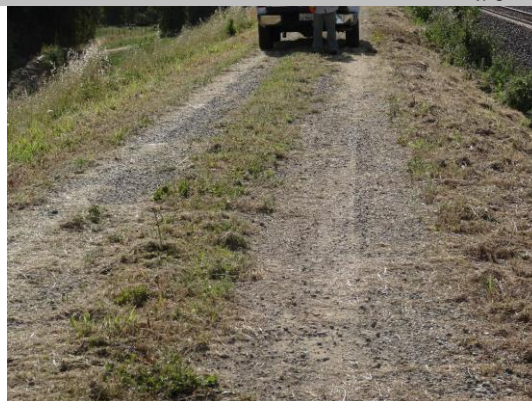
Photo 2 of 3 : UCIP\_SP\_2020\_24806\_44541.jpg

View of levee crown looking downstream.

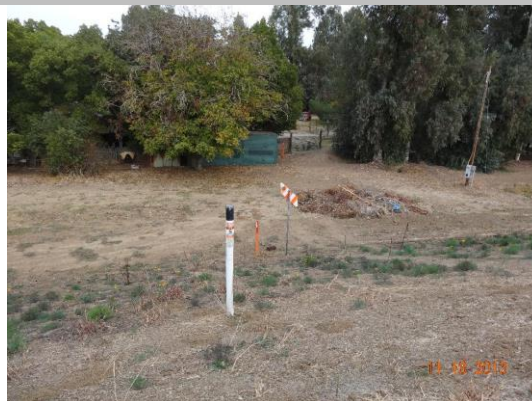
Photo 3 of 3 : UCIP\_SP\_2020\_24806\_44543.jpg

View of landward side--gas marker and conduit line marker.

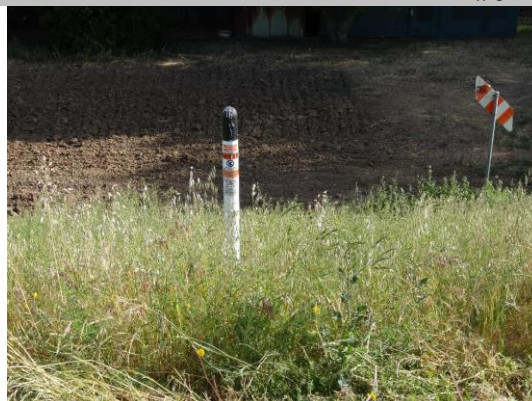
Photo 1 of 2 : UCIP\_SP\_2020\_27713\_51366.jpg

LM Start	0.41	Rating **	M	Issue No.	74	
LM End	0.41	Issue Type +	En	Location *		
Category	Supplemental			GPS Latitude/Longitude		
				Start	End	
Item	DWR UCIP Field Study			39.162853 °	39.162853 °	
				-121.602435 °	-121.602435 °	
DWR ID	24654					
Comment Code						
Inspector Comment						
DS_ID:24654 FS_ID:27713 EP_NO: N/A Repair Type: Non-Urgent Crossing Status: Indicator Found UCIP Comments: 04/29/2013 Need to contact owner--unable to determine if crossing is authorized (no permit found) also need to determine if crossing goes through levee. (DWR UCIP - O. Magana) FIELD_STRUCT_DESC: Fiber optics line markers on levee slope. Unable to determine if line goes through the levee. This line was field discovered. FS Date: 4/29/2013

View of landward side--communication line marker.

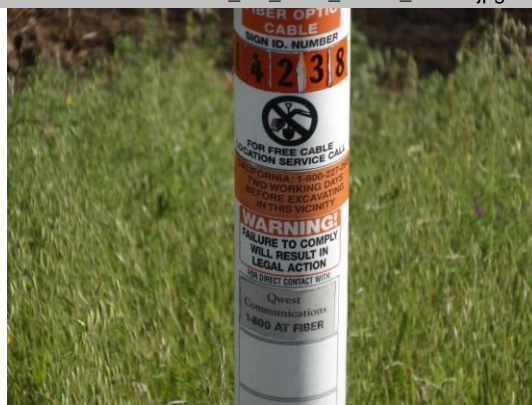
Photo 2 of 2 : UCIP\_SP\_2020\_27713\_51367.jpg

Contact information for communication line.

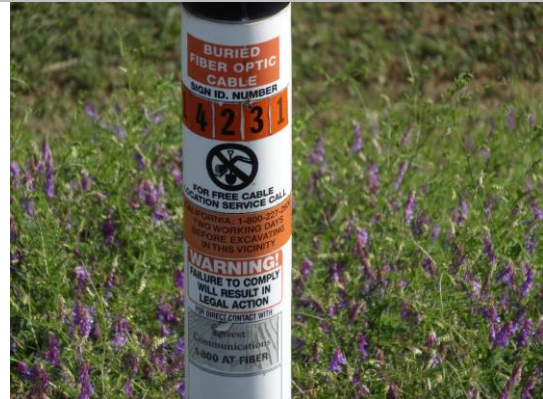
Photo 1 of 2 : UCIP\_SP\_2020\_27710\_51361.jpg

LM Start	0.53	Rating **	M	Issue No.	75	
LM End	0.53	Issue Type +	En	Location *		
Category	Supplemental			GPS Latitude/Longitude		
				Start	End	
Item	DWR UCIP Field Study			39.162277 °	39.162277 °	
				-121.600219 °	-121.600219 °	
DWR ID	24655					
Comment Code						
Inspector Comment						
DS_ID:24655 FS_ID:27710 EP_NO: N/A Repair Type: Non-Urgent Crossing Status: Indicator Found UCIP Comments: 04/29/2013 Need to contact owner--unable to determine if crossing is authorized (no permit found) also need to determine if crossing goes through levee. (DWR UCIP - O. Magana) FIELD_STRUCT_DESC: Fiber optics line markers on levee slope. Unable to determine if line goes through the levee. This line was field discovered. FS Date: 4/29/2013

Contact information for fiber optic cable and ID number.

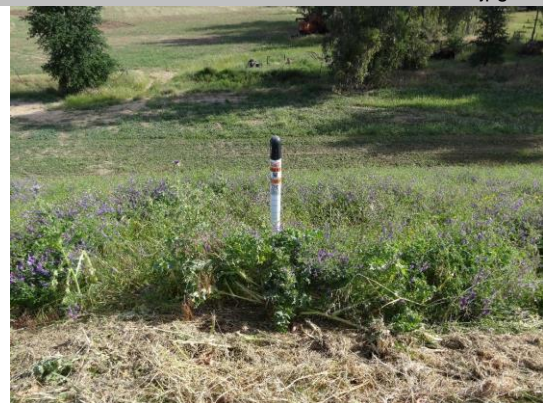
Photo 2 of 2 : UCIP\_SP\_2020\_27710\_51360.jpg

View of marker located on landward side.

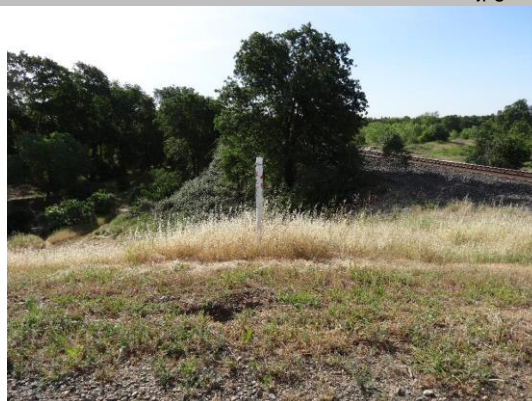
Photo 1 of 2 : UCIP\_SP\_2020\_27715\_51371.jpg

LM Start	0.72	Rating **	M	Issue No.	76	
LM End	0.72	Issue Type +	En	Location *		
Category	Supplemental			GPS Latitude/Longitude		
				Start		End
Item	DWR UCIP Field Study			39.161229 °		39.161229 °
				-121.597072 °		-121.597072 °
DWR ID	24656					
Comment Code						
Inspector Comment						
DS_ID:24656						
FS_ID:27715						
EP_NO: N/A						
Repair Type: Non-Urgent						
Crossing Status: Indicator Found						
UCIP Comments: 04/29/2013 Need to contact owner--unable to						
determine if crossing is authorized (no permit found) also need to						
determine if crossing goes through levee. (DWR UCIP - O. Magana)						
FIELD_STRUCT_DESC: Fiber optics line markers on levee slope.						
Unable to determine if line goes through the levee. This line was field						
discovered.						
FS Date: 4/29/2013

View of marker located on waterward side.

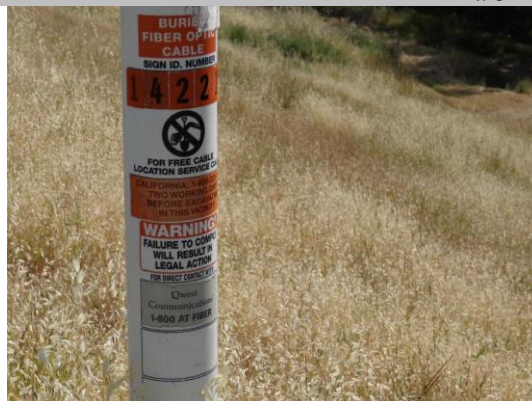
Photo 2 of 2 : UCIP\_SP\_2020\_27715\_51370.jpg

Contact information and ID number for buried fiber optic cable.

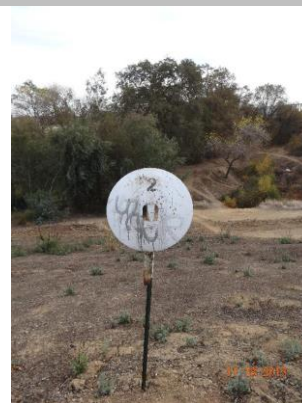
Photo 1 of 3 : UCIP\_SP\_2020\_50058\_51415.jpg

DS\_ID:21258  
FS\_ID:50058  
EP\_NO: N/A  
Repair Type: Non-Urgent  
Crossing Status: Found  
UCIP Comments: 7/01/2016 Gate has been repaired--WS gate is functional. LS gate still needs new stem for the gate to properly function--stem is bent. USACE's PI issue references permit number 13710 this is incorrect permit is associated with DS\_ID 21259 (CLM 0.767). (DWR UCIP - omagana)4/29/2013 Damaged flap gate on waterward side and damaged stem on screw gate on landward side. Need to contact owner to determine if crossing is still active. If crossing is still in use owner will need to address damage on flap gate and screw gate. If crossing is no longer in use owner will need to contact the CVFPB to comply with Title 23. This crossing is referenced in the USACE Periodic Inspection as item USACE\_CESPK\_HON1\_2013\_p\_0053 and 0057. (DWR UCIP - omagana)  
FIELD\_STRUCT\_DESC: 24-inch corrugated metal gravity drainage pipe through the levee, 31 feet below the crown. Two corrugated metal cutoff walls around pipe. Concrete headwall at each end. Flap gate on the waterside (WS) end. Slide gate on the landside (LS) end. Pipe discharges into 6-foot concrete splash apron on the WS. [Additional Reference(s): DWR Levee Log, 2005. USACE Sacramento O&M Manual 151, May 1953, (Station 46+60)].

View of WS--Marker indicates crossing is labelled as 2.

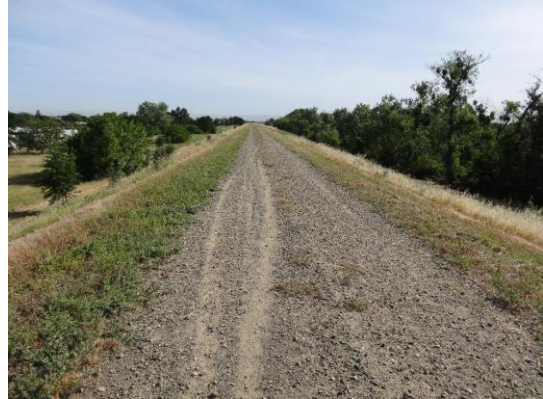
Photo 2 of 3 : UCIP\_SP\_2020\_50058\_51410.jpg

View of levee crown looking downstream.

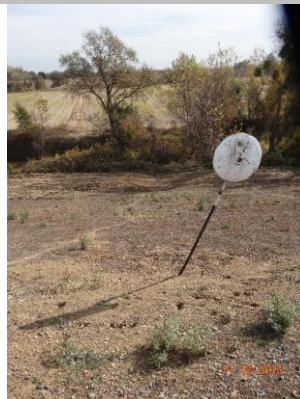
Photo 1 of 3 : UCIP\_SP\_2020\_27748\_51453.jpg

Comment Code						
Inspector Comment						
DS_ID:21261 FS_ID:27748 EP_NO: N/A Repair Type: No Action Needed Crossing Status: Found UCIP Comments: 04/29/2013 No signs of damage to levee present during inspection. This crossing is referenced in the USACE Periodic Inspection as item USACE_CESPK_HON1_2013_p_0037 and 0040. (DWR UCIP - O. Magana) FIELD_STRUCT_DESC: 24-inch corrugated metal gravity drainage pipe through the levee, 29.5 feet below the crown. Two corrugated metal cutoff walls around the pipe on each end. Slide gate on the landside (LS) end. Flap gate on the waterside (WS) end. Concrete headwall at the LS toe. [Additional Reference(s): DWR Levee Log, 2005. USACE Sacramento O&M Manual 151, May 1953, (Station 37+66)]. FS Date: 4/29/2013

View of waterward side--slope and marker for pipe crossing.

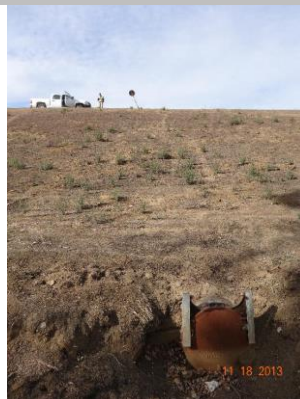
Photo 2 of 3 : UCIP\_SP\_2020\_27748\_51450.jpg

View of slope located on waterward side.

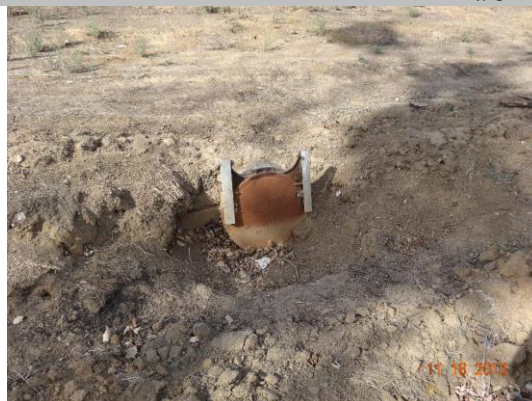
Photo 3 of 3 : UCIP\_SP\_2020\_27748\_51451.jpg

View of flap gate located on waterward side.

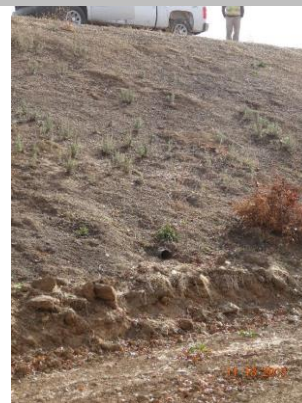
Photo 1 of 1 : UCIP\_SP\_2020\_40545\_51418.jpg

DS\_ID:21260  
 FS\_ID:40545  
 EP\_NO: 4555  
 Repair Type: Non-Urgent  
 Crossing Status: Indicator Found  
 UCIP Comments: 04/29/2013 Pipe is approximately 4-6 inches in diameter located near the toe of levee. Crossing is approximately 50 feet downstream of 24-inch pipe. Need to contact owner to determine status of this crossing and to verify the purpose of crossing. If crossing is no longer in use owner will need to contact the CVFPB to comply with Title 23. (DWR UCIP - O. Magana)  
 FIELD\_STRUCT\_DESC: \*ABANDONED\* 6-inch steel drainage discharge pipe through the levee, 1 foot below the crown. Siphon breaker on the waterside (WS) shoulder. Pump at the landside (LS) toe. Revetment around the discharge end of the pipe. Pipe drains into a ditch at the WS toe. Pipe is not buried in berms. Gravel pad over pipe across levee crown for vehicular access. (Plans for installing a drainage pipe across the levee authorized under Permit No. 4555, 1964 - Ledbetter, Carbah, and Huddle). [Additional Reference(s): DWR Levee Log, 2005].

Pipe through levee near waterward toe.

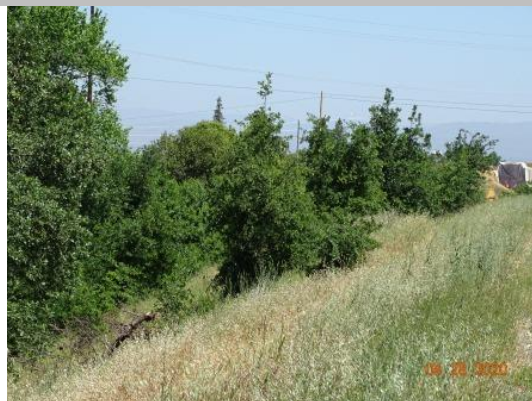
Photo 1 of 1 : SP\_2020\_RD0010\_163\_45\_20200429\_00086.jpg

LM Start	1.22	Rating **	M	Issue No.	45
LM End	1.29	Issue Type +	Ma	Location *	LS
Category	Earthen Levee			GPS Latitude/Longitude	
				Start	End
Item	Trim / Thin Trees			39.167401 °	39.168268 °
				-121.592133 °	-121.591415 °
DWR ID	DWR_RD0010_01_s_2020_45				
Comment Code					
T3 : Trim and thin trees to allow visibility of the ground and room to flood fight.					
Inspector Comment					
Trees with less than 4" diameter at chest height should be removed, Spring 2020.

View looking upstream landside at small starter trees on levee slope, Spring 2020.

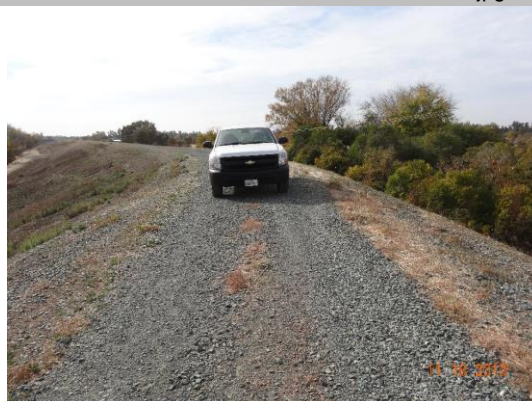
Photo 1 of 3 : UCIP\_SP\_2020\_27725\_51386.jpg

Comment Code					
Inspector Comment					
DS_ID:21262 FS_ID:27725 EP_NO: N/A Repair Type: Non-Urgent Crossing Status: Found UCIP Comments: 04/29/2013 Crossing appears not to be in use--need to contact owner. Need to coordinate with owner to determine status of crossing. If crossing is no longer in use owner will need to contact the CVFPB to comply with Title 23. This crossing is referenced in the USACE Periodic Inspection as item USACE_CESPK_HON1_2013_p_0012. (DWR UCIP - O. Magana) FIELD_STRUCT_DESC: 10-inch steel irrigation discharge pipe through the levee, 7.3 feet below the crown. Siphon breaker in a corrugated metal pipe (CMP) riser on the waterside (WS) slope. Pump on the WS berm. Pump not present. Switch house on the WS slope. No switch house present. 24-inch concrete standpipe at the landside (LS) toe. Concrete pad is still present on the WS. [Additional Reference(s): DWR Levee Log, 2005. USACE Sacramento O&M Manual 151, May 1953, (Station 14+82)]. FS Date: 4/29/2013

View of levee crown looking upstream.

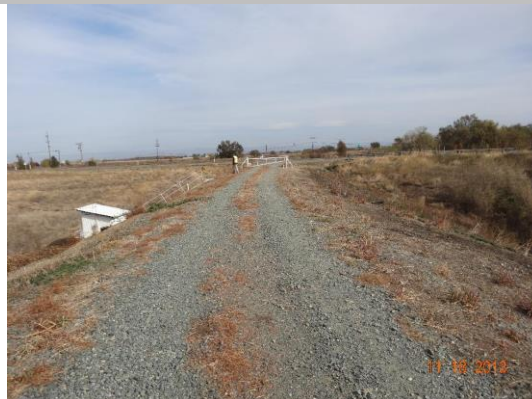
Photo 2 of 3 : UCIP\_SP\_2020\_27725\_51387.jpg

View of levee crown looking downstream.

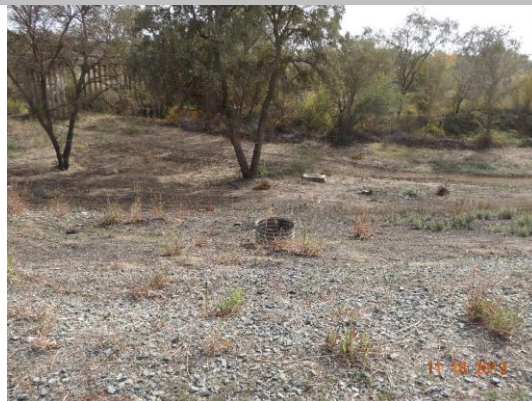
Photo 3 of 3 : UCIP\_SP\_2020\_27725\_51384.jpg

View of waterward side-slopes cleared.

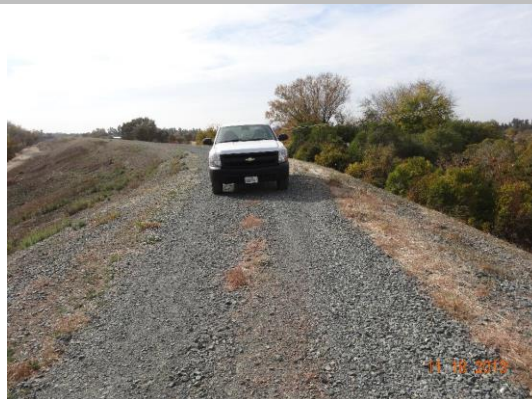
Photo 1 of 3 : UCIP\_SP\_2020\_24810\_44576.jpg

DS\_ID:21263  
FS\_ID:24810  
EP\_NO: N/A  
Repair Type: Non-Urgent  
Crossing Status: Found  
UCIP Comments: 04/29/2013 Pipe has been capped on waterward side--see photos. Need to coordinate with DWR Inspector to determine whether crossing is compliant with Title 23. This crossing is referenced in the USACE Periodic Inspection as item USACE\_CESPK\_HON1\_2013\_p\_0016. (DWR UCIP - O. Magana)  
FIELD\_STRUCT\_DESC: 10-inch steel irrigation discharge pipe through the levee, 6.8 feet below the crown. Steel cutoff plate around the pipe at the center of the levee. Siphon breaker in corrugated metal pipe (CMP) riser on the waterside (WS) slope. Pump on a concrete base on the WS berm, not present. 36-inch concrete standpipe at the landside (LS) toe. Metal shed and service pole on the WS slope, not present. [Additional Reference(s): DWR Levee Log, 2005. USACE Sacramento O&M Manual 151, May 1953, (Station 14+16)].

View of levee crown lookin upstream.

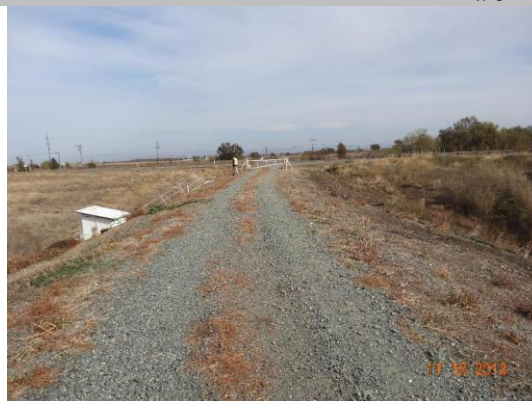
Photo 2 of 3 : UCIP\_SP\_2020\_24810\_44577.jpg

View of levee crown looking downstream.

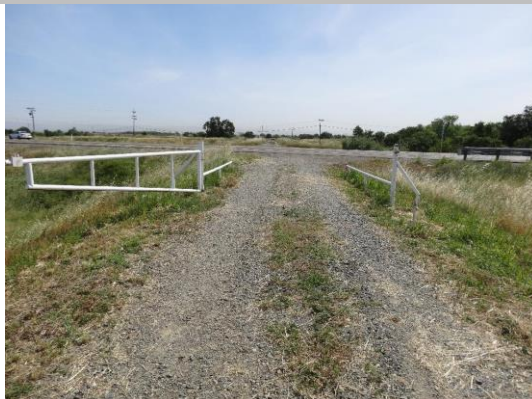
Photo 2 of 3 : UCIP\_SP\_2020\_24811\_44581.jpg

View of levee crown looking downstream--access gate near HWY 70.

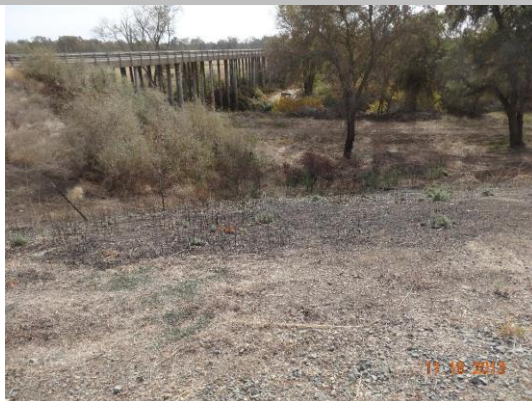
Photo 3 of 3 : UCIP\_SP\_2020\_24811\_44585.jpg

View of waterward side.

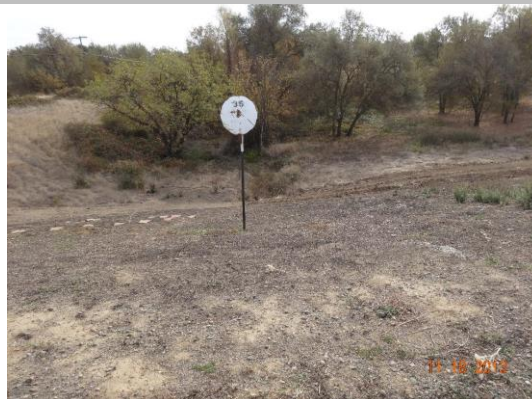
Photo 1 of 3 : UCIP\_SP\_2020\_53136\_44588.jpg

DS\_ID:21318  
FS\_ID:53136  
EP\_NO: N/A  
Repair Type: Urgent  
Crossing Status: Found  
UCIP Comments: 10/18/2018 No change since the last inspection. Pipe remains Urgent due to deteriorated wall (visible holes present inside) near WS flap gate. This pipe is part of DWR's Deferred Maintenance Project (DMP). According to LMA representative, the video inspection of DMP pipes is expected to be completed next year. Levee height is about 25-30 feet. (O. Magana - DWR UCIP)7/01/2016 Pipe wall in poor condition--deteriorated pipe wall indicated by holes at the inlet and outlet pipe collar. Recommend internal integrity inspection of the pipe through the levee to determine extent of damage. (DWR UCIP - omagana)4/29/2013 Holes present on pipe wall. Need to contact owner to notify of issue with pipe. Also need to contact DWR Inspector and CVFPB to determine how to address issue. This crossing is referenced in the USACE Periodic Inspection as item USACE\_CESPK\_HON1\_2013\_p\_0140. Pipe should be 30-inch instead of 36-inch mentioned Periodic Inspection. (DWR UCIP - omagana)

View of WS--marker present on WS shoulder.

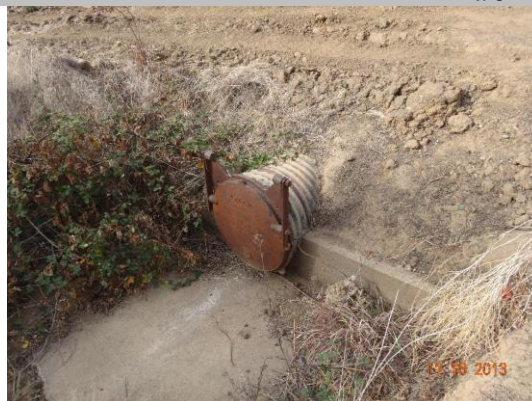
Photo 2 of 3 : UCIP\_SP\_2020\_53136\_44587.jpg

View of headwall, pipe, and flap gate located on WS.

Deteriorated pipe wall at the outlet (WS).

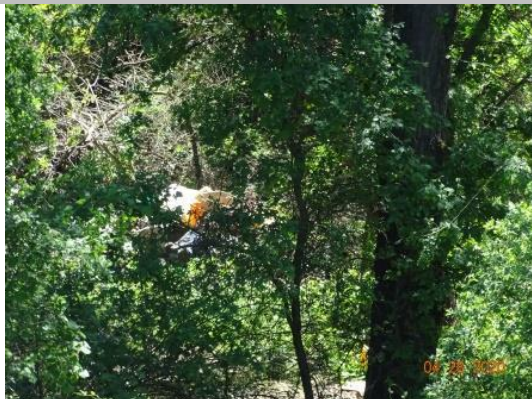
Photo 1 of 1 : SP\_2020\_RD0010\_163\_32\_20200430\_00088.jpg

LM Start	1.59	Rating **	U	Issue No.	32
LM End	1.59	Issue Type +	En	Location *	WS
Category	Earthen Levee			GPS Latitude/Longitude	
				Start	End
Item	Encroachments			39.169228 °	39.169228 °
				-121.586196 °	-121.586196 °
DWR ID	DWR_RD0010_01_f_2019_32				
Comment Code					
DE : Debris					
Inspector Comment					
Debris off levee on waterside, Spring 2020.

View looking waterside at unauthorized campers, Spring 2020.

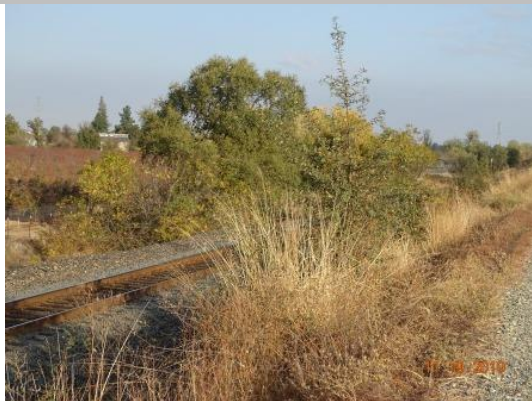
Photo 1 of 1 : SP\_2020\_RD0010\_163\_34\_20200227\_00002.jpg

LM Start	1.65	Rating **	M	Issue No.	34
LM End	1.69	Issue Type +	Ma	Location *	LS
Category	Earthen Levee			GPS Latitude/Longitude	
				Start	End
Item	Trim / Thin Trees			39.169788 °	39.170335 °
				-121.585746 °	-121.585683 °
DWR ID	DWR_RD0010_01_f_2019_34				
Comment Code					
T3 : Trim and thin trees to allow visibility of the ground and room to flood fight.					
Inspector Comment					
Trees with less than 4" diameter at chest height should be removed, Spring 2020.

View looking upstream landside of small starter trees that need to be removed, Fall 2019.

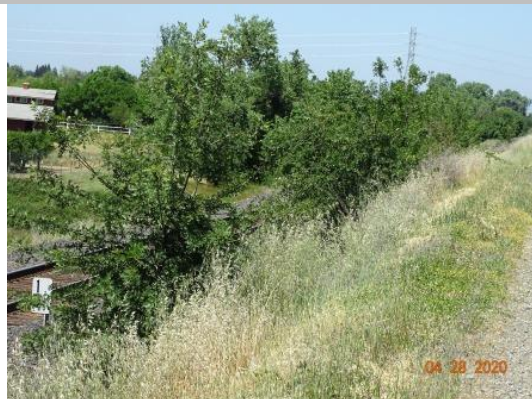
Photo 1 of 1 : SP\_2020\_RD0010\_163\_68\_20200430\_00089.jpg

LM Start	1.76	Rating **	M	Issue No.	68
LM End	1.79	Issue Type +	Ma	Location *	LS
Category	Earthen Levee			GPS Latitude/Longitude	
				Start	End
Item	Trim / Thin Trees			39.171328 °	39.171855 °
				-121.585561 °	-121.585503 °
DWR ID	DWR_RD0010_01_s _ 2020_68				
Comment Code					
T3 : Trim and thin trees to allow visibility of the ground and room to flood fight.					
Inspector Comment					
Trees with less than 4" diameter at chest height should be removed, Spring 2020.

View looking upstream landside at small starter trees on levee slope, Spring 2020.

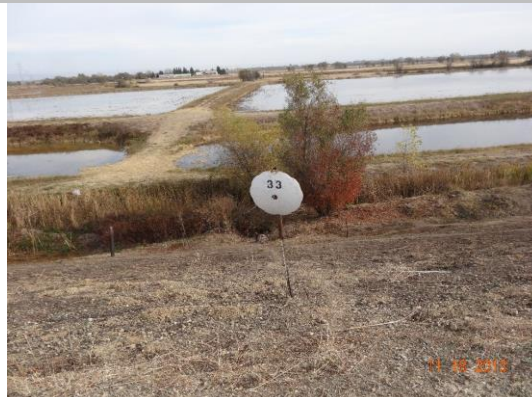
Photo 1 of 3 : UCIP\_SP\_2020\_27745\_51429.jpg

Comment Code						
Inspector Comment						
DS_ID:21271 FS_ID:27745 EP_NO: N/A Repair Type: Non-Urgent Crossing Status: Found UCIP Comments: 04/29/2013 Unable to determine if crossing is still present on landward side--need to confirm. Need to contact owner to determine status of crossing. This crossing is referenced in the USACE Periodic Inspection as item USACE_CESPK_HON1_2013_p_0185. (DWR UCIP - O. Magana) FIELD_STRUCT_DESC: 24-inch gravity drainage pipe of an unknown material through the levee, 30 feet below the crown. Flap gate on the waterside (WS) end. Concrete headwall at each toe. [Additional Reference(s): DWR Levee Log, 2005]. FS Date: 4/29/2013

View of waterward side--marker indicating crossing visible on waterward shoulder.

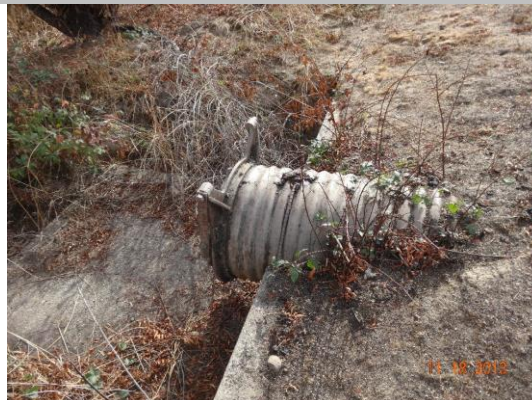
Photo 2 of 3 : UCIP\_SP\_2020\_27745\_51432.jpg

View of pipe, headwall, and flap gate located on waterward side.

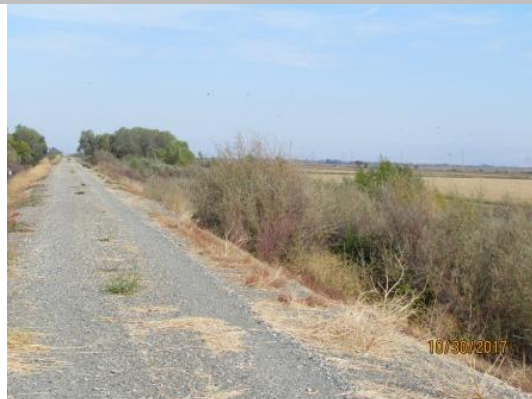
Photo 1 of 1 : SP\_2020\_RD0010\_163\_35\_20200227\_00003.jpg

LM Start	2.70	Rating **	M	Issue No.	35
LM End	2.70	Issue Type +	Ma	Location *	WS
Category	Earthen Levee			GPS Latitude/Longitude	
				Start	End
Item	Trim / Thin Trees			39.184974 °	39.184974 °
				-121.583836 °	-121.583836 °
DWR ID	DWR_RD0010_01_f_2017_35				
Comment Code					
T3 : Trim and thin trees to allow visibility of the ground and room to flood fight.					
Inspector Comment					
Trees with less than 4" diameter at chest height should be removed, Spring 2020.

View looking upstream waterside at Willow Trees that need to be removed.

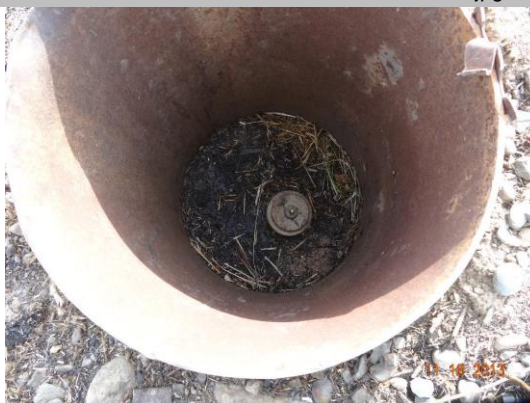
Photo 3 of 3 : UCIP\_SP\_2020\_53137\_44606.jpg

DS\_ID:21272  
FS\_ID:53137  
EP\_NO: 14020  
Repair Type: Urgent  
Crossing Status: Indicator Found  
UCIP Comments: 10/30/2018 Erosion around the concrete box is still present. Erosion does not appear to have progressed since 2013. Unable to determine reason for subsidence around the concrete box located on the WS toe. Recommend internal inspection to determine the condition of the pipe through the levee. Permit recordation indicates that the 10-inch pipe was sleeved through a 16-inch pipe where the annular space between the pipes was grouted, adding some protection to the levee. Photo of the inside of the 10-inch pipe shows that the tar coating is coming off. Continue to monitor site for any changes at the WS toe and the WS slope. Crossing remains Urgent until an internal inspection can be completed to determine the integrity of the pipe through the levee. (O. Magana - DWR UCIP)7/01/2016 Dense vegetation--unable to determine if the sink hole/slope depression noted back in Jan 2013 in the USACE's PI Report is still present. Need to revisit the site once vegetation from the slopes has been cleared. (DWR UCIP - omagana)4/29/2013 Unable to determine status of crossing--sink hole was observed as part of the USACE Periodic Inspection Report dated May 2013. Need to coordinate with owner to determine status of crossing. If crossing is no longer in use owner will need to contact the CVFPB to comply with Title 23. Need to confirm with Finney to determine if pump and controls belong to pipe crossing located on landward side. This crossing is referenced in the USACE Periodic Inspection as item USACE\_CESPK\_HON1\_2013\_p\_0192. (DWR UCIP - omagana)

View of siphon breaker located inside steel riser.

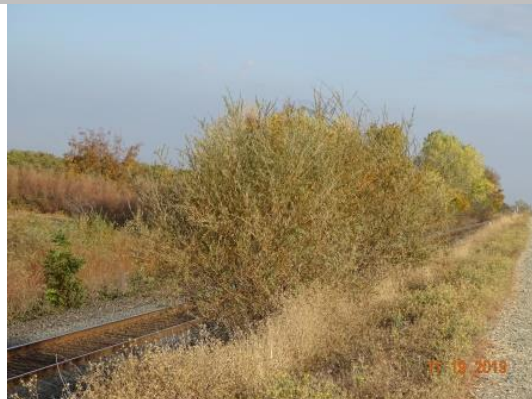
Photo 1 of 1 : SP\_2020\_RD0010\_163\_38\_20200227\_00006.jpg

LM Start	2.92	Rating **	M	Issue No.	38
LM End	2.92	Issue Type +	Ma	Location *	LS
Category	Earthen Levee			GPS Latitude/Longitude	
				Start	End
Item	Trim / Thin Trees			39.188073 °	39.188073 °
				-121.583483 °	-121.583483 °
DWR ID	DWR_RD0010_01_f_2019_38				
Comment Code					
T3 : Trim and thin trees to allow visibility of the ground and room to flood fight.					
Inspector Comment					
Trees with less than 4" diameter at chest height should be removed, Spring 2020.

View looking upstream landside at small starter trees that need to be removed, Fall 2019.

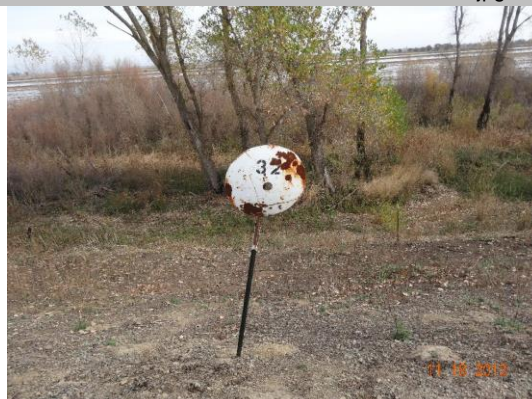
Photo 1 of 3 : UCIP\_SP\_2020\_24816\_44611.jpg

Comment Code						
Inspector Comment						
DS_ID:21317 FS_ID:24816 EP_NO: N/A Repair Type: Non-Urgent Crossing Status: Indicator Found UCIP Comments: 04/29/2013 Indicator marker visible on WS; Dense vegetation on waterward toe and landward side access limits the inspector's visibility to identify signs of pipe failure (leaks) along the slope. Recommend removing vegetation along pipe alignment to conduct proper inspection of structure and appurtances. Access to landward side will need to be coordinated with railroad. Need to coordinate with owner to determine status of crossing. If crossing is no longer in use owner will need to contact the CVFPB to comply with Title 23. This crossing is referenced in the USACE Periodic Inspection as item USACE_CESPK_HON1_2013_p_0204. (DWR UCIP - O. Magana) FIELD_STRUCT_DESC: 24-inch corrugated metal gravity drainage pipe through the levee, 23 feet below the crown. Flap gate on the waterside (WS) end. Concrete headwall at each toe. Siphon breaker on the WS shoulder, unable to find. Concrete saddle and apron on the WS. [Additional Reference(s): DWR Levee Log, 2005. USACE Sacramento O&M Manual 151, May 1953, (Station 299+56)]. FS Date: 4/29/2013

View of marker visible on waterward shoulder.

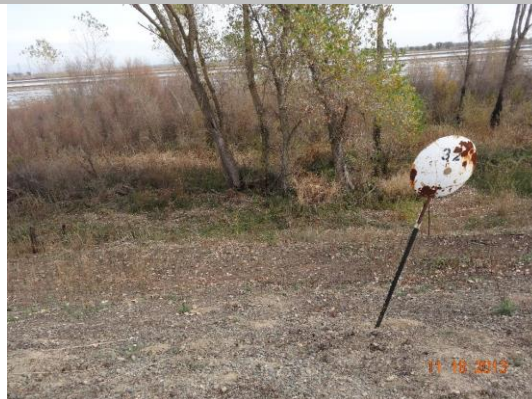
Photo 2 of 3 : UCIP\_SP\_2020\_24816\_44610.jpg

View of waterward slope.

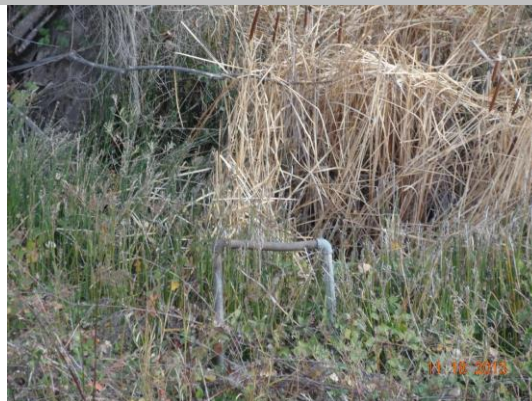
Photo 3 of 3 : UCIP\_SP\_2020\_24816\_44612.jpg

Unable to confirm crossing--only visible sign is U shaped pipe through vegetation.

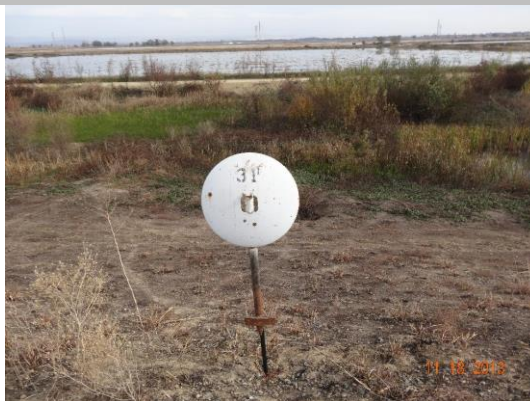
Photo 1 of 3 : UCIP\_SP\_2020\_27746\_51436.jpg

LM Start	3.70	Rating **	A/W	Issue No.	89
LM End	3.70	Issue Type +	Ma	Location *	
Category	Supplemental			GPS Latitude/Longitude	
				Start	End
Item	DWR UCIP LMA Responsibility			39.199281 °	39.199281 °
				-121.582091 °	-121.582091 °
DWR ID	21273				
Comment Code					
Inspector Comment					
DS_ID:21273 FS_ID:27746 EP_NO: N/A Repair Type: No Action Needed Crossing Status: Found UCIP Comments: 04/29/2013 This crossing is referenced in the USACE Periodic Inspection as item USACE_CESPK_HON1_2013_p_0217. (DWR UCIP - O. Magana) FIELD_STRUCT_DESC: 24-inch reinforced concrete gravity drainage pipe through the levee, 19.5 feet below the crown. Flap gate on the waterside (WS) end. Concrete headwall at each toe. Concrete saddle and apron on the WS. [Additional Reference(s): DWR Levee Log, 2005. USACE Sacramento O&M Manual 151, May 1953, (Station 317+80)]. FS Date: 4/29/2013

View of waterward side--marker for pipe visible on waterward shoulder.

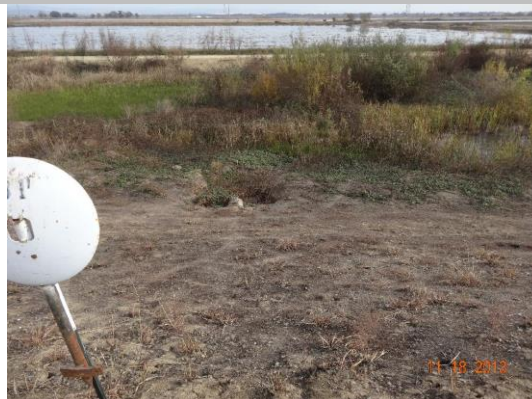
Photo 2 of 3 : UCIP\_SP\_2020\_27746\_51435.jpg

View of pipe on waterward toe.

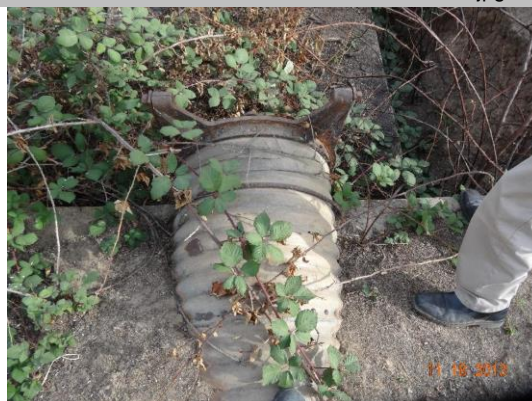
Photo 3 of 3 : UCIP\_SP\_2020\_27746\_51439.jpg

View of pipe, headwall, and concrete apron on waterward toe.

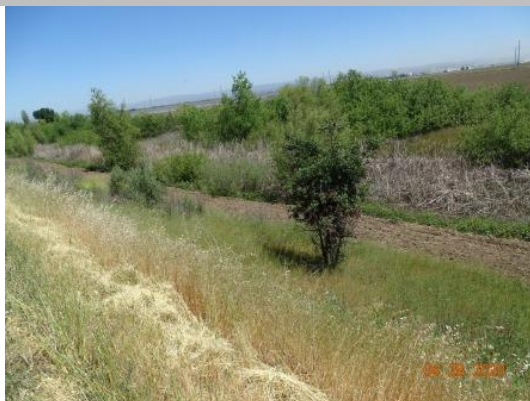
Photo 1 of 1 : SP\_2020\_RD0010\_163\_49\_20200430\_00091.jpg

LM Start	3.91	Rating **	M	Issue No.	49
LM End	3.91	Issue Type +	Ma	Location *	WS
Category	Earthen Levee			GPS Latitude/Longitude	
				Start	End
Item	Trim / Thin Trees			39.202358 °	39.202358 °
				-121.581714 °	-121.581714 °
DWR ID	DWR_RD0010_01_s_2016_49				
Comment Code					
T3 : Trim and thin trees to allow visibility of the ground and room to flood fight.					
Inspector Comment					
Trees with less than 4" diameter at chest height should be removed, Spring 2020.

View looking upstream waterside at small starter trees on levee slope, Spring 2020.

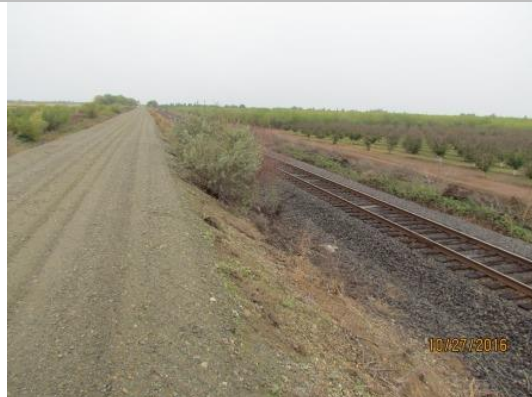
Photo 1 of 1 : SP\_2020\_RD0010\_163\_47\_20200227\_00012.jpg

LM Start	3.92	Rating **	M	Issue No.	47
LM End	3.92	Issue Type +	Ma	Location *	LS
Category	Earthen Levee			GPS Latitude/Longitude	
				Start	End
Item	Trim / Thin Trees			39.202515 °	39.202515 °
				-121.581692 °	-121.581692 °
DWR ID	DWR_RD0010_01_s_2016_47				
Comment Code					
T3 : Trim and thin trees to allow visibility of the ground and room to flood fight.					
Inspector Comment					
Trees with less than 4" diameter at chest height should be removed, Spring 2020.

View of a small willow tree that should be removed on the landside looking downstream.

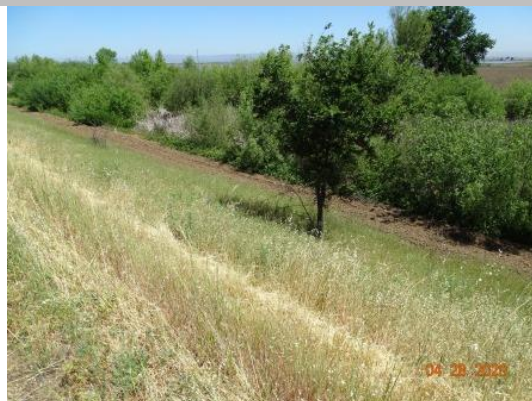
Photo 1 of 1 : SP\_2020\_RD0010\_163\_30\_20200430\_00092.jpg

LM Start	4.04	Rating **	M	Issue No.	30
LM End	4.04	Issue Type +	Ma	Location *	WS
Category	Earthen Levee			GPS Latitude/Longitude	
				Start	End
Item	Trim / Thin Trees			39.204192 °	39.204192 °
				-121.581490 °	-121.581490 °
DWR ID	DWR_RD0010_01_s_2020_30				
Comment Code					
T3 : Trim and thin trees to allow visibility of the ground and room to flood fight.					
Inspector Comment					
Trees with less than 4" diameter at chest height should be removed, Spring 2020.

View looking upstream waterside at small starter tree on levee slope, Spring 2020.

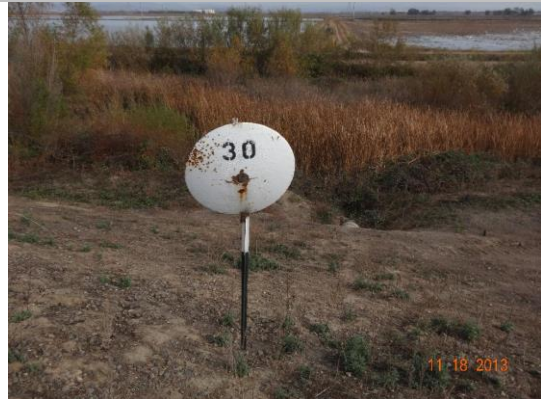
Photo 1 of 3 : UCIP\_SP\_2020\_27747\_51441.jpg

Comment Code						
Inspector Comment						
DS_ID:21274						
FS_ID:27747						
EP_NO: N/A						
Repair Type: Non-Urgent						
Crossing Status: Indicator Found						
UCIP Comments: 04/29/2013 sign marker on WS 30; Unable to confirm landward side. This crossing is referenced in the USACE Periodic Inspection as item USACE_CESPK_HON1_2013_p_0232. (DWR UCIP - O. Magana)						
FIELD_STRUCT_DESC: 24-inch corrugated metal gravity drainage pipe through the levee, 18 feet below the crown. Corrugated metal cutoff wall around the pipe at the center of the levee. Flap gate and 6-foot by 6-foot splash apron on the waterside (WS) end. [Additional Reference(s): DWR Levee Log, 2005. USACE Sacramento O&M Manual 151, May 1953, (Station 339+55.10)].						
FS Date: 4/29/2013

View of waterward side--marker indicating crossing located on waterward shoulder.

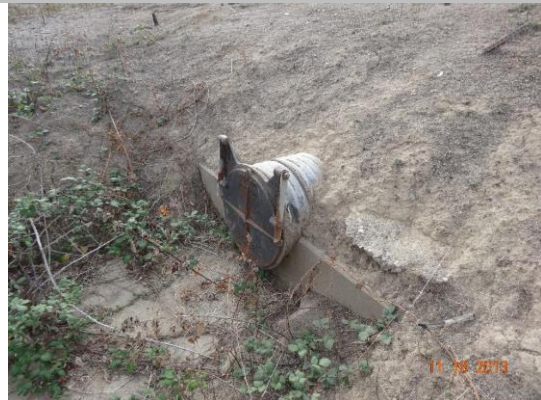
Photo 2 of 3 : UCIP\_SP\_2020\_27747\_51445.jpg

View of pipe, flap gate, and headwall located on waterward toe.

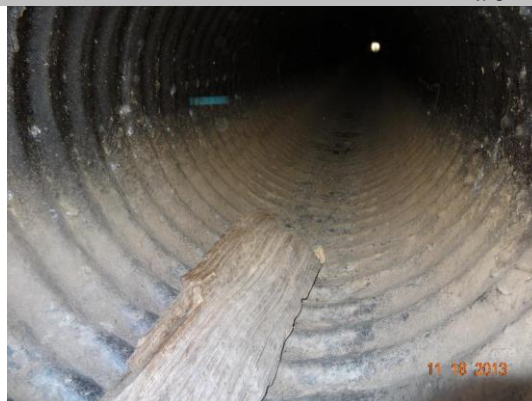
Photo 3 of 3 : UCIP\_SP\_2020\_27747\_51443.jpg

LM Start	4.11	Rating **	M	Issue No.	90 (cont)
LM End	4.11	Issue Type +	En	Location *	
Category	Supplemental			GPS Latitude/Longitude	
				Start	End
Item	DWR UCIP Field Study			39.205209 °	39.205209 °
				-121.581340 °	-121.581340 °
DWR ID	21274

Internal view of pipe wall using camera with flash.

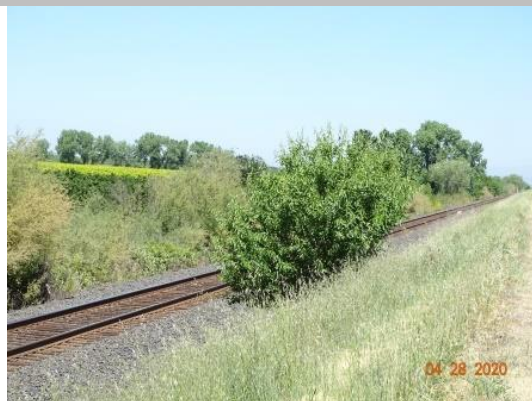
Photo 1 of 1 : SP\_2020\_RD0010\_163\_31\_20200430\_00093.jpg

LM Start	4.21	Rating **	M	Issue No.	31
LM End	4.21	Issue Type +	Ma	Location *	LS
Category	Earthen Levee			GPS Latitude/Longitude	
				Start	End
Item	Trim / Thin Trees			39.206674 °	39.206674 °
				-121.581163 °	-121.581163 °
DWR ID	DWR_RD0010_01_s_2020_31				
Comment Code					
T3 : Trim and thin trees to allow visibility of the ground and room to flood fight.					
Inspector Comment					
Trees with less than 4" diameter at chest height should be removed, Spring 2020.

View looking upstream landside at small starter trees on levee slope, Spring 2020.

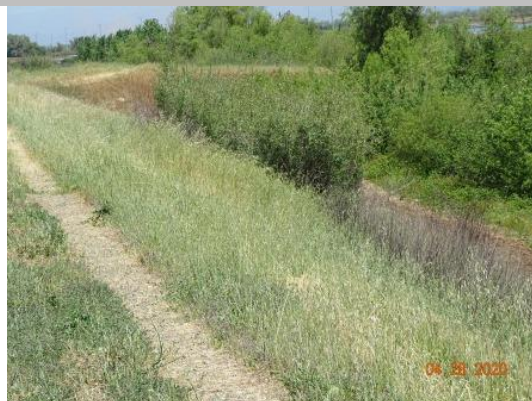
Photo 1 of 1 : SP\_2020\_RD0010\_163\_53\_20200430\_00094.jpg

LM Start	4.28	Rating **	M	Issue No.	53
LM End	4.28	Issue Type +	Ma	Location *	WS
Category	Earthen Levee			GPS Latitude/Longitude	
				Start	End
Item	Trim / Thin Trees			39.207621 °	39.207621 °
				-121.581050 °	-121.581050 °
DWR ID	DWR_RD0010_01_s _ 2020_53				
Comment Code					
T3 : Trim and thin trees to allow visibility of the ground and room to flood fight.					
Inspector Comment					
Trees with less than 4" diameter at chest height should be removed, Spring 2020.

View looking upstream waterside at small starter trees on levee slope, Spring 2020.

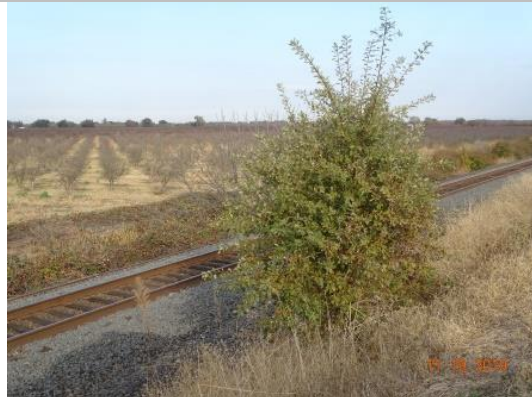
Photo 1 of 1 : SP\_2020\_RD0010\_163\_39\_20200227\_00007.jpg

LM Start	4.63	Rating **	M	Issue No.	39
LM End	4.63	Issue Type +	Ma	Location *	LS
Category	Earthen Levee			GPS Latitude/Longitude	
				Start	End
Item	Trim / Thin Trees			39.212749 °	39.212749 °
				-121.580406 °	-121.580406 °
DWR ID	DWR_RD0010_01_f_2019_39				
Comment Code					
T3 : Trim and thin trees to allow visibility of the ground and room to flood fight.					
Inspector Comment					
Trees with less than 4" diameter at chest height should be removed, Spring 2020.

View looking upstream landside at small starter trees that need to be removed, Fall 2019.

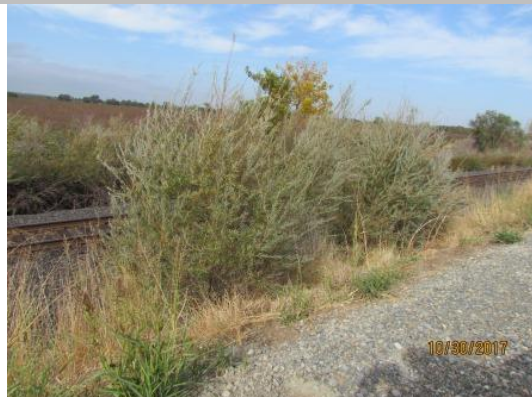
Photo 1 of 1 : SP\_2020\_RD0010\_163\_37\_20200227\_00005.jpg

LM Start	4.83	Rating **	M	Issue No.	37
LM End	4.83	Issue Type +	Ma	Location *	LS
Category	Earthen Levee			GPS Latitude/Longitude	
				Start	End
Item	Trim / Thin Trees			39.215597 °	39.215597 °
				-121.580046 °	-121.580046 °
DWR ID	DWR_RD0010_01_f_2017_37				
Comment Code					
T3 : Trim and thin trees to allow visibility of the ground and room to flood fight.					
Inspector Comment					
Trees with less than 4" diameter at chest height should be removed, Spring 2020.

View of small willow trees on the landside slope looking upstream.

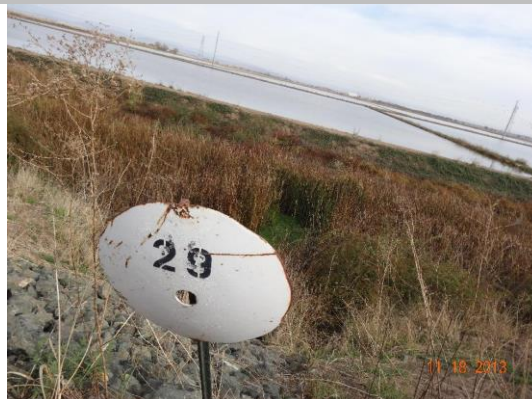
Photo 1 of 3 : UCIP\_SP\_2020\_53138\_44811.jpg

UCIP Comments: 10/18/2018 According to the LMA representative, a small pipe repair was completed near the WS gate (pipe was leaking at pipe collar). Pipe has been upgraded from Non-Urgent to Urgent due to the wall deterioration near the outlet and an unknown condition through the levee. Levee is about 20 feet high. Recommend video inspection to determine pipe condition through the levee. This pipe is part of DWR's Deferred Maintenance Project (DMP), video inspection is expected to be completed next year for this crossing. (O. Magana - DWR UCIP)7/01/2016 WS slope appears to be stable; UCIP issue has been downgraded from Urgent to Non-Urgent due to what appears to be a stable slope--no other issues were observed during the site visit. The reason for the Non-Urgent classification is due to the limited documentation available to support extent of repair--need to obtain repair records to determine extent of repair and to determine if pipe was replaced through the levee. (DWR UCIP - omagana)4/29/2013 limited access; steep slopes, and dense vegetation; New riprap has been placed along pipe alignment need to contact owner to determine work authorization. Also need to find out if the design for riprap was due to slope failure at this location. This crossing is referenced in the USACE Periodic Inspection as item USACE\_CESPK\_HON1\_2013\_p\_0246. (DWR UCIP - omagana)

FIELD\_STRUCT\_DESC: 36-inch corrugated metal gravity drainage pipe through the levee, 20 feet below the crown. Two corrugated metal cutoff walls around the pipe on each shoulder. Flap gate on the waterside (WS) end. Concrete headwall on the WS toe. Grouted cobble headwall on the landside (LS) toe. Concrete saddle and apron on the WS. [Additional Reference(s): DWR Levee Log, 2005. USACE Sacramento O&M Manual 151, May 1953, (Station 381+76.24)].  
FS Date: 10/18/2018

Marker for pipe crossing visible on WS shoulder.

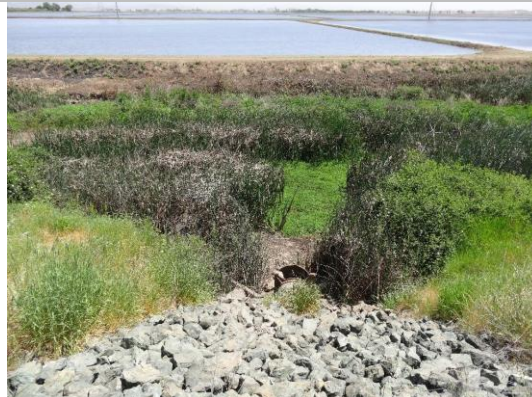
Photo 2 of 3 : UCIP\_SP\_2020\_53138\_44809.jpg

LM Start	4.90	Rating **	U	Issue No.	91 (cont)
LM End	4.90	Issue Type +	Ma	Location *	
Category	Supplemental			GPS Latitude/Longitude	
				Start	End
Item	DWR UCIP LMA Responsibility			39.216591 °	39.216591 °
				-121.579919 °	-121.579919 °
DWR ID	21275

View of WS during April.

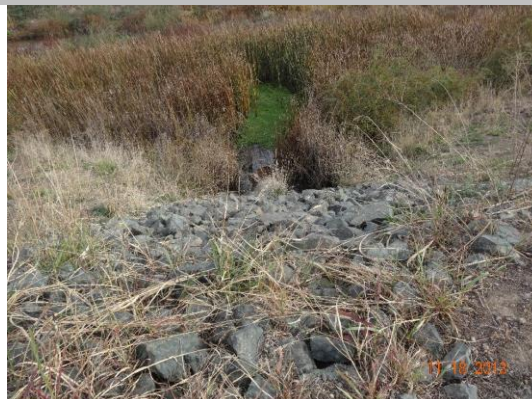
Photo 3 of 3 : UCIP\_SP\_2020\_53138\_44810.jpg

LM Start	<b>4.90</b>	Rating **	U	Issue No.	<b>91 (cont)</b>
LM End	<b>4.90</b>	Issue Type +	Ma	Location *

View of WS slope covered with rip rap along pipe alignment.

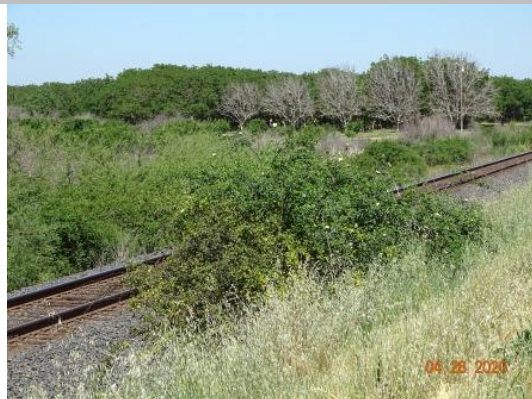
Photo 1 of 1 : SP\_2020\_RD0010\_163\_55\_20200430\_00096.jpg

LM Start	4.94	Rating **	M	Issue No.	55
LM End	4.94	Issue Type +	Ma	Location *	LS
Category	Earthen Levee			GPS Latitude/Longitude	
				Start	End
Item	Trim / Thin Trees			39.217206 °	39.217206 °
				-121.579855 °	-121.579855 °
DWR ID	DWR_RD0010_01_s _ 2020_55				
Comment Code					
T2 : Thin trees to allow visibility of the ground and room to flood fight.					
Inspector Comment					
Remove wild rose bush, Spring 2020.

View looking upstream landside at wild rose bush on levee slope, Spring 2020.

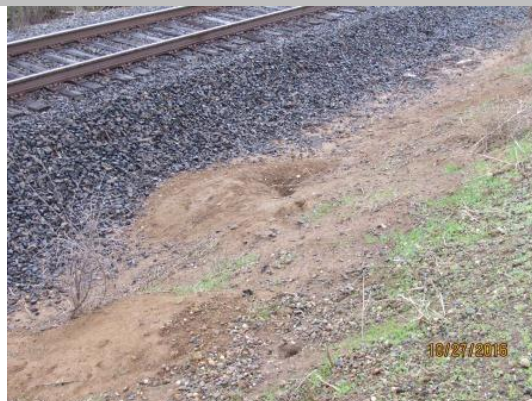
Photo 1 of 1 : SP\_2020\_RD0010\_163\_42\_20200227\_00010.jpg

LM Start	5.04	Rating **	M	Issue No.	42
LM End	5.04	Issue Type +	Ma	Location *	LS
Category	Earthen Levee			GPS Latitude/Longitude	
				Start	End
Item	Animal Control			39.218564 °	39.218564 °
				-121.579682 °	-121.579682 °
DWR ID	DWR_RD0010_01_s _ 2016_42				
Comment Code					
A3 : No rodents visible, but rodent burrows visible; need to backfill and compact or grout burrows.					
Inspector Comment					
Squirrel holes still are visible but there is no sign of activity.

View of squirrel holes on landside toe, no sign of activity.

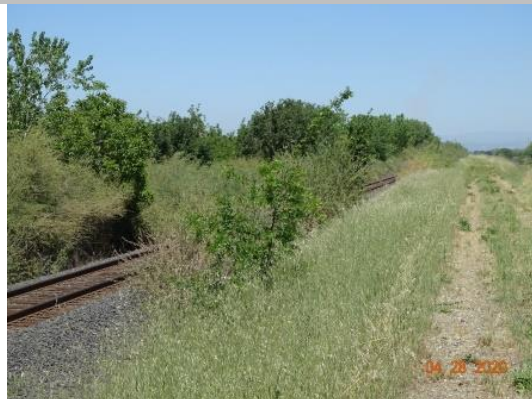
Photo 1 of 1 : SP\_2020\_RD0010\_163\_56\_20200430\_00097.jpg

LM Start	5.42	Rating **	M	Issue No.	56
LM End	5.42	Issue Type +	Ma	Location *	LS
Category	Earthen Levee			GPS Latitude/Longitude	
				Start	End
Item	Trim / Thin Trees			39.224014 °	39.224014 °
				-121.579012 °	-121.579012 °
DWR ID	DWR_RD00010_01_s _ 2020_56				
Comment Code					
T3 : Trim and thin trees to allow visibility of the ground and room to flood fight.					
Inspector Comment					
Trees with less than 4" diameter at chest height should be removed, Spring 2020.

View looking upstream landside at small starter trees on levee slope, Spring 2020.

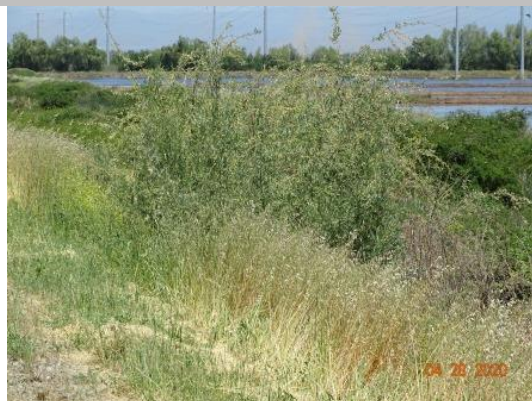
Photo 1 of 1 : SP\_2020\_RD0010\_163\_62\_20200430\_00098.jpg

LM Start	5.42	Rating **	M	Issue No.	62
LM End	5.42	Issue Type +	Ma	Location *	WS
Category	Earthen Levee			GPS Latitude/Longitude	
				Start	End
Item	Trim / Thin Trees			39.224041 °	39.224041 °
				-121.579008 °	-121.579008 °
DWR ID	DWR_RD0010_01_s _ 2020_62				
Comment Code					
T3 : Trim and thin trees to allow visibility of the ground and room to flood fight.					
Inspector Comment					
Trees with less than 4" diameter at chest height should be removed, Spring 2020.

View looking upstream waterside at small starter tree on levee slope, Spring 2020.

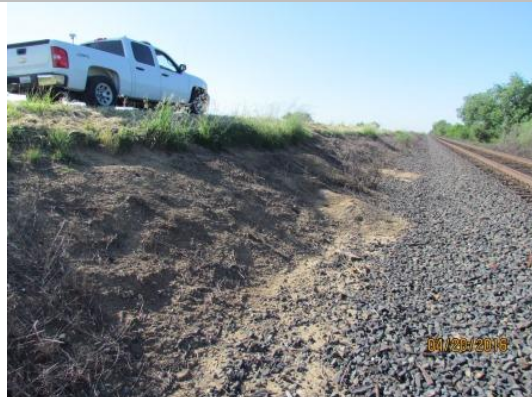
Photo 1 of 1 : SP\_2020\_RD0010\_163\_41\_20200227\_00009.jpg

LM Start	5.45	Rating **	M	Issue No.	41
LM End	5.45	Issue Type +	Ma	Location *	LS
Category	Earthen Levee			GPS Latitude/Longitude	
				Start	End
Item	Animal Control			39.224485 °	39.224485 °
				-121.578944 °	-121.578944 °
DWR ID	DWR_RD0010_01_s_2016_41				
Comment Code					
A3 : No rodents visible, but rodent burrows visible; need to backfill and compact or grout burrows.					
Inspector Comment					
Squirrel holes still are visible but there is no sign of activity.

View of multiple ground squirrel holes on landside slope looking downstream. There is no evidence of active squirrels.
