**Flood Control Project Maintenance  
Levee Inspections**  
**LMA District Cover Sheet**  
**Spring 2020 Levee Inspection Results**

**Reclamation District No. 0010 Honcut**

**Spring 2020 Levee Inspection Results**

Waterway			Bank	Unit Miles
Unit No. 01 Simmerly Slough			Right	7.65
	Spring (March - May)	Summer (June - August)	(September - November) Fall	Winter (December - February)
Unit Maintenance Rating (Fall Only)				
Date of Inspection	4/28/2020 - 4/28/2020			
DWR Inspector	Sterling York			
Accompanied By	Finlay Williams

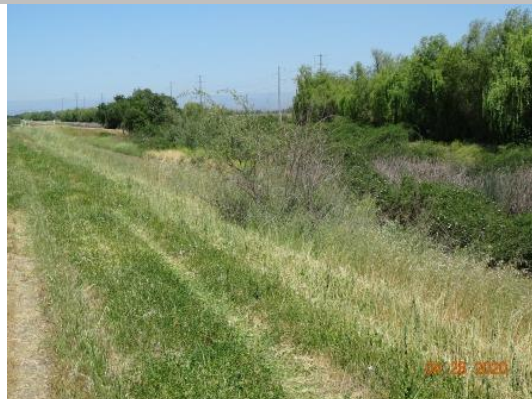
Photo 1 of 1 : SP\_2020\_RD0010\_163\_65\_20200430\_00099.jpg

LM Start	5.46	Rating **	M	Issue No.	65
LM End	5.52	Issue Type +	Ma	Location *	WS
Category	Earthen Levee			GPS Latitude/Longitude	
				Start	End
Item	Trim / Thin Trees			39.224652 °	39.225433 °
				-121.578929 °	-121.578832 °
DWR ID	DWR_RD0010_01_s_2020_65				
Comment Code					
T3 : Trim and thin trees to allow visibility of the ground and room to flood fight.					
Inspector Comment					
Trees with less than 4" diameter at chest height should be removed, Spring 2020.

View looking upstream waterside at small starter tree on levee slope, Spring 2020.

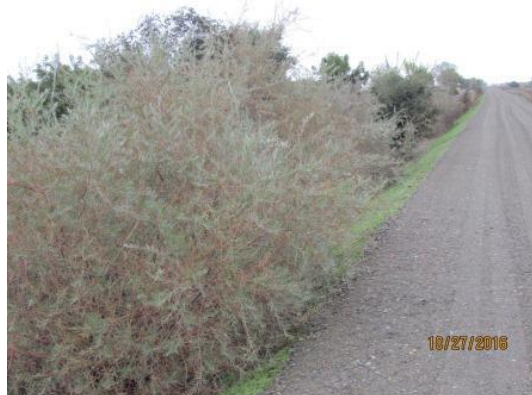
Photo 1 of 1 : SP\_2020\_RD0010\_163\_40\_20200227\_00008.jpg

LM Start	5.60	Rating **	M	Issue No.	40
LM End	5.60	Issue Type +	Ma	Location *	LS
Category	Earthen Levee			GPS Latitude/Longitude	
				Start	End
Item	Trim / Thin Trees			39.226679 °	39.226679 °
				-121.578670 °	-121.578670 °
DWR ID	DWR_RD0010_01_s_2016_40				
Comment Code					
T3 : Trim and thin trees to allow visibility of the ground and room to flood fight.					
Inspector Comment					
Trees with less than 4" diameter at chest height should be removed, Spring 2020.

View of willow trees on the landside slope looking upstream.

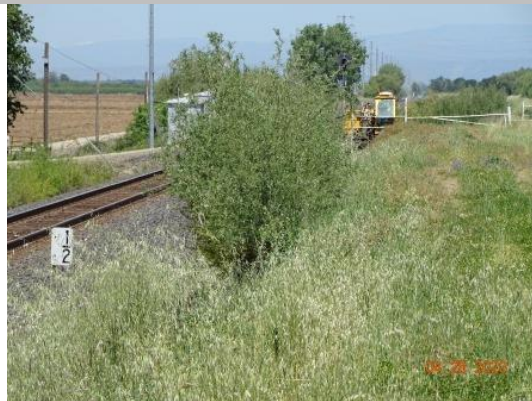
Photo 1 of 1 : SP\_2020\_RD0010\_163\_66\_20200430\_00100.jpg

LM Start	6.01	Rating **	M	Issue No.	66
LM End	6.01	Issue Type +	Ma	Location *	LS
Category	Earthen Levee			GPS Latitude/Longitude	
				Start	End
Item	Trim / Thin Trees			39.232602 °	39.232602 °
				-121.577954 °	-121.577954 °
DWR ID	DWR_RD0010_01_s_2020_66				
Comment Code					
T3 : Trim and thin trees to allow visibility of the ground and room to flood fight.					
Inspector Comment					
Trees with less than 4" diameter at chest height should be removed, Spring 2020.

View looking upstream landside at small starter tree on levee slope, Spring 2020.

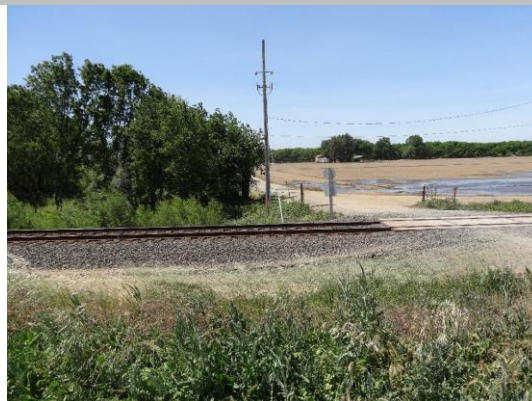
Photo 1 of 3 : UCIP\_SP\_2020\_27531\_51124.jpg

Comment Code						
Inspector Comment						
DS_ID:21277 FS_ID:27531 EP_NO: 6127 Repair Type: Non-Urgent Crossing Status: Indicator Found UCIP Comments: 04/29/2013 Recommend removing vegetation along pipe alignment to conduct proper inspection of structure and appurtances. (DWR UCIP - O. Magana) FIELD_STRUCT_DESC: Two 1-inch aluminum electrical conduits through the levee, 3 feet below the crown. Cutoff wall around the conduits at the center of the levee. (Plans to construct a low levee along the bank of the canal authorized under Permit No. 6127, 1968 - Morgan C. Chambers and Edgar Meyer). [Additional Reference(s): DWR Levee Log, 2005]. FS Date: 4/29/2013

LS view overview.

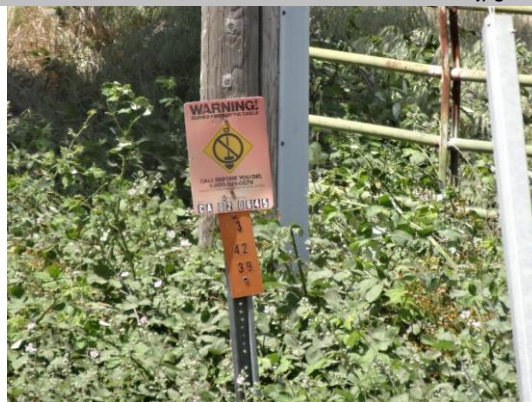
Photo 2 of 3 : UCIP\_SP\_2020\_27531\_51123.jpg

Buried fiber optic cable marker located on LS.

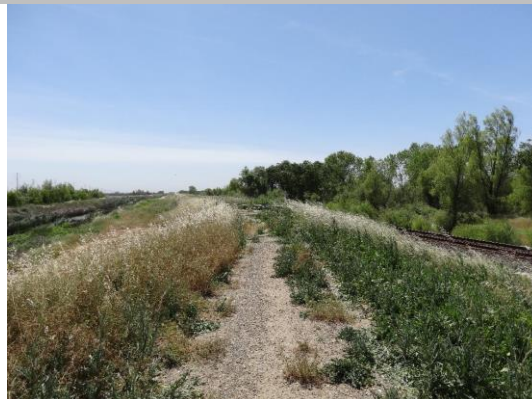
Photo 3 of 3 : UCIP\_SP\_2020\_27531\_51122.jpg

LM Start	6.14	Rating **	M	Issue No.	92 (cont)
LM End	6.14	Issue Type +	En	Location *	
Category	Supplemental			GPS Latitude/Longitude	
				Start	End
Item	DWR UCIP Field Study			39.234389 °	39.234389 °
				-121.577620 °	-121.577620 °
DWR ID	21277

View of levee crown.

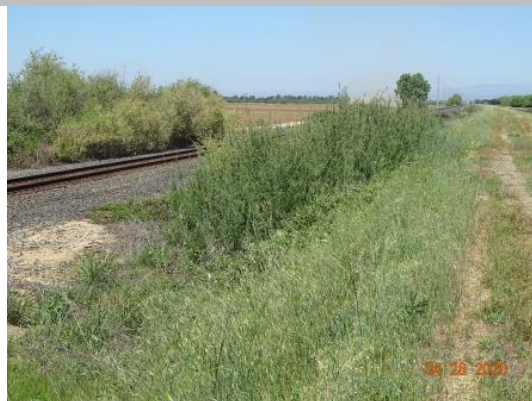
Photo 1 of 1 : SP\_2020\_RD0010\_163\_33\_20200430\_00102.jpg

LM Start	6.19	Rating **	M	Issue No.	33
LM End	6.19	Issue Type +	Ma	Location *	LS
Category	Earthen Levee			GPS Latitude/Longitude	
				Start	End
Item	Trim / Thin Trees			39.235216 °	39.235216 °
				-121.577532 °	-121.577532 °
DWR ID	DWR_RD0010_01_s_2020_33				
Comment Code					
T3 : Trim and thin trees to allow visibility of the ground and room to flood fight.					
Inspector Comment					
Trees with less than 4" diameter at chest height should be removed, Spring 2020.

View looking upstream landside at small starter trees on levee slope, Spring 2020.

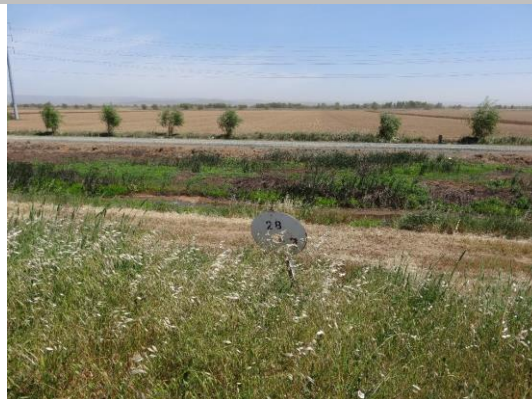
Photo 1 of 3 : UCIP\_SP\_2020\_24438\_43503.jpg

DS\_ID:21278  
FS\_ID:24438  
EP\_NO: N/A  
Repair Type: Non-Urgent  
Crossing Status: Found  
UCIP Comments: 04/29/2013 Dense vegetation limits the inspector's visibility to identify signs of pipe failure (leaks) along the slope. Recommend removing vegetation along pipe alignment to conduct proper inspection of structure and appurtenances. This crossing is referenced in the USACE Periodic Inspection as item USACE\_CESPK\_HON1\_2013\_p\_0290. (DWR UCIP - O. Magana)  
FIELD\_STRUCT\_DESC: 30-inch corrugated metal gravity drainage pipe through the levee, 12.5 feet below the crown. Corrugated metal cutoff wall around the pipe at each shoulder. Flap gate on the waterside (WS) end. Concrete headwall, saddle, and apron on the WS end.  
[Additional Reference(s): DWR Levee Log, 2005. USACE Sacramento O&M Manual 151, May 1953, (Station 455+00)].  
FS Date: 4/29/2013

Marker visible on waterward shoulder.

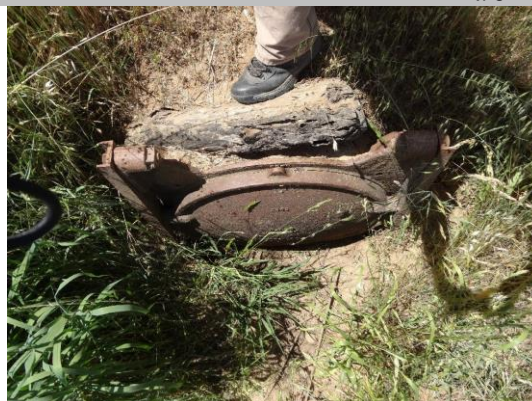
Photo 3 of 3 : UCIP\_SP\_2020\_24438\_43501.jpg

Pipe and flap gate confirmed on waterward side.

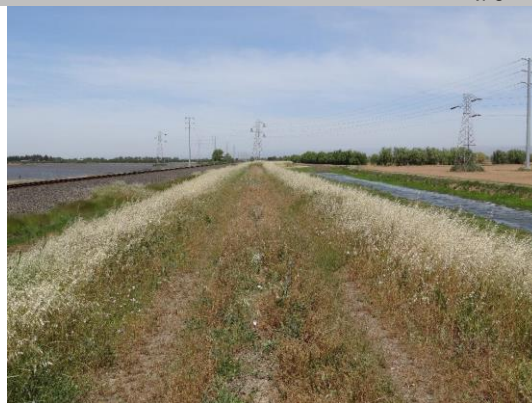
Photo 1 of 3 : UCIP\_SP\_2020\_27532\_51129.jpg

DS\_ID:21279  
FS\_ID:27532  
EP\_NO: N/A  
Repair Type: Non-Urgent  
Crossing Status: Found  
UCIP Comments: 04/29/2013 Need to clear sediment near gate. Need to coordinate with owner to determine status of crossing. If crossing is no longer in use owner will need to contact the CVFPB to comply with Title 23. This crossing is referenced in the USACE Periodic Inspection as item USACE\_CESPK\_HON1\_2013\_p\_0291-294. (DWR UCIP - O. Magana)  
FIELD\_STRUCT\_DESC: 16-inch steel drainage pipe through the levee, 10.3 feet below the crown. Cutoff wall around the pipe at the center of the levee. Slide gate on the waterside (WS) end. Pipe exposed across irrigation canal on the landside (LS). [Additional Reference(s): DWR Levee Log, 2005. USACE Sacramento O&M Manual 151, May 1953, (Station 473+58)].  
FS Date: 4/29/2013

View of levee looking upstream.

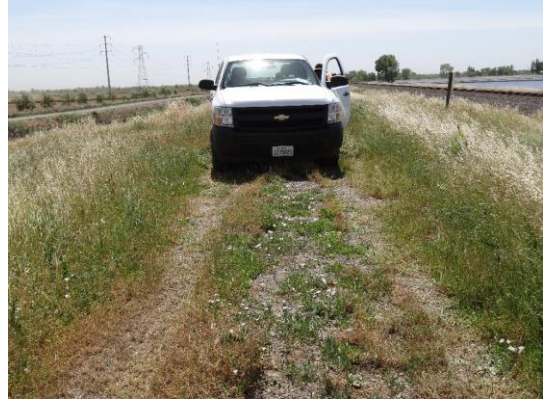
Photo 2 of 3 : UCIP\_SP\_2020\_27532\_51128.jpg

View of levee looking downstream.

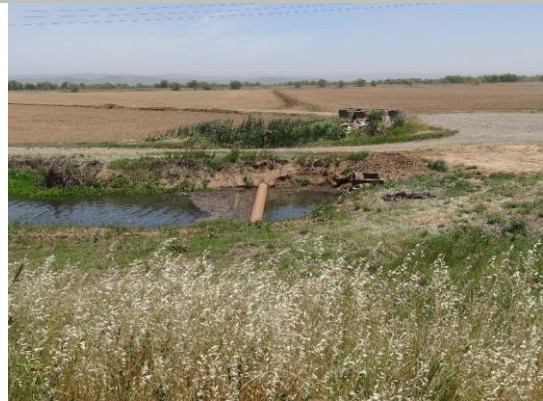
Photo 3 of 3 : UCIP\_SP\_2020\_27532\_51130.jpg

View of waterward side--pipe goes through Simmerly Slough.

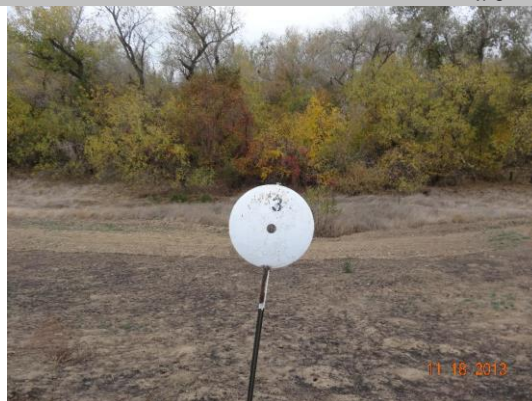
Photo 1 of 3 : UCIP\_SP\_2020\_27533\_51135.jpg

Comment Code					
Inspector Comment					
DS_ID:21280 FS_ID:27533 EP_NO: N/A Repair Type: Non-Urgent Crossing Status: Found UCIP Comments: 04/30/2013 Recommend removing vegetation and debris along pipe alignment (debris blocking gate on waterward side and vegetation blocking access to screw gate on landward side). Need to coordinate with owner to determine status of crossing. If crossing is no longer in use owner will need to contact the CVFPB to comply with Title 23. This crossing is referenced in the USACE Periodic Inspection as item USACE_CESPK_HON2_2013_p_0027. (DWR UCIP - O. Magana) FIELD_STRUCT_DESC: 24-inch corrugated metal gravity drainage pipe through the levee, 25.6 feet below the crown. Corrugated metal cutoff wall around the pipe at each shoulder. Flap gate on the waterside (WS) end. Concrete headwall, saddle, and apron on the WS end. [Additional Reference(s): DWR Levee Log, 2005. USACE Sacramento O&M Manual 151, May 1953, (Station 106+00)]. FS Date: 4/30/2013

View of waterward side.

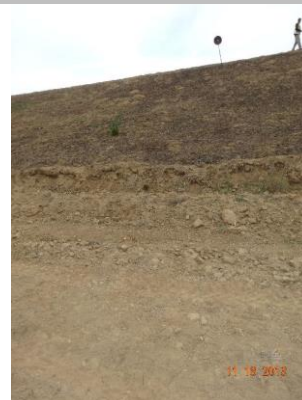
Photo 2 of 3 : UCIP\_SP\_2020\_27533\_51137.jpg

View of waterward slope.

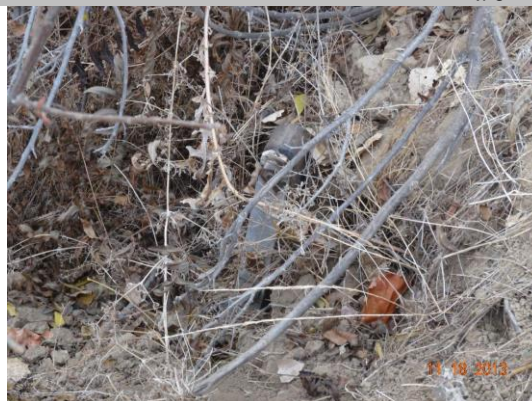
Photo 3 of 3 : UCIP\_SP\_2020\_27533\_51138.jpg

Buried flap gate on waterward side.

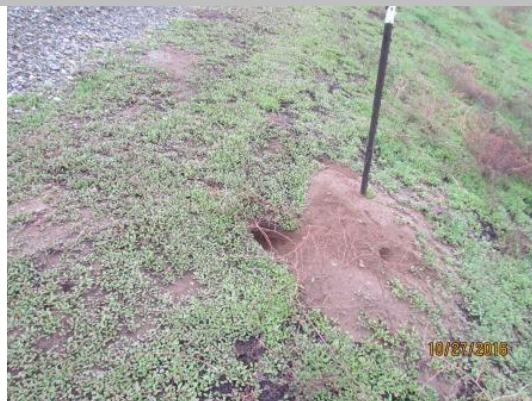
Photo 1 of 1 : SP\_2020\_RD0010\_164\_28\_20200227\_00002.jpg

LM Start	0.38	Rating **	M	Issue No.	28
LM End	0.38	Issue Type +	Ma	Location *	WS
Category	Earthen Levee			GPS Latitude/Longitude	
				Start	End
Item	Animal Control			39.169231 °	39.169231 °
				-121.610711 °	-121.610711 °
DWR ID	DWR_RD0010_02_f _ 2015_28				
Comment Code					
A3 : No rodents visible, but rodent burrows visible; need to backfill and compact or grout burrows.					
Inspector Comment					
No rodent activity but squirrel hole needs to be backfilled.

View of squirrel hole on the waterside looking downstream.

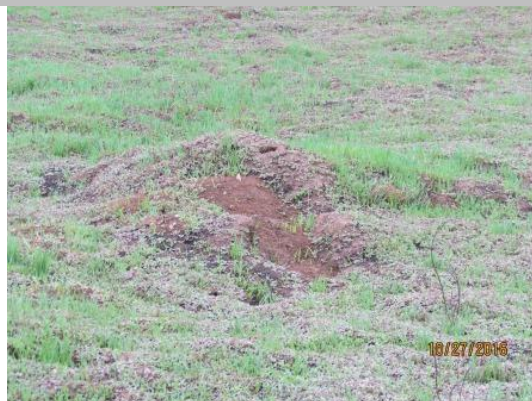
Photo 1 of 1 : SP\_2020\_RD0010\_164\_29\_20200227\_00003.jpg

LM Start	0.94	Rating **	U	Issue No.	29
LM End	0.94	Issue Type +	Ma	Location *	WS
Category	Earthen Levee			GPS Latitude/Longitude	
				Start	End
Item	Animal Control			39.177289 °	39.177289 °
				-121.609860 °	-121.609860 °
DWR ID	DWR_RD0010_02_f_2015_29				
Comment Code					
A3 : No rodents visible, but rodent burrows visible; need to backfill and compact or grout burrows.					
Inspector Comment					
No rodent activity but squirrel hole needs to be backfilled.

View of rodent hole that has more than 2 cubic feet of material on the waterside.

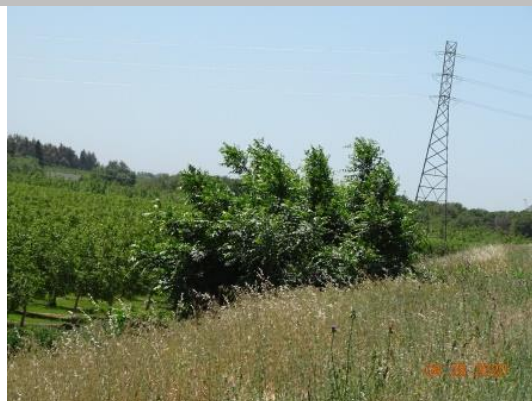
Photo 1 of 1 : SP\_2020\_RD0010\_164\_70\_20200429\_00111.jpg

LM Start	1.09	Rating **	M	Issue No.	70
LM End	1.09	Issue Type +	Ma	Location *	LS
Category	Earthen Levee			GPS Latitude/Longitude	
				Start	End
Item	Trim / Thin Trees			39.179456 °	39.179456 °
				-121.610000 °	-121.610000 °
DWR ID	DWR_RD0010_02_s_2020_70				
Comment Code					
T3 : Trim and thin trees to allow visibility of the ground and room to flood fight.					
Inspector Comment					
Trees with less than 4" diameter at chest height should be removed, Spring 2020.

View looking downstream landside at small starter tree on levee slope, Spring 2020.

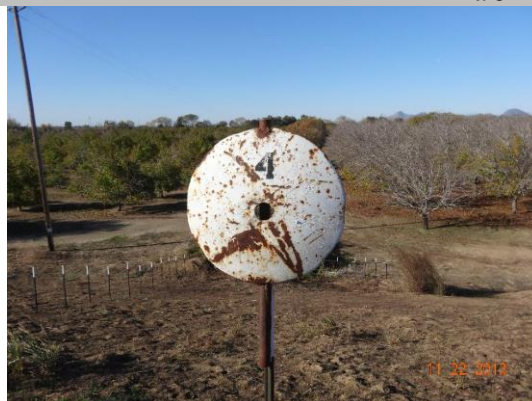
Photo 1 of 3 : UCIP\_SP\_2020\_24821\_44640.jpg

DS\_ID:21281  
FS\_ID:24821  
EP\_NO: N/A  
Repair Type: Non-Urgent  
Crossing Status: Found  
UCIP Comments: 04/30/2013 Screw gate on landward side is blocked by sediment. Recommend removing sediment in front of gate. This crossing is referenced in the USACE Periodic Inspection as item USACE\_CESPK\_HON2\_2013\_p\_0082. (DWR UCIP - O. Magana)  
FIELD\_STRUCT\_DESC: 24-inch corrugated metal gravity drainage pipe through the levee, 26 feet below the crown. Corrugated metal cutoff wall around the pipe at each shoulder. Flap gate on the waterside (WS) end. Slide gate on the landside (LS) end. Concrete headwall, saddle, and apron on the WS end. [Additional Reference(s): DWR Levee Log, 2005. USACE Sacramento O&M Manual 151, May 1953, (Station 149+88)].  
FS Date: 4/30/2013

Marker visible on waterward side--No. 4.

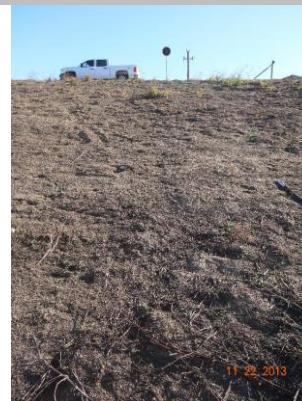
Photo 2 of 3 : UCIP\_SP\_2020\_24821\_44639.jpg

View of waterward slope side.

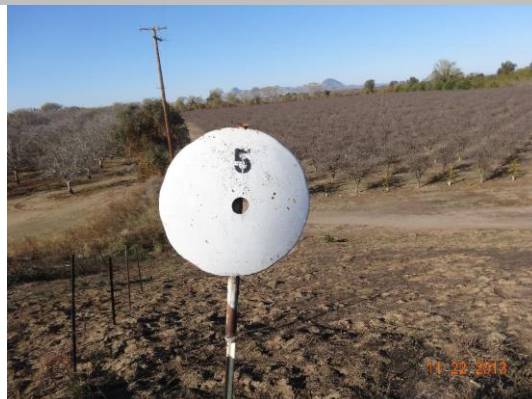
Photo 1 of 3 : UCIP\_SP\_2020\_24822\_44647.jpg

Comment Code						
Inspector Comment						
DS_ID:21282						
FS_ID:24822						
EP_NO: N/A						
Repair Type: No Action Needed						
Crossing Status: Found						
UCIP Comments: 04/29/2013 This crossing is referenced in the						
USACE Periodic Inspection as item						
USACE_CESPK_HON2_2013_p_0109. (DWR UCIP - O. Magana)						
FIELD_STRUCT_DESC: 36-inch corrugated metal gravity drainage						
pipe through the levee, 25 feet below the crown. Corrugated metal						
cutoff wall around the pipe at each shoulder. Flap gate on the waterside						
(WS) end. Slide gate on the landside (LS) end. Concrete headwall,						
saddle, and apron on the WS end. [Additional Reference(s): DWR						
Levee Log, 2005. USACE Sacramento O&M Manual 151, May 1953,						
(Station 164+65)].						
FS Date: 4/30/2013

Marker visible on waterward side--No. 5.

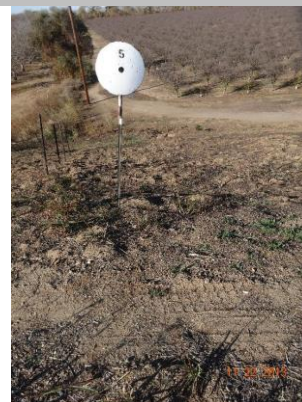
Photo 2 of 3 : UCIP\_SP\_2020\_24822\_44648.jpg

Overview of waterward slope--dense burrow activity on slope.

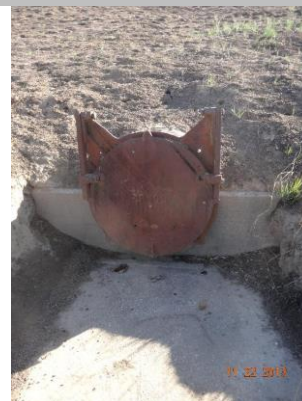
Photo 3 of 3 : UCIP\_SP\_2020\_24822\_44645.jpg

View of flap gate on waterward side.

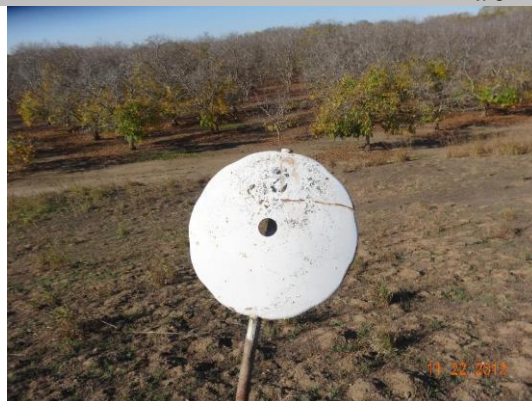
Photo 1 of 3 : UCIP\_SP\_2020\_27773\_51461.jpg

LM Start	3.10	Rating **	M	Issue No.	75	
LM End	3.10	Issue Type +	En	Location *		
Category	Supplemental			GPS Latitude/Longitude		
				Start		End
Item	DWR UCIP Field Study			39.208193 °	39.208193 °	
				-121.609909 °	-121.609909 °	
DWR ID	21283					
Comment Code						
Inspector Comment						
DS_ID:21283						
FS_ID:27773						
EP_NO: N/A						
Repair Type: Non-Urgent						
Crossing Status: Found						
UCIP Comments: 04/30/2013 High rodent activity along pipe alignment--animal control would be beneficial. This crossing is referenced in the USACE Periodic Inspection as item USACE_CESPK_HON2_2013_p_0150. (DWR UCIP - O. Magana)						
FIELD_STRUCT_DESC: 30-inch corrugated metal gravity drainage pipe through the levee, 22.5 feet below the crown. Flap gate on the waterside (WS) end. Metal marker on the WS shoulder. [Additional Reference(s): DWR Levee Log, 2005].						
FS Date: 4/30/2013

Marker visible on waterward side.

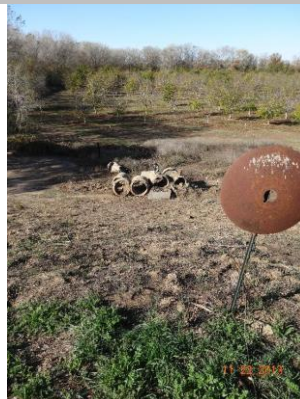
Photo 2 of 3 : UCIP\_SP\_2020\_52889\_44657.jpg

Overview of waterward slope--barrier placed at toe to discourage damage to crossing.

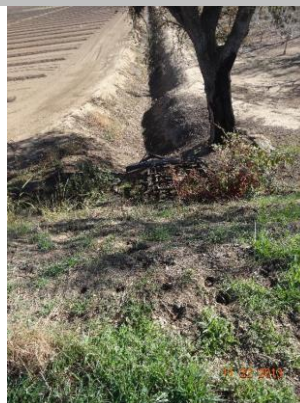
Photo 3 of 3 : UCIP\_SP\_2020\_52889\_44656.jpg

View of landward side--barrier used to discourage damage to crossing near toe.

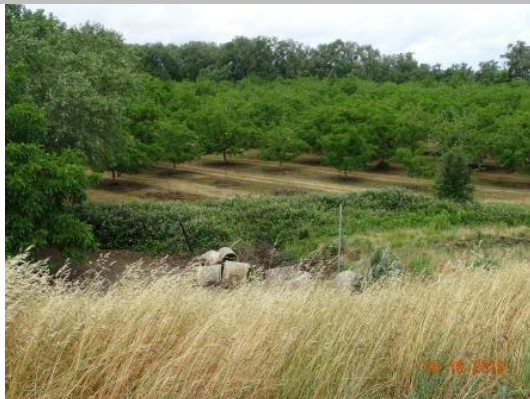
Photo 1 of 1 : SP\_2020\_RD0010\_164\_47\_20200227\_00012.jpg

LM Start	3.30	Rating **	M	Issue No.	47
LM End	3.30	Issue Type +	En	Location *	WS
Category	Earthen Levee			GPS Latitude/Longitude	
				Start	End
Item	Encroachments			39.211085 °	39.211085 °
				-121.610172 °	-121.610172 °
DWR ID	DWR_RD0010_02_s _ 2019_47				
Comment Code					
DE : Debris					
Inspector Comment					
Remove debris at the levee toe, Spring 2020.

View looking at the waterside levee toe where debris has been stacked, Spring 2019.

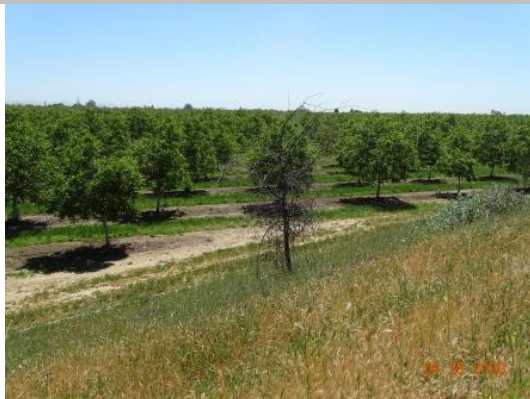
Photo 1 of 1 : SP\_2020\_RD0010\_164\_66\_20200429\_00107.jpg

LM Start	3.48	Rating **	M	Issue No.	66
LM End	3.48	Issue Type +	Ma	Location *	LS
Category	Earthen Levee			GPS Latitude/Longitude	
				Start	End
Item	Trim / Thin Trees			39.213634 °	39.213634 °
				-121.610084 °	-121.610084 °
DWR ID	DWR_RD0010_02_s _ 2020_66				
Comment Code					
T3 : Trim and thin trees to allow visibility of the ground and room to flood fight.					
Inspector Comment					
Trees with less than 4" diameter at chest height should be removed, Spring 2020.

View looking downstream landside at small starter tree on levee slope, Spring 2020.

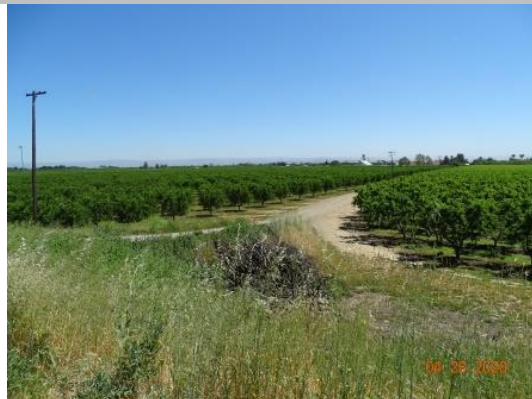
Photo 1 of 1 : SP\_2020\_RD0010\_164\_65\_20200429\_00106.jpg

LM Start	3.60	Rating **	M	Issue No.	65
LM End	3.60	Issue Type +	En	Location *	LS
Category	Earthen Levee			GPS Latitude/Longitude	
				Start	End
Item	Encroachments			39.215349 °	39.215349 °
				-121.610741 °	-121.610741 °
DWR ID	DWR_RD0010_02_s_2020_65				
Comment Code					
PR : Prunings					
Inspector Comment					
Remove prunings from levee toe, Spring 2020.

View looking landside at prunings on levee toe, Spring 2020.

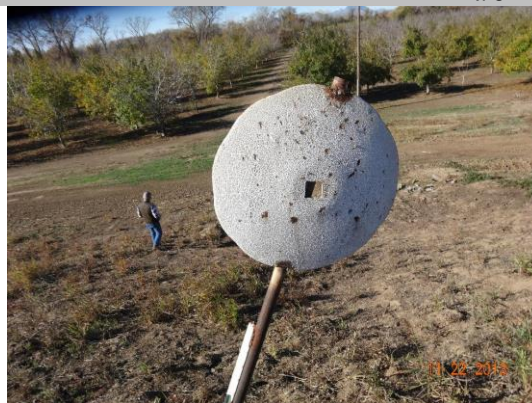
Photo 1 of 3 : UCIP\_SP\_2020\_24825\_44664.jpg

Comment Code					
Inspector Comment					
DS_ID:21285 FS_ID:24825 EP_NO: N/A Repair Type: Non-Urgent Crossing Status: Found UCIP Comments: 04/30/2013 Sediment blocking flap gate and screw gate--recommend removing material. Dense burrow activity present along levee slopes (large holes visible on landward side)--recommend addressing issue. This crossing is referenced in the USACE Periodic Inspection as item USACE_CESPK_HON2_2013_p_0169. (DWR UCIP - O. Magana) FIELD_STRUCT_DESC: 30-inch corrugated metal gravity drainage pipe through the levee, 19.5 feet below the crown. Corrugated metal cutoff wall around the pipe at each shoulder. Flap gate on the waterside (WS) end. Slide gate on the landside (LS) end. Concrete headwall at each end. [Additional Reference(s): DWR Levee Log, 2005. USACE Sacramento O&M Manual 151, May 1953, (Station 277+00)]. FS Date: 4/30/2013

Marker visible on waterward side.

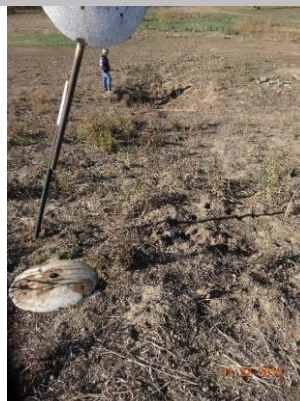
Photo 2 of 3 : UCIP\_SP\_2020\_24825\_44663.jpg

View of waterward slope--burrow activity present.

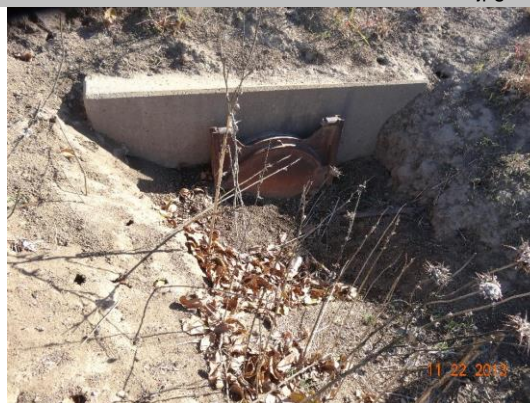
Photo 3 of 3 : UCIP\_SP\_2020\_24825\_44662.jpg

Flap gate located on waterward side--debris blocking gate.

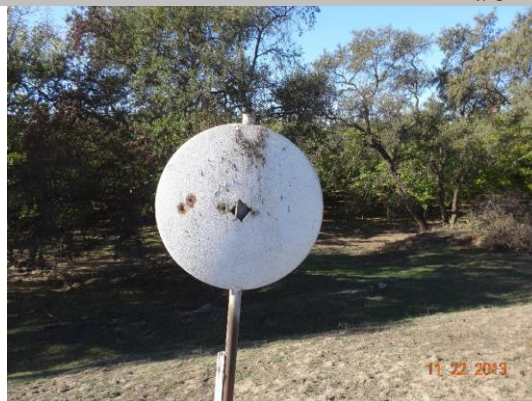
Photo 1 of 3 : UCIP\_SP\_2020\_24826\_44669.jpg

DS\_ID:21286  
FS\_ID:24826  
EP\_NO: N/A  
Repair Type: Non-Urgent  
Crossing Status: Found  
UCIP Comments: 04/30/2013 Deformation observed on the top wall of pipe at the entrance of landward side--need to contact owner to address issue. This crossing is referenced in the USACE Periodic Inspection as item USACE\_CESPK\_HON2\_2013\_p\_0180. (DWR UCIP - O. Magana)  
FIELD\_STRUCT\_DESC: 30-inch corrugated metal gravity drainage pipe through the levee, 21.5 feet below the crown. Corrugated metal cutoff walls around the pipe at each shoulder. Flap gate on the waterside (WS) end. Slide gate on the landside (LS) end. Concrete headwall at each end. [Additional Reference(s): DWR Levee Log, 2005. USACE Sacramento O&M Manual 151, May 1953, (Station 294+84)].  
FS Date: 4/30/2013

View of marker located on waterward shoulder, no reference number is visible.

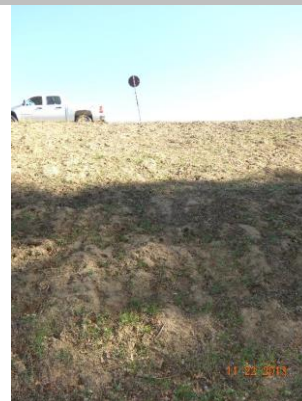
Photo 2 of 3 : UCIP\_SP\_2020\_24826\_44668.jpg

View of waterward slope.

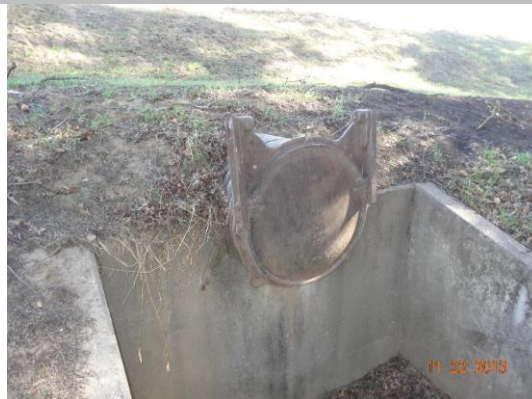
Photo 3 of 3 : UCIP\_SP\_2020\_24826\_44673.jpg

LM Start	3.95	Rating **	M	Issue No.	78 (cont)
LM End	3.95	Issue Type +	Ma	Location *	
Category	Supplemental			GPS Latitude/Longitude	
				Start	End
Item	DWR UCIP LMA Responsibility			39.220374 °	39.220374 °
				-121.610903 °	-121.610903 °
DWR ID	21286

View of flapgate on concrete head wall on waterward side.

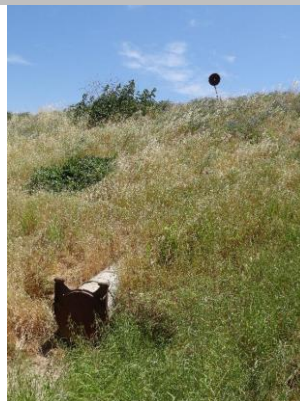
Photo 1 of 3 : UCIP\_SP\_2020\_24751\_44375.jpg

Comment Code						
Inspector Comment						
DS_ID:21288 FS_ID:24751 EP_NO: N/A Repair Type: Non-Urgent Crossing Status: Found UCIP Comments: 04/30/2013 Need to updated photos showing cleared slopes. This crossing is referenced in the USACE Periodic Inspection as item USACE_CESPK_HON2_2013_p_0193. (DWR UCIP - O. Magana) FIELD_STRUCT_DESC: 24-inch corrugated metal gravity drainage pipe through the levee, 19 feet below the crown. Corrugated metal cutoff wall around the pipe at each shoulder. Flap gate on the waterside (WS) end. Slide gate on the landside (LS). Concrete headwall, saddle, and apron on the WS end. [Additional Reference(s): DWR Levee Log, 2005. USACE Sacramento O&M Manual 151, May 1953, (Station 322+25)]. FS Date: 4/30/2013

View of waterward side--dense vegetation on slope.

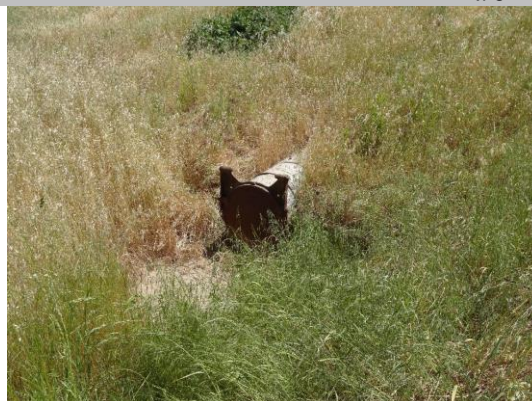
Photo 2 of 3 : UCIP\_SP\_2020\_24751\_44376.jpg

LM Start	4.44	Rating **	M	Issue No.	79 (cont)
LM End	4.44	Issue Type +	Ma	Location *	
Category	Supplemental			GPS Latitude/Longitude	
				Start	End
Item	DWR UCIP LMA Responsibility			39.226938 °	39.226938 °
				-121.613174 °	-121.613174 °
DWR ID	21288

View of flap gate on waterward side.

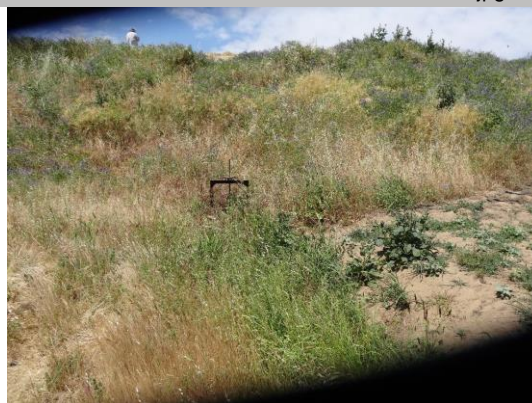
Photo 3 of 3 : UCIP\_SP\_2020\_24751\_44373.jpg

View of landward side--dense vegetation.

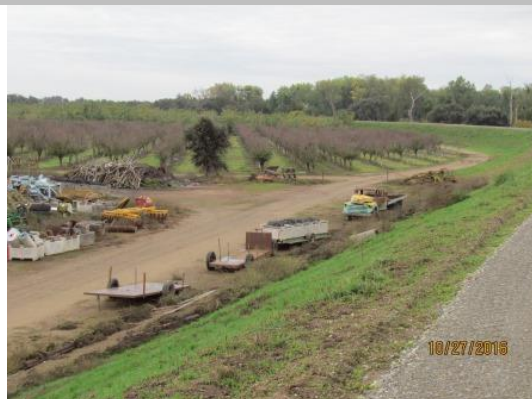
Photo 1 of 1 : SP\_2020\_RD0010\_164\_31\_20200227\_00004.jpg

LM Start	4.44	Rating **	M	Issue No.	31
LM End	4.48	Issue Type +	En	Location *	LS
Category	Earthen Levee			GPS Latitude/Longitude	
				Start	End
Item	Encroachments			39.226946 °	39.227445 °
				-121.613048 °	-121.612718 °
DWR ID	DWR_RD0010_02_f_2015_31				
Comment Code					
EQ : Equipment					
Inspector Comment					
Remove existing equipment from the levee toe.

View of the equipment at the toe of the levee on the landward side of the levee looking downstream.

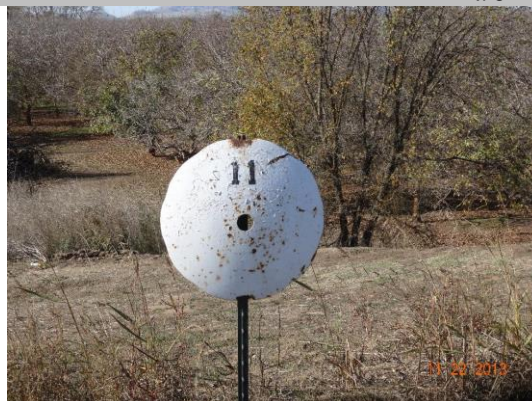
Photo 1 of 3 : UCIP\_SP\_2020\_27774\_51467.jpg

LM Start	4.78	Rating **	M	Issue No.	81
LM End	4.78	Issue Type +	En	Location *	
Category	Supplemental			GPS Latitude/Longitude	
				Start	End
Item	DWR UCIP Field Study			39.231251 °	39.231251 °
				-121.614494 °	-121.614494 °
DWR ID	21289				
Comment Code					
Inspector Comment					
DS_ID:21289 FS_ID:27774 EP_NO: N/A Repair Type: Non-Urgent Crossing Status: Indicator Found UCIP Comments: 04/30/2013 Sediment build-up inside and at the opening pipe. This crossing is referenced in the USACE Periodic Inspection as item USACE_CESPK_HON2_2013_p_0206. (DWR UCIP - O. Magana) FIELD_STRUCT_DESC: 30-inch gravity drainage pipe of an unknown material through the levee, 20 feet below the crown. Flap gate on the waterside (WS) end. Slide gate on the landside (LS) end. [Additional Reference(s): DWR Levee Log, 2005]. FS Date: 4/30/2013

Marker visible on waterward shoulder, Reference ID No. 11 for crossing.

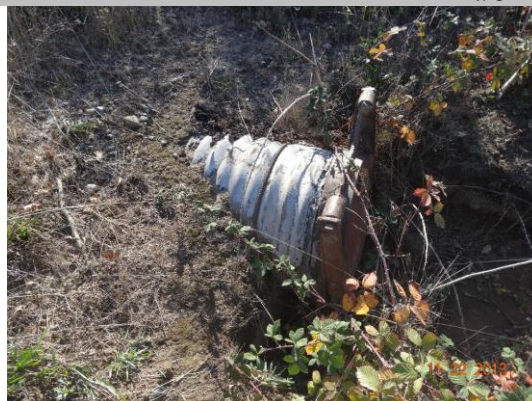
Photo 3 of 3 : UCIP\_SP\_2020\_27774\_51469.jpg

LM Start	<b>4.78</b>	Rating **	M	Issue No.	<b>81 (cont)</b>
LM End	<b>4.78</b>	Issue Type +	En	Location *	
Category	Supplemental		GPS Latitude/Longitude		
			Start	End	
Item	DWR UCIP Field Study		39.231251 °	39.231251 °	
			-121.614494 °	-121.614494 °	
DWR ID	21289

View of flap gate located on waterward side.

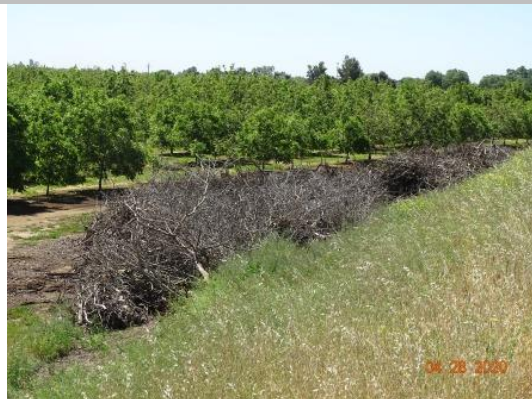
Photo 1 of 1 : SP\_2020\_RD0010\_164\_63\_20200429\_00104.jpg

LM Start	4.88	Rating **	U	Issue No.	63
LM End	4.92	Issue Type +	En	Location *	LS
Category	Earthen Levee			GPS Latitude/Longitude	
				Start	End
Item	Encroachments			39.232773 °	39.233336 °
				-121.614588 °	-121.614659 °
DWR ID	DWR_RD0010_02_s_2020_63				
Comment Code					
PR : Prunings					
Inspector Comment					
Remove prunings from levee toe and slope, Spring 2020.

View looking downstream landside at prunings on levee toe and slope, Spring 2020.

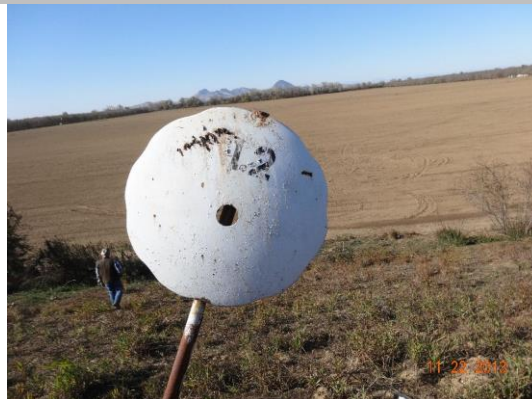
Photo 1 of 3 : UCIP\_SP\_2020\_24828\_44680.jpg

DS\_ID:21290  
FS\_ID:24828  
EP\_NO: N/A  
Repair Type: No Action Needed  
Crossing Status: Found  
UCIP Comments: 04/30/2013 This crossing is referenced in the USACE Periodic Inspection as item USACE\_CESPK\_HON2\_2013\_p\_0212. (DWR UCIP - O. Magana)  
FIELD\_STRUCT\_DESC: 30-inch corrugated metal gravity drainage pipe through the levee, 20 feet below the crown. Corrugated metal cutoff wall around the pipe at each shoulder. Flap gate on the waterside (WS) end. Slide gate on the landside (LS). Concrete headwall, saddle, and apron on the WS end. Pipe discharges into a 5-foot by 5-foot concrete distribution box at the WS toe. [Additional Reference(s): DWR Levee Log, 2005. USACE Sacramento O&M Manual 151, May 1953, (Station 354+96)].  
FS Date: 4/30/2013

View of marker located on waterward shoulder--crossing referenced as No. 12.

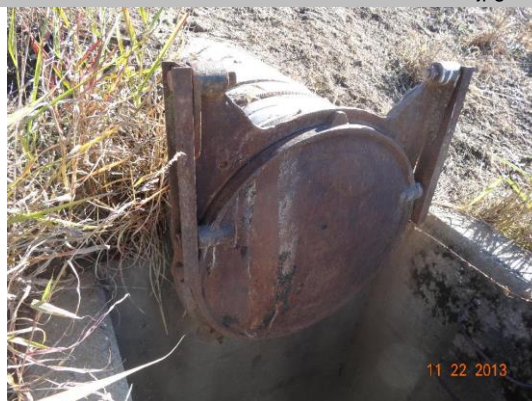
Photo 2 of 3 : UCIP\_SP\_2020\_24828\_44684.jpg

View of flap gate located on waterward side.

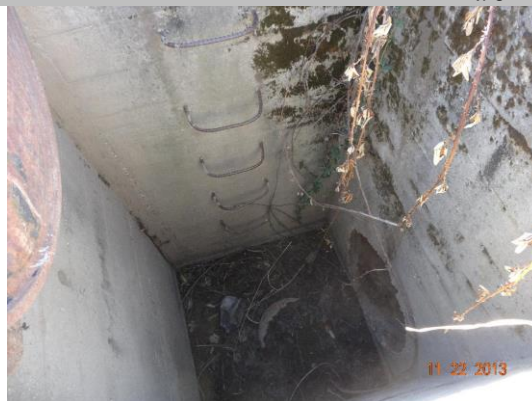
Photo 3 of 3 : UCIP\_SP\_2020\_24828\_44683.jpg

LM Start	5.04	Rating **	A/W	Issue No.	82 (cont)
LM End	5.04	Issue Type +	Ma	Location *	
Category	Supplemental			GPS Latitude/Longitude	
				Start	End
Item	DWR UCIP LMA Responsibility			39.235082 °	39.235082 °
				-121.614925 °	-121.614925 °
DWR ID	21290

Inside view of concrete distribution box.

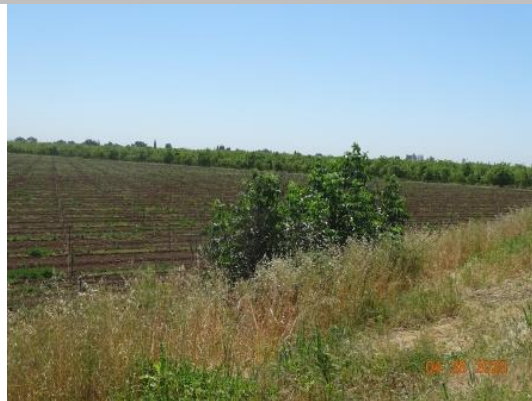
Photo 1 of 1 : SP\_2020\_RD0010\_164\_62\_20200429\_00103.jpg

LM Start	5.18	Rating **	M	Issue No.	62
LM End	5.18	Issue Type +	Ma	Location *	LS
Category	Earthen Levee			GPS Latitude/Longitude	
				Start	End
Item	Trim / Thin Trees			39.237106 °	39.237106 °
				-121.615358 °	-121.615358 °
DWR ID	DWR_RD0010_02_s_2020_62				
Comment Code					
T3 : Trim and thin trees to allow visibility of the ground and room to flood fight.					
Inspector Comment					
Trees with less than 4" diameter at chest height should be removed, Spring 2020.

View looking downstream landside at small starter tree on levee slope, Spring 2020.

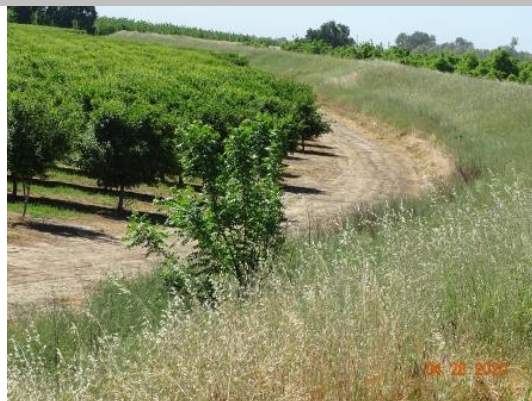
Photo 1 of 1 : SP\_2020\_RD0010\_164\_61\_20200429\_00102.jpg

LM Start	6.08	Rating **	M	Issue No.	61
LM End	6.08	Issue Type +	Ma	Location *	LS
Category	Earthen Levee			GPS Latitude/Longitude	
				Start	End
Item	Trim / Thin Trees			39.249441 °	39.249441 °
				-121.619291 °	-121.619291 °
DWR ID	DWR_RD0010_02_s _ 2020_61				
Comment Code					
T3 : Trim and thin trees to allow visibility of the ground and room to flood fight.					
Inspector Comment					
Trees with less than 4" diameter at chest height should be removed, Spring 2020.

View looking downstream landside at small starter tree on levee slope, Spring 2020.

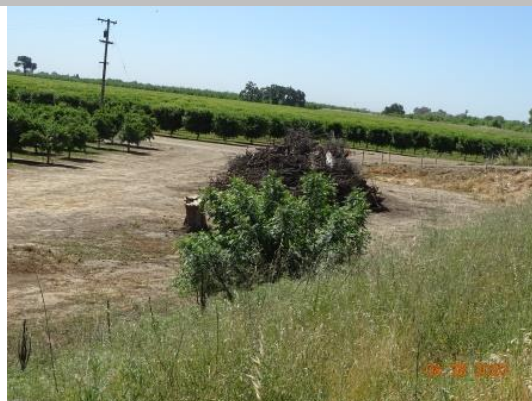
Photo 1 of 1 : SP\_2020\_RD0010\_164\_60\_20200429\_00101.jpg

LM Start	6.15	Rating **	M	Issue No.	60
LM End	6.15	Issue Type +	Ma	Location *	LS
Category	Earthen Levee			GPS Latitude/Longitude	
				Start	End
Item	Trim / Thin Trees			39.250463 °	39.250463 °
				-121.619194 °	-121.619194 °
DWR ID	DWR_RD00010_02_s _ 2020_60				
Comment Code					
T3 : Trim and thin trees to allow visibility of the ground and room to flood fight.					
Inspector Comment					
Trees with less than 4" diameter at chest height should be removed, Spring 2020.

View looking downstream landside at small starter tree on levee slope, Spring 2020.

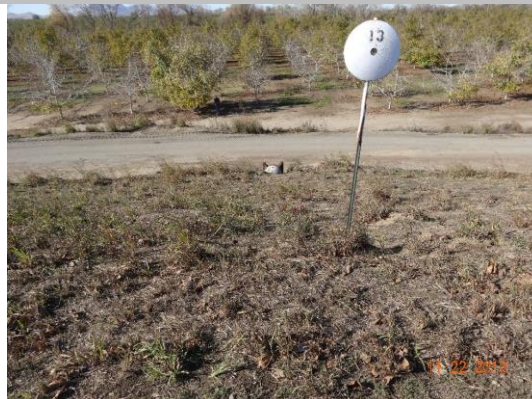
Photo 1 of 3 : UCIP\_SP\_2020\_27793\_51514.jpg

Comment Code						
Inspector Comment						
DS_ID:21291						
FS_ID:27793						
EP_NO: N/A						
Repair Type: Non-Urgent						
Crossing Status: Found						
UCIP Comments: 04/30/2013 Need to contact owner to remove debris inside concrete distribution box and on slope. This crossing is referenced in the USACE Periodic Inspection as item USACE_CESPK_HON2_2013_p_0244. (DWR UCIP - O. Magana)						
FIELD_STRUCT_DESC: 30-inch corrugated metal gravity drainage pipe through the levee, 17.3 feet below the crown. Corrugated metal cutoff wall around the pipe at each shoulder. Flap gate on the waterside (WS) end. Slide gate on the landside (LS) end. Concrete headwall at each end. [Additional Reference(s): DWR Levee Log, 2005. USACE Sacramento O&M Manual 151, May 1953, (Station 413+81)].						
FS Date: 4/30/2013

View of marker located on waterward shoulder, pipe is reference as No. 13.

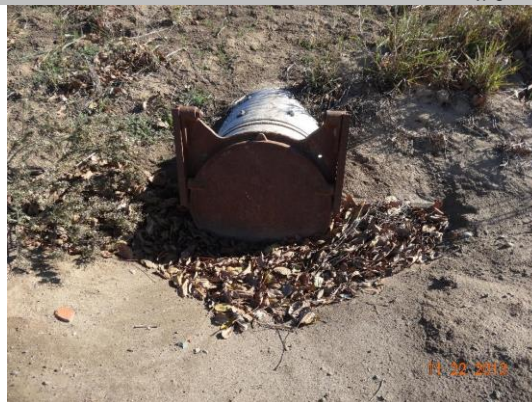
Photo 2 of 3 : UCIP\_SP\_2020\_27793\_51517.jpg

View of flap gate located on waterward side.

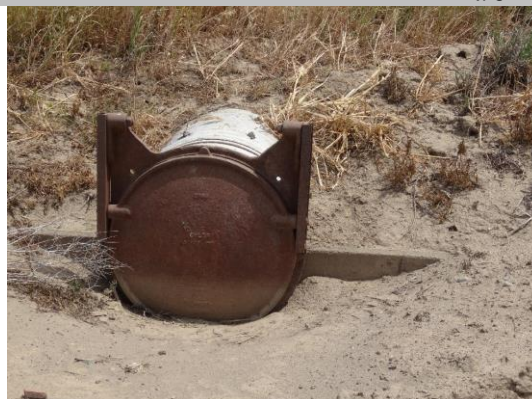
Photo 3 of 3 : UCIP\_SP\_2020\_27793\_51513.jpg

LM Start	<b>6.16</b>	Rating **	M	Issue No.	<b>83 (cont)</b>
LM End	<b>6.16</b>	Issue Type +	Ma	Location *	
Category	Supplemental		GPS Latitude/Longitude		
			Start	End	
Item	DWR UCIP LMA Responsibility		39.250593 °	39.250593 °	
			-121.619178 °	-121.619178 °	
DWR ID	21291

Flap gate and concrete headwall visible on waterward side.

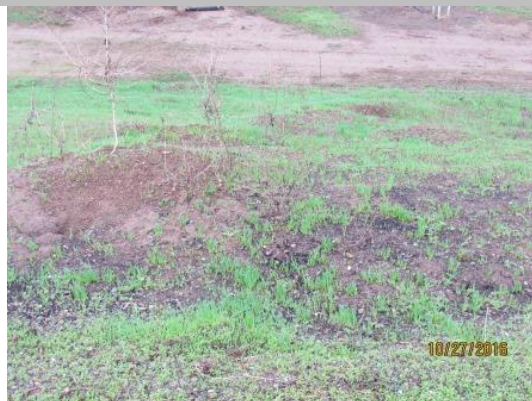
Photo 1 of 1 : SP\_2020\_RD0010\_164\_32\_20200227\_00005.jpg

LM Start	6.72	Rating **	M	Issue No.	32
LM End	6.72	Issue Type +	Ma	Location *	WS
Category	Earthen Levee			GPS Latitude/Longitude	
				Start	End
Item	Animal Control			39.257859 °	39.257859 °
				-121.617667 °	-121.617667 °
DWR ID	DWR_RD0010_02_f_2015_32				
Comment Code					
A3 : No rodents visible, but rodent burrows visible; need to backfill and compact or grout burrows.					
Inspector Comment					
No rodent activity but holes need to be properly backfilled.

View of rodent holes on waterside levee slope.

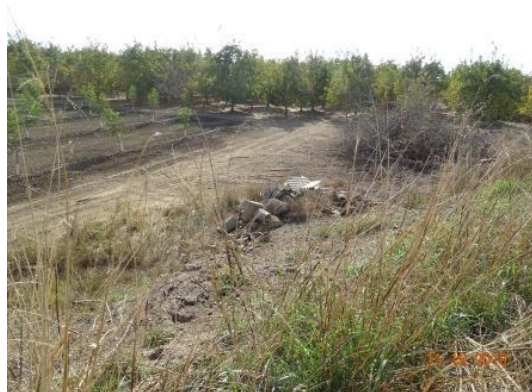
Photo 1 of 1 : SP\_2020\_RD0010\_164\_53\_20200227\_00014.jpg

LM Start	7.07	Rating **	M	Issue No.	53
LM End	7.07	Issue Type +	En	Location *	LS
Category	Earthen Levee			GPS Latitude/Longitude	
				Start	End
Item	Encroachments			39.262290 °	39.262290 °
				-121.614390 °	-121.614390 °
DWR ID	DWR_RD0010_02_s_2016_53				
Comment Code					
DE : Debris					
Inspector Comment					
Remove debris and prunings from the levee toe, Spring 2020.

View looking downstream of debris at landside levee toe.

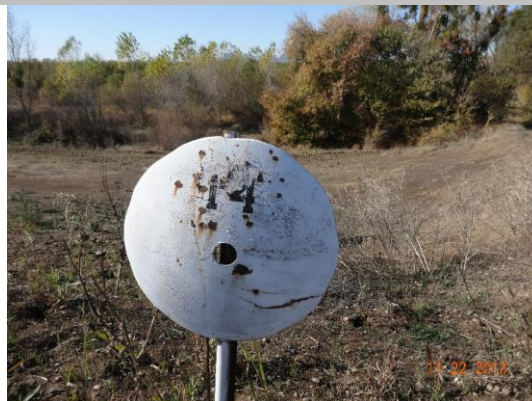
Photo 1 of 3 : UCIP\_SP\_2020\_50059\_44693.jpg

Comment Code					
Inspector Comment					
DS_ID:21293 FS_ID:50059 EP_NO: N/A Repair Type: Non-Urgent Crossing Status: Indicator Found UCIP Comments: 7/01/2016 Crossing is blocked by sediment and debris on both WS and LS. Screw gate is missing on LS. (DWR UCIP - omagana)4/30/2013 Both openings of crossing are blocked by sediment--screw gate is damage. Recommend notifying owner to repair screw gate and remove sediment build-up blocking openings. This crossing is referenced in the USACE Periodic Inspection as item USACE_CESPK_HON2_2013_p_0295. (DWR UCIP - omagana) FIELD_STRUCT_DESC: 24-inch corrugated metal gravity drainage pipe through the levee, 13 feet below the crown. Corrugated metal cutoff wall around the pipe at each shoulder. Flap gate on the waterside (WS) end. Slide gate on the landside (LS). Concrete headwall, saddle, and apron on the WS end. [Additional Reference(s): DWR Levee Log, 2005. USACE Sacramento O&M Manual 151, May 1953, (Station 471+21)]. FS Date: 7/1/2016

Marker visible on WS shoulder, crossing referenced as No. 14.

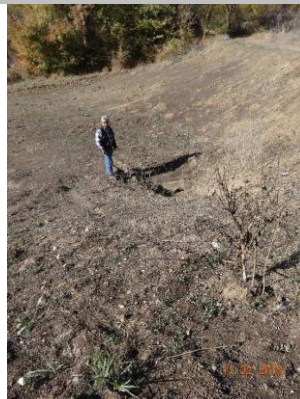
Photo 2 of 3 : UCIP\_SP\_2020\_50059\_44692.jpg

LM Start	<b>7.24</b>	Rating **	M	Issue No.	<b>84 (cont)</b>
LM End	<b>7.24</b>	Issue Type +	En	Location *	
Category	Supplemental		GPS Latitude/Longitude		
			Start	End	
Item	DWR UCIP Field Study		39.264639 °	39.264639 °	
			-121.613745 °	-121.613745 °	
DWR ID	21293

View of WS slope.

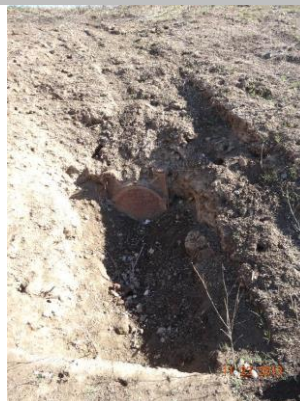
Photo 3 of 3 : UCIP\_SP\_2020\_50059\_44697.jpg

LM Start	<b>7.24</b>	Rating **	M	Issue No.	<b>84 (cont)</b>
LM End	<b>7.24</b>	Issue Type +	En	Location *

View of flap gate and concrete distribution box on WS.

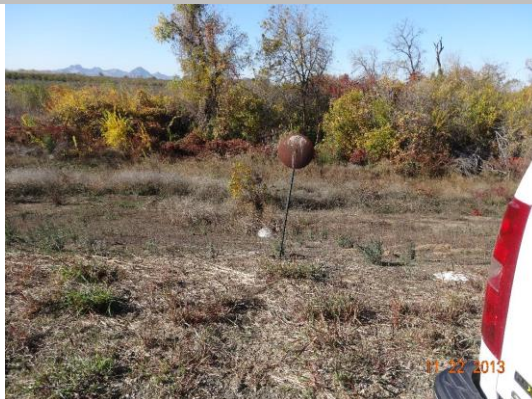
Photo 1 of 3 : UCIP\_SP\_2020\_24831\_44700.jpg

Comment Code						
Inspector Comment						
DS_ID:21294						
FS_ID:24831						
EP_NO: N/A						
Repair Type: No Action Needed						
Crossing Status: Found						
UCIP Comments: 04/30/2013 This crossing is referenced in the						
USACE Periodic Inspection as item						
USACE_CESPK_HON2_2013_p_0312. (DWR UCIP - O. Magana)						
FIELD_STRUCT_DESC: 24-inch corrugated metal gravity drainage						
pipe through the levee, 13 feet below the crown. Corrugated metal						
cutoff wall around the pipe at each shoulder. Flap gate on the waterside						
(WS) end. Slide gate on the landside (LS) end. Concrete headwall at						
each end. Metal marker on the LS shoulder. [Additional Reference(s):						
DWR Levee Log, 2005. USACE Sacramento O&M Manual 151, May						
1953, (Station 493+50)].						
FS Date: 4/30/2013

Visible marker located on waterward shoulder--no id number noted.

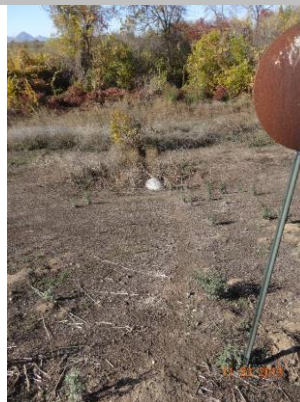
Photo 2 of 3 : UCIP\_SP\_2020\_24831\_44699.jpg

View of waterward slope.

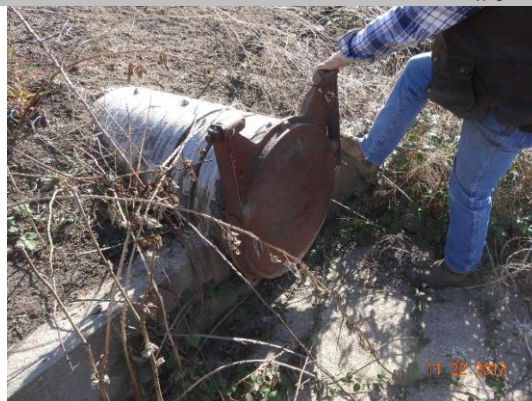
Photo 3 of 3 : UCIP\_SP\_2020\_24831\_44698.jpg

Flap gate visible on waterward side.

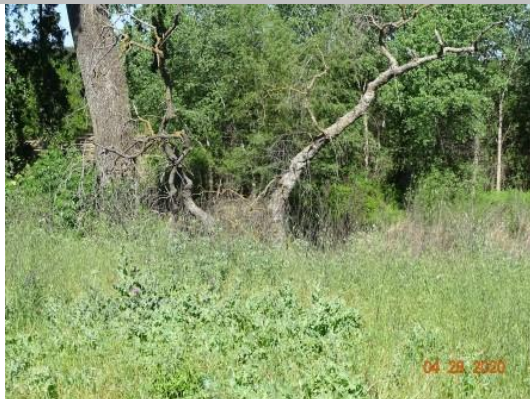
Photo 1 of 1 : SP\_2020\_RD0010\_164\_52\_20200429\_00099.jpg

LM Start	7.91	Rating **	M	Issue No.	52
LM End	7.91	Issue Type +	Ma	Location *	WS
Category	Earthen Levee			GPS Latitude/Longitude	
				Start	End
Item	Encroachments			39.273011 °	39.273011 °
				-121.613011 °	-121.613011 °
DWR ID	DWR_RD0010_02_s_2020_52				
Comment Code					
TR : Tree or limb					
Inspector Comment					
Remove downed tree from levee slope, Spring 2020.

View looking waterside at a downed tree on the levee slope, Spring 2020.

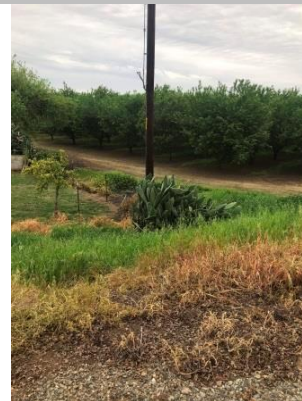
Photo 1 of 1 : SP\_2020\_RD0010\_164\_41\_20200227\_00010.jpg

LM Start	8.02	Rating **	M	Issue No.	41
LM End	8.02	Issue Type +	En	Location *	LS
Category	Earthen Levee			GPS Latitude/Longitude	
				Start	End
Item	Vegetation			39.274334 °	39.274334 °
				-121.611986 °	-121.611986 °
DWR ID	DWR_RD0010_02_s_2018_41				
Comment Code					
V6 : Landscaping					
Inspector Comment					
Remove landscape from the levee toe.

View looking downstream landside of a landscape bush at the levee toe.

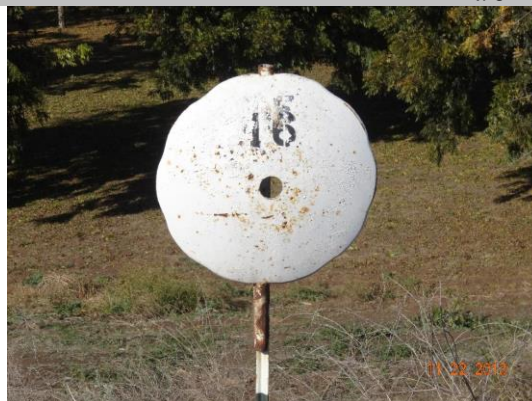
Photo 1 of 3 : UCIP\_SP\_2020\_24832\_44705.jpg

Marker visible on waterward shoulder, crossing is referenced as No. 16.

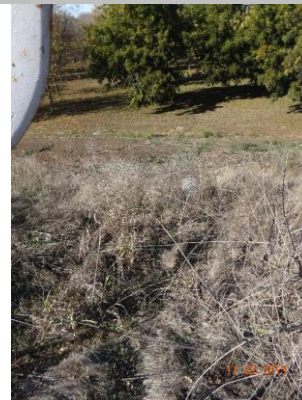
Photo 2 of 3 : UCIP\_SP\_2020\_24832\_44704.jpg

View of waterward side.

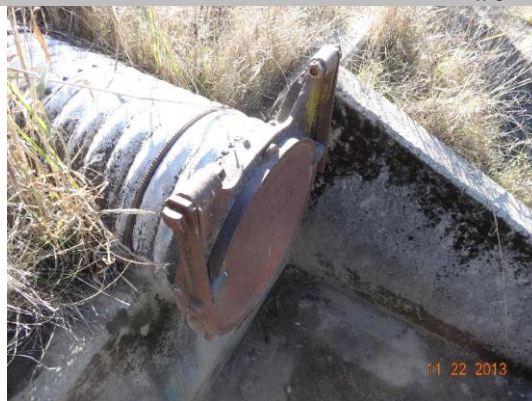
Photo 3 of 3 : UCIP\_SP\_2020\_24832\_44703.jpg

View of flap gate located on waterward side.

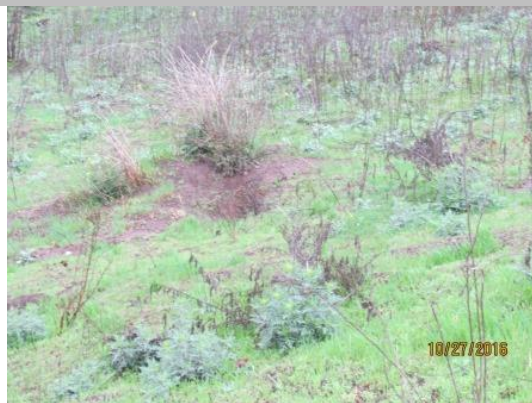
Photo 1 of 1 : SP\_2020\_RD0010\_164\_35\_20200227\_00007.jpg

LM Start	8.09	Rating **	M	Issue No.	35
LM End	8.09	Issue Type +	Ma	Location *	WS
Category	Earthen Levee			GPS Latitude/Longitude	
				Start	End
Item	Animal Control			39.275179 °	39.275179 °
				-121.611283 °	-121.611283 °
DWR ID	DWR_RD0010_02_f_2015_35				
Comment Code					
A3 : No rodents visible, but rodent burrows visible; need to backfill and compact or grout burrows.					
Inspector Comment					
No rodent activity but holes need to be backfilled.

View of rodent hole on waterside.

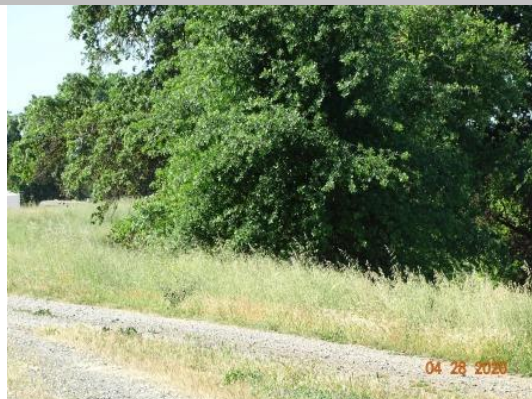
Photo 1 of 1 : SP\_2020\_RD0010\_164\_37\_20200429\_00097.jpg

LM Start	8.20	Rating **	M	Issue No.	37
LM End	8.20	Issue Type +	Ma	Location *	WS
Category	Earthen Levee			GPS Latitude/Longitude	
				Start	End
Item	Trim / Thin Trees			39.276607 °	39.276607 °
				-121.610626 °	-121.610626 °
DWR ID	DWR_RD0010_02_s_2020_37				
Comment Code					
T2 : Thin trees to allow visibility of the ground and room to flood fight.					
Inspector Comment					
Trim low hanging limbs for access and visibility, Spring 2020.

View looking downstream waterside at a tree with low hanging limbs, Spring 2020.

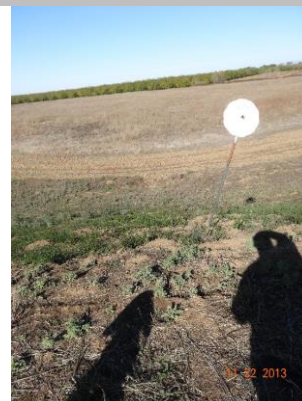
Photo 1 of 3 : UCIP\_SP\_2020\_27775\_51473.jpg

Comment Code					
Inspector Comment					
DS_ID:21296 FS_ID:27775 EP_NO: N/A Repair Type: Non-Urgent Crossing Status: Found UCIP Comments: 04/30/2013 Sediment build-up at the inlet--recommend clearing sediment. This crossing is referenced in the USACE Periodic Inspection as item USACE_CESPK_HON2_2013_p_0348. (DWR UCIP - O. Magana) FIELD_STRUCT_DESC: 30-inch corrugated metal gravity drainage pipe through the levee, 23 feet below the crown. Corrugated metal cutoff wall around the pipe at each shoulder. Flap gate on the waterside (WS) end. Slide gate on the landside (LS) end. Concrete headwall at each end. Metal marker on the WS shoulder. [Additional Reference(s): DWR Levee Log, 2005. USACE Sacramento O&M Manual 151, May 1953, (Station 551+96)]. FS Date: 4/30/2013

View of waterward side.

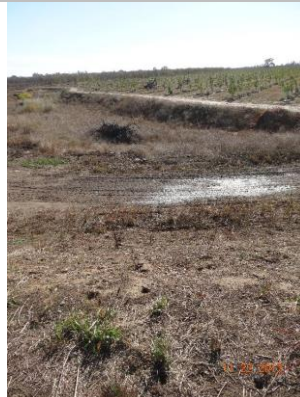
Photo 2 of 3 : UCIP\_SP\_2020\_27775\_51472.jpg

View of landward side.

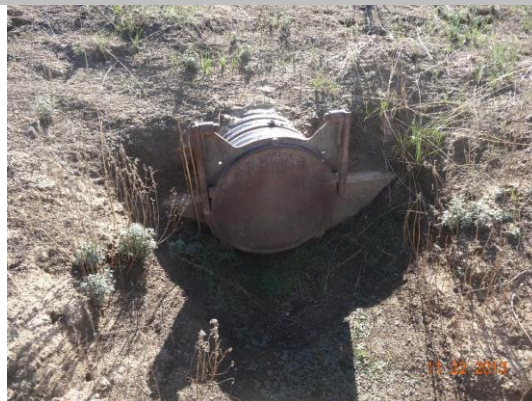
Photo 3 of 3 : UCIP\_SP\_2020\_27775\_51477.jpg

View of flap gate visible on waterward side.
