**Flood Control Project Maintenance  
Levee Inspections**  
**LMA District Cover Sheet**  
**Spring 2020 Levee Inspection Results**

**Reclamation District No. 0010 Honcut**

**Spring 2020 Levee Inspection Results**

Waterway			Bank	Unit Miles
Unit No. 01 Simmerly Slough			Right	7.65
	Spring (March - May)	Summer (June - August)	(September - November) Fall	Winter (December - February)
Unit Maintenance Rating (Fall Only)				
Date of Inspection	4/28/2020 - 4/28/2020			
DWR Inspector	Sterling York			
Accompanied By	Finlay Williams

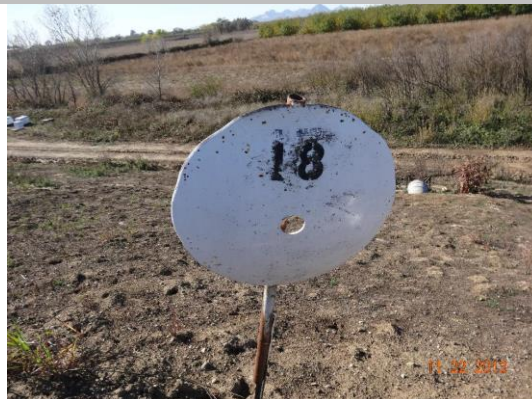
Photo 1 of 3 : UCIP\_SP\_2020\_24834\_44715.jpg

DS\_ID:21297  
FS\_ID:24834  
EP\_NO: N/A  
Repair Type: Non-Urgent  
Crossing Status: Found  
UCIP Comments: 04/30/2013 Slide gate missing on landward side. Need to contact owner to determine status of crossing. This crossing is referenced in the USACE Periodic Inspection as item USACE\_CESPK\_HON2\_2013\_p\_0367. (DWR UCIP - O. Magana)  
FIELD\_STRUCT\_DESC: 24-inch corrugated metal gravity drainage pipe through the levee, 14 feet below the crown. Corrugated metal cutoff wall around the pipe at each shoulder. Flap gate on the waterside (WS) end. Slide gate on the landside (LS), slide gate missing. Concrete headwall, saddle, and apron on the WS end. 6-foot by 6-foot concrete splash apron at the WS toe. [Additional Reference(s): DWR Levee Log, 2005. USACE Sacramento O&M Manual 151, May 1953, (Station 565+74)].  
FS Date: 4/30/2013

Marker visible on waterward shoulder, crossing is referenced as No. 18.

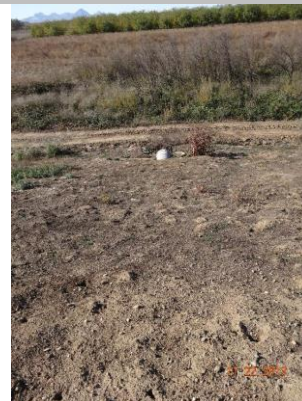
Photo 2 of 3 : UCIP\_SP\_2020\_24834\_44714.jpg

View of waterward side.

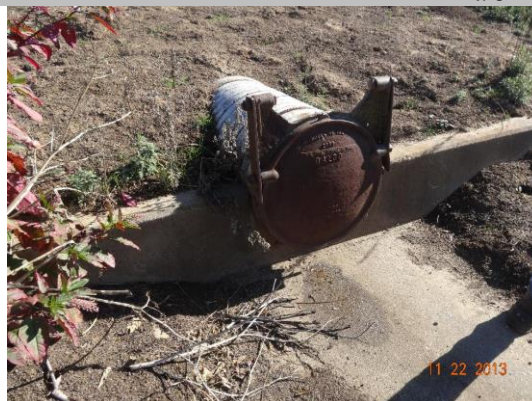
Photo 3 of 3 : UCIP\_SP\_2020\_24834\_44716.jpg

View of flap gate visible on waterward side.

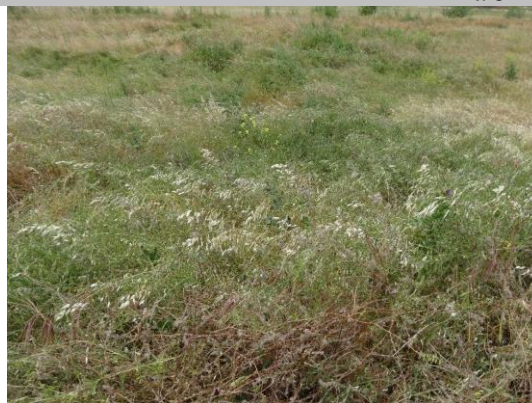
Photo 1 of 3 : UCIP\_SP\_2020\_24768\_44450.jpg

DS\_ID:21298  
 FS\_ID:24768  
 EP\_NO: N/A  
 Repair Type: Non-Urgent  
 Crossing Status: Found  
 UCIP Comments: 04/30/2013 Crossing is buried--found indicators of concrete headwall. Need to contact owner to determine status of crossing. This crossing is referenced in the USACE Periodic Inspection as item USACE\_CESPK\_HON2\_2013\_p\_0378. (DWR UCIP - O. Magana)  
 FIELD\_STRUCT\_DESC: 24-inch corrugated metal gravity drainage pipe through the levee, 13 feet below the crown. Corrugated metal cutoff wall around the pipe at each shoulder. Flap gate on the waterside (WS) end. Slide gate on the landside (LS) end. Concrete headwall at each end. Metal marker on the WS slope. [Additional Reference(s): DWR Levee Log, 2005. USACE Sacramento O&M Manual 151, May 1953, (Station 576+75)].  
 FS Date: 4/30/2013

View of waterward slope.

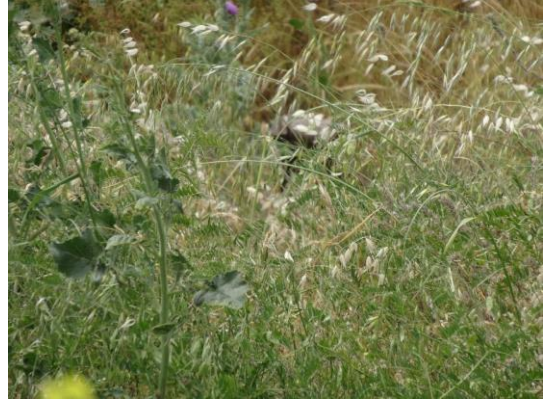
Photo 2 of 3 : UCIP\_SP\_2020\_24768\_44451.jpg

Dense vegetation on landward side.

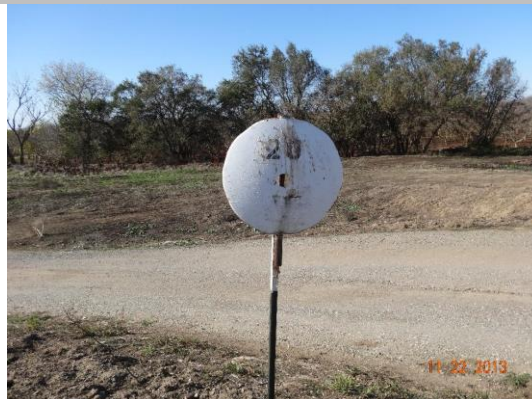
Photo 1 of 3 : UCIP\_SP\_2020\_24769\_44454.jpg

DS\_ID:21299  
FS\_ID:24769  
EP\_NO: N/A  
Repair Type: Non-Urgent  
Crossing Status: Found  
UCIP Comments: 04/30/2013 Need to contact owner. Need to clear debris from concrete distribution box on waterward and remove debris blocking landward side. This crossing is referenced in the USACE Periodic Inspection as item USACE\_CESPK\_HON2\_2013\_p\_0383. (DWR UCIP - O. Magana)  
FIELD\_STRUCT\_DESC: 24-inch corrugated metal gravity drainage pipe through the levee, 12 feet below the crown. Corrugated metal cutoff wall around the pipe at each shoulder. Flap gate on the waterside (WS) end. Slide gate on the landside (LS). Concrete headwall, saddle, and apron on the WS end. Metal marker on the WS shoulder.  
[Additional Reference(s): DWR Levee Log, 2005. USACE Sacramento O&M Manual 151, May 1953, (Station 582+72)].  
FS Date: 4/30/2013

Marker visible on waterward side shoulder, crossing is referenced as No. 20.

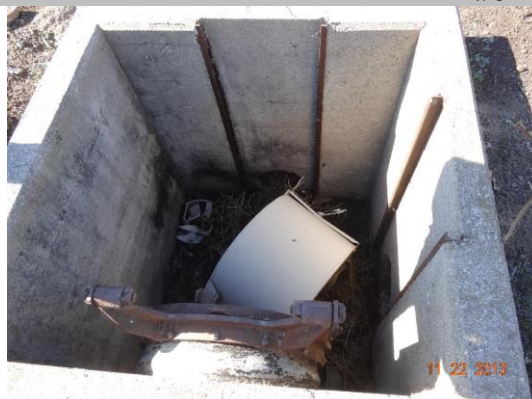
Photo 3 of 3 : UCIP\_SP\_2020\_24769\_44452.jpg

View of concrete distribution box located on waterward side.

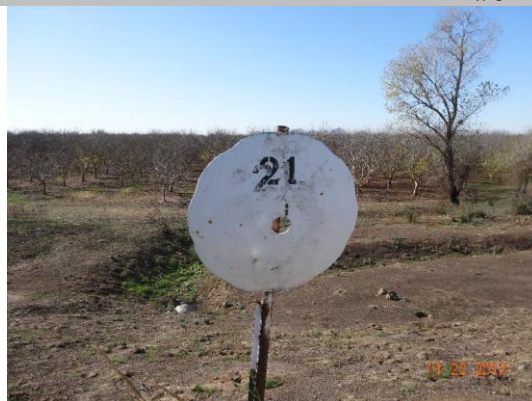
Photo 1 of 3 : UCIP\_SP\_2020\_24835\_44721.jpg

Marker visible on waterward shoulder, crossing referenced as No. 21.

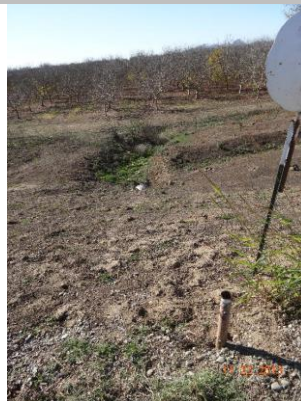
Photo 2 of 3 : UCIP\_SP\_2020\_24835\_44720.jpg

View of waterward side.

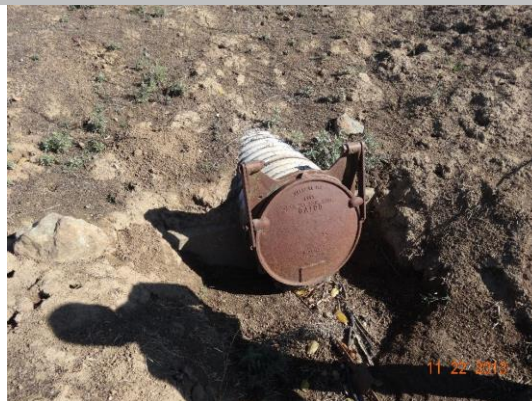
Photo 3 of 3 : UCIP\_SP\_2020\_24835\_44725.jpg

View of flap gate located on waterward side.

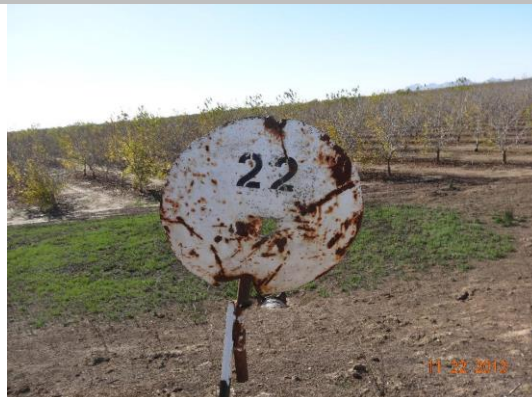
Photo 1 of 3 : UCIP\_SP\_2020\_27776\_51478.jpg

LM Start	9.71	Rating **	M	Issue No.	92	
LM End	9.71	Issue Type +	En	Location *		
Category	Supplemental			GPS Latitude/Longitude		
				Start		End
Item	DWR UCIP Field Study			39.291474 °	39.291474 °	
				-121.603677 °	-121.603677 °	
DWR ID	21301					
Comment Code						
Inspector Comment						
DS_ID:21301 FS_ID:27776 EP_NO: N/A Repair Type: Non-Urgent Crossing Status: Found UCIP Comments: 04/30/2013 Recommend removing debris blocking slide gate on landward side. This crossing is referenced in the USACE Periodic Inspection as item USACE_CESPK_HON2_2013_p_0402. (DWR UCIP - O. Magana) FIELD_STRUCT_DESC: 24-inch gravity drainage pipe of an unknown material through the levee, 13 feet below the crown. Flap gate on the waterside (WS) end. Slide gate on the landside (LS) end. Concrete headwall at the LS toe. [Additional Reference(s): DWR Levee Log, 2005]. FS Date: 4/30/2013

Marker visible on waterward shoulder, crossing referenced as No. 22.

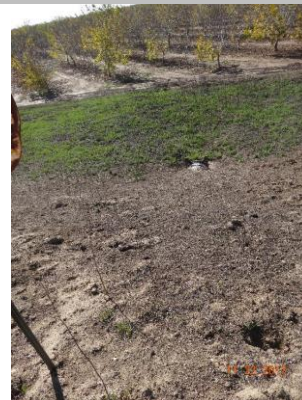
Photo 2 of 3 : UCIP\_SP\_2020\_27776\_51482.jpg

View of waterward side.

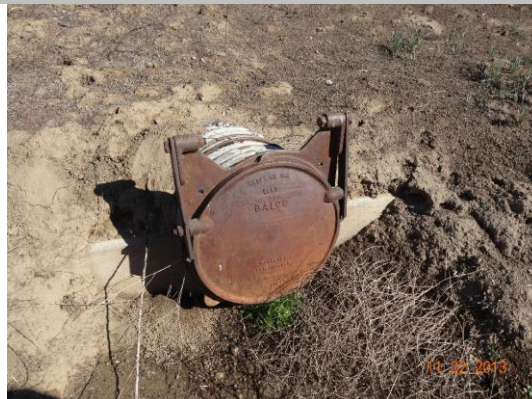
Photo 3 of 3 : UCIP\_SP\_2020\_27776\_51481.jpg

View of flap gate located on waterward toe.

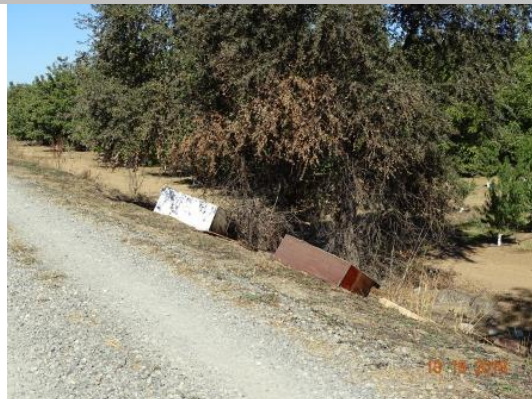
Photo 1 of 1 : SP\_2020\_RD0010\_164\_45\_20200227\_00011.jpg

LM Start	9.94	Rating **	M	Issue No.	45
LM End	9.94	Issue Type +	En	Location *	LS
Category	Earthen Levee			GPS Latitude/Longitude	
				Start	End
Item	Encroachments			39.293608 °	39.293608 °
				-121.606922 °	-121.606922 °
DWR ID	DWR_RD0010_02_f _ 2018_45				
Comment Code					
DE : Debris					
Inspector Comment					
Remove debris from the levee slope.

View looking at the landside levee slope where debris has been dumped.

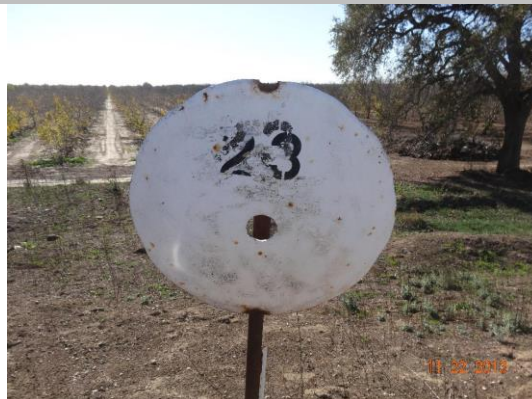
Photo 1 of 3 : UCIP\_SP\_2020\_24837\_44731.jpg

Marker visible on waterward shoulder, crossing is referenced as No. 23.

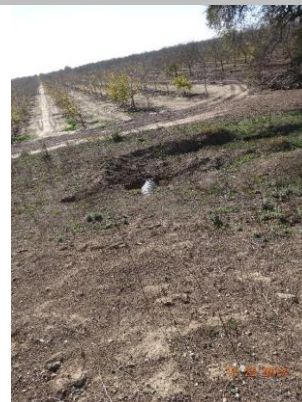
Photo 2 of 3 : UCIP\_SP\_2020\_24837\_44735.jpg

Overview of waterward side.

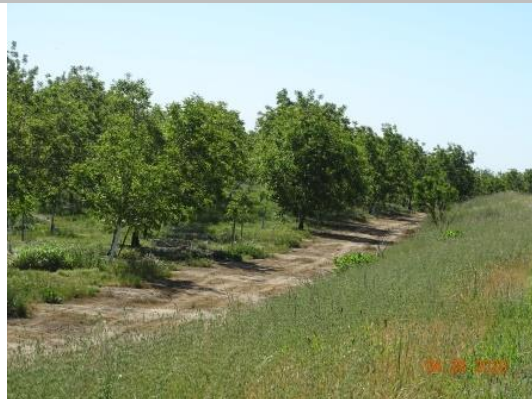
Photo 1 of 1 : SP\_2020\_RD0010\_164\_46\_20200429\_00095.jpg

LM Start	10.36	Rating **	M	Issue No.	46
LM End	10.36	Issue Type +	Ma	Location *	LS
Category	Earthen Levee			GPS Latitude/Longitude	
				Start	End
Item	Trim / Thin Trees			39.297507 °	39.297507 °
				-121.612875 °	-121.612875 °
DWR ID	DWR_RD0010_02_s_2020_46				
Comment Code					
T3 : Trim and thin trees to allow visibility of the ground and room to flood fight.					
Inspector Comment					
Trees with less than 4" diameter at chest height should be removed, Spring 2020.

View looking downstream landside at small starter tree on levee slope, Spring 2020.

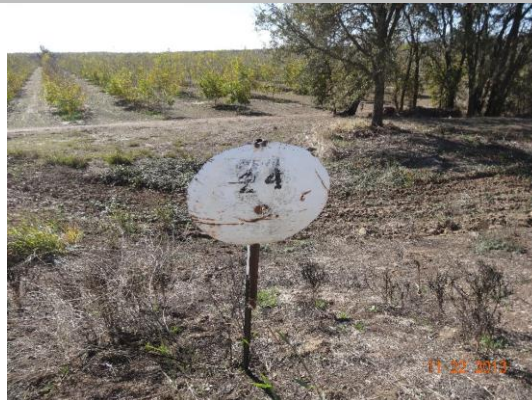
Photo 1 of 3 : UCIP\_SP\_2020\_24838\_44737.jpg

Comment Code						
Inspector Comment						
DS_ID:21303 FS_ID:24838 EP_NO: 1069 Repair Type: Non-Urgent Crossing Status: Found UCIP Comments: 04/30/2013 Unable to find the crossing on landward side--indicators found of crossing. Need to coordinate with owner to determine status of crossing. If crossing is no longer in use owner will need to contact the CVFPB to comply with Title 23. This crossing is referenced in the USACE Periodic Inspection as item USACE_CESPK_HON2_2013_p_0442. (DWR UCIP - O. Magana) FIELD_STRUCT_DESC: 24-inch steel gravity irrigation pipe through the levee, 13 feet below the crown. Concrete cutoff wall around the pipe at each shoulder. Flap gate and concrete headwall on the waterside (WS) end. Slide gate, concrete saddle, and apron on the landside (LS) end. (Plans for installation of a 24-inch corrugated iron pipe through the levee authorized under Permit No. 1069, 1946 - Pacific Ranch, care of Chas. J. Mathews). [Additional Reference(s): DWR Levee Log, 2005. USACE Sacramento O&M Manual 151, May 1953, (Station 638+00)]. FS Date: 4/30/2013

Marker visible on waterward shoulder, this crossing is reference as No. 24.

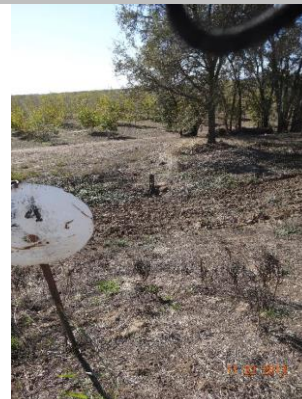
Photo 2 of 3 : UCIP\_SP\_2020\_24838\_44741.jpg

View of waterward side.

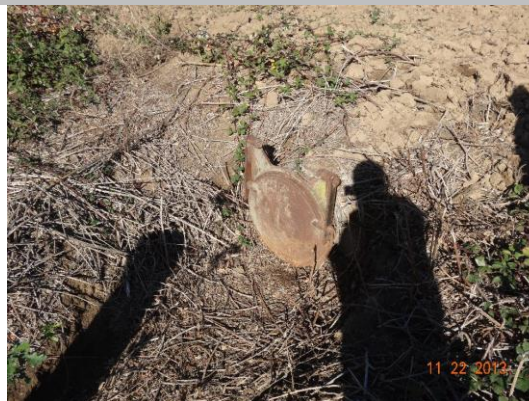
Photo 3 of 3 : UCIP\_SP\_2020\_24838\_44740.jpg

View of flap gate located on waterward side.

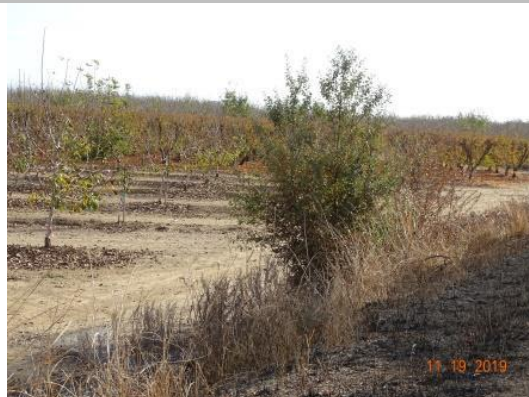
Photo 1 of 1 : SP\_2020\_RD0010\_164\_56\_20200227\_00016.jpg

LM Start	10.53	Rating **	M	Issue No.	56
LM End	10.53	Issue Type +	Ma	Location *	LS
Category	Earthen Levee			GPS Latitude/Longitude	
				Start	End
Item	Trim / Thin Trees			39.299244 °	39.299244 °
				-121.615166 °	-121.615166 °
DWR ID	DWR_RD0010_02_f_2019_56				
Comment Code					
T3 : Trim and thin trees to allow visibility of the ground and room to flood fight.					
Inspector Comment					
Trees with less than 4" diameter at chest height should be removed, Spring 2020.

View looking downstream landside at a small starter tree that needs to be removed.

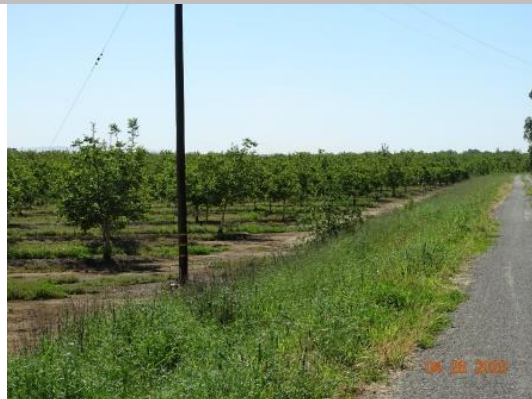
Photo 1 of 1 : SP\_2020\_RD0010\_164\_44\_20200429\_00094.jpg

LM Start	10.65	Rating **	M	Issue No.	44
LM End	10.65	Issue Type +	Ma	Location *	LS
Category	Earthen Levee			GPS Latitude/Longitude	
				Start	End
Item	Trim / Thin Trees			39.300273 °	39.300273 °
				-121.616903 °	-121.616903 °
DWR ID	DWR_RD0010_02_s_2020_44				
Comment Code					
T3 : Trim and thin trees to allow visibility of the ground and room to flood fight.					
Inspector Comment					
Trees with less than 4" diameter at chest height should be removed, Spring 2020.

View looking downstream landside at small starter tree on levee slope, Spring 2020.

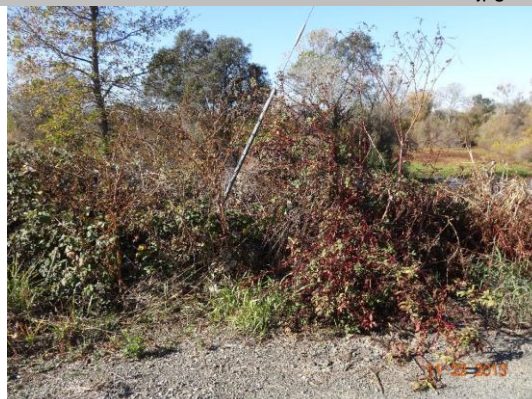
Photo 1 of 3 : UCIP\_SP\_2020\_24839\_44745.jpg

Comment Code						
Inspector Comment						
DS_ID:21304 FS_ID:24839 EP_NO: N/A Repair Type: Non-Urgent Crossing Status: Found UCIP Comments: 04/30/2013 Rip rap was used to stabilize the waterward slope during high water as a means of emergency repair--unable to determine storm event when repair was performed. Recommend obtaining records of the repair and to determine if crossing is still being used. Need to determine owner. Dense vegetation limits the inspector's visibility to identify signs of pipe failure (leaks) along the slope. Recommend removing vegetation along pipe alignment to conduct proper inspection of structure and appurtances. This crossing is referenced in the USACE Periodic Inspection as item USACE_CESPK_HON2_2013_p_0458 and 460. (DWR UCIP - O. Magana) FIELD_STRUCT_DESC: 24-inch steel irrigation discharge pipe through the levee, 5 feet below the crown. Slide gate in a 36-inch concrete riser on the landside (LS) shoulder. Gate valve in a pump house on the waterside (WS) slope. Concrete headwall, saddle, and apron on the WS end. [Additional Reference(s): DWR Levee Log, 2005. USACE Sacramento O&M Manual 151, May 1953, (Station 655+65)]. FS Date: 4/30/2013

View of waterward shoulder behind vegetation is standpipe.

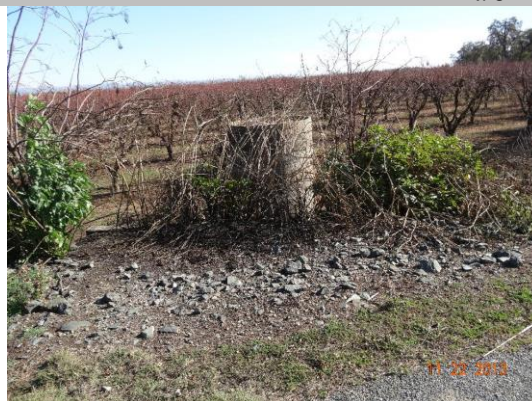
Photo 2 of 3 : UCIP\_SP\_2020\_24839\_44742.jpg

View of standpipe located on landward side.

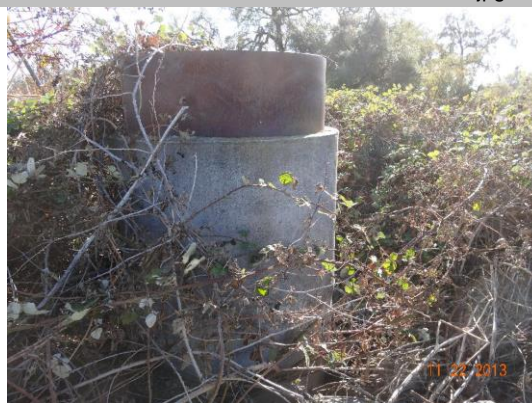
Photo 3 of 3 : UCIP\_SP\_2020\_24839\_44748.jpg

View of standpipe located on waterward side.

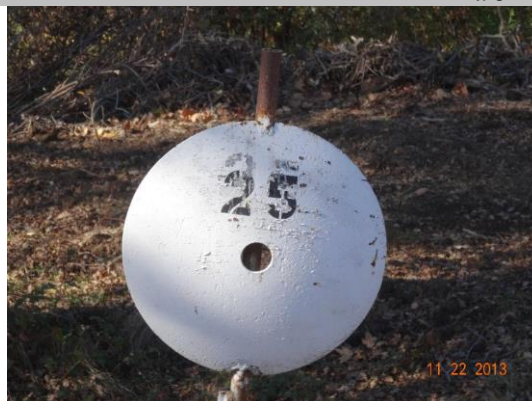
Photo 1 of 3 : UCIP\_SP\_2020\_24840\_44753.jpg

DS\_ID:21305  
FS\_ID:24840  
EP\_NO: N/A  
Repair Type: Non-Urgent  
Crossing Status: Found  
UCIP Comments: 04/30/2013 Burrow activity--large holes found on landward side. Crossing on landward side is blocked. Recommend clearing headwall and crossing. Need to coordinate with owner to determine status of crossing. If crossing is no longer in use owner will need to contact the CVFPB to comply with Title 23. This crossing is referenced in the USACE Periodic Inspection as item USACE\_CESPK\_HON2\_2013\_p\_0476. (DWR UCIP - O. Magana)  
FIELD\_STRUCT\_DESC: 24-inch corrugated metal gravity drainage pipe through the levee, 7.5 feet below the crown. Corrugated metal cutoff wall around the pipe at each shoulder. Flap gate on the waterside (WS) end. Concrete headwall at each toe. Saddle and apron on the WS. [Additional Reference(s): DWR Levee Log, 2005. USACE Sacramento O&M Manual 151, May 1953, (Station 674+73)].

Marker visible on waterward side, crossing is referenced as No. 25.

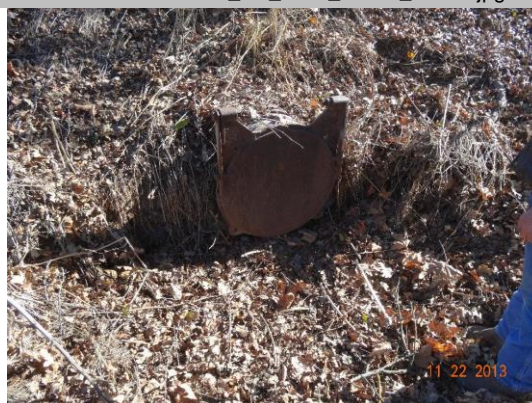
Photo 2 of 3 : UCIP\_SP\_2020\_24840\_44752.jpg

View of flap gate located on waterward side.

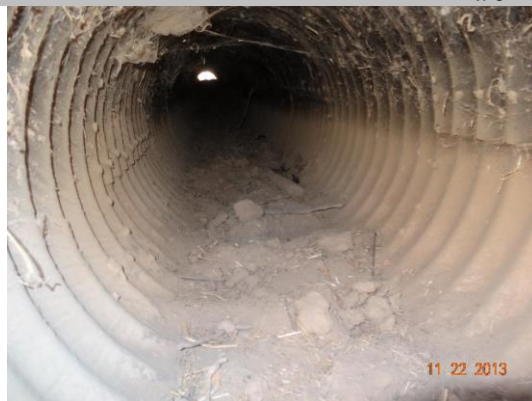
Photo 3 of 3 : UCIP\_SP\_2020\_24840\_44751.jpg

Internal view of pipe wall from waterward side.

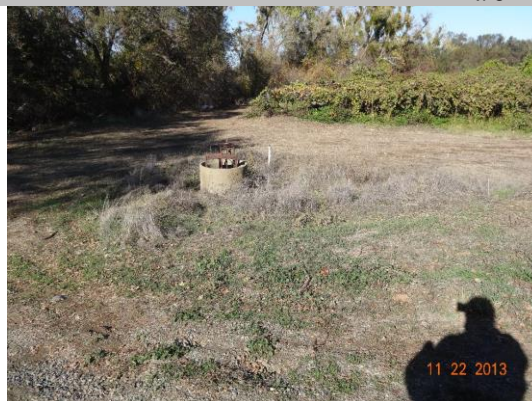
Photo 1 of 3 : UCIP\_SP\_2020\_24841\_44759.jpg

LM Start	0.01	Rating **	M	Issue No.	24
LM End	0.01	Issue Type +	En	Location *	
Category	Supplemental			GPS Latitude/Longitude	
				Start	End
Item	DWR UCIP Field Study			39.310096 °	39.310096 °
				-121.616250 °	-121.616250 °
DWR ID	21306				
Comment Code					
Inspector Comment					
DS_ID:21306 FS_ID:24841 EP_NO: N/A Repair Type: Non-Urgent Crossing Status: Found UCIP Comments: 05/01/2013 Debris found inside crossing-- recommend removing it. (DWR UCIP - O. Magana) FIELD_STRUCT_DESC: 24-inch corrugated metal gravity drainage pipe through the levee, 6 feet below the crown. Slide gate in a concrete standpipe on the waterside (WS) end. [Additional Reference(s): DWR Levee Log, 2005]. FS Date: 5/1/2013

View of waterward side.

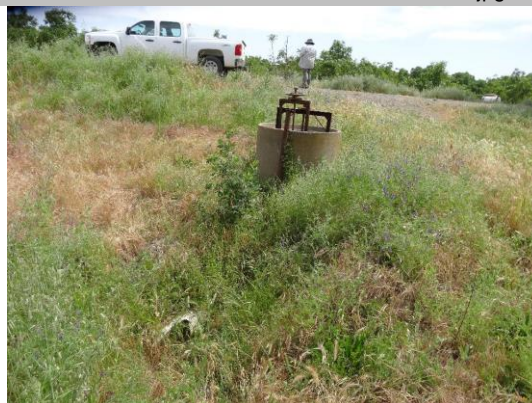
Photo 2 of 3 : UCIP\_SP\_2020\_24841\_44757.jpg

View of concrete standpipe and plastic pipe extension visible on waterward side.

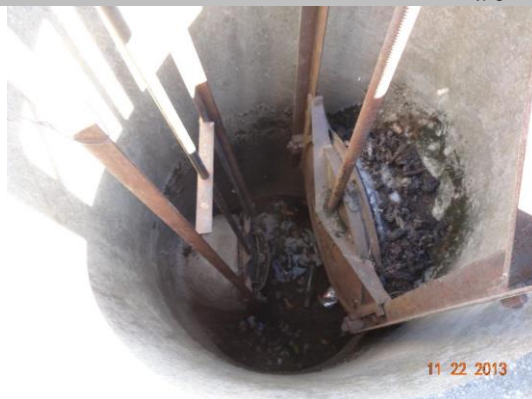
Photo 3 of 3 : UCIP\_SP\_2020\_24841\_44758.jpg

Inside view of concrete standpipe with 2 screw gates inside.

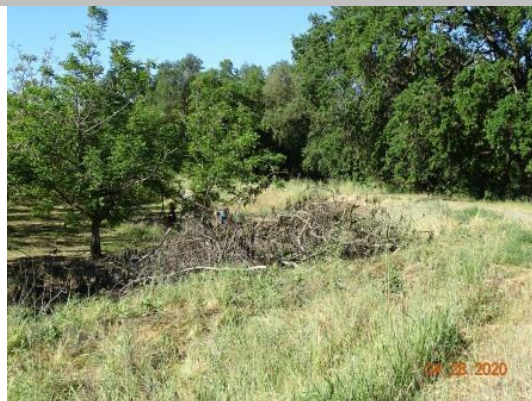
Photo 1 of 1 : SP\_2020\_RD0010\_165\_23\_20200429\_00028.jpg

LM Start	0.01	Rating **	M	Issue No.	23
LM End	0.01	Issue Type +	En	Location *	LS
Category	Earthen Levee			GPS Latitude/Longitude	
				Start	End
Item	Encroachments			39.310141 °	39.310141 °
				-121.616138 °	-121.616138 °
DWR ID	DWR_RD0010_03_s_2020_23				
Comment Code					
PR : Prunings					
Inspector Comment					
Remove prunings from levee toe, Spring 2020.

View looking downstream landside at prunings on levee slope, Spring 2020.

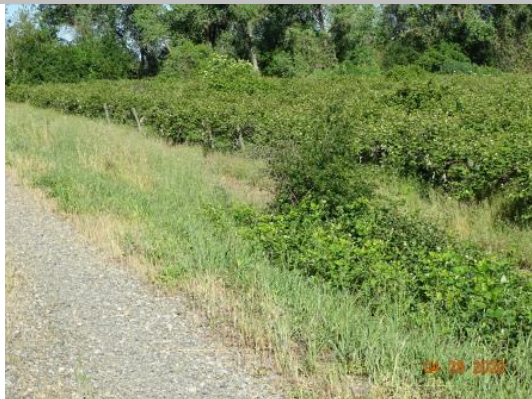
Photo 1 of 1 : SP\_2020\_RD0010\_165\_22\_20200429\_00027.jpg

LM Start	0.09	Rating **	M	Issue No.	22
LM End	0.09	Issue Type +	Ma	Location *	WS
Category	Earthen Levee			GPS Latitude/Longitude	
				Start	End
Item	Trim / Thin Trees			39.310229 °	39.310229 °
				-121.614697 °	-121.614697 °
DWR ID	DWR_RD0010_03_s_2020_22				
Comment Code					
T3 : Trim and thin trees to allow visibility of the ground and room to flood fight.					
Inspector Comment					
Trees with less than 4" diameter at chest height should be removed, Spring 2020.

View looking downstream waterside at a small starter tree and wild growth that needs to be removed, Spring 2020.

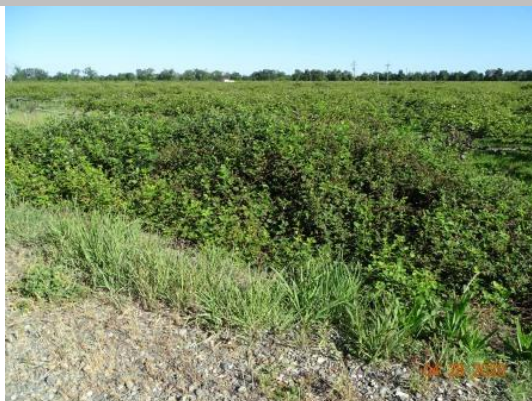
Photo 1 of 1 : SP\_2020\_RD0010\_165\_21\_20200429\_00026.jpg

LM Start	0.51	Rating **	M	Issue No.	21
LM End	0.51	Issue Type +	Ma	Location *	WS
Category	Earthen Levee			GPS Latitude/Longitude	
				Start	End
Item	Vegetation			39.310231 °	39.310231 °
				-121.606856 °	-121.606856 °
DWR ID	DWR_RD0010_03_s_2020_21				
Comment Code					
V2 : Remove the wild growth other than native grasses from the levee slopes.					
Inspector Comment					
Remove blackberries from levee slope, Spring 2020.

View looking downstream waterside at blackberries on levee slope, Spring 2020.

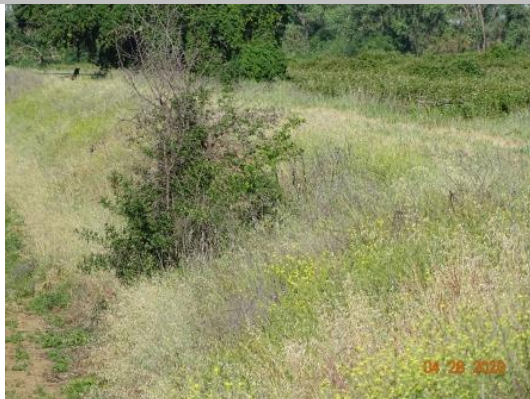
Photo 1 of 1 : SP\_2020\_RD0010\_165\_20\_20200429\_00025.jpg

LM Start	0.56	Rating **	M	Issue No.	20
LM End	0.56	Issue Type +	Ma	Location *	LS
Category	Earthen Levee			GPS Latitude/Longitude	
				Start	End
Item	Trim / Thin Trees			39.310227 °	39.310227 °
				-121.606027 °	-121.606027 °
DWR ID	DWR_RD0010_03_s_2020_20				
Comment Code					
T3 : Trim and thin trees to allow visibility of the ground and room to flood fight.					
Inspector Comment					
Trees with less than 4" diameter at chest height should be removed, Spring 2020.

View looking downstream landside at a small starter tree that needs to be removed, Spring 2020.

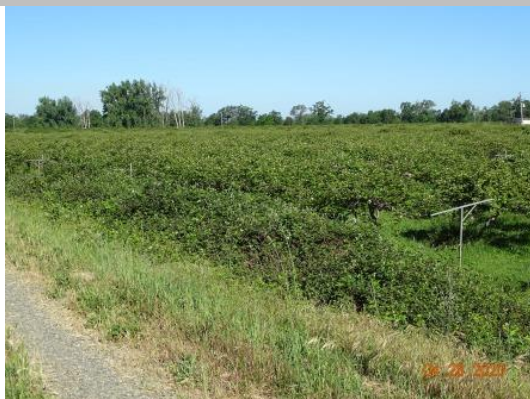
Photo 1 of 1 : SP\_2020\_RD0010\_165\_19\_20200429\_00024.jpg

LM Start	0.56	Rating **	M	Issue No.	19
LM End	0.56	Issue Type +	Ma	Location *	WS
Category	Earthen Levee			GPS Latitude/Longitude	
				Start	End
Item	Vegetation			39.310229 °	39.310229 °
				-121.605899 °	-121.605899 °
DWR ID	DWR_RD0010_03_s_2020_19				
Comment Code					
V2 : Remove the wild growth other than native grasses from the levee slopes.					
Inspector Comment					
Remove blackberries from levee slope, Spring 2020.

View looking downstream waterside at black berries on the levee slope, Spring 2020.

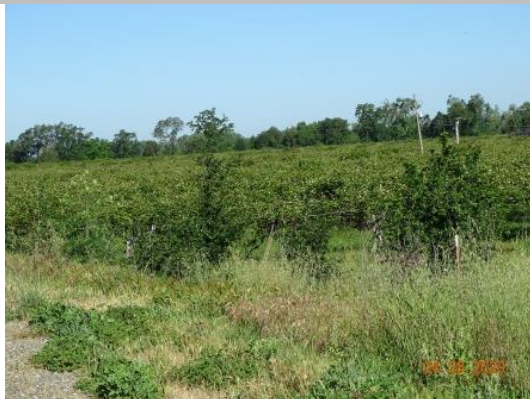
Photo 1 of 1 : SP\_2020\_RD0010\_165\_18\_20200429\_00023.jpg

LM Start	0.59	Rating **	M	Issue No.	18
LM End	0.59	Issue Type +	Ma	Location *	WS
Category	Earthen Levee			GPS Latitude/Longitude	
				Start	End
Item	Trim / Thin Trees			39.310209 °	39.310209 °
				-121.605456 °	-121.605456 °
DWR ID	DWR_RD0010_03_s_2020_18				
Comment Code					
T3 : Trim and thin trees to allow visibility of the ground and room to flood fight.					
Inspector Comment					
Trees with less than 4" diameter at chest height should be removed, Spring 2020.

View looking downstream waterside at a small starter trees that needs to be removed, Spring 2020.

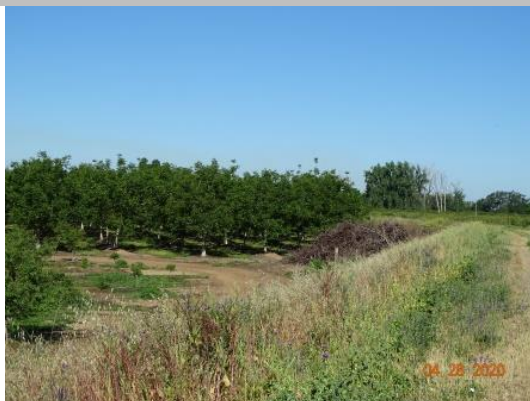
Photo 1 of 1 : SP\_2020\_RD0010\_165\_17\_20200429\_00022.jpg

LM Start	0.62	Rating **	U	Issue No.	17
LM End	0.62	Issue Type +	En	Location *	LS
Category	Earthen Levee			GPS Latitude/Longitude	
				Start	End
Item	Encroachments			39.310069 °	39.310069 °
				-121.604884 °	-121.604884 °
DWR ID	DWR_RD0010_03_s_2020_17				
Comment Code					
PR : Prunings					
Inspector Comment					
Remove prunings from levee toe, Spring 2020.

View looking downstream landside at prunings on levee slope, Spring 2020.

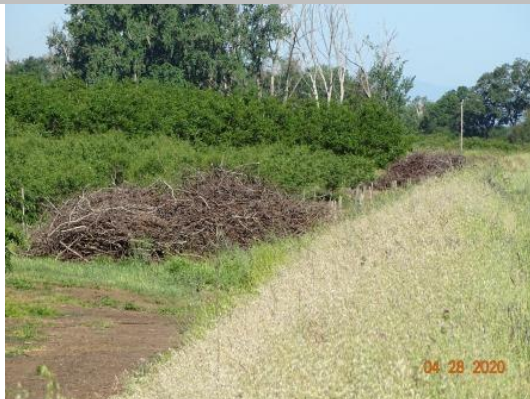
Photo 1 of 1 : SP\_2020\_RD0010\_165\_16\_20200429\_00021.jpg

LM Start	0.76	Rating **	U	Issue No.	16
LM End	0.76	Issue Type +	En	Location *	LS
Category	Earthen Levee			GPS Latitude/Longitude	
				Start	End
Item	Encroachments			39.309200 °	39.309200 °
				-121.602474 °	-121.602474 °
DWR ID	DWR_RD0010_03_s_2020_16				
Comment Code					
PR : Prunings					
Inspector Comment					
Remove prunings from levee toe, Spring 2020.

View looking downstream landside at prunings on levee slope, Spring 2020.

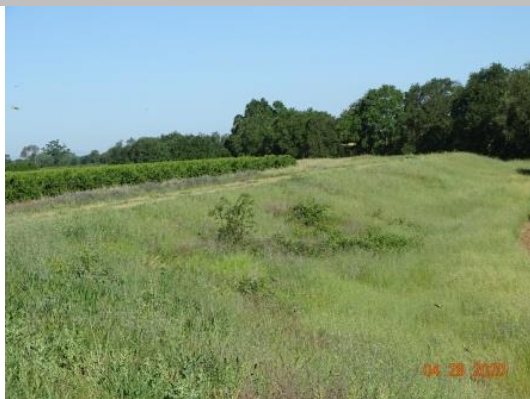
Photo 1 of 1 : SP\_2020\_RD0010\_165\_15\_20200429\_00020.jpg

LM Start	0.95	Rating **	M	Issue No.	15
LM End	0.95	Issue Type +	Ma	Location *	WS
Category	Earthen Levee			GPS Latitude/Longitude	
				Start	End
Item	Trim / Thin Trees			39.307583 °	39.307583 °
				-121.599640 °	-121.599640 °
DWR ID	DWR_RD0010_03_s_2020_15				
Comment Code					
T3 : Trim and thin trees to allow visibility of the ground and room to flood fight.					
Inspector Comment					
Trees with less than 4" diameter at chest height should be removed, Spring 2020.

View looking downstream waterside at a small starter trees that needs to be removed, Spring 2020.

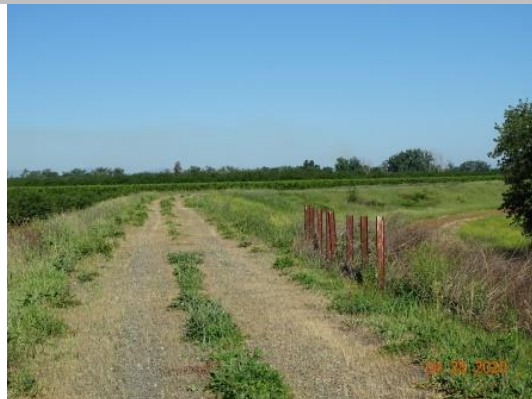
Photo 1 of 1 : SP\_2020\_RD0010\_165\_14\_20200429\_00019.jpg

LM Start	1.05	Rating **	A	Issue No.	14
LM End	1.05	Issue Type +	En	Location *	CR
Category	Earthen Levee			GPS Latitude/Longitude	
				Start	End
Item	Encroachments			39.307153 °	39.307153 °
				-121.598040 °	-121.598040 °
DWR ID	DWR_RD0010_03_s_2020_14				
Comment Code					
PO : Pole					
Inspector Comment					
Metal I beams vertically in Levee hinge point to prevent vehicle access.

View looking downstream waterside crown at vertical "I" beam post installed to prevent vehicle access.

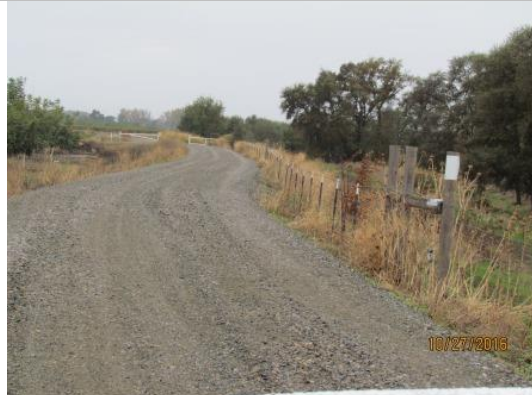
Photo 1 of 1 : SP\_2020\_RD0010\_165\_8\_20200227\_00003.jpg

LM Start	1.08	Rating **	M	Issue No.	8
LM End	1.21	Issue Type +	En	Location *	WS
Category	Earthen Levee			GPS Latitude/Longitude	
				Start	End
Item	Encroachments			39.307106 °	39.306422 °
				-121.597439 °	-121.595205 °
DWR ID	DWR_RD0010_03_s_2016_8				
Comment Code					
FE : Fence					
Inspector Comment					
Unpermitted fence on waterside levee hinge point.

View of an unpermitted fence on waterside levee hinge point.

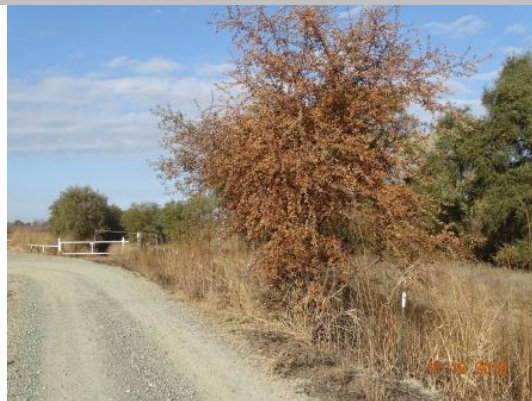
Photo 1 of 1 : SP\_2020\_RD0010\_165\_10\_20200227\_00004.jpg

LM Start	1.10	Rating **	M	Issue No.	10
LM End	1.10	Issue Type +	Ma	Location *	WS
Category	Earthen Levee			GPS Latitude/Longitude	
				Start	End
Item	Trim / Thin Trees			39.306995 °	39.306995 °
				-121.597116 °	-121.597116 °
DWR ID	DWR_RD0010_03_s_2018_10				
Comment Code					
T2 : Thin trees to allow visibility of the ground and room to flood fight.					
Inspector Comment					
Trees with less than 4" diameter at chest height should be removed, Spring 2020.

View looking downstream waterside of a tree that needs to be trimmed for access and visibility.

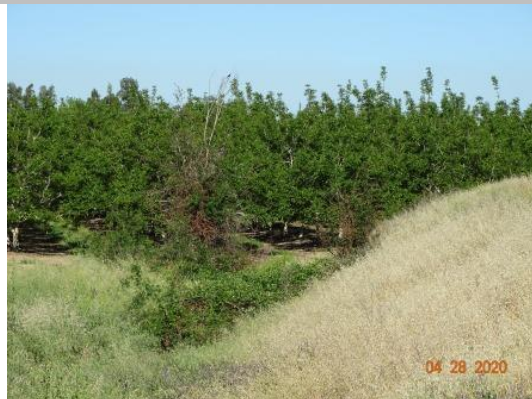
Photo 1 of 1 : SP\_2020\_RD0010\_165\_13\_20200429\_00018.jpg

LM Start	1.47	Rating **	M	Issue No.	13
LM End	1.47	Issue Type +	Ma	Location *	LS
Category	Earthen Levee			GPS Latitude/Longitude	
				Start	End
Item	Trim / Thin Trees			39.303777 °	39.303777 °
				-121.591853 °	-121.591853 °
DWR ID	DWR_RD0010_03_s_2020_13				
Comment Code					
T3 : Trim and thin trees to allow visibility of the ground and room to flood fight.					
Inspector Comment					
Trees with less than 4" diameter at chest height should be removed, Spring 2020.

View looking downstream landside at small starter trees that need to be removed, Spring 2020.

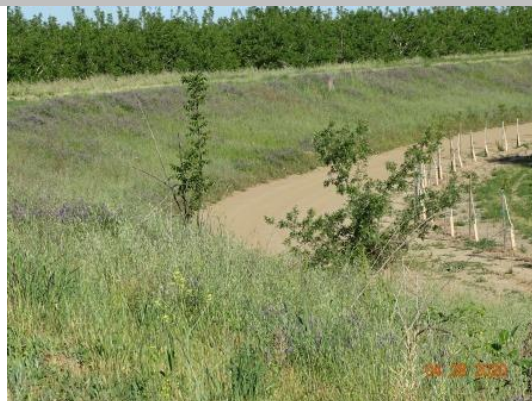
Photo 1 of 1 : SP\_2020\_RD0010\_165\_12\_20200429\_00017.jpg

LM Start	1.49	Rating **	M	Issue No.	12
LM End	1.49	Issue Type +	Ma	Location *	WS
Category	Earthen Levee			GPS Latitude/Longitude	
				Start	End
Item	Trim / Thin Trees			39.303738 °	39.303738 °
				-121.591548 °	-121.591548 °
DWR ID	DWR_RD0010_03_s_2020_12				
Comment Code					
T3 : Trim and thin trees to allow visibility of the ground and room to flood fight.					
Inspector Comment					
Trees with less than 4" diameter at chest height should be removed, Spring 2020.

View looking downstream waterside at small starter trees that need to be removed, Spring 2020.

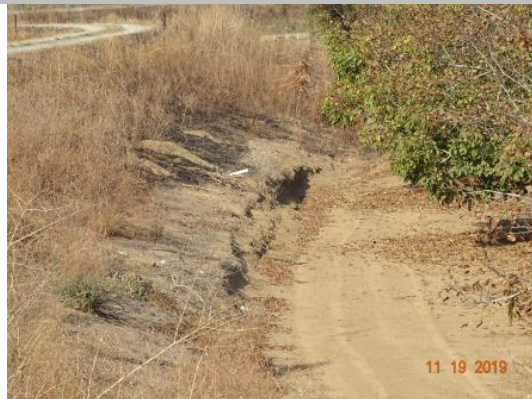
Photo 1 of 1 : SP\_2020\_RD0010\_165\_7\_20200227\_00002.jpg

LM Start	1.56	Rating **	U	Issue No.	7
LM End	1.60	Issue Type +	En	Location *	WS
Category	Earthen Levee			GPS Latitude/Longitude	
				Start	End
Item	Encroachments			39.303316 °	39.302962 °
				-121.590452 °	-121.589812 °
DWR ID	DWR_RD0010_03_f_2019_7				
Comment Code					
AT : Agricultural tilling					
Inspector Comment					
2 foot vertical cut in levee toe by the farmer.

View looking downstream waterside at a 2 foot vertical cut in the levee toe.

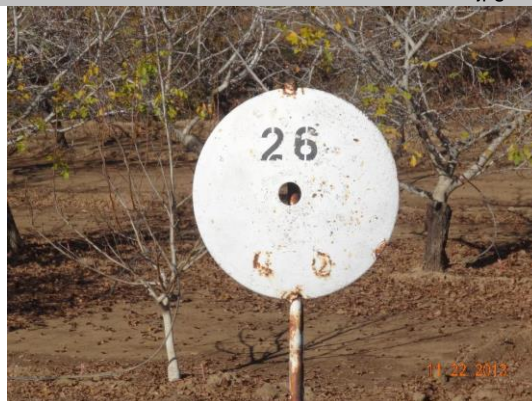
Photo 1 of 3 : UCIP\_SP\_2020\_24842\_44764.jpg

Comment Code						
Inspector Comment						
DS_ID:21307 FS_ID:24842 EP_NO: N/A Repair Type: Non-Urgent Crossing Status: Found UCIP Comments: 05/01/2013 Sediment deposit inside pipe--Need to coordinate with owner to determine status of crossing. If crossing is no longer in use owner will need to contact the CVFPB to comply with Title 23. (DWR UCIP - O. Magana) FIELD_STRUCT_DESC: 24-inch corrugated metal gravity drainage pipe through the levee, 15 feet below the crown. Corrugated metal cutoff wall around the pipe at each shoulder. Flap gate on the waterside (WS) end. Slide gate on the landside (LS) end. Concrete headwall at each toe. [Additional Reference(s): DWR Levee Log, 2005. USACE Sacramento O&M Manual 151, May 1953, (Station 134+06)]. FS Date: 5/1/2013

Marker visible on waterward side--No. 26.

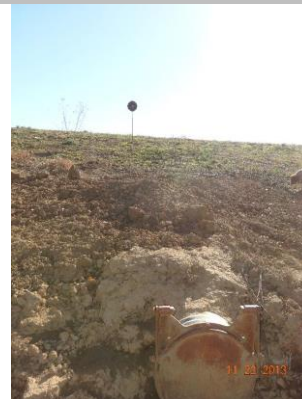
Photo 2 of 3 : UCIP\_SP\_2020\_24842\_44762.jpg

View of waterward slope.

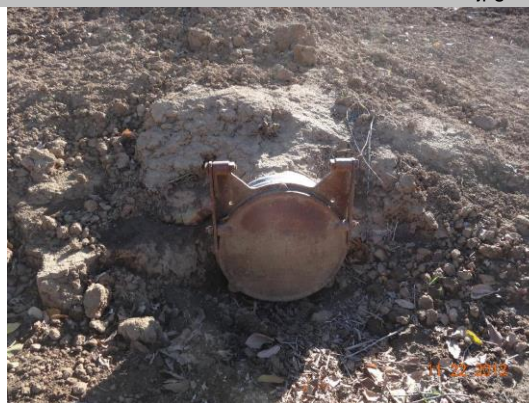
Photo 3 of 3 : UCIP\_SP\_2020\_24842\_44763.jpg

View of flap gate located on waterward side.

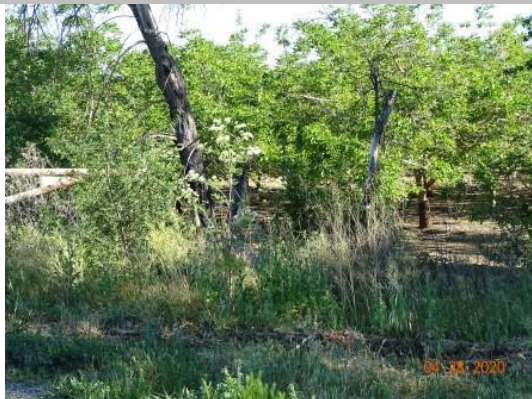
Photo 1 of 1 : SP\_2020\_RD0010\_165\_11\_20200429\_00016.jpg

LM Start	2.47	Rating **	M	Issue No.	11
LM End	2.47	Issue Type +	Ma	Location *	WS
Category	Earthen Levee			GPS Latitude/Longitude	
				Start	End
Item	Trim / Thin Trees			39.301406 °	39.301406 °
				-121.574435 °	-121.574435 °
DWR ID	DWR_RD0010_03_s_2020_11				
Comment Code					
T3 : Trim and thin trees to allow visibility of the ground and room to flood fight.					
Inspector Comment					
Trees with less than 4" diameter at chest height should be removed, Spring 2020.

View looking downstream waterside at a small starter tree that needs to be removed, Spring 2020.

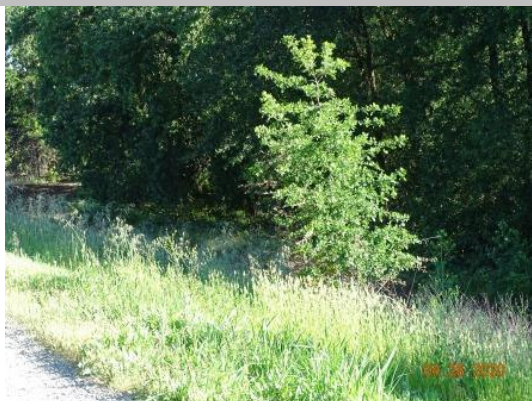
Photo 1 of 1 : SP\_2020\_RD0010\_165\_9\_20200429\_00015.jpg

LM Start	2.51	Rating **	M	Issue No.	9
LM End	2.51	Issue Type +	Ma	Location *	WS
Category	Earthen Levee			GPS Latitude/Longitude	
				Start	End
Item	Trim / Thin Trees			39.300973 °	39.300973 °
				-121.574087 °	-121.574087 °
DWR ID	DWR_RD0010_03_s_2020_9				
Comment Code					
T3 : Trim and thin trees to allow visibility of the ground and room to flood fight.					
Inspector Comment					
Trees with less than 4" diameter at chest height should be removed, Spring 2020.

View looking downstream waterside at a small starter tree that needs to be removed, Spring 2020.

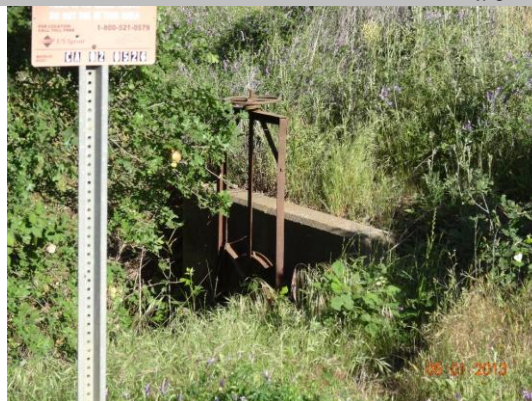
Photo 1 of 2 : UCIP\_SP\_2020\_24883\_44820.jpg

Comment Code						
Inspector Comment						
DS_ID:21308 FS_ID:24883 EP_NO: N/A Repair Type: Non-Urgent Crossing Status: Found UCIP Comments: 05/01/2013 Dense vegetation limits the inspector's visibility to identify signs of pipe failure (leaks) along the slope. Recommend removing vegetation along pipe alignment to conduct proper inspection of structure and appurtances. (DWR UCIP - O. Magana) FIELD_STRUCT_DESC: 24-inch corrugated metal gravity drainage pipe through the levee, 12 feet below the crown. Corrugated metal cutoff wall around the pipe at each shoulder. Flap gate on the waterside (WS) end. Slide gate on the landside (LS) end. Concrete headwall at the LS toe. [Additional Reference(s): DWR Levee Log, 2005. USACE Sacramento O&M Manual 151, May 1953, (Station 192+33)]. FS Date: 5/1/2013

View of slide gate and concrete headwall located on landward side.
