**Flood Control Project Maintenance
Levee Inspections
Unit Cover Sheet**

Reclamation District No. 0010 Honcut

Levee Inspection Report By Mile - Spring 2021

Waterway	Bank	Unit Miles	Inspection Start/End	Inspector
Unit No. 01 Simmerly Slough	Right	7.65	04/14/2021 04/14/2021	Brooks Weisser

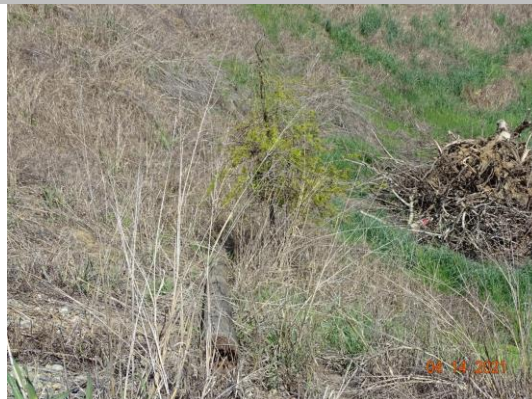
Photo 1 of 1 : SP_2021_RD0010_163_44_20210427_00108.jpg

LM Start	0.00	Rating **	M	Issue No.	44
LM End	0.00	Issue Type +	Ma	Location *	LS
Category	Earthen Levee			GPS Latitude/Longitude	
				Start	End
Item	Trim / Thin Trees			39.163708 °	39.163708 °
				-121.609906 °	-121.609906 °
DWR ID	DWR_RD0010_01_s_2020_44				
Comment Code					
T3 : Trim and thin trees to allow visibility of the ground and room to flood fight.					
Inspector Comment					
Trees with less than 4" diameter at chest height should be removed, Spring 2021.

View of small starter tree on levee slope, Spring 2021.

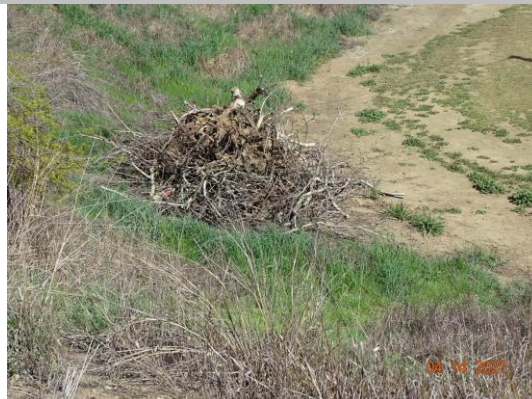
Photo 1 of 1 : SP_2021_RD0010_163_32_20210427_00109.jpg

LM Start	0.01	Rating **	M	Issue No.	32
LM End	0.01	Issue Type +	En	Location *	LS
Category	Earthen Levee			GPS Latitude/Longitude	
				Start	End
Item	Encroachments			39.163673 °	39.163673 °
				-121.609787 °	-121.609787 °
DWR ID	DWR_RD0010_01_s_2021_32				
Comment Code					
PR : Prunings					
Inspector Comment					
A pile of prunings on the land side toe need to be removed, Spring 2021.

View of pile of pruning on the land side toe, Spring 2021.

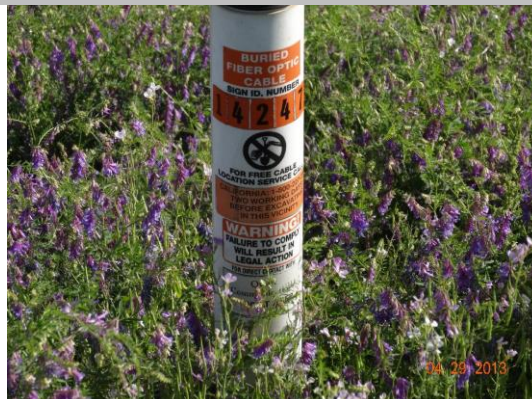
Photo 1 of 2 : UCIP_SP_2021_62537_51365.jpg

LM Start	0.23	Rating **	M	Issue No.	1	
LM End	0.23	Issue Type +	En	Location *		
Category	Supplemental			GPS Latitude/Longitude		
				Start	End	
Item	DWR UCIP Field Study			39.163407 °	39.163407 °	
				-121.605645 °	-121.605645 °	
DWR ID	24653					
Comment Code						
Inspector Comment						
FS_ID:62537						
DS_ID:24653						
EP_NO: N/A						
Repair Type: Non-Urgent						
Crossing Status: Indicator Found						
UCIP Comments: 04/29/2013 Need to contact owner--unable to determine if crossing is authorized (no permit found) also need to determine if crossing goes through levee. (O. Magana - DWR UCIP)						
FIELD_STRUCT_DESC: Fiber optics line markers on the levee slope.						
Unable to determine if this line goes through the levee. This line was field discovered.						
FS Date: 4/29/2013

Contact information for buried fiber optic cable.

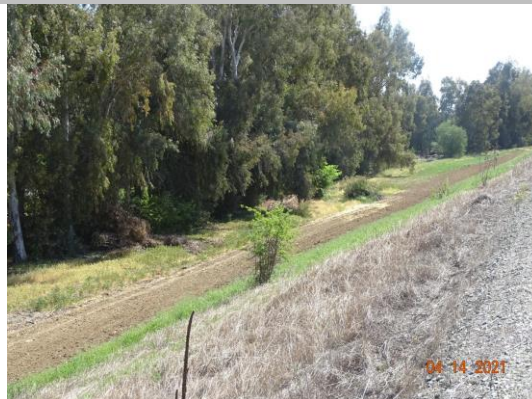
Photo 1 of 1 : SP_2021_RD0010_163_43_20210427_00110.jpg

LM Start	0.40	Rating **	M	Issue No.	43
LM End	0.40	Issue Type +	Ma	Location *	LS
Category	Earthen Levee			GPS Latitude/Longitude	
				Start	End
Item	Trim / Thin Trees			39.162893 °	39.162893 °
				-121.602631 °	-121.602631 °
DWR ID	DWR_RD0010_01_f _ 2020_43				
Comment Code					
T3 : Trim and thin trees to allow visibility of the ground and room to flood fight.					
Inspector Comment					
Trees with less than 4" diameter at chest height should be removed, Spring 2021.

View of starter tree on landside slope that should be removed, Spring 2021.

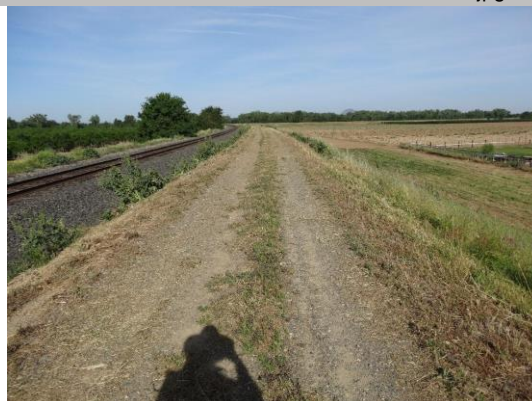
Photo 1 of 3 : UCIP_SP_2021_62540_44540.jpg

Comment Code					
Inspector Comment					
FS_ID:62540 DS_ID:21257 EP_NO: 13015 Repair Type: Non-Urgent Crossing Status: Found UCIP Comments: 04/29/2013 New gravel indicates work was recently completed. Will need to contact owner to obtain information pertaining to work completed. Need to contact owner to determine if crossing is still active and to determine last inspection date. Will need copy of letter showing crossings passed inspection. This crossing is referenced in the USACE Periodic Inspection as item USACE_CESPK_HON1_2013_p_0075. (O. Magana - DWR UCIP) FIELD_STRUCT_DESC: 4-inch steel natural gas pipeline sleeved through an 8-inch pipe through the levee, 30 feet below the crown. Annular space grouted. Cutoff wall on each end within the levee. (Plans to reinforce an existing 4-inch gas main with a parallel 4-inch main through the levee authorized under Permit No. 13015, 1980 - Pacific Gas and Electric Company [PG&E]). [Additional Reference(s): DWR Levee Log, 2005 (HLM 0.44), listed as a 4-inch gas line]. FS Date: 4/29/2013

View of levee crown looking upstream.

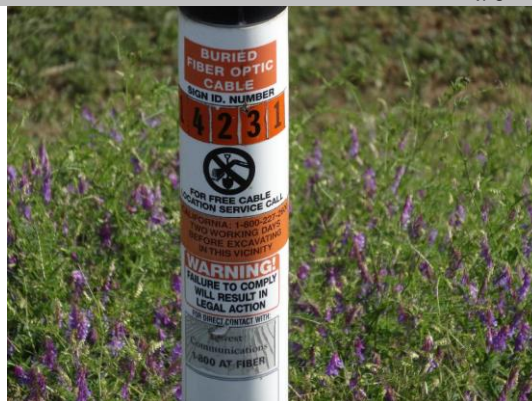
Photo 1 of 2 : UCIP_SP_2021_62542_51361.jpg

LM Start	0.53	Rating **	M	Issue No.	4	
LM End	0.53	Issue Type +	En	Location *		
Category	Supplemental			GPS Latitude/Longitude		
				Start	End	
Item	DWR UCIP Field Study			39.162277 °	39.162277 °	
				-121.600219 °	-121.600219 °	
DWR ID	24655					
Comment Code						
Inspector Comment						
FS_ID:62542						
DS_ID:24655						
EP_NO: N/A						
Repair Type: Non-Urgent						
Crossing Status: Indicator Found						
UCIP Comments: 04/29/2013 Need to contact owner--unable to determine if crossing is authorized (no permit found) also need to determine if crossing goes through levee. (O. Magana - DWR UCIP)						
FIELD_STRUCT_DESC: Fiber optics line markers on levee slope.						
Unable to determine if line goes through the levee. This line was field discovered.						
FS Date: 4/29/2013

Contact information for fiber optic cable and ID number.

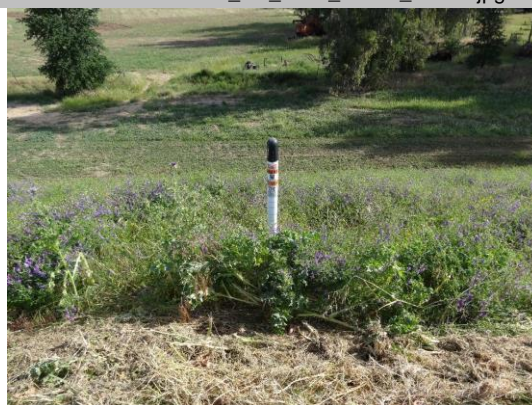
Photo 2 of 2 : UCIP_SP_2021_62542_51360.jpg

View of marker located on landward side.

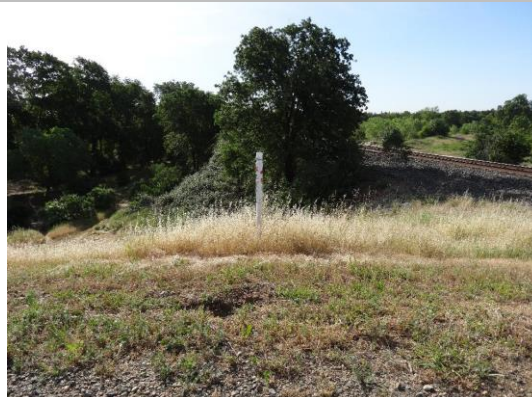
Photo 1 of 2 : UCIP_SP_2021_62543_51371.jpg

LM Start	0.72	Rating **	M	Issue No.	5	
LM End	0.72	Issue Type +	En	Location *		
Category	Supplemental			GPS Latitude/Longitude		
				Start	End	
Item	DWR UCIP Field Study			39.161229 °	39.161229 °	
				-121.597072 °	-121.597072 °	
DWR ID	24656					
Comment Code						
Inspector Comment						
FS_ID:62543 DS_ID:24656 EP_NO: N/A Repair Type: Non-Urgent Crossing Status: Indicator Found UCIP Comments: 04/29/2013 Need to contact owner--unable to determine if crossing is authorized (no permit found) also need to determine if crossing goes through levee. (O. Magana - DWR UCIP) FIELD_STRUCT_DESC: Fiber optics line markers on levee slope. Unable to determine if line goes through the levee. This line was field discovered. FS Date: 4/29/2013

View of marker located on waterward side.

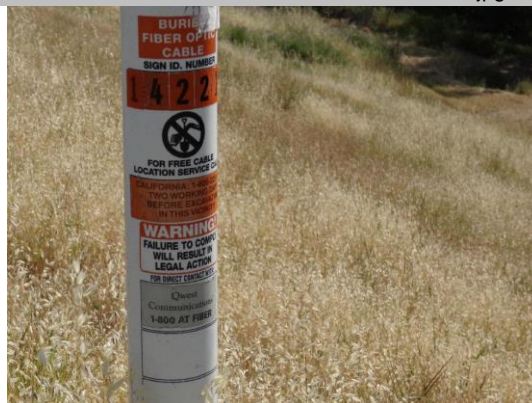
Photo 2 of 2 : UCIP_SP_2021_62543_51370.jpg

Contact information and ID number for buried fiber optic cable.

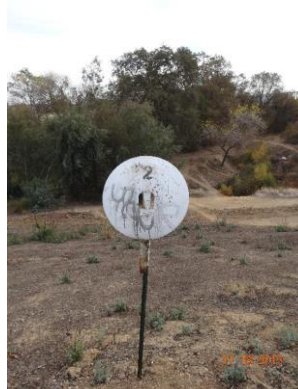
Photo 1 of 3 : UCIP_SP_2021_62557_51415.jpg

Comment Code					
Inspector Comment					
FS_ID:62557					
DS_ID:21258					
EP_NO: N/A					
Repair Type: Non-Urgent					
Crossing Status: Found					
UCIP Comments: 11/25/2020 see UCIP marked up RD0010 USACE O&M manual OM151_IrrDRNSect.pdf and USACE drawing AB_4-4-295.pdf for approximate location and station. Reference files have been filed under UCIP's share drive desk study background folder for RD0010. (O. Magana - DWR UCIP)7/01/2016 Gate has been repaired--WS gate is functional. LS gate still needs new stem for the gate to properly function--stem is bent. USACE's PI issue references permit number 13710 this is incorrect permit is associated with DS_ID 21259 (CLM 0.767). (O. Magana - DWR UCIP)4/29/2013 Damaged flap gate on waterward side and damaged stem on screw gate on landward side. Need to contact owner to determine if crossing is still active. If crossing is still in use owner will need to address damage on flap gate and screw gate. If crossing is no longer in use owner will need to contact the CVFPB to comply with Title 23. This crossing is referenced in the USACE Periodic Inspection as item USACE_CESPK_HON1_2013_p_0053 and 0057. (O. Magana - DWR UCIP)

FIELD_STRUCT_DESC: 24-inch corrugated metal gravity drainage pipe through the levee, 31 feet below the crown. Two corrugated metal cutoff walls around pipe. Concrete headwall at each end. Flap gate on the waterside (WS) end. Slide gate on the landside (LS) end. Pipe discharges into 6-foot concrete splash apron on the WS. [Additional Reference(s): DWR Levee Log, 2005 (HLM 0.74), listed as a 24-inch corrugated metal pipe (CMP). USACE Sacramento O&M Manual, Unit No. 151, May 1953, Revised 6 Jun 2017, (Station 46+60). USACE As-built Drawing No. 04-04-0295, Sheet 2 of 5, pdf file - page 2 of 4, November 1947, Revised December 1947, referenced as Station 45+60, listed as a 24-inch CMP]					
FS Date: 7/1/2016

View of WS--Marker indicates crossing is labelled as 2.

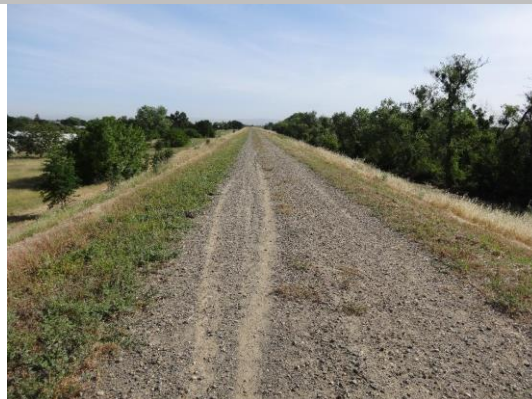
Photo 2 of 3 : UCIP_SP_2021_62557_51410.jpg

View of levee crown looking downstream.

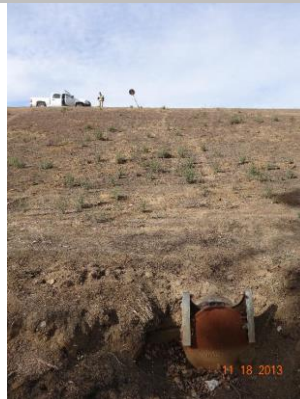
Photo 2 of 3 : UCIP_SP_2021_62556_51450.jpg

View of slope located on waterward side.

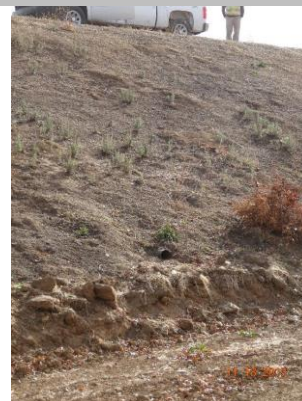
Photo 1 of 1 : UCIP_SP_2021_62547_51418.jpg

FS_ID:62547
DS_ID:21260
EP_NO: 4555
Repair Type: Non-Urgent
Crossing Status: Indicator Found
UCIP Comments: 04/29/2013 Pipe is approximately 4-6 inches in diameter located near the toe of levee. Crossing is approximately 50 feet downstream of 24-inch pipe. Need to contact owner to determine status of this crossing and to verify the purpose of crossing. If crossing is no longer in use owner will need to contact the CVFPB to comply with Title 23. (O. Magana - DWR UCIP)
FIELD_STRUCT_DESC: 6-inch steel drainage discharge pipe through the levee, 1 foot below the crown. Siphon breaker on the waterside (WS) shoulder. Pump at the landside (LS) toe. Revetment around the discharge end of the pipe. Pipe drains into a ditch at the WS toe. Pipe is not buried in berms. Gravel pad over pipe across levee crown for vehicular access. (Plans for installing a drainage pipe across the levee authorized under Permit No. 4555, 1964 - Ledbetter, Carbah, and Huddle). [Additional Reference(s): DWR Levee Log, 2005 (HLM 0.90), listed as an abandoned 6-inch steel pipe].

Pipe through levee near waterward toe.

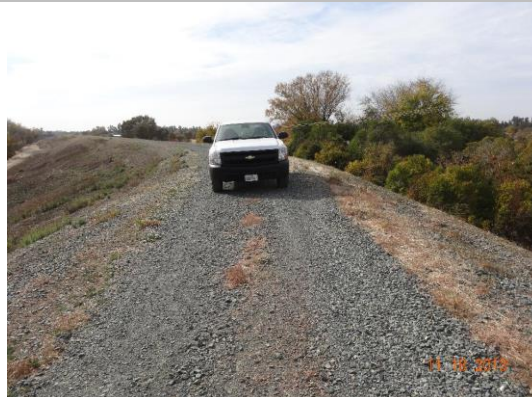
Photo 1 of 3 : UCIP_SP_2021_62558_51386.jpg

FS_ID:62558
DS_ID:21262
EP_NO: N/A
Repair Type: Non-Urgent
Crossing Status: Found
UCIP Comments: 11/25/2020 see UCIP marked up RD0010 USACE O&M manual OM151_IrrDRNSect.pdf and USACE drawing AB_4-295.pdf for approximate location and station. Reference files have been filed under UCIP's share drive desk study background folder for RD0010. (O. Magana - DWR UCIP)04/29/2013 Crossing appears not to be in use--need to contact owner. Need to coordinate with owner to determine status of crossing. If crossing is no longer in use owner will need to contact the CVFPB to comply with Title 23. This crossing is referenced in the USACE Periodic Inspection as item USACE_CESPK_HON1_2013_p_0012. (O. Magana - DWR UCIP) FIELD_STRUCT_DESC: 10-inch steel irrigation discharge pipe through the levee, 7.3 feet below the crown. Siphon breaker in a corrugated metal pipe (CMP) riser on the waterside (WS) slope. Pump on the WS berm. Pump not present. Switch house on the WS slope. No switch house present. 24-inch concrete standpipe at the landside (LS) toe. Concrete pad is still present on the WS. [Additional Reference(s): DWR Levee Log 2005 (HLM 1.33), listed as a 10-inch steel pipe. USACE Sacramento O&M Manual, Unit No. 151, May 1953, Revised 6 Jun 2017, (Station 14+82). USACE As-built Drawing No. 04-04-0295, Sheet 2 of 5, pdf file - page 2 of 4, November 1947, Revised December 1947, referenced as Station 14+82, listed as a 10-inch pipe].

View of levee crown looking upstream.

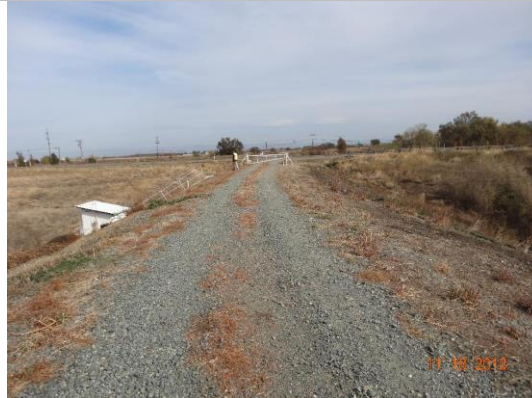
Photo 2 of 3 : UCIP_SP_2021_62558_51387.jpg

View of levee crown looking downstream.

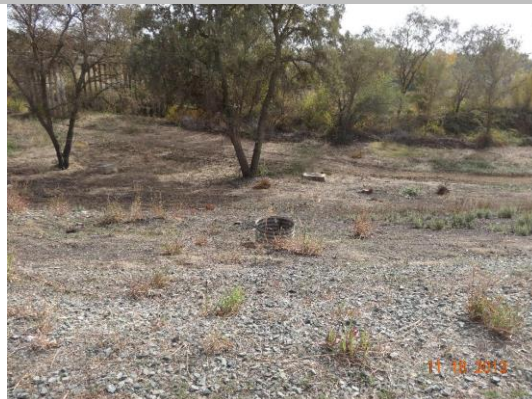
Photo 3 of 3 : UCIP_SP_2021_62558_51384.jpg

View of waterward side-slopes cleared.

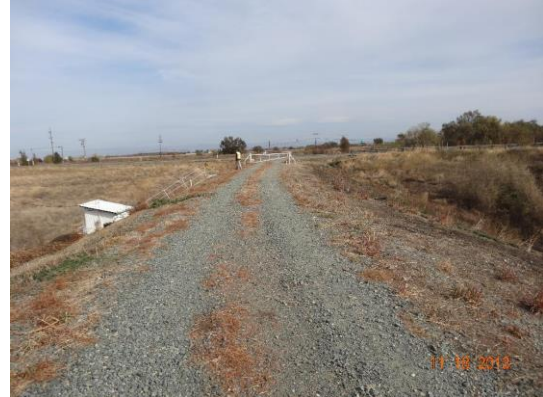
Photo 2 of 3 : UCIP_SP_2021_62549_44577.jpg

View of levee crown looking downstream.

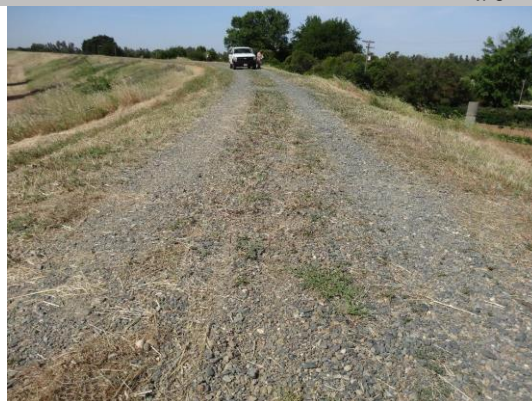
Photo 1 of 3 : UCIP_SP_2021_62559_44582.jpg

FS_ID:62559
DS_ID:21264
EP_NO: N/A
Repair Type: No Action Needed
Crossing Status: Found
UCIP Comments: 11/25/2020 see UCIP marked up RD0010 USACE O&M manual OM151_IrrDRNSect.pdf and USACE drawing AB_4-4-295.pdf for approximate location and station. Reference files have been filed under UCIP's share drive desk study background folder for RD0010. (O. Magana - DWR UCIP)04/29/2013 This crossing is referenced in the USACE Periodic Inspection as item USACE_CESPK_HON1_2013_p_0004. (O. Magana - DWR UCIP) FIELD_STRUCT_DESC: [Reclamation District No. 10 (RD0010) Drainage Plant] 16-inch steel drainage discharge pipe through the levee, 7 feet below the crown. Steel cutoff plate around the pipe at the center of the levee. Siphon breaker on the landside (LS) slope. Flap gate on the waterside (WS) end. Pump in a pit at the LS toe with steps along the LS slope. Saddle and 8-foot splash apron at the discharge end of the pipe. Concrete headwall at the LS toe. Metal shed on the LS slope. [Additional Reference(s): DWR Levee Log, 2005 (HLM 1.35), listed as a 16-inch steel pipe. USACE Sacramento O&M Manual, Unit No. 151, May 1953, Revised 6 Jun 2017, (Station 13+88), listed as a 16-inch steel pipe. USACE As-built Drawing No. 04-04-0295, Sheet 2 of 5, pdf file - page 2 of 4, November 1947, Revised December 1947, referenced as 13+88, listed as a 10-inch pipe]

View of levee crown looking upstream of crossing.

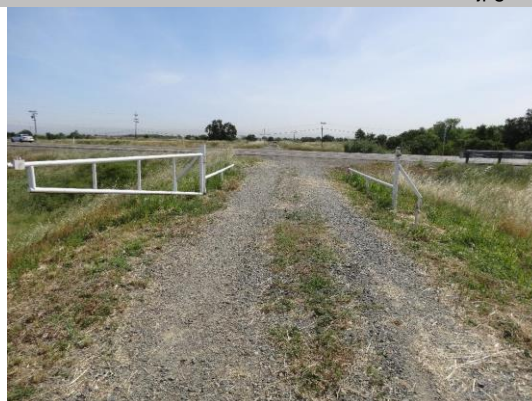
Photo 2 of 3 : UCIP_SP_2021_62559_44581.jpg

View of levee crown looking downstream--access gate near HWY 70.

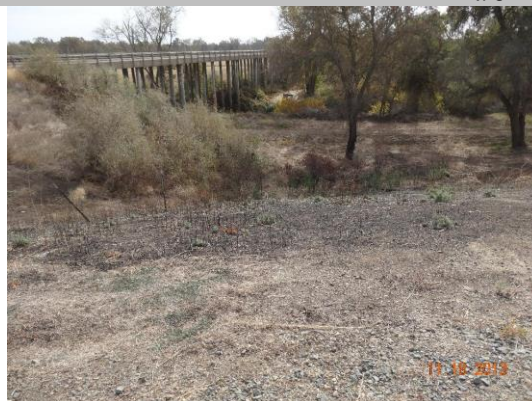
Photo 3 of 3 : UCIP_SP_2021_62559_44585.jpg

View of waterward side.

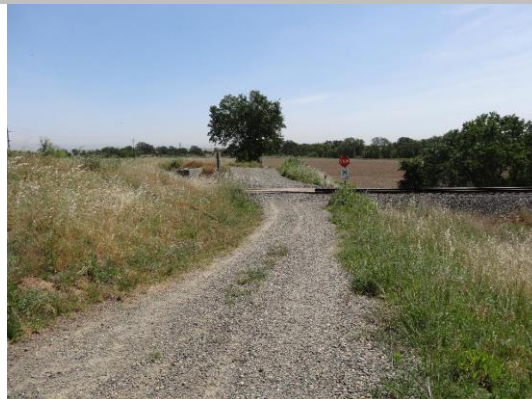
Photo 1 of 3 : UCIP_SP_2021_62535_51501.jpg

FS_ID:62535
DS_ID:21268
EP_NO: N/A
Repair Type: Non-Urgent
Crossing Status: Found
UCIP Comments: 11/25/2020 see UCIP marked up RD0010 USACE O&M manual OM151_IrrDRNSect.pdf and USACE drawing AB_4-295.pdf for approximate location and station. Reference files have been filed under UCIP's share drive desk study background folder for RD0010. (O. Magana - DWR UCIP)04/29/2013 Vegetation has been cleared from slope. This crossing is referenced in the USACE Periodic Inspection as item USACE_CESPK_HON1_2013_p_0158. (O. Magana - DWR UCIP)
FIELD_STRUCT_DESC: 24-inch corrugated metal gravity drainage pipe through the levee, 30 feet below the crown. Flap gate on the waterside (WS) end. Slide gate on the landside (LS) end. Concrete saddle and apron on the WS. [Additional Reference(s): DWR Levee Log, 2005 (HLM 1.60), listed as a 24-inch corrugated metal pipe (CMP). USACE Sacramento O&M Manual, Unit No. 151, May 1953, Revised 6 Jun 2017, (Station 1+00). USACE As-built Drawing No. 04-04-0295, Sheet 2 of 5, pdf file - page 2 of 4, November 1947, Revised December 1947, referenced as Station 0+82, listed as a 24-inch CMP. USACE As-built Drawing No. 04-04-0245-3, pdf file - page 1 of 2, Revised October 1940, referenced as Station 208+11, listed as a 48-inch corrugated metal pipe (CMP) and remove existing 24-inch concrete pipe]

View of levee crown looking downstream.

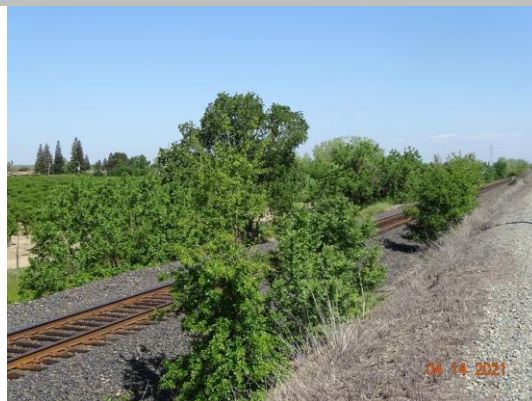
Photo 1 of 1 : SP_2021_RD0010_163_34_20210427_00115.jpg

LM Start	1.65	Rating **	M	Issue No.	34
LM End	1.69	Issue Type +	Ma	Location *	LS
Category	Earthen Levee			GPS Latitude/Longitude	
				Start	End
Item	Trim / Thin Trees			39.169788 °	39.170335 °
				-121.585746 °	-121.585683 °
DWR ID	DWR_RD0010_01_f_2019_34				
Comment Code					
T3 : Trim and thin trees to allow visibility of the ground and room to flood fight.					
Inspector Comment					
Trees with less than 4" diameter at chest height should be removed, Spring 2021.

View looking upstream landside of small starter trees that need to be removed, Spring 2021.

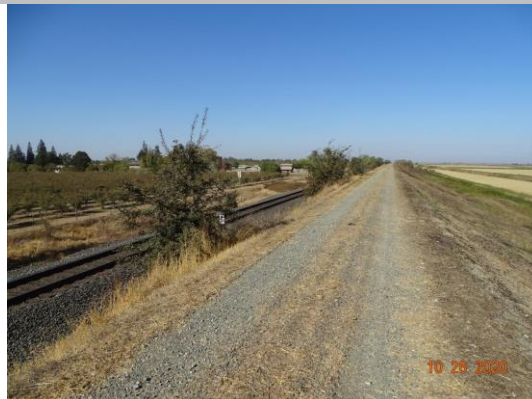
Photo 1 of 1 : SP_2021_RD0010_163_68_20210301_00039.jpg

LM Start	1.76	Rating **	M	Issue No.	68
LM End	1.79	Issue Type +	Ma	Location *	LS
Category	Earthen Levee			GPS Latitude/Longitude	
				Start	End
Item	Trim / Thin Trees			39.171328 °	39.171855 °
				-121.585561 °	-121.585503 °
DWR ID	DWR_RD0010_01_s _ 2020_68				
Comment Code					
T3 : Trim and thin trees to allow visibility of the ground and room to flood fight.					
Inspector Comment					
Trees with less than 4" diameter at chest height should be removed, Spring 2021.

View looking upstream landside at small starter trees on levee slope, Fall 2020.

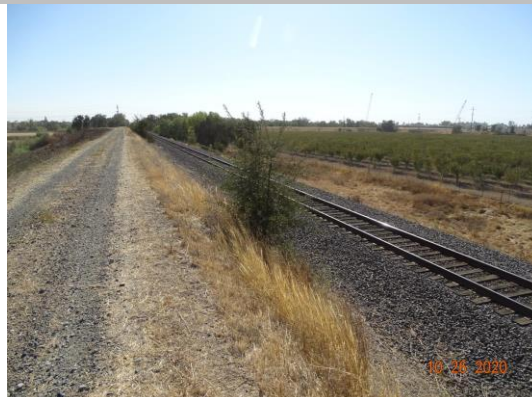
Photo 1 of 1 : SP_2021_RD0010_163_77_20210301_00047.jpg

LM Start	1.83	Rating **	M	Issue No.	77
LM End	1.83	Issue Type +	Ma	Location *	LS
Category	Earthen Levee			GPS Latitude/Longitude	
				Start	End
Item	Trim / Thin Trees			39.172385 °	39.172385 °
				-121.585433 °	-121.585433 °
DWR ID	DWR_RD0010_01_f_2020_77				
Comment Code					
T3 : Trim and thin trees to allow visibility of the ground and room to flood fight.					
Inspector Comment					
Trees with less than 4" diameter at chest height should be removed, Spring 2021.

View looking downstream landside at small starter trees that need to be removed, Fall 2020

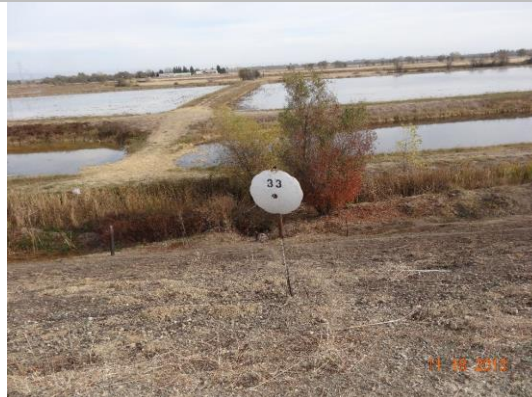
Photo 1 of 3 : UCIP_SP_2021_27745_51429.jpg

Comment Code						
Inspector Comment						
FS_ID:27745 DS_ID:21271 EP_NO: N/A Repair Type: Non-Urgent Crossing Status: Found UCIP Comments: 04/29/2013 Unable to determine if crossing is still present on landward side--need to confirm. Need to contact owner to determine status of crossing. This crossing is referenced in the USACE Periodic Inspection as item USACE_CESPK_HON1_2013_p_0185. (O. Magana - DWR UCIP) FIELD_STRUCT_DESC: 24-inch gravity drainage pipe of an unknown material through the levee, 30 feet below the crown. Flap gate on the waterside (WS) end. Concrete headwall at each toe. [Additional Reference(s): DWR Levee Log, 2005 (HLM 2.16), listed as a 24-inch pipe] FS Date: 4/29/2013

View of waterward side--marker indicating crossing visible on waterward shoulder.

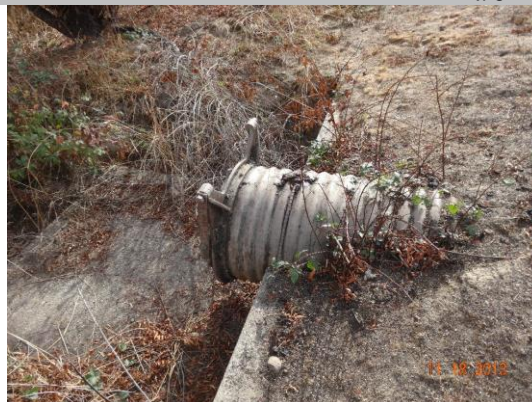
Photo 2 of 3 : UCIP_SP_2021_27745_51432.jpg

View of pipe, headwall, and flap gate located on waterward side.

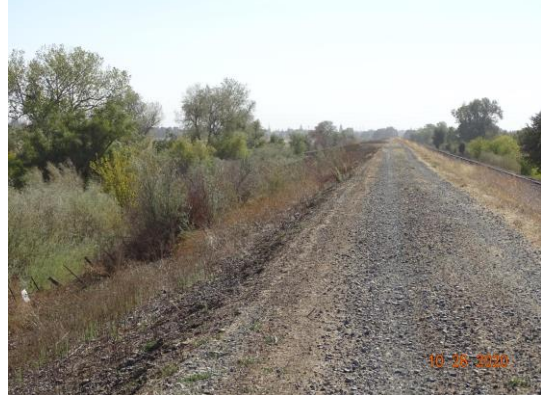
Photo 1 of 1 : SP_2021_RD0010_163_35_20210301_00007.jpg

LM Start	2.70	Rating **	M	Issue No.	35
LM End	2.70	Issue Type +	Ma	Location *	WS
Category	Earthen Levee			GPS Latitude/Longitude	
				Start	End
Item	Trim / Thin Trees			39.184974 °	39.184974 °
				-121.583836 °	-121.583836 °
DWR ID	DWR_RD0010_01_f_2017_35				
Comment Code					
T3 : Trim and thin trees to allow visibility of the ground and room to flood fight.					
Inspector Comment					
Trees with less than 4" diameter at chest height should be removed, Spring 2021.

View looking downstream waterside at Willow Trees that need to be removed, Fall 2020.

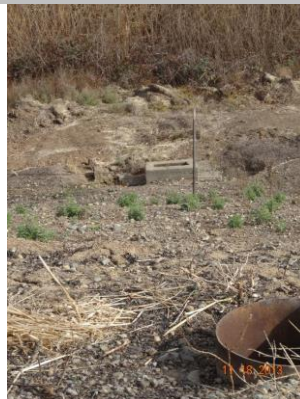
Photo 1 of 3 : UCIP_SP_2021_53137_44608.jpg

FS_ID:53137
DS_ID:21272
EP_NO: 14020
Repair Type: Urgent
Crossing Status: Indicator Found
UCIP Comments: 10/30/2018 Erosion around the concrete box is still present. Erosion does not appear to have progressed since 2013. Unable to determine reason for subsidence around the concrete box located on the WS toe. Recommend internal inspection to determine the condition of the pipe through the levee. Permit recordation indicates that the 10-inch pipe was sleeved through a 16-inch pipe where the annular space between the pipes was grouted, adding some protection to the levee. Photo of the inside of the 10-inch pipe shows that the tar coating is coming off. Continue to monitor site for any changes at the WS toe and the WS slope. Crossing remains Urgent until an internal inspection can be completed to determine the integrity of the pipe through the levee. (O. Magana - DWR UCIP)7/01/2016 Dense vegetation--unable to determine if the sink hole/slope depression noted back in Jan 2013 in the USACE's PI Report is still present. Need to revisit the site once vegetation from the slopes has been cleared. (O. Magana - DWR UCIP)4/29/2013 Unable to determine status of crossing--sink hole was observed as part of the USACE Periodic Inspection Report dated May 2013. Need to coordinate with owner to determine status of crossing. If crossing is no longer in use owner will need to contact the CVFPB to comply with Title 23. Need to confirm with Finney to determine if pump and controls belong to pipe crossing located on landward side. This crossing is referenced in the USACE Periodic Inspection as item USACE_CESPK_HON1_2013_p_0192. (O. Magana - DWR UCIP)

FIELD_STRUCT_DESC: 10-inch coated steel gravity drainage pipe sleeved through a 16-inch steel pipe, 5 feet below the crown. Annular space between the 10-inch and the 16-inch pipes has been grouted. Concrete cutoff wall around pipe at the center of the levee. Siphon breaker on the waterside (WS) shoulder. Flap gate and concrete headwall on the WS toe. Pump on the landside (LS). This drainage pipe is used to divert water from the drainage ponds that serve the residential development located on the LS to Jack Slough. (Plans to install a 10-inch steel storm water discharge pipe through the levee authorized under Permit No. 14020, 1985 - California North Lands, Inc.). [Additional Reference(s): DWR Levee Log, 2005 (HLM 2.82), listed as a 10-inch pipe]
FS Date: 10/30/2018

View of WS--concrete box located located at WS toe.

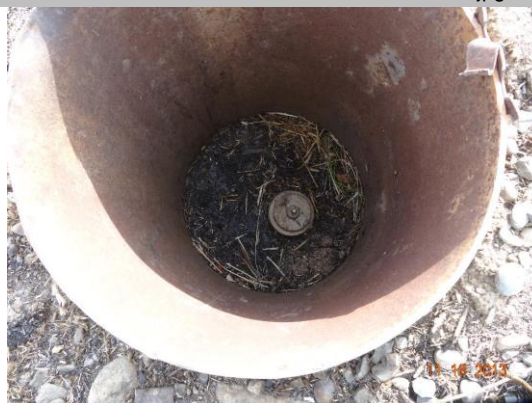
Photo 3 of 3 : UCIP_SP_2021_53137_44606.jpg

LM Start	2.78	Rating **	U	Issue No.	20 (cont)
LM End	2.78	Issue Type +	En	Location *

View of siphon breaker located inside steel riser.

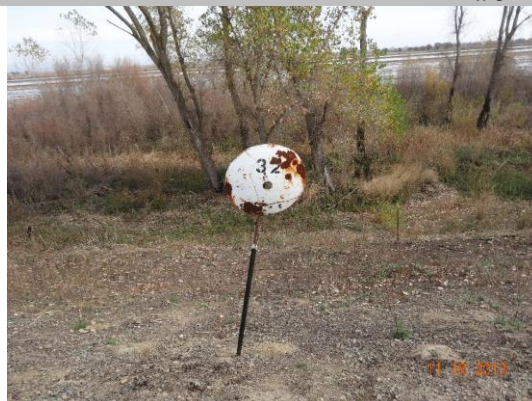
Photo 1 of 3 : UCIP_SP_2021_24816_44611.jpg

FS_ID:14816
DS_ID:21317
EP_NO: N/A
Repair Type: Non-Urgent
Crossing Status: Indicator Found
UCIP Comments: 12/01/2020 see UCIP marked up RD0010 USACE O&M manual OM151_IrrDRNSect.pdf and USACE drawing AB_4-4-245-3.pdf for approximate location and station. Reference files have been filed under UCIP's share drive desk study background folder for RD0010. (O. Magana - DWR UCIP)
04/29/2013 Indicator marker visible on WS; Dense vegetation on waterward toe and landward side access limits the inspector's visibility to identify signs of pipe failure (leaks) along the slope. Recommend removing vegetation along pipe alignment to conduct proper inspection of structure and appurtenances. Access to landward side will need to be coordinated with railroad. Need to coordinate with owner to determine status of crossing. If crossing is no longer in use owner will need to contact the CVFPB to comply with Title 23. This crossing is referenced in the USACE Periodic Inspection as item

USACE_CESPK_HON1_2013_p_0204. (O. Magana - DWR UCIP)
FIELD_STRUCT_DESC: 24-inch corrugated metal gravity drainage pipe through the levee, 23 feet below the crown. Flap gate on the waterside (WS) end. Concrete headwall at each toe. Siphon breaker on the WS shoulder, unable to find. Concrete saddle and apron on the WS. [Additional Reference(s): DWR Levee Log, 2005 (HLM 3.36), listed as a 24-inch corrugated metal pipe (CMP). USACE Sacramento O&M Manual, Unit No. 151, May 1953, Revised 6 Jun 2017, (Station 299+56). USACE As-built Drawing No. 04-04-0245-3, pdf file - page 1 of 2, Revised October 1940, referenced as Station 299+56, listed as a 24-inch CMP]
FS Date: 4/29/2013

View of marker visible on waterward shoulder.

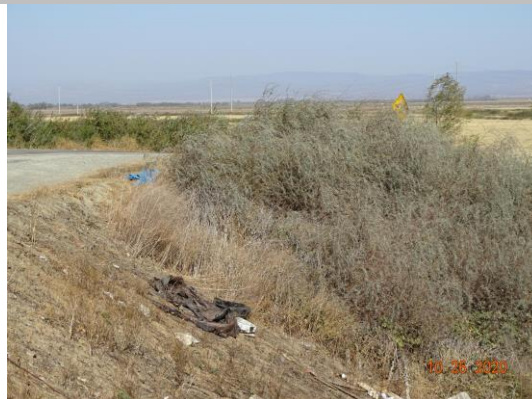
Photo 1 of 1 : SP_2021_RD0010_163_70_20210301_00041.jpg

LM Start	3.60	Rating **	M	Issue No.	70
LM End	3.60	Issue Type +	Ma	Location *	WS
Category	Earthen Levee			GPS Latitude/Longitude	
				Start	End
Item	Trim / Thin Trees			39.197886 °	39.197886 °
				-121.582069 °	-121.582069 °
DWR ID	DWR_RD0010_01_s_2020_70				
Comment Code					
T3 : Trim and thin trees to allow visibility of the ground and room to flood fight.					
Inspector Comment					
Trees with less than 4" diameter at chest height should be removed, Spring 2021.

View looking upstreamwaterside at small starter tree on levee slope, Fall 2020.

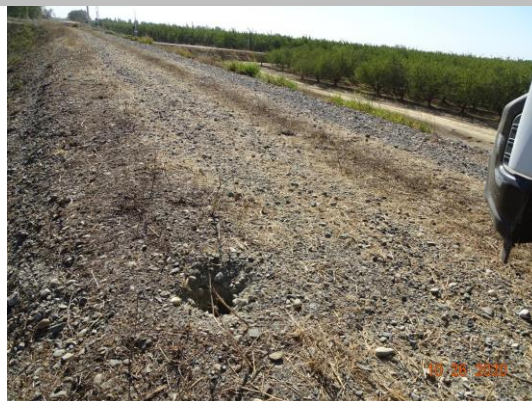
Photo 1 of 1 : SP_2021_RD0010_163_73_20210301_00044.jpg

LM Start	3.67	Rating **	M	Issue No.	73
LM End	3.67	Issue Type +	Ma	Location *	CR
Category	Earthen Levee			GPS Latitude/Longitude	
				Start	End
Item	Animal Control			39.198929 °	39.198929 °
				-121.582140 °	-121.582140 °
DWR ID	DWR_RD0010_01_f_2020_73				
Comment Code					
A3 : No rodents visible, but rodent burrows visible; need to backfill and compact or grout burrows.					
Inspector Comment					
Squirrel holes still are visible but there is no sign of activity, Fall 2020.

View of rodent hole on levee crown, Fall 2020.

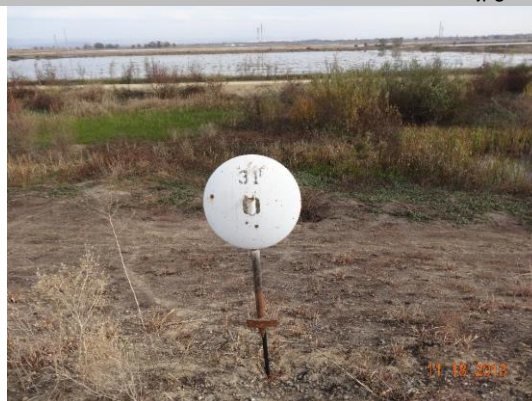
Photo 1 of 3 : UCIP_SP_2021_27746_51436.jpg

Comment Code					
Inspector Comment					
FS_ID:27746 DS_ID:21273 EP_NO: N/A Repair Type: No Action Needed Crossing Status: Found UCIP Comments: 12/01/2020 see UCIP marked up RD0010 USACE O&M manual OM151_IrrDRNSect.pdf and USACE drawing AB_4-4-245-3.pdf for approximate location and station. Reference files have been filed under UCIP's share drive desk study background folder for RD0010. (O. Magana - DWR UCIP) 04/29/2013 This crossing is referenced in the USACE Periodic Inspection as item USACE_CESPK_HON1_2013_p_0217. (O. Magana - DWR UCIP) FIELD_STRUCT_DESC: 24-inch reinforced concrete gravity drainage pipe through the levee, 19.5 feet below the crown. Flap gate on the waterside (WS) end. Concrete headwall at each toe. Concrete saddle and apron on the WS. [Additional Reference(s): DWR Levee Log, 2005 (HLM 3.71), listed as a 24-inch pipe. USACE Sacramento O&M Manual, Unit No. 151, May 1953, Revised 6 Jun 2017, (Station 317+80). USACE As-built Drawing No. 04-04-0245-3, pdf file - page 1 of 2, Revised October 1940, referenced as Station 317+80, listed as a 24-inch concrete pipe] FS Date: 4/29/2013

View of waterward side--marker for pipe visible on waterward shoulder.

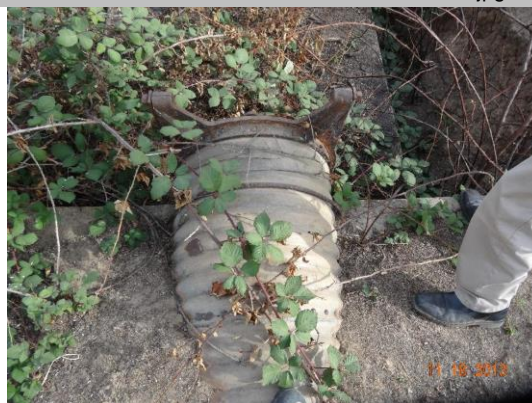
Photo 3 of 3 : UCIP_SP_2021_27746_51439.jpg

LM Start	3.70	Rating **	A/W	Issue No.	22 (cont)
LM End	3.70	Issue Type +	Ma	Location *

View of pipe, headwall, and concrete apron on waterward toe.

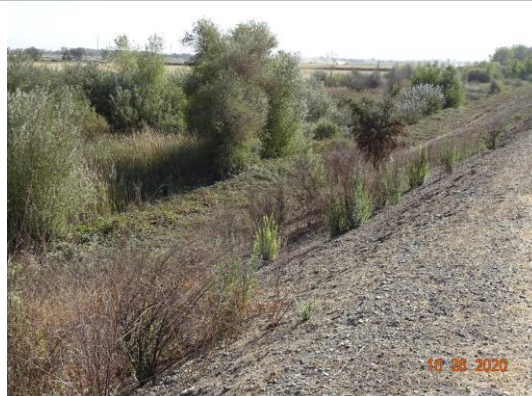
Photo 1 of 1 : SP_2021_RD0010_163_49_20210301_00021.jpg

LM Start	3.91	Rating **	M	Issue No.	49
LM End	3.91	Issue Type +	Ma	Location *	WS
Category	Earthen Levee			GPS Latitude/Longitude	
				Start	End
Item	Trim / Thin Trees			39.202358 °	39.202358 °
				-121.581714 °	-121.581714 °
DWR ID	DWR_RD0010_01_s_2016_49				
Comment Code					
T3 : Trim and thin trees to allow visibility of the ground and room to flood fight.					
Inspector Comment					
Trees with less than 4" diameter at chest height should be removed, Spring 2021.

View looking downstream waterside at small starter trees on levee slope, Fall 2020.

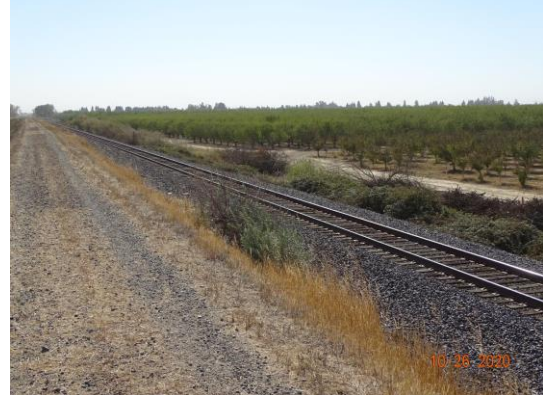
Photo 1 of 1 : SP_2021_RD0010_163_47_20210301_00019.jpg

LM Start	3.92	Rating **	M	Issue No.	47
LM End	3.92	Issue Type +	Ma	Location *	LS
Category	Earthen Levee			GPS Latitude/Longitude	
				Start	End
Item	Trim / Thin Trees			39.202515 °	39.202515 °
				-121.581692 °	-121.581692 °
DWR ID	DWR_RD0010_01_s_2016_47				
Comment Code					
T3 : Trim and thin trees to allow visibility of the ground and room to flood fight.					
Inspector Comment					
Trees with less than 4" diameter at chest height should be removed, Spring 2021.

View of a small willow tree that should be removed on the landside looking downstream.

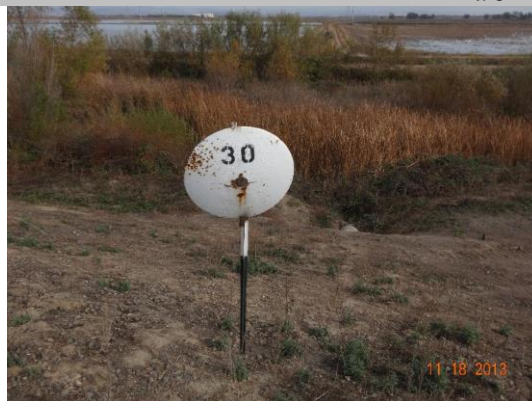
Photo 1 of 3 : UCIP_SP_2021_27747_51441.jpg

Comment Code					
Inspector Comment					
FS_ID:27747 DS_ID:21274 EP_NO: N/A Repair Type: Non-Urgent Crossing Status: Indicator Found UCIP Comments: 12/01/2020 see UCIP marked up RD0010 USACE O&M manual OM151_IrrDRNSect.pdf and USACE drawing AB_4-4-320.pdf for approximate location and station. Reference files have been filed under UCIP's share drive desk study background folder for RD0010. (O. Magana - DWR UCIP) 04/29/2013 sign marker on WS 30; Unable to confirm landward side. This crossing is referenced in the USACE Periodic Inspection as item USACE_CESPK_HON1_2013_p_0232. (O. Magana - DWR UCIP) FIELD_STRUCT_DESC: 24-inch corrugated metal gravity drainage pipe through the levee, 18 feet below the crown. Corrugated metal cutoff wall around the pipe at the center of the levee. Flap gate and 6-foot by 6-foot splash apron on the waterside (WS) end. [Additional Reference(s): DWR Levee Log, 2005 (HLM 4.13), listed as a 24-inch corrugated metal pipe (CMP). USACE Sacramento O&M Manual, Unit No. 151, May 1953, Revised 6 Jun 2017, (Station 339+55.10). USACE As-built Drawing No. 04-04-0320, Sheet 320/2.1, pdf file - page 2 of 3, Revised January 1951, referenced as Station 339+55.10, listed as a 24-inch CMP] FS Date: 4/29/2013

LM Start	4.11	Rating **	M	Issue No.	23 (cont)
LM End	4.11	Issue Type +	En	Location *

View of waterward side--marker indicating crossing located on waterward shoulder.

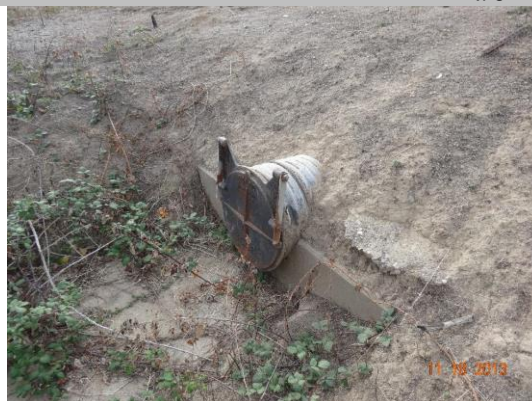
Photo 2 of 3 : UCIP_SP_2021_27747_51445.jpg

View of pipe, flap gate, and headwall located on waterward toe.

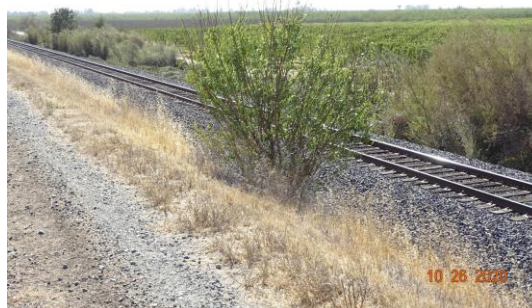
Photo 1 of 1 : SP_2021_RD0010_163_31_20210301_00004.jpg

LM Start	4.21	Rating **	M	Issue No.	31
LM End	4.21	Issue Type +	Ma	Location *	LS
Category	Earthen Levee			GPS Latitude/Longitude	
				Start	End
Item	Trim / Thin Trees			39.206674 °	39.206674 °
				-121.581163 °	-121.581163 °
DWR ID	DWR_RD0010_01_s_2020_31				
Comment Code					
T3 : Trim and thin trees to allow visibility of the ground and room to flood fight.					
Inspector Comment					
Trees with less than 4" diameter at chest height should be removed, Spring 2021.

View looking downstream landside at small starter trees on levee slope, Fall 2020.

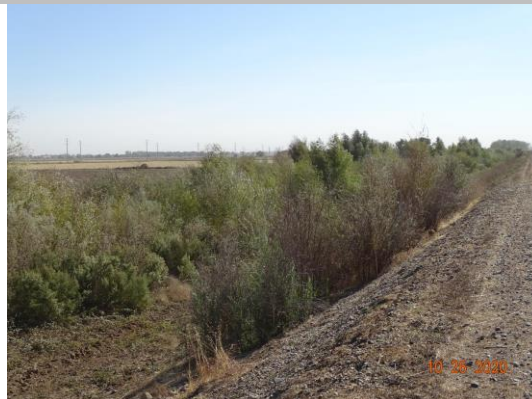
Photo 1 of 1 : SP_2021_RD0010_163_53_20210301_00025.jpg

LM Start	4.28	Rating **	M	Issue No.	53
LM End	4.28	Issue Type +	Ma	Location *	WS
Category	Earthen Levee			GPS Latitude/Longitude	
				Start	End
Item	Trim / Thin Trees			39.207621 °	39.207621 °
				-121.581050 °	-121.581050 °
DWR ID	DWR_RD0010_01_s _ 2020_53				
Comment Code					
T3 : Trim and thin trees to allow visibility of the ground and room to flood fight.					
Inspector Comment					
Trees with less than 4" diameter at chest height should be removed, Spring 2021.

View looking downstream waterside at small starter trees on levee slope, Fall 2020.

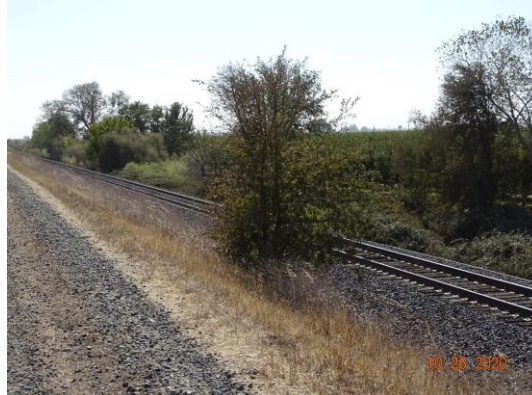
Photo 1 of 1 : SP_2021_RD0010_163_39_20210301_00011.jpg

LM Start	4.63	Rating **	M	Issue No.	39
LM End	4.63	Issue Type +	Ma	Location *	LS
Category	Earthen Levee			GPS Latitude/Longitude	
				Start	End
Item	Trim / Thin Trees			39.212749 °	39.212749 °
				-121.580406 °	-121.580406 °
DWR ID	DWR_RD0010_01_f_2019_39				
Comment Code					
T3 : Trim and thin trees to allow visibility of the ground and room to flood fight.					
Inspector Comment					
Trees with less than 4" diameter at chest height should be removed, Spring 2021.

View looking downstream landside at small starter trees that need to be removed, Fall 2020

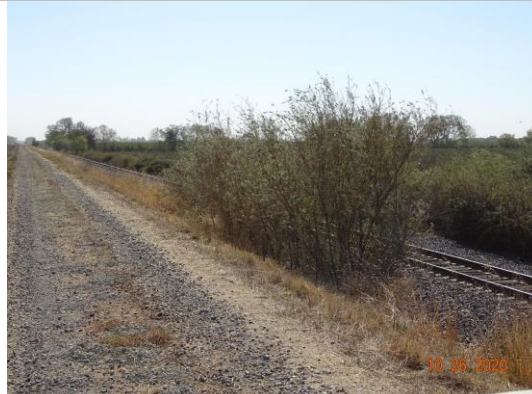
Photo 1 of 1 : SP_2021_RD0010_163_37_20210301_00009.jpg

LM Start	4.83	Rating **	M	Issue No.	37
LM End	4.83	Issue Type +	Ma	Location *	LS
Category	Earthen Levee			GPS Latitude/Longitude	
				Start	End
Item	Trim / Thin Trees			39.215597 °	39.215597 °
				-121.580046 °	-121.580046 °
DWR ID	DWR_RD0010_01_f_2017_37				
Comment Code					
T3 : Trim and thin trees to allow visibility of the ground and room to flood fight.					
Inspector Comment					
Trees with less than 4" diameter at chest height should be removed, Spring 2021.

View of small willow trees on the landside slope looking downstream, Fall 2020

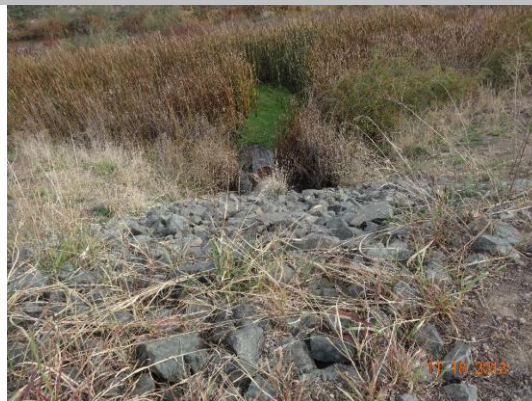
Photo 3 of 3 : UCIP_SP_2021_53138_44810.jpg

LM Start	4.90	Rating **	U	Issue No.	24 (cont)
LM End	4.90	Issue Type +	Ma	Location *

View of WS slope covered with rip rap along pipe alignment.

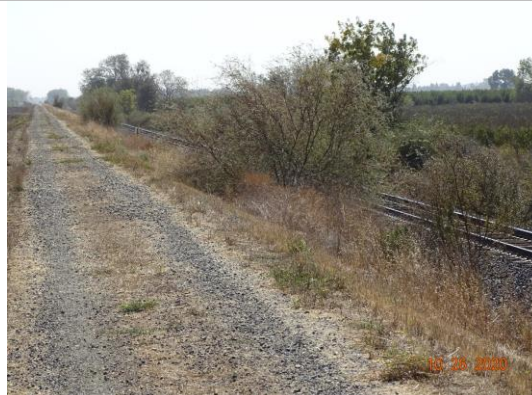
Photo 1 of 1 : SP_2021_RD0010_163_54_20210301_00026.jpg

LM Start	4.92	Rating **	M	Issue No.	54
LM End	4.92	Issue Type +	Ma	Location *	LS
Category	Earthen Levee			GPS Latitude/Longitude	
				Start	End
Item	Trim / Thin Trees			39.216829 °	39.216829 °
				-121.579900 °	-121.579900 °
DWR ID	DWR_RD0010_01_s_2020_54				
Comment Code					
T3 : Trim and thin trees to allow visibility of the ground and room to flood fight.					
Inspector Comment					
Trees with less than 4" diameter at chest height should be removed, Spring 2021.

View looking downstream landside at small starter tree on levee slope, Fall 2020.

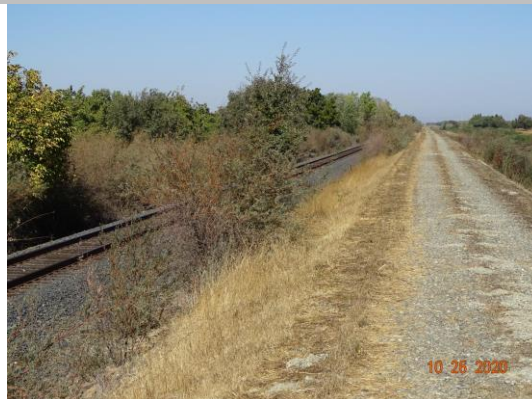
Photo 1 of 1 : SP_2021_RD0010_163_56_20210301_00028.jpg

LM Start	5.42	Rating **	M	Issue No.	56
LM End	5.42	Issue Type +	Ma	Location *	LS
Category	Earthen Levee			GPS Latitude/Longitude	
				Start	End
Item	Trim / Thin Trees			39.224014 °	39.224014 °
				-121.579012 °	-121.579012 °
DWR ID	DWR_RD0010_01_s_2021_56				
Comment Code					
T3 : Trim and thin trees to allow visibility of the ground and room to flood fight.					
Inspector Comment					
Trees with less than 4" diameter at chest height should be removed, Spring 2021.

View looking upstream landside at small starter trees on levee slope, Fall 2020.

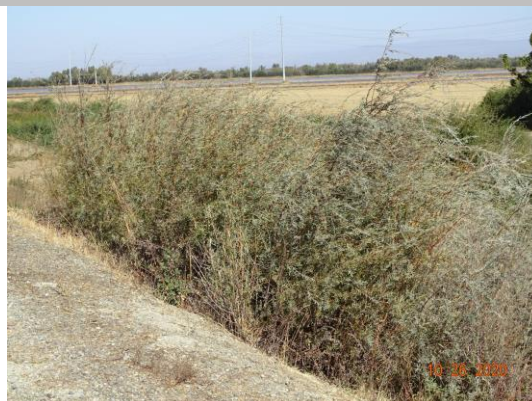
Photo 1 of 1 : SP_2021_RD0010_163_62_20210301_00034.jpg

LM Start	5.42	Rating **	M	Issue No.	62
LM End	5.42	Issue Type +	Ma	Location *	WS
Category	Earthen Levee			GPS Latitude/Longitude	
				Start	End
Item	Trim / Thin Trees			39.224041 °	39.224041 °
				-121.579008 °	-121.579008 °
DWR ID	DWR_RD0010_01_s_2020_62				
Comment Code					
T3 : Trim and thin trees to allow visibility of the ground and room to flood fight.					
Inspector Comment					
Trees with less than 4" diameter at chest height should be removed, Spring 2021.

View looking upstream waterside at small starter tree on levee slope, Fall 2020.

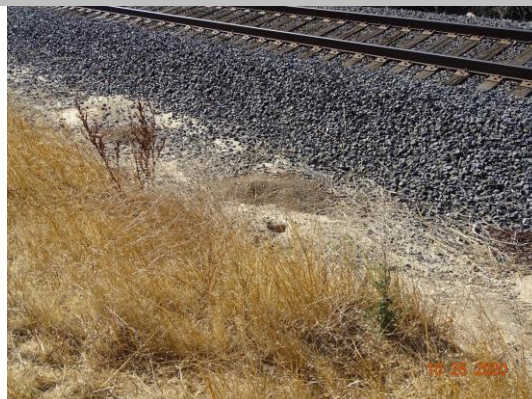
Photo 1 of 1 : SP_2021_RD0010_163_41_20210301_00013.jpg

LM Start	5.45	Rating **	M	Issue No.	41
LM End	5.45	Issue Type +	Ma	Location *	LS
Category	Earthen Levee			GPS Latitude/Longitude	
				Start	End
Item	Animal Control			39.224485 °	39.224485 °
				-121.578944 °	-121.578944 °
DWR ID	DWR_RD0010_01_s_2016_41				
Comment Code					
A3 : No rodents visible, but rodent burrows visible; need to backfill and compact or grout burrows.					
Inspector Comment					
Squirrel holes still are visible but there is no sign of activity.

View of multiple ground squirrel holes on landside slope looking downstream. There is no evidence of active squirrels. Fall 2020

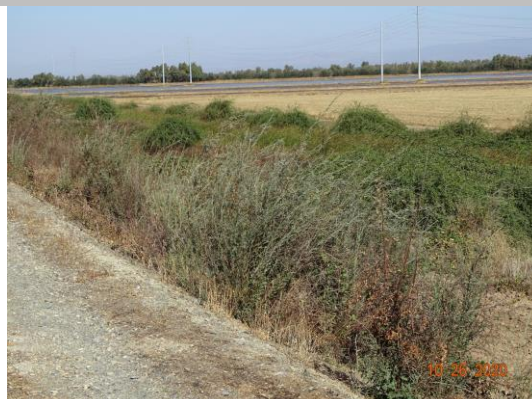
Photo 1 of 1 : SP_2021_RD0010_163_65_20210301_00037.jpg

LM Start	5.46	Rating **	M	Issue No.	65
LM End	5.52	Issue Type +	Ma	Location *	WS
Category	Earthen Levee			GPS Latitude/Longitude	
				Start	End
Item	Trim / Thin Trees			39.224652 °	39.225433 °
				-121.578929 °	-121.578832 °
DWR ID	DWR_RD00010_01_s_2020_65				
Comment Code					
T3 : Trim and thin trees to allow visibility of the ground and room to flood fight.					
Inspector Comment					
Trees with less than 4" diameter at chest height should be removed, Spring 2021.

View looking upstream waterside at small starter tree on levee slope, Fall 2020.

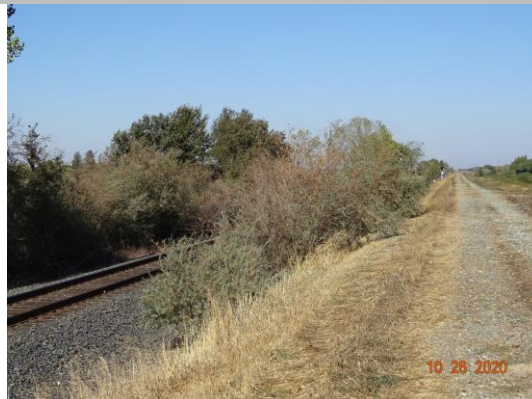
Photo 1 of 1 : SP_2021_RD0010_163_40_20210301_00012.jpg

LM Start	5.60	Rating **	M	Issue No.	40
LM End	5.60	Issue Type +	Ma	Location *	LS
Category	Earthen Levee			GPS Latitude/Longitude	
				Start	End
Item	Trim / Thin Trees			39.226679 °	39.226679 °
				-121.578670 °	-121.578670 °
DWR ID	DWR_RD0010_01_s_2016_40				
Comment Code					
T3 : Trim and thin trees to allow visibility of the ground and room to flood fight.					
Inspector Comment					
Trees with less than 4" diameter at chest height should be removed, Spring 2021.

View of willow trees on the landside slope looking upstream, Fall 2020

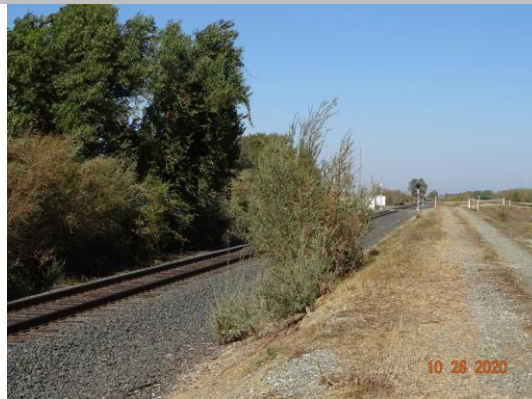
Photo 1 of 1 : SP_2021_RD0010_163_66_20210301_00038.jpg

LM Start	6.01	Rating **	M	Issue No.	66
LM End	6.01	Issue Type +	Ma	Location *	LS
Category	Earthen Levee			GPS Latitude/Longitude	
				Start	End
Item	Trim / Thin Trees			39.232602 °	39.232602 °
				-121.577954 °	-121.577954 °
DWR ID	DWR_RD0010_01_s_2020_66				
Comment Code					
T3 : Trim and thin trees to allow visibility of the ground and room to flood fight.					
Inspector Comment					
Trees with less than 4" diameter at chest height should be removed, Spring 2021.

View looking upstream landside at small starter tree on levee slope, Fall 2020.

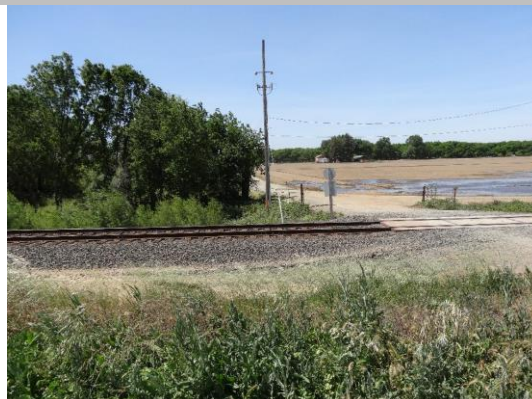
Photo 1 of 3 : UCIP_SP_2021_27531_51124.jpg

Comment Code						
Inspector Comment						
FS_ID:27531 DS_ID:21277 EP_NO: 6127 Repair Type: Non-Urgent Crossing Status: Indicator Found UCIP Comments: 04/29/2013 Recommend removing vegetation along pipe alignment to conduct proper inspection of structure and appurtances. (O. Magana - DWR UCIP) FIELD_STRUCT_DESC: Two 1-inch aluminum electrical conduits through the levee, 3 feet below the crown. Cutoff wall around the conduits at the center of the levee. (Plans to construct a low levee along the bank of the canal authorized under Permit No. 6127, 1968 - Morgan C. Chambers and Edgar Meyer). [Additional Reference(s): DWR Levee Log, 2005 (HLM 6.16), listed as two 22KV cables] FS Date: 4/29/2013

LM Start	6.14	Rating **	M	Issue No.	25 (cont)
LM End	6.14	Issue Type +	En	Location *

LS view overview.

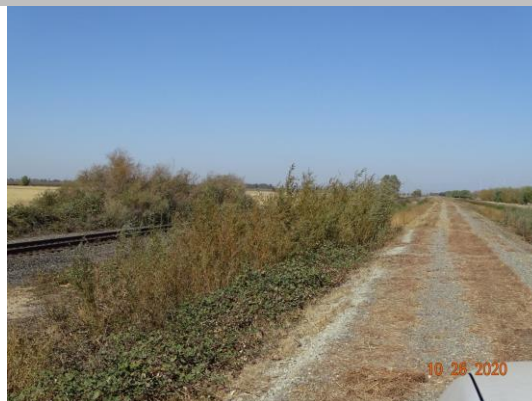
Photo 1 of 1 : SP_2021_RD0010_163_33_20210301_00005.jpg

LM Start	6.19	Rating **	M	Issue No.	33
LM End	6.19	Issue Type +	Ma	Location *	LS
Category	Earthen Levee			GPS Latitude/Longitude	
				Start	End
Item	Trim / Thin Trees			39.235216 °	39.235216 °
				-121.577532 °	-121.577532 °
DWR ID	DWR_RD0010_01_s_2020_33				
Comment Code					
T3 : Trim and thin trees to allow visibility of the ground and room to flood fight.					
Inspector Comment					
Trees with less than 4" diameter at chest height should be removed, Spring 2021.

View looking upstream landside at small starter trees on levee slope, Fall 2020.

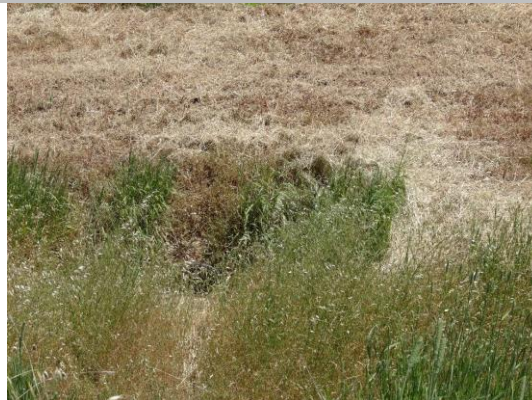
Photo 2 of 3 : UCIP_SP_2021_24438_43502.jpg

View of waterward toe where pipe daylights.

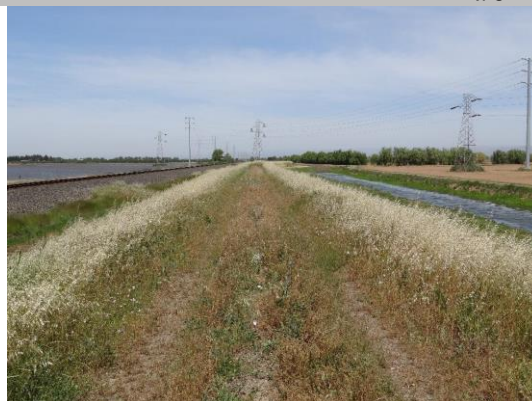
Photo 1 of 3 : UCIP_SP_2021_27532_51129.jpg

FS_ID:27532
DS_ID:21279
EP_NO: N/A
Repair Type: Non-Urgent
Crossing Status: Found
UCIP Comments: 12/01/2020 see UCIP marked up RD0010 USACE O&M manual OM151_IrrDRNSect.pdf and USACE drawing AB_4-4-320.pdf for approximate location and station. Reference files have been filed under UCIP's share drive desk study background folder for RD0010. (O. Magana - DWR UCIP)
04/29/2013 Need to clear sediment near gate. Need to coordinate with owner to determine status of crossing. If crossing is no longer in use owner will need to contact the CVFPB to comply with Title 23. This crossing is referenced in the USACE Periodic Inspection as item USACE_CESPK_HON1_2013_p_0291-294. (O. Magana - DWR UCIP)
FIELD_STRUCT_DESC: 16-inch steel drainage pipe through the levee, 10.3 feet below the crown. Cutoff wall around the pipe at the center of the levee. Slide gate on the waterside (WS) end. Pipe exposed across irrigation canal on the landside (LS). [Additional Reference(s): DWR Levee Log, 2005 (HLM 6.66), listed as a 16-inch steel pipe. USACE Sacramento O&M Manual, Unit No. 151, May 1953, Revised 6 Jun 2017, (Station 473+58). USACE As-built Drawing No. 04-04-0320, Sheet 320/3.1, pdf file - page 3 of 3, Revised January 1951, referenced as Station 473+58, listed as a 15-inch steel pipe]

View of levee looking upstream.

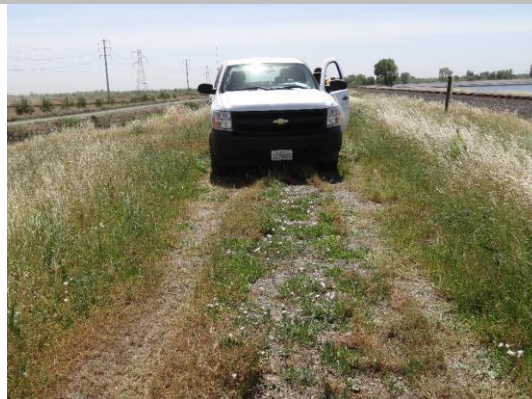
Photo 2 of 3 : UCIP_SP_2021_27532_51128.jpg

View of levee looking downstream.

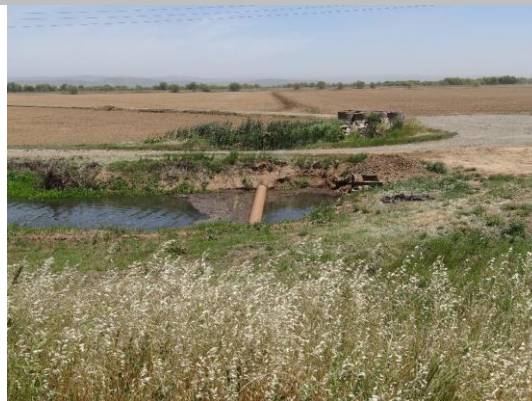
Photo 3 of 3 : UCIP_SP_2021_27532_51130.jpg

View of waterward side--pipe goes through Simmerly Slough.
