**Flood Control Project Maintenance
Levee Inspections
Unit Cover Sheet**

Reclamation District No. 0010 Honcut

Levee Inspection Report By Mile - Spring 2021

Waterway	Bank	Unit Miles	Inspection Start/End	Inspector
Unit No. 01 Simmerly Slough	Right	7.65	04/14/2021 04/14/2021	Brooks Weisser

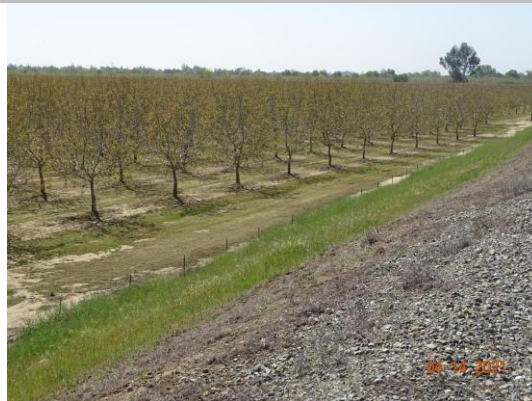
Photo 1 of 1 : SP_2021_RD0010_164_79_20210427_00151.jpg

LM Start	0.03	Rating **	M	Issue No.	79
LM End	0.16	Issue Type +	En	Location *	LS
Category	Earthen Levee			GPS Latitude/Longitude	
				Start	End
Item	Encroachments			39.164086 °	39.165935 °
				-121.610066 °	-121.610294 °
DWR ID	DWR_RD0010_02_f_2020_79				
Comment Code					
FE : Fence					
Inspector Comment					
An unpermitted fence runs along the landside toe, Spring 2021.

View of fence that runs along landside toe, Spring 2021.

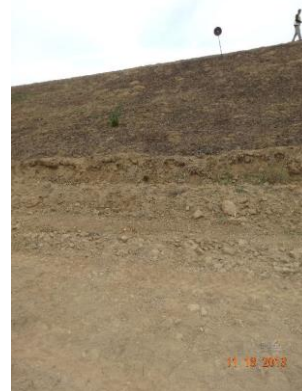
Photo 2 of 3 : UCIP_SP_2021_27533_51137.jpg

View of waterward slope.

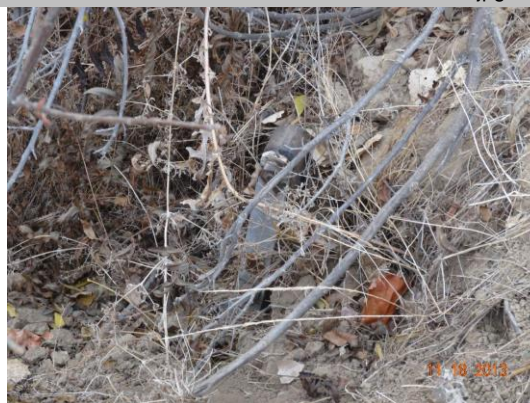
Photo 3 of 3 : UCIP_SP_2021_27533_51138.jpg

Buried flap gate on waterward side.

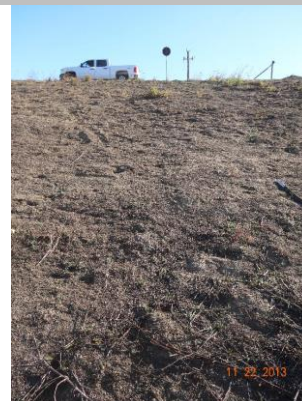
Photo 2 of 3 : UCIP_SP_2021_24821_44639.jpg

View of waterward slope side.

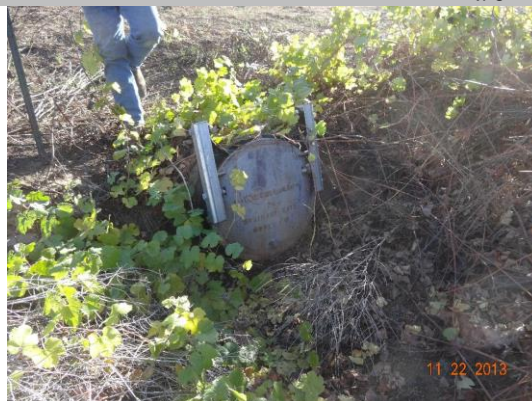
Photo 3 of 3 : UCIP_SP_2021_24821_44638.jpg

View of flap gate located on waterward side.

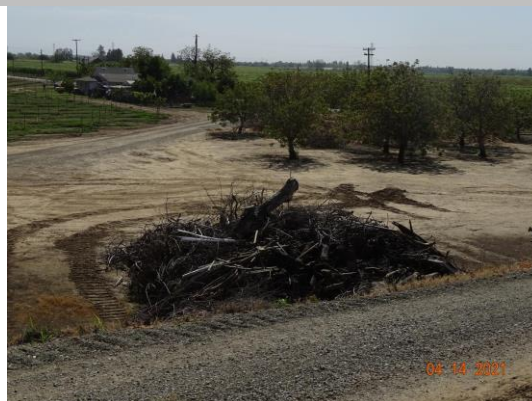
Photo 1 of 1 : SP_2021_RD0010_164_77_20210427_00149.jpg

LM Start	1.23	Rating **	M	Issue No.	77
LM End	1.23	Issue Type +	En	Location *	LS
Category	Earthen Levee			GPS Latitude/Longitude	
				Start	End
Item	Encroachments			39.181482 °	39.181482 °
				-121.610111 °	-121.610111 °
DWR ID	DWR_RD0010_02_f _ 2020_77				
Comment Code					
DE : Debris					
Inspector Comment					
Debris along landside toe should be removed, Spring 2021.

View of debris along landside toe, Spring 2021.

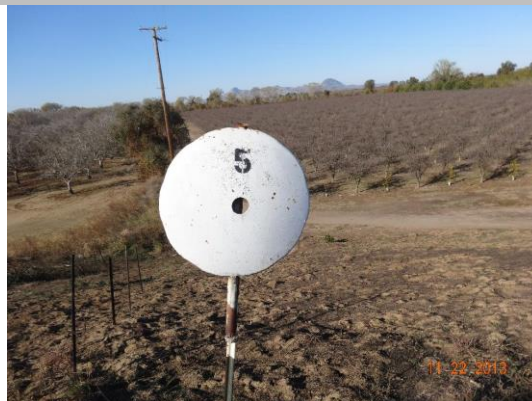
Photo 1 of 3 : UCIP_SP_2021_24822_44647.jpg

Comment Code						
Inspector Comment						
FS_ID:24822						
DS_ID:21282						
EP_NO: N/A						
Repair Type: No Action Needed						
Crossing Status: Found						
UCIP Comments: 12/01/2020 see UCIP marked up RD0010 USACE O&M manual OM151_IrrDRNSect.pdf and USACE drawing AB_4-4-295.pdf for approximate location and station. Reference files have been filed under UCIP's share drive desk study background folder for RD0010. (O. Magana - DWR UCIP)						
04/29/2013 This crossing is referenced in the USACE Periodic Inspection as item USACE_CESPK_HON2_2013_p_0109. (O. Magana - DWR UCIP)						
FIELD_STRUCT_DESC: 36-inch corrugated metal gravity drainage pipe through the levee, 25 feet below the crown. Corrugated metal cutoff wall around the pipe at each shoulder. Flap gate on the waterside (WS) end. Slide gate on the landside (LS) end. Concrete headwall, saddle, and apron on the WS end. [Additional Reference(s): DWR Levee Log, 2005 (HLM 1.49), listed as a 36-inch corrugated metal pipe (CMP). USACE Sacramento O&M Manual, Unit No. 151, May 1953, Revised 6 Jun 1971, (Station 164+65). USACE As-built Drawing No. 04-04-0295, Sheet 3 of 5, pdf file - page 3 of 4, November 1947, Revised December 1947, referenced as Station 164+65, listed as a 36-inch CMP]

Marker visible on waterward side--No. 5.

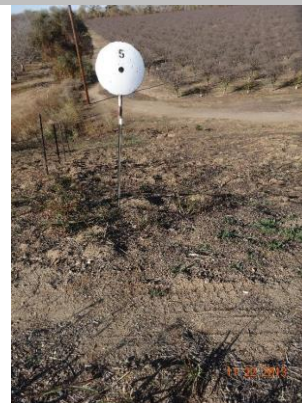
Photo 2 of 3 : UCIP_SP_2021_24822_44648.jpg

Overview of waterward slope--dense burrow activity on slope.

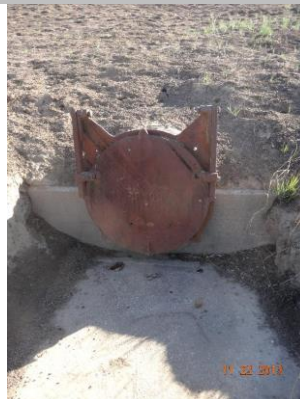
Photo 3 of 3 : UCIP_SP_2021_24822_44645.jpg

View of flap gate on waterward side.

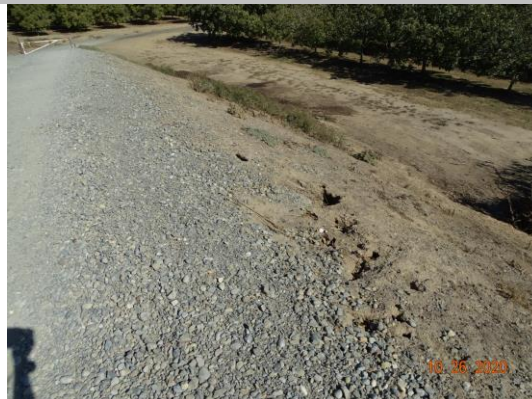
Photo 1 of 1 : SP_2021_RD0010_164_68_20210301_00034.jpg

LM Start	3.06	Rating **	M	Issue No.	68
LM End	3.06	Issue Type +	Ma	Location *	LS
Category	Earthen Levee			GPS Latitude/Longitude	
				Start	End
Item	Animal Control			39.207600 °	39.207600 °
				-121.609843 °	-121.609843 °
DWR ID	DWR_RD0010_02_s_2020_68				
Comment Code					
A1 : Exterminate rodents and backfill and compact or grout burrows.					
Inspector Comment					
Backfill squirrel hole, Spring 2021.

View looking landside at squirrel activity on the levee slope, Fall 2020.

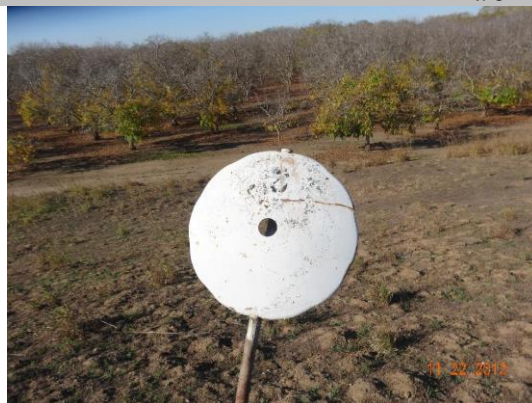
Photo 1 of 3 : UCIP_SP_2021_27773_51461.jpg

Comment Code						
Inspector Comment						
FS_ID:27773 DS_ID:21283 EP_NO: N/A Repair Type: Non-Urgent Crossing Status: Found UCIP Comments: 04/30/2013 High rodent activity along pipe alignment--animal control would be beneficial. This crossing is referenced in the USACE Periodic Inspection as item USACE_CESPK_HON2_2013_p_0150. (O. Magana - DWR UCIP) FIELD_STRUCT_DESC: 30-inch corrugated metal gravity drainage pipe through the levee, 22.5 feet below the crown. Flap gate on the waterside (WS) end. Metal marker on the WS shoulder. [Additional Reference(s): DWR Levee Log, 2005 (HLM 3.11), listed as a 30-inch corrugated metal pipe (CMP)]. FS Date: 4/30/2013

Marker visible on waterward side.

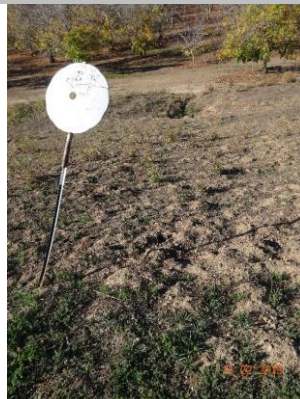
Photo 2 of 3 : UCIP_SP_2021_27773_51460.jpg

View of waterward side--burrow activity present on slope.

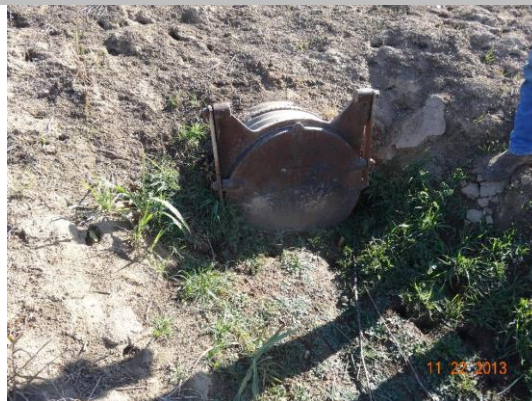
Photo 3 of 3 : UCIP_SP_2021_27773_51464.jpg

View of gate on waterward side.

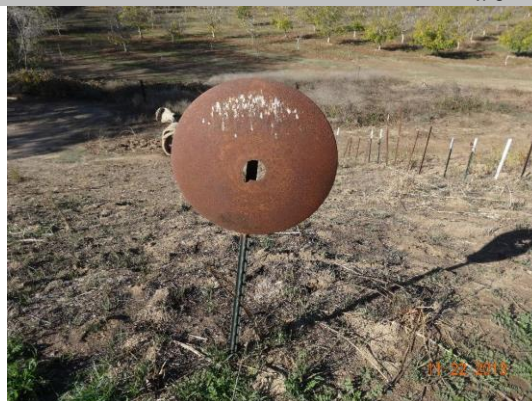
Photo 1 of 3 : UCIP_SP_2021_52889_44658.jpg

FS_ID:52889
DS_ID:21284
EP_NO: N/A
Repair Type: Non-Urgent
Crossing Status: Found
UCIP Comments: 12/01/2020 see UCIP marked up RD0010 USACE O&M manual OM151_IrrDRNSect.pdf and USACE drawing AB_4-4-318.pdf for approximate location and station. Reference files have been filed under UCIP's share drive desk study background folder for RD0010. (O. Magana - DWR UCIP)
04/30/2013 Remove concrete piece preventing complete closure of screw gate on landward side. This crossing is referenced in the USACE Periodic Inspection as item USACE_CESPK_HON2_2013_p_0152. (O. Magana - DWR UCIP)
FIELD_STRUCT_DESC: 36-inch corrugated metal gravity drainage pipe through the levee, 24 feet below the crown. Corrugated metal cutoff wall around the pipe at each shoulder. Flap gate on the waterside (WS) end. Slide gate on the landside (LS) end. Concrete headwall at each end. [Additional Reference(s): DWR Levee Log, 2005 (HLM 3.30), listed as a 36-inch corrugated metal pipe (CMP). USACE Sacramento O&M Manual, Unit No. 151, May 1953, Revised 6 Jun 2017, (Station 259+76). USACE As-built Drawing No. 04-04-0318, Sheet 318/2.1, pdf file - page 2 of 9, Revised January 1951, referenced as Station 259+76, listed as a 36-inch CMP]

Marker visible on waterward side.

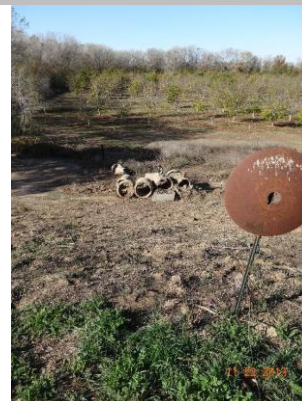
Photo 2 of 3 : UCIP_SP_2021_52889_44657.jpg

Overview of waterward slope--barrier placed at toe to discourage damage to crossing.

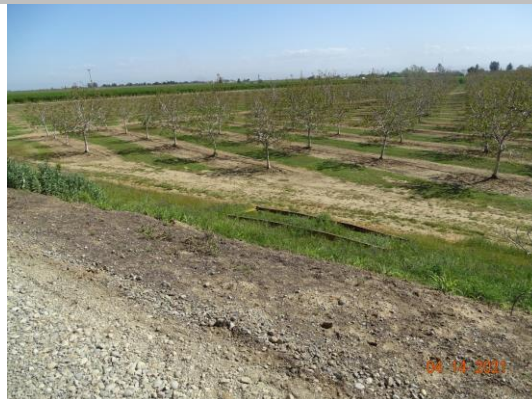
Photo 1 of 1 : SP_2021_RD0010_164_71_20210427_00145.jpg

LM Start	3.47	Rating **	M	Issue No.	71
LM End	3.47	Issue Type +	En	Location *	LS
Category	Earthen Levee			GPS Latitude/Longitude	
				Start	End
Item	Encroachments			39.213618 °	39.213618 °
				-121.610078 °	-121.610078 °
DWR ID	DWR_RD0010_02_s_2021_71				
Comment Code					
EQ : Equipment					
Inspector Comment					
Equipment along landside toe needs to be removed, Spring 2021.

View of equipment stored along landside toe, Spring 2021.

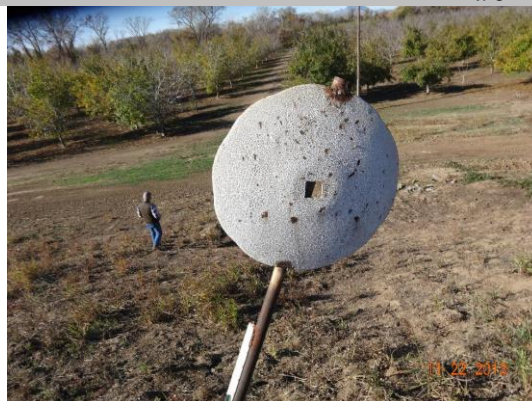
Photo 1 of 3 : UCIP_SP_2021_24825_44664.jpg

FS_ID:24825
DS_ID:21285
EP_NO: N/A
Repair Type: Non-Urgent
Crossing Status: Found
UCIP Comments: 12/01/2020 see UCIP marked up RD0010 USACE O&M manual OM151_IrrDRNSect.pdf and USACE drawing AB_4-4-318.pdf for approximate location and station. Reference files have been filed under UCIP's share drive desk study background folder for RD0010. (O. Magana - DWR UCIP)
04/30/2013 Sediment blocking flap gate and screw gate--recommend removing material. Dense burrow activity present along levee slopes (large holes visible on landward side)--recommend addressing issue. This crossing is referenced in the USACE Periodic Inspection as item USACE_CESPK_HON2_2013_p_0169. (O. Magana - DWR UCIP)
FIELD_STRUCT_DESC: 30-inch corrugated metal gravity drainage pipe through the levee, 19.5 feet below the crown. Corrugated metal cutoff wall around the pipe at each shoulder. Flap gate on the waterside (WS) end. Slide gate on the landside (LS) end. Concrete headwall at each end. [Additional Reference(s): DWR Levee Log, 2005 (HLM 3.63), listed as a 30-inch pipe. USACE Sacramento O&M Manual, Unit No. 151, May 1953, Revised 6 Jun 2017, (Station 277+00). USACE As-built Drawing No. 04-04-0318, Sheet 318/2.1, pdf file - page 2 of 9, Revised January 1951, referenced as Station 277+00, listed as a 30-inch corrugated metal pipe (CMP)]

Marker visible on waterward side.

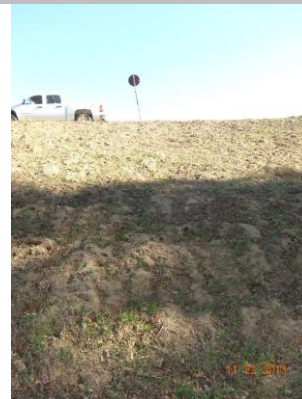
Photo 2 of 3 : UCIP_SP_2021_24826_44668.jpg

View of waterward slope.

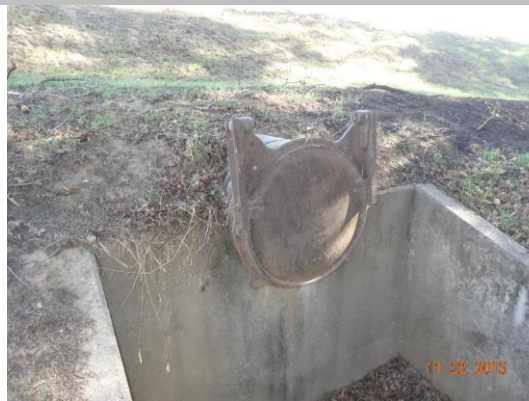
Photo 3 of 3 : UCIP_SP_2021_24826_44673.jpg

View of flapgate on concrete head wall on waterward side.

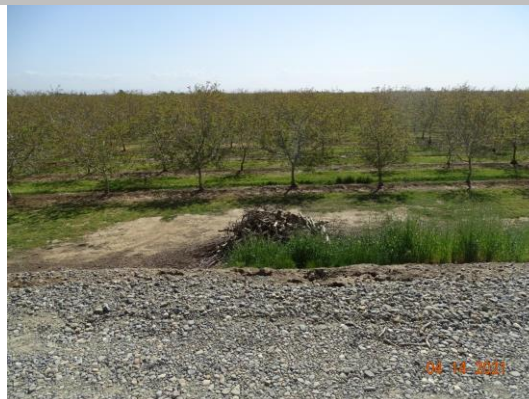
Photo 1 of 1 : SP_2021_RD0010_164_65_20210427_00144.jpg

LM Start	4.04	Rating **	M	Issue No.	65
LM End	4.04	Issue Type +	En	Location *	LS
Category	Earthen Levee			GPS Latitude/Longitude	
				Start	End
Item	Encroachments			39.221527 °	39.221527 °
				-121.611661 °	-121.611661 °
DWR ID	DWR_RD0010_02_s_2021_65				
Comment Code					
PR : Prunings					
Inspector Comment					
A pile of prunings on the landside toe need to be removed, Spring 2021.

View of a pile of prunings on the landside toe, Spring 2021.

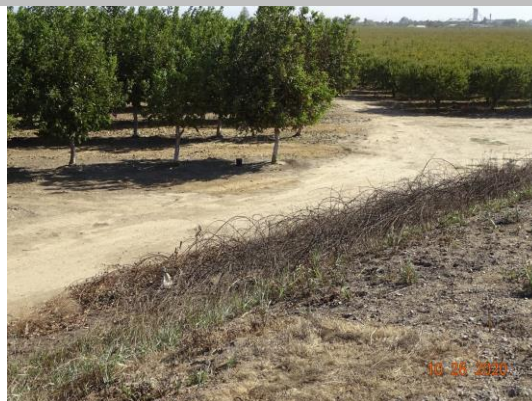
Photo 1 of 1 : SP_2021_RD0010_164_58_20210301_00025.jpg

LM Start	4.17	Rating **	M	Issue No.	58
LM End	4.17	Issue Type +	Ma	Location *	LS
Category	Earthen Levee			GPS Latitude/Longitude	
				Start	End
Item	Vegetation			39.223276 °	39.223276 °
				-121.612510 °	-121.612510 °
DWR ID	DWR_RD0010_02_f_2019_58				
Comment Code					
V2 : Remove the wild growth other than native grasses from the levee slopes.					
Inspector Comment					
Remove blackberry bushes from levee slope, Spring 2021.

View looking at blackberry bushes on the landside levee slope that need to be removed, Fall 2020.

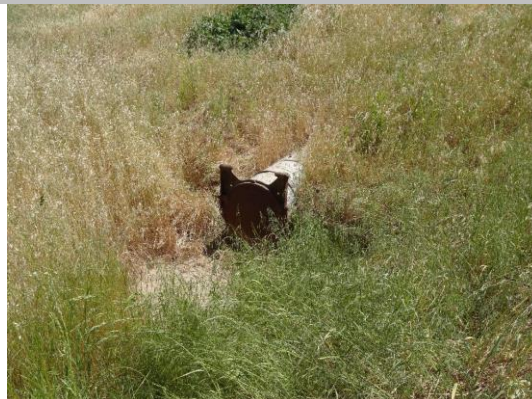
Photo 2 of 3 : UCIP_SP_2021_24751_44376.jpg

LM Start	4.44	Rating **	M	Issue No.	11 (cont)
LM End	4.44	Issue Type +	Ma	Location *	
Category	Supplemental		GPS Latitude/Longitude		
			Start	End	
Item	DWR UCIP LMA Responsibility		39.226938 °	39.226938 °	
			-121.613174 °	-121.613174 °	
DWR ID	21288

View of flap gate on waterward side.

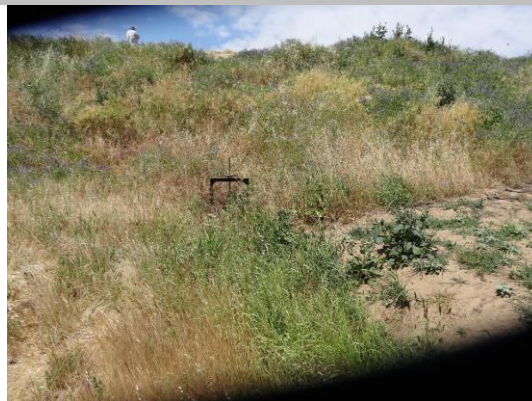
Photo 3 of 3 : UCIP_SP_2021_24751_44373.jpg

View of landward side--dense vegetation.

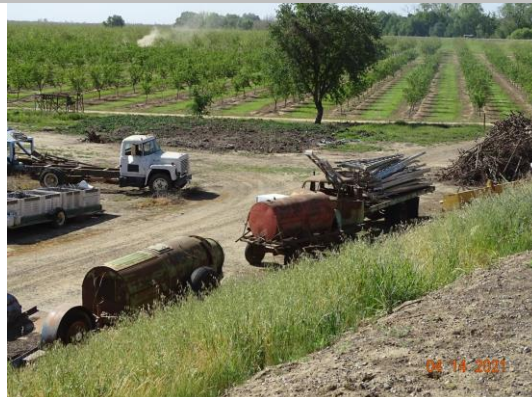
Photo 1 of 1 : SP_2021_RD0010_164_31_20210427_00141.jpg

LM Start	4.44	Rating **	M	Issue No.	31
LM End	4.48	Issue Type +	En	Location *	LS
Category	Earthen Levee			GPS Latitude/Longitude	
				Start	End
Item	Encroachments			39.226946 °	39.227445 °
				-121.613048 °	-121.612718 °
DWR ID	DWR_RD0010_02_f_2015_31				
Comment Code					
EQ : Equipment					
Inspector Comment					
Remove existing equipment from the levee toe, Sprig 2021.

View of the equipment at the toe of the levee on the landward side of the levee looking downstream, Spring 2021.

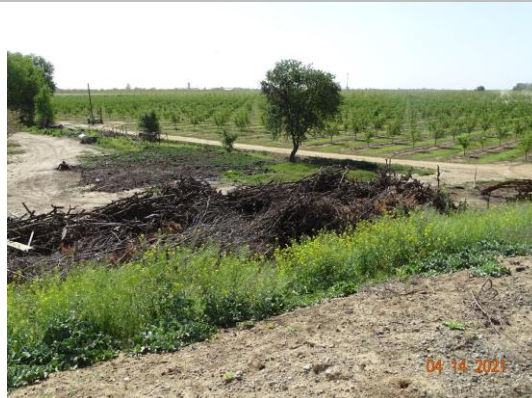
Photo 1 of 1 : SP_2021_RD0010_164_40_20210427_00140.jpg

LM Start	4.46	Rating **	U	Issue No.	40
LM End	4.46	Issue Type +	En	Location *	LS
Category	Earthen Levee			GPS Latitude/Longitude	
				Start	End
Item	Encroachments			39.227226 °	39.227226 °
				-121.612888 °	-121.612888 °
DWR ID	DWR_RD0010_02_s_2021_40				
Comment Code					
PR : Prunings					
Inspector Comment					
A pile of prunings on the landside toe needs to be removed, Spring 2021.

View of a pile of prunings on the landside toe that needs to be removed, Spring 2021.

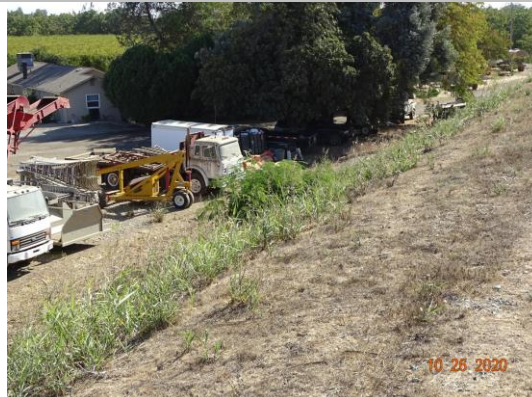
Photo 1 of 1 : SP_2021_RD0010_164_64_20210301_00031.jpg

LM Start	4.66	Rating **	M	Issue No.	64
LM End	4.66	Issue Type +	Ma	Location *	LS
Category	Earthen Levee			GPS Latitude/Longitude	
				Start	End
Item	Trim / Thin Trees			39.229835 °	39.229835 °
				-121.613278 °	-121.613278 °
DWR ID	DWR_RD0010_02_s_2020_64				
Comment Code					
T3 : Trim and thin trees to allow visibility of the ground and room to flood fight.					
Inspector Comment					
Trees with less than 4" diameter at chest height should be removed, Spring 2021.

View looking downstream landside at small starter trees on levee slope, Fall 2020.

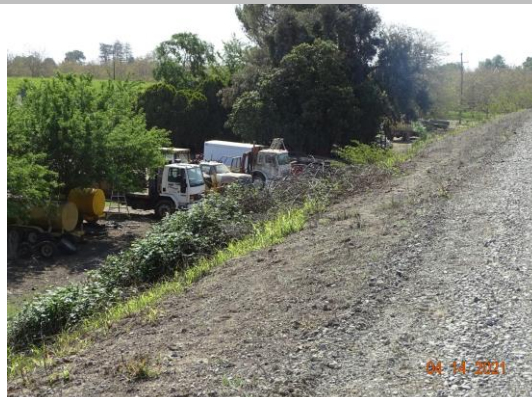
Photo 1 of 1 : SP_2021_RD0010_164_55_20210427_00139.jpg

LM Start	4.67	Rating **	M	Issue No.	55
LM End	4.67	Issue Type +	Ma	Location *	LS
Category	Earthen Levee			GPS Latitude/Longitude	
				Start	End
Item	Vegetation			39.229963 °	39.229963 °
				-121.613416 °	-121.613416 °
DWR ID	DWR_RD0010_02_f_2020_55				
Comment Code					
V2 : Remove the wild growth other than native grasses from the levee slopes.					
Inspector Comment					
Blackberry bushes on landside slope should be cleared, Spring 2021.

View of black berry bushes on landside slope, Spring 2021.

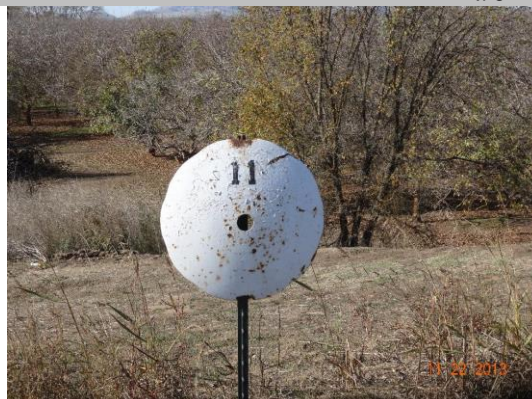
Photo 1 of 3 : UCIP_SP_2021_27774_51467.jpg

Comment Code						
Inspector Comment						
FS_ID:27774						
DS_ID:21289						
EP_NO: N/A						
Repair Type: Non-Urgent						
Crossing Status: Indicator Found						
UCIP Comments: 04/30/2013 Sediment build-up inside and at the opening pipe. This crossing is referenced in the USACE Periodic Inspection as item USACE_CESPK_HON2_2013_p_0206. (DWR UCIP - O. Magana)						
FIELD_STRUCT_DESC: 30-inch gravity drainage pipe of an unknown material through the levee, 20 feet below the crown. Flap gate on the waterside (WS) end. Slide gate on the landside (LS) end. [Additional Reference(s): DWR Levee Log, 2005 (HLM 4.80), listed as a 30-inch pipe].						
FS Date: 4/30/2013

Marker visible on waterward shoulder, Reference ID No. 11 for crossing.

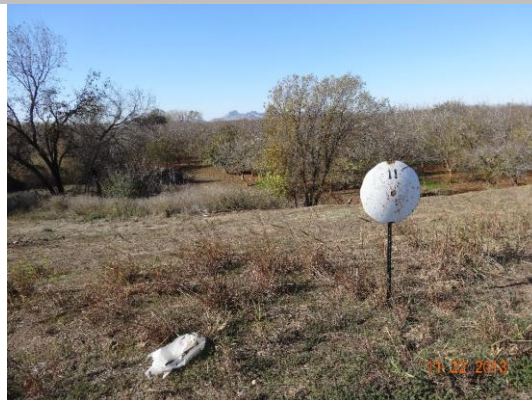
Photo 2 of 3 : UCIP_SP_2021_27774_51470.jpg

View of waterward side.

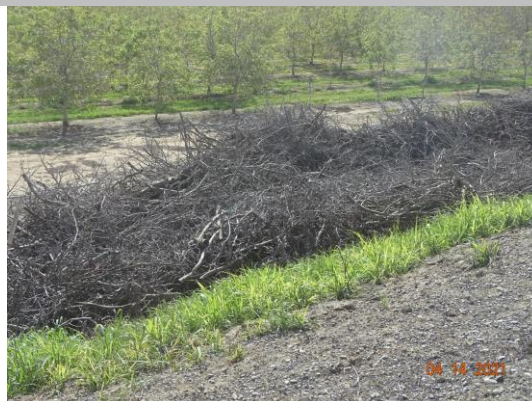
Photo 1 of 1 : SP_2021_RD0010_164_63_20210427_00138.jpg

LM Start	4.88	Rating **	M	Issue No.	63
LM End	4.92	Issue Type +	En	Location *	LS
Category	Earthen Levee			GPS Latitude/Longitude	
				Start	End
Item	Encroachments			39.232773 °	39.233336 °
				-121.614588 °	-121.614659 °
DWR ID	DWR_RD0010_02_s_2020_63				
Comment Code					
PR : Prunings					
Inspector Comment					
Remove prunings from levee toe and slope, Spring 2021.

View looking downstream landside at prunings on levee toe and slope, Spring 2021.

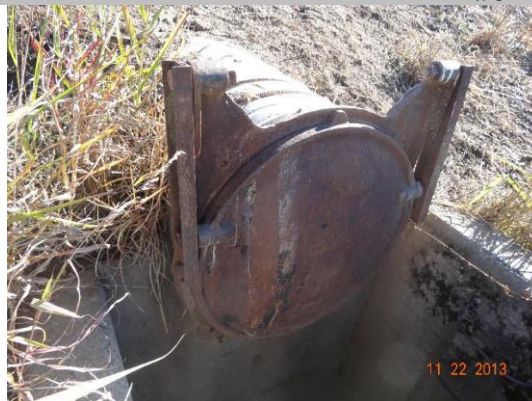
Photo 2 of 3 : UCIP_SP_2021_24828_44684.jpg

View of flap gate located on waterward side.

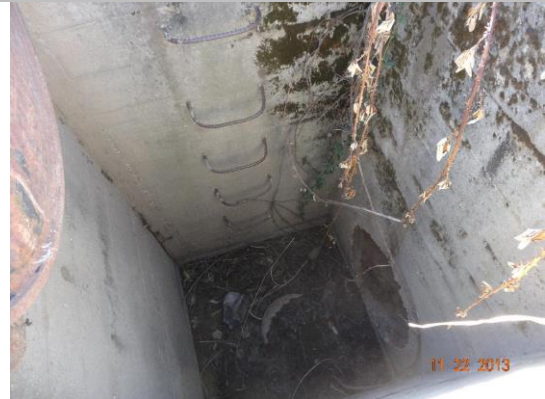
Photo 3 of 3 : UCIP_SP_2021_24828_44683.jpg

Inside view of concrete distribution box.

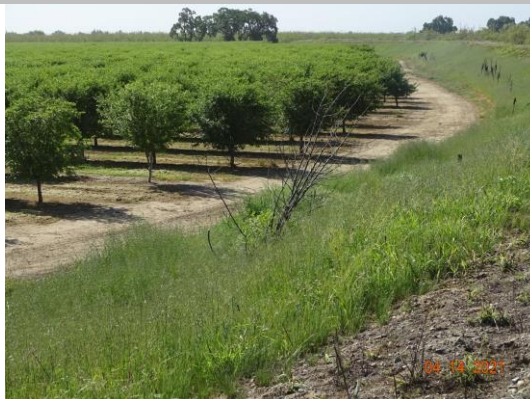
Photo 1 of 1 : SP_2021_RD0010_164_61_20210427_00136.jpg

LM Start	6.08	Rating **	M	Issue No.	61
LM End	6.08	Issue Type +	Ma	Location *	LS
Category	Earthen Levee			GPS Latitude/Longitude	
				Start	End
Item	Trim / Thin Trees			39.249441 °	39.249441 °
				-121.619291 °	-121.619291 °
DWR ID	DWR_RD0010_02_s_2020_61				
Comment Code					
T3 : Trim and thin trees to allow visibility of the ground and room to flood fight.					
Inspector Comment					
Trees with less than 4" diameter at chest height should be removed, Spring 2021.

View looking downstream landside at small starter tree on levee slope, Spring 2021.

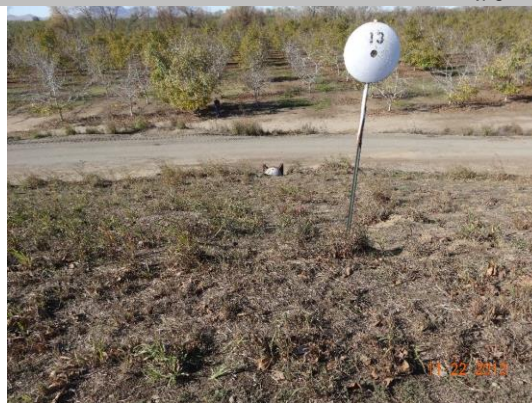
Photo 1 of 3 : UCIP_SP_2021_27793_51514.jpg

Comment Code						
Inspector Comment						
FS_ID:27793						
DS_ID:21291						
EP_NO: N/A						
Repair Type: Non-Urgent						
Crossing Status: Found						
UCIP Comments: 12/01/2020 see UCIP marked up RD0010 USACE O&M manual OM151_IrrDRNSect.pdf and USACE drawing AB_4-4-318.pdf for approximate location and station. Reference files have been filed under UCIP's share drive desk study background folder for RD0010. (O. Magana - DWR UCIP)						
04/30/2013 Need to contact owner to remove debris inside concrete distribution box and on slope. This crossing is referenced in the USACE Periodic Inspection as item USACE_CESPK_HON2_2013_p_0244. (O. Magana - DWR UCIP)						
FIELD_STRUCT_DESC: 30-inch corrugated metal gravity drainage pipe through the levee, 17.3 feet below the crown. Corrugated metal cutoff wall around the pipe at each shoulder. Flap gate on the waterside (WS) end. Slide gate on the landside (LS) end. Concrete headwall at each end. [Additional Reference(s): DWR Levee Log, 2005 (HLM 6.18), listed as a 30-inch corrugated metal pipe (CMP). USACE Sacramento O&M Manual, Unit No. 151, May 1953, Revised 6 Jun 2017, (Station 413+81). USACE As-built Drawing No. 04-04-0318, Sheet 318/3, pdf file - page 3 of 9, Revised January 1951, referenced as Station 413+81, listed as a 30-inch CMP]

View of marker located on waterward shoulder, pipe is reference as No. 13.

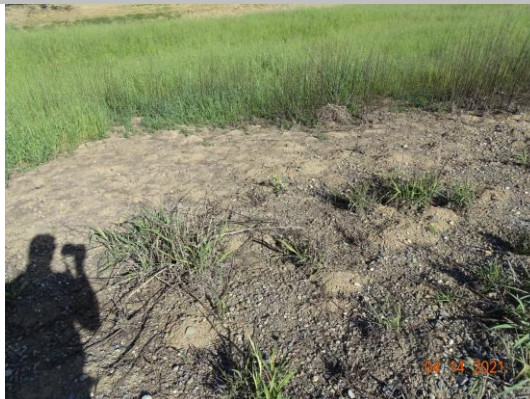
Photo 1 of 1 : SP_2021_RD0010_164_33_20210427_00133.jpg

LM Start	6.88	Rating **	U	Issue No.	33
LM End	6.88	Issue Type +	Ma	Location *	WS
Category	Earthen Levee			GPS Latitude/Longitude	
				Start	End
Item	Animal Control			39.259843 °	39.259843 °
				-121.616013 °	-121.616013 °
DWR ID	DWR_RD0010_02_f_2015_33				
Comment Code					
A3 : No rodents visible, but rodent burrows visible; need to backfill and compact or grout burrows.					
Inspector Comment					
Rodent hole that has more than 2 cubic feet of material, this hole is not active but needs to be backfilled properly.

View of rodent hole that is not active but needs to be backfilled properly, Spring 2021.

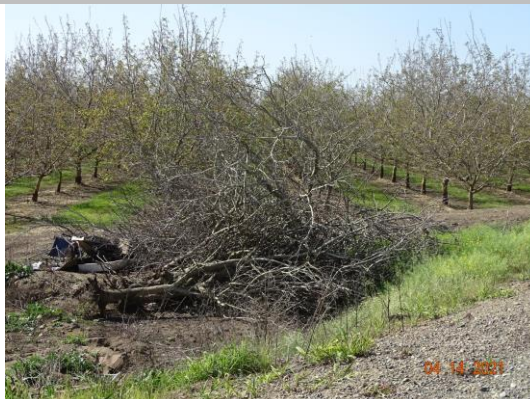
Photo 1 of 1 : SP_2021_RD0010_164_53_20210427_00132.jpg

LM Start	7.07	Rating **	U	Issue No.	53
LM End	7.07	Issue Type +	En	Location *	LS
Category	Earthen Levee			GPS Latitude/Longitude	
				Start	End
Item	Encroachments			39.262290 °	39.262290 °
				-121.614390 °	-121.614390 °
DWR ID	DWR_RD0010_02_s_2016_53				
Comment Code					
DE : Debris					
Inspector Comment					
Remove debris and pruning's from the levee toe, Spring 2021.

View looking downstream of debris at landside levee toe, Spring 2021.

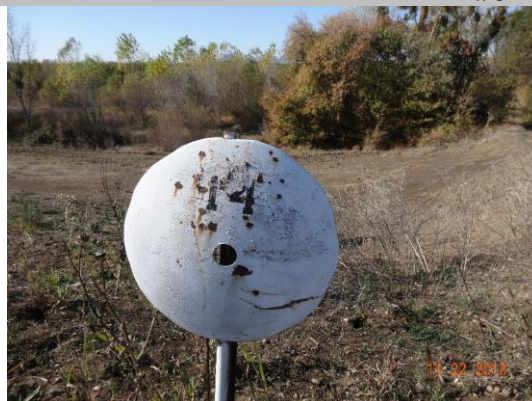
Photo 1 of 3 : UCIP_SP_2021_50059_44693.jpg

Comment Code						
Inspector Comment						
FS_ID:50059 DS_ID:21293 EP_NO: N/A Repair Type: Non-Urgent Crossing Status: Indicator Found UCIP Comments: 12/01/2020 see UCIP marked up RD0010 USACE O&M manual OM151_IrrDRNSect.pdf and USACE drawing AB_4-4-318.pdf for approximate location and station. Reference files have been filed under UCIP's share drive desk study background folder for RD0010. (O. Magana - DWR UCIP) 7/01/2016 Crossing is blocked by sediment and debris on both WS and LS. Screw gate is missing on LS. (DWR UCIP - omagana)4/30/2013 Both openings of crossing are blocked by sediment--screw gate is damage. Recommend notifying owner to repair screw gate and remove sediment build-up blocking openings. This crossing is referenced in the USACE Periodic Inspection as item USACE_CESPK_HON2_2013_p_0295. (O. Magana - DWR UCIP) FIELD_STRUCT_DESC: 24-inch corrugated metal gravity drainage pipe through the levee, 13 feet below the crown. Corrugated metal cutoff wall around the pipe at each shoulder. Flap gate on the waterside (WS) end. Slide gate on the landside (LS). Concrete headwall, saddle, and apron on the WS end. [Additional Reference(s): DWR Levee Log, 2005 (HLM 7.28), listed as 24-inch corrugated metal pipe (CMP). USACE Sacramento O&M Manual, Unit No. 151, May 1953, Revised 6 Jun 2017, (Station 471+21). USACE As-built Drawing No. 04-04-0318, Sheet 318/4.1, pdf file - page 4 of 9, Revised January 1951, referenced as Station 471+21, listed as a 24-inch CMP] FS Date: 7/1/2016

Marker visible on WS shoulder, crossing referenced as No. 14.

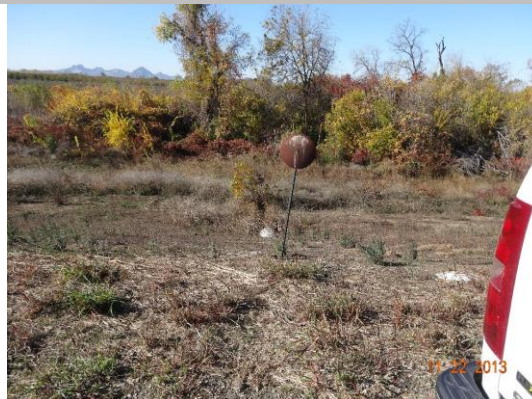
Photo 1 of 3 : UCIP_SP_2021_24831_44700.jpg

Visible marker located on waterward shoulder--no id number noted.

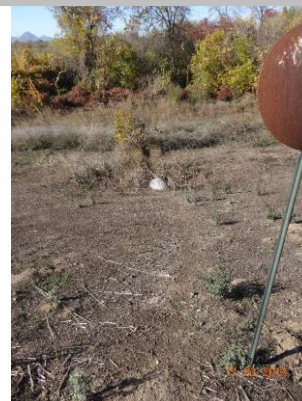
Photo 2 of 3 : UCIP_SP_2021_24831_44699.jpg

View of waterward slope.

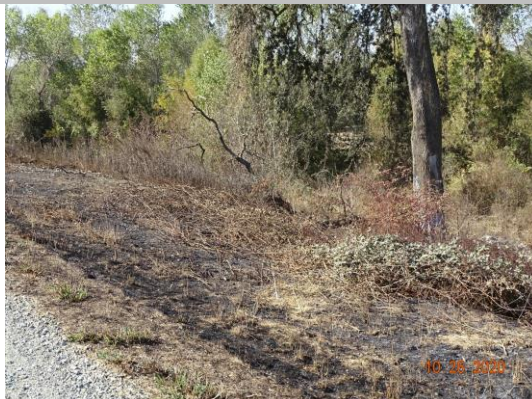
Photo 1 of 2 : SP_2021_RD0010_164_52_20210301_00020.jpg

LM Start	7.91	Rating **	M	Issue No.	52
LM End	7.91	Issue Type +	Ma	Location *	WS
Category	Earthen Levee			GPS Latitude/Longitude	
				Start	End
Item	Encroachments			39.273011 °	39.273011 °
				-121.613011 °	-121.613011 °
DWR ID	DWR_RD0010_02_s_2020_52				
Comment Code					
TR : Tree or limb					
Inspector Comment					
Remove downed tree from levee slope, Spring 2021.

View looking waterside at a downed tree on the levee slope, Fall 2020.

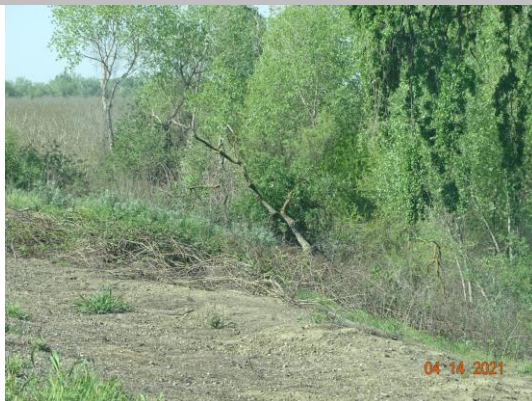
Photo 2 of 2 : SP_2021_RD0010_164_52_20210427_00131.jpg

LM Start	7.91	Rating **	M	Issue No.	52 (cont)
LM End	7.91	Issue Type +	Ma	Location *	WS

View looking waterside at a downed tree on the levee slope, Spring 2021.

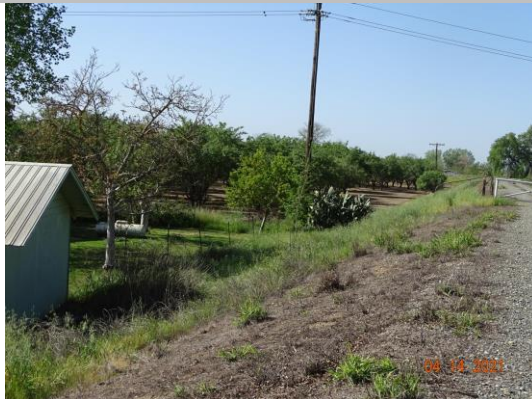
Photo 1 of 1 : SP_2021_RD0010_164_41_20210427_00130.jpg

LM Start	8.02	Rating **	M	Issue No.	41
LM End	8.02	Issue Type +	En	Location *	LS
Category	Earthen Levee			GPS Latitude/Longitude	
				Start	End
Item	Vegetation			39.274334 °	39.274334 °
				-121.611986 °	-121.611986 °
DWR ID	DWR_RD0010_02_s_2018_41				
Comment Code					
V6 : Landscaping					
Inspector Comment					
Remove landscape from the levee toe, Spring 2021.

View looking downstream landside of a landscape bush at the levee toe, Spring 2021.

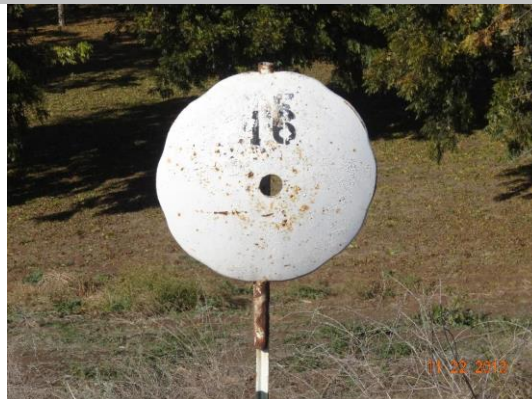
Photo 1 of 3 : UCIP_SP_2021_24832_44705.jpg

Marker visible on waterward shoulder, crossing is referenced as No. 16.

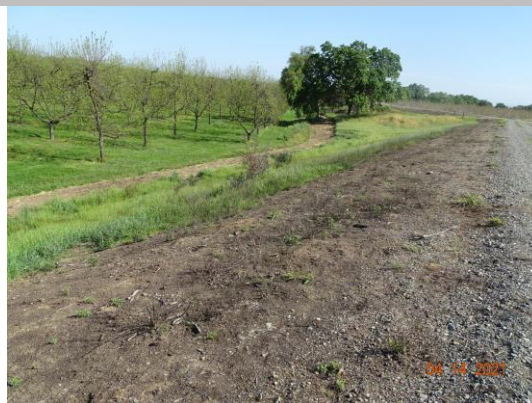
Photo 1 of 1 : SP_2021_RD0010_164_35_20210427_00129.jpg

LM Start	8.09	Rating **	M	Issue No.	35
LM End	8.09	Issue Type +	Ma	Location *	WS
Category	Earthen Levee			GPS Latitude/Longitude	
				Start	End
Item	Animal Control			39.275179 °	39.275179 °
				-121.611283 °	-121.611283 °
DWR ID	DWR_RD0010_02_f_2015_35				
Comment Code					
A3 : No rodents visible, but rodent burrows visible; need to backfill and compact or grout burrows.					
Inspector Comment					
No rodent activity but holes need to be backfilled, Spring 2021.

View of rodent hole on waterside, Spring 2021.

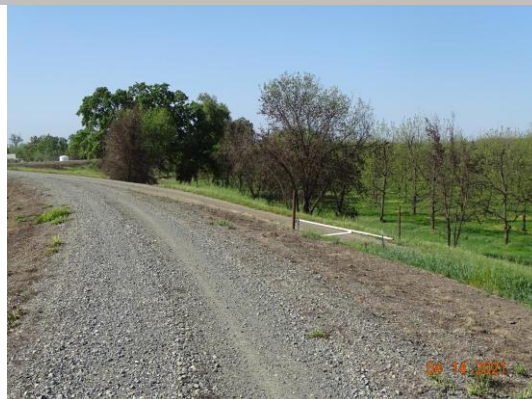
Photo 1 of 1 : SP_2021_RD0010_164_37_20210427_00127.jpg

LM Start	8.20	Rating **	M	Issue No.	37
LM End	8.20	Issue Type +	Ma	Location *	WS
Category	Earthen Levee			GPS Latitude/Longitude	
				Start	End
Item	Trim / Thin Trees			39.276607 °	39.276607 °
				-121.610626 °	-121.610626 °
DWR ID	DWR_RD0010_02_s_2020_37				
Comment Code					
T2 : Thin trees to allow visibility of the ground and room to flood fight.					
Inspector Comment					
Trim low hanging limbs for access and visibility, Spring 2021.

View looking downstream waterside at a tree with low hanging limbs, Spring 2021.

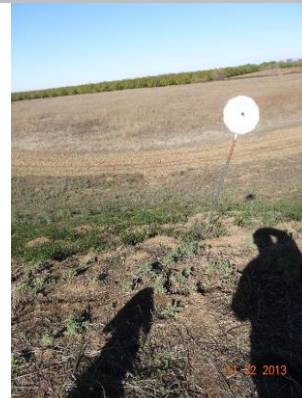
Photo 1 of 3 : UCIP_SP_2021_27775_51473.jpg

Comment Code						
Inspector Comment						
FS_ID:27775 DS_ID:21296 EP_NO: N/A Repair Type: Non-Urgent Crossing Status: Found UCIP Comments: 12/01/2020 see UCIP marked up RD0010 USACE O&M manual OM151_IrrDRNSect.pdf and USACE drawing AB_4-4-318.pdf for approximate location and station. Reference files have been filed under UCIP's share drive desk study background folder for RD0010. (O. Magana - DWR UCIP) 04/30/2013 Sediment build-up at the inlet--recommend clearing sediment. This crossing is referenced in the USACE Periodic Inspection as item USACE_CESPK_HON2_2013_p_0348. (O. Magana - DWR UCIP) FIELD_STRUCT_DESC: 30-inch corrugated metal gravity drainage pipe through the levee, 23 feet below the crown. Corrugated metal cutoff wall around the pipe at each shoulder. Flap gate on the waterside (WS) end. Slide gate on the landside (LS) end. Concrete headwall at each end. Metal marker on the WS shoulder. [Additional Reference(s): DWR Levee Log, 2005 (HLM 8.80), listed as 30-inch corrugated metal pipe (CMP). USACE Sacramento O&M Manual, Unit No. 151, May 1953, Revised 6 Jun 2017, (Station 551+96). USACE As-built Drawing No. 04-04-0318, Sheet 318/4.1, pdf file - page 4 of 9, Revised January 1951, referenced as Station 551+96, listed as a 30-inch CMP] FS Date: 4/30/2013

View of waterward side.

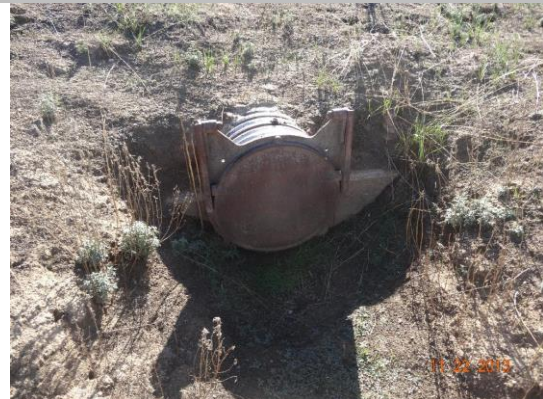
Photo 3 of 3 : UCIP_SP_2021_27775_51477.jpg

View of flap gate visible on waterward side.

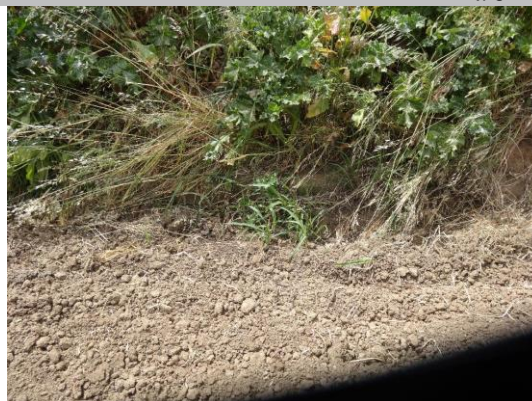
Photo 3 of 3 : UCIP_SP_2021_24768_44449.jpg

View of concrete headwall visible through dense vegetation.

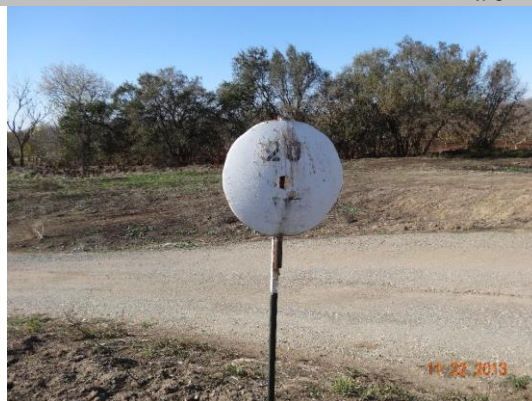
Photo 1 of 3 : UCIP_SP_2021_24769_44454.jpg

FS_ID:24769
DS_ID:21299
EP_NO: N/A
Repair Type: Non-Urgent
Crossing Status: Found
UCIP Comments: 12/01/2020 see UCIP marked up RD0010 USACE O&M manual OM151_IrrDRNSect.pdf and USACE drawing AB_4-4-318.pdf for approximate location and station. Reference files have been filed under UCIP's share drive desk study background folder for RD0010. (O. Magana - DWR UCIP)
04/30/2013 Need to contact owner. Need to clear debris from concrete distribution box on waterward and remove debris blocking landward side. This crossing is referenced in the USACE Periodic Inspection as item USACE_CESPK_HON2_2013_p_0383. (O. Magana - DWR UCIP)
FIELD_STRUCT_DESC: 24-inch corrugated metal gravity drainage pipe through the levee, 12 feet below the crown. Corrugated metal cutoff wall around the pipe at each shoulder. Flap gate on the waterside (WS) end. Slide gate on the landside (LS). Concrete headwall, saddle, and apron on the WS end. Metal marker on the WS shoulder.

[Additional Reference(s): DWR Levee Log, 2005 (HLM 9.38), listed as 24-inch pipe. USACE Sacramento O&M Manual, Unit No. 151, May 1953, Revised 6 Jun 2017, (Station 582+72). USACE As-built Drawing No. 04-04-0318, Sheet 318/4.1, pdf file - page 4 of 9, Revised January 1951, referenced as Station 582+72, listed as a 24-inch corrugated metal pipe (CMP)]
FS Date: 4/30/2013

Marker visible on waterward side shoulder, crossing is referenced as No. 20.

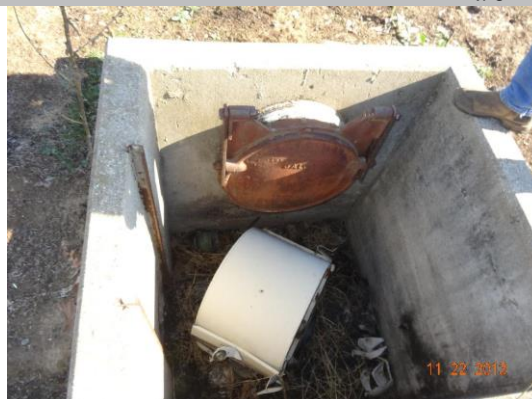
Photo 2 of 3 : UCIP_SP_2021_24769_44453.jpg

View of flap gate located inside concrete distribution box. Debris scattered inside box.

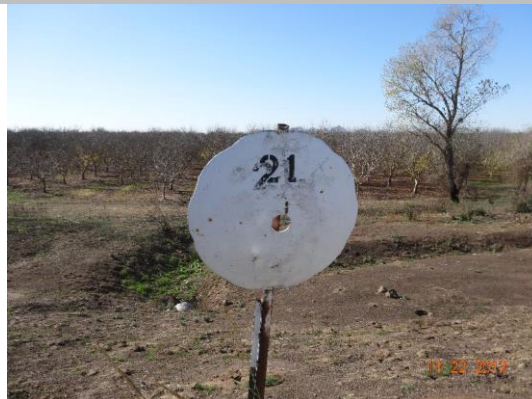
Photo 1 of 3 : UCIP_SP_2021_24835_44721.jpg

Comment Code					
Inspector Comment					
FS_ID:24835 DS_ID:21300 EP_NO: N/A Repair Type: No Action Needed Crossing Status: Found UCIP Comments: 12/01/2020 see UCIP marked up RD0010 USACE O&M manual OM151_IrrDRNSect.pdf and USACE drawing AB_4-4-318.pdf for approximate location and station. Reference files have been filed under UCIP's share drive desk study background folder for RD0010. (O. Magana - DWR UCIP) 04/30/2013 This crossing is referenced in the USACE Periodic Inspection as item USACE_CESPK_HON2_2013_p_0388. (O. Magana - DWR UCIP) FIELD_STRUCT_DESC: 24-inch corrugated metal gravity drainage pipe through the levee, 14 feet below the crown. Corrugated metal cutoff wall around the pipe at each shoulder. Flap gate on the waterside (WS) end. Slide gate on the landside (LS). Concrete headwall, saddle, and apron on the WS end. Metal marker on the WS shoulder. [Additional Reference(s): DWR Levee Log, 2005 (HLM 9.54), listed as 24-inch pipe. USACE Sacramento O&M Manual, Unit No. 151, May 1953, Revised 6 Jun 2017, (Station 591+77). USACE As-built Drawing No. 04-04-0318, Sheet 318/5.1, pdf file - page 5 of 9, Revised January 1951, referenced as Station 591+77, listed as a 24-inch corrugated metal pipe (CMP)] FS Date: 4/30/2013

Marker visible on waterward shoulder, crossing referenced as No. 21.

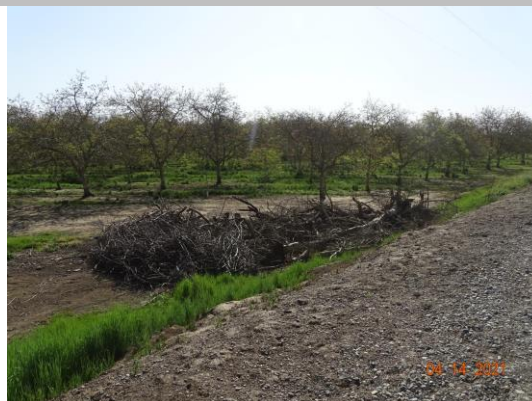
Photo 1 of 1 : SP_2021_RD0010_164_34_20210427_00125.jpg

LM Start	9.60	Rating **	M	Issue No.	34
LM End	9.60	Issue Type +	En	Location *	LS
Category	Earthen Levee			GPS Latitude/Longitude	
				Start	End
Item	Encroachments			39.290406 °	39.290406 °
				-121.602336 °	-121.602336 °
DWR ID	DWR_RD0010_02_s_2021_34				
Comment Code					
PR : Prunings					
Inspector Comment					
A pile of prunings on the landside toe need to be removed, Spring 2021.

View of a pile of prunings on the landside toe that need to be removed, Spring 2021.

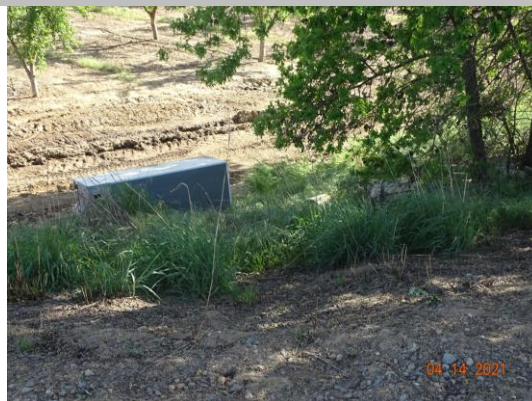
Photo 1 of 1 : SP_2021_RD0010_164_45_20210427_00124.jpg

LM Start	9.94	Rating **	M	Issue No.	45
LM End	9.94	Issue Type +	En	Location *	LS
Category	Earthen Levee			GPS Latitude/Longitude	
				Start	End
Item	Encroachments			39.293608 °	39.293608 °
				-121.606922 °	-121.606922 °
DWR ID	DWR_RD0010_02_f_2018_45				
Comment Code					
DE : Debris					
Inspector Comment					
Remove debris from the levee slope.

View looking at the landside levee slope where debris has been dumped, Spring 2021.

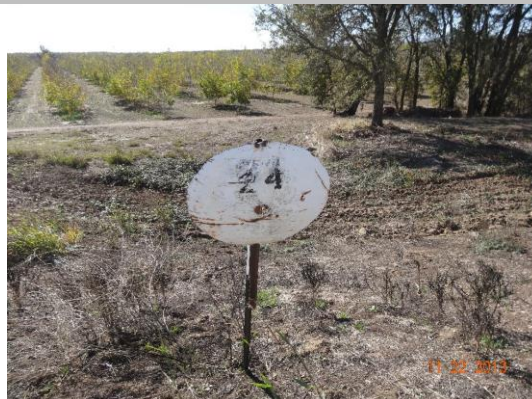
Photo 1 of 3 : UCIP_SP_2021_24838_44737.jpg

FS_ID:24838
DS_ID:21303
EP_NO: 1069
Repair Type: Non-Urgent
Crossing Status: Found
UCIP Comments: 12/01/2020 see UCIP marked up RD0010 USACE O&M manual OM151_IrrDRNSect.pdf and USACE drawing AB_4-4-318.pdf for approximate location and station. Reference files have been filed under UCIP's share drive desk study background folder for RD0010. (O. Magana - DWR UCIP)
04/30/2013 Unable to find the crossing on landward side--indicators found of crossing. Need to coordinate with owner to determine status of crossing. If crossing is no longer in use owner will need to contact the CVFPB to comply with Title 23. This crossing is referenced in the USACE Periodic Inspection as item
USACE_CESPK_HON2_2013_p_0442. (O. Magana - DWR UCIP)
FIELD_STRUCT_DESC: 24-inch steel gravity irrigation pipe through the levee, 13 feet below the crown. Concrete cutoff wall around the pipe at each shoulder. Flap gate and concrete headwall on the waterside (WS) end. Slide gate, concrete saddle, and apron on the landside (LS) end. (Plans for installation of a 24-inch corrugated iron pipe through the levee authorized under Permit No. 1069, 1946 - Pacific Ranch, care of Chas. J. Mathews). [Additional Reference(s): DWR Levee Log, 2005 (HLM 10.42), listed as 24-inch pipe. USACE Sacramento O&M Manual, Unit No. 151, May 1953, Revised 6 Jun 2017, (Station 638+00). USACE As-built Drawing No. 04-04-0318, Sheet 318/5.1, pdf file - page 5 of 9, Revised January 1951, referenced as Station 638+00, listed as a 24-inch corrugated metal pipe (CMP)]

Marker visible on waterward shoulder, this crossing is reference as No. 24.

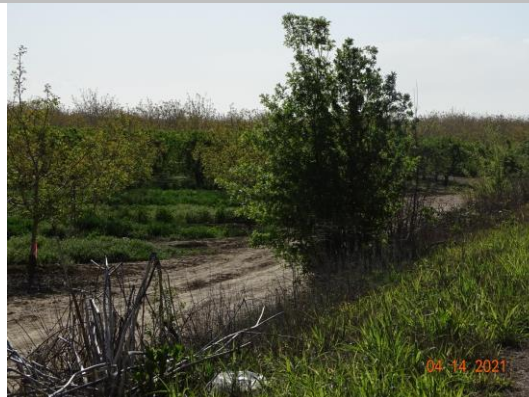
Photo 1 of 1 : SP_2021_RD0010_164_56_20210427_00121.jpg

LM Start	10.53	Rating **	M	Issue No.	56
LM End	10.53	Issue Type +	Ma	Location *	LS
Category	Earthen Levee			GPS Latitude/Longitude	
				Start	End
Item	Trim / Thin Trees			39.299244 °	39.299244 °
				-121.615166 °	-121.615166 °
DWR ID	DWR_RD0010_02_f_2019_56				
Comment Code					
T3 : Trim and thin trees to allow visibility of the ground and room to flood fight.					
Inspector Comment					
Trees with less than 4" diameter at chest height should be removed, Spring 2021.

View looking downstream landside at a small starter tree that needs to be removed, Spring 2021.

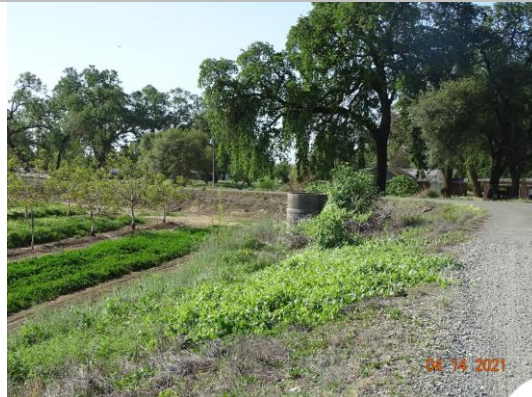
Photo 1 of 1 : SP_2021_RD0010_164_44_20210427_00120.jpg

LM Start	10.65	Rating **	M	Issue No.	44
LM End	10.65	Issue Type +	Ma	Location *	LS
Category	Earthen Levee			GPS Latitude/Longitude	
				Start	End
Item	Trim / Thin Trees			39.300273 °	39.300273 °
				-121.616903 °	-121.616903 °
DWR ID	DWR_RD0010_02_s_2020_44				
Comment Code					
T3 : Trim and thin trees to allow visibility of the ground and room to flood fight.					
Inspector Comment					
Trees with less than 4" diameter at chest height should be removed, Spring 2021.

View looking downstream landside at small starter tree on levee slope, Spring 2021.

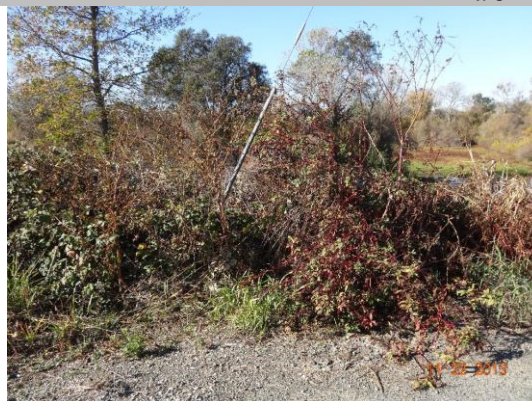
Photo 1 of 3 : UCIP_SP_2021_24839_44745.jpg

FIELD_STRUCT_DESC: 24-inch steel irrigation discharge pipe through the levee, 5 feet below the crown. Slide gate in a 36-inch concrete riser on the landside (LS) shoulder. Gate valve in a pump house on the waterside (WS) slope. Concrete headwall, saddle, and apron on the WS end. [Additional Reference(s): DWR Levee Log, 2005 (HLM 10.75), listed as 24-inch pipe. USACE Sacramento O&M Manual, Unit No. 151, May 1953, Revised 6 Jun 2017, (Station 655+65). USACE As-built Drawing No. 04-04-0318, Sheet 318/5.1, pdf file - page 5 of 9, Revised January 1951, referenced as Station 655+65, listed as a 24-inch steel pipe]
FS Date: 4/30/2013

View of waterward shoulder behind vegetation is standpipe.

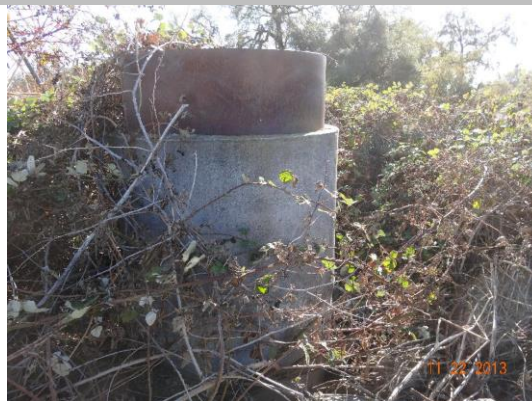
Photo 3 of 3 : UCIP_SP_2021_24839_44748.jpg

View of standpipe located on waterward side.

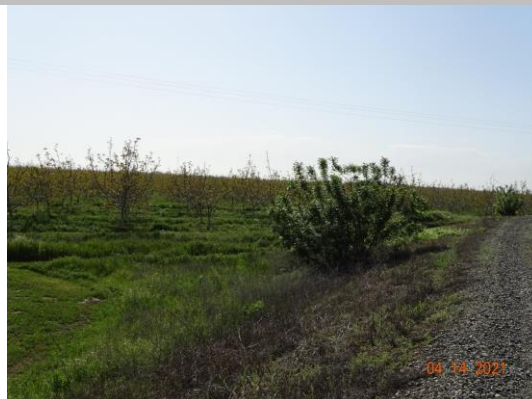
Photo 1 of 1 : SP_2021_RD0010_164_43_20210427_00119.jpg

LM Start	10.79	Rating **	M	Issue No.	43
LM End	10.79	Issue Type +	Ma	Location *	LS
Category	Earthen Levee			GPS Latitude/Longitude	
				Start	End
Item	Trim / Thin Trees			39.302080 °	39.302080 °
				-121.617745 °	-121.617745 °
DWR ID	DWR_RD0010_02_s_2020_43				
Comment Code					
T3 : Trim and thin trees to allow visibility of the ground and room to flood fight.					
Inspector Comment					
Trees with less than 4" diameter at chest height should be removed, Spring 2021.

View looking downstream landside at small starter tree on levee slope, Spring 2021.

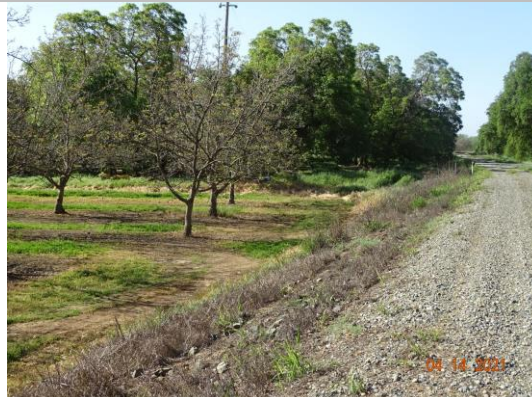
Photo 1 of 1 : SP_2021_RD0010_164_39_20210427_00118.jpg

LM Start	10.95	Rating **	M	Issue No.	39
LM End	11.34	Issue Type +	Ma	Location *	LS
Category	Earthen Levee			GPS Latitude/Longitude	
				Start	End
Item	Vegetation			39.304180 °	39.309789 °
				-121.618059 °	-121.616494 °
DWR ID	DWR_RD0010_02_f_2020_39				
Comment Code					
V2 : Remove the wild growth other than native grasses from the levee slopes.					
Inspector Comment					
Annual vegetation should be maintained, Spring 2021.

View looking downstream of annual vegetation on the landside slope that needs to be maintained, Spring 2021.

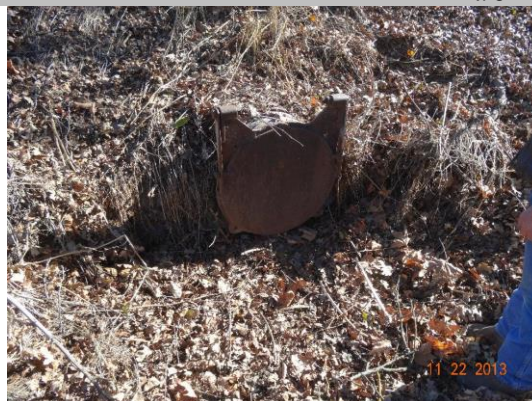
Photo 2 of 3 : UCIP_SP_2021_24840_44752.jpg

View of flap gate located on waterward side.

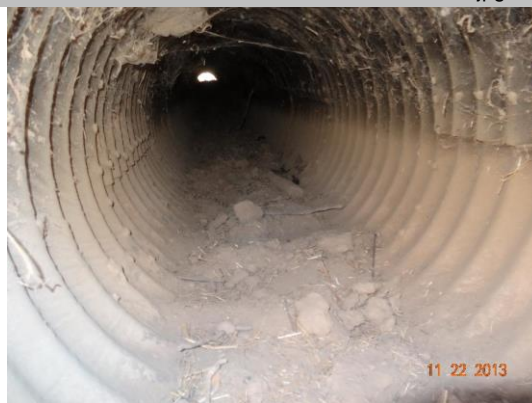
Photo 3 of 3 : UCIP_SP_2021_24840_44751.jpg

Internal view of pipe wall from waterward side.

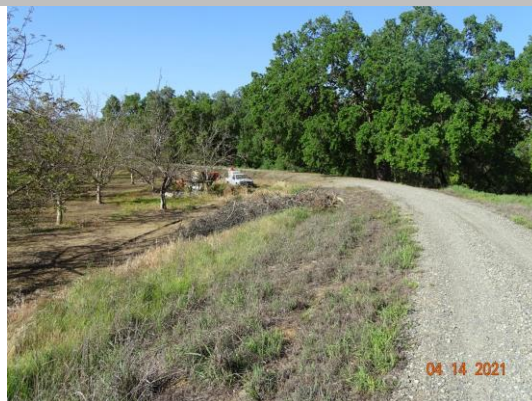
Photo 1 of 1 : SP_2021_RD0010_165_23_20210427_00054.jpg

LM Start	0.01	Rating **	M	Issue No.	23
LM End	0.01	Issue Type +	En	Location *	LS
Category	Earthen Levee			GPS Latitude/Longitude	
				Start	End
Item	Encroachments			39.310141 °	39.310141 °
				-121.616138 °	-121.616138 °
DWR ID	DWR_RD0010_03_s_2020_23				
Comment Code					
PR : Prunings					
Inspector Comment					
Remove prunings from levee toe, Spring 2021.

View looking downstream landside at prunings on levee slope, Spring 2021.

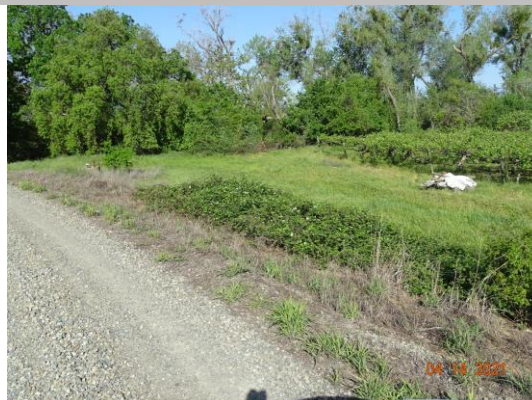
Photo 1 of 1 : SP_2021_RD0010_165_26_20210427_00053.jpg

LM Start	0.02	Rating **	M	Issue No.	26
LM End	0.57	Issue Type +	Ma	Location *	WS
Category	Earthen Levee			GPS Latitude/Longitude	
				Start	End
Item	Vegetation			39.310165 °	39.310229 °
				-121.616055 °	-121.605678 °
DWR ID	DWR_RD0010_03_f_2020_26				
Comment Code					
V1 : Control annual grass and weeds on the levee slopes and easements.					
Inspector Comment					
Annual vegetation on landside slope needs to be maintained, Spring 2021.

View of annual vegetation that needs to be maintained, Spring 2021.

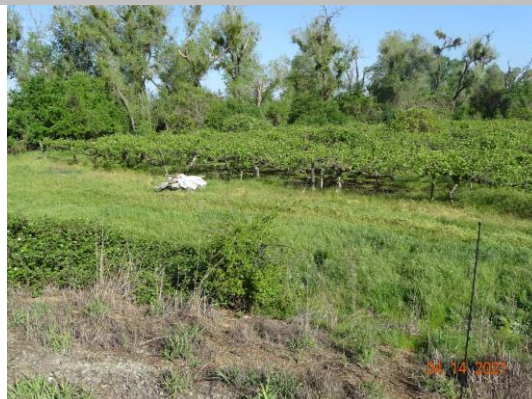
Photo 1 of 1 : SP_2021_RD0010_165_27_20210427_00052.jpg

LM Start	0.02	Rating **	M	Issue No.	27
LM End	0.02	Issue Type +	Ma	Location *	WS
Category	Earthen Levee			GPS Latitude/Longitude	
				Start	End
Item	Trim / Thin Trees			39.310164 °	39.310164 °
				-121.616054 °	-121.616054 °
DWR ID	DWR_RD0010_03_f_2020_27				
Comment Code					
T1 : Trim trees to at least five feet above ground level.					
Inspector Comment					
Trees with less than 4" diameter at chest height should be removed, Spring 2021.

View looking downstream waterside at a small starter trees that needs to be removed, Spring 2021.
