**Flood Control Project Maintenance
Levee Inspections
Unit Cover Sheet**

Reclamation District No. 0010 Honcut

Levee Inspection Report By Mile - Spring 2021

Waterway	Bank	Unit Miles	Inspection Start/End	Inspector
Unit No. 01 Simmerly Slough	Right	7.65	04/14/2021 04/14/2021	Brooks Weisser

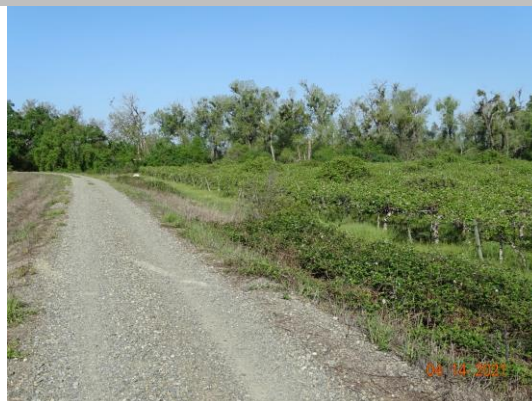
Photo 1 of 1 : SP_2021_RD0010_165_22_20210427_00051.jpg

LM Start	0.09	Rating **	M	Issue No.	22
LM End	0.09	Issue Type +	Ma	Location *	WS
Category	Earthen Levee			GPS Latitude/Longitude	
				Start	End
Item	Trim / Thin Trees			39.310229 °	39.310229 °
				-121.614697 °	-121.614697 °
DWR ID	DWR_RD0010_03_s_2020_22				
Comment Code					
T3 : Trim and thin trees to allow visibility of the ground and room to flood fight.					
Inspector Comment					
Trees with less than 4" diameter at chest height should be removed, Spring 2021.

View looking downstream waterside at a small starter trees that needs to be removed, Spring 2021.

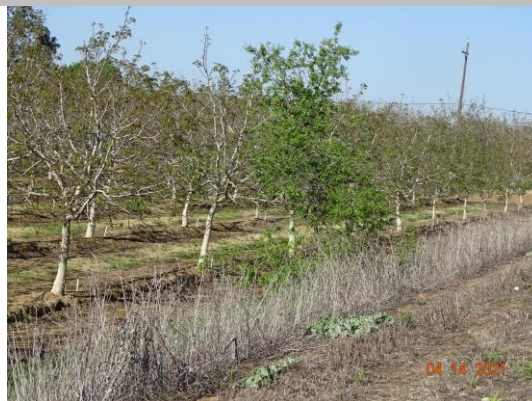
Photo 1 of 1 : SP_2021_RD0010_165_14_20210427_00050.jpg

LM Start	0.42	Rating **	M	Issue No.	14
LM End	0.42	Issue Type +	Ma	Location *	LS
Category	Earthen Levee			GPS Latitude/Longitude	
				Start	End
Item	Trim / Thin Trees			39.310229 °	39.310229 °
				-121.608610 °	-121.608610 °
DWR ID	DWR_RD0010_03_s_2021_14				
Comment Code					
T3 : Trim and thin trees to allow visibility of the ground and room to flood fight.					
Inspector Comment					
A starter tree on the landside slope needs to be removed, Spring 2021.

View of a starter tree on the landside slope that needs to be removed, Spring 2021.

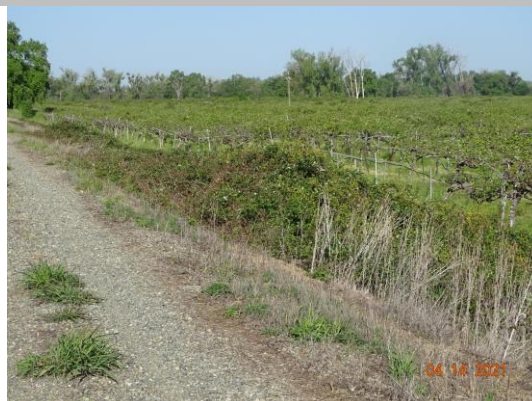
Photo 1 of 1 : SP_2021_RD0010_165_21_20210427_00049.jpg

LM Start	0.51	Rating **	M	Issue No.	21
LM End	0.51	Issue Type +	Ma	Location *	WS
Category	Earthen Levee			GPS Latitude/Longitude	
				Start	End
Item	Vegetation			39.310231 °	39.310231 °
				-121.606856 °	-121.606856 °
DWR ID	DWR_RD0010_03_s_2020_21				
Comment Code					
V2 : Remove the wild growth other than native grasses from the levee slopes.					
Inspector Comment					
Remove blackberries from levee slope, Spring 2021.

View looking downstream waterside at blackberries on levee slope, Spring 2021.

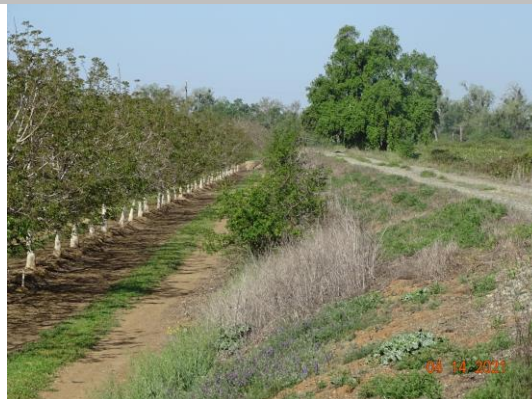
Photo 1 of 1 : SP_2021_RD0010_165_20_20210427_00048.jpg

LM Start	0.56	Rating **	M	Issue No.	20
LM End	0.56	Issue Type +	Ma	Location *	LS
Category	Earthen Levee			GPS Latitude/Longitude	
				Start	End
Item	Trim / Thin Trees			39.310227 °	39.310227 °
				-121.606027 °	-121.606027 °
DWR ID	DWR_RD0010_03_s_2020_20				
Comment Code					
T3 : Trim and thin trees to allow visibility of the ground and room to flood fight.					
Inspector Comment					
Trees with less than 4" diameter at chest height should be removed, Spring 2021.

View looking downstream landside at small starter trees on levee slope, Spring 2021.

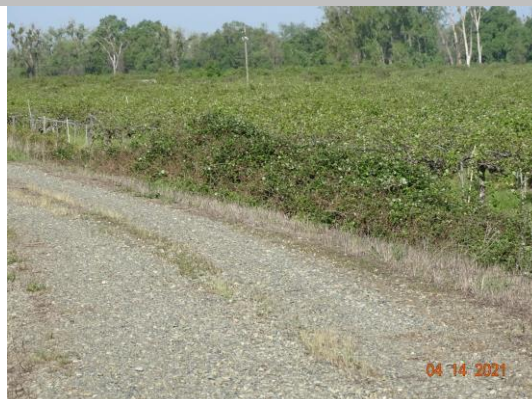
Photo 1 of 1 : SP_2021_RD0010_165_19_20210427_00047.jpg

LM Start	0.56	Rating **	M	Issue No.	19
LM End	0.56	Issue Type +	Ma	Location *	WS
Category	Earthen Levee			GPS Latitude/Longitude	
				Start	End
Item	Vegetation			39.310229 °	39.310229 °
				-121.605899 °	-121.605899 °
DWR ID	DWR_RD0010_03_s_2020_19				
Comment Code					
V2 : Remove the wild growth other than native grasses from the levee slopes.					
Inspector Comment					
Remove blackberries from levee slope, Fspring 2021.

View looking downstream waterside at black berries on the levee slope, Spring 2021.

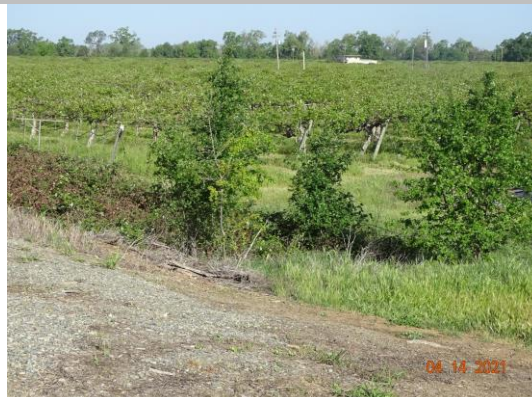
Photo 1 of 1 : SP_2021_RD0010_165_18_20210427_00046.jpg

LM Start	0.59	Rating **	M	Issue No.	18
LM End	0.59	Issue Type +	Ma	Location *	WS
Category	Earthen Levee			GPS Latitude/Longitude	
				Start	End
Item	Trim / Thin Trees			39.310209 °	39.310209 °
				-121.605456 °	-121.605456 °
DWR ID	DWR_RD0010_03_s_2020_18				
Comment Code					
T3 : Trim and thin trees to allow visibility of the ground and room to flood fight.					
Inspector Comment					
Trees with less than 4" diameter at chest height should be removed, Spring 2021.

View looking downstream waterside at a small starter trees that needs to be removed, Spring 2021.

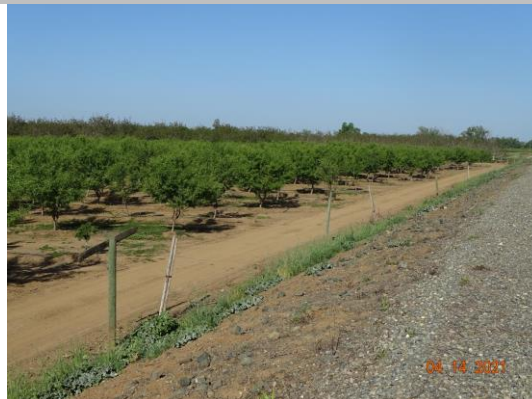
Photo 1 of 1 : SP_2021_RD0010_165_25_20210427_00045.jpg

LM Start	0.65	Rating **	M	Issue No.	25
LM End	0.75	Issue Type +	En	Location *	LS
Category	Earthen Levee			GPS Latitude/Longitude	
				Start	End
Item	Encroachments			39.309878 °	39.309267 °
				-121.604365 °	-121.602678 °
DWR ID	DWR_RD0010_03_f_2020_25				
Comment Code					
FE : Fence					
Inspector Comment					
Unpermitted fence that runs along landside toe should be removed, Spring 2021.

View looking downstream of fence that runs along landside toe, Spring 2021.

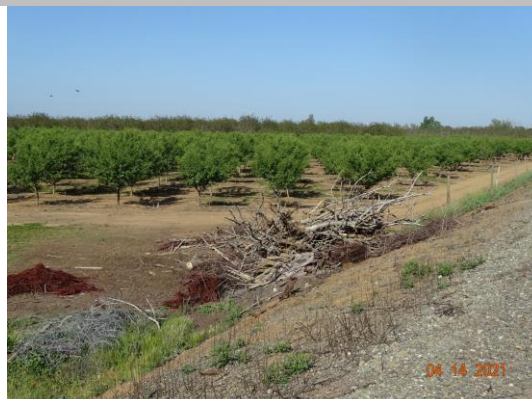
Photo 1 of 1 : SP_2021_RD0010_165_16_20210427_00044.jpg

LM Start	0.76	Rating **	U	Issue No.	16
LM End	0.76	Issue Type +	En	Location *	LS
Category	Earthen Levee			GPS Latitude/Longitude	
				Start	End
Item	Encroachments			39.309200 °	39.309200 °
				-121.602474 °	-121.602474 °
DWR ID	DWR_RD0010_03_s_2020_16				
Comment Code					
PR : Prunings					
Inspector Comment					
Remove prunings from levee toe, Spring 2021.

View looking downstream landside at prunings on levee slope, Spring 2021.

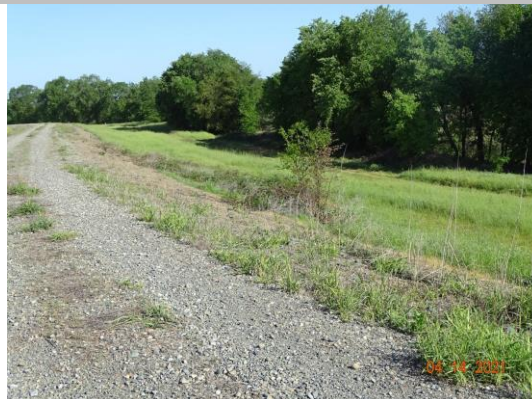
Photo 1 of 1 : SP_2021_RD0010_165_15_20210427_00043.jpg

LM Start	0.95	Rating **	M	Issue No.	15
LM End	0.95	Issue Type +	Ma	Location *	WS
Category	Earthen Levee			GPS Latitude/Longitude	
				Start	End
Item	Trim / Thin Trees			39.307583 °	39.307583 °
				-121.599640 °	-121.599640 °
DWR ID	DWR_RD0010_03_s_2020_15				
Comment Code					
T3 : Trim and thin trees to allow visibility of the ground and room to flood fight.					
Inspector Comment					
Trees with less than 4" diameter at chest height should be removed, Spring 2021.

View looking downstream waterside at a small starter trees that needs to be removed, Spring 2021.

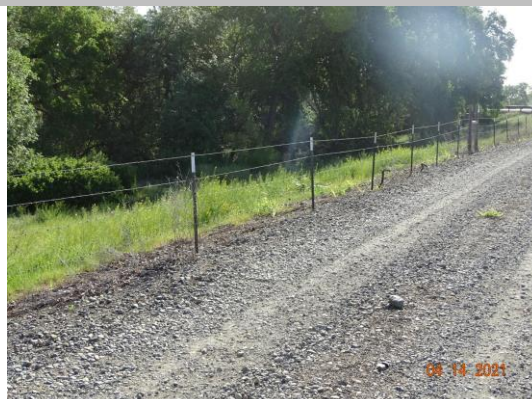
Photo 1 of 1 : SP_2021_RD0010_165_8_20210427_00042.jpg

LM Start	1.08	Rating **	M	Issue No.	8
LM End	1.21	Issue Type +	En	Location *	WS
Category	Earthen Levee			GPS Latitude/Longitude	
				Start	End
Item	Encroachments			39.307106 °	39.306422 °
				-121.597439 °	-121.595205 °
DWR ID	DWR_RD0010_03_s_2016_8				
Comment Code					
FE : Fence					
Inspector Comment					
Unpermitted fence on waterside levee hinge point.

View of an unpermitted fence on waterside levee hinge point, Spring 2021.

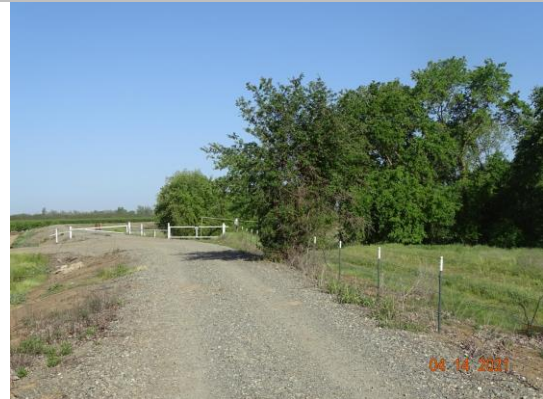
Photo 1 of 1 : SP_2021_RD0010_165_10_20210427_00041.jpg

LM Start	1.10	Rating **	M	Issue No.	10
LM End	1.10	Issue Type +	Ma	Location *	WS
Category	Earthen Levee			GPS Latitude/Longitude	
				Start	End
Item	Trim / Thin Trees			39.306995 °	39.306995 °
				-121.597116 °	-121.597116 °
DWR ID	DWR_RD0010_03_s_2018_10				
Comment Code					
T2 : Thin trees to allow visibility of the ground and room to flood fight.					
Inspector Comment					
Trees with less than 4" diameter at chest height should be removed, Spring 2021.

View looking downstream waterside of a tree that needs to be trimmed for access and visibility, Spring 2021.

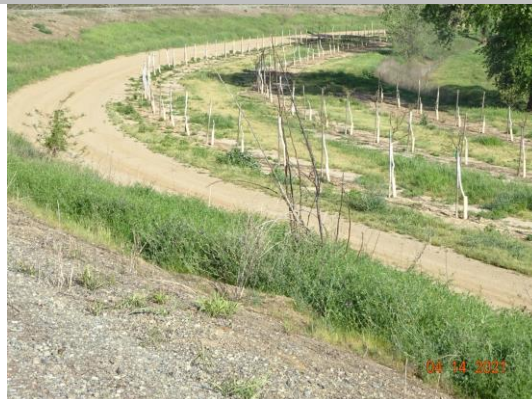
Photo 1 of 1 : SP_2021_RD0010_165_12_20210427_00039.jpg

LM Start	1.49	Rating **	M	Issue No.	12
LM End	1.49	Issue Type +	Ma	Location *	WS
Category	Earthen Levee			GPS Latitude/Longitude	
				Start	End
Item	Trim / Thin Trees			39.303738 °	39.303738 °
				-121.591548 °	-121.591548 °
DWR ID	DWR_RD0010_03_s_2020_12				
Comment Code					
T3 : Trim and thin trees to allow visibility of the ground and room to flood fight.					
Inspector Comment					
Trees with less than 4" diameter at chest height should be removed, Spring 2021.

View looking downstream waterside at a small starter trees that needs to be removed, Spring 2021.

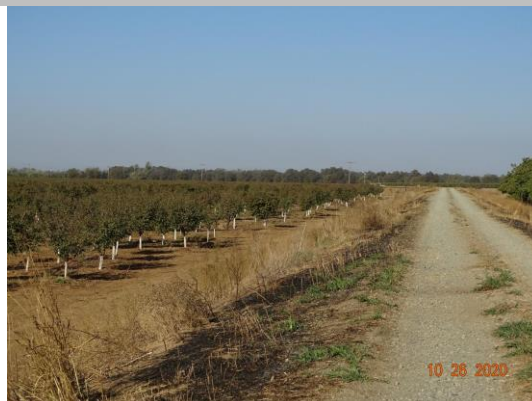
Photo 1 of 1 : SP_2021_RD0010_165_24_20210301_00019.jpg

LM Start	1.54	Rating **	M	Issue No.	24
LM End	2.44	Issue Type +	Ma	Location *	LS
Category	Earthen Levee			GPS Latitude/Longitude	
				Start	End
Item	Vegetation			39.303479 °	39.301671 °
				-121.590725 °	-121.574926 °
DWR ID	DWR_RD0010_03_f_2020_24				
Comment Code					
V1 : Control annual grass and weeds on the levee slopes and easements.					
Inspector Comment					
Annual vegetaion on landside slope needs to be maintained, Spring 2021.

View looking downstream of annual vegetation on landside slope, Fall 2020.

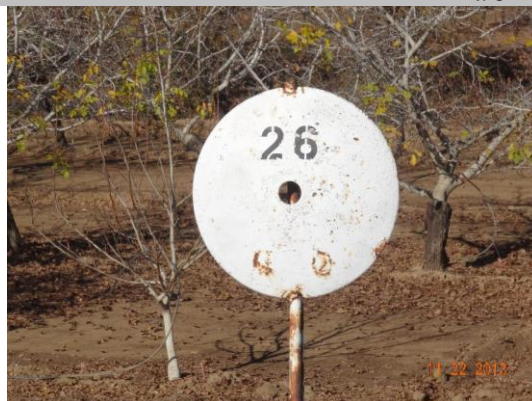
Photo 1 of 3 : UCIP_SP_2021_24842_44764.jpg

FS_ID:24842
DS_ID:21307
EP_NO: N/A
Repair Type: Non-Urgent
Crossing Status: Found
UCIP Comments: 12/01/2020 see UCIP marked up RD0010 USACE O&M manual OM151_IrrDRNSect.pdf and USACE drawing AB_4-4-318.pdf for approximate location and station. Reference files have been filed under UCIP's share drive desk study background folder for RD0010. (O. Magana - DWR UCIP)
05/01/2013 Sediment deposit inside pipe--Need to coordinate with owner to determine status of crossing. If crossing is no longer in use owner will need to contact the CVFPB to comply with Title 23. (O. Magana - DWR UCIP)
FIELD_STRUCT_DESC: 24-inch corrugated metal gravity drainage pipe through the levee, 15 feet below the crown. Corrugated metal cutoff wall around the pipe at each shoulder. Flap gate on the waterside (WS) end. Slide gate on the landside (LS) end. Concrete headwall at each toe. [Additional Reference(s): DWR Levee Log, 2005 (HLM 1.89), listed as a 24-inch corrugated metal pipe (CMP). USACE Sacramento O&M Manual, Unit No. 151, May 1953, Revised 6 Jun 2017, (Station 134+06). USACE As-built Drawing No. 04-04-0318, Sheet 318/6.1, pdf file - page 6 of 9, Revised January 1951, referenced as Station 134+06, listed as a 24-inch CMP]

Marker visible on waterward side--No. 26.

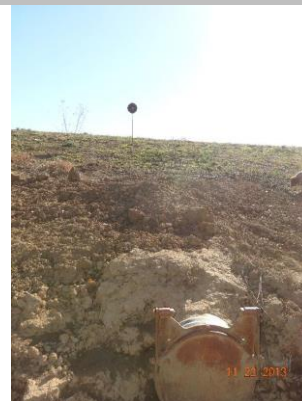
Photo 2 of 3 : UCIP_SP_2021_24842_44762.jpg

View of waterward slope.
