Flood Control Project Maintenance Levee Inspections LMA District Cover Sheet

Reclamation District No. 0010 Honcut

**Flood Control Project Maintenance
Levee Inspections
Unit Cover Sheet**

Waterway			Bank	Unit Miles
Unit No. 01 Simmerly Slough			Right	7.65
	Spring (March - May)	Summer (June - August)	(September - November) Fall	Winter (December - February)
Unit Maintenance Rating (Fall Only)				
Date of Inspection	5/5/2022 - 5/5/2022			
DWR Inspector	Brooks Weisser			
Accompanied By	Finlay Williams

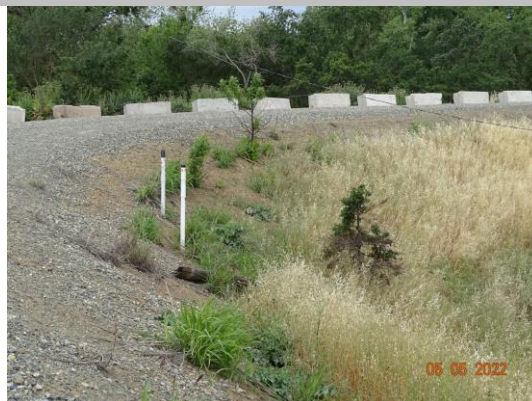
Photo 1 of 1 : SP_2022_RD0010_163_44_20220516_00130.jpg

LM Start	0.00	Rating **	M	Issue No.	44
LM End	0.00	Issue Type +	Ma	Location *	LS
Category	Earthen Levee			GPS Latitude/Longitude	
				Start	End
Item	Trim / Thin Trees			39.163708 °	39.163708 °
				-121.609906 °	-121.609906 °
DWR ID	DWR_RD0010_01_s_2020_44				
Comment Code					
T1 : Trim and thin trees to at least five feet above ground level to allow visibility of the ground and room to flood fight.					
Inspector Comment					
Trees with less than 4" diameter at chest height should be removed, Spring 2022.

View of small starter tree on levee slope, Spring 2022.

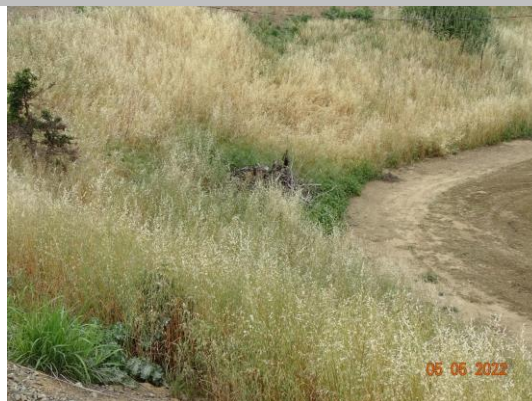
Photo 1 of 1 : SP_2022_RD0010_163_32_20220516_00131.jpg

LM Start	0.01	Rating **	M	Issue No.	32
LM End	0.01	Issue Type +	En	Location *	LS
Category	Earthen Levee			GPS Latitude/Longitude	
				Start	End
Item	Encroachments			39.163673 °	39.163673 °
				-121.609787 °	-121.609787 °
DWR ID	DWR_RD0010_01_s_2021_32				
Comment Code					
PR : Prunings					
Inspector Comment					
A pile of prunings on the landside toe need to be removed, Spring 2022.

View of pile of pruning on the landside toe, Spring 2022.

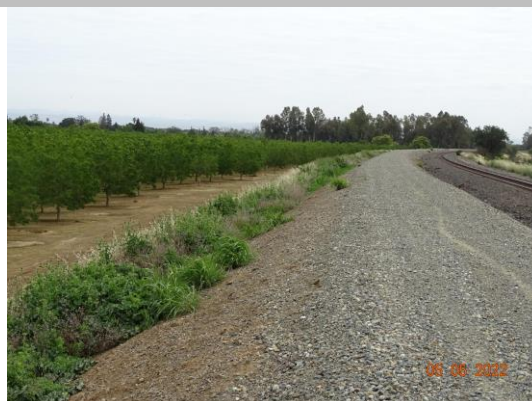
Photo 1 of 1 : SP_2022_RD0010_163_75_20220516_00135.jpg

LM Start	0.01	Rating **	M	Issue No.	75
LM End	1.65	Issue Type +	Ma	Location *	LS
Category	Earthen Levee			GPS Latitude/Longitude	
				Start	End
Item	Vegetation			39.163694 °	39.169788 °
				-121.609774 °	-121.609774 °
DWR ID	DWR_RD0010_01_s_2022_75				
Comment Code					
V1 : Control annual grass and weeds on the levee slopes and easements.					
Inspector Comment					
Annual vegetation needs to be maintained, Spring 2022.

View of annual vegetation on the landside slope, Spring 2022.

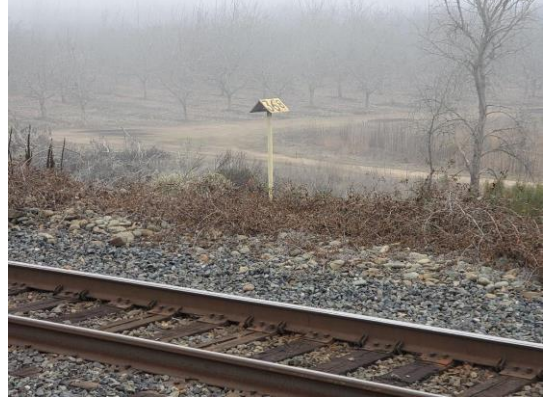
Photo 2 of 3 : UCIP_SP_2022_70580_97561.jpg

Comment Code						
Inspector Comment						
FS_ID:70580 DS_ID:24652 EP_NO: N/A Repair Type: Non-Urgent Crossing Status: Indicator Found UCIP Comments: 12/21/2020 Record has been updated to Non-Urgent. No permit was found authorizing this encroachment. Owner of this encroachment, Kinder Morgan, will need to coordinate with the CVFPB to meet Title 23 requirements for regulated streams. No maintenance or inspection records were made available to determine integrity of the line within Simmerly Slough. (O. Magana - DWR UCIP)01/24/2014 Spoke with Brian Gamble and crossing does not cross levee at this point the line goes parallel to along Valley Sub Railroad tracks towards Marysville. Crossing was kept for LMA's records. No action further action needed. (O. Magana - DWR UCIP)12/03/2013 Spoke to Frank Villalobos (supervisor-530-624-4048) and Doug Hubbard (maps-916-416-2972) was told to contact Brian Gamble (916-869-7148) to find out additional information about crossing and the status. Additional information can be requested through Kinder Morgan's Engineering Department by sending email to pipelineinquiries@kindermorgan.com ATTN: Engineering Department (O. Magana - DWR UCIP)04/29/2013 Unable to determine if crossing goes through the levee. Need to contact owner. Will need copy of letter showing crossings passed inspection. (O. Magana - DWR UCIP) FIELD_STRUCT_DESC: *NOT THROUGH LEVEE* Natural gas pipeline of an unknown size or material parallel to the levee, at an unknown depth. Gas line markers visible on the waterside (WS). No markers on the landside (LS). Pipeline does not cross the levee. This line was field discovered. (No permit found authorizing this pipe. Owner is Kinder Morgan). FS Date: 12/21/2020

WS view: marker visible on WS.

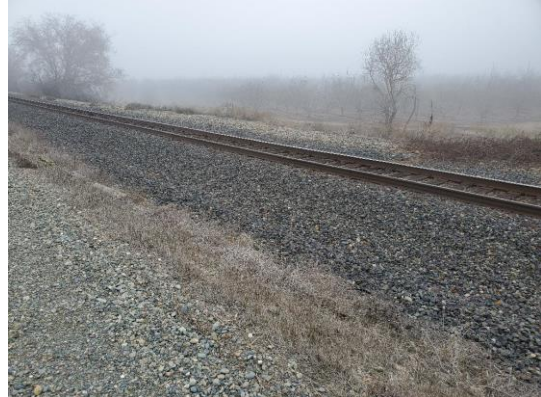
Photo 1 of 3 : UCIP_SP_2022_70537_97564.jpg

Comment Code						
Inspector Comment						
FS_ID:70537						
DS_ID:24653						
EP_NO: N/A						
Repair Type: Non-Urgent						
Crossing Status: Indicator Found						
UCIP Comments: 12/21/2020 Record remains Non-Urgent. No permit was found authorizing this encroachment. CVFPB will need to review crossing to determine owner. (O. Magana - DWR UCIP)04/29/2013						
Need to contact owner--unable to determine if crossing is authorized (no permit found) also need to determine if crossing goes through levee. (O. Magana - DWR UCIP)						
FIELD_STRUCT_DESC: Fiber optics line markers on the levee slope. Unable to determine if this line goes through the levee. This line was field discovered. (No permit found authorizing this line. Owner unknown).						
FS Date: 12/21/2020

WS view: cross-section of WS levee and location of railroad tracks along WS.

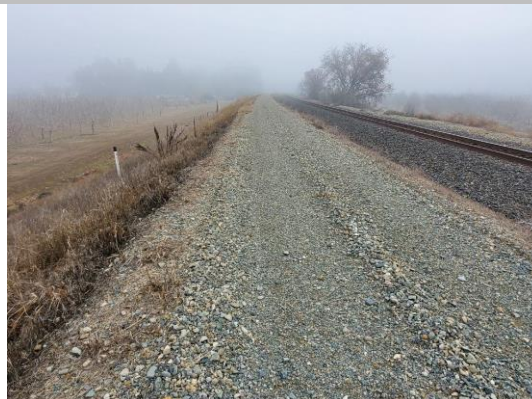
Photo 3 of 3 : UCIP_SP_2022_70537_97566.jpg

Overview of levee crown looking upstream towards crossing.

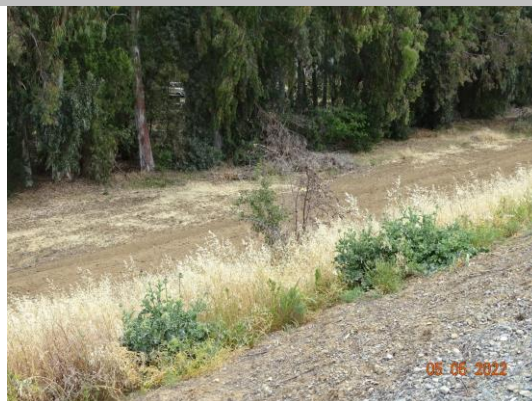
Photo 1 of 1 : SP_2022_RD0010_163_43_20220516_00139.jpg

LM Start	0.40	Rating **	M	Issue No.	43
LM End	0.40	Issue Type +	Ma	Location *	LS
Category	Earthen Levee			GPS Latitude/Longitude	
				Start	End
Item	Trim / Thin Trees			39.162893 °	39.162893 °
				-121.602631 °	-121.602631 °
DWR ID	DWR_RD0010_01_f_2020_43				
Comment Code					
T1 : Trim and thin trees to at least five feet above ground level to allow visibility of the ground and room to flood fight.					
Inspector Comment					
Trees with less than 4" diameter at chest height should be removed, Spring 2022.

View of starter tree on landside slope that should be removed, Spring 2022.

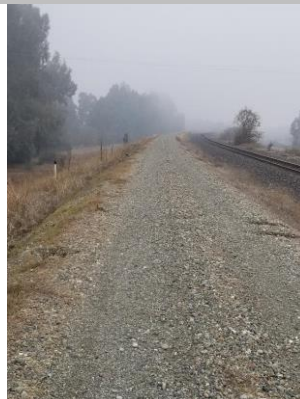
Photo 1 of 3 : UCIP_SP_2022_70581_97580.jpg

Comment Code						
Inspector Comment						
FS_ID:70581 DS_ID:24654 EP_NO: N/A Repair Type: Non-Urgent Crossing Status: Indicator Found UCIP Comments: 12/21/2020 Record remains Non-Urgent. No permit was found authorizing the installation of this structure. Need to contact Quest Communications as indicated in the marker found on the LS slope. Owner will need to coordinate with the CVFPB to meet Title 23 requirements. (O. Magana - DWR UCIP)04/29/2013 Need to contact owner--unable to determine if crossing is authorized (no permit found) also need to determine if crossing goes through levee. (O. Magana - DWR UCIP) FIELD_STRUCT_DESC: Fiber optics line markers on levee slope. Unable to determine if this line goes through the levee. This line was field discovered. (No permit found authorizing this line. Owner is Quest Communications). FS Date: 12/21/2020

Overview of levee crown looking upstream towards crossings.

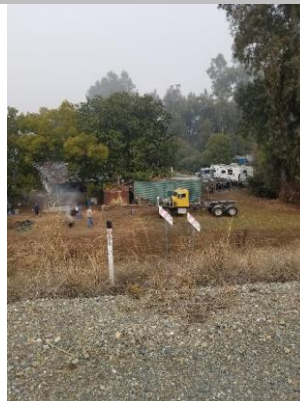
Photo 2 of 3 : UCIP_SP_2022_70581_97581.jpg

LS view: overview of LS with markers visible for 3 crossings in this section of the levee.

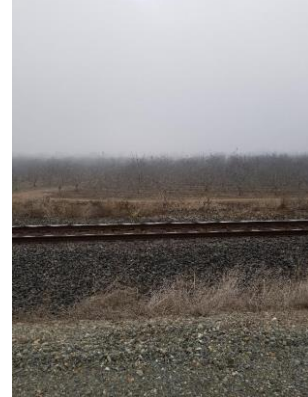
Photo 3 of 3 : UCIP_SP_2022_70581_97582.jpg

WS view: overview of WS. Railroad tracks found on the WS.

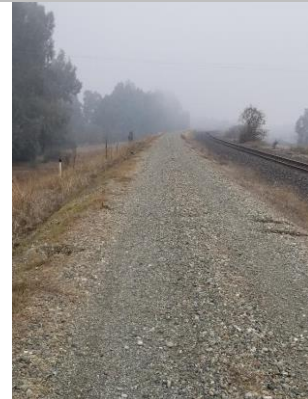
Photo 1 of 3 : UCIP_SP_2022_70539_97573.jpg

FS_ID:70539
DS_ID:21256
EP_NO: 1798
Repair Type: Non-Urgent
Crossing Status: Not Found
UCIP Comments: 12/21/2020 Record remains Non-Urgent. No maintenance or inspection records have been provided by the owner to determine the integrity of line through the levee. Need to contact owner to determine the status of gas line and request confirmation that the line is being maintained and no integrity issues have been found through the portion that goes through the levee. (O. Magana - DWR UCIP)04/29/2013 Dense vegetation limits the inspector's visibility to identify signs of pipe failure (leaks) along the slope. Recommend removing vegetation along pipe alignment to conduct proper inspection of structure and appurtenances. (O. Magana - DWR UCIP)
FIELD_STRUCT_DESC: 4-inch steel natural gas pipeline through the levee, 3.0 feet below the crown. Concrete headwall at each shoulder. Marker on each slope. Pipe extends through three 5-foot by 5-foot by 6-foot concrete regulator pits on the landside (LS). (4-inch gas main authorized under Permit No. 1798, 1953 - Pacific Gas and Electric Company [PG&E]). [Additional Reference(s): DWR Levee Log, 2005 (HLM 0.41)].

Overview of levee crown looking upstream towards crossings.

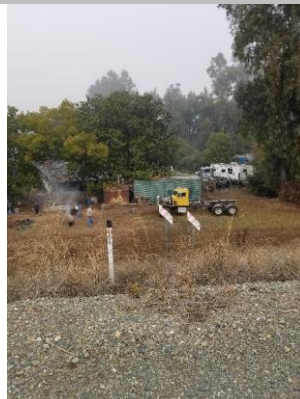
Photo 2 of 3 : UCIP_SP_2022_70539_97574.jpg

LS view: overview of LS with markers indicating 3 crossings.

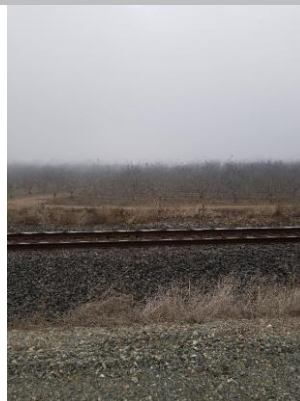
Photo 3 of 3 : UCIP_SP_2022_70539_97575.jpg

WS view: overview of WS and railroad tracks located on the WS. No signage was found on the WS.

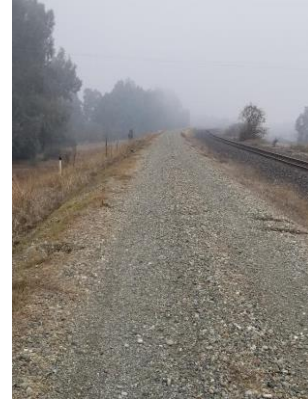
Photo 1 of 3 : UCIP_SP_2022_70540_97586.jpg

Comment Code						
Inspector Comment						
FS_ID:70540 DS_ID:21257 EP_NO: 13015 Repair Type: Non-Urgent Crossing Status: Found UCIP Comments: 12/21/2020 Record remains Non-Urgent. No maintenance or inspection records have been provided by the owner to determine the integrity of line through the levee. Need to contact owner to determine the status of gas line and request confirmation that the line is being maintained and no integrity issues have been found through the portion that goes through the levee. (O. Magana - DWR UCIP)04/29/2013 New gravel indicates work was recently completed. Will need to contact owner to obtain information pertaining to work completed. Need to contact owner to determine if crossing is still active and to determine last inspection date. Will need copy of letter showing crossings passed inspection. This crossing is referenced in the USACE Periodic Inspection as item USACE_CESPK_HON1_2013_p_0075. (O. Magana - DWR UCIP) FIELD_STRUCT_DESC: 8-inch pipe containing a 4-inch steel natural gas pipeline through the levee, 30.0 feet below the crown. Annular space grouted. Cutoff wall on each end within the levee. (Reinforcement of an existing 4-inch gas main with a parallel 4-inch main authorized under Permit No. 13015, 1980 - Pacific Gas and Electric Company [PG&E]). [Additional Reference(s): DWR Levee Log, 2005, (HLM 0.44)]. FS Date: 12/21/2020

Overview of levee crown looking upstream towards crossings.

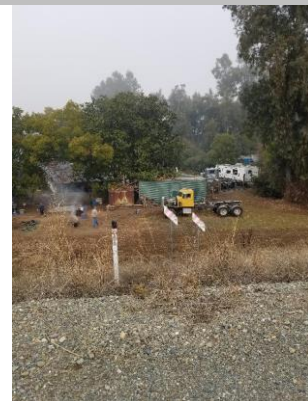
Photo 2 of 3 : UCIP_SP_2022_70540_97587.jpg

LS view: overview of LS with markers indicating three utility crossings.

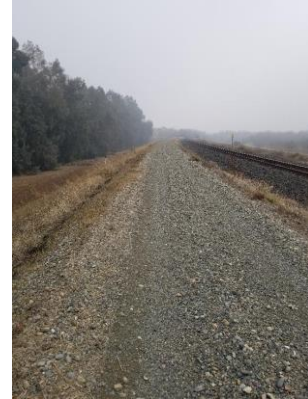
Photo 1 of 3 : UCIP_SP_2022_70582_99118.jpg

FS_ID:70582
DS_ID:24655
EP_NO: N/A
Repair Type: Non-Urgent
Crossing Status: Indicator Found
UCIP Comments: 12/21/2020 Record remains Non-Urgent. No permit was found authorizing the installation of this structure. Need to contact Quest Communications, owner of utility, as indicated in the marker found on the LS slope to request permit authorizing installation. Owner will need to coordinate with the CVFPB to meet Title 23 requirements. (O. Magana - DWR UCIP)04/29/2013 Need to contact owner--unable to determine if crossing is authorized (no permit found) also need to determine if crossing goes through levee. (O. Magana - DWR UCIP) FIELD_STRUCT_DESC: Fiber optics line markers on the levee slope. Unable to determine if this line goes through the levee. This line was field discovered. (No permit found authorizing this line. Owner is Quest Communications).
FS Date: 12/21/2020

Overview of levee crown looking upstream towards pipe crossing.

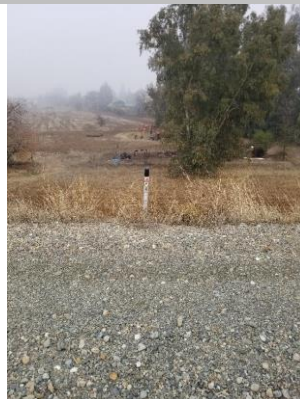
Photo 2 of 3 : UCIP_SP_2022_70582_99119.jpg

LS view: marker visible on the LS slope.

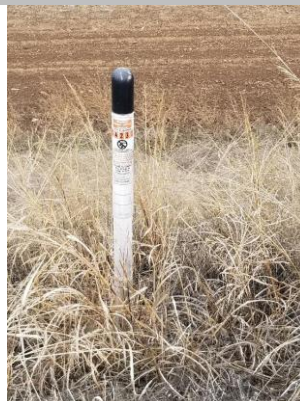
Photo 3 of 3 : UCIP_SP_2022_70582_99120.jpg

LS view: close up of utility contact information and owner.

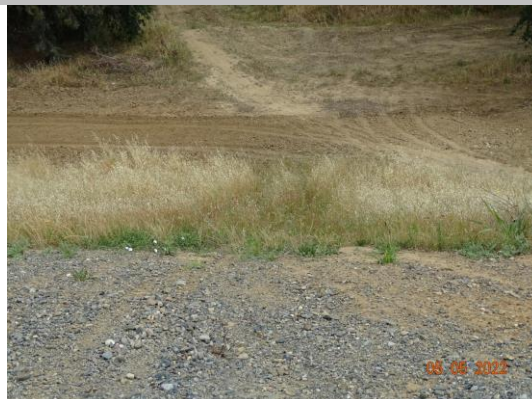
Photo 1 of 1 : SP_2022_RD0010_163_71_20220516_00132.jpg

LM Start	0.68	Rating **	M	Issue No.	71
LM End	0.68	Issue Type +	Ma	Location *	LS
Category	Earthen Levee			GPS Latitude/Longitude	
				Start	End
Item	Erosion / Vehicle Traffic			39.161381 °	39.161381 °
				-121.597657 °	-121.597657 °
DWR ID	DWR_RD0010_01_f_2020_71				
Comment Code					
E6 : Repair the levee slope damaged by vehicle traffic and prevent access where possible.					
Inspector Comment					
Ramp is caused by constant ATV foot traffic use on levee slope, there is no sign of separation, cracking, or caving. Spring 2022.

View of the slope stability caused by ATV foot traffic on the landward side of the levee, Spring 2022.

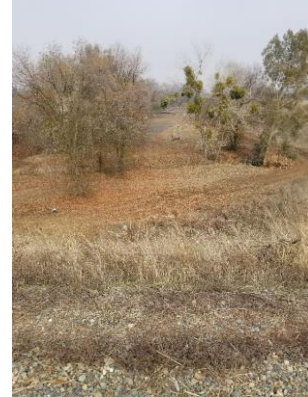
Photo 1 of 3 : UCIP_SP_2022_70542_97591.jpg

Comment Code						
Inspector Comment						
FS_ID:70542 DS_ID:21310 EP_NO: 3922 Repair Type: Non-Urgent Crossing Status: Not Found UCIP Comments: 12/21/2020 Record has been updated to Non-Urgent. DWR DMP geophysical study found no positive signal of pipe at latitude, longitude 39.161309, -121.597460. No signage or evidence of pipe was found during site inspection. Record will remain in UCIP's database and should be monitored until a levee improvement project can confirm that this crossing has been removed from the levee. (O. Magana - DWR UCIP) FIELD_STRUCT_DESC: 18-inch steel pipeline of an unknown purpose through the levee, 3.4 feet below the crown. Standard corrugated metal (CM) cutoff wall around the pipe at the center of the levee. Siphon breaker on the apex of the pipe at the landside (LS) shoulder. (18-inch pipeline authorized under Permit No. 3922, 1962 - R. Barr, Helen T. Shaver, et al.). FS Date: 12/21/2020

LS view: overview of LS. No evidence of pipe was found.

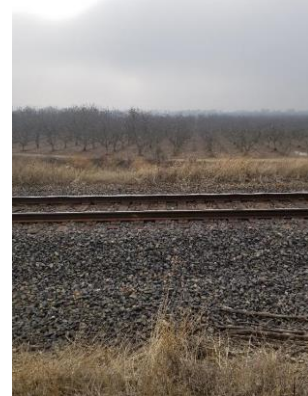
Photo 2 of 3 : UCIP_SP_2022_70542_97592.jpg

WS view: overview of WS. No evidence of pipe was found.

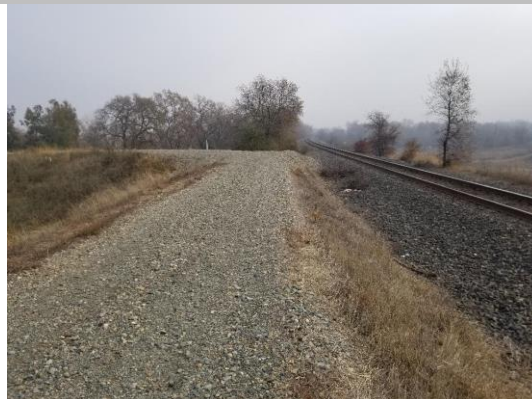
Photo 3 of 3 : UCIP_SP_2022_70542_97593.jpg

Overview of levee crown looking upstream toward where crossing should be.

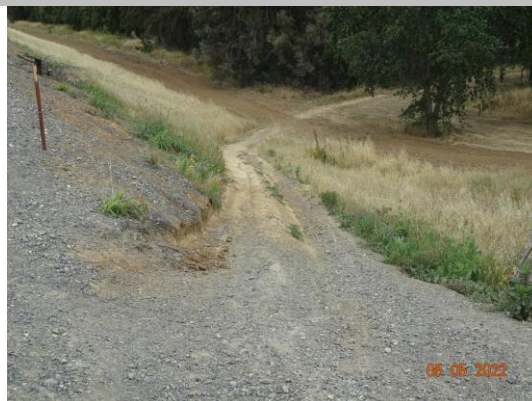
Photo 1 of 1 : SP_2022_RD0010_163_48_20220516_00133.jpg

LM Start	0.72	Rating **	M	Issue No.	48
LM End	0.72	Issue Type +	Ma	Location *	LS
Category	Earthen Levee			GPS Latitude/Longitude	
				Start	End
Item	Erosion / Vehicle Traffic			39.161198 °	39.161198 °
				-121.597102 °	-121.597102 °
DWR ID	DWR_RD0010_01_f_2013_48				
Comment Code					
E6 : Repair the levee slope damaged by vehicle traffic and prevent access where possible.					
Inspector Comment					
Ramp is caused by constant ATV foot traffic use on levee slope, there is no sign of separation, cracking, or caving, Fall 2021.

View of the slope stability caused by ATV foot traffic on the landward side of the levee looking downstream, Spring 2022.

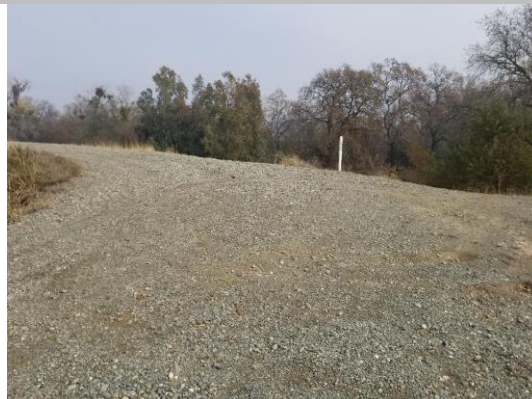
Photo 1 of 3 : UCIP_SP_2022_70583_97594.jpg

FS_ID:70583
DS_ID:24656
EP_NO: N/A
Repair Type: Non-Urgent
Crossing Status: Indicator Found
UCIP Comments: 12/21/2020 Record remains Non-Urgent. No permit was found authorizing the installation of this structure. Need to contact Quest Communications, owner identified, as indicated in the marker found on the LS slope to request permit authorizing installation. Owner will need to coordinate with the CVFPB to meet Title 23 requirements. (O. Magana - DWR UCIP)04/29/2013 Need to contact owner--unable to determine if crossing is authorized (no permit found) also need to determine if crossing goes through levee. (O. Magana - DWR UCIP)
FIELD_STRUCT_DESC: Fiber optics line markers on levee slope. Unable to determine if this line goes through the levee. This line was field discovered. (No permit found authorizing this line. Owner is Quest Communications).
FS Date: 12/21/2020

Overview of levee crown looking upstream toward pipe crossing.

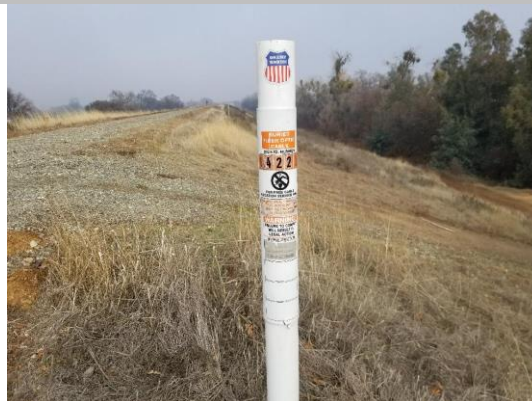
Photo 2 of 3 : UCIP_SP_2022_70583_97595.jpg

WS view: marker found on the WS slope.

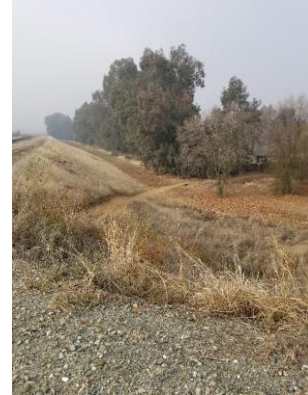
Photo 3 of 3 : UCIP_SP_2022_70583_97596.jpg

LS view: overview of LS. No marker found on the LS.

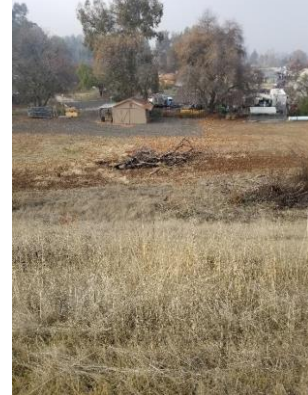
Photo 1 of 3 : UCIP_SP_2022_70544_97599.jpg

Comment Code					
Inspector Comment					
FS_ID:70544 DS_ID:21258 EP_NO: N/A Repair Type: Non-Urgent Crossing Status: Found UCIP Comments: 12/21/2020 Record remains Non-Urgent. No permit was found authorizing this encroachment. CVFPB will need to review crossing to determine owner. DWR DMP has not found internal issues, LOF between 1 and 2. Recommend inspection in 5 years. (O. Magana - DWR UCIP)11/25/2020 see UCIP marked up RD0010 USACE O&M manual OM151_IrrDRNSect.pdf and USACE drawing AB_4-4-295.pdf for approximate location and station. Reference files have been filed under UCIP's share drive desk study background folder for RD0010. (O. Magana - DWR UCIP)7/01/2016 Gate has been repaired--WS gate is functional. LS gate still needs new stem for the gate to properly function--stem is bent. USACE's PI issue references permit number 13710 this is incorrect permit is associated with DS_ID 21259 (CLM 0.767). (O. Magana - DWR UCIP)4/29/2013 Damaged flap gate on waterward side and damaged stem on screw gate on landward side. Need to contact owner to determine if crossing is still active. If crossing is still in use owner will need to address damage on flap gate and screw gate. If crossing is no longer in use owner will need to contact the CVFPB to comply with Title 23. This crossing is referenced in the USACE Periodic Inspection as item USACE_CESPK_HON1_2013_p_0053 and 0057. (O. Magana - DWR UCIP) FIELD_STRUCT_DESC: 24-inch corrugated metal (CM) gravity drainage pipe through the levee, 31.0 feet below the crown. Two CM cutoff walls around the pipe. Concrete headwall at each end. Flap gate on the waterside (WS) end. Slide gate on the landside (LS) end. Pipe discharges into a 6-foot concrete splash apron on the WS. (No permit found authorizing this pipe. Owner unknown). [Additional Reference(s): DWR Levee Log, 2005, (HLM 0.74). USACE Sacramento O&M Manual, Unit No. 151, May 1953, Revised 6 June 2017, (Station 46+60). USACE As-Built Drawing No. 4-4-295, Sheet 295/2, November 1947, Revised December 1947, (Station 45+60)]. FS Date: 12/21/2020

LS view: overview of LS. Dense vegetation along pipe alignment.

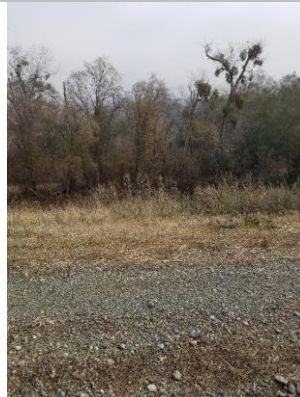
Photo 2 of 3 : UCIP_SP_2022_70544_97600.jpg

LM Start	0.74	Rating **	M	Issue No.	12 (cont)
LM End	0.74	Issue Type +	Ma	Location *	
Category	Supplemental			GPS Latitude/Longitude	
				Start	End
Item	DWR UCIP LMA Responsibility			39.161497 °	39.161497 °
				-121.596816 °	-121.596816 °
DWR ID	21258

WS view: overview of WS. Dense vegetation along pipe alignment.

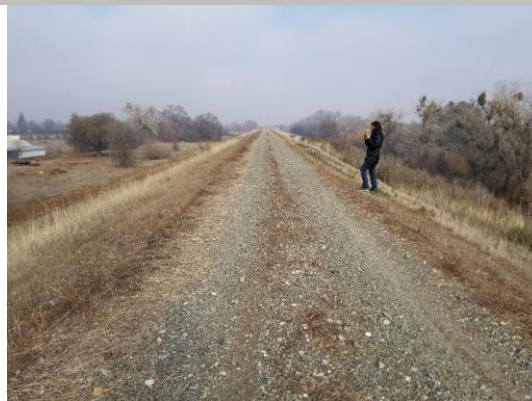
Photo 3 of 3 : UCIP_SP_2022_70544_97601.jpg

Overview of levee crown looking upstream towards pipe crossing.

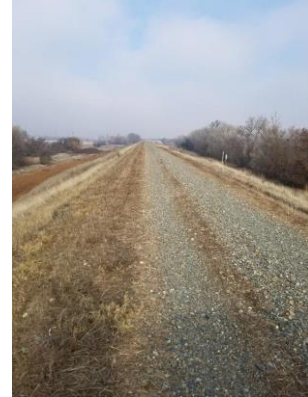
Photo 1 of 3 : UCIP_SP_2022_70569_97603.jpg

Comment Code						
Inspector Comment						
FS_ID:70569 DS_ID:21261 EP_NO: N/A Repair Type: Urgent Crossing Status: Found UCIP Comments: 09/08/2021 CIPP-lining of this crossing approved under project authorization WC2021104. 12/21/2020 Record has been updated from No Action Needed to Urgent. DWR DMP has found integrity issues, LOF between 5 and 6. Recommend monitoring crossing until funding becomes available to address. No permit was found authorizing this encroachment. CVFPB will need to review crossing to determine owner. Dense vegetation along the WS and LS limited site inspection. (O. Magana - DWR UCIP)11/25/2020 see UCIP marked up RD0010 USACE O&M manual OM151_IrrDRNSect.pdf and USACE drawing AB_4-4-295.pdf for approximate location and station. Reference files have been filed under UCIP's share drive desk study background folder for RD0010. (O. Magana - DWR UCIP)04/29/2013 No signs of damage to levee present during inspection. This crossing is referenced in the USACE Periodic Inspection as item USACE_CESPK_HON1_2013_p_0037 and 0040. (O. Magana - DWR UCIP) FIELD_STRUCT_DESC: 24-inch corrugated metal (CM) gravity drainage pipe through the levee, 29.5 feet below the crown. Two CM cutoff walls around the pipe on each end. Slide gate on the landside (LS) end. Flap gate on the waterside (WS) end. Concrete headwall at the LS toe. (No permit found authorizing this pipe. Owner unknown). [Additional Reference(s): DWR Levee Log, 2005, (HLM 0.90). USACE Sacramento O&M Manual, Unit No. 151, May 1953, Revised 6 June 2017, (Station 37+66). USACE As-Built Drawing No. 4-4-295, Sheet No. 295/2, November 1947, Revised December 1947, (Station 37+66)]. FS Date: 12/21/2020

Overview of levee crown looking upstream towards pipe crossing.

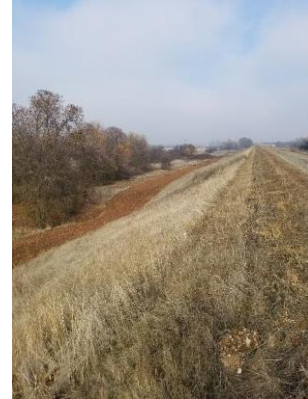
Photo 2 of 3 : UCIP_SP_2022_70569_97604.jpg

LM Start	0.89	Rating **	U	Issue No.	14 (cont)
LM End	0.89	Issue Type +	Ma	Location *	
Category	Supplemental		GPS Latitude/Longitude		
			Start	End	
Item	DWR UCIP LMA Responsibility		39.163341 °	39.163341 °	
			-121.595340 °	-121.595340 °	
DWR ID	21261

LS view: cross-section of LS slope.

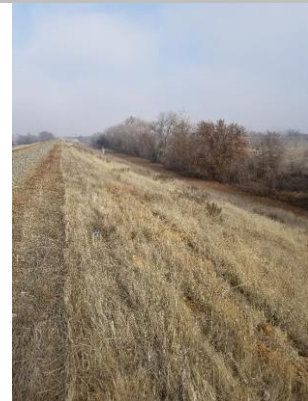
Photo 3 of 3 : UCIP_SP_2022_70569_97605.jpg

WS view: cross-section of WS slope.

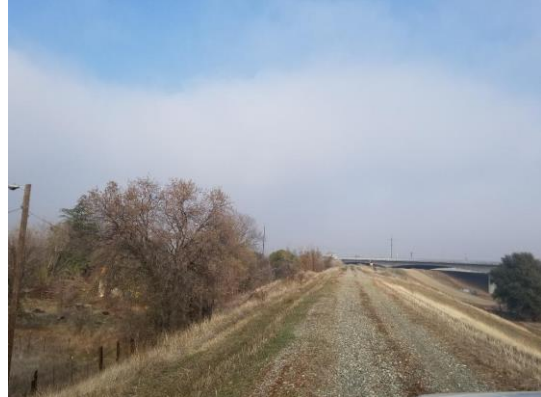
Photo 1 of 2 : UCIP_SP_2022_70547_97606.jpg

FS_ID:70547
DS_ID:21260
EP_NO: 4555
Repair Type: Non-Urgent
Crossing Status: Indicator Found
UCIP Comments: 12/21/2020 Record remains Non-Urgent. Dense vegetation along the WS and LS limited site inspection. Previous 2013 inspection found pipe at the WS toe and pipe appeared abandoned. If crossing is no longer needed, owner will need to coordinate with the CVFPB to properly remove crossing from the levee. (O. Magana - DWR UCIP)04/29/2013 Pipe is approximately 4-6 inches in diameter located near the toe of levee. Crossing is approximately 50 feet downstream of 24-inch pipe. Need to contact owner to determine status of this crossing and to verify the purpose of crossing. If crossing is no longer in use owner will need to contact the CVFPB to comply with Title 23. (O. Magana - DWR UCIP)
FIELD_STRUCT_DESC: 6-inch steel drainage discharge pipe through the levee, 1.0 foot below the crown. Siphon breaker on the waterside (WS) shoulder. Pump at the landside (LS) toe. Revetment around the discharge end of the pipe. Pipe drains into a ditch at the WS toe. Pipe is not buried in berms. Gravel pad over pipe across levee crown for vehicular access. (6-inch drainage pipe authorized under Permit No. 4555, 1964 - Ledbetter, Carbah, and Huddle). [Additional Reference(s): DWR Levee Log, 2005, (HLM 0.90), listed as an abandoned pipe].

Overview of levee crown looking upstream towards pipe crossing.

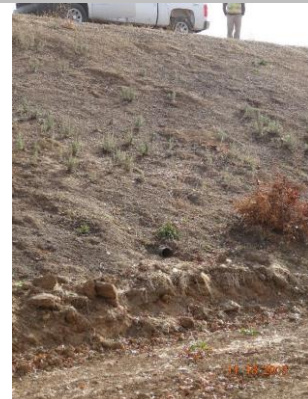
Photo 2 of 2 : UCIP_SP_2022_70547_51418.jpg

Pipe through levee near waterward toe.

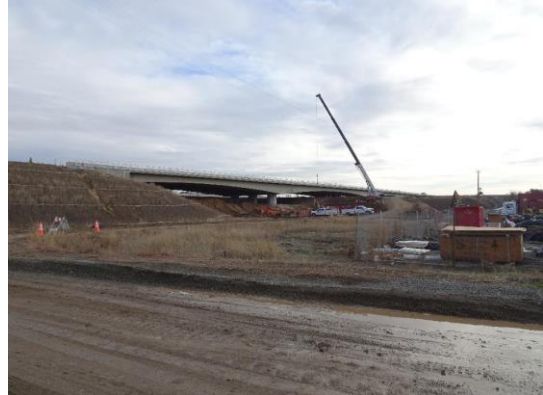
Photo 2 of 3 : UCIP_SP_2022_70570_99126.jpg

LM Start	1.33	Rating **	M	Issue No.	16 (cont)
LM End	1.33	Issue Type +	En	Location *	
Category	Supplemental		GPS Latitude/Longitude		
			Start	End	
Item	DWR UCIP Field Study		39.168583 °	39.168583 °	
			-121.590929 °	-121.590929 °	
DWR ID	21262

LS view: staging area for Caltrans construction site, photo 1 of 3.

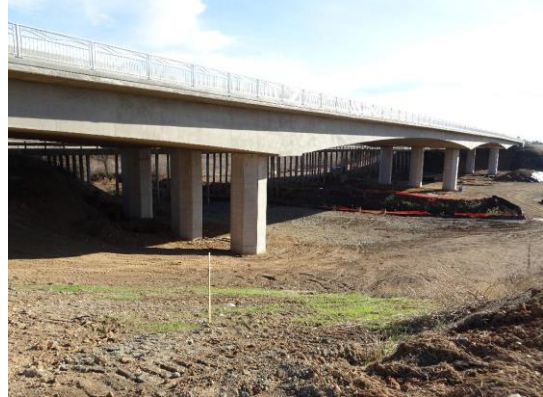
Photo 2 of 3 : UCIP_SP_2022_70571_97607.jpg

LM Start	1.34	Rating **	M	Issue No.	17 (cont)
LM End	1.34	Issue Type +	En	Location *	
Category	Supplemental		GPS Latitude/Longitude		
			Start	End	
Item	DWR UCIP Field Study		39.168671 °	39.168671 °	
			-121.590731 °	-121.590731 °	
DWR ID	21263

WS view: Caltrans' construction site, photo 2 of 4.

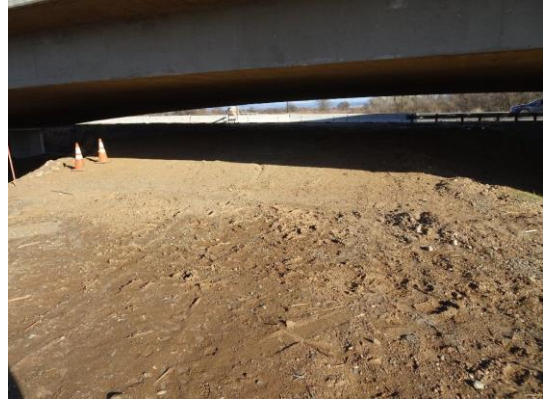
Photo 2 of 3 : UCIP_SP_2022_70550_97614.jpg

LM Start	1.35	Rating **	M	Issue No.	18 (cont)
LM End	1.35	Issue Type +	En	Location *	
Category	Supplemental			GPS Latitude/Longitude	
				Start	End
Item	DWR UCIP Field Study			39.168717 °	39.168717 °
				-121.590570 °	-121.590570 °
DWR ID	21264

Overview of levee crown alignment under newly constructed HWY 70, photo 2 of 6.

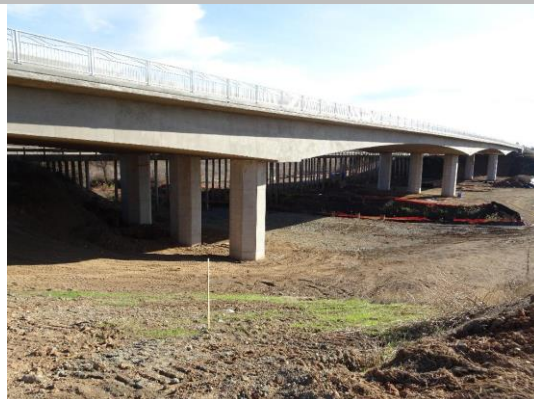
Photo 1 of 3 : UCIP_SP_2022_70551_97617.jpg

Comment Code					
Inspector Comment					
FS_ID:70551 DS_ID:21265 EP_NO: 12081 Repair Type: Non-Urgent Crossing Status: Not Found UCIP Comments: 12/21/2020 Record remains Non-Urgent. No signage or evidence of pipe was found during site inspection. Need to contact owner to determine the status of the crossing through the levee. (O. Magana - DWR UCIP)04/29/2013 Need to contact owner--unable to determine if crossing is authorized (no permit found) also need to determine if crossing goes through levee. (O. Magana - DWR UCIP) FIELD_STRUCT_DESC: 3-inch steel telephone conduit through the levee, 3.0 feet below the crown. (Replacement of an aerial cable with an underground conduit authorized under Permit No. 12081, 1977 - Pacific Telephone and Telegraph Company [PT&T]). FS Date: 12/21/2020

WS view: overview of WS with new construction.

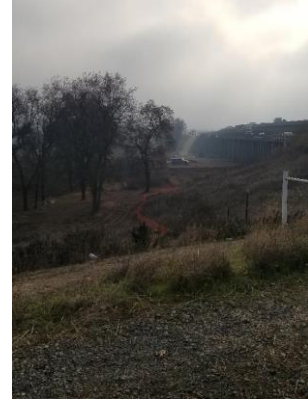
Photo 1 of 3 : UCIP_SP_2022_70572_97620.jpg

FS_ID:70572
DS_ID:21318
EP_NO: N/A
Repair Type: Urgent
Crossing Status: Found
UCIP Comments: 09/08/2021 CIPP-lining of this crossing approved under project authorization WC2021104.
12/21/2020 Record remains Non-Urgent. No permit was found authorizing this encroachment. CVFPB will need to review crossing to determine owner. Caltrans lined pipe as part of the construction project in 2020. Caltrans contact, Resident Engineer, is Mr. Selvendran "Mano" Manoharan for the Construction of State Highway 70. His email is Selvendran.Monoharan@dot.ca.gov. DWR DMP internal inspection found integrity issues in 2019, LOF between 5 and 6. No CVFPB authorization letter was found authorizing the lining of the 30-inch pipe. Information obtained from Caltrans regarding the lining of the pipe was forwarded to DWR DMP. Need to determine if internal video inspection was conducted by Caltrans and reasoning for lining pipe. Dense vegetation along the WS and LS limited site inspection. (O. Magana - DWR UCIP)11/25/2020 see UCIP marked up RD0010 USACE O&M manual OM151_IrrDRNSect.pdf and USACE drawing AB_4-4-295.pdf for approximate location and station. Reference files have been filed under UCIP's share drive desk study background folder for RD0010. (O. Magana - DWR UCIP)10/18/2018 No change since the last inspection. Pipe remains Urgent due to deteriorated wall (visible holes present inside) near WS flap gate. This pipe is part of DWR's Deferred Maintenance Project (DMP). According to LMA representative, the video inspection of DMP pipes is expected to be completed next year. Levee height is about 25-30 feet. (O. Magana - DWR UCIP)7/01/2016 Pipe wall in poor condition--deteriorated pipe wall indicated by holes at the inlet and outlet pipe collar. Recommend internal integrity inspection of the pipe through the levee to determine extent of damage. (O. Magana - DWR UCIP)4/29/2013 Holes present on pipe wall. Need to contact owner to notify of issue with pipe. Also need to contact DWR Inspector and CVFPB to determine how to address issue. This crossing is referenced in the USACE Periodic Inspection as item USACE_CESPK_HON1_2013_p_0140. Pipe should be 30-inch instead of 36-inch mentioned Periodic Inspection. (O. Magana - DWR UCIP)

FIELD_STRUCT_DESC: 30-inch corrugated metal (CM) gravity drainage pipe through the levee, approximately 30.0 feet below the crown. Two CM cutoff walls around the pipe on each side. Saddle and splash apron at the waterside (WS) discharge point. Concrete headwall and sluice gate on the landside (LS). (No permit found authorizing this pipe. Owner unknown). [Additional Reference(s): DWR Levee Log, 2005, (HLM 1.42), listed as a 36-inch pipe. USACE Sacramento O&M Manual, Unit No. 151, May 1953, (Station 10+38). USACE As-Built

WS view: overview of WS. Caltrans construction area.

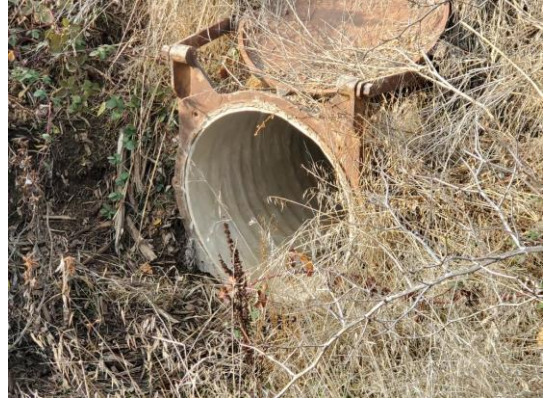
Photo 2 of 3 : UCIP_SP_2022_70572_97621.jpg

LM Start	1.41	Rating **	U	Issue No.	20 (cont)
LM End	1.41	Issue Type +	Ma	Location *

WS view: pipe lined

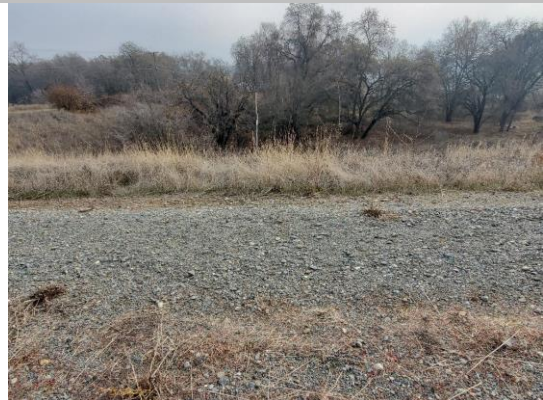
Photo 3 of 3 : UCIP_SP_2022_70572_97622.jpg

WS view: overview of WS.

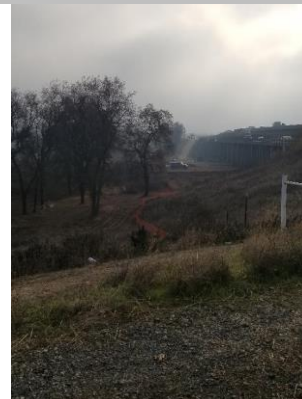
Photo 1 of 3 : UCIP_SP_2022_70554_97625.jpg

LM Start	1.41	Rating **	M	Issue No.	21	
LM End	1.41	Issue Type +	En	Location *		
Category	Supplemental			GPS Latitude/Longitude		
				Start		End
Item	DWR UCIP Field Study			39.169078 °	39.169078 °	
				-121.589458 °	-121.589458 °	
DWR ID	21267					
Comment Code						
Inspector Comment						
FS_ID:70554 DS_ID:21267 EP_NO: N/A Repair Type: Non-Urgent Crossing Status: Not Found UCIP Comments: 12/21/2020 Record has been updated Non-Urgent. No permit was found authorizing the installation of this structure. CVFPB will need to review crossing to determine owner. No signage or evidence of pipe was found during site inspection. (O. Magana - DWR UCIP) FIELD_STRUCT_DESC: Steel telephone conduit of an unknown size through the levee, at an unknown depth. (No permit found authorizing this pipe. Owner unknown). [Additional Reference(s): DWR Levee Log, 2005, (HLM 1.42)]. FS Date: 12/21/2020

WS view: overview of WS.

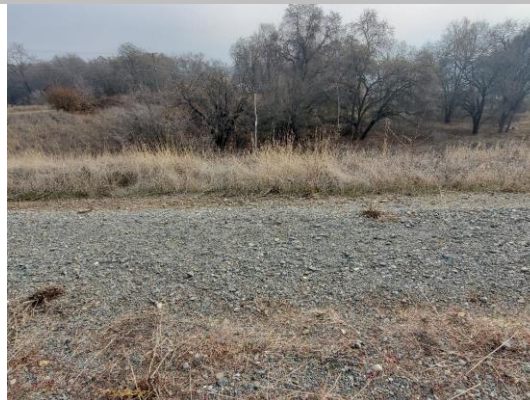
Photo 2 of 3 : UCIP_SP_2022_70554_97627.jpg

WS view: overview of WS. No signage was found on the WS.

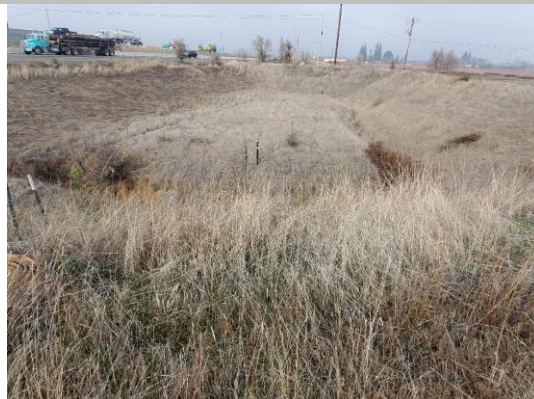
Photo 3 of 3 : UCIP_SP_2022_70554_97628.jpg

LM Start	1.41	Rating **	M	Issue No.	21 (cont)
LM End	1.41	Issue Type +	En	Location *	
Category	Supplemental			GPS Latitude/Longitude	
				Start	End
Item	DWR UCIP Field Study			39.169078 °	39.169078 °
				-121.589458 °	-121.589458 °
DWR ID	21267

LS view: overview of LS. No signage was found on the LS.

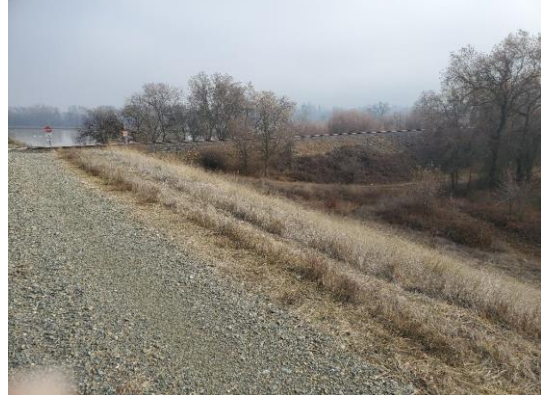
Photo 1 of 3 : UCIP_SP_2022_70574_97636.jpg

Comment Code					
Inspector Comment					
FS_ID:70574 DS_ID:21268 EP_NO: N/A Repair Type: Non-Urgent Crossing Status: Found UCIP Comments: 09/08/2021 CIPP-lining of this crossing approved under project authorization WC2021104. 12/21/2020 Record remains Non-Urgent. DWR DMP has found integrity issues, LOF between 4 and 5. Crossing will be monitored until funding becomes available for rehabilitation. No permit was found authorizing this encroachment. CVFPB will need to review crossing to determine owner. Dense vegetation limited site inspection. Recommend removing vegetation along the pipe alignment. (O. Magana - DWR UCIP)11/25/2020 see UCIP marked up RD0010 USACE O&M manual OM151_IrrDRNSect.pdf and USACE drawing AB_4-4-295.pdf for approximate location and station. Reference files have been filed under UCIP's share drive desk study background folder for RD0010. (O. Magana - DWR UCIP)04/29/2013 Vegetation has been cleared from slope. This crossing is referenced in the USACE Periodic Inspection as item USACE_CESPK_HON1_2013_p_0158. (O. Magana - DWR UCIP) FIELD_STRUCT_DESC: 24-inch corrugated metal (CM) gravity drainage pipe through the levee, 30.0 feet below the crown. Flap gate on the waterside (WS) end. Slide gate on the landside (LS) end. Concrete saddle and apron on the WS. (No permit found authorizing this pipe. Owner unknown). [Additional Reference(s): DWR Levee Log, 2005, (HLM 1.60). USACE Sacramento O&M Manual, Unit No. 151, May 1953, Revised 6 June 2017, (Station 1+00). USACE As-Built Drawing No. 4-4-295, Sheet No. 295/2, November 1947, Revised December 1947, (Station 1+00). USACE Sacramento O&M Manual, Unit No. 151, May 1953, Revised 6 June 2017, (Station 208+11). USACE As-Built Drawing No. 4-4-245-3, Sheet No. 245-3/1, Revised October 1940, (Station 208+11)]. FS Date: 12/21/2020

WS view: partial view of levee crown and densely vegetated WS slope.

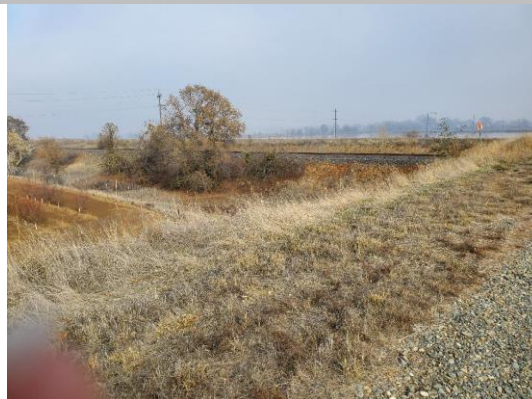
Photo 2 of 3 : UCIP_SP_2022_70574_97637.jpg

LM Start	1.59	Rating **	M	Issue No.	22 (cont)
LM End	1.59	Issue Type +	Ma	Location *	
Category	Supplemental		GPS Latitude/Longitude		
			Start	End	
Item	DWR UCIP LMA Responsibility		39.169234 °	39.169234 °	
			-121.586203 °	-121.586203 °	
DWR ID	21268

LS view: partial view of levee shoulder and densely vegetated LS slope.

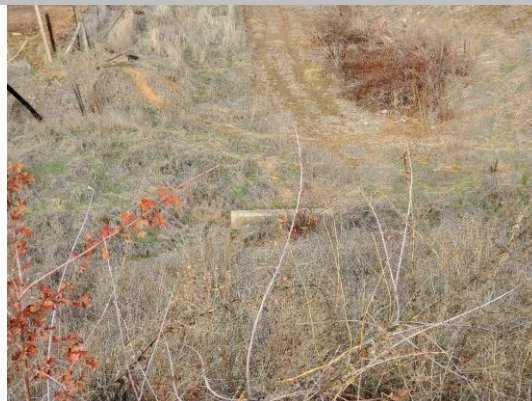
Photo 3 of 3 : UCIP_SP_2022_70574_97638.jpg

LS view: concrete headwall visible on LS toe.

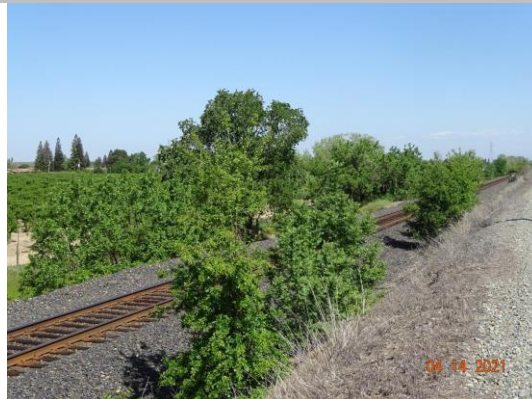
Photo 1 of 1 : SP_2022_RD0010_163_34_20220314_00006.jpg

LM Start	1.65	Rating **	M	Issue No.	34
LM End	1.69	Issue Type +	Ma	Location *	LS
Category	Earthen Levee			GPS Latitude/Longitude	
				Start	End
Item	Trim / Thin Trees			39.169788 °	39.170335 °
				-121.585746 °	-121.585683 °
DWR ID	DWR_RD0010_01_f_2019_34				
Comment Code					
T1 : Trim and thin trees to at least five feet above ground level to allow visibility of the ground and room to flood fight.					
Inspector Comment					
Trees with less than 4" diameter at chest height should be removed, Spring 2022.

View looking upstream landside of small starter trees that need to be removed, Spring 2021.

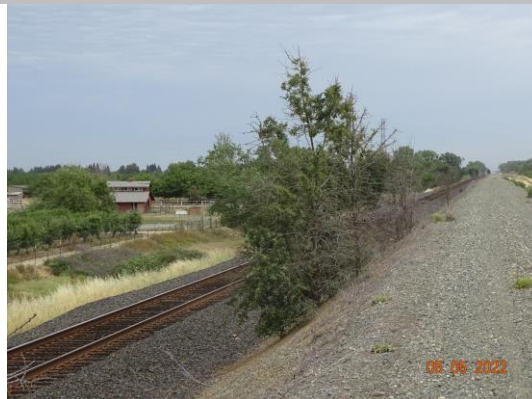
Photo 1 of 1 : SP_2022_RD0010_163_68_20220516_00140.jpg

LM Start	1.76	Rating **	M	Issue No.	68
LM End	1.79	Issue Type +	Ma	Location *	LS
Category	Earthen Levee			GPS Latitude/Longitude	
				Start	End
Item	Trim / Thin Trees			39.171328 °	39.171855 °
				-121.585561 °	-121.585503 °
DWR ID	DWR_RD0010_01_s _ 2020_68				
Comment Code					
T1 : Trim and thin trees to at least five feet above ground level to allow visibility of the ground and room to flood fight.					
Inspector Comment					
Trees with less than 4" diameter at chest height should be removed, Spring 2022.

View looking upstream landside at small starter trees on levee slope, Spring 2022.

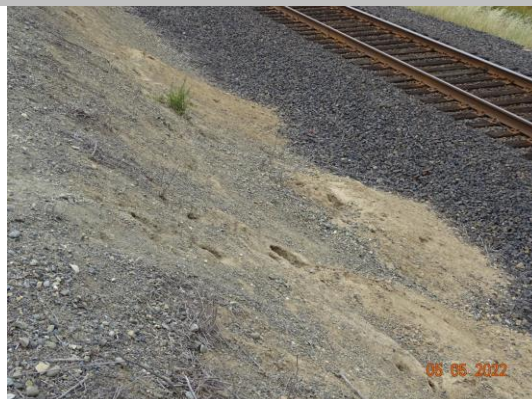
Photo 1 of 1 : SP_2022_RD0010_163_64_20220516_00141.jpg

LM Start	1.81	Rating **	M	Issue No.	64
LM End	1.81	Issue Type +	Ma	Location *	LS
Category	Earthen Levee			GPS Latitude/Longitude	
				Start	End
Item	Animal Control			39.172094 °	39.172094 °
				-121.585472 °	-121.585472 °
DWR ID	DWR_RD0010_01_s _ 2016_64				
Comment Code					
A3 : No rodents visible, but rodent burrows visible; need to backfill and compact or grout burrows.					
Inspector Comment					
Squirrel holes still are visible but there is no sign of activity.

View of squirrel holes on the landside, no rodent activity was observed, Spring 2022.

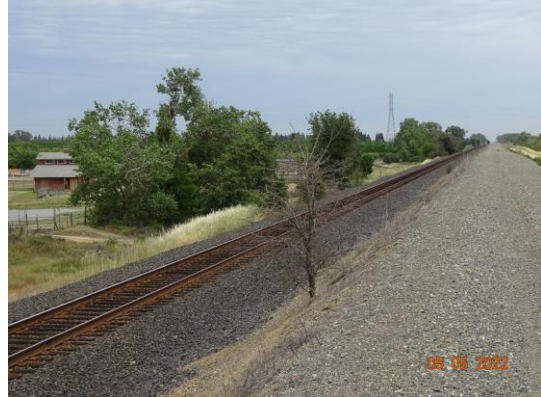
Photo 1 of 1 : SP_2022_RD0010_163_77_20220516_00142.jpg

LM Start	1.83	Rating **	M	Issue No.	77
LM End	1.83	Issue Type +	Ma	Location *	LS
Category	Earthen Levee			GPS Latitude/Longitude	
				Start	End
Item	Trim / Thin Trees			39.172385 °	39.172385 °
				-121.585433 °	-121.585433 °
DWR ID	DWR_RD0010_01_f _ 2020_77				
Comment Code					
T1 : Trim and thin trees to at least five feet above ground level to allow visibility of the ground and room to flood fight.					
Inspector Comment					
Trees with less than 4" diameter at chest height should be removed, Spring 2022.

View looking downstream landside at small starter trees that need to be removed, Spring 2022.

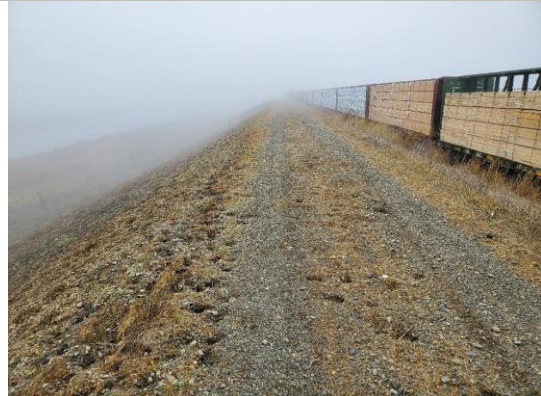
Photo 1 of 3 : UCIP_SP_2022_70557_97640.jpg

LM Start	1.88	Rating **	M	Issue No.	23	
LM End	1.88	Issue Type +	En	Location *		
Category	Supplemental			GPS Latitude/Longitude		
				Start		End
Item	DWR UCIP Field Study			39.173143 °		39.173143 °
				-121.585337 °		-121.585337 °
DWR ID	21270

Comment Code						
Inspector Comment						
FS_ID:70557 DS_ID:21270 EP_NO: 3574A Repair Type: Non-Urgent Crossing Status: Indicator Found UCIP Comments: 12/21/2020 Record has been updated to from No Action Needed to Non-Urgent. No maintenance or inspection records have been provided by the owner to determine the integrity of line through the levee. Need to contact owner to determine the status of gas line. If line, is no longer in service the owner will need to coordinate with the CVFPB to meet Title 23 requirements. As a safety measure, need to contact owner to obtain inspection records to confirm integrity of line through the levee. Unable to inspect LS due to train obstructing access to LS. Dense burrow activity found through this stretch of the levee. (O. Magana - DWR UCIP)04/29/2013 This crossing is referenced in the USACE Periodic Inspection as item USACE_CESPK_HON1_2013_p_0179. (O. Magana - DWR UCIP) FIELD_STRUCT_DESC: 4-inch steel natural gas pipeline through the levee, 3.0 feet below the crown. Steel cutoff wall around the pipe at the center of the levee. (4-inch gas line authorized under Permit No. 3574-A, 1962 - Pacific Gas and Electric Company [PG&E]). [Additional Reference(s): DWR Levee Log, 2005, (HLM 1.88)]. FS Date: 12/21/2020

Overview of levee crown.

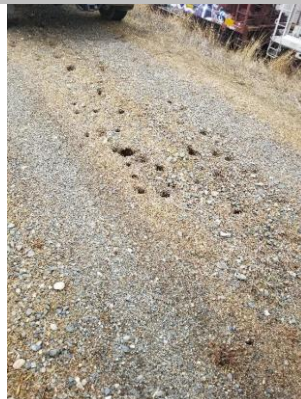
Photo 2 of 3 : UCIP_SP_2022_70557_97645.jpg

LM Start	1.88	Rating **	M	Issue No.	23 (cont)
LM End	1.88	Issue Type +	En	Location *	
Category	Supplemental			GPS Latitude/Longitude	
				Start	End
Item	DWR UCIP Field Study			39.173143 °	39.173143 °
				-121.585337 °	-121.585337 °
DWR ID	21270

Burrow activity found on the levee crown.

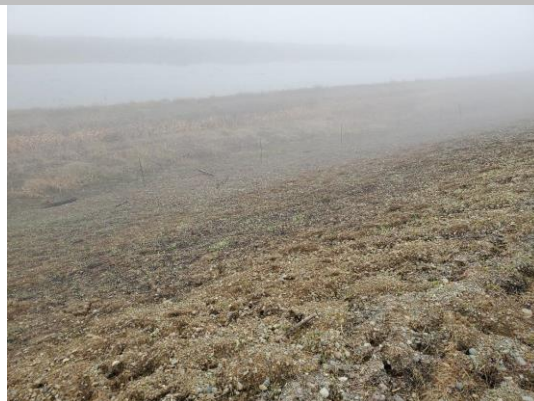
Photo 3 of 3 : UCIP_SP_2022_70557_97641.jpg

WS view: dense burrow activity along the WS slope.

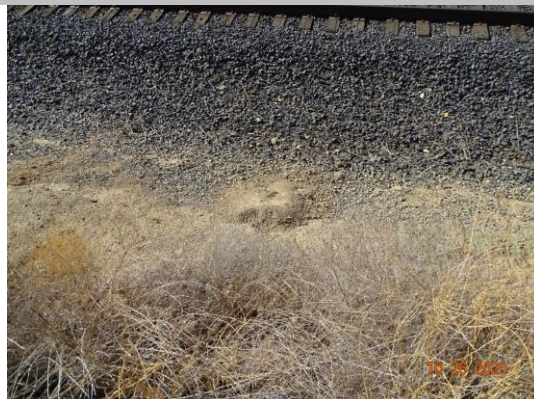
Photo 1 of 1 : SP_2022_RD0010_163_63_20220314_00030.jpg

LM Start	2.09	Rating **	M	Issue No.	63
LM End	2.09	Issue Type +	Ma	Location *	LS
Category	Earthen Levee			GPS Latitude/Longitude	
				Start	End
Item	Animal Control			39.176153 °	39.176153 °
				-121.584958 °	-121.584958 °
DWR ID	DWR_RD0010_01_s_2016_63				
Comment Code					
A3 : No rodents visible, but rodent burrows visible; need to backfill and compact or grout burrows.					
Inspector Comment					
Squirrel holes still are visible but there is no sign of activity.

View of squirrel holes on the landside, no rodent activity was observed, Fall 2020.

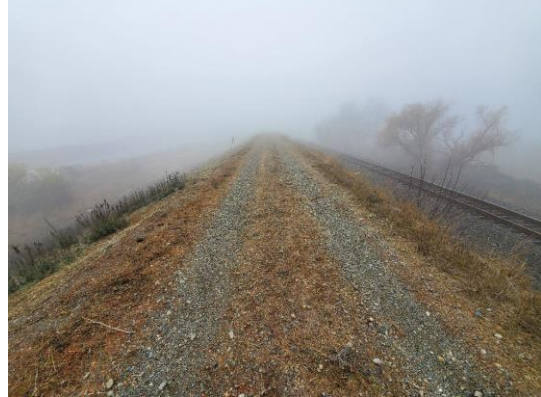
Photo 1 of 3 : UCIP_SP_2022_70575_97653.jpg

Comment Code						
Inspector Comment						
FS_ID:70575 DS_ID:21271 EP_NO: N/A Repair Type: Urgent Crossing Status: Found UCIP Comments: 12/21/2020 Record has been updated from Non-Urgent to Urgent. DWR DMP has found integrity issues, LOF between 5 and 6. Recommend monitoring crossing until funding becomes available to address. No permit was found authorizing this encroachment. CVFPB will need to review crossing to determine owner. (O. Magana - DWR UCIP)04/29/2013 Unable to determine if crossing is still present on landward side--need to confirm. Need to contact owner to determine status of crossing. This crossing is referenced in the USACE Periodic Inspection as item USACE_CESPK_HON1_2013_p_0185. (O. Magana - DWR UCIP) FIELD_STRUCT_DESC: 24-inch steel gravity drainage pipe through the levee, 30.0 feet below the crown. Flap gate on the waterside (WS) end. Concrete headwall at each toe. (No permit found authorizing this pipe. Owner unknown). [Additional Reference(s): DWR Levee Log, 2005, (HLM 2.16)]. FS Date: 12/21/2020

Overview of levee crown looking downstream.

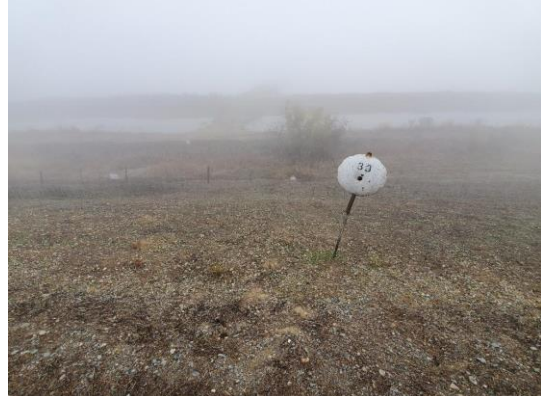
Photo 2 of 3 : UCIP_SP_2022_70575_97654.jpg

WS view: overview of WS.

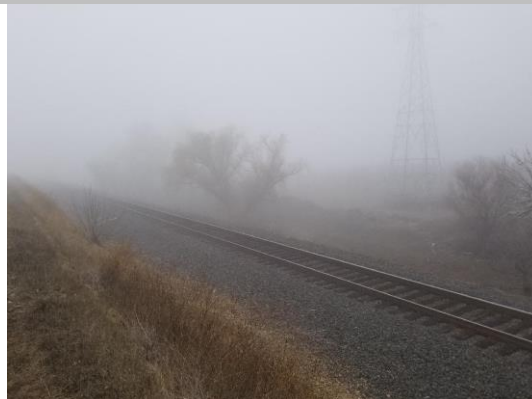
Photo 3 of 3 : UCIP_SP_2022_70575_97651.jpg

LS view: overview of LS

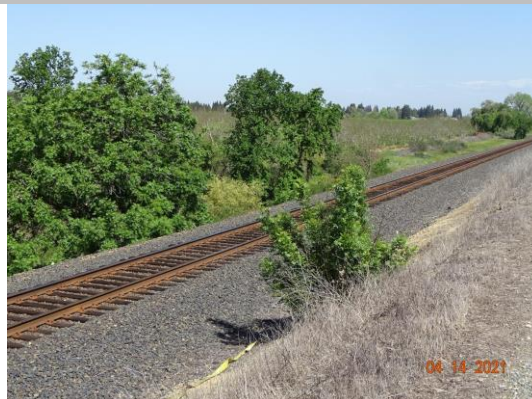
Photo 1 of 1 : SP_2022_RD0010_163_76_20220314_00041.jpg

LM Start	2.16	Rating **	M	Issue No.	76
LM End	2.16	Issue Type +	Ma	Location *	LS
Category	Earthen Levee			GPS Latitude/Longitude	
				Start	End
Item	Trim / Thin Trees			39.177111 °	39.177111 °
				-121.584836 °	-121.584836 °
DWR ID	DWR_RD0010_01_f_2020_76				
Comment Code					
T1 : Trim and thin trees to at least five feet above ground level to allow visibility of the ground and room to flood fight.					
Inspector Comment					
Trees with less than 4" diameter at chest height should be removed, Spring 2022.

View looking upstream landside at small starter trees that need to be removed, Spring 2021.

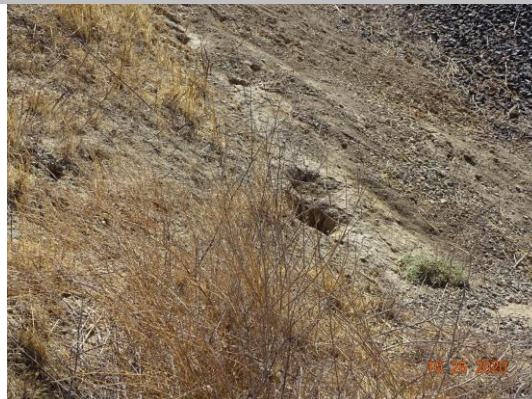
Photo 1 of 1 : SP_2022_RD0010_163_61_20220314_00028.jpg

LM Start	2.16	Rating **	M	Issue No.	61
LM End	2.38	Issue Type +	Ma	Location *	LS
Category	Earthen Levee			GPS Latitude/Longitude	
				Start	End
Item	Animal Control			39.177129 °	39.180309 °
				-121.584841 °	-121.584451 °
DWR ID	DWR_RD0010_01_s_2016_61				
Comment Code					
A3 : No rodents visible, but rodent burrows visible; need to backfill and compact or grout burrows.					
Inspector Comment					
Squirrel holes still are visible but there is no sign of activity.

View of squirrel holes on the landside slope and toe, no rodent activity was observed, Fall 2020.

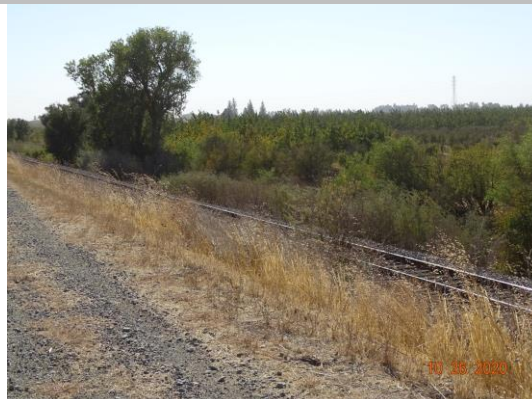
Photo 1 of 1 : SP_2022_RD0010_163_69_20220314_00035.jpg

LM Start	2.50	Rating **	M	Issue No.	69
LM End	2.50	Issue Type +	Ma	Location *	LS
Category	Earthen Levee			GPS Latitude/Longitude	
				Start	End
Item	Trim / Thin Trees			39.182029 °	39.182029 °
				-121.584220 °	-121.584220 °
DWR ID	DWR_RD0010_01_s_2020_69				
Comment Code					
T1 : Trim and thin trees to at least five feet above ground level to allow visibility of the ground and room to flood fight.					
Inspector Comment					
Trees with less than 4" diameter at chest height should be removed, Spring 2022.

View looking downstream landside at small starter trees that need to be removed, Fall 2020
