Flood Control Project Maintenance Levee Inspections LMA District Cover Sheet

Reclamation District No. 0010 Honcut

**Flood Control Project Maintenance
Levee Inspections
Unit Cover Sheet**

Waterway			Bank	Unit Miles
Unit No. 01 Simmerly Slough			Right	7.65
	Spring (March - May)	Summer (June - August)	(September - November) Fall	Winter (December - February)
Unit Maintenance Rating (Fall Only)				
Date of Inspection	5/5/2022 - 5/5/2022			
DWR Inspector	Brooks Weisser			
Accompanied By	Finlay Williams

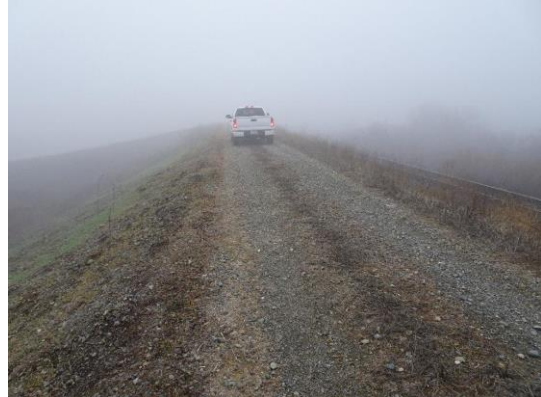
Photo 1 of 3 : UCIP_SP_2022_70559_97656.jpg

Comment Code						
Inspector Comment						
FS_ID:70559 DS_ID:21316 EP_NO: N/A Repair Type: Non-Urgent Crossing Status: Not Found UCIP Comments: 12/21/2020 Record remains Non-Urgent. DWR DMP geophysical study found no positive signal of pipe at latitude, longitude 39.182654, -121.584133. No signage or evidence of pipe was found during site inspection. No permit was found authorizing this encroachment. CVFPB will need to review crossing to determine owner. Record will remain in UCIP's database and should be monitored until a levee improvement project can confirm that this crossing has been removed from the levee. (O. Magana - DWR UCIP)12/01/2020 see UCIP marked up RD0010 USACE O&M manual OM151_IrrDRNSect.pdf and USACE drawing AB_4-4-245-3.pdf for approximate location and station. Reference files have been filed under UCIP's share drive desk study background folder for RD0010. (O. Magana - DWR UCIP) 04/29/2013 vegetation too high; no indicators found. (O. Magana - DWR UCIP) FIELD_STRUCT_DESC: 36-inch reinforced concrete (RC) gravity drainage pipe through the levee, at an unknown depth. Concrete saddle and apron on the waterside (WS). (No permit found authorizing this pipe. Owner unknown). [Additional Reference(s): USACE Sacramento O&M Manual, Unit No. 151, May 1953, Revised 6 June 2017, (Station 255+35). USACE As-Built Drawing No. 4-4-245-3, Sheet No. 245-3/1, Revised October 1940, (Station 255+35)]. FS Date: 12/21/2020

Overview of levee crown looking downstream towards pipe crossing.

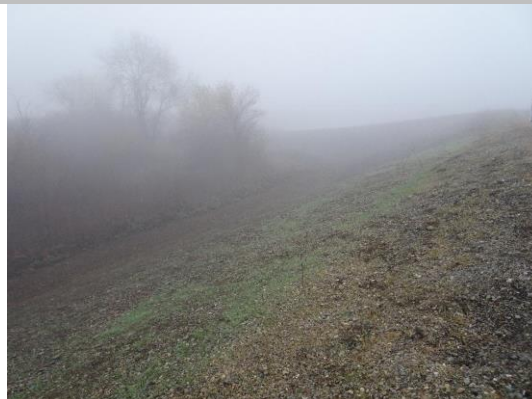
Photo 2 of 3 : UCIP_SP_2022_70559_97657.jpg

WS view: cross-section of WS slope.

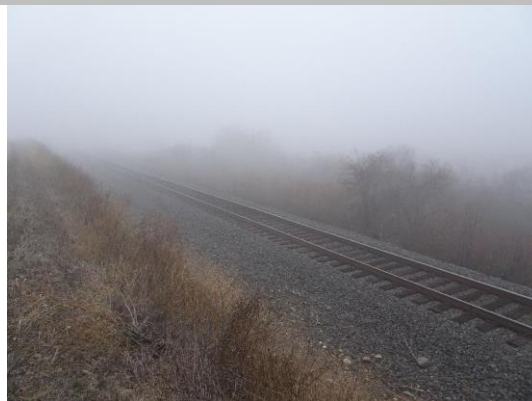
Photo 3 of 3 : UCIP_SP_2022_70559_97658.jpg

LS view: overview of LS.

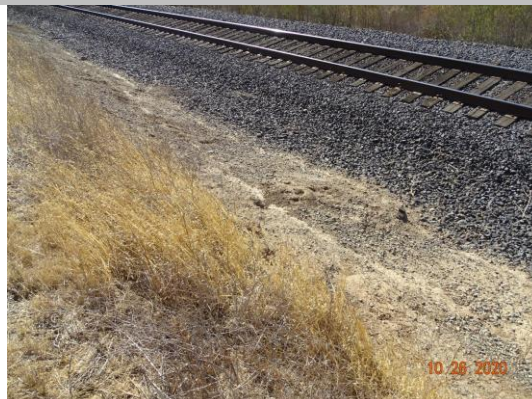
Photo 1 of 1 : SP_2022_RD0010_163_60_20220314_00027.jpg

LM Start	2.56	Rating **	M	Issue No.	60
LM End	2.61	Issue Type +	Ma	Location *	LS
Category	Earthen Levee			GPS Latitude/Longitude	
				Start	End
Item	Animal Control			39.182940 °	39.183721 °
				-121.584115 °	-121.584019 °
DWR ID	DWR_RD0010_01_s_2016_60				
Comment Code					
A3 : No rodents visible, but rodent burrows visible; need to backfill and compact or grout burrows.					
Inspector Comment					
Squirrel holes still are visible but there is no sign of activity.

View of squirrel holes on the landside slope and toe, no rodent activity was observed, Fall 2020.

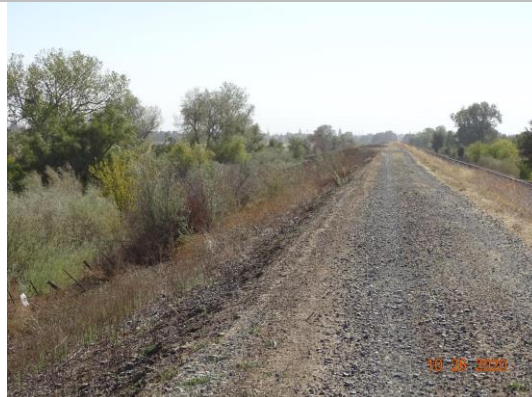
Photo 1 of 1 : SP_2022_RD0010_163_35_20220314_00007.jpg

LM Start	2.70	Rating **	M	Issue No.	35
LM End	2.70	Issue Type +	Ma	Location *	WS
Category	Earthen Levee			GPS Latitude/Longitude	
				Start	End
Item	Trim / Thin Trees			39.184974 °	39.184974 °
				-121.583836 °	-121.583836 °
DWR ID	DWR_RD0010_01_f_2017_35				
Comment Code					
T1 : Trim and thin trees to at least five feet above ground level to allow visibility of the ground and room to flood fight.					
Inspector Comment					
Trees with less than 4" diameter at chest height should be removed, Spring 2022.

View looking downstream waterside at Willow Trees that need to be removed, Fall 2020.

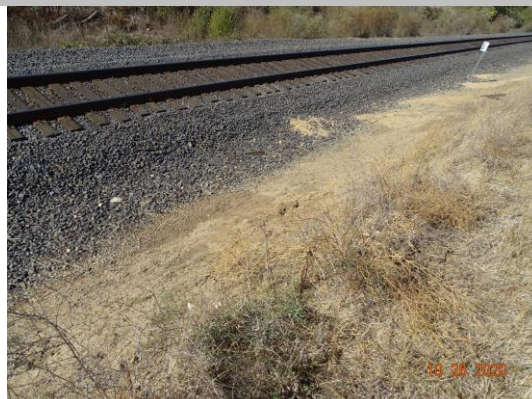
Photo 1 of 1 : SP_2022_RD0010_163_57_20220314_00024.jpg

LM Start	2.76	Rating **	M	Issue No.	57
LM End	2.76	Issue Type +	Ma	Location *	LS
Category	Earthen Levee			GPS Latitude/Longitude	
				Start	End
Item	Animal Control			39.185845 °	39.185845 °
				-121.583760 °	-121.583760 °
DWR ID	DWR_RD0010_01_s_2016_57				
Comment Code					
A3 : No rodents visible, but rodent burrows visible; need to backfill and compact or grout burrows.					
Inspector Comment					
Squirrel holes still are visible but there is no sign of activity.

View of squirrel holes on the landside slope and toe, no rodent activity was observed, Fall 2020.

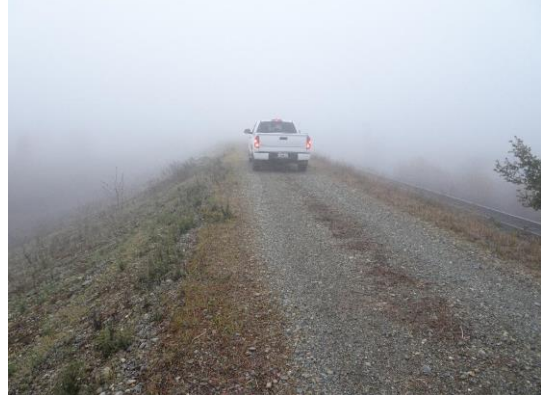
Photo 1 of 3 : UCIP_SP_2022_70560_97661.jpg

FS_ID:70560
DS_ID:21272
EP_NO: 14020
Repair Type: Urgent
Crossing Status: Found
UCIP Comments: 12/21/2020 Record remains Urgent. Scour around the concrete headwall is still present on the WS toe. Need to continue monitoring to document progression at this pipe location. (O. Magana - DWR UCIP)10/30/2018 Erosion around the concrete box is still present. Erosion does not appear to have progressed since 2013. Unable to determine reason for subsidence around the concrete box located on the WS toe. Recommend internal inspection to determine the condition of the pipe through the levee. Permit recordation indicates that the 10-inch pipe was sleeved through a 16-inch pipe where the annular space between the pipes was grouted, adding some protection to the levee. Photo of the inside of the 10-inch pipe shows that the tar coating is coming off. Continue to monitor site for any changes at the WS toe and the WS slope. Crossing remains Urgent until an internal inspection can be completed to determine the integrity of the pipe through the levee. (O. Magana - DWR UCIP)7/01/2016 Dense vegetation--unable to determine if the sink hole/slope depression noted back in Jan 2013 in the USACE's PI Report is still present. Need to revisit the site once vegetation from the slopes has been cleared. (O. Magana - DWR UCIP)4/29/2013 Unable to determine status of crossing--sink hole was observed as part of the USACE Periodic Inspection Report dated May 2013. Need to coordinate with owner to determine status of crossing. If crossing is no longer in use owner will need to contact the CVFPB to comply with Title 23. Need to confirm with Finney to determine if pump and controls belong to pipe crossing located on landward side. This crossing is referenced in the USACE Periodic Inspection as item USACE_CESPK_HON1_2013_p_0192. (O. Magana - DWR UCIP)

Overview of levee crown looking downstream towards crossing.

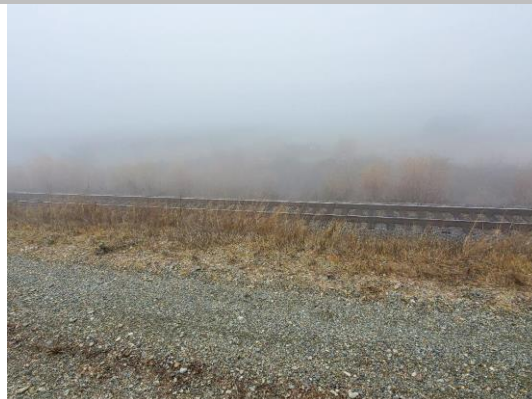
Photo 2 of 3 : UCIP_SP_2022_70560_97662.jpg

LS view: overview of LS.

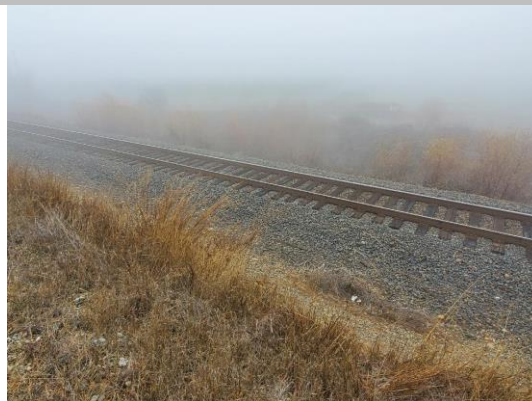
Photo 3 of 3 : UCIP_SP_2022_70560_97663.jpg

LS view: side view of LS slope and railroad tracks.

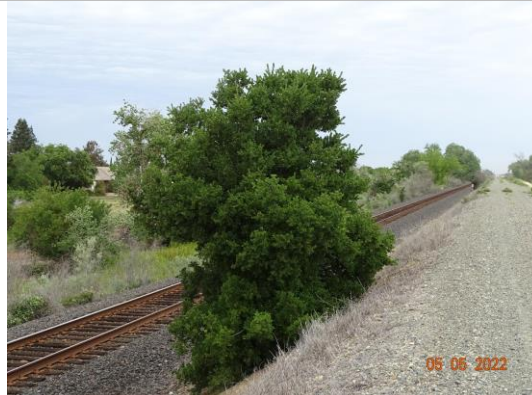
Photo 1 of 1 : SP_2022_RD0010_163_36_20220516_00143.jpg

LM Start	2.79	Rating **	M	Issue No.	36
LM End	2.79	Issue Type +	Ma	Location *	LS
Category	Earthen Levee			GPS Latitude/Longitude	
				Start	End
Item	Trim / Thin Trees			39.186285 °	39.186285 °
				-121.583707 °	-121.583707 °
DWR ID	DWR_RD0010_01_f_2019_36				
Comment Code					
T1 : Trim and thin trees to at least five feet above ground level to allow visibility of the ground and room to flood fight.					
Inspector Comment					
Trees with less than 4" diameter at chest height should be removed, Spring 2022.

View looking upstream landside at small starter trees that need to be removed, Spring 2022.

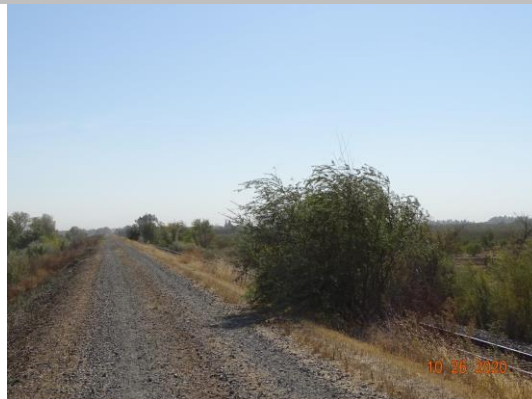
Photo 1 of 1 : SP_2022_RD0010_163_38_20220314_00009.jpg

LM Start	2.92	Rating **	M	Issue No.	38
LM End	2.92	Issue Type +	Ma	Location *	LS
Category	Earthen Levee			GPS Latitude/Longitude	
				Start	End
Item	Trim / Thin Trees			39.188073 °	39.188073 °
				-121.583483 °	-121.583483 °
DWR ID	DWR_RD0010_01_f_2019_38				
Comment Code					
T1 : Trim and thin trees to at least five feet above ground level to allow visibility of the ground and room to flood fight.					
Inspector Comment					
Trees with less than 4" diameter at chest height should be removed, Spring 2022.

View looking downstream landside at small starter trees that need to be removed, Fall 2020.

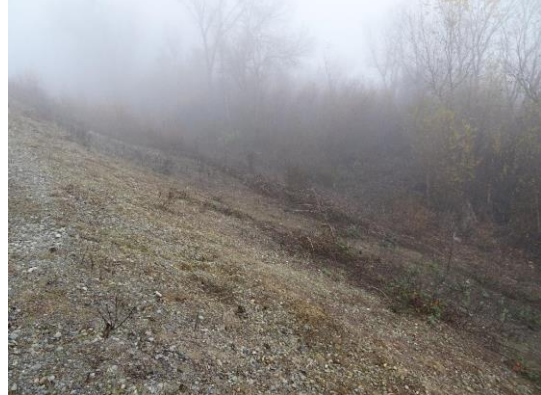
Photo 1 of 3 : UCIP_SP_2022_70576_99134.jpg

Comment Code					
Inspector Comment					
FS_ID:70576 DS_ID:21317 EP_NO: N/A Repair Type: Urgent Crossing Status: Indicator Found UCIP Comments: 09/08/2021 CIPP-lining of this crossing approved under project authorization WC2021104. 12/21/2020 Record has been updated from Non-Urgent to Urgent. DWR DMP has found integrity issues, LOF between 5 and 6. Recommend monitoring crossing until funding becomes available to address. No permit was found authorizing this encroachment. CVFPB will need to review crossing to determine owner. (O. Magana - DWR UCIP)12/01/2020 see UCIP marked up RD0010 USACE O&M manual OM151_IrrDRNSect.pdf and USACE drawing AB_4-4-245-3.pdf for approximate location and station. Reference files have been filed under UCIP's share drive desk study background folder for RD0010. (O. Magana - DWR UCIP) 04/29/2013 Indicator marker visible on WS; Dense vegetation on waterward toe and landward side access limits the inspector's visibility to identify signs of pipe failure (leaks) along the slope. Recommend removing vegetation along pipe alignment to conduct proper inspection of structure and appurtances. Access to landward side will need to be coordinated with railroad. Need to coordinate with owner to determine status of crossing. If crossing is no longer in use owner will need to contact the CVFPB to comply with Title 23. This crossing is referenced in the USACE Periodic Inspection as item USACE_CESPK_HON1_2013_p_0204. (O. Magana - DWR UCIP) FIELD_STRUCT_DESC: 24-inch corrugated metal (CM) gravity drainage pipe through the levee, 23.0 feet below the crown. Flap gate on the waterside (WS) end. Concrete headwall at each toe. Siphon breaker on the WS shoulder. Concrete saddle and apron on the WS. (No permit found authorizing this pipe. Owner unknown). [Additional Reference(s): DWR Levee Log, 2005, (HLM 3.36). USACE Sacramento O&M Manual, Unit No. 151, May 1953, Revised 6 June 2017, (Station 299+56). USACE As-Built Drawing No. 4-4-245-3, Sheet No. 245-3/1, Revised October 1940, (Station 299+56)]. FS Date: 12/21/2020

WS view: cross-section view of WS slope.

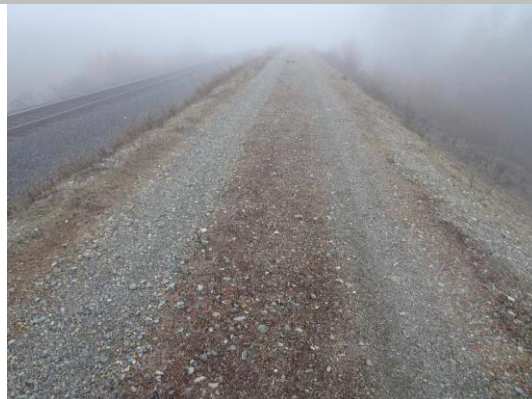
Photo 2 of 3 : UCIP_SP_2022_70576_99135.jpg

Overview of levee crown looking upstream towards pipe crossing.

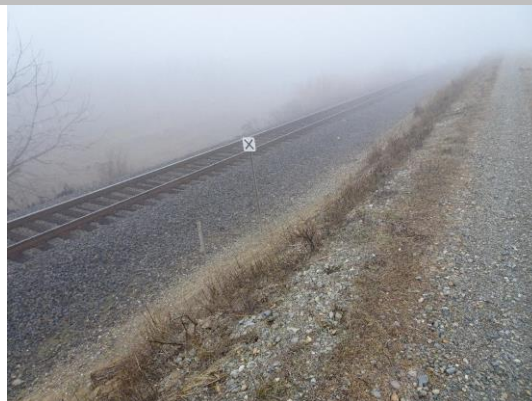
Photo 3 of 3 : UCIP_SP_2022_70576_99136.jpg

LS view: cross-section view of LS slope.

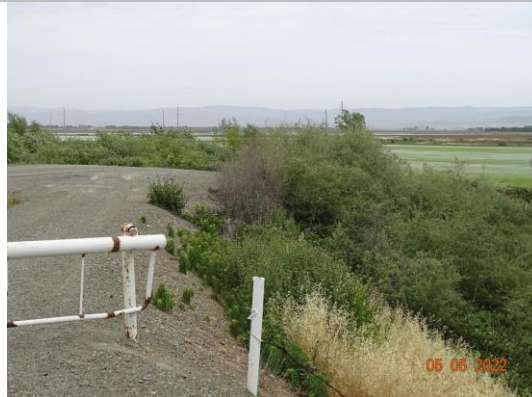
Photo 1 of 1 : SP_2022_RD0010_163_70_20220516_00144.jpg

LM Start	3.60	Rating **	M	Issue No.	70
LM End	3.60	Issue Type +	Ma	Location *	WS
Category	Earthen Levee			GPS Latitude/Longitude	
				Start	End
Item	Trim / Thin Trees			39.197886 °	39.197886 °
				-121.582069 °	-121.582069 °
DWR ID	DWR_RD0010_01_s_2020_70				
Comment Code					
T1 : Trim and thin trees to at least five feet above ground level to allow visibility of the ground and room to flood fight.					
Inspector Comment					
Trees with less than 4" diameter at chest height should be removed, Spring 2022.

View looking upstream waterside at small starter tree on levee slope, Spring 2022.

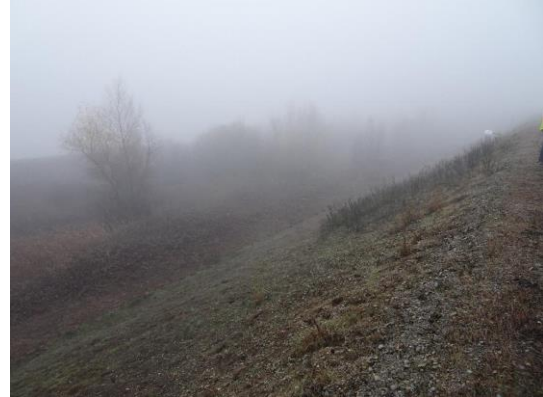
Photo 1 of 3 : UCIP_SP_2022_70562_97667.jpg

Comment Code						
Inspector Comment						
FS_ID:70562 DS_ID:21273 EP_NO: N/A Repair Type: Urgent Crossing Status: Found UCIP Comments: 09/08/2021 CIPP-lining of this crossing approved under project authorization WC2021104. 12/21/2020 Record has been updated from No Action Needed to Urgent. DWR DMP has found integrity issues, LOF between 5 and 6. Recommend monitoring crossing until funding becomes available to address. No permit was found authorizing this encroachment. CVFPB will need to review crossing to determine owner. (O. Magana - DWR UCIP)12/01/2020 see UCIP marked up RD0010 USACE O&M manual OM151_IrrDRNSect.pdf and USACE drawing AB_4-4-245-3.pdf for approximate location and station. Reference files have been filed under UCIP's share drive desk study background folder for RD0010. (O. Magana - DWR UCIP) 04/29/2013 This crossing is referenced in the USACE Periodic Inspection as item USACE_CESPK_HON1_2013_p_0217. (O. Magana - DWR UCIP) FIELD_STRUCT_DESC: 24-inch reinforced concrete (RC) gravity drainage pipe through the levee, 19.5 feet below the crown. Flap gate on the waterside (WS) end. Concrete headwall at each toe. Concrete saddle and apron on the WS. (No permit found authorizing this pipe. Owner unknown). [Additional Reference(s): DWR Levee Log, 2005, (HLM 3.71). USACE Sacramento O&M Manual, Unit No. 151, May 1953, Revised 6 June 2017, (Station 317+80). USACE As-Built Drawing No. 4-4-245-3, Sheet No. 245-3/2, Revised October 1940, (Station 317+80)]. FS Date: 12/21/2020

WS view: cross-section of WS slope

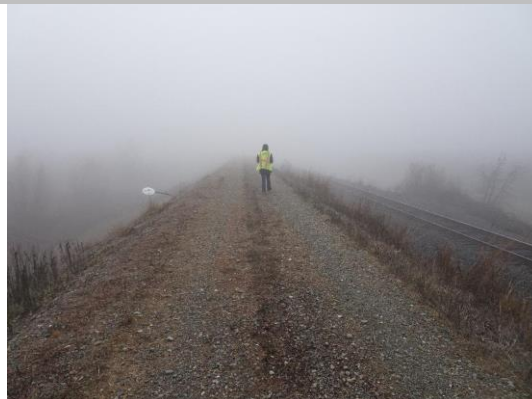
Photo 2 of 3 : UCIP_SP_2022_70562_97668.jpg

LM Start	3.70	Rating **	U	Issue No.	28 (cont)
LM End	3.70	Issue Type +	Ma	Location *	
Category	Supplemental		GPS Latitude/Longitude		
			Start	End	
Item	DWR UCIP LMA Responsibility		39.199281 °	39.199281 °	
			-121.582091 °	-121.582091 °	
DWR ID	21273

Overview of levee crown looking downstream towards pipe crossing.

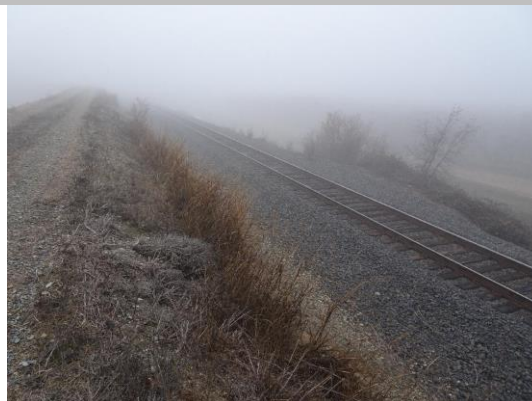
Photo 3 of 3 : UCIP_SP_2022_70562_97669.jpg

LM Start	3.70	Rating **	U	Issue No.	28 (cont)
LM End	3.70	Issue Type +	Ma	Location *

LS view: LS slope and railroad tracks

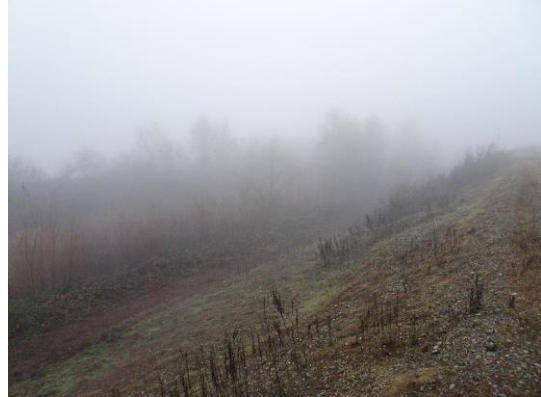
Photo 1 of 3 : UCIP_SP_2022_70577_97675.jpg

Comment Code					
Inspector Comment					
FS_ID:70577 DS_ID:21274 EP_NO: N/A Repair Type: Urgent Crossing Status: Found UCIP Comments: 09/08/2021 CIPP-lining of this crossing approved under project authorization WC2021104. 12/21/2020 Record has been updated from Non-Urgent to Urgent. DWR DMP has found integrity issues, LOF between 5 and 6. Recommend monitoring crossing until funding becomes available to address. No permit was found authorizing this encroachment. CVFPB will need to review crossing to determine owner. (O. Magana - DWR UCIP)12/01/2020 see UCIP marked up RD0010 USACE O&M manual OM151_IrrDRNSect.pdf and USACE drawing AB_4-4-320.pdf for approximate location and station. Reference files have been filed under UCIP's share drive desk study background folder for RD0010. (O. Magana - DWR UCIP) 04/29/2013 sign marker on WS 30; Unable to confirm landward side. This crossing is referenced in the USACE Periodic Inspection as item USACE_CESPK_HON1_2013_p_0232. (O. Magana - DWR UCIP) FIELD_STRUCT_DESC: 24-inch corrugated metal (CM) gravity drainage pipe through the levee, 18.0 feet below the crown. CM cutoff wall around the pipe at the center of the levee. Flap gate and 6-foot by 6-foot splash apron on the waterside (WS) end. (No permit found authorizing this pipe. Owner unknown). [Additional Reference(s): DWR Levee Log, 2005, (HLM 4.13). USACE Sacramento O&M Manual, Unit No. 151, May 1953, Revised 6 June 2017, (Station 339+55.10). USACE As-Built Drawing No. 4-4-320, Sheet No. 320/2, Revised January 1951, (Station 339+55.10)]. FS Date: 12/21/2020

WS view: cross-section of WS slope.

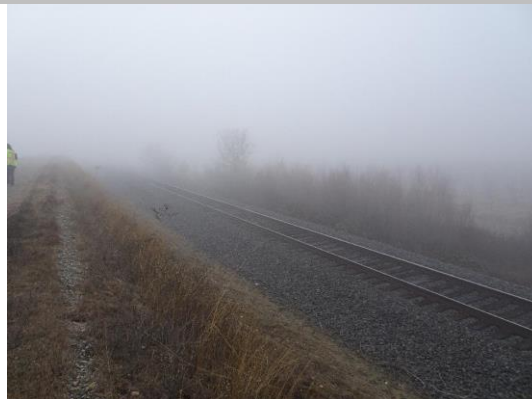
Photo 2 of 3 : UCIP_SP_2022_70577_97676.jpg

LM Start	4.11	Rating **	U	Issue No.	37 (cont)
LM End	4.11	Issue Type +	Ma	Location *	
Category	Supplemental		GPS Latitude/Longitude		
			Start	End	
Item	DWR UCIP LMA Responsibility		39.205209 °	39.205209 °	
			-121.581340 °	-121.581340 °	
DWR ID	21274

LS view: cross-section of LS slope and railroad tracks

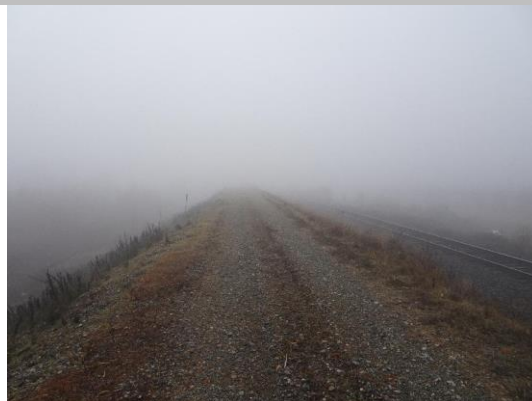
Photo 3 of 3 : UCIP_SP_2022_70577_97677.jpg

LM Start	4.11	Rating **	U	Issue No.	37 (cont)
LM End	4.11	Issue Type +	Ma	Location *

Overview of levee crown looking downstream towards pipe crossing.

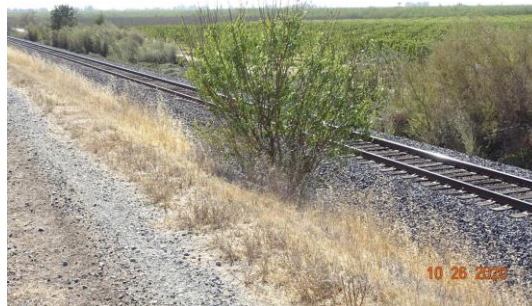
Photo 1 of 1 : SP_2022_RD0010_163_31_20220314_00003.jpg

LM Start	4.21	Rating **	M	Issue No.	31
LM End	4.21	Issue Type +	Ma	Location *	LS
Category	Earthen Levee			GPS Latitude/Longitude	
				Start	End
Item	Trim / Thin Trees			39.206674 °	39.206674 °
				-121.581163 °	-121.581163 °
DWR ID	DWR_RD0010_01_s_2020_31				
Comment Code					
T1 : Trim and thin trees to at least five feet above ground level to allow visibility of the ground and room to flood fight.					
Inspector Comment					
Trees with less than 4" diameter at chest height should be removed, Spring 2022.

View looking downstream landside at small starter trees on levee slope, Fall 2020.

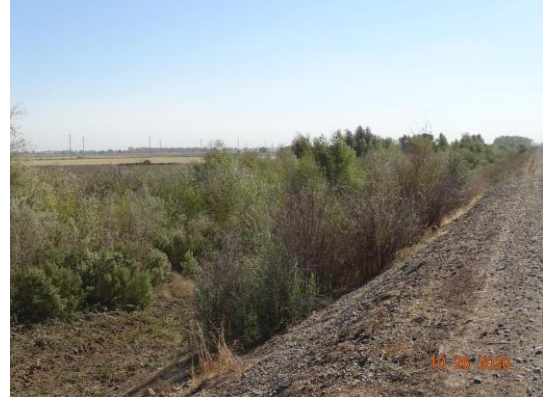
Photo 1 of 1 : SP_2022_RD0010_163_53_20220314_00022.jpg

LM Start	4.28	Rating **	M	Issue No.	53
LM End	4.28	Issue Type +	Ma	Location *	WS
Category	Earthen Levee			GPS Latitude/Longitude	
				Start	End
Item	Trim / Thin Trees			39.207621 °	39.207621 °
				-121.581050 °	-121.581050 °
DWR ID	DWR_RD0010_01_s _ 2020_53				
Comment Code					
T1 : Trim and thin trees to at least five feet above ground level to allow visibility of the ground and room to flood fight.					
Inspector Comment					
Trees with less than 4" diameter at chest height should be removed, Spring 2022.

View looking downstream waterside at small starter trees on levee slope, Fall 2020.

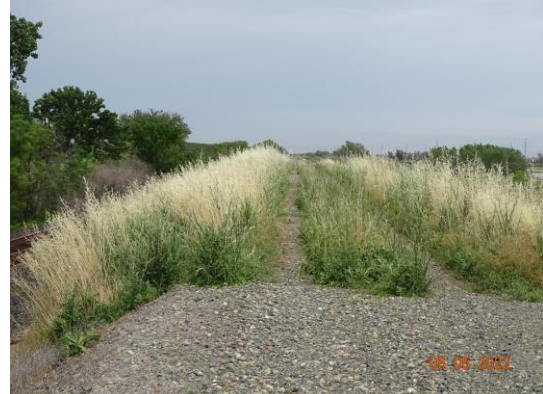
Photo 1 of 1 : SP_2022_RD0010_163_79_20220516_00136.jpg

LM Start	4.42	Rating **	U	Issue No.	79
LM End	4.53	Issue Type +	Ma	Location *	CR
Category	Earthen Levee			GPS Latitude/Longitude	
				Start	End
Item	Vegetation			39.209672 °	39.211195 °
				-121.580821 °	-121.580607 °
DWR ID	DWR_RD0010_01_s _ 2022_79				
Comment Code					
V1 : Control annual grass and weeds on the levee slopes and easements.					
Inspector Comment					
Annual vegetation needs to be maintained, Spring 2022.

View of annual vegetation on the levee crown, Spring 2022.

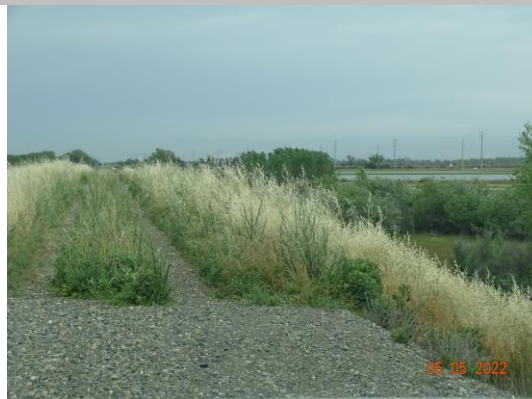
Photo 1 of 1 : SP_2022_RD0010_163_80_20220516_00138.jpg

LM Start	4.42	Rating **	U	Issue No.	80
LM End	4.53	Issue Type +	Ma	Location *	WS
Category	Earthen Levee			GPS Latitude/Longitude	
				Start	End
Item	Vegetation			39.209678 °	39.211195 °
				-121.580824 °	-121.580616 °
DWR ID	DWR_RD0010_01_s_2022_80				
Comment Code					
V1 : Control annual grass and weeds on the levee slopes and easements.					
Inspector Comment					
Annual vegetation needs to be maintained, Spring 2022.

View of annual vegetation on the landside slope, Spring 2022.

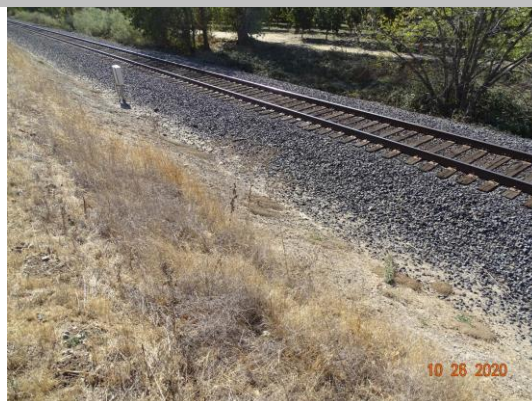
Photo 1 of 1 : SP_2022_RD0010_163_46_20220314_00017.jpg

LM Start	4.50	Rating **	M	Issue No.	46
LM End	4.50	Issue Type +	Ma	Location *	LS
Category	Earthen Levee			GPS Latitude/Longitude	
				Start	End
Item	Animal Control			39.210790 °	39.210790 °
				-121.580654 °	-121.580654 °
DWR ID	DWR_RD0010_01_s_2016_46				
Comment Code					
A3 : No rodents visible, but rodent burrows visible; need to backfill and compact or grout burrows.					
Inspector Comment					
Squirrel holes still are visible but there is no sign of activity.

View of squirrel holes on the landside slope and toe, no rodent activity was observed, Fall 2020

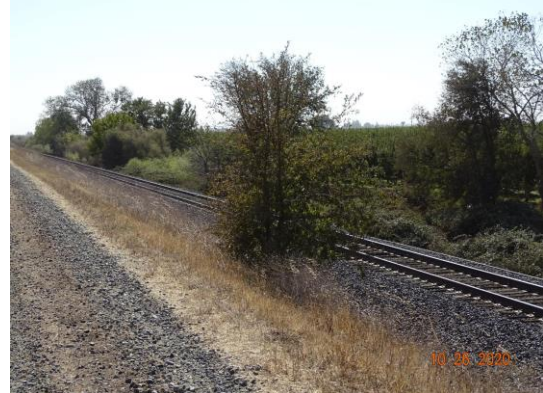
Photo 1 of 1 : SP_2022_RD0010_163_39_20220314_00010.jpg

LM Start	4.63	Rating **	M	Issue No.	39
LM End	4.63	Issue Type +	Ma	Location *	LS
Category	Earthen Levee			GPS Latitude/Longitude	
				Start	End
Item	Trim / Thin Trees			39.212749 °	39.212749 °
				-121.580406 °	-121.580406 °
DWR ID	DWR_RD0010_01_f_2019_39				
Comment Code					
T1 : Trim and thin trees to at least five feet above ground level to allow visibility of the ground and room to flood fight.					
Inspector Comment					
Trees with less than 4" diameter at chest height should be removed, Spring 2022.

View looking downstream landside at small starter trees that need to be removed, Fall 2020

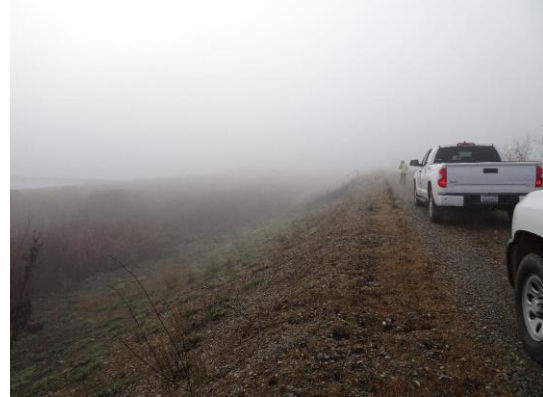
Photo 1 of 3 : UCIP_SP_2022_70564_97679.jpg

FS_ID:70564
DS_ID:21275
EP_NO: N/A
Repair Type: Non-Urgent
Crossing Status: Found
UCIP Comments: 09/08/2021 CIPP-lining of this crossing approved under project authorization WC2021104.
12/21/2020 Record was downgraded from Urgent to Non-Urgent. DWR DMP has found integrity issues, LOF between 4 and 5. Crossing will be monitored until funding becomes available for rehabilitation. No permit was found authorizing this encroachment. CVFPB will need to review crossing to determine owner. (O. Magana - DWR UCIP)12/01/2020 see UCIP marked up RD0010 USACE O&M manual OM151_IrrDRNSect.pdf and USACE drawing AB_4-4-320.pdf for approximate location and station. Reference files have been filed under UCIP's share drive desk study background folder for RD0010. (O. Magana - DWR UCIP)
10/18/2018 According to the LMA representative, a small pipe repair was completed near the WS gate (pipe was leaking at pipe collar). Pipe has been upgraded from Non-Urgent to Urgent due to the wall deterioration near the outlet and an unknown condition through the levee. Levee is about 20 feet high. Recommend video inspection to determine pipe condition through the levee. This pipe is part of DWR's Deferred Maintenance Project (DMP), video inspection is expected to be completed next year for this crossing. (O. Magana - DWR UCIP)7/01/2016 WS slope appears to be stable; UCIP issue has been downgraded from Urgent to Non-Urgent due to what appears to be a stable slope--no other issues were observed during the site visit. The reason for the Non-Urgent classification is due to the limited documentation available to support extent of repair--need to obtain repair records to determine extent of repair and to determine if pipe was replaced through the levee. (DWR UCIP - omagana)4/29/2013 limited access; steep slopes, and dense vegetation; New riprap has been placed along pipe alignment need to contact owner to determine work authorization. Also need to find out if the design for riprap was due to slope failure at this location. This crossing is referenced in the USACE Periodic Inspection as item USACE_CESPK_HON1_2013_p_0246. (DWR UCIP - omagana)

FIELD_STRUCT_DESC: 36-inch corrugated metal (CM) gravity drainage pipe through the levee, 20.0 feet below the crown. Two CM cutoff walls around the pipe under each shoulder. Flap gate on the waterside (WS) end. Concrete headwall on the WS toe. Grouted cobble headwall on the landside (LS) toe. Concrete saddle and apron on the WS. (No permit found authorizing this pipe. Owner unknown).
[Additional Reference(s): DWR Levee Log, 2005, (HLM 4.92). USACE Sacramento O&M Manual, Unit No. 151, May 1953, Revised 6 June 2017, (Station 381+76.24). USACE As-Built Drawing No. 4-4-320,

WS view: cross-section view of WS slope

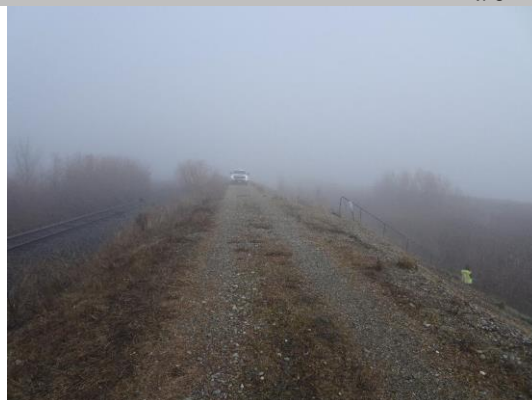
Photo 2 of 3 : UCIP_SP_2022_70564_97680.jpg

LM Start	4.90	Rating **	M	Issue No.	47 (cont)
LM End	4.90	Issue Type +	Ma	Location *

Overview of levee crown looking upstream towards pipe crossing.

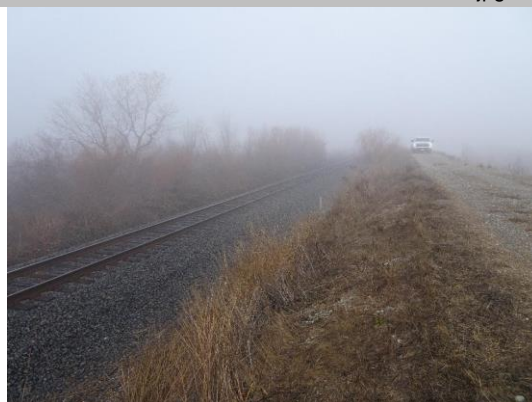
Photo 3 of 3 : UCIP_SP_2022_70564_97681.jpg

LM Start	4.90	Rating **	M	Issue No.	47 (cont)
LM End	4.90	Issue Type +	Ma	Location *

LS view: cross-section view of LS slope and railroad tracks

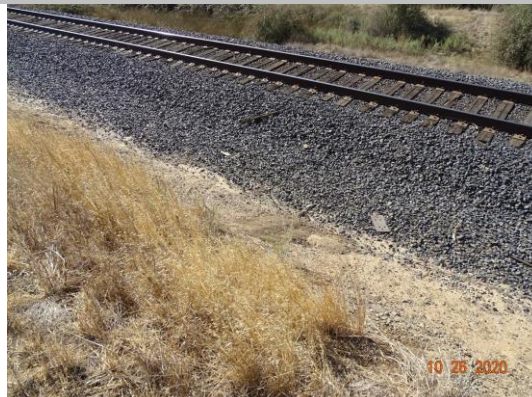
Photo 1 of 1 : SP_2022_RD0010_163_42_20220314_00013.jpg

LM Start	5.04	Rating **	M	Issue No.	42
LM End	5.04	Issue Type +	Ma	Location *	LS
Category	Earthen Levee			GPS Latitude/Longitude	
				Start	End
Item	Animal Control			39.218564 °	39.218564 °
				-121.579682 °	-121.579682 °
DWR ID	DWR_RD0010_01_s_2016_42				
Comment Code					
A3 : No rodents visible, but rodent burrows visible; need to backfill and compact or grout burrows.					
Inspector Comment					
Squirrel holes still are visible but there is no sign of activity.

View of squirrel holes on landside toe, no sign of activity, Fall 2020.

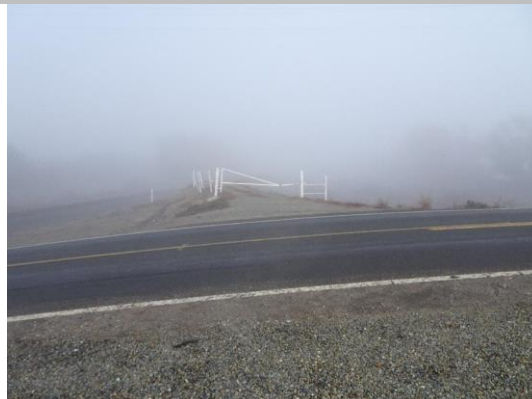
Photo 1 of 3 : UCIP_SP_2022_70578_97687.jpg

LM Start	5.12	Rating **	M	Issue No.	49	
LM End	5.12	Issue Type +	En	Location *		
Category	Supplemental			GPS Latitude/Longitude		
				Start	End	
Item	DWR UCIP Field Study			39.219748 °	39.219748 °	
				-121.579394 °	-121.579394 °	
DWR ID	21276

Comment Code						
Inspector Comment						
FS_ID:70578 DS_ID:21276 EP_NO: 3511 Repair Type: Non-Urgent Crossing Status: Not Found UCIP Comments: 12/21/2020 Record has been updated to Non-Urgent. No signage or evidence of pipe was found during site inspection. Need to contact owner to determine the status of the crossing through the levee. (O. Magana - DWR UCIP) FIELD_STRUCT_DESC: Steel communications conduit of an unknown size through the levee, 3.0 feet below the crown. Corrugated metal (CM) cutoff wall around the pipe at the center of the levee. Rock revetment on the waterside (WS) slope. (Communications conduit authorized under Permit No. 3511, 1960 - U.S. Army Engineer District). [Additional Reference(s): DWR Levee Log, 2005, (HLM 5.14)]. FS Date: 12/21/2020

Overview of levee crown looking towards pipe location.

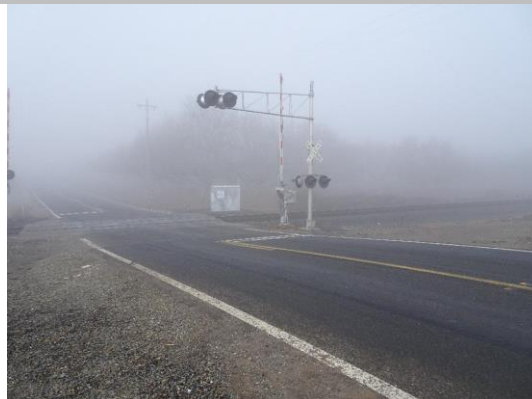
Photo 2 of 3 : UCIP_SP_2022_70578_97688.jpg

LM Start	5.12	Rating **	M	Issue No.	49 (cont)
LM End	5.12	Issue Type +	En	Location *	
Category	Supplemental		GPS Latitude/Longitude		
			Start	End	
Item	DWR UCIP Field Study		39.219748 °	39.219748 °	
			-121.579394 °	-121.579394 °	
DWR ID	21276

LS view: LS view

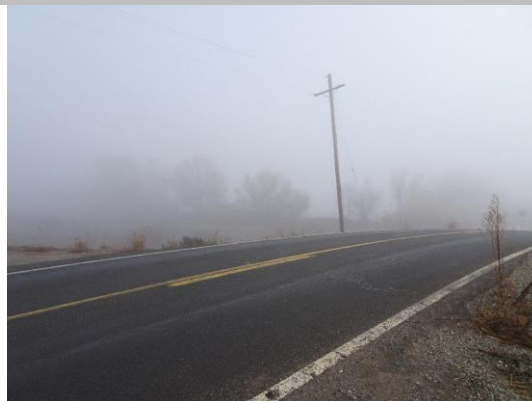
Photo 3 of 3 : UCIP_SP_2022_70578_97689.jpg

LM Start	5.12	Rating **	M	Issue No.	49 (cont)
LM End	5.12	Issue Type +	En	Location *

WS view: WS view

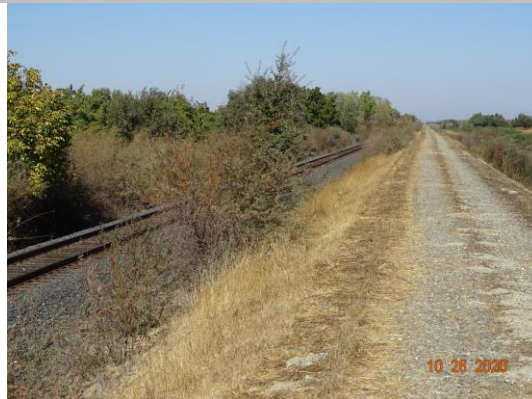
Photo 1 of 1 : SP_2022_RD0010_163_56_20220314_00023.jpg

LM Start	5.42	Rating **	M	Issue No.	56
LM End	5.42	Issue Type +	Ma	Location *	LS
Category	Earthen Levee			GPS Latitude/Longitude	
				Start	End
Item	Trim / Thin Trees			39.224014 °	39.224014 °
				-121.579012 °	-121.579012 °
DWR ID	DWR_RD0010_01_s_2021_56				
Comment Code					
T1 : Trim and thin trees to at least five feet above ground level to allow visibility of the ground and room to flood fight.					
Inspector Comment					
Trees with less than 4" diameter at chest height should be removed, Spring 2022.

View looking upstream landside at small starter trees on levee slope, Fall 2020.

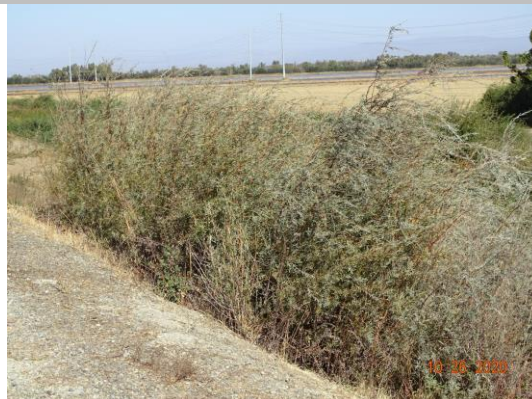
Photo 1 of 1 : SP_2022_RD0010_163_62_20220314_00029.jpg

LM Start	5.42	Rating **	M	Issue No.	62
LM End	5.42	Issue Type +	Ma	Location *	WS
Category	Earthen Levee			GPS Latitude/Longitude	
				Start	End
Item	Trim / Thin Trees			39.224041 °	39.224041 °
				-121.579008 °	-121.579008 °
DWR ID	DWR_RD0010_01_s _ 2020_62				
Comment Code					
T1 : Trim and thin trees to at least five feet above ground level to allow visibility of the ground and room to flood fight.					
Inspector Comment					
Trees with less than 4" diameter at chest height should be removed, Spring 2022.

View looking upstream waterside at small starter tree on levee slope, Fall 2020.

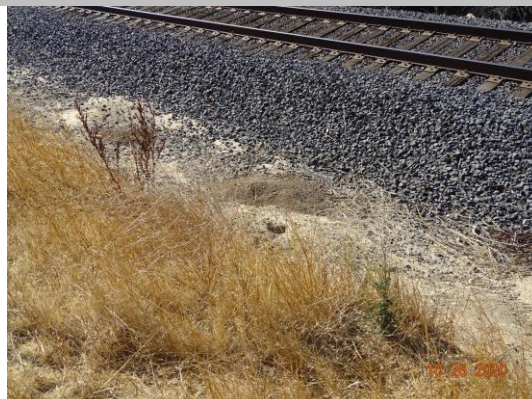
Photo 1 of 1 : SP_2022_RD0010_163_41_20220314_00012.jpg

LM Start	5.45	Rating **	M	Issue No.	41
LM End	5.45	Issue Type +	Ma	Location *	LS
Category	Earthen Levee			GPS Latitude/Longitude	
				Start	End
Item	Animal Control			39.224485 °	39.224485 °
				-121.578944 °	-121.578944 °
DWR ID	DWR_RD0010_01_s _ 2016_41				
Comment Code					
A3 : No rodents visible, but rodent burrows visible; need to backfill and compact or grout burrows.					
Inspector Comment					
Squirrel holes still are visible but there is no sign of activity.

View of multiple ground squirrel holes on landside slope looking downstream. There is no evidence of active squirrels. Fall 2020

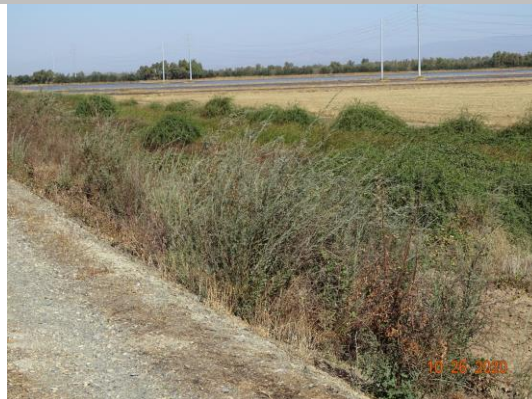
Photo 1 of 1 : SP_2022_RD0010_163_65_20220314_00032.jpg

LM Start	5.46	Rating **	M	Issue No.	65
LM End	5.52	Issue Type +	Ma	Location *	WS
Category	Earthen Levee			GPS Latitude/Longitude	
				Start	End
Item	Trim / Thin Trees			39.224652 °	39.225433 °
				-121.578929 °	-121.578832 °
DWR ID	DWR_RD0010_01_s _ 2020_65				
Comment Code					
T1 : Trim and thin trees to at least five feet above ground level to allow visibility of the ground and room to flood fight.					
Inspector Comment					
Trees with less than 4" diameter at chest height should be removed, Spring 2022.

View looking upstream waterside at small starter tree on levee slope, Fall 2020.

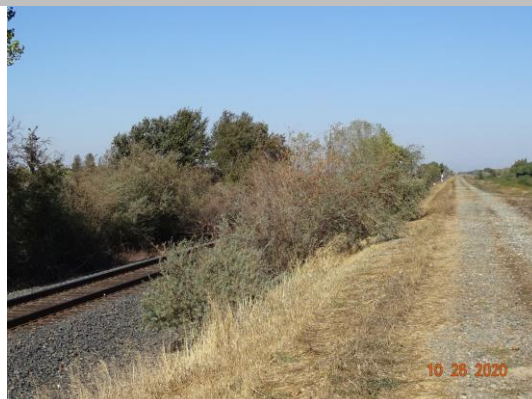
Photo 1 of 1 : SP_2022_RD0010_163_40_20220314_00011.jpg

LM Start	5.60	Rating **	M	Issue No.	40
LM End	5.60	Issue Type +	Ma	Location *	LS
Category	Earthen Levee			GPS Latitude/Longitude	
				Start	End
Item	Trim / Thin Trees			39.226679 °	39.226679 °
				-121.578670 °	-121.578670 °
DWR ID	DWR_RD0010_01_s _ 2016_40				
Comment Code					
T1 : Trim and thin trees to at least five feet above ground level to allow visibility of the ground and room to flood fight.					
Inspector Comment					
Trees with less than 4" diameter at chest height should be removed, Spring 2022.

View of willow trees on the landside slope looking upstream, Fall 2020

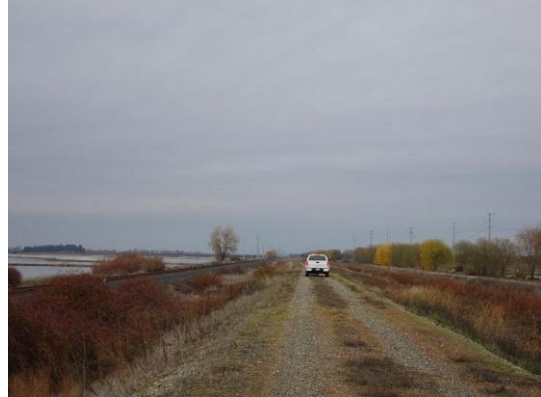
Photo 1 of 3 : UCIP_SP_2022_70579_97699.jpg

Comment Code						
Inspector Comment						
FS_ID:70579 DS_ID:21278 EP_NO: N/A Repair Type: Non-Urgent Crossing Status: Found UCIP Comments: 12/16/2020 Record remains Non-Urgent. No permit was found authorizing this encroachment. CVFPB will need to review crossing to determine owner. DWR DMP has not found internal issues, LOF between 1 and 2. Recommend inspection in 5 years. (O. Magana - DWR UCIP)12/01/2020 see UCIP marked up RD0010 USACE O&M manual OM151_IrrDRNSect.pdf and USACE drawing AB_4-4-320.pdf for approximate location and station. Reference files have been filed under UCIP's share drive desk study background folder for RD0010. (O. Magana - DWR UCIP) 04/29/2013 Dense vegetation limits the inspector's visibility to identify signs of pipe failure (leaks) along the slope. Recommend removing vegetation along pipe alignment to conduct proper inspection of structure and appurtances. This crossing is referenced in the USACE Periodic Inspection as item USACE_CESPK_HON1_2013_p_0290. (O. Magana - DWR UCIP) FIELD_STRUCT_DESC: 30-inch corrugated metal (CM) gravity drainage pipe through the levee, 12.5 feet below the crown. CM cutoff wall around the pipe under each shoulder. Flap gate, concrete headwall, saddle, and apron on the waterside (WS) end. (No permit found authorizing this pipe. Owner unknown). [Additional Reference(s): DWR Levee Log, 2005, (HLM 6.33). USACE Sacramento O&M Manual, Unit No. 151, May 1953, Revised 6 June 2017, (Station 455+00). USACE As-Built Drawing No. 4-4-320, Sheet No. 320/2, Revised January 1951, (Station 455+00)]. FS Date: 12/16/2020

Overview of levee crown looking upstream towards pipe crossing.

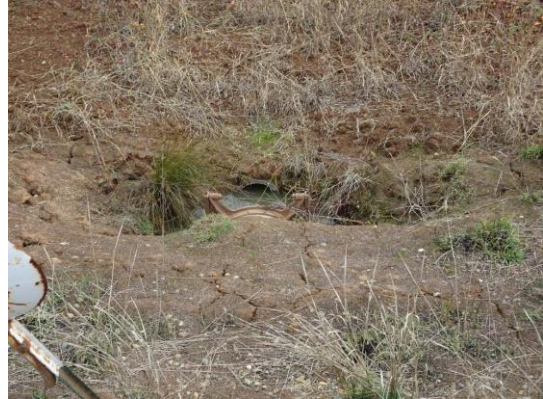
Photo 2 of 3 : UCIP_SP_2022_70579_97700.jpg

LM Start	6.31	Rating **	M	Issue No.	54 (cont)
LM End	6.31	Issue Type +	Ma	Location *	
Category	Supplemental			GPS Latitude/Longitude	
				Start	End
Item	DWR UCIP LMA Responsibility			39.236827 °	39.236827 °
				-121.577262 °	-121.577262 °
DWR ID	21278

WS view: pipe daylights on WS toe.

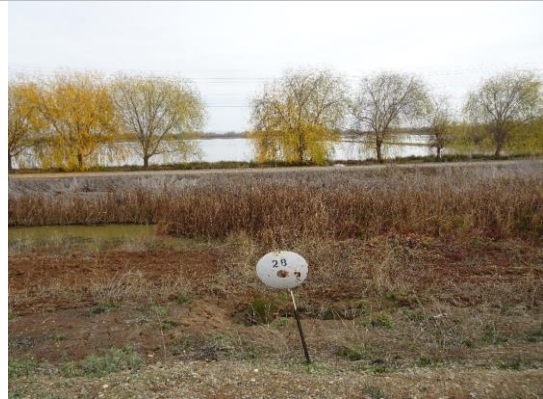
Photo 3 of 3 : UCIP_SP_2022_70579_97701.jpg

WS view: overview of WS.

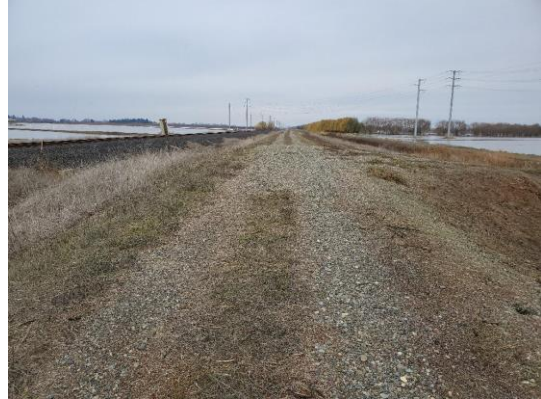
Photo 1 of 3 : UCIP_SP_2022_70568_97709.jpg

FS_ID:70568
DS_ID:21279
EP_NO: N/A
Repair Type: Urgent
Crossing Status: Found
UCIP Comments: 09/08/2021 CIPP-lining of this crossing approved under project authorization WC2021104.
12/16/2020 Record has been updated from Non-Urgent to Urgent. DWR DMP has found integrity issues, LOF between 5 and 6. Recommend monitoring crossing until funding becomes available to address. No permit was found authorizing this encroachment. CVFPB will need to review crossing to determine owner. (O. Magana - DWR UCIP)12/01/2020 see UCIP marked up RD0010 USACE O&M manual OM151_IrrDRNSect.pdf and USACE drawing AB_4-4-320.pdf for approximate location and station. Reference files have been filed under UCIP's share drive desk study background folder for RD0010. (O. Magana - DWR UCIP)
04/29/2013 Need to clear sediment near gate. Need to coordinate with owner to determine status of crossing. If crossing is no longer in use owner will need to contact the CVFPB to comply with Title 23. This crossing is referenced in the USACE Periodic Inspection as item USACE_CESPK_HON1_2013_p_0291-294. (O. Magana - DWR UCIP)

FIELD_STRUCT_DESC: 16-inch steel drainage pipe through the levee, 10.3 feet below the crown. Cutoff wall around the pipe at the center of the levee. Slide gate on the waterside (WS) end. Pipe exposed across irrigation canal on the landside (LS). (No permit found authorizing this pipe. Owner unknown). [Additional Reference(s): DWR Levee Log, 2005, (HLM 6.66). USACE Sacramento O&M Manual, Unit No. 151, May 1953, Revised 6 June 2017, (Station 473+58). USACE As-Built Drawing No. 4-4-320, Sheet No. 320/3, Revised January 1951, (Station 473+58), listed as a 15-inch pipe].
FS Date: 12/16/2020

Overview of levee crown looking towards pipe crossing.

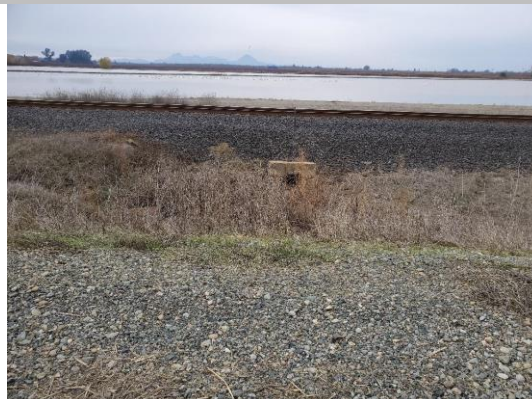
Photo 2 of 3 : UCIP_SP_2022_70568_97710.jpg

LM Start	6.65	Rating **	U	Issue No.	55 (cont)
LM End	6.65	Issue Type +	Ma	Location *	
Category	Supplemental		GPS Latitude/Longitude		
			Start	End	
Item	DWR UCIP LMA Responsibility		39.241726 °	39.241726 °	
			-121.576488 °	-121.576488 °	
DWR ID	21279

LS view: overview of LS--concrete headwall visible

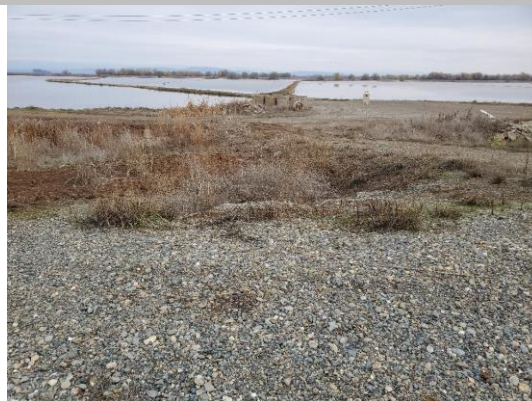
Photo 3 of 3 : UCIP_SP_2022_70568_97711.jpg

WS view: overview of WS

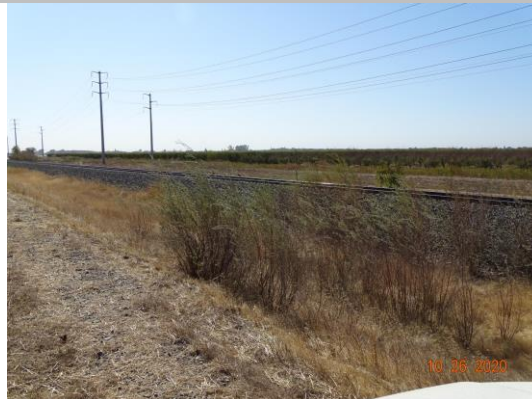
Photo 1 of 1 : SP_2022_RD0010_163_72_20220314_00038.jpg

LM Start	7.40	Rating **	M	Issue No.	72
LM End	7.40	Issue Type +	Ma	Location *	LS
Category	Earthen Levee			GPS Latitude/Longitude	
				Start	End
Item	Trim / Thin Trees			39.252592 °	39.252592 °
				-121.575356 °	-121.575356 °
DWR ID	DWR_RD0010_01_f_2020_72				
Comment Code					
T1 : Trim and thin trees to at least five feet above ground level to allow visibility of the ground and room to flood fight.					
Inspector Comment					
Trees with less than 4" diameter at chest height should be removed, Spring 2022.

View looking upstream landside at small starter trees on levee slope, Fall 2020.

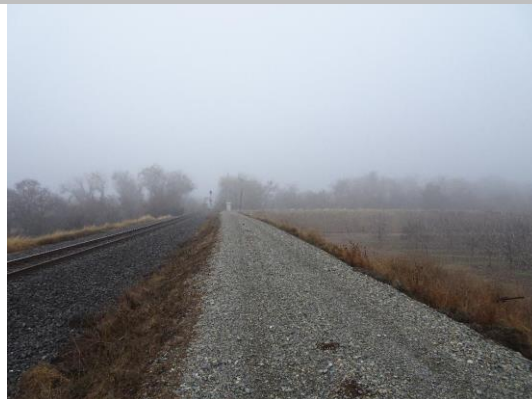
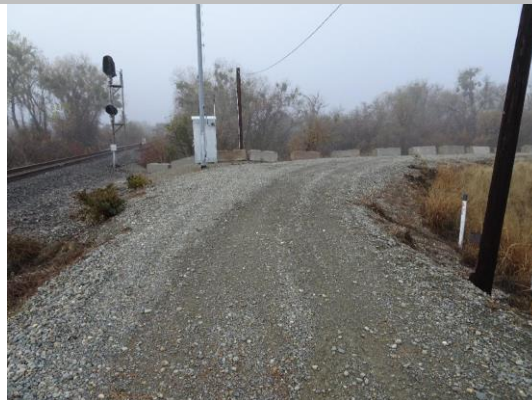
Comment Code						
Inspector Comment						
FS_ID:70594 DS_ID:24651 EP_NO: N/A Repair Type: Non-Urgent Crossing Status: Indicator Found UCIP Comments: 12/14/2020 Record remains Non-Urgent. No permit was found authorizing the installation of this structure. CVFPB will need to review crossing to determine owner. (O. Magana - DWR UCIP)04/29/2013 Need to contact owner--unable to determine if crossing is authorized (no permit found). (O. Magana - DWR UCIP) FIELD_STRUCT_DESC: Fiber optics line markers on the levee slope. Unable to determine if the line goes through the levee. Multiple markers visible on each side. This line was field discovered. (No permit found authorizing this line. Owner unknown). FS Date: 12/14/2020

Overview of levee crown looking downstream towards confluence point, photo 1 of 2.

Overview of levee crown looking downstream towards confluence point, photo 2 of 2.

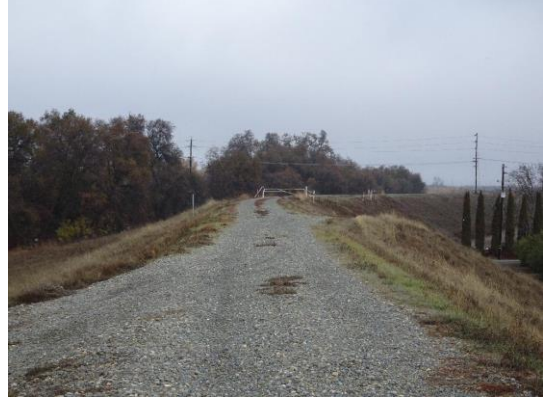
Photo 1 of 3 : UCIP_SP_2022_70595_97754.jpg

Comment Code					
Inspector Comment					
FS_ID:70595 DS_ID:21280 EP_NO: N/A Repair Type: Non-Urgent Crossing Status: Found UCIP Comments: 09/08/2021 CIPP-lining of this crossing approved under project authorization WC2021104. 12/14/2020 Record remains Non-Urgent. DWR DMP has found integrity issues, LOF between 4 and 5. Crossing will be monitored until funding becomes available for rehabilitation. No permit was found authorizing this encroachment. CVFPB will need to review crossing to determine owner. (O. Magana - DWR UCIP)12/01/2020 see UCIP marked up RD0010 USACE O&M manual OM151_IrrDRNSect.pdf and USACE drawing AB_4-4-295.pdf for approximate location and station. Reference files have been filed under UCIP's share drive desk study background folder for RD0010. (O. Magana - DWR UCIP) 04/30/2013 Recommend removing vegetation and debris along pipe alignment (debris blocking gate on waterward side and vegetation blocking access to screw gate on landward side). Need to coordinate with owner to determine status of crossing. If crossing is no longer in use owner will need to contact the CVFPB to comply with Title 23. This crossing is referenced in the USACE Periodic Inspection as item USACE_CESPK_HON2_2013_p_0027. (O. Magana - DWR UCIP) FIELD_STRUCT_DESC: 24-inch corrugated metal (CM) gravity drainage pipe through the levee, 25.6 feet below the crown. CM cutoff wall around the pipe under each shoulder. Concrete headwall, flap gate, saddle, and apron on the waterside (WS) end. (No permit found authorizing this pipe. Owner unknown). [Additional Reference(s): DWR Levee Log, 2005, (HLM 0.37). USACE Sacramento O&M Manual, Unit No. 151, May 1953, Revised 6 June 2017, (Station 106+00). Pipe not referenced in USACE As-Built Drawing No. 4-4-295, Sheet No. 295/2, November 1947, Revised December 1947]. FS Date: 12/14/2020

Overview of levee crown looking upstream towards pipe crossing, photo 1 of 2.

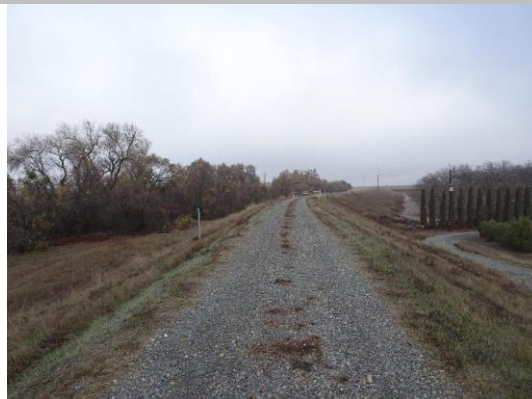
Photo 2 of 3 : UCIP_SP_2022_70595_97755.jpg

LM Start	0.38	Rating **	M	Issue No.	2 (cont)
LM End	0.38	Issue Type +	Ma	Location *	
Category	Supplemental		GPS Latitude/Longitude		
			Start	End	
Item	DWR UCIP LMA Responsibility		39.169174 °	39.169174 °	
			-121.610698 °	-121.610698 °	
DWR ID	21280

Overview of levee crown looking upstream towards pipe crossing, photo 2 of 2.

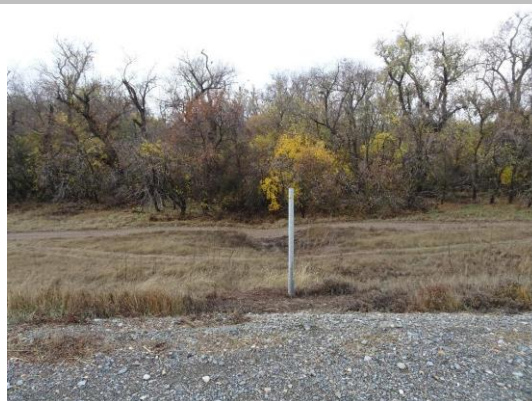
Photo 3 of 3 : UCIP_SP_2022_70595_97756.jpg

WS view: overview of WS.

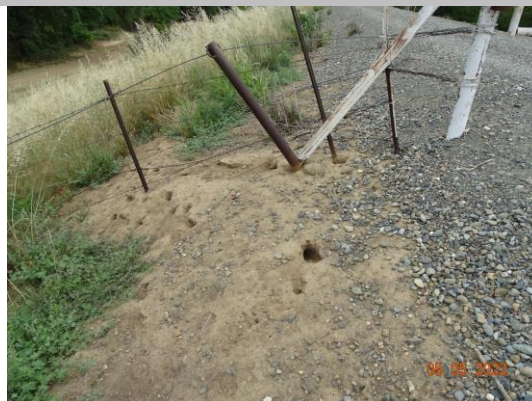
Photo 1 of 1 : SP_2022_RD0010_164_81_20220510_00171.jpg

LM Start	0.40	Rating **	M	Issue No.	81
LM End	0.40	Issue Type +	Ma	Location *	WS
Category	Earthen Levee			GPS Latitude/Longitude	
				Start	End
Item	Animal Control			39.169528 °	39.169528 °
				-121.610713 °	-121.610713 °
DWR ID	DWR_RD0010_02_s _ 2022_81				
Comment Code					
A1 : Exterminate rodents and backfill and compact or grout burrows.					
Inspector Comment					
No rodent activity but squirrel hole needs to be backfilled, Spring 2022

View of rodent hole on the landside slope, Spring 2022.

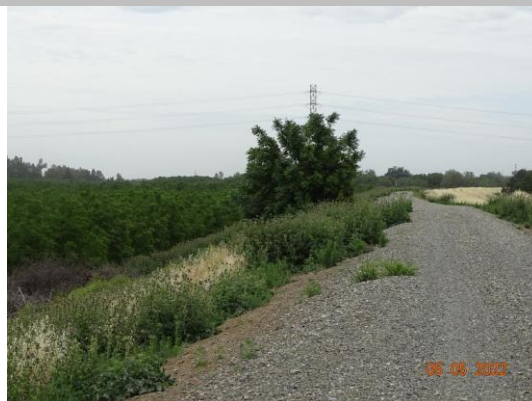
Photo 1 of 1 : SP_2022_RD0010_164_70_20220510_00168.jpg

LM Start	1.09	Rating **	M	Issue No.	70
LM End	1.09	Issue Type +	Ma	Location *	LS
Category	Earthen Levee			GPS Latitude/Longitude	
				Start	End
Item	Trim / Thin Trees			39.179456 °	39.179456 °
				-121.610000 °	-121.610000 °
DWR ID	DWR_RD0010_02_s _ 2020_70				
Comment Code					
T1 : Trim and thin trees to at least five feet above ground level to allow visibility of the ground and room to flood fight.					
Inspector Comment					
Trees with less than 4" diameter at chest height should be removed, Spring 2022.

View looking downstream landside at small starter tree on levee slope, Spring 2022.

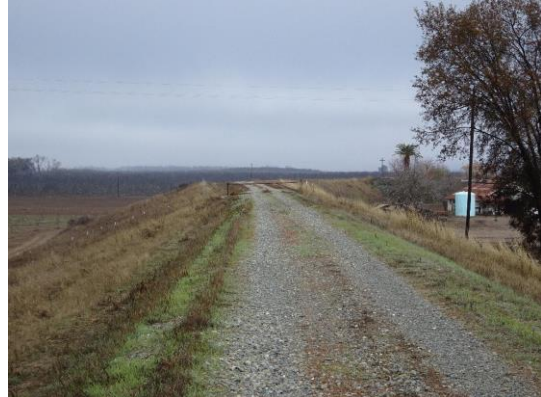
Photo 1 of 3 : UCIP_SP_2022_70596_97760.jpg

Comment Code						
Inspector Comment						
FS_ID:70596 DS_ID:21281 EP_NO: N/A Repair Type: Non-Urgent Crossing Status: Found UCIP Comments: 12/14/2020 Record remains Non-Urgent. No permit was found authorizing this encroachment. CVFPB will need to review crossing to determine owner. DWR DMP has not found internal issues, LOF between 1 and 2. Recommend inspection in 5 years. Dense vegetation along the WS and LS limited site inspection. (O. Magana - DWR UCIP)12/01/2020 see UCIP marked up RD0010 USACE O&M manual OM151_IrrDRNSect.pdf and USACE drawing AB_4-4-295.pdf for approximate location and station. Reference files have been filed under UCIP's share drive desk study background folder for RD0010. (O. Magana - DWR UCIP) 04/30/2013 Screw gate on landward side is blocked by sediment. Recommend removing sediment in front of gate. This crossing is referenced in the USACE Periodic Inspection as item USACE_CESPK_HON2_2013_p_0082. (O. Magana - DWR UCIP) FIELD_STRUCT_DESC: 24-inch corrugated metal (CM) gravity drainage pipe through the levee, 26.0 feet below the crown. CM cutoff wall around the pipe under each shoulder. Concrete headwall, flap gate, saddle, and apron on the waterside (WS) end. Slide gate on the landside (LS) end. (No permit found authorizing this pipe. Owner unknown). [Additional Reference(s): DWR Levee Log, 2005, (HLM 1.19). USACE Sacramento O&M Manual, Unit No. 151, May 1953, Revised 6 June 2017, (Station 149+88). USACE As-Built Drawing No. 4-4-295, Sheet No. 295/3, November 1947, Revised December 1947, (Station 149+88)]. FS Date: 12/14/2020

Overview of levee crown looking upstream towards pipe crossing, photo 1 of 2.
