Flood Control Project Maintenance Levee Inspections LMA District Cover Sheet

Reclamation District No. 0010 Honcut

**Flood Control Project Maintenance
Levee Inspections
Unit Cover Sheet**

Waterway			Bank	Unit Miles
Unit No. 01 Simmerly Slough			Right	7.65
	Spring (March - May)	Summer (June - August)	(September - November) Fall	Winter (December - February)
Unit Maintenance Rating (Fall Only)				
Date of Inspection	5/5/2022 - 5/5/2022			
DWR Inspector	Brooks Weisser			
Accompanied By	Finlay Williams

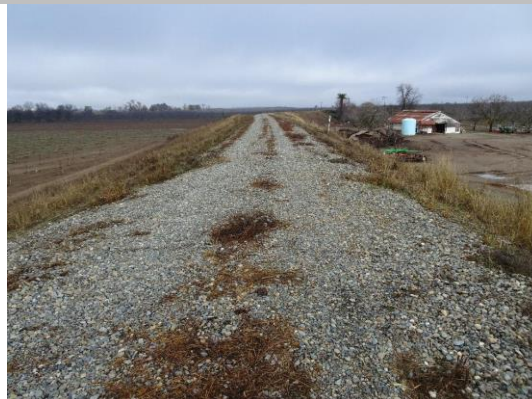
Photo 2 of 3 : UCIP_SP_2022_70596_97761.jpg

LM Start	1.19	Rating **	M	Issue No.	3 (cont)
LM End	1.19	Issue Type +	Ma	Location *	
Category	Supplemental		GPS Latitude/Longitude		
			Start	End	
Item	DWR UCIP LMA Responsibility		39.180875 °	39.180875 °	
			-121.610053 °	-121.610053 °	
DWR ID	21281

Overview of levee crown looking upstream towards pipe crossing, photo 2 of 2.

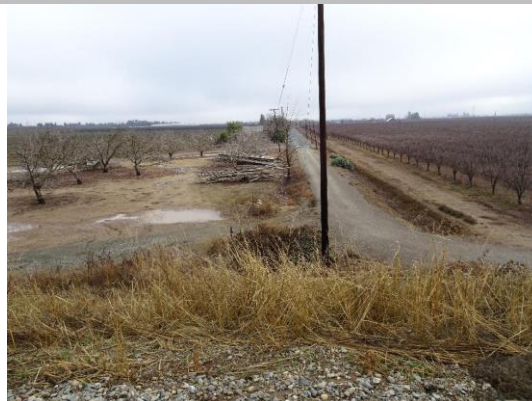
Photo 3 of 3 : UCIP_SP_2022_70596_97762.jpg

LS view: overview of LS.

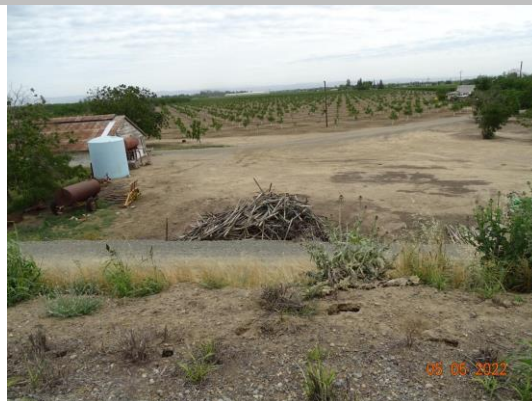
Photo 1 of 1 : SP_2022_RD0010_164_77_20220510_00167.jpg

LM Start	1.23	Rating **	M	Issue No.	77
LM End	1.23	Issue Type +	En	Location *	LS
Category	Earthen Levee			GPS Latitude/Longitude	
				Start	End
Item	Encroachments			39.181482 °	39.181482 °
				-121.610111 °	-121.610111 °
DWR ID	DWR_RD0010_02_f_2020_77				
Comment Code					
DE : Debris					
Inspector Comment					
Debris along landside toe should be removed, Spring 2022.

View of debris along landside toe, Spring 2022.

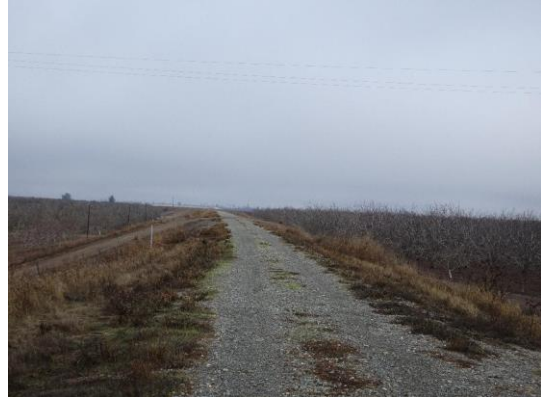
Photo 1 of 3 : UCIP_SP_2022_70597_97765.jpg

Comment Code					
Inspector Comment					
FS_ID:70597 DS_ID:21282 EP_NO: N/A Repair Type: Non-Urgent Crossing Status: Found UCIP Comments: 12/14/2020 Record has been updated from No Action Needed to Non-Urgent. No permit was found authorizing this encroachment. CVFPB will need to review crossing to determine owner. DWR DMP has not found internal issues, LOF between 1 and 2. Recommend inspection in 5 years. Dense vegetation along the WS and LS limited site inspection. (O. Magana - DWR UCIP)12/01/2020 see UCIP marked up RD0010 USACE O&M manual OM151_IrrDRNSect.pdf and USACE drawing AB_4-4-295.pdf for approximate location and station. Reference files have been filed under UCIP's share drive desk study background folder for RD0010. (O. Magana - DWR UCIP) 04/29/2013 This crossing is referenced in the USACE Periodic Inspection as item USACE_CESPK_HON2_2013_p_0109. (O. Magana - DWR UCIP) FIELD_STRUCT_DESC: 36-inch corrugated metal (CM) gravity drainage pipe through the levee, 25.0 feet below the crown. CM cutoff wall around the pipe under each shoulder. Concrete headwall, flap gate, saddle, and apron on the waterside (WS) end. Slide gate on the landside (LS) end. (No permit found authorizing this pipe. Owner unknown). [Additional Reference(s): DWR Levee Log, 2005, (HLM 1.49). USACE Sacramento O&M Manual, Unit No. 151, May 1953, Revised 6 June 2017, (Station 164+65). USACE As-Built Drawing No. 4-4-295, Sheet No. 295/3, November 1947, Revised December 1947, (Station 164+65)]. FS Date: 12/14/2020

Overview of levee crown looking upstream towards pipe crossing.

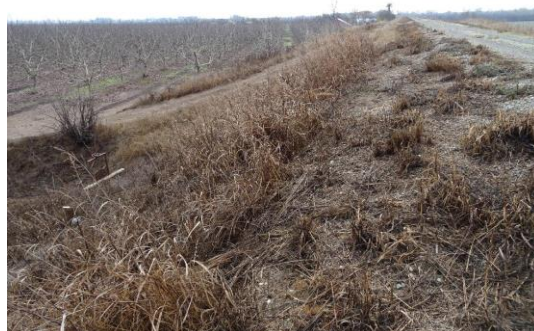
Photo 2 of 3 : UCIP_SP_2022_70597_97766.jpg

LS view: cross-section view of LS slope.

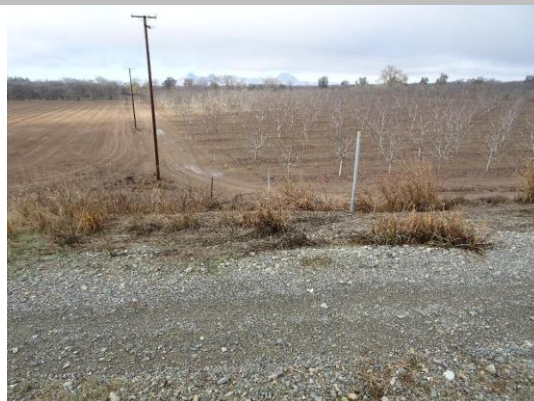
Photo 3 of 3 : UCIP_SP_2022_70597_97767.jpg

WS view: overview of WS.

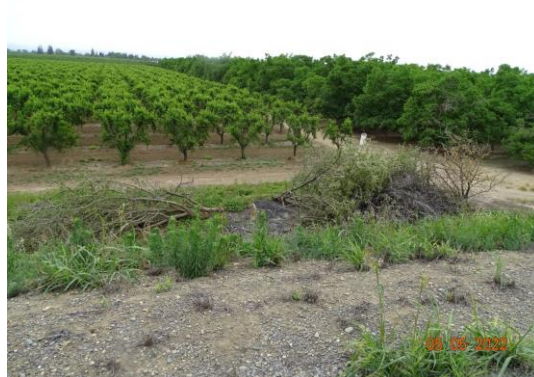
Photo 1 of 1 : SP_2022_RD0010_164_80_20220510_00165.jpg

LM Start	1.80	Rating **	M	Issue No.	80
LM End	1.80	Issue Type +	En	Location *	LS
Category	Earthen Levee			GPS Latitude/Longitude	
				Start	End
Item	Encroachments			39.189528 °	39.189528 °
				-121.607953 °	-121.607953 °
DWR ID	DWR_RD0010_02_s_2022_80				
Comment Code					
PR : Prunings					
Inspector Comment					
A small pile of prunings on the landside toe needs to be removed, Spring 2022.

View of prunings on the landside slope, Spring 2022.

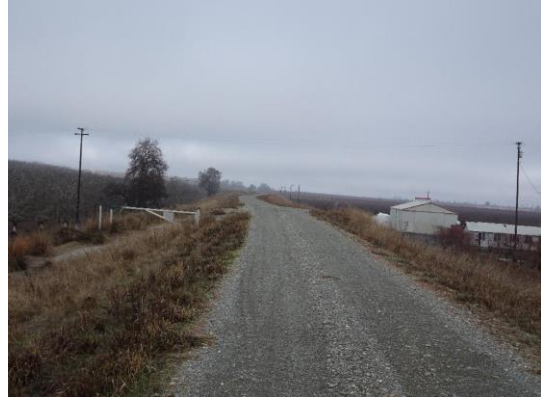
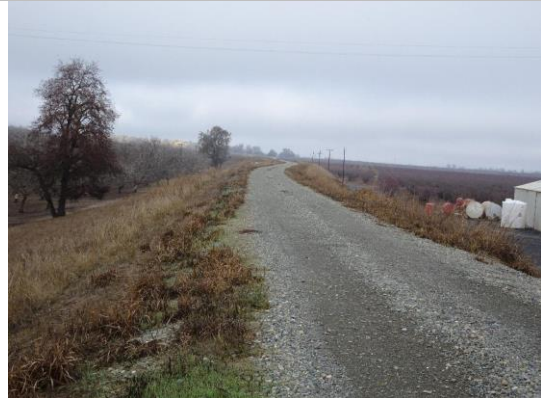
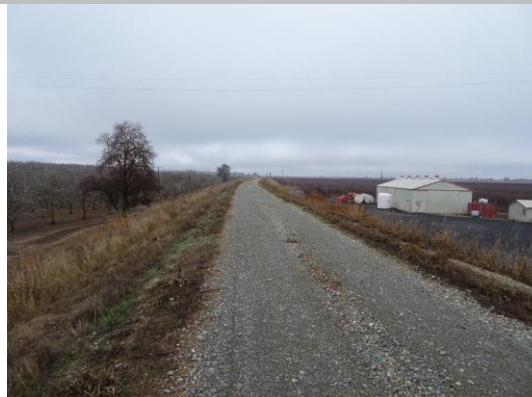
FS_ID:70598
DS_ID:21312
EP_NO: N/A
Repair Type: Non-Urgent
Crossing Status: Not Found
UCIP Comments: 12/14/2020 Record has been updated to Non-Urgent. DWR DMP geophysical study found no positive signal of pipe at latitude, longitude 38.193591, -121.607736. No signage or evidence of pipe was found during site inspection. No permit was found authorizing this encroachment. CVFPB will need to review crossing to determine owner. Record will remain in UCIP's database and should be monitored until a levee improvement project can confirm that this crossing has been removed from the levee. (O. Magana - DWR UCIP)12/01/2020 see UCIP marked up RD0010 USACE O&M manual OM151_IrrDRNSect.pdf and USACE drawing AB_4-4-295.pdf for approximate location and station. Reference files have been filed under UCIP's share drive desk study background folder for RD0010. (O. Magana - DWR UCIP)
FIELD_STRUCT_DESC: 30-inch corrugated metal (CM) gravity drainage pipe through the levee, at an unknown depth. CM cutoff wall around the pipe under each shoulder. Concrete headwall, saddle, and apron on the waterside (WS) end. (No permit found authorizing this pipe. Owner unknown). [Additional Reference(s): USACE Sacramento O&M Manual, Unit No. 151, May 1953, Revised 6 June 2017, (Station 249+29). Pipe is not referenced in USACE As-Built Drawing No. 4-4-295, Sheet No. 295/4, November 1947, Revised December 1947].

Overview of levee crown looking towards pipe location, photo 1 of 3.

Overview of levee crown looking towards pipe location, photo 2 of 3.

Overview of levee crown looking towards pipe location, photo 3 of 3.

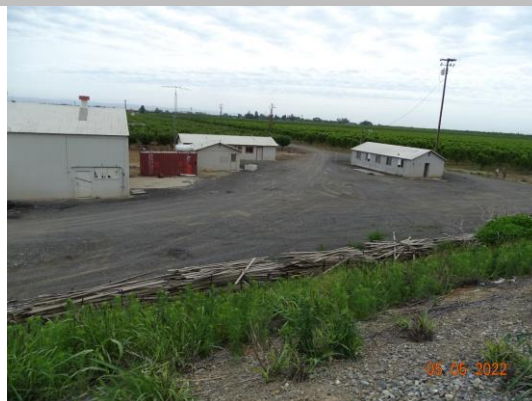
Photo 1 of 1 : SP_2022_RD0010_164_73_20220510_00164.jpg

LM Start	2.14	Rating **	M	Issue No.	73
LM End	2.14	Issue Type +	En	Location *	LS
Category	Earthen Levee			GPS Latitude/Longitude	
				Start	End
Item	Encroachments			39.194341 °	39.194341 °
				-121.607896 °	-121.607896 °
DWR ID	DWR_RD0010_02_f_2020_73				
Comment Code					
DE : Debris					
Inspector Comment					
Debris along landside toe should be removed, Spring 2022.

View of debris on landside toe, Spring 2022.

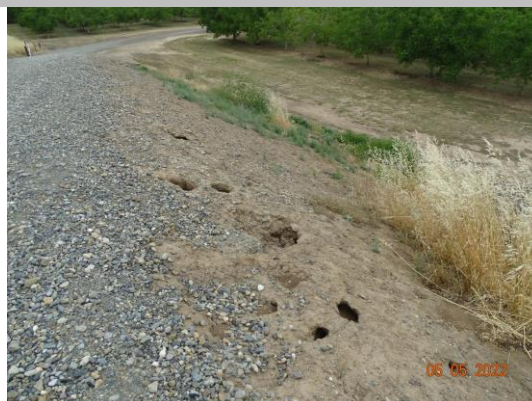
Photo 1 of 1 : SP_2022_RD0010_164_68_20220510_00163.jpg

LM Start	3.06	Rating **	M	Issue No.	68
LM End	3.06	Issue Type +	Ma	Location *	LS
Category	Earthen Levee			GPS Latitude/Longitude	
				Start	End
Item	Animal Control			39.207600 °	39.207600 °
				-121.609843 °	-121.609843 °
DWR ID	DWR_RD0010_02_s_2020_68				
Comment Code					
A1 : Exterminate rodents and backfill and compact or grout burrows.					
Inspector Comment					
Backfill squirrel hole, Spring 2022.

View looking landside at squirrel activity on the levee slope, Spring 2022.

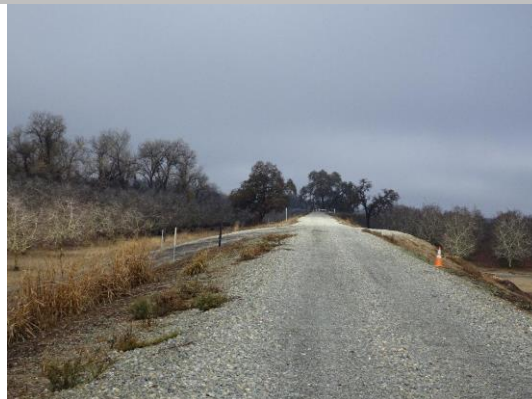
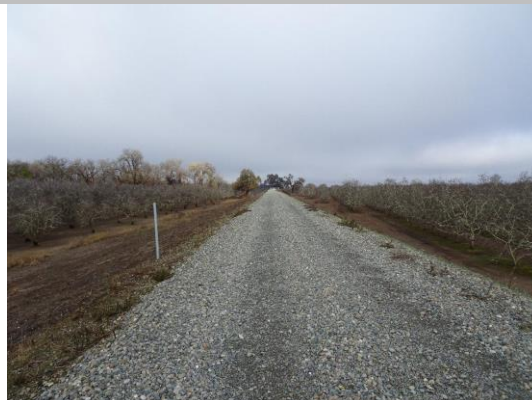
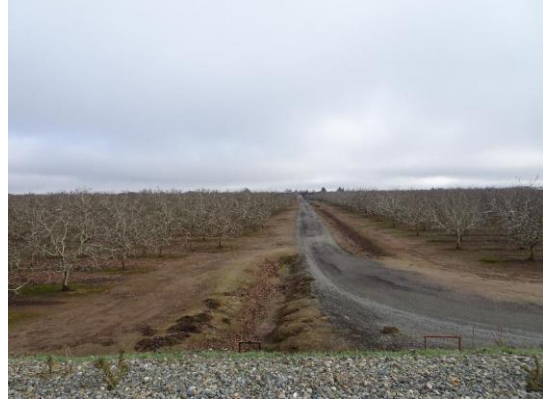
Comment Code						
Inspector Comment						
FS_ID:70599 DS_ID:21283 EP_NO: N/A Repair Type: Non-Urgent Crossing Status: Found UCIP Comments: 12/14/2020 Record remains Non-Urgent. No permit was found authorizing this encroachment. CVFPB will need to review crossing to determine owner. DWR DMP has not found internal issues, LOF between 1 and 2. Recommend inspection in 5 years. Dense vegetation along the WS and LS limited site inspection. (O. Magana - DWR UCIP)04/30/2013 High rodent activity along pipe alignment--animal control would be beneficial. This crossing is referenced in the USACE Periodic Inspection as item USACE_CESPK_HON2_2013_p_0150. (O. Magana - DWR UCIP) FIELD_STRUCT_DESC: 30-inch corrugated metal (CM) gravity drainage pipe through the levee, 22.5 feet below the crown. Flap gate on the waterside (WS) end. Metal marker on the WS shoulder. (No permit found authorizing this pipe. Owner unknown). [Additional Reference(s): DWR Levee Log, 2005, (HLM 3.11)]. FS Date: 12/14/2020

Overview of levee crown of looking upstream towards pipe crossing, photo 2 of 2.

Overview of levee crown of looking upstream towards pipe crossing, photo 1 of 2.

LS view: overview of LS

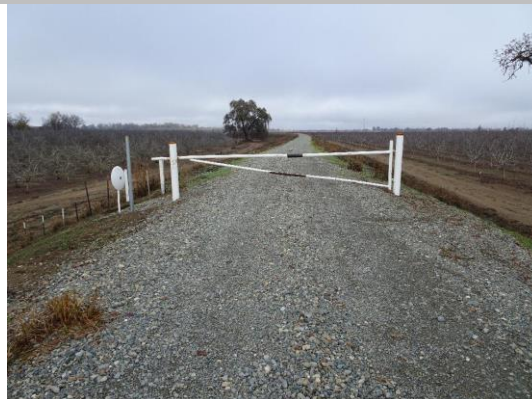
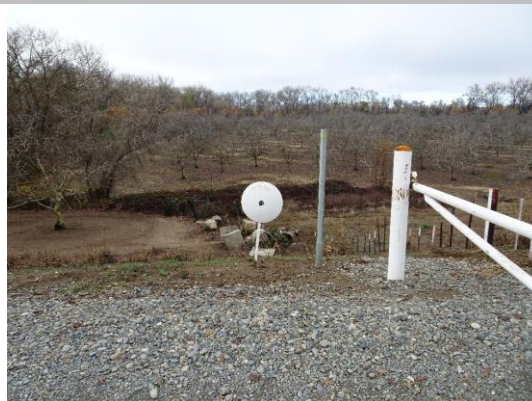
Overview of levee crown looking upstream towards pipe crossing, photo 2 of 2.

WS view: overview of WS.

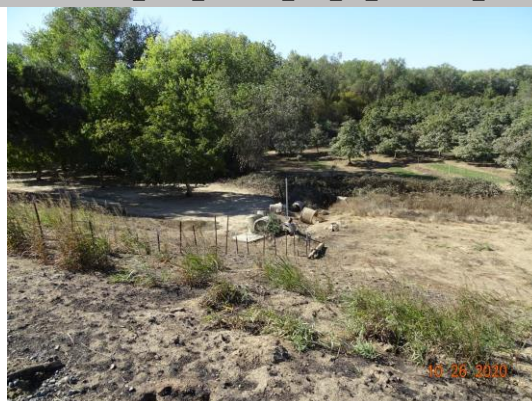
Photo 1 of 1 : SP_2022_RD0010_164_47_20220314_00016.jpg

LM Start	3.30	Rating **	M	Issue No.	47
LM End	3.30	Issue Type +	En	Location *	WS
Category	Earthen Levee			GPS Latitude/Longitude	
				Start	End
Item	Encroachments			39.211085 °	39.211085 °
				-121.610172 °	-121.610172 °
DWR ID	DWR_RD0010_02_s_2019_47				
Comment Code					
DE : Debris					
Inspector Comment					
Remove debris at the levee toe, Spring 2022.

View looking at the waterside levee toe where debris has been stacked, Fall 2020.

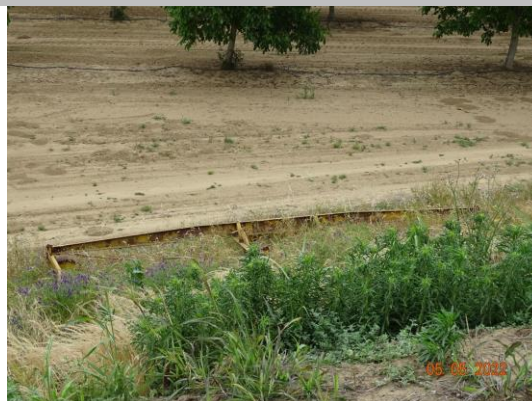
Photo 1 of 1 : SP_2022_RD0010_164_71_20220510_00160.jpg

LM Start	3.47	Rating **	M	Issue No.	71
LM End	3.47	Issue Type +	En	Location *	LS
Category	Earthen Levee			GPS Latitude/Longitude	
				Start	End
Item	Encroachments			39.213618 °	39.213618 °
				-121.610078 °	-121.610078 °
DWR ID	DWR_RD0010_02_s_2021_71				
Comment Code					
EQ : Equipment					
Inspector Comment					
Equipment along landside toe needs to be removed, Spring 2022.

View of equipment stored along landside toe, Spring 2022.

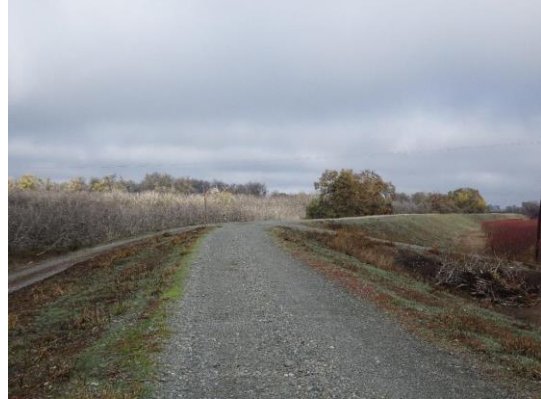
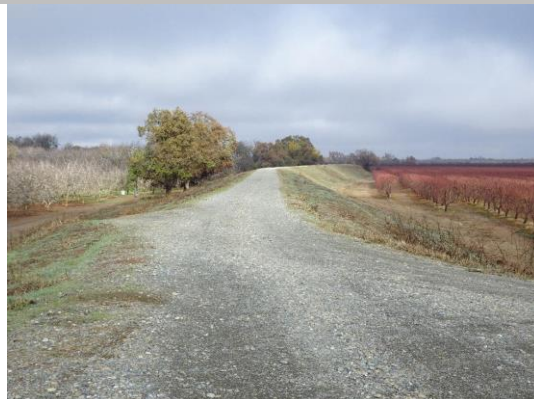
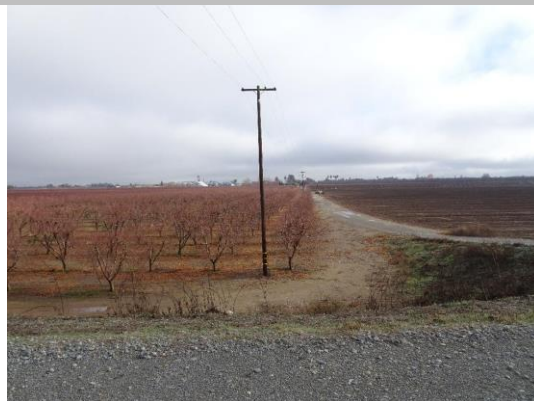
Comment Code						
Inspector Comment						
FS_ID:70601 DS_ID:21285 EP_NO: N/A Repair Type: Non-Urgent Crossing Status: Found UCIP Comments: 12/14/2020 Record remains Non-Urgent. No permit was found authorizing this encroachment. CVFPB will need to review crossing to determine owner. DWR DMP has not found internal issues, LOF between 1 and 2. Recommend inspection in 5 years. (O. Magana - DWR UCIP)12/01/2020 see UCIP marked up RD0010 USACE O&M manual OM151_IrrDRNSect.pdf and USACE drawing AB_4-4-318.pdf for approximate location and station. Reference files have been filed under UCIP's share drive desk study background folder for RD0010. (O. Magana - DWR UCIP) 04/30/2013 Sediment blocking flap gate and screw gate--recommend removing material. Dense burrow activity present along levee slopes (large holes visible on landward side)--recommend addressing issue. This crossing is referenced in the USACE Periodic Inspection as item USACE_CESPK_HON2_2013_p_0169. (O. Magana - DWR UCIP) FIELD_STRUCT_DESC: 30-inch corrugated metal (CM) gravity drainage pipe through the levee, 19.5 feet below the crown. CM cutoff wall around the pipe under each shoulder. Flap gate on the waterside (WS) end. Slide gate on the landside (LS) end. Concrete headwall at each end. (No permit found authorizing this pipe. Owner unknown). [Additional Reference(s): DWR Levee Log, 2005, (HLM 3.63). USACE Sacramento O&M Manual, Unit No. 151, May 1953, Revised 6 June 2017, (Station 277+00). USACE As-Built Drawing No. 4-4-318, Sheet No. 318/2, Revised January 1951, (Station 277+00)]. FS Date: 12/14/2020

Overview of levee crown looking towards pipe crossing, photo 1 of 2.

Overview of levee crown looking towards pipe crossing, photo 2 of 2.

LS view: overview of LS.

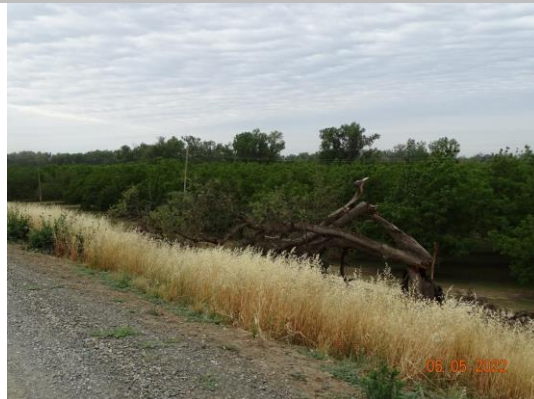
Photo 1 of 1 : SP_2022_RD0010_164_75_20220510_00161.jpg

LM Start	3.72	Rating **	M	Issue No.	75
LM End	3.72	Issue Type +	Ma	Location *	WS
Category	Earthen Levee			GPS Latitude/Longitude	
				Start	End
Item	Trim / Thin Trees			39.217145 °	39.217145 °
				-121.610836 °	-121.610836 °
DWR ID	DWR_RD0010_02_s_2022_75				
Comment Code					
T6 : Trees / Falling Tree.					
Inspector Comment					
Downed tree on the waterside slope need to be removed, Spring 2022.

View of downed tree on the waterside slope, Spring 2022.

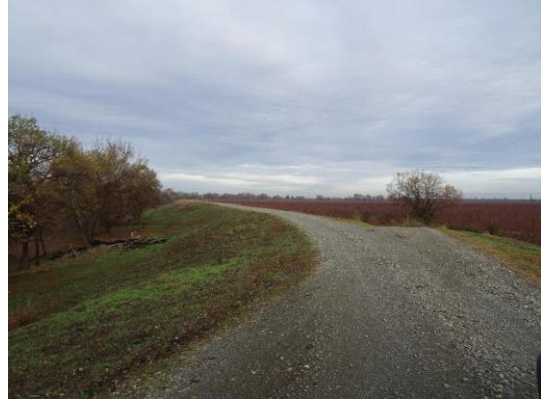
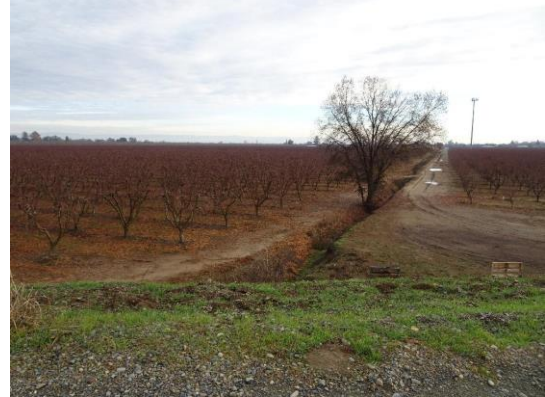
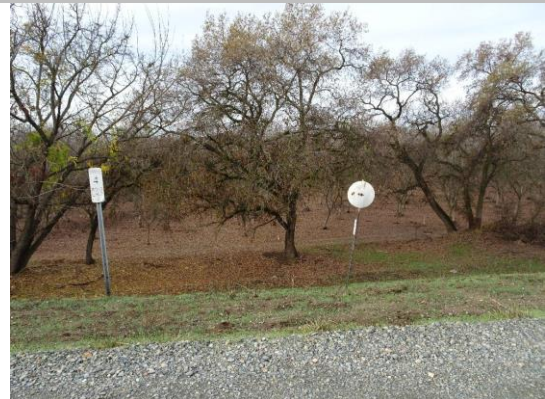
Comment Code						
Inspector Comment						
FS_ID:70602						
DS_ID:21286						
EP_NO: N/A						
Repair Type: Non-Urgent						
Crossing Status: Found						
UCIP Comments: 12/15/2020 Record remains Non-Urgent. No permit was found authorizing this encroachment. CVFPB will need to review crossing to determine owner. DWR DMP has not found internal issues, LOF between 1 and 2. Recommend inspection in 5 years. (O. Magana - DWR UCIP)12/01/2020 see UCIP marked up RD0010 USACE O&M manual OM151_IrrDRNSect.pdf and USACE drawing AB_4-4-318.pdf for approximate location and station. Reference files have been filed under UCIP's share drive desk study background folder for RD0010. (O. Magana - DWR UCIP)						
04/30/2013 Deformation observed on the top wall of pipe at the entrance of landward side--need to contact owner to address issue. This crossing is referenced in the USACE Periodic Inspection as item USACE_CESPK_HON2_2013_p_0180. (O. Magana - DWR UCIP)

FIELD_STRUCT_DESC: 30-inch corrugated metal (CM) gravity drainage pipe through the levee, 21.5 feet below the crown. CM cutoff wall around the pipe under each shoulder. Flap gate on the waterside (WS) end. Slide gate on the landside (LS) end. Concrete headwall at each end. (No permit found authorizing this pipe. Owner unknown).						
[Additional Reference(s): DWR Levee Log, 2005, (HLM 3.97). USACE Sacramento O&M Manual, Unit No. 151, May 1953, Revised 6 June 2017, (Station 294+84). USACE As-Built Drawing No. 4-4-318, Sheet No. 318/2, Revised January 1951, (Station 294+84)].						
FS Date: 12/15/2020

Overview of levee crown looking upstream towards pipe crossing, photo 1 of 2.

LS view: overview of LS.

WS view: overview of WS.

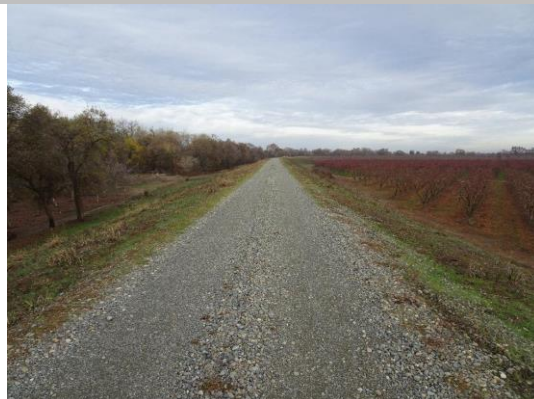
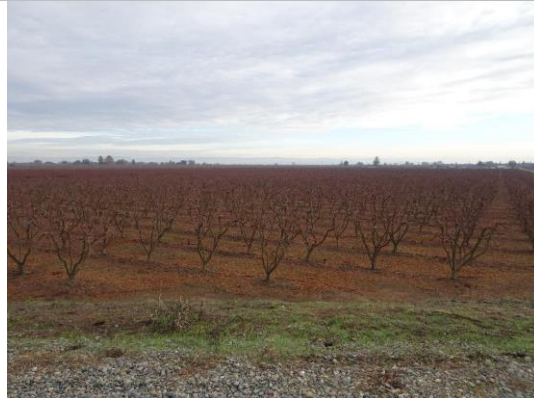
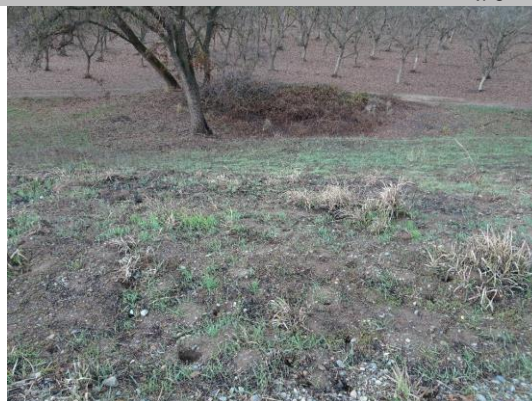
Comment Code						
Inspector Comment						
FS_ID:70626 DS_ID:21287 EP_NO: 3511 Repair Type: Non-Urgent Crossing Status: Not Found UCIP Comments: 12/15/2020 Record has been updated to Non-Urgent. No signage or evidence of pipe was found during the field inspection. Need to contact owner to determine the status of the crossing through the levee. (O. Magana - DWR UCIP) FIELD_STRUCT_DESC: Steel communications conduit of an unknown size through the levee, 3.0 feet below the crown. Corrugated metal (CM) cutoff wall around the pipe at the center of the levee. Rock revetment on the waterside (WS) slope. (Communications conduit authorized under Permit No. 3511, 1960 - United States Army Engineer District). [Additional Reference(s): DWR Levee Log, 2005, (HLM 3.98)]. FS Date: 12/15/2020

Overview of levee crown looking upstream toward pipe location.

LS view: overview of LS.

WS view: no pipe visible on the WS.

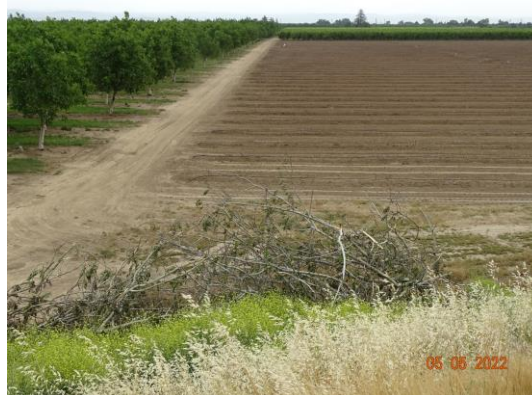
Photo 1 of 1 : SP_2022_RD0010_164_72_20220510_00162.jpg

A small pile of prunings on the landside toe needs to be removed, Spring 2022.

View of prunings on the landside slope, Spring 2022.

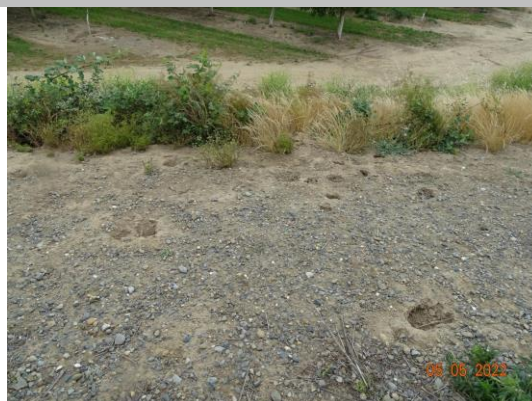
Photo 1 of 1 : SP_2022_RD0010_164_69_20220510_00159.jpg

No rodent activity observed, but holes need to be properly backfilled, Spring 2022.

View of rodent holes on the landside slope, Spring 2022.

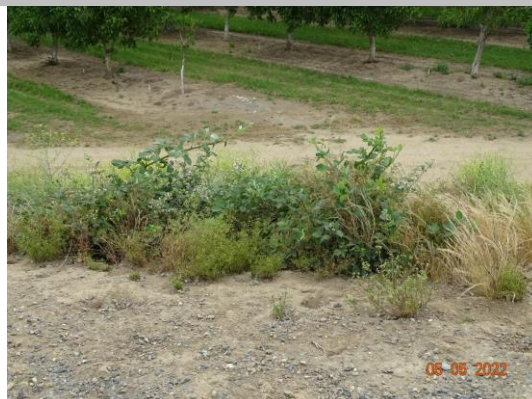
Photo 1 of 1 : SP_2022_RD0010_164_58_20220510_00158.jpg

LM Start	4.17	Rating **	M	Issue No.	58
LM End	4.17	Issue Type +	Ma	Location *	LS
Category	Earthen Levee			GPS Latitude/Longitude	
				Start	End
Item	Vegetation			39.223276 °	39.223276 °
				-121.612510 °	-121.612510 °
DWR ID	DWR_RD0010_02_f_2019_58				
Comment Code					
V2 : Remove the wild growth and woody vegetation other than native grasses from the levee slopes.					
Inspector Comment					
Remove blackberry bushes from levee slope, Spring 2022.

View looking at blackberry bushes on the landside levee slope that need to be removed, Spring 2022.

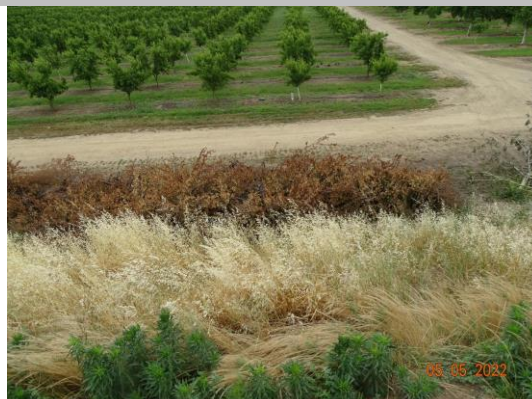
Photo 1 of 1 : SP_2022_RD0010_164_67_20220510_00157.jpg

LM Start	4.33	Rating **	M	Issue No.	67
LM End	4.33	Issue Type +	En	Location *	LS
Category	Earthen Levee			GPS Latitude/Longitude	
				Start	End
Item	Encroachments			39.225484 °	39.225484 °
				-121.613489 °	-121.613489 °
DWR ID	DWR_RD0010_02_s_2022_67				
Comment Code					
PR : Prunings					
Inspector Comment					
Prunings on the landside slope need to be removed, Spring 2022.

View of prunings on the landside slope, Spring 2022.

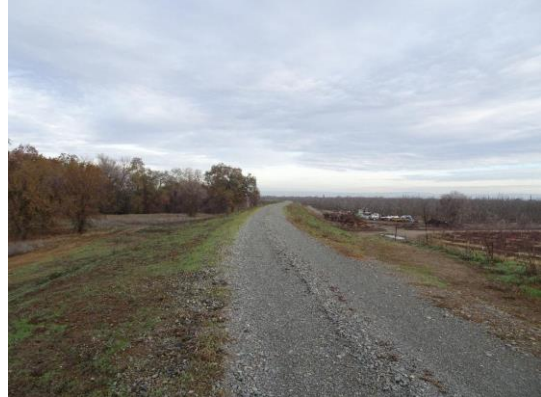
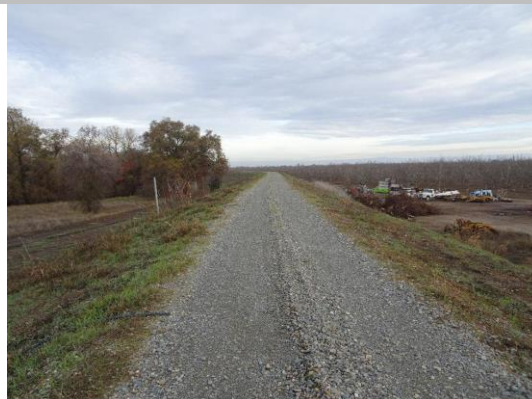
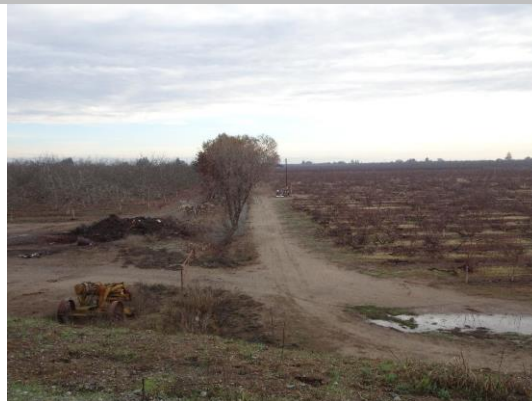
Comment Code						
Inspector Comment						
FS_ID:70604 DS_ID:21288 EP_NO: N/A Repair Type: Non-Urgent Crossing Status: Found UCIP Comments: 12/15/2020 Record remains Non-Urgent. No permit was found authorizing this encroachment. CVFPB will need to review crossing to determine owner. DWR DMP has not found internal issues, LOF between 1 and 2. Recommend inspection in 5 years. (O. Magana - DWR UCIP)12/01/2020 see UCIP marked up RD0010 USACE O&M manual OM151_IrrDRNSect.pdf and USACE drawing AB_4-4-318.pdf for approximate location and station. Reference files have been filed under UCIP's share drive desk study background folder for RD0010. (O. Magana - DWR UCIP) 04/30/2013 Need to updated photos showing cleared slopes. This crossing is referenced in the USACE Periodic Inspection as item USACE_CESPK_HON2_2013_p_0193. (O. Magana - DWR UCIP) FIELD_STRUCT_DESC: 24-inch corrugated metal (CM) gravity drainage pipe through the levee, 19.0 feet below the crown. CM cutoff wall around the pipe under each shoulder. Concrete headwall, flap gate, saddle, and apron on the waterside (WS) end. Slide gate on the landside (LS) end. Pipe crosses levee at an angle. (No permit found authorizing this pipe. Owner unknown). [Additional Reference(s): DWR Levee Log, 2005, (HLM 4.45). USACE Sacramento O&M Manual, Unit No. 151, May 1953, Revised 6 June 2017, (Station 322+25). Pipe is not referenced in USACE As-Built Drawing No. 4-4-318, Sheet No. 318/2, Revised January 1951]. FS Date: 12/15/2020

Overview of levee crown looking upstream towards pipe crossing, photo 1 of 2.

Overview of levee crown looking upstream towards pipe crossing, photo 2 of 2.

LS view: overview of LS.

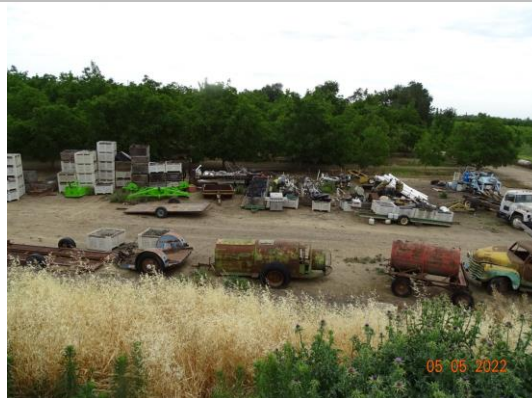
Photo 1 of 1 : SP_2022_RD0010_164_31_20220510_00156.jpg

LM Start	4.44	Rating **	M	Issue No.	31
LM End	4.48	Issue Type +	En	Location *	LS
Category	Earthen Levee			GPS Latitude/Longitude	
				Start	End
Item	Encroachments			39.226946 °	39.227445 °
				-121.613048 °	-121.612718 °
DWR ID	DWR_RD0010_02_f_2015_31				
Comment Code					
EQ : Equipment					
Inspector Comment					
Remove existing equipment from the levee toe, Spring 2022

View of the equipment at the toe of the levee on the landward side of the levee looking downstream, Spring 2022.

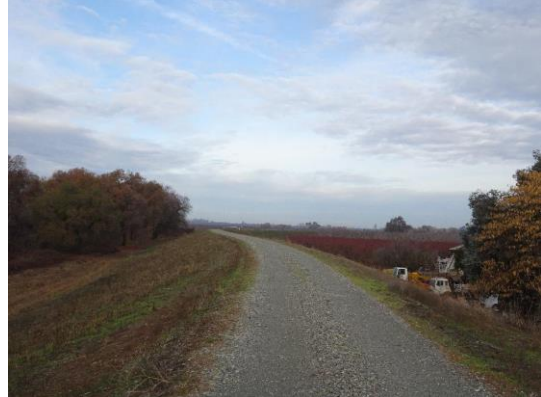
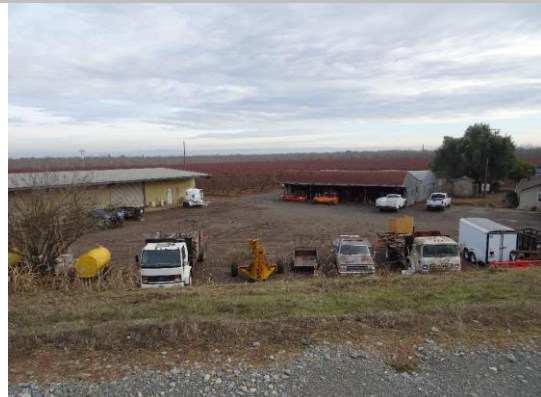
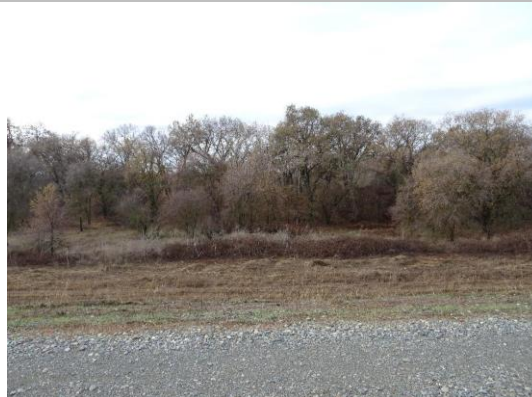
FS_ID:70606
DS_ID:21313
EP_NO: N/A
Repair Type: Non-Urgent
Crossing Status: Not Found
UCIP Comments: 12/15/2020 Record has been updated to Non-Urgent. DWR DMP geophysical study found no positive signal of pipe at latitude, longitude 39.229775, -121.613234. No signage or evidence of pipe was found during site inspection. No permit was found authorizing this encroachment. CVFPB will need to review crossing to determine owner. Record will remain in UCIP's database and should be monitored until a levee improvement project can confirm that this crossing has been removed from the levee. (O. Magana - DWR UCIP)12/01/2020 see UCIP marked up RD0010 USACE O&M manual OM151_IrrDRNSect.pdf and USACE drawing AB_4-4-318.pdf for approximate location and station. Reference files have been filed under UCIP's share drive desk study background folder for RD0010. (O. Magana - DWR UCIP)
FIELD_STRUCT_DESC: 24-inch corrugated metal (CM) gravity drainage pipe through the levee, at an unknown depth. CM cutoff wall around the pipe under each shoulder. Concrete headwall, saddle, and apron on the waterside (WS) end. (No permit found authorizing this pipe. Owner unknown). [Additional Reference(s): USACE Sacramento O&M Manual, Unit No. 151, May 1953, Revised 6 June 2017, (Station 341+70). Pipe is not referenced in USACE As-Built Drawing No. 4-4-318, Sheet No. 318/2, Revised January 1951].

Overview of levee crown looking upstream towards pipe crossing.

LS view: overview of LS.

WS view: overview of WS.

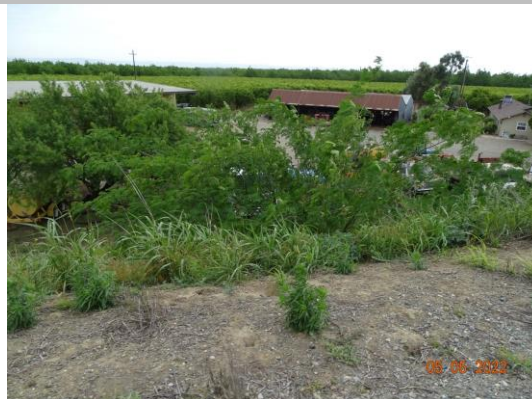
Photo 1 of 1 : SP_2022_RD0010_164_64_20220510_00154.jpg

LM Start	4.66	Rating **	M	Issue No.	64
LM End	4.66	Issue Type +	Ma	Location *	LS
Category	Earthen Levee			GPS Latitude/Longitude	
				Start	End
Item	Trim / Thin Trees			39.229835 °	39.229835 °
				-121.613278 °	-121.613278 °
DWR ID	DWR_RD0010_02_s_2020_64				
Comment Code					
T1 : Trim and thin trees to at least five feet above ground level to allow visibility of the ground and room to flood fight.					
Inspector Comment					
Trees with less than 4" diameter at chest height should be removed, Spring 2022.

View looking downstream landside at small starter trees on levee slope, Spring 2022.

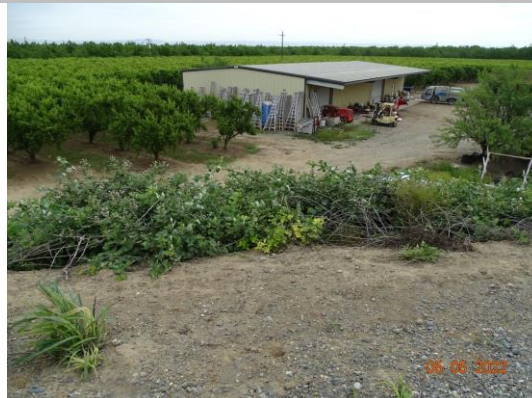
Photo 1 of 1 : SP_2022_RD0010_164_55_20220510_00153.jpg

LM Start	4.67	Rating **	M	Issue No.	55
LM End	4.67	Issue Type +	Ma	Location *	LS
Category	Earthen Levee			GPS Latitude/Longitude	
				Start	End
Item	Vegetation			39.229963 °	39.229963 °
				-121.613416 °	-121.613416 °
DWR ID	DWR_RD0010_02_f_2020_55				
Comment Code					
V2 : Remove the wild growth and woody vegetation other than native grasses from the levee slopes.					
Inspector Comment					
Blackberry bushes on landside slope should be cleared, Spring 2022.

View of black berry bushes on landside slope, Spring 2022.

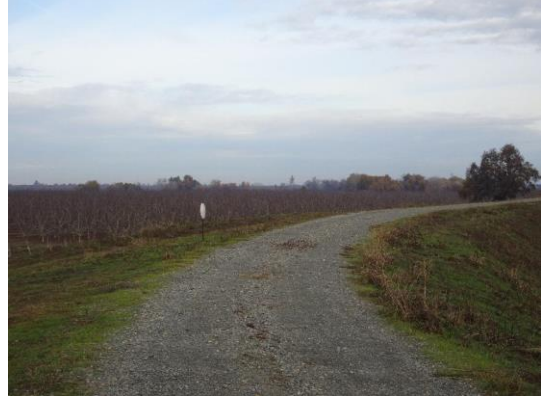
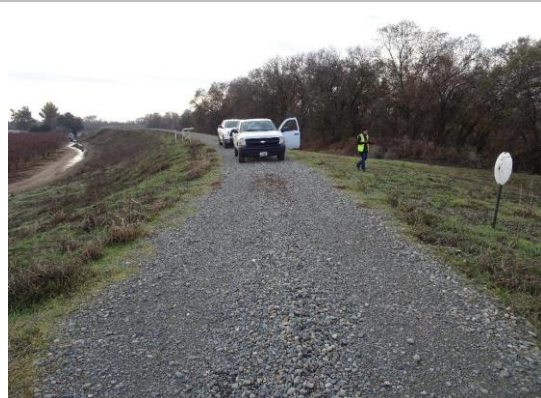
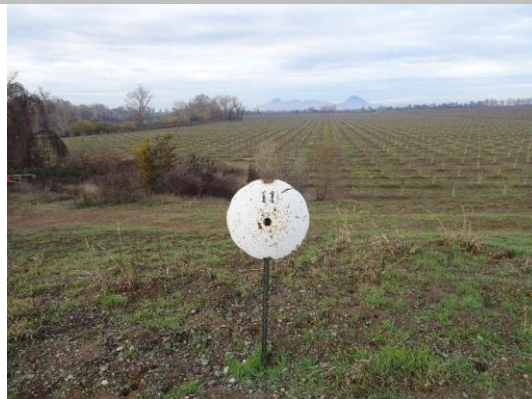
Comment Code					
Inspector Comment					
FS_ID:70607 DS_ID:21289 EP_NO: N/A Repair Type: Non-Urgent Crossing Status: Indicator Found UCIP Comments: 12/15/2020 Record remains Non-Urgent. No permit was found authorizing this encroachment. CVFPB will need to review crossing to determine owner. DWR DMP has not found internal issues, LOF between 1 and 2. Recommend inspection in 5 years. (O. Magana - DWR UCIP)04/30/2013 Sediment build-up inside and at the opening pipe. This crossing is referenced in the USACE Periodic Inspection as item USACE_CESPK_HON2_2013_p_0206. (DWR UCIP - O. Magana) FIELD_STRUCT_DESC: 30-inch steel gravity drainage pipe through the levee, 20.0 feet below the crown. Flap gate on the waterside (WS) end. Slide gate on the landside (LS) end. (No permit found authorizing this pipe. Owner unknown). [Additional Reference(s): DWR Levee Log, 2005, (HLM 4.80)]. FS Date: 12/15/2020

Overview of levee crown looking upstream towards pipe crossing.

Overview of levee crown looking downstream towards pipe crossing.

WS view: overview of WS

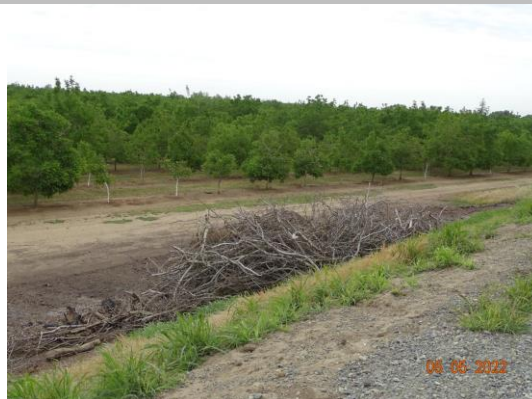
Photo 1 of 1 : SP_2022_RD0010_164_63_20220510_00152.jpg

LM Start	4.88	Rating **	M	Issue No.	63
LM End	4.92	Issue Type +	En	Location *	LS
Category	Earthen Levee			GPS Latitude/Longitude	
				Start	End
Item	Encroachments			39.232773 °	39.233336 °
				-121.614588 °	-121.614659 °
DWR ID	DWR_RD0010_02_s_2020_63				
Comment Code					
PR : Prunings					
Inspector Comment					
Remove prunings from levee toe and slope, Spring 2022.

View looking downstream landside at prunings on levee toe and slope, Spring 2022.

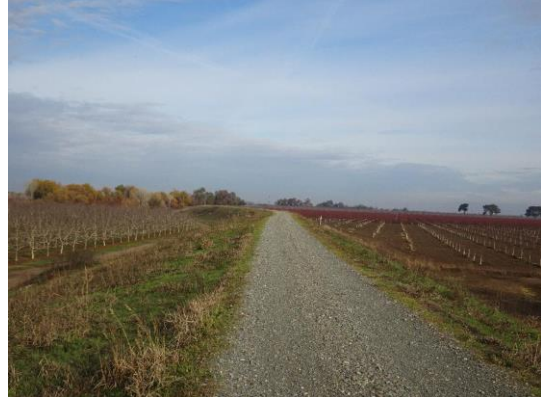
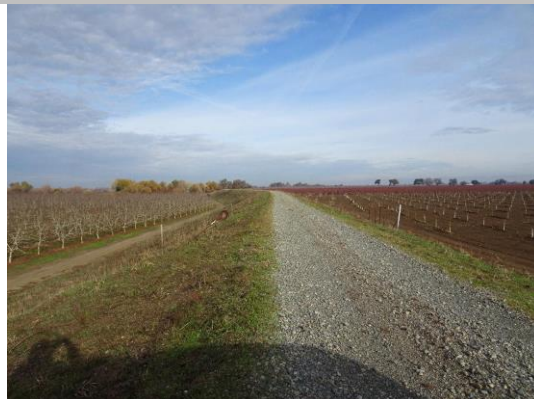
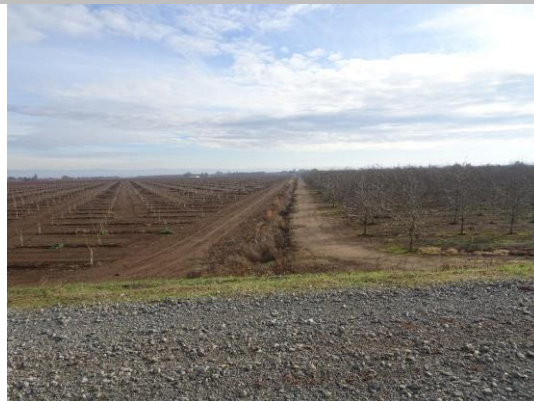
Comment Code					
Inspector Comment					
FS_ID:70627 DS_ID:21290 EP_NO: N/A Repair Type: Non-Urgent Crossing Status: Found UCIP Comments: 12/15/2020 Record has been updated from No Action Needed to Non-Urgent. No permit was found authorizing this encroachment. CVFPB will need to review crossing to determine owner. DWR DMP has not found internal issues, LOF between 1 and 2. Recommend inspection in 5 years. (O. Magana - DWR UCIP)12/01/2020 see UCIP marked up RD0010 USACE O&M manual OM151_IrrDRNSect.pdf and USACE drawing AB_4-4-318.pdf for approximate location and station. Reference files have been filed under UCIP's share drive desk study background folder for RD0010. (O. Magana - DWR UCIP) 04/30/2013 This crossing is referenced in the USACE Periodic Inspection as item USACE_CESPK_HON2_2013_p_0212. (O. Magana - DWR UCIP) FIELD_STRUCT_DESC: 30-inch corrugated metal (CM) gravity drainage pipe through the levee, 20.0 feet below the crown. CM cutoff wall around the pipe under each shoulder. Concrete headwall, flap gate, saddle, and apron on the waterside (WS) end. Slide gate on the landside (LS) end. Pipe discharges into a 5-foot by 5-foot concrete distribution box at the WS toe. (No permit found authorizing this pipe. Owner unknown). [Additional Reference(s): DWR Levee Log, 2005, (HLM 5.06). USACE Sacramento O&M Manual, Unit No. 151, May 1953, Revised 6 June 2017, (Station 354+96). USACE As-Built Drawing No. 4-4-318, Sheet No. 318/3, Revised January 1951, (Station 354+96), listed as a 36-inch pipe]. FS Date: 12/15/2020

Overview of levee crown looking upstream towards pipe crossing, photo 1 of 2.

Overview of levee crown looking upstream towards pipe crossing, photo 2 of 2.

LS view: overview of LS

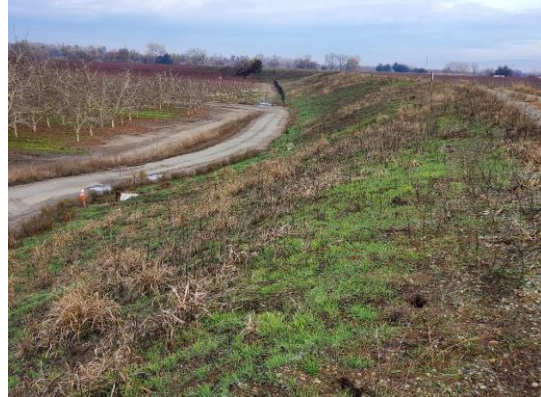
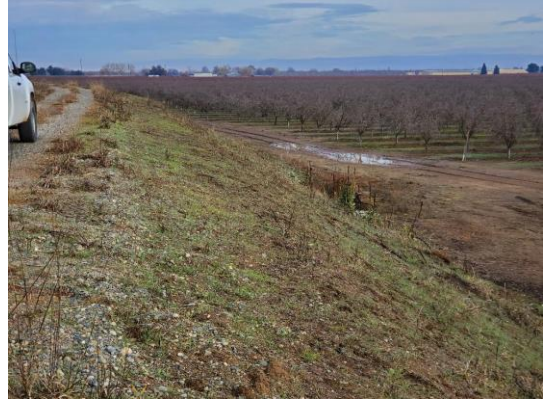
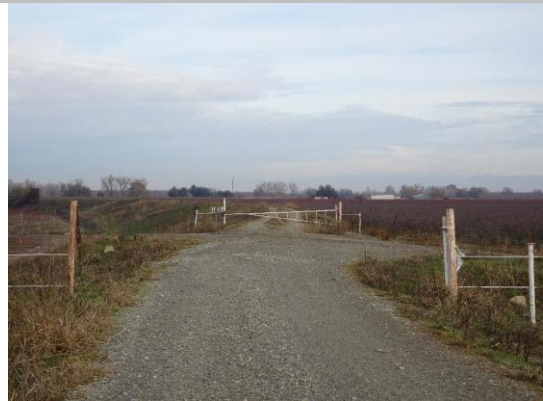
Comment Code						
Inspector Comment						
FS_ID:70609 DS_ID:21291 EP_NO: N/A Repair Type: Non-Urgent Crossing Status: Found UCIP Comments: 12/15/2020 Record remains Non-Urgent. No permit was found authorizing this encroachment. CVFPB will need to review crossing to determine owner. DWR DMP has not found internal issues, LOF between 1 and 2. Recommend inspection in 5 years. (O. Magana - DWR UCIP)12/01/2020 see UCIP marked up RD0010 USACE O&M manual OM151_IrrDRNSect.pdf and USACE drawing AB_4-4-318.pdf for approximate location and station. Reference files have been filed under UCIP's share drive desk study background folder for RD0010. (O. Magana - DWR UCIP) 04/30/2013 Need to contact owner to remove debris inside concrete distribution box and on slope. This crossing is referenced in the USACE Periodic Inspection as item USACE_CESPK_HON2_2013_p_0244. (O. Magana - DWR UCIP) FIELD_STRUCT_DESC: 30-inch corrugated metal (CM) gravity drainage pipe through the levee, 17.3 feet below the crown. CM cutoff wall around the pipe under each shoulder. Flap gate on the waterside (WS) end. Slide gate on the landside (LS) end. Concrete headwall at each end. (No permit found authorizing this pipe. Owner unknown). [Additional Reference(s): DWR Levee Log, 2005, (HLM 6.18). USACE Sacramento O&M Manual, Unit No. 151, May 1953, Revised 6 June 2017, (Station 413+81). USACE As-Built Drawing No. 4-4-318, Sheet No. 318/3, Revised January 1951, (Station 413+81)]. FS Date: 12/15/2020

WS view: cross-section view of the WS slope

LS view: cross-section view of the LS slope

Overview of levee crown looking towards pipe crossing.

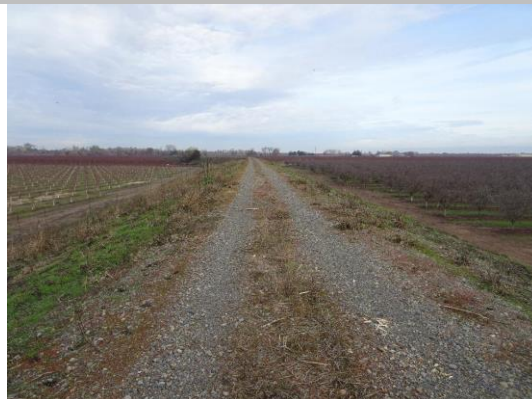
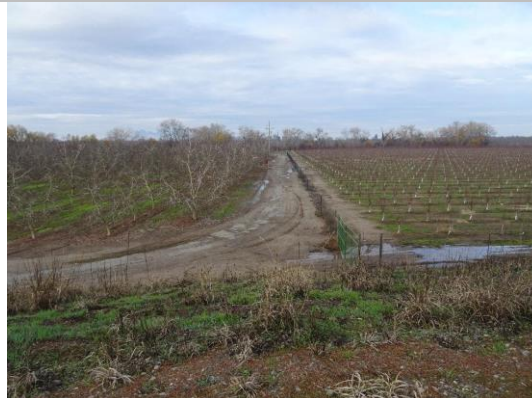
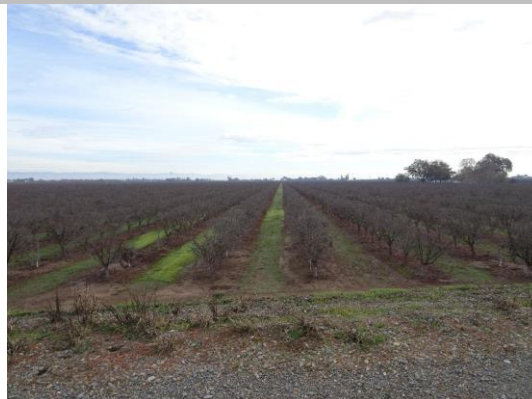
Comment Code						
Inspector Comment						
FS_ID:70610 DS_ID:21292 EP_NO: N/A Repair Type: Non-Urgent Crossing Status: Not Found UCIP Comments: 12/15/2020 Record has been updated to Non-Urgent. No signage or evidence of pipe was found during the field inspection. Need to contact owner to determine the status of the crossing through the levee. (O. Magana - DWR UCIP) FIELD_STRUCT_DESC: 2.25-inch galvanized iron pipe of an unknown purpose through the levee, at an unknown depth. Seepage well at the waterside (WS) toe. (No permit found authorizing this pipe. Owner unknown). [Additional Reference(s): DWR Levee Log, 2005, (HLM 6.26)]. FS Date: 12/15/2020

Overview of levee crown looking upstream towards pipe crossing.

WS view: overview of WS

LS view: overview of LS

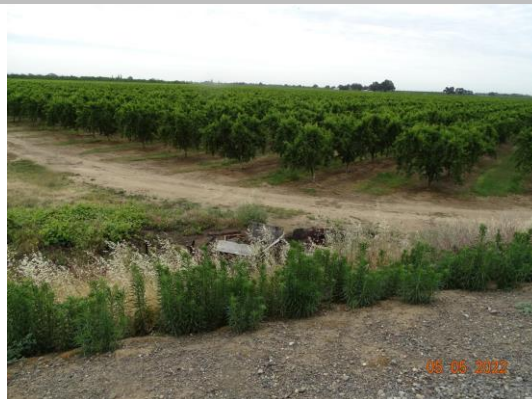
Photo 1 of 1 : SP_2022_RD0010_164_78_20220510_00149.jpg

LM Start	6.62	Rating **	M	Issue No.	78
LM End	6.62	Issue Type +	En	Location *	LS
Category	Earthen Levee			GPS Latitude/Longitude	
				Start	End
Item	Encroachments			39.256721 °	39.256721 °
				-121.618737 °	-121.618737 °
DWR ID	DWR_RD0010_02_f_2021_78				
Comment Code					
DE : Debris					
Inspector Comment					
Pile of debris on the landside toe needs to be removed, Spring 2022.

View of debris at landside levee toe, Spring 2022.

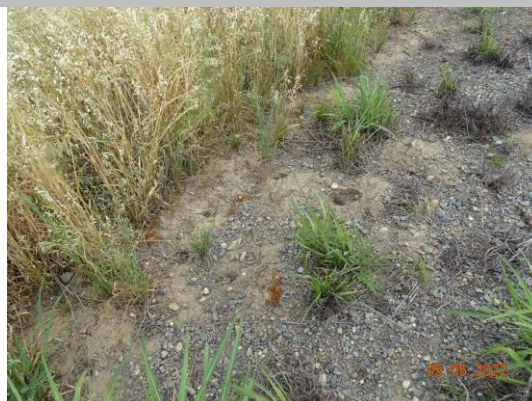
Photo 1 of 1 : SP_2022_RD0010_164_32_20220510_00148.jpg

LM Start	6.72	Rating **	M	Issue No.	32
LM End	6.72	Issue Type +	Ma	Location *	WS
Category	Earthen Levee			GPS Latitude/Longitude	
				Start	End
Item	Animal Control			39.257859 °	39.257859 °
				-121.617667 °	-121.617667 °
DWR ID	DWR_RD0010_02_f_2015_32				
Comment Code					
A3 : No rodents visible, but rodent burrows visible; need to backfill and compact or grout burrows.					
Inspector Comment					
No rodent activity but holes need to be properly backfilled.

View of rodent holes on waterside levee slope, Spring 2022.

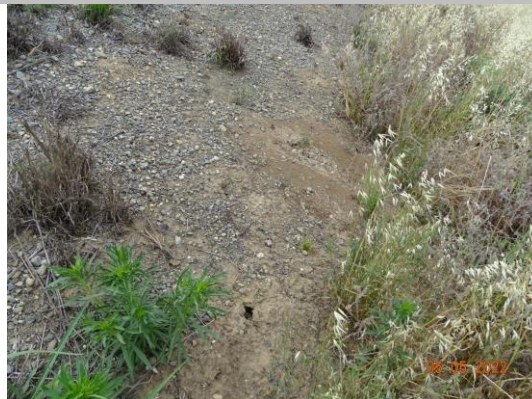
Photo 1 of 1 : SP_2022_RD0010_164_33_20220510_00147.jpg

LM Start	6.88	Rating **	U	Issue No.	33
LM End	6.88	Issue Type +	Ma	Location *	WS
Category	Earthen Levee			GPS Latitude/Longitude	
				Start	End
Item	Animal Control			39.259843 °	39.259843 °
				-121.616013 °	-121.616013 °
DWR ID	DWR_RD0010_02_f_2015_33				
Comment Code					
A3 : No rodents visible, but rodent burrows visible; need to backfill and compact or grout burrows.					
Inspector Comment					
Rodent hole that has more than 2 cubic feet of material, this hole is not active but needs to be backfilled properly.

View of rodent hole that is not active but needs to be backfilled properly, Spring 2022.

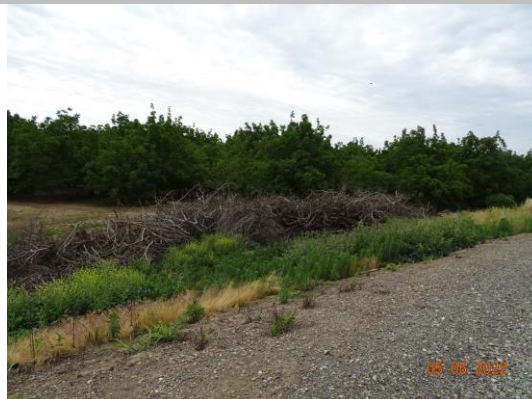
Photo 1 of 1 : SP_2022_RD0010_164_53_20220510_00146.jpg

LM Start	7.07	Rating **	U	Issue No.	53
LM End	7.07	Issue Type +	En	Location *	LS
Category	Earthen Levee			GPS Latitude/Longitude	
				Start	End
Item	Encroachments			39.262290 °	39.262290 °
				-121.614390 °	-121.614390 °
DWR ID	DWR_RD0010_02_s_2016_53				
Comment Code					
DE : Debris					
Inspector Comment					
Remove debris and prunings from the levee toe, Spring 2022.

View looking downstream of debris at landside levee toe, Spring 2022.

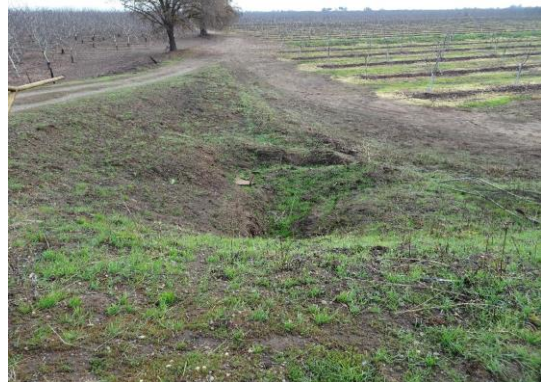
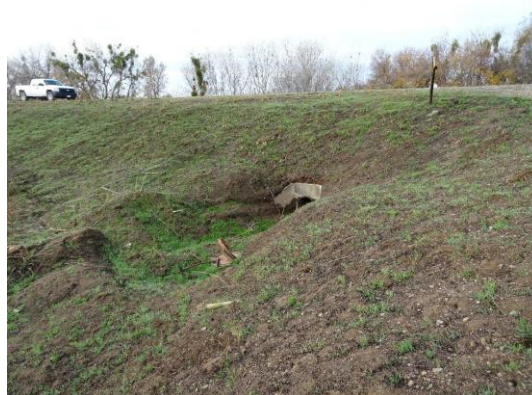
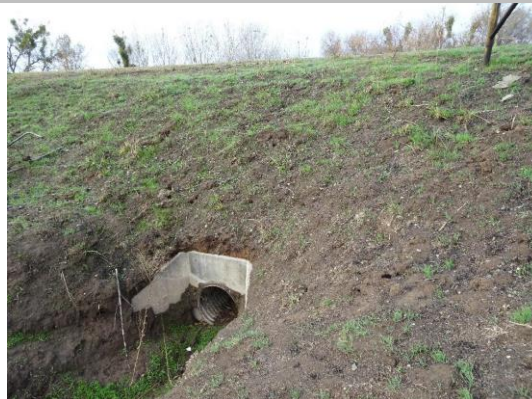
FS_ID:70611
DS_ID:21293
EP_NO: N/A
Repair Type: Non-Urgent
Crossing Status: Indicator Found
UCIP Comments: 12/15/2020 Record remains Non-Urgent. No permit was found authorizing this encroachment. CVFPB will need to review crossing to determine owner. DWR DMP has not found internal issues, LOF between 1 and 2. Recommend inspection in 5 years. (O. Magana - DWR UCIP)12/01/2020 see UCIP marked up RD0010 USACE O&M manual OM151_IrrDRNSect.pdf and USACE drawing AB_4-4-318.pdf for approximate location and station. Reference files have been filed under UCIP's share drive desk study background folder for RD0010. (O. Magana - DWR UCIP)
7/01/2016 Crossing is blocked by sediment and debris on both WS and LS. Screw gate is missing on LS. (DWR UCIP - omagana)4/30/2013 Both openings of crossing are blocked by sediment--screw gate is damage. Recommend notifying owner to repair screw gate and remove sediment build-up blocking openings. This crossing is referenced in the USACE Periodic Inspection as item

USACE_CESPK_HON2_2013_p_0295. (O. Magana - DWR UCIP)
FIELD_STRUCT_DESC: 24-inch corrugated metal (CM) gravity drainage pipe through the levee, 13.0 feet below the crown. CM cutoff wall around the pipe under each shoulder. Concrete headwall, flap gate, saddle, and apron on the waterside (WS) end. Slide gate on the landside (LS) end. (No permit found authorizing this pipe. Owner unknown). [Additional Reference(s): DWR Levee Log, 2005, (HLM 7.28). USACE Sacramento O&M Manual, Unit No. 151, May 1953, Revised 6 June 2017, (Station 471+21). USACE As-Built Drawing No. 4-4-318, Sheet 318/4, Revised January 1951, (Station 471+21)].
FS Date: 12/15/2020

LS view: overview of LS

LS view: view of LS slope and inlet located at the LS toe, photo 1 of 2.

LS view: view of LS slope and inlet located at the LS toe, photo 2 of 2.
