Flood Control Project Maintenance Levee Inspections LMA District Cover Sheet

Reclamation District No. 0010 Honcut

**Flood Control Project Maintenance
Levee Inspections
Unit Cover Sheet**

Waterway			Bank	Unit Miles
Unit No. 01 Simmerly Slough			Right	7.65
	Spring (March - May)	Summer (June - August)	(September - November) Fall	Winter (December - February)
Unit Maintenance Rating (Fall Only)				
Date of Inspection	5/5/2022 - 5/5/2022			
DWR Inspector	Brooks Weisser			
Accompanied By	Finlay Williams

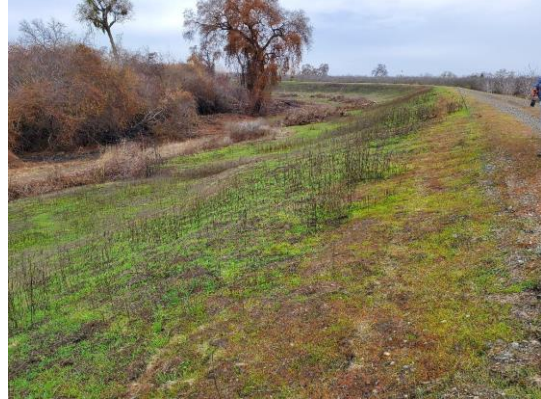
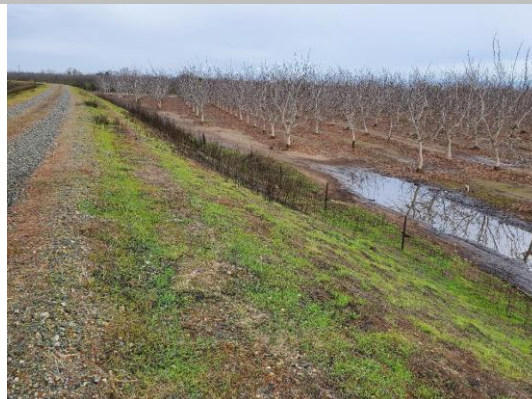
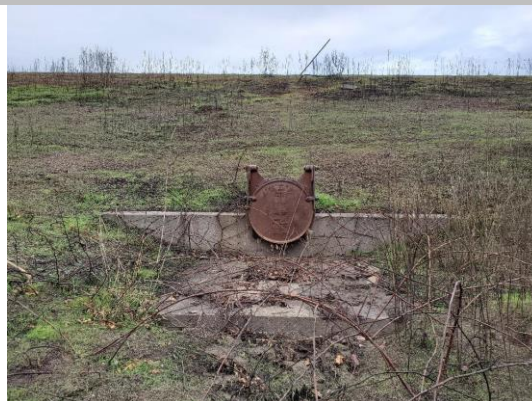
Comment Code					
Inspector Comment					
FS_ID:70612 DS_ID:21294 EP_NO: N/A Repair Type: Non-Urgent Crossing Status: Found UCIP Comments: 12/15/2020 Record has been updated from No Action Needed to Non-Urgent. No permit was found authorizing this encroachment. CVFPB will need to review crossing to determine owner. DWR DMP has not found internal issues, LOF between 1 and 2. Recommend inspection in 5 years. (O. Magana - DWR UCIP)12/01/2020 see UCIP marked up RD0010 USACE O&M manual OM151_IrrDRNSect.pdf and USACE drawing AB_4-4-318.pdf for approximate location and station. Reference files have been filed under UCIP's share drive desk study background folder for RD0010. (O. Magana - DWR UCIP) 04/30/2013 This crossing is referenced in the USACE Periodic Inspection as item USACE_CESPK_HON2_2013_p_0312. (O. Magana - DWR UCIP) FIELD_STRUCT_DESC: 24-inch corrugated metal (CM) gravity drainage pipe through the levee, 13.0 feet below the crown. CM cutoff wall around the pipe under each shoulder. Flap gate on the waterside (WS) end. Slide gate on the landside (LS) end. Concrete headwall at each end. Metal marker on the LS shoulder. (No permit found authorizing this pipe. Owner unknown). [Additional Reference(s): DWR Levee Log, 2005, (HLM 7.69). USACE Sacramento O&M Manual, Unit No. 151, May 1953, Revised 6 June 2017, (Station 493+50). Pipe is not referenced in USACE As-Built Drawing No. 4-4-318, Sheet No. 318/4, Revised January 1951]. FS Date: 12/15/2020

WS view: overview of WS

LS view: overview of LS

WS view: concrete headwall and pipe visible on the WS toe, photo 1 of

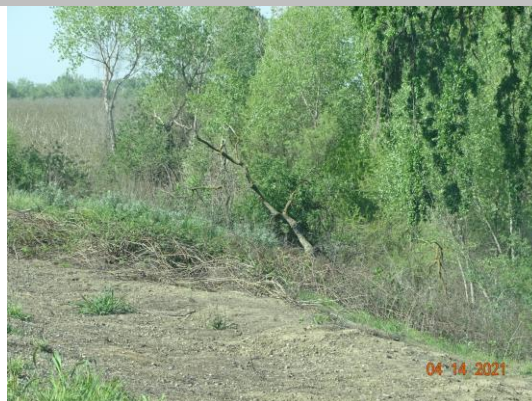
Photo 1 of 1 : SP_2022_RD0010_164_52_20220314_00019.jpg

LM Start	7.91	Rating **	M	Issue No.	52
LM End	7.91	Issue Type +	Ma	Location *	WS
Category	Earthen Levee			GPS Latitude/Longitude	
				Start	End
Item	Encroachments			39.273011 °	39.273011 °
				-121.613011 °	-121.613011 °
DWR ID	DWR_RD0010_02_s_2020_52				
Comment Code					
TR : Tree or limb					
Inspector Comment					
Remove downed tree from levee slope, Spring 2022.

View looking waterside at a downed tree on the levee slope, Spring 2021.

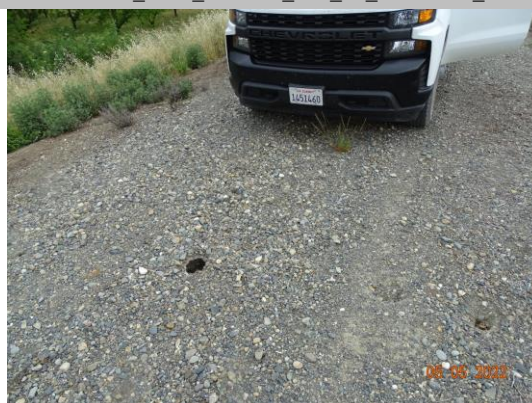
Photo 1 of 1 : SP_2022_RD0010_164_66_20220510_00145.jpg

LM Start	8.02	Rating **	M	Issue No.	66
LM End	8.02	Issue Type +	Ma	Location *	CR
Category	Earthen Levee			GPS Latitude/Longitude	
				Start	End
Item	Animal Control			39.274308 °	39.274308 °
				-121.611985 °	-121.611985 °
DWR ID	DWR_RD0010_02_s_2022_66				
Comment Code					
A3 : No rodents visible, but rodent burrows visible; need to backfill and compact or grout burrows.					
Inspector Comment					
No rodent activity but holes need to be backfilled, Spring 2022.

View of a rodent hole on the levee road, Spring 2022.

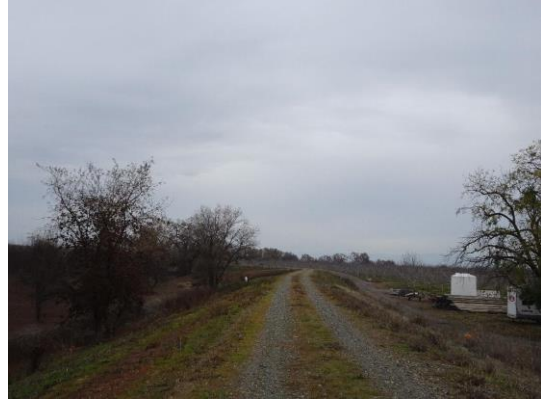
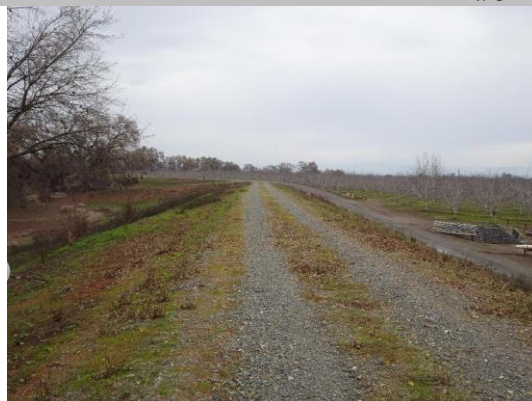
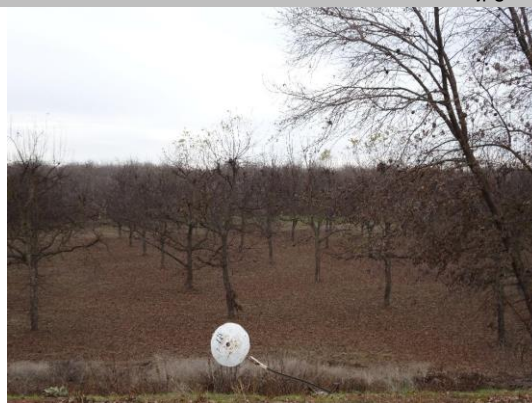
Comment Code					
Inspector Comment					
FS_ID:70613 DS_ID:21295 EP_NO: N/A Repair Type: Non-Urgent Crossing Status: Found UCIP Comments: 12/15/2020 Record has been updated from No Action Needed to Non-Urgent. No permit was found authorizing this encroachment. CVFPB will need to review crossing to determine owner. DWR DMP has not found internal issues, LOF between 1 and 2. Recommend inspection in 5 years. (O. Magana - DWR UCIP)12/01/2020 see UCIP marked up RD0010 USACE O&M manual OM151_IrrDRNSect.pdf and USACE drawing AB_4-4-318.pdf for approximate location and station. Reference files have been filed under UCIP's share drive desk study background folder for RD0010. (O. Magana - DWR UCIP) 04/30/2013 This crossing is referenced in the USACE Periodic Inspection as item USACE_CESPK_HON2_2013_p_0329. (O. Magana - DWR UCIP) FIELD_STRUCT_DESC: 24-inch corrugated metal (CM) gravity drainage pipe through the levee, 12.5 feet below the crown. CM cutoff wall around the pipe under each shoulder. Flap gate on the waterside (WS) end. Slide gate on the landside (LS) end. Concrete headwall at each end. (No permit found authorizing this pipe. Owner unknown). [Additional Reference(s): DWR Levee Log, 2005, (HLM 8.10). USACE Sacramento O&M Manual, Unit No. 151, May 1953, Revised 6 June 2017, (Station 515+52). USACE As-Built Drawing No. 4-4-318, Sheet No. 318/4, Revised January 1951, (Station 515+52)]. FS Date: 12/15/2020

Overview of levee crown looking towards pipe crossing, photo 1 of 2.

Overview of levee crown looking towards pipe crossing, photo 2 of 2.

WS view: overview of WS

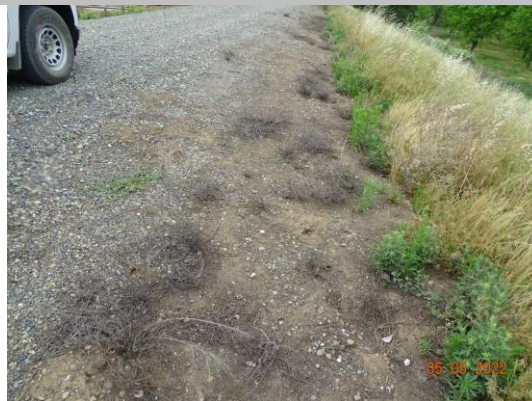
Photo 1 of 1 : SP_2022_RD0010_164_35_20220510_00143.jpg

LM Start	8.09	Rating **	M	Issue No.	35
LM End	8.09	Issue Type +	Ma	Location *	WS
Category	Earthen Levee			GPS Latitude/Longitude	
				Start	End
Item	Animal Control			39.275179 °	39.275179 °
				-121.611283 °	-121.611283 °
DWR ID	DWR_RD0010_02_f_2015_35				
Comment Code					
A3 : No rodents visible, but rodent burrows visible; need to backfill and compact or grout burrows.					
Inspector Comment					
No rodent activity but holes need to be backfilled, Spring 2022.

View of rodent hole on waterside, Spring 2022

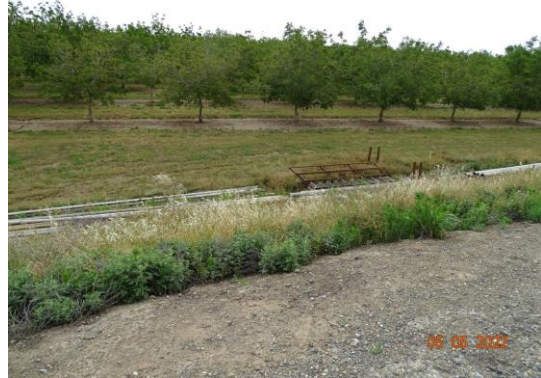
Photo 1 of 1 : SP_2022_RD0010_164_65_20220510_00142.jpg

LM Start	8.18	Rating **	M	Issue No.	65
LM End	8.18	Issue Type +	En	Location *	LS
Category	Earthen Levee			GPS Latitude/Longitude	
				Start	End
Item	Encroachments			39.276404 °	39.276404 °
				-121.610625 °	-121.610625 °
DWR ID	DWR_RD0010_02_s_2022_65				
Comment Code					
EQ : Equipment					
Inspector Comment					
Equipment parked along the landside toe needs to be moved, Spring 2022.

View of equipment parked along the landside toe, Spring 2022.

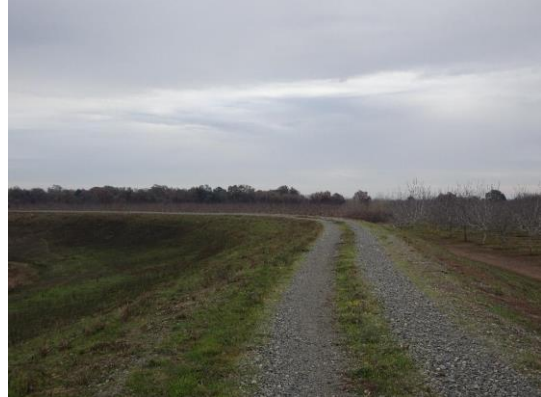
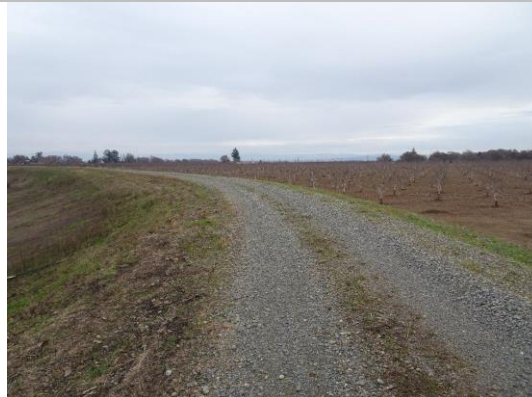
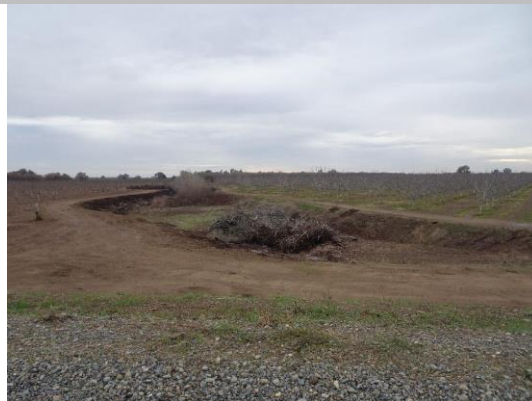
Comment Code						
Inspector Comment						
FS_ID:70614 DS_ID:21296 EP_NO: N/A Repair Type: Non-Urgent Crossing Status: Found UCIP Comments: 12/15/2020 Record remains Non-Urgent. No permit was found authorizing this encroachment. CVFPB will need to review crossing to determine owner. DWR DMP has not found internal issues, LOF between 1 and 2. Recommend inspection in 5 years. (O. Magana - DWR UCIP)12/01/2020 see UCIP marked up RD0010 USACE O&M manual OM151_IrrDRNSect.pdf and USACE drawing AB_4-4-318.pdf for approximate location and station. Reference files have been filed under UCIP's share drive desk study background folder for RD0010. (O. Magana - DWR UCIP) 04/30/2013 Sediment build-up at the inlet--recommend clearing sediment. This crossing is referenced in the USACE Periodic Inspection as item USACE_CESPK_HON2_2013_p_0348. (O. Magana - DWR UCIP) FIELD_STRUCT_DESC: 30-inch corrugated metal (CM) gravity drainage pipe through the levee, 23.0 feet below the crown. CM cutoff wall around the pipe under each shoulder. Flap gate on the waterside (WS) end. Slide gate on the landside (LS) end. Concrete headwall at each end. Metal marker on the WS shoulder. (No permit found authorizing this pipe. Owner unknown). [Additional Reference(s): DWR Levee Log, 2005, (HLM 8.80). USACE Sacramento O&M Manual, Unit No. 151, May 1953, Revised 6 June 2017, (Station 551+96). USACE As-Built Drawing No. 4-4-318, Sheet No. 318/4, Revised January 1951, (Station 551+96)]. FS Date: 12/15/2020

Overview of levee crown looking upstream towards pipe crossing, photo 1 of 2.

Overview of levee crown looking upstream towards pipe crossing, photo 2 of 2.

LS view: overview of LS

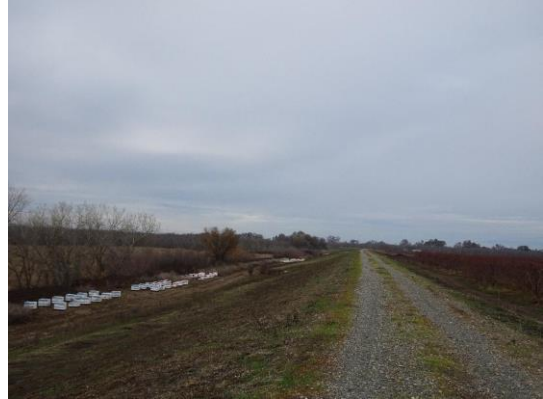
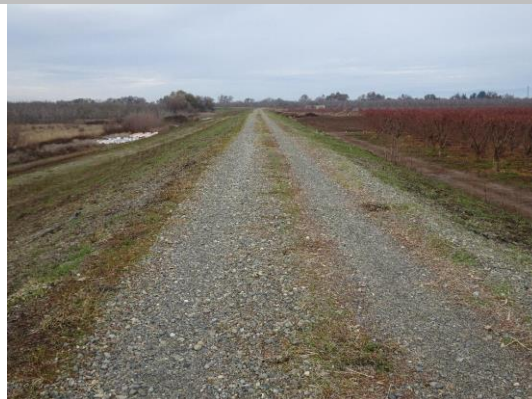
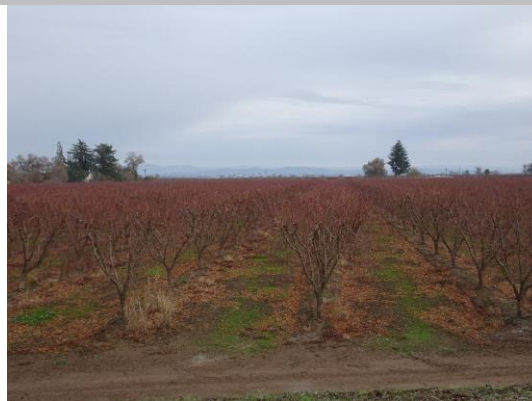
Comment Code					
Inspector Comment					
FS_ID:70628 DS_ID:21297 EP_NO: N/A Repair Type: Non-Urgent Crossing Status: Found UCIP Comments: 12/15/2020 Record remains Non-Urgent. No permit was found authorizing this encroachment. CVFPB will need to review crossing to determine owner. DWR DMP has not found internal issues, LOF between 1 and 2. Recommend inspection in 5 years. (O. Magana - DWR UCIP)12/01/2020 see UCIP marked up RD0010 USACE O&M manual OM151_IrrDRNSect.pdf and USACE drawing AB_4-4-318.pdf for approximate location and station. Reference files have been filed under UCIP's share drive desk study background folder for RD0010. (O. Magana - DWR UCIP) 04/30/2013 Slide gate missing on landward side. Need to contact owner to determine status of crossing. This crossing is referenced in the USACE Periodic Inspection as item USACE_CESPK_HON2_2013_p_0367. (O. Magana - DWR UCIP) FIELD_STRUCT_DESC: 24-inch corrugated metal (CM) gravity drainage pipe through the levee, 14.0 feet below the crown. CM cutoff wall around the pipe under each shoulder. Concrete headwall, flap gate, saddle, and apron on the waterside (WS) end. Slide gate missing on the landside (LS) end. 6-foot by 6-foot concrete splash apron at the WS toe. (No permit found authorizing this pipe. Owner unknown). [Additional Reference(s): DWR Levee Log, 2005, (HLM 9.04). USACE Sacramento O&M Manual, Unit No. 151, May 1953, Revised 6 June 2017, (Station 565+74). USACE As-Built Drawing No. 4-4-318, Sheet No. 318/4, Revised January 1951, (Station 565+74)]. FS Date: 12/15/2020

Overview of levee crown looking towards pipe crossing, photo 1 of 2.

Overview of levee crown looking towards pipe crossing, photo 2 of 2.

LS view: overview of LS.

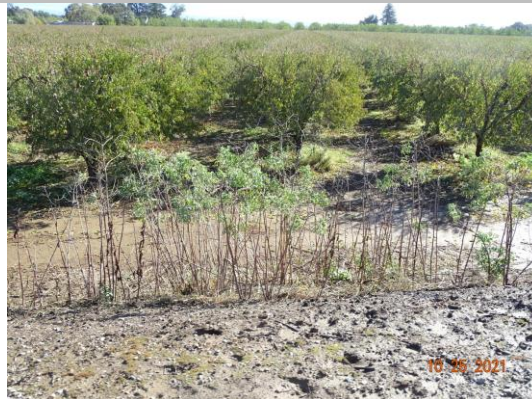
Photo 1 of 1 : SP_2022_RD0010_164_74_20220314_00033.jpg

LM Start	9.03	Rating **	M	Issue No.	74
LM End	9.03	Issue Type +	Ma	Location *	LS
Category	Earthen Levee			GPS Latitude/Longitude	
				Start	End
Item	Trim / Thin Trees			39.282440 °	39.282440 °
				-121.600164 °	-121.600164 °
DWR ID	DWR_RD0010_02_f_2021_74				
Comment Code					
T1 : Trim and thin trees to at least five feet above ground level to allow visibility of the ground and room to flood fight.					
Inspector Comment					
Starter trees on the landside hinge point should be removed, Spring 2022.

View of starter trees on the landside slope, Fall 2021.

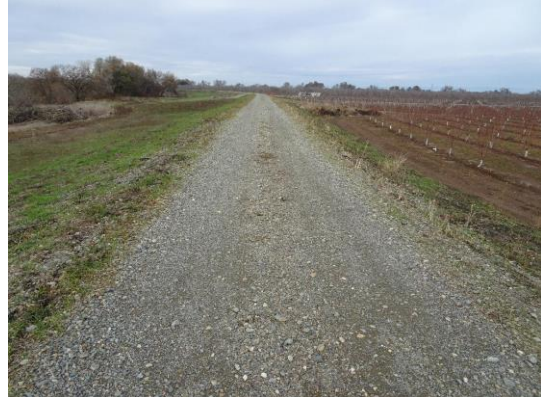
Photo 1 of 3 : UCIP_SP_2022_70616_97903.jpg

Comment Code					
Inspector Comment					
FS_ID:70616 DS_ID:21298 EP_NO: N/A Repair Type: Non-Urgent Crossing Status: Found UCIP Comments: 12/15/2020 Record remains Non-Urgent. No permit was found authorizing this encroachment. CVFPB will need to review crossing to determine owner. DWR DMP has not found internal issues, LOF between 1 and 2. Recommend inspection in 5 years. (O. Magana - DWR UCIP)12/01/2020 see UCIP marked up RD0010 USACE O&M manual OM151_IrrDRNSect.pdf and USACE drawing AB_4-4-318.pdf for approximate location and station. Reference files have been filed under UCIP's share drive desk study background folder for RD0010. (O. Magana - DWR UCIP) 04/30/2013 Crossing is buried--found indicators of concrete headwall. Need to contact owner to determine status of crossing. This crossing is referenced in the USACE Periodic Inspection as item USACE_CESPK_HON2_2013_p_0378. (O. Magana - DWR UCIP) FIELD_STRUCT_DESC: 24-inch corrugated metal (CM) gravity drainage pipe through the levee, 13.0 feet below the crown. CM cutoff wall around the pipe under each shoulder. Flap gate on the waterside (WS) end. Slide gate on the landside (LS) end. Concrete headwall at each end. Metal marker on the WS slope. (No permit found authorizing this pipe. Owner unknown). [Additional Reference(s): DWR Levee Log, 2005, (HLM 9.26). USACE Sacramento O&M Manual, Unit No. 151, May 1953, Revised 6 June 2017, (Station 576+75). USACE As-Built Drawing No. 4-4-318, Sheet No. 318/4, Revised January 1951, (Station 576+75)]. FS Date: 12/15/2020

Overview of levee crown looking upstream towards pipe crossing, photo 1 of 2.

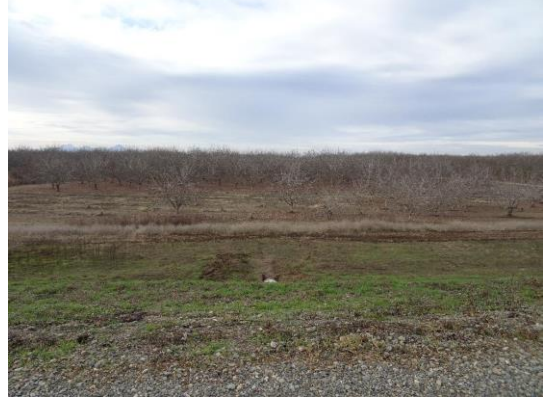
Photo 2 of 3 : UCIP_SP_2022_70616_97904.jpg

WS view: overview of WS

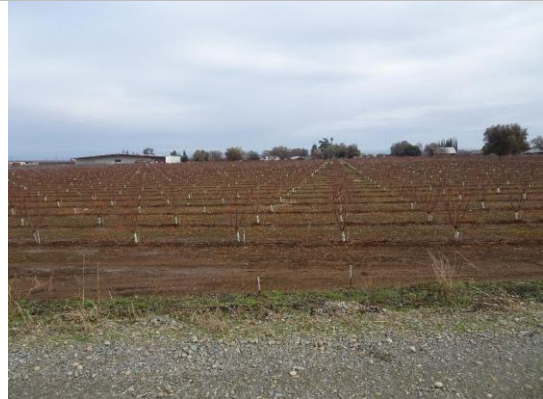
Photo 3 of 3 : UCIP_SP_2022_70616_97905.jpg

LS view: overview of LS

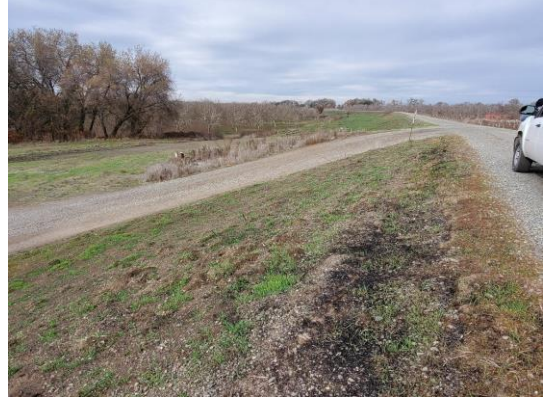
Photo 1 of 3 : UCIP_SP_2022_70617_97909.jpg

Comment Code					
Inspector Comment					
<p>FS_ID:70617 DS_ID:21299 EP_NO: N/A Repair Type: Non-Urgent Crossing Status: Found UCIP Comments: 09/08/2021 CIPP-lining of this crossing approved under project authorization WC2021104. 12/15/2020 Record remains Non-Urgent. DWR DMP has found integrity issues, LOF between 4 and 5. Crossing will be monitored until funding becomes available for rehabilitation. No permit was found authorizing this encroachment. CVFPB will need to review crossing to determine owner. (O. Magana - DWR UCIP)12/01/2020 see UCIP marked up RD0010 USACE O&M manual OM151_IrrDRNSect.pdf and USACE drawing AB_4-4-318.pdf for approximate location and station. Reference files have been filed under UCIP's share drive desk study background folder for RD0010. (O. Magana - DWR UCIP) 04/30/2013 Need to contact owner. Need to clear debris from concrete distribution box on waterward and remove debris blocking landward side.This crossing is referenced in the USACE Periodic Inspection as item USACE_CESPK_HON2_2013_p_0383. (O. Magana - DWR UCIP) FIELD_STRUCT_DESC: 24-inch corrugated metal (CM) gravity drainage pipe through the levee, 12.0 feet below the crown. CM cutoff wall around the pipe under each shoulder. Concrete headwall, flap gate, saddle, and apron on the waterside (WS) end. Slide gate on the landside (LS) end. Metal marker on the WS shoulder. (No permit found authorizing this pipe. Owner unknown). [Additional Reference(s): DWR Levee Log, 2005, (HLM 9.38). USACE Sacramento O&M Manual, Unit No. 151, May 1953, Revised 6 June 2017, (Station 582+72). USACE As-Built Drawing No. 4-4-318, Sheet No. 318/4, Revised January 1951, (Station 582+72)]. FS Date: 12/15/2020</p>

WS view: cross-section view of WS slope

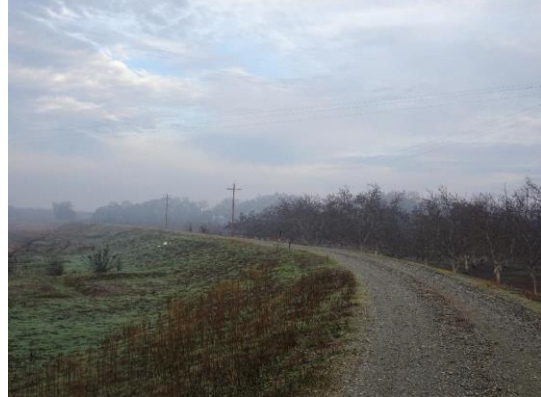
Photo 1 of 3 : UCIP_SP_2022_70629_97927.jpg

Comment Code					
Inspector Comment					
FS_ID:70629 DS_ID:21300 EP_NO: N/A Repair Type: Non-Urgent Crossing Status: Found UCIP Comments: 12/16/2020 Record has been updated from No Action Needed to Non-Urgent. No permit was found authorizing this encroachment. CVFPB will need to review crossing to determine owner. DWR DMP has not found internal issues, LOF between 1 and 2. Recommend inspection in 5 years. (O. Magana - DWR UCIP)12/01/2020 see UCIP marked up RD0010 USACE O&M manual OM151_IrrDRNSect.pdf and USACE drawing AB_4-4-318.pdf for approximate location and station. Reference files have been filed under UCIP's share drive desk study background folder for RD0010. (O. Magana - DWR UCIP) 04/30/2013 This crossing is referenced in the USACE Periodic Inspection as item USACE_CESPK_HON2_2013_p_0388. (O. Magana - DWR UCIP) FIELD_STRUCT_DESC: 24-inch corrugated metal (CM) gravity drainage pipe through the levee, 14.0 feet below the crown. CM cutoff wall around the pipe under each shoulder. Concrete headwall, flap gate, saddle, and apron on the waterside (WS) end. Slide gate on the landside (LS) end. Metal marker on the WS shoulder. (No permit found authorizing this pipe. Owner unknown). [Additional Reference(s): DWR Levee Log, 2005, (HLM 9.54). USACE Sacramento O&M Manual, Unit No. 151, May 1953, Revised 6 June 2017, (Station 591+77). USACE As-Built Drawing No. 4-4-318, Sheet No. 318/5, Revised January 1951, (Station 591+77)]. FS Date: 12/16/2020

Overview of levee crown looking upstream towards pipe crossing, photo 1 of 2.

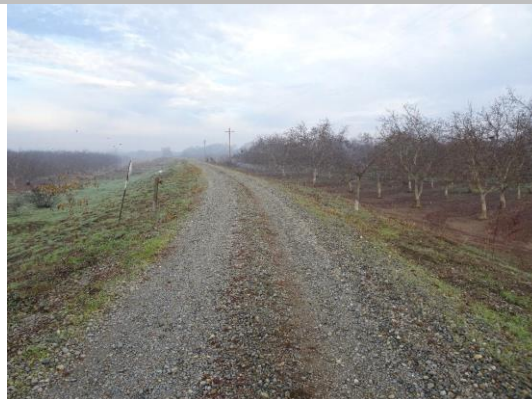
Photo 2 of 3 : UCIP_SP_2022_70629_97928.jpg

Overview of levee crown looking upstream towards pipe crossing, photo 2 of 2.

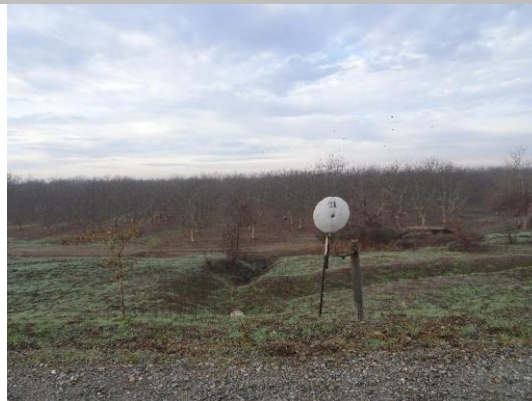
Photo 3 of 3 : UCIP_SP_2022_70629_97929.jpg

WS view: overview of WS

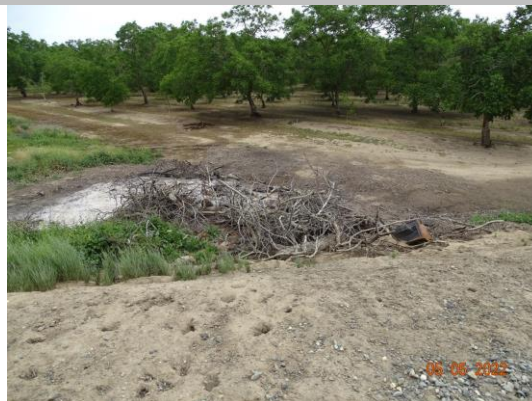
Photo 1 of 1 : SP_2022_RD0010_164_34_20220510_00140.jpg

LM Start	9.60	Rating **	M	Issue No.	34
LM End	9.60	Issue Type +	En	Location *	LS
Category	Earthen Levee			GPS Latitude/Longitude	
				Start	End
Item	Encroachments			39.290406 °	39.290406 °
				-121.602336 °	-121.602336 °
DWR ID	DWR_RD0010_02_s_2021_34				
Comment Code					
PR : Prunings					
Inspector Comment					
A pile of prunings on the landside toe need to be removed, Spring 2022.

View of a pile of prunings on the landside toe that need to be removed, Spring 2022.

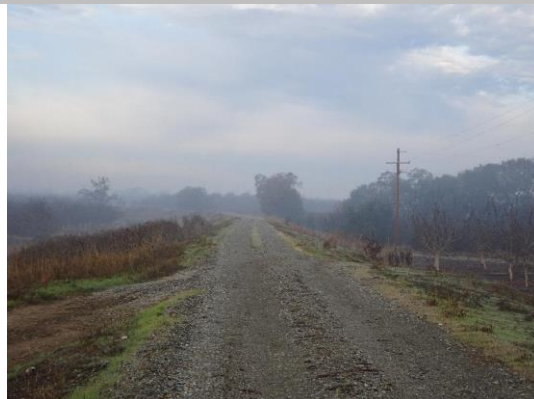
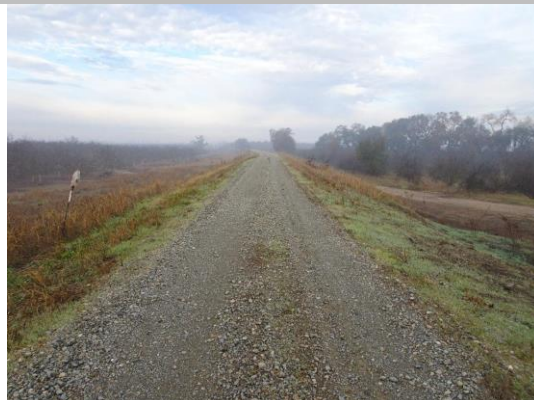
Comment Code						
Inspector Comment						
FS_ID:70619 DS_ID:21301 EP_NO: N/A Repair Type: Non-Urgent Crossing Status: Found UCIP Comments: 12/16/2020 Record remains Non-Urgent. No permit was found authorizing this encroachment. CVFPB will need to review crossing to determine owner. DWR DMP has not found internal issues, LOF between 1 and 2. Recommend inspection in 5 years. (O. Magana - DWR UCIP)04/30/2013 Recommend removing debris blocking slide gate on landward side. This crossing is referenced in the USACE Periodic Inspection as item USACE_CESPK_HON2_2013_p_0402. (O. Magana - DWR UCIP) FIELD_STRUCT_DESC: 24-inch steel gravity drainage pipe through the levee, 13.0 feet below the crown. Flap gate on the waterside (WS) end. Slide gate on the landside (LS) end. Concrete headwall at the LS toe. (No permit found authorizing this pipe. Owner unknown). [Additional Reference(s): DWR Levee Log, 2005, (HLM 9.74)]. FS Date: 12/16/2020

Overview of levee crown looking towards pipe crossing, photo 1 of 2.

Overview of levee crown looking towards pipe crossing, photo 2 of 2.

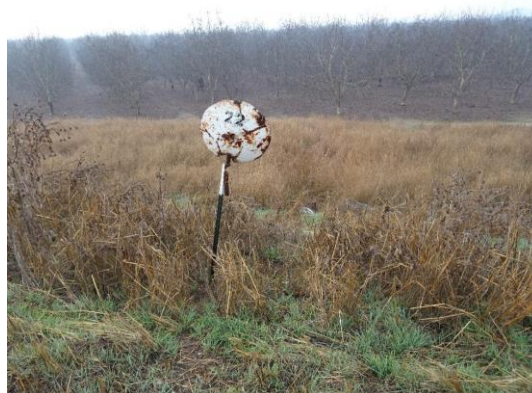
Photo 3 of 3 : UCIP_SP_2022_70619_97936.jpg

WS view: overview of WS

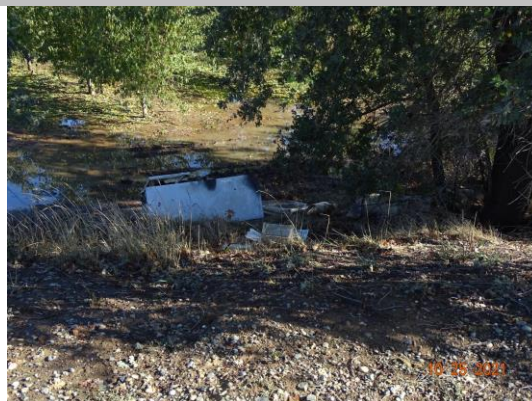
Photo 1 of 1 : SP_2022_RD0010_164_45_20220314_00014.jpg

LM Start	9.94	Rating **	M	Issue No.	45
LM End	9.94	Issue Type +	En	Location *	LS
Category	Earthen Levee			GPS Latitude/Longitude	
				Start	End
Item	Encroachments			39.293608 °	39.293608 °
				-121.606922 °	-121.606922 °
DWR ID	DWR_RD0010_02_f_2018_45				
Comment Code					
DE : Debris					
Inspector Comment					
Remove debris from the levee slope, Spring 2022.

View looking at the landside levee slope where debris has been dumped, Fall 2021.

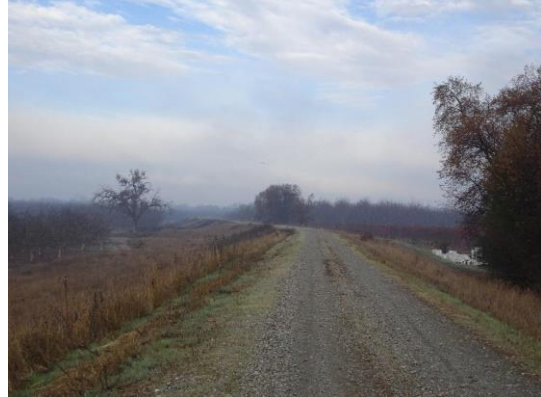
Photo 1 of 3 : UCIP_SP_2022_70620_97945.jpg

Comment Code						
Inspector Comment						
FS_ID:70620 DS_ID:21302 EP_NO: N/A Repair Type: Non-Urgent Crossing Status: Found UCIP Comments: 12/16/2020 Record has been updated from No Action Needed to Non-Urgent. No permit was found authorizing this encroachment. CVFPB will need to review crossing to determine owner. DWR DMP has not found internal issues, LOF between 1 and 2. Recommend inspection in 5 years. Dense vegetation along the WS and LS limited site inspection. (O. Magana - DWR UCIP)12/01/2020 see UCIP marked up RD0010 USACE O&M manual OM151_IrrDRNSect.pdf and USACE drawing AB_4-4-318.pdf for approximate location and station. Reference files have been filed under UCIP's share drive desk study background folder for RD0010. (O. Magana - DWR UCIP) 04/30/2013 This crossing is referenced in the USACE Periodic Inspection as item USACE_CESPK_HON2_2013_p_0418. (O. Magana - DWR UCIP) FIELD_STRUCT_DESC: 24-inch corrugated metal (CM) gravity drainage pipe through the levee, 13.0 feet below the crown. CM cutoff wall around the pipe under each shoulder. Flap gate on the waterside (WS) end. Concrete headwall and 6-foot by 6-foot splash apron at the WS toe. 5-foot by 5-foot distribution box at the landside (LS) toe. (No permit found authorizing this pipe. Owner unknown). [Additional Reference(s): DWR Levee Log, 2005, (HLM 9.98). USACE Sacramento O&M Manual, Unit No. 151, May 1953, Revised 6 June 2017, (Station 602+47). USACE As-Built Drawing No. 4-4-318, Sheet No. 318/5, Revised January 1951, (Station 602+47)]. FS Date: 12/16/2020

Overview of the levee crown looking upstream towards the pipe crossing, photo 1 of 2.

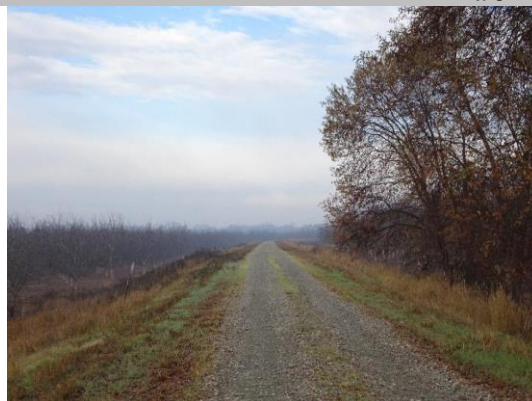
Photo 2 of 3 : UCIP_SP_2022_70620_97946.jpg

Overview of the levee crown looking upstream towards the pipe crossing, photo 2 of 2.

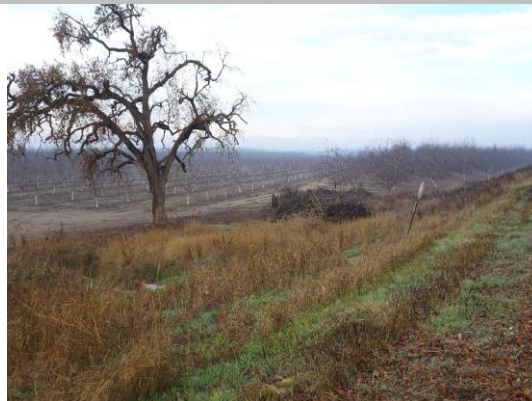
Photo 3 of 3 : UCIP_SP_2022_70620_97947.jpg

WS view: side view of the WS slope

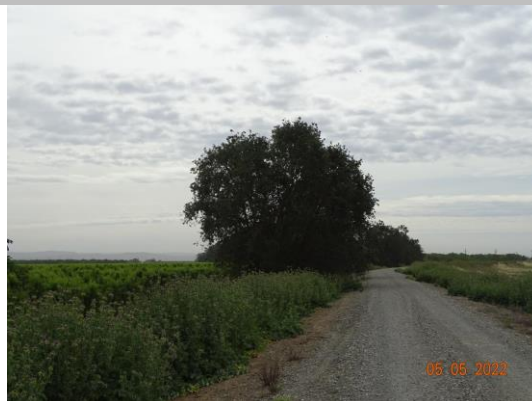
Photo 1 of 1 : SP_2022_RD0010_164_50_20220510_00139.jpg

LM Start	9.94	Rating **	M	Issue No.	50
LM End	9.94	Issue Type +	Ma	Location *	LS
Category	Earthen Levee			GPS Latitude/Longitude	
				Start	End
Item	Trim / Thin Trees			39.293675 °	39.293675 °
				-121.607055 °	-121.607055 °
DWR ID	DWR_RD0010_02_s_2020_50				
Comment Code					
T1 : Trim and thin trees to at least five feet above ground level to allow visibility of the ground and room to flood fight.					
Inspector Comment					
Trim tree limbs for access and visibility, Spring 2022.

View looking downstream landside at a tree with low hanging limbs, Spring 2022.

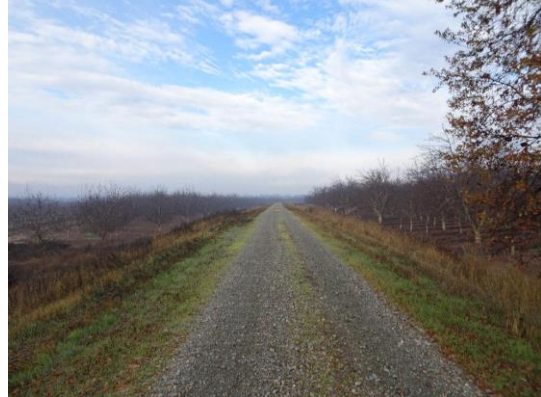
Photo 1 of 3 : UCIP_SP_2022_70621_97949.jpg

Comment Code						
Inspector Comment						
FS_ID:70621 DS_ID:21314 EP_NO: N/A Repair Type: Non-Urgent Crossing Status: Not Found UCIP Comments: 12/16/2020 Record has been updated to Non-Urgent. DWR DMP geophysical study found no positive signal of pipe at latitude, longitude 39.293876, -121.607495. No signage or evidence of pipe was found during site inspection. No permit was found authorizing this encroachment. CVFPB will need to review crossing to determine owner. Record will remain in UCIP's database and should be monitored until a levee improvement project can confirm that this crossing has been removed from the levee. (O. Magana - DWR UCIP)12/01/2020 see UCIP marked up RD0010 USACE O&M manual OM151_IrrDRNSect.pdf and USACE drawing AB_4-4-318.pdf for approximate location and station. Reference files have been filed under UCIP's share drive desk study background folder for RD0010. (O. Magana - DWR UCIP) FIELD_STRUCT_DESC: 24-inch corrugated metal (CM) gravity drainage pipe through the levee, at an unknown depth. CM cutoff wall around the pipe under each shoulder. Slide gate on the landside (LS) end. Concrete headwall, saddle, and apron on the waterside (WS) end. (No permit found authorizing this pipe. Owner unknown). [Additional Reference(s): USACE Sacramento O&M Manual, Unit No. 151, May 1953, Revised 6 June 2017, (Station 614+60). USACE As-Built Drawing No. 4-4-318, Sheet No. 318/5, Revised January 1951, (Station 614+60)]. FS Date: 12/16/2020

Overview of levee crown looking towards pipe crossing.

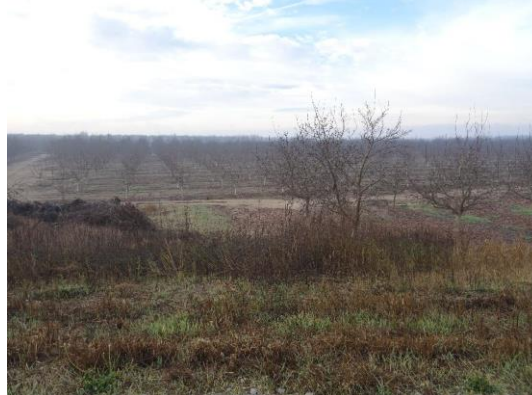
Photo 2 of 3 : UCIP_SP_2022_70621_97950.jpg

WS view: overview of WS.

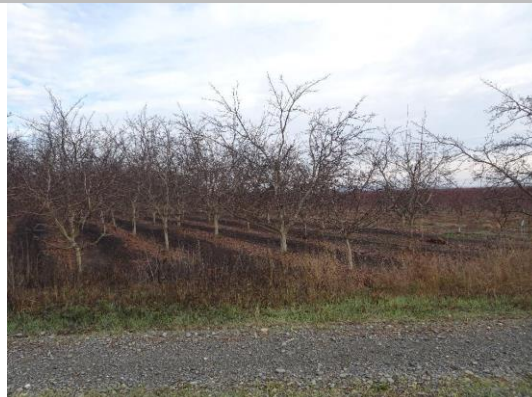
Photo 3 of 3 : UCIP_SP_2022_70621_97951.jpg

LS view: overview of LS.

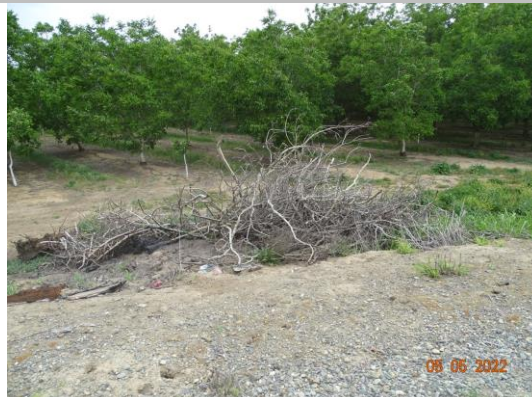
Photo 1 of 1 : SP_2022_RD0010_164_57_20220510_00138.jpg

LM Start	10.06	Rating **	M	Issue No.	57
LM End	10.06	Issue Type +	En	Location *	LS
Category	Earthen Levee			GPS Latitude/Longitude	
				Start	End
Item	Encroachments			39.294559 °	39.294559 °
				-121.608958 °	-121.608958 °
DWR ID	DWR_RD0010_02_f_2019_57				
Comment Code					
PR : Prunings					
Inspector Comment					
Remove prunings from the levee slope, Spring 2022.

View looking at the prunings on the landside levee toe, Spring 2022.

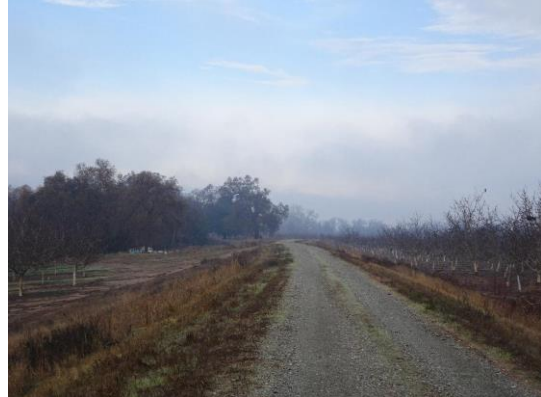
Photo 1 of 3 : UCIP_SP_2022_70622_97956.jpg

Comment Code					
Inspector Comment					
FS_ID:70622 DS_ID:21303 EP_NO: 1069 Repair Type: Non-Urgent Crossing Status: Found UCIP Comments: 12/16/2020 Record remains Non-Urgent. No permit was found authorizing this encroachment. CVFPB will need to review crossing to determine owner. DWR DMP has not found internal issues, LOF between 1 and 2. Recommend inspection in 5 years. Recommend having the CVFPB review Permit 1069 to make sure this structure is for private use and not part of the system. (O. Magana - DWR UCIP)12/01/2020 see UCIP marked up RD0010 USACE O&M manual OM151_IrrDRNSect.pdf and USACE drawing AB_4-4-318.pdf for approximate location and station. Reference files have been filed under UCIP's share drive desk study background folder for RD0010. (O. Magana - DWR UCIP) 04/30/2013 Unable to find the crossing on landward side--indicators found of crossing. Need to coordinate with owner to determine status of crossing. If crossing is no longer in use owner will need to contact the CVFPB to comply with Title 23. This crossing is referenced in the USACE Periodic Inspection as item USACE_CESPK_HON2_2013_p_0442. (O. Magana - DWR UCIP) FIELD_STRUCT_DESC: 24-inch steel gravity drainage pipe through the levee, 13.0 feet below the crown. Concrete cutoff wall around the pipe under each shoulder. Concrete headwall and flap gate on the waterside (WS) end. Slide gate, concrete saddle, and apron on the landside (LS) end. (24-inch corrugated iron pipe authorized under Permit No. 1069, 1946 - Pacific Ranch, care of Charles J. Mathews). [Additional Reference(s): DWR Levee Log, 2005, (HLM 10.42). USACE Sacramento O&M Manual, Unit No. 151, May 1953, Revised 6 June 2017, (Station 638+00). USACE As-Built Drawing No. 4-4-318, Sheet No. 318/5, Revised January 1951, (Station 638+00), listed as a corrugated metal pipe (CMP)]. FS Date: 12/16/2020

Overview of levee crown looking upstream towards pipe crossing, photo 1 of 2.

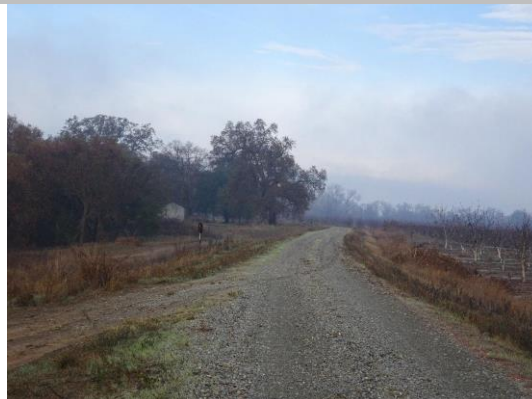
Photo 2 of 3 : UCIP_SP_2022_70622_97957.jpg

Overview of levee crown looking upstream towards pipe crossing, photo 2 of 2.

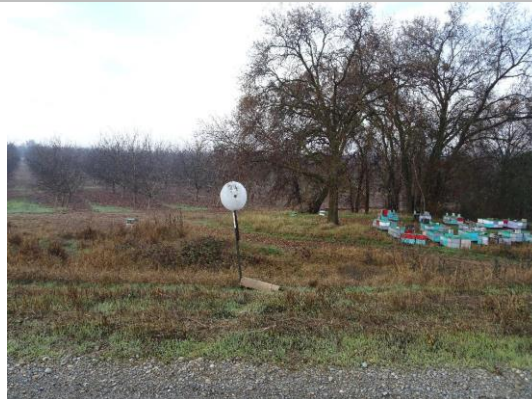
Photo 3 of 3 : UCIP_SP_2022_70622_97958.jpg

WS view: overview of WS

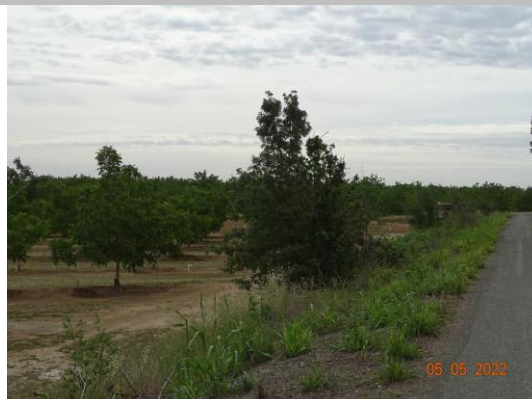
Photo 1 of 1 : SP_2022_RD0010_164_56_20220510_00136.jpg

LM Start	10.53	Rating **	M	Issue No.	56
LM End	10.53	Issue Type +	Ma	Location *	LS
Category	Earthen Levee			GPS Latitude/Longitude	
				Start	End
Item	Trim / Thin Trees			39.299244 °	39.299244 °
				-121.615166 °	-121.615166 °
DWR ID	DWR_RD0010_02_f_2019_56				
Comment Code					
T1 : Trim and thin trees to at least five feet above ground level to allow visibility of the ground and room to flood fight.					
Inspector Comment					
Trees with less than 4" diameter at chest height should be removed, Spring 2022.

View looking downstream landside at a small starter tree that needs to be removed, Spring 2022.

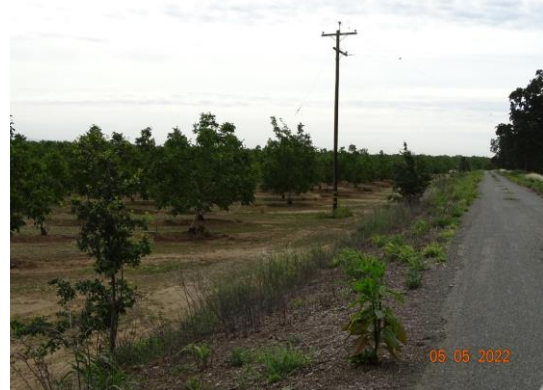
Photo 1 of 1 : SP_2022_RD0010_164_44_20220510_00135.jpg

LM Start	10.65	Rating **	M	Issue No.	44
LM End	10.65	Issue Type +	Ma	Location *	LS
Category	Earthen Levee			GPS Latitude/Longitude	
				Start	End
Item	Trim / Thin Trees			39.300273 °	39.300273 °
				-121.616903 °	-121.616903 °
DWR ID	DWR_RD0010_02_s_2020_44				
Comment Code					
T1 : Trim and thin trees to at least five feet above ground level to allow visibility of the ground and room to flood fight.					
Inspector Comment					
Trees with less than 4" diameter at chest height should be removed, Spring 2022.

View looking downstream landside at small starter tree on levee slope, Spring 2022.

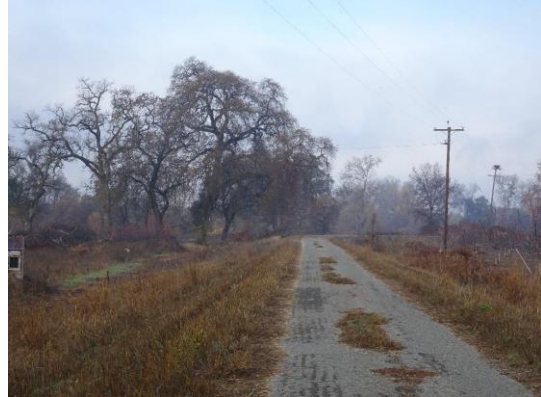
Photo 1 of 3 : UCIP_SP_2022_70623_97969.jpg

Comment Code					
Inspector Comment					
FS_ID:70623 DS_ID:21304 EP_NO: N/A Repair Type: Non-Urgent Crossing Status: Found UCIP Comments: 12/16/2020 Record remains Non-Urgent. No permit was found authorizing this encroachment. CVFPB will need to review crossing to determine owner. Dense vegetation along the WS and LS limited site inspection. (O. Magana - DWR UCIP)12/01/2020 see UCIP marked up RD0010 USACE O&M manual OM151_IrrDRNSect.pdf and USACE drawing AB_4-4-318.pdf for approximate location and station. Reference files have been filed under UCIP's share drive desk study background folder for RD0010. (O. Magana - DWR UCIP) 04/30/2013 Rip rap was used to stabilize the waterward slope during high water as a means of emergency repair--unable to determine storm event when repair was performed. Recommend obtaining records of the repair and to determine if crossing is still being used. Need to determine owner. Dense vegetation limits the inspector's visibility to identify signs of pipe failure (leaks) along the slope. Recommend removing vegetation along pipe alignment to conduct proper inspection of structure and appurtances. This crossing is referenced in the USACE Periodic Inspection as item USACE_CESPK_HON2_2013_p_0458 and 460. (O. Magana - DWR UCIP) FIELD_STRUCT_DESC: 24-inch steel irrigation discharge pipe through the levee, 5.0 feet below the crown. Slide gate in a 36-inch concrete riser unit on the landside (LS) shoulder. Gate valve in a pump house on the waterside (WS) slope. Concrete headwall, saddle, and apron on the WS end. (No permit found authorizing this pipe. Owner unknown). [Additional Reference(s): DWR Levee Log, 2005, (HLM 10.75). USACE Sacramento O&M Manual, Unit No. 151, May 1953, Revised 6 June 2017, (Station 655+65). USACE As-Built Drawing No. 4-4-318, Sheet No. 318/5, Revised January 1951, (Station 655+65)]. FS Date: 12/16/2020

Overview of levee crown looking upstream towards pipe crossing, photo 1 of 2.

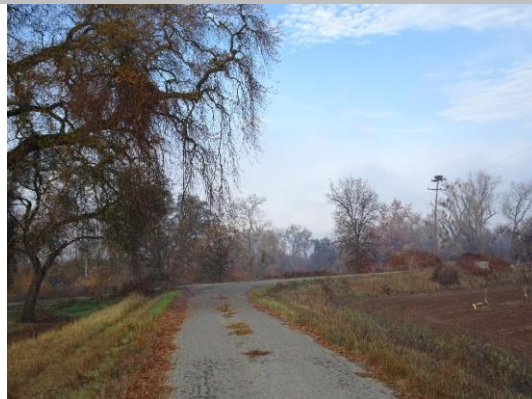
Photo 2 of 3 : UCIP_SP_2022_70623_97961.jpg

LM Start	10.71	Rating **	M	Issue No.	48 (cont)
LM End	10.71	Issue Type +	En	Location *	
Category	Supplemental		GPS Latitude/Longitude		
			Start	End	
Item	DWR UCIP Field Study		39.300931 °	39.300931 °	
			-121.617490 °	-121.617490 °	
DWR ID	21304

Overview of levee crown looking upstream towards pipe crossing, photo 2 of 2.

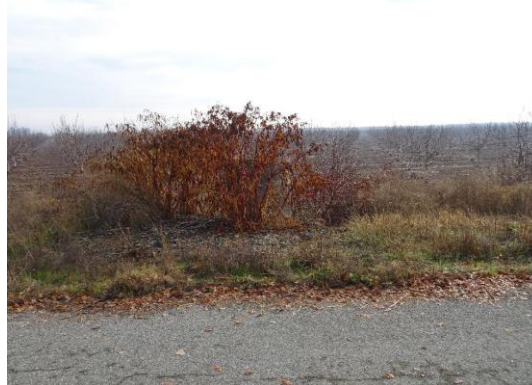
Photo 3 of 3 : UCIP_SP_2022_70623_97962.jpg

LS view: overview of LS

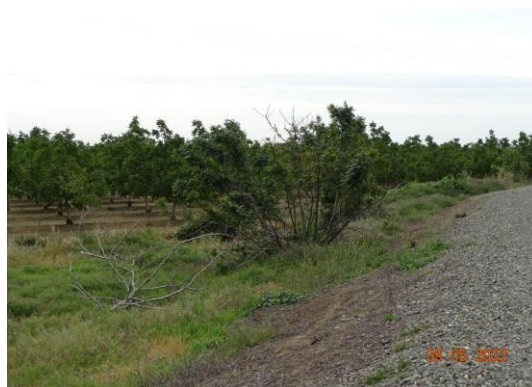
Photo 1 of 1 : SP_2022_RD0010_164_43_20220510_00134.jpg

LM Start	10.79	Rating **	M	Issue No.	43
LM End	10.79	Issue Type +	Ma	Location *	LS
Category	Earthen Levee			GPS Latitude/Longitude	
				Start	End
Item	Trim / Thin Trees			39.302080 °	39.302080 °
				-121.617745 °	-121.617745 °
DWR ID	DWR_RD0010_02_s_2020_43				
Comment Code					
T1 : Trim and thin trees to at least five feet above ground level to allow visibility of the ground and room to flood fight.					
Inspector Comment					
Trees with less than 4" diameter at chest height should be removed, Spring 2022.

View looking downstream landside at small starter tree on levee slope, Spring 2022.

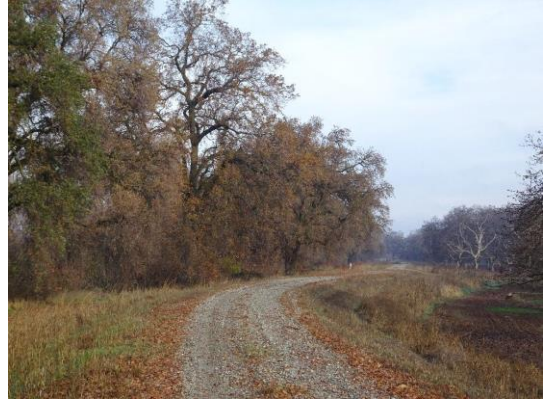
Photo 1 of 3 : UCIP_SP_2022_70630_97973.jpg

Comment Code					
Inspector Comment					
FS_ID:70630 DS_ID:21305 EP_NO: N/A Repair Type: Non-Urgent Crossing Status: Found UCIP Comments: 12/16/2020 Record remains Non-Urgent. No permit was found authorizing this encroachment. CVFPB will need to review crossing to determine owner. DWR DMP has not found internal issues, LOF between 1 and 2. Recommend inspection in 5 years. (O. Magana - DWR UCIP)12/01/2020 see UCIP marked up RD0010 USACE O&M manual OM151_IrrDRNSect.pdf and USACE drawing AB_4-4-318.pdf for approximate location and station. Reference files have been filed under UCIP's share drive desk study background folder for RD0010. (O. Magana - DWR UCIP) 04/30/2013 Burrow activity--large holes found on landward side. Crossing on landward side is blocked. Recommend clearing headwall and crossing. Need to coordinate with owner to determine status of crossing. If crossing is no longer in use owner will need to contact the CVFPB to comply with Title 23. This crossing is referenced in the USACE Periodic Inspection as item USACE_CESPK_HON2_2013_p_0476. (O. Magana - DWR UCIP) FIELD_STRUCT_DESC: 24-inch corrugated metal (CM) gravity drainage pipe through the levee, 7.5 feet below the crown. CM cutoff wall around the pipe under each shoulder. Flap gate, saddle, and apron on the waterside (WS) end. Concrete headwall at each toe. (No permit found authorizing this pipe. Owner unknown). [Additional Reference(s): DWR Levee Log, 2005, (HLM 11.11). USACE Sacramento O&M Manual, Unit No. 151, May 1953, Revised 6 June 2017, (Station 674+73). USACE As-Built Drawing No. 4-4-318, Sheet No. 318/5, Revised January 1951, (Station 674+73)]. FS Date: 12/16/2020

Overview of levee crown looking towards pipe crossing, photo 1 of 2.

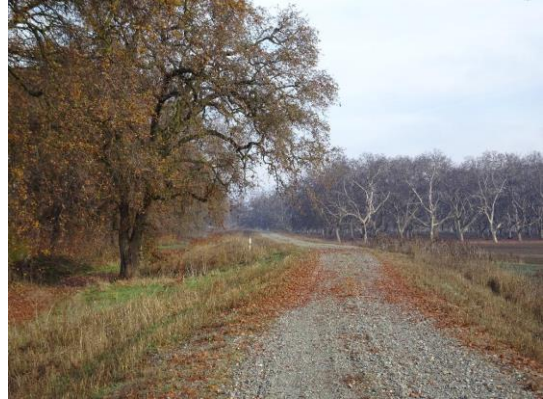
Photo 2 of 3 : UCIP_SP_2022_70630_97974.jpg

LM Start	11.07	Rating **	M	Issue No.	51 (cont)
LM End	11.07	Issue Type +	Ma	Location *	
Category	Supplemental			GPS Latitude/Longitude	
				Start	End
Item	DWR UCIP LMA Responsibility			39.305915 °	39.305915 °
				-121.617698 °	-121.617698 °
DWR ID	21305

Overview of levee crown looking towards pipe crossing, photo 2 of 2.

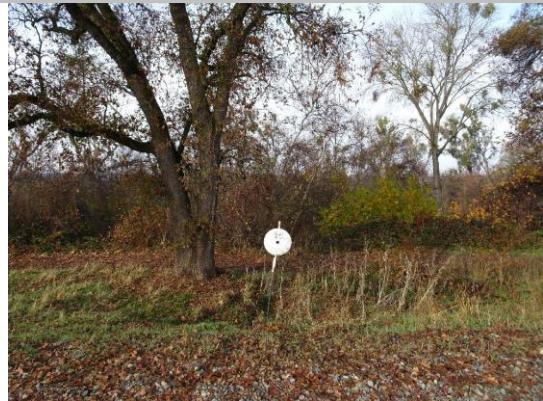
Photo 3 of 3 : UCIP_SP_2022_70630_97975.jpg

WS view: overview of WS

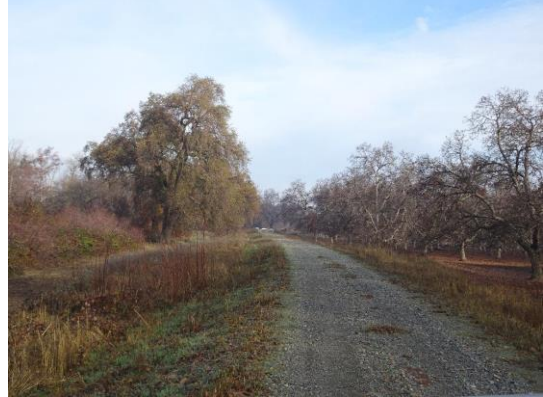
Photo 1 of 3 : UCIP_SP_2022_70625_97978.jpg

Comment Code						
Inspector Comment						
FS_ID:70625 DS_ID:21315 EP_NO: N/A Repair Type: Non-Urgent Crossing Status: Not Found UCIP Comments: 12/16/2020 Record has been updated to Non-Urgent. DWR DMP geophysical study found no positive signal of pipe at latitude, longitude 39.307798, -121.617000. No signage or evidence of pipe was found during site inspection. No permit was found authorizing this encroachment. CVFPB will need to review crossing to determine owner. Record will remain in UCIP's database and should be monitored until a levee improvement project can confirm that this crossing has been removed from the levee. (O. Magana - DWR UCIP)12/01/2020 see UCIP marked up RD0010 USACE O&M manual OM151_IrrDRNSect.pdf and USACE drawing AB_4-4-318.pdf for approximate location and station. Reference files have been filed under UCIP's share drive desk study background folder for RD0010. (O. Magana - DWR UCIP) FIELD_STRUCT_DESC: 24-inch corrugated metal (CM) gravity drainage pipe through the levee, 4.5 feet below the crown. CM cutoff wall around the pipe under each shoulder. Concrete headwall at each toe. Saddle and apron on the waterside (WS) end. (No permit found authorizing this pipe. Owner unknown). [Additional Reference(s): USACE Sacramento O&M Manual, Unit No. 151, May 1953, Revised 6 June 2017, (Station 0+65.5 "A"). USACE As-Built Drawing No. 4-4-318, Sheet No. 318/5, Revised January 1951, (Station 0+65.5 "A")]. FS Date: 12/16/2020

Overview of levee crown looking upstream towards pipe crossing, pipe 1 of 2.

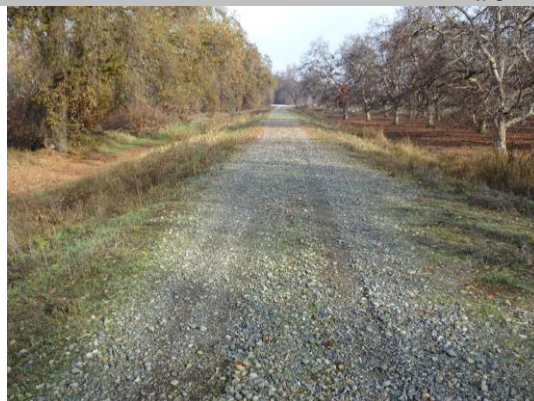
Photo 2 of 3 : UCIP_SP_2022_70625_97979.jpg

LM Start	11.20	Rating **	M	Issue No.	54 (cont)
LM End	11.20	Issue Type +	En	Location *	
Category	Supplemental		GPS Latitude/Longitude		
			Start	End	
Item	DWR UCIP Field Study		39.307798 °	39.307798 °	
			-121.617000 °	-121.617000 °	
DWR ID	21315

Overview of levee crown looking upstream towards pipe crossing, pipe 2 of 2.

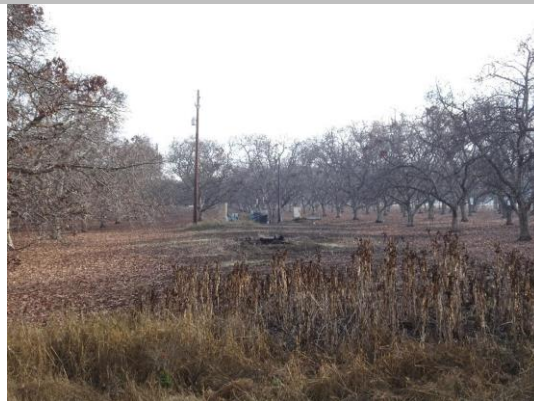
Photo 3 of 3 : UCIP_SP_2022_70625_97980.jpg

LS view: overview of LS

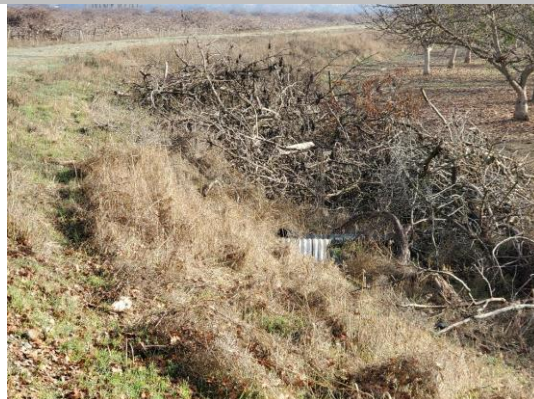
Photo 1 of 3 : UCIP_SP_2022_70631_97749.jpg

Comment Code						
Inspector Comment						
FS_ID:70631 DS_ID:21306 EP_NO: N/A Repair Type: Non-Urgent Crossing Status: Found UCIP Comments: 12/16/2020 Record remains Non-Urgent. No permit was found authorizing this encroachment. CVFPB will need to review crossing to determine owner. DWR DMP has not found internal issues, LOF between 1 and 2. Recommend inspection in 5 years. (O. Magana - DWR UCIP)05/01/2013 Debris found inside crossing--recommend removing it. (O. Magana - DWR UCIP) FIELD_STRUCT_DESC: 24-inch corrugated metal (CM) gravity drainage pipe through the levee, 6.0 feet below the crown. Slide gate in a concrete standpipe on the waterside (WS) end. (No permit found authorizing this pipe. Owner unknown). [Additional Reference(s): DWR Levee Log, 2005, (HLM 0.18)]. FS Date: 12/16/2020

LS view: overview of LS--pipe visible on the LS toe.

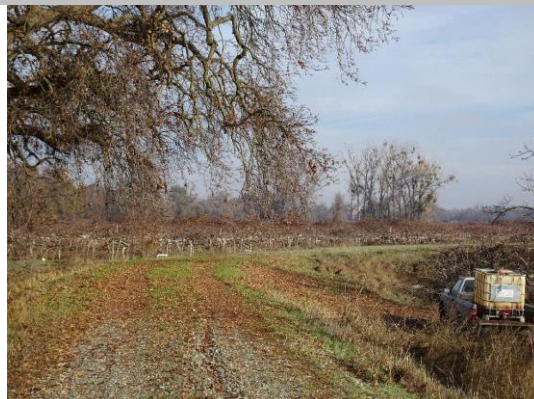
Photo 2 of 3 : UCIP_SP_2022_70631_97750.jpg

Overview of levee crown looking upstream towards pipe crossing.

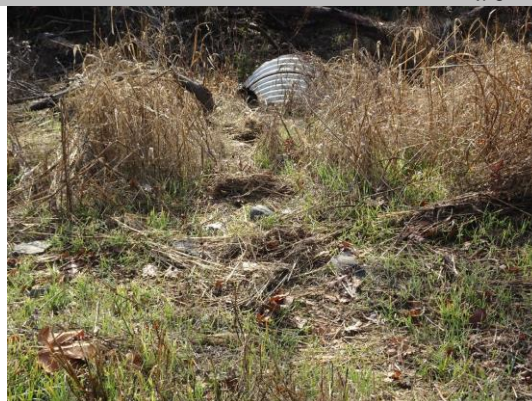
Photo 3 of 3 : UCIP_SP_2022_70631_97751.jpg

LM Start	0.01	Rating **	M	Issue No.	1 (cont)
LM End	0.01	Issue Type +	En	Location *	
Category	Supplemental			GPS Latitude/Longitude	
				Start	End
Item	DWR UCIP Field Study			39.310096 °	39.310096 °
				-121.616250 °	-121.616250 °
DWR ID	21306

LS view: pipe daylight visible on the LS toe.

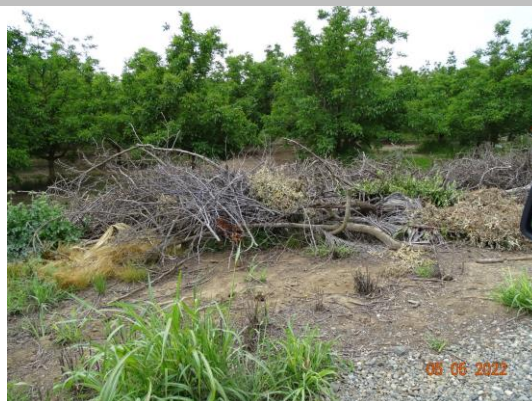
Photo 1 of 1 : SP_2022_RD0010_165_23_20220510_00049.jpg

LM Start	0.01	Rating **	M	Issue No.	23
LM End	0.01	Issue Type +	En	Location *	LS
Category	Earthen Levee			GPS Latitude/Longitude	
				Start	End
Item	Encroachments			39.310141 °	39.310141 °
				-121.616138 °	-121.616138 °
DWR ID	DWR_RD0010_03_s_2020_23				
Comment Code					
PR : Prunings					
Inspector Comment					
Remove prunings from levee toe, Spring 2022.

View looking downstream landside at prunings on levee slope, Spring 2022.

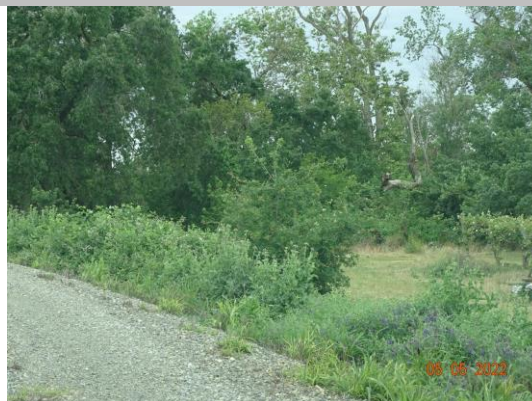
Photo 1 of 1 : SP_2022_RD0010_165_27_20220510_00048.jpg

LM Start	0.02	Rating **	M	Issue No.	27
LM End	0.02	Issue Type +	Ma	Location *	WS
Category	Earthen Levee			GPS Latitude/Longitude	
				Start	End
Item	Trim / Thin Trees			39.310164 °	39.310164 °
				-121.616054 °	-121.616054 °
DWR ID	DWR_RD0010_03_f_2020_27				
Comment Code					
T1 : Trim and thin trees to at least five feet above ground level to allow visibility of the ground and room to flood fight.					
Inspector Comment					
Trees with less than 4" diameter at chest height should be removed, Spring 2022.

View looking downstream waterside at a small starter tree that needs to be removed, Spring 2022.
