Flood Control Project Maintenance Levee Inspections LMA District Cover Sheet

Reclamation District No. 0010 Honcut

**Flood Control Project Maintenance
Levee Inspections
Unit Cover Sheet**

Waterway			Bank	Unit Miles
Unit No. 01 Simmerly Slough			Right	7.65
	Spring (March - May)	Summer (June - August)	(September - November) Fall	Winter (December - February)
Unit Maintenance Rating (Fall Only)				
Date of Inspection	5/5/2022 - 5/5/2022			
DWR Inspector	Brooks Weisser			
Accompanied By	Finlay Williams

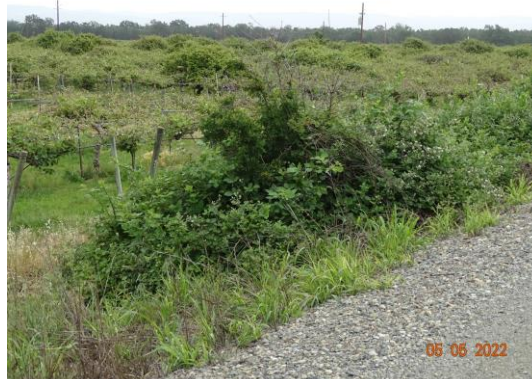
Photo 1 of 1 : SP_2022_RD0010_165_22_20220510_00047.jpg

LM Start	0.09	Rating **	M	Issue No.	22
LM End	0.09	Issue Type +	Ma	Location *	WS
Category	Earthen Levee			GPS Latitude/Longitude	
				Start	End
Item	Trim / Thin Trees			39.310229 °	39.310229 °
				-121.614697 °	-121.614697 °
DWR ID	DWR_RD0010_03_s_2020_22				
Comment Code					
T1 : Trim and thin trees to at least five feet above ground level to allow visibility of the ground and room to flood fight.					
Inspector Comment					
Trees with less than 4" diameter at chest height should be removed, Spring 2022.

View looking upstream waterside at a small starter tree that needs to be removed, Spring 2022.

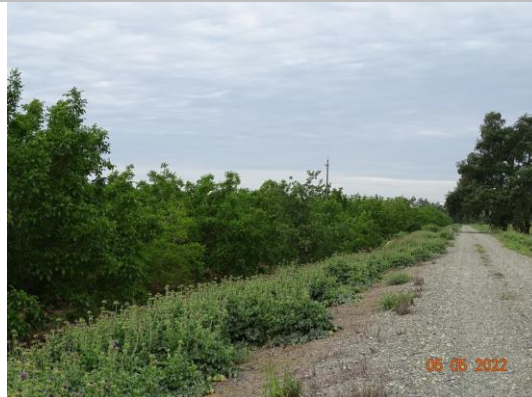
Photo 1 of 1 : SP_2022_RD0010_165_14_20220510_00046.jpg

LM Start	0.42	Rating **	M	Issue No.	14
LM End	0.42	Issue Type +	Ma	Location *	LS
Category	Earthen Levee			GPS Latitude/Longitude	
				Start	End
Item	Trim / Thin Trees			39.310229 °	39.310229 °
				-121.608610 °	-121.608610 °
DWR ID	DWR_RD0010_03_s_2021_14				
Comment Code					
T1 : Trim and thin trees to at least five feet above ground level to allow visibility of the ground and room to flood fight.					
Inspector Comment					
A starter tree on the landside slope needs to be removed, Spring 2022.

View of a starter tree on the landside slope that needs to be removed, Spring 2022.

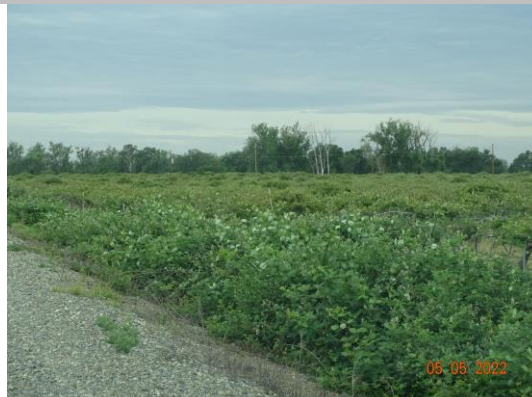
Photo 1 of 1 : SP_2022_RD0010_165_21_20220510_00045.jpg

LM Start	0.51	Rating **	M	Issue No.	21
LM End	0.51	Issue Type +	Ma	Location *	WS
Category	Earthen Levee			GPS Latitude/Longitude	
				Start	End
Item	Vegetation			39.310231 °	39.310231 °
				-121.606856 °	-121.606856 °
DWR ID	DWR_RD0010_03_s_2020_21				
Comment Code					
V2 : Remove the wild growth and woody vegetation other than native grasses from the levee slopes.					
Inspector Comment					
Remove blackberries from levee slope, Spring 2022.

View looking downstream waterside at blackberries on levee slope, Spring 2022.

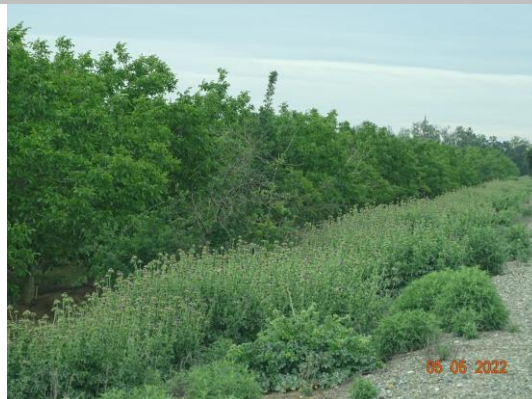
Photo 1 of 1 : SP_2022_RD0010_165_20_20220510_00044.jpg

LM Start	0.56	Rating **	M	Issue No.	20
LM End	0.56	Issue Type +	Ma	Location *	LS
Category	Earthen Levee			GPS Latitude/Longitude	
				Start	End
Item	Trim / Thin Trees			39.310227 °	39.310227 °
				-121.606027 °	-121.606027 °
DWR ID	DWR_RD0010_03_s_2020_20				
Comment Code					
T1 : Trim and thin trees to at least five feet above ground level to allow visibility of the ground and room to flood fight.					
Inspector Comment					
Trees with less than 4" diameter at chest height should be removed, Spring 2022.

View looking downstream landside at small starter trees on levee slope, Spring 2022.

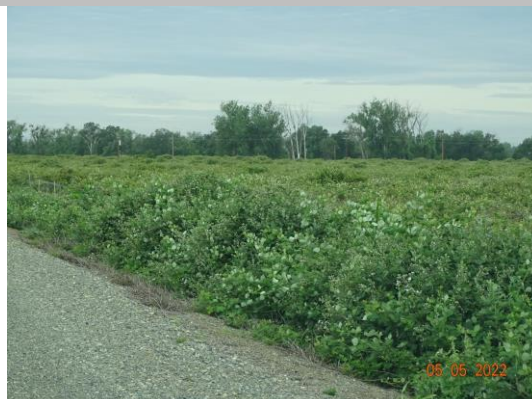
Photo 1 of 1 : SP_2022_RD0010_165_19_20220510_00043.jpg

LM Start	0.56	Rating **	M	Issue No.	19
LM End	0.56	Issue Type +	Ma	Location *	WS
Category	Earthen Levee			GPS Latitude/Longitude	
				Start	End
Item	Vegetation			39.310229 °	39.310229 °
				-121.605899 °	-121.605899 °
DWR ID	DWR_RD0010_03_s_2020_19				
Comment Code					
V2 : Remove the wild growth and woody vegetation other than native grasses from the levee slopes.					
Inspector Comment					
Remove blackberries from levee slope, Spring 2022.

View looking downstream waterside at blackberries on the levee slope, Spring 2022.

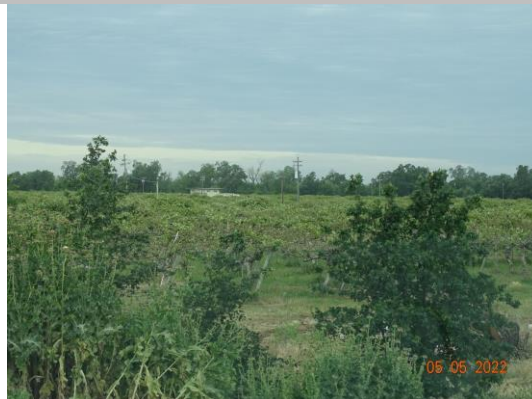
Photo 1 of 1 : SP_2022_RD0010_165_18_20220510_00042.jpg

LM Start	0.59	Rating **	M	Issue No.	18
LM End	0.59	Issue Type +	Ma	Location *	WS
Category	Earthen Levee			GPS Latitude/Longitude	
				Start	End
Item	Trim / Thin Trees			39.310209 °	39.310209 °
				-121.605456 °	-121.605456 °
DWR ID	DWR_RD0010_03_s_2020_18				
Comment Code					
T1 : Trim and thin trees to at least five feet above ground level to allow visibility of the ground and room to flood fight.					
Inspector Comment					
Trees with less than 4" diameter at chest height should be removed, Spring 2022.

View looking downstream waterside at a small starter tree that needs to be removed, Spring 2022.

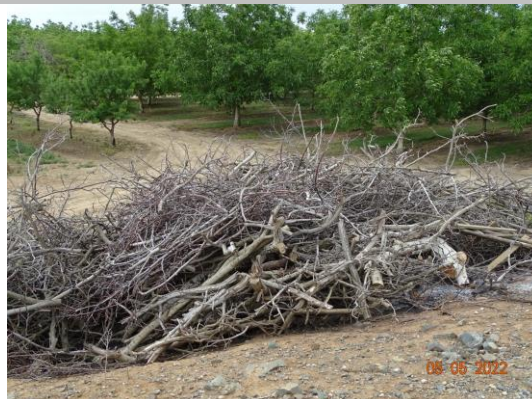
Photo 1 of 1 : SP_2022_RD0010_165_17_20220510_00041.jpg

LM Start	0.62	Rating **	M	Issue No.	17
LM End	0.62	Issue Type +	En	Location *	LS
Category	Earthen Levee			GPS Latitude/Longitude	
				Start	End
Item	Encroachments			39.310056 °	39.310056 °
				-121.604810 °	-121.604810 °
DWR ID	DWR_RD0010_03_f_2021_17				
Comment Code					
PR : Prunings					
Inspector Comment					
Remove prunings from levee toe, Spring 2022.

View looking downstream landside at prunings on levee slope, Spring 2022.

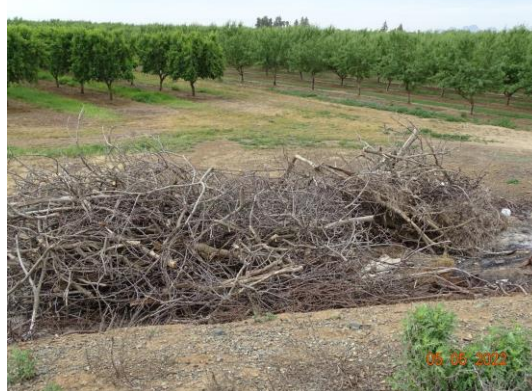
Photo 1 of 1 : SP_2022_RD0010_165_16_20220510_00040.jpg

LM Start	0.76	Rating **	U	Issue No.	16
LM End	0.76	Issue Type +	En	Location *	LS
Category	Earthen Levee			GPS Latitude/Longitude	
				Start	End
Item	Encroachments			39.309200 °	39.309200 °
				-121.602474 °	-121.602474 °
DWR ID	DWR_RD0010_03_s_2020_16				
Comment Code					
PR : Prunings					
Inspector Comment					
Remove prunings from levee toe, Spring 2022.

View looking downstream landside at prunings on levee slope, Spring 2022.

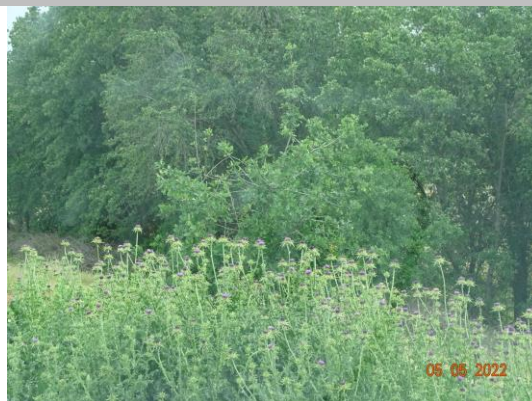
Photo 1 of 1 : SP_2022_RD0010_165_15_20220510_00039.jpg

LM Start	0.95	Rating **	M	Issue No.	15
LM End	0.95	Issue Type +	Ma	Location *	WS
Category	Earthen Levee			GPS Latitude/Longitude	
				Start	End
Item	Trim / Thin Trees			39.307583 °	39.307583 °
				-121.599640 °	-121.599640 °
DWR ID	DWR_RD0010_03_s_2020_15				
Comment Code					
T1 : Trim and thin trees to at least five feet above ground level to allow visibility of the ground and room to flood fight.					
Inspector Comment					
Trees with less than 4" diameter at chest height should be removed, Spring 2022.

View looking downstream waterside at a small starter tree that needs to be removed, Spring 2022.

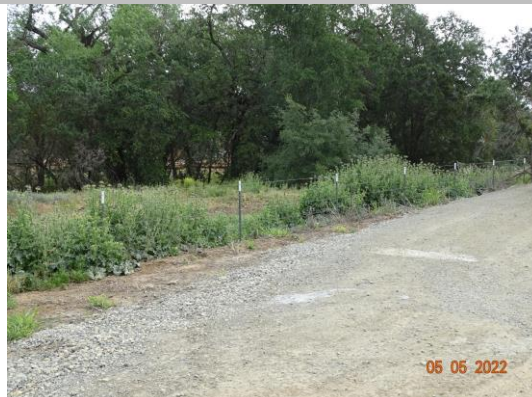
Photo 1 of 1 : SP_2022_RD0010_165_8_20220510_00038.jpg

LM Start	1.08	Rating **	M	Issue No.	8
LM End	1.21	Issue Type +	En	Location *	WS
Category	Earthen Levee			GPS Latitude/Longitude	
				Start	End
Item	Encroachments			39.307106 °	39.306422 °
				-121.597439 °	-121.595205 °
DWR ID	DWR_RD0010_03_s_2016_8				
Comment Code					
FE : Fence					
Inspector Comment					
Unpermitted fence on waterside levee hinge point, Spring 2022.

View of an unpermitted fence on waterside levee hinge point, Spring 2022

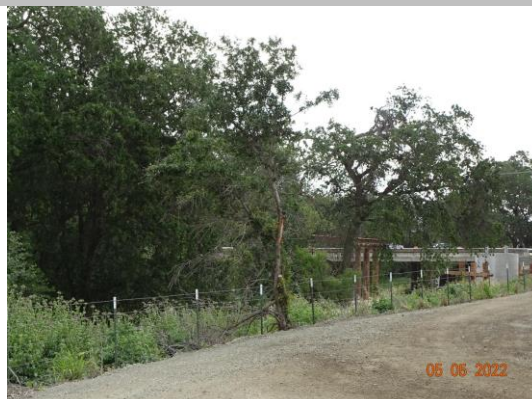
Photo 1 of 1 : SP_2022_RD0010_165_10_20220510_00037.jpg

LM Start	1.10	Rating **	M	Issue No.	10
LM End	1.10	Issue Type +	Ma	Location *	WS
Category	Earthen Levee			GPS Latitude/Longitude	
				Start	End
Item	Trim / Thin Trees			39.306995 °	39.306995 °
				-121.597116 °	-121.597116 °
DWR ID	DWR_RD0010_03_s_2018_10				
Comment Code					
T1 : Trim and thin trees to at least five feet above ground level to allow visibility of the ground and room to flood fight.					
Inspector Comment					
Trees with less than 4" diameter at chest height should be removed, Spring 2022.

View looking upstream waterside of a tree that needs to be trimmed for access and visibility, Spring 2022

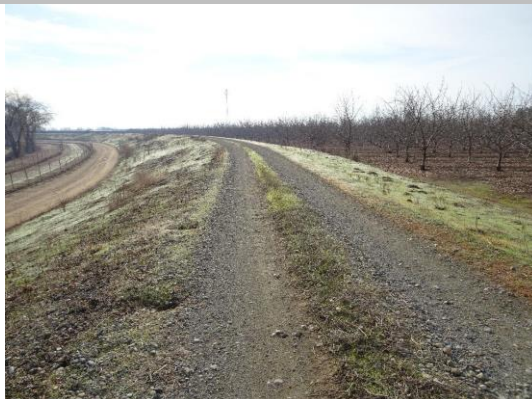
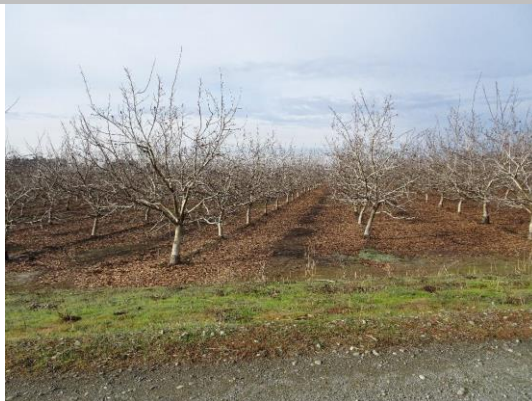
Photo 1 of 3 : UCIP_SP_2022_70632_97744.jpg

LM Start	1.32	Rating **	M	Issue No.	2	
LM End	1.32	Issue Type +	En	Location *		
Category	Supplemental			GPS Latitude/Longitude		
				Start	End	
Item	DWR UCIP Field Study			39.305480 °	39.305480 °	
				-121.593681 °	-121.593681 °	
DWR ID	21311					
Comment Code						
Inspector Comment						
FS_ID:70632 DS_ID:21311 EP_NO: 16136 Repair Type: Non-Urgent Crossing Status: Not Found UCIP Comments: 12/16/2020 Record has been updated to Non-Urgent. No signage or evidence of pipe was found during site inspection. Need to contact owner to determine the status of the crossing through the levee. (O. Magana - DWR UCIP) FIELD_STRUCT_DESC: 2-inch galvanized iron irrigation pipe through the levee, 2.0 feet below the crown. (2-inch irrigation pipe authorized under Permit No. 16136, 1993 - Nagra and Thiara Farms). FS Date: 12/16/2020

Overview of levee crown looking upstream towards pipe crossing.

LS view: overview of LS, photo 1 of 2.

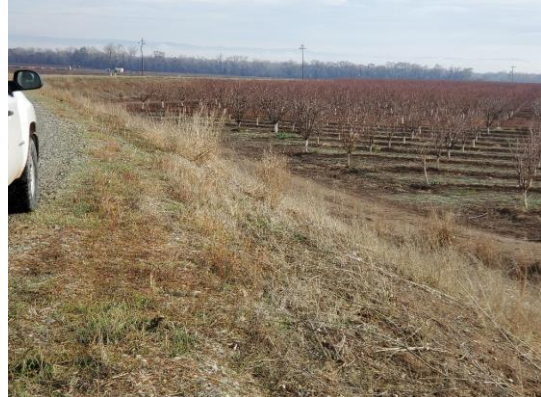
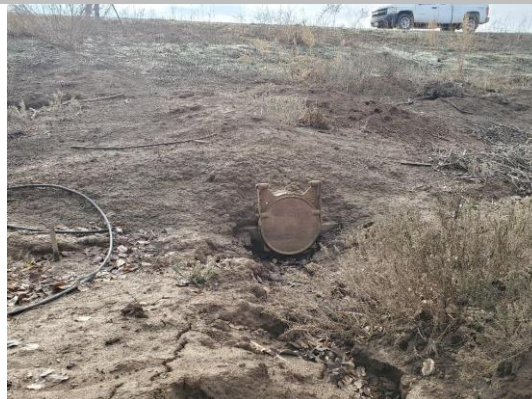
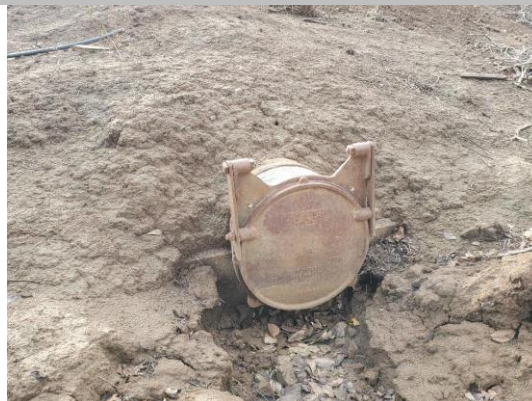
Photo 1 of 3 : UCIP_SP_2022_70633_97739.jpg

Comment Code						
Inspector Comment						
FS_ID:70633 DS_ID:21307 EP_NO: N/A Repair Type: Urgent Crossing Status: Found UCIP Comments: 09/08/2021 CIPP-lining of this crossing approved under project authorization WC2021104. 12/16/2020 Record has been updated from Non-Urgent to Urgent. DWR DMP has found integrity issues, LOF between 5 and 6. Recommend monitoring crossing until funding becomes available to address. No permit was found authorizing this encroachment. CVFPB will need to review crossing to determine owner. (O. Magana - DWR UCIP)12/01/2020 see UCIP marked up RD0010 USACE O&M manual OM151_IrrDRNSect.pdf and USACE drawing AB_4-4-318.pdf for approximate location and station. Reference files have been filed under UCIP's share drive desk study background folder for RD0010. (O. Magana - DWR UCIP) 05/01/2013 Sediment deposit inside pipe--Need to coordinate with owner to determine status of crossing. If crossing is no longer in use owner will need to contact the CVFPB to comply with Title 23. (O. Magana - DWR UCIP) FIELD_STRUCT_DESC: 24-inch corrugated metal (CM) gravity drainage pipe through the levee, 15.0 feet below the crown. CM cutoff wall around the pipe under each shoulder. Flap gate on the waterside (WS) end. Slide gate on the landside (LS) end. Concrete headwall at each toe. (No permit found authorizing this pipe. Owner unknown). [Additional Reference(s): DWR Levee Log, 2005, (HLM 1.89). USACE Sacramento O&M Manual, Unit No. 151, May 1953, Revised 6 June 2017, (Station 134+06). USACE As-Built Drawing No. 4-4-318, Sheet No. 318/6, Revised January 1951, (Station 134+06)]. FS Date: 12/16/2020

LS view: cross-section view of LS slope

WS view: overview of WS slope and pipe visible on WS toe.

WS view: close up view of pipe with flap gate.

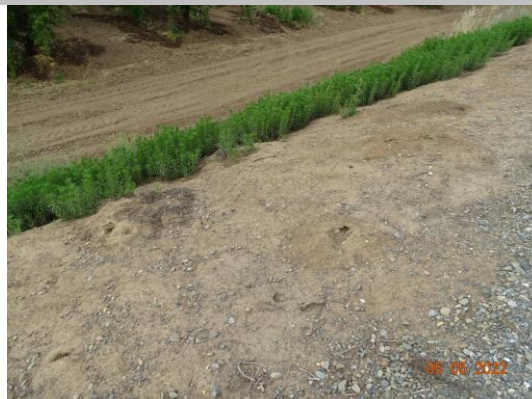
Photo 1 of 1 : SP_2022_RD0010_165_24_20220510_00035.jpg

LM Start	1.96	Rating **	M	Issue No.	24
LM End	1.96	Issue Type +	Ma	Location *	LS
Category	Earthen Levee			GPS Latitude/Longitude	
				Start	End
Item	Animal Control			39.303411 °	39.303411 °
				-121.583273 °	-121.583273 °
DWR ID	DWR_RD0010_03_s_2022_24				
Comment Code					
A3 : No rodents visible, but rodent burrows visible; need to backfill and compact or grout burrows.					
Inspector Comment					
No rodents seen, but rodent holes need to be backfilled and regraded, Spring 2022.

View of rodent holes on the landside slope, Spring 2022.

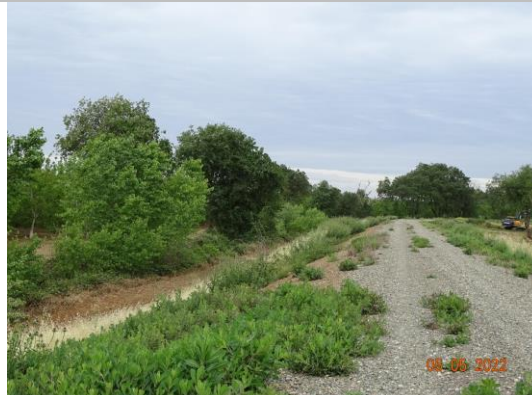
Photo 1 of 1 : SP_2022_RD0010_165_5_20220517_00050.jpg

LM Start	2.32	Rating **	M	Issue No.	5
LM End	2.78	Issue Type +	Ma	Location *	LS
Category	Earthen Levee			GPS Latitude/Longitude	
				Start	End
Item	Vegetation			39.302604 °	39.298610 °
				-121.576884 °	-121.570211 °
DWR ID	DWR_RD0010_03_s_2022_5				
Comment Code					
V1 : Control annual grass and weeds on the levee slopes and easements.					
Inspector Comment					
Annual vegetation needs to be maintained, Spring 2022.

View of annual vegetation on the landside slope, Spring 2022.

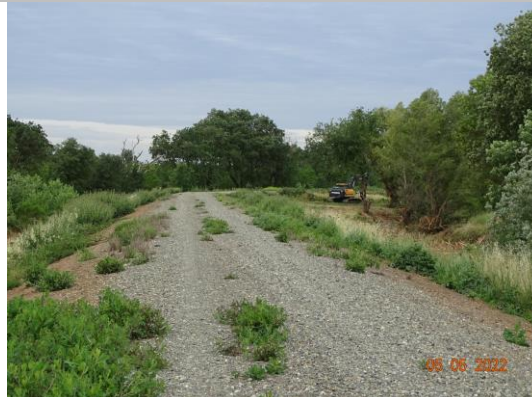
Photo 1 of 1 : SP_2022_RD0010_165_6_20220517_00051.jpg

LM Start	2.32	Rating **	M	Issue No.	6
LM End	2.78	Issue Type +	Ma	Location *	WS
Category	Earthen Levee			GPS Latitude/Longitude	
				Start	End
Item	Vegetation			39.302602 °	39.298604 °
				-121.576884 °	-121.570218 °
DWR ID	DWR_RD0010_03_s_2022_6				
Comment Code					
V1 : Control annual grass and weeds on the levee slopes and easements.					
Inspector Comment					
Annual vegetation needs to be maintained, Spring 2022.

View of annual vegetation on the waterside slope, Spring 2022.

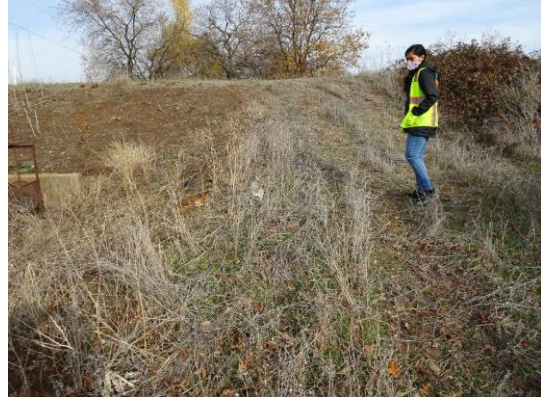
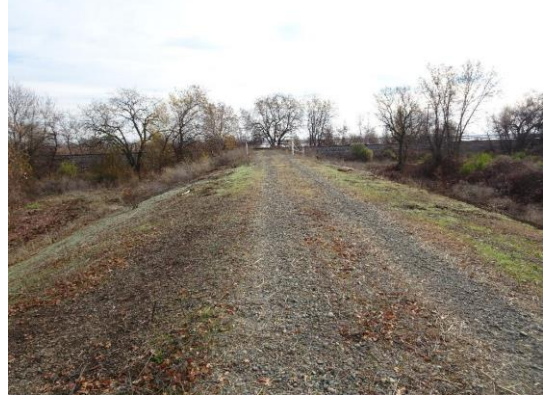
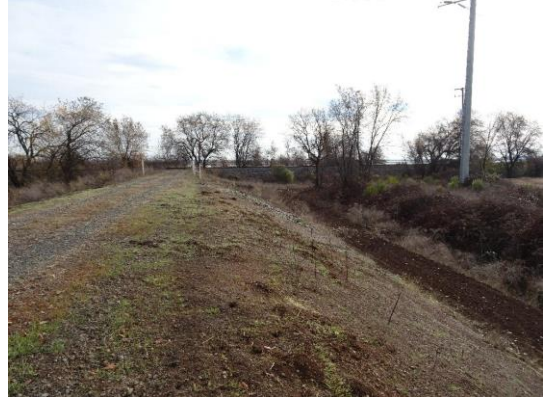
Photo 1 of 3 : UCIP_SP_2022_70634_97725.jpg

Comment Code						
Inspector Comment						
FS_ID:70634 DS_ID:21308 EP_NO: N/A Repair Type: Non-Urgent Crossing Status: Found UCIP Comments: 09/08/2021 CIPP-lining of this crossing approved under project authorization WC2021104. 12/16/2020 Record remains Non-Urgent. DWR DMP has found integrity issues, LOF between 4 and 5. Crossing will be monitored until funding becomes available for rehabilitation. No permit was found authorizing this encroachment. CVFPB will need to review crossing to determine owner. (O. Magana - DWR UCIP)12/01/2020 see UCIP marked up RD0010 USACE O&M manual OM151_IrrDRNSect.pdf and USACE drawing AB_4-4-318.pdf for approximate location and station. Reference files have been filed under UCIP's share drive desk study background folder for RD0010. (O. Magana - DWR UCIP) 05/01/2013 Dense vegetation limits the inspector's visibility to identify signs of pipe failure (leaks) along the slope. Recommend removing vegetation along pipe alignment to conduct proper inspection of structure and appurtenances. (O. Magana - DWR UCIP) FIELD_STRUCT_DESC: 24-inch corrugated metal (CM) gravity drainage pipe through the levee, 12.0 feet below the crown. CM cutoff wall around the pipe under each shoulder. Flap gate on the waterside (WS) end. Slide gate on the landside (LS) end. Concrete headwall at the LS toe. (No permit found authorizing this pipe. Owner unknown). [Additional Reference(s): DWR Levee Log, 2005, (HLM 3.00). USACE Sacramento O&M Manual, Unit No. 151, May 1953, Revised 6 June 2017, (Station 192+33). USACE As-Built Drawing No. 4-4-318, Sheet No. 318/7, Revised January 1951, (Station 192+33)]. FS Date: 12/16/2020

WS view: view of WS slope.

Overview of levee crown looking upstream towards pipe crossing.

WS view: cross-section of WS slope
