**Flood Control Project Maintenance  
Levee Inspections**

**Fall 2015 Levee Maintenance Deficiency Summary Report**

**Sacramento River Basin**

**Reclamation District No. 0070 Meridian**

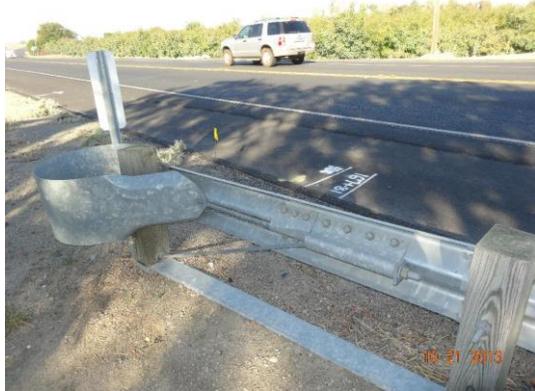
Photo 3 of 3 : UCIP\_FA\_2015\_2186.jpg

LM Start	<b>0.63</b>	Rating **	M	Issue No.	<b>46 (cont)</b>
LM End	<b>0.63</b>	Issue Type +	En	Location *	WS
Category	Supplemental			GPS Latitude/Longitude	
				Start	End
Item	DWR UCIP Field Study			39.143380 °	39.143380 °
				-121.842606 °	-121.842606 °
DWR ID					
Action/Comments					
Inspector Comments: FS_ID:23467 DS_ID:21354 EP_NO: 14802 FS_HLM: 0.67 Repair Type: Non-Urgent Crossing Status: Indicator Found

Underground Service Alert (USA) flag located at the end of Hwy 20 confirming gas line goes through.

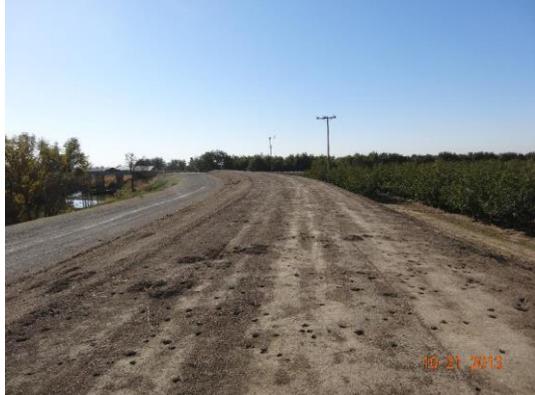
Photo 1 of 3 : UCIP\_FA\_2015\_2140.jpg

Item	DWR UCIP Field Study			39.144369 °	39.144369 °
				-121.842778 °	-121.842778 °
DWR ID					
Action/Comments					
Inspector Comments: FS_ID:23526 DS_ID:21355 EP_NO: 9961 FS_HLM: 0.745 Repair Type: Non-Urgent Crossing Status: Found UCIP Comments: Dense burrow activity present on both waterward side and landward side. Recommend addressing burrow activity at this location. Also recommend having owner clear vegetation blocking access along walkway. This crossing is referenced in the USACE Periodic Inspection as item USACE_CESPK_MRD1_2012_p_290. FIELD_STRUCT_DESC: 10-inch (not 12-inch as noted in desk study) steel pipe through the levee, 5.4 feet below the crown. Siphon breaker in CM pipe riser on landward slope. 24-inch concrete standpipe at landward toe. Walkway to pump on pile structure in stream. This pipe was retained under ABO No. 9961 (1974). FS Date: 10/21/2013

View of levee crown and waterward berm looking upstream from crossing.

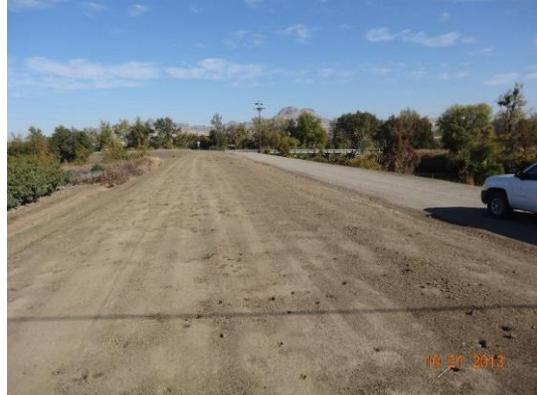
Photo 3 of 3 : UCIP\_FA\_2015\_2142.jpg

View of levee crown and waterward berm looking downstream from crossing.

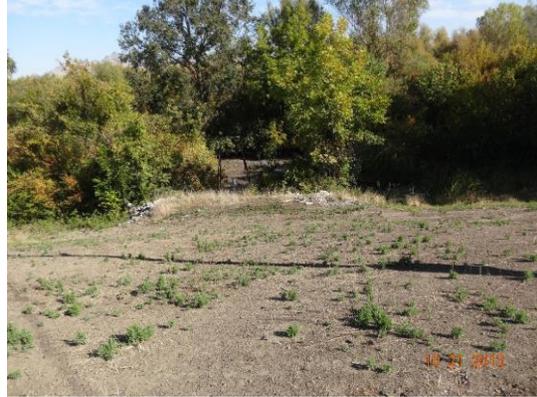
Photo 2 of 3 : UCIP\_FA\_2015\_2200.jpg

View of waterward side.

Inspector Comments: FS\_ID:23508  
 DS\_ID:21336  
 EP\_NO: N/A  
 FS\_HLM: 1.889  
 Repair Type: Non-Urgent  
 Crossing Status: Found  
 UCIP Comments: Need to find owner to determine if crossing is still in use. If crossing is no longer in use owner will need to coordinate with DWR inspector and CVFPB to remove according to Title 23 requirements. Evidence of high burrow activity on waterward side recommend addressing issue. This crossing is referenced as USACE\_CESPK\_MRD1\_2012\_p\_0230 in the USACE's PI report for no USACE recommendation letter available -- correction pipe is 12-inch not 16-inch.  
 FIELD\_STRUCT\_DESC: 12-inch pipe through the levee, 4.0 feet below the crown. Siphon breaker on the landward slope. Concrete distribution box (7 ft by 9 ft) at landward toe. Service pole on waterward slope. Pump on concrete sump on waterward slope. Overhead power line crosses levee at location. This pipe was retained under ABO No. 9948 (1974) issued to Edward E. and Doris M. Nall. Permit No. 613 issued in May 29, 1934 is for 12 inch pipe issued to Waldo Nall.

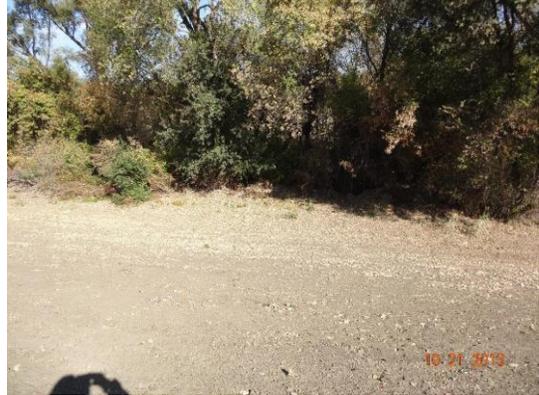
Photo 1 of 3 : UCIP\_FA\_2015\_2179.jpg

LM Start	<b>2.82</b>	Rating **	M	Issue No.	<b>49</b>
LM End	<b>2.82</b>	Issue Type +	En	Location *	WS
Category	Supplemental			GPS Latitude/Longitude	
				Start	End
Item	DWR UCIP Field Study			39.158151 °	39.158151 °
				-121.873005 °	-121.873005 °
DWR ID					
<b>Action/Comments</b>					
Inspector Comments: FS_ID:23530 DS_ID:21322 EP_NO: N/A FS_HLM: 2.879 Repair Type: Non-Urgent Crossing Status: Indicator Found

View of waterward side.

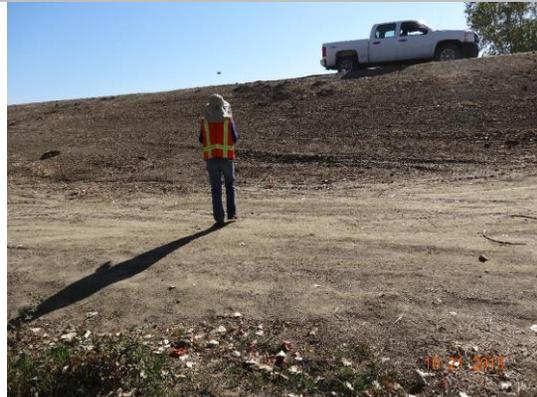
Photo 2 of 3 : UCIP\_FA\_2015\_2170.jpg

View of waterward side slope and berm.

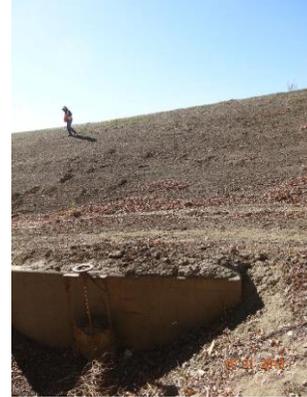
Photo 2 of 3 : UCIP\_FA\_2015\_2210.jpg

Item	DWR UCIP Field Study			39.157330 °	39.157330 °
				-121.887113 °	-121.887113 °
DWR ID					
<b>Action/Comments</b>					
Inspector Comments: FS_ID:23510 DS_ID:21362 EP_NO: 9944 FS_HLM: 3.697 Repair Type: Non-Urgent Crossing Status: Found UCIP Comments: No pump connection. Need to coordinate with owner to determine status of crossing. If crossing is no longer in use owner will need to contact the CVFPB to comply with Title 23. This crossing is referenced in the USACE Periodic Inspection as item USACE_CESPK_MRD1_2012_p_0183 no USACE recommendation letter available. FIELD_STRUCT_DESC: 18-inch pipe through the levee, 19.5 feet below the crown. Slide gate on waterward end. Pump on waterward side. Concrete distribution box on landward slope. (USACE-1953). This entry matches the Drainage or Irrigation Structure referenced in O&M manual (Station 180+50). This pipe was retained under ABO No. 9944 (1974). FS Date: 10/21/2013

Concrete head wall and screw gate at waterward toe.

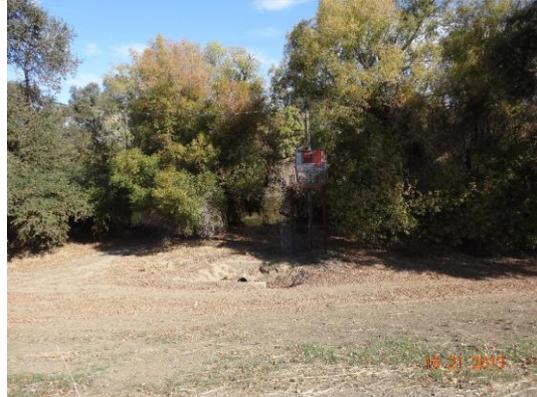
Photo 3 of 3 : UCIP\_FA\_2015\_2211.jpg

Inspector Comments: FS\_ID:23510  
 DS\_ID:21362  
 EP\_NO: 9944  
 FS\_HLM: 3.697  
 Repair Type: Non-Urgent  
 Crossing Status: Found  
 UCIP Comments: No pump connection. Need to coordinate with owner to determine status of crossing. If crossing is no longer in use owner will need to contact the CVFPB to comply with Title 23. This crossing is referenced in the USACE Periodic Inspection as item USACE\_CESPK\_MRD1\_2012\_p\_0183 no USACE recommendation letter available.  
 FIELD\_STRUCT\_DESC: 18-inch pipe through the levee, 19.5 feet below the crown. Slide gate on waterward end. Pump on waterward side. Concrete distribution box on landward slope. (USACE-1953). This entry matches the Drainage or Irrigation Structure referenced in O&M manual (Station 180+50). This pipe was retained under ABO No. 9944 (1974).  
 FS Date: 10/21/2013

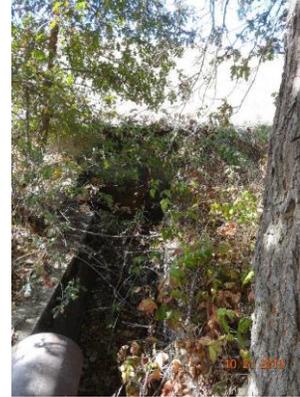
Photo 1 of 3 : UCIP\_FA\_2015\_0689.jpg

Item	DWR UCIP Field Study			39.168832 °	39.168832 °
				-121.900436 °	-121.900436 °
DWR ID					
Action/Comments					
Inspector Comments: FS_ID:23517 DS_ID:21340 EP_NO: 9954 FS_HLM: 4.778 Repair Type: Non-Urgent Crossing Status: Found UCIP Comments: Burrow activity present on waterward slope. Need to coordinate with owner to determine status of crossing. If crossing is no longer in use owner will need to contact the CVFPB to comply with Title 23. This crossing is referenced in the USACE Periodic Inspection as item USACE_CESPK_MRD1_2012_p_0134. FIELD_STRUCT_DESC: 24-inch CM pipe through the levee, 19.0 feet below the crown. Slide gate on the waterward. Concrete distribution box at landward toe. This pipe was retained under ABO No. 9954 (1974). FS Date: 10/21/2013

View of pipe located on waterward side.

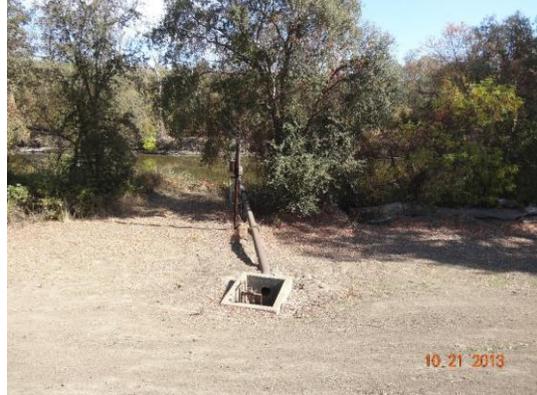
Photo 2 of 3 : UCIP\_FA\_2015\_0692.jpg

LM Start	4.99	Rating **	M	Issue No.	55 (cont)
LM End	4.99	Issue Type +	En	Location *	WS
Category	Supplemental			GPS Latitude/Longitude	
			Start	End	
Item	DWR UCIP Field Study			39.172334 °	39.172334 °
DWR ID				-121.902998 °	-121.902998 °
Action/Comments					
Inspector Comments: FS_ID:23518 DS_ID:21338 EP_NO: 9940 FS_HLM: 5.057 Repair Type: Non-Urgent Crossing Status: Found UCIP Comments: No connection present--need to contact owner to determine if owner plans to use. If crossing is no longer in use owner will need to coordinate with DWR inspector and CVFPB to remove according to Title 23 requirements. Unable to determine if crossing is in use. This crossing is referenced in the USACE Periodic Inspection as item USACE_CESPK_MRD1_2012_p_0125. FIELD_STRUCT_DESC: 18-inch steel pipe through the levee, 19.0 feet below the crown. Cutoff wall around pipe at center of levee. Slide gate in concrete distribution box on landward side. Pump on waterward side. Discharges into concrete box on the landward side. (USACE-1953). This entry matches the Drainage or Irrigation Structure referenced in O&M manual (Station 251+30). This pipe was retained under ABO No. 9940 (1974). FS Date: 10/21/2013

View of waterward side--pipe and concrete distribution box.

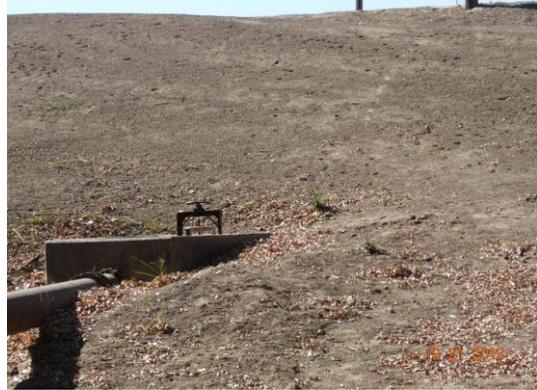
Photo 3 of 3 : UCIP\_FA\_2015\_0693.jpg

View of waterward slope.

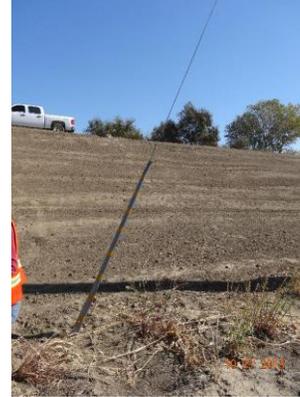
Photo 2 of 3 : UCIP\_FA\_2015\_0566.jpg

LM Start	5.41	Rating **	M	Issue No.	56 (cont)
LM End	5.41	Issue Type +	En	Location *	WS
Category	Supplemental			GPS Latitude/Longitude	
	Start		End		
Item	DWR UCIP Field Study			39.176780 °	39.176780 °
DWR ID				-121.908025 °	-121.908025 °
Action/Comments					
Inspector Comments: FS_ID:23519 DS_ID:21357 EP_NO: 9957 FS_HLM: 5.484 Repair Type: Non-Urgent Crossing Status: Found UCIP Comments: Burrow activity on slopes -- recommend addressing issue. This crossing is referenced in the USACE Periodic Inspection as item USACE_CESPK_MRD1_2012_p_0110. FIELD_STRUCT_DESC: 12-inch steel pipe through the levee, 5.5 feet below the crown. Siphon breaker in CM pipe riser on landward slope. Pump on waterward slope. Discharges into concrete box and service pole at landward toe. This pipe was retained under ABO No. 9957 (1975). FS Date: 10/21/2013

View of landward slope.

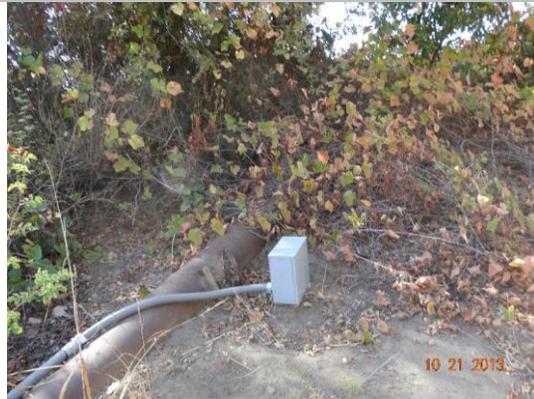
Photo 3 of 3 : UCIP\_FA\_2015\_2342.jpg

Pipe and electrical conduit exposed on levee berm.

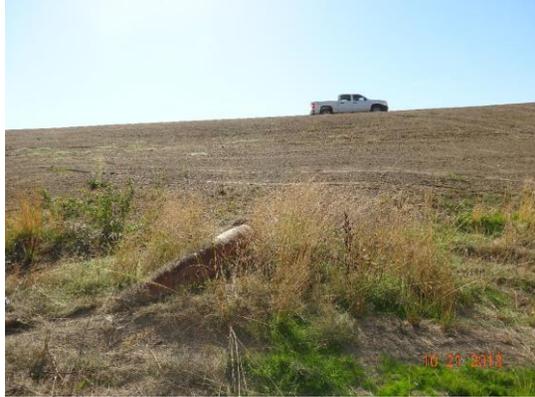
Photo 1 of 3 : UCIP\_FA\_2015\_2343.jpg

View of waterward slope and pipe at levee toe.

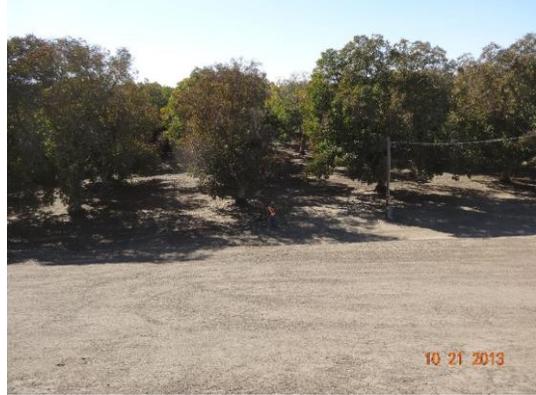
Photo 2 of 2 : UCIP\_FA\_2015\_2346.jpg

LM Start	<b>6.74</b>	Rating **	M	Issue No.	<b>59 (cont)</b>
LM End	<b>6.74</b>	Issue Type +	En	Location *	WS
Category	Supplemental			GPS Latitude/Longitude	
				Start	End
Item	DWR UCIP Field Study			39.194042 °	39.194042 °
				-121.916630 °	-121.916630 °
DWR ID					
Action/Comments					
Inspector Comments: FS_ID:23523 DS_ID:21342 EP_NO: N/A FS_HLM: 6.82 Repair Type: Non-Urgent Crossing Status: Indicator Found UCIP Comments: Unable to determine if this is an irrigation pipe or groundwater pipe. This crossing is referenced in the USACE Periodic Inspection as item USACE_CESPK_MRD1_2012_p_0062--no permit available. FIELD_STRUCT_DESC: 8-inch (not 12-inch as found in desk study) pipe through the levee. Pump and service pole at landward toe. FS Date: 10/21/2013

View of landward side.

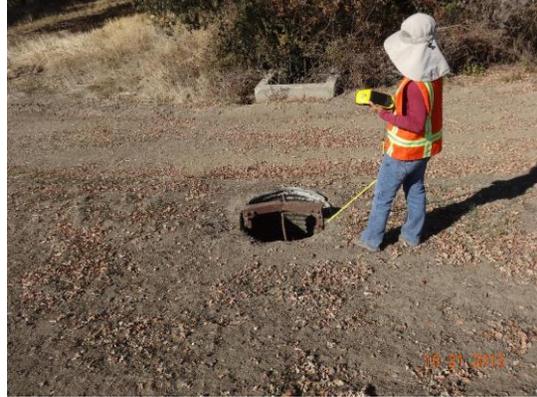
Photo 2 of 3 : UCIP\_FA\_2015\_2144.jpg

Inspector Comments: FS\_ID:23529  
 DS\_ID:21345  
 EP\_NO: 9942  
 FS\_HLM: 7.884  
 Repair Type: Non-Urgent  
 Crossing Status: Found  
 UCIP Comments: Dense vegetation limits the inspector's visibility to identify signs of pipe failure (leaks) along the slope. Recommend removing vegetation along pipe alignment to conduct proper inspection of structure and appurtenances. This crossing is referenced in the USACE Periodic Inspection as item USACE\_CESPK\_MRD1\_2012\_p\_0005.  
 FIELD\_STRUCT\_DESC: 24-inch CM pipe through the levee, 16.5 feet below the crown. Slide gate in CM pipe rise on waterward slope. Incline pump on waterward side. Discharges to concrete box at the landward toe. Service pole on landward side. (USACE-1953). This entry matches the Drainage or Irrigation Structure referenced in O&M manual (Station 330+00). This pipe was retained under ABO No. 9942 (1974).  
 FS Date: 10/21/2013

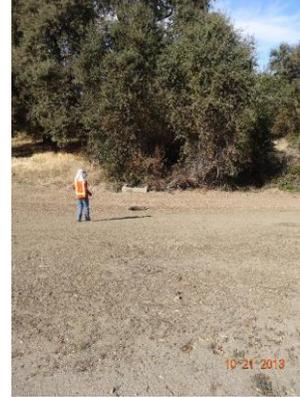
Photo 3 of 3 : UCIP\_FA\_2015\_2145.jpg

Item	DWR UCIP Field Study			39.195148 °	39.195148 °
				-121.933849 °	-121.933849 °
DWR ID					
<b>Action/Comments</b>					
Inspector Comments: FS_ID:23529 DS_ID:21345 EP_NO: 9942 FS_HLM: 7.884 Repair Type: Non-Urgent Crossing Status: Found UCIP Comments: Dense vegetation limits the inspector's visibility to identify signs of pipe failure (leaks) along the slope. Recommend removing vegetation along pipe alignment to conduct proper inspection of structure and appurtenances. This crossing is referenced in the USACE Periodic Inspection as item USACE_CESPK_MRD1_2012_p_0005. FIELD_STRUCT_DESC: 24-inch CM pipe through the levee, 16.5 feet below the crown. Slide gate in CM pipe rise on waterward slope. Incline pump on waterward side. Discharges to concrete box at the landward toe. Service pole on landward side. (USACE-1953). This entry matches the Drainage or Irrigation Structure referenced in O&M manual (Station 330+00). This pipe was retained under ABO No. 9942 (1974). FS Date: 10/21/2013

View of waterward slope.

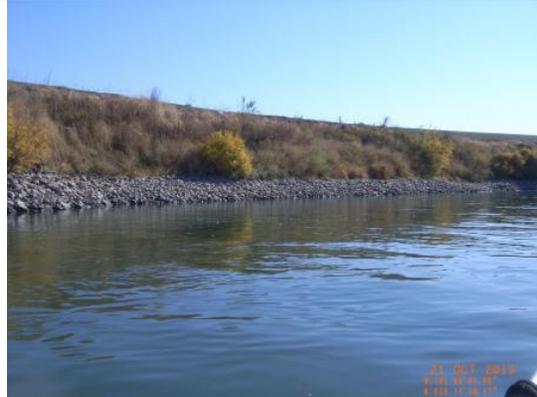
Photo 1 of 1 : USACE2013A\_SAC\_138-1\_L\_5.jpg

LM Start	<b>0.05</b>	Rating **	M	Issue No.	<b>10</b>
LM End	<b>0.32</b>	Issue Type +	Ma	Location *	WS
Category	Supplemental			GPS Latitude/Longitude	
				Start	End
Item	2015 USACE Erosion Survey, DRAFT			39.193219 °	39.190038 °
				-121.935783 °	-121.934199 °
DWR ID					
Action/Comments					
Inspector Comments: 1997 - Loss of cobble revetment in levee section. 2004 - New fresh erosion in a short section of the downstream end. 2010 - New deposition on cobbles. 2015: No observed changes. [2015 Site ID: SAC_138-1_L]

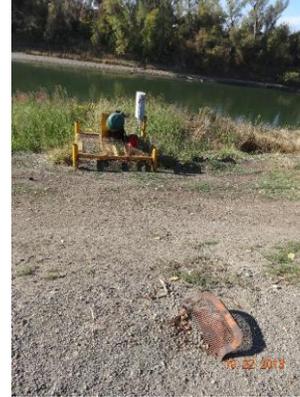
Photo 2 of 3 : UCIP\_FA\_2015\_2657.jpg

Item	DWR UCIP Field Study			39.193396 °	39.193396 °
				-121.935434 °	-121.935434 °
DWR ID					
<b>Action/Comments</b>					
Inspector Comments: FS_ID:23952 DS_ID:21382 EP_NO: 12707 FS_HLM: 0.05 Repair Type: Non-Urgent Crossing Status: Found UCIP Comments: Burrow activity noticed at this location. Crossing appurtenances have been modified. No 36-inch concrete distribution stand pipe present instead there is a concrete distribution box located at the landward toe. Also siphon breaker housing unit damage. Will need to contact owner. Need to obtain maintenance records and clarify modifications made at to crossing. Recommend having owner clear vegetation on waterward side. This crossing is referenced in the USACE Periodic Inspection as item USACE_CESPK_MRD2_2012_p_0018. FIELD_STRUCT_DESC: 14-inch steel pipe through the levee, 3.0 feet below the crown. Steel cutoff wall around pipe at center of levee. Siphon breaker on apex of pipe at waterward shoulder. Pump on metal (not timber as noted in desk study) platform on waterward side. 36-inch concrete standpipe (not found during 10/2013 inspection) and service pole at landward toe. Rock revetment on waterward slope. (Permit No. 12707-1979) FS Date: 10/22/2013

View of waterward side--siphon breaker housing unit, pipe daylight, pump, and platform.

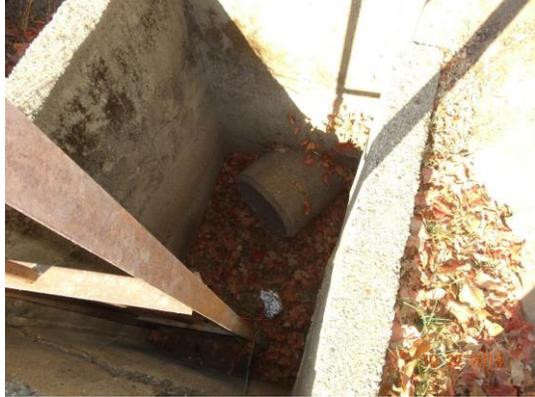
Photo 3 of 3 : UCIP\_FA\_2015\_2858.jpg

LM Start	<b>1.04</b>	Rating **	M	Issue No.	<b>773 (cont)</b>
LM End	<b>1.04</b>	Issue Type +	En	Location *	LS
Category	Supplemental			GPS Latitude/Longitude	
				Start	End
Item	DWR UCIP Field Study			39.183211 °	39.183211 °
				-121.943237 °	-121.943237 °
DWR ID					
Action/Comments					
Inspector Comments: FS_ID:42923 DS_ID:21412 EP_NO: 1575 FS_HLM: 1.05 Repair Type: Non-Urgent Crossing Status: Found

Inside view of concrete distribution box located on waterward side.

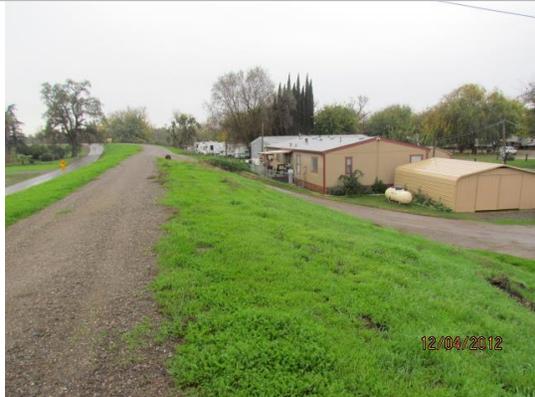
Photo 1 of 1 : FA\_2015\_RD0070\_30\_12\_20150910\_00009.jpg

LM Start	<b>1.18</b>	Rating **	M	Issue No.	<b>12</b>
LM End	<b>1.18</b>	Issue Type +	En	Location *	WS
Category	Earthen Levee			GPS Latitude/Longitude	
				Start	End
Item	Encroachments			39.181247 °	39.181247 °
				-121.943808 °	-121.943808 °
DWR ID	DWR_RD0070_02_f_2012_12				
Action/Comments					
Building

View of the buildings along the waterside toe of the levee.

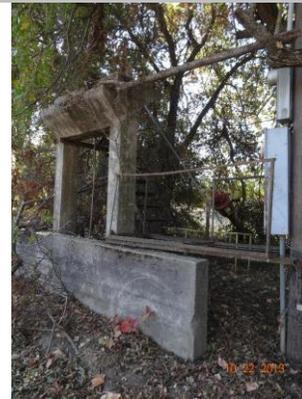
Photo 2 of 3 : UCIP\_FA\_2015\_2474.jpg

LM Start	1.35	Rating **	M	Issue No.	774	
LM End	1.35	Issue Type +	En	Location *	WS	
Category	Supplemental			GPS Latitude/Longitude		
			Start	End		
Item	DWR UCIP Field Study			39.178895 °	39.178895 °	
				-121.943340 °	-121.943340 °	
DWR ID						
Action/Comments						
Inspector Comments: FS_ID:23885 DS_ID:21365 EP_NO: 9973 FS_HLM: 1.36 Repair Type: Non-Urgent Crossing Status: Found UCIP Comments: Cut to levee toe found on landward side. Unable to determine if crossing is being used. If crossing is no longer used by owner, the owner will need to coordinate with DWR Inspector and CVFPB to remove crossing according to Title 23 requirements. This crossing is referenced in the USACE Periodic Inspection as item USACE_CESPK_MRD2_2012_p_0099. FIELD_STRUCT_DESC: 18-inch steel pipe through the levee, 18.8 feet below the crown. Slide gate on gate structure on waterward side. Slant pump on waterward side. (USACE-1953). This entry matches the Drainage or Irrigation Structure referenced in O&M manual (Station 399+34). This pipe was retained under ABO No. 9973 (1974). FS Date: 10/22/2013

Concrete structure located on waterward side with screw gate.

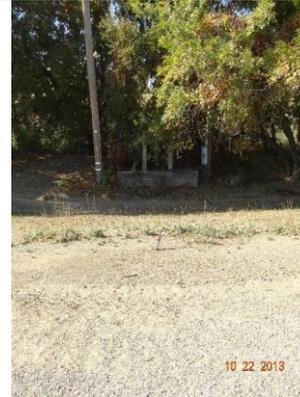
Photo 3 of 3 : UCIP\_FA\_2015\_2564.jpg

LM Start	<b>1.35</b>	Rating **	M	Issue No.	<b>774 (cont)</b>
LM End	<b>1.35</b>	Issue Type +	En	Location *	WS
Category	Supplemental			GPS Latitude/Longitude	
				Start	End
Item	DWR UCIP Field Study			39.178895 °	39.178895 °
				-121.943340 °	-121.943340 °
DWR ID					
Action/Comments					
Inspector Comments: FS_ID:23885 DS_ID:21365 EP_NO: 9973 FS_HLM: 1.36 Repair Type: Non-Urgent Crossing Status: Found

Overview of waterward slope.

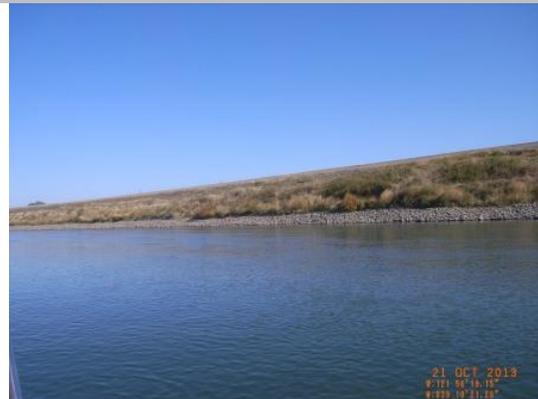
Photo 1 of 2 : USACE2013A\_SAC\_136-6\_L\_5.jpg

LM Start	<b>1.78</b>	Rating **	M	Issue No.	<b>16</b>
LM End	<b>1.90</b>	Issue Type +	Ma	Location *	WS
Category	Supplemental			GPS Latitude/Longitude	
				Start	End
Item	2015 USACE Erosion Survey, DRAFT			39.173912 °	39.172344 °
				-121.938745 °	-121.937925 °
DWR ID					
Action/Comments					
Inspector Comments: 1997 - Toe erosion on a cobble revetment on the outside of a low receding bend. 2012 - Toe appears pretty stable with old cobbles. 2015: No observed changes. [2015 Site ID: SAC_136-6_L]

USACE 2013 Photo #1

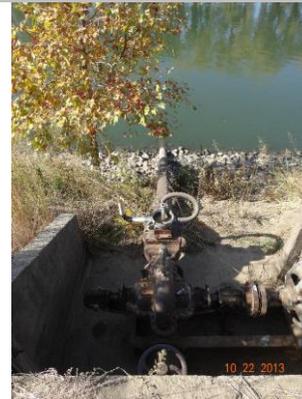
Photo 2 of 3 : UCIP\_FA\_2015\_2243.jpg

LM Start	<b>1.87</b>	Rating **	M	Issue No.	<b>775</b>
LM End	<b>1.87</b>	Issue Type +	En	Location *	WS
Category	Supplemental			GPS Latitude/Longitude	
				Start	End
Item	DWR UCIP Field Study			39.172778 °	39.172778 °
				-121.937791 °	-121.937791 °
DWR ID					
Action/Comments					
Inspector Comments: FS_ID:23888 DS_ID:21366 EP_NO: 9996 FS_HLM: 1.887 Repair Type: Non-Urgent Crossing Status: Found

View of U-concrete headwall with positive closure device, photo 1 of 2.

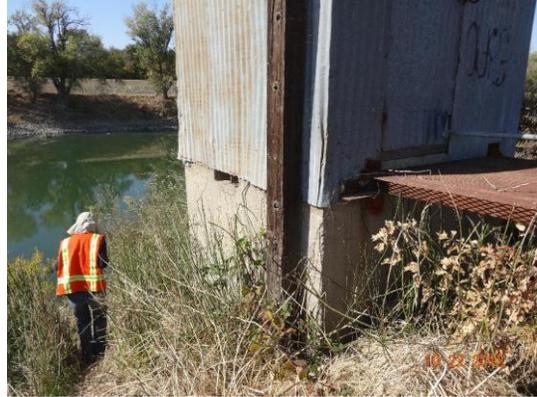
Photo 1 of 3 : UCIP\_FA\_2015\_2245.jpg

Inspector Comments: FS\_ID:23891  
 DS\_ID:21368  
 EP\_NO: 9969  
 FS\_HLM: 2.633  
 Repair Type: Non-Urgent  
 Crossing Status: Found  
 UCIP Comments: Landward slope too steep--need photo of the inside of concrete distribution box. Dense vegetation limits the inspector's visibility to identify signs of pipe failure (leaks) along the waterward slope. Recommend removing vegetation along pipe alignment to conduct proper inspection of structure and appurtenances. This crossing is referenced in the USACE Periodic Inspection as item USACE\_CESPK\_MRD2\_2012\_p\_0158.  
 FIELD\_STRUCT\_DESC: 20-inch (not 24-inch as mentioned in desk study) steel pipe through the levee, 27.0 feet below the crown. CM cutoff wall around pipe at center of levee. Pump and gate valve in pump house on the waterward slope. Discharges into concrete box at the landward toe. (USACE-1953). This entry matches the Drainage or Irrigation Structure referenced in O&M manual (Station 455+39). This pipe was retained under ABO No. 9969 (1974).

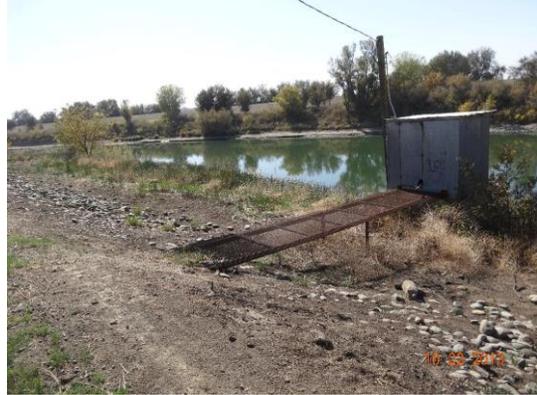
Photo 2 of 3 : UCIP\_FA\_2015\_2246.jpg

View of waterward side.

Inspector Comments: FS\_ID:23891  
 DS\_ID:21368  
 EP\_NO: 9969  
 FS\_HLM: 2.633  
 Repair Type: Non-Urgent  
 Crossing Status: Found  
 UCIP Comments: Landward slope too steep--need photo of the inside of concrete distribution box. Dense vegetation limits the inspector's visibility to identify signs of pipe failure (leaks) along the waterward slope. Recommend removing vegetation along pipe alignment to conduct proper inspection of structure and appurtenances. This crossing is referenced in the USACE Periodic Inspection as item USACE\_CESPK\_MRD2\_2012\_p\_0158.  
 FIELD\_STRUCT\_DESC: 20-inch (not 24-inch as mentioned in desk study) steel pipe through the levee, 27.0 feet below the crown. CM cutoff wall around pipe at center of levee. Pump and gate valve in pump house on the waterward slope. Discharges into concrete box at the landward toe. (USACE-1953). This entry matches the Drainage or Irrigation Structure referenced in O&M manual (Station 455+39). This pipe was retained under ABO No. 9969 (1974).

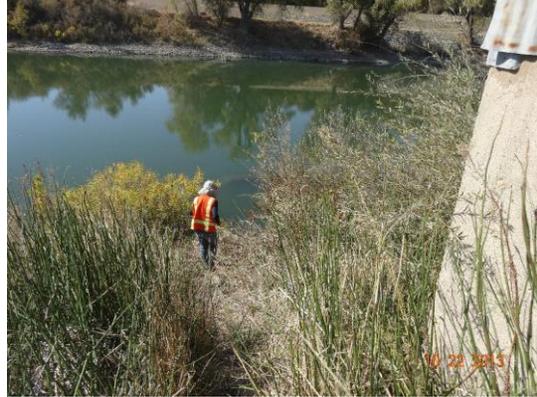
Photo 3 of 3 : UCIP\_FA\_2015\_2247.jpg

Inspector Comments: FS\_ID:23891  
 DS\_ID:21368  
 EP\_NO: 9969  
 FS\_HLM: 2.633  
 Repair Type: Non-Urgent  
 Crossing Status: Found  
 UCIP Comments: Landward slope too steep--need photo of the inside of concrete distribution box. Dense vegetation limits the inspector's visibility to identify signs of pipe failure (leaks) along the waterward slope. Recommend removing vegetation along pipe alignment to conduct proper inspection of structure and appurtenances. This crossing is referenced in the USACE Periodic Inspection as item USACE\_CESPK\_MRD2\_2012\_p\_0158.  
 FIELD\_STRUCT\_DESC: 20-inch (not 24-inch as mentioned in desk study) steel pipe through the levee, 27.0 feet below the crown. CM cutoff wall around pipe at center of levee. Pump and gate valve in pump house on the waterward slope. Discharges into concrete box at the landward toe. (USACE-1953). This entry matches the Drainage or Irrigation Structure referenced in O&M manual (Station 455+39). This pipe was retained under ABO No. 9969 (1974).

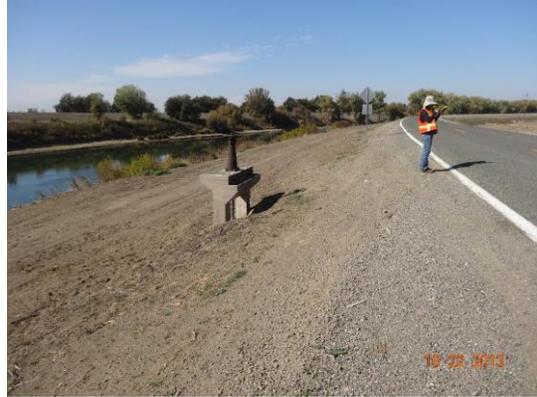
Photo 1 of 3 : UCIP\_FA\_2015\_2248.jpg

Item	DWR UCIP Field Study			39.160540 °	39.160540 °
				-121.932382 °	-121.932382 °
DWR ID					
Action/Comments					
Inspector Comments: FS_ID:23892 DS_ID:21369 EP_NO: N/A FS_HLM: 2.7984 Repair Type: Non-Urgent Crossing Status: Found UCIP Comments: If crossing is no longer used by owner, the owner will need to coordinate with DWR Inspector and CVFPB to remove crossing according to Title 23 requirements. Dense vegetation limits the inspector's visibility to identify signs of pipe failure (leaks) along the slope. Recommend removing vegetation along pipe alignment to conduct proper inspection of structure and appurtenances. This crossing is referenced in the USACE Periodic Inspection as item USACE_CESPK_MRD1_2012_p_0167. FIELD_STRUCT_DESC: Abandoned 24-inch CM pipe through the levee, 21.0 feet below the crown. Slide gate on waterward end. (Cat. IVA) FS Date: 10/22/2013

View of waterward side.

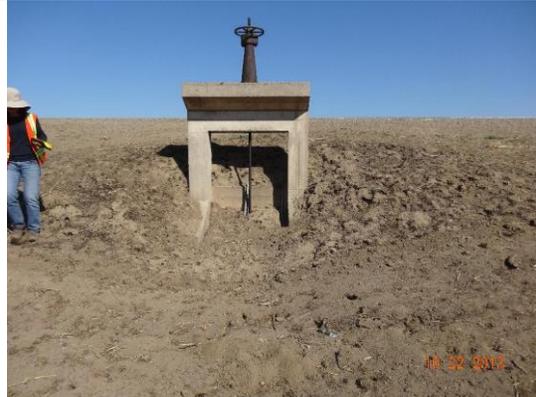
Photo 3 of 3 : UCIP\_FA\_2015\_2250.jpg

LM Start	<b>2.78</b>	Rating **	M	Issue No.	<b>778 (cont)</b>
LM End	<b>2.78</b>	Issue Type +	En	Location *	LS
Category	Supplemental			GPS Latitude/Longitude	
				Start	End
Item	DWR UCIP Field Study			39.160540 °	39.160540 °
				-121.932382 °	-121.932382 °
DWR ID					
Action/Comments					
Inspector Comments: FS_ID:23892 DS_ID:21369 EP_NO: N/A FS_HLM: 2.7984 Repair Type: Non-Urgent Crossing Status: Found

Buried screw gate located on waterward shoulder.

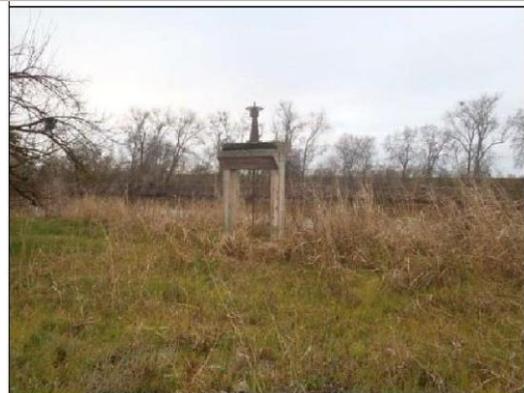
Photo 1 of 2 : UCIP\_FA\_2015\_0592.jpg

LM Start	<b>3.35</b>	Rating **	M	Issue No.	<b>779</b>
LM End	<b>3.35</b>	Issue Type +	En	Location *	LS
Category	Supplemental			GPS Latitude/Longitude	
				Start	End
Item	DWR UCIP Field Study			39.156068 °	39.156068 °
				-121.923453 °	-121.923453 °
DWR ID					
Action/Comments					
Inspector Comments: FS_ID:24115 DS_ID:21370 EP_NO: N/A FS_HLM: 3.38 Repair Type: Non-Urgent Crossing Status: Found UCIP Comments: No connection present--need to contact owner to determine if owner plans to use. If crossing is no longer in use owner will need to coordinate with DWR inspector and CVFPB to remove according to Title 23 requirements. This crossing is referenced in the USACE Periodic Inspection as USACE_CESPK_MRD2_2012_p_0197. FIELD_STRUCT_DESC: Abandoned 24-inch pipe through the levee, 18.5 feet below the crown. Slide gate on concrete gate structure on berm. FS Date: 10/22/2013

View of waterward side--photo is from USACE PI Report draft final issue USACE\_CESPK\_MRD2\_2012\_p\_0197.

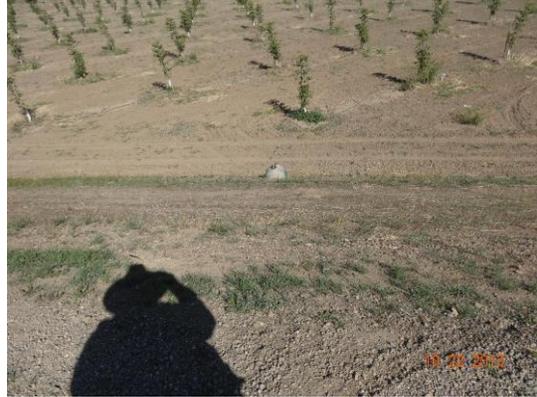
Photo 2 of 2 : UCIP\_FA\_2015\_2758.jpg

LM Start	3.40	Rating **	M	Issue No.	780 (cont)	
LM End	3.40	Issue Type +	En	Location *	LS	
Category	Supplemental			GPS Latitude/Longitude		
			Start	End		
Item	DWR UCIP Field Study			39.155648 °	39.155648 °	
				-121.922823 °	-121.922823 °	
DWR ID						
Action/Comments						
Inspector Comments: FS_ID:24117 DS_ID:21371 EP_NO: N/A FS_HLM: 3.4227 Repair Type: Non-Urgent Crossing Status: Found UCIP Comments: No connection present--need to contact owner to determine if owner plans to use. If crossing is no longer in use owner will need to coordinate with DWR inspector and CVFPB to remove according to Title 23 requirements. This crossing is referenced in the USACE Periodic Inspection as USACE_CESPK_MRD2_2012_p_0197. FIELD_STRUCT_DESC: Abandoned 24-inch pipe through the levee, 18.5 feet below the crown. Slide gate on concrete gate structure on berm. FS Date: 10/22/2013

View of pipe on landward side.

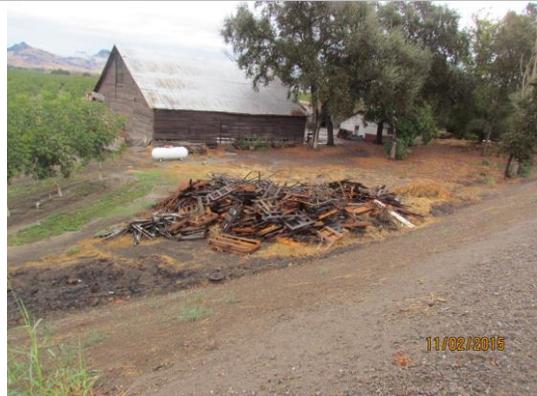
Photo 1 of 1 : FA\_2015\_RD0070\_30\_66\_20151116\_00052.jpg

View of the wood and debris along the landside toe.

LM Start	3.48	Rating **	M	Issue No.	66	
LM End	3.48	Issue Type +	En	Location *	LS	
Category	Earthen Levee			GPS Latitude/Longitude		
			Start	End		
Item	Encroachments			39.154950 °	39.154950 °	
				-121.921628 °	-121.921628 °	
DWR ID	DWR_RD0070_02_f_2015_66					
Action/Comments						
Debris Inspector Comments: Remove the wood and debris from the landside toe.

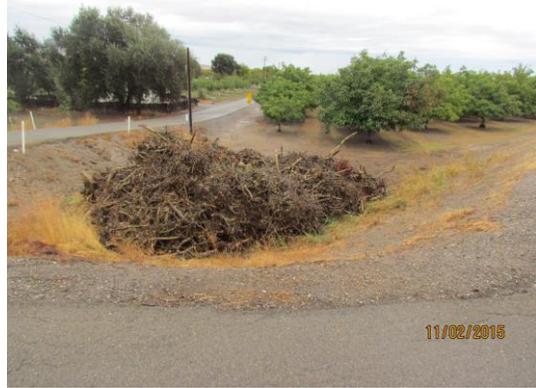
Photo 1 of 1 : FA\_2015\_RD0070\_30\_68\_20151116\_00053.jpg

View of the prunings along the landside toe.

LM Start	<b>3.57</b>	Rating **	M	Issue No.	<b>68</b>
LM End	<b>3.57</b>	Issue Type +	En	Location *	LS
Category	Earthen Levee			GPS Latitude/Longitude	
				Start	End
Item	Encroachments			39.154117 °	39.154117 °
				-121.920237 °	-121.920237 °
DWR ID	DWR_RD0070_02_f_2015_68				
Action/Comments					
Prunings Inspector Comments: Remove the prunings from the landside toe.

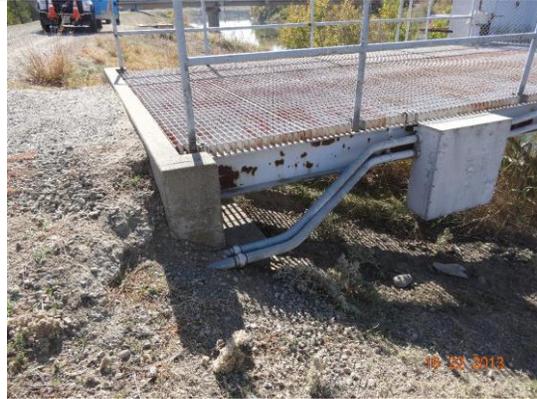
Photo 1 of 1 : UCIP\_FA\_2015\_2763.jpg

Inspector Comments: FS\_ID:24164  
 DS\_ID:21428  
 EP\_NO: N/A  
 FS\_HLM: 4.137  
 Repair Type: Non-Urgent  
 Crossing Status: Found  
 UCIP Comments: Pump station will be removed. This crossing will need to be updated once the pump station is removed. This crossing is referenced in the USACE Periodic Inspection as item USACE\_CESPK\_MRD2\_2012\_p\_0235.  
 FIELD\_STRUCT\_DESC: [Farms Water Company Pumping Plant No. 2] 3 of 3: 2.5-inch steel (not iron as mentioned in desk study) pipe through the levee, 1.9 feet below the crown. Two concrete cutoff walls, one at each shoulder. Concrete pump pit on the waterward slope. Three pumps on structure on the waterward side. Walkway to the pumps. Concrete headwall on landward side. Debris deflectors in river. (Permit No. 4525-1965). Pumping plant is to be demolished with all pipes removed and replaced with single 72-inch gravity feed pipe under Permit No. 18762 (2013).

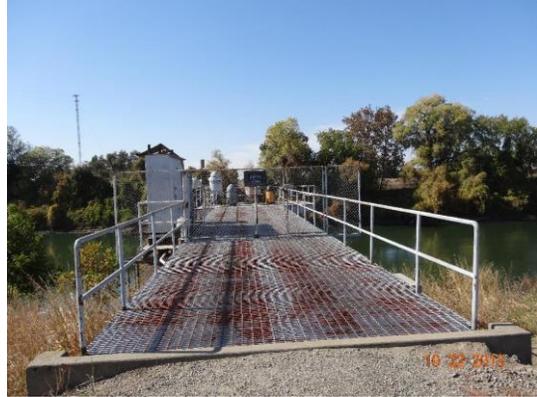
Photo 1 of 3 : UCIP\_FA\_2015\_2760.jpg

Inspector Comments: FS\_ID:24163  
 DS\_ID:21429  
 EP\_NO: N/A  
 FS\_HLM: 4.1397  
 Repair Type: Non-Urgent  
 Crossing Status: Found  
 UCIP Comments: Pump is to be demolished will all pipes removed. Will need to update record. This crossing is referenced in the USACE Periodic Inspection as item USACE\_CESPK\_MRD2\_2012\_p\_0235.  
 FIELD\_STRUCT\_DESC: [Farms Water Company Pumping Plant No. 2] 42-inch steel pipe and 2-inch PVC electrical conduit through the levee, 24.0 and 3.0 feet below the crown, respectively. Pipe is concrete encased through the levee. Two concrete cutoff walls, one at each shoulder. Slide gate in surge box on the waterward side. Concrete pump pit on the waterward slope. Three pumps on structure on the waterward side. Walkway to the pumps with electrical control box. Concrete headwall on landward side. Discharges into concrete lined irrigation ditch on the landward side. Debris deflectors in river. Power poles on landward side. (Permit No. 13380-2002). Pumping plant is to be demolished with all pipes removed and replaced with single 72-inch gravity feed pipe under Permit No. 18762 (2013).

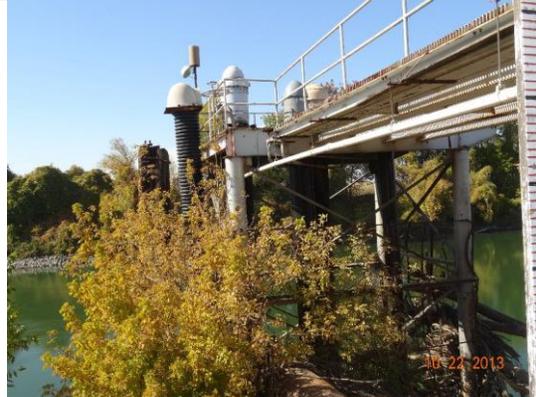
Photo 3 of 3 : UCIP\_FA\_2015\_2762.jpg

Item	DWR UCIP Field Study			39.147259 °	39.147259 °
				-121.916725 °	-121.916725 °
DWR ID					
Action/Comments					
Inspector Comments: FS_ID:24163 DS_ID:21429 EP_NO: N/A FS_HLM: 4.1397 Repair Type: Non-Urgent Crossing Status: Found UCIP Comments: Pump is to be demolished will all pipes removed. Will need to update record. This crossing is referenced in the USACE Periodic Inspection as item USACE_CESPK_MRD2_2012_p_0235. FIELD_STRUCT_DESC: [Farms Water Company Pumping Plant No. 2] 42-inch steel pipe and 2-inch PVC electrical conduit through the levee, 24.0 and 3.0 feet below the crown, respectively. Pipe is concrete encased through the levee. Two concrete cutoff walls, one at each shoulder. Slide gate in surge box on the waterward side. Concrete pump pit on the waterward slope. Three pumps on structure on the waterward side. Walkway to the pumps with electrical control box. Concrete headwall on landward side. Discharges into concrete lined irrigation ditch on the landward side. Debris deflectors in river. Power poles on landward side. (Permit No. 13380-2002). Pumping plant is to be demolished with all pipes removed and replaced with single 72-inch gravity feed pipe under Permit No. 18762 (2013). FS Date: 10/22/2013

View of pumps located on waterward side.

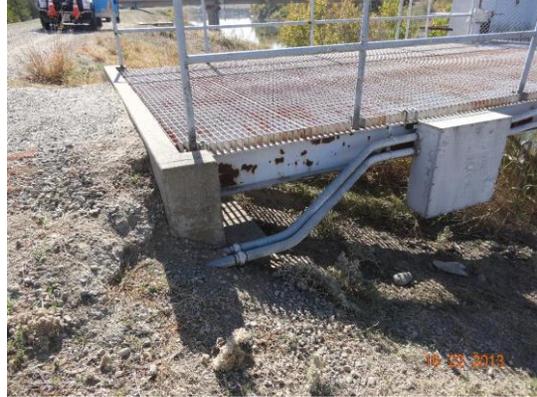
Photo 2 of 3 : UCIP\_FA\_2015\_2660.jpg

Inspector Comments: FS\_ID:23954  
 DS\_ID:21373  
 EP\_NO: N/A  
 FS\_HLM: 4.14  
 Repair Type: Non-Urgent  
 Crossing Status: Indicator Found  
 UCIP Comments: Unable to confirm 52-inch pipe only found 42-inch pipe. Pump station is to be removed. Need to update record once crossing has been modified. This crossing is referenced in the USACE Periodic Inspection as item USACE\_CESPK\_MRD2\_2012\_p\_0235.  
 FIELD\_STRUCT\_DESC: [Farms Water Company Pumping Plant No. 1] 1 of 3: 54-inch steel pipe through the levee, 24.0 feet below the crown. Pipe is concrete encased through the levee. Two concrete cutoff walls, one at each shoulder. Slide gate in surge box on the waterward side. Concrete pump pit on the waterward slope. Three pumps on structure on the waterward side. Walkway to the pumps. Concrete headwall on landward side. Discharges into concrete lined irrigation ditch on the landward side. Debris deflectors in river. (Permit No. 4525-1965). Pumping plant is to be demolished with all pipes removed and replaced with single 72-inch gravity feed pipe under Permit No. 18762 (2013).

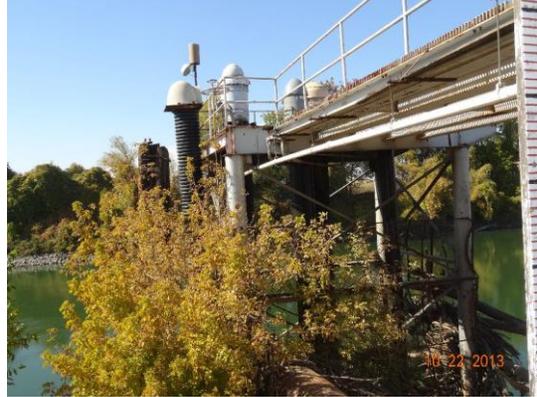
Photo 3 of 3 : UCIP\_FA\_2015\_2661.jpg

Inspector Comments: FS\_ID:23954  
 DS\_ID:21373  
 EP\_NO: N/A  
 FS\_HLM: 4.14  
 Repair Type: Non-Urgent  
 Crossing Status: Indicator Found  
 UCIP Comments: Unable to confirm 52-inch pipe only found 42-inch pipe. Pump station is to be removed. Need to update record once crossing has been modified. This crossing is referenced in the USACE Periodic Inspection as item USACE\_CESPK\_MRD2\_2012\_p\_0235.  
 FIELD\_STRUCT\_DESC: [Farms Water Company Pumping Plant No. 1] 1 of 3: 54-inch steel pipe through the levee, 24.0 feet below the crown. Pipe is concrete encased through the levee. Two concrete cutoff walls, one at each shoulder. Slide gate in surge box on the waterward side. Concrete pump pit on the waterward slope. Three pumps on structure on the waterward side. Walkway to the pumps. Concrete headwall on landward side. Discharges into concrete lined irrigation ditch on the landward side. Debris deflectors in river. (Permit No. 4525-1965). Pumping plant is to be demolished with all pipes removed and replaced with single 72-inch gravity feed pipe under Permit No. 18762 (2013).

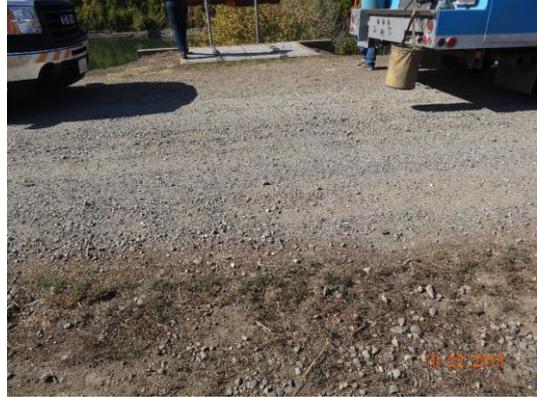
Photo 1 of 3 : UCIP\_FA\_2015\_2764.jpg

View of levee crown.

Inspector Comments: FS\_ID:24165  
 DS\_ID:21374  
 EP\_NO: 767  
 FS\_HLM: 4.153  
 Repair Type: Non-Urgent  
 Crossing Status: Found  
 UCIP Comments: Need to contact owner to determine if crossing is still active and to determine last inspection date. Will need copy of letter showing crossings passed inspection. This crossing is referenced in the USACE Periodic Inspection as item USACE\_CESPK\_MRD2\_2012\_p\_0237.  
 FIELD\_STRUCT\_DESC: 3.0-inch steel gas pipe (not 3.5-inch as mentioned in desk study) through the levee, 3.0 feet below the crown. Concrete inspection well (8x10x1 foot) with metal cover on waterward shoulder. Painted aluminum marker on waterward side. Rock revetment on waterward slope. (Permit No. 767-1938) Contact information provided on marker 916-742-7344 and for emergencies call 916-742-3251.  
 FS Date: 10/22/2013

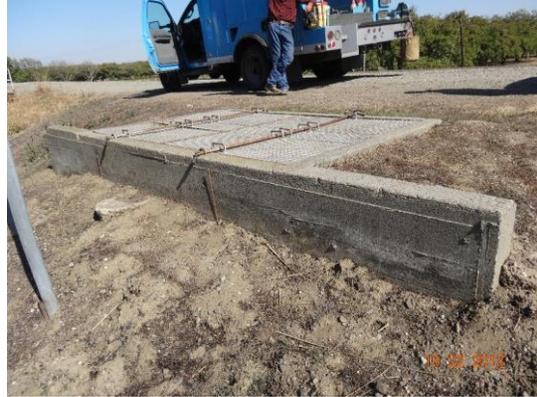
Photo 2 of 3 : UCIP\_FA\_2015\_2765.jpg

Concrete headwall on waterward side.

Inspector Comments: FS\_ID:24165  
 DS\_ID:21374  
 EP\_NO: 767  
 FS\_HLM: 4.153  
 Repair Type: Non-Urgent  
 Crossing Status: Found  
 UCIP Comments: Need to contact owner to determine if crossing is still active and to determine last inspection date. Will need copy of letter showing crossings passed inspection. This crossing is referenced in the USACE Periodic Inspection as item USACE\_CESPK\_MRD2\_2012\_p\_0237.  
 FIELD\_STRUCT\_DESC: 3.0-inch steel gas pipe (not 3.5-inch as mentioned in desk study) through the levee, 3.0 feet below the crown. Concrete inspection well (8x10x1 foot) with metal cover on waterward shoulder. Painted aluminum marker on waterward side. Rock revetment on waterward slope. (Permit No. 767-1938) Contact information provided on marker 916-742-7344 and for emergencies call 916-742-3251.  
 FS Date: 10/22/2013

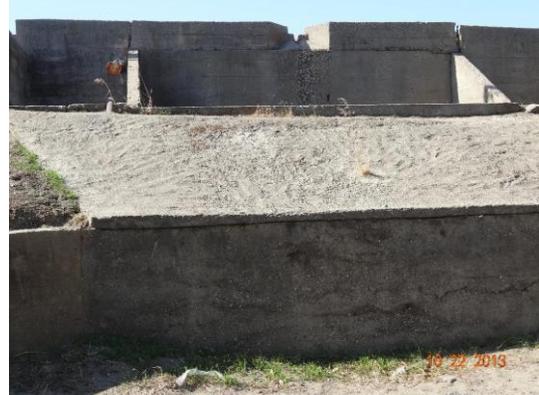
Photo 1 of 1 : UCIP\_FA\_2015\_2815.jpg

Inspector Comments: FS\_ID:23959  
 DS\_ID:21375  
 EP\_NO: 1123  
 FS\_HLM: 4.203  
 Repair Type: Non-Urgent  
 Crossing Status: Indicator Found  
 UCIP Comments: No connection present. If crossing is no longer in use owner will need to coordinate with DWR inspector and CVFPB to remove according to Title 23 requirements. This crossing is referenced in the USACE Periodic Inspection as item USACE\_CESPK\_MRD2\_2012\_p\_0240.  
 FIELD\_STRUCT\_DESC: 1 of 3: 10-inch pipe through the levee, 2.0 feet below the crown. Seed washing plant with concrete catch basin and pan on the landward slope. Concrete sump on waterward slope. Intake pump on waterward slope. (Permit No. 1123-1946) This entry matches the Drainage or Irrigation Structure referenced in O&M manual (Station 496+25).  
 FS Date: 10/22/2013

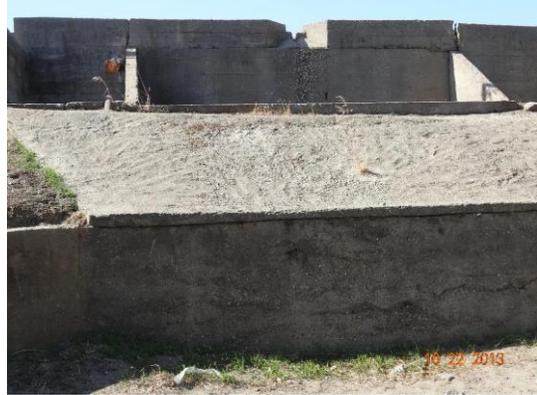
Photo 1 of 1 : UCIP\_FA\_2015\_0579.jpg

**Action/Comments**  
 Inspector Comments: FS\_ID:23960  
 DS\_ID:21424  
 EP\_NO: 1123  
 FS\_HLM: 4.206  
 Repair Type: Non-Urgent  
 Crossing Status: Indicator Found  
 UCIP Comments: No connection present. If crossing is no longer in use owner will need to coordinate with DWR inspector and CVFPB to remove according to Title 23 requirements. This crossing is referenced in the USACE Periodic Inspection as item USACE\_CESPK\_MRD2\_2012\_p\_0240.  
 FIELD\_STRUCT\_DESC: 2 of 3: 4-inch pipe through the levee, 2.0 feet below the crown. Seed washing plant with concrete catch basin and pan on the landward slope. Concrete sump on waterward slope. Intake pump on waterward slope. (Permit No. 1123-1946) This entry matches the Drainage or Irrigation Structure referenced in O&M manual (Station 496+25).  
 FS Date: 10/22/2013

Concrete headwall located on landward side--no pipe. Only visible pipe is the pipe located at the far left (downstream end).

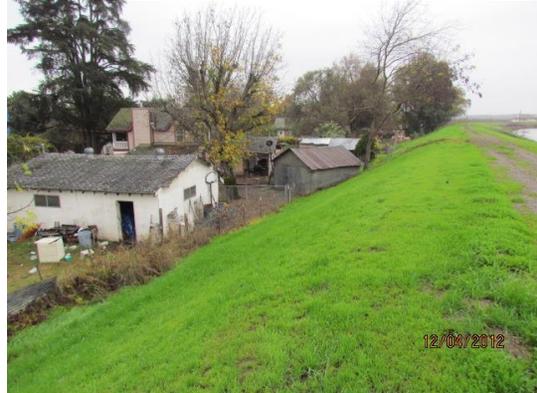
Photo 1 of 1 : FA\_2015\_RD0070\_30\_13\_20150910\_00010.jpg

LM Start	<b>4.32</b>	Rating **	M	Issue No.	<b>13</b>
LM End	<b>4.32</b>	Issue Type +	En	Location *	LS
Category	Earthen Levee			GPS Latitude/Longitude	
				Start	End
Item	Encroachments			39.144233 °	39.144233 °
				-121.917413 °	-121.917413 °
DWR ID	DWR_RD0070_02_f_2012_13				
Action/Comments					
Building

View of the buildings along the landside toe of the levee.

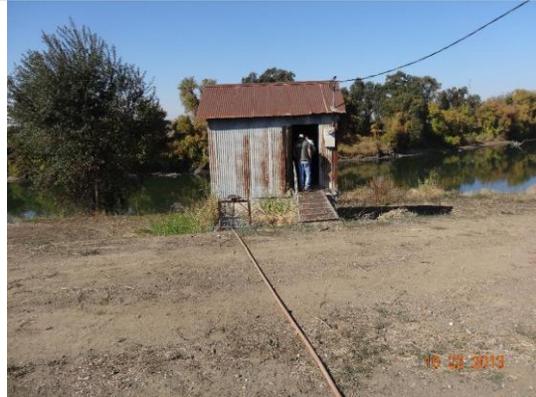
Photo 1 of 3 : UCIP\_FA\_2015\_2752.jpg

LM Start	<b>4.55</b>	Rating **	M	Issue No.	<b>789</b>
LM End	<b>4.55</b>	Issue Type +	En	Location *	WS
Category	Supplemental			GPS Latitude/Longitude	
				Start	End
Item	DWR UCIP Field Study			39.141254 °	39.141254 °
				-121.919221 °	-121.919221 °
DWR ID					
Action/Comments					
Inspector Comments: FS_ID:23962 DS_ID:21379 EP_NO: 9998 FS_HLM: 4.59 Repair Type: Non-Urgent Crossing Status: Found

View of pump house located on waterward side.

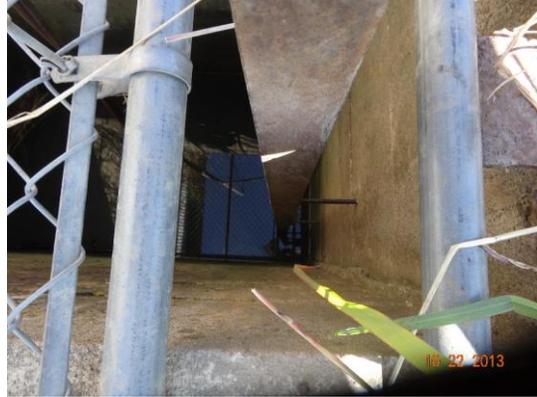
Photo 2 of 3 : UCIP\_FA\_2015\_2753.jpg

Inspector Comments: FS\_ID:23962  
 DS\_ID:21379  
 EP\_NO: 9998  
 FS\_HLM: 4.59  
 Repair Type: Non-Urgent  
 Crossing Status: Found  
 UCIP Comments: Unable to confirm if crossing corresponds to permit 9998. Pipe size is different then the pipe size listed in the desk study. Unable to confirm if structure on landward side is a pump house. Need to coordinate with owner to obtain permit record for crossing. Need to verify status of crossing. Permit authorized 24 inch pipe. Pipe through levee is 30 inches. Unable to find stand pipe in field. Dense vegetation limits the inspector's visibility to identify signs of pipe failure (leaks) along the slope. Recommend removing vegetation along pipe alignment to conduct proper inspection of structure and appurtenances. This crossing is referenced in the USACE Periodic Inspection as item USACE\_CESPK\_MRD2\_2012\_p\_0264.  
 FIELD\_STRUCT\_DESC: 30-inch (not 24-inch as indicated in desk study) CM pipe through the levee, 15.5 feet below the crown. Slide gate in concrete distribution box at landward toe. Pump in pumphouse at landward side. Service pole and ramp on waterward slope. Concrete box with air vents at waterward end. (USACE-1953). This entry matches the Drainage or Irrigation Structure referenced in O&M manual (Station 516+06). This pipe was retained under ABO No. 9998 (1974). 18-inch PVC pipe sleeved through the 24-inch pipe under Permit No. 16228 (1994). Annular gap grouted.

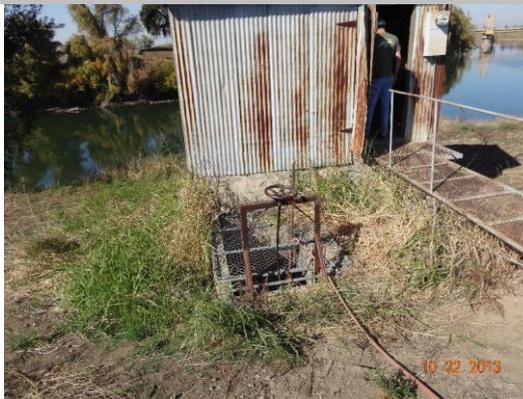
Photo 3 of 3 : UCIP\_FA\_2015\_2754.jpg

Inspector Comments: FS\_ID:23962  
 DS\_ID:21379  
 EP\_NO: 9998  
 FS\_HLM: 4.59  
 Repair Type: Non-Urgent  
 Crossing Status: Found  
 UCIP Comments: Unable to confirm if crossing corresponds to permit 9998. Pipe size is different then the pipe size listed in the desk study. Unable to confirm if structure on landward side is a pump house. Need to coordinate with owner to obtain permit record for crossing. Need to verify status of crossing. Permit authorized 24 inch pipe. Pipe through levee is 30 inches. Unable to find stand pipe in field. Dense vegetation limits the inspector's visibility to identify signs of pipe failure (leaks) along the slope. Recommend removing vegetation along pipe alignment to conduct proper inspection of structure and appurtenances. This crossing is referenced in the USACE Periodic Inspection as item USACE\_CESPK\_MRD2\_2012\_p\_0264.  
 FIELD\_STRUCT\_DESC: 30-inch (not 24-inch as indicated in desk study) CM pipe through the levee, 15.5 feet below the crown. Slide gate in concrete distribution box at landward toe. Pump in pumphouse at landward side. Service pole and ramp on waterward slope. Concrete box with air vents at waterward end. (USACE-1953). This entry matches the Drainage or Irrigation Structure referenced in O&M manual (Station 516+06). This pipe was retained under ABO No. 9998 (1974). 18-inch PVC pipe sleeved through the 24-inch pipe under Permit No. 16228 (1994). Annular gap grouted.

Positive closure device located at the waterward side inside concrete distribution box.

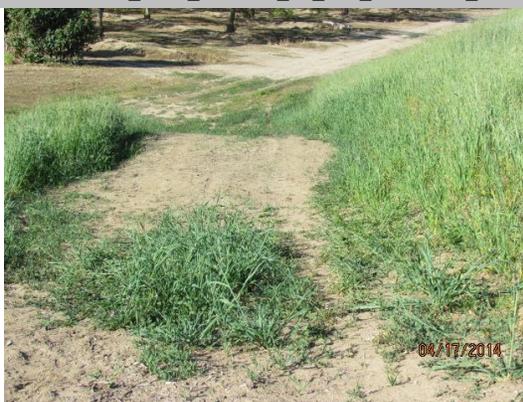
Photo 1 of 1 : FA\_2015\_RD0070\_30\_770\_20150910\_00021.jpg

LM Start	<b>4.57</b>	Rating **	M	Issue No.	<b>770</b>
LM End	<b>4.57</b>	Issue Type +	Ma	Location *	LS
Category	Earthen Levee			GPS Latitude/Longitude	
				Start	End
Item	Erosion / Bank Caving			39.141155 °	39.141155 °
				-121.919432 °	-121.919432 °
DWR ID	DWR_RD0070_02_s_2014_770

View of the damaged ramp along the landside slope.

Schedule repair of erosion site prior to the next inspection.

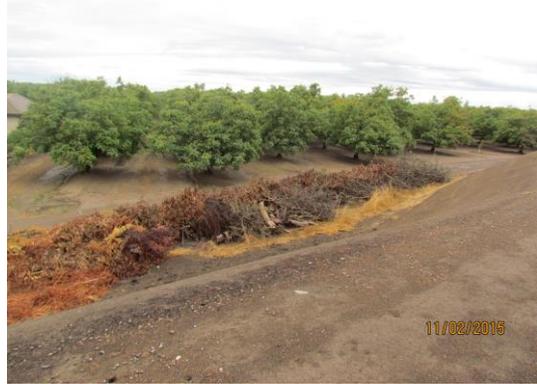
Photo 1 of 1 : FA\_2015\_RD0070\_30\_69\_20151116\_00055.jpg

LM Start	<b>4.59</b>	Rating **	M	Issue No.	<b>69</b>
LM End	<b>4.59</b>	Issue Type +	En	Location *	LS
Category	Earthen Levee			GPS Latitude/Longitude	
				Start	End
Item	Encroachments			39.140965 °	39.140965 °
				-121.919900 °	-121.919900 °
DWR ID	DWR_RD0070_02_f_2015_69				
Action/Comments					
Prunings Inspector Comments: Remove the prunings from the landside toe.

View of the prunings along the landside toe.

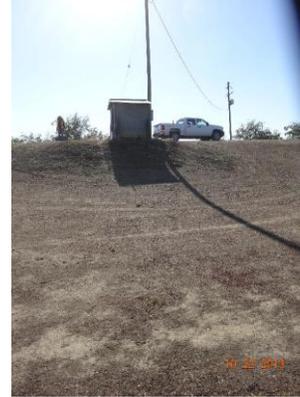
Photo 2 of 3 : UCIP\_FA\_2015\_2768.jpg

Item	DWR UCIP Field Study			39.141136 °	39.141136 °
				-121.922785 °	-121.922785 °
DWR ID					
<b>Action/Comments</b>					
Inspector Comments: FS_ID:24166 DS_ID:21380 EP_NO: 9970 FS_HLM: 4.795 Repair Type: Non-Urgent Crossing Status: Found UCIP Comments: Need to coordinate with owner to determine status of crossing. No pump is located inside the pump house located on waterward side. If crossing is no longer in use owner will need to contact the CVFPB to comply with Title 23. Dense vegetation limits the inspector's visibility to identify signs of pipe failure (leaks) along the slope. Recommend removing vegetation along pipe alignment to conduct proper inspection of structure and appurtenances. This crossing is referenced in the USACE Periodic Inspection as item USACE_CESPK_MRD2_2012_p_0274. FIELD_STRUCT_DESC: 10-inch steel pipe through the levee, 4.8 feet below the crown. CM cutoff wall around pipe at center of levee. Siphon breaker on landward slope--not found. Pump in pump house on waterward shoulder. Shut-off valve on landward side. Concrete discharge box at landward toe. (USACE-1953). This entry matches the Drainage or Irrigation Structure referenced in O&M manual (Station 526+71). This pipe was retained under ABO No. 9970 (1974). FS Date: 10/22/2013

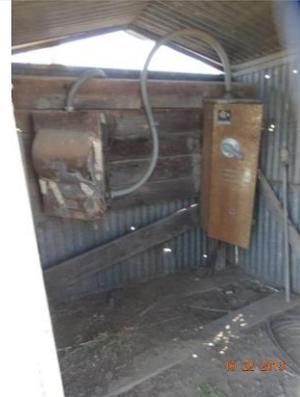
Photo 3 of 3 : UCIP\_FA\_2015\_2769.jpg

LM Start	4.76	Rating **	M	Issue No.	790 (cont)
LM End	4.76	Issue Type +	En	Location *	LS
Category	Supplemental			GPS Latitude/Longitude	
			Start	End	
Item	DWR UCIP Field Study			39.141136 °	39.141136 °
				-121.922785 °	-121.922785 °
DWR ID					
Action/Comments					
Inspector Comments: FS_ID:24166 DS_ID:21380 EP_NO: 9970 FS_HLM: 4.795 Repair Type: Non-Urgent Crossing Status: Found UCIP Comments: Need to coordinate with owner to determine status of crossing. No pump is located inside the pump house located on waterward side. If crossing is no longer in use owner will need to contact the CVFPB to comply with Title 23. Dense vegetation limits the inspector's visibility to identify signs of pipe failure (leaks) along the slope. Recommend removing vegetation along pipe alignment to conduct proper inspection of structure and appurtenances. This crossing is referenced in the USACE Periodic Inspection as item USACE_CESPK_MRD2_2012_p_0274. FIELD_STRUCT_DESC: 10-inch steel pipe through the levee, 4.8 feet below the crown. CM cutoff wall around pipe at center of levee. Siphon breaker on landward slope--not found. Pump in pump breaker on waterward shoulder. Shut-off valve on landward side. Concrete discharge box at landward toe. (USACE-1953). This entry matches the Drainage or Irrigation Structure referenced in O&M manual (Station 526+71). This pipe was retained under ABO No. 9970 (1974). FS Date: 10/22/2013

View of the inside of pump house--no pump.

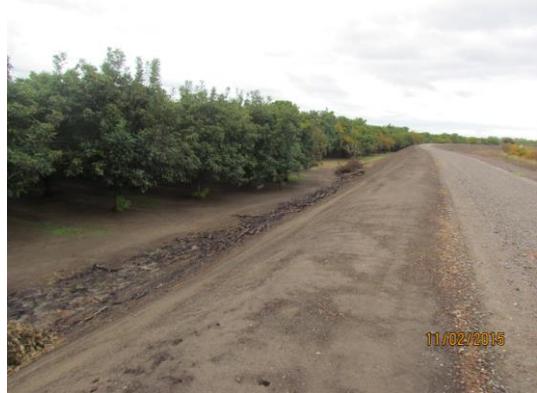
Photo 1 of 1 : FA\_2015\_RD0070\_30\_18\_20151116\_00056.jpg

LM Start	<b>5.04</b>	Rating **	M	Issue No.	<b>18</b>
LM End	<b>5.04</b>	Issue Type +	En	Location *	LS
Category	Earthen Levee			GPS Latitude/Longitude	
				Start	End
Item	Encroachments			39.142023 °	39.142023 °
				-121.927828 °	-121.927828 °
DWR ID	DWR_RD0070_02_s_2012_18				
Action/Comments					
Prunings Inspector Comments: Remove the prunings from the landside toe

View of the prunings along the landside toe.
