**Flood Control Project Maintenance  
Levee Inspections**

**Fall 2015 Levee Maintenance Deficiency Summary Report**

**Sacramento River Basin**

**Reclamation District No. 0070 Meridian**

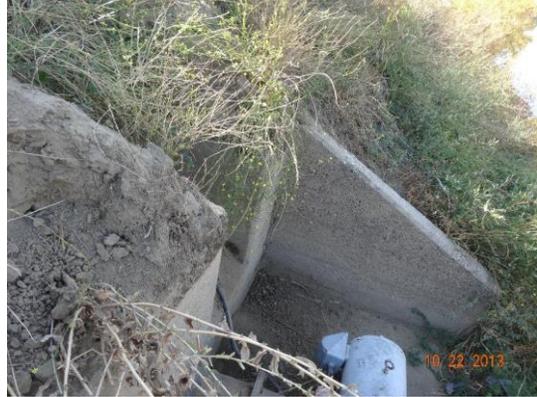
Photo 2 of 3 : UCIP\_FA\_2015\_2755.jpg

LM Start	5.30	Rating **	M	Issue No.	771 (cont)
LM End	5.30	Issue Type +	En	Location *	LS
Category	Supplemental			GPS Latitude/Longitude	
			Start	End	
Item	DWR UCIP Field Study			39.142049 °	39.142049 °
				-121.932651 °	-121.932651 °
DWR ID	DWR_RD0070_02_f_2015_771				
Action/Comments					
Inspector Comments: FS_ID:23964 DS_ID:21383 EP_NO: 9984 FS_HLM: 5.3411 Repair Type: Non-Urgent Crossing Status: Found UCIP Comments: Will need to contact owner. Need to obtain maintenance records and clarify modifications made at to crossing (size). Additional crossing visible through concrete headwall on landward side--crossing has been capped (see photo). NEED TO CONFIRM PIPE SIZE!!! This crossing is referenced in the USACE Periodic Inspection as item USACE_CESPK_MRD2_2012_p_0289. FIELD_STRUCT_DESC: 12-inch (not 24-inch as mentioned in desk study) steel pipe through the levee, 13.8 feet below the crown. Gate valve on the waterward side. Pump in pump house on the waterward side. Concrete distribution box at the landward toe. (USACE-1953). This entry matches the Drainage or Irrigation Structure referenced in O&M manual (Station 555+09). This pipe was retained under ABO No. 9984 (1974). FS Date: 10/22/2013

Crossing appears altered on waterward side.

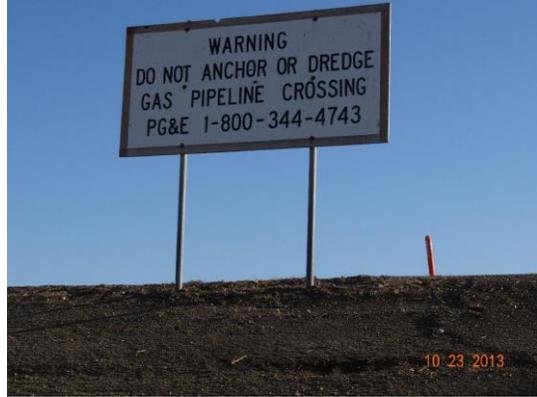
Photo 2 of 3 : UCIP\_FA\_2015\_0582.jpg

LM Start	6.28	Rating **	M	Issue No.	791 (cont)
LM End	6.28	Issue Type +	En	Location *	LS
Category	Supplemental			GPS Latitude/Longitude	
				Start	End
Item	DWR UCIP Field Study			39.133847 °	39.133847 °
				-121.937689 °	-121.937689 °
DWR ID					
Action/Comments					
Inspector Comments: FS_ID:23965 DS_ID:21385 EP_NO: 4383 FS_HLM: 6.335 Repair Type: Non-Urgent Crossing Status: Found UCIP Comments: Need to contact owner to determine if crossing is still active and to determine last inspection date. Will need copy of letter showing crossings passed inspection. This crossing is referenced in the USACE Periodic Inspection as item USACE_CESPK_MRD2_2012_p_0319. FIELD_STRUCT_DESC: 8 5/8-inch steel gas pipe through the levee, 3.5 feet below the crown. Concrete cutoff wall around pipe at center of levee. Rock revetment on waterward slope. (Permit No. 4383-1963) FS Date: 10/23/2013

Sign visible on waterward side.

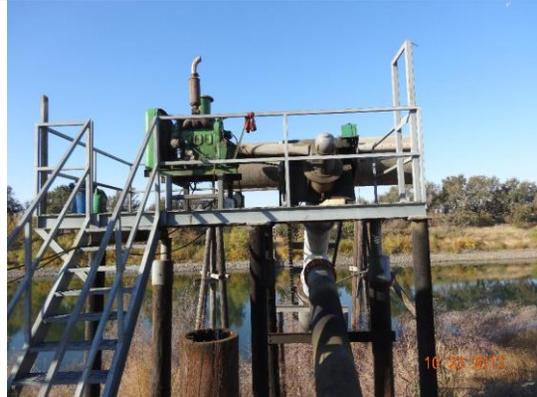
Photo 1 of 3 : UCIP\_FA\_2015\_0594.jpg

LM Start	<b>6.33</b>	Rating **	M	Issue No.	<b>792</b>
LM End	<b>6.33</b>	Issue Type +	En	Location *	LS
Category	Supplemental			GPS Latitude/Longitude	
				Start	End
Item	DWR UCIP Field Study			39.133219 °	39.133219 °
				-121.937169 °	-121.937169 °
DWR ID					
Action/Comments					
Inspector Comments: FS_ID:46424 DS_ID:21386 EP_NO: 9994 FS_HLM: 6.387 Repair Type: Non-Urgent Crossing Status: Found

Stairs and platform located on waterward side.

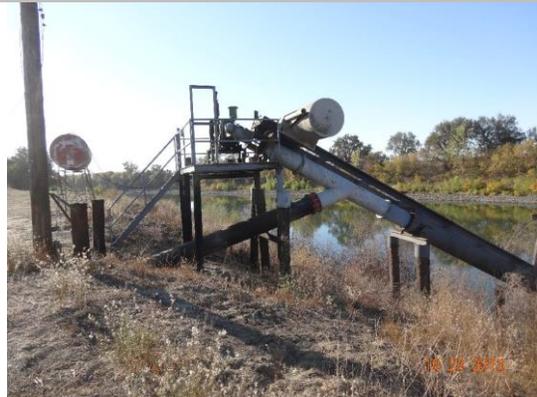
Photo 2 of 3 : UCIP\_FA\_2015\_0595.jpg

Pipe and pump set up on waterward side.

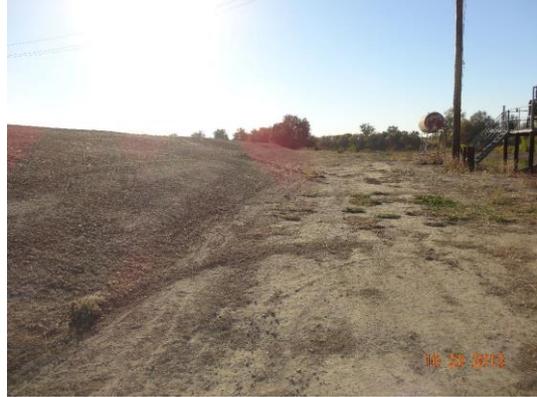
Photo 3 of 3 : UCIP\_FA\_2015\_2859.jpg

LM Start	<b>6.33</b>	Rating **	M	Issue No.	<b>792 (cont)</b>
LM End	<b>6.33</b>	Issue Type +	En	Location *	LS
Category	Supplemental			GPS Latitude/Longitude	
				Start	End
Item	DWR UCIP Field Study			39.133219 °	39.133219 °
				-121.937169 °	-121.937169 °
DWR ID					
Action/Comments					
Inspector Comments: FS_ID:46424 DS_ID:21386 EP_NO: 9994 FS_HLM: 6.387 Repair Type: Non-Urgent Crossing Status: Found

View of levee slope and berm on waterward side.

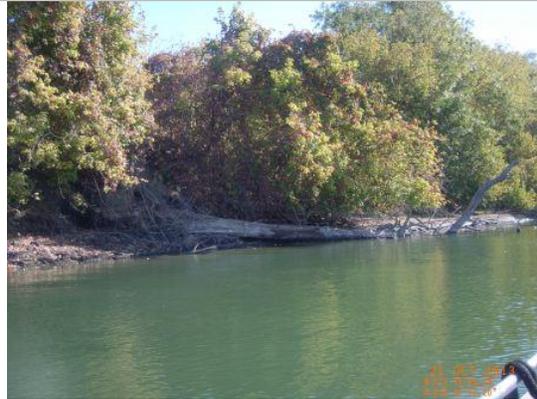
Photo 1 of 1 : USACE2013A\_SAC\_131-8\_L\_6.jpg

LM Start	<b>6.42</b>	Rating **	M	Issue No.	<b>11</b>
LM End	<b>6.54</b>	Issue Type +	Ma	Location *	WS
Category	Supplemental			GPS Latitude/Longitude	
				Start	End
Item	2015 USACE Erosion Survey, DRAFT			39.132040 °	39.130900 °
				-121.936521 °	-121.934690 °
DWR ID					
Action/Comments					
Inspector Comments: 2005 - (known as 132) On inside of bend. Erosion of berm toe. Levee slope is steep. Erosion probably due to eddy scour off upstream cobble. 2009 - Groins may be a good option for repair. 2010 - Scour off the upstream rock, some new erosion. 2011 - Site extended downstream. 2012 - Minor new erosion since last year and new animal holes. 2012 - Minor new erosion since last year and new animal holes. 2013 - New tree popout. 2015: No observed changes. [2015 Site ID: SAC_131-8_L]

USACE 2013 Photo #1

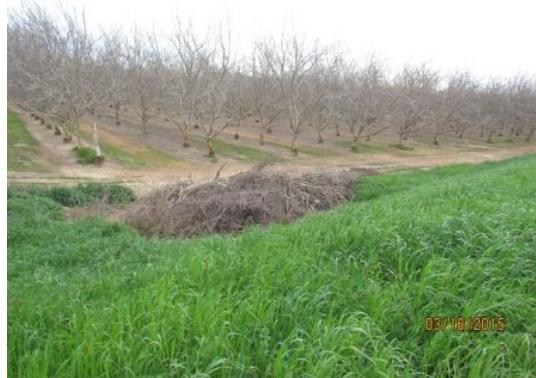
Photo 1 of 1 : FA\_2015\_RD0070\_30\_26\_20150910\_00017.jpg

LM Start	<b>7.64</b>	Rating **	M	Issue No.	<b>26</b>
LM End	<b>7.64</b>	Issue Type +	En	Location *	LS
Category	Earthen Levee		GPS Latitude/Longitude		
			Start	End	
Item	Encroachments		39.124493 °	39.124493 °	
			-121.917105 °	-121.917105 °	
DWR ID	DWR_RD0070_02_s_2013_26				
Action/Comments					
Prunings Inspector Comments: Remove the prunings from the landside toe.

View of the prunings along the landside toe.

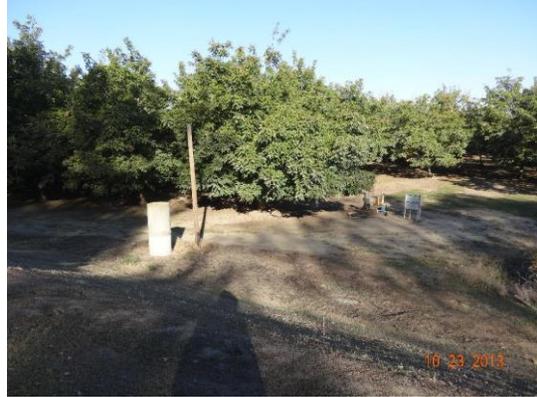
Photo 2 of 3 : UCIP\_FA\_2015\_0585.jpg

Action/Comments					
Inspector Comments: FS_ID:23966 DS_ID:21387 EP_NO: 9966 FS_HLM: 7.8857 Repair Type: Non-Urgent Crossing Status: Indicator Found UCIP Comments: Pipe daylight at waterward side blocked. Unable to determine if connection is present--need to contact owner to determine if owner plans to use. If crossing is no longer in use owner will need to coordinate with DWR inspector and CVFPB to remove according to Title 23 requirements. Unable to determine if crossing is in use. This crossing is referenced in the USACE Periodic Inspection as item USACE_CESPK_MRD2_2012_p_0371. FIELD_STRUCT_DESC: 10-inch steel pipe and 1.5-inch electrical conduit through the levee, 12.0 and 8.0 feet below the crown, respectively. Pipe is concrete encased under the crown, between the shoulders. Two concrete cutoff walls under each shoulder. Pump and gate valve on pile structure in stream. Walkway to pump. Concrete standpipe on the landward side. (USACE-1953). This entry matches the Drainage or Irrigation Structure referenced in O&M manual (Station 689+50). Pipe and conduit were retained under ABO No. 11496 (1975). FS Date: 10/23/2013

Stand pipe located on landward side.

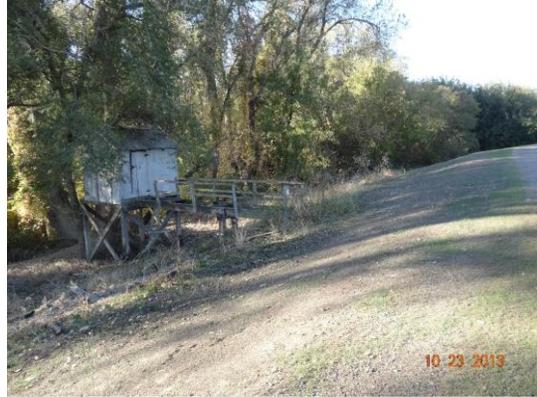
Photo 3 of 3 : UCIP\_FA\_2015\_0586.jpg

Action/Comments					
Inspector Comments: FS_ID:23966 DS_ID:21387 EP_NO: 9966 FS_HLM: 7.8857 Repair Type: Non-Urgent Crossing Status: Indicator Found UCIP Comments: Pipe daylight at waterward side blocked. Unable to determine if connection is present--need to contact owner to determine if owner plans to use. If crossing is no longer in use owner will need to coordinate with DWR inspector and CVFPB to remove according to Title 23 requirements. Unable to determine if crossing is in use. This crossing is referenced in the USACE Periodic Inspection as item USACE_CESPK_MRD2_2012_p_0371. FIELD_STRUCT_DESC: 10-inch steel pipe and 1.5-inch electrical conduit through the levee, 12.0 and 8.0 feet below the crown, respectively. Pipe is concrete encased under the crown, between the shoulders. Two concrete cutoff walls under each shoulder. Pump and gate valve on pile structure in stream. Walkway to pump. Concrete standpipe on the landward side. (USACE-1953). This entry matches the Drainage or Irrigation Structure referenced in O&M manual (Station 689+50). Pipe and conduit were retained under ABO No. 11496 (1975). FS Date: 10/23/2013

Pump house located on waterward side.

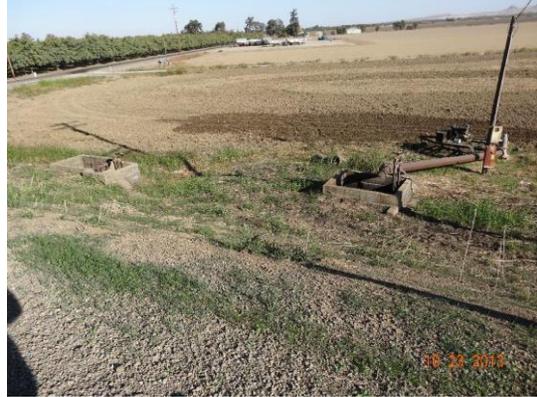
Photo 1 of 3 : UCIP\_FA\_2015\_0568.jpg

Item	DWR UCIP Field Study			39.124543 °	39.124543 °
				-121.911996 °	-121.911996 °
DWR ID					
Action/Comments					
Inspector Comments: FS_ID:24191 DS_ID:21389 EP_NO: 1264 FS_HLM: 7.9825 Repair Type: Non-Urgent Crossing Status: Indicator Found UCIP Comments: Need to coordinate with owner to determine status of crossing. If crossing is no longer in use owner will need to contact the CVFPB to comply with Title 23. This crossing is referenced in the USACE Periodic Inspection as item USACE_CESPK_MRD2_2012_p_0124. FIELD_STRUCT_DESC: Abandoned 10-inch (not 14-inch as specified in desk study) pipe through the levee, 5.0 feet below the crown. Pump on the waterward side. Double concrete discharge box at landward toe. (Permit No. 1264-1948) FS Date: 10/23/2013

View of landward side--two crossing nearby.

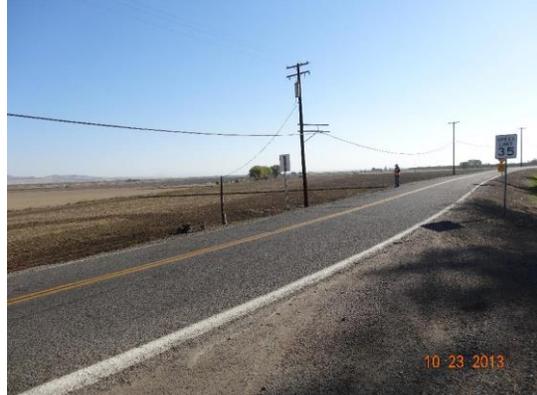
Photo 2 of 3 : UCIP\_FA\_2015\_0569.jpg

View of levee crown at crossing.

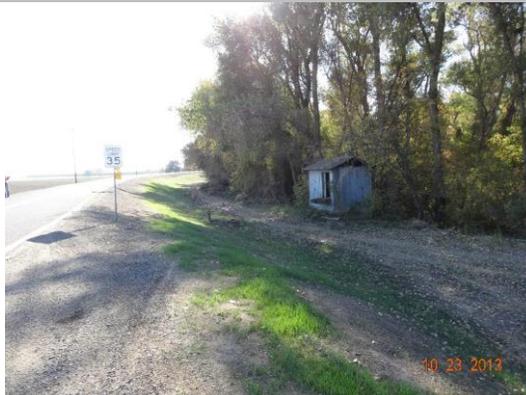
Photo 3 of 3 : UCIP\_FA\_2015\_0570.jpg

View of waterward side--only pump house of nearby crossing located downstream from crossing.

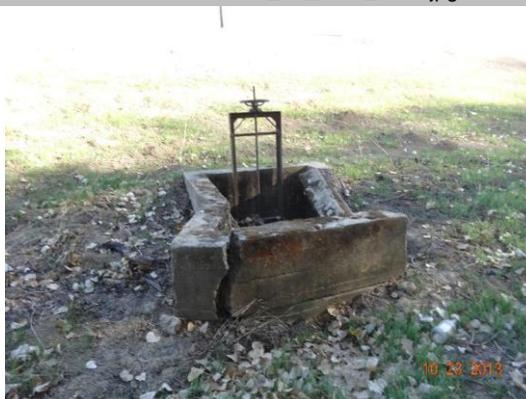
Photo 1 of 3 : UCIP\_FA\_2015\_0567.jpg

Item	DWR UCIP Field Study			39.124460 °	39.124460 °
				-121.911932 °	-121.911932 °
DWR ID					
Action/Comments					
Inspector Comments: FS_ID:24190 DS_ID:21388 EP_NO: 10008 FS_HLM: 7.9873 Repair Type: Non-Urgent Crossing Status: Found UCIP Comments: Concrete distribution box is damage on waterward side. Need to contact owner to determine status of crossing. If crossing is no longer in use owner will need to coordinate with DWR inspector and CVFPB to remove according to Title 23 requirements. This crossing is referenced in the USACE Periodic Inspection as item USACE_CESPK_MRD2_2012_p_0380. FIELD_STRUCT_DESC: Abandoned 18-inch steel pipe through the levee, 15.0 feet below the crown. Pump in pump house and slide gate on the waterward side. (USACE-1953). This entry matches the Drainage or Irrigation Structure referenced in O&M manual (Station 694+85). Concrete distribution box on landward side. This pipe was retained under ABO No. 10008 (1974). During field verification additional appurtenances were observed. An additional pipe on landward side drains into concrete distribution box. The concrete box connects to a second set of distribution boxes through a 24-inch concrete pipe approximately 36 feet upstream of crossing. Those boxes have a 10-inch pipe that appears to go through levee. FS Date: 10/23/2013

Damage concrete distribution box located on waterward side.

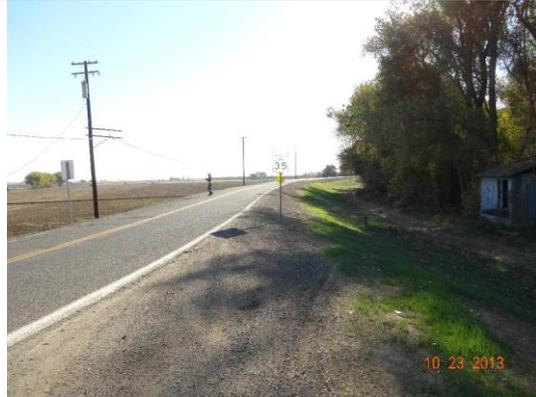
Photo 2 of 3 : UCIP\_FA\_2015\_2726.jpg

Inspector Comments: FS\_ID:24190  
 DS\_ID:21388  
 EP\_NO: 10008  
 FS\_HLM: 7.9873  
 Repair Type: Non-Urgent  
 Crossing Status: Found  
 UCIP Comments: Concrete distribution box is damage on waterward side. Need to contact owner to determine status of crossing. If crossing is no longer in use owner will need to coordinate with DWR inspector and CVFPB to remove according to Title 23 requirements. This crossing is referenced in the USACE Periodic Inspection as item USACE\_CESPK\_MRD2\_2012\_p\_0380.  
 FIELD\_STRUCT\_DESC: Abandoned 18-inch steel pipe through the levee, 15.0 feet below the crown. Pump in pump house and slide gate on the waterward side. (USACE-1953). This entry matches the Drainage or Irrigation Structure referenced in O&M manual (Station 694+85). Concrete distribution box on landward side. This pipe was retained under ABO No. 10008 (1974). During field verification additional appurtenances were observed. An additional pipe on landward side drains into concrete distribution box. The concrete box connects to a second set of distribution boxes through a 24-inch concrete pipe approximately 36 feet upstream of crossing. Those boxes have a 10-inch pipe that appears to go through levee.

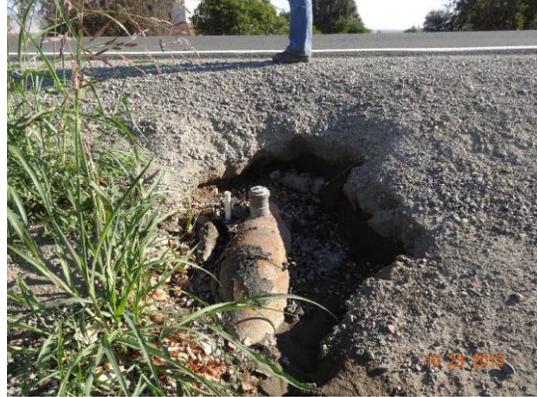
Photo 1 of 3 : UCIP\_FA\_2015\_0571.jpg

Inspector Comments: FS\_ID:46401  
 DS\_ID:21390  
 EP\_NO: 10371  
 FS\_HLM: 8.187  
 Repair Type: Urgent  
 Crossing Status: Found  
 UCIP Comments: Hole present on waterward slope has gotten worse since last inspection. The hole is located less than 2 feet from S Meridian Road (county road). Dense vegetation on waterward slope limits visual inspection to determine extent of levee damage or cause. According to LMA representative the damage on the slope was caused by leaky siphon breaker. LMA representative has notified owner to stop use of pipe. Based on the extent of the damage visible from prior inspection and the age of the pipe, this pipe would be a good candidate for video or pressure test to confirm the integrity of pipe through levee (county road). Owner will need to coordinate with DWR Inspector and CVFPB to address leaky pipe per Title 23 requirements.  
 FIELD\_STRUCT\_DESC: 12-inch steel pipe and electrical conduit through the levee, 3.0 and 2.0 feet below the crown, respectively. Steel cutoff wall around pipe and conduit at center of levee. Siphon breaker in protective housing at waterward shoulder. Discharge structure at landward toe. Slant pump on the waterward side. Power pole on landward side. (Permit No. 10371-1975). Pipe was replaced by 15-inch steel pipe under Permit No. 10371A (1982).

Damage to waterward shoulder due to leaky pipe or siphon breaker.

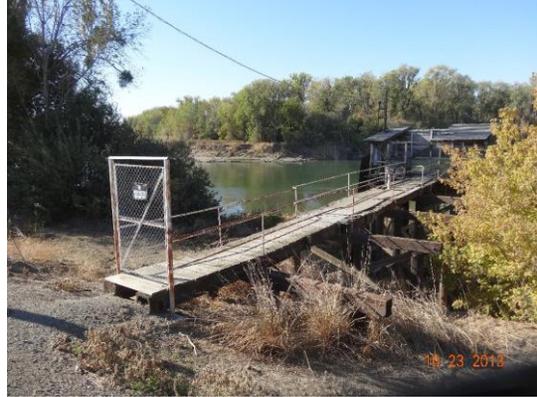
Photo 1 of 3 : UCIP\_FA\_2015\_2665.jpg

Item	DWR UCIP Field Study			39.110878 °	39.110878 °
				-121.902775 °	-121.902775 °
DWR ID					
Action/Comments					
Inspector Comments: FS_ID:24108 DS_ID:21423 EP_NO: 9971 FS_HLM: 9.0697 Repair Type: Non-Urgent Crossing Status: Found UCIP Comments: Will need to contact owner. Need to obtain maintenance records and clarify modifications made to crossing (size). This crossing is referenced in the USACE Periodic Inspection as item USACE_CESPK_MRD2_2012_p_0433. FIELD_STRUCT_DESC: [Meridian Farms Water Com. Pumping Plant No. 3] 2 of 3: 16-inch pipe (not a 30-inch pipe as mentioned in desk study) through the levee, 20.5 feet below the crown. Gate valve on the waterward end. Pump on pile structure in stream. Wooden walkway to pump. Concrete distribution box on landward side. This pipe was retained under ABO No. 9971 (1974). Pumping plant is to be demolished under Permit No. 18762 (2013). FS Date: 10/23/2013

View of landward side--pump station and walkway

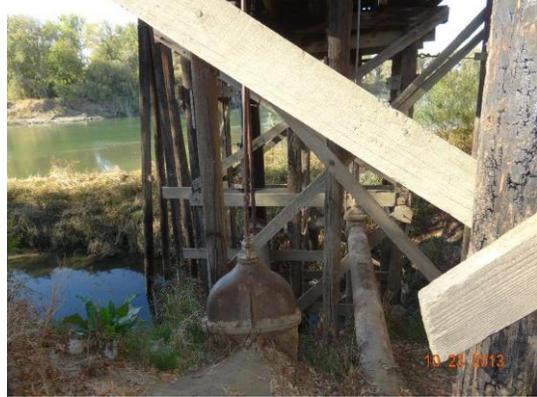
Photo 3 of 3 : UCIP\_FA\_2015\_2667.jpg

View of 16-inch pipe and 24-inch pipe with screw gate located on waterward side.

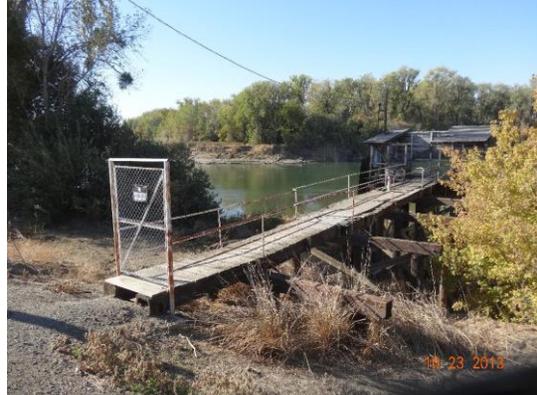
Photo 1 of 3 : UCIP\_FA\_2015\_2662.jpg

Item	DWR UCIP Field Study			39.110869 °	39.110869 °
				-121.902771 °	-121.902771 °
DWR ID					
Action/Comments					
Inspector Comments: FS_ID:24107 DS_ID:21394 EP_NO: N/A FS_HLM: 9.0704 Repair Type: Non-Urgent Crossing Status: Found UCIP Comments: This pump station is to be demolished. This crossing will need to be updated once the work has been completed. This crossing is referenced in the USACE Periodic Inspection as item USACE_CESPK_MRD2_2012_p_0433. FIELD_STRUCT_DESC: [Meridian Farms Water Com. Pumping Plant No. 3] 3 of 3: 24-inch pipe through the levee, 20.5 feet below the crown. Gate valve on the waterward end. Pump on pile structure in stream. Wooden walkway to pump. Concrete distribution box on landward side. Pumping plant is to be demolished under Permit No. 18762 (2013). FS Date: 10/23/2013

View of waterward side--pump station and walkway.

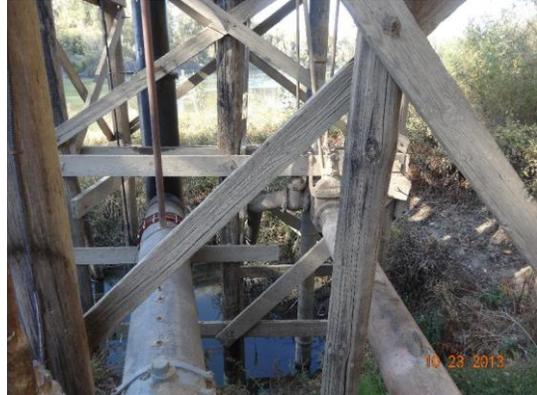
Photo 3 of 3 : UCIP\_FA\_2015\_2664.jpg

View of pipes located on waterward side.

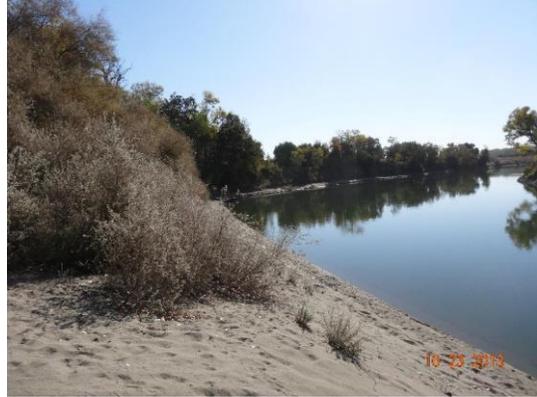
Photo 3 of 3 : UCIP\_FA\_2015\_0589.jpg

No pipe exists levee on waterward side only CMP riser present on landward side.

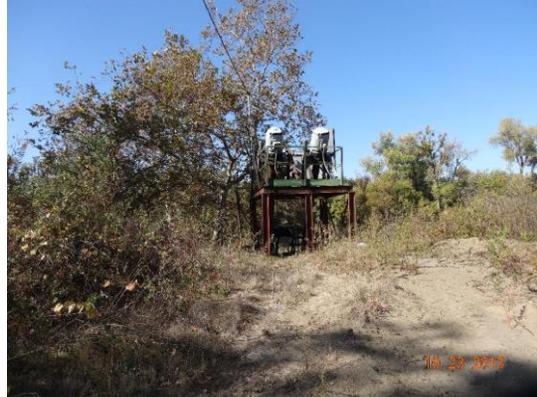
Photo 1 of 3 : UCIP\_FA\_2015\_0573.jpg

LM Start	10.40	Rating **	M	Issue No.	800	
LM End	10.40	Issue Type +	En	Location *	CR	
Category	Supplemental			GPS Latitude/Longitude		
			Start	End		
Item	DWR UCIP Field Study			39.093712 °	39.093712 °	
DWR ID				-121.892553 °	-121.892553 °	
Action/Comments						
Inspector Comments: FS_ID:24195 DS_ID:21398 EP_NO: 1162 FS_HLM: 10.4666 Repair Type: Non-Urgent Crossing Status: Found UCIP Comments: Need to verify status of crossing--variation in pipe size. 18 inch pipe listed in desk study and 20 inch pipe found in field. Damage to siphon breaker housing unit. This crossing is referenced in the USACE Periodic Inspection as item USACE_CESPK_MRD2_2012_p_0482. FIELD_STRUCT_DESC: 1 of 2: 20-inch (not 18-inch as listed in desk study) steel pipe through the levee, 3.7 feet below the crown. Two concrete cutoff walls around pipe, at levee shoulders. Siphon breakers in steel pipe risers on landward shoulder. Slant pumps on wooden pump structure on waterward side. Two CM pipe risers under pump structure at waterward toe. Distribution box at landward toe. (Permit No. 1162-1946) This entry matches the Drainage or Irrigation Structure referenced in O&M manual (Station 824+00). FS Date: 10/23/2013

Pump station located on waterward side.

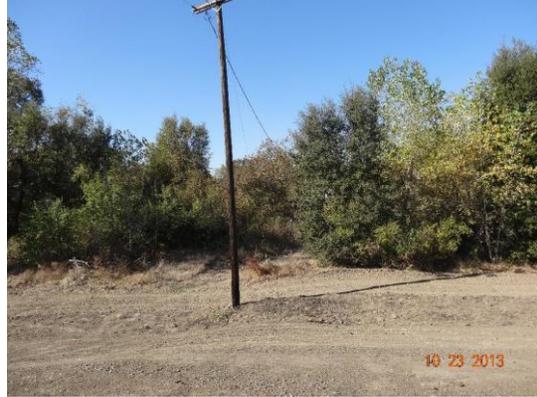
Photo 2 of 3 : UCIP\_FA\_2015\_0574.jpg

Inspector Comments: FS\_ID:24195  
 DS\_ID:21398  
 EP\_NO: 1162  
 FS\_HLM: 10.4666  
 Repair Type: Non-Urgent  
 Crossing Status: Found  
 UCIP Comments: Need to verify status of crossing--variation in pipe size. 18 inch pipe listed in desk study and 20 inch pipe found in field. Damage to siphon breaker housing unit. This crossing is referenced in the USACE Periodic Inspection as item USACE\_CESPK\_MRD2\_2012\_p\_0482.  
 FIELD\_STRUCT\_DESC: 1 of 2: 20-inch (not 18-inch as listed in desk study) steel pipe through the levee, 3.7 feet below the crown. Two concrete cutoff walls around pipe, at levee shoulders. Siphon breakers in steel pipe risers on landward shoulder. Slant pumps on wooden pump structure on waterward side. Two CM pipe risers under pump structure at waterward toe. Distribution box at landward toe. (Permit No. 1162-1946) This entry matches the Drainage or Irrigation Structure referenced in O&M manual (Station 824+00).

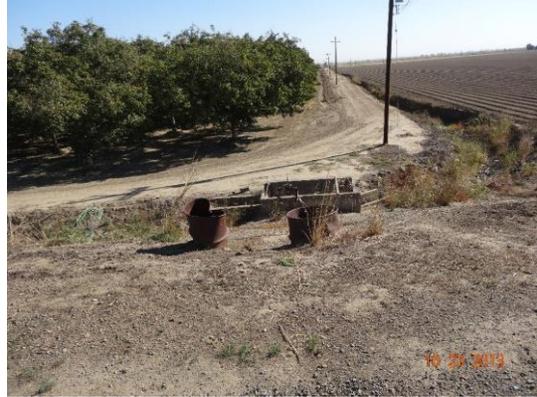
Photo 3 of 3 : UCIP\_FA\_2015\_0575.jpg

View of landward side.

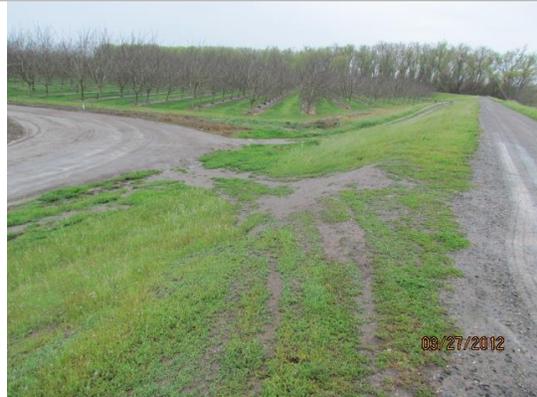
Photo 1 of 1 : FA\_2015\_RD0070\_30\_6\_20150910\_00005.jpg

View of vehicle erosion along landside slope.

LM Start	10.64	Rating **	M	Issue No.	6
LM End	10.64	Issue Type +	Ma	Location *	LS
Category	Earthen Levee			GPS Latitude/Longitude	
				Start	End
Item	Slope Stability			39.090300 °	39.090300 °
DWR ID	DWR_RD0070_02_s_2012_6			-121.893102 °	-121.893102 °
Action/Comments					
Repair the levee slope damaged by vehicle traffic and prevent access where possible.

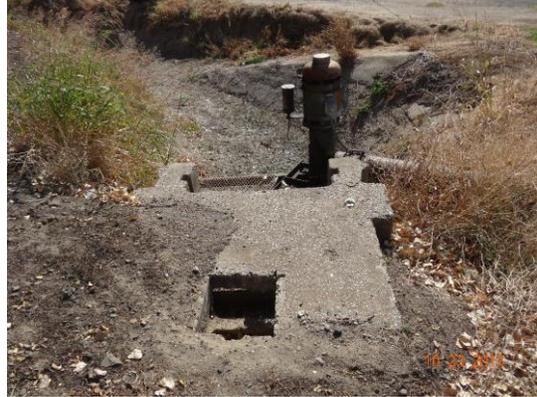
Photo 1 of 3 : UCIP\_FA\_2015\_2798.jpg

Inspector Comments: FS\_ID:24197  
 DS\_ID:21400  
 EP\_NO: 9986  
 FS\_HLM: 11.68  
 Repair Type: Non-Urgent  
 Crossing Status: Indicator Found  
 UCIP Comments: Need to coordinate with owner to determine status of crossing. If crossing is no longer in use owner will need to contact the CVFPB to comply with Title 23. This crossing is referenced in the USACE Periodic Inspection as item USACE\_CESPK\_MRD2\_2012\_p\_0527.  
 FIELD\_STRUCT\_DESC: 30-inch steel pipe through the levee, 27.5 feet below the crown. Two electric gate valves in concrete pit on waterward end at end of discharge pipe. Two slant pumps on waterward slope. Control switches in CM shed at waterward shoulder. (USACE-1953). This entry matches the Drainage or Irrigation Structure referenced in O&M manual (Station 889+72). This pipe was retained under ABO No. 9986 (1974). One pump and one gate valve installed under Permit No. 5193 (1966). This pumping plant was demolished with pipes grouted and abandoned under Permit No. 18323 (2009).

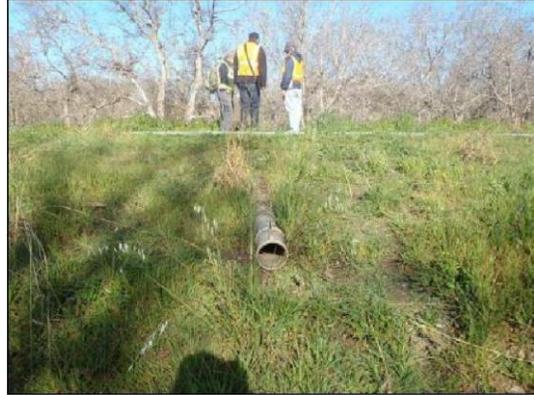
Photo 1 of 3 : UCIP\_FA\_2015\_2720.jpg

Item	DWR UCIP Field Study			39.072480 °	39.072480 °
				-121.886540 °	-121.886540 °
DWR ID					
Action/Comments					
Inspector Comments: FS_ID:46426 DS_ID:24744 EP_NO: N/A FS_HLM: 12.504 Repair Type: Urgent Crossing Status: Found UCIP Comments: 07/28/2015 Dense vegetation on both slopes. Need to recheck during winter.10/23/2013 No records were found during initial desk study--need to contact owner to obtain permit number authorizing work. Owner will need to coordinate with DWR Inspector and CVFPB to remove crossing according to Title 23 requirements. FIELD_STRUCT_DESC: 6-inch diameter aluminum irrigation pipe through the levee 18 inches below the crown through a 10 inch corrugated metal pipe. Pipe extends down both slopes about 2 feet below crown. FS Date: 07/28/2015

View of pipe through levee--photo is from USACE PI Draft Report dated 6-2012.

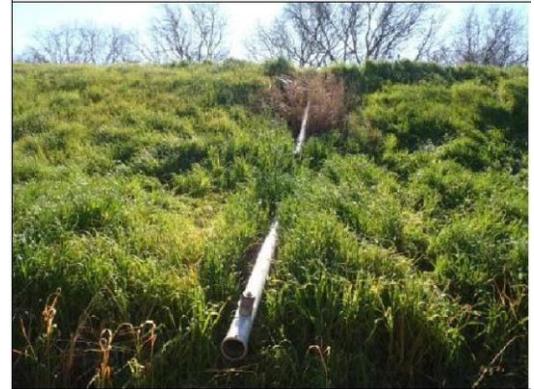
Photo 2 of 3 : UCIP\_FA\_2015\_2721.jpg

View of pipe through levee--photo is from USACE PI Draft Report dated 6-2012.

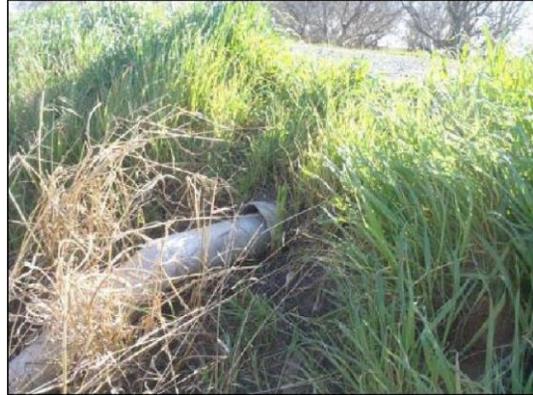
Photo 3 of 3 : UCIP\_FA\_2015\_2722.jpg

LM Start	<b>12.43</b>	Rating **	U	Issue No.	<b>803 (cont)</b>
LM End	<b>12.43</b>	Issue Type +	En	Location *	WS
Category	Supplemental			GPS Latitude/Longitude	
				Start	End
Item	DWR UCIP Field Study			39.072480 °	39.072480 °
				-121.886540 °	-121.886540 °
DWR ID					
Action/Comments					
Inspector Comments: FS_ID:46246 DS_ID:24744 EP_NO: N/A FS_HLM: 12.504 Repair Type: Urgent Crossing Status: Found

View of pipe through levee--photo is from USACE PI Draft Report dated 6-2012.

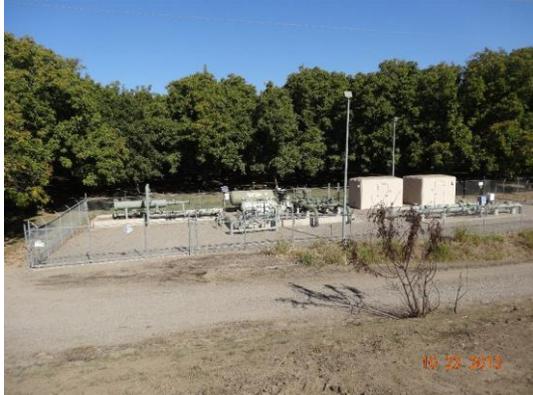
Photo 1 of 3 : UCIP\_FA\_2015\_2818.jpg

Item	DWR UCIP Field Study			39.072512 °	39.072512 °
				-121.886000 °	-121.886000 °
DWR ID					
Action/Comments					
Inspector Comments: FS_ID:23984 DS_ID:21403 EP_NO: 3800 FS_HLM: 12.5335 Repair Type: Non-Urgent Crossing Status: Indicator Found UCIP Comments: Need to contact owner to determine if crossing is still active and to determine last inspection date. Will need copy of letter showing crossings passed inspection. This crossing is referenced in the USACE Periodic Inspection as item USACE_CESPK_MRD2_2012_p_0568. FIELD_STRUCT_DESC: 20-inch steel gas pipe through the levee, 3.0 feet below the crown. Concrete cutoff wall around pipe at center of levee. Marker sign on waterward shoulder. Natural gas equipment pad at landward toe. (Permit No. 3800-1962) FS Date: 10/23/2013

Additional appurtenances located on landward side.

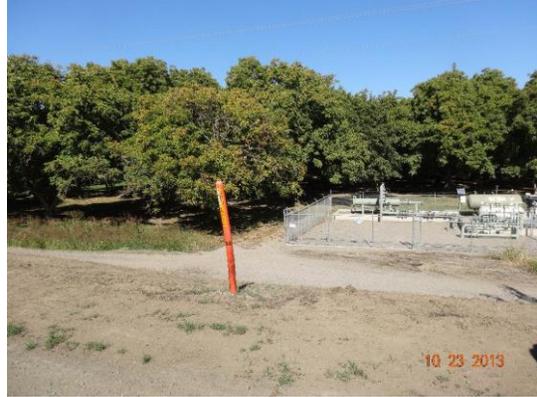
Photo 2 of 3 : UCIP\_FA\_2015\_2819.jpg

Marker on landward side.

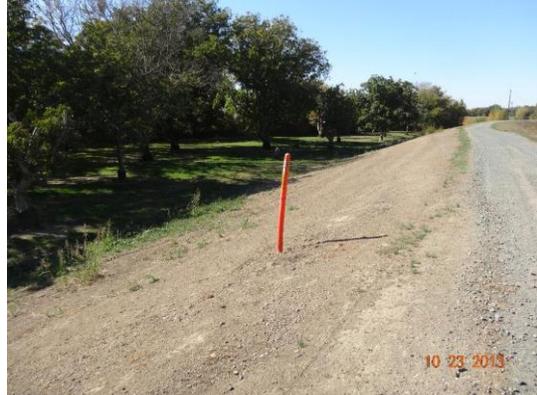
Photo 3 of 3 : UCIP\_FA\_2015\_2820.jpg

Marker located on waterward side.

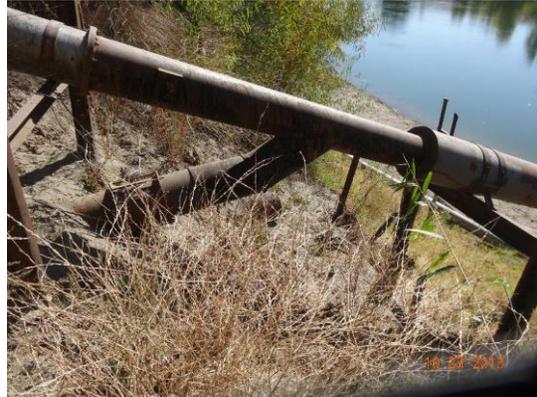
Photo 1 of 4 : UCIP\_FA\_2015\_0590.jpg

LM Start	<b>12.69</b>	Rating **	M	Issue No.	<b>805</b>
LM End	<b>12.69</b>	Issue Type +	En	Location *	WS
Category	Supplemental			GPS Latitude/Longitude	
				Start	End
Item	DWR UCIP Field Study			39.072530 °	39.072530 °
				-121.881797 °	-121.881797 °
DWR ID					
Action/Comments					
Inspector Comments: FS_ID:23969 DS_ID:21402 EP_NO: 9997 FS_HLM: 12.436 Repair Type: Non-Urgent Crossing Status: Found

Pipe crossing on waterward side. Second pipe comes out approximately 3 feet downstream from this crossing.

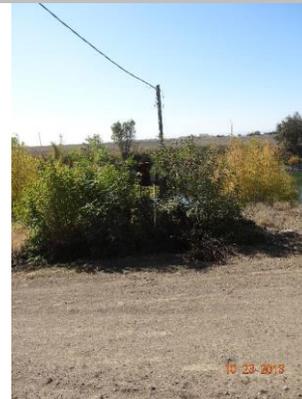
Photo 2 of 4 : UCIP\_FA\_2015\_0591.jpg

Crossing appurtenances located near brush and power pole on waterward side.

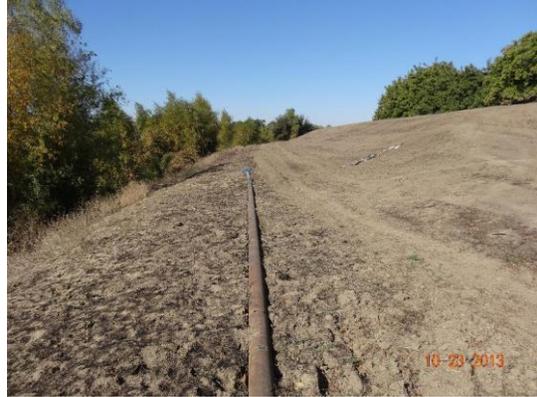
Photo 3 of 4 : UCIP\_FA\_2015\_2816.jpg

Abandoned steel pipe located on waterward slope.

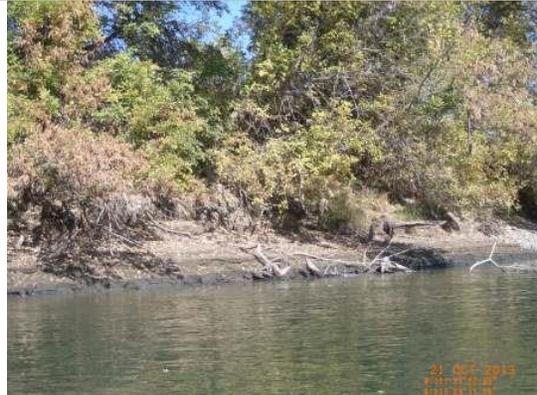
Photo 1 of 2 : USACE2013A\_SAC\_123-3\_L\_6.jpg

LM Start	<b>14.08</b>	Rating **	M	Issue No.	<b>14</b>
LM End	<b>14.21</b>	Issue Type +	Ma	Location *	WS
Category	Supplemental		GPS Latitude/Longitude		
			Start	End	
Item	2015 USACE Erosion Survey, DRAFT		39.069166 °	39.070105 °	
			-121.857995 °	-121.855929 °	
DWR ID					
Action/Comments					
Inspector Comments: 2006 - Erosion into the levee toe. Rock at upstream end has poor transition causing eddy scour. 2010 - Minor new erosion. 2011 - Some fresh erosion. 2012 - Additional slumping on the previously slumped bank, site extended downstream. 2015: No observed changes. [2015 Site ID: SAC_123-3_L]

USACE 2013 Photo #1

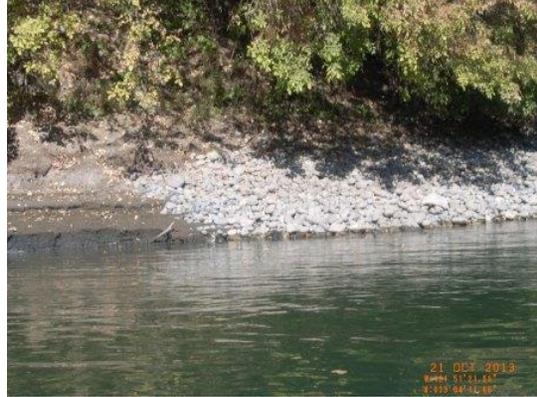
Photo 2 of 2 : USACE2013A\_SAC\_123-3\_L\_7.jpg

USACE 2013 Photo #2

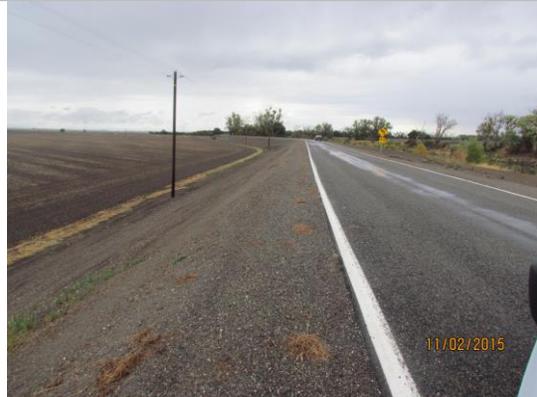
Photo 1 of 1 : FA\_2015\_RD0070\_30\_71\_20151116\_00060.jpg

LM Start	<b>14.96</b>	Rating **	A	Issue No.	<b>71</b>
LM End	<b>14.96</b>	Issue Type +	Ma	Location *	LS
Category	Earthen Levee			GPS Latitude/Longitude	
				Start	End
Item	Vegetation			39.068708 °	39.068708 °
				-121.844612 °	-121.844612 °
DWR ID	DWR_RD0070_02_f_2015_71				
Action/Comments					
Control annual grass and weeds on the levee slopes and easements. Inspector Comments: The Reclamation District burned and dragged both slopes.

View of no vegetation on both slopes.

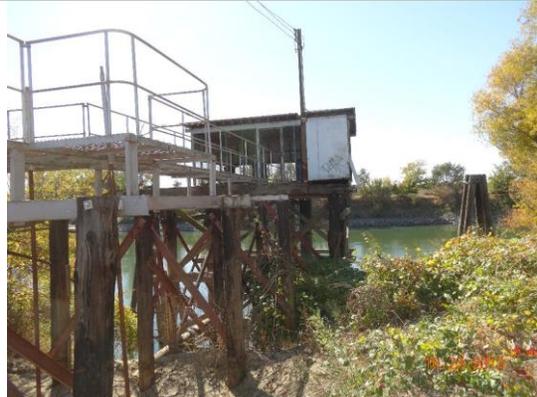
Photo 2 of 3 : UCIP\_FA\_2015\_2902.jpg

Pump house located on waterward side.

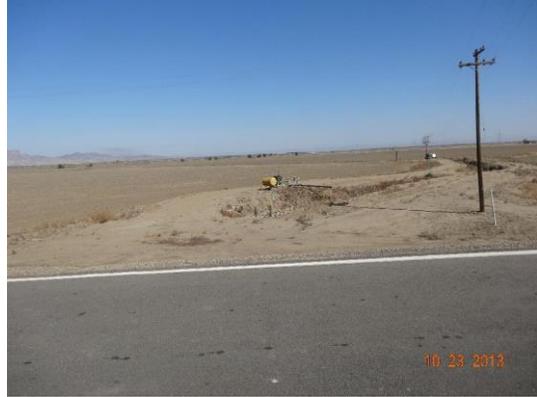
Photo 3 of 3 : UCIP\_FA\_2015\_2903.jpg

Overview of landward side.

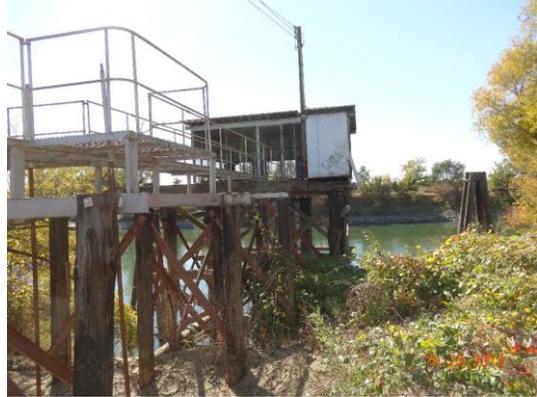
Photo 2 of 3 : UCIP\_FA\_2015\_2905.jpg

LM Start	15.34	Rating **	M	Issue No.	807 (cont)
LM End	15.34	Issue Type +	En	Location *	LS
Category	Supplemental			GPS Latitude/Longitude	
				Start	End
Item	DWR UCIP Field Study			39.065294 °	39.065294 °
				-121.839215 °	-121.839215 °
DWR ID					
Action/Comments					
Inspector Comments: FS_ID:24230 DS_ID:21409 EP_NO: 9990 FS_HLM: 15.408 Repair Type: Non-Urgent Crossing Status: Found UCIP Comments: Need to determine if crossing is still being used. This crossing is referenced in the USACE Periodic Inspection as item USACE_CESPK_MRD2_2012_p_0685. FIELD_STRUCT_DESC: 2 of 2: 24-inch steel pipe sleeved through a 30-inch steel pipe through the levee, 24.0 feet below the crown. Gate valves on waterward end. Concrete headwall with flap gate on landward side. Pumps on pile structure in stream. Wooden walkway to pumps. (USACE-1953). This entry matches the Drainage or Irrigation Structure referenced in O&M manual (Station 1086+55). This pipe was retained under ABO No. 9990 (1974). FS Date: 10/23/2013

Pump located on waterward side.

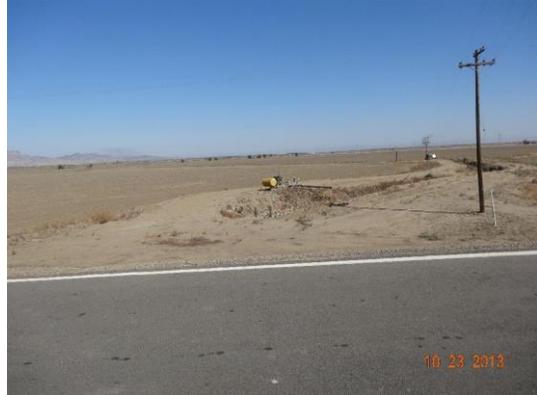
Photo 3 of 3 : UCIP\_FA\_2015\_2906.jpg

Overview of landward side.

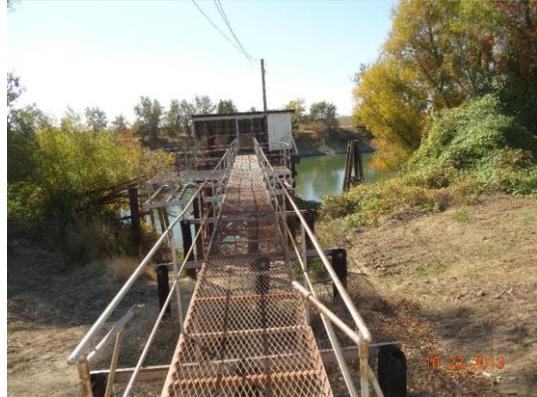
Photo 1 of 3 : UCIP\_FA\_2015\_2907.jpg

LM Start	<b>15.34</b>	Rating **	M	Issue No.	<b>808</b>
LM End	<b>15.34</b>	Issue Type +	En	Location *	LS
Category	Supplemental			GPS Latitude/Longitude	
				Start	End
Item	DWR UCIP Field Study			39.065285 °	39.065285 °
				-121.839202 °	-121.839202 °
DWR ID					
Action/Comments					
Inspector Comments: FS_ID:24231 DS_ID:21420 EP_NO: N/A FS_HLM: 15.4088 Repair Type: Non-Urgent Crossing Status: Found

Walkway and structure located on waterward side.
