**Flood Control Project Maintenance  
Levee Inspections**  
**LMA District Cover Sheet**  
**Spring 2014 Levee Inspection Results**

**Reclamation District No. 0070 Meridian**

Waterway		Bank	Unit Miles
Unit No. 01 Sutter Bypass		Right	8.00

**Levee Inspection Report By Mile - Spring 2014**

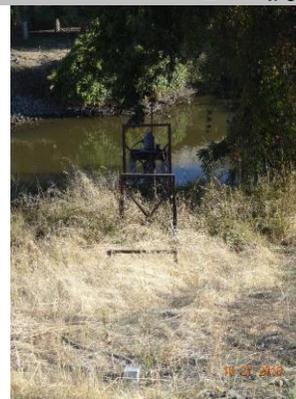
Photo 1 of 1 : UCIP\_3417.jpg

Item	DWR UCIP Field Study			39.142682 °	39.142682 °
				-121.841913 °	-121.841913 °
DWR ID	DWR_RD0070_01_s_2014_337				
Action/Comments					
Inspector Comments: FS_ID:23503 EP_NO: 3686 Repair Type: Crossing Status: UCIP Comments: Dense vegetation limits the inspector's visibility to identify signs of pipe failure (leaks) along the waterward slope. Recommend removing vegetation along pipe alignment to conduct proper inspection of structure and appurtenances. Unable to find the gate valve on landward side. Walkway on waterward side in bad shape. This crossing is referenced in the USACE Periodic Inspection as item USACE_CESPK_MRD1_2012_p_0300 for 18 inch pipe. Pipe on LS is 10 inch not 18 inch. SEE UCIP DS_ID 21350 for details pertaining to 18 inch pipe. FIELD_STRUCT_DESC: 10-inch pipe and electrical conduit through the levee, 14.8 and 1.0 feet below the crown, respectively. Gate valve on landward end--not found during 10/21/13 pipe inventory. Pump on pile structure in stream. Walkway to slide gate on waterward end. Rock revetment on waterward slope. Pump and concrete support piers at waterward toe installed under Permit No. 3686 (1963). Service pole with meter and control panel at landward toe. FS Date: 10/21/2013

Electrical box located on waterward slope.

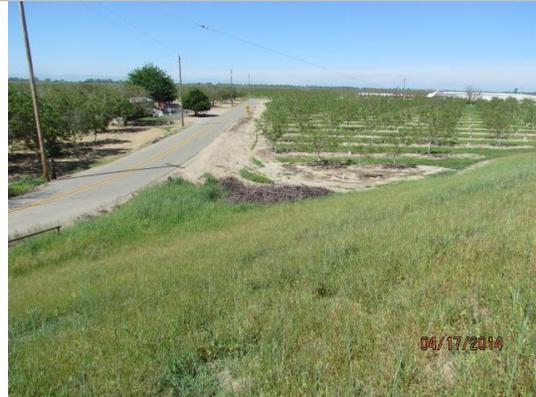
Photo 1 of 1 : rduffey\_s\_20140421\_189.jpg

LM Start	<b>4.71</b>	Rating **	M	Issue No.	<b>357</b>
LM End	<b>4.71</b>	Issue Type +	En	Location *	LS
Category	Earthen Levee		GPS Latitude/Longitude		
			Start	End	
Item	Encroachments		39.168037 °	39.168037 °	
			-121.899854 °	-121.899854 °	
DWR ID	DWR_RD0070_01_s_2014_357				
Action/Comments					
Prunings

View of the prunings at the landside toe.

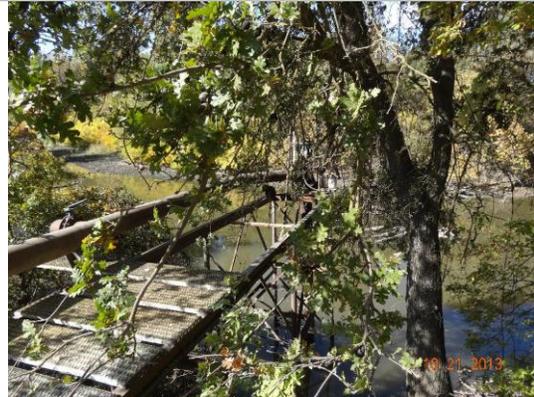
Photo 1 of 1 : UCIP\_3505.jpg

Item	DWR UCIP Field Study		39.196692 °	39.196692 °	
			-121.929331 °	-121.929331 °	
DWR ID	DWR_RD0070_01_s_2014_353				
Action/Comments					
Inspector Comments: FS_ID:23528 EP_NO: 5921 Repair Type: Crossing Status: UCIP Comments: Pipe leaking on landward side--damage to levee slope just behind concrete distribution box. Need to coordinate with owner to address leak. Recommend pipe stop being used until leak is address. Will need to coordinate with DWR inspector and CVFPB to address issue. This crossing is referenced in the USACE Periodic Inspection as item USACE_CESPK_MRD1_2012_p_0030 for pipe damage. Dense vegetation limits the inspector's visibility to identify signs of pipe failure (leaks) along the slope. Recommend removing vegetation along pipe alignment to conduct proper inspection of structure and appurtenances. FIELD_STRUCT_DESC: 12-inch pipe through the levee, 3.7 feet below the crown. CM cutoff wall around pipe at center of levee. Siphon breaker in steel pipe riser on landward slope. Pump on platform on waterward side with walkway access. Pipe discharges into concrete box (irrigation outlet structure) at landward toe. Service pole with one anchor on waterward berm. Pipe exposed along waterward slope. (Permit No. 5921-1973). FS Date: 10/21/2013

View walkway located on waterward side.

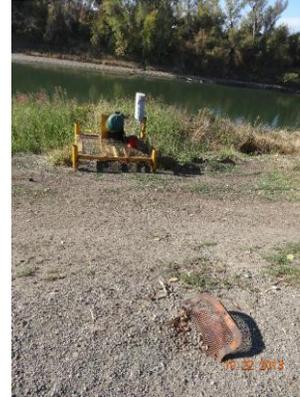
Photo 1 of 1 : UCIP\_3866.jpg

Item	DWR UCIP Field Study			39.193396 °	39.193396 °
				-121.935434 °	-121.935434 °
DWR ID	DWR_RD0070_02_s_2014_729				
Action/Comments					
Inspector Comments: FS_ID:23952 EP_NO: 12707 Repair Type: Crossing Status: UCIP Comments: Burrow activity noticed at this location. Crossing appurtenances have been modified. No 36-inch concrete distribution stand pipe present instead there is a concrete distribution box located at the landward toe. Also siphon breaker housing unit damage. Will need to contact owner. Need to obtain maintenance records and clarify modifications made at to crossing. Recommend having owner clear vegetation on waterward side. This crossing is referenced in the USACE Periodic Inspection as item USACE_CESPK_MRD2_2012_p_0018. FIELD_STRUCT_DESC: 14-inch steel pipe through the levee, 3.0 feet below the crown. Steel cutoff wall around pipe at center of levee. Siphon breaker on apex of pipe at waterward shoulder. Pump on metal (not timber as noted in desk study) platform on waterward side. 36-inch concrete standpipe (not found during 10/2013 inspection) and service pole at landward toe. Rock revetment on waterward slope. (Permit No. 12707-1979) FS Date: 10/22/2013

View of waterward side--siphon breaker housing unit, pipe daylight, pump, and platform.

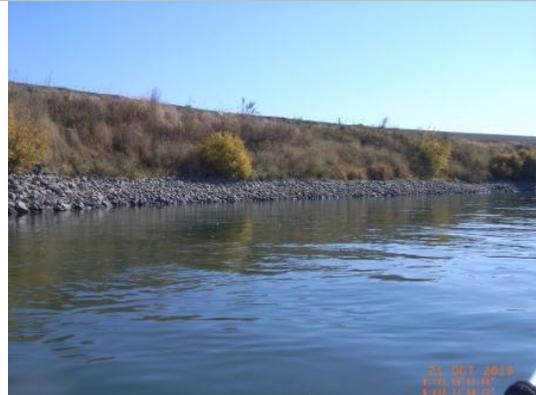
Photo 1 of 1 : USACE2013A\_SAC\_138-1\_L\_5.jpg

LM Start	<b>0.08</b>	Rating **	M	Issue No.	<b>16</b>
LM End	<b>0.17</b>	Issue Type +	Ma	Location *	WS
Category	Supplemental			GPS Latitude/Longitude	
				Start	End
Item	USACE Erosion Survey			39.193219 °	39.190038 °
				-121.935783 °	-121.934199 °
DWR ID					
Action/Comments					
Inspector Comments: 1997 - Loss of cobble revetment in levee section. 2004 - New fresh erosion in a short section of the downstream end. 2010 - New deposition on cobbles. 2013: No observed changes. [2013 Site ID: SAC_138-1_L]

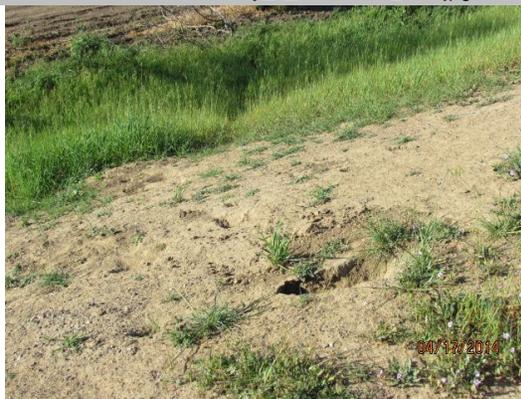
Photo 1 of 1 : rduffey\_s\_20140421\_179.jpg

LM Start	<b>0.57</b>	Rating **	A/W	Issue No.	<b>767</b>
LM End	<b>0.57</b>	Issue Type +	Ma	Location *	LS
Category	Earthen Levee			GPS Latitude/Longitude	
				Start	End
Item	Animal Control			39.187912 °	39.187912 °
				-121.937172 °	-121.937172 °
DWR ID	DWR_RD0070_02_s_2014_767				
Action/Comments					
No rodents visible, but rodent burrows visible; need to backfill and compact or grout burrows.

View of the rodent activity along the landside slope.

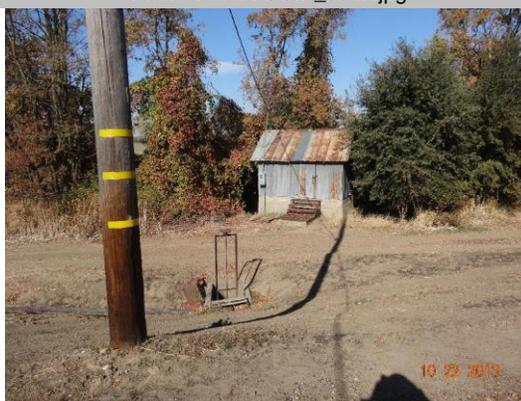
Photo 1 of 1 : UCIP\_3847.jpg

Item	DWR UCIP Field Study			39.183211 °	39.183211 °
				-121.943237 °	-121.943237 °
DWR ID	DWR_RD0070_02_s_2014_730				
Action/Comments					
Inspector Comments: FS_ID:23949 EP_NO: 1575 Repair Type: Crossing Status: UCIP Comments: Debris scattered on waterward side. Concrete structure on waterward side shows major cracks on the walls. Will need to notify owner. Need to obtain maintenance records to confirm integrity of pipe. This crossing is referenced in the USACE Periodic Inspection as item USACE_CESPK_MRD2_2012_p_0075. FIELD_STRUCT_DESC: 20-inch steel pipe through the levee, 17.0 feet below the crown. Pump in pump house and slide gate (10-inch) on waterward side. Concrete collar at waterward toe. Power pole on waterward slope, anchor on landward slope. Rock revetment on waterward slope. (Permit No. 1575-1959) FS Date: 10/23/2013

View of waterward side--appurtenances present pump house, concrete distribution box, screw gate, and power pole.

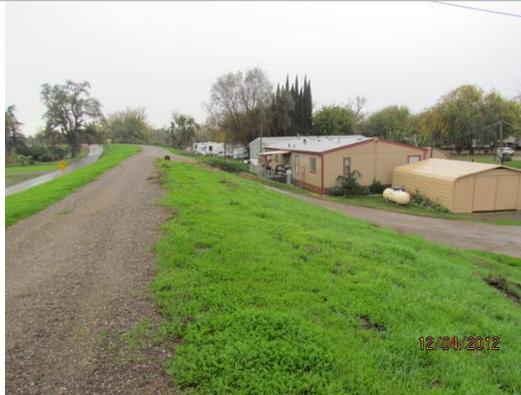
Photo 1 of 1 : rduffey\_s\_20140304\_283.jpg

LM Start	<b>1.19</b>	Rating **	M	Issue No.	<b>12</b>
LM End	<b>1.19</b>	Issue Type +	En	Location *	WS
Category	Earthen Levee		GPS Latitude/Longitude		
			Start	End	
Item	Encroachments		39.181247 °	39.181247 °	
			-121.943808 °	-121.943808 °	
DWR ID	DWR_RD0070_02_f_2012_12				
Action/Comments					
Building

View of the buildings along the waterside toe of the levee.

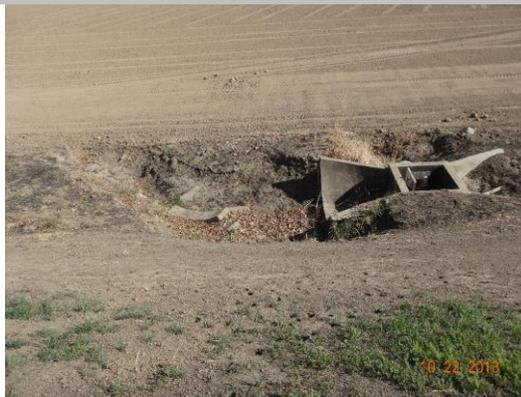
Photo 1 of 1 : UCIP\_3817.jpg

Item	DWR UCIP Field Study		39.178895 °	39.178895 °	
			-121.943340 °	-121.943340 °	
DWR ID	DWR_RD0070_02_s_2014_731				
Action/Comments					
Inspector Comments: FS_ID:23885 EP_NO: 9973 Repair Type: Crossing Status: UCIP Comments: Cut to levee toe found on landward side. Unable to determine if crossing is being used. If crossing is no longer used by owner, the owner will need to coordinate with DWR Inspector and CVFPB to remove crossing according to Title 23 requirements. This crossing is referenced in the USACE Periodic Inspection as item USACE_CESPK_MRD2_2012_p_0099. FIELD_STRUCT_DESC: 18-inch steel pipe through the levee, 18.8 feet below the crown. Slide gate on gate structure on waterward side. Slant pump on waterward side. (USACE-1953). This entry matches the Drainage or Irrigation Structure referenced in O&M manual (Station 399+34). This pipe was retained under ABO No. 9973 (1974). FS Date: 10/22/2013

View of landward side--unable to take photos of distribution box due to steep landward slope.

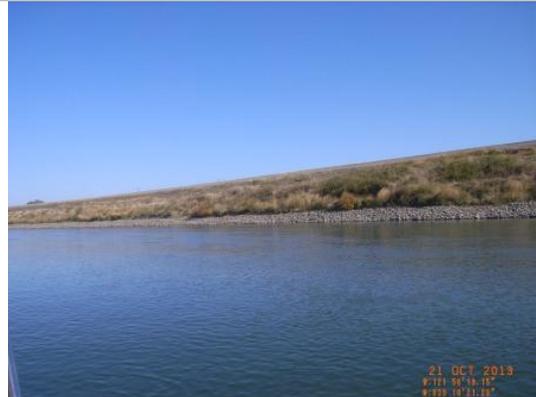
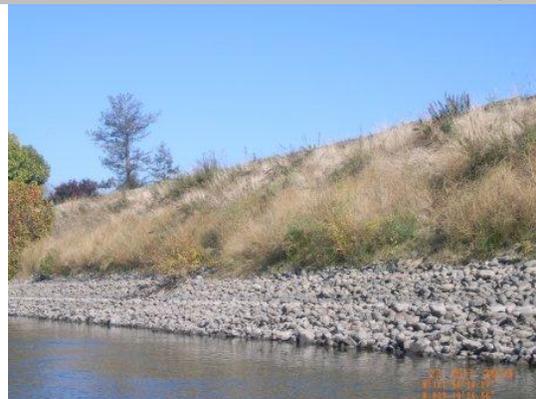
Photo 1 of 2 : USACE2013A\_SAC\_136-6\_L\_5.jpg

LM Start	<b>1.78</b>	Rating **	M	Issue No.	<b>15</b>
LM End	<b>1.91</b>	Issue Type +	Ma	Location *	WS
Category	Supplemental			GPS Latitude/Longitude	
				Start	End
Item	USACE Erosion Survey			39.173912 °	39.172344 °
				-121.938745 °	-121.937925 °
DWR ID					
Action/Comments					
Inspector Comments: 1997 - Toe erosion on a cobble revetment on the outside of a low receding bend. 2012 - Toe appears pretty stable with old cobbles. 2013: No observed changes. [2013 Site ID: SAC_136-6_L]

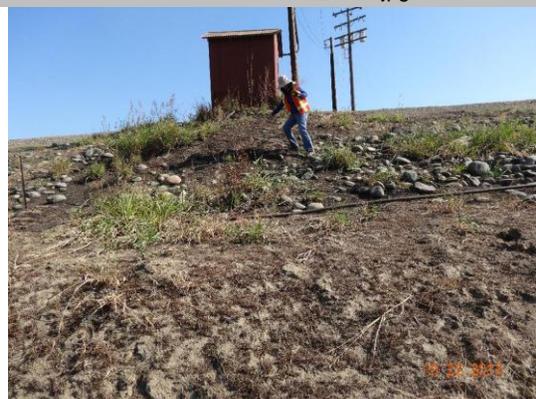
Photo 1 of 1 : UCIP\_3823.jpg

LM Start	<b>1.89</b>	Rating **	M	Issue No.	<b>732</b>
LM End	<b>1.89</b>	Issue Type +	En	Location *	WS
Category	Supplemental			GPS Latitude/Longitude	
				Start	End
Item	DWR UCIP Field Study			39.172778 °	39.172778 °
				-121.937791 °	-121.937791 °
DWR ID	DWR_RD0070_02_s_2014_732				
Action/Comments					
Inspector Comments: FS_ID:23888

View of slope on waterward side.

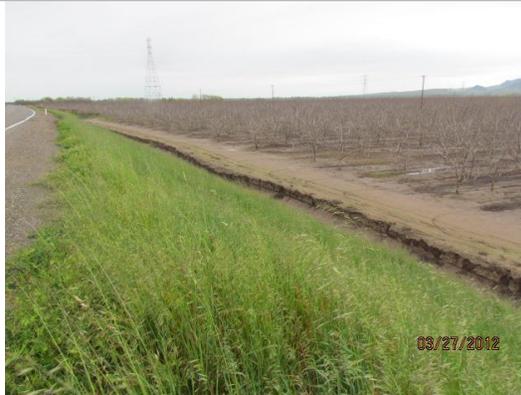
Photo 1 of 1 : rduffey\_s\_20140304\_275.jpg

LM Start	<b>2.17</b>	Rating **	M	Issue No.	<b>1</b>
LM End	<b>2.35</b>	Issue Type +	En	Location *	LS
Category	Earthen Levee		GPS Latitude/Longitude		
			Start	End	
Item	Encroachments		39.168854 °	39.166503 °	
			-121.936223 °	-121.935547 °	
DWR ID	DWR_RD0070_02_s_2012_1				
Action/Comments					
Ditch

Ag ditch along the landside toe.

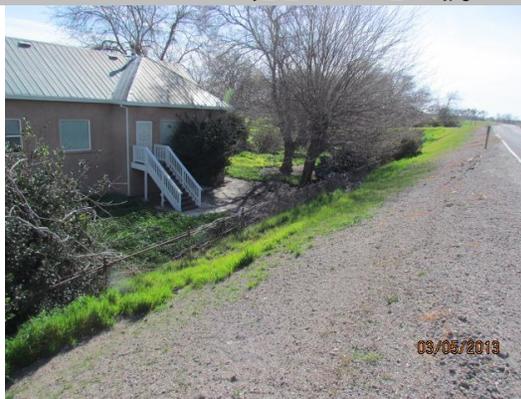
Photo 1 of 1 : rduffey\_s\_20140304\_300.jpg

LM Start	<b>2.40</b>	Rating **	M	Issue No.	<b>21</b>
LM End	<b>2.42</b>	Issue Type +	En	Location *	LS
Category	Earthen Levee		GPS Latitude/Longitude		
			Start	End	
Item	Encroachments		39.165658 °	39.165364 °	
			-121.935272 °	-121.935164 °	
DWR ID	DWR_RD0070_02_s_2013_21				
Action/Comments					
Fence

View of the fence on the land side slope.

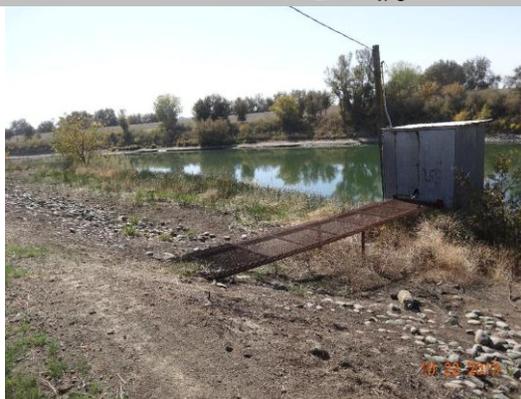
Photo 1 of 1 : UCIP\_3826.jpg

Item	DWR UCIP Field Study		39.162424 °	39.162424 °	
			-121.934201 °	-121.934201 °	
DWR ID	DWR_RD0070_02_s_2014_734				
Action/Comments					
<p>Inspector Comments: FS_ID:23891                      EP_NO: 9969                      Repair Type:                      Crossing Status:                      UCIP Comments: Landward slope too steep--need photo of the inside of concrete distribution box. Dense vegetation limits the inspector's visibility to identify signs of pipe failure (leaks) along the waterward slope. Recommend removing vegetation along pipe alignment to conduct proper inspection of structure and appurtenances. This crossing is referenced in the USACE Periodic Inspection as item USACE_CESPK_MRD2_2012_p_0158.                      FIELD_STRUCT_DESC: 20-inch (not 24-inch as mentioned in desk study) steel pipe through the levee, 27.0 feet below the crown. CM cutoff wall around pipe at center of levee. Pump and gate valve in pump house on the waterward slope. Discharges into concrete box at the landward toe. (USACE-1953). This entry matches the Drainage or Irrigation Structure referenced in O&amp;M manual (Station 455+39). This pipe was retained under ABO No. 9969 (1974).                      FS Date: 10/22/2013</p>

View of waterward side.

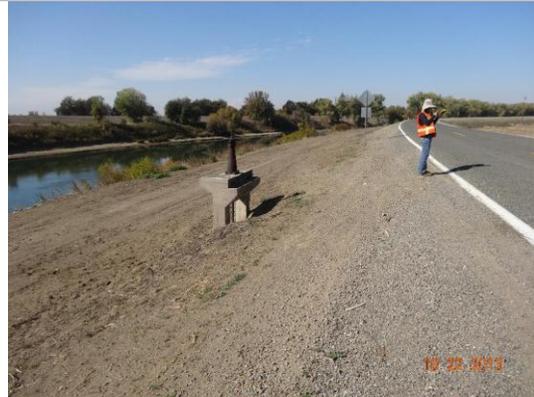
Photo 1 of 1 : UCIP\_3830.jpg

Item	DWR UCIP Field Study			39.160540 °	39.160540 °
				-121.932382 °	-121.932382 °
DWR ID	DWR_RD0070_02_s_2014_735				
Action/Comments					
Inspector Comments: FS_ID:23892 EP_NO: N/A Repair Type: Crossing Status: UCIP Comments: If crossing is no longer used by owner, the owner will need to coordinate with DWR Inspector and CVFPB to remove crossing according to Title 23 requirements. Dense vegetation limits the inspector's visibility to identify signs of pipe failure (leaks) along the slope. Recommend removing vegetation along pipe alignment to conduct proper inspection of structure and appurtenances. This crossing is referenced in the USACE Periodic Inspection as item USACE_CESPK_MRD1_2012_p_0167. FIELD_STRUCT_DESC: Abandoned 24-inch CM pipe through the levee, 21.0 feet below the crown. Slide gate on waterward end. (Cat. IVA) FS Date: 10/22/2013

View of waterward side.

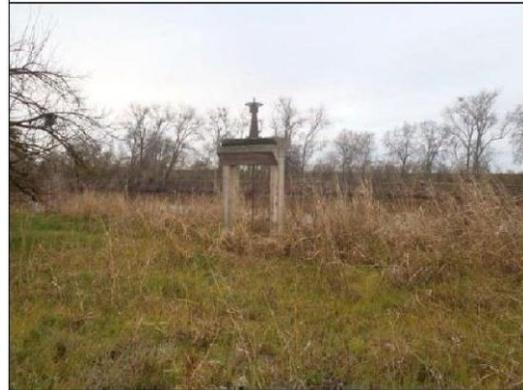
Photo 1 of 1 : UCIP\_3962.jpg

LM Start	<b>3.38</b>	Rating **	M	Issue No.	<b>736</b>
LM End	<b>3.38</b>	Issue Type +	En	Location *	LS
Category	Supplemental			GPS Latitude/Longitude	
				Start	End
Item	DWR UCIP Field Study			39.156068 °	39.156068 °
				-121.923453 °	-121.923453 °
DWR ID	DWR_RD0070_02_s_2014_736				
Action/Comments					
Inspector Comments: FS_ID:24115 EP_NO: N/A Repair Type: Crossing Status: UCIP Comments: No connection present--need to contact owner to determine if owner plans to use. If crossing is no longer in use owner will need to coordinate with DWR inspector and CVFPB to remove according to Title 23 requirements. This crossing is referenced in the USACE Periodic Inspection as USACE_CESPK_MRD2_2012_p_0197. FIELD_STRUCT_DESC: Abandoned 24-inch pipe through the levee, 18.5 feet below the crown. Slide gate on concrete gate structure on berm. FS Date: 10/22/2013

View of waterward side--photo is from USACE PI Report draft final issue USACE\_CESPK\_MRD2\_2012\_p\_0197.

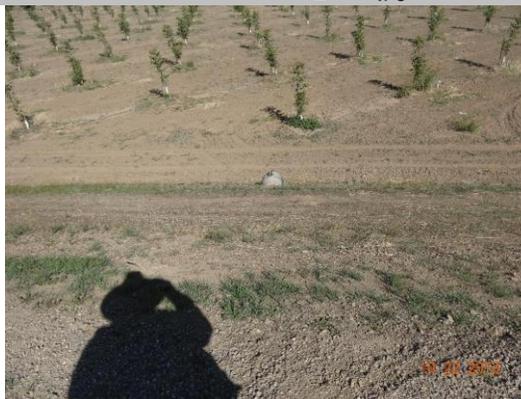
Photo 1 of 1 : UCIP\_3969.jpg

LM Start	<b>3.42</b>	Rating **	M	Issue No.	<b>737</b>
LM End	<b>3.42</b>	Issue Type +	En	Location *	LS
Category	Supplemental		GPS Latitude/Longitude		
			Start	End	
Item	DWR UCIP Field Study		39.155648 °	39.155648 °	
			-121.922822 °	-121.922822 °	
DWR ID	DWR_RD0070_02_s_2014_737				
Action/Comments					
Inspector Comments: FS_ID:24117 EP_NO: N/A Repair Type: Crossing Status: UCIP Comments: No connection present--need to contact owner to determine if owner plans to use. If crossing is no longer in use owner will need to coordinate with DWR inspector and CVFPB to remove according to Title 23 requirements. This crossing is referenced in the USACE Periodic Inspection as USACE_CESPK_MRD2_2012_p_0197. FIELD_STRUCT_DESC: Abandoned 24-inch pipe through the levee, 18.5 feet below the crown. Slide gate on concrete gate structure on berm. FS Date: 10/22/2013

View of pipe on landward side.

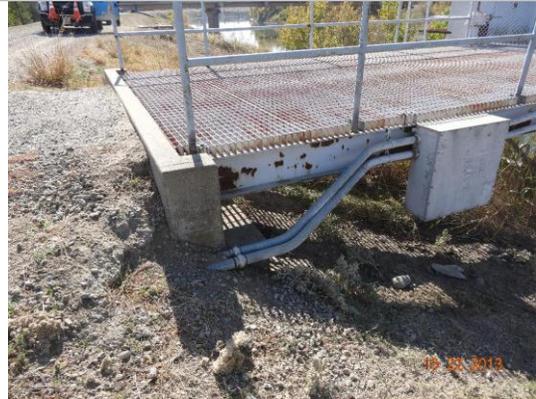
Photo 1 of 1 : UCIP\_3970.jpg

Item	DWR UCIP Field Study			39.147298 °	39.147298 °
				-121.916723 °	-121.916723 °
DWR ID	DWR_RD0070_02_s_2014_738				
<b>Action/Comments</b>					
Inspector Comments: FS_ID:24123 EP_NO: N/A Repair Type: Crossing Status: UCIP Comments: Pump station to be removed. This record will need to be updated once the pump station is removed. This crossing is referenced in the USACE Periodic Inspection as item USACE_CESPK_MRD2_2012_p_0235. FIELD_STRUCT_DESC: [Farms Water Company Pumping Plant No. 2] 2 of 3: 2.5-inch steel (not iron as mentioned in desk study) pipe through the levee, 1.9 feet below the crown. Two concrete cutoff walls, one at each shoulder. Concrete pump pit on the waterward slope. Three pumps on structure on the waterward side. Walkway to the pumps. Concrete headwall on landward side. Debris deflectors in river. (Permit No. 4525-1965). Pumping plant is to be demolished with all pipes removed and replaced with single 72-inch gravity feed pipe under Permit No. 18762 (2013). FS Date: 10/22/2013

Conduits through levee along walkway.

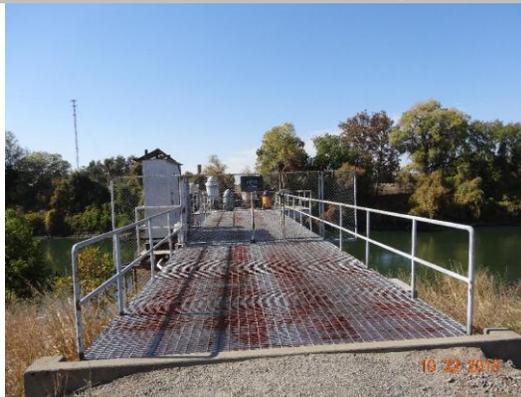
Photo 1 of 1 : UCIP\_3998.jpg

View of walkway and pump station on waterward side.

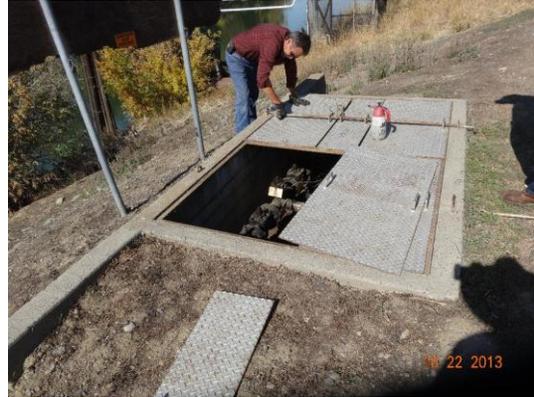
Photo 1 of 1 : UCIP\_4006.jpg

Item	DWR UCIP Field Study			39.147072 °	39.147072 °
				-121.916783 °	-121.916783 °
DWR ID	DWR_RD0070_02_s_2014_742				
Action/Comments					
Inspector Comments: FS_ID:24165 EP_NO: 767 Repair Type: Crossing Status: UCIP Comments: Need to contact owner to determine if crossing is still active and to determine last inspection date. Will need copy of letter showing crossings passed inspection. This crossing is referenced in the USACE Periodic Inspection as item USACE_CESPK_MRD2_2012_p_0237. FIELD_STRUCT_DESC: 3.0-inch steel gas pipe (not 3.5-inch as mentioned in desk study) through the levee, 3.0 feet below the crown. Concrete inspection well (8x10x1 foot) with metal cover on waterward shoulder. Painted aluminum marker on waterward side. Rock revetment on waterward slope. (Permit No. 767-1938) Contact information provided on marker 916-742-7344 and for emergencies call 916-742-3251. FS Date: 10/22/2013

PG&E maintenance employee checking crossing.

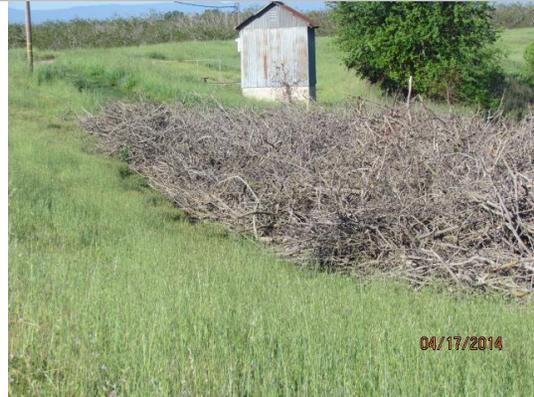
Photo 1 of 1 : rduffey\_s\_20140421\_181.jpg

LM Start	<b>4.53</b>	Rating **	M	Issue No.	<b>3</b>
LM End	<b>4.57</b>	Issue Type +	Ma	Location *	WS
Category	Earthen Levee		GPS Latitude/Longitude		
			Start	End	
Item	Encroachments		39.141707 °	39.141379 °	
			-121.918480 °	-121.918972 °	
DWR ID	DWR_RD0070_02_s_2012_3				
Action/Comments					
Prunings

View of the prunings along the waterside toe.

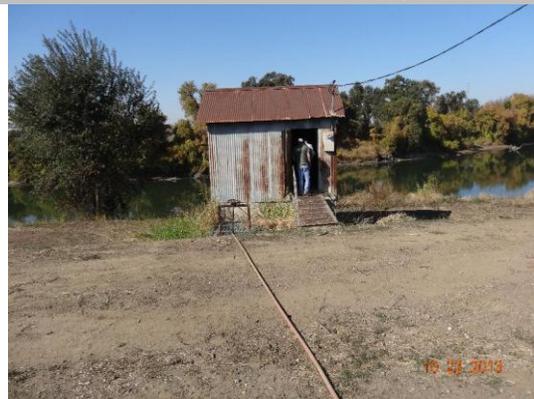
Photo 1 of 1 : UCIP\_3881.jpg

LM Start	<b>4.59</b>	Rating **	M	Issue No.	<b>746</b>
LM End	<b>4.59</b>	Issue Type +	En	Location *	WS
Category	Supplemental		GPS Latitude/Longitude		
			Start	End	
Item	DWR UCIP Field Study		39.141254 °	39.141254 °	
			-121.919221 °	-121.919221 °	
DWR ID	DWR_RD0070_02_s_2014_746				
Action/Comments

View of pump house located on waterward side.

Inspector Comments: FS\_ID:23962  
EP\_NO: 9998  
Repair Type:  
Crossing Status:  
UCIP Comments: Unable to confirm if crossing corresponds to permit 9998. Pipe size is different then the pipe size listed in the desk study. Unable to confirm if structure on landward side is a pump house. Need to coordinate with owner to obtain permit record for crossing. Need to verify status of crossing. Permit authorized 24 inch pipe. Pipe through levee is 30 inches. Unable to find stand pipe in field. Dense vegetation limits the inspector's visibility to identify signs of pipe failure (leaks) along the slope. Recommend removing vegetation along pipe alignment to conduct proper inspection of structure and appurtenances. This crossing is referenced in the USACE Periodic Inspection as item USACE\_CESPK\_MRD2\_2012\_p\_0264.  
FIELD\_STRUCT\_DESC: 30-inch (not 24-inch as indicated in desk study) CM pipe through the levee, 15.5 feet below the crown. Slide gate in concrete distribution box at landward toe. Pump in pumphouse at landward side. Service pole and ramp on waterward slope. Concrete box with air vents at waterward end. (USACE-1953). This entry matches the Drainage or Irrigation Structure referenced in O&M manual (Station 516+06). This pipe was retained under ABO No. 9998 (1974). 18-inch PVC pipe sleeved through the 24-inch pipe under Permit No. 16228 (1994). Annular gap grouted.

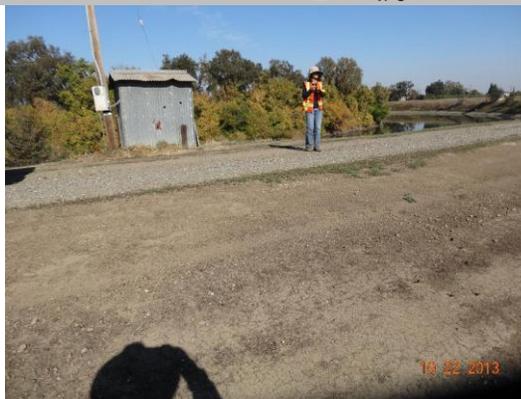
Photo 1 of 1 : UCIP\_4015.jpg

Item	DWR UCIP Field Study			39.141136 °	39.141136 °
				-121.922785 °	-121.922785 °
DWR ID	DWR_RD0070_02_s_2014_747				
Action/Comments					
<p>Inspector Comments: FS_ID:24166                      EP_NO: 9970                      Repair Type:                      Crossing Status:                      UCIP Comments: Need to coordinate with owner to determine status of crossing. No pump is located inside the pump house located on waterward side. If crossing is no longer in use owner will need to contact the CVFPB to comply with Title 23. Dense vegetation limits the inspector's visibility to identify signs of pipe failure (leaks) along the slope. Recommend removing vegetation along pipe alignment to conduct proper inspection of structure and appurtenances. This crossing is referenced in the USACE Periodic Inspection as item USACE_CESPK_MRD2_2012_p_0274.                      FIELD_STRUCT_DESC: 10-inch steel pipe through the levee, 4.8 feet below the crown. CM cutoff wall around pipe at center of levee. Siphon breaker on landward slope--not found. Pump in pump house on waterward shoulder. Shut-off valve on landward side. Concrete discharge box at landward toe. (USACE-1953). This entry matches the Drainage or Irrigation Structure referenced in O&amp;M manual (Station 526+71). This pipe was retained under ABO No. 9970 (1974).                      FS Date: 10/22/2013</p>

View of levee crown and pump house photo taken from landward side.

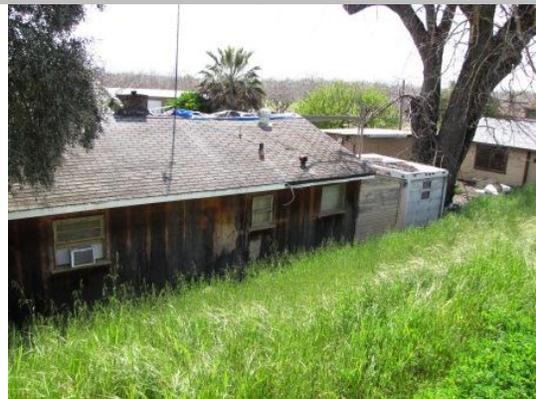
Photo 1 of 1 : rduffey\_s\_20140304\_277.jpg

LM Start	<b>4.99</b>	Rating **	U	Issue No.	<b>9</b>
LM End	<b>5.02</b>	Issue Type +	En	Location *	LS
Category	Earthen Levee		GPS Latitude/Longitude		
			Start	End	
Item	Encroachments		39.142008 °	39.142032 °	
			-121.926267 °	-121.926855 °	
DWR ID	DWR_RD0070_02_s_2012_9				
Action/Comments					
Building

View of the building along the toe.

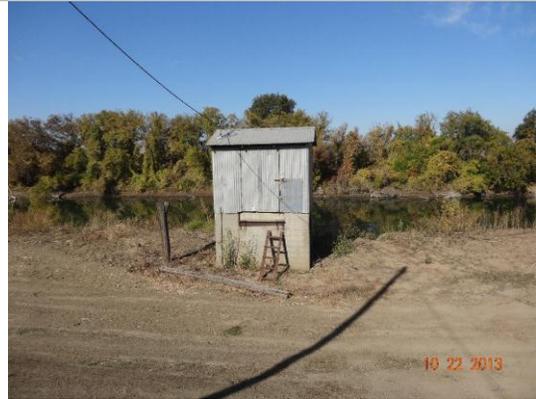
Photo 1 of 1 : UCIP\_3890.jpg

**Action/Comments**  
 Inspector Comments: FS\_ID:23964  
 EP\_NO: 9984  
 Repair Type:  
 Crossing Status:  
 UCIP Comments: Will need to contact owner. Need to obtain maintenance records and clarify modifications made at to crossing (size). Additional crossing visible through concrete headwall on landward side--crossing has been capped (see photo). NEED TO CONFIRM PIPE SIZE!!! This crossing is referenced in the USACE Periodic Inspection as item USACE\_CESPK\_MRD2\_2012\_p\_0289. FIELD\_STRUCT\_DESC: 12-inch (not 24-inch as mentioned in desk study) steel pipe through the levee, 13.8 feet below the crown. Gate valve on the waterward side. Pump in pump house on the waterward side. Concrete distribution box at the landward toe. (USACE-1953). This entry matches the Drainage or Irrigation Structure referenced in O&M manual (Station 555+09). This pipe was retained under ABO No. 9984 (1974).  
 FS Date: 10/22/2013

Pump house located on waterward side.

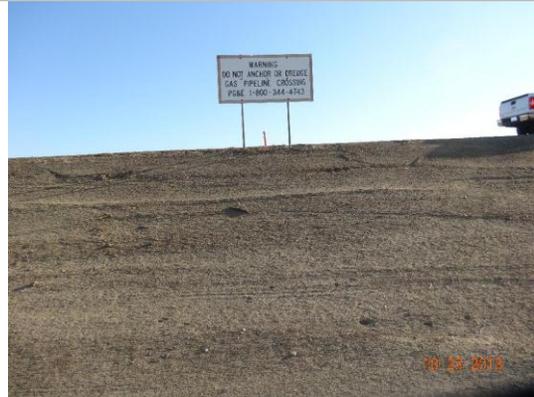
Photo 1 of 1 : UCIP\_3897.jpg

LM Start	<b>6.34</b>	Rating **	M	Issue No.	<b>749</b>
LM End	<b>6.34</b>	Issue Type +	En	Location *	LS
Category	Supplemental			GPS Latitude/Longitude	
				Start	End
Item	DWR UCIP Field Study			39.133847 °	39.133847 °
				-121.937689 °	-121.937689 °
DWR ID	DWR_RD0070_02_s_2014_749				
Action/Comments					
Inspector Comments: FS_ID:23965 EP_NO: 4383 Repair Type: Crossing Status: UCIP Comments: Need to contact owner to determine if crossing is still active and to determine last inspection date. Will need copy of letter showing crossings passed inspection. This crossing is referenced in the USACE Periodic Inspection as item USACE_CESPK_MRD2_2012_p_0319. FIELD_STRUCT_DESC: 8 5/8-inch steel gas pipe through the levee, 3.5 feet below the crown. Concrete cutoff wall around pipe at center of levee. Rock revetment on waterward slope. (Permit No. 4383-1963) FS Date: 10/23/2013

View of waterward slope.

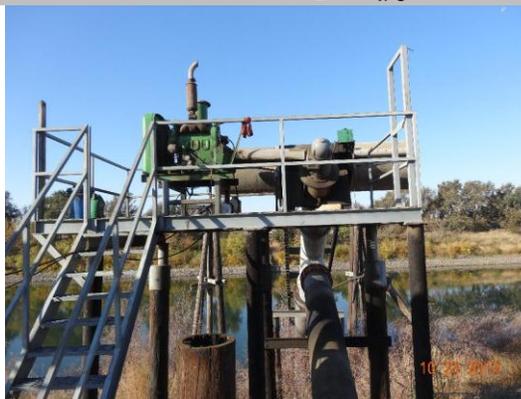
Photo 1 of 1 : UCIP\_3858.jpg

Item	DWR UCIP Field Study			39.133219 °	39.133219 °
				-121.937169 °	-121.937169 °
DWR ID	DWR_RD0070_02_s_2014_750				
Action/Comments					
Inspector Comments: FS_ID:23950 EP_NO: 9994 Repair Type: Crossing Status: UCIP Comments: Erosion visible on landward side behind concrete headwall. Plastic sheeting has been placed to protect slope. Need to determine cause for erosion, is pipe leaking? Pipe wall on landward side has deteriorated significantly that the wall is gone. Owner will need to coordinate with DWR inspector and CVFPB to address issue. Recommend notifying owner to stop using crossing until issue has been addressed. This crossing is referenced in the USACE Periodic Inspection as item USACE_CESPK_MRD2_2012_p_0324. FIELD_STRUCT_DESC: 20-inch steel pipe on waterward side and 24-inch steel pipe on landward side through the levee, 12.5 feet below the crown. Pipe is concrete encased under the crown, between the shoulders. Slide gate in metal well on waterward slope. Pump on pile structure in stream. Concrete discharge box at landward toe. Service pole on waterward slope. (USACE-1953). This entry matches the Drainage or Irrigation Structure referenced in O&M manual (Station 610+84). This pipe was retained under ABO No. 9994 (1974). FS Date: 10/23/2013

Stairs and platform located on waterward side.

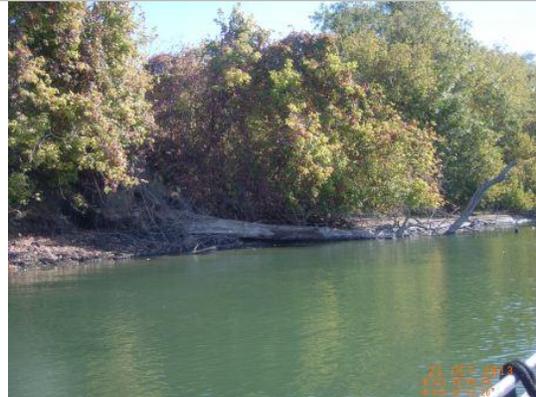
Photo 1 of 1 : USACE2013A\_SAC\_131-8\_L\_6.jpg

LM Start	<b>6.50</b>	Rating **	M	Issue No.	<b>14</b>
LM End	<b>6.60</b>	Issue Type +	Ma	Location *	WS
Category	Supplemental			GPS Latitude/Longitude	
				Start	End
Item	USACE Erosion Survey			39.132040 °	39.130900 °
				-121.936521 °	-121.934690 °
DWR ID					
<b>Action/Comments</b>					
Inspector Comments: 2005 - (known as 132) On inside of bend. Erosion of berm toe. Levee slope is steep. Erosion probably due to eddy scour off upstream cobble. 2009 - Groins may be a good option for repair. 2010 - Scour off the upstream rock, some new erosion. 2011 - Site extended downstream. 2012 - Minor new erosion since last year and new animal holes. 2012 - Minor new erosion since last year and new animal holes. 2013: New tree popout. [2013 Site ID: SAC_131-8_L]

USACE 2013 Photo #1

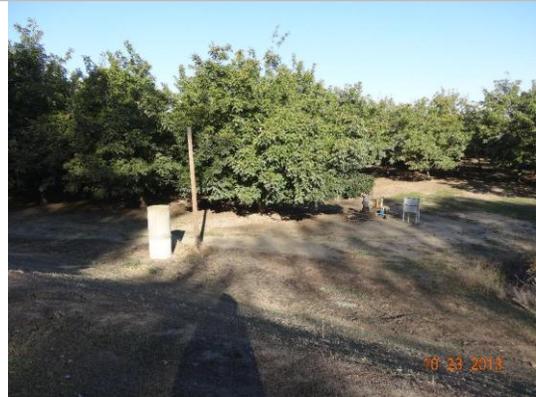
Photo 1 of 1 : UCIP\_3903.jpg

Item	DWR UCIP Field Study			39.124562 °	39.124562 °
				-121.913758 °	-121.913758 °
DWR ID	DWR_RD0070_02_s_2014_751				
Action/Comments					
<p>Inspector Comments: FS_ID:23966                  EP_NO: 9966                  Repair Type:                  Crossing Status:                  UCIP Comments: Pipe daylight at waterward side blocked. Unable to determine if connection is present--need to contact owner to determine if owner plans to use. If crossing is no longer in use owner will need to coordinate with DWR inspector and CVFPB to remove according to Title 23 requirements. Unable to determine if crossing is in use. This crossing is referenced in the USACE Periodic Inspection as item USACE_CESPK_MRD2_2012_p_0371.                  FIELD_STRUCT_DESC: 10-inch steel pipe and 1.5-inch electrical conduit through the levee, 12.0 and 8.0 feet below the crown, respectively. Pipe is concrete encased under the crown, between the shoulders. Two concrete cutoff walls under each shoulder. Pump and gate valve on pile structure in stream. Walkway to pump. Concrete standpipe on the landward side. (USACE-1953). This entry matches the Drainage or Irrigation Structure referenced in O&amp;M manual (Station 689+50). Pipe and conduit were retained under ABO No. 11496 (1975).                  FS Date: 10/23/2013</p>

Stand pipe located on landward side.

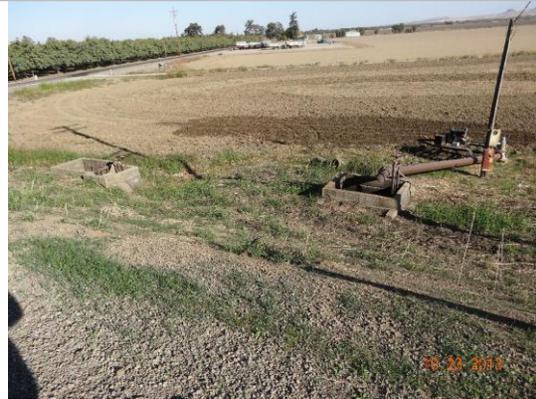
Photo 1 of 1 : UCIP\_4030.jpg

Item	DWR UCIP Field Study			39.124542 °	39.124542 °
				-121.911996 °	-121.911996 °
DWR ID	DWR_RD0070_02_s_2014_752				
Action/Comments					
Inspector Comments: FS_ID:24191 EP_NO: 1264 Repair Type: Crossing Status: UCIP Comments: Need to coordinate with owner to determine status of crossing. If crossing is no longer in use owner will need to contact the CVFPB to comply with Title 23. This crossing is referenced in the USACE Periodic Inspection as item USACE_CESPK_MRD2_2012_p_0124. FIELD_STRUCT_DESC: Abandoned 10-inch (not 14-inch as specified in desk study) pipe through the levee, 5.0 feet below the crown. Pump on the waterward side. Double concrete discharge box at landward toe. (Permit No. 1264-1948) FS Date: 10/23/2013

View of landward side--two crossing nearby.

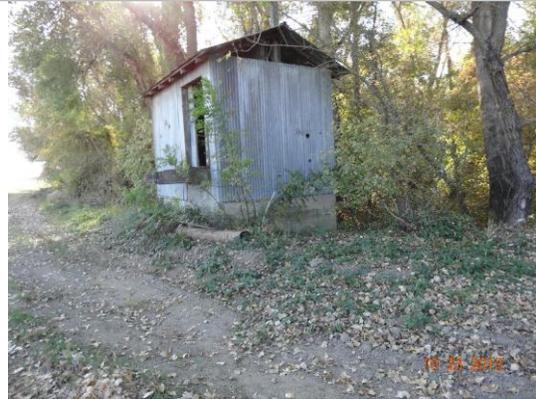
Photo 1 of 1 : UCIP\_4022.jpg

Inspector Comments: FS\_ID:24190  
 EP\_NO: 10008  
 Repair Type:  
 Crossing Status:  
 UCIP Comments: Concrete distribution box is damage on waterward side. Need to contact owner to determine status of crossing. If crossing is no longer in use owner will need to coordinate with DWR inspector and CVFPB to remove according to Title 23 requirements. This crossing is referenced in the USACE Periodic Inspection as item USACE\_CESPK\_MRD2\_2012\_p\_0380.  
 FIELD\_STRUCT\_DESC: Abandoned 18-inch steel pipe through the levee, 15.0 feet below the crown. Pump in pump house and slide gate on the waterward side. (USACE-1953). This entry matches the Drainage or Irrigation Structure referenced in O&M manual (Station 694+85). Concrete distribution box on landward side. This pipe was retained under ABO No. 10008 (1974). During field verification additional appurtenances were observed. An additional pipe on landward side drains into concrete distribution box. The concrete box connects to a second set of distribution boxes through a 24-inch concrete pipe approximately 36 feet upstream of crossing. Those boxes have a 10-inch pipe that appears to go through levee.

Pump house located on waterward side.

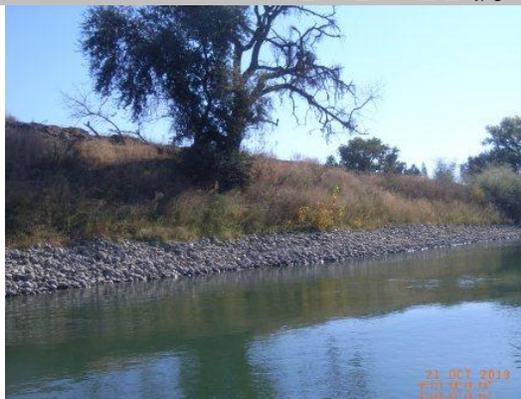
Photo 1 of 1 : USACE2013A\_SAC\_130-0\_L\_5.jpg

LM Start	<b>8.16</b>	Rating **	M	Issue No.	<b>11</b>
LM End	<b>8.32</b>	Issue Type +	Ma	Location *	WS
Category	Supplemental			GPS Latitude/Longitude	
				Start	End
Item	USACE Erosion Survey			39.122459 °	39.120684 °
				-121.910121 °	-121.909152 °
DWR ID					
Action/Comments					
Inspector Comments: 1997 - Critical Site - Erosion of cobble site on outside of a bend. Failure caused by erosion of a material from behind the cobbles and cobbles rolling down the slope. Failure is just above the toe levee. Some repairs had been done at the upstream end. 2004 - Some minor new erosion at the top of the berm. 2005 - Trees look okay and the downstream end has some new rock repair. Site is no longer critical. 2006 - No longer critical, some repairs. 2013: No observed changes. [2013 Site ID: SAC_130-0_L]

USACE 2013 Photo #1

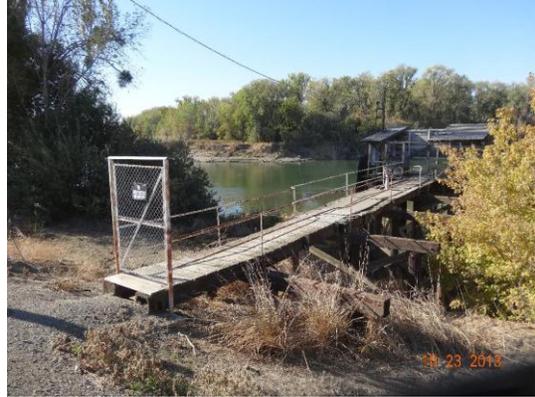
Photo 1 of 1 : UCIP\_3942.jpg

Item	DWR UCIP Field Study			39.110878 °	39.110878 °
				-121.902774 °	-121.902774 °
DWR ID	DWR_RD0070_02_s_2014_755				
Action/Comments					
Inspector Comments: FS_ID:24108 EP_NO: 9971 Repair Type: Crossing Status: UCIP Comments: Will need to contact owner. Need to obtain maintenance records and clarify modifications made to crossing (size). This crossing is referenced in the USACE Periodic Inspection as item USACE_CESPK_MRD2_2012_p_0433. FIELD_STRUCT_DESC: [Meridian Farms Water Com. Pumping Plant No. 3] 2 of 3: 16-inch pipe (not a 30-inch pipe as mentioned in desk study) through the levee, 20.5 feet below the crown. Gate valve on the waterward end. Pump on pile structure in stream. Wooden walkway to pump. Concrete distribution box on landward side. This pipe was retained under ABO No. 9971 (1974). Pumping plant is to be demolished under Permit No. 18762 (2013). FS Date: 10/23/2013

View of landward side--pump station and walkway

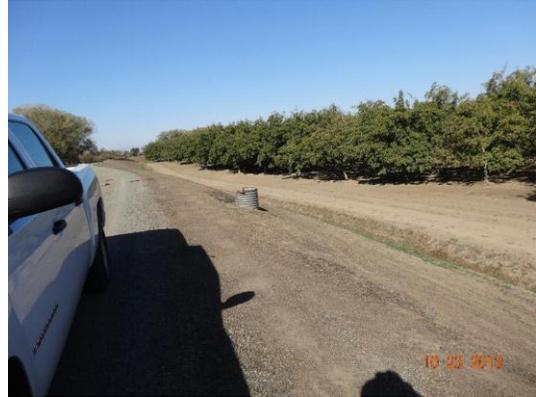
Photo 1 of 1 : UCIP\_3907.jpg

Item	DWR UCIP Field Study			39.096935 °	39.096935 °
				-121.893870 °	-121.893870 °
DWR ID	DWR_RD0070_02_s_2014_757				
Action/Comments					
Inspector Comments: FS_ID:23967 EP_NO: N/A Repair Type: Crossing Status: UCIP Comments: No evidence of pipe is visible on waterward side. Need to coordinate with owner to determine status of crossing. If crossing is no longer in use owner will need to contact the CVFPB to comply with Title 23. This crossing is referenced in the USACE Periodic Inspection as item USACE_CESPK_MRD2_2012_p_0477. FIELD_STRUCT_DESC: Abandoned 12-inch pipe through the levee, 3.1 feet below the crown. Siphon breaker in CM pipe riser on landward shoulder. Concrete plug at landward end. Wood distribution box on landward side at discharge end. (USACE-1953). This entry matches the Drainage or Irrigation Structure referenced in O&M manual (Station 813+00). (Cat. IV-A) FS Date: 10/23/2013

CMP riser located on landward shoulder.

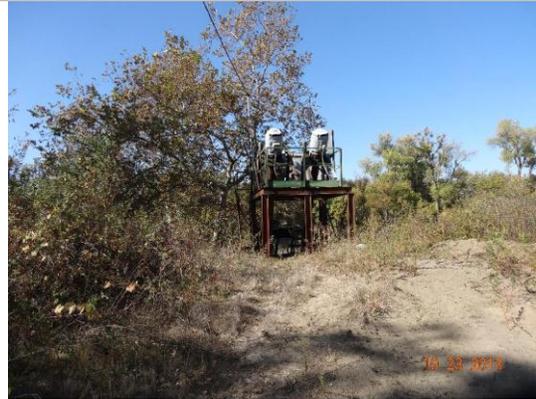
Photo 1 of 1 : UCIP\_4039.jpg

Item	DWR UCIP Field Study			39.093712 °	39.093712 °
				-121.892552 °	-121.892552 °
DWR ID	DWR_RD0070_02_s_2014_758				
Action/Comments					
Inspector Comments: FS_ID:24195 EP_NO: 1162 Repair Type: Crossing Status: UCIP Comments: Need to verify status of crossing--variation in pipe size. 18 inch pipe listed in desk study and 20 inch pipe found in field. Damage to siphon breaker housing unit. This crossing is referenced in the USACE Periodic Inspection as item USACE_CESPK_MRD2_2012_p_0482. FIELD_STRUCT_DESC: 1 of 2: 20-inch (not 18-inch as listed in desk study) steel pipe through the levee, 3.7 feet below the crown. Two concrete cutoff walls around pipe, at levee shoulders. Siphon breakers in steel pipe risers on landward shoulder. Slant pumps on wooden pump structure on waterward side. Two CM pipe risers under pump structure at waterward toe. Distribution box at landward toe. (Permit No. 1162-1946) This entry matches the Drainage or Irrigation Structure referenced in O&M manual (Station 824+00). FS Date: 10/23/2013

Pump station located on waterward side.

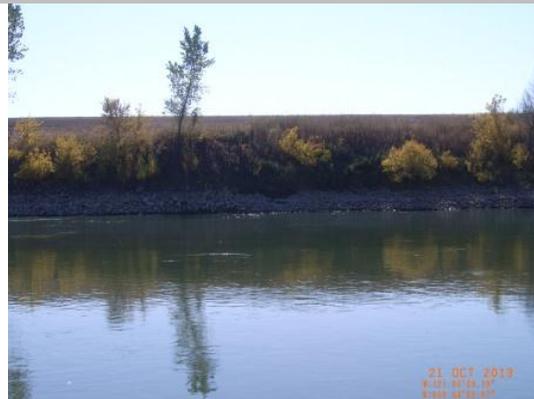
Photo 1 of 1 : USACE2013A\_SAC\_125-8\_L\_2.jpg

LM Start	<b>11.63</b>	Rating **	M	Issue No.	<b>10</b>
LM End	<b>11.68</b>	Issue Type +	Ma	Location *	WS
Category	Supplemental		GPS Latitude/Longitude		
			Start	End	
Item	USACE Erosion Survey		39.080669 °	39.080621 °	
			-121.891164 °	-121.891564 °	
DWR ID					
Action/Comments					
Inspector Comments: 2005 - Site was repaired. 2009 - Site is at upstream end of the repair site. 2011 - Still minor erosion. 2012 - Site shortened to remove non-eroding section, minor erosion with failing cobbles. 2013: No observed changes. [2013 Site ID: SAC_125-8_L]

USACE 2013 Photo #1

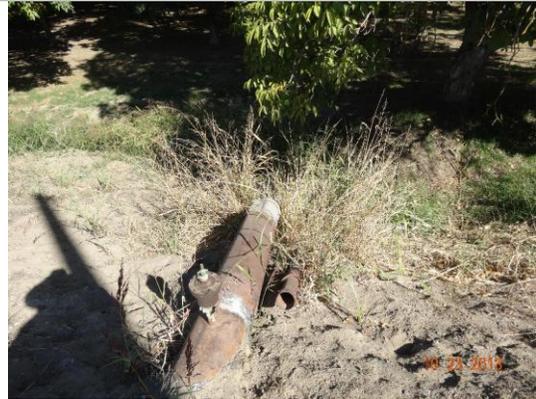
Photo 1 of 1 : UCIP\_3909.jpg

Inspector Comments: FS\_ID:23969  
 EP\_NO: 9997  
 Repair Type:  
 Crossing Status:  
 UCIP Comments: Debris found on waterward side along berm running parallel to levee. Two crossing found--Need to coordinate with owner to determine permit for second crossing and status of crossing. If crossing is no longer in use owner will need to contact the CVFPB to comply with Title 23. Dense vegetation limits the inspector's visibility to identify signs of pipe failure (leaks) along the waterward slope. Recommend removing vegetation along pipe alignment to conduct proper inspection of structure and appurtenances. This crossing is referenced in the USACE Periodic Inspection as item USACE\_CESPK\_MRD2\_2012\_p\_0559.  
 FIELD\_STRUCT\_DESC: 12-inch steel pipe through the levee, 3.5 feet below the crown. Siphon breaker in CM pipe riser on landward shoulder. Control valve and pump on waterward side. Power pole on waterward shoulder. Discharge box at landward toe. (USACE-1953). This entry matches the Drainage or Irrigation Structure referenced in O&M manual (Station 930+22). This pipe was retained under ABO No. 9997 (1974).

Close up view of pipe on landward side.

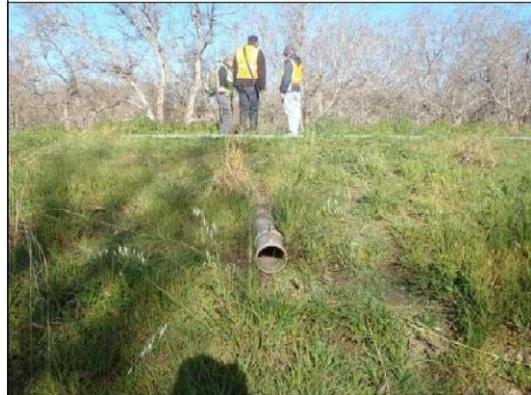
Photo 1 of 1 : UCIP\_4077.jpg

LM Start	<b>12.50</b>	Rating **	M	Issue No.	<b>762</b>
LM End	<b>12.50</b>	Issue Type +	En	Location *	WS
Category	Supplemental			GPS Latitude/Longitude	
				Start	End
Item	DWR UCIP Field Study			39.072480 °	39.072480 °
				-121.886540 °	-121.886540 °
DWR ID	DWR_RD0070_02_s_2014_762				
<b>Action/Comments</b>					
Inspector Comments: FS_ID:24245 EP_NO: N/A Repair Type: Crossing Status: UCIP Comments: No records were found during initial desk study--need to contact owner to obtain permit number authorizing work. Owner will need to coordinate with DWR Inspector and CVFPB to remove crossing according to Title 23 requirements. FIELD_STRUCT_DESC: 6-inch diameter aluminum irrigation pipe through the levee 18 inches below the crown through a 10 inch corrugated metal pipe. Pipe extends down both slopes about 2 feet below crown. FS Date: 10/23/2013 2:43:00 PM

View of pipe through levee--photo is from USACE PI Draft Report dated 6-2012.

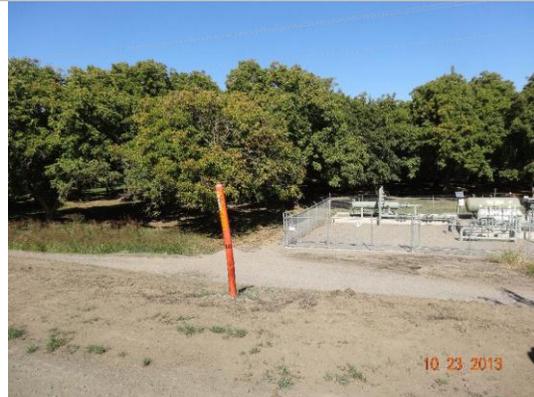
Photo 1 of 1 : UCIP\_3916.jpg

Item	DWR UCIP Field Study			39.072512 °	39.072512 °
				-121.886000 °	-121.886000 °
DWR ID	DWR_RD0070_02_s_2014_763				
Action/Comments					
Inspector Comments: FS_ID:23984 EP_NO: 3800 Repair Type: Crossing Status: UCIP Comments: Need to contact owner to determine if crossing is still active and to determine last inspection date. Will need copy of letter showing crossings passed inspection. This crossing is referenced in the USACE Periodic Inspection as item USACE_CESPK_MRD2_2012_p_0568. FIELD_STRUCT_DESC: 20-inch steel gas pipe through the levee, 3.0 feet below the crown. Concrete cutoff wall around pipe at center of levee. Marker sign on waterward shoulder. Natural gas equipment pad at landward toe. (Permit No. 3800-1962) FS Date: 10/23/2013

Marker on landward side.

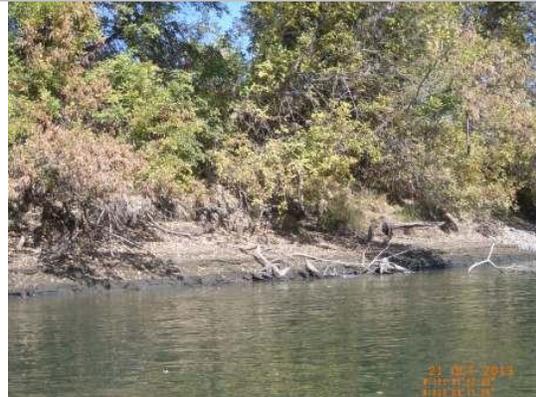
Photo 1 of 2 : USACE2013A\_SAC\_123-3\_L\_6.jpg

LM Start	<b>14.10</b>	Rating **	M	Issue No.	<b>2</b>
LM End	<b>14.28</b>	Issue Type +	Ma	Location *	WS
Category	Supplemental		GPS Latitude/Longitude		
			Start	End	
Item	USACE Erosion Survey		39.069166 °	39.070105 °	
			-121.857995 °	-121.855929 °	
DWR ID					
Action/Comments					
Inspector Comments: 2006 - Erosion into the levee toe. Rock at upstream end has poor transition causing eddy scour. 2010 - Minor new erosion. 2011 - Some fresh erosion. 2012 - Additional slumping on the previously slumped bank, site extended downstream. 2013: No observed changes. [2013 Site ID: SAC_123-3_L]

USACE 2013 Photo #1

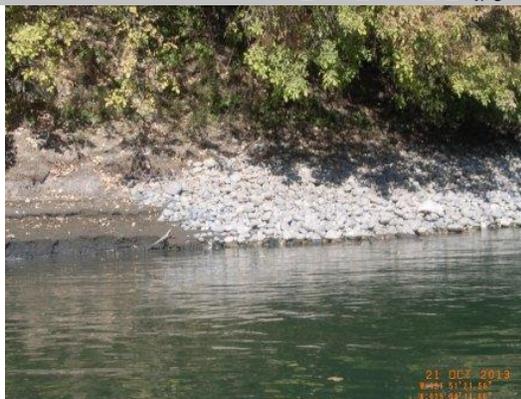
Photo 2 of 2 : USACE2013A\_SAC\_123-3\_L\_7.jpg

LM Start	<b>14.10</b>	Rating **	M	Issue No.	<b>2 (cont)</b>
LM End	<b>14.28</b>	Issue Type +	Ma	Location *	WS
Category	Supplemental		GPS Latitude/Longitude		
			Start	End	
Item	USACE Erosion Survey		39.069166 °	39.070105 °	
			-121.857995 °	-121.855929 °	
DWR ID					
Action/Comments					
Inspector Comments: 2006 - Erosion into the levee toe. Rock at upstream end has poor transition causing eddy scour. 2010 - Minor new erosion. 2011 - Some fresh erosion. 2012 - Additional slumping on the previously slumped bank, site extended downstream. 2013: No observed changes. [2013 Site ID: SAC_123-3_L]

USACE 2013 Photo #2

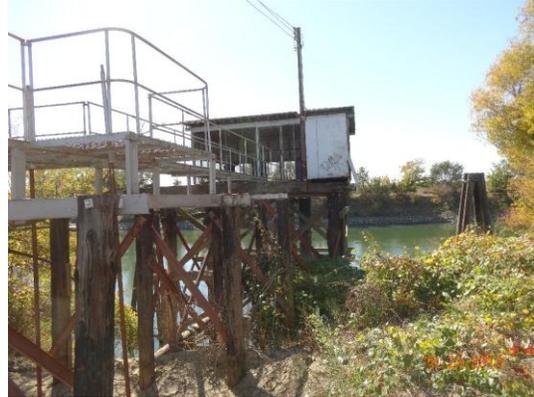
Photo 1 of 1 : UCIP\_4057.jpg

Pump house located on waterward side.
