**Flood Control Project Maintenance
Levee Inspections**
LMA District Cover Sheet
Spring 2016 Levee Inspection Results

Reclamation District No. 0070 Meridian

Waterway		Bank	Unit Miles
Unit No. 01 Sutter Bypass		Right	7.92

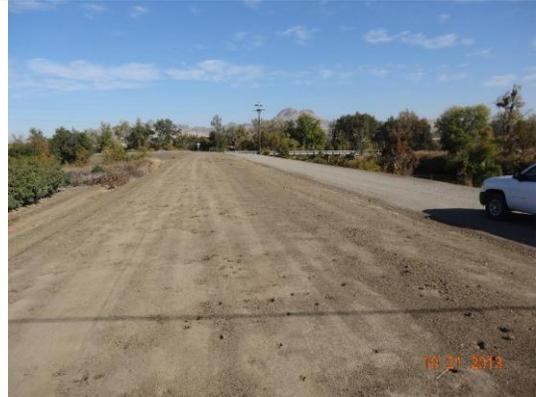
Photo 1 of 2 : UCIP_SP_2016_23526_40942.jpg

View of levee crown and waterward berm looking downstream from crossing.

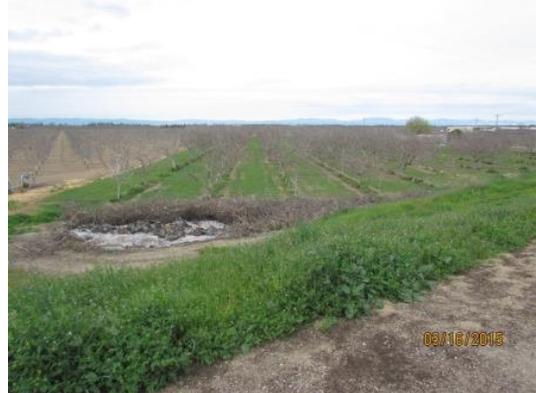
Photo 1 of 1 : SP_2016_RD0070_29_34_20160316_00003.jpg

LM Start	4.57	Rating **	U	Issue No.	34
LM End	4.57	Issue Type +	En	Location *	LS
Category	Earthen Levee		GPS Latitude/Longitude		
			Start	End	
Item	Encroachments		39.167168 °	39.167168 °	
			-121.899102 °	-121.899102 °	
DWR ID	DWR_RD0070_01_s_2015_34				
Comment Code					
PR : Prunings					
Inspector Comment

View of the prunings along the landside toe.

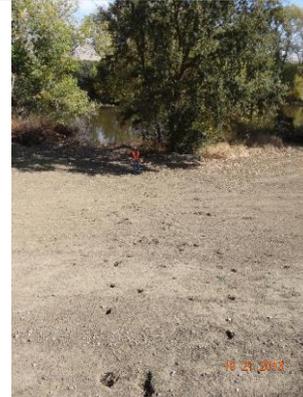
Photo 1 of 2 : UCIP_SP_2016_23517_40883.jpg

Comment Code					
Inspector Comment					
FS_ID:23517 DS_ID:21340 EP_NO: 9954 Repair Type: Non-Urgent Crossing Status: Found UCIP Comments: Burrow activity present on waterward slope. Need to coordinate with owner to determine status of crossing. If crossing is no longer in use owner will need to contact the CVFPB to comply with Title 23. This crossing is referenced in the USACE Periodic Inspection as item USACE_CESPK_MRD1_2012_p_0134. FIELD_STRUCT_DESC: 24-inch CM pipe through the levee, 19.0 feet below the crown. Slide gate on the waterward. Concrete distribution box at landward toe. This pipe was retained under ABO No. 9954 (1974). FS Date: 10/21/2013

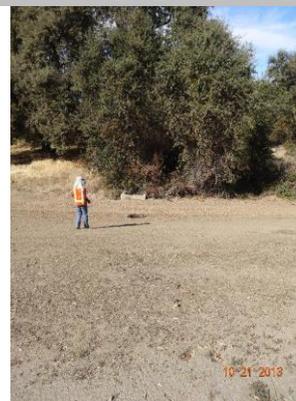
Photo 1 of 2 : UCIP_SP_2016_23529_40964.jpg

Comment Code					
Inspector Comment					
FS_ID:23529 DS_ID:21345 EP_NO: 9942 Repair Type: Non-Urgent Crossing Status: Found UCIP Comments: Dense vegetation limits the inspector's visibility to identify signs of pipe failure (leaks) along the slope. Recommend removing vegetation along pipe alignment to conduct proper inspection of structure and appurtenances. This crossing is referenced in the USACE Periodic Inspection as item USACE_CESPK_MRD1_2012_p_0005. FIELD_STRUCT_DESC: 24-inch CM pipe through the levee, 16.5 feet below the crown. Slide gate in CM pipe rise on waterward slope. Incline pump on waterward side. Discharges to concrete box at the landward toe. Service pole on landward side. (USACE-1953). This entry matches the Drainage or Irrigation Structure referenced in O&M manual (Station 330+00). This pipe was retained under ABO No. 9942 (1974). FS Date: 10/21/2013

View of waterward slope.

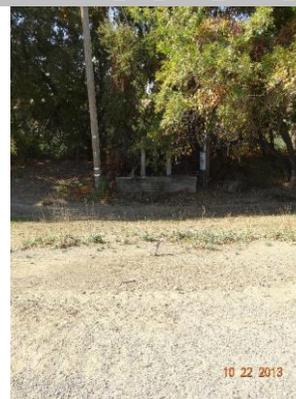
Photo 2 of 2 : UCIP_SP_2016_23885_41817.jpg

Overview of waterward slope.

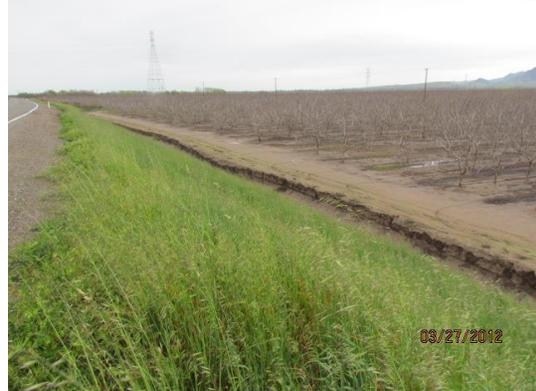
Photo 1 of 1 : SP_2016_RD0070_30_1_20160316_00001.jpg

LM Start	2.16	Rating **	M	Issue No.	1
LM End	2.32	Issue Type +	En	Location *	LS
Category	Earthen Levee		GPS Latitude/Longitude		
			Start	End	
Item	Encroachments		39.168854 °	39.166503 °	
			-121.936223 °	-121.935547 °	
DWR ID	DWR_RD0070_02_s_2012_1				
Comment Code					
DT : Ditch					
Inspector Comment

Agricultural ditch along the landside toe.

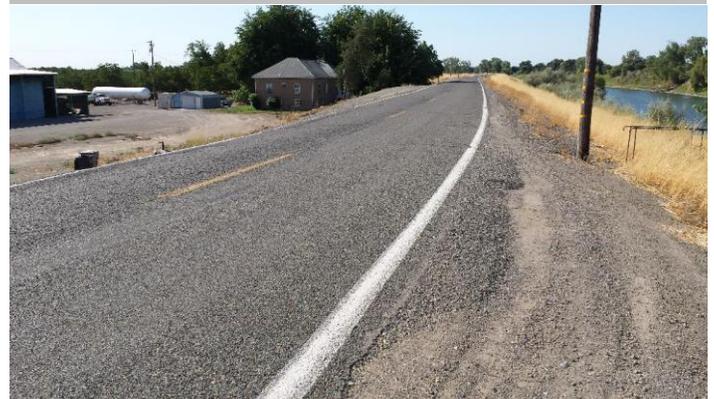
Photo 1 of 2 : UCIP_SP_2016_46407_74608.jpg

Comment Code					
Inspector Comment					
<p>FS_ID:46407 DS_ID:21367 EP_NO: 1158 Repair Type: Urgent Crossing Status: Found UCIP Comments: Pipe was running during site visit. Scour hole located at landward side (LS) toe is still present. New signs of stress on slope are visible on LS near concrete box. On the waterward side (WS) 2 leaks are present. The first leak is located at the pipe joint near the WS toe, the joint connection is leaking significantly. The second potential leak is near the pipe daylight on WS. Unable to confirm cause of leak but downstream seepage is present along pipe alignment. Seepage indicates that pipe may be leaking and causing internal erosion and void along pipe alignment. Recommend LMA superintendent notify owner to stop using crossing to avoid further damage to levee. Owner will need to coordinate with DWR Inspector and CVFPB to address leaky pipe per Title 23 requirements. FIELD_STRUCT_DESC: 18-inch steel pipe through the levee, 4.1 feet below the crown. Pump in pumphouse on waterward shoulder on concrete stand. Pipe discharges into concrete box at landward toe. Walkway to pumphouse on waterward side. (Permit No. 1158-1946) FS Date: 7/28/2015 10:46:00 AM</p>

View of county road where pipe crosses.

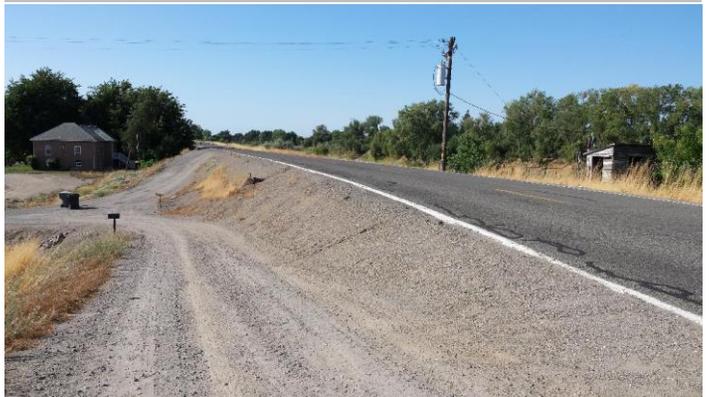
Photo 2 of 2 : UCIP_SP_2016_46407_74603.jpg

Comment Code					
Inspector Comment					
<p>FS_ID:46407 DS_ID:21367 EP_NO: 1158 Repair Type: Urgent Crossing Status: Found UCIP Comments: Pipe was running during site visit. Scour hole located at landward side (LS) toe is still present. New signs of stress on slope are visible on LS near concrete box. On the waterward side (WS) 2 leaks are present. The first leak is located at the pipe joint near the WS toe, the joint connection is leaking significantly. The second potential leak is near the pipe daylight on WS. Unable to confirm cause of leak but downstream seepage is present along pipe alignment. Seepage indicates that pipe may be leaking and causing internal erosion and void along pipe alignment. Recommend LMA superintendent notify owner to stop using crossing to avoid further damage to levee. Owner will need to coordinate with DWR Inspector and CVFPB to address leaky pipe per Title 23 requirements. FIELD_STRUCT_DESC: 18-inch steel pipe through the levee, 4.1 feet below the crown. Pump in pumphouse on waterward shoulder on concrete stand. Pipe discharges into concrete box at landward toe. Walkway to pumphouse on waterward side. (Permit No. 1158-1946) FS Date: 7/28/2015 10:46:00 AM</p>

View of landward side and county road (N. Meridian Road).

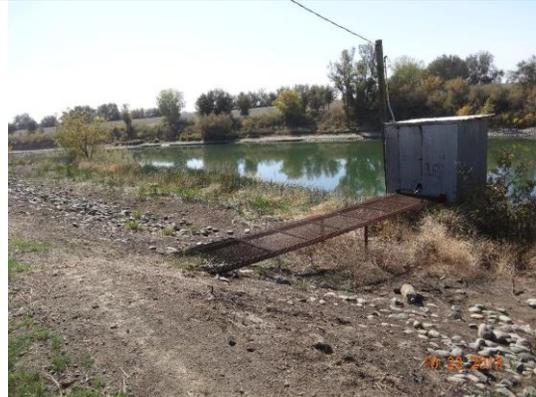
Photo 1 of 2 : UCIP_SP_2016_23891_41835.jpg

View of waterward side.

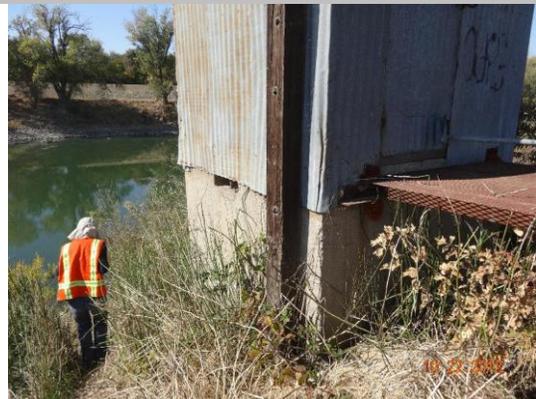
Photo 2 of 2 : UCIP_SP_2016_23891_41833.jpg

Pump station located on waterward side.

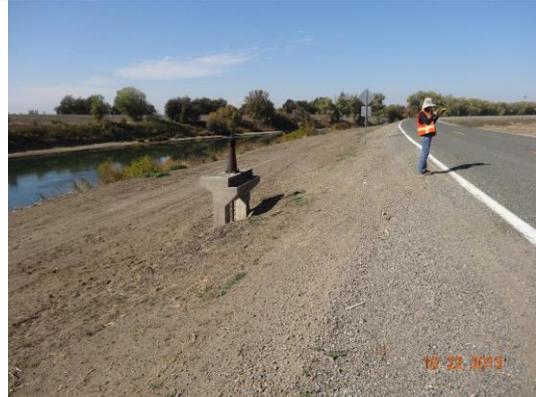
Photo 1 of 2 : UCIP_SP_2016_23892_41839.jpg

Comment Code					
Inspector Comment					
FS_ID:23892 DS_ID:21369 EP_NO: N/A Repair Type: Non-Urgent Crossing Status: Found UCIP Comments: If crossing is no longer used by owner, the owner will need to coordinate with DWR Inspector and CVFPB to remove crossing according to Title 23 requirements. Dense vegetation limits the inspector's visibility to identify signs of pipe failure (leaks) along the slope. Recommend removing vegetation along pipe alignment to conduct proper inspection of structure and appurtenances. This crossing is referenced in the USACE Periodic Inspection as item USACE_CESPK_MRD1_2012_p_0167. FIELD_STRUCT_DESC: Abandoned 24-inch CM pipe through the levee, 21.0 feet below the crown. Slide gate on waterward end. (Cat. IVA) FS Date: 10/22/2013

View of waterward side.

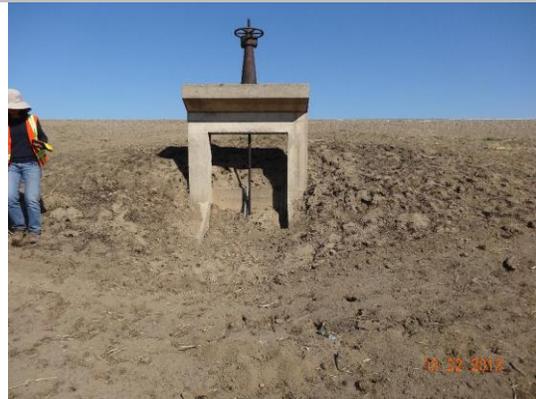
Photo 2 of 2 : UCIP_SP_2016_23892_41841.jpg

Buried screw gate located on waterward shoulder.

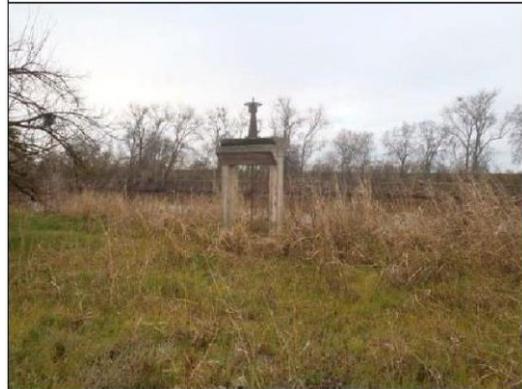
Photo 1 of 2 : UCIP_SP_2016_24115_42495.jpg

LM Start	3.35	Rating **	M	Issue No.	35
LM End	3.35	Issue Type +	En	Location *	LS
Category	Supplemental			GPS Latitude/Longitude	
				Start	End
Item	DWR UCIP Field Study			39.156068 °	39.156068 °
				-121.923453 °	-121.923453 °
DWR ID					
Comment Code					
Inspector Comment					
FS_ID:24115 DS_ID:21370 EP_NO: N/A Repair Type: Non-Urgent Crossing Status: Found UCIP Comments: No connection present--need to contact owner to determine if owner plans to use. If crossing is no longer in use owner will need to coordinate with DWR inspector and CVFPB to remove according to Title 23 requirements. This crossing is referenced in the USACE Periodic Inspection as USACE_CESPK_MRD2_2012_p_0197. FIELD_STRUCT_DESC: Abandoned 24-inch pipe through the levee, 18.5 feet below the crown. Slide gate on concrete gate structure on berm. FS Date: 10/22/2013

View of waterward side--photo is from USACE PI Report draft final issue USACE_CESPK_MRD2_2012_p_0197.

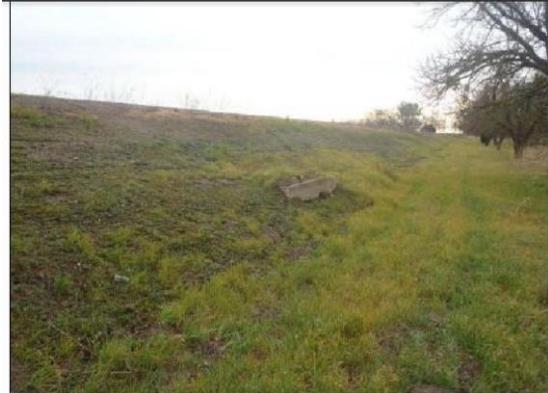
Photo 2 of 2 : UCIP_SP_2016_24115_42496.jpg

View of landward side--photo is from USACE PI Report draft final issue USACE_CESPK_MRD2_2012_p_0197.

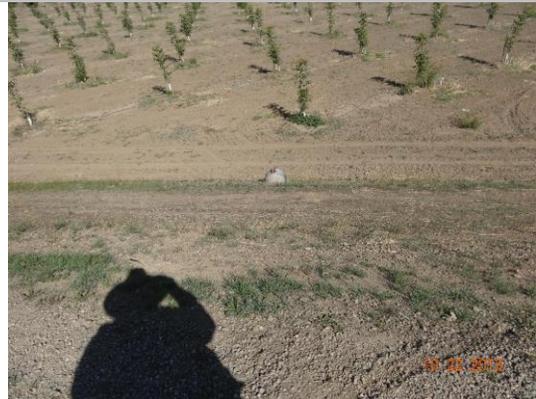
Photo 1 of 2 : UCIP_SP_2016_24117_42502.jpg

LM Start	3.40	Rating **	M	Issue No.	36
LM End	3.40	Issue Type +	En	Location *	LS
Category	Supplemental			GPS Latitude/Longitude	
				Start	End
Item	DWR UCIP Field Study			39.155648 °	39.155648 °
				-121.922823 °	-121.922823 °
DWR ID					
Comment Code					
Inspector Comment					
FS_ID:24117 DS_ID:21371 EP_NO: N/A Repair Type: Non-Urgent Crossing Status: Found UCIP Comments: No connection present--need to contact owner to determine if owner plans to use. If crossing is no longer in use owner will need to coordinate with DWR inspector and CVFPB to remove according to Title 23 requirements. This crossing is referenced in the USACE Periodic Inspection as USACE_CESPK_MRD2_2012_p_0197. FIELD_STRUCT_DESC: Abandoned 24-inch pipe through the levee, 18.5 feet below the crown. Slide gate on concrete gate structure on berm. FS Date: 10/22/2013

View of pipe on landward side.

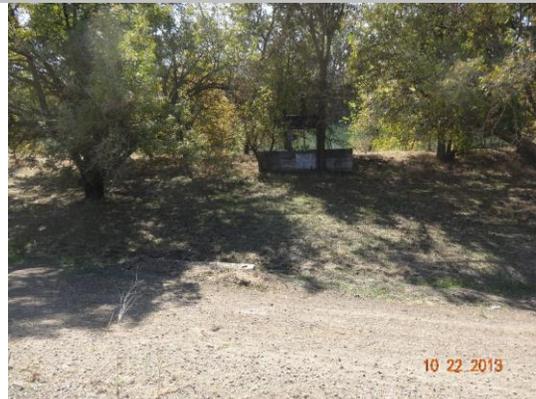
Photo 2 of 2 : UCIP_SP_2016_24117_42501.jpg

View of concrete headwall and screw gate on waterward side.

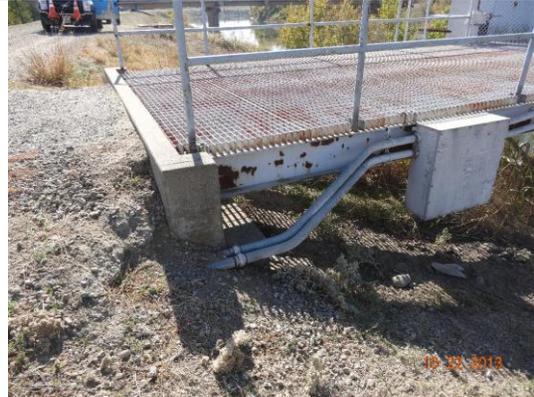
Photo 1 of 1 : UCIP_SP_2016_47029_42511.jpg

Comment Code					
Inspector Comment					
FS_ID:47029 DS_ID:21427 EP_NO: N/A Repair Type: Non-Urgent Crossing Status: Found UCIP Comments: Pump station to be removed. This record will need to be updated once the pump station is removed. This crossing is referenced in the USACE Periodic Inspection as item USACE_CESPK_MRD2_2012_p_0235. FIELD_STRUCT_DESC: [Farms Water Company Pumping Plant No. 2] 2 of 4: 2.5-inch steel (not iron as mentioned in desk study) pipe through the levee, 1.9 feet below the crown. Two concrete cutoff walls, one at each shoulder. Concrete pump pit on the waterward slope. Three pumps on structure on the waterward side. Walkway to the pumps. Concrete headwall on landward side. Debris deflectors in river. (Permit No. 4525-1965). Pumping plant is to be demolished with all pipes removed and replaced with single 72-inch gravity feed pipe under Permit No. 18762 (2013). FS Date: 10/22/2013

Conduits through levee along walkway.

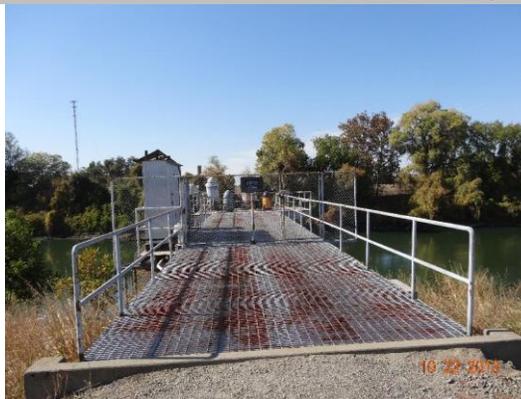
Photo 1 of 2 : UCIP_SP_2016_47030_42563.jpg

View of walkway and pump station on waterward side.

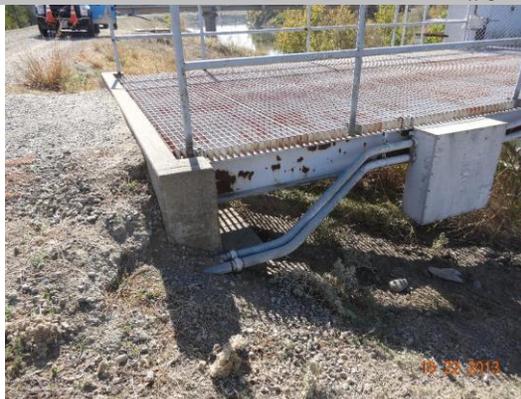
Photo 2 of 2 : UCIP_SP_2016_47030_42567.jpg

View of conduit pipes through levee.

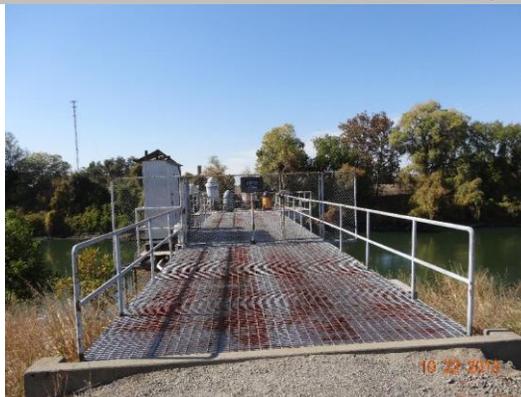
Photo 1 of 2 : UCIP_SP_2016_47032_42076.jpg

View of walkway and pump station on waterward side.

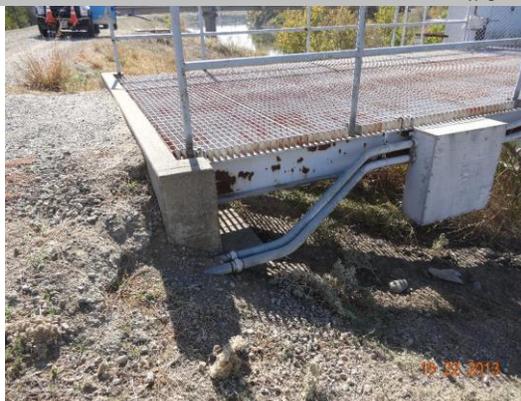
Photo 2 of 2 : UCIP_SP_2016_47032_42080.jpg

View of conduit pipes through levee.

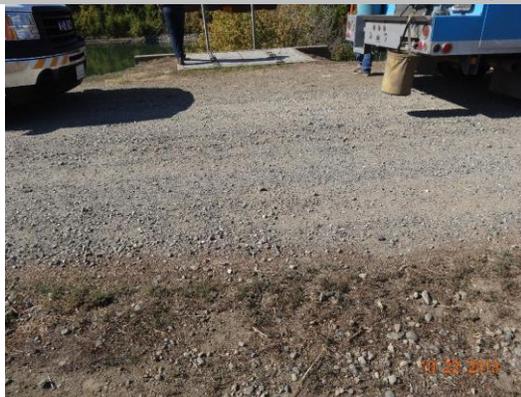
Photo 1 of 2 : UCIP_SP_2016_24165_42573.jpg

View of levee crown.

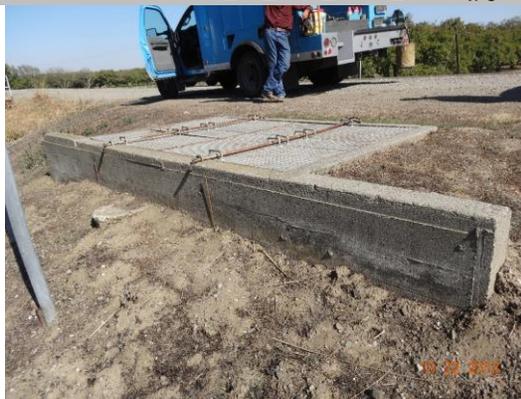
Photo 2 of 2 : UCIP_SP_2016_24165_42575.jpg

Concrete headwall on waterward side.

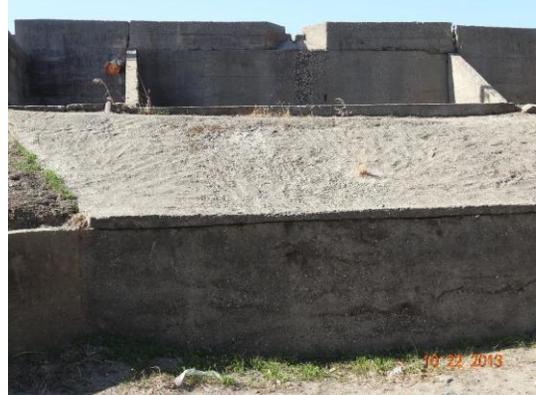
Photo 1 of 1 : UCIP_SP_2016_23959_42096.jpg

Comment Code					
Inspector Comment					
FS_ID:23959 DS_ID:21375 EP_NO: 1123 Repair Type: Non-Urgent Crossing Status: Indicator Found UCIP Comments: No connection present. If crossing is no longer in use owner will need to coordinate with DWR inspector and CVFPB to remove according to Title 23 requirements. This crossing is referenced in the USACE Periodic Inspection as item USACE_CESPK_MRD2_2012_p_0240. FIELD_STRUCT_DESC: 1 of 3: 10-inch pipe through the levee, 2.0 feet below the crown. Seed washing plant with concrete catch basin and pan on the landward slope. Concrete sump on waterward slope. Intake pump on waterward slope. (Permit No. 1123-1946) This entry matches the Drainage or Irrigation Structure referenced in O&M manual (Station 496+25). FS Date: 10/22/2013

Concrete headwall located on landward side--no pipe. Only visible pipe is the pipe located at the far left (downstream end).

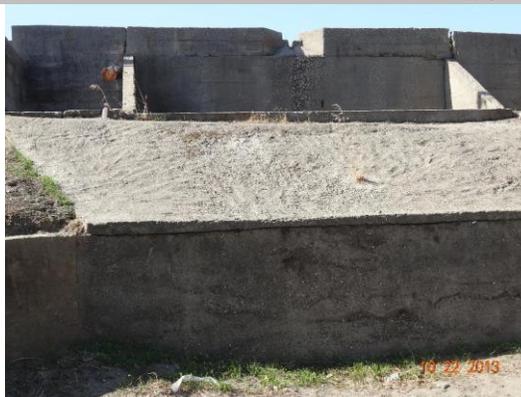
Photo 1 of 1 : UCIP_SP_2016_23960_42097.jpg

Comment Code					
Inspector Comment					
FS_ID:23960 DS_ID:21424 EP_NO: 1123 Repair Type: Non-Urgent Crossing Status: Indicator Found UCIP Comments: No connection present. If crossing is no longer in use owner will need to coordinate with DWR inspector and CVFPB to remove according to Title 23 requirements. This crossing is referenced in the USACE Periodic Inspection as item USACE_CESPK_MRD2_2012_p_0240. FIELD_STRUCT_DESC: 2 of 3: 4-inch pipe through the levee, 2.0 feet below the crown. Seed washing plant with concrete catch basin and pan on the landward slope. Concrete sump on waterward slope. Intake pump on waterward slope. (Permit No. 1123-1946) This entry matches the Drainage or Irrigation Structure referenced in O&M manual (Station 496+25). FS Date: 10/22/2013

Concrete headwall located on landward side--no pipe. Only visible pipe is the pipe located at the far left (downstream end).

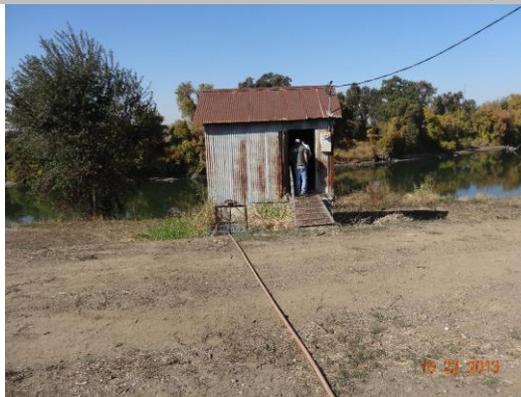
Photo 1 of 2 : UCIP_SP_2016_23962_42099.jpg

FS_ID:23962
 DS_ID:21379
 EP_NO: 9998
 Repair Type: Non-Urgent
 Crossing Status: Found
 UCIP Comments: Unable to confirm if crossing corresponds to permit 9998. Pipe size is different then the pipe size listed in the desk study. Unable to confirm if structure on landward side is a pump house. Need to coordinate with owner to obtain permit record for crossing. Need to verify status of crossing. Permit authorized 24 inch pipe. Pipe through levee is 30 inches. Unable to find stand pipe in field. Dense vegetation limits the inspector's visibility to identify signs of pipe failure (leaks) along the slope. Recommend removing vegetation along pipe alignment to conduct proper inspection of structure and appurtenances. This crossing is referenced in the USACE Periodic Inspection as item USACE_CESPK_MRD2_2012_p_0264.
 FIELD_STRUCT_DESC: 30-inch (not 24-inch as indicated in desk study) CM pipe through the levee, 15.5 feet below the crown. Slide gate in concrete distribution box at landward toe. Pump in pumphouse at landward side. Service pole and ramp on waterward slope. Concrete box with air vents at waterward end. (USACE-1953). This entry matches the Drainage or Irrigation Structure referenced in O&M manual (Station 516+06). This pipe was retained under ABO No. 9998 (1974). 18-inch PVC pipe sleeved through the 24-inch pipe under Permit No. 16228 (1994). Annular gap grouted.

View of pump house located on waterward side.

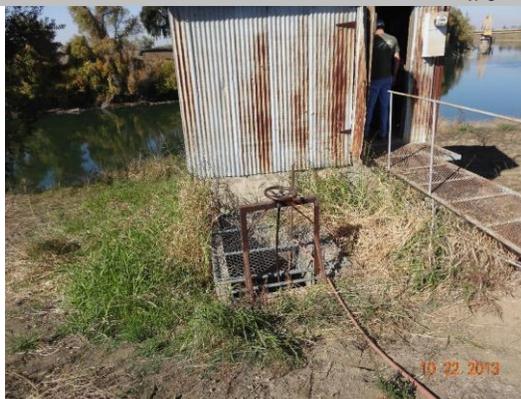
Photo 2 of 2 : UCIP_SP_2016_23962_42104.jpg

Positive closure device located at the waterward side inside concrete distribution box.

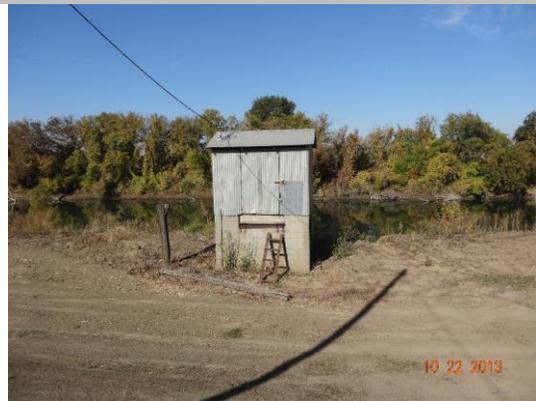
Photo 1 of 2 : UCIP_SP_2016_23964_42114.jpg

Comment Code					
Inspector Comment					
FS_ID:23964 DS_ID:21383 EP_NO: 9984 Repair Type: Non-Urgent Crossing Status: Found UCIP Comments: Will need to contact owner. Need to obtain maintenance records and clarify modifications made at to crossing (size). Additional crossing visible through concrete headwall on landward side--crossing has been capped (see photo). NEED TO CONFIRM PIPE SIZE!!! This crossing is referenced in the USACE Periodic Inspection as item USACE_CESPK_MRD2_2012_p_0289. FIELD_STRUCT_DESC: 12-inch (not 24-inch as mentioned in desk study) steel pipe through the levee, 13.8 feet below the crown. Gate valve on the waterward side. Pump in pump house on the waterward side. Concrete distribution box at the landward toe. (USACE-1953). This entry matches the Drainage or Irrigation Structure referenced in O&M manual (Station 555+09). This pipe was retained under ABO No. 9984 (1974). FS Date: 10/22/2013

Pump house located on waterward side.

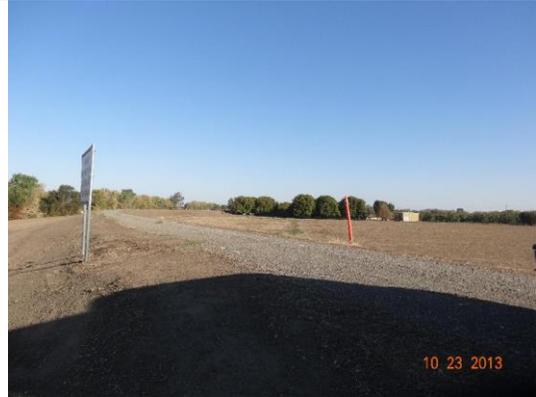
Photo 1 of 2 : UCIP_SP_2016_23965_42123.jpg

LM Start	6.28	Rating **	M	Issue No.	20
LM End	6.28	Issue Type +	En	Location *	LS
Category	Supplemental			GPS Latitude/Longitude	
				Start	End
Item	DWR UCIP Field Study			39.133847 °	39.133847 °
				-121.937689 °	-121.937689 °
DWR ID					
Comment Code					
Inspector Comment					
FS_ID:23965 DS_ID:21385 EP_NO: 4383 Repair Type: Non-Urgent Crossing Status: Found UCIP Comments: Need to contact owner to determine if crossing is still active and to determine last inspection date. Will need copy of letter showing crossings passed inspection. This crossing is referenced in the USACE Periodic Inspection as item USACE_CESPK_MRD2_2012_p_0319. FIELD_STRUCT_DESC: 8 5/8-inch steel gas pipe through the levee, 3.5 feet below the crown. Concrete cutoff wall around pipe at center of levee. Rock revetment on waterward slope. (Permit No. 4383-1963) FS Date: 10/23/2013

Markers visible on both levee shoulders.

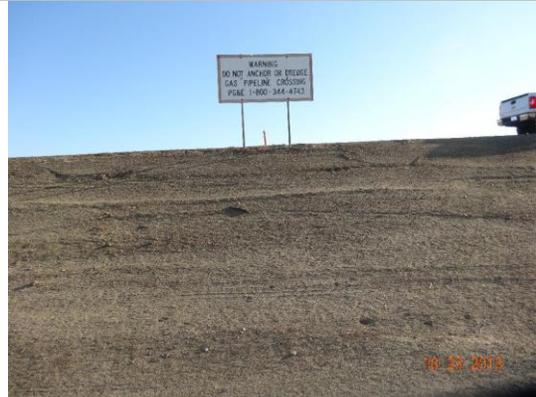
Photo 2 of 2 : UCIP_SP_2016_23965_42121.jpg

View of waterward slope.

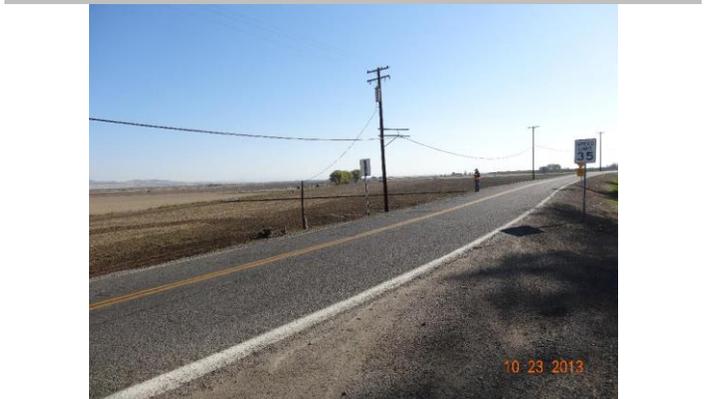
Photo 1 of 2 : UCIP_SP_2016_24191_42677.jpg

LM Start	7.92	Rating **	M	Issue No.	33
LM End	7.92	Issue Type +	En	Location *	LS
Category	Supplemental		GPS Latitude/Longitude		
			Start	End	
Item	DWR UCIP Field Study		39.124543 °	39.124543 °	
			-121.911996 °	-121.911996 °	
DWR ID					
Comment Code					
Inspector Comment					
FS_ID:24191 DS_ID:21389 EP_NO: 1264 Repair Type: Non-Urgent Crossing Status: Indicator Found UCIP Comments: Need to coordinate with owner to determine status of crossing. If crossing is no longer in use owner will need to contact the CVFPB to comply with Title 23. This crossing is referenced in the USACE Periodic Inspection as item USACE_CESPK_MRD2_2012_p_0124. FIELD_STRUCT_DESC: Abandoned 10-inch (not 14-inch as specified in desk study) pipe through the levee, 5.0 feet below the crown. Pump on the waterward side. Double concrete discharge box at landward toe. (Permit No. 1264-1948) FS Date: 10/23/2013

View of levee crown at crossing.

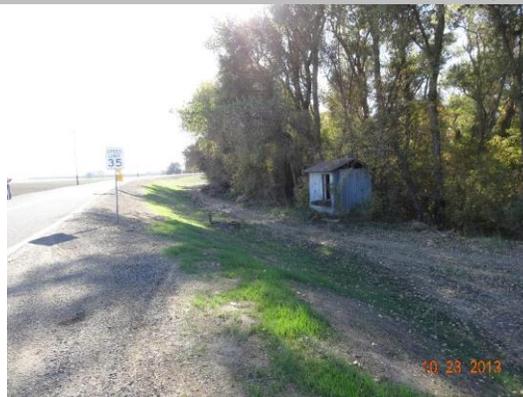
Photo 2 of 2 : UCIP_SP_2016_24191_42678.jpg

Comment Code					
Inspector Comment					
FS_ID:24191 DS_ID:21389 EP_NO: 1264 Repair Type: Non-Urgent Crossing Status: Indicator Found UCIP Comments: Need to coordinate with owner to determine status of crossing. If crossing is no longer in use owner will need to contact the CVFPB to comply with Title 23. This crossing is referenced in the USACE Periodic Inspection as item USACE_CESPK_MRD2_2012_p_0124. FIELD_STRUCT_DESC: Abandoned 10-inch (not 14-inch as specified in desk study) pipe through the levee, 5.0 feet below the crown. Pump on the waterward side. Double concrete discharge box at landward toe. (Permit No. 1264-1948) FS Date: 10/23/2013

View of waterward side--only pump house of nearby crossing located downstream from crossing.

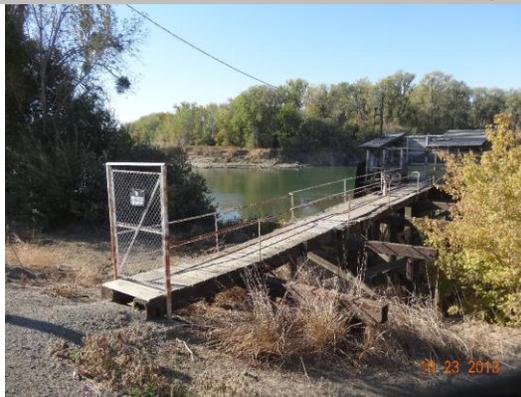
Photo 1 of 2 : UCIP_SP_2016_24108_42463.jpg

Comment Code					
Inspector Comment					
FS_ID:24108 DS_ID:21423 EP_NO: 9971 Repair Type: Non-Urgent Crossing Status: Found UCIP Comments: Will need to contact owner. Need to obtain maintenance records and clarify modifications made to crossing (size). This crossing is referenced in the USACE Periodic Inspection as item USACE_CESPK_MRD2_2012_p_0433. FIELD_STRUCT_DESC: [Meridian Farms Water Com. Pumping Plant No. 3] 2 of 3: 16-inch pipe (not a 30-inch pipe as mentioned in desk study) through the levee, 20.5 feet below the crown. Gate valve on the waterward end. Pump on pile structure in stream. Wooden walkway to pump. Concrete distribution box on landward side. This pipe was retained under ABO No. 9971 (1974). Pumping plant is to be demolished under Permit No. 18762 (2013). FS Date: 10/23/2013

View of landward side--pump station and walkway

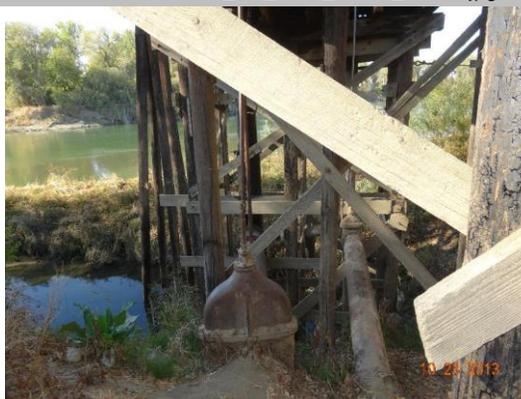
Photo 2 of 2 : UCIP_SP_2016_24108_42465.jpg

View of 16-inch pipe and 24-inch pipe with screw gate located on waterward side.

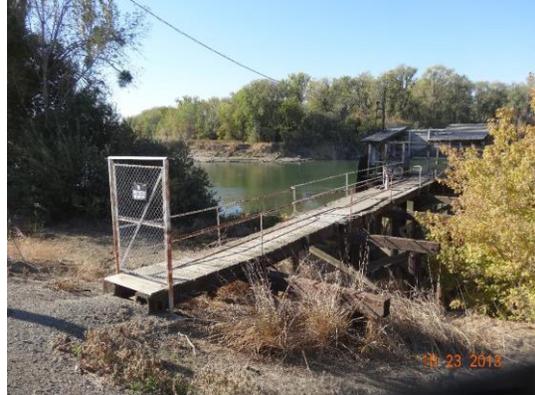
Photo 1 of 2 : UCIP_SP_2016_24107_42457.jpg

Comment Code					
Inspector Comment					
FS_ID:24107 DS_ID:21394 EP_NO: N/A Repair Type: Non-Urgent Crossing Status: Found UCIP Comments: This pump station is to be demolished. This crossing will need to be updated once the work has been completed. This crossing is referenced in the USACE Periodic Inspection as item USACE_CESPK_MRD2_2012_p_0433. FIELD_STRUCT_DESC: [Meridian Farms Water Com. Pumping Plant No. 3] 3 of 3: 24-inch pipe through the levee, 20.5 feet below the crown. Gate valve on the waterward end. Pump on pile structure in stream. Wooden walkway to pump. Concrete distribution box on landward side. Pumping plant is to be demolished under Permit No. 18762 (2013). FS Date: 10/23/2013

View of waterward side--pump station and walkway.

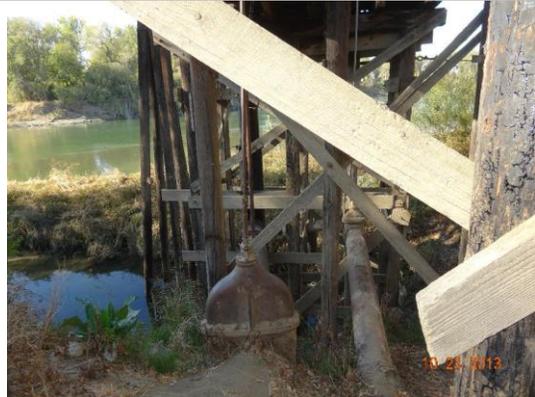
Photo 2 of 2 : UCIP_SP_2016_24107_42458.jpg

View of 16-inch pipe and 24-inch pipe through levee on waterward side.

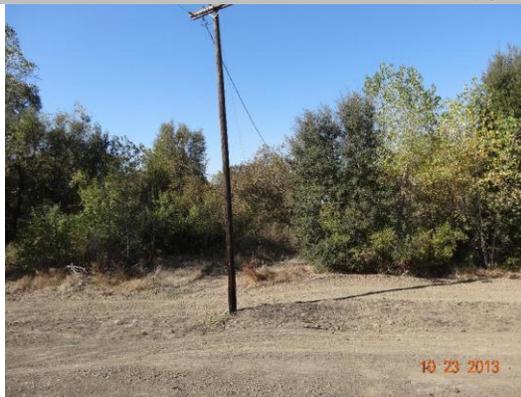
Photo 1 of 2 : UCIP_SP_2016_24195_42686.jpg

FS_ID:24195
 DS_ID:21398
 EP_NO: 1162
 Repair Type: Non-Urgent
 Crossing Status: Found
 UCIP Comments: Need to verify status of crossing--variation in pipe size. 18 inch pipe listed in desk study and 20 inch pipe found in field. Damage to siphon breaker housing unit. This crossing is referenced in the USACE Periodic Inspection as item USACE_CESPK_MRD2_2012_p_0482.
 FIELD_STRUCT_DESC: 1 of 2: 20-inch (not 18-inch as listed in desk study) steel pipe through the levee, 3.7 feet below the crown. Two concrete cutoff walls around pipe, at levee shoulders. Siphon breakers in steel pipe risers on landward shoulder. Slant pumps on wooden pump structure on waterward side. Two CM pipe risers under pump structure at waterward toe. Distribution box at landward toe. (Permit No. 1162-1946) This entry matches the Drainage or Irrigation Structure referenced in O&M manual (Station 824+00).
 FS Date: 10/23/2013

View of waterward side pathway behind power pole leads to pump station.

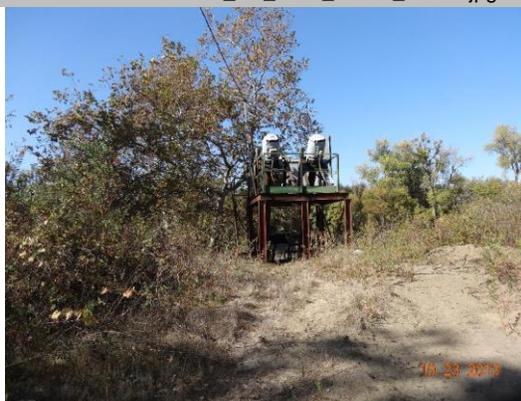
Photo 2 of 2 : UCIP_SP_2016_24195_42685.jpg

Pump station located on waterward side.

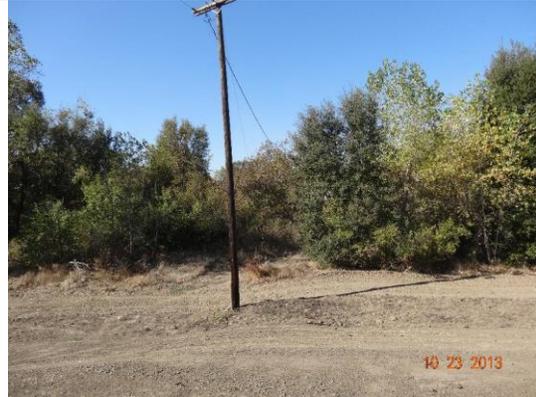
Photo 1 of 2 : UCIP_SP_2016_24196_42693.jpg

FS_ID:24196
 DS_ID:21430
 EP_NO: 1162
 Repair Type: Non-Urgent
 Crossing Status: Found
 UCIP Comments: Need to verify status of crossing--variation in pipe size. 18 inch pipe listed in desk study and 20 inch pipe found in field. This crossing is referenced in the USACE Periodic Inspection as item USACE_CESPK_MRD2_2012_p_0482.
 FIELD_STRUCT_DESC: 2 of 2: 20-inch (not 18-inch as listed in desk study) steel pipe through the levee, 3.7 feet below the crown. Two concrete cutoff walls around pipe, at levee shoulders. Siphon breakers in steel pipe risers on landward shoulder. Slant pumps on wooden pump structure on waterward side. Two CM pipe risers under pump structure at waterward toe. Distribution box at landward toe. (Permit No. 1162-1946) This entry matches the Drainage or Irrigation Structure referenced in O&M manual (Station 824+00).
 FS Date: 10/23/2013

View of waterward side path to pump station is behind the power pole.

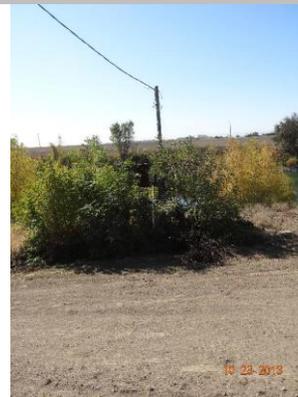
Photo 1 of 2 : UCIP_SP_2016_47033_42141.jpg

FS_ID:47033
 DS_ID:21402
 EP_NO: 9997
 Repair Type: Non-Urgent
 Crossing Status: Found
 UCIP Comments: Debris found on waterward side along berm running parallel to levee. Two crossing found--Need to coordinate with owner to determine permit for second crossing and status of crossing. If crossing is no longer in use owner will need to contact the CVFPB to comply with Title 23. Dense vegetation limits the inspector's visibility to identify signs of pipe failure (leaks) along the waterward slope. Recommend removing vegetation along pipe alignment to conduct proper inspection of structure and appurtenances. This crossing is referenced in the USACE Periodic Inspection as item USACE_CESPK_MRD2_2012_p_0559.
 FIELD_STRUCT_DESC: 12-inch steel pipe through the levee, 3.5 feet below the crown. Siphon breaker in CM pipe riser on landward shoulder. Control valve and pump on waterward side. Power pole on waterward shoulder. Discharge box at landward toe. (USACE-1953). This entry matches the Drainage or Irrigation Structure referenced in O&M manual (Station 930+22). This pipe was retained under ABO No. 9997 (1974).

Crossing appurtenances located near brush and power pole on waterward side.

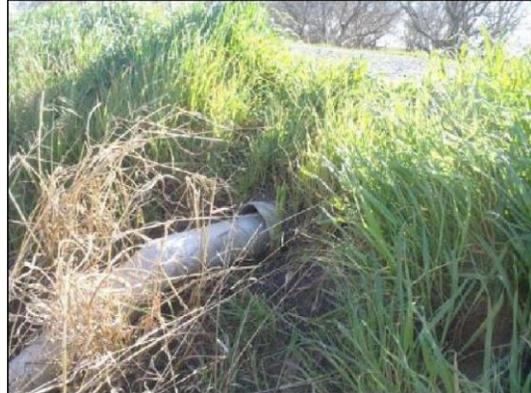
Photo 1 of 2 : UCIP_SP_2016_46426_42883.jpg

Comment Code					
Inspector Comment					
FS_ID:46426 DS_ID:24744 EP_NO: N/A Repair Type: Urgent Crossing Status: Found UCIP Comments: 07/28/2015 Dense vegetation on both slopes. Need to recheck during winter.10/23/2013 No records were found during initial desk study--need to contact owner to obtain permit number authorizing work. Owner will need to coordinate with DWR Inspector and CVFPB to remove crossing according to Title 23 requirements. FIELD_STRUCT_DESC: 6-inch diameter alumnum irrigation pipe through the levee 18 inches below the crown through a 10 inch corrugated metal pipe. Pipe extends down both slopes about 2 feet below crown. FS Date: 7/28/2015 4:00:00 PM

View of pipe through levee--photo is from USACE PI Draft Report dated 6-2012.

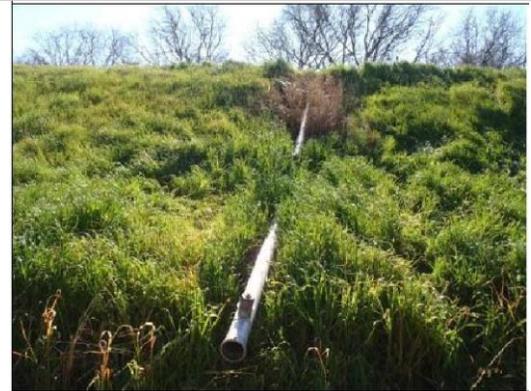
Photo 2 of 2 : UCIP_SP_2016_46426_42882.jpg

View of pipe through levee--photo is from USACE PI Draft Report dated 6-2012.

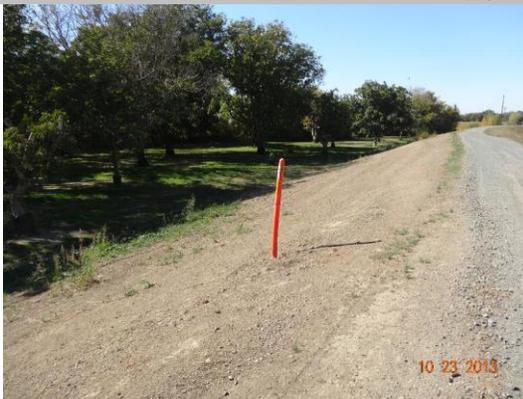
Photo 1 of 2 : UCIP_SP_2016_23984_42172.jpg

Comment Code					
Inspector Comment					
FS_ID:23984 DS_ID:21403 EP_NO: 3800 Repair Type: Non-Urgent Crossing Status: Indicator Found UCIP Comments: Need to contact owner to determine if crossing is still active and to determine last inspection date. Will need copy of letter showing crossings passed inspection. This crossing is referenced in the USACE Periodic Inspection as item USACE_CESPK_MRD2_2012_p_0568. FIELD_STRUCT_DESC: 20-inch steel gas pipe through the levee, 3.0 feet below the crown. Concrete cutoff wall around pipe at center of levee. Marker sign on waterward shoulder. Natural gas equipment pad at landward toe. (Permit No. 3800-1962) FS Date: 10/23/2013

Marker located on waterward side.

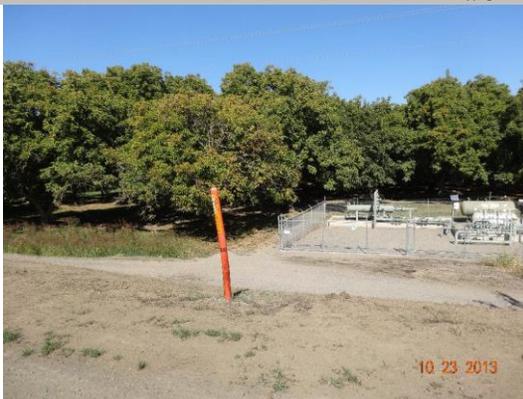
Photo 2 of 2 : UCIP_SP_2016_23984_42171.jpg

Marker on landward side.

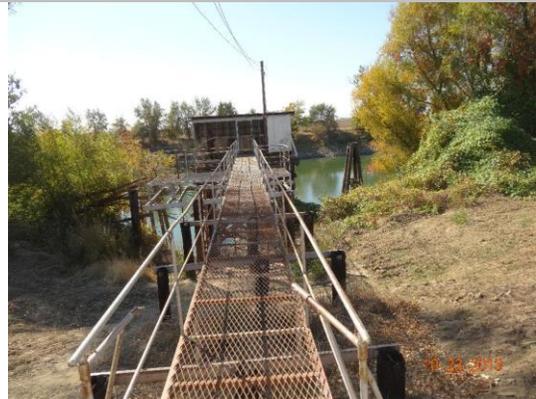
Photo 1 of 2 : UCIP_SP_2016_24229_42848.jpg

Comment Code					
Inspector Comment					
FS_ID:24229 DS_ID:21421 EP_NO: 9990 Repair Type: Non-Urgent Crossing Status: Found UCIP Comments: Need to determine if crossings are still being used. This crossing is referenced in the USACE Periodic Inspection as item USACE_CESPK_MRD2_2012_p_0685. FIELD_STRUCT_DESC: 1 of 2: 24-inch steel pipe sleeved through a 30-inch steel pipe through the levee, 24.0 feet below the crown. Gate valves on waterward end. Concrete headwall with flap gate on landward side. Pumps on pile structure in stream. Wooden walkway to pumps. (USACE-1953). This entry matches the Drainage or Irrigation Structure referenced in O&M manual (Station 1086+55). This pipe was retained under ABO No. 9990 (1974). FS Date: 10/23/2013

Walkway and pump house on waterward side.

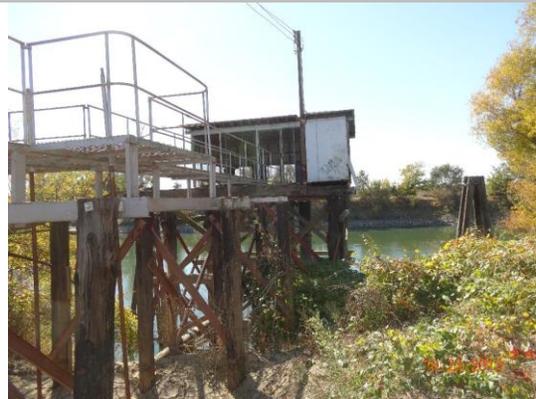
Photo 2 of 2 : UCIP_SP_2016_24229_42849.jpg

Pump house located on waterward side.

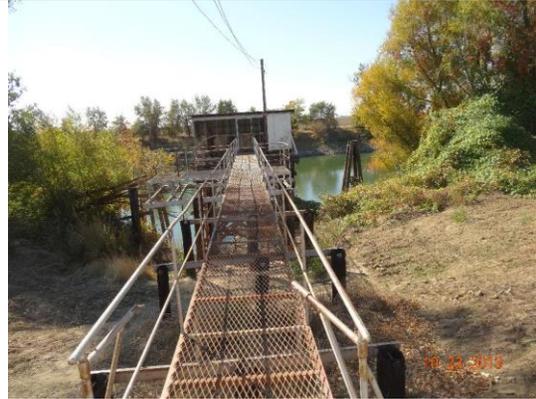
Photo 1 of 2 : UCIP_SP_2016_24230_42854.jpg

Comment Code					
Inspector Comment					
FS_ID:24230 DS_ID:21409 EP_NO: 9990 Repair Type: Non-Urgent Crossing Status: Found UCIP Comments: Need to determine if crossing is still being used. This crossing is referenced in the USACE Periodic Inspection as item USACE_CESPK_MRD2_2012_p_0685. FIELD_STRUCT_DESC: 2 of 2: 24-inch steel pipe sleeved through a 30-inch steel pipe through the levee, 24.0 feet below the crown. Gate valves on waterward end. Concrete headwall with flap gate on landward side. Pumps on pile structure in stream. Wooden walkway to pumps. (USACE-1953). This entry matches the Drainage or Irrigation Structure referenced in O&M manual (Station 1086+55). This pipe was retained under ABO No. 9990 (1974). FS Date: 10/23/2013

Walkway and Pump house located on waterward side.

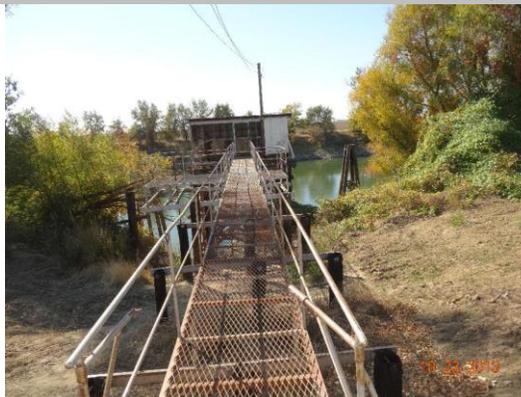
Photo 1 of 2 : UCIP_SP_2016_24231_42859.jpg

LM Start	15.34	Rating **	M	Issue No.	29
LM End	15.34	Issue Type +	En	Location *	LS
Category	Supplemental		GPS Latitude/Longitude		
			Start	End	
Item	DWR UCIP Field Study		39.065285 °	39.065285 °	
			-121.839202 °	-121.839202 °	
DWR ID					
Comment Code					
Inspector Comment					
FS_ID:24231 DS_ID:21420 EP_NO: N/A Repair Type: Non-Urgent Crossing Status: Found UCIP Comments: No daylight visible on landward side. Pipe was visible on waterward side. Need to contact owner to determine status of crossing. This crossing is referenced in the USACE Periodic Inspection as item USACE_CESPK_MRD2_2012_p_0685. FIELD_STRUCT_DESC: 16-inch steel pipe through the levee, approximately 15.0 feet below the crown. Gate valves on waterward end. Pumps on waterward side. (USACE-1953). This entry matches the Drainage or Irrigation Structure referenced in O&M manual (Station 1086+55). FS Date: 10/23/2013

Walkway and structure located on waterward side.

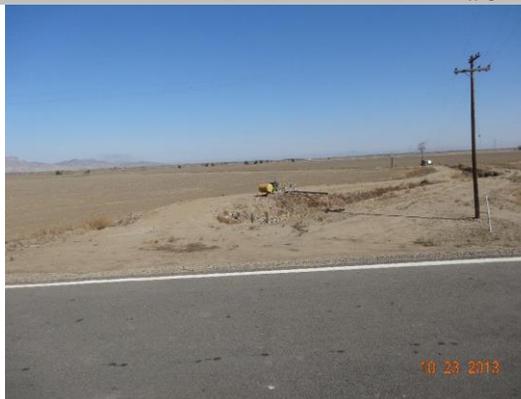
Photo 2 of 2 : UCIP_SP_2016_24231_42863.jpg

View of landward side.
