**Flood Control Project Maintenance  
Levee Inspections**

**Fall 2017 Levee Maintenance Deficiency Summary Report**

**Reclamation District No. 0108 River Farms**

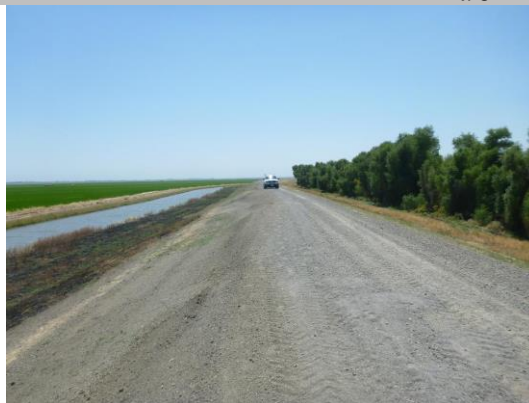
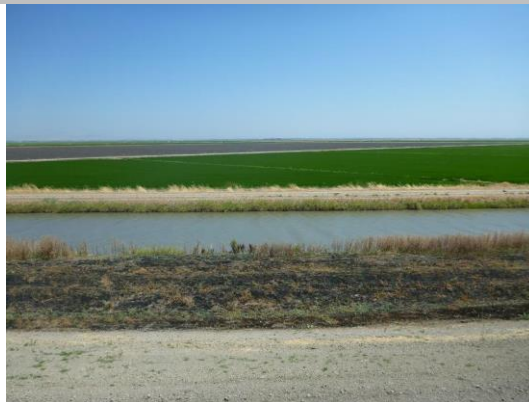
LM Start	14.47	Rating **	A/W	Issue No.	20	
LM End	14.55	Issue Type +	Ma	Location *		
Category	Supplemental			GPS Latitude/Longitude		
				Start		End
Item	2017 Storm Damage			38.967062 °		38.967770 °
				-121.923103 °		-121.924178 °
DWR ID	DWR_RD0108_01_f_2017_20					
Comment Code						
Inspector Comment						
Levee Evaluation Comments						
Description:						
Site ID No:217						
Site Designation:RD 108-02						
Repair Type: Erosion						
Rating:Critical						
Field Date:7/18/2017						
Notes:

LM Start	<b>14.47</b>	Rating **	A/W	Issue No.	<b>20 (cont)</b>
LM End	<b>14.55</b>	Issue Type +	Ma	Location *

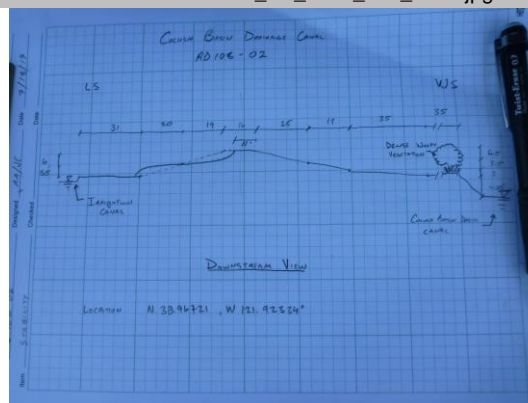
Photo 3 of 3 : LEVAL\_FA\_2017\_217\_1499.jpg

LM Start	14.47	Rating **	A/W	Issue No.	20 (cont)	
LM End	14.55	Issue Type +	Ma	Location *		
Category	Supplemental			GPS Latitude/Longitude		
				Start	End	
Item	2017 Storm Damage			38.967062 °	38.967770 °	
				-121.923103 °	-121.924178 °	
DWR ID	DWR_RD0108_01_f_2017_20					
Comment Code						
Inspector Comment						
Levee Evaluation Comments						
Description:						
Site ID No:217						
Site Designation:RD 108-02						
Repair Type: Erosion						
Rating:Critical						
Field Date:7/18/2017						
Notes:

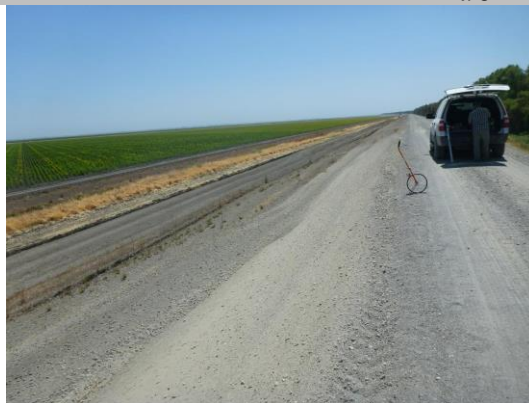
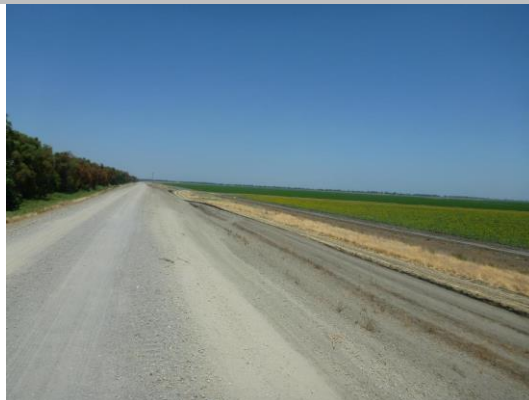
LM Start	17.26	Rating **	A/W	Issue No.	22
LM End	17.30	Issue Type +	Ma	Location *	
Category	Supplemental			GPS Latitude/Longitude	
				Start	End
Item	2017 Storm Damage			38.995187 °	38.995772 °
				-121.960158 °	-121.960617 °
DWR ID	DWR_RD0108_01_f_2017_22				
Comment Code					
Inspector Comment					
Levee Evaluation Comments					
Description:					
Site ID No:216					
Site Designation:RD 108-01					
Repair Type: Erosion					
Rating:Serious					
Field Date:7/18/2017					
Notes:

LM Start	17.26	Rating **	A/W	Issue No.	22 (cont)
LM End	17.30	Issue Type +	Ma	Location *
