**Flood Control Project Maintenance
Levee Inspections**

Fall 2009 Levee Maintenance Deficiency Summary Report

Reclamation District No. 0150 Merrit Island

Levee Inspection Report By Mile - Fall 2009

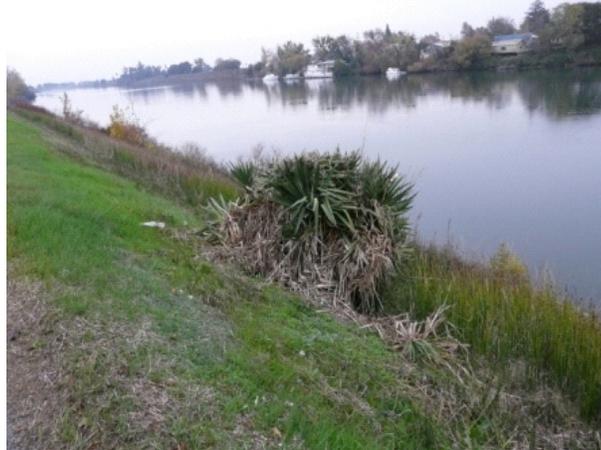
Levee Mile Report Line	4
Start Levee Mile	0.24
End Levee Mile	0.24
Location	Water Side
Category	Earthen Levee
Item	Vegetation
Remove century plant within 20' of waterside shoulder on waterside of the levee at LM 0.24	
dpesaven_20091028_236.JPG

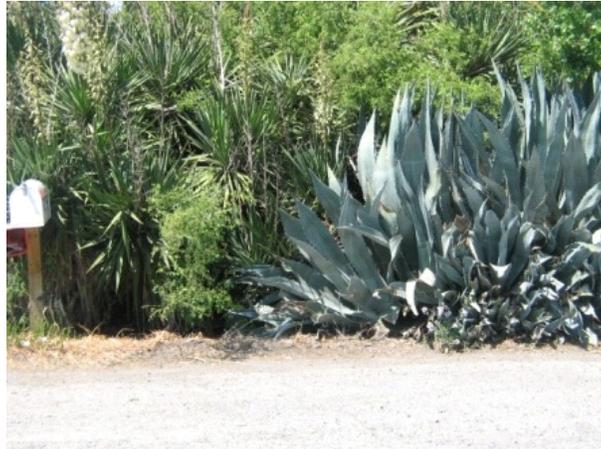
Levee Mile Report Line	5
Start Levee Mile	0.25
End Levee Mile	0.25
Location	Land Side
Category	Earthen Levee
Item	Encroachments
Landscaping on landward slope at LM 0.25 blocking view of levee slope.	
dpesaven_20091028_228.jpg

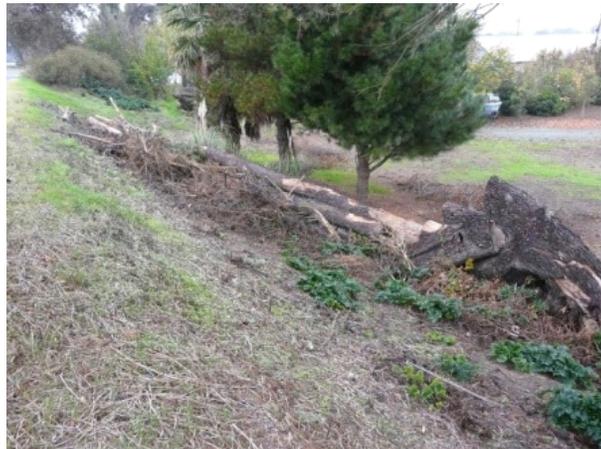
Levee Mile Report Line	6
Start Levee Mile	0.27
End Levee Mile	0.27
Location	Land Side
Category	Earthen Levee
Item	Encroachments
Remove tree branches from landside of levee at LM 0.27	
dpesaven_20091028_249.JPG

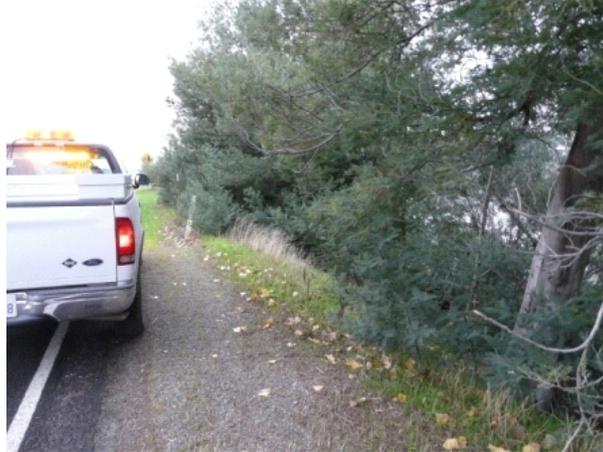
Levee Mile Report Line	9
Start Levee Mile	0.59
End Levee Mile	0.59
Location	Water Side
Category	Earthen Levee
Item	Trim / Thin Trees
Trim trees above 5' from surface of the wateside of the levee within 20' from shoulder at LM 0.59	
dpesaven_20091028_237.JPG

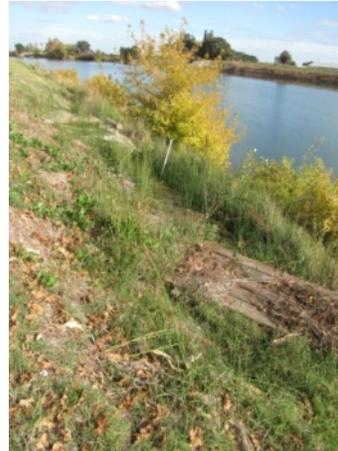
Levee Mile Report Line	25
Start Levee Mile	2.46
End Levee Mile	2.46
Location	Water Side
Category	Earthen Levee
Item	Encroachments
View of debris located on the waterward slope looking upstream.	
dpesaven_20091110_409.jpg

25	2.46	2.46	Earthen Levee	Encroachments	WS	M	Debris Inspector Comments: A platform and sitting/fishing area has been cut into the waterward slope. The encroachment should be removed and the slope repaired	38.347614 ° -121.541988 °	38.347614 ° -121.541988 °	960 Y
26	2.48	2.49	Earthen Levee	Encroachments	LS	PO	Landscaping	38.347720 ° -121.541737 °	38.347800 ° -121.541435 °	983
27	2.51	2.52	Earthen Levee	Vegetation	LS	M	Remove the wild growth other than native grasses from the levee slopes.	38.347845 ° -121.541231 °	38.347891 ° -121.541046 °	13
28	2.79	2.79	Earthen Levee	Vegetation	LS	C	Remove the wild growth other than native grasses from the levee slopes.	38.349941 ° -121.537000 °	38.349941 ° -121.537000 °	86
29	2.80	2.80	Earthen Levee	Slope Stability	WS	C	Repair the levee slope damaged by foot traffic and prevent access where possible.	38.349965 ° -121.536820 °	38.349965 ° -121.536820 °	53
30	2.84	2.84	Earthen Levee	Encroachments	LS	M	Tree or limb	38.350375 ° -121.536152 °	38.350375 ° -121.536152 °	15 Y

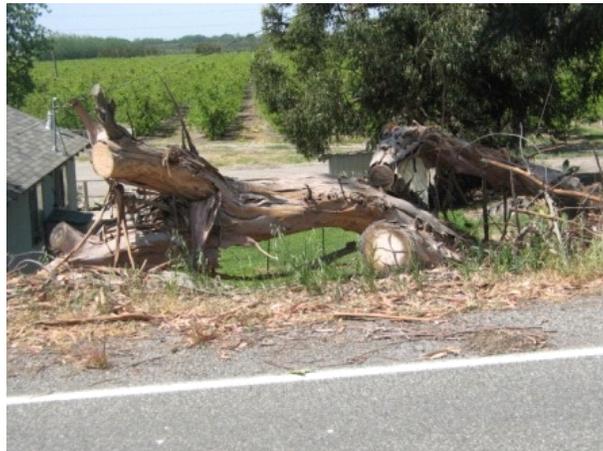
Levee Mile Report Line	30
Start Levee Mile	2.84
End Levee Mile	2.84
Location	Land Side
Category	Earthen Levee
Item	Encroachments
Down tree limbs on landward slope at LM 2.84	
dpesaven_20091028_229.jpg

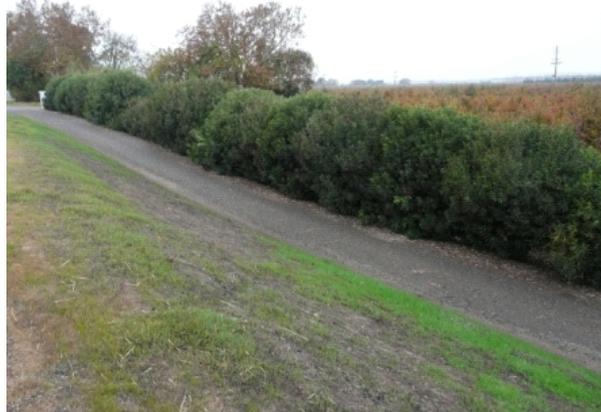
Levee Mile Report Line	31
Start Levee Mile	3.02
End Levee Mile	3.06
Location	Land Side
Category	Earthen Levee
Item	Encroachments
Landscaping providing a screen for a residence on landside of levee from LM 3.02 to LM 3.06	
dpesaven_20091028_248.JPG

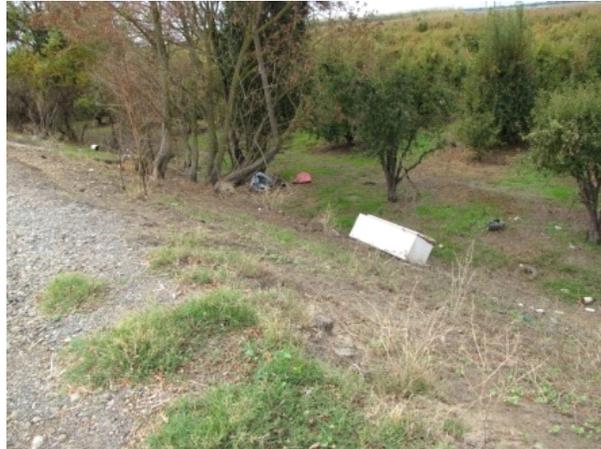
Levee Mile Report Line	35
Start Levee Mile	3.26
End Levee Mile	3.26
Location	Land Side
Category	Earthen Levee
Item	Encroachments
View of debris, including a refrigerator, on the landward slope looking downstream.	
dpesaven_20091110_426.jpg

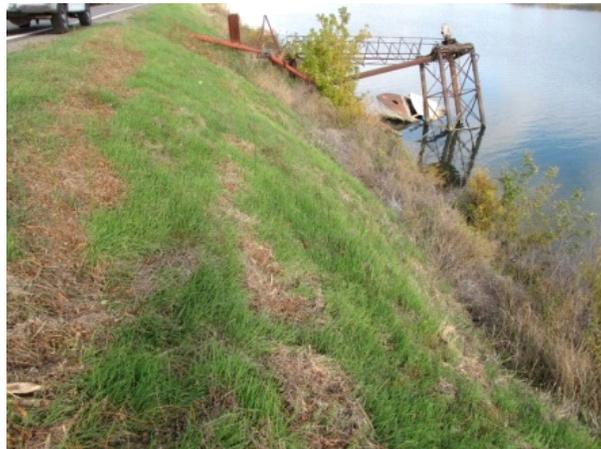
Levee Mile Report Line	37
Start Levee Mile	3.29
End Levee Mile	3.29
Location	Water Side
Category	Earthen Levee
Item	Erosion / Bank Caving
View of erosion on the waterward slope looking upstream. Depressions into the slope can be seen in several places.	
dpesaven_20091110_410.jpg

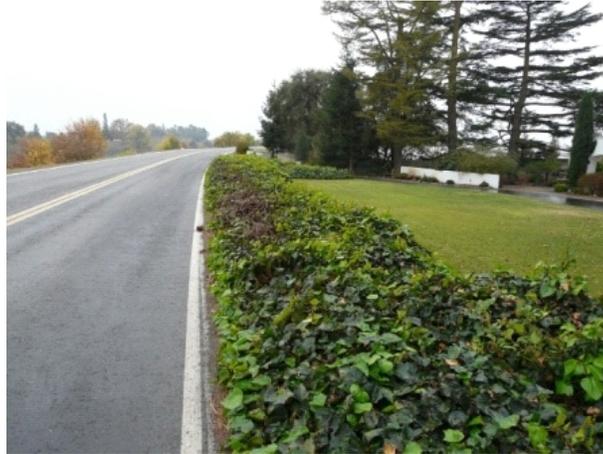
Levee Mile Report Line	46
Start Levee Mile	3.90
End Levee Mile	3.93
Location	Land Side
Category	Earthen Levee
Item	Encroachments
<p>Landscaping in front of a residence on landside of levee from LM 3.90 to LM 3.93. The levee in this location is greater than 100' wide.</p>	
<p>dpesaven_20091028_246.JPG</p>

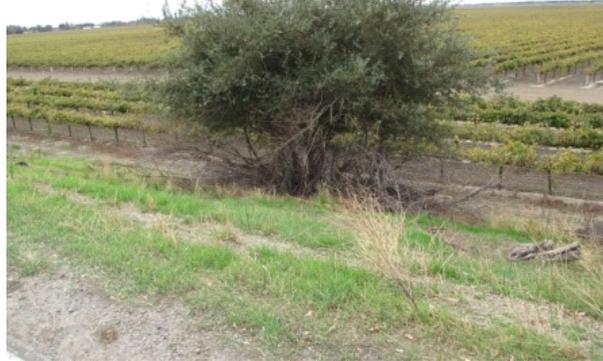
Levee Mile Report Line	54
Start Levee Mile	4.68
End Levee Mile	4.68
Location	Land Side
Category	Earthen Levee
Item	Trim / Thin Trees
View of a tree on the landward slope with lower branches blocking visibility and access. Most of these branches appear to already be dead and should be removed.	
dpesaven_20091110_424.jpg

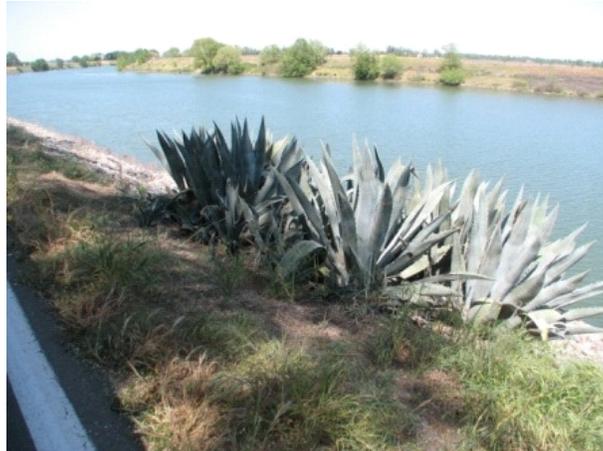
Levee Mile Report Line	55
Start Levee Mile	4.76
End Levee Mile	4.76
Location	Water Side
Category	Earthen Levee
Item	Vegetation
Century plant on waterward slope at LM 4.76	
dpesaven_20091028_231.jpg

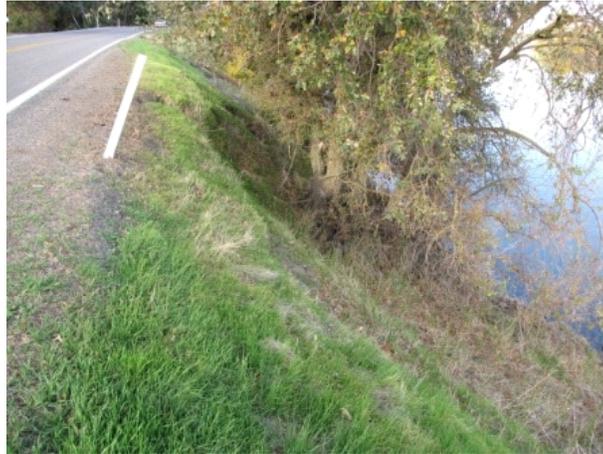
Levee Mile Report Line	61
Start Levee Mile	5.08
End Levee Mile	5.08
Location	Water Side
Category	Earthen Levee
Item	Erosion / Bank Caving
View of erosion occurring along the waterward slope behind some trees looking upstream.	
dpesaven_20091110_414.jpg

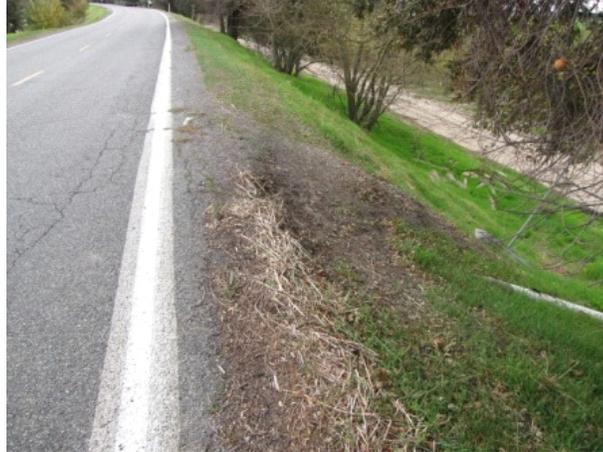
Levee Mile Report Line	65
Start Levee Mile	5.33
End Levee Mile	5.33
Location	Land Side
Category	Earthen Levee
Item	Slope Stability
View of a minor depression along the landward slope of the levee over a pipe penetration looking downstream.	
dpesaven_20091110_421.jpg

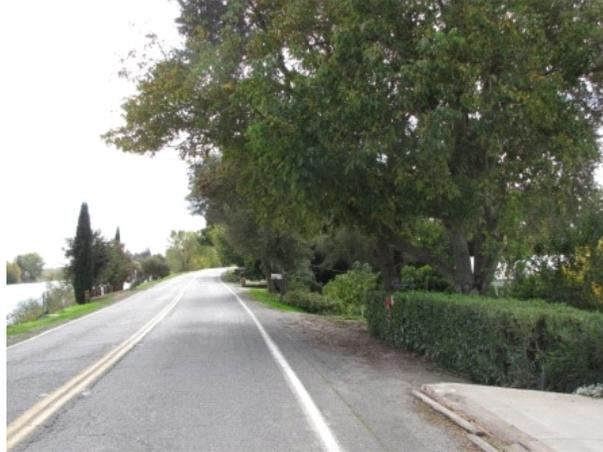
Levee Mile Report Line	79
Start Levee Mile	6.50
End Levee Mile	6.57
Location	Land Side
Category	Earthen Levee
Item	Encroachments
View of landscaping along the waterward shoulder and slope looking downstream.	
dpesaven_20091110_420.jpg

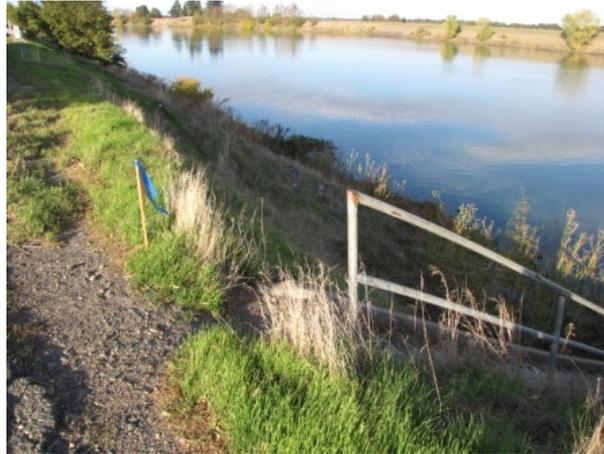
Levee Mile Report Line	86
Start Levee Mile	6.83
End Levee Mile	6.83
Location	Water Side
Category	Earthen Levee
Item	Erosion / Bank Caving
View of erosion occurring just upstream of a concrete stair on the waterward slope of the levee. The erosion is starting to undermine the stairs.	
dpesaven_20091110_416.jpg

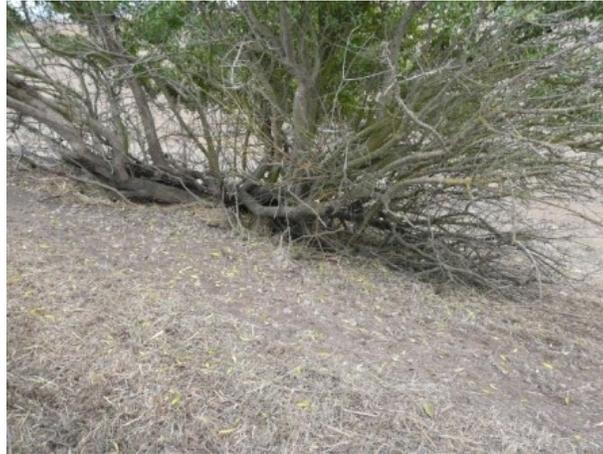
Levee Mile Report Line	93
Start Levee Mile	7.25
End Levee Mile	7.25
Location	Land Side
Category	Earthen Levee
Item	Trim / Thin Trees
Trim or remove brush to allow for visibility on landside of levee at LM 7.25	
dpesaven_20091028_233.JPG

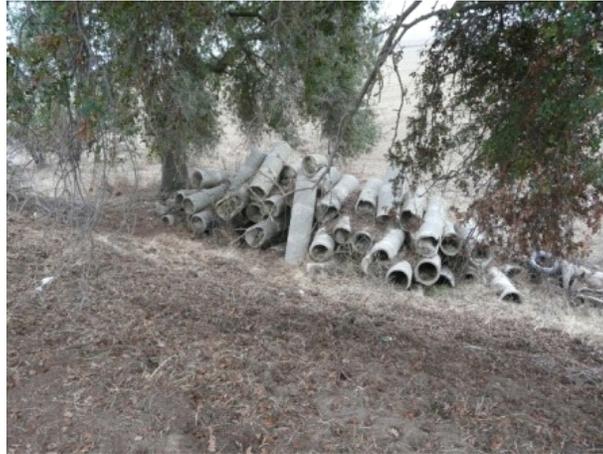
Levee Mile Report Line	96
Start Levee Mile	7.32
End Levee Mile	7.32
Location	Land Side
Category	Earthen Levee
Item	Encroachments
Remove pipes piled on landside of levee to at least 10' from levee toe at LM 7.32	
dpesaven_20091028_239.JPG

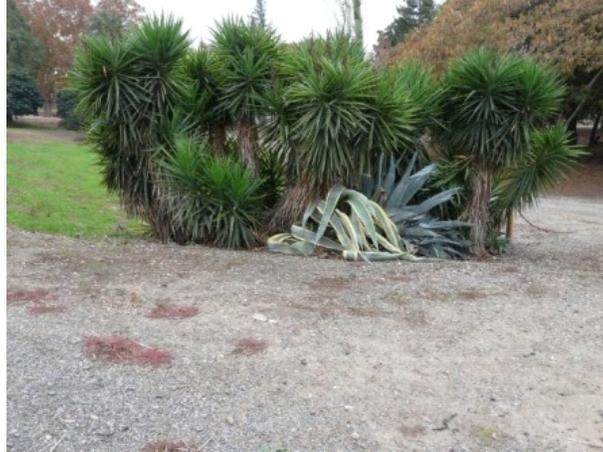
Levee Mile Report Line	100
Start Levee Mile	7.92
End Levee Mile	7.92
Location	Land Side
Category	Earthen Levee
Item	Encroachments
Landscaping on landside of levee at LM 7.92	
dpesaven_20091028_238.JPG

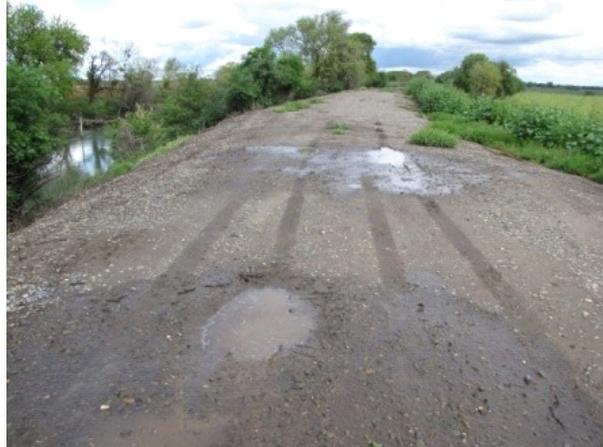
Levee Mile Report Line	2
Start Levee Mile	0.09
End Levee Mile	0.09
Location	Crown
Category	Earthen Levee
Item	Crown Surface / Depressions / Rutting
Re-grade crown access road to remove depressions at LM 0.09.	
dpesaven_20091028_273.jpg

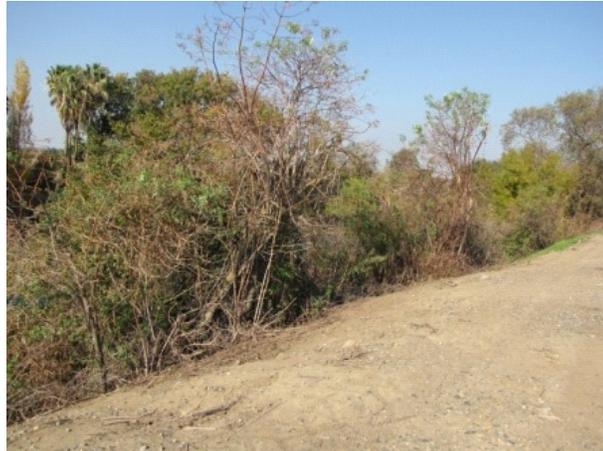
Levee Mile Report Line	3
Start Levee Mile	0.11
End Levee Mile	0.11
Location	Water Side
Category	Earthen Levee
Item	Vegetation
View of elderberry bush within 20 feet of shoulder blocking visibility and access.	
dpesaven_20091105_392.jpg

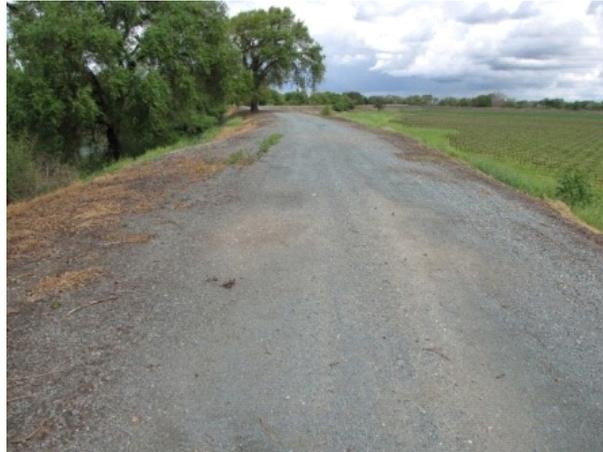
Levee Mile Report Line	8
Start Levee Mile	0.68
End Levee Mile	0.77
Location	Crown
Category	Earthen Levee
Item	Crown Surface / Depressions / Rutting
Good gravel surface of crown access road from LM 0.68 to LM 0.77.	
dpesaven_20091028_274.jpg

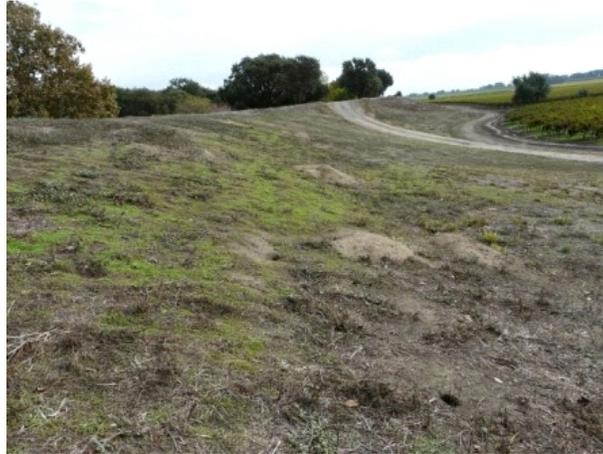
Levee Mile Report Line	14
Start Levee Mile	2.03
End Levee Mile	2.06
Location	Land Side
Category	Earthen Levee
Item	Animal Control
Backfill or grout rodent holes at LM 2.03 to LM 2.06.	
dpesaven_20091028_264.JPG

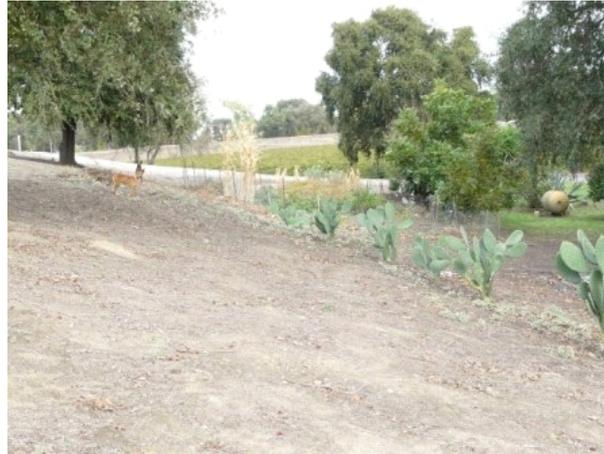
Levee Mile Report Line	18
Start Levee Mile	3.50
End Levee Mile	3.54
Location	Land Side
Category	Earthen Levee
Item	Encroachments
Landscaping & garden on landward slope of levee at LM 3.50 to LM 3.54.	
dpesaven_20091028_265.JPG

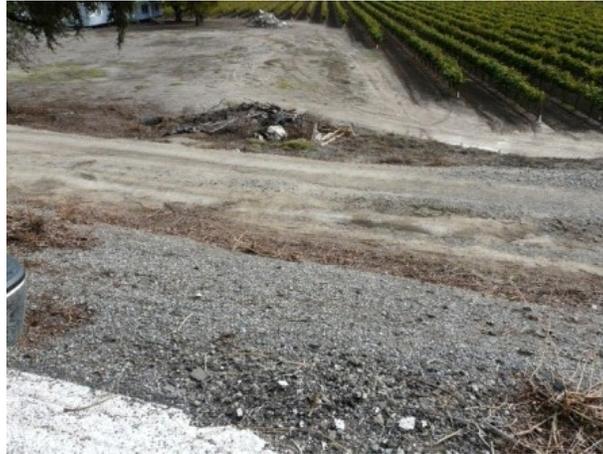
Levee Mile Report Line	21
Start Levee Mile	3.95
End Levee Mile	3.95
Location	Land Side
Category	Earthen Levee
Item	Encroachments
Debris pile on landward slope at LM 3.95.	
dpesaven_20091028_266.JPG

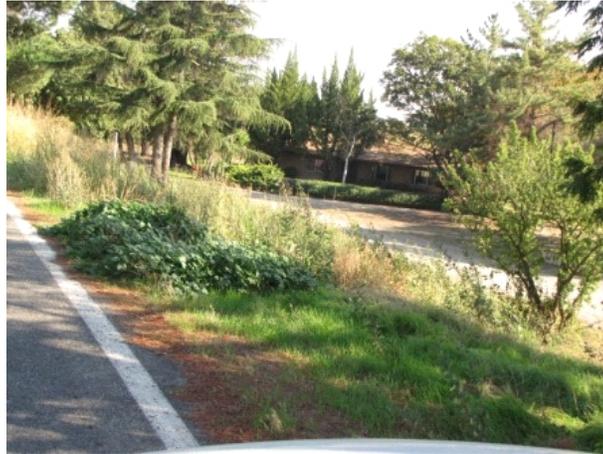
Levee Mile Report Line	24
Start Levee Mile	4.51
End Levee Mile	4.54
Location	Land Side
Category	Earthen Levee
Item	Vegetation
View of landscaping along landward slope.	
dpesaven_20091105_396.jpg

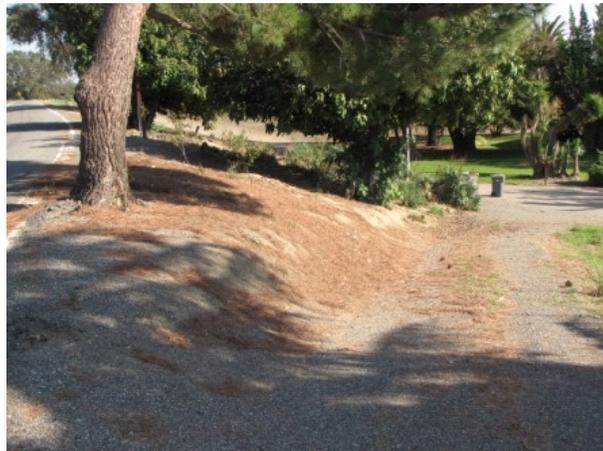
Levee Mile Report Line	26
Start Levee Mile	4.55
End Levee Mile	4.58
Location	Land Side
Category	Earthen Levee
Item	Encroachments
Updated view of landscaping along landward slope.	
dpesaven_20091105_397.jpg

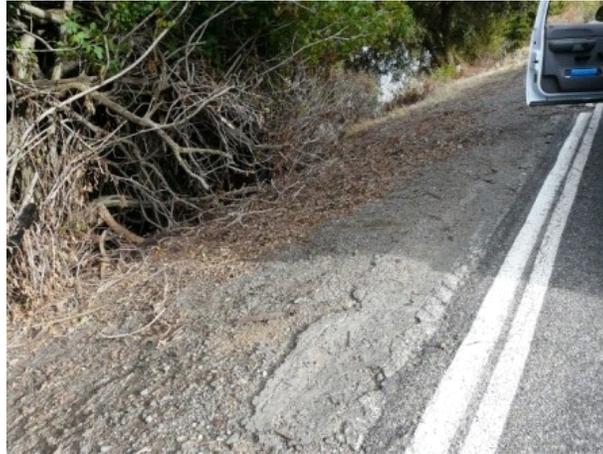
Levee Mile Report Line	27
Start Levee Mile	4.59
End Levee Mile	4.59
Location	Water Side
Category	Earthen Levee
Item	Trim / Thin Trees
Thin/trim trees to allow for the top 20' waterward slope of levee to be seen at LM 4.59.	
dpesaven_20091028_268.JPG

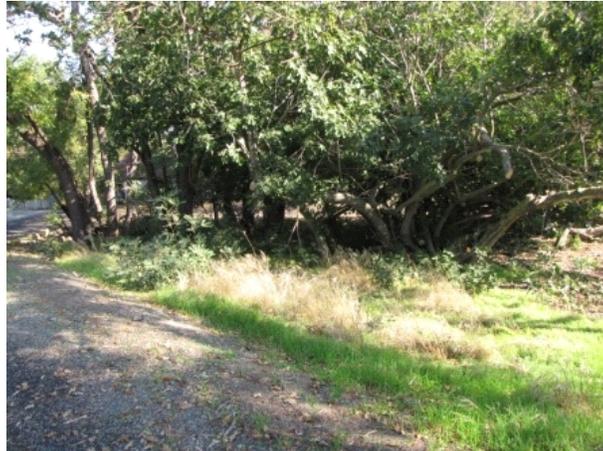
Levee Mile Report Line	29
Start Levee Mile	4.99
End Levee Mile	4.99
Location	Land Side
Category	Earthen Levee
Item	Trim / Thin Trees
View of trees along the landward slope blocking visibility and access.	
dpesaven_20091105_398.jpg

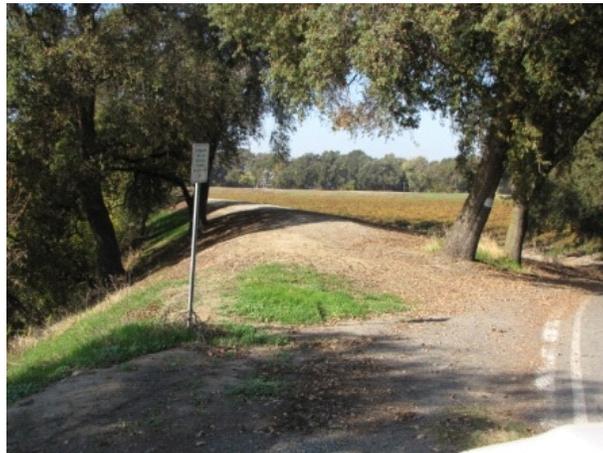
Levee Mile Report Line	31
Start Levee Mile	5.22
End Levee Mile	5.22
Location	Crown
Category	Earthen Levee
Item	Crown Surface / Depressions / Rutting
View of varying elevations in the crown of the levee at the transition from county road to access road.	
dpesaven_20091105_399.jpg

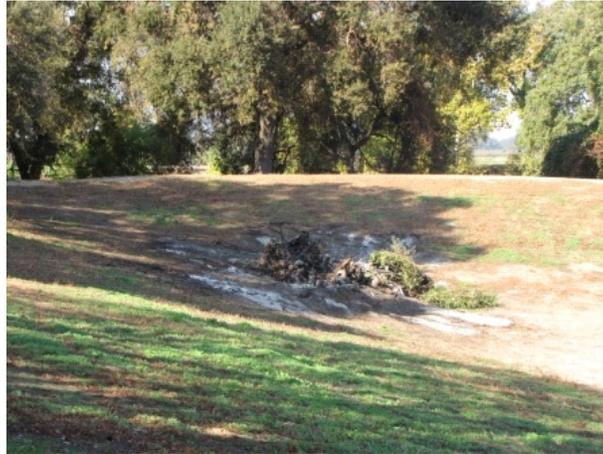
Levee Mile Report Line	33
Start Levee Mile	5.61
End Levee Mile	5.61
Location	Land Side
Category	Earthen Levee
Item	Encroachments
View of prunings pile on the landward slope of the levee.	
dpesaven_20091105_400.jpg

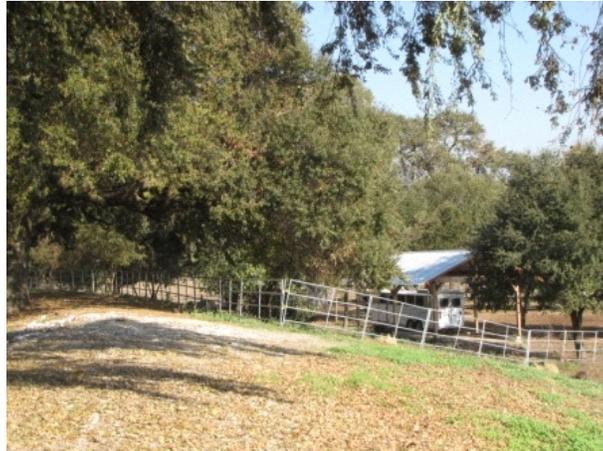
Levee Mile Report Line	35
Start Levee Mile	5.89
End Levee Mile	5.94
Location	Land Side
Category	Earthen Levee
Item	Encroachments
View of fence around a horse pen along the shoulder of the levee and the landward slope.	
dpesaven_20091105_401.jpg

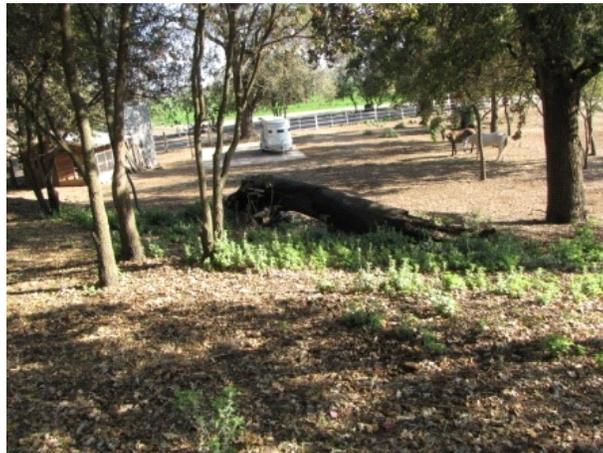
Levee Mile Report Line	36
Start Levee Mile	5.93
End Levee Mile	5.93
Location	Land Side
Category	Earthen Levee
Item	Encroachments
View of a tree trunk laying on the landward slope blocking visibility.	
dpesaven_20091105_402.jpg

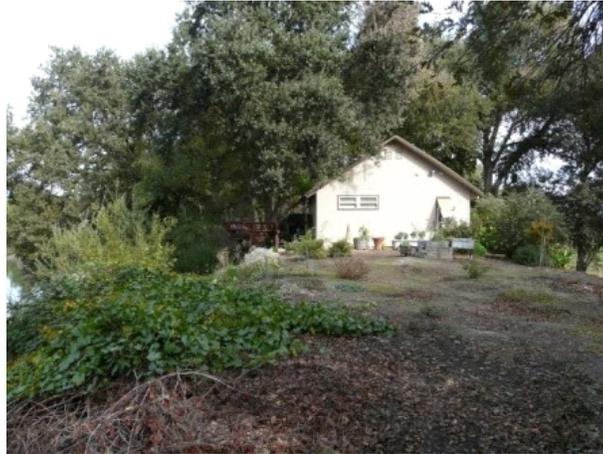
Levee Mile Report Line	37
Start Levee Mile	5.93
End Levee Mile	5.93
Location	Crown
Category	Earthen Levee
Item	Encroachments
Building & associated landscaping on levee crown at LM 5.93.	
dpesaven_20091028_269.JPG

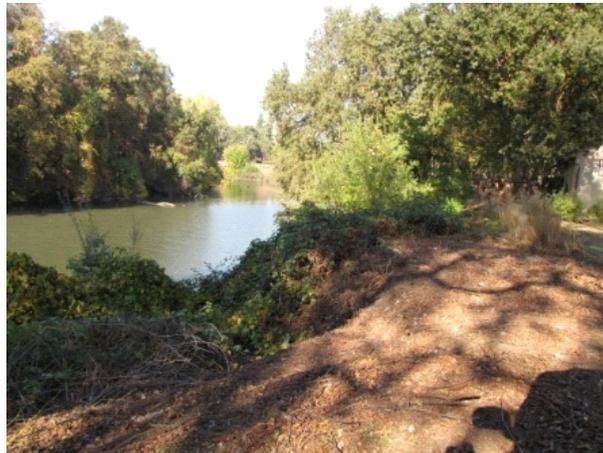
Levee Mile Report Line	38
Start Levee Mile	5.94
End Levee Mile	5.94
Location	Water Side
Category	Earthen Levee
Item	Vegetation
View of vegetation along the waterward slope blocking visibility and access.	
dpesaven_20091105_403.jpg

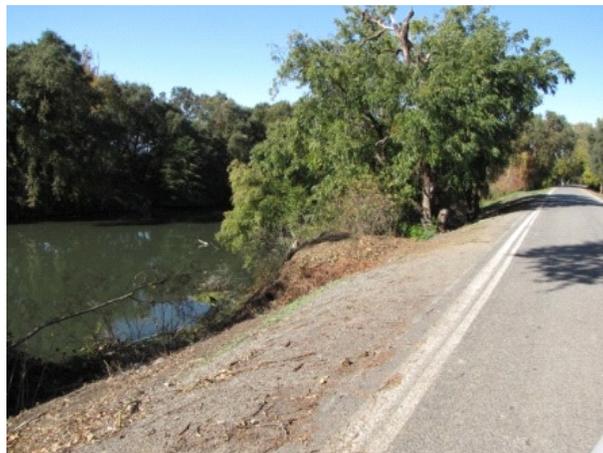
Levee Mile Report Line	42
Start Levee Mile	6.16
End Levee Mile	6.16
Location	Water Side
Category	Earthen Levee
Item	Encroachments
View of a pile of leaves and clippings on the waterward slope.	
dpesaven_20091105_404.jpg

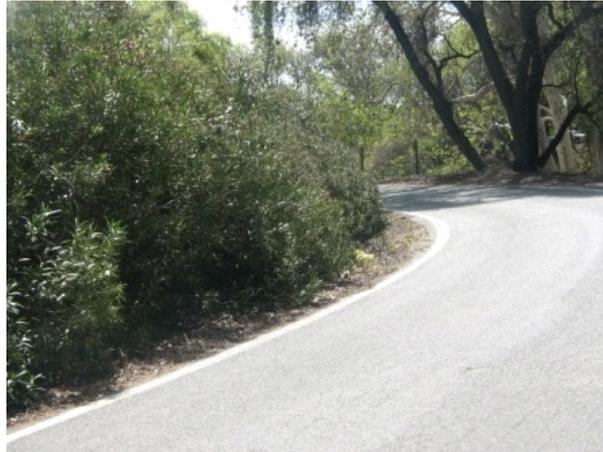
Levee Mile Report Line	43
Start Levee Mile	6.24
End Levee Mile	6.31
Location	Land Side
Category	Earthen Levee
Item	Encroachments
Oleander on landward slope blocking view of levee from LM 6.24 to 6.32	
dpesaven_20091028_258.jpg

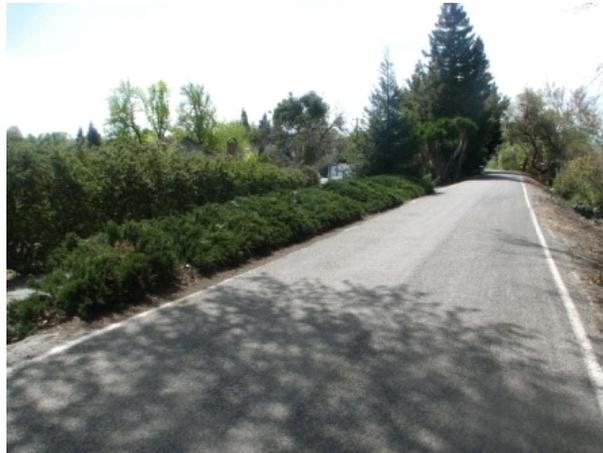
Levee Mile Report Line	45
Start Levee Mile	6.37
End Levee Mile	6.40
Location	Land Side
Category	Earthen Levee
Item	Encroachments
Landscaping on landward slope blocking view from LM 6.37 to 6.40	
dpesaven_20091028_259.jpg

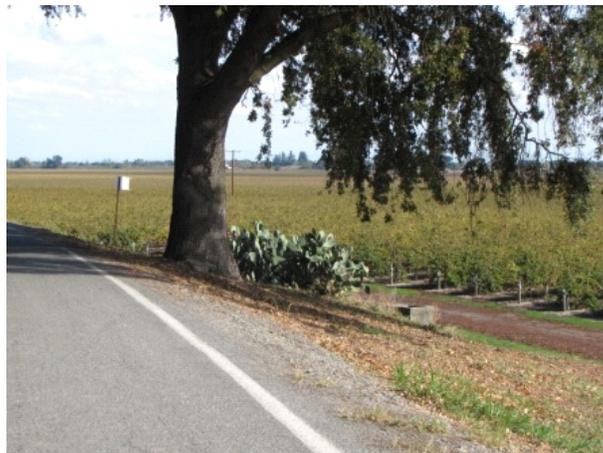
Levee Mile Report Line	47
Start Levee Mile	6.56
End Levee Mile	6.56
Location	Land Side
Category	Earthen Levee
Item	Encroachments
View of landscaping along the landward slope.	
dpesaven_20091105_405.jpg

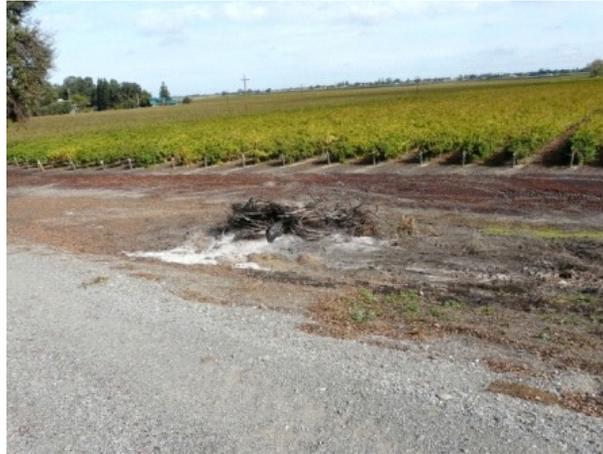
Levee Mile Report Line	48
Start Levee Mile	6.65
End Levee Mile	6.65
Location	Land Side
Category	Earthen Levee
Item	Encroachments
Remove debris from landward slope at LM 6.65.	
dpesaven_20091028_260.JPG

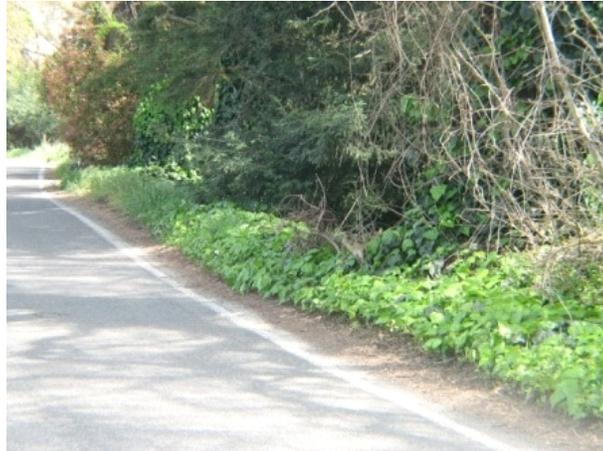
Levee Mile Report Line	50
Start Levee Mile	6.87
End Levee Mile	6.95
Location	Land Side
Category	Earthen Levee
Item	Encroachments
Landscaping on landward slope blocking view from LM 6.87 to 6.95	
dpesaven_20091028_261.jpg

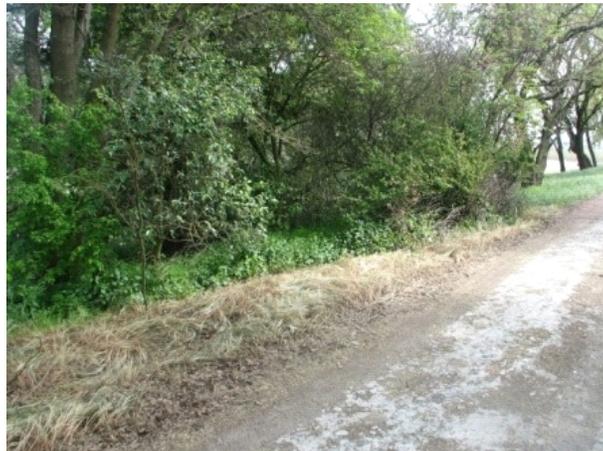
Levee Mile Report Line	56
Start Levee Mile	7.42
End Levee Mile	7.47
Location	Land Side
Category	Earthen Levee
Item	Encroachments
Landscaping on landward slope blocking view from LM 7.42 to 7.47	
dpesaven_20091028_262.jpg

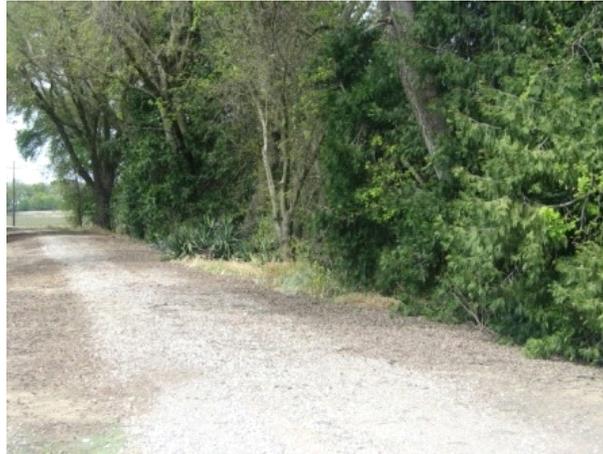
Levee Mile Report Line	59
Start Levee Mile	7.55
End Levee Mile	7.55
Location	Land Side
Category	Earthen Levee
Item	Encroachments
Landscaping on landward slope blocking view from LM 7.52 to 7.58	
dpesaven_20091028_263.jpg

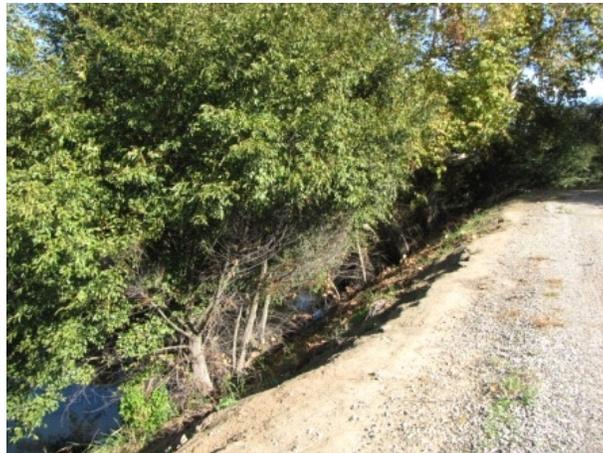
Levee Mile Report Line	62
Start Levee Mile	8.21
End Levee Mile	8.21
Location	Water Side
Category	Earthen Levee
Item	Erosion / Bank Caving
View of erosion occurring along the waterward slope.	
dpesaven_20091105_406.jpg

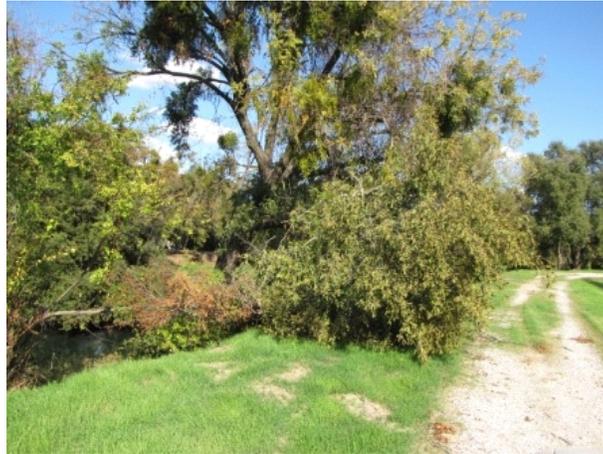
Levee Mile Report Line	69
Start Levee Mile	9.12
End Levee Mile	9.12
Location	Water Side
Category	Earthen Levee
Item	Trim / Thin Trees
View of a tree branch that has fallen and is blocking visibility and access.	
dpesaven_20091105_407.jpg

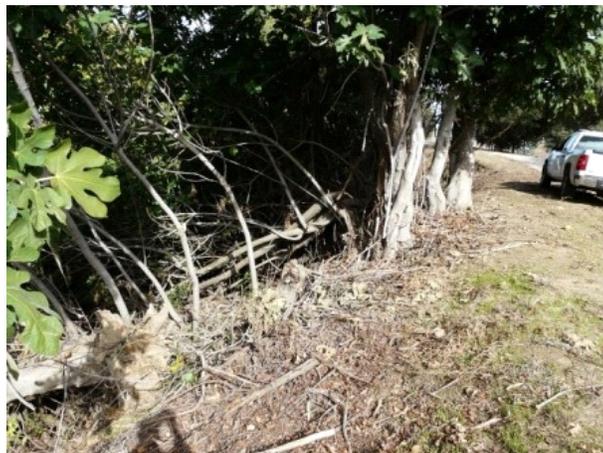
Levee Mile Report Line	74
Start Levee Mile	9.51
End Levee Mile	9.51
Location	Water Side
Category	Earthen Levee
Item	Trim / Thin Trees
Thin/trim trees to allow for visibility of top 20' of waterward slope at LM 9.51.	
dpesaven_20091028_271.JPG
