**Flood Control Project Maintenance  
Levee Inspections**

**Fall 2010 Levee Maintenance Deficiency Summary Report**

**Reclamation District No. 0150 Merrit Island**

**Levee Inspection Report By Mile - Fall 2010**

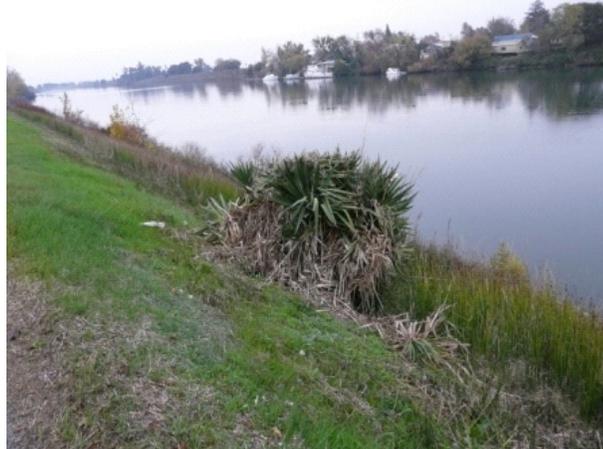
Levee Mile Report Line	5
Start Levee Mile	0.24
End Levee Mile	0.24
Location	Water Side
Category	Earthen Levee
Item	Vegetation
Remove century plant within 20' of waterside shoulder on waterside of the levee at LM 0.24	
rduffey_f_20101007_110.JPG

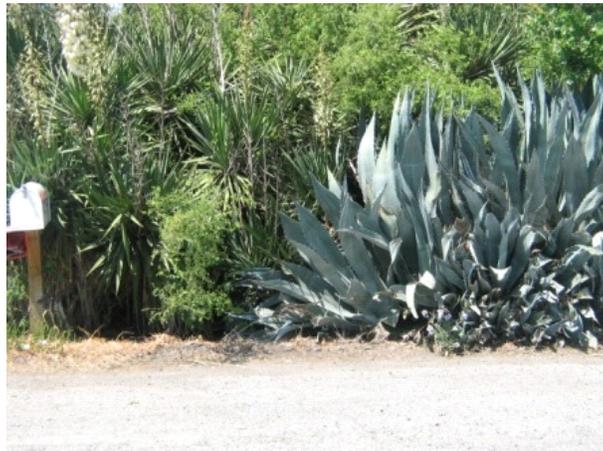
Levee Mile Report Line	6
Start Levee Mile	0.25
End Levee Mile	0.25
Location	Land Side
Category	Earthen Levee
Item	Encroachments
Landscaping on landward slope at LM 0.25 blocking view of levee slope.	
rduffey_f_20101007_096.jpg

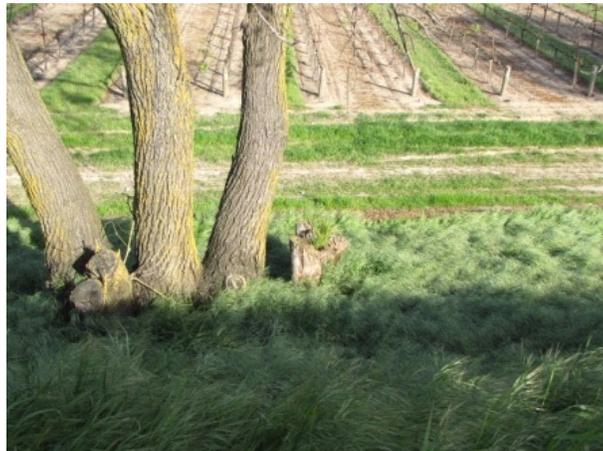
Levee Mile Report Line	15
Start Levee Mile	1.16
End Levee Mile	1.16
Location	Land Side
Category	Earthen Levee
Item	Trim / Thin Trees
View of a tree stump on the landward slope.	
rduffey_f_20101007_097.jpg

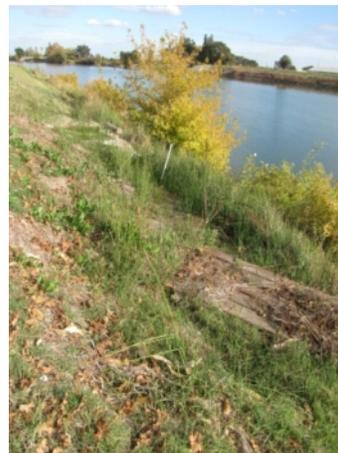
Levee Mile Report Line	29
Start Levee Mile	2.46
End Levee Mile	2.46
Location	Water Side
Category	Earthen Levee
Item	Encroachments
View of debris located on the waterward slope looking upstream.	
rduffey_f_20101007_126.jpg

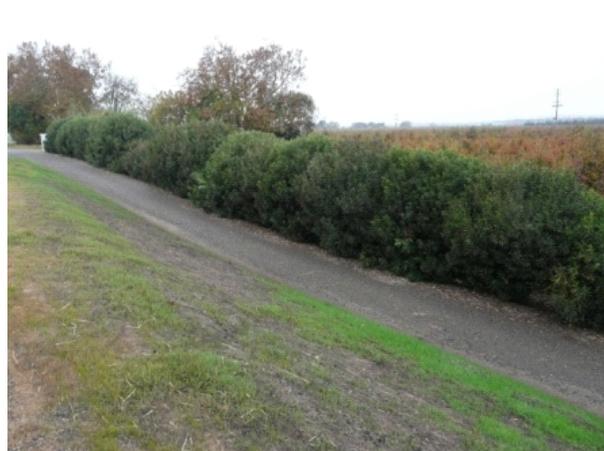
Levee Mile Report Line	35
Start Levee Mile	3.02
End Levee Mile	3.06
Location	Land Side
Category	Earthen Levee
Item	Encroachments
Landscaping providing a screen for a residence on landside of levee from LM 3.02 to LM 3.06	
rduffey_f_20101007_121.JPG

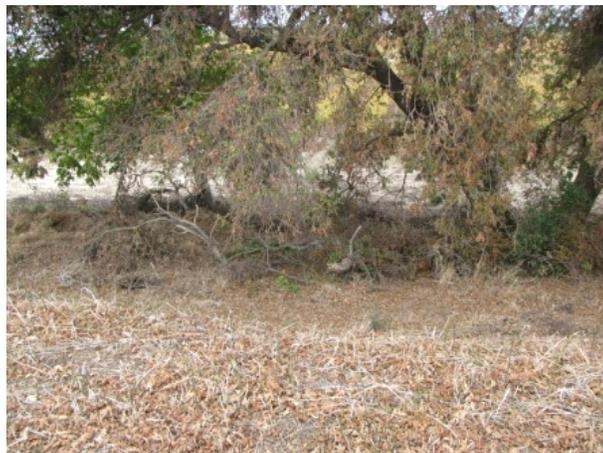
Levee Mile Report Line	42
Start Levee Mile	3.57
End Levee Mile	3.57
Location	Land Side
Category	Earthen Levee
Item	Encroachments
View of dead branches and plant material on the landward slope blocking visibility and access.	
rduffey_f_20101007_135.jpg

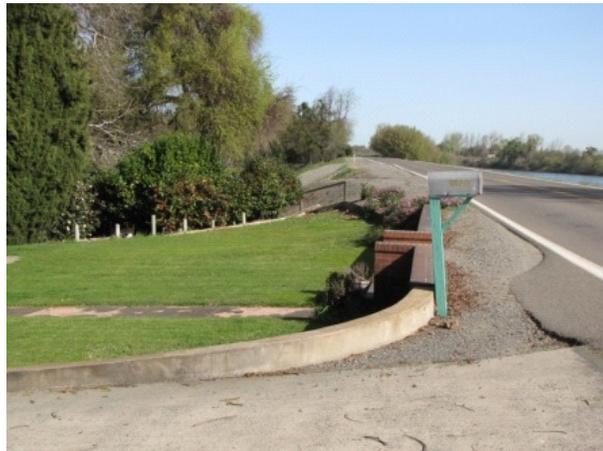
Levee Mile Report Line	46
Start Levee Mile	4.15
End Levee Mile	4.16
Location	Land Side
Category	Earthen Levee
Item	Encroachments
View of a retaining wall on the landward slope looking upstream.	
rduffey_f_20101007_100.jpg

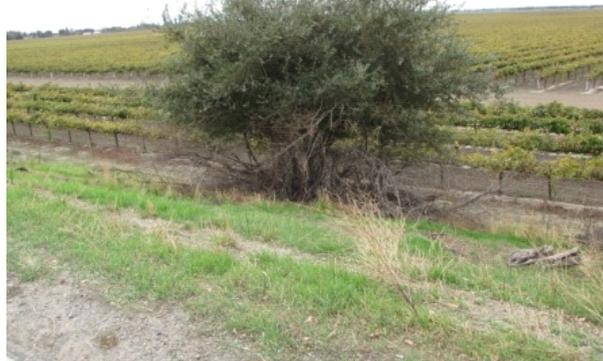
Levee Mile Report Line	52
Start Levee Mile	4.68
End Levee Mile	4.68
Location	Land Side
Category	Earthen Levee
Item	Trim / Thin Trees
View of a tree on the landward slope with lower branches blocking visibility and access. Most of these branches appear to already be dead and should be removed.	
rduffey_f_20101007_134.jpg

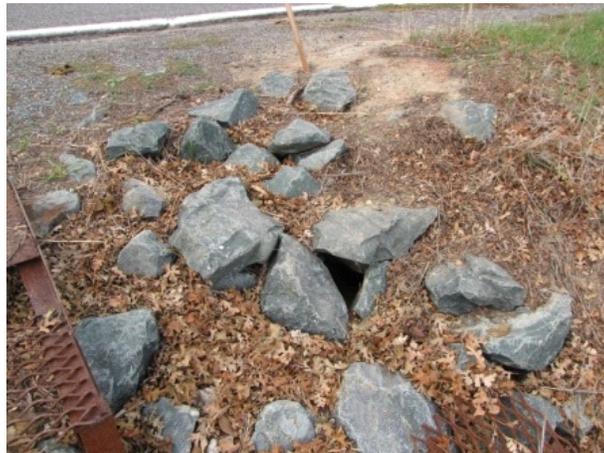
Levee Mile Report Line	59
Start Levee Mile	5.33
End Levee Mile	5.33
Location	Water Side
Category	Earthen Levee
Item	Slope Stability
View of rock placed on a pipe penetration on the waterward slope. Cavities can be seen under the rocks.	
rduffey_f_20101007_133.jpg

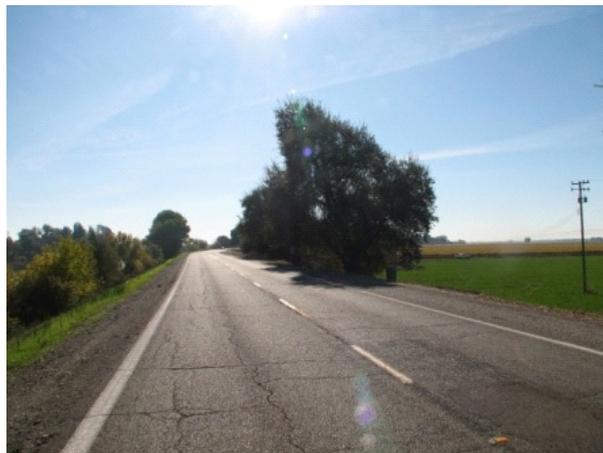
Levee Mile Report Line	68
Start Levee Mile	6.18
End Levee Mile	6.27
Location	Land Side
Category	Earthen Levee
Item	Trim / Thin Trees
View of the trees that need to be trimmed up 5 feet.	
rduffey_f_20101123_338.jpg

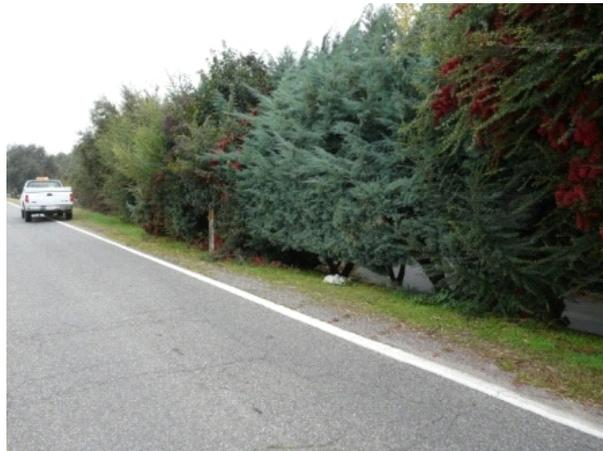
Levee Mile Report Line	78
Start Levee Mile	6.67
End Levee Mile	6.72
Location	Land Side
Category	Earthen Levee
Item	Encroachments
Landscaping providing a screen for a residence on landside of levee from LM 6.68 to LM 6.72	
rduffey_f_20101007_116.JPG

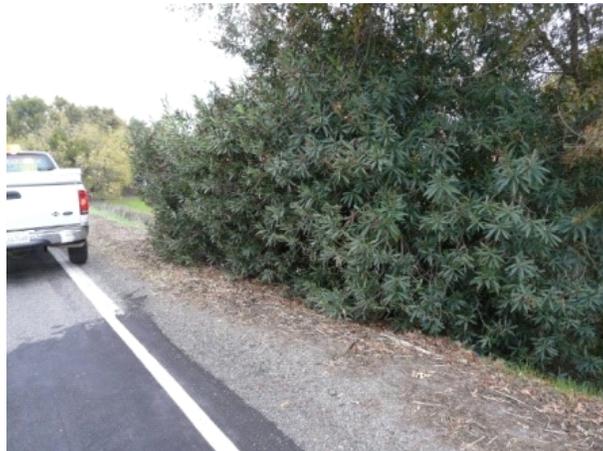
Levee Mile Report Line	84
Start Levee Mile	7.12
End Levee Mile	7.12
Location	Land Side
Category	Earthen Levee
Item	Encroachments
Landscaping providing a screen for a residence on landside of levee at LM 7.12	
rduffey_f_20101007_114.JPG

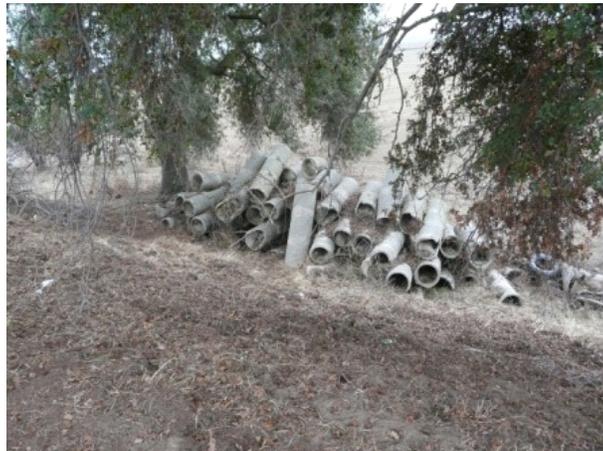
Levee Mile Report Line	88
Start Levee Mile	7.32
End Levee Mile	7.32
Location	Land Side
Category	Earthen Levee
Item	Encroachments
Remove pipes piled on landside of levee to at least 10' from levee toe at LM 7.32	
rduffey_f_20101007_113.JPG

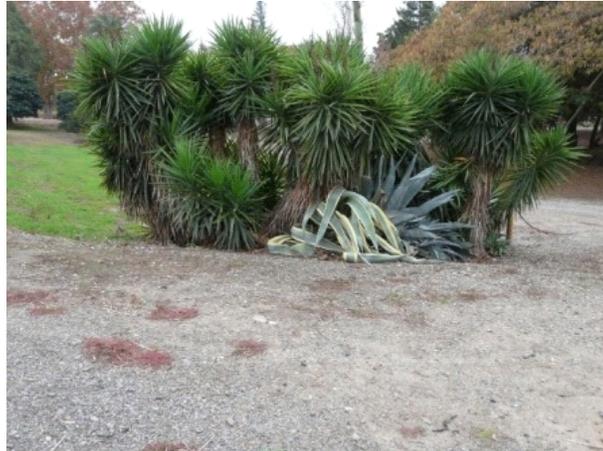
Levee Mile Report Line	92
Start Levee Mile	7.92
End Levee Mile	7.92
Location	Land Side
Category	Earthen Levee
Item	Encroachments
Landscaping on landside of levee at LM 7.92	
rduffey_f_20101007_112.JPG

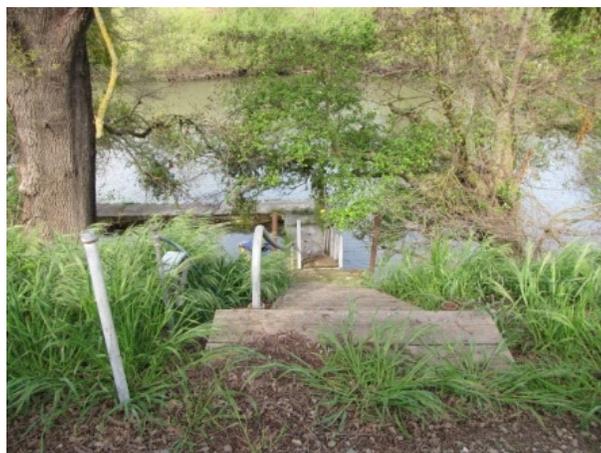
Levee Mile Report Line	3
Start Levee Mile	0.36
End Levee Mile	0.36
Location	Water Side
Category	Earthen Levee
Item	Encroachments
View of steps, a dock, and associated utilities on the waterward slope.	
rduffey_f_20101007_136.jpg

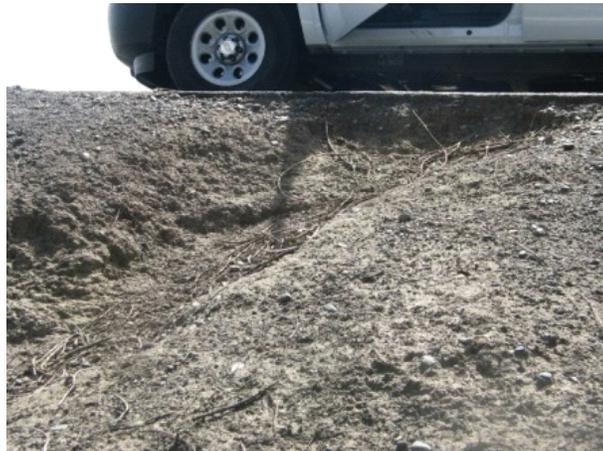
Levee Mile Report Line	7
Start Levee Mile	1.23
End Levee Mile	1.23
Location	Land Side
Category	Earthen Levee
Item	Slope Stability
Damaged slope from foot traffic and rain runoff at LM 1.23	
rduffey_f_20101007_139.jpg

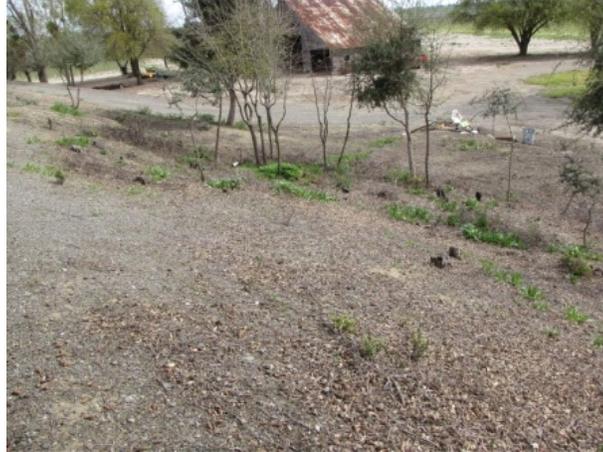
rduffey\_f\_20101007\_140.jpg

View of tree stumps on the landward slope.

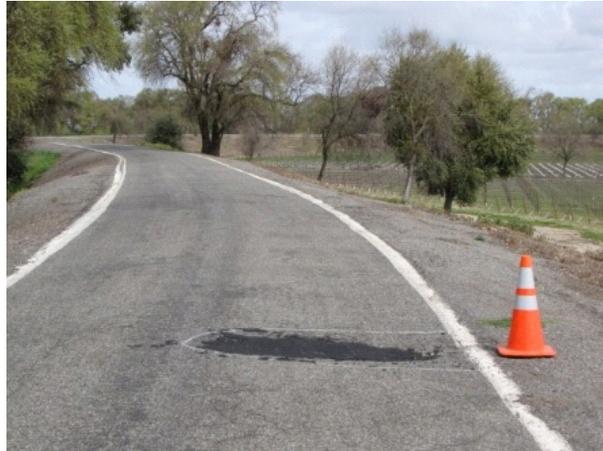
rduffey\_f\_20101007\_141.jpg

Levee Mile Report Line	11
Start Levee Mile	2.78
End Levee Mile	2.78
Location	Crown
Category	Earthen Levee
Item	Crown Surface / Depressions / Rutting

View of a depression in the crown roadway looking upstream.

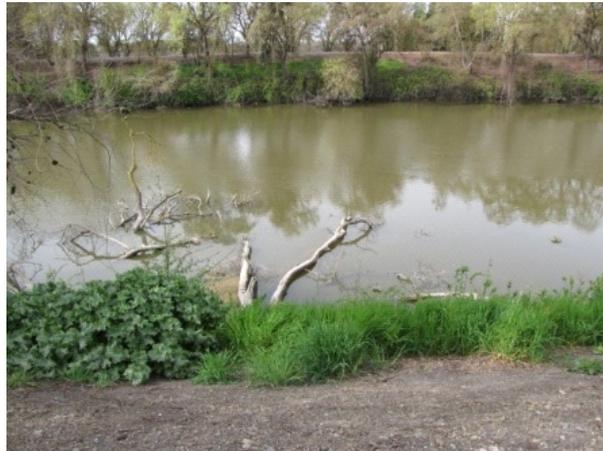
rduffey\_f\_20101007\_146.jpg

Levee Mile Report Line	12
Start Levee Mile	2.87
End Levee Mile	2.87
Location	Water Side
Category	Earthen Levee
Item	Trim / Thin Trees

View of tree stumps on the waterward slope.

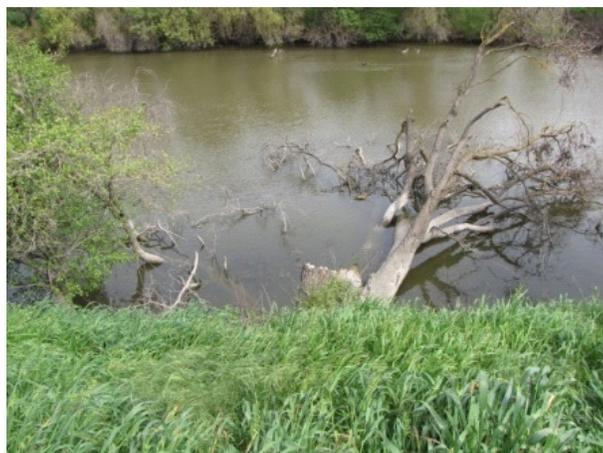
Levee Mile Report Line	15
Start Levee Mile	3.21
End Levee Mile	3.21
Location	Water Side
Category	Earthen Levee
Item	Trim / Thin Trees
View of tree stumps on the waterward slope.	
rduffey_f_20101007_149.jpg

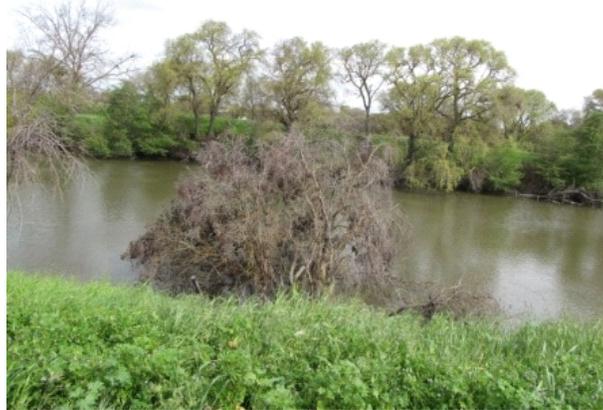
Levee Mile Report Line	16
Start Levee Mile	3.26
End Levee Mile	3.26
Location	Water Side
Category	Earthen Levee
Item	Trim / Thin Trees
View of tree stumps on the waterward slope.	
rduffey_f_20101007_150.jpg

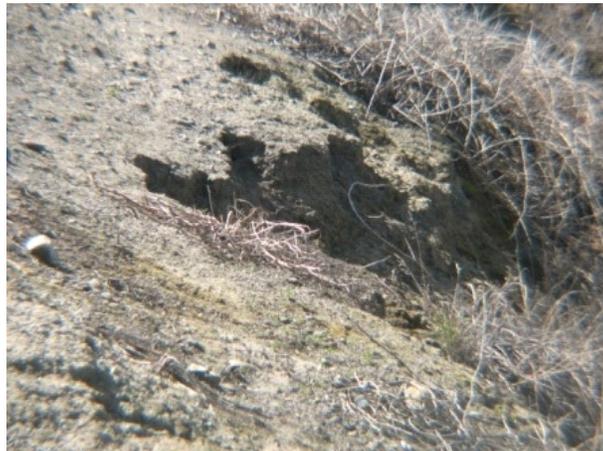
Levee Mile Report Line	18
Start Levee Mile	3.43
End Levee Mile	3.48
Location	Water Side
Category	Earthen Levee
Item	Erosion / Bank Caving
Erosion damage on waterward toe from LM 3.43 to 3.48	
rduffey_f_20101007_142.jpg

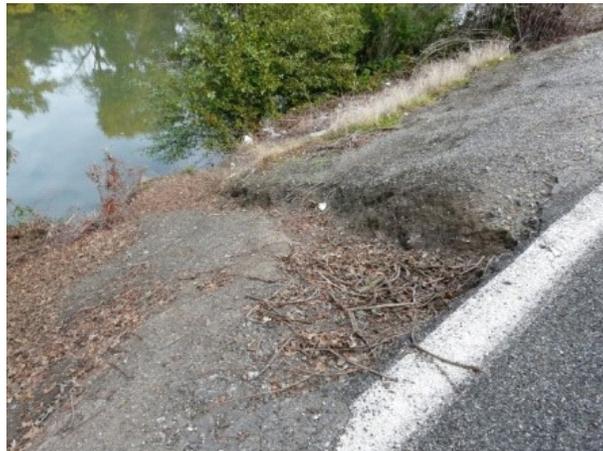
Levee Mile Report Line	21
Start Levee Mile	3.77
End Levee Mile	3.77
Location	Water Side
Category	Earthen Levee
Item	Slope Stability
Repair slope damaged by foot traffic at LM 3.77.	
rduffey_f_20101007_143.JPG

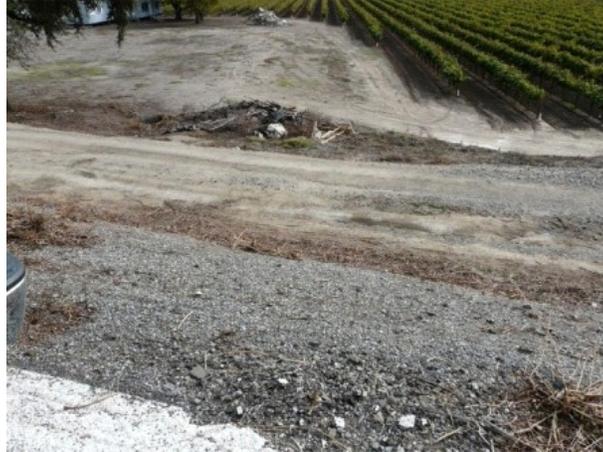
Levee Mile Report Line	22
Start Levee Mile	3.95
End Levee Mile	3.95
Location	Land Side
Category	Earthen Levee
Item	Encroachments
Debris pile on landward slope at LM 3.95.	
rduffey_f_20101007_164.JPG

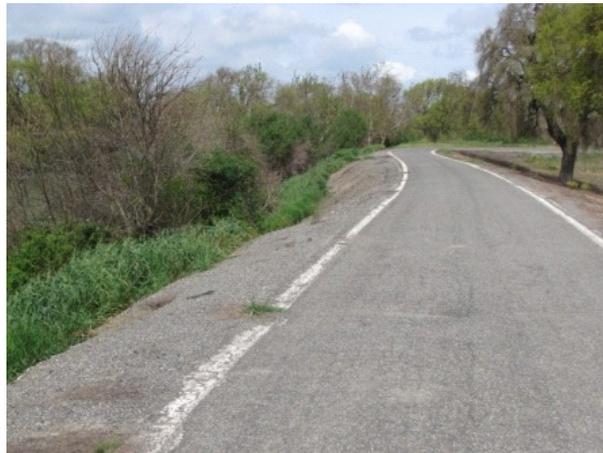
Levee Mile Report Line	23
Start Levee Mile	4.06
End Levee Mile	4.06
Location	Crown
Category	Earthen Levee
Item	Crown Surface / Depressions / Rutting
View of depressions in the roadway looking upstream.	
rduffey_f_20101007_157.jpg

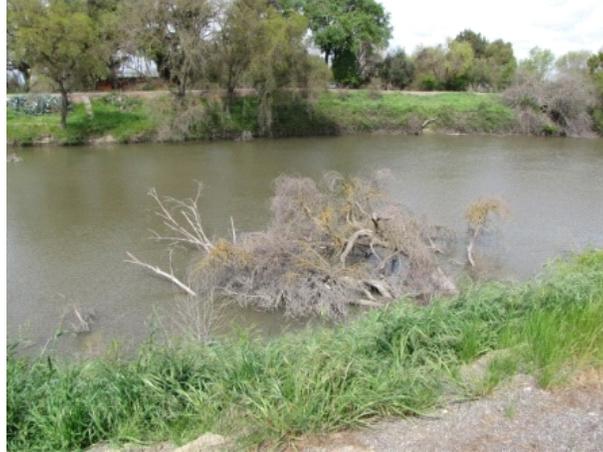
Levee Mile Report Line	24
Start Levee Mile	4.35
End Levee Mile	4.35
Location	Water Side
Category	Earthen Levee
Item	Trim / Thin Trees
View of tree stumps on the waterward slope.	
rduffey_f_20101007_158.jpg

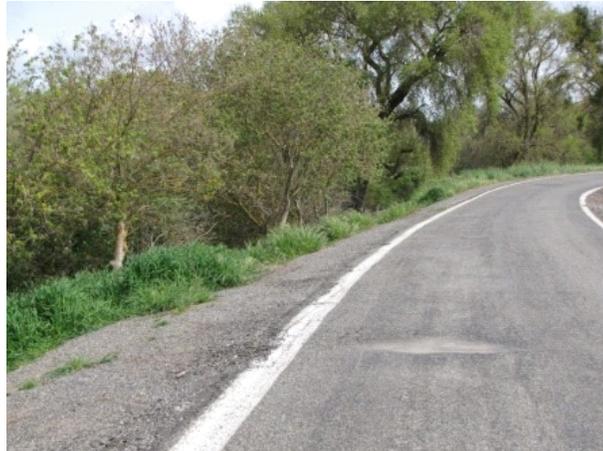
Levee Mile Report Line	26
Start Levee Mile	4.39
End Levee Mile	4.39
Location	Crown
Category	Earthen Levee
Item	Crown Surface / Depressions / Rutting
View of depressions in the crown roadway looking upstream.	
rduffey_f_20101007_159.jpg

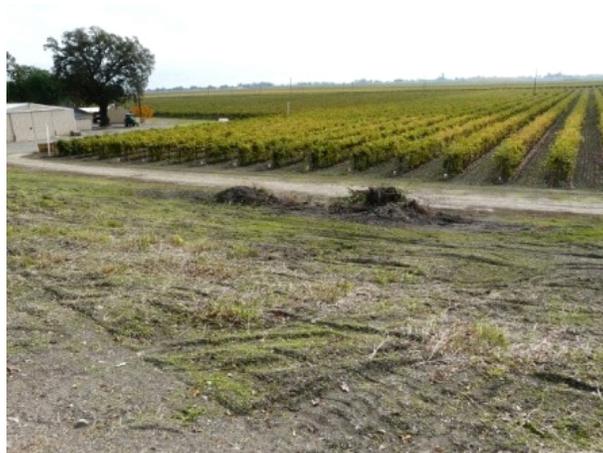
Levee Mile Report Line	27
Start Levee Mile	4.46
End Levee Mile	4.46
Location	Land Side
Category	Earthen Levee
Item	Encroachments
Remove pruning pile on landward slope at LM 4.46.	
rduffey_f_20101007_167.JPG

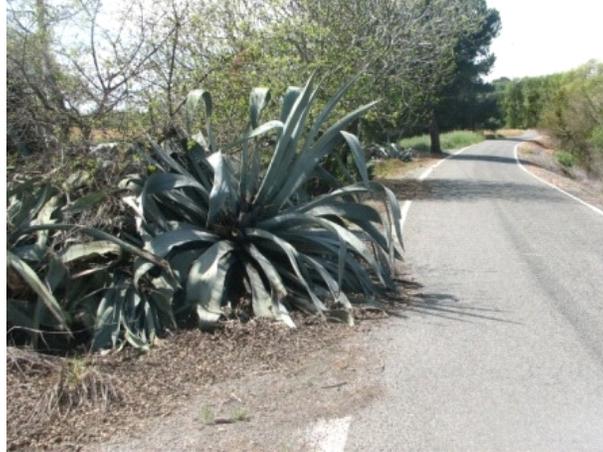
Levee Mile Report Line	29
Start Levee Mile	4.56
End Levee Mile	4.56
Location	Land Side
Category	Earthen Levee
Item	Encroachments
Landscaping blocking view of landward slope from 4.50 to 4.58	
rduffey_f_20101007_144.jpg

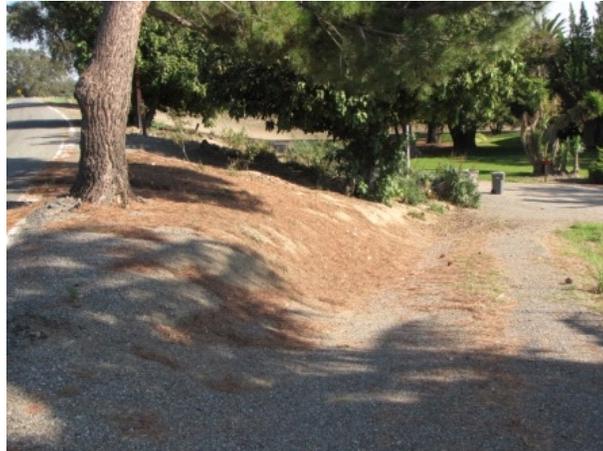
Levee Mile Report Line	29
Start Levee Mile	4.56
End Levee Mile	4.56
Location	Land Side
Category	Earthen Levee
Item	Encroachments
Updated view of landscaping along landward slope.	
rduffey_f_20101007_145.jpg

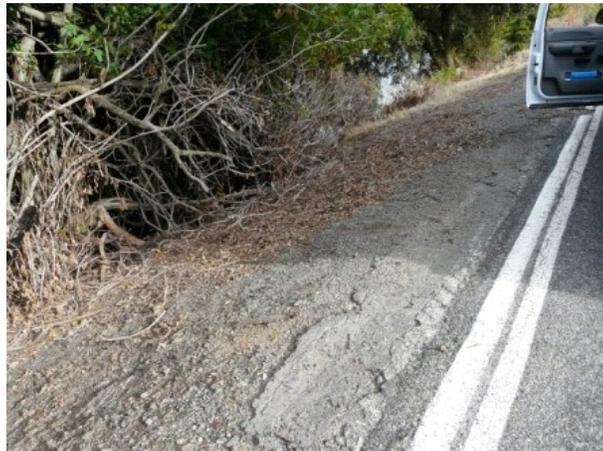
Levee Mile Report Line	30
Start Levee Mile	4.59
End Levee Mile	4.59
Location	Water Side
Category	Earthen Levee
Item	Trim / Thin Trees
Thin/trim trees to allow for the top 20' waterward slope of levee to be seen at LM 4.59.	
rduffey_f_20101007_168.JPG

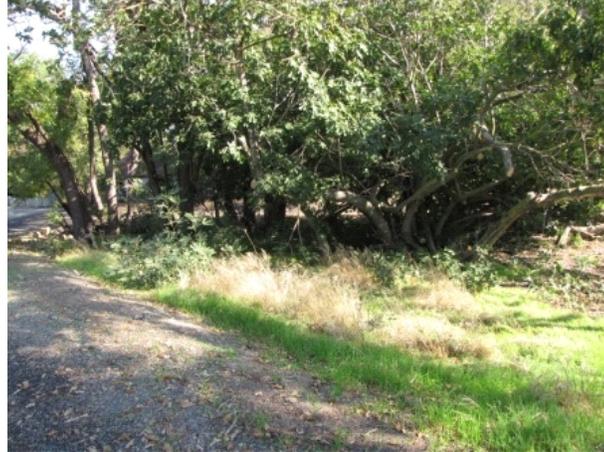
Levee Mile Report Line	32
Start Levee Mile	4.99
End Levee Mile	4.99
Location	Land Side
Category	Earthen Levee
Item	Trim / Thin Trees
View of trees along the landward slope blocking visibility and access.	
rduffey_f_20101007_182.jpg

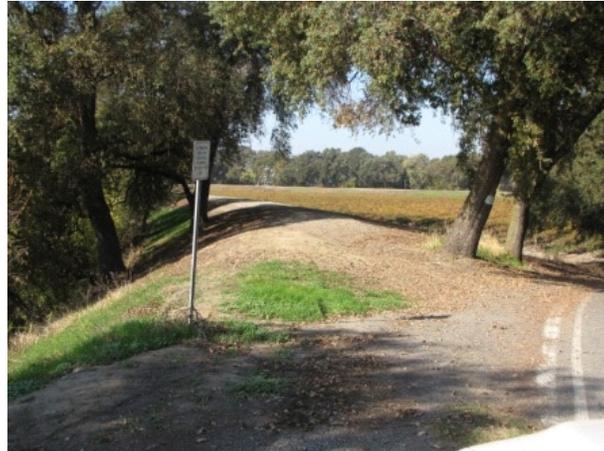
Levee Mile Report Line	34
Start Levee Mile	5.22
End Levee Mile	5.22
Location	Crown
Category	Earthen Levee
Item	Crown Surface / Depressions / Rutting
View of varying elevations in the crown of the levee at the transition from county road to access road.	
rduffey_f_20101007_183.jpg

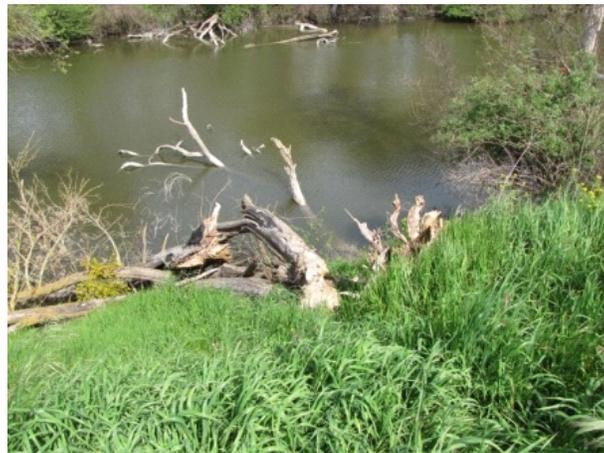
Levee Mile Report Line	36
Start Levee Mile	5.80
End Levee Mile	5.80
Location	Water Side
Category	Earthen Levee
Item	Trim / Thin Trees
View of a tree stump on the waterward slope.	
rduffey_f_20101007_160.jpg

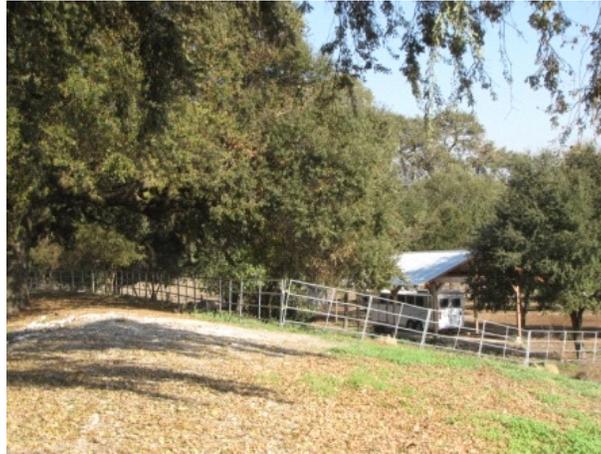
Levee Mile Report Line	37
Start Levee Mile	5.89
End Levee Mile	5.94
Location	Land Side
Category	Earthen Levee
Item	Encroachments

View of fence around a horse pen along the shoulder of the levee and the landward slope.

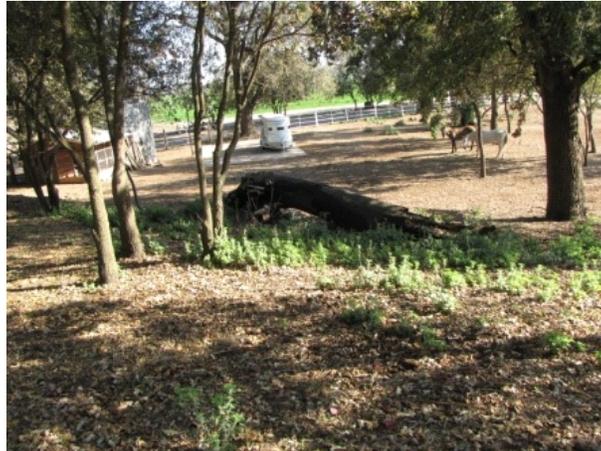
Levee Mile Report Line	38
Start Levee Mile	5.93
End Levee Mile	5.93
Location	Land Side
Category	Earthen Levee
Item	Encroachments

View of a tree trunk lying on the landward slope blocking visibility.

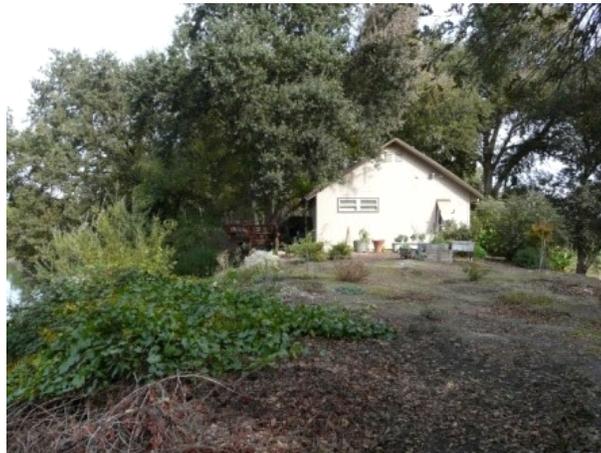
Levee Mile Report Line	39
Start Levee Mile	5.93
End Levee Mile	5.93
Location	Crown
Category	Earthen Levee
Item	Encroachments

Building & associated landscaping on levee crown at LM 5.93.

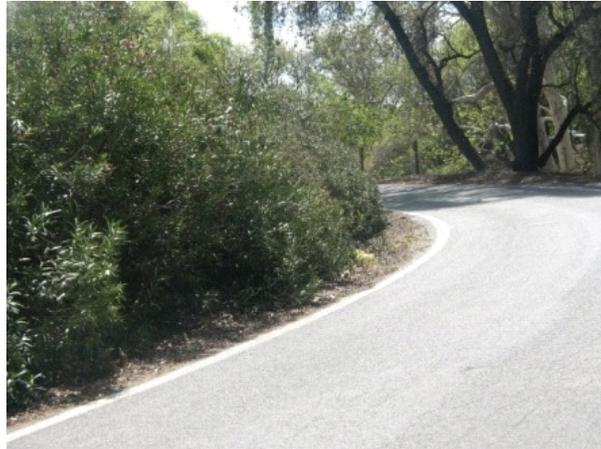
Levee Mile Report Line	44
Start Levee Mile	6.24
End Levee Mile	6.31
Location	Land Side
Category	Earthen Levee
Item	Encroachments
Oleander on landward slope blocking view of levee from LM 6.24 to 6.32	
rduffey_f_20101007_151.jpg

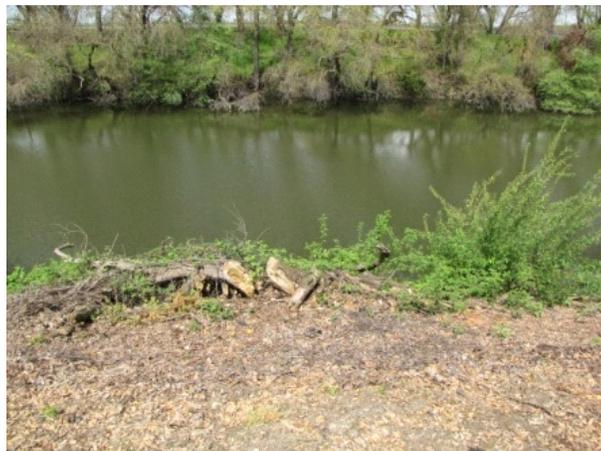
Levee Mile Report Line	45
Start Levee Mile	6.34
End Levee Mile	6.34
Location	Water Side
Category	Earthen Levee
Item	Trim / Thin Trees
View of tree stumps on the waterward slope.	
rduffey_f_20101007_166.jpg

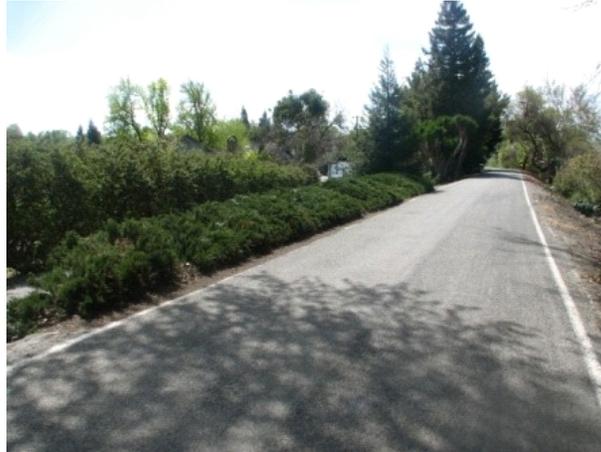
Levee Mile Report Line	47
Start Levee Mile	6.37
End Levee Mile	6.40
Location	Land Side
Category	Earthen Levee
Item	Encroachments
Landscaping on landward slope blocking view from LM 6.37 to 6.40	
rduffey_f_20101007_152.jpg

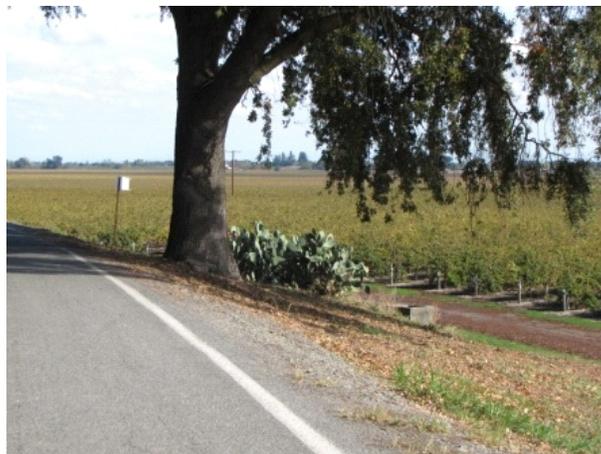
Levee Mile Report Line	48
Start Levee Mile	6.56
End Levee Mile	6.56
Location	Land Side
Category	Earthen Levee
Item	Encroachments
View of landscaping along the landward slope.	
rduffey_f_20101007_172.jpg

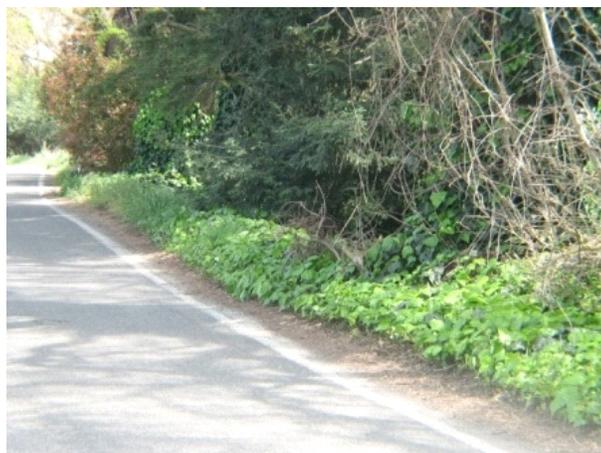
Levee Mile Report Line	50
Start Levee Mile	6.87
End Levee Mile	6.95
Location	Land Side
Category	Earthen Levee
Item	Encroachments
Landscaping on landward slope blocking view from LM 6.87 to 6.95	
rduffey_f_20101007_154.jpg

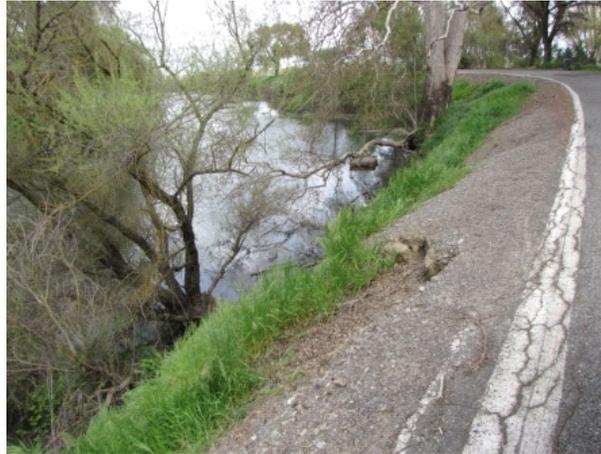
Levee Mile Report Line	52
Start Levee Mile	7.02
End Levee Mile	7.02
Location	Water Side
Category	Earthen Levee
Item	Erosion / Bank Caving

View of erosion on the waterward shoulder looking upstream.

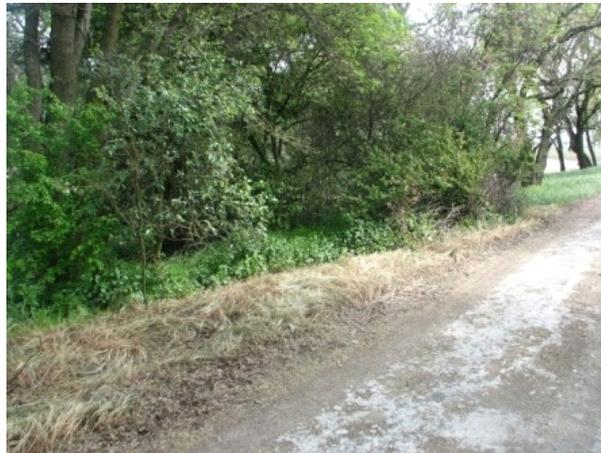
Levee Mile Report Line	56
Start Levee Mile	7.42
End Levee Mile	7.47
Location	Land Side
Category	Earthen Levee
Item	Encroachments

Landscaping on landward slope blocking view from LM 7.42 to 7.47

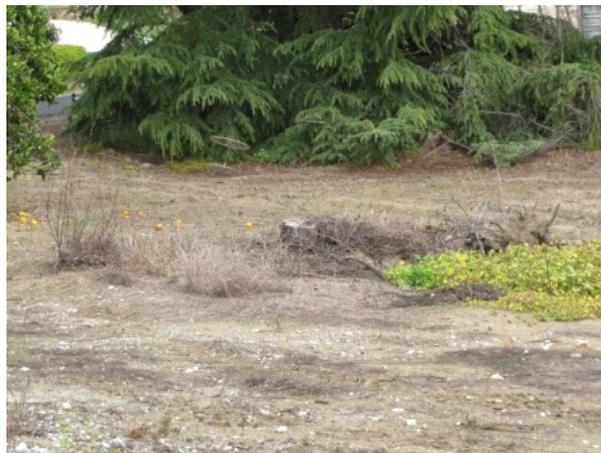
Levee Mile Report Line	57
Start Levee Mile	7.50
End Levee Mile	7.50
Location	Land Side
Category	Earthen Levee
Item	Trim / Thin Trees

View of a tree stump on the landward slope.

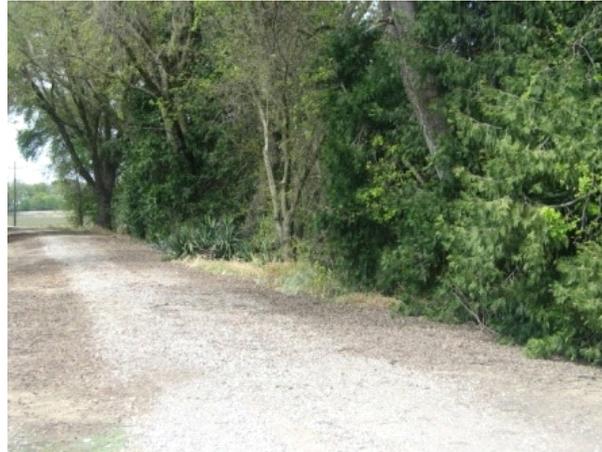
Levee Mile Report Line	58
Start Levee Mile	7.55
End Levee Mile	7.55
Location	Land Side
Category	Earthen Levee
Item	Encroachments
Landscaping on landward slope blocking view from LM 7.52 to 7.58	
rduffey_f_20101007_156.jpg

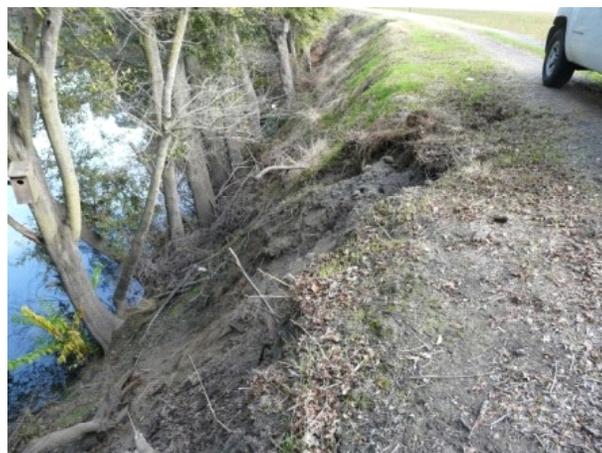
Levee Mile Report Line	62
Start Levee Mile	8.46
End Levee Mile	8.46
Location	Water Side
Category	Earthen Levee
Item	Erosion / Bank Caving
Repair erosion on waterward slope near shoulder at LM 8.46.	
rduffey_f_20101007_175.JPG

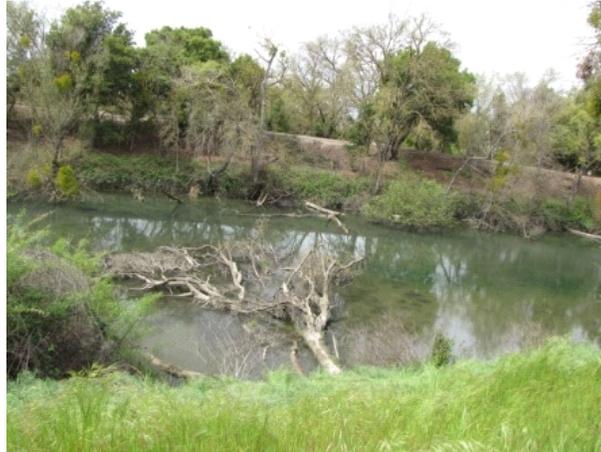
Levee Mile Report Line	65
Start Levee Mile	9.10
End Levee Mile	9.10
Location	Water Side
Category	Earthen Levee
Item	Trim / Thin Trees
View of a tree stump on the waterward slope.	
rduffey_f_20101007_177.jpg

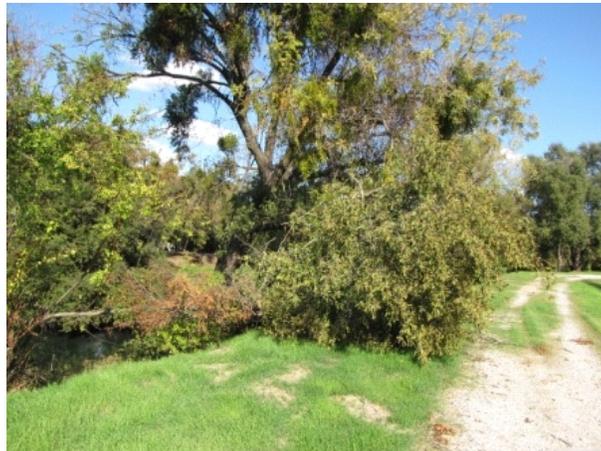
Levee Mile Report Line	66
Start Levee Mile	9.12
End Levee Mile	9.12
Location	Water Side
Category	Earthen Levee
Item	Trim / Thin Trees
View of a tree branch that has fallen and is blocking visibility and access.	
rduffey_f_20101007_186.jpg

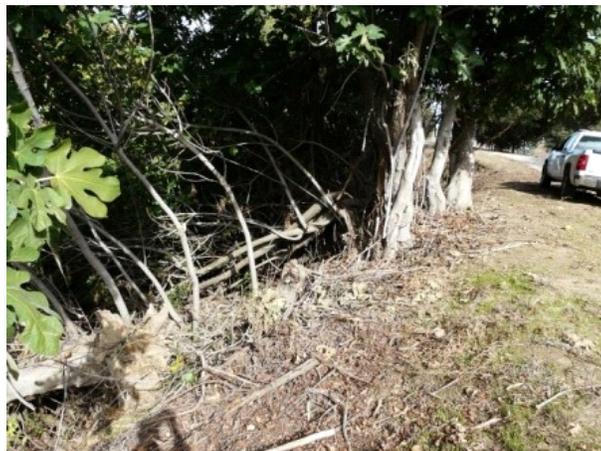
Levee Mile Report Line	69
Start Levee Mile	9.51
End Levee Mile	9.51
Location	Water Side
Category	Earthen Levee
Item	Trim / Thin Trees
Thin/trim trees to allow for visibility of top 20' of waterward slope at LM 9.51.	
rduffey_f_20101007_176.JPG
