**Flood Control Project Maintenance  
Levee Inspections**

**Fall 2015 Levee Maintenance Deficiency Summary Report**

**Sacramento River Basin**

| RD0150<br>Reclamation District No. 0150 Merrit Island | | Overall LMA Rating | Total LMA Miles | * Overall LMA Threshold Percent is less than 10.00%; however, U Rated Miles are present, so the Overall LMA Rating is M instead of A. | | | | | |

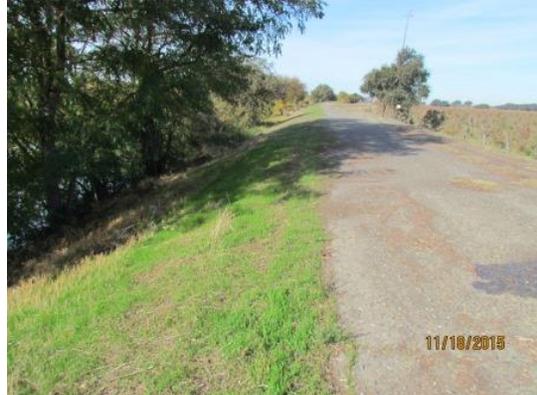
Photo 1 of 1 : FA\_2015\_RD0150\_15\_1\_20151119\_00004.jpg

| Control annual grass and weeds on the levee slopes and easements.<br>Inspector Comments: Accetable vegetation. | | | | | |

LMA mowed the vegetation on the waterside of the levee.

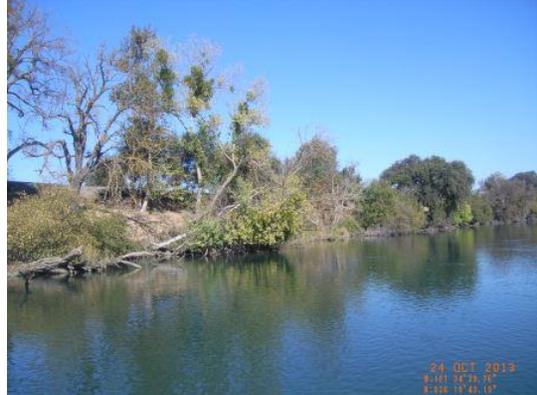
Photo 2 of 2 : USACE2013A\_STR\_28-4\_R\_17.jpg

| Inspector Comments: 2013 - Old toe repair unraveling. Bridge at upstream end of site. 2015: No observed changes. [2015 Site ID: STR_28-4_R] | | | | | |

USACE 2013 Photo #2

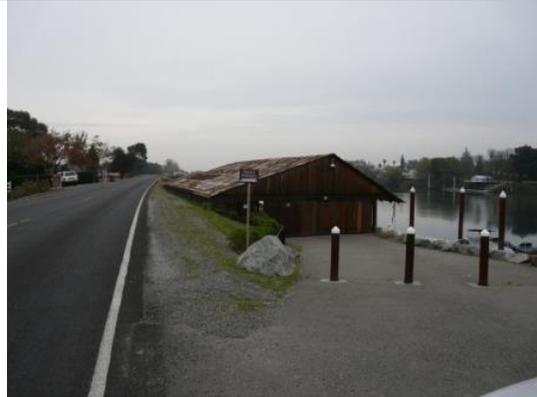
Photo 1 of 1 : FA\_2015\_RD0150\_16\_49\_20150911\_00027.jpg

Building located on waterside of levee at LM 0.16

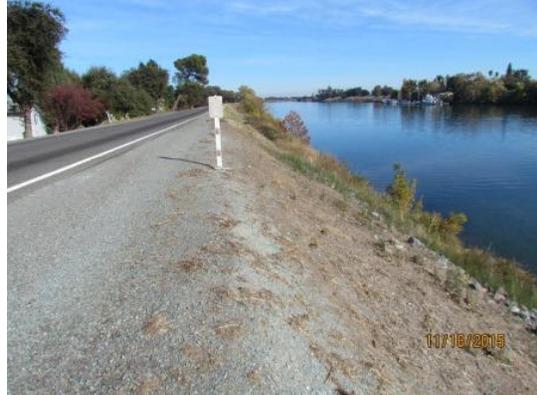
Photo 1 of 1 : FA\_2015\_RD0150\_16\_57\_20151119\_00077.jpg

| Control annual grass and weeds on the levee slopes and easements.<br>Inspector Comments: Acceptable vegetation. | | | | | |

View of acceptable vegetation on the waterside of the levee.

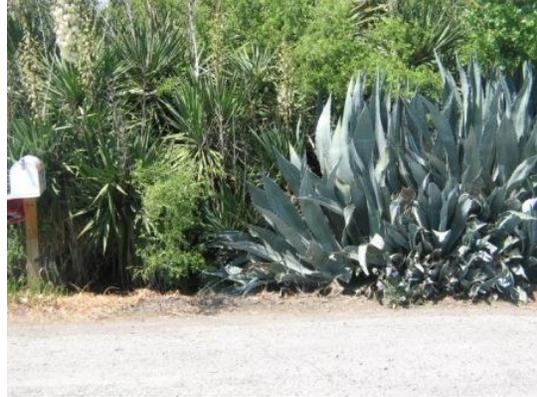
Photo 1 of 1 : FA\_2015\_RD0150\_16\_4\_20150911\_00001.jpg

Landscaping on landward slope of the levee.

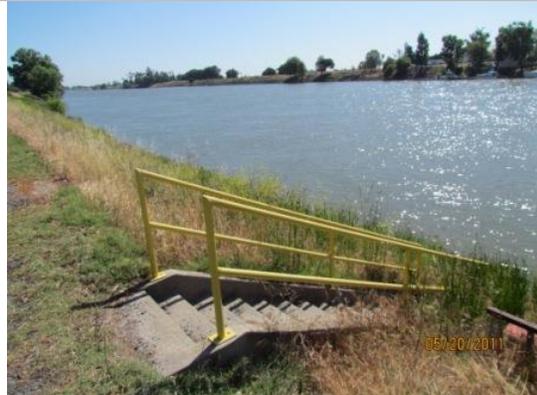
Photo 1 of 1 : FA\_2015\_RD0150\_16\_13\_20150911\_00008.jpg

A stairway was found on the waterside of the levee. The picture was taken from the crown looking upstream.

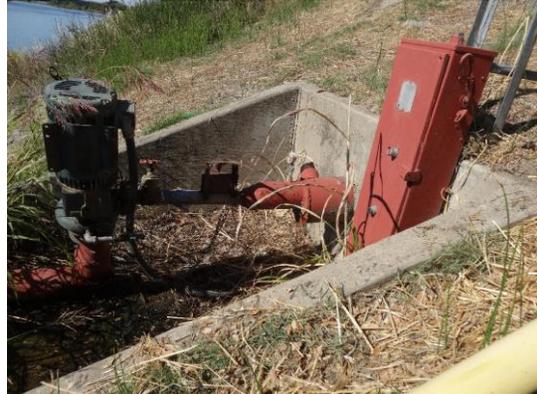
Photo 2 of 3 : UCIP\_FA\_2015\_1999.jpg

**Action/Comments**  
 Inspector Comments: FS\_ID:20268  
 DS\_ID:22417  
 EP\_NO: N/A  
 FS\_HLM: 0.3906  
 Repair Type: Non-Urgent  
 Crossing Status: Found  
 UCIP Comments: - Water leaks from pressure breaker.- Distribution box at the landward toe not found/visible.- Service pole on LS toe.  
 FIELD\_STRUCT\_DESC: 4-inch steel pipe joined to 6-inch steel pipe and the 6-inch pipe joined to 10-inch steel pipe through the levee, 5.8 feet below the crown. 1.5-inch conduit through the levee, 3 feet below the crown. Pump and gate valve on the waterward slope. (Runyon).  
 FS Date: 08/27/2013

WS view: pump, electric control box, electric conduit on concrete pad. Water leaks from pressure breaker.

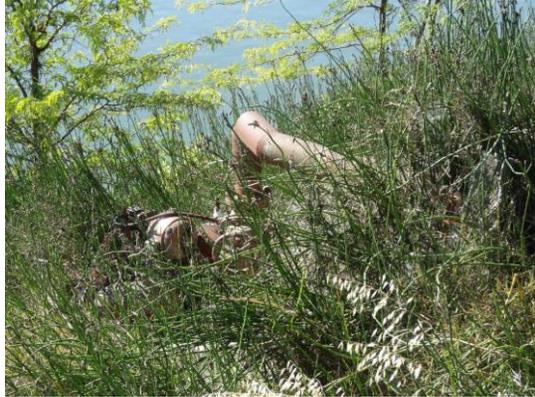
Photo 3 of 3 : UCIP\_FA\_2015\_1904.jpg

| Inspector Comments: FS_ID:20267<br>DS_ID:22418<br>EP_NO: N/A<br>FS_HLM: 0.467<br>Repair Type: Non-Urgent<br>Crossing Status: Found | | | | | |

WS view: steel pipe and pump on levee slope. Dense vegetation on waterside.

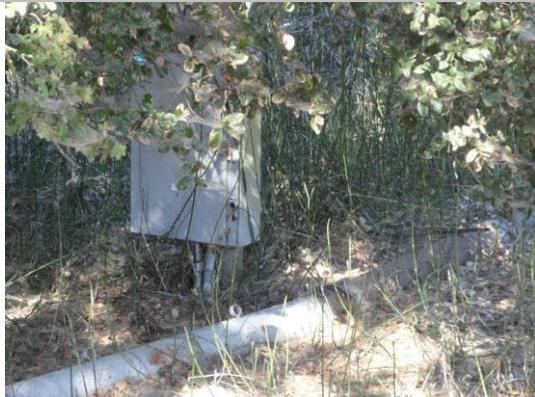
Photo 1 of 2 : UCIP\_FA\_2015\_2039.jpg

| Inspector Comments: FS_ID:20284<br>DS_ID:22419<br>EP_NO: N/A<br>FS_HLM: 0.488<br>Repair Type: Non-Urgent<br>Crossing Status: Found<br>UCIP Comments: Needs proper abandonment.<br>FIELD_STRUCT_DESC: 8-inch steel pipe through the levee, 5.7 feet below the crown. Power line on landside.(Mrs. J. Olson) O&M Manual SAC 112, March 1957.<br>FS Date: 08/27/2013 | | | | | |

LS view: exposed steel pipe and power pole on levee toe.

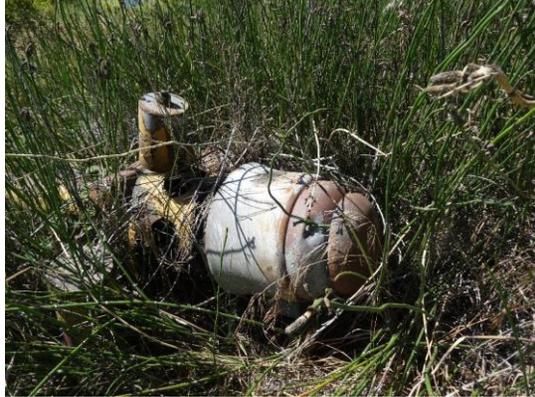
Photo 2 of 2 : UCIP\_FA\_2015\_2040.jpg

| Inspector Comments: FS_ID:20284<br>DS_ID:22419<br>EP_NO: N/A<br>FS_HLM: 0.488<br>Repair Type: Non-Urgent<br>Crossing Status: Found<br>UCIP Comments: Needs proper abandonment.<br>FIELD_STRUCT_DESC: 8-inch steel pipe through the levee, 5.7 feet below the crown. Power line on landside.(Mrs. J. Olson) O&M Manual SAC 112, March 1957.<br>FS Date: 08/27/2013 | | | | | |

WS view: abandoned pump on levee slope. Dense vegetation on waterside.

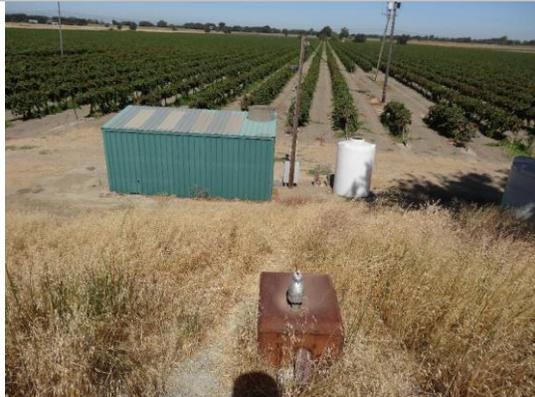
Photo 1 of 3 : UCIP\_FA\_2015\_2041.jpg

| Inspector Comments: FS_ID:20303<br>DS_ID:22421<br>EP_NO: 16109<br>FS_HLM: 0.7128<br>Repair Type: Non-Urgent<br>Crossing Status: Found<br>UCIP Comments: - 10" steel pipe on both sides of the levee. According to permit and inspectors note- 16" steel pipe through the levee.- concrete standpipe inside water filtration plant on landside toe.- air pressure tank on waterside steel deck.<br>FIELD_STRUCT_DESC: 16 inch steel pipe and 2-inch conduit through the levee, 6.2 feet below the crown, slant pump on steel platform on the waterward slope. 4-inch abandoned pipe on the waterside slope. Concrete stand pipe and power pole at landside toe. (App. No. 18258, Wilson 2007) O&M Manual SAC 112, March 1957.<br>FS Date: 08/27/2013 | | | | | |

LS view: 10-inch pipe and air vent on levee slope. Concrete standpipe inside water filtration plant.

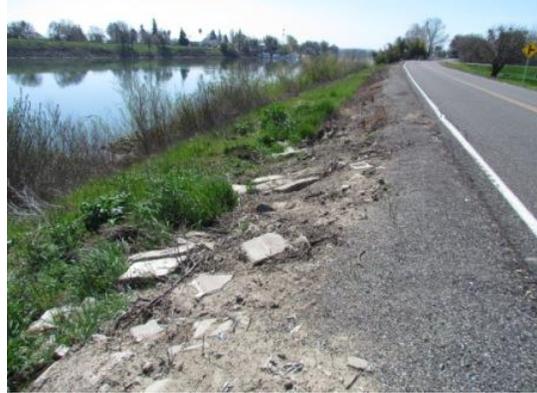
Photo 1 of 1 : FA\_2015\_RD0150\_16\_10\_20150911\_00006.jpg

Debris was found on the waterside slope of the levee looking downstream during Spring 2013 inspection.

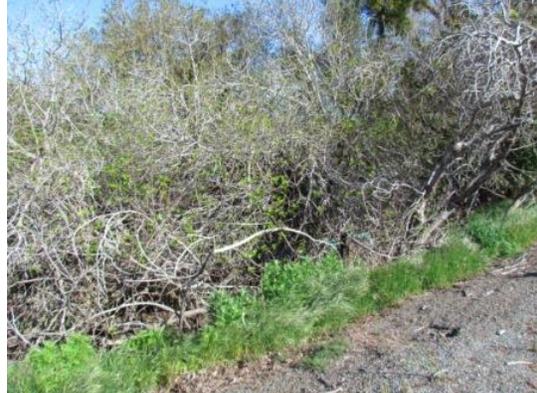
Photo 1 of 1 : FA\_2015\_RD0150\_16\_12\_20150911\_00007.jpg

Overgrown trees were obstructing the landside slope of the levee looking upstream.

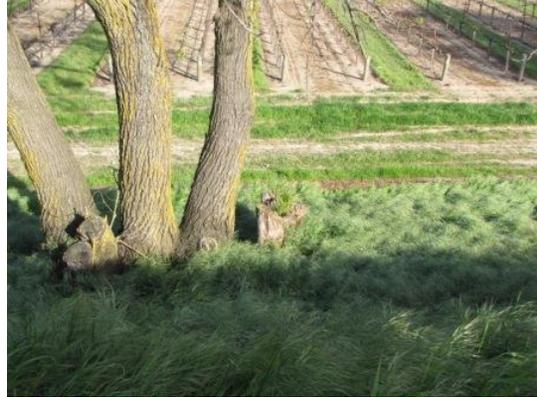
Photo 1 of 1 : FA\_2015\_RD0150\_16\_8\_20150911\_00004.jpg

View of a tree stump on the landward slope.

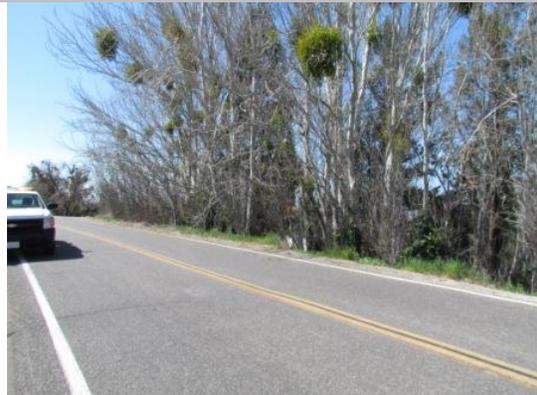
Photo 1 of 2 : FA\_2015\_RD0150\_16\_91\_20150911\_00046.jpg

Landscaping was obstructing the view of the landside slope of the levee looking downstream. This picture was taken during spring 2013 inspection.

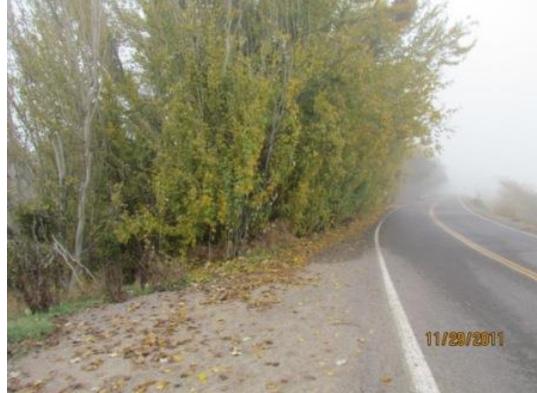
Photo 2 of 2 : FA\_2015\_RD0150\_16\_91\_20150911\_00047.jpg

Landscaping was found landside of the levee looking upstream.

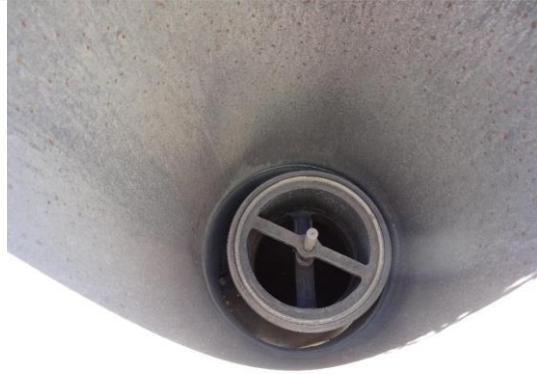
Photo 2 of 3 : UCIP\_FA\_2015\_1721.jpg

| LM Start | 1.34 | Rating ** | M | Issue No. | 996 (cont) |
|--|---|---|---|---|---|
| Inspector Comments: FS_ID:20727<br>DS_ID:22393<br>EP_NO: 18221<br>FS_HLM: 1.358<br>Repair Type: Non-Urgent<br>Crossing Status: Found<br>UCIP Comments: Pump house and drainage ditch about 250 feet from the levee on landside. Pumps on piling structure with shed in drainage ditch. Siphon breaker cover missing. Needs to fix it.<br>FIELD_STRUCT_DESC: 1 of 2: 30-inch pipe (of 30-inch and 24-inch steel pipes), 7.0 feet below the crown replaced 36-inch and 24-inch pipes through the levee, 9.0 and 8.0 feet below the crown respectively. Flap gates on the waterward ends. Siphon breakers on the waterward slope. Pumps on piling structure with shed in drainage ditch. (App. No. 18221 - R.D. No. 150 drainage plant). O&M Manual SAC 112, March 1957.<br>FS Date: 08/27/2013 | | | | | |

WS view: siphon breaker in pipe riser on levee shoulder.

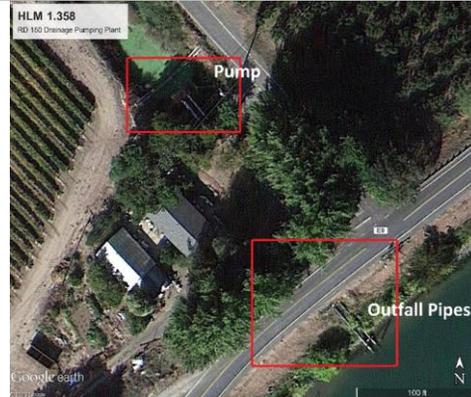
Photo 3 of 3 : UCIP\_FA\_2015\_1722.jpg

Bird's eye view: outfall pipes (bottom) and pump structure in drainage ditch (top)

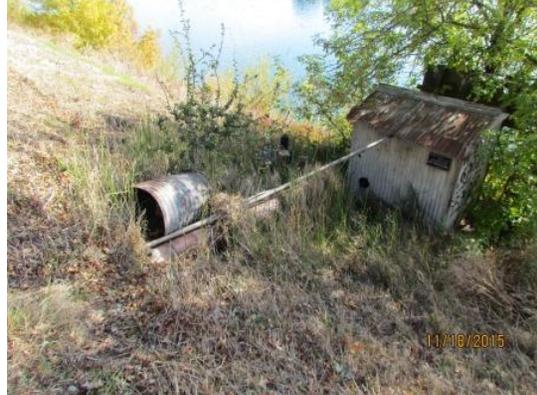
Photo 1 of 1 : FA\_2015\_RD0150\_16\_53\_20151119\_00076.jpg

| Pipe<br>Inspector Comments: Abandoned pipes were found on the waterside slope. | | | | | |

Abandon pipes and debris was found on the waterside of the levee.

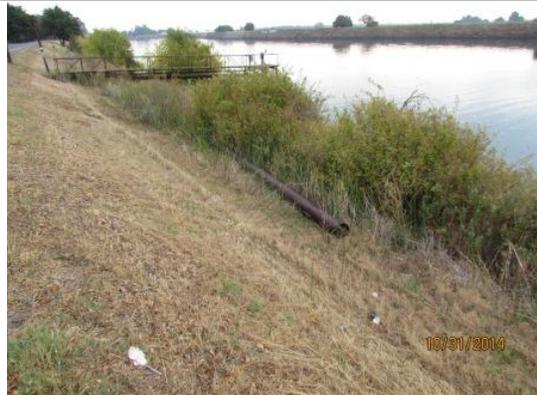
Photo 1 of 1 : FA\_2015\_RD0150\_16\_50\_20150911\_00028.jpg

| Pipe<br>Inspector Comments: An abandoned pipe was found on the waterside of the levee. | | | | | |

A pipe was found on the waterside toe of the levee looking upstream.

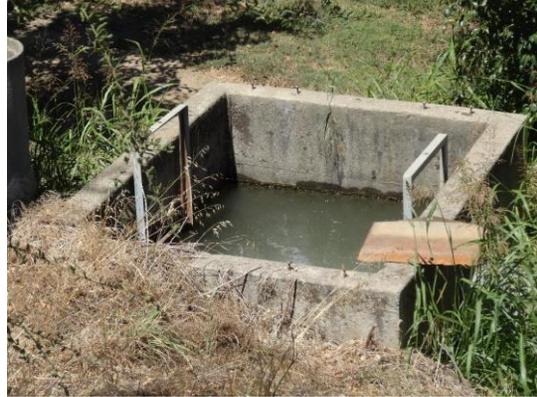
Photo 1 of 3 : UCIP\_FA\_2015\_1943.jpg

Inspector Comments: FS\_ID:20348  
 DS\_ID:22395  
 EP\_NO: N/A  
 FS\_HLM: 1.9412  
 Repair Type: Non-Urgent  
 Crossing Status: Found  
 UCIP Comments: - Operating during inspection.- Overhead powerline crossing- CMP riser with siphon breaker needs cleaning.  
 FIELD\_STRUCT\_DESC: 12-inch steel pipe through the levee, 4.0 feet below the crown; pump on the piling in the stream. Power poles on both slopes. Ramp on the landward slope. Siphon breaker on the landward shoulder. (T. Wilson). O&M Manual SAC 112, March 1957.  
 FS Date: 08/27/2013

LS view: concrete distribution box on levee toe.

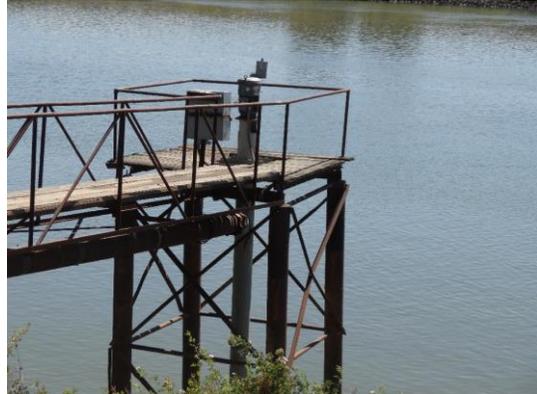
Photo 2 of 3 : UCIP\_FA\_2015\_1944.jpg

WS view: pipe & pump on piling structure in the stream.

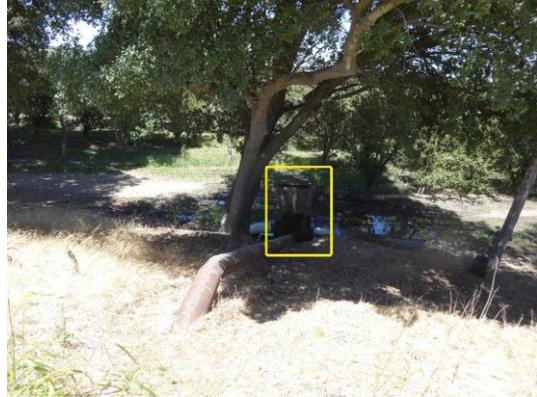
Photo 1 of 2 : UCIP\_FA\_2015\_1723.jpg

Inspector Comments: FS\_ID:20731  
 DS\_ID:22396  
 EP\_NO: N/A  
 FS\_HLM: 2.173  
 Repair Type: Non-Urgent  
 Crossing Status: Found  
 UCIP Comments: - Operating during inspection. Leaky join at the concrete box.- Power overhead crossing. Power pole at waterside shoulder, and landside toe.  
 FIELD\_STRUCT\_DESC: 12-inch steel pipe through the levee, 5.0 feet below the crown, slant pump on the waterward slope. Power pole on the waterward shoulder. (Wilcox) O&M Manual SAC 112, March 1957.  
 FS Date: 08/27/2013

LS view: concrete distribution box on levee toe and exposed steel pipe on levee slope.

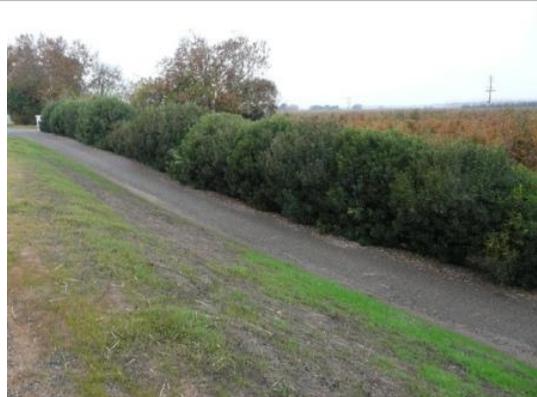
Photo 1 of 1 : FA\_2015\_RD0150\_16\_85\_20150911\_00044.jpg

Landscaping providing a screen for a residence on the landside of levee.

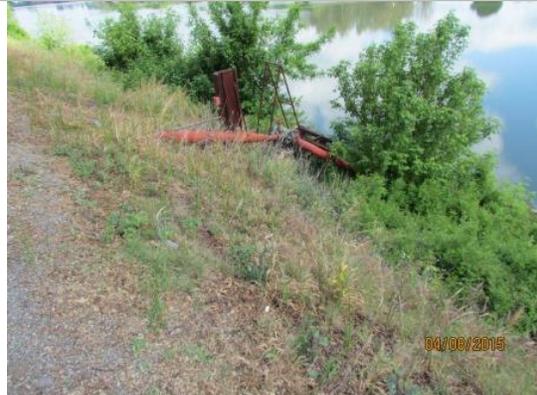
Photo 1 of 5 : FA\_2015\_RD0150\_16\_961\_20150911\_00050.jpg

| Schedule repair of erosion site prior to the next inspection.<br>Inspector Comments: Depressions into the waterward slope can be seen along the waterward slope at this site. Also note the damaged pump support, pump, and pipe just upstream of the site; they may contribute to the erosion in a high water event and should be removed. | | | | | |

Updated picture of the erosion on the waterside of the levee during spring 2015 inspection.

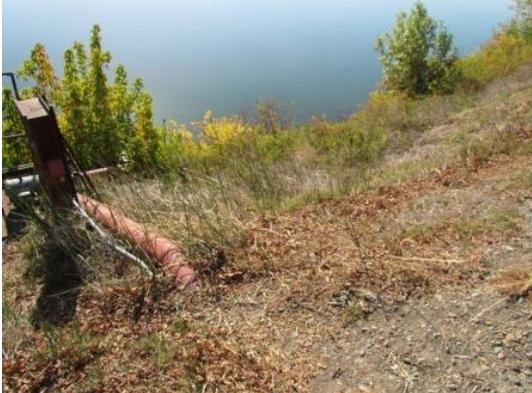
Photo 2 of 5 : FA\_2015\_RD0150\_16\_961\_20150911\_00051.jpg

| Schedule repair of erosion site prior to the next inspection.<br>Inspector Comments: Depressions into the waterward slope can be seen along the waterward slope at this site. Also note the damaged pump support, pump, and pipe just upstream of the site; they may contribute to the erosion in a high water event and should be removed. | | | | | |

View of the erosion on the waterside slope of the levee near the pipe looking downstream. This picture was taken during the fall 2013 inspection.

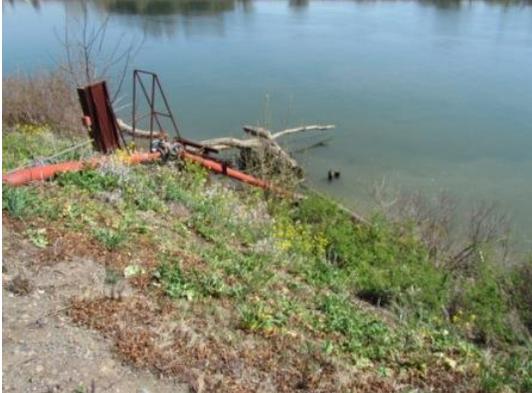
Photo 3 of 5 : FA\_2015\_RD0150\_16\_961\_20150911\_00052.jpg

View of the erosion on the waterside slope of the levee looking upstream during spring 2013 inspection.

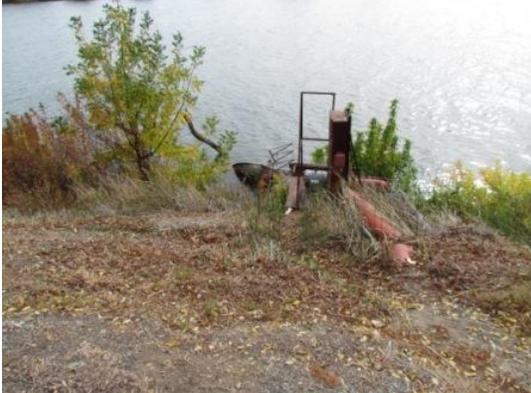
Photo 4 of 5 : FA\_2015\_RD0150\_16\_961\_20150911\_00053.jpg

| Schedule repair of erosion site prior to the next inspection.<br>Inspector Comments: Depressions into the waterward slope can be seen along the waterward slope at this site. Also note the damaged pump support, pump, and pipe just upstream of the site; they may contribute to the erosion in a high water event and should be removed. | | | | | |

View of erosion and damaged pipe and abandoned boat on the waterside of the levee looking upstream. This picture was taken during fall 2012 inspection.

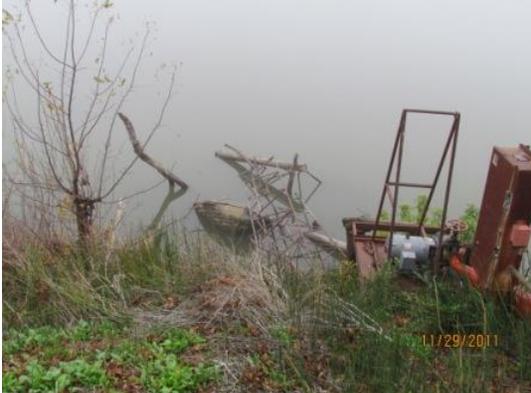
Photo 5 of 5 : FA\_2015\_RD0150\_16\_961\_20150911\_00054.jpg

View of the erosion site, and broken pump support along with a boat on the waterside of the levee. The picture was taken from the crown looking towards the toe of the levee during fall 2011 inspection.

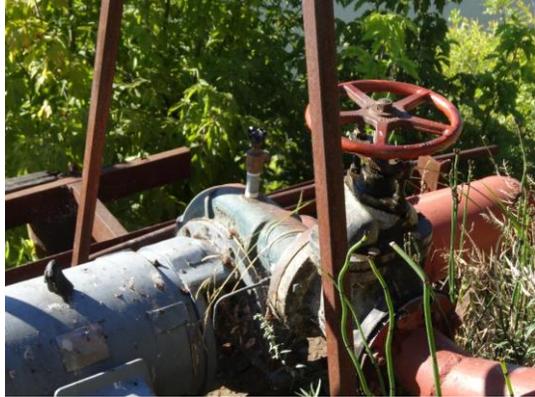
Photo 1 of 3 : UCIP\_FA\_2015\_1812.jpg

| Inspector Comments: FS_ID:20736<br>DS_ID:22402<br>EP_NO: N/A<br>FS_HLM: 3.296<br>Repair Type: Non-Urgent<br>Crossing Status: Found | | | | | |

WS view: pipe and pump on levee slope. Gate valve and air vent on the pipe.

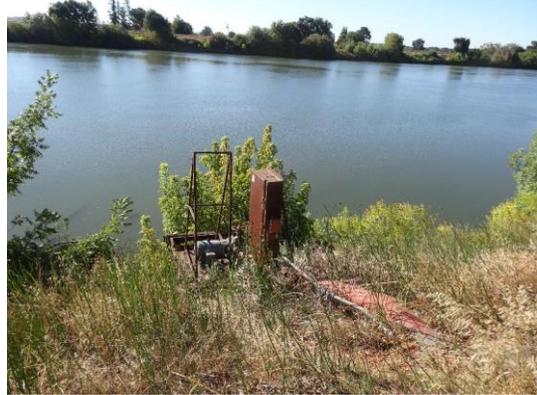
Photo 3 of 3 : UCIP\_FA\_2015\_1814.jpg

| Inspector Comments: FS_ID:20736<br>DS_ID:22402<br>EP_NO: N/A<br>FS_HLM: 3.296<br>Repair Type: Non-Urgent<br>Crossing Status: Found | | | | | |

WS view: pipe, conduit and pump on levee slope.

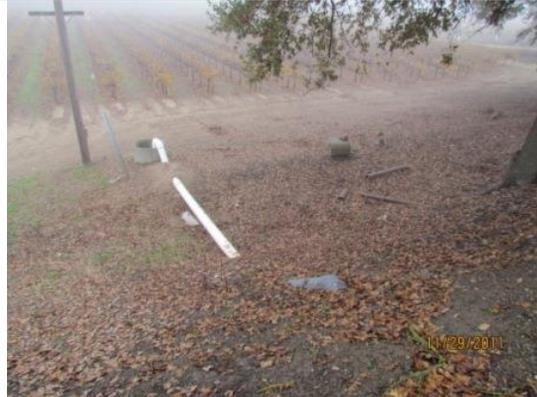
Photo 2 of 2 : FA\_2015\_RD0150\_16\_15\_20150911\_00011.jpg

| Pipe<br>Inspector Comments: PVC pipe is sleeving through an old steel pipe. The steel pipe appears to be fine for now, but we should keep an eye on it. | | | | | |

A PVC pipe was used under the levee crown for irrigation purpose. The picture was taken from the crown looking downstream.

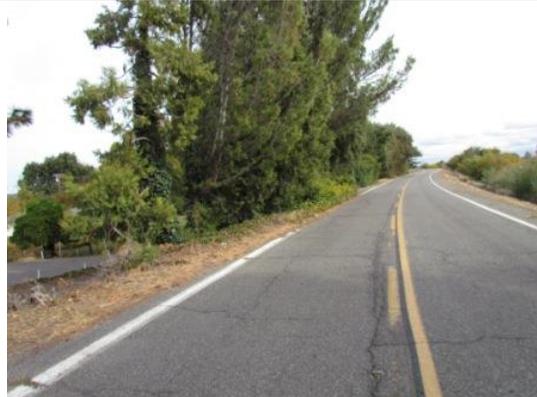
Photo 1 of 1 : FA\_2015\_RD0150\_16\_82\_20150911\_00043.jpg

| Landscaping | | | | | |

Landscaping was blocking the visibility on the landside of the levee looking upstream.

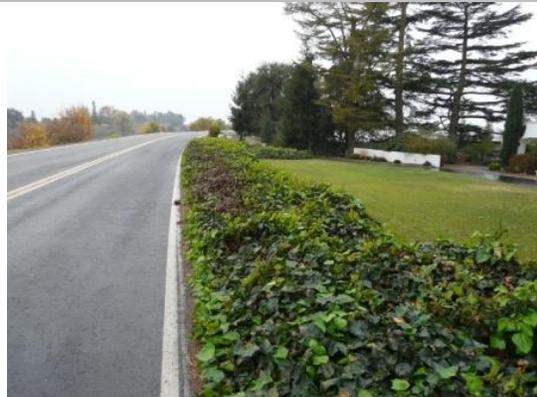
Photo 1 of 1 : FA\_2015\_RD0150\_16\_80\_20150911\_00042.jpg

| Landscaping | | | | | |

Landscaping in front of a residence on landside of levee from LM 3.90 to LM 3.93. The levee in this location is greater than 100' wide.

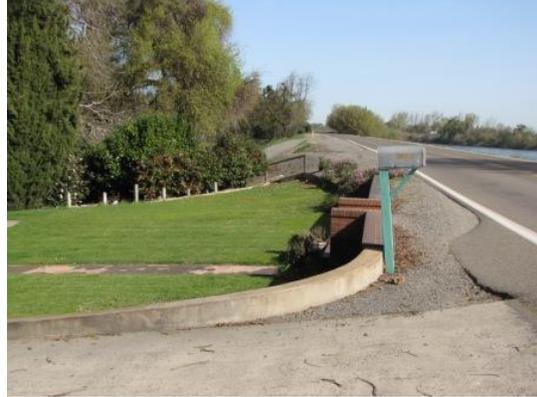
Photo 1 of 1 : FA\_2015\_RD0150\_16\_20\_20150911\_00014.jpg

| Building<br>Inspector Comments: 3' retaining wall at the landward shoulder. | | | | | |

View of a retaining wall on the landward slope looking upstream.

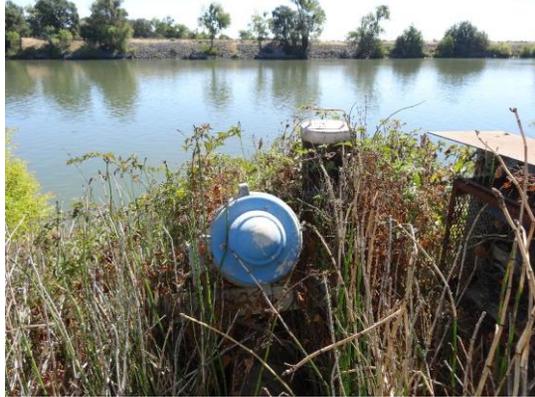
Photo 3 of 3 : UCIP\_FA\_2015\_1942.jpg

| Inspector Comments: FS_ID:42702<br>DS_ID:22407<br>EP_NO: 13505<br>FS_HLM: 4.238<br>Repair Type: Non-Urgent<br>Crossing Status: Found | | | | | |

WS view: slanted pump on levee slope.

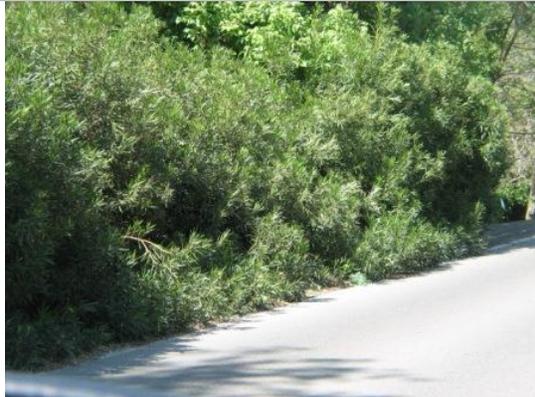
Photo 1 of 1 : FA\_2015\_RD0150\_16\_24\_20150911\_00016.jpg

| Landscaping | | | | | |

Landscaping (Oleander) on landward slope from 4.33 to 4.35

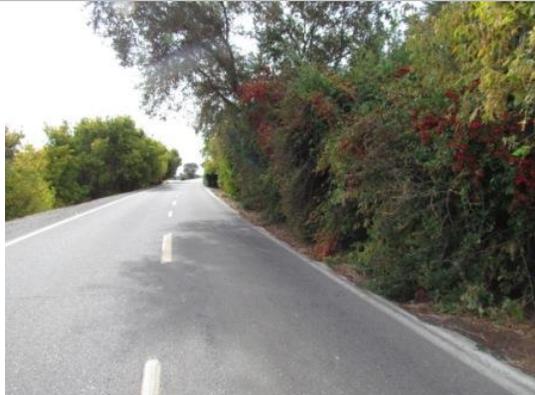
Photo 1 of 1 : FA\_2015\_RD0150\_16\_79\_20150911\_00041.jpg

| Landscaping | | | | | |

Trees were obstructing the views on the landside slope of the levee looking downstream.

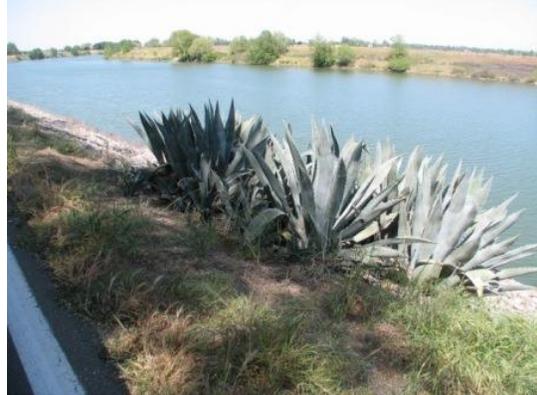
Photo 1 of 1 : FA\_2015\_RD0150\_16\_28\_20150911\_00018.jpg

Century plant on waterward slope at LM 4.76

| Remove the wild growth other than native grasses from the levee slopes. | | | | | |

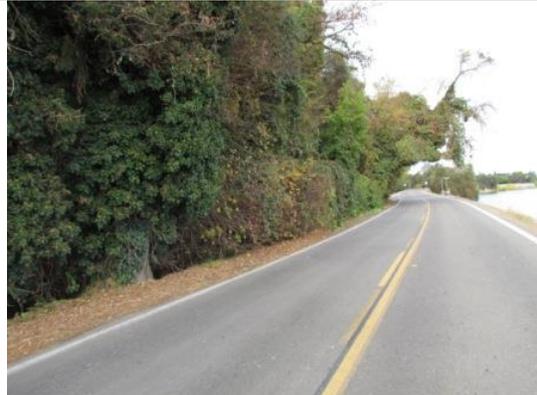
Photo 1 of 1 : FA\_2015\_RD0150\_16\_76\_20150911\_00040.jpg

| Landscaping | | | | | |

Trees were obstructing the view of the landside slope of the levee looking upstream.

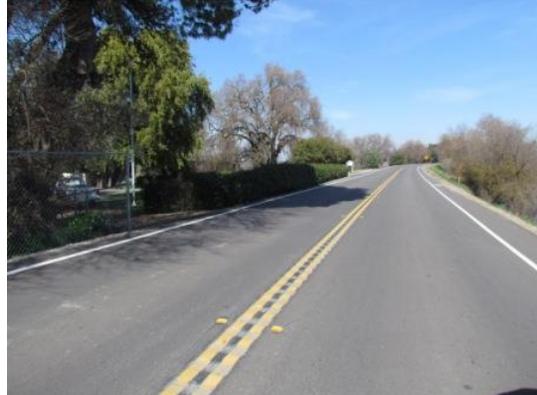
Photo 1 of 1 : FA\_2015\_RD0150\_16\_30\_20150911\_00019.jpg

| Landscaping | | | | | |

Landscaping was found on the landside shoulder of the levee looking upstream.

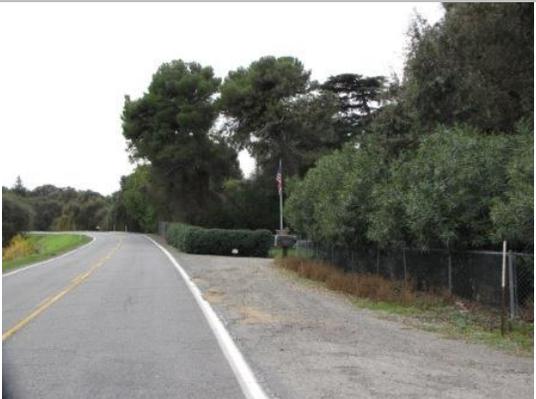
Photo 1 of 1 : FA\_2015\_RD0150\_16\_75\_20150911\_00039.jpg

| Landscaping | | | | | |

View of landscaping along the landward shoulder and slope looking downstream.

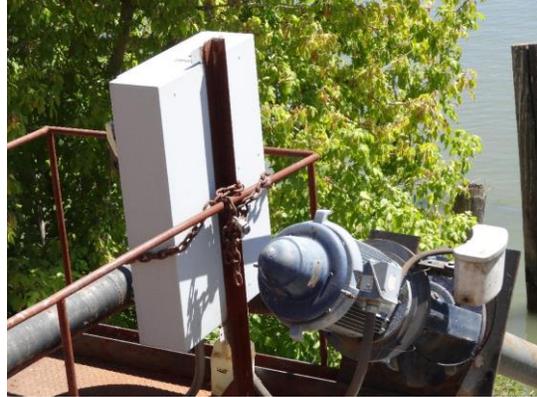
Photo 2 of 3 : UCIP\_FA\_2015\_1871.jpg

Inspector Comments: FS\_ID:20740  
 DS\_ID:22410  
 EP\_NO: N/A  
 FS\_HLM: 5.324  
 Repair Type: Non-Urgent  
 Crossing Status: Found  
 UCIP Comments: - 2" electric conduit and gate valve on WS.- abandoned old pump not removed from WS- working during field survey  
 FIELD\_STRUCT\_DESC: 12-inch pipe and 2-inch electric conduit through the levee, 3.0 feet below the crown. Service pole and standpipe at the toe of the landward slope. (C. Sakai) O&M Manual SAC 112, March 1957.  
 FS Date: 08/30/2013

WS view: pipe, slant pump & pump platform on stream bank.

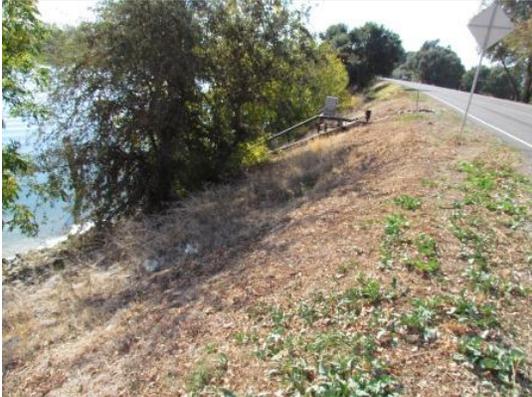
Photo 1 of 2 : FA\_2015\_RD0150\_16\_975\_20150911\_00055.jpg

| Repair slope instability.<br>Inspector Comments: Depression in the waterward slope at the shoulder over an irrigation pipe. | | | | | |

View of minor slope instability on the waterside slope of the levee looking downstream during fall 2013 inspection.

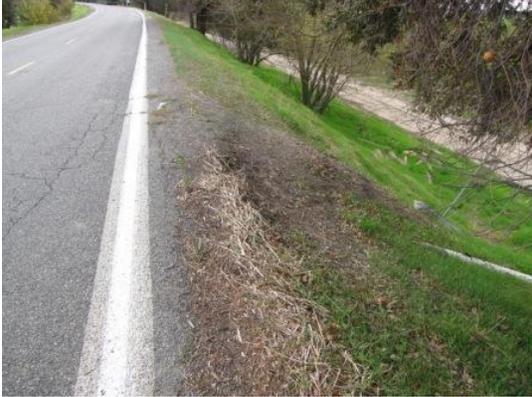
Photo 2 of 2 : FA\_2015\_RD0150\_16\_975\_20150911\_00056.jpg

View of a minor depression along the landward slope of the levee over a pipe penetration looking downstream.

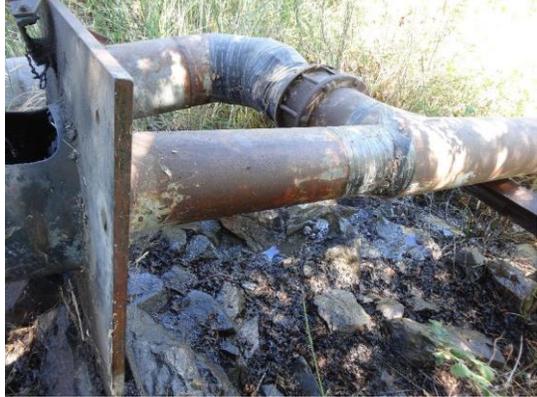
Photo 2 of 3 : UCIP\_FA\_2015\_1828.jpg

Inspector Comments: FS\_ID:20748  
 DS\_ID:22412  
 EP\_NO: N/A  
 FS\_HLM: 6.23  
 Repair Type: Non-Urgent  
 Crossing Status: Found  
 UCIP Comments: - slope erosion due leaky siphon breaker at CMP riser- leaky pipe and pump- service pole on LS- 2" electric conduit on WS  
 FIELD\_STRUCT\_DESC: 10-inch steel pipe and an electric conduit through the levee, 4.8 feet below the crown. Slant pump on the waterward slope. Siphon breaker in corrugated metal pipe riser on the landward shoulder. Slope erosion on landside of levee at siphon breaker. (Ed. Boyles) O&M Manual SAC 112, March 1957.  
 FS Date: 08/30/2013

WS view: leaky steel pipe and slant pump on levee slope.

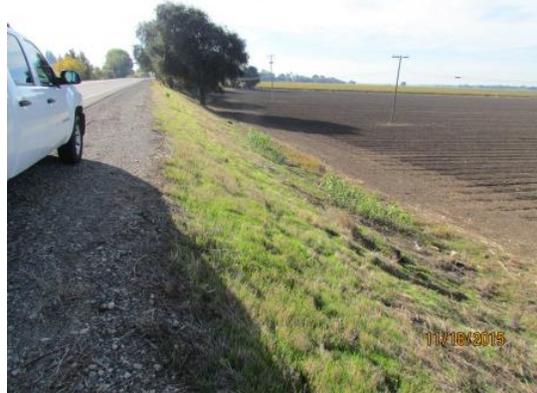
Photo 1 of 1 : FA\_2015\_RD0150\_16\_46\_20151119\_00074.jpg

| Control annual grass and weeds on the levee slopes and easements.<br>Inspector Comments: LMA has maintained the landside vegetation. | | | | | |

View of acceptable vegetation on the landside of the levee.

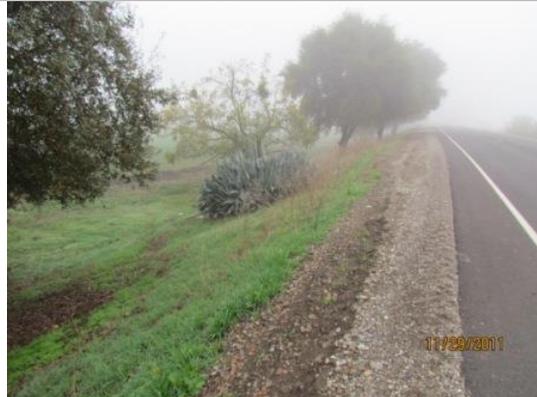
Photo 1 of 1 : FA\_2015\_RD0150\_16\_27\_20150911\_00017.jpg

| Landscaping<br>Inspector Comments: Century plant on the landward slope. | | | | | |

Century plant was found on the landside of the levee looking upstream.

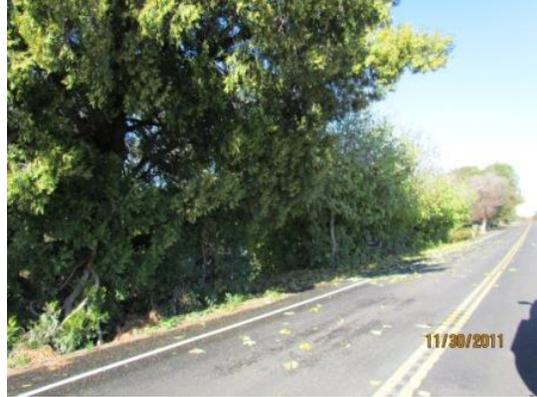
Photo 1 of 1 : FA\_2015\_RD0150\_16\_31\_20150911\_00020.jpg

| Landscaping | | | | | |

Trees need to be trimmed on the landside of the levee looking upstream.

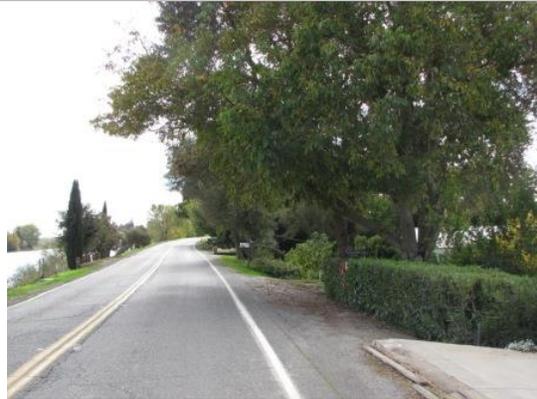
Photo 1 of 1 : FA\_2015\_RD0150\_16\_65\_20150911\_00037.jpg

| Landscaping | | | | | |

View of landscaping along the waterward shoulder and slope looking downstream.

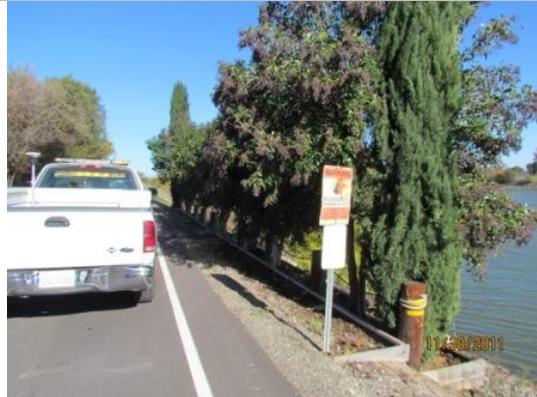
Photo 1 of 1 : FA\_2015\_RD0150\_16\_34\_20150911\_00022.jpg

| Landscaping | | | | | |

Landscaping was found on the waterside of the levee looking upstream.

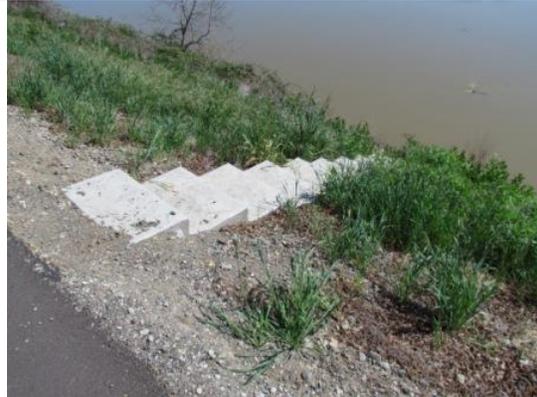
Photo 1 of 1 : FA\_2015\_RD0150\_16\_42\_20150911\_00024.jpg

| Stairway<br>Inspector Comments: Unpermitted stairway. | | | | | |

A stairway was found on the waterside slope of the levee looking upstream.

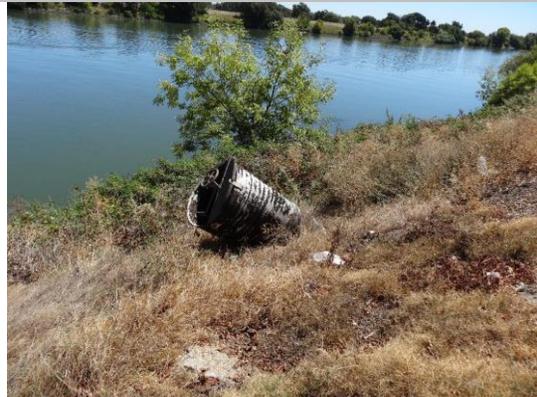
Photo 1 of 3 : UCIP\_FA\_2015\_1830.jpg

| Inspector Comments: FS_ID:20754<br>DS_ID:22413<br>EP_NO: N/A<br>FS_HLM: 6.607<br>Repair Type: Non-Urgent<br>Crossing Status: Found<br>UCIP Comments: Only an abandoned and dismantled CMP riser with gate valve found on WS levee slope. May need proper abandonment.<br>FIELD_STRUCT_DESC: Only an abandoned and dismantled CMP riser with gate valve found on waterside levee slope.<br>FS Date: 08/30/2013 | | | | | |

WS view: an abandoned and dismantled CMP riser with gate valve handle on WS levee slope.

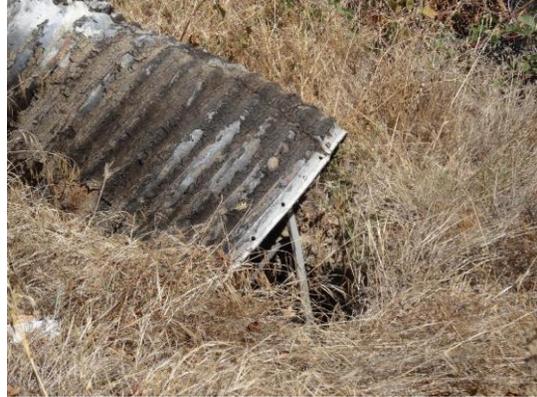
Photo 2 of 3 : UCIP\_FA\_2015\_1831.jpg

| LM Start | 6.50 | Rating ** | M | Issue No. | 1006 (cont) |
|---|---|---|---|---|---|
| Inspector Comments: FS_ID:20754<br>DS_ID:22413<br>EP_NO: N/A<br>FS_HLM: 6.607<br>Repair Type: Non-Urgent<br>Crossing Status: Found<br>UCIP Comments: Only an abandoned and dismantled CMP riser with gate valve found on WS levee slope. May need proper abandonment.<br>FIELD_STRUCT_DESC: Only an abandoned and dismantled CMP riser with gate valve found on waterside levee slope.<br>FS Date: 08/30/2013 | | | | | |

WS view: closer view of an abandoned and dismantled CMP riser on WS levee slope.

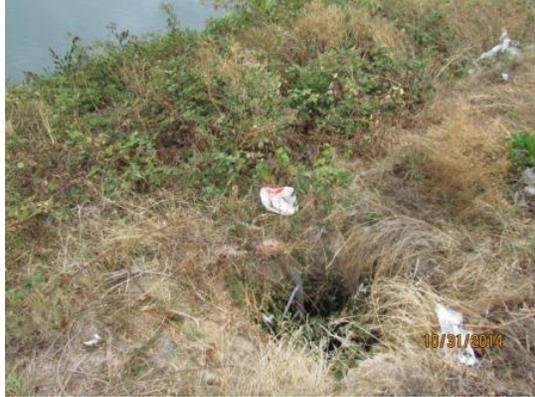
Photo 1 of 1 : FA\_2015\_RD0150\_16\_55\_20150911\_00032.jpg

| Pipe<br>Inspector Comments: The pipe gate needs to be covered on the waterside toe of the levee. | | | | | |

An open pipe valve was found without a cover on the waterside toe of the levee.

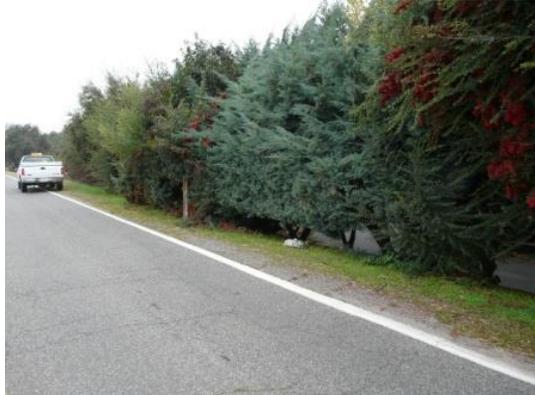
Photo 1 of 1 : FA\_2015\_RD0150\_16\_64\_20150911\_00036.jpg

| Landscaping | | | | | |

Landscaping providing a screen for a residence on landside of levee from LM 6.68 to LM 6.72

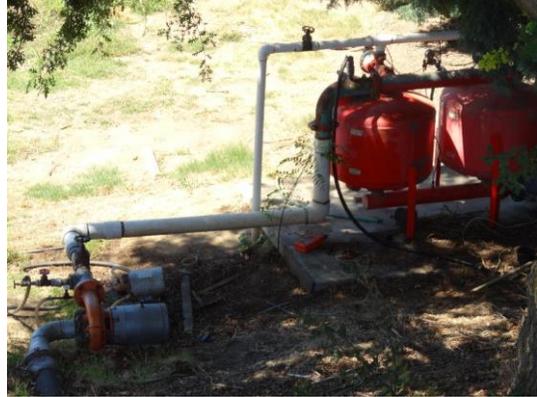
Photo 1 of 2 : UCIP\_FA\_2015\_2089.jpg

LS view: concrete vault, pipe, and pump in water filtration plant.

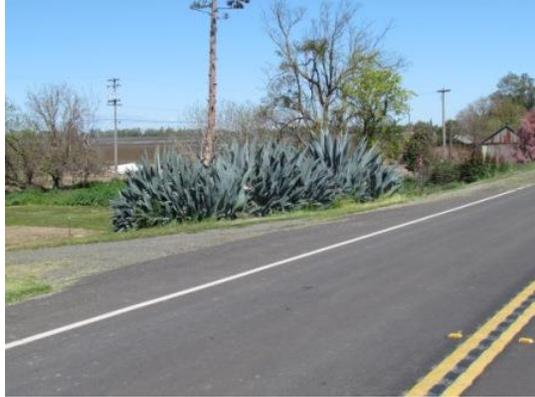
Photo 1 of 1 : FA\_2015\_RD0150\_16\_43\_20150911\_00025.jpg

| Landscaping<br>Inspector Comments: Century plant on landside of the levee. | | | | | |

Century plants were found on the landside of the levee looking upstream.

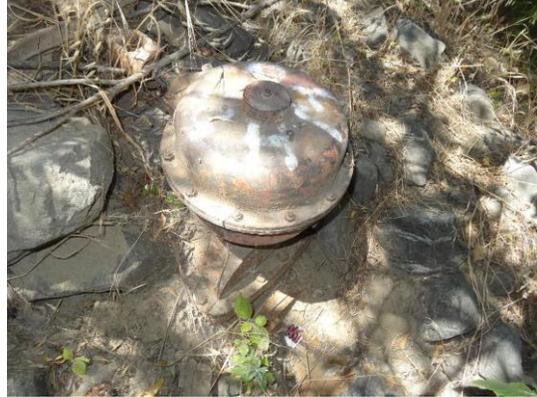
Photo 2 of 3 : UCIP\_FA\_2015\_2092.jpg

| LM Start | 6.69 | Rating ** | M | Issue No. | 1008 (cont) |
|---|---|---|---|---|---|
| Inspector Comments: FS_ID:41646<br>DS_ID:22426<br>EP_NO: N/A<br>FS_HLM: 6.798<br>Repair Type: Non-Urgent<br>Crossing Status: Found<br>UCIP Comments: - abandoned very old gate valve also found on WS.<br>Rest of pipe should be evaluated due to its age.<br>FIELD_STRUCT_DESC: 9-inch steel pipe through the levee, 9.7 feet below the crown, gate valve and pump house on the landside. (A. Souza). O&M Manual SAC 112, March 1957.<br>FS Date: 08/30/2013 | | | | | |

WS view: An abandoned old gate valve on inlet steel pipe on stream bank.

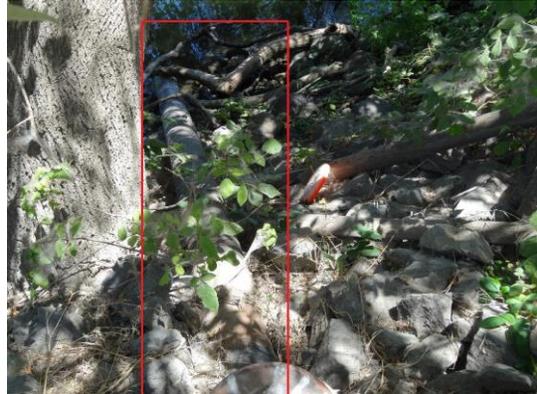
Photo 3 of 3 : UCIP\_FA\_2015\_2093.jpg

WS view: inlet steel pipe on stream bank.

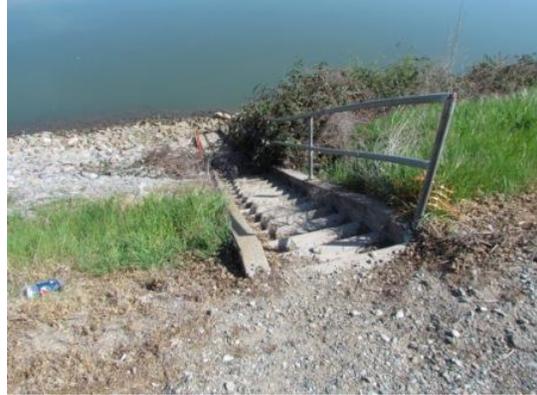
Photo 1 of 1 : FA\_2015\_RD0150\_16\_38\_20150911\_00023.jpg

| Stairway | | | | | |

A stairway was found on the waterside slope of the levee looking upstream during spring 2013 inspection.

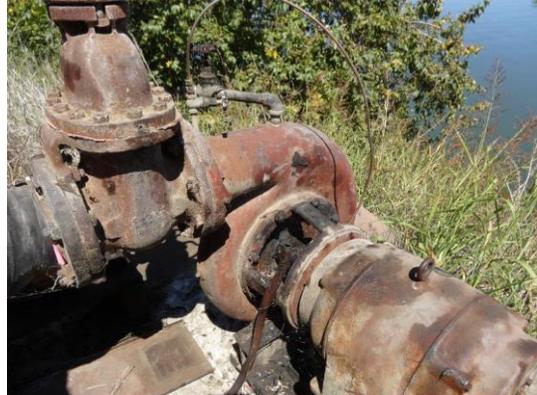
Photo 1 of 3 : UCIP\_FA\_2015\_1833.jpg

| Inspector Comments: FS_ID:42903<br>DS_ID:22427<br>EP_NO: 1703<br>FS_HLM: 6.916<br>Repair Type: Urgent<br>Crossing Status: Found<br>UCIP Comments: - significant erosion along pipe alignment on LS slope.- pump on concrete pad- service pole on LS slope.<br>FIELD_STRUCT_DESC: 12-inch steel pipe through the levee, 4.5 feet below the crown, pump and gate valve on the waterward slope. Service pole and standpipe on the landward shoulder. (App. No. 1703 - M. Silva).<br>FS Date: 08/30/2013 | | | | | |

WS view: closer view of gate valve and pump on levee slope

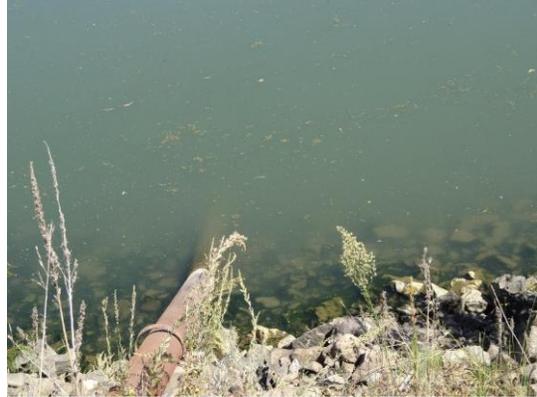
Photo 2 of 3 : UCIP\_FA\_2015\_1834.jpg

| LM Start | 6.80 | Rating ** | U | Issue No. | 1009 (cont) |
|--|---|---|---|---|---|
| Inspector Comments: FS_ID:42903<br>DS_ID:22427<br>EP_NO: 1703<br>FS_HLM: 6.916<br>Repair Type: Urgent<br>Crossing Status: Found<br>UCIP Comments: - significant erosion along pipe alignment on LS slope.- pump on concrete pad- service pole on LS slope.<br>FIELD_STRUCT_DESC: 12-inch steel pipe through the levee, 4.5 feet below the crown, pump and gate valve on the waterward slope. Service pole and standpipe on the landward shoulder. (App. No. 1703 - M. Silva).<br>FS Date: 08/30/2013 | | | | | |

WS view: steel inlet pipe in the stream and bank.

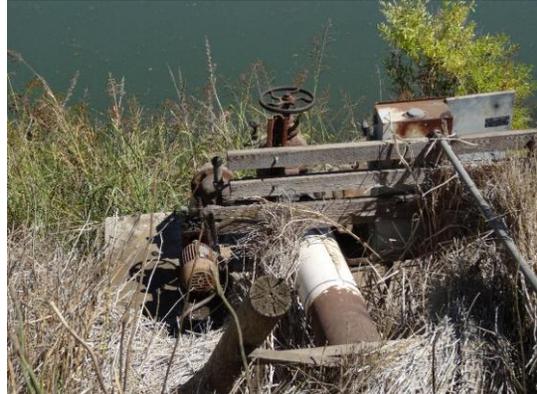
Photo 3 of 3 : UCIP\_FA\_2015\_1835.jpg

WS view: steel pipe, electric conduit, gate valve, and pump on levee slope.

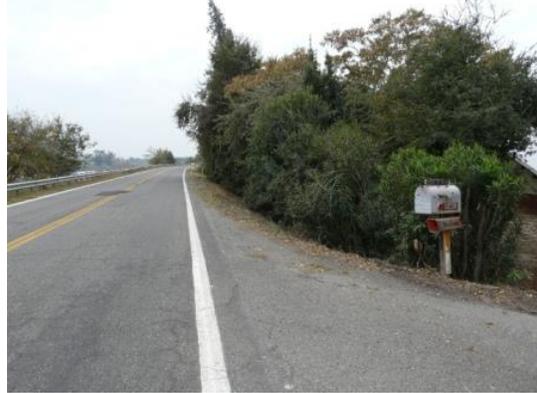
Photo 1 of 1 : FA\_2015\_RD0150\_16\_60\_20150911\_00035.jpg

Landscaping providing a screen for a residence on the landside of levee from LM 6.93 to LM 7.05

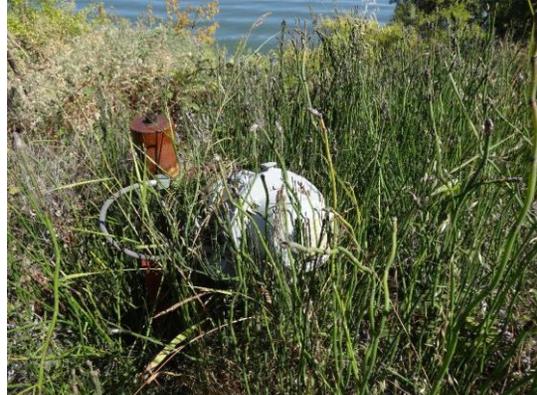
Photo 1 of 3 : UCIP\_FA\_2015\_1728.jpg

| Inspector Comments: FS_ID:20203<br>DS_ID:22429<br>EP_NO: N/A<br>FS_HLM: 7.1138<br>Repair Type: Urgent<br>Crossing Status: Found<br>UCIP Comments: - soil erosion along pipe alignment on LS slope.- needs more investigation and mitigation for soil erosion.<br>FIELD_STRUCT_DESC: 8-inch steel pipe through the levee 10.0 feet below the crown, pump on concrete slab and slide gate in CMP riser on the waterward slope. Pipe through the levee section encased in reinforced concrete. A concrete standpipe on landside toe. (A. Monice).<br>FS Date: 08/30/2013 | | | | | |

WS view: pump on levee slope. Dense vegetation on levee slope.

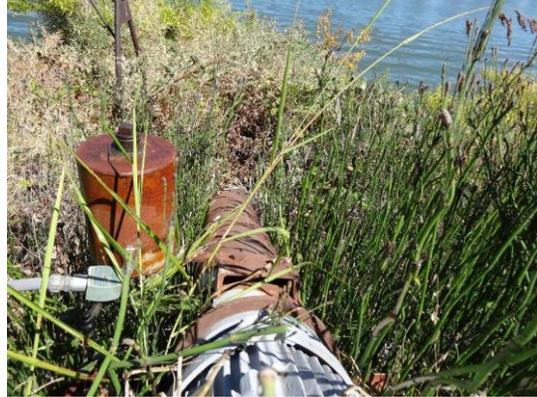
Photo 2 of 3 : UCIP\_FA\_2015\_1729.jpg

**Action/Comments**  
 Inspector Comments: FS\_ID:20203  
 DS\_ID:22429  
 EP\_NO: N/A  
 FS\_HLM: 7.1138  
 Repair Type: Urgent  
 Crossing Status: Found  
 UCIP Comments: - soil erosion along pipe alignment on LS slope.- needs more investigation and mitigation for soil erosion.  
 FIELD\_STRUCT\_DESC: 8-inch steel pipe through the levee 10.0 feet below the crown, pump on concrete slab and slide gate in CMP riser on the waterward slope. Pipe through the levee section encased in reinforced concrete. A concrete standpipe on landside toe. (A. Monice).  
 FS Date: 08/30/2013

WS view: steel intake pipe and pump on levee slope. Dense vegetation on levee slope.

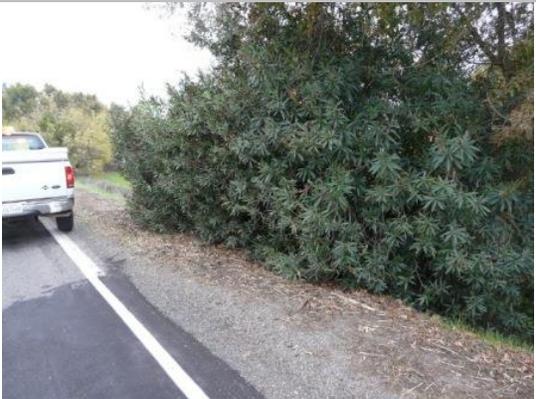
Photo 1 of 1 : FA\_2015\_RD0150\_16\_58\_20150911\_00034.jpg

Landscaping providing a screen for a residence on landside of levee at LM 7.12

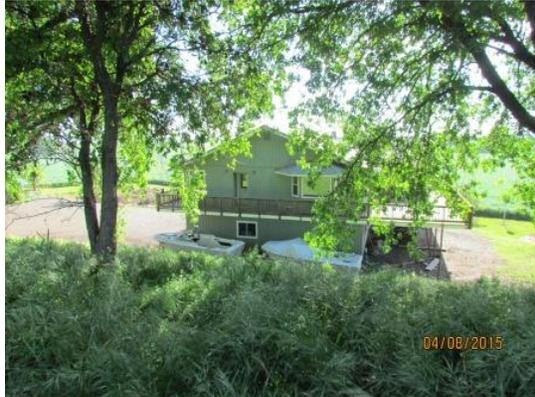
Photo 1 of 2 : FA\_2015\_RD0150\_17\_3\_20150911\_00001.jpg

| Building<br>Inspector Comments: Steps, water, electricity, and dock on waterward slope. | | | | | |

View of a house on the landside toe of the levee looking upstream.

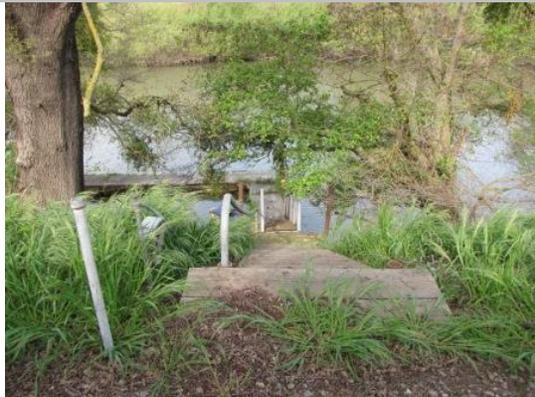
Photo 2 of 2 : FA\_2015\_RD0150\_17\_3\_20150911\_00002.jpg

View of steps, a dock, and associated utilities on the waterward slope.

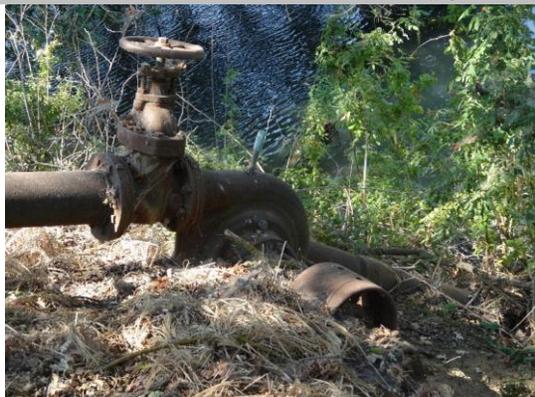
Photo 1 of 3 : UCIP\_FA\_2015\_1624.jpg

WS view: abandoned pipe, gate valve, and pump on levee slope.

| Inspector Comments: FS_ID:42694<br>DS_ID:22453<br>EP_NO: 13612<br>FS_HLM: 0.394<br>Repair Type: Non-Urgent<br>Crossing Status: Found<br>UCIP Comments: Abandoned. Proper abandone needs.<br>FIELD_STRUCT_DESC: Abandoned 6-inch steel pipe through the levee, 3.5 feet below the crown. Pump and gate valve on the waterward slope.<br>FS Date: 08/20/2013 | | | | | |

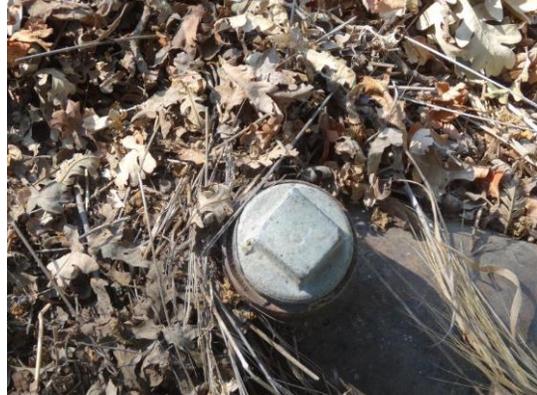
Photo 2 of 3 : UCIP\_FA\_2015\_1625.jpg

WS view: safety valve on steel pipe.

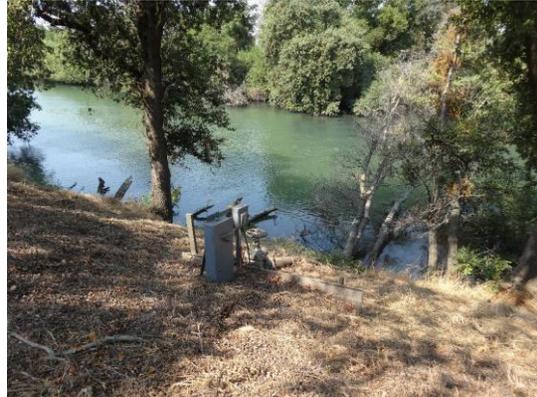
Photo 1 of 3 : UCIP\_FA\_2015\_1621.jpg

WS view: pipe and pump on levee slope.

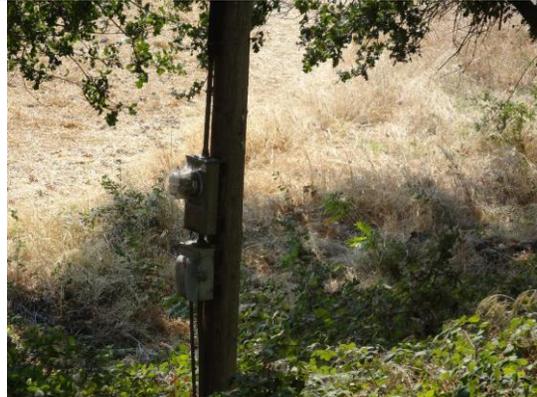
Photo 3 of 3 : UCIP\_FA\_2015\_1623.jpg

LS view: service pole on levee slope.

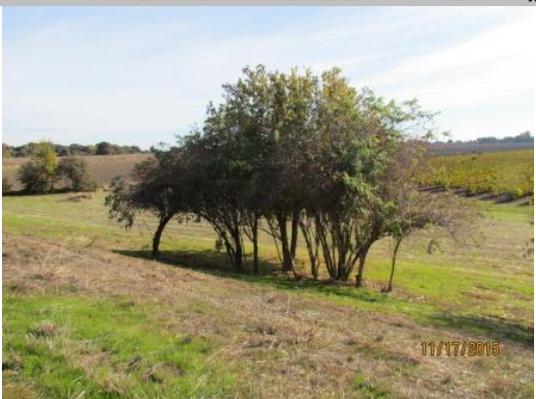
Photo 1 of 1 : FA\_2015\_RD0150\_17\_5\_20151119\_00120.jpg

| Elderberries are blocking visibility and flood fight capability. Inspector Comments: Elderberries are partially blocking visibility. | | | | | |

View of elderberries on the landward slope of the levee.

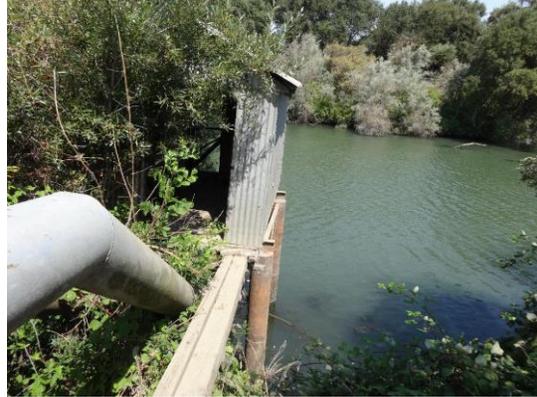
Photo 1 of 3 : UCIP\_FA\_2015\_1507.jpg

| Inspector Comments: FS_ID:19112<br>DS_ID:22433<br>EP_NO: N/A<br>FS_HLM: 1.377<br>Repair Type: Non-Urgent<br>Crossing Status: Found<br>UCIP Comments: No handrail on wooden walkway.<br>FIELD_STRUCT_DESC: 14-inch steel pipe through the levee, 8.0 feet below the crown, pump in pump house on the waterward slope. Service pole and steel distribution box on the landward slope.<br>FS Date: 08/20/2013 | | | | | |

WS view: pipe, wooden walkway and pump house in channel.
