**Flood Control Project Maintenance  
Levee Inspections**

**Fall 2015 Levee Maintenance Deficiency Summary Report**

**Sacramento River Basin**

| RD0150<br>Reclamation District No. 0150 Merrit Island | | Overall LMA Rating | Total LMA Miles | * Overall LMA Threshold Percent is less than 10.00%; however, U Rated Miles are present, so the Overall LMA Rating is M instead of A. | | | | | |

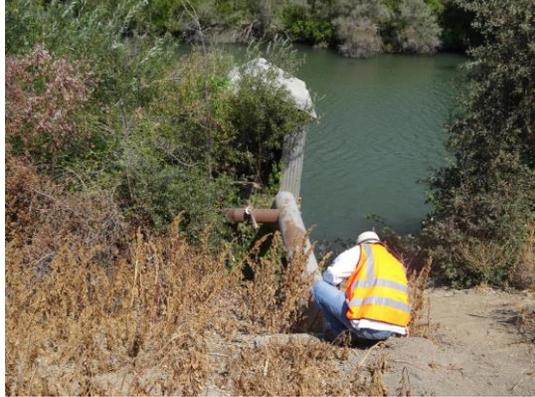
Photo 3 of 3 : UCIP\_FA\_2015\_1509.jpg

WS view: pipe on levee slope and pump house in channel.

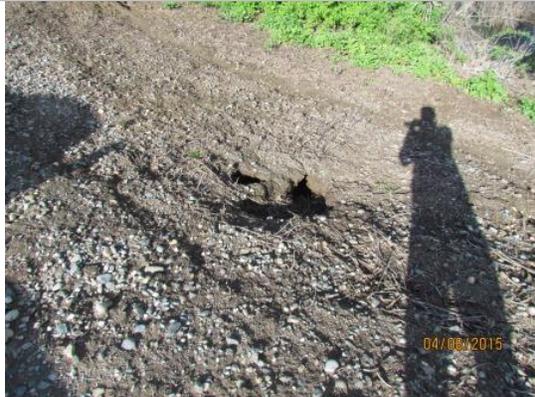
Photo 1 of 1 : FA\_2015\_RD0150\_17\_393\_20150911\_00097.jpg

Rodent holes were found on the waterside of the levee looking downstream.

| No rodents visible, but rodent burrows visible; need to backfill and compact or grout burrows. | | | | | |

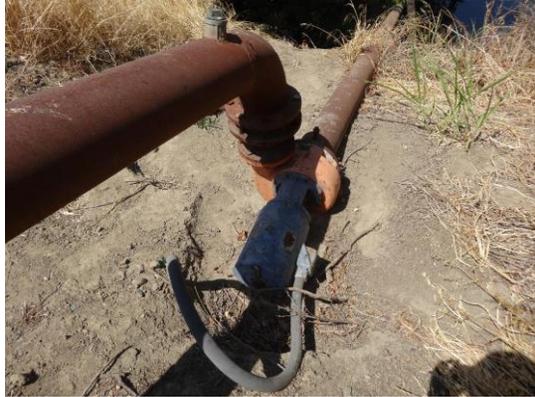
Photo 1 of 3 : UCIP\_FA\_2015\_1559.jpg

| Inspector Comments: FS_ID:19137<br>DS_ID:22434<br>EP_NO: N/A<br>FS_HLM: 1.809<br>Repair Type: Non-Urgent<br>Crossing Status: Found<br>UCIP Comments: Small depression on WS slope due to leak from pump. Pipe opens on LS ditch/depression.<br>FIELD_STRUCT_DESC: 10-inch pipe through the levee, 3.4 feet below the crown, pump, gate valve and service pole on the waterward slope.<br>FS Date: 08/20/2013 | | | | | |

WS view: pipe and slant pump on levee slope.

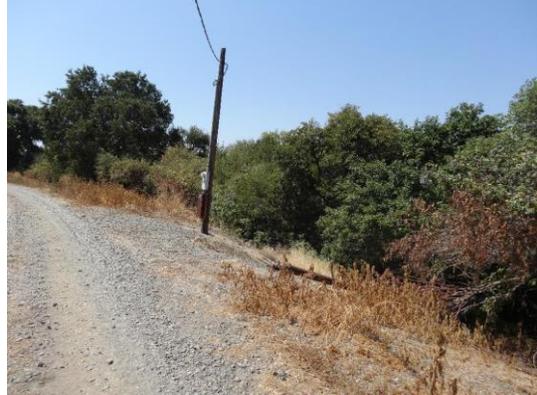
Photo 3 of 3 : UCIP\_FA\_2015\_1561.jpg

WS view: exposed pipe and power pole on levee slope.

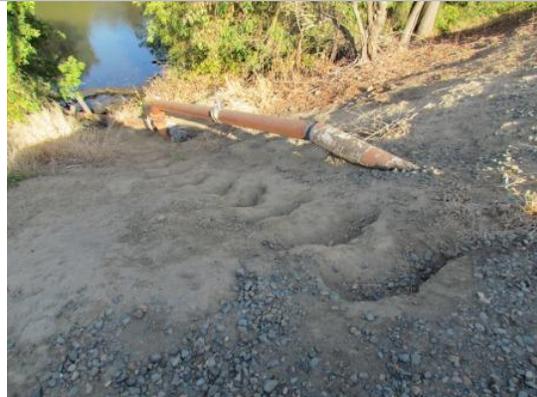
Photo 1 of 1 : FA\_2015\_RD0150\_17\_50\_20150911\_00041.jpg

| Note and monitor erosion site.<br>Inspector Comments: Erosion appeared under the pipe. | | | | | |

Steps were dug next to the pipe and also erosion was found near the vicinity of the pipe on the waterside slope of the levee looking upstream.

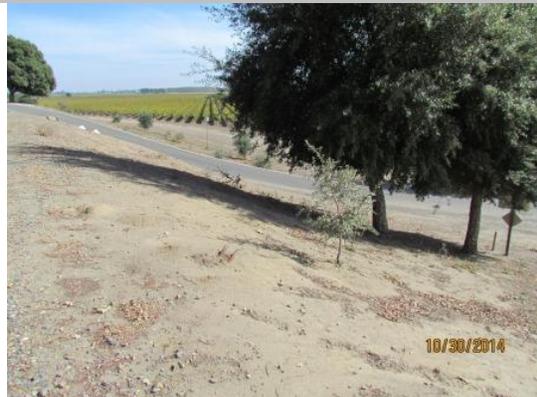
Photo 1 of 1 : FA\_2015\_RD0150\_17\_75\_20150911\_00070.jpg

View of a few trees that were planted on the landside slope of the levee looking upstream.

| Remove the wild growth other than native grasses from the levee slopes.<br>Inspector Comments: Newly planted tree was found on the landside slope of the levee. | | | | | |

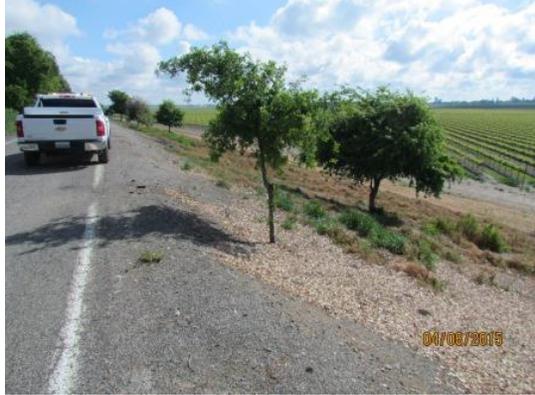
Photo 1 of 4 : FA\_2015\_RD0150\_17\_78\_20150911\_00074.jpg

| Tree or limb<br>Inspector Comments: New tree was planted on the landside slope. | | | | | |

Updated picture of the trees on the landside of the levee during spring 2015 inspection.

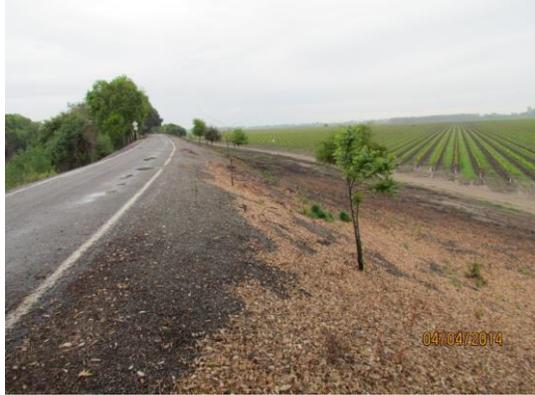
Photo 2 of 4 : FA\_2015\_RD0150\_17\_78\_20150911\_00075.jpg

View of the newly planted tree on the landside slope of the levee during spring 2014 inspection.

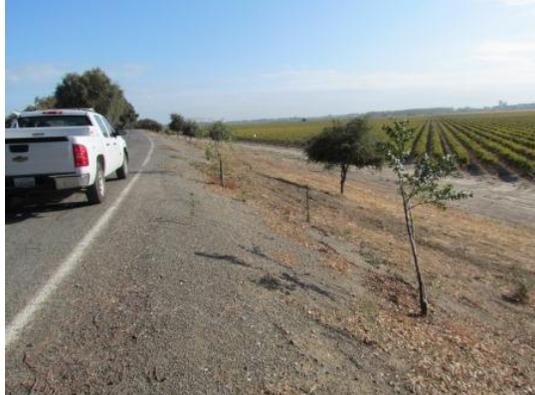
Photo 3 of 4 : FA\_2015\_RD0150\_17\_78\_20150911\_00076.jpg

Several newly planted trees were found on the landside slope of the levee looking upstream during the fall 2013 inspection.

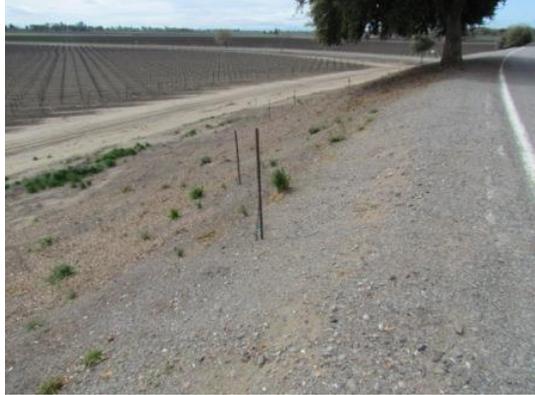
Photo 4 of 4 : FA\_2015\_RD0150\_17\_78\_20150911\_00078.jpg

| Tree or limb<br>Inspector Comments: New tree was planted on the landside slope. | | | | | |

New tree was planted on the landside of the levee looking downstream.

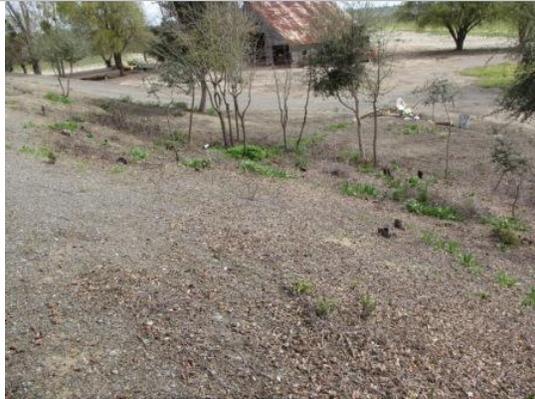
Photo 1 of 1 : FA\_2015\_RD0150\_17\_11\_20150911\_00008.jpg

| Tree stumps. | | | | | |

View of tree stumps on the landward slope.

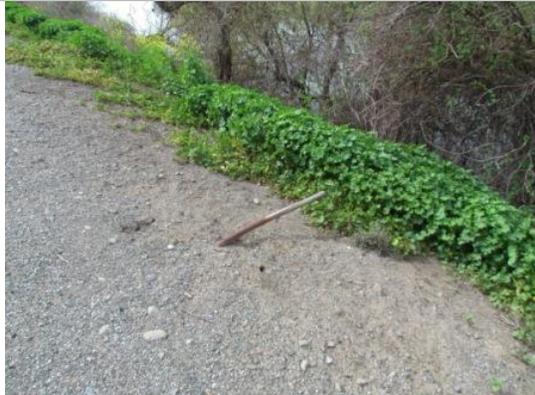
Photo 1 of 1 : FA\_2015\_RD0150\_17\_34\_20150911\_00027.jpg

A pipe was found on the waterside shoulder of the levee looking downstream during spring 2013 inspection.

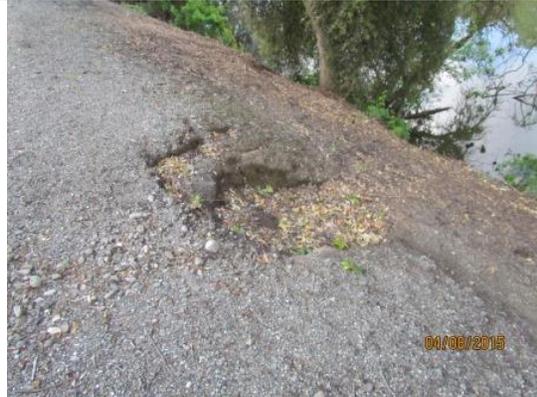
Photo 1 of 2 : FA\_2015\_RD0150\_17\_35\_20150911\_00028.jpg

Updated picture of the erosion on the waterside of the levee during spring 2015 inspection.

| Schedule repair of erosion site prior to the next inspection. | | | | | |

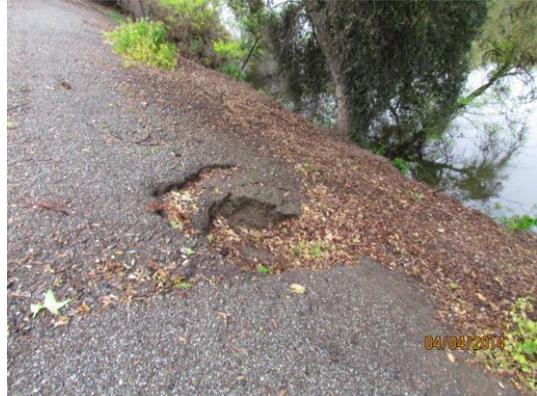
Photo 2 of 2 : FA\_2015\_RD0150\_17\_35\_20150911\_00029.jpg

Updated picture of the erosion on the waterside slope of the levee during spring 2014 inspection.

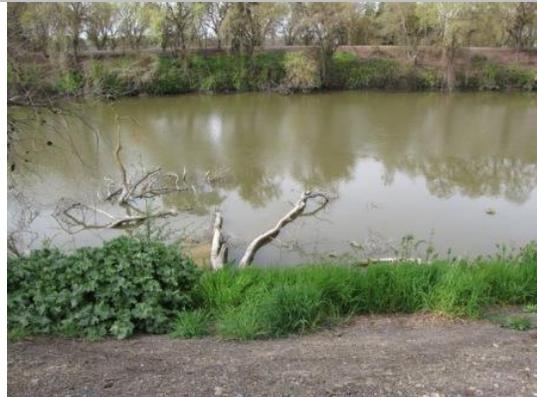
Photo 1 of 1 : FA\_2015\_RD0150\_17\_17\_20150911\_00015.jpg

| Tree stumps. | | | | | |

View of tree stumps on the waterward slope.

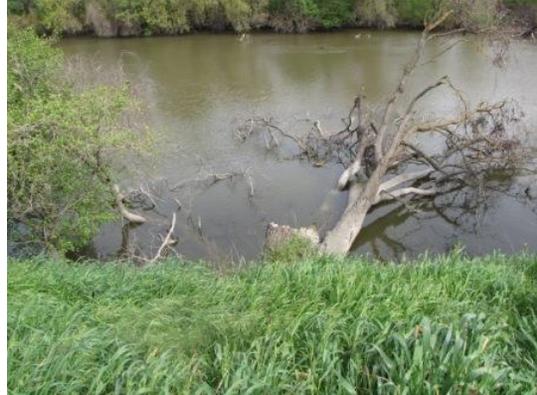
Photo 1 of 1 : FA\_2015\_RD0150\_17\_20\_20150911\_00016.jpg

| Tree stumps. | | | | | |

View of tree stumps on the waterward slope.

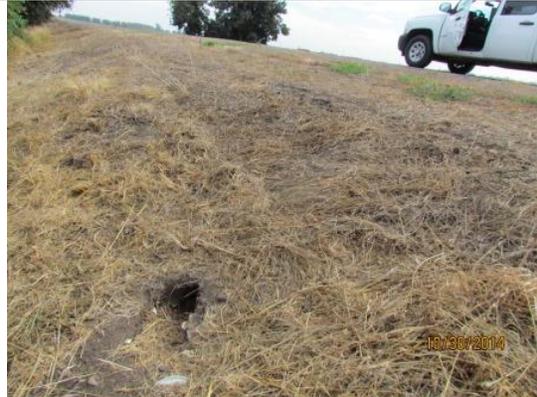
Photo 1 of 1 : FA\_2015\_RD0150\_17\_77\_20150911\_00073.jpg

A rodent hole was found on the waterside of the levee looking upstream.

| No rodents visible, but rodent burrows visible; need to backfill and compact or grout burrows. | | | | | |

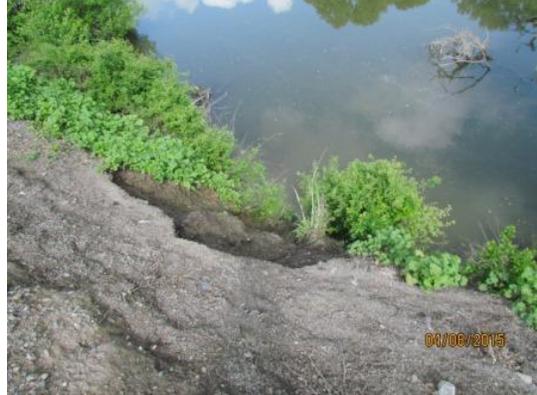
Photo 1 of 2 : FA\_2015\_RD0150\_17\_40\_20150911\_00033.jpg

Updated picture of the erosion on the waterside of the levee during spring 2015 inspection.

| Schedule repair of erosion site prior to the next inspection. | | | | | |

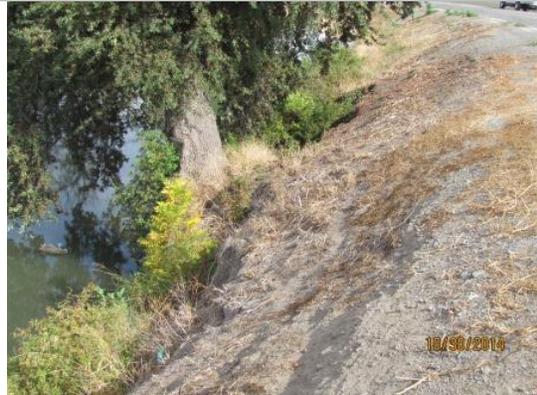
Photo 2 of 2 : FA\_2015\_RD0150\_17\_40\_20150911\_00034.jpg

Updated picture of the erosion on the waterside of the levee looking upstream during fall 2014 inspection.

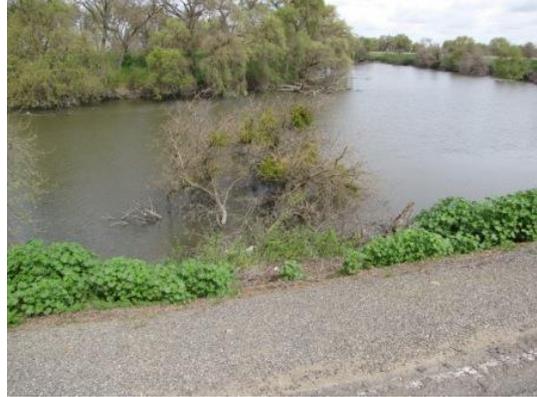
Photo 1 of 1 : FA\_2015\_RD0150\_17\_27\_20150911\_00020.jpg

| Tree stumps. | | | | | |

View of tree stumps on the waterside slope looking upstream.

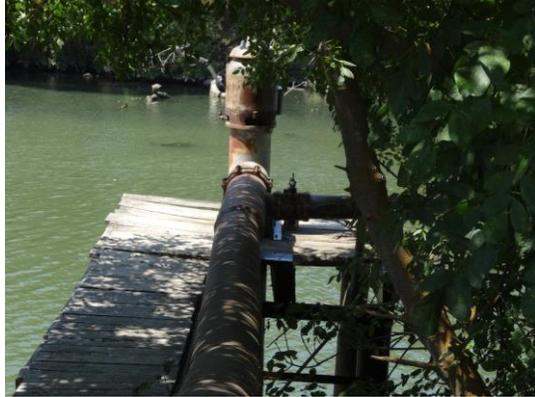
Photo 2 of 3 : UCIP\_FA\_2015\_1837.jpg

Inspector Comments: FS\_ID:41729  
 DS\_ID:22439  
 EP\_NO: N/A  
 FS\_HLM: 3.451  
 Repair Type: Non-Urgent  
 Crossing Status: Found  
 UCIP Comments: Leaky concrete standpipe on landside levee toe creating some erosion.- pump was working at the time of inspection.  
 FIELD\_STRUCT\_DESC: 8-inch steel pipe through the levee, 3.7 feet below the crown. Service pole on the waterward slope and pump on piling in the stream. Concrete stand pipe on landside levee toe. (A. Pylman) O&M Manual SAC 112, March 1957.  
 FS Date: 08/20/2013

WS view: steel pipe & pump, walkway, pump support in the channel.

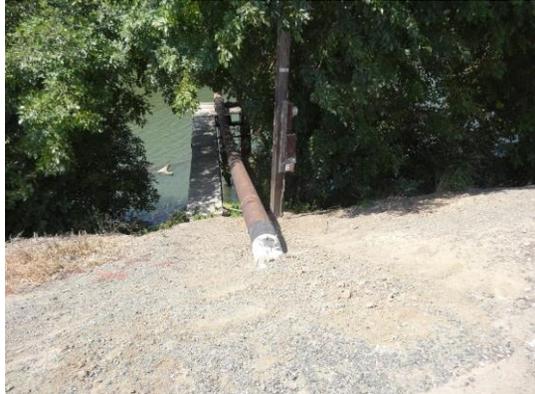
Photo 3 of 3 : UCIP\_FA\_2015\_1908.jpg

WS view: exposed pipe, walkway, service pole on levee slope and pump support in channel.

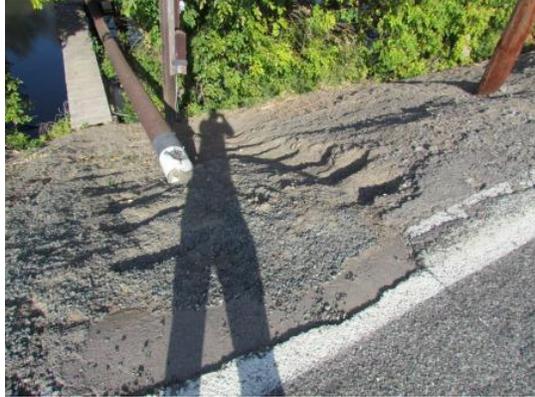
Photo 1 of 1 : FA\_2015\_RD0150\_17\_114\_20150911\_00092.jpg

| Stairway | | | | | |

View of steps that were dug on the waterside slope of the levee looking upstream.

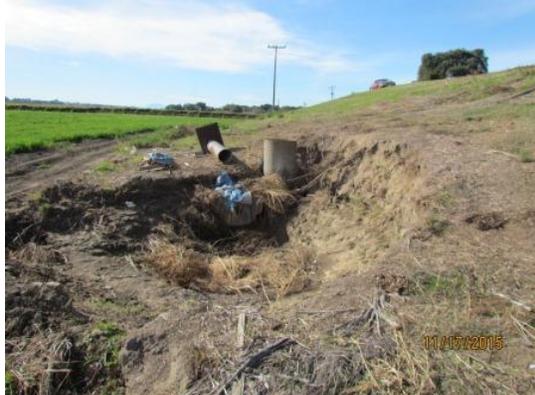
Photo 1 of 2 : FA\_2015\_RD0150\_17\_115\_20151119\_00121.jpg

Updated picture of the ditch on the landside toe of the levee during fall 2015 inspection.

| Schedule repair of erosion site prior to the next inspection.<br>Inspector Comments: Erosion (ditch) was found on the landside toe of the levee. | | | | | |

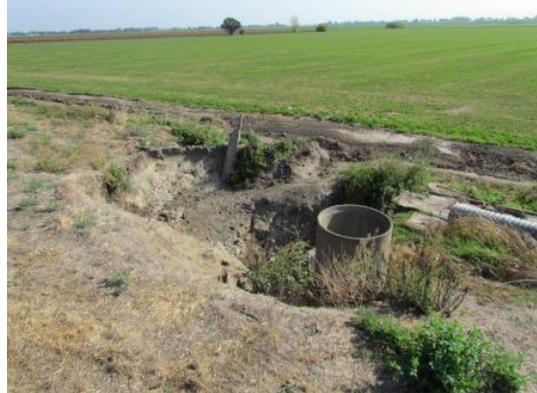
Photo 2 of 2 : FA\_2015\_RD0150\_17\_115\_20150911\_00094.jpg

A drainage ditch with depth of 4 feet and width of 15 feet was found on the landside toe of the levee. The picture was taken from the landside slope looking upstream during the fall 2013 inspection.

| Schedule repair of erosion site prior to the next inspection.<br>Inspector Comments: Erosion (ditch) was found on the landside toe of the levee. | | | | | |

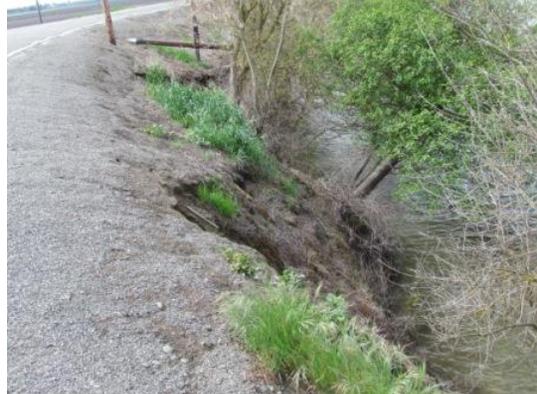
Photo 1 of 1 : FA\_2015\_RD0150\_17\_98\_20150911\_00091.jpg

Erosion was found on the waterside of the levee looking downstream.

| Note and monitor erosion site.<br>Inspector Comments: Erosion was located on the waterside of the levee looking downstream. | | | | | |

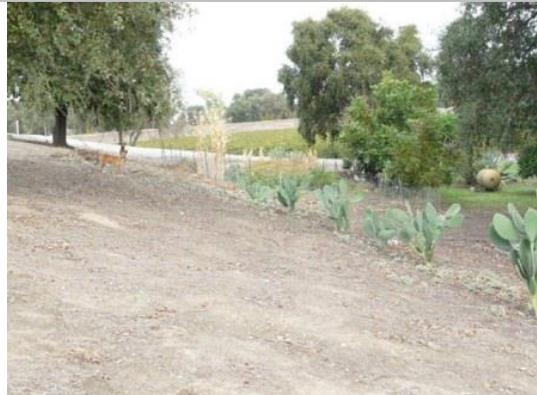
Photo 1 of 1 : FA\_2015\_RD0150\_17\_47\_20150911\_00039.jpg

| Landscaping | | | | | |

Landscaping & garden on landward slope of levee at LM 3.50 to LM 3.54.

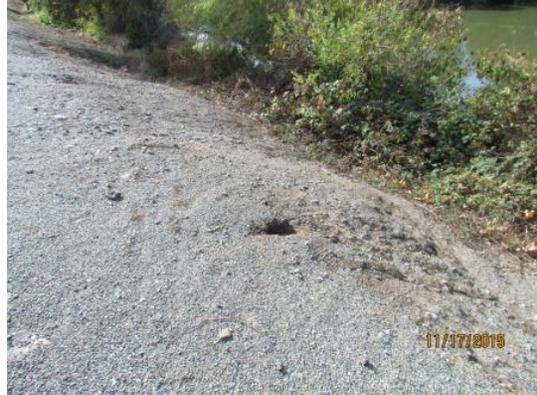
Photo 1 of 1 : FA\_2015\_RD0150\_17\_42\_20151119\_00122.jpg

View of a rodent hole on the waterside of the levee.

| No rodents visible, but rodent burrows visible; need to backfill and compact or grout burrows. | | | | | |

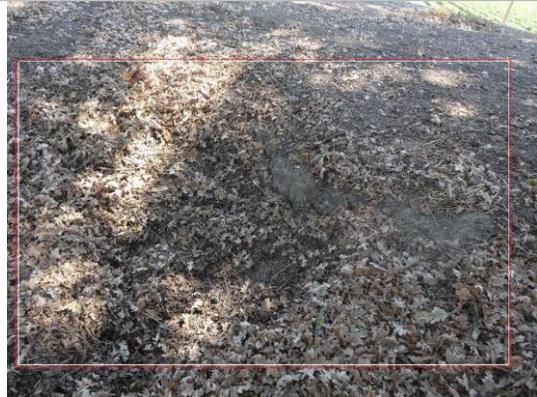
Photo 1 of 3 : UCIP\_FA\_2015\_1909.jpg

| Inspector Comments: FS_ID:20766<br>DS_ID:22440<br>EP_NO: N/A<br>FS_HLM: 3.722<br>Repair Type: Urgent<br>Crossing Status: Found<br>UCIP Comments: Concrete standpipe on LS. Levee damage. Gate valve on WS not found. Safety valve on WS pipe.<br>FIELD_STRUCT_DESC: 12-inch steel pipe through the levee, 5.9 feet below the crown. Pump on the waterward slope. Concrete standpipe at the landward toe. (R. & J. Pylman) O&M Manual SAC 112, March 1957.<br>FS Date: 08/20/2013 | | | | | |

WS view: soil erosion (depression) on levee slope.

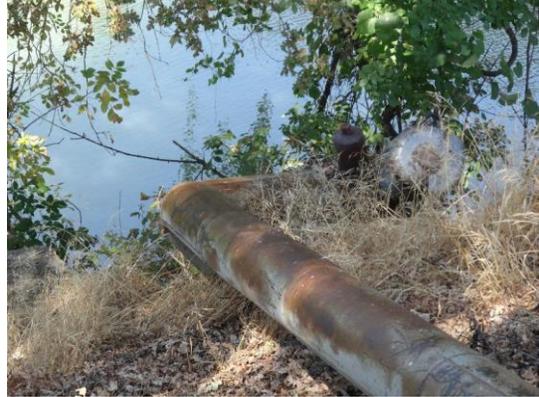
Photo 2 of 3 : UCIP\_FA\_2015\_1948.jpg

WS view: steel pipe and pump on levee slope.

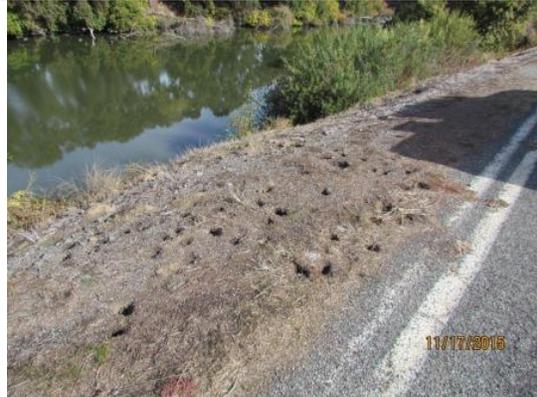
Photo 1 of 1 : FA\_2015\_RD0150\_17\_45\_20151119\_00123.jpg

View of rodent holes on the waterside shoulder of the levee.

| No rodents visible, but rodent burrows visible; need to backfill and compact or grout burrows.<br>Inspector Comments: Rodent holes with shallow depth was found. | | | | | |

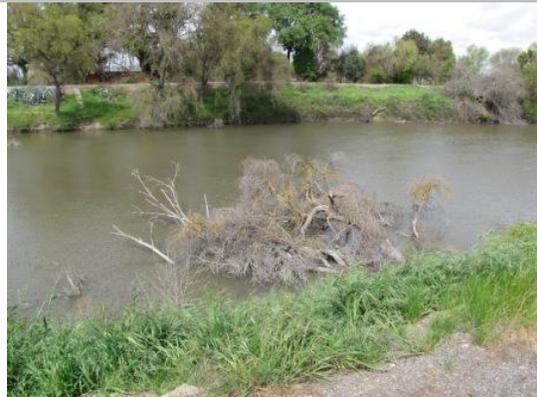
Photo 1 of 1 : FA\_2015\_RD0150\_17\_37\_20150911\_00032.jpg

| Tree stumps. | | | | | |

View of tree stumps on the waterward slope.

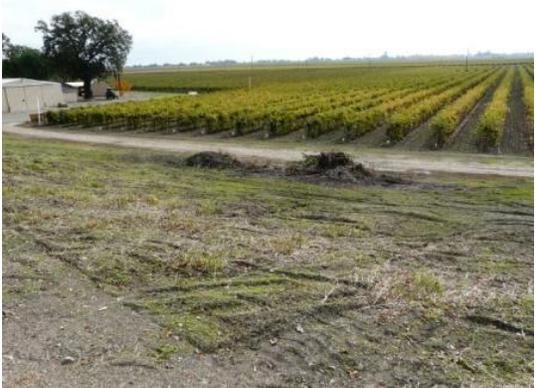
Photo 1 of 4 : FA\_2015\_RD0150\_17\_51\_20150911\_00043.jpg

| Prunings | | | | | |

Remove pruning pile on landward slope at LM 4.46.

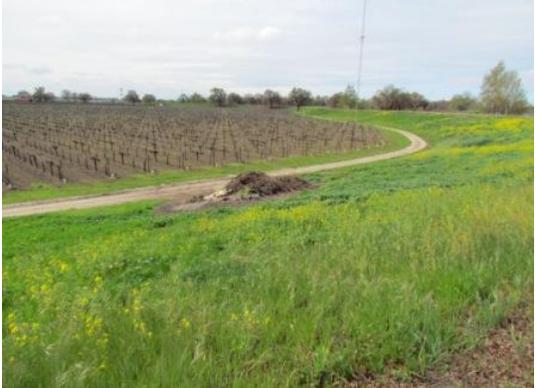
Photo 2 of 4 : FA\_2015\_RD0150\_17\_51\_20150911\_00044.jpg

Prunings were found on the landside of the levee looking downstream.

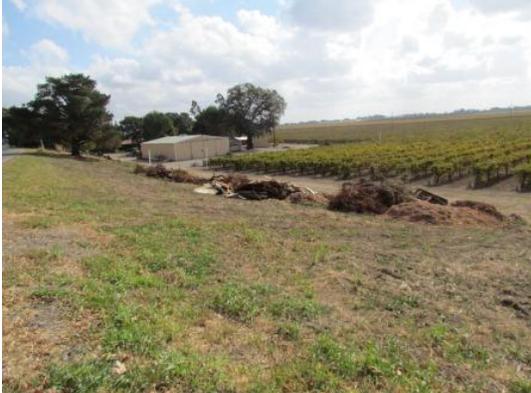
Photo 4 of 4 : FA\_2015\_RD0150\_17\_51\_20150911\_00046.jpg

| Prunings | | | | | |

Updated picture of the pruning pile on the landside of the levee looking upstream during the fall 2013 inspection.

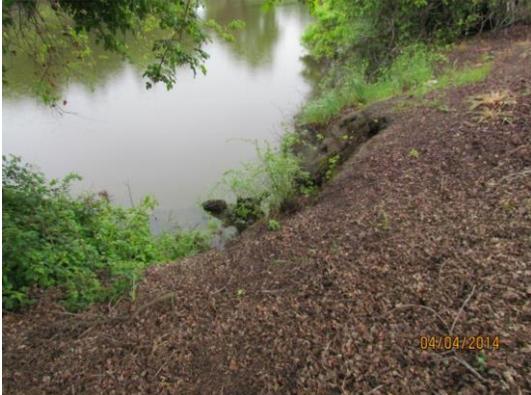
Photo 1 of 1 : FA\_2015\_RD0150\_17\_80\_20150911\_00079.jpg

View of an erosion site on the waterside toe of the levee looking upstream.

| Schedule repair of erosion site prior to the next inspection. | | | | | |

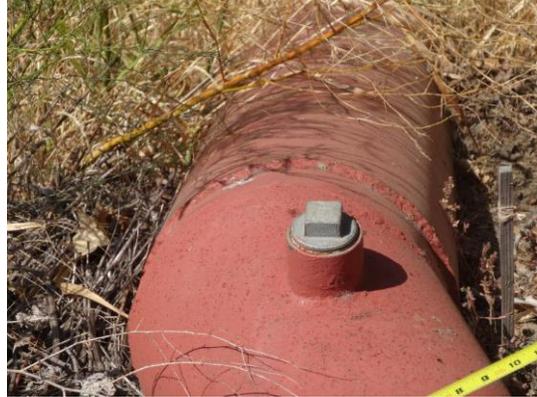
Photo 1 of 3 : UCIP\_FA\_2015\_1399.jpg

| Inspector Comments: FS_ID:19281<br>DS_ID:22444<br>EP_NO: N/A<br>FS_HLM: 4.7117<br>Repair Type: Non-Urgent<br>Crossing Status: Found<br>UCIP Comments: - service pole on LS. 1" conduit on WS. - levee toe cut out on landside.- walkway and gate.<br>FIELD_STRUCT_DESC: 10-inch steel pipe through the levee, 3.8 feet below the crown, pump on piling in stream. Concrete standpipe at the landward toe. (P. Cook) O&M Manual SAC 112, March 1957.<br>FS Date: 08/20/2013 | | | | | |

WS view: safety valve on steel pipe.

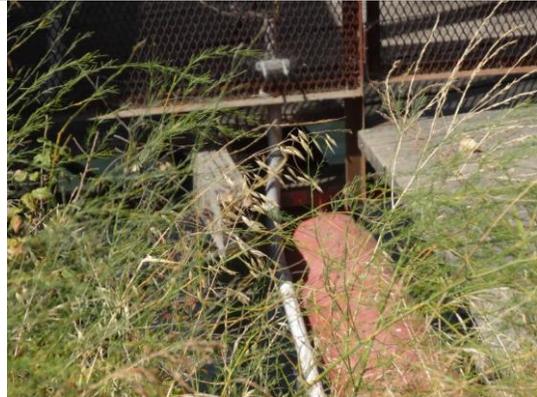
Photo 2 of 3 : UCIP\_FA\_2015\_1400.jpg

WS view: 1-inch GI conduit (left) and steel pipe (right)

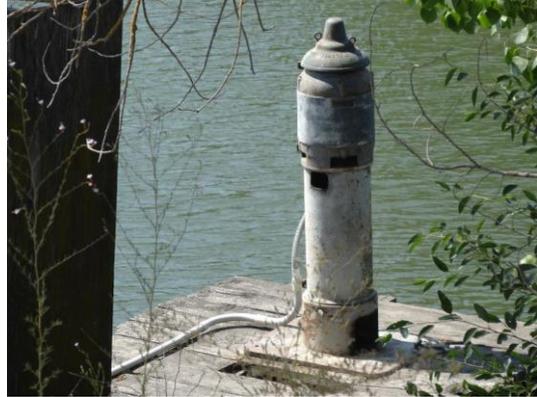
Photo 3 of 3 : UCIP\_FA\_2015\_1401.jpg

WS view: vertical pump on deck.

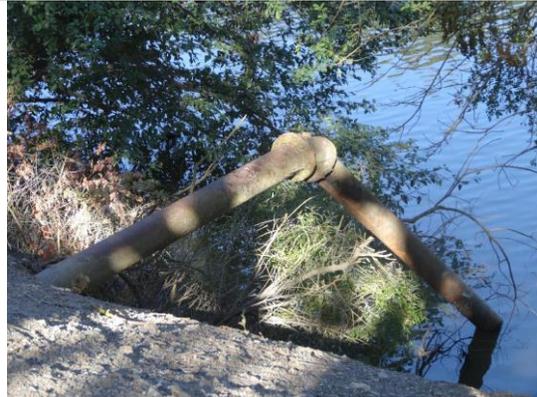
Photo 3 of 3 : UCIP\_FA\_2015\_1404.jpg

| Inspector Comments: FS_ID:19283<br>DS_ID:22445<br>EP_NO: N/A<br>FS_HLM: 4.993<br>Repair Type: Non-Urgent<br>Crossing Status: Found<br>UCIP Comments: - seems abandoned.- may need proper abandonment<br>FIELD_STRUCT_DESC: Abandoned 10-inch steel pipe through the levee, 7.2 feet below the crown, gate valve on the landward end. (D. Conner) O&M Manual SAC 112, March 1957.<br>FS Date: 08/23/2013 | | | | | |

WS view: steel pipe on levee slope and in the stream.

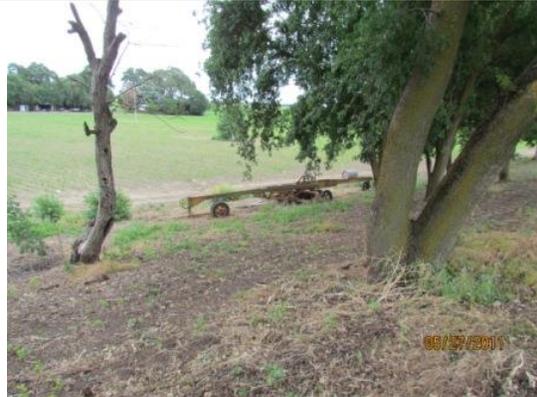
Photo 1 of 1 : FA\_2015\_RD0150\_17\_9\_20150911\_00007.jpg

| Equipment | | | | | |

Equipment on the landside toe of the levee. The picture was taken from crown looking downstream.

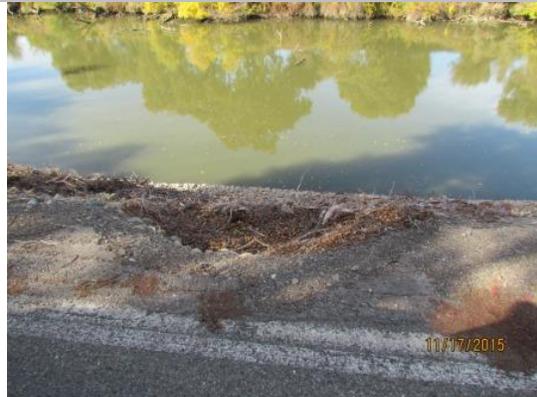
Photo 1 of 2 : FA\_2015\_RD0150\_17\_36\_20151119\_00124.jpg

Updated picture of the slope instability of the waterside shoulder of the levee during fall 2015 inspection.

| Repair slope instability. | | | | | |

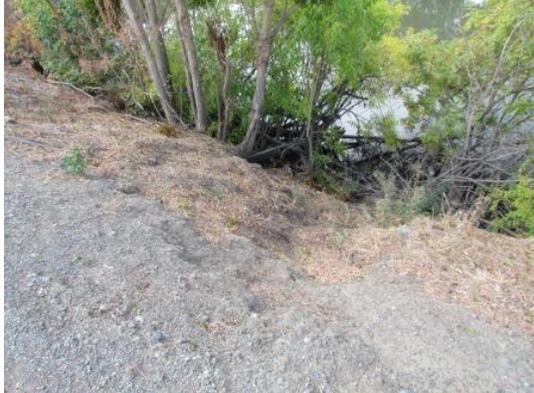
Photo 1 of 2 : FA\_2015\_RD0150\_17\_4\_20150911\_00003.jpg

Updated picture of the slope instability on the waterside slope of the levee looking downstream during the fall 2013 inspection.

| Repair slope instability. | | | | | |

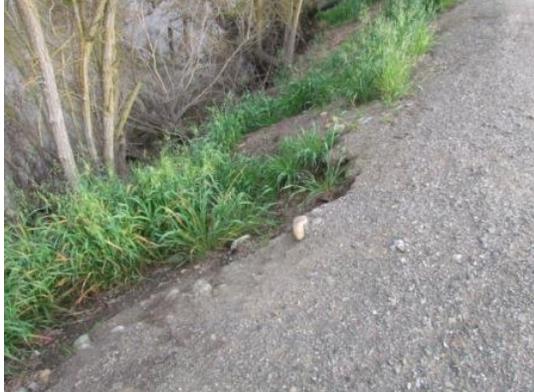
Photo 2 of 2 : FA\_2015\_RD0150\_17\_4\_20150911\_00004.jpg

Slope instability was found on the waterside of the levee looking upstream.

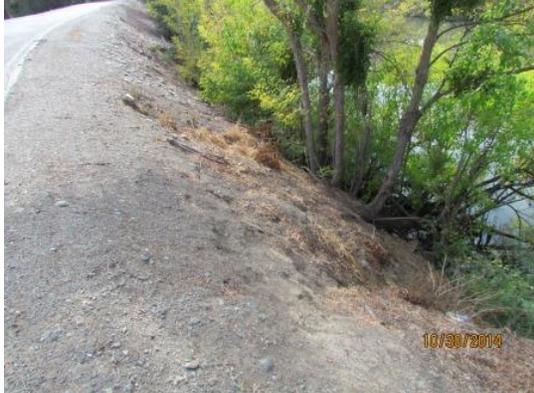
Photo 1 of 1 : FA\_2015\_RD0150\_17\_81\_20150911\_00080.jpg

View of erosion on the waterside of the levee looking downstream.

| Schedule repair of erosion site prior to the next inspection. | | | | | |

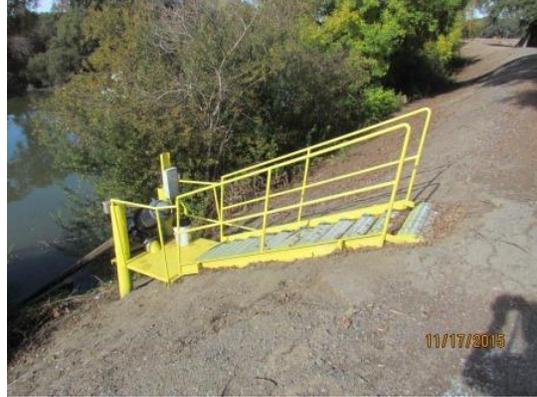
Photo 1 of 1 : FA\_2015\_RD0150\_17\_48\_20151119\_00125.jpg

| Stairway<br>Inspector Comments: Unpermitted stairway. | | | | | |

View of a stairway on the waterside of the levee.

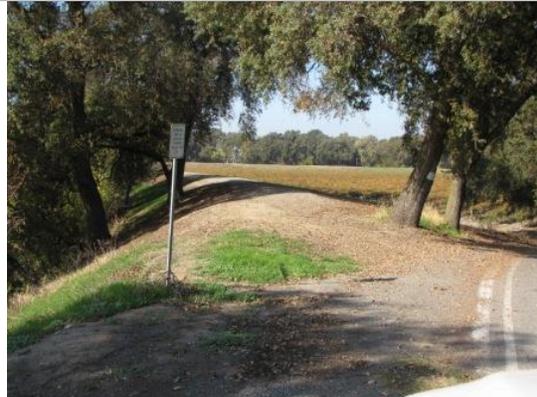
Photo 1 of 1 : FA\_2015\_RD0150\_17\_941\_20150911\_00107.jpg

View of varying elevations in the crown of the levee at the transition from county road to access road.

| Repair depressions or ruts in the crown or slope.<br>Inspector Comments: There is a significant difference in the crown roadway elevation as it transitions from the paved roadway to the gravel access road. | | | | | |

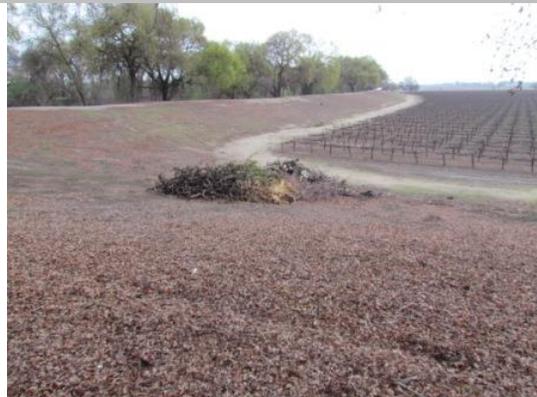
Photo 1 of 4 : FA\_2015\_RD0150\_17\_12\_20150911\_00009.jpg

| Prunings | | | | | |

Prunings were found on the landside of the levee looking upstream.

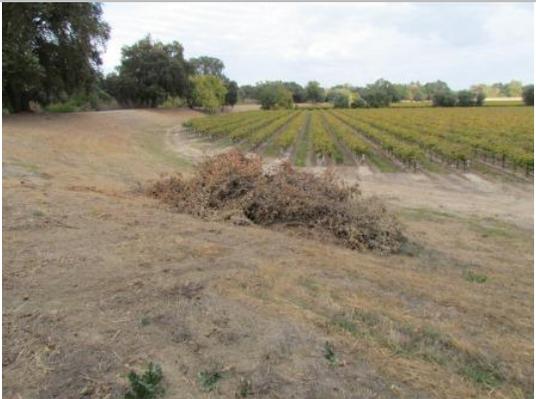
Photo 2 of 4 : FA\_2015\_RD0150\_17\_12\_20150911\_00010.jpg

| Prunings | | | | | |

Updated picture of pruning pile on the landside toe of the levee looking upstream during the fall 2013 inspection.

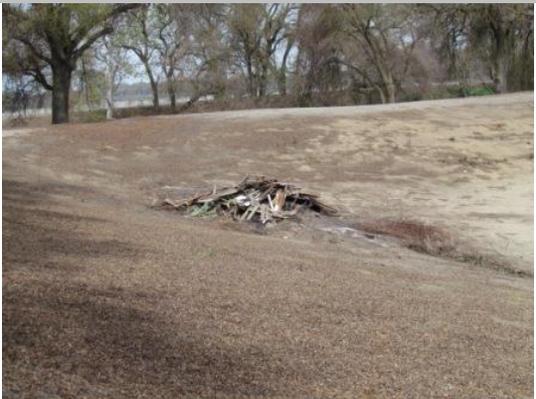
Photo 3 of 4 : FA\_2015\_RD0150\_17\_12\_20150911\_00011.jpg

Updated picture of debris and pruning on the landside toe of the levee looking upstream. This picture was taken during spring 2013 inspection.

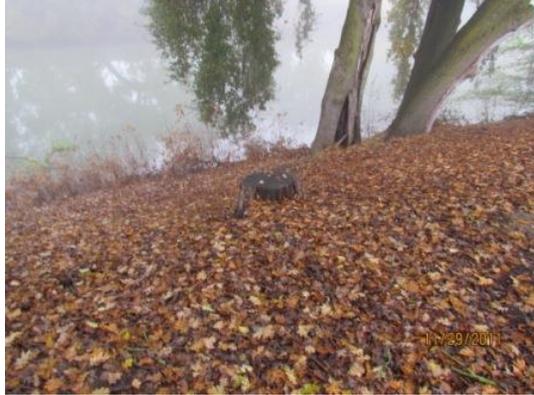
Photo 1 of 1 : FA\_2015\_RD0150\_17\_68\_20150911\_00067.jpg

| Tree stumps. | | | | | |

Tree stump was found on the waterside of the levee looking upstream.

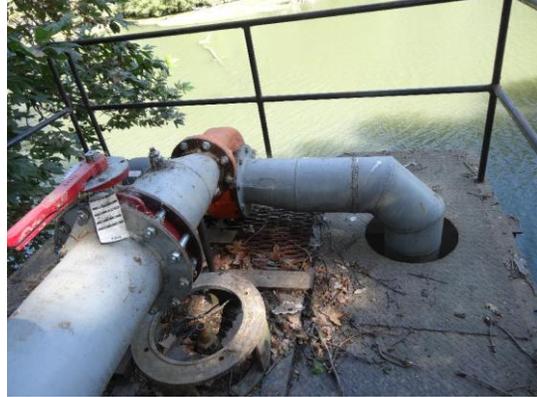
Photo 1 of 3 : UCIP\_FA\_2015\_3256.jpg

| Inspector Comments: FS_ID:28265<br>DS_ID:22448<br>EP_NO: N/A<br>FS_HLM: 5.806<br>Repair Type: Non-Urgent<br>Crossing Status: Found<br>UCIP Comments: - levee toe cut out at open end of the pipe.- service pole and control box on river bank.<br>FIELD_STRUCT_DESC: 10-inch steel pipe through the levee, 7.8 feet below crown. Pump and gate valve on steel platform. Cross fence, wire drag gate. (Permit No. 1167, D. Conner) O&M Manual SAC 112, March 1957.<br>FS Date: 08/23/2013 | | | | | |

WS view: pipe, pump and gate valve on pump deck.

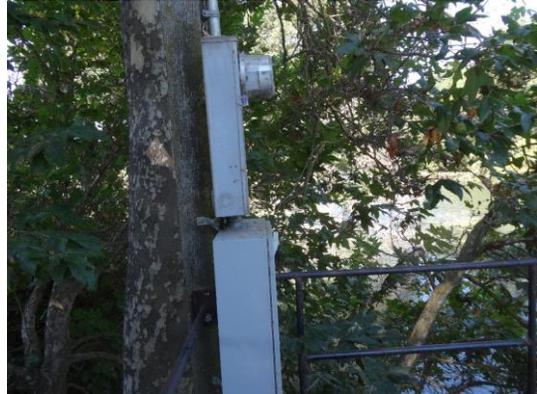
Photo 2 of 3 : UCIP\_FA\_2015\_3257.jpg

WS view: electric control box and power pole.

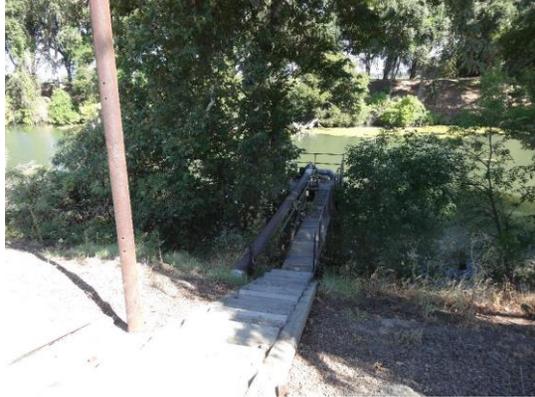
Photo 3 of 3 : UCIP\_FA\_2015\_3258.jpg

| Inspector Comments: FS_ID:28265<br>DS_ID:22448<br>EP_NO: N/A<br>FS_HLM: 5.806<br>Repair Type: Non-Urgent<br>Crossing Status: Found | | | | | |

WS view: walkway, pipe, pump and support deck on river bank.

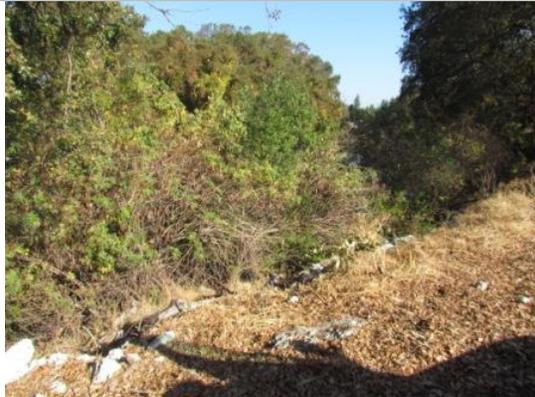
Photo 1 of 1 : FA\_2015\_RD0150\_17\_28\_20150911\_00021.jpg

Wild growth was found on the waterside slope of the levee looking upstream.

| Remove the wild growth other than native grasses from the levee slopes. | | | | | |

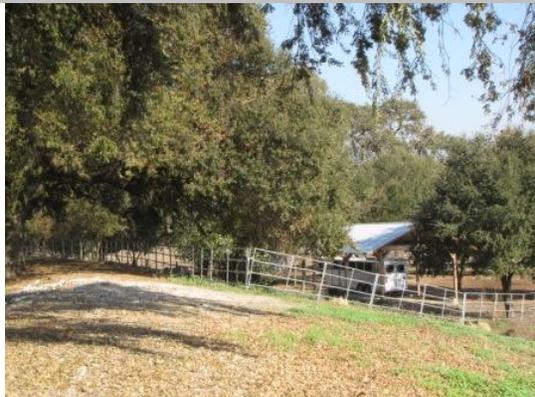
Photo 1 of 1 : FA\_2015\_RD0150\_17\_56\_20150911\_00049.jpg

| Fence | | | | | |

View of fence around a horse pen along the shoulder of the levee and the landward slope.

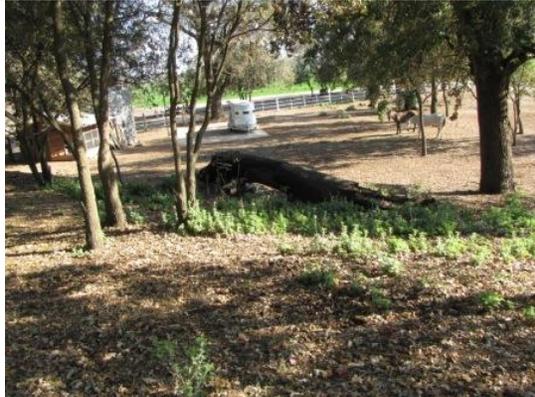
Photo 1 of 1 : FA\_2015\_RD0150\_17\_57\_20150911\_00050.jpg

| Tree or limb | | | | | |

View of a tree trunk lying on the landward slope blocking visibility.

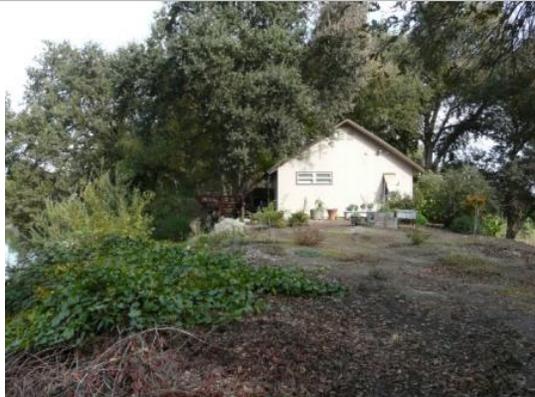
Photo 1 of 1 : FA\_2015\_RD0150\_17\_58\_20150911\_00051.jpg

| Building | | | | | |

Building & associated landscaping on levee crown.

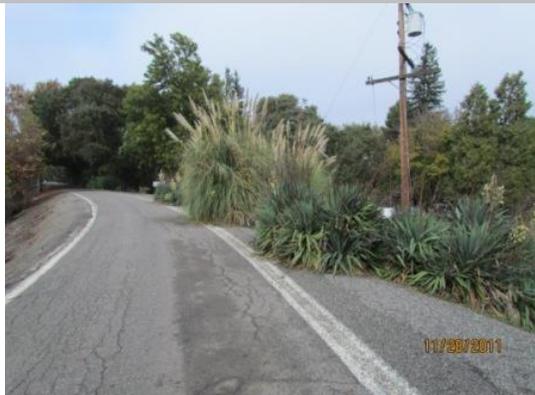
Photo 1 of 1 : FA\_2015\_RD0150\_17\_21\_20150911\_00017.jpg

| Landscaping | | | | | |

Landscaping was found on the landside of the levee looking upstream.

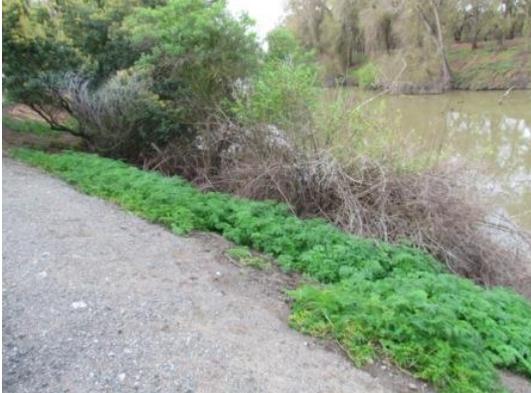
Photo 1 of 1 : FA\_2015\_RD0150\_17\_33\_20150911\_00026.jpg

Tree trunks and vegetation was obstructing the visibility on the waterside slope of the levee looking downstream.

| Thin trees to allow visibility of the ground and room to flood fight. | | | | | |

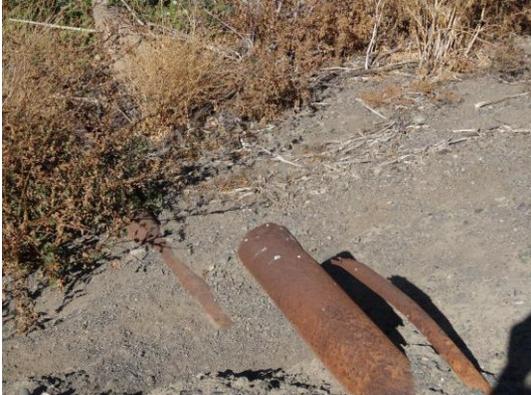
Photo 1 of 3 : UCIP\_FA\_2015\_2082.jpg

| Inspector Comments: FS_ID:19403<br>DS_ID:22451<br>EP_NO: N/A<br>FS_HLM: 6.0618<br>Repair Type: Non-Urgent<br>Crossing Status: Found<br>UCIP Comments: - pipe ends open on both sides of the levee.- abandoned concrete box on WS.- two abandoned steel pipes (6" and 1") also found on WS. - needs proper abandonment<br>FIELD_STRUCT_DESC: Abandoned 6-inch steel pipe through the levee, 2.5 feet below the crown. Power pole on the landward slope. (W. Bogle). O&M Manual SAC 112, March 1957.<br>FS Date: 08/23/2013 | | | | | |

WS view: Abandoned concrete box (top). Open ended 6" steel pipe, 1" steel pipe, and another 6" steel pipe on levee slope.

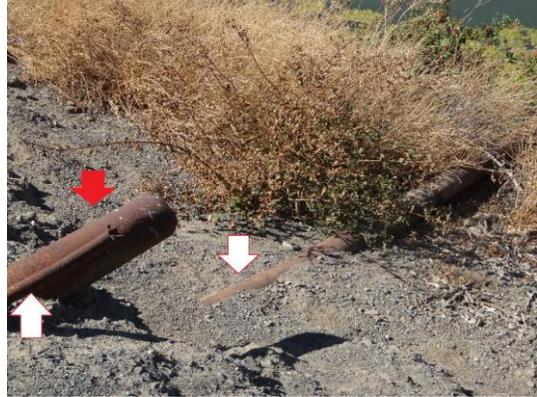
Photo 2 of 3 : UCIP\_FA\_2015\_2083.jpg

| LM Start | 5.95 | Rating ** | M | Issue No. | 960 (cont) |
|---|---|---|---|---|---|
| Inspector Comments: FS_ID:19403<br>DS_ID:22451<br>EP_NO: N/A<br>FS_HLM: 6.0618<br>Repair Type: Non-Urgent<br>Crossing Status: Found<br>UCIP Comments: - pipe ends open on both sides of the levee.- abandoned concrete box on WS.- two abandoned steel pipes (6" and 1") also found on WS. - needs proper abandonment<br>FIELD_STRUCT_DESC: Abandoned 6-inch steel pipe through the levee, 2.5 feet below the crown. Power pole on the landward slope. (W. Bogle). O&M Manual SAC 112, March 1957.<br>FS Date: 08/23/2013 | | | | | |

WS view: open ended 6" steel pipe (top-left), 1" steel pipe (bottom), and another 6" steel pipe (right) on levee slope.

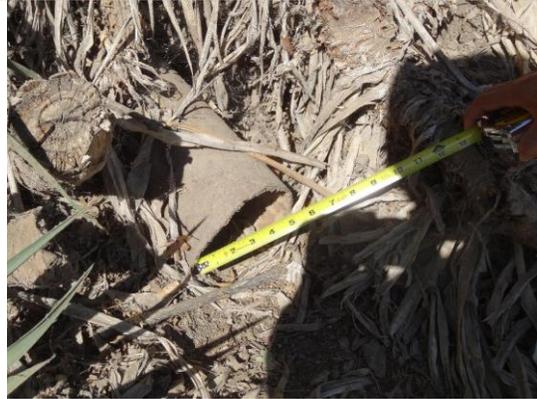
Photo 3 of 3 : UCIP\_FA\_2015\_2084.jpg

LS view: open end steel pipe on levee toe.

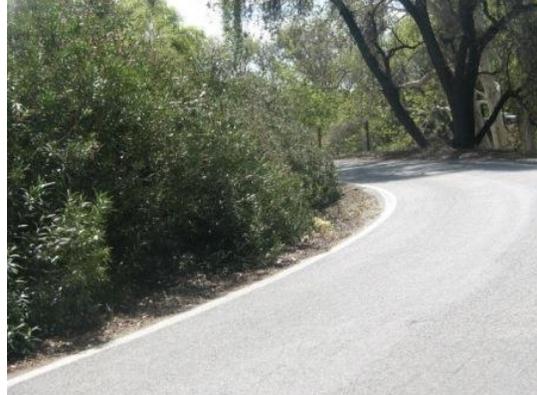
Photo 1 of 1 : FA\_2015\_RD0150\_17\_24\_20150911\_00018.jpg

| Landscaping | | | | | |

Oleander on landward slope blocking view of levee.

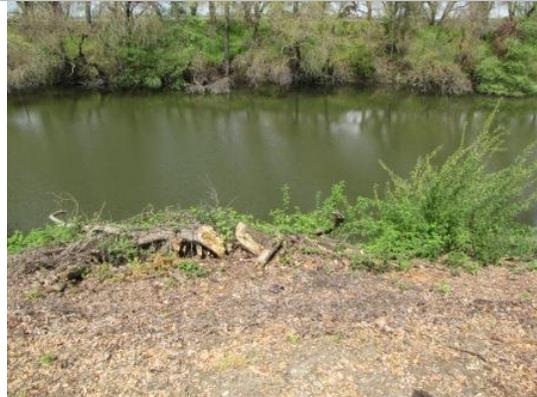
Photo 1 of 1 : FA\_2015\_RD0150\_17\_49\_20150911\_00040.jpg

| Tree stumps. | | | | | |

View of tree stumps on the waterward slope.

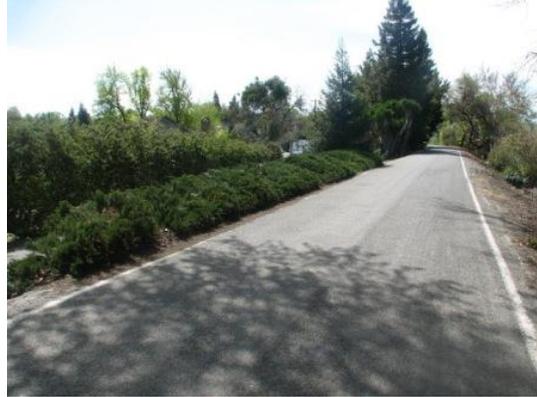
Photo 1 of 1 : FA\_2015\_RD0150\_17\_26\_20150911\_00019.jpg

| Landscaping | | | | | |

Landscaping on landward slope.

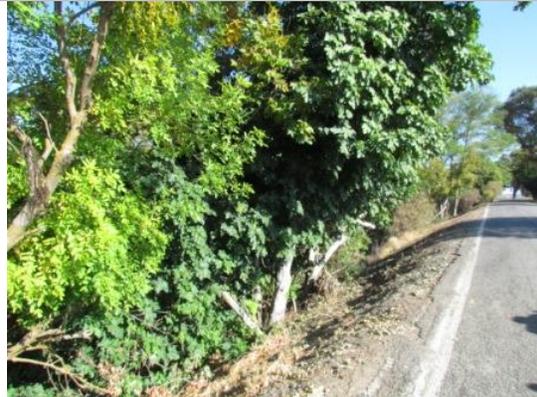
Photo 1 of 2 : FA\_2015\_RD0150\_17\_62\_20150911\_00058.jpg

Tree was blocking the visibility on the waterside of the levee looking upstream. This picture was taken during fall 2012 inspection.

| Trim and thin trees to allow visibility of the ground and room to flood fight. | | | | | |

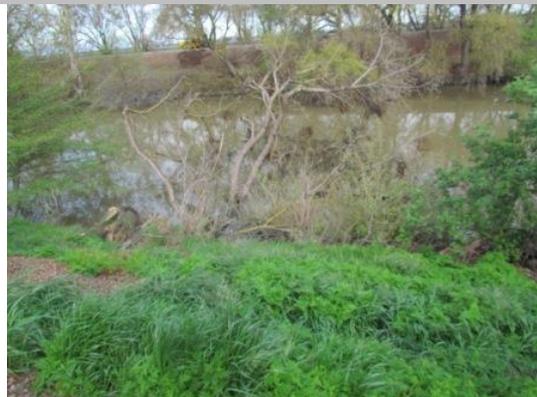
Photo 2 of 2 : FA\_2015\_RD0150\_17\_62\_20150911\_00059.jpg

Vegetation on the waterside of the levee looking downstream.

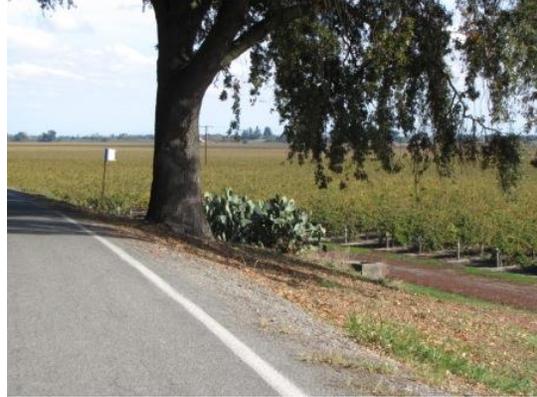
Photo 1 of 1 : FA\_2015\_RD0150\_17\_60\_20150911\_00053.jpg

| Landscaping | | | | | |

View of landscaping along the landward slope.

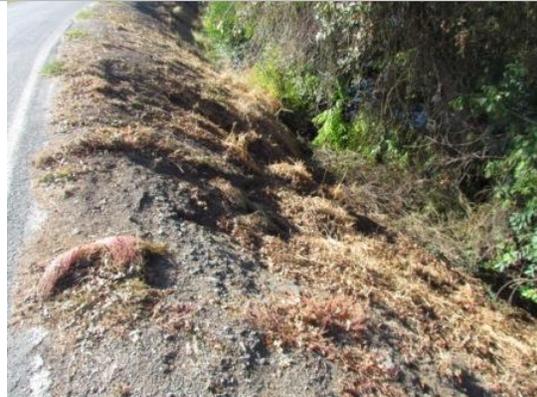
Photo 1 of 1 : FA\_2015\_RD0150\_17\_43\_20150911\_00036.jpg

Slope instability was found on the waterside of the levee looking downstream.

| Repair slope instability. | | | | | |

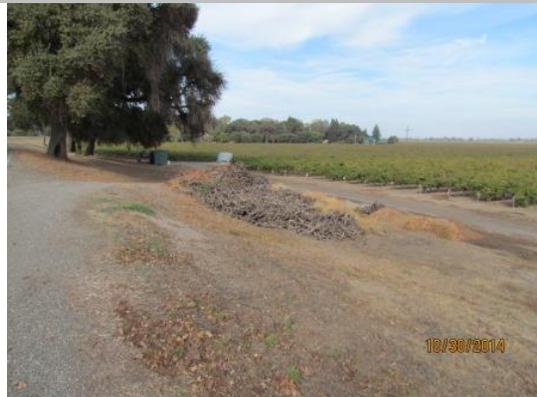
Photo 1 of 1 : FA\_2015\_RD0150\_17\_83\_20150911\_00082.jpg

| Prunings | | | | | |

Prunings were found on the landside toe of the levee looking upstream.

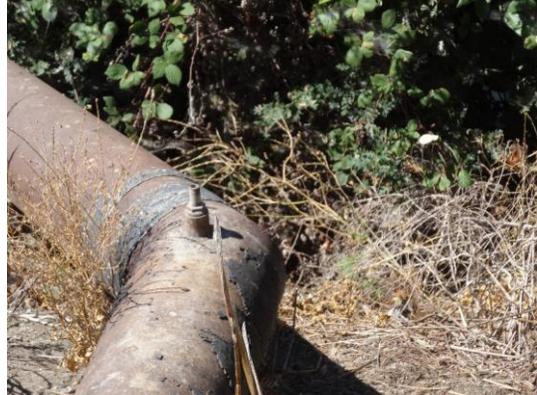
Photo 1 of 3 : UCIP\_FA\_2015\_1690.jpg

| Inspector Comments: FS_ID:42692<br>DS_ID:22457<br>EP_NO: 14650<br>FS_HLM: 6.752<br>Repair Type: Non-Urgent<br>Crossing Status: Found<br>UCIP Comments: Appears abandoned and if so should be done so properly.<br>FIELD_STRUCT_DESC: 12-inch steel irrigation pipe through the levee, 5 feet below the crown. Concrete distribution box on landside levee toe. Diesel powered slant pump on water side. (Permit No. 14650 - Webber)<br>FS Date: 08/23/2013 | | | | | |

WS view: air vent on steel pipe.

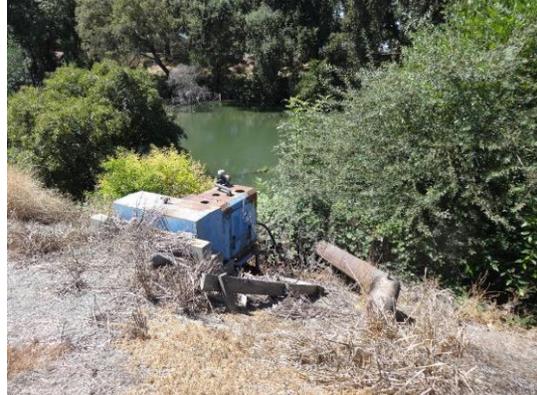
Photo 3 of 3 : UCIP\_FA\_2015\_1692.jpg

| Inspector Comments: FS_ID:42692<br>DS_ID:22457<br>EP_NO: 14650<br>FS_HLM: 6.752<br>Repair Type: Non-Urgent<br>Crossing Status: Found | | | | | |

WS view: steel pipe (right) and diesel pump on levee slope.

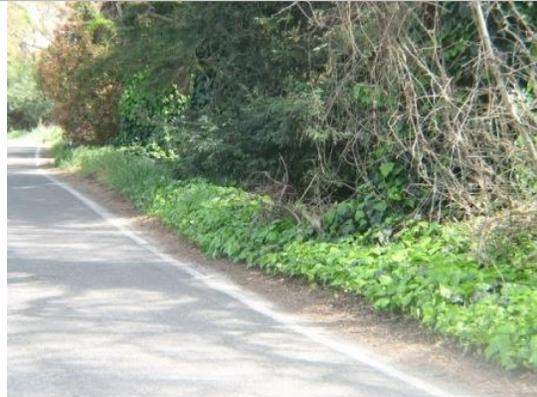
Photo 1 of 1 : FA\_2015\_RD0150\_17\_30\_20150911\_00022.jpg

| Landscaping | | | | | |

Landscaping on landward slope blocking view from LM 6.87 to 6.95

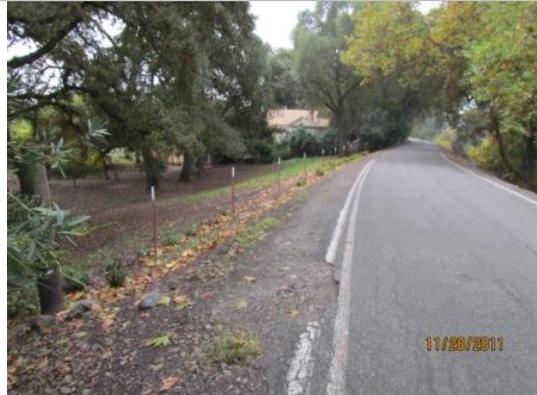
Photo 1 of 1 : FA\_2015\_RD0150\_17\_13\_20150911\_00013.jpg

| Fence | | | | | |

Fence was found on the landside of the levee looking downstream.

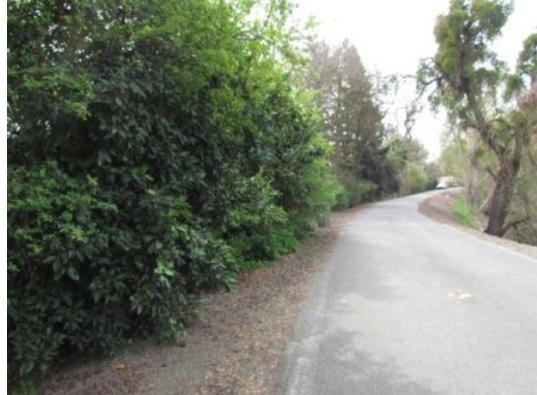
Photo 1 of 1 : FA\_2015\_RD0150\_17\_933\_20150911\_00101.jpg

| Landscaping<br>Inspector Comments: Landscaping has been maintained better, but some obstructions still exist. | | | | | |

View of the landscape on the landside shoulder of the levee looking downstream.

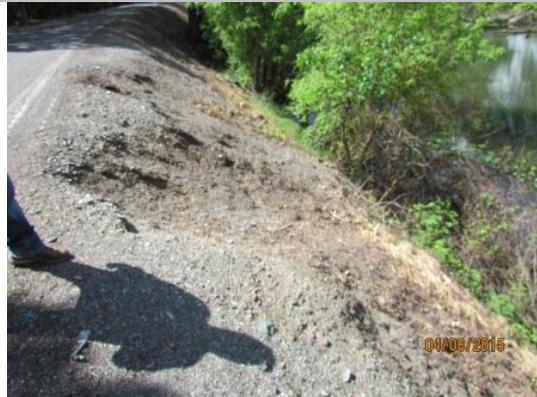
Photo 1 of 2 : FA\_2015\_RD0150\_17\_61\_20150911\_00054.jpg

Updated picture of the erosion on the waterside of the levee during spring 2015 inspection.

| Note and monitor erosion site. | | | | | |

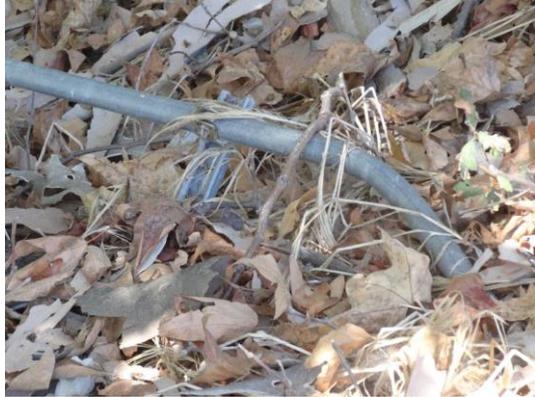
Photo 1 of 3 : UCIP\_FA\_2015\_1989.jpg

| Inspector Comments: FS_ID:42689<br>DS_ID:22463<br>EP_NO: N/A<br>FS_HLM: 7.339<br>Repair Type: Urgent<br>Crossing Status: Found<br>UCIP Comments: - Safety valve on pipe on waterside.- Power pole on waterside.- gully formation (erosion) on waterside levee slope<br>FIELD_STRUCT_DESC: 8-inch steel pipe through the levee, 7.7 feet below the crown, pump and gate valve on the waterward slope. Power pole on waterside. O&M Manual Sac 112, March 1957.<br>FS Date: 08/23/2013 | | | | | |

WS view: electric GI conduit on levee slope.

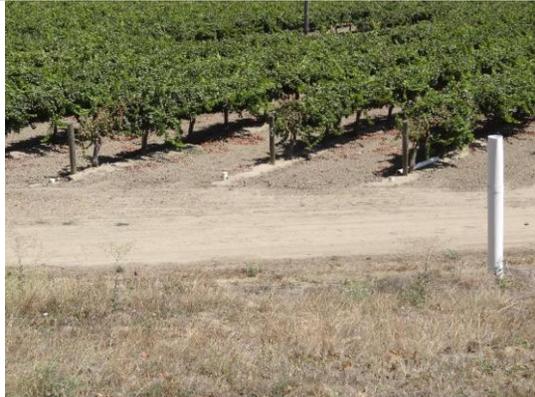
Photo 2 of 3 : UCIP\_FA\_2015\_1990.jpg

LS view: overview of levee slope and levee toe. No pipe and structure found.

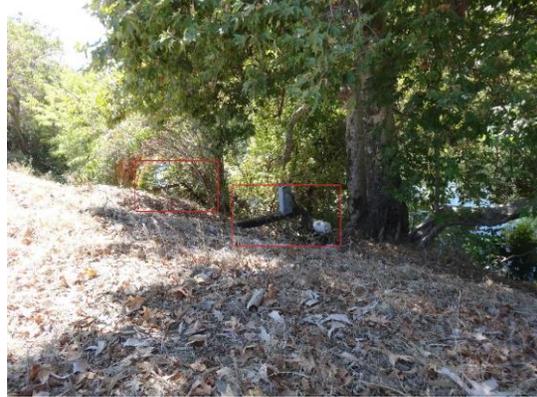
Photo 3 of 3 : UCIP\_FA\_2015\_1991.jpg

| Inspector Comments: FS_ID:42689<br>DS_ID:22463<br>EP_NO: N/A<br>FS_HLM: 7.339<br>Repair Type: Urgent<br>Crossing Status: Found | | | | | |

WS view: 8-inch pipe and pump on levee slope (right)

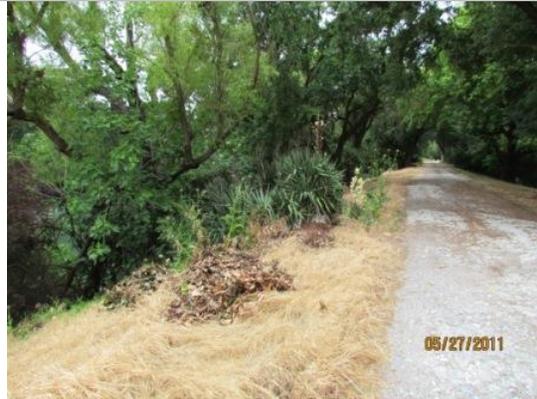
Photo 1 of 1 : FA\_2015\_RD0150\_17\_64\_20150911\_00061.jpg

| Landscaping | | | | | |

Landscaping on the waterside of the levee. The picture was taken from the crown looking upstream.
