**Flood Control Project Maintenance  
Levee Inspections**

**Fall 2015 Levee Maintenance Deficiency Summary Report**

**Sacramento River Basin**

| RD0150<br>Reclamation District No. 0150 Merrit Island | | Overall LMA Rating | Total LMA Miles | * Overall LMA Threshold Percent is less than 10.00%; however, U Rated Miles are present, so the Overall LMA Rating is M instead of A. | | | | | |

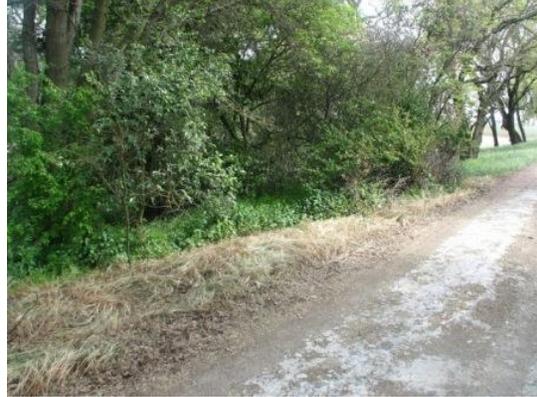
Photo 2 of 2 : FA\_2015\_RD0150\_17\_32\_20150911\_00025.jpg

| Landscaping | | | | | |

Landscaping on landward slope blocking view from LM 7.42 to 7.47

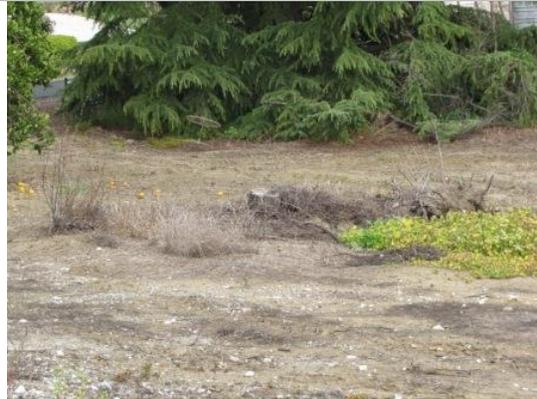
Photo 1 of 1 : FA\_2015\_RD0150\_17\_63\_20150911\_00060.jpg

| Tree stumps. | | | | | |

View of a tree stump on the landward slope.

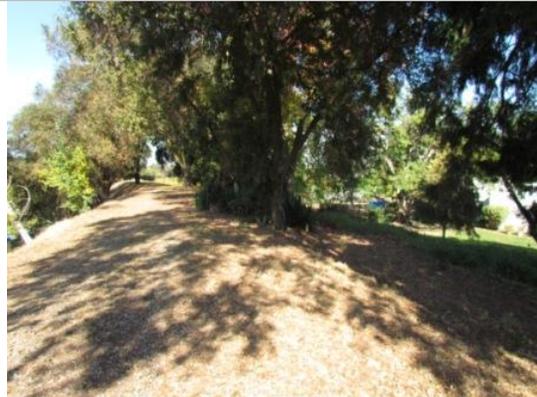
Photo 1 of 1 : FA\_2015\_RD0150\_17\_84\_20150911\_00083.jpg

| Landscaping | | | | | |

Landscaping was found on the landside shoulder of the levee looking upstream.

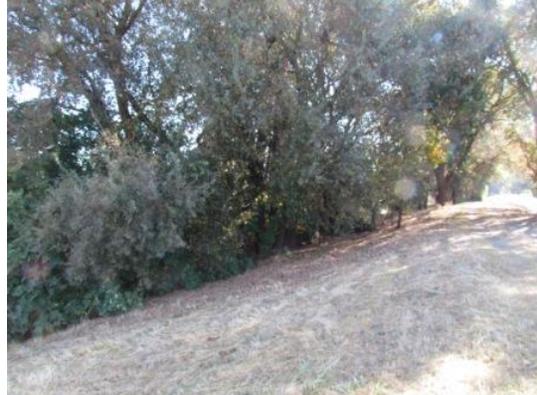
Photo 1 of 1 : FA\_2015\_RD0150\_17\_934\_20150911\_00102.jpg

| Landscaping | | | | | |

Landscaping was blocking the visibility on the landside of the levee looking downstream.

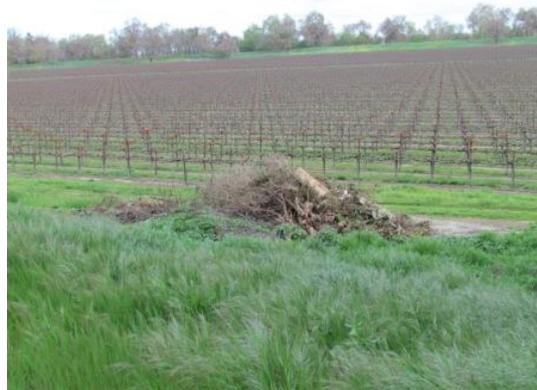
Photo 1 of 2 : FA\_2015\_RD0150\_17\_935\_20150911\_00104.jpg

| Prunings | | | | | |

Prunings were found on the landside of the levee looking upstream.

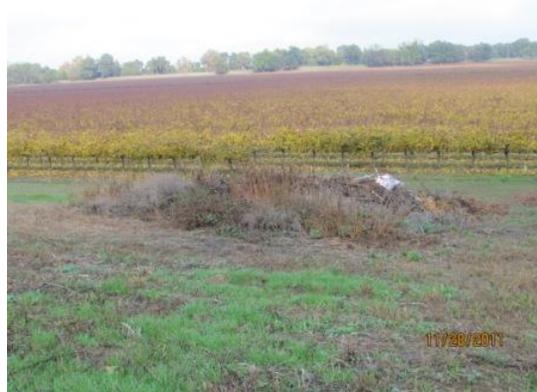
Photo 2 of 2 : FA\_2015\_RD0150\_17\_935\_20150911\_00105.jpg

Prunings were found on the landside of the levee looking upstream. This picture was taken during fall 2011 inspection.

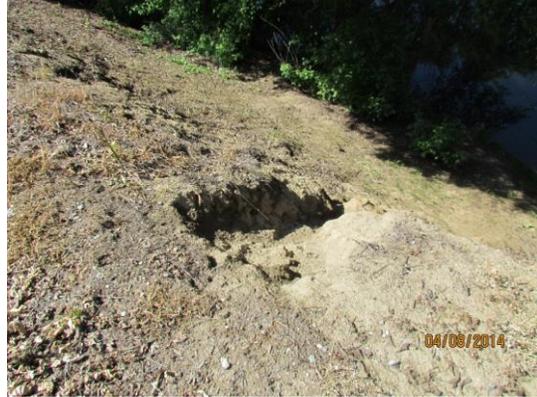
Photo 2 of 2 : FA\_2015\_RD0150\_17\_92\_20150911\_00090.jpg

A slope instability was found on the waterside of the levee looking downstream.

| Repair slope instability. | | | | | |

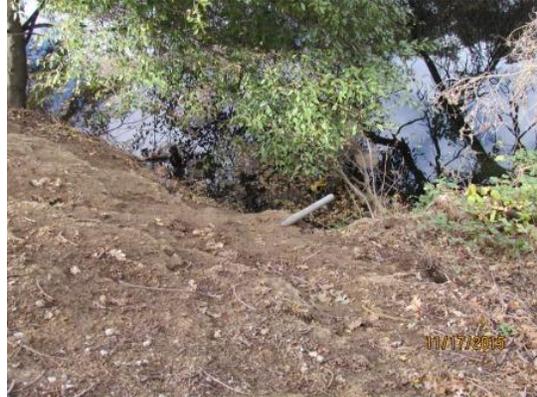
Photo 1 of 1 : FA\_2015\_RD0150\_17\_53\_20151119\_00127.jpg

| Pipe<br>Inspector Comments: An abandon pipe. | | | | | |

View of a pipe on the waterside of the levee.

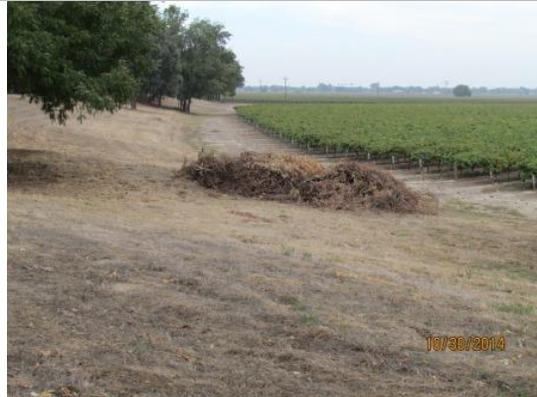
Photo 1 of 1 : FA\_2015\_RD0150\_17\_82\_20150911\_00081.jpg

| Prunings | | | | | |

Prunings were found on the landside toe of the levee looking upstream.

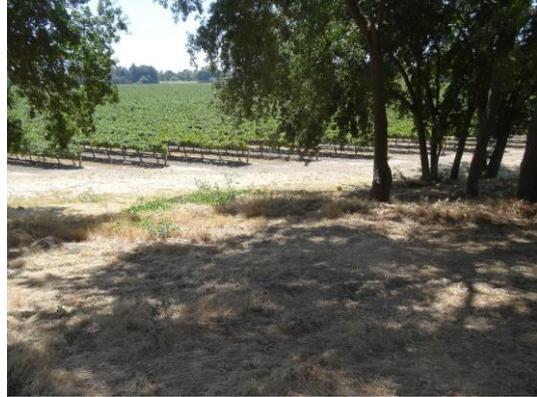
Photo 1 of 3 : UCIP\_FA\_2015\_1992.jpg

| Inspector Comments: FS_ID:42688<br>DS_ID:22466<br>EP_NO: N/A<br>FS_HLM: 8.349<br>Repair Type: Urgent<br>Crossing Status: Found<br>UCIP Comments: - needs proper abandonment- pile structure in stream- may need proper abandonment<br>FIELD_STRUCT_DESC: 10-inch abandoned steel pipe through the levee, 13.8 feet below the crown. Gate valve on the waterward end. Service pole with guy wire on the landward slope. (A. Colby) O&M Manual SAC 112, March 1957.<br>FS Date: 08/23/2013 | | | | | |

LS view: no pipe and structure found on landside.

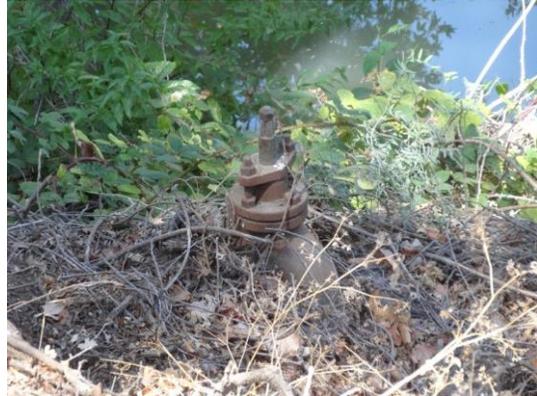
Photo 2 of 3 : UCIP\_FA\_2015\_1993.jpg

WS view: abandoned gate valve found on levee slope.

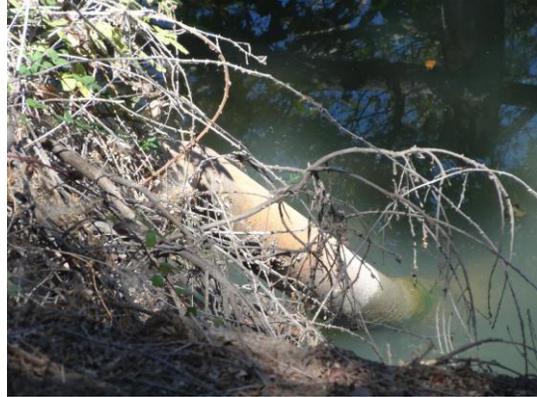
Photo 3 of 3 : UCIP\_FA\_2015\_1994.jpg

WS view: pipe visible on levee slope and in the stream.

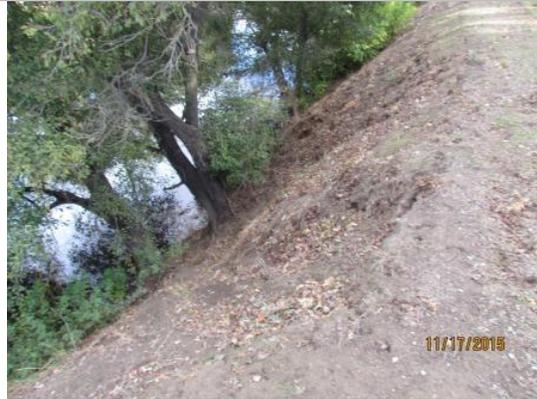
Photo 1 of 1 : FA\_2015\_RD0150\_17\_65\_20151119\_00128.jpg

View of erosion on the waterside of the levee.

| Note and monitor erosion site. | | | | | |

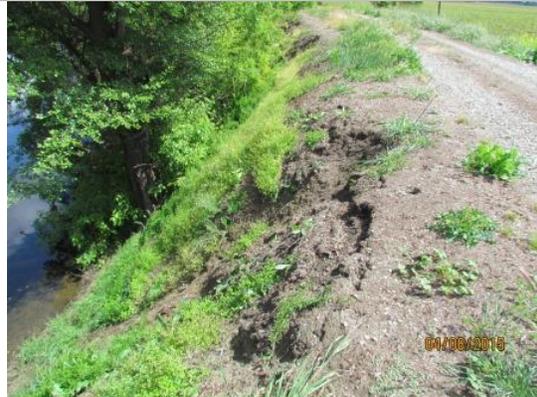
Photo 1 of 1 : FA\_2015\_RD0150\_17\_66\_20150911\_00062.jpg

Updated picture of the erosion on the waterside of the levee.

| Note and monitor erosion site. | | | | | |

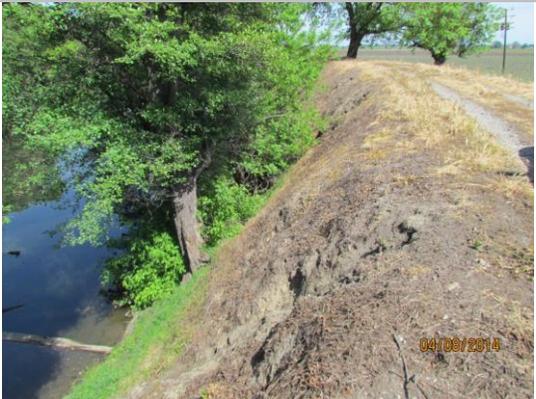
Photo 1 of 2 : FA\_2015\_RD0150\_17\_67\_20150911\_00064.jpg

Updated picture of the erosion on the waterside shoulder looking upstream during spring 2014 inspection.

| Note and monitor erosion site. | | | | | |

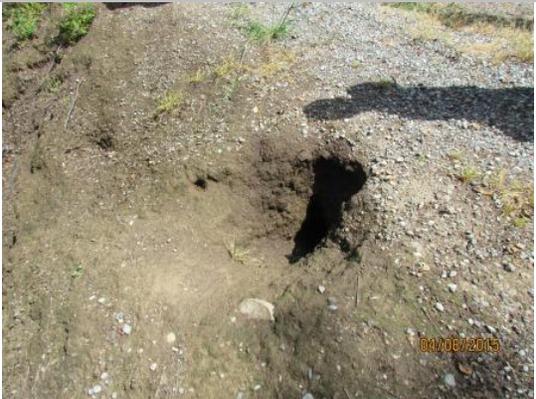
Photo 1 of 2 : FA\_2015\_RD0150\_17\_89\_20150911\_00085.jpg

Updated picture of a rodent hole on the waterside shoulder of the levee during spring 2015 inspection.

| Exterminate rodents and backfill and compact or grout burrows. | | | | | |

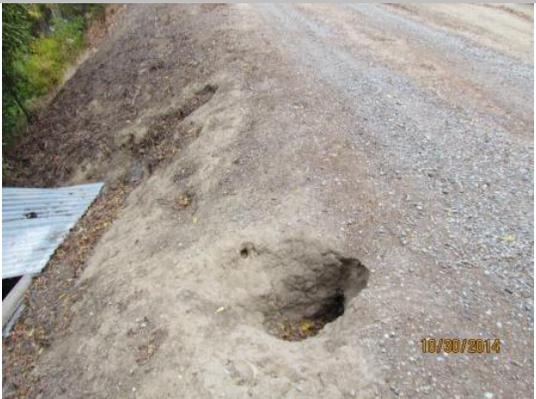
Photo 2 of 2 : FA\_2015\_RD0150\_17\_89\_20150911\_00086.jpg

Updated picture of a rodent hole on the waterside shoulder of the levee during fall 2014 inspection.

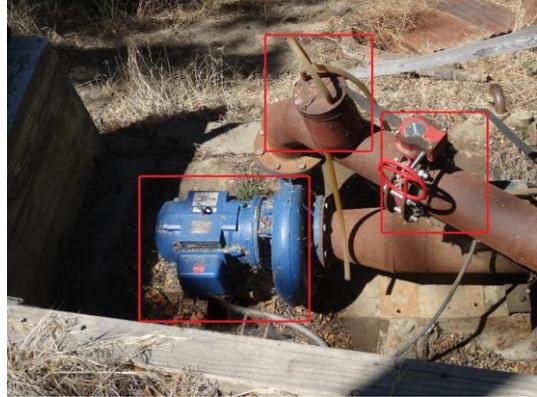
Photo 2 of 3 : UCIP\_FA\_2015\_1996.jpg

| LM Start | 8.37 | Rating ** | M | Issue No. | 964 (cont) |
|--|---|---|---|---|---|
| Inspector Comments: FS_ID:41648<br>DS_ID:22467<br>EP_NO: N/A<br>FS_HLM: 8.522<br>Repair Type: Non-Urgent<br>Crossing Status: Found<br>UCIP Comments: - walkway in poor functional condition- an abandoned 8-inch steel pipe next to 12" pipe. This 8" pipe might have merged with 12" pipe under the levee .- Pipe and pump inside concrete masonry wall.<br>FIELD_STRUCT_DESC: 12-inch steel pipe through the levee, 13.0 feet below the crown, pump and gate valve in pump house on the waterward slope. Concrete distribution box at the landward toe. Service pole on the waterward shoulder. O&M Manual SAC 112, March 1957.<br>FS Date: 08/23/2013 | | | | | |

WS view: pump, gate valve, and airvent on pipe inside concrete masonry box.

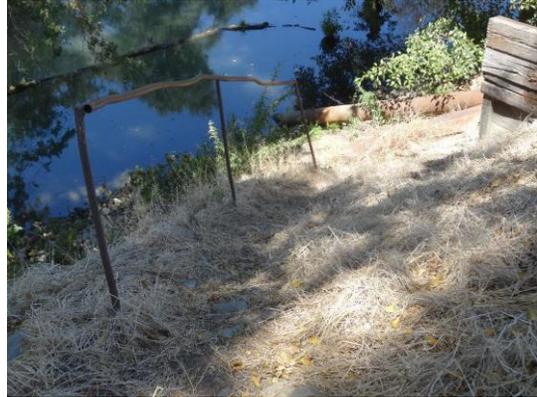
Photo 3 of 3 : UCIP\_FA\_2015\_1997.jpg

WS view: walkway and inlet pipe on levee slope.

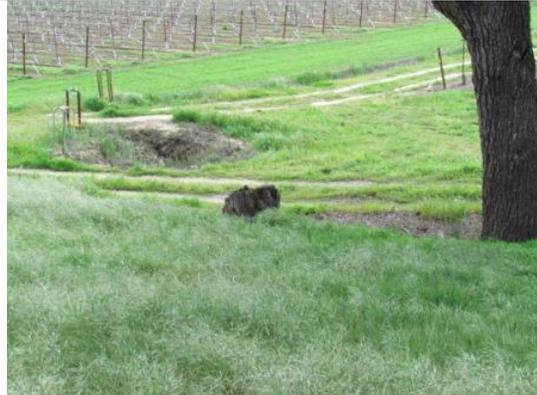
Photo 1 of 1 : FA\_2015\_RD0150\_17\_90\_20150911\_00088.jpg

| Tree stumps. | | | | | |

A tree stump was found on the landside of the levee looking upstream.

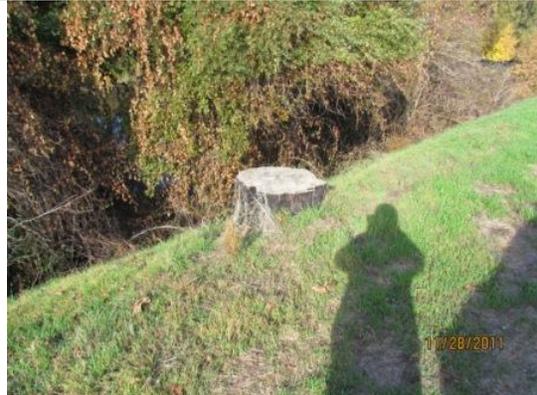
Photo 1 of 1 : FA\_2015\_RD0150\_17\_55\_20150911\_00048.jpg

| Tree stumps. | | | | | |

A tree stump was found on the waterside of the levee looking upstream.

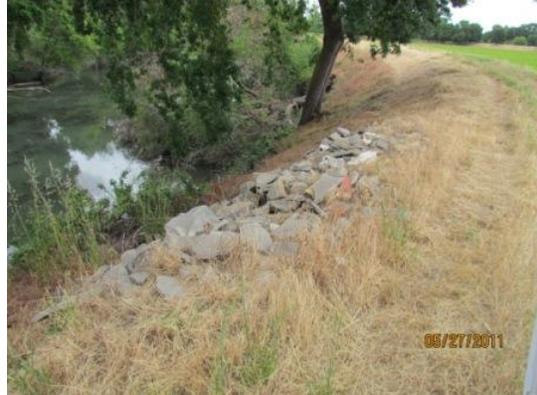
Photo 1 of 1 : FA\_2015\_RD0150\_17\_7\_20150911\_00006.jpg

| Debris | | | | | |

Broken concrete pipe was left on the waterside slope of the levee. The picture was taken from the crown looking upstream.

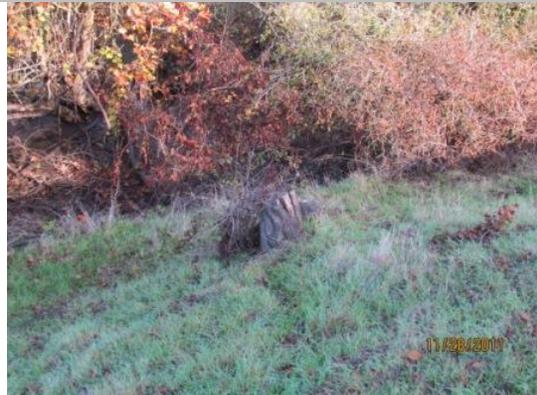
Photo 1 of 1 : FA\_2015\_RD0150\_17\_59\_20150911\_00052.jpg

| Tree stumps. | | | | | |

A tree stump was found on the waterside of the levee looking upstream.

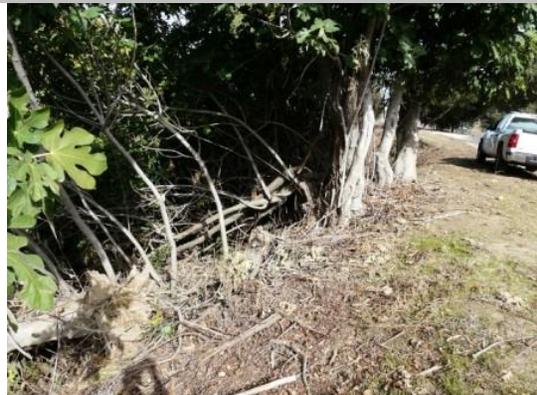
Photo 1 of 1 : FA\_2015\_RD0150\_17\_73\_20150911\_00068.jpg

Thin/trim trees to allow for visibility of top 20' of waterward slope.

| Trim and thin trees to allow visibility of the ground and room to flood fight. | | | | | |
