**Flood Control Project Maintenance
Levee Inspections
LMA District Cover Sheet
Spring 2010 Levee Inspection Results**

Reclamation District No. 0150 Merrit Island

Levee Inspection Report By Mile - Spring 2010

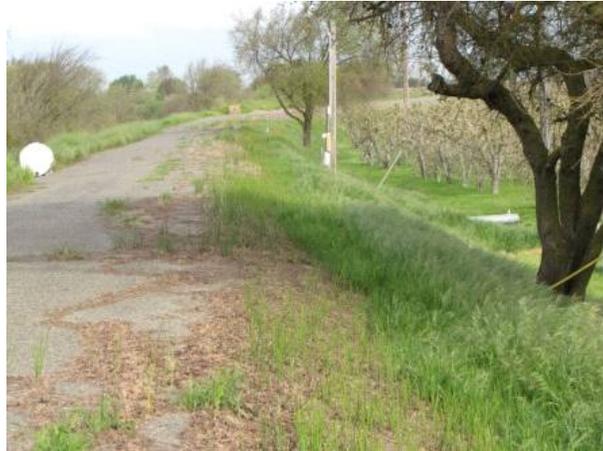
Levee Mile Report Line	2
Start Levee Mile	0.00
End Levee Mile	0.53
Location	Land Side
Category	Earthen Levee
Item	Vegetation
View of the landward slope with vegetation looking west.	
jhirabay_s_20100701_002.jpg

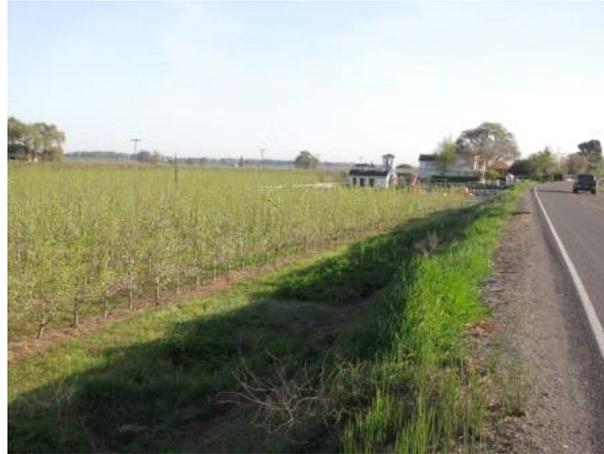
Levee Mile Report Line	2
Start Levee Mile	0.01
End Levee Mile	7.92
Location	Land Side
Category	Earthen Levee
Item	Vegetation
View of vegetation on the landward slope looking upstream.	
jhirabay_s_20100701_472.jpg

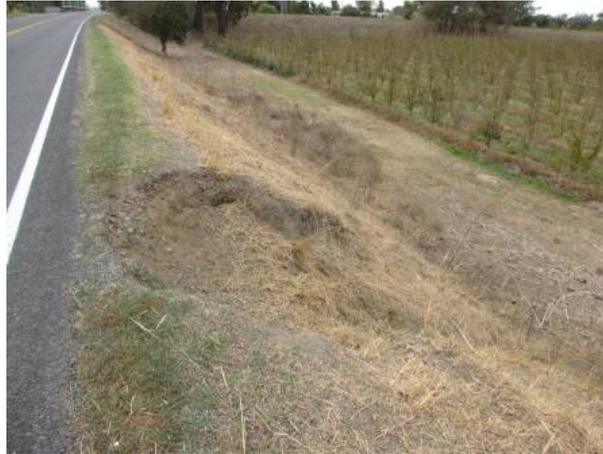
Levee Mile Report Line	4
Start Levee Mile	0.06
End Levee Mile	0.06
Location	Land Side
Category	Earthen Levee
Item	Erosion / Bank Caving
Updated view of erosion occurring on the landward slope looking downstream. The erosion appears to be getting larger.	
dpesaven_s_20100316_451.jpg

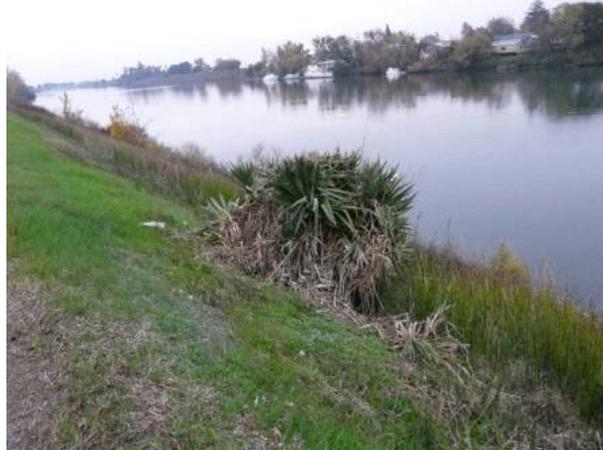
Levee Mile Report Line	7
Start Levee Mile	0.24
End Levee Mile	0.24
Location	Water Side
Category	Earthen Levee
Item	Vegetation
Remove century plant within 20' of waterside shoulder on waterside of the levee at LM 0.24	
dpesaven_s_20100316_436.JPG

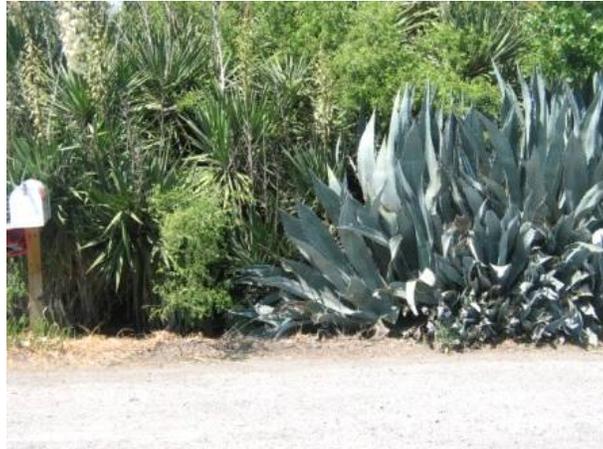
Levee Mile Report Line	8
Start Levee Mile	0.25
End Levee Mile	0.25
Location	Land Side
Category	Earthen Levee
Item	Encroachments
Landscaping on landward slope at LM 0.25 blocking view of levee slope.	
dpesaven_s_20100316_428.jpg

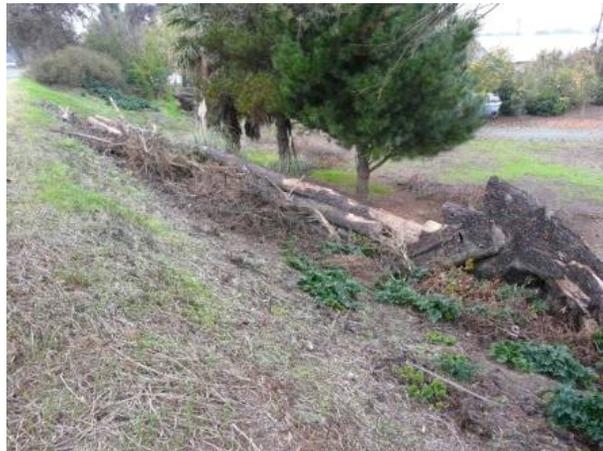
Levee Mile Report Line	9
Start Levee Mile	0.27
End Levee Mile	0.27
Location	Land Side
Category	Earthen Levee
Item	Encroachments
Remove tree branches from landside of levee at LM 0.27	
dpesaven_s_20100316_449.JPG

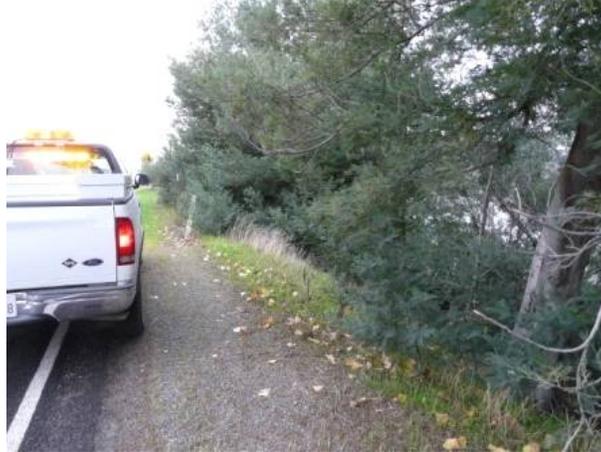
Levee Mile Report Line	13
Start Levee Mile	0.59
End Levee Mile	0.59
Location	Water Side
Category	Earthen Levee
Item	Trim / Thin Trees
Trim trees above 5' from surface of the wateside of the levee within 20' from shoulder at LM 0.59	
dpesaven_s_20100316_437.JPG

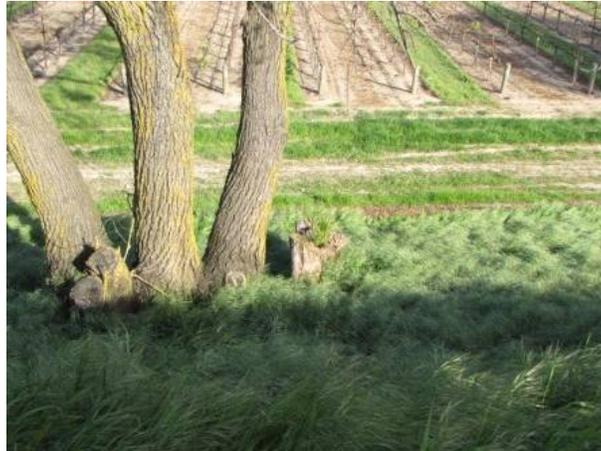
Levee Mile Report Line	18
Start Levee Mile	1.16
End Levee Mile	1.16
Location	Land Side
Category	Earthen Levee
Item	Trim / Thin Trees
View of a tree stump on the landward slope.	
jhirabay_s_20100701_474.jpg

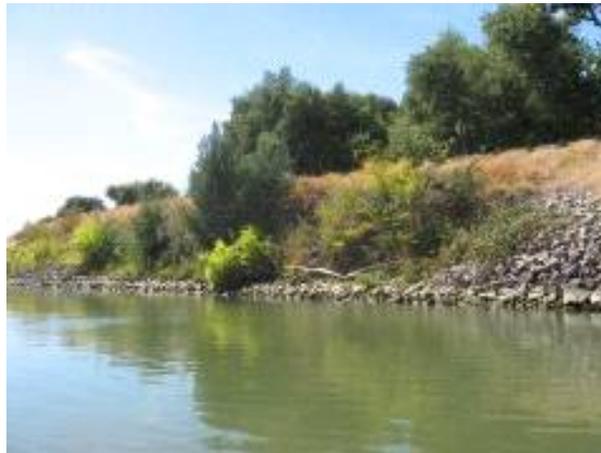
Levee Mile Report Line	19
Start Levee Mile	1.24
End Levee Mile	1.28
Location	Water Side
Category	Supplemental
Item	USACE Erosion Survey
2009: no berm, 1.5:1 slope, no stability issues, clays and silts, 5.89 ft/s [2009 SiteID:SAC_35-3_R]	
USACE2009_SAC_35-3_R_2009_09_17-D3bP36_small.JPG

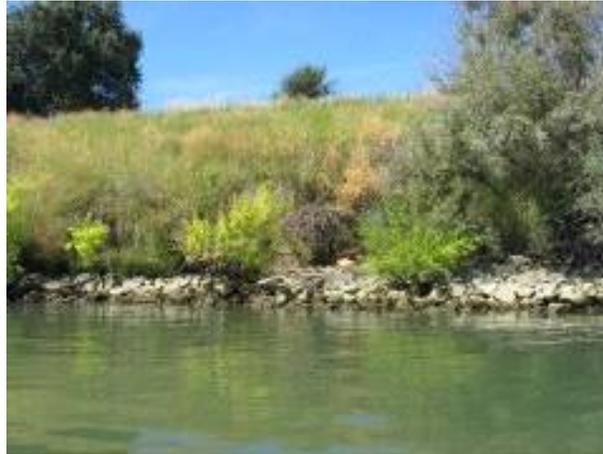
Levee Mile Report Line	22
Start Levee Mile	1.42
End Levee Mile	1.45
Location	Water Side
Category	Supplemental
Item	USACE Erosion Survey
2009: no berm, 2:1 slope, holes and slumping, clays and silts, 6.52 ft/s [2009 SiteID:SAC_35-4_R]	
USACE2009_SAC_35-4_R_2009_09_17-D3bP35_small.JPG

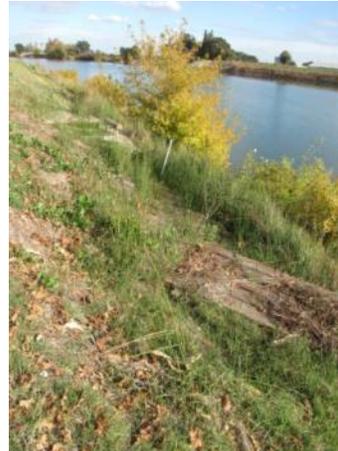
Levee Mile Report Line	33
Start Levee Mile	2.46
End Levee Mile	2.46
Location	Water Side
Category	Earthen Levee
Item	Encroachments
View of debris located on the waterward slope looking upstream.	
dpesaven_s_20100316_452.jpg

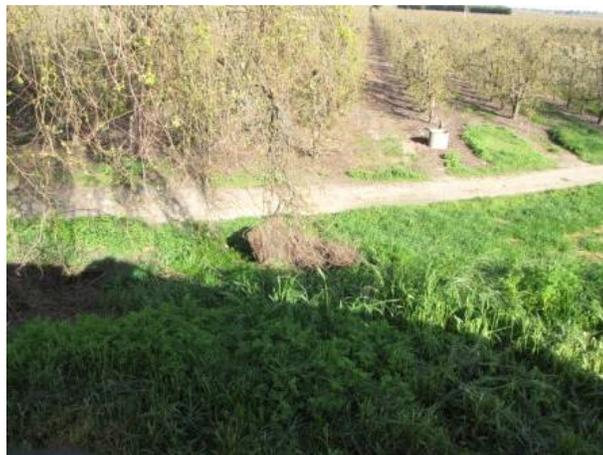
Levee Mile Report Line	37
Start Levee Mile	2.80
End Levee Mile	2.80
Location	Land Side
Category	Earthen Levee
Item	Trim / Thin Trees
View of a tree stump on the landward slope.	
jhirabay_s_20100701_475.jpg

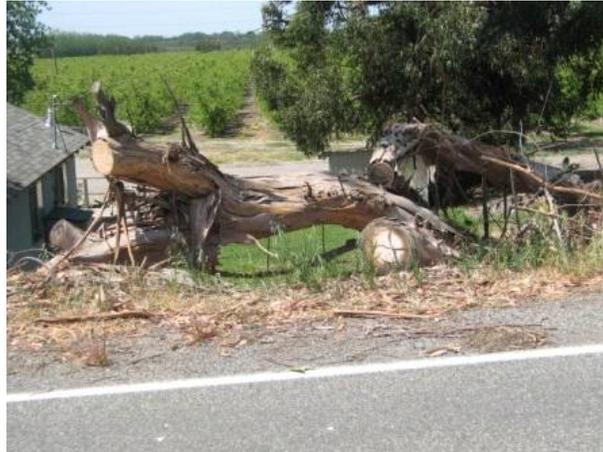
Levee Mile Report Line	39
Start Levee Mile	2.84
End Levee Mile	2.84
Location	Land Side
Category	Earthen Levee
Item	Encroachments
Down tree limbs on landward slope at LM 2.84	
dpesaven_s_20100316_429.jpg

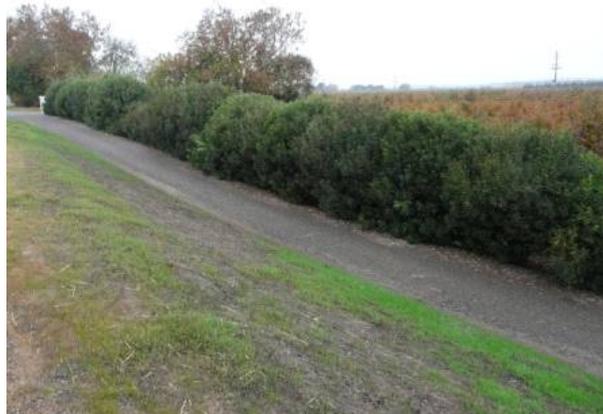
Levee Mile Report Line	40
Start Levee Mile	3.02
End Levee Mile	3.06
Location	Land Side
Category	Earthen Levee
Item	Encroachments
Landscaping providing a screen for a residence on landside of levee from LM 3.02 to LM 3.06	
dpesaven_s_20100316_448.JPG

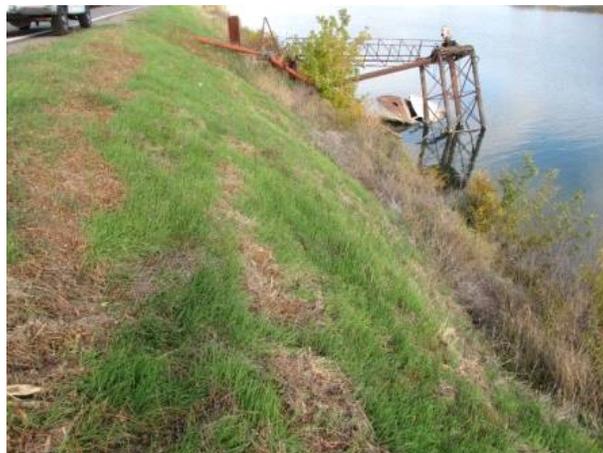
42	3.26	3.26	Earthen Levee	Encroachments	LS	C	Debris	38.355036 ° -121.531324 °	38.355036 ° -121.531324 °	981
43	3.28	3.28	Earthen Levee	Encroachments	LS	M	Prunings	38.355306 ° -121.531008 °	38.355306 ° -121.531008 °	980
44	3.29	3.29	Earthen Levee	Erosion / Bank Caving	WS	M	Schedule repair of erosion site prior to the next inspection. Inspector Comments: Depressions into the waterward slope can be seen along the waterward slope at this site. Also note the damaged pump support, pump, and pipe just upstream of the site; they may contribute to the erosion in a high water event and should be removed.	38.355321 ° -121.530902 °	38.355321 ° -121.530902 °	961 Y
45	3.31	3.31	Earthen Levee	Trim / Thin Trees	LS	M	Thin trees to allow visibility of the ground and room to flood fight.	38.355632 ° -121.530740 °	38.355632 ° -121.530740 °	952
46	3.35	3.35	Earthen Levee	Vegetation	LS	M	Elderberries are blocking visibility and flood fight capability.	38.355979 ° -121.530288 °	38.355979 ° -121.530288 °	17

Levee Mile Report Line	44
Start Levee Mile	3.29
End Levee Mile	3.29
Location	Water Side
Category	Earthen Levee
Item	Erosion / Bank Caving
View of erosion on the waterward slope looking upstream. Depressions into the slope can be seen in several places.	
dpesaven_s_20100316_453.jpg

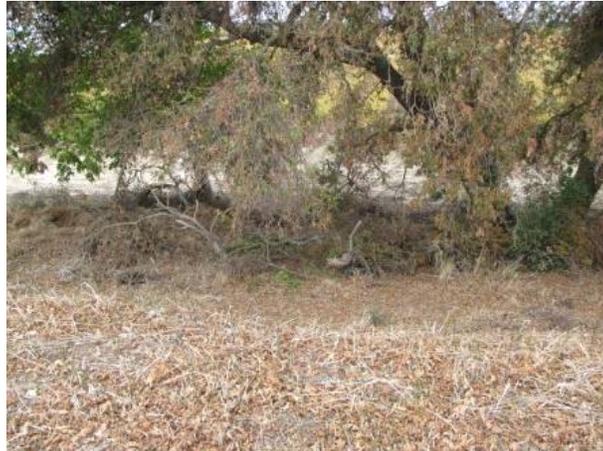
Levee Mile Report Line	50
Start Levee Mile	3.57
End Levee Mile	3.57
Location	Land Side
Category	Earthen Levee
Item	Encroachments
View of dead branches and plant material on the landward slope blocking visibility and access.	
dpesaven_s_20100316_466.jpg

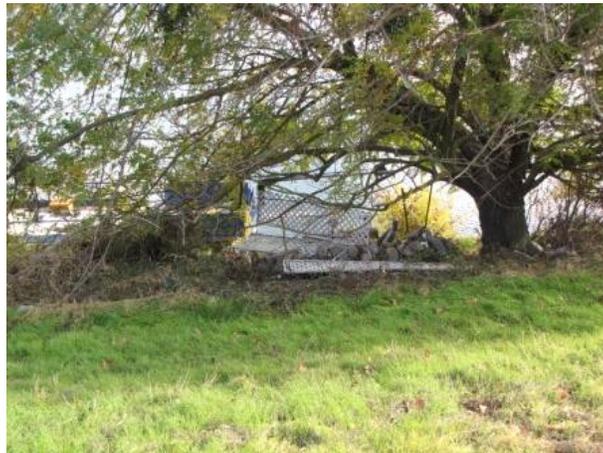
Levee Mile Report Line	53
Start Levee Mile	3.76
End Levee Mile	3.76
Location	Water Side
Category	Earthen Levee
Item	Encroachments
View of debris along the waterward slope.	
dpesaven_s_20100316_455.jpg

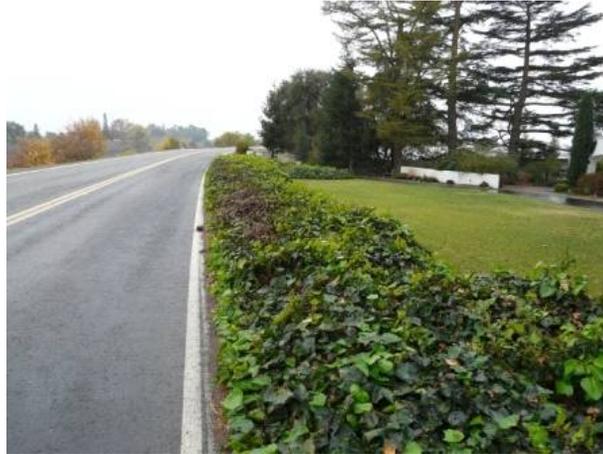
Levee Mile Report Line	54
Start Levee Mile	3.90
End Levee Mile	3.93
Location	Land Side
Category	Earthen Levee
Item	Encroachments
<p>Landscaping in front of a residence on landside of levee from LM 3.90 to LM 3.93. The levee in this location is greater than 100' wide.</p>	
<p>dpesaven_s_20100316_447.JPG</p>

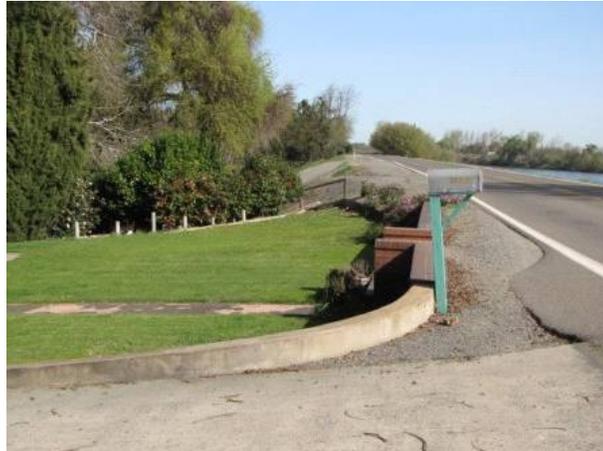
Levee Mile Report Line	55
Start Levee Mile	4.15
End Levee Mile	4.16
Location	Land Side
Category	Earthen Levee
Item	Encroachments
<p>View of a retaining wall on the landward slope looking upstream.</p>	
<p>jhirabay_s_20100701_476.jpg</p>

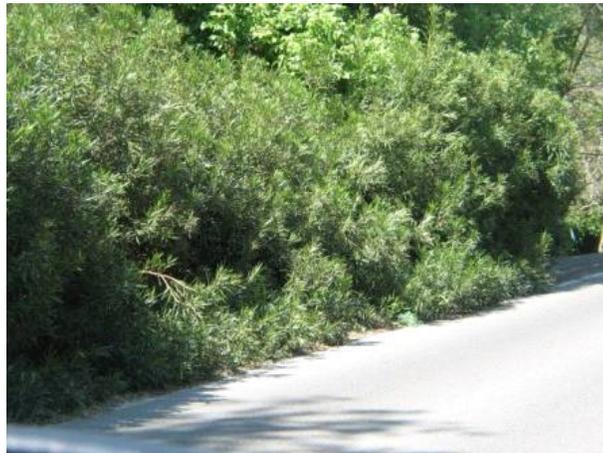
Levee Mile Report Line	57
Start Levee Mile	4.33
End Levee Mile	4.35
Location	Land Side
Category	Earthen Levee
Item	Encroachments
<p>Landscaping (Oleander) on landward slope from 4.33 to 4.35</p>	
<p>dpesaven_s_20100316_430.jpg</p>

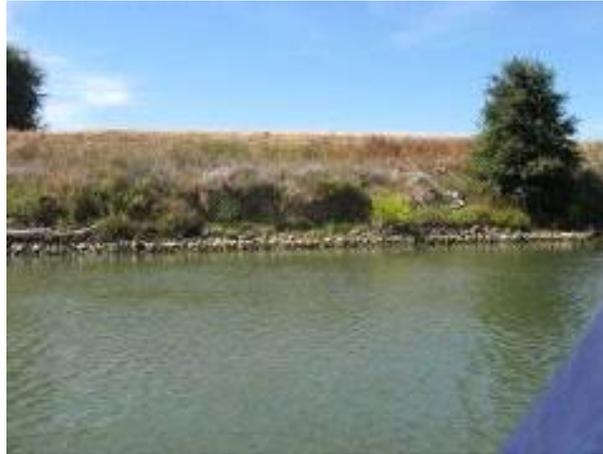
Levee Mile Report Line	61
Start Levee Mile	4.57
End Levee Mile	4.64
Location	Water Side
Category	Supplemental
Item	USACE Erosion Survey
<p>2009: 5 ft berm, 1.5:1 slope, slumping, clays and silts, 5.46 ft/s [2009 SiteID:SAC_38-5_R]</p> <p>USACE2009_SAC_38-5_R_2009_09_17-D3bP30_small.JPG</p>

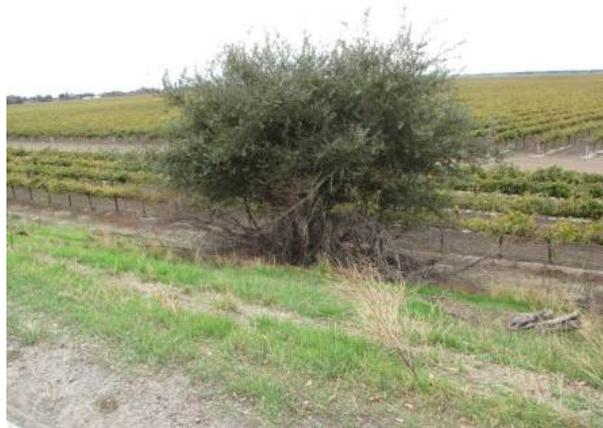
Levee Mile Report Line	62
Start Levee Mile	4.68
End Levee Mile	4.68
Location	Land Side
Category	Earthen Levee
Item	Trim / Thin Trees
<p>View of a tree on the landward slope with lower branches blocking visibility and access. Most of these branches appear to already be dead and should be removed.</p> <p>dpesaven_s_20100316_465.jpg</p>

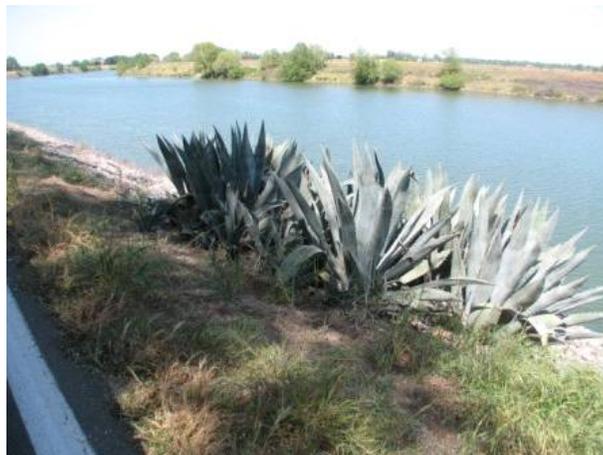
Levee Mile Report Line	63
Start Levee Mile	4.76
End Levee Mile	4.76
Location	Water Side
Category	Earthen Levee
Item	Vegetation
<p>Century plant on waterward slope at LM 4.76</p> <p>dpesaven_s_20100316_431.jpg</p>

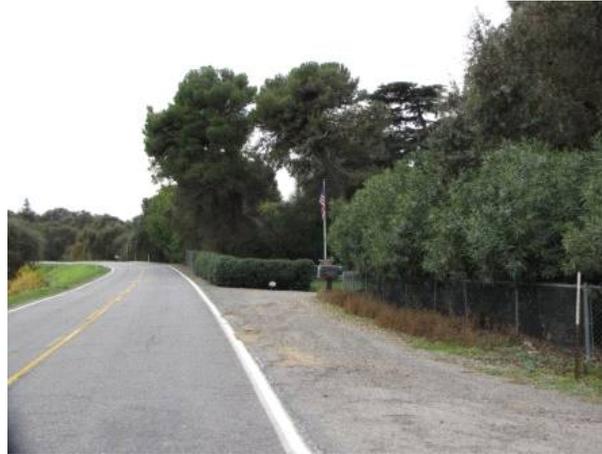
Levee Mile Report Line	70
Start Levee Mile	5.17
End Levee Mile	5.22
Location	Land Side
Category	Earthen Levee
Item	Encroachments
View of landscaping along the landward shoulder and slope looking downstream.	
dpesaven_s_20100316_445.jpg

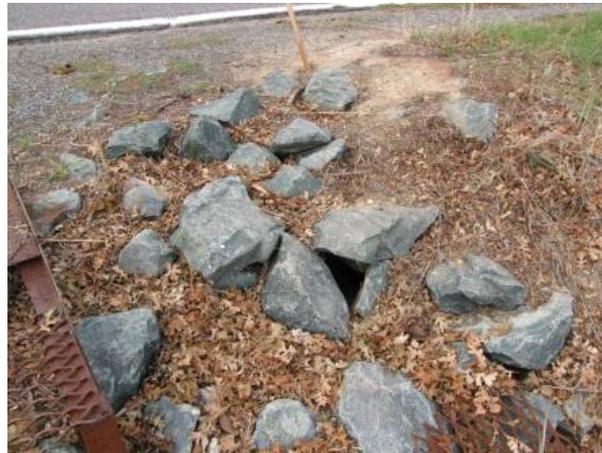
Levee Mile Report Line	71
Start Levee Mile	5.33
End Levee Mile	5.33
Location	Water Side
Category	Earthen Levee
Item	Slope Stability
View of rock placed on a pipe penetration on the waterward slope. Cavities can be seen under the rocks.	
dpesaven_s_20100316_464.jpg

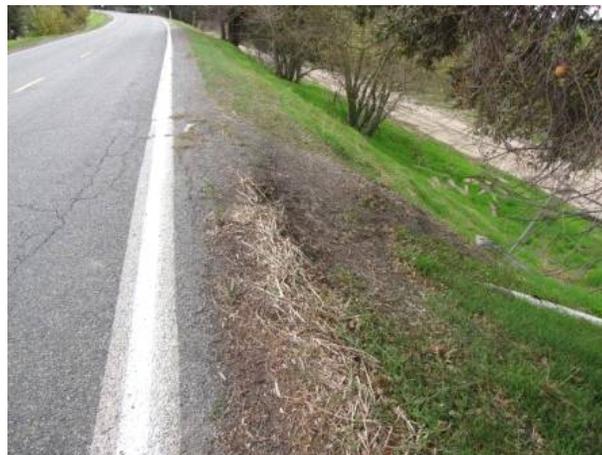
Levee Mile Report Line	72
Start Levee Mile	5.33
End Levee Mile	5.33
Location	Land Side
Category	Earthen Levee
Item	Slope Stability
View of a minor depression along the landward slope of the levee over a pipe penetration looking downstream.	
dpesaven_s_20100316_463.jpg

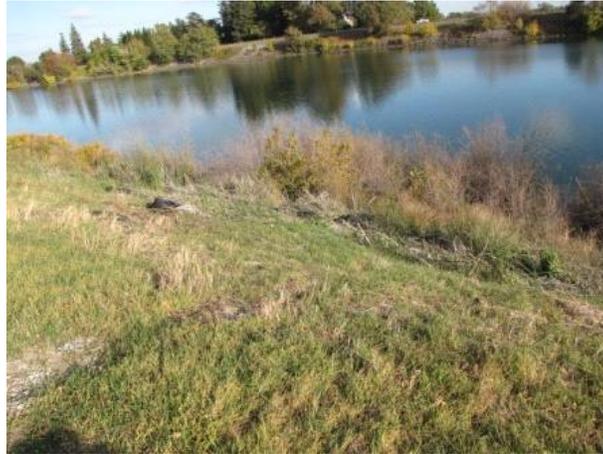
Levee Mile Report Line	79
Start Levee Mile	5.81
End Levee Mile	5.81
Location	Water Side
Category	Earthen Levee
Item	Encroachments
View of several tires along the waterward slope.	
dpesaven_s_20100316_458.jpg

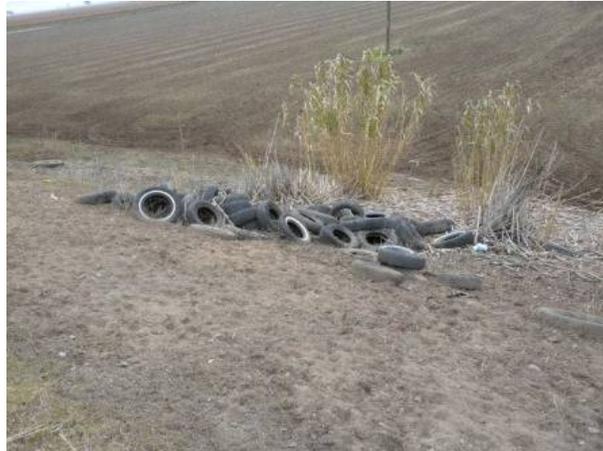
Levee Mile Report Line	84
Start Levee Mile	6.28
End Levee Mile	6.28
Location	Land Side
Category	Earthen Levee
Item	Encroachments
Remove tires from landside of levee at LM 6.28	
dpesaven_s_20100316_444.JPG

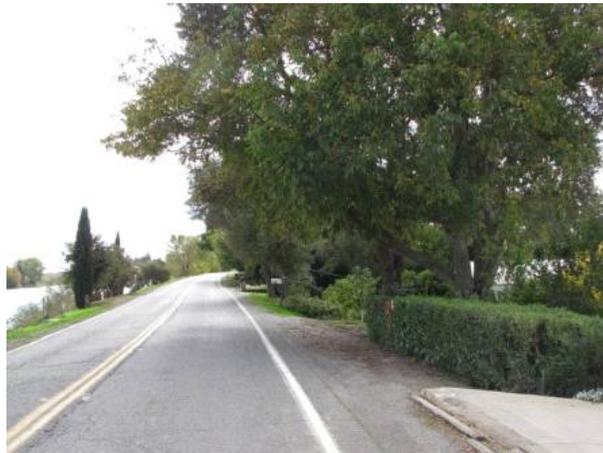
Levee Mile Report Line	92
Start Levee Mile	6.50
End Levee Mile	6.57
Location	Land Side
Category	Earthen Levee
Item	Encroachments
View of landscaping along the waterward shoulder and slope looking downstream.	
dpesaven_s_20100316_443.jpg

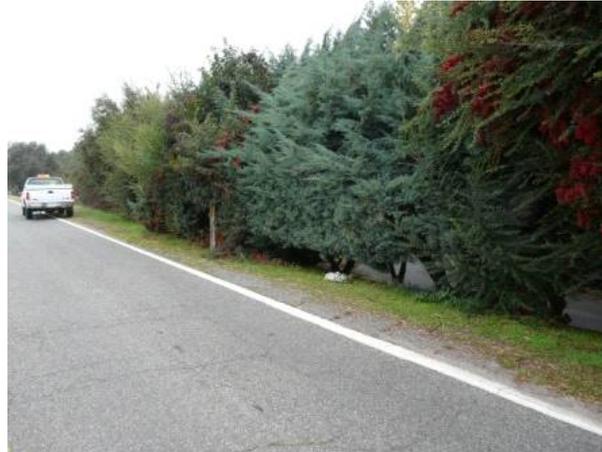
Levee Mile Report Line	95
Start Levee Mile	6.67
End Levee Mile	6.72
Location	Land Side
Category	Earthen Levee
Item	Encroachments
Landscaping providing a screen for a residence on landside of levee from LM 6.68 to LM 6.72	
dpesaven_s_20100316_442.JPG

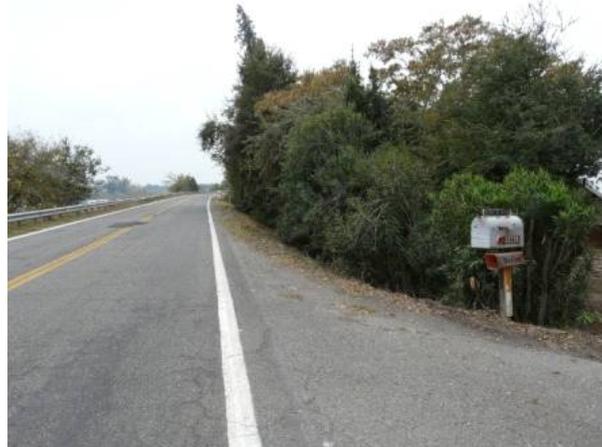
Levee Mile Report Line	102
Start Levee Mile	6.93
End Levee Mile	7.05
Location	Land Side
Category	Earthen Levee
Item	Encroachments
Landscaping providing a screen for a residence on landside of levee from LM 6.93 to LM 7.05	
dpesaven_s_20100316_441.JPG

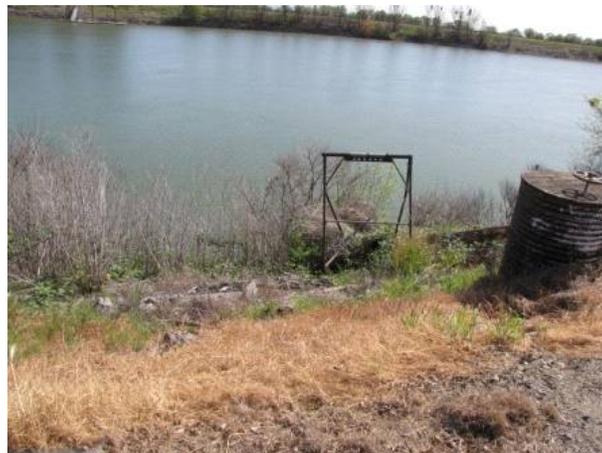
Levee Mile Report Line	103
Start Levee Mile	7.12
End Levee Mile	7.12
Location	Water Side
Category	Earthen Levee
Item	Encroachments
View of debris from an old pump on the waterward slope.	
jhirabay_s_20100701_477.jpg

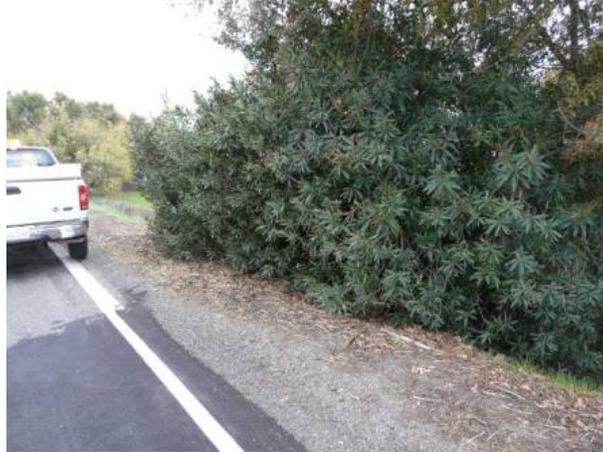
Levee Mile Report Line	104
Start Levee Mile	7.12
End Levee Mile	7.12
Location	Land Side
Category	Earthen Levee
Item	Encroachments
Landscaping providing a screen for a residence on landside of levee at LM 7.12	
dpesaven_s_20100316_440.JPG

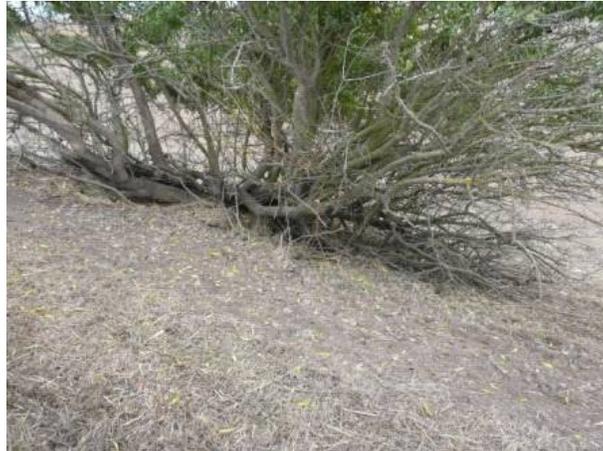
Levee Mile Report Line	106
Start Levee Mile	7.25
End Levee Mile	7.25
Location	Land Side
Category	Earthen Levee
Item	Trim / Thin Trees
Trim or remove brush to allow for visibility on landside of levee at LM 7.25	
dpesaven_s_20100316_433.JPG

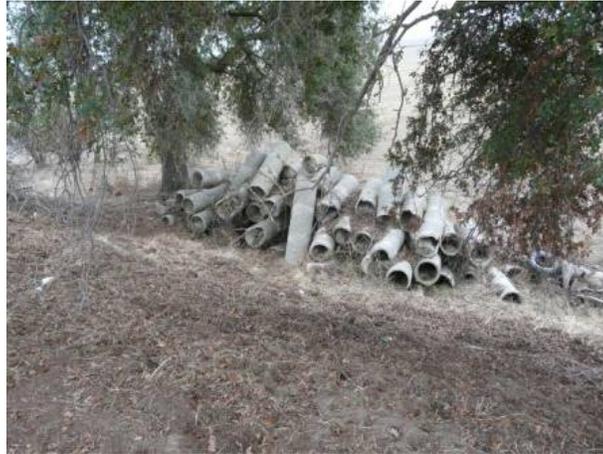
Levee Mile Report Line	109
Start Levee Mile	7.32
End Levee Mile	7.32
Location	Land Side
Category	Earthen Levee
Item	Encroachments
Remove pipes piled on landside of levee to at least 10' from levee toe at LM 7.32	
dpesaven_s_20100316_439.JPG

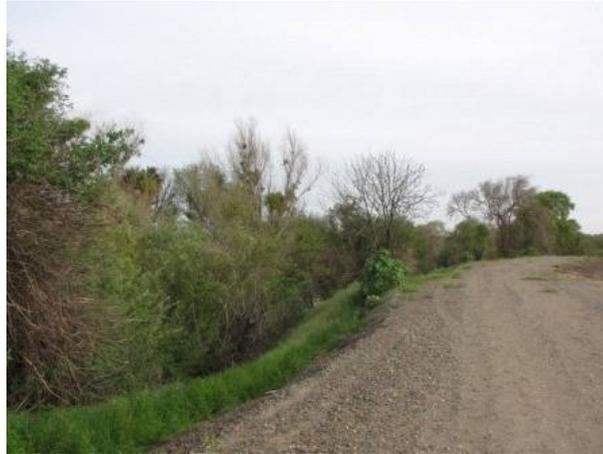
Levee Mile Report Line	1
Start Levee Mile	0.00
End Levee Mile	9.57
Location	Water Side
Category	Earthen Levee
Item	Vegetation
View of vegetation on the waterward slope looking upstream.	
jhirabay_s_20100701_507.jpg

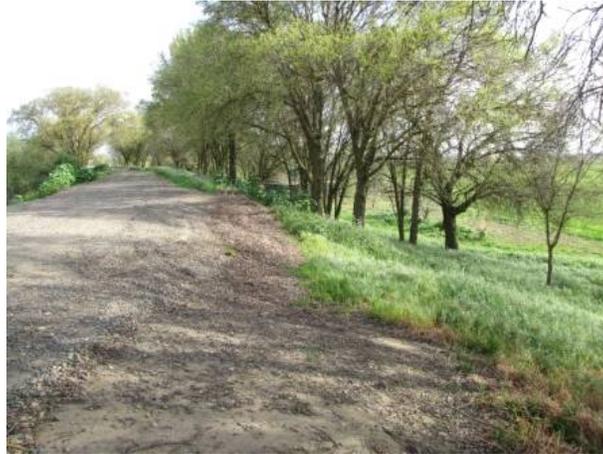
Levee Mile Report Line	5
Start Levee Mile	0.30
End Levee Mile	0.60
Location	Land Side
Category	Earthen Levee
Item	Vegetation
View of vegetation on the landward slope looking upstream.	
jhirabay_s_20100701_508.jpg

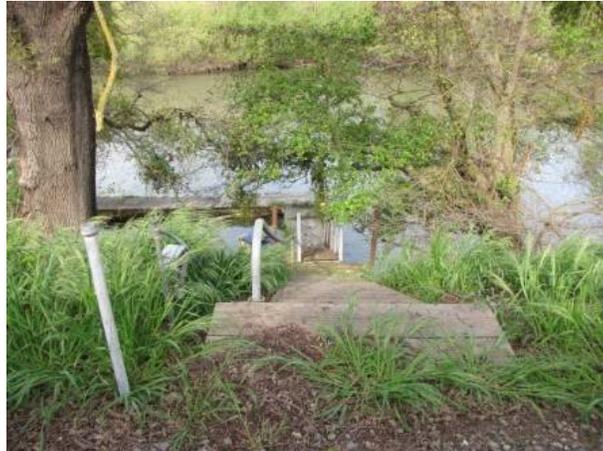
Levee Mile Report Line	6
Start Levee Mile	0.36
End Levee Mile	0.36
Location	Water Side
Category	Earthen Levee
Item	Encroachments
View of steps, a dock, and associated utilities on the waterward slope.	
jhirabay_s_20100701_509.jpg

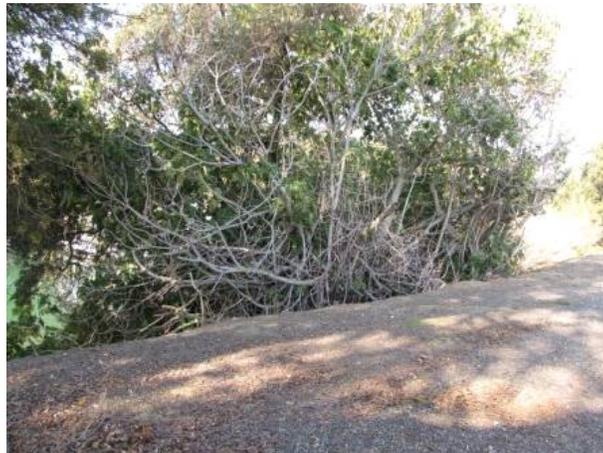
Levee Mile Report Line	9
Start Levee Mile	0.56
End Levee Mile	0.56
Location	Water Side
Category	Earthen Levee
Item	Trim / Thin Trees
View of trees and bushes within 20 feet of the shoulder blocking visibility and access.	
dpesaven_s_20100316_495.jpg

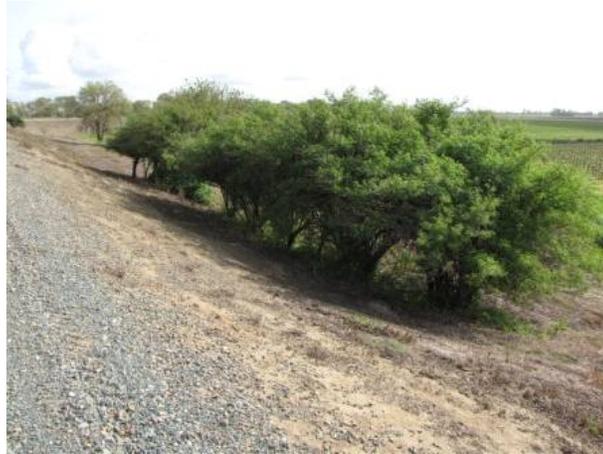
Levee Mile Report Line	12
Start Levee Mile	0.92
End Levee Mile	0.95
Location	Land Side
Category	Earthen Levee
Item	Vegetation
View of elderberries on the landward slope blocking visibility and access.	
jhirabay_s_20100701_510.jpg

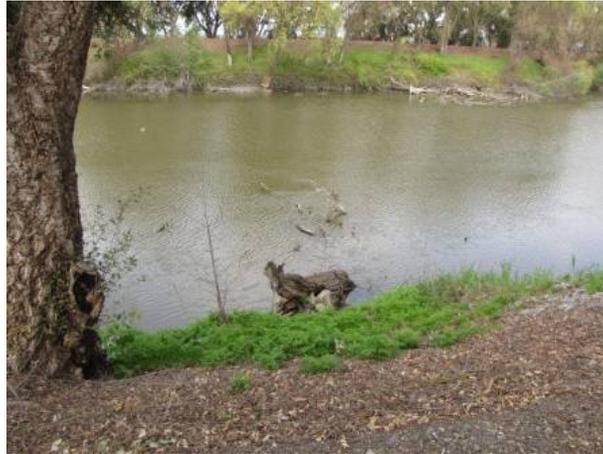
Levee Mile Report Line	19
Start Levee Mile	2.57
End Levee Mile	2.57
Location	Water Side
Category	Earthen Levee
Item	Trim / Thin Trees
View of a tree stump on the waterward slope.	
jhirabay_s_20100701_511.jpg

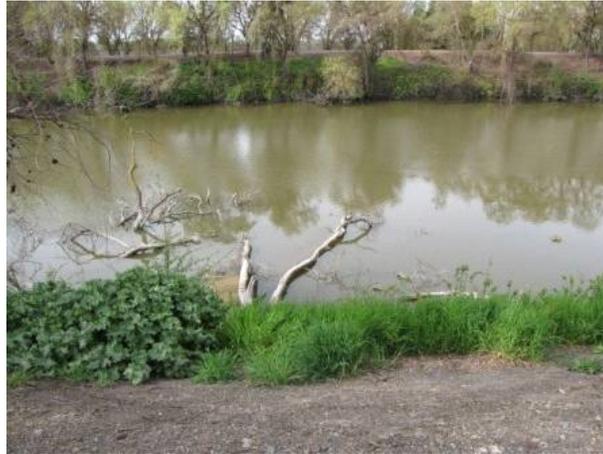
Levee Mile Report Line	23
Start Levee Mile	2.87
End Levee Mile	2.87
Location	Water Side
Category	Earthen Levee
Item	Trim / Thin Trees
View of tree stumps on the waterward slope.	
jhirabay_s_20100701_514.jpg

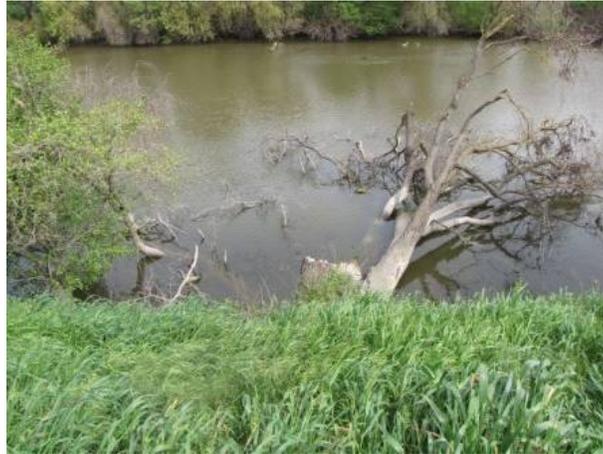
Levee Mile Report Line	26
Start Levee Mile	3.21
End Levee Mile	3.21
Location	Water Side
Category	Earthen Levee
Item	Trim / Thin Trees
View of tree stumps on the waterward slope.	
jhirabay_s_20100701_517.jpg

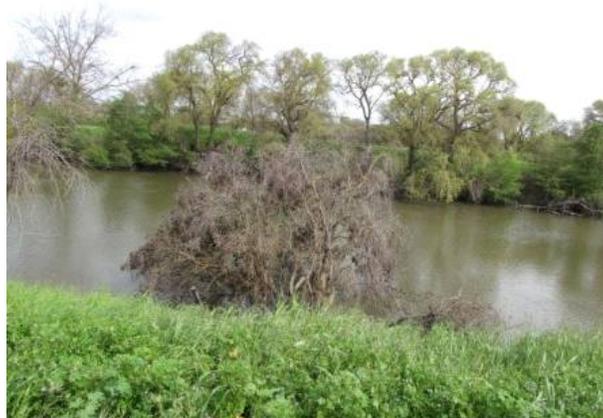
Levee Mile Report Line	27
Start Levee Mile	3.26
End Levee Mile	3.26
Location	Water Side
Category	Earthen Levee
Item	Trim / Thin Trees
View of tree stumps on the waterward slope.	
jhirabay_s_20100701_518.jpg

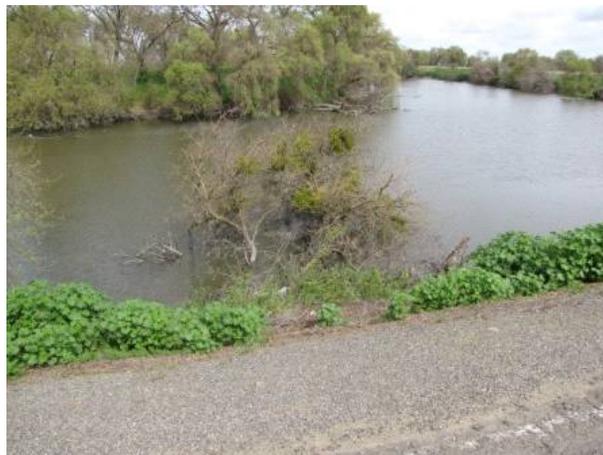
Levee Mile Report Line	29
Start Levee Mile	3.41
End Levee Mile	3.41
Location	Water Side
Category	Earthen Levee
Item	Trim / Thin Trees
View of tree stumps on the waterward slope.	
jhirabay_s_20100701_519.jpg

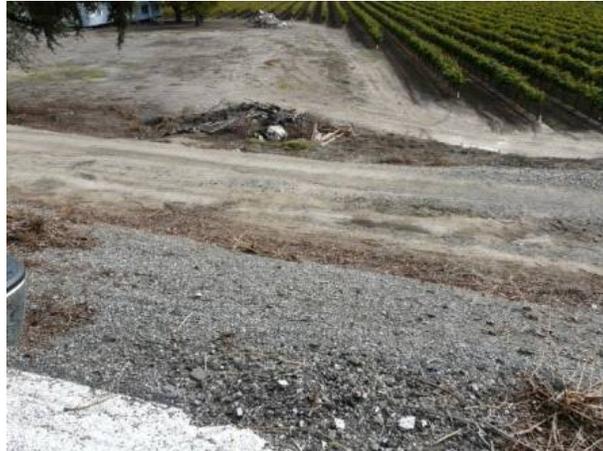
Levee Mile Report Line	35
Start Levee Mile	3.95
End Levee Mile	3.95
Location	Land Side
Category	Earthen Levee
Item	Encroachments
Debris pile on landward slope at LM 3.95.	
dpesaven_s_20100316_482.JPG

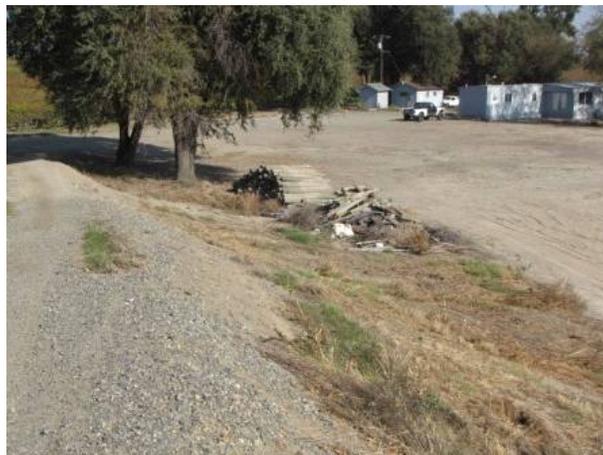
Levee Mile Report Line	35
Start Levee Mile	3.95
End Levee Mile	3.95
Location	Land Side
Category	Earthen Levee
Item	Encroachments
Updated view of material piled at the toe of the levee as of fall 2009.	
dpesaven_s_20100316_483.jpg

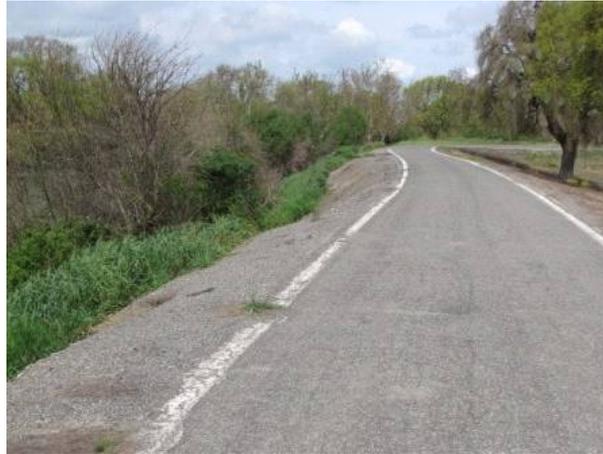
Levee Mile Report Line	36
Start Levee Mile	4.06
End Levee Mile	4.06
Location	Crown
Category	Earthen Levee
Item	Crown Surface / Depressions / Rutting
View of depressions in the roadway looking upstream.	
jhirabay_s_20100701_520.jpg

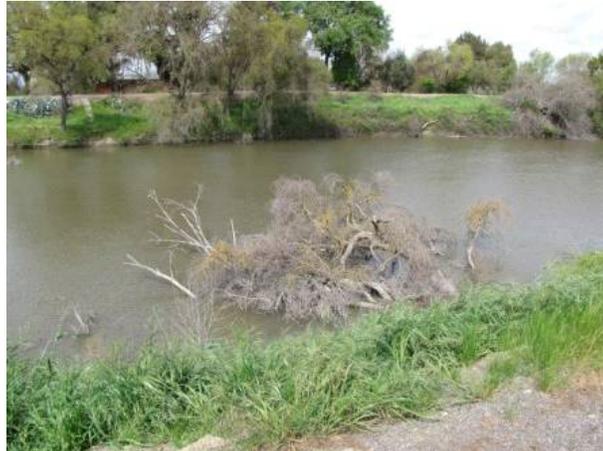
Levee Mile Report Line	38
Start Levee Mile	4.35
End Levee Mile	4.35
Location	Water Side
Category	Earthen Levee
Item	Trim / Thin Trees
View of tree stumps on the waterward slope.	
jhirabay_s_20100701_521.jpg

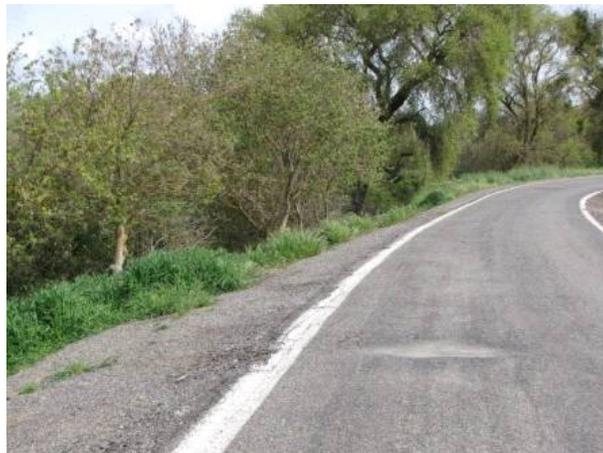
Levee Mile Report Line	40
Start Levee Mile	4.39
End Levee Mile	4.39
Location	Crown
Category	Earthen Levee
Item	Crown Surface / Depressions / Rutting
View of depressions in the crown roadway looking upstream.	
jhirabay_s_20100701_522.jpg

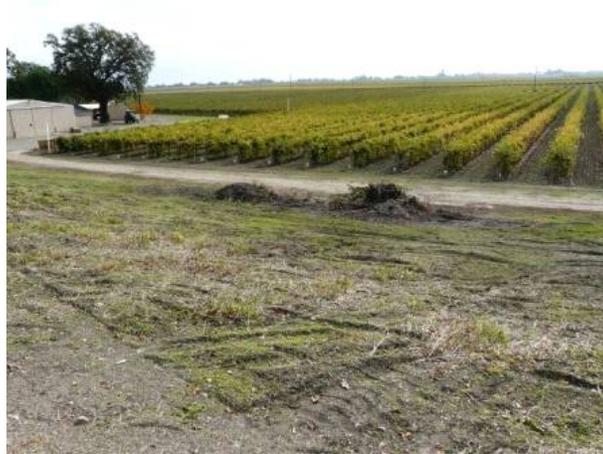
Levee Mile Report Line	41
Start Levee Mile	4.46
End Levee Mile	4.46
Location	Land Side
Category	Earthen Levee
Item	Encroachments
Remove pruning pile on landward slope at LM 4.46.	
dpesaven_s_20100316_484.JPG

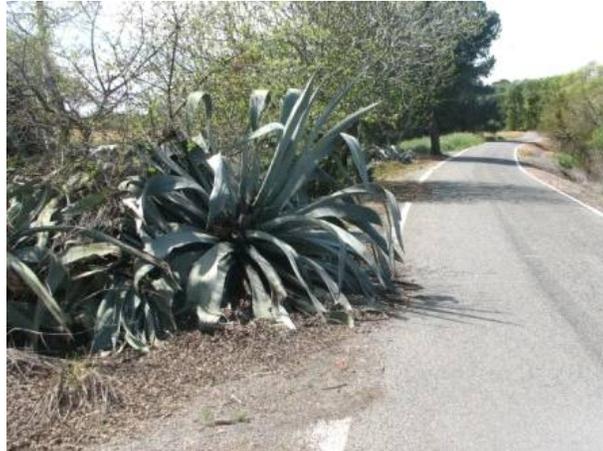
Levee Mile Report Line	44
Start Levee Mile	4.56
End Levee Mile	4.56
Location	Land Side
Category	Earthen Levee
Item	Encroachments
Landscaping blocking view of landward slope from 4.50 to 4.58	
dpesaven_s_20100316_472.jpg

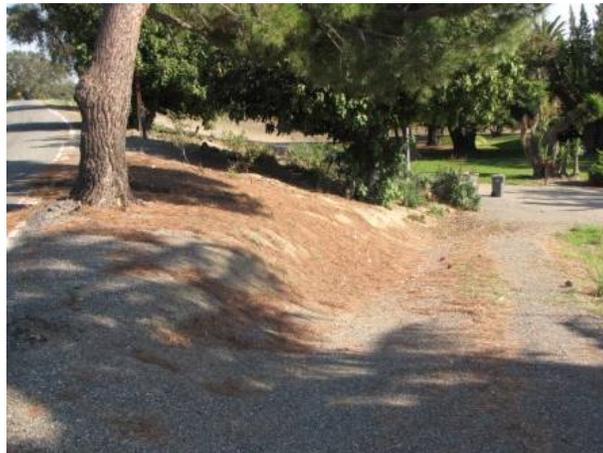
Levee Mile Report Line	44
Start Levee Mile	4.56
End Levee Mile	4.56
Location	Land Side
Category	Earthen Levee
Item	Encroachments
Updated view of landscaping along landward slope.	
dpesaven_s_20100316_473.jpg

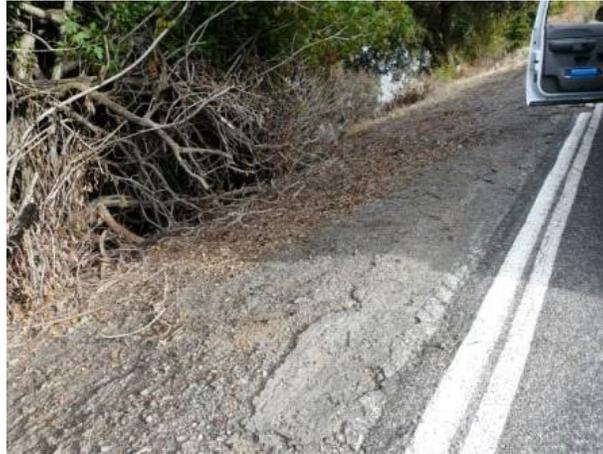
Levee Mile Report Line	45
Start Levee Mile	4.59
End Levee Mile	4.59
Location	Water Side
Category	Earthen Levee
Item	Trim / Thin Trees
Thin/trim trees to allow for the top 20' waterward slope of levee to be seen at LM 4.59.	
dpesaven_s_20100316_485.JPG

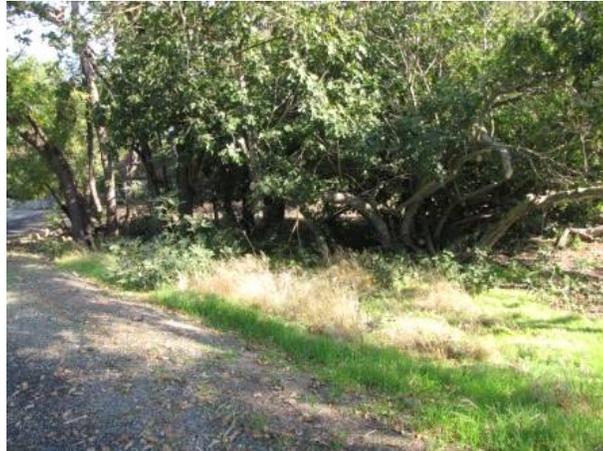
Levee Mile Report Line	48
Start Levee Mile	4.99
End Levee Mile	4.99
Location	Land Side
Category	Earthen Levee
Item	Trim / Thin Trees
View of trees along the landward slope blocking visibility and access.	
dpesaven_s_20100316_498.jpg

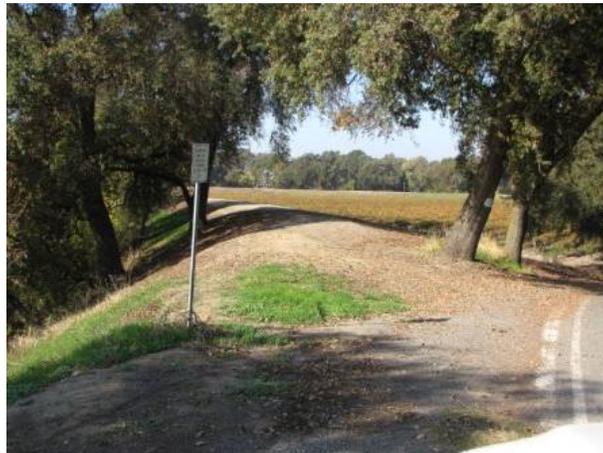
Levee Mile Report Line	50
Start Levee Mile	5.22
End Levee Mile	5.22
Location	Crown
Category	Earthen Levee
Item	Crown Surface / Depressions / Rutting
View of varying elevations in the crown of the levee at the transition from county road to access road.	
dpesaven_s_20100316_499.jpg

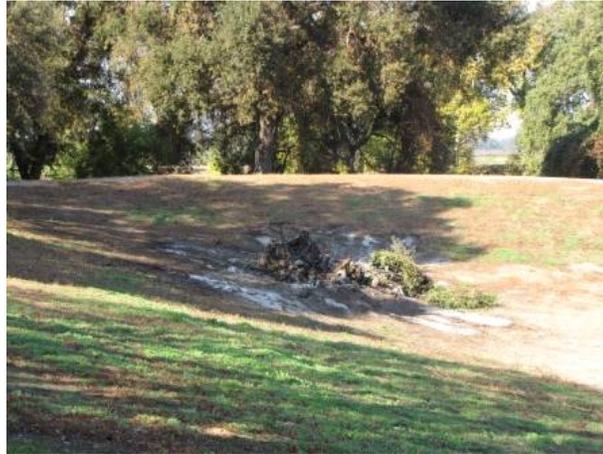
52	5.61	5.61	Earthen Levee	Encroachments	LS	M	Prunings Inspector Comments: Burn pile with unburned material on the landward slope and toe.	38.383329 ° -121.545809 °	38.383329 ° -121.545809 °	942 Y
53	5.80	5.80	Earthen Levee	Trim / Thin Trees	WS	N	Tree stumps.	38.383969 ° -121.542806 °	38.383969 ° -121.542806 °	41 Y
54	5.89	5.94	Earthen Levee	Encroachments	LS	PO	Fences	38.384363 ° -121.541161 °	38.384796 ° -121.540525 °	56 Y
55	5.93	5.93	Earthen Levee	Encroachments	LS	M	Tree or limb	38.384648 ° -121.540669 °	38.384648 ° -121.540669 °	57 Y
56	5.93	5.93	Earthen Levee	Encroachments	CR	CO	Buildings	38.384803 ° -121.540545 °	38.384803 ° -121.540545 °	58 Y
57	5.94	5.94	Earthen Levee	Vegetation	WS	C	Remove the wild growth other than native grasses from the levee slopes.	38.384807 ° -121.540556 °	38.384807 ° -121.540556 °	943
58	5.98	5.98	Earthen Levee	Encroachments	LS	M	Prunings	38.385277 ° -121.540070 °	38.385277 ° -121.540070 °	43

Levee Mile Report Line	52
Start Levee Mile	5.61
End Levee Mile	5.61
Location	Land Side
Category	Earthen Levee
Item	Encroachments
View of prunings pile on the landward slope of the levee.	
dpesaven_s_20100316_500.jpg

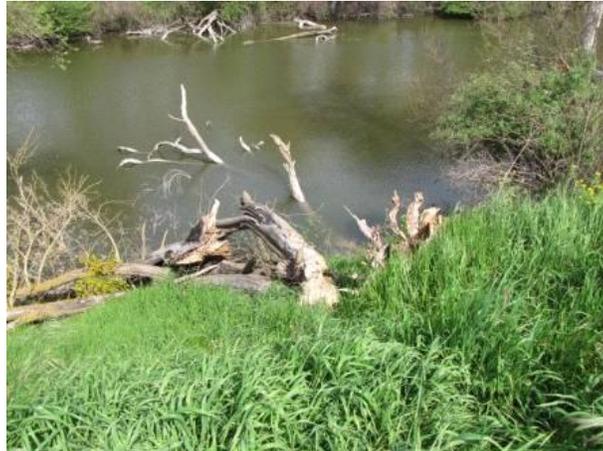
Levee Mile Report Line	53
Start Levee Mile	5.80
End Levee Mile	5.80
Location	Water Side
Category	Earthen Levee
Item	Trim / Thin Trees
View of a tree stump on the waterward slope.	
jhirabay_s_20100701_523.jpg

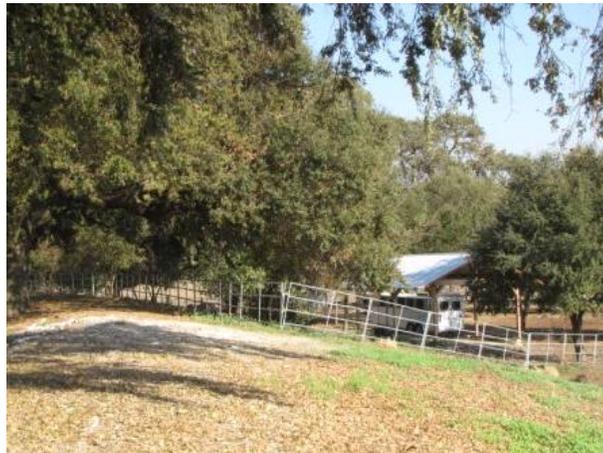
Levee Mile Report Line	54
Start Levee Mile	5.89
End Levee Mile	5.94
Location	Land Side
Category	Earthen Levee
Item	Encroachments
View of fence around a horse pen along the shoulder of the levee and the landward slope.	
dpesaven_s_20100316_486.jpg

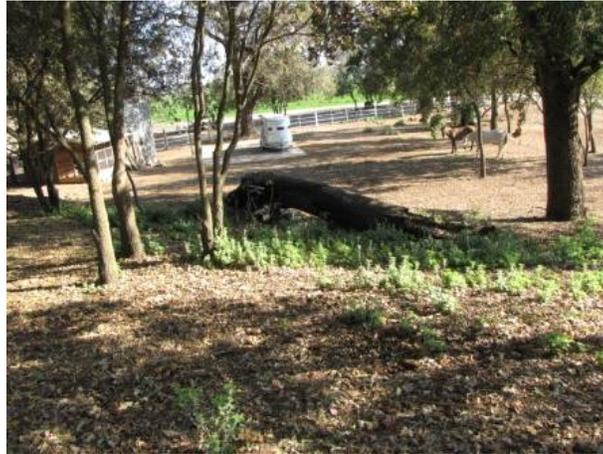
Levee Mile Report Line	55
Start Levee Mile	5.93
End Levee Mile	5.93
Location	Land Side
Category	Earthen Levee
Item	Encroachments
View of a tree trunk lying on the landward slope blocking visibility.	
dpesaven_s_20100316_487.jpg

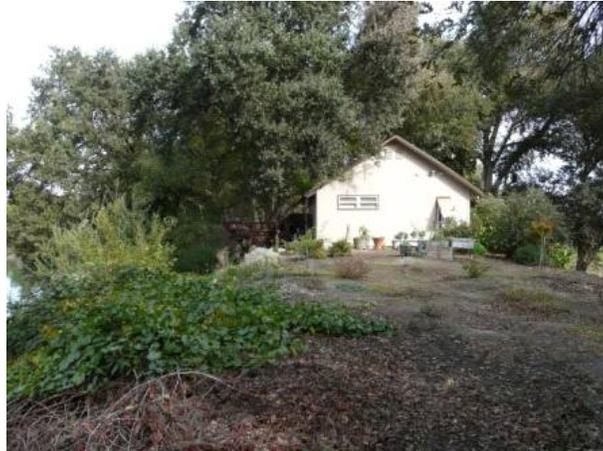
Levee Mile Report Line	56
Start Levee Mile	5.93
End Levee Mile	5.93
Location	Crown
Category	Earthen Levee
Item	Encroachments
Building & associated landscaping on levee crown at LM 5.93.	
dpesaven_s_20100316_488.JPG

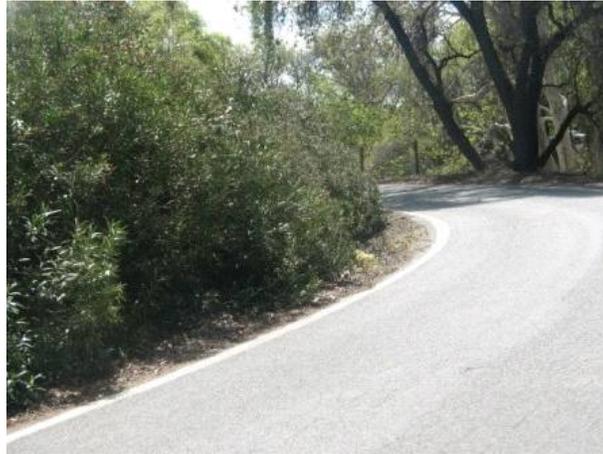
Levee Mile Report Line	64
Start Levee Mile	6.24
End Levee Mile	6.31
Location	Land Side
Category	Earthen Levee
Item	Encroachments
Oleander on landward slope blocking view of levee from LM 6.24 to 6.32	
dpesaven_s_20100316_474.jpg

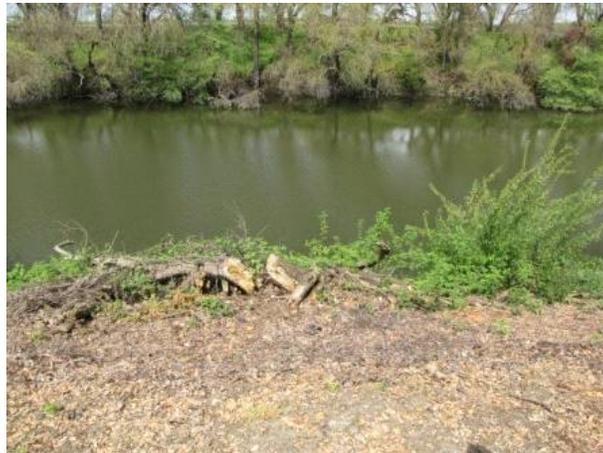
Levee Mile Report Line	65
Start Levee Mile	6.34
End Levee Mile	6.34
Location	Water Side
Category	Earthen Levee
Item	Trim / Thin Trees
View of tree stumps on the waterward slope.	
jhirabay_s_20100701_525.jpg

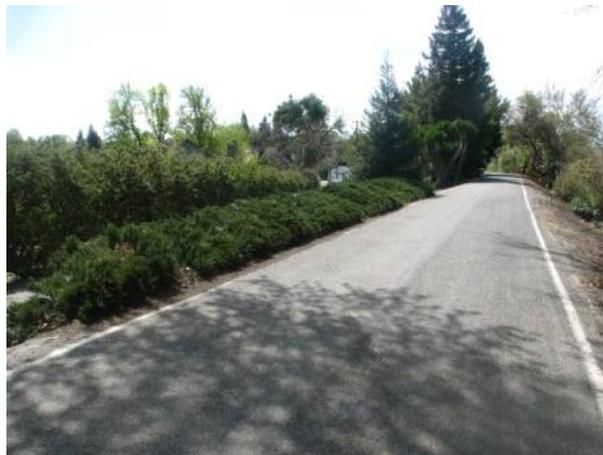
Levee Mile Report Line	67
Start Levee Mile	6.37
End Levee Mile	6.40
Location	Land Side
Category	Earthen Levee
Item	Encroachments
Landscaping on landward slope blocking view from LM 6.37 to 6.40	
dpesaven_s_20100316_475.jpg

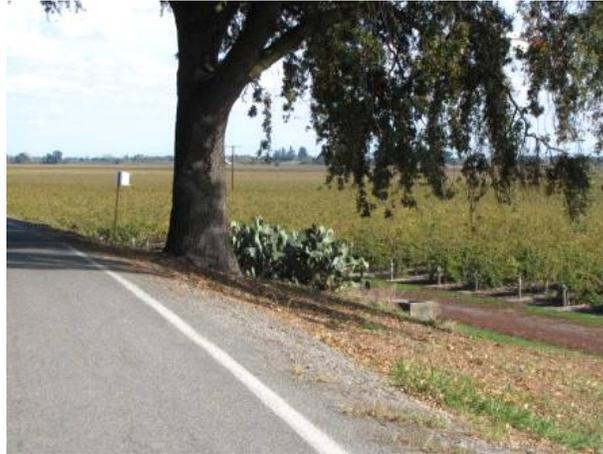
Levee Mile Report Line	68
Start Levee Mile	6.56
End Levee Mile	6.56
Location	Land Side
Category	Earthen Levee
Item	Encroachments
View of landscaping along the landward slope.	
dpesaven_s_20100316_489.jpg

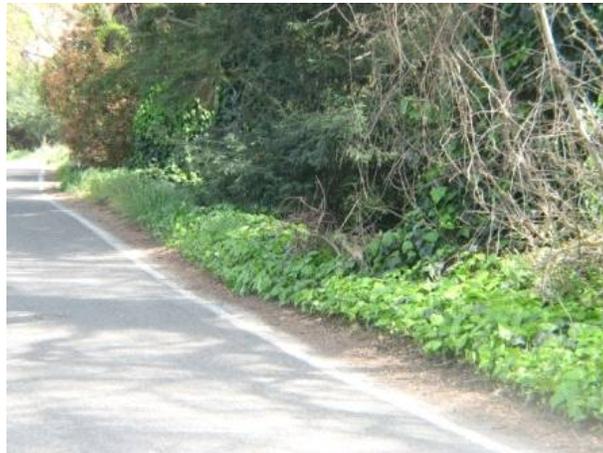
Levee Mile Report Line	71
Start Levee Mile	6.87
End Levee Mile	6.95
Location	Land Side
Category	Earthen Levee
Item	Encroachments
Landscaping on landward slope blocking view from LM 6.87 to 6.95	
dpesaven_s_20100316_477.jpg
