**Flood Control Project Maintenance
Levee Inspections
LMA District Cover Sheet
Spring 2010 Levee Inspection Results**

Reclamation District No. 0150 Merrit Island

Levee Inspection Report By Mile - Spring 2010

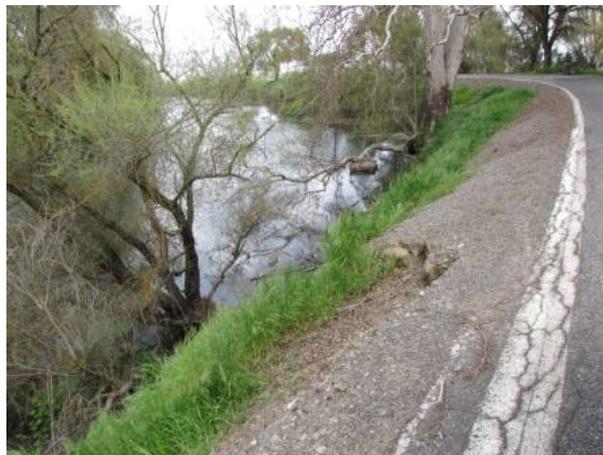
Levee Mile Report Line	73
Start Levee Mile	7.02
End Levee Mile	7.02
Location	Water Side
Category	Earthen Levee
Item	Erosion / Bank Caving
View of erosion on the waterward shoulder looking upstream.	
jhirabay_s_20100701_526.jpg

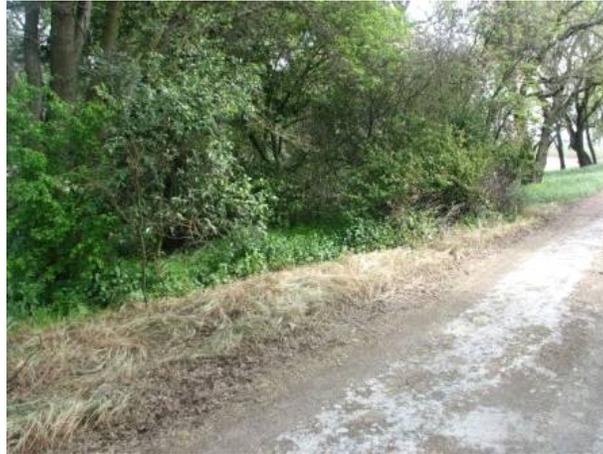
Levee Mile Report Line	78
Start Levee Mile	7.42
End Levee Mile	7.47
Location	Land Side
Category	Earthen Levee
Item	Encroachments
Landscaping on landward slope blocking view from LM 7.42 to 7.47	
dpesaven_s_20100316_478.jpg

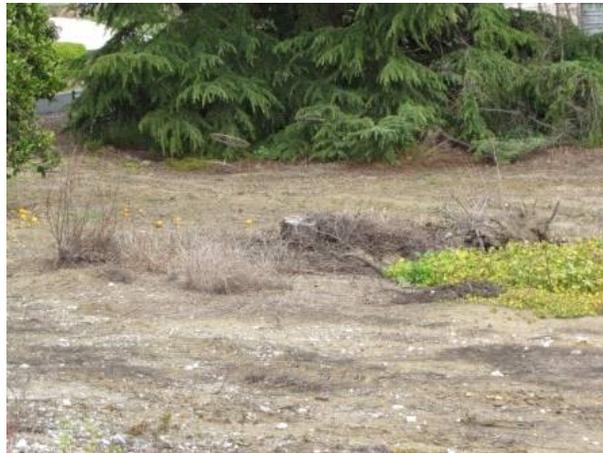
Levee Mile Report Line	79
Start Levee Mile	7.50
End Levee Mile	7.50
Location	Land Side
Category	Earthen Levee
Item	Trim / Thin Trees
View of a tree stump on the landward slope.	
jhirabay_s_20100701_527.jpg

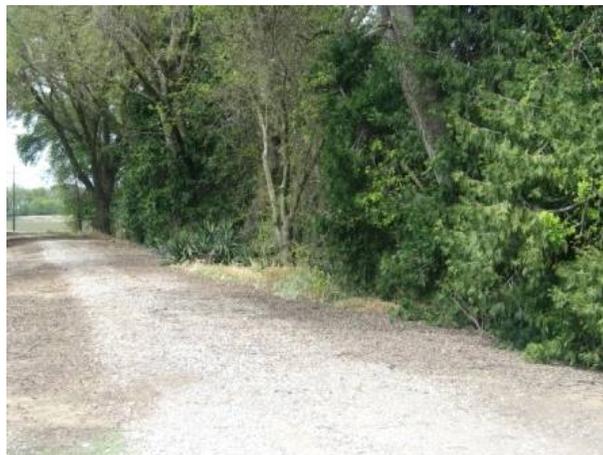
Levee Mile Report Line	81
Start Levee Mile	7.55
End Levee Mile	7.55
Location	Land Side
Category	Earthen Levee
Item	Encroachments
Landscaping on landward slope blocking view from LM 7.52 to 7.58	
dpesaven_s_20100316_479.jpg

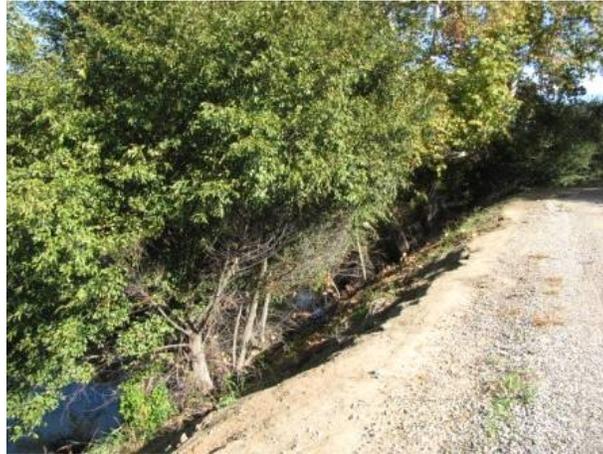
Levee Mile Report Line	87
Start Levee Mile	8.21
End Levee Mile	8.21
Location	Water Side
Category	Earthen Levee
Item	Erosion / Bank Caving
View of erosion occurring along the waterward slope.	
dpesaven_s_20100316_503.jpg

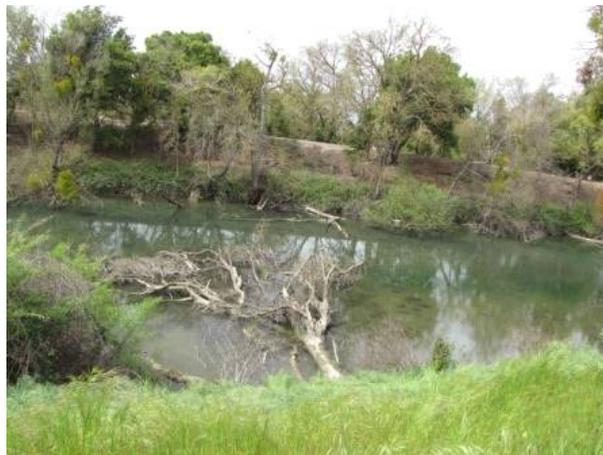
Levee Mile Report Line	95
Start Levee Mile	9.10
End Levee Mile	9.10
Location	Water Side
Category	Earthen Levee
Item	Trim / Thin Trees
View of a tree stump on the waterward slope.	
jhirabay_s_20100701_528.jpg

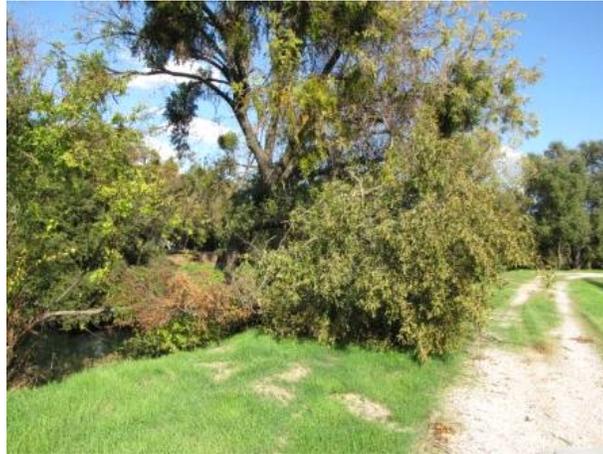
Levee Mile Report Line	96
Start Levee Mile	9.12
End Levee Mile	9.12
Location	Water Side
Category	Earthen Levee
Item	Trim / Thin Trees
View of a tree branch that has fallen and is blocking visibility and access.	
dpesaven_s_20100316_504.jpg
